east lake sammamish trail

NEPA/SEPA
Final Environmental
Impact Statement
VOLUME II: Plan Sheets

East Lake Sammamish Master Plan Trail

Federal Highway Administration,
Washington State Department of Transportation, and
King County Facilities Management Division

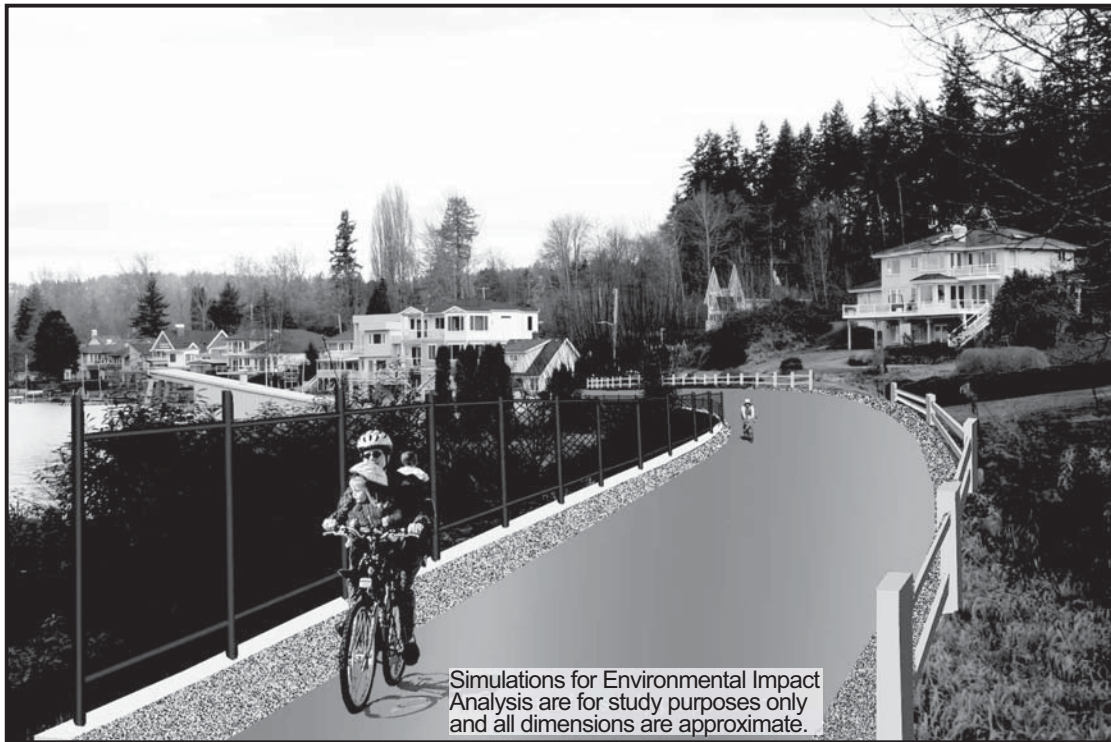
Corridor Alternative; Looking north from railbed in north-end Sammamish Place neighborhood. Paved path is 12 ft. wide with 3 ft. equestrian path on left and 2 ft. gravel shoulder on right.

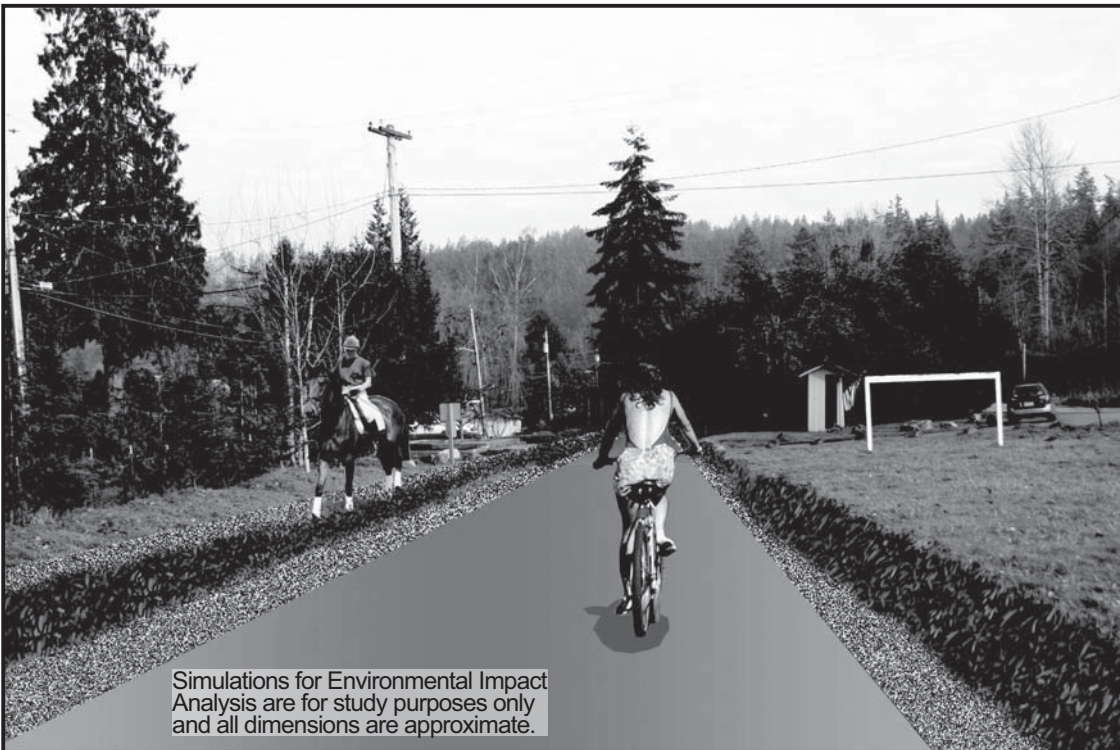
Corridor Alternative; Looking north from railbed just south of Shoreland entrance. Paved path is 12 ft. wide with 2 ft. gravel shoulders and 4 ft. equestrian path on left.

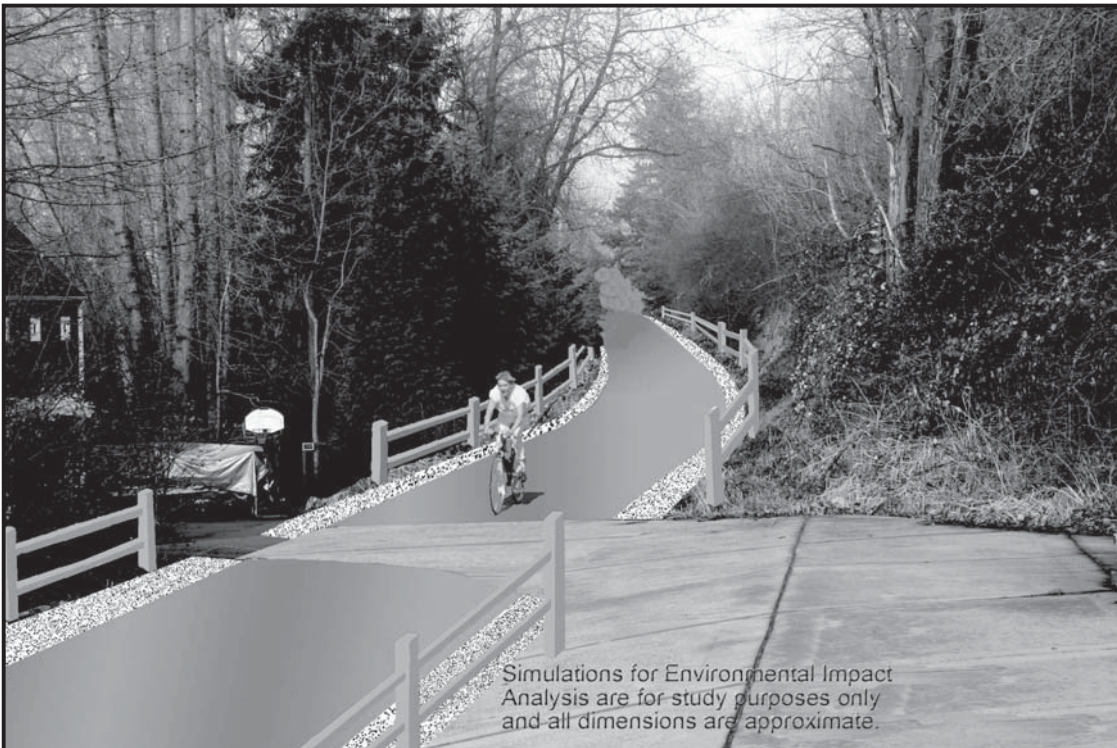
Corridor Alternative; Looking northwest from railbed and driveway across from NE 33rd Place. Paved path is 12 ft. wide with 2 ft. gravel shoulders.

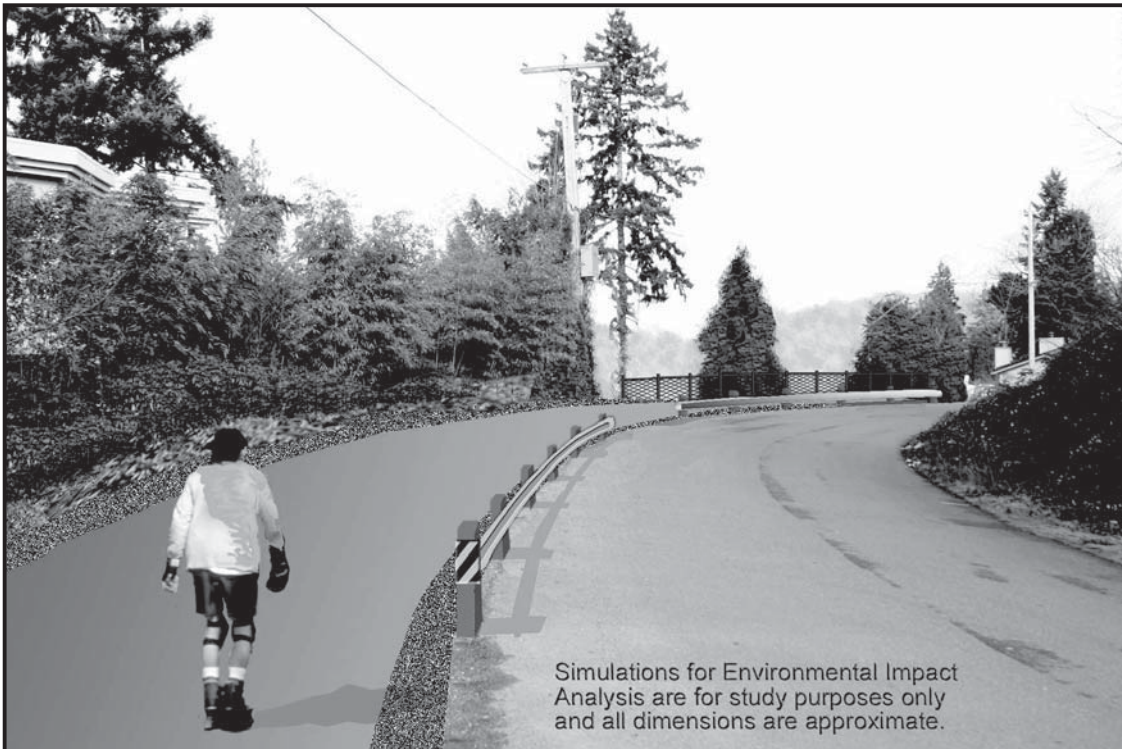
East Alternative; Looking north from about 2100 block on E Lake Sammamish Place SE. Paved path is 12 ft. wide with 2 ft. shoulders.
