## Report to the Historical Resources Board

SUBJECT: **719-721 14<sup>th</sup> Street (HRB Site #403 Daggett Family Residence and HRB Site #404 Murray Apartments) –SITE DEVELOPMENT PERMIT NO. 2017-18**

# HISTORICAL RESOURCES TECHNICAL REPORT

# EAST VILLAGE GREEN

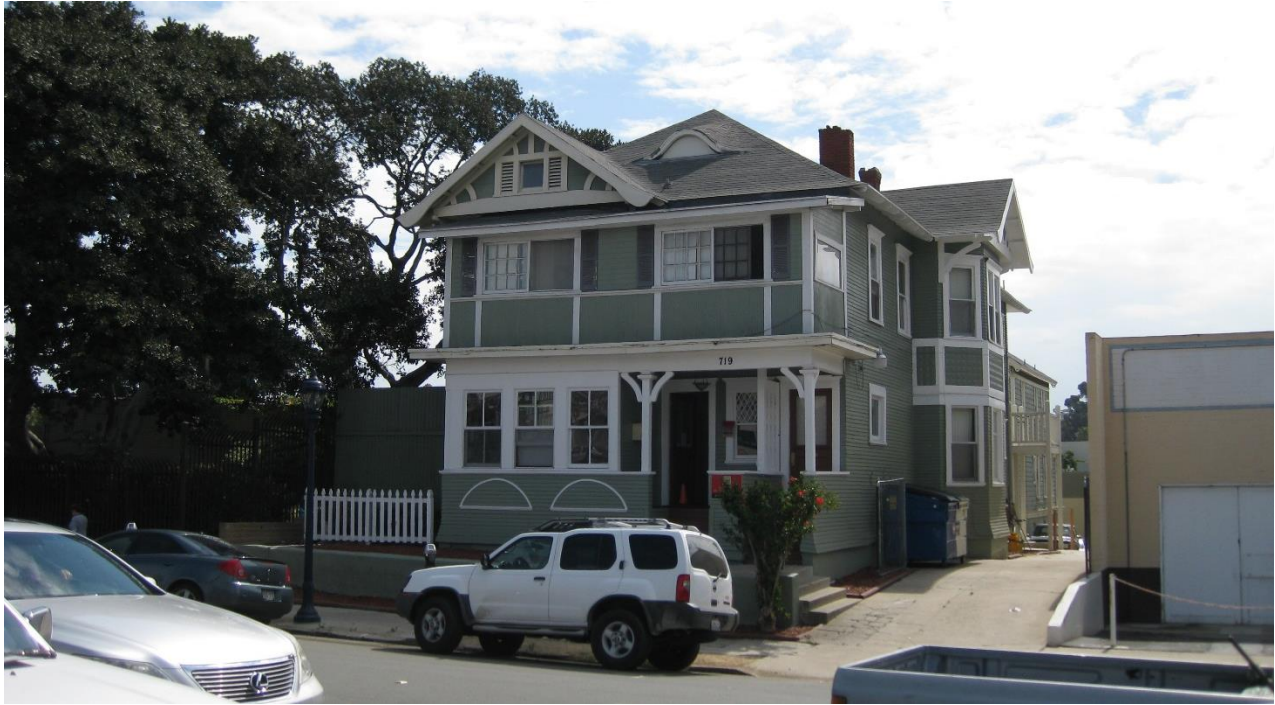
*Figure 3-2: The Murray Apartments, 719 14<sup>th</sup> Street looking northeast.*

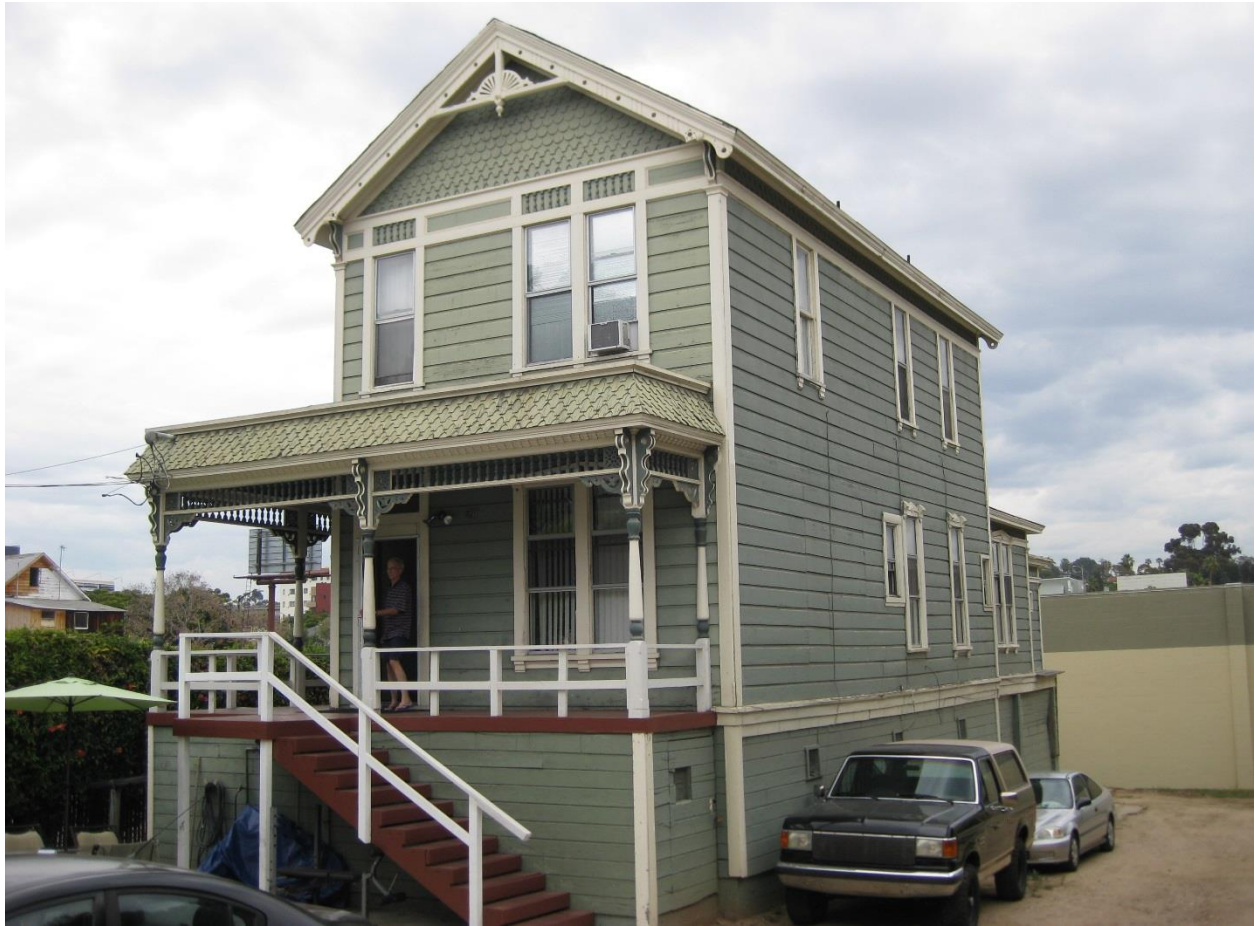
*Figure 3-3: The Daggett Family Residence, looking northeast. Note the non-historic porch stairs which were added to accommodate the basement and garage which have been added below the original house. The entire house was lifted at least six-feet when it was moved to its present location at 721 14<sup>th</sup> Street.*

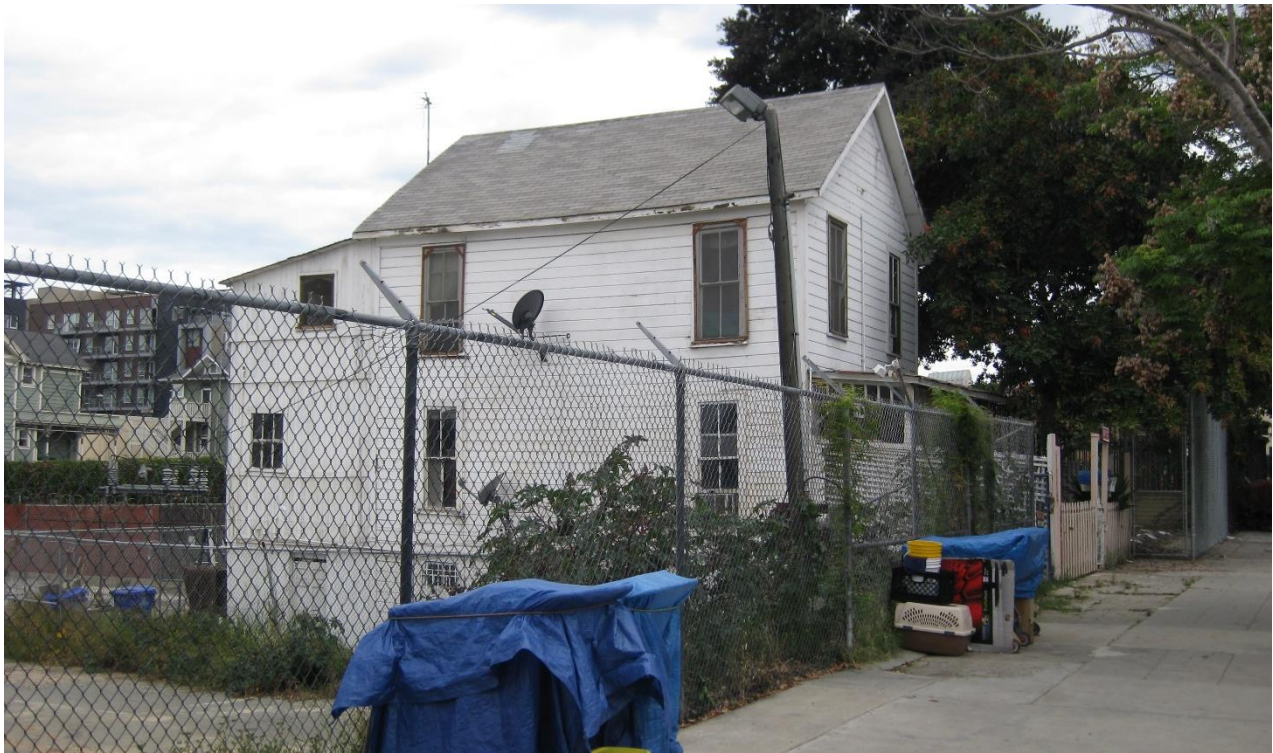
*Figure 3-4: The Mattie Bearn House, 1455 F Street, looking southwest at the east façade.*

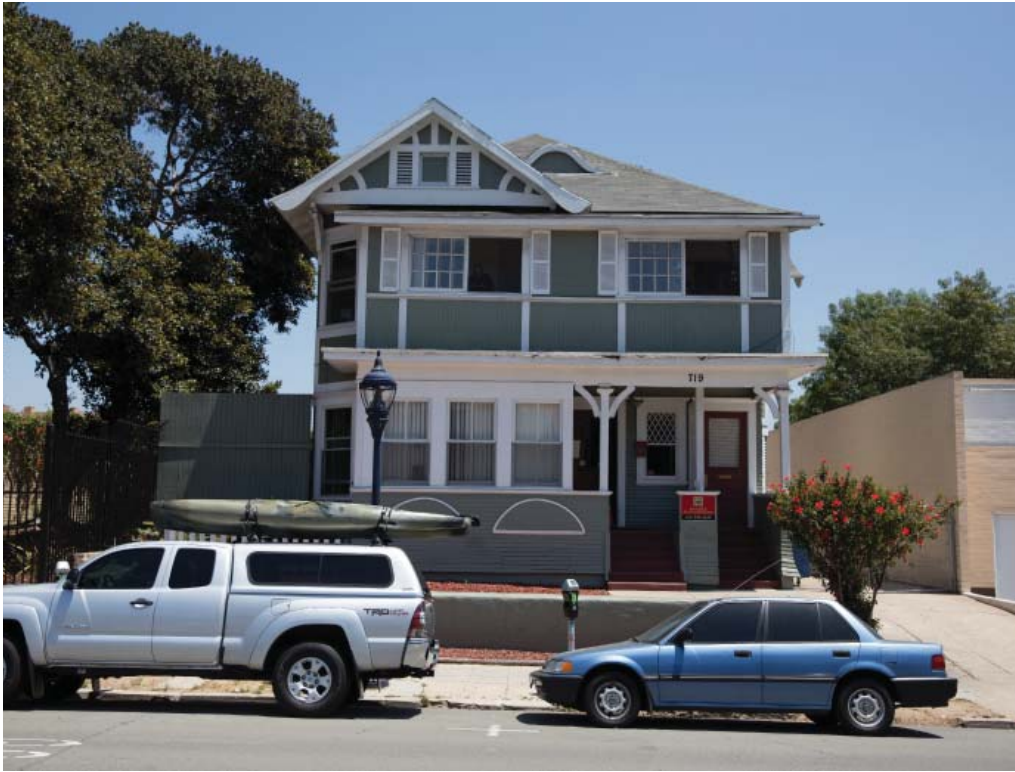
Figure 3-5: View of the Murray Apartments, primary west façade from 14th Street.

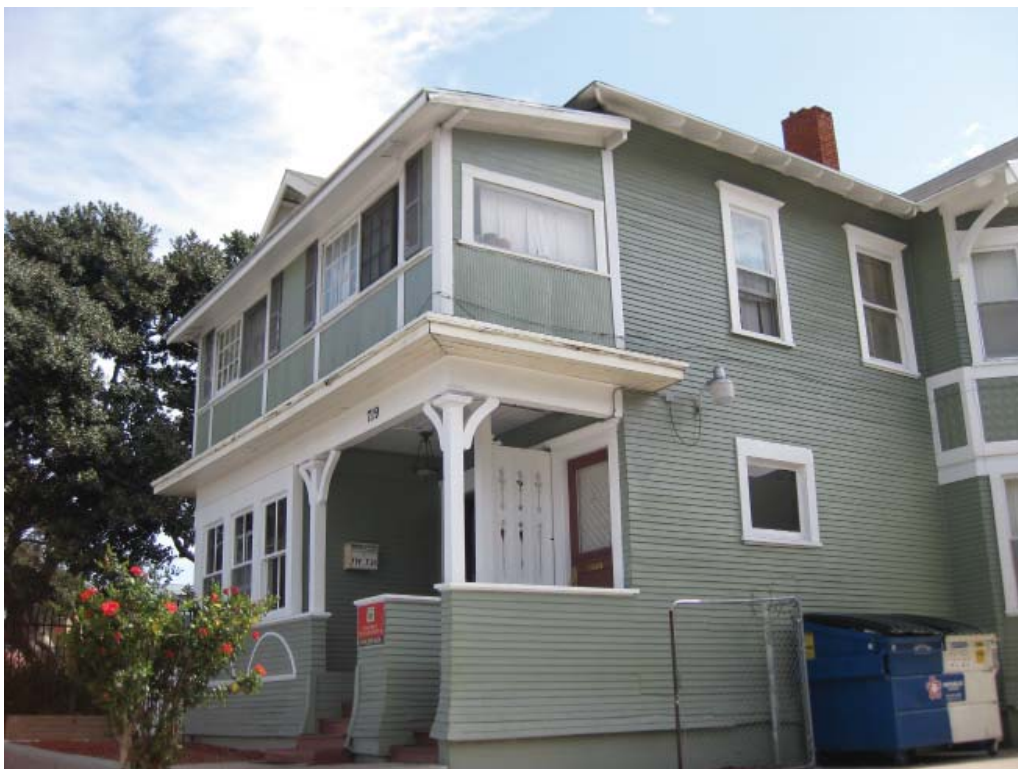
Figure 3-6: The Murray Apartments, view looking northeast at the porch. The second floor was extended on top of the original single-story porch.

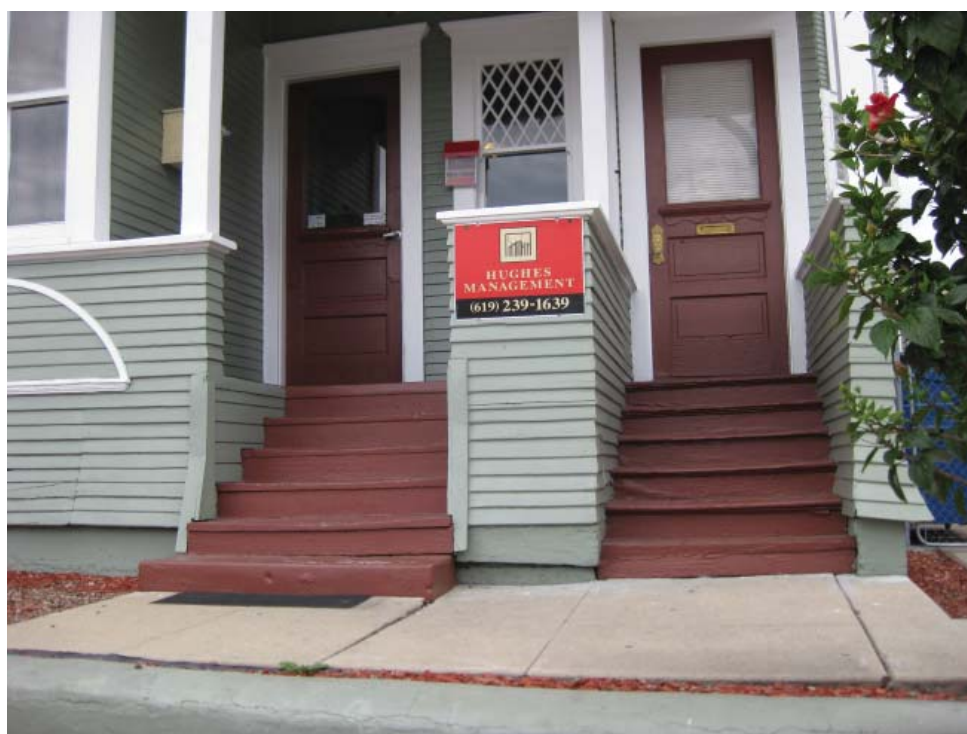
Figure 3-7: The Murray Apartments, view of the front steps on the west facade. The stairs on the right appear to be original. The stairs on the left appear to have been altered to replace the original treads and risers. The front doors and window are original. The door hardware on the right door also appears to be historic.

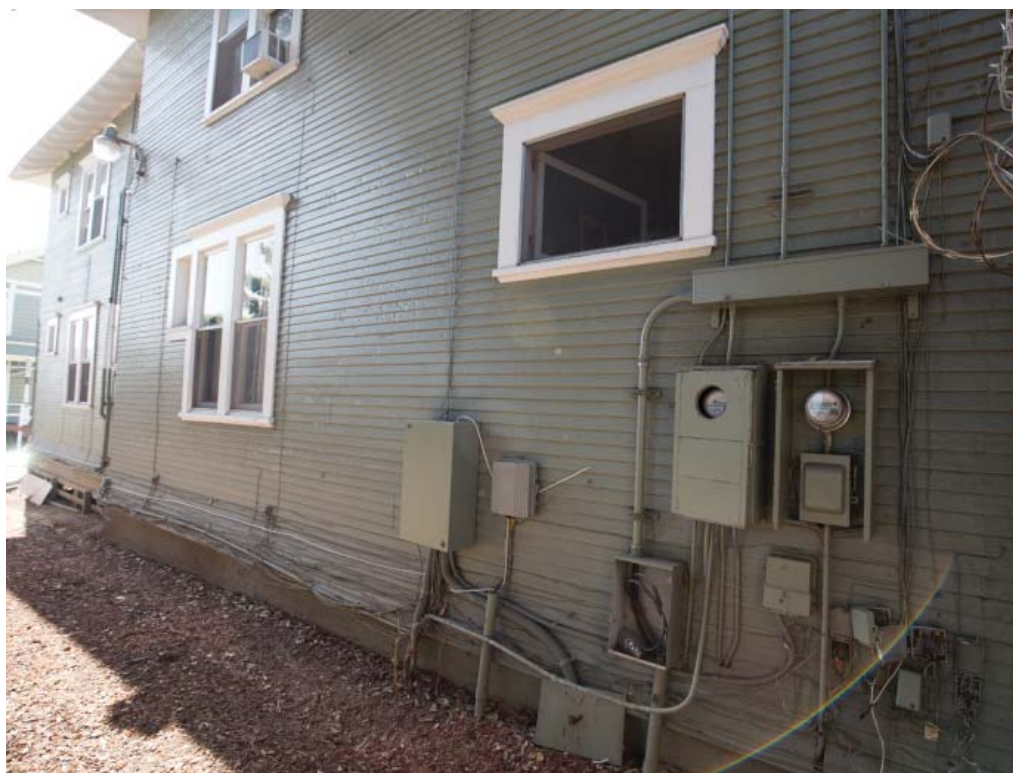
Figure 3-8: The Murray Apartments, view of portions of the north facade.

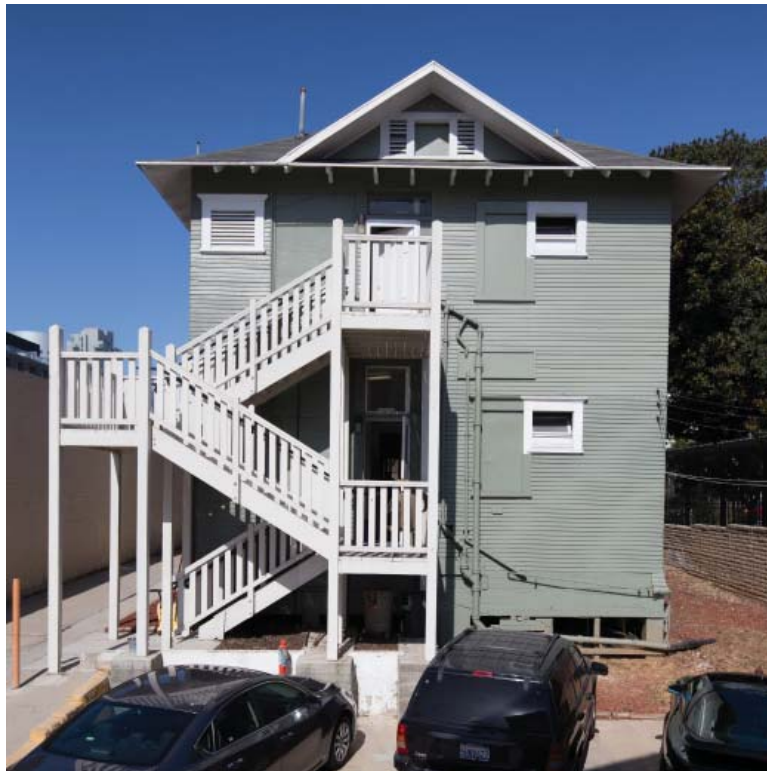
Figure 3-9: The Murray Apartments, view looking west at the east facade. Note the non-original exterior stairs and most of the fenestration has been in-filled.

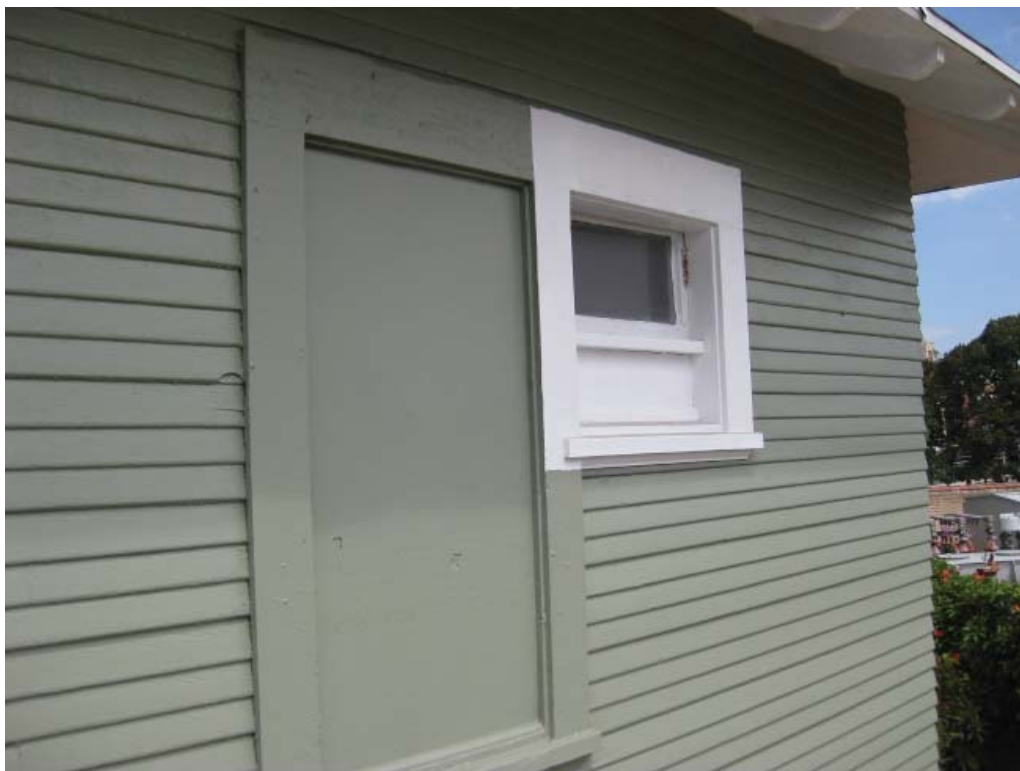
Figure 3-10: The Murray Apartments, detail of in-filled window at the east facade.

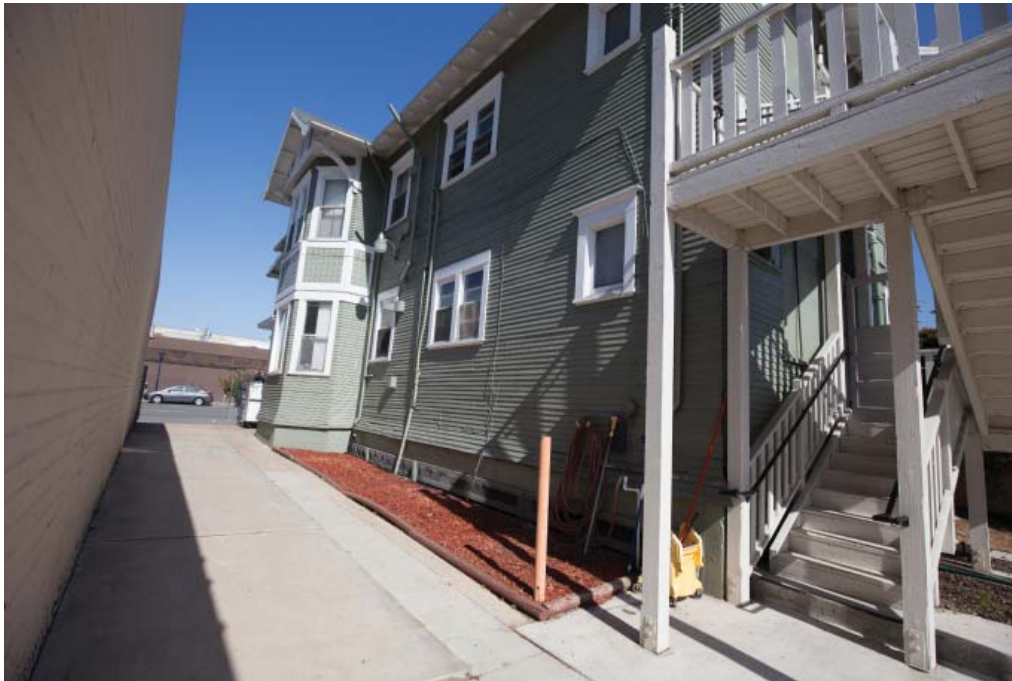
Figure 3-11: The Murray Apartments, view of the south façade.

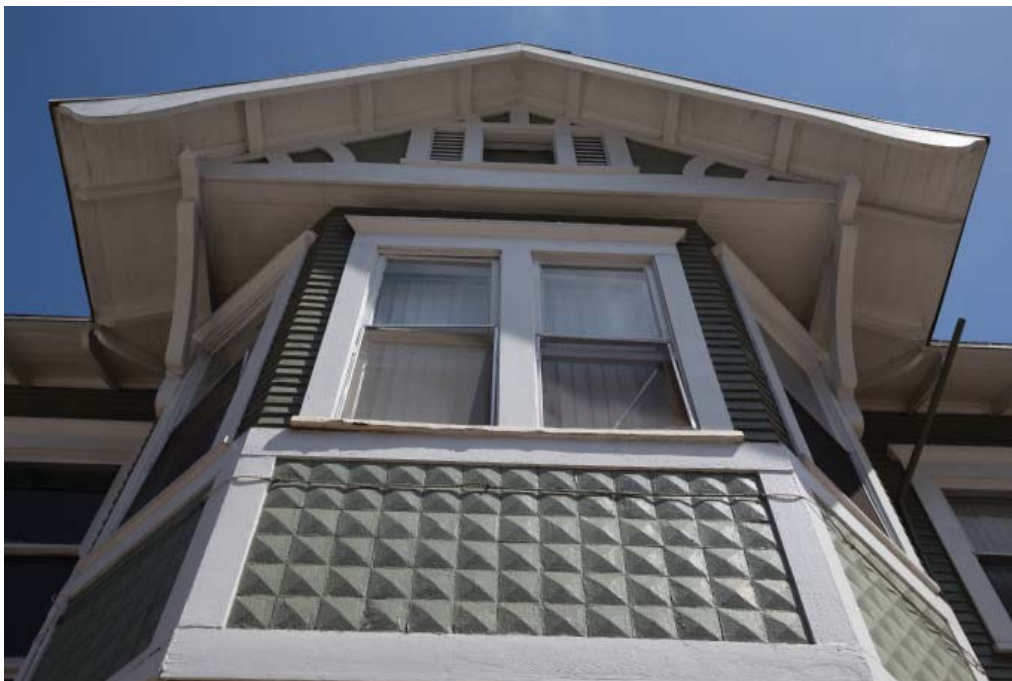
Figure 3-12: The Murray Apartments, detail at the south facade's second floor bay window, siding, and eaves.

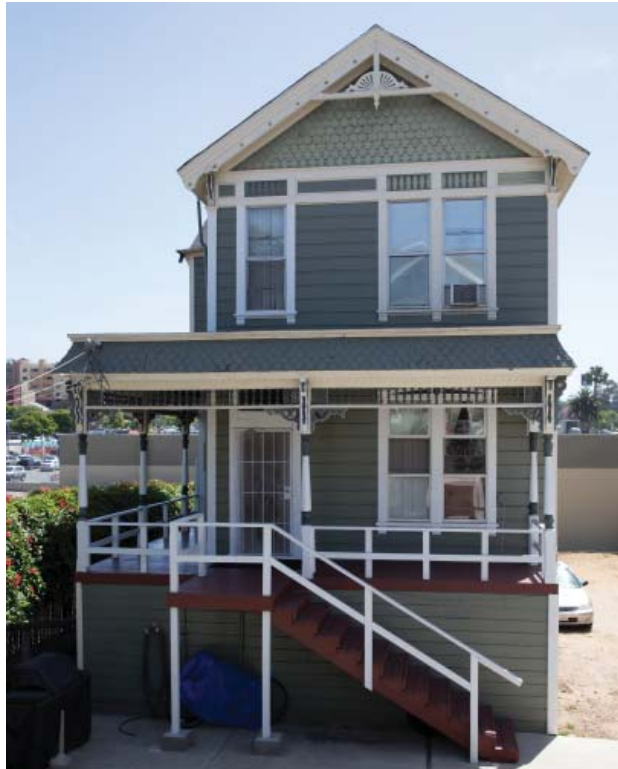
Figure 3-13: View looking east at the Daggett Family Residence's primary west façade. The porch railing and stairs were added later.

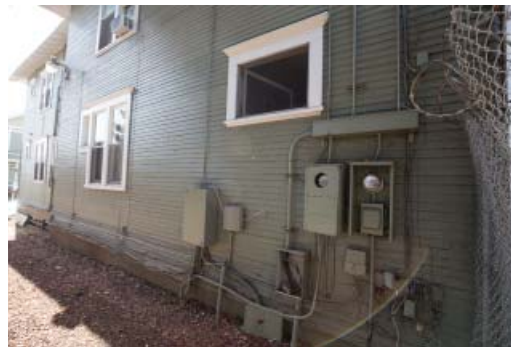
Figure 3-14: The Daggett Family Residence, view of portions of the north façade.

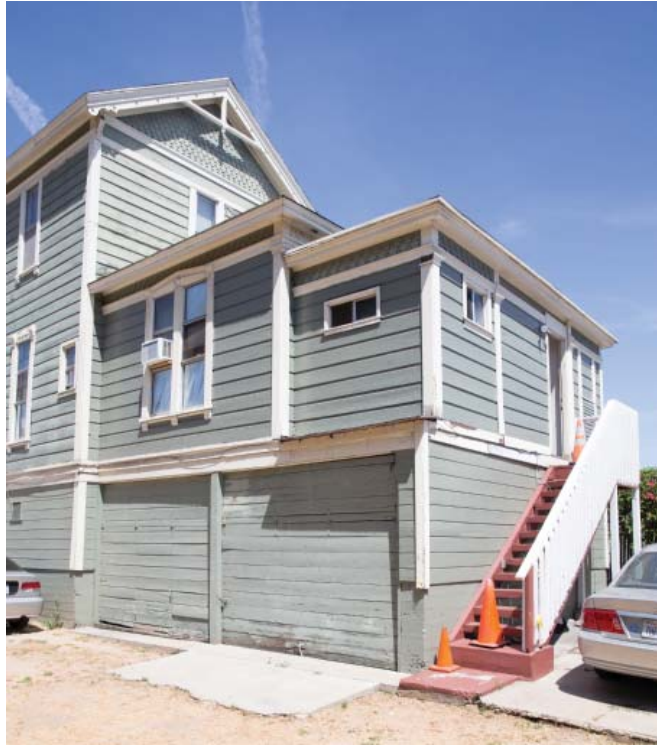
Figure 3-15: The Daggett Family Residence, view of portions of the east and south facades. The former porch (in the foreground) has been filled in to add an additional apartment unit. The garages beneath were added below the original house, raising the house above its original height.

The existing cast-in-place concrete foundation is not original, it was replaced in the late 1940s when the house was moved to the site. There are no apparent signs of structural failure, but the foundation should be replaced as part of any future rehabilitation efforts and the house should be lowered to match its original height.

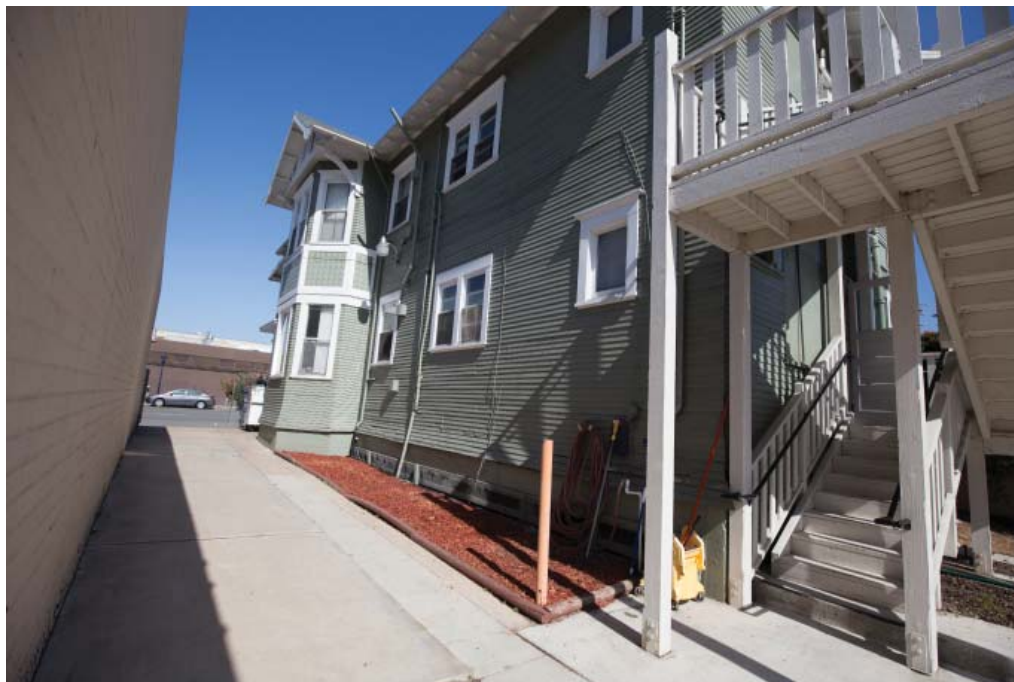
Figure 3-16: The Daggett Family Residence, view looking northeast at the south facade.

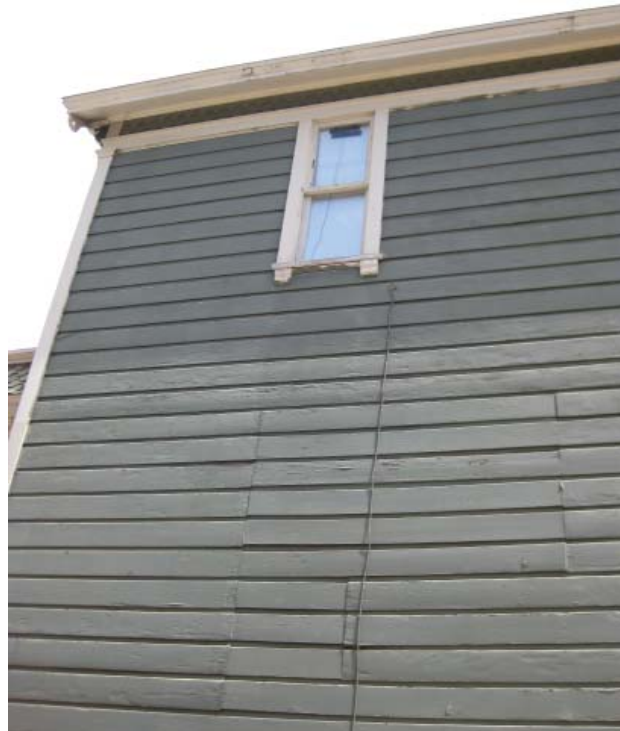
The original wood windows have been replaced with aluminum windows that detract from the historical character of the building. There is one existing wood double-hung window on the second floor of the south façade which appears to be original.

Figure 3-17: The Daggett Family Residence's only remaining historic window located at the second floor of the south facade. All other windows have been replaced.

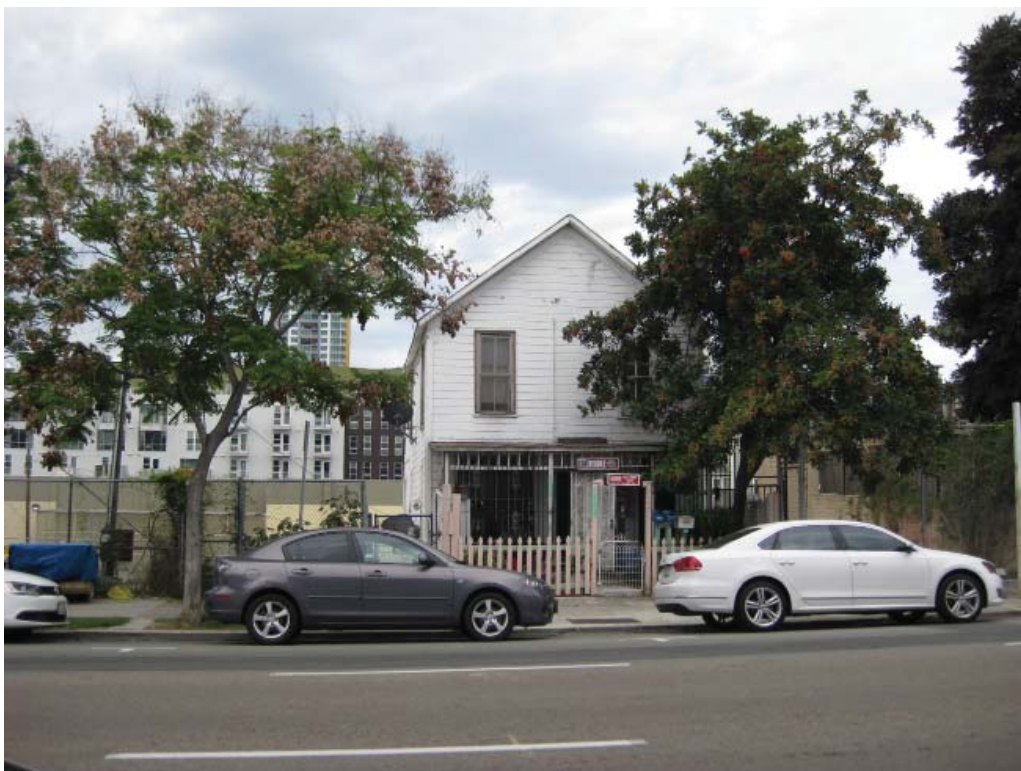
Figure 3-18: View looking south at the Mattie Bearns House's primary north facade.

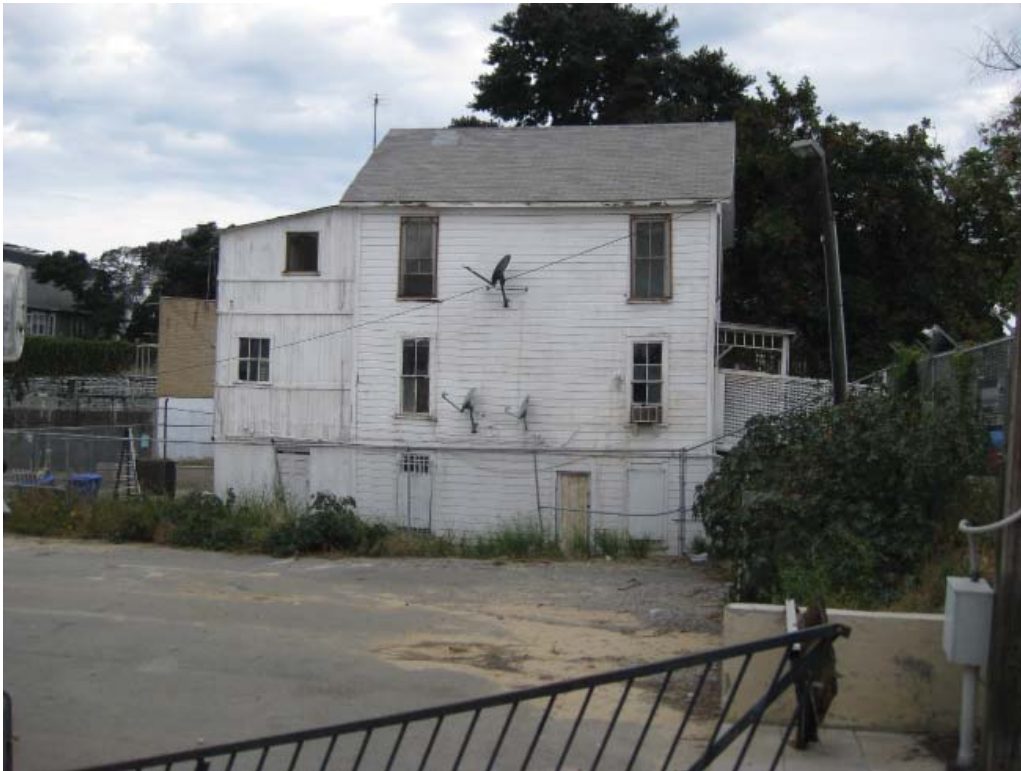
Figure 3-19: The Mattie Bearn House, view looking west at the east facade.

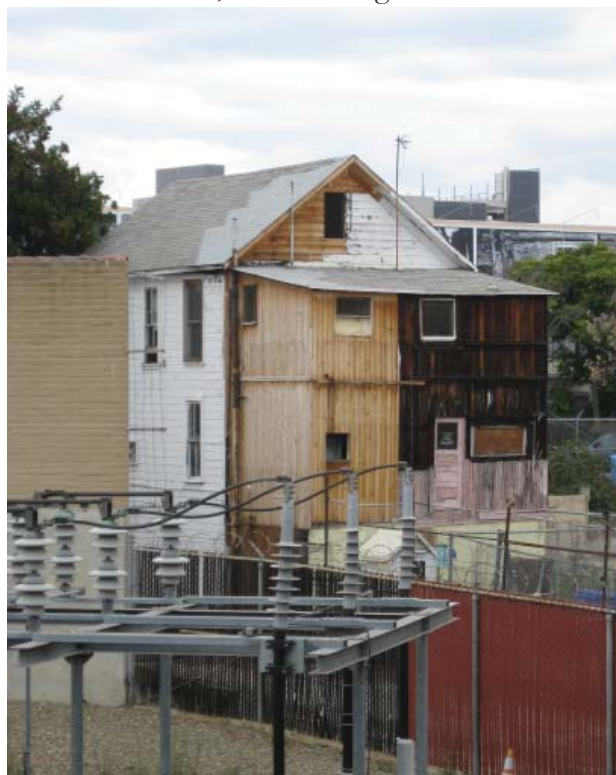
Figure 3-20: The Mattie Bearn House, view looking northeast at the south facade from the 14th Street properties. The shed roof addition on the back of the house is old, but non-historic.

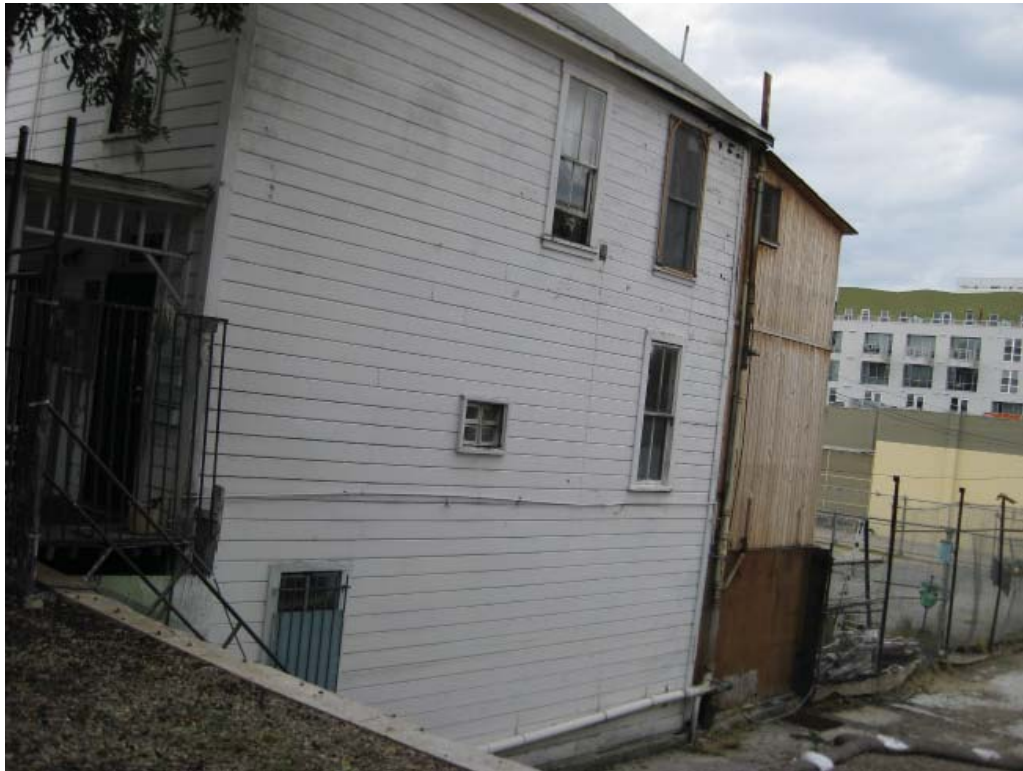
Figure 3-21: The Mattie Bearns House, view looking southeast at the west facade.

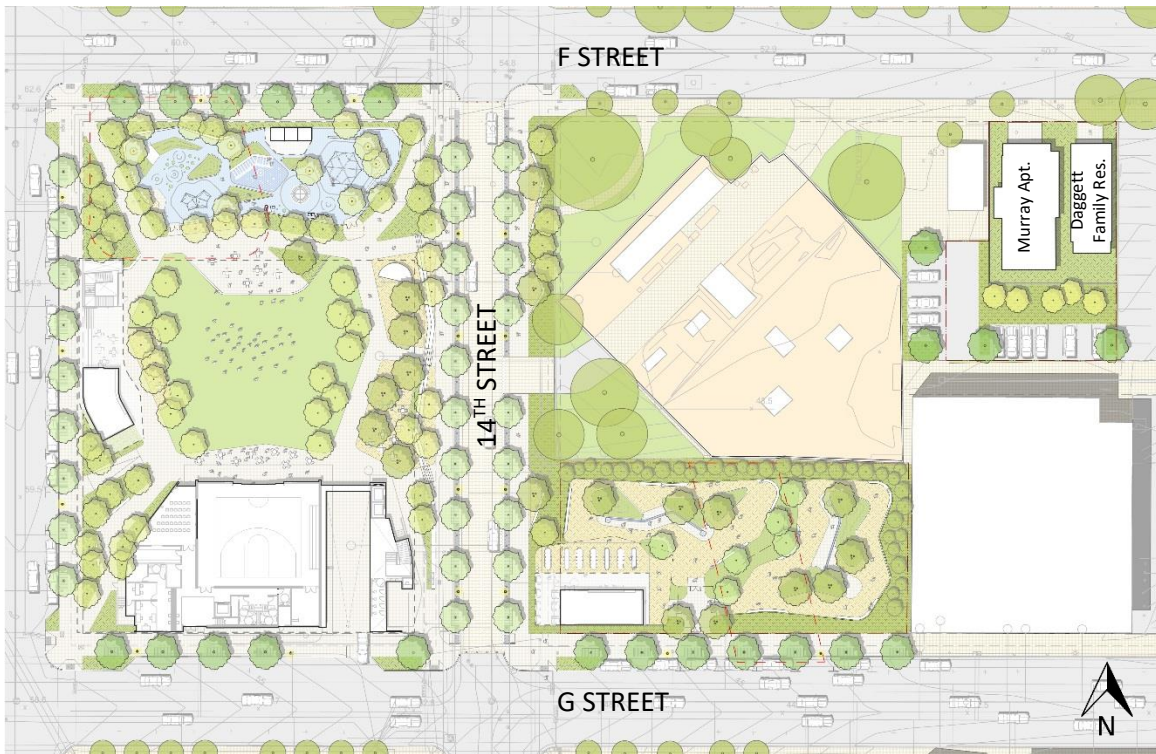
Figure 5-2: East Village Green proposed site plan.

Downtown San Diego, and 13<sup>th</sup> and 14<sup>th</sup> Streets. The block of 14<sup>th</sup> Street between F and G Streets is envisioned as a pedestrian plaza that could be closed to accommodate street fairs, farmers markets, and community events. East Village Green will be the signature urban park and open space for the neighborhood and is envisioned as the hub of community activity.

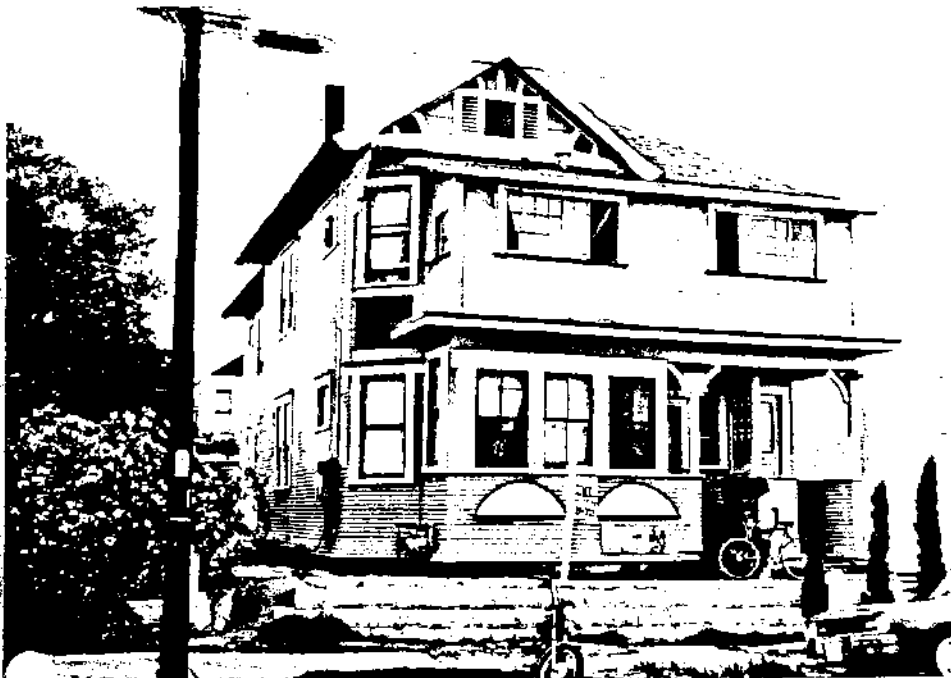
An example of certain pre-First World War expressions of the Queen Anne style, this two-story house was altered by a second story addition to the west elevation. It has a combined gable and hipped roof, the gable end of the west elevation exhibiting a decorative half-timbered look that was common to Queen Anne houses. Original portions of the building have clapboard siding. The fascia on the gabled portion of the roof is flared at the ends. The second story addition hides other details which may have provided more definition to the house. Windows are predominantly double hung sash, either one over one or two over two lights. What may once have been a single porch entry has since been divided into two entries.

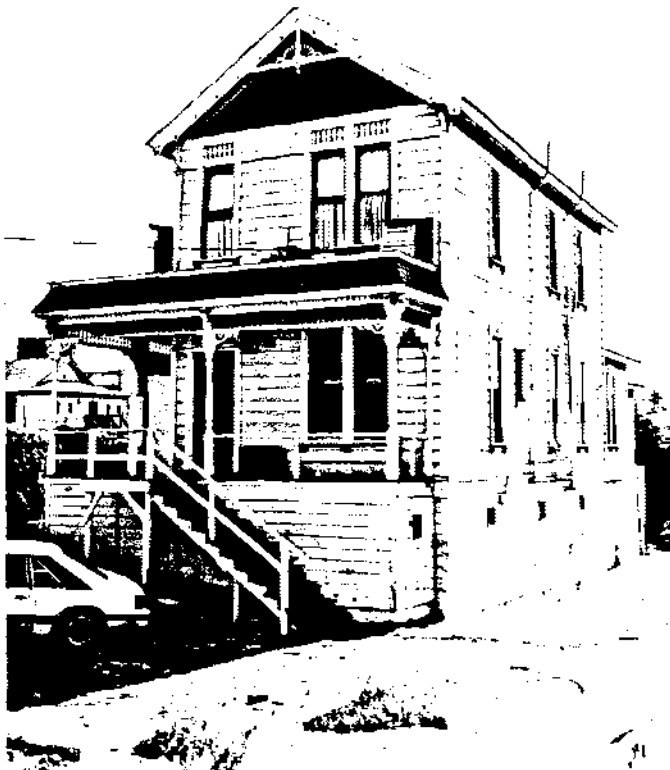
The two-story house on the rear of the lot shared with 719 14th Avenue, is a typical Queen Anne, "shotgun" cottage, with a wrap-around porch and single gable roof. The Queen Anne detailing included in the house's design begins with spindle work at the gable end. The spindle work was also used under the cornice of the porch. Fish scale shingles appear on the gable end and on the mansard porch roof. Turned posts supporting the porch are braced against the cornice and the spindle work with brackets. Shiplap siding was used over most of the exterior. Double hung sash windows of the first floor have ornamental pediments above them. On the second floor, windows have spindle work in the place of pediments. No major alterations have been noted.

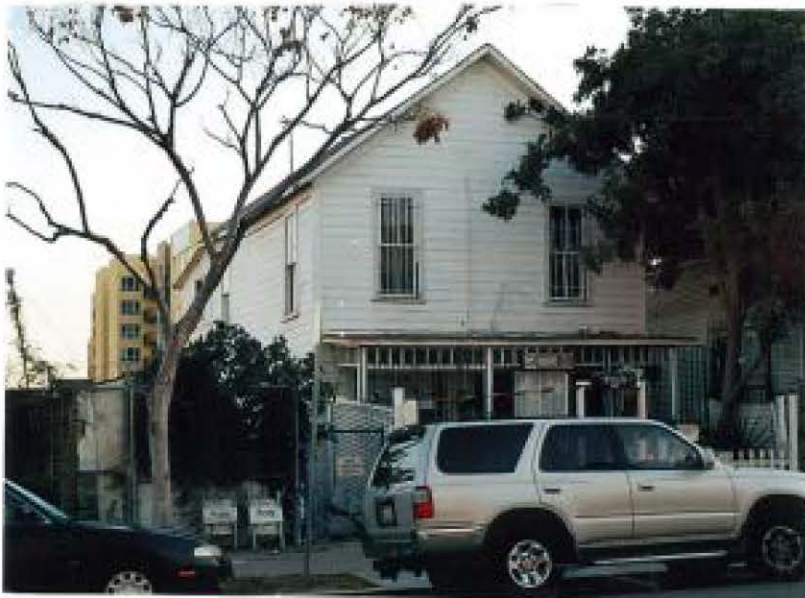
The building addressed as 1455 F Street is a three level, rectangular-shaped Folk Victorian Vernacular style, multiple family residential building located on a sloping lot in the East Village. The original building is constructed of redwood. The parcel containing this building is small, 25' x 70' or 1750 square feet, and the building occupies three-quarters of it. A three story addition has been added to the rear. The building is wood frame with a gable roof. The building is in poor condition.

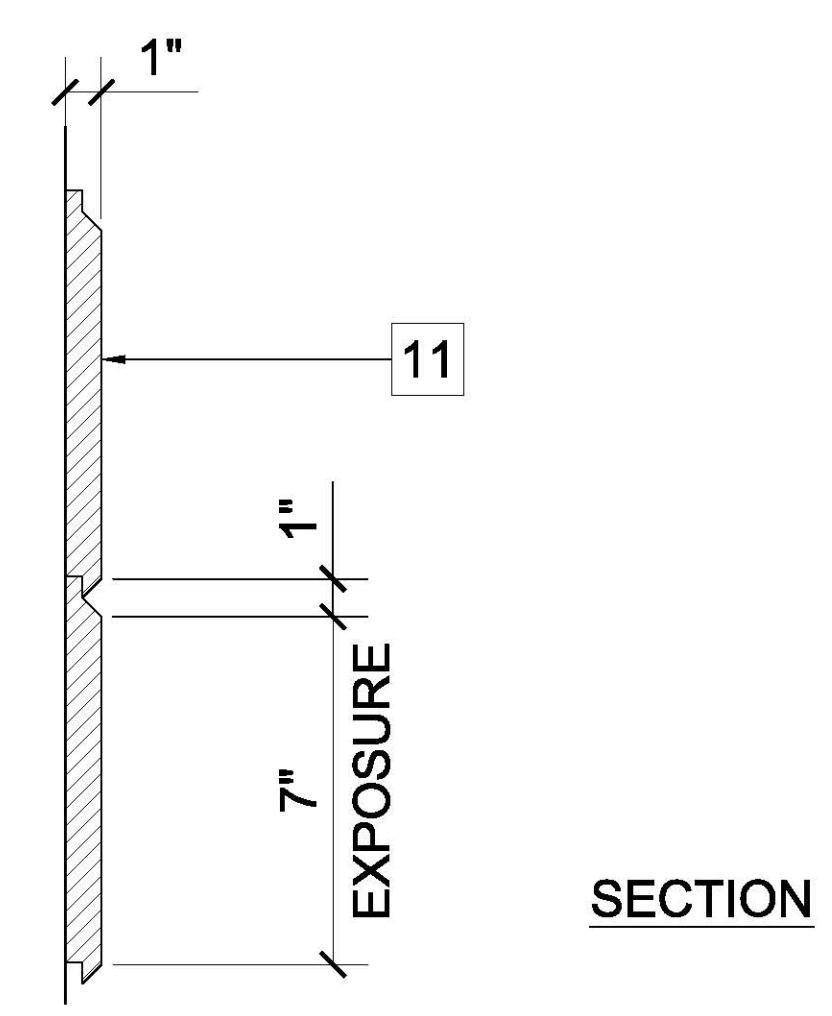
**DETAIL F - HORIZONTAL T&G WOOD SIDING**

- 1 HISTORIC WOOD WINDOW OPENING WITH NON-HISTORIC ALUMINUM REPLACEMENT WINDOW
- 2 HOLE IN FASCIA
- 3 VERTICAL WOOD BANDING
- 4 ORNAMENTAL FAN MOTIF
- 5 ORNATE WOOD BRACKET
- 6 ORNATE WOOD SPINDELS
- 7 DECORATIVE WOOD BLOCK
- 8 DECORATIVE WOOD COLUMN
- 9 NON-HISTORIC WOOD RAILING
- 10 ORNATE WOOD TRIM
- 11 TONGUE AND GROOVE WOOD SIDING
- 12 SHAPED SHINGLE SIDING
- 13 ORNATE WOOD EAVE BRACKET

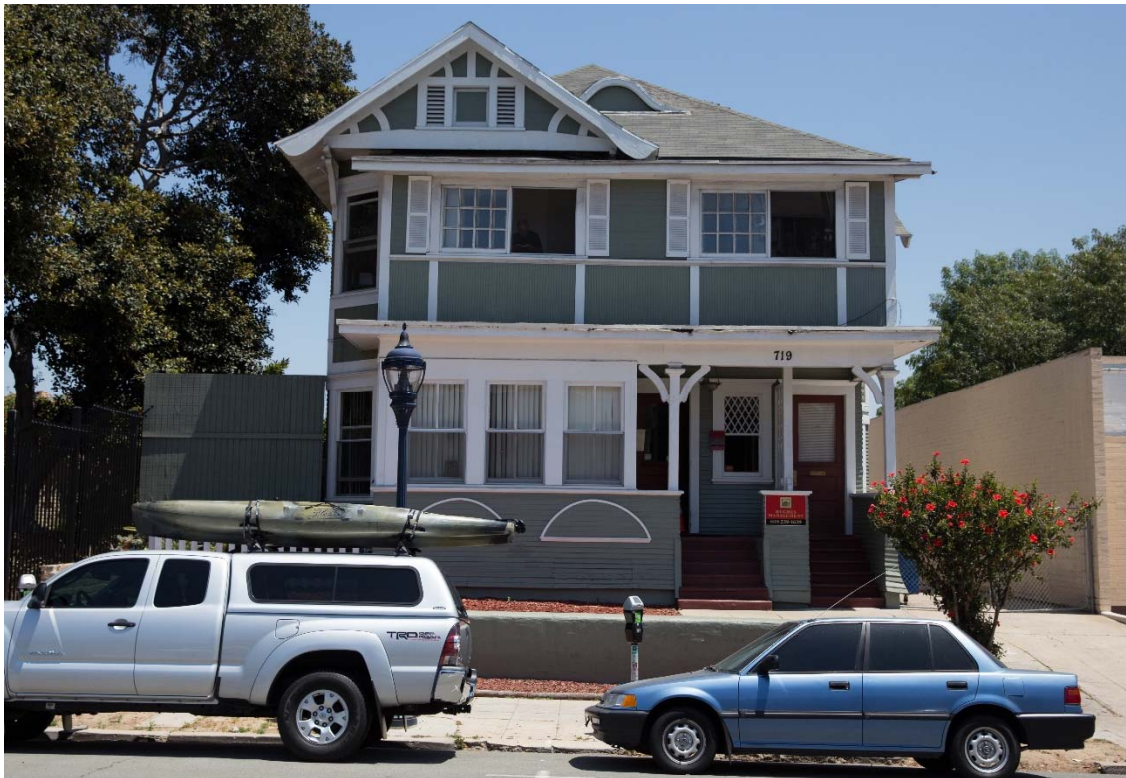
Figure 1: Street facade of the Murray Apartments.

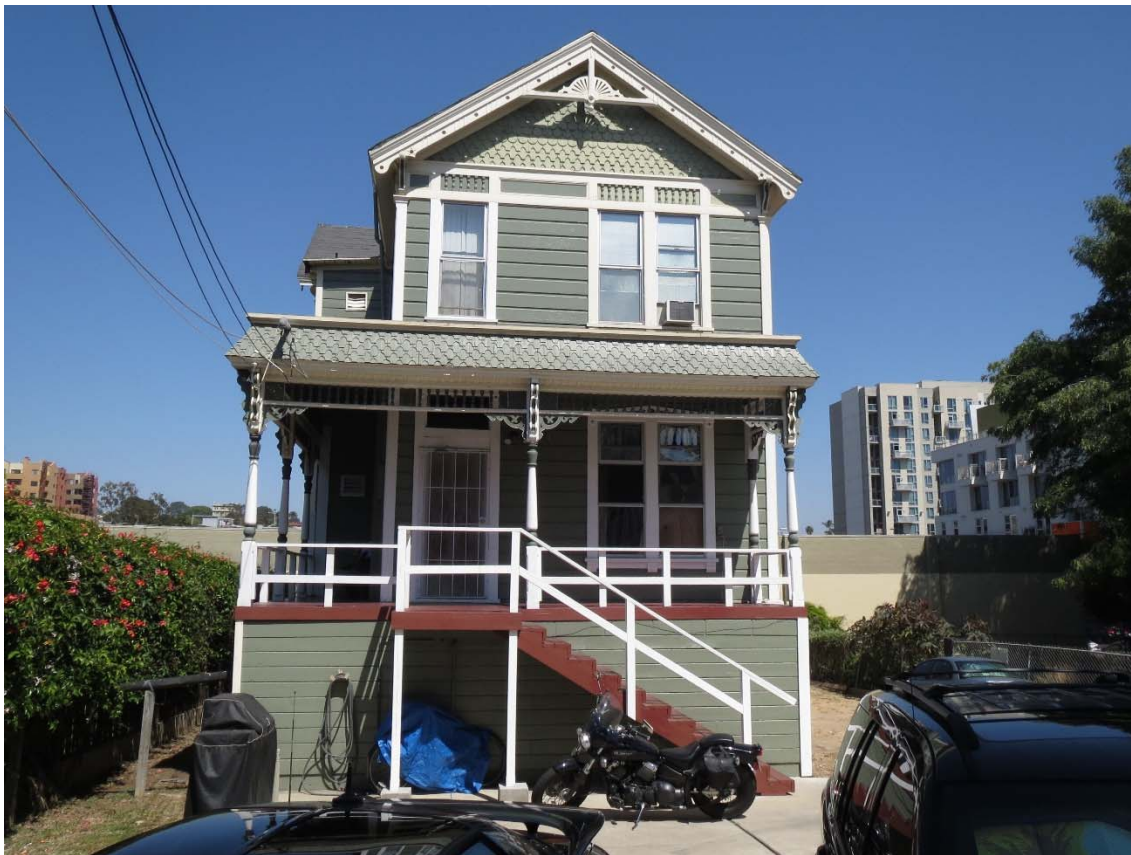
Figure 1: West facade of the Daggett Family Residence.
