**SONOMA COUNTY AGRICULTURAL
PRESERVATION & OPEN SPACE DISTRICT**

**CALABAZAS CREEK
OPEN SPACE PRESERVE
RESOURCE MANAGEMENT PLAN**

SEPTEMBER 2015

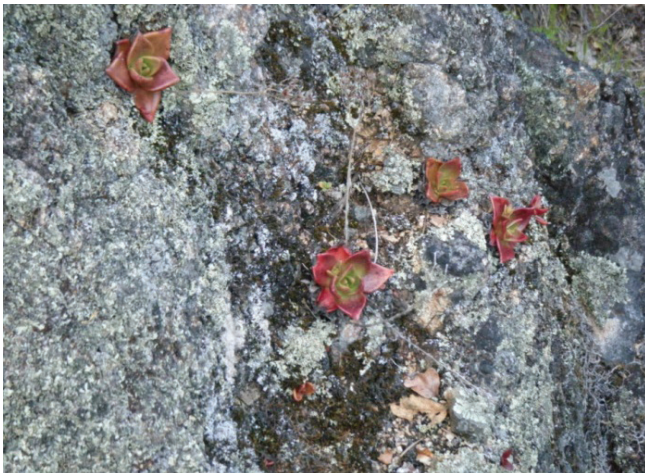
Photo 2: Western Sonoma Volcanics rock outcrop

Within the Preserve, this formation consists of two disparate volcanic rock types — more basic andesitic and basaltic flows and more acidic rhyolitic flows and ash-flow *tuff* (Figure 2.5). This is a reflection of the ‘bimodal’ nature of the volcanic eruptions in the WSV whereby the overlying crust only partially melted and resulted in the formation and subsequent eruption of the two distinct volcanic rock types. These different volcanic rock types were laid down as subsequent flows and occur as interbedded strata. As shown on Figure 2.5, andesitic to basaltic flows are widely exposed on and around the Preserve and are capped in local areas by rhyolitic flows. They are interbedded in the western portion of the Preserve with ash-flow *tuff*.

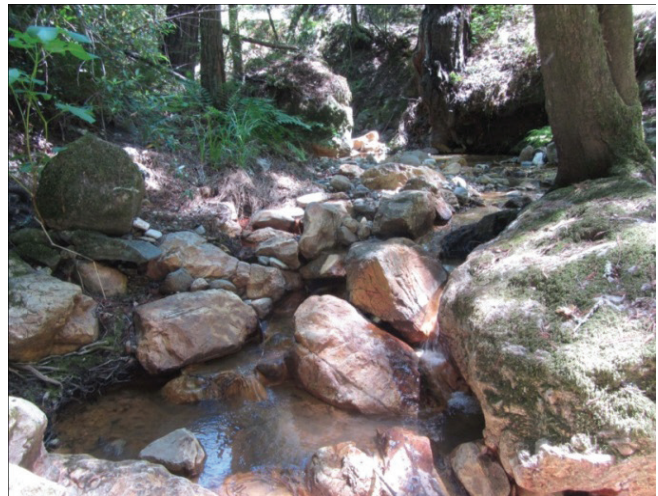
Photo 28: Calabazas Creek conditions demonstrating high percentage of large boulders indicating high velocity rain events capable of moving significant material.
