Bus Rapid Transit

I-405 corridor

Historic and Archaeological Resources Technical Memorandum

September 2020

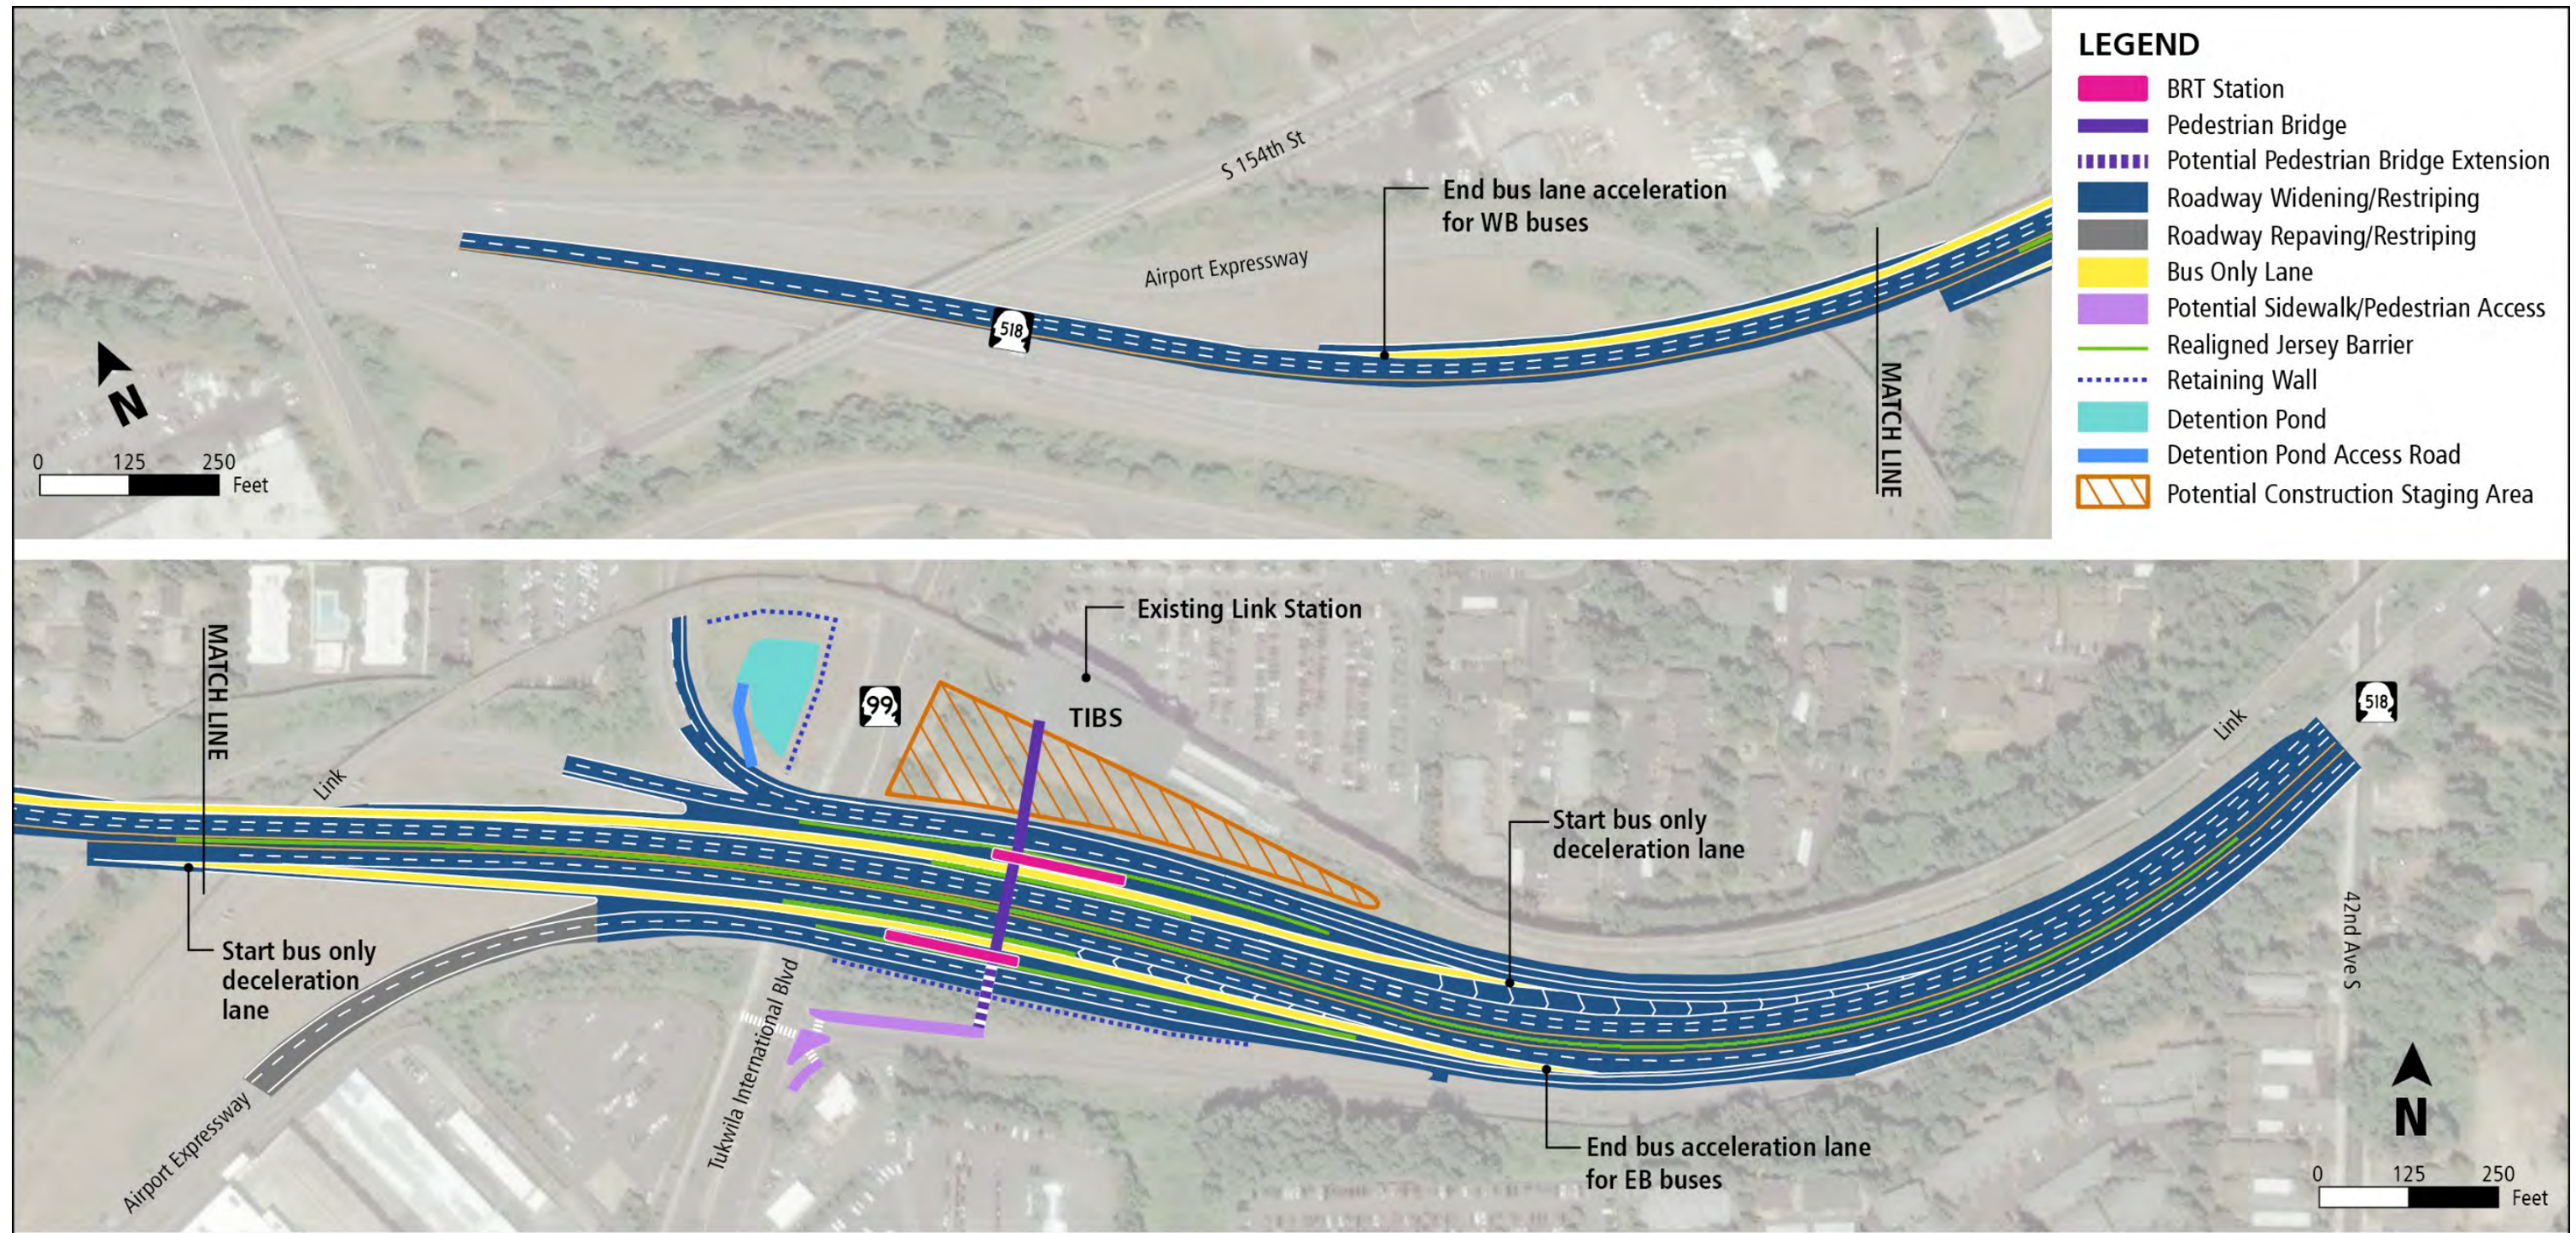
Figure 2-2 provides a graphic representation of the proposed Tukwila International Boulevard BRT Station, the new pedestrian bridge, and associated roadway improvements. The proposed BRT station would be accessed by a new pedestrian bridge that would be constructed from the mezzanine level of the Tukwila International Boulevard Link light rail station and extended south across SR 518, connecting to the eastbound and westbound BRT station platforms. The walking surface of the pedestrian bridge would be level with the mezzanine floor level of the Link station and roughly level with the existing Tukwila International Boulevard bridge over SR 518. From the pedestrian bridge, access down to each BRT station platform would be provided by stairs and an elevator. The pedestrian bridge is also anticipated to extend to the south and connect at grade to an existing sidewalk on the eastbound on-ramp to SR 518 that connects to sidewalks on Tukwila International Boulevard.

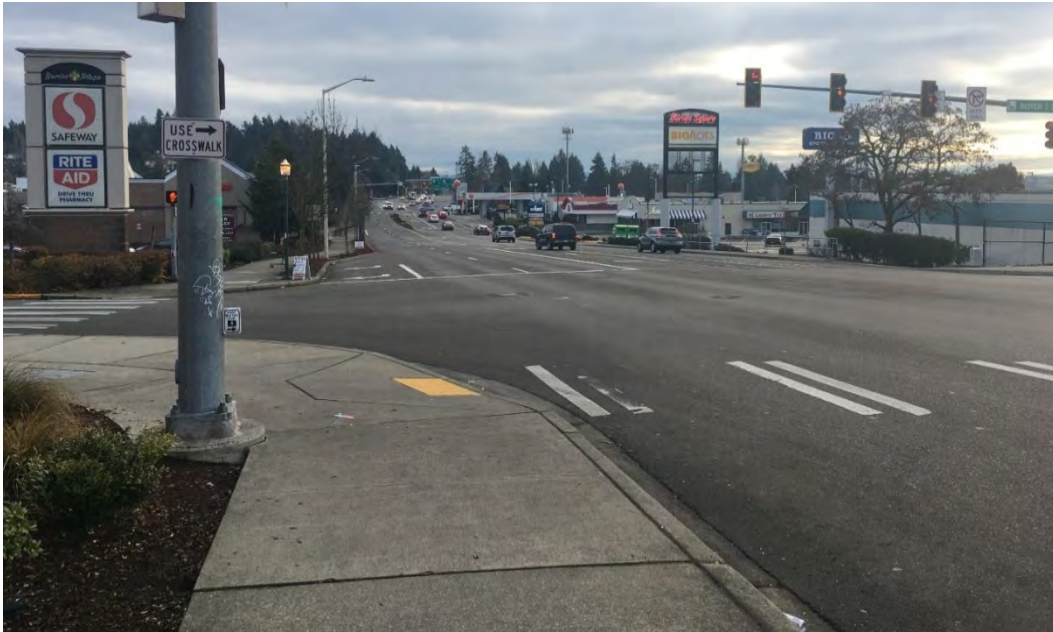
SW 148th Street has been constructed via cut and fill, resulting in occasional slopes and short walls on the south side of the roadway (fill portion of road construction). Eastward of the Burien Transit Center, SW 148th Street becomes SR 518 and crosses over SR 509 on a bridge. Both margins of SW 148th Street contain extensive buried utilities; utilities are also located beneath the roadway (**Figure 5-2**). The north side of SW 148th Street is bounded by multiple buildings that are within 30 feet of the road curb. Sidewalks and occasional landscaping strips are also located along the road curb (**Figure 5-1** and **Figure 5-2**).

Figure 5-1 East-facing overview of north side of SW 148th Street

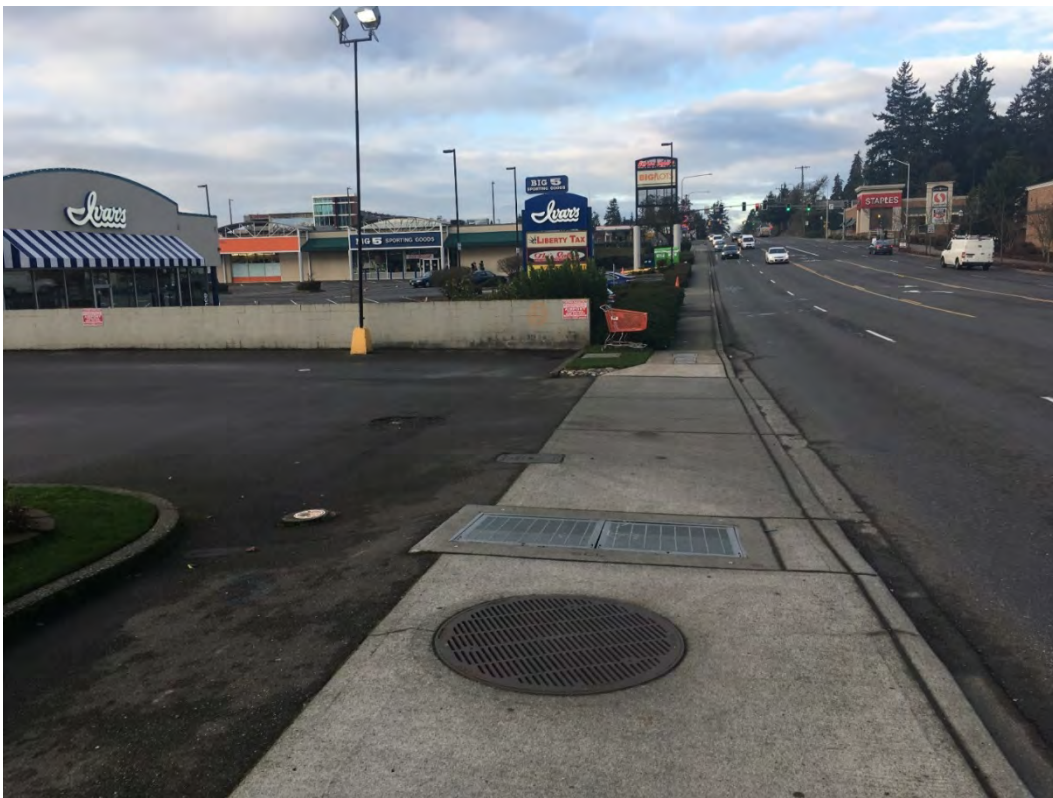
Figure 5-2 West-facing overview of south side of SW 148th Street; note multiple buried utilities

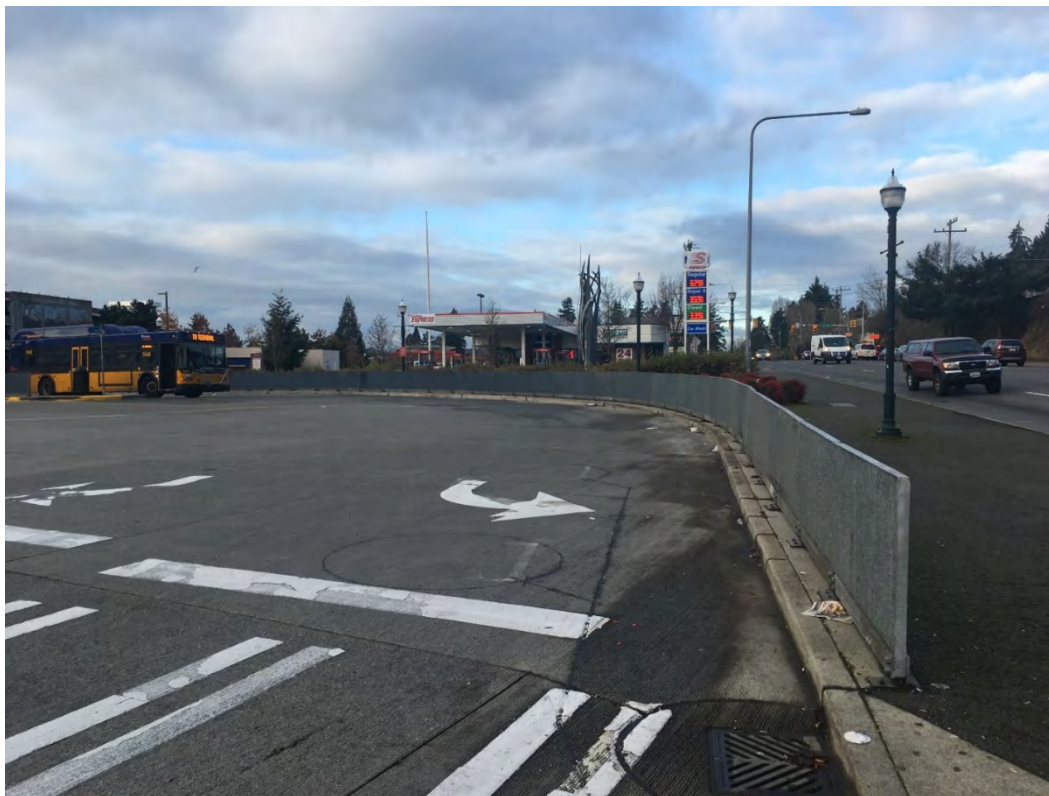
The Burien Transit Center is almost completely paved. A retaining wall is located at the eastern end, and the northwestern corner includes a landscaped planting area (**Figure 5-3**). This planting area contains an array of buried utilities; buried utilities were also observed across the remainder of the property.

Figure 5-3 Southeast facing view of Burien Transit Center location; landscaped planting area beyond the fence, center of frame

The planned improvements are located in an area that appears to have been subject to widespread and shallow surface grading and paving. Due to the probable lack of significant natural depositions during the Holocene epoch, this area is unlikely to have contained deeply buried archaeological resources prior to urbanization. Archaeological sites, if present, would be expected to have been located at or near the ground surface and are unlikely to have remained intact with grading.

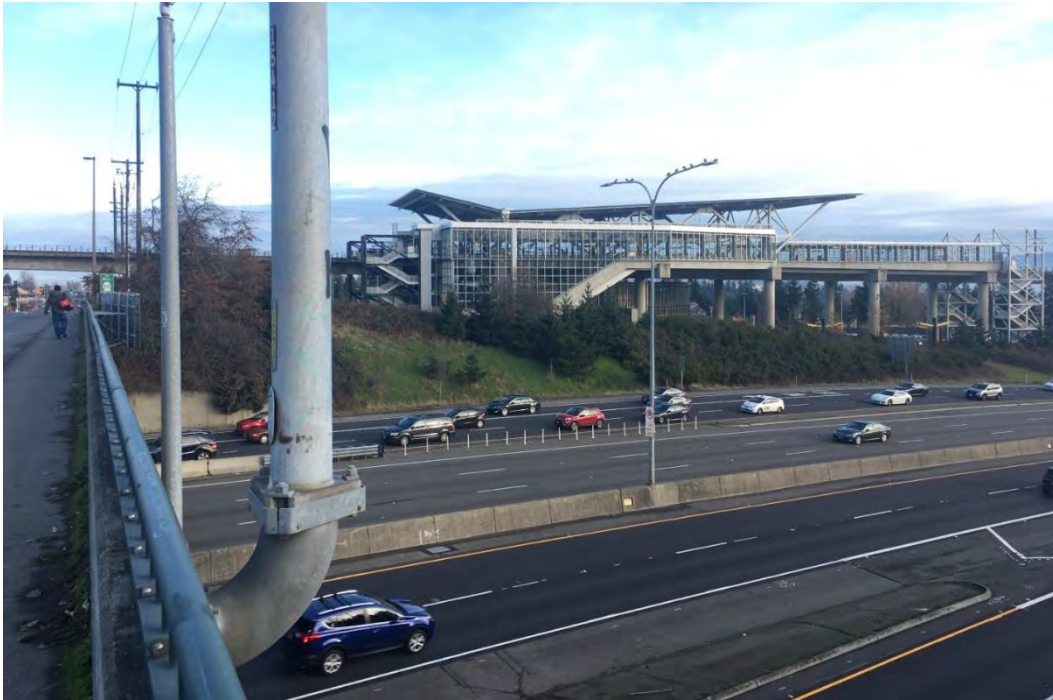
South of the freeway, the top of slope appears to be at or near the natural grade; however, extensive disturbances have occurred associated with construction of the overpass, SR 99, and the State Patrol building. The north side of SR 518 (along the top of slope) was extensively modified by construction of the existing Tukwila International Boulevard light rail station. Multiple buried utilities were also observed along the freeway and along the top of slope.

Figure 5-4 Northwest-facing overview of the SR 518 cut and Tukwila International Boulevard Station

The planned improvements are located in an area that appears to have been subject to widespread cutting, grading, and paving. Due to the probable lack of significant natural depositions during the Holocene epoch, this area is unlikely to have contained deeply buried archaeological resources prior to urbanization. Archaeological sites, if present, are expected to have been located at or near the ground surface, and are unlikely to have remained intact with cutting and grading.

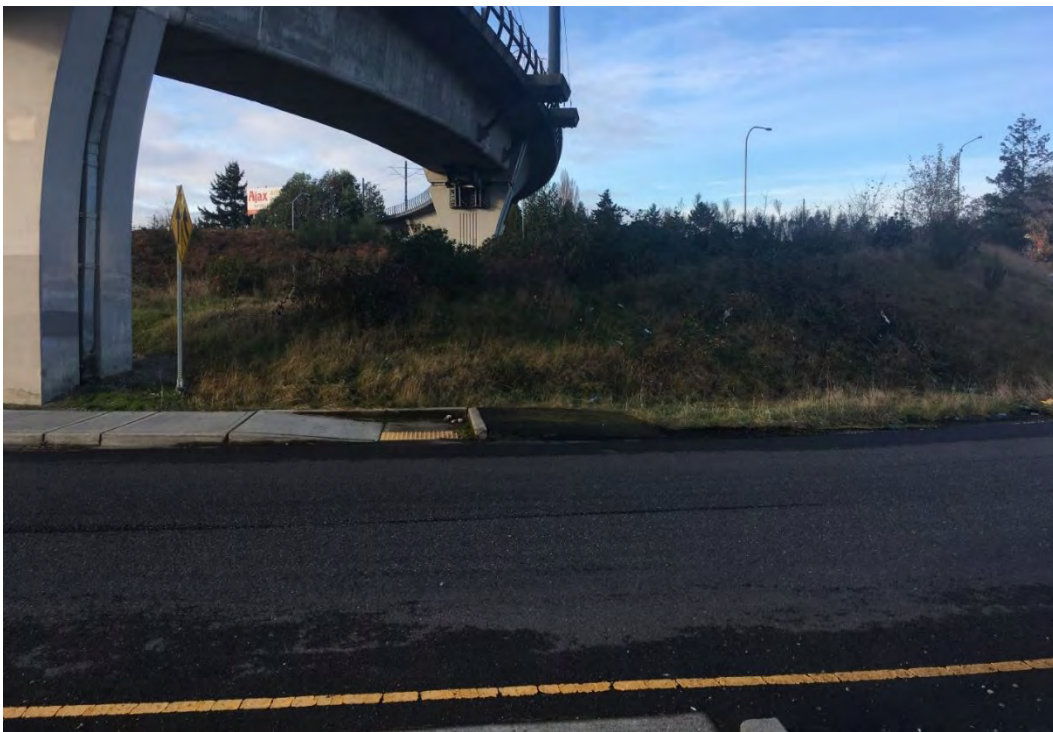
The proposed detention pond is located within a grass/Scotch broom/blackberry field that appears to have been mounded with fill sediment (**Figure 5-5**). The mound is higher than neighboring elevations and does not appear to be at native ground surface. This area would have been extensively impacted by highway off-ramp construction, highway construction, and elevated light rail line construction. No buried utilities were evident within this area.

Figure 5-5 North-facing overview of the planned retention pond location

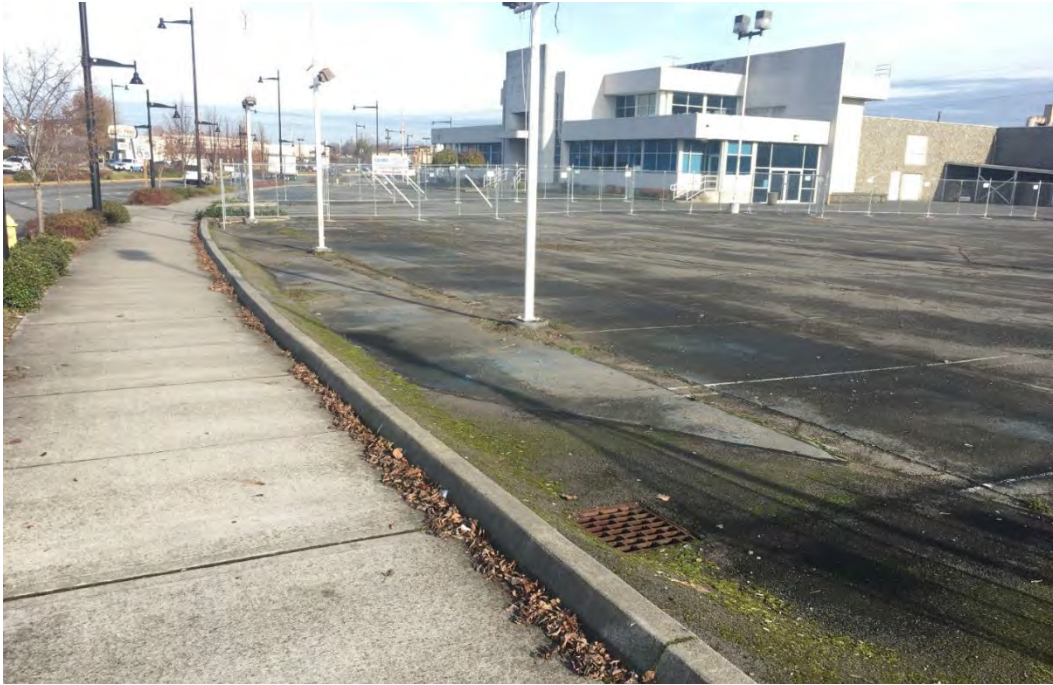
The South Renton Transit Center location is within an area that has been extensively developed and urbanized and is currently for car sales and repair businesses (**Figure 5-6**). Very little non-paved areas exist, and these are confined to small grass and planting strips. This area has been at least superficially graded flat for use as parking area as well as extensively disturbed at the location of multiple buildings. Buried utilities are prevalent along the street margins (**Figure 5-7**) as well as occasionally extending across the site, feeding multiple buildings and light poles. Large aboveground power lines are located at the southern end (oriented east/west), as well as along the eastern end (oriented north/south). The area appears to be at or near the historic/native ground surface (no major grade changes with neighboring properties), but is 99 percent paved.

Figure 5-6 North-facing overview of the abandoned car dealership and extensively paved ground surface

The planned improvements are located in an area that appears to have been subject to widespread and shallow surface grading and paving. Due to the significant natural deposition during the Holocene epoch, this area has the potential to contain deeply buried archaeological resources prior to urbanization. Archaeological sites, if present, may be present at depths deeper than previous grading.

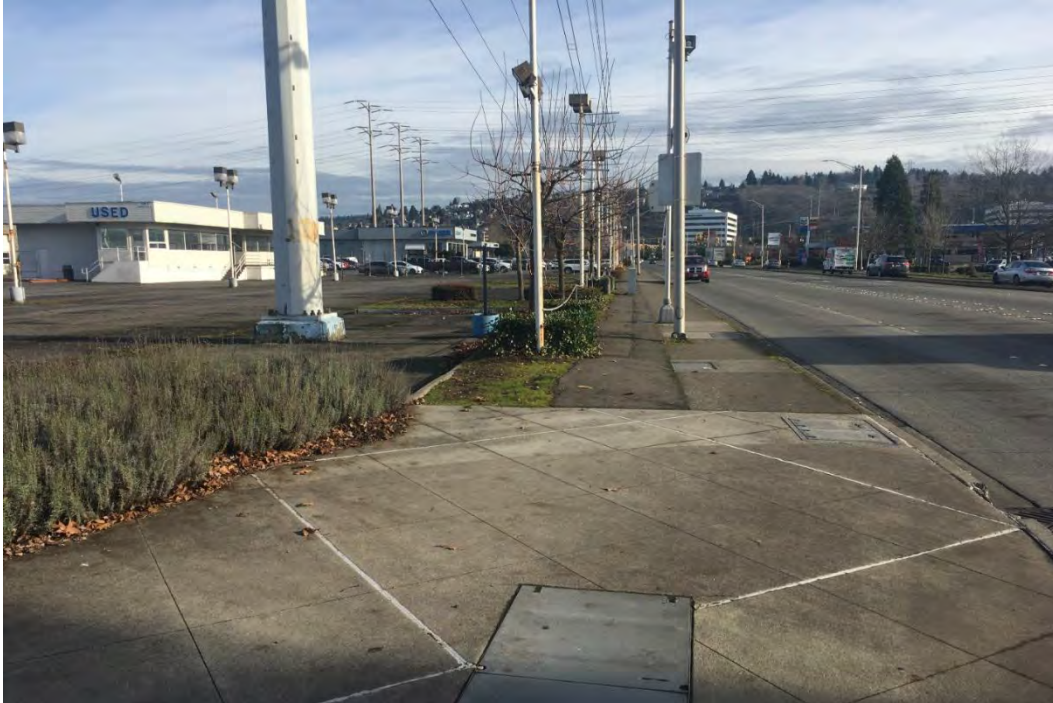
The South Renton Transit Center and Roadway Improvements project component AI is situated within an area mapped as Holocene-aged alluvial deposits (WDNR 2019). Based on age and environment of deposition, this geological unit has a high potential for intact archaeological sites. In October 2019, four geotechnical borings at this location were monitored by an archaeologist. Preliminary results indicate mixed fill deposits from surface to approximately 8 feet, followed by bedded alluvial deposits ranging from silt/fine sand to gravels. Occasional organic-rich peat layers were also observed bedded within the alluvium. This stratigraphic sequence is consistent with geological mapping.

Figure 5-7 East-facing overview of the southern end of the planned South Renton Transit Center site; note multiple buried utilities, paved surfaces, aboveground power lines, and flat landform

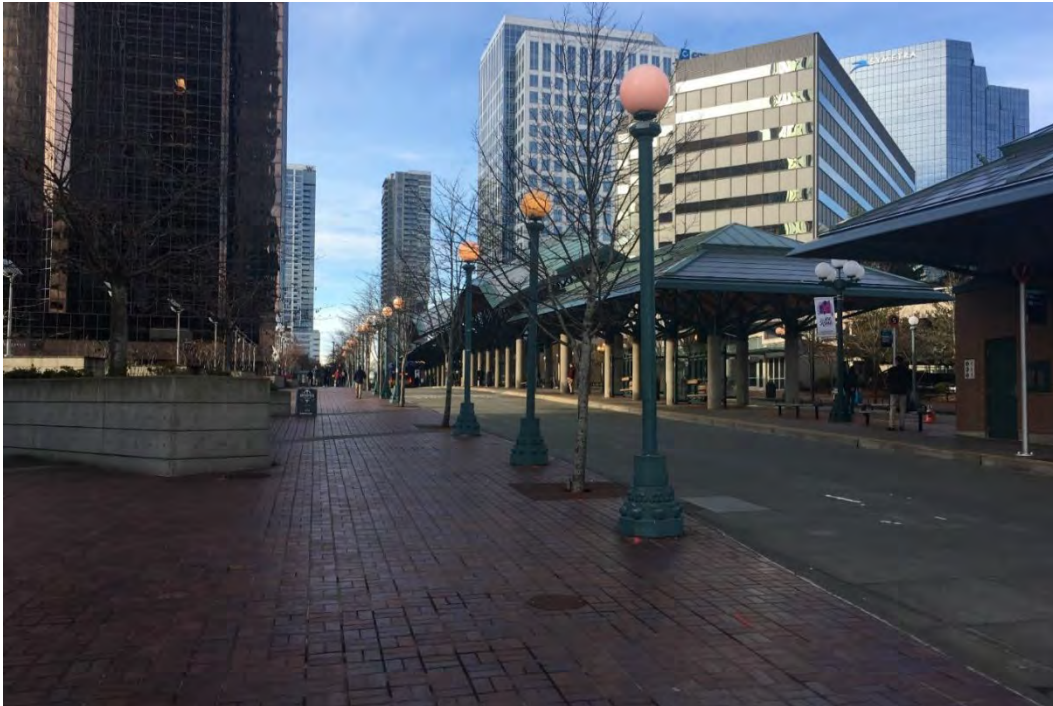
The proposed Bellevue Transit Center project components, including the layover area, are located within an extensively urbanized environment. The ground surface has been modified by roadway construction as well large building construction. Buried utilities are prevalent. Although it is difficult to determine due to the extent of urbanization, it appears that the ground surface is near where the natural ground surface would be. All surfaces are paved, including the transit center location (**Figure 5-8**) and the bus layover area (**Figure 5-9**).

Figure 5-8 West-facing overview of the Bellevue Transit Center location

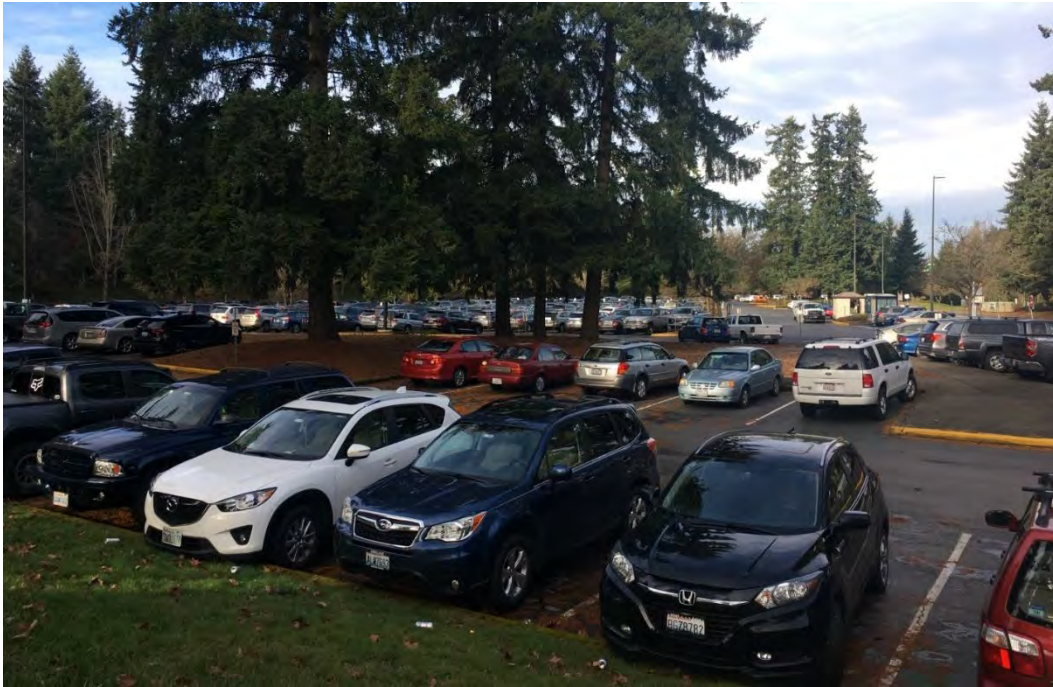
The Kingsgate Park-and-Ride location is extensively paved with trees and grass areas around the periphery and within strips throughout the parking lot (**Figure 5-10**). Many of the parking strips contain mature cedar and fir trees that may predate the parking lot. The ground surface is generally level and does not appear overly graded. A detention pond is located at the southeast corner of the property. The only observable utilities across the site are for power to light poles.

A 1- to 2-meter-high earthen berm is located along the south and east edge of the property, and is covered with ivy and mature to young firs. While extensive grading has likely occurred across the site as preparation for the parking lot, the depth and degree of disturbance may be minimal as the ground surface at this location appears similar to that of neighboring properties.

Figure 5-10 Northwest-facing overview of the parking lot and mature trees

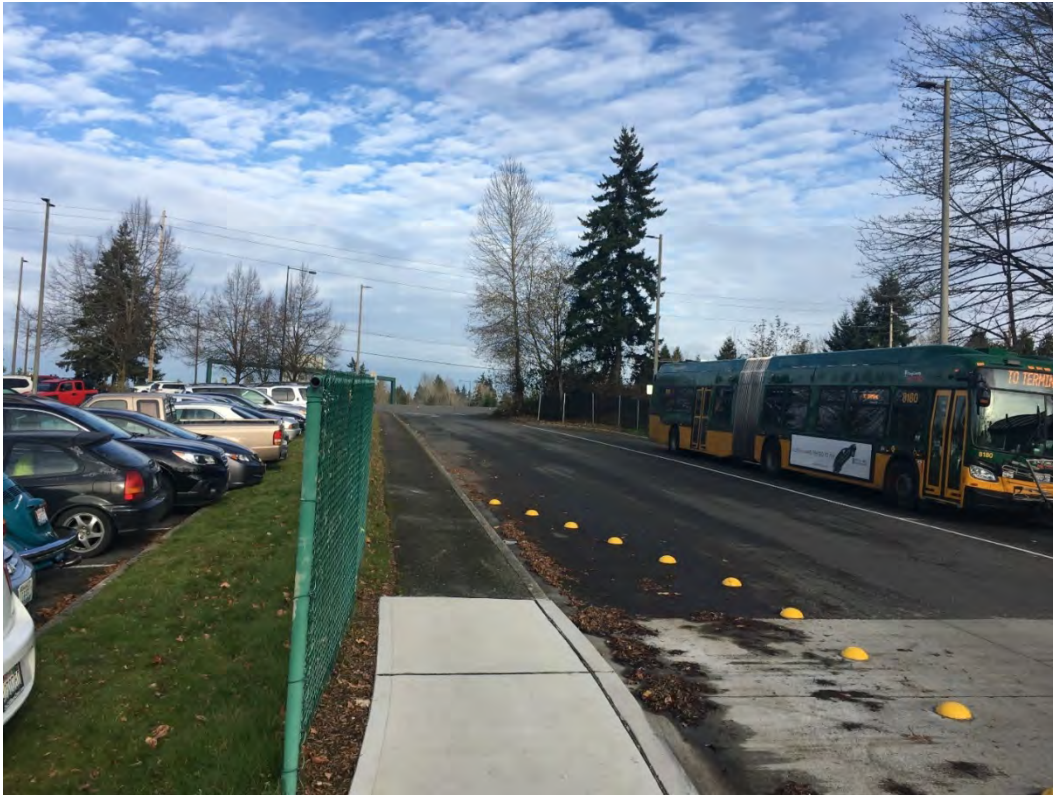
The Brickyard Station Park-and-Ride is located on a southwest-aspect slope just east of I-405. It appears the I-405 was constructed just below natural grade with the parking lot situated along the natural ground surface elevation. The park-and-ride is bounded to the south by a densely vegetated natural area. The parking lot is primarily paved with occasional planting strips between the parking lanes (**Figure 5-11**) and along the periphery. Buried utilities are present but relatively minimal. There is evidence of grading along the downslope edge (southwestern corner) with small slopes containing exposed fill material extending from the edge of pavement. The degree of prior ground disturbance at this location is difficult to determine; the parking lot appears to follow the general slope of the surrounding landform but superficial grading would have occurred to construct the parking lot. Ground disturbance associated with the freeway construction may have also impacted the site.

Figure 5-11 North-facing view of the bus lane along the eastern edge of the parking lot

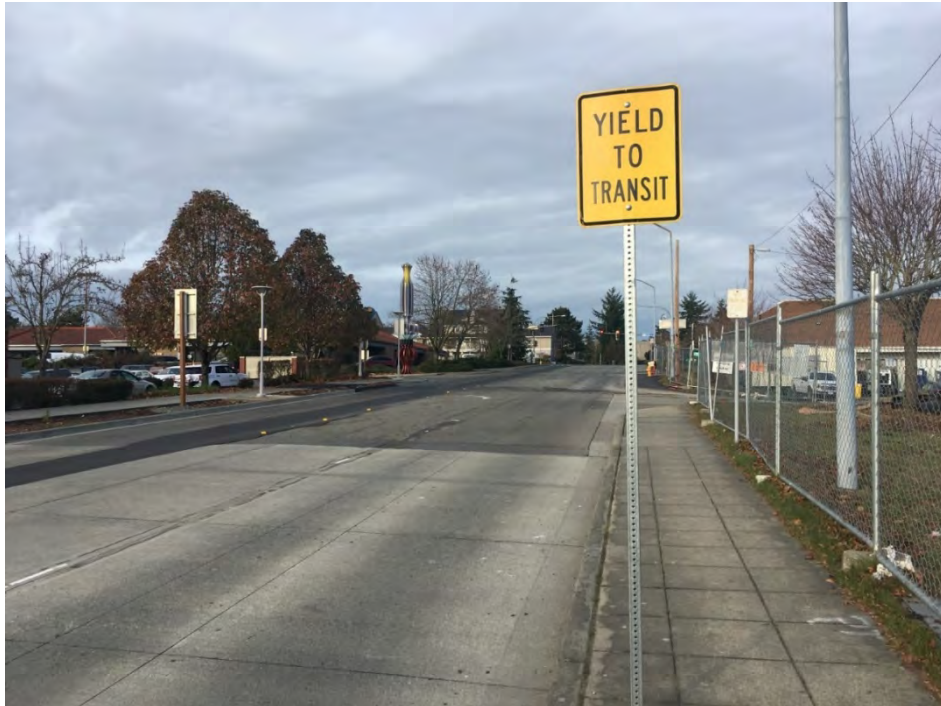
Figure 5-12 North-facing view along 46th Avenue W; note the landscaping strip and paved surfaces

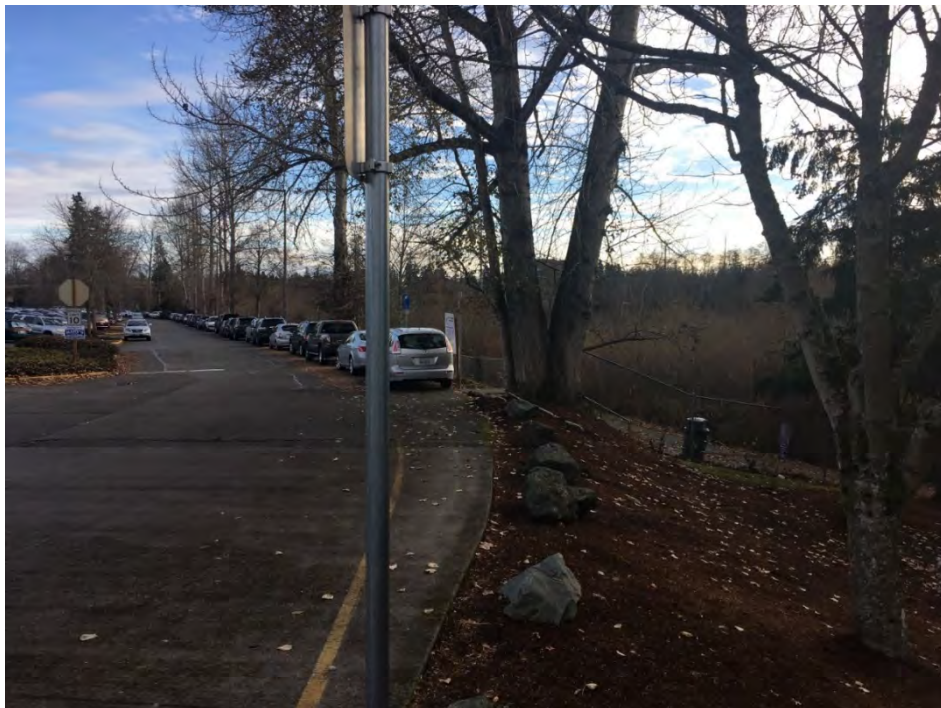
This area has likely been subjected to extensive grading; however, the current ground surface appears similar to that of neighboring properties. The area along the edge of Scriber Creek Park is steeper (extending into the creek drainage), implying that some material has been graded downslope to create a somewhat level parking area (**Figure 5-13**).

Figure 5-13 South-facing overview of the southwest end of the parking area (at the proposed bus layover area); note the steep graded slope above the Scriber Creek drainage along the right side of the frame

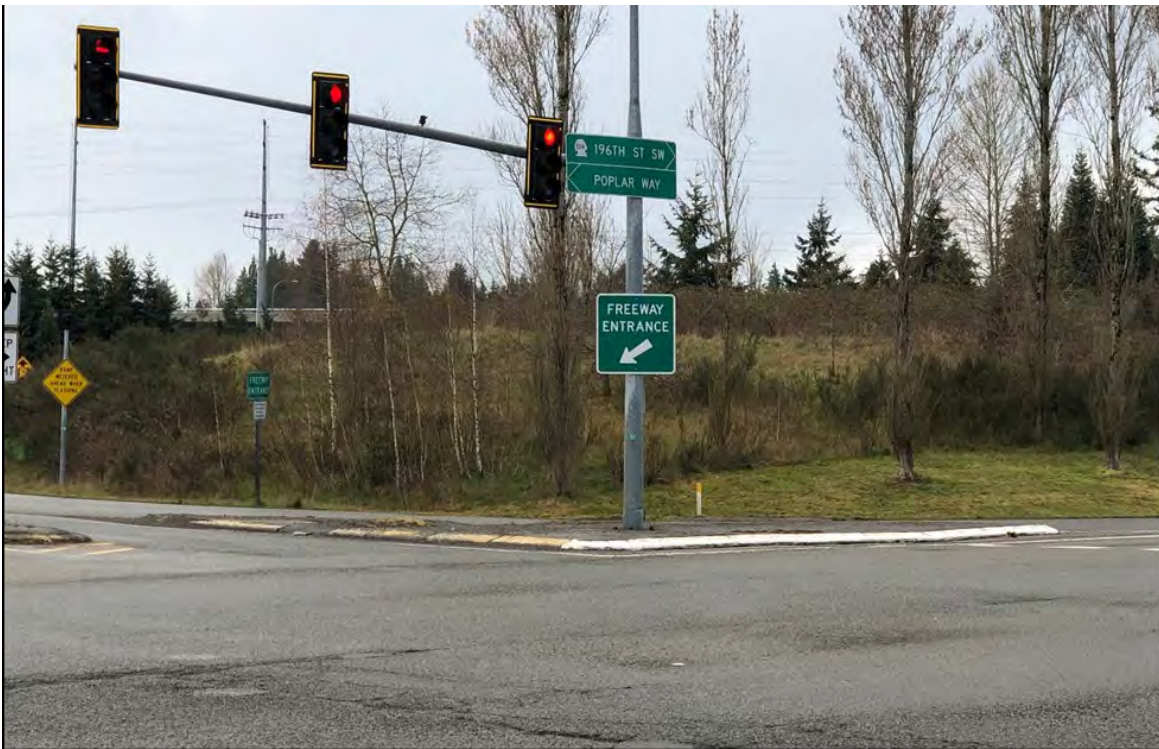
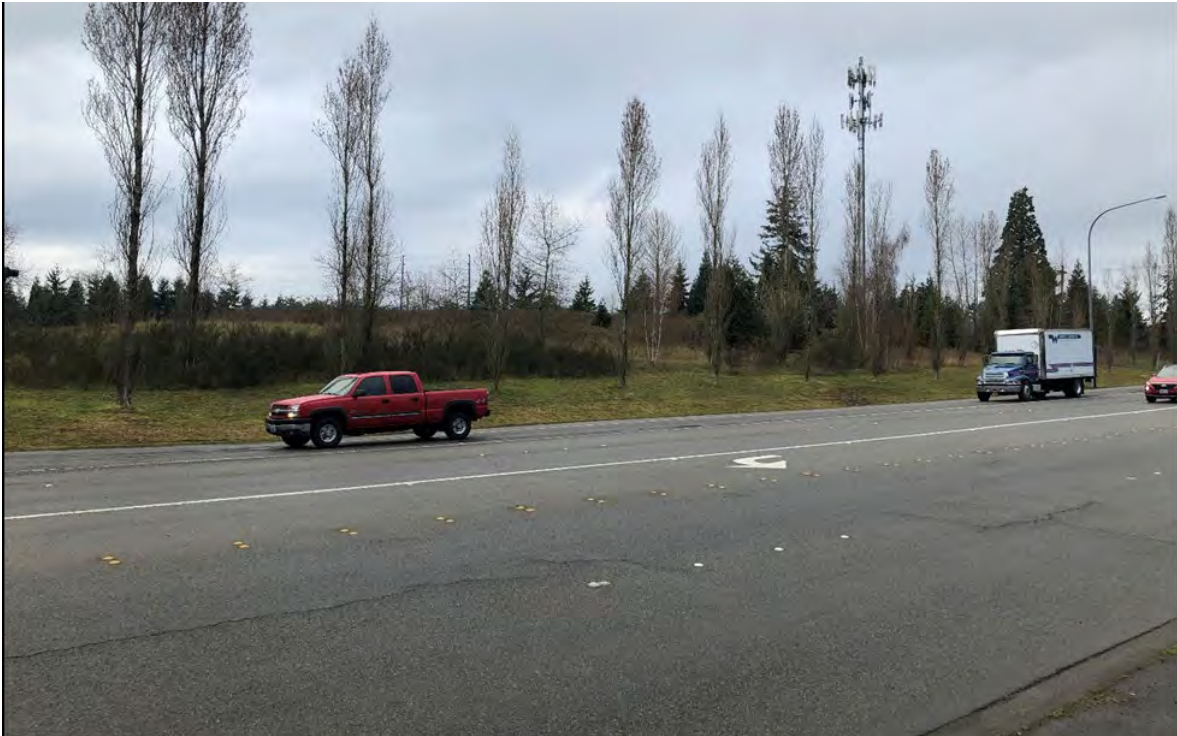
The Poplar Way I-5 on-ramp area is a heavily vegetated, hummocky area that stands approximately 8 to 10 feet above the surface of Poplar Way and the I-5 on-ramp (**Figure 5-14**). These roads appear to have been constructed primarily through cutting. The area contains poplars and blackberry brambles. It also contains a cell tower (**Figure 5-15**).

Figure 5-14 West-facing overview of the Poplar Way I-5 ramp area

Figure 5-15 West-facing overview of the Poplar Way Interstate-5 ramp area

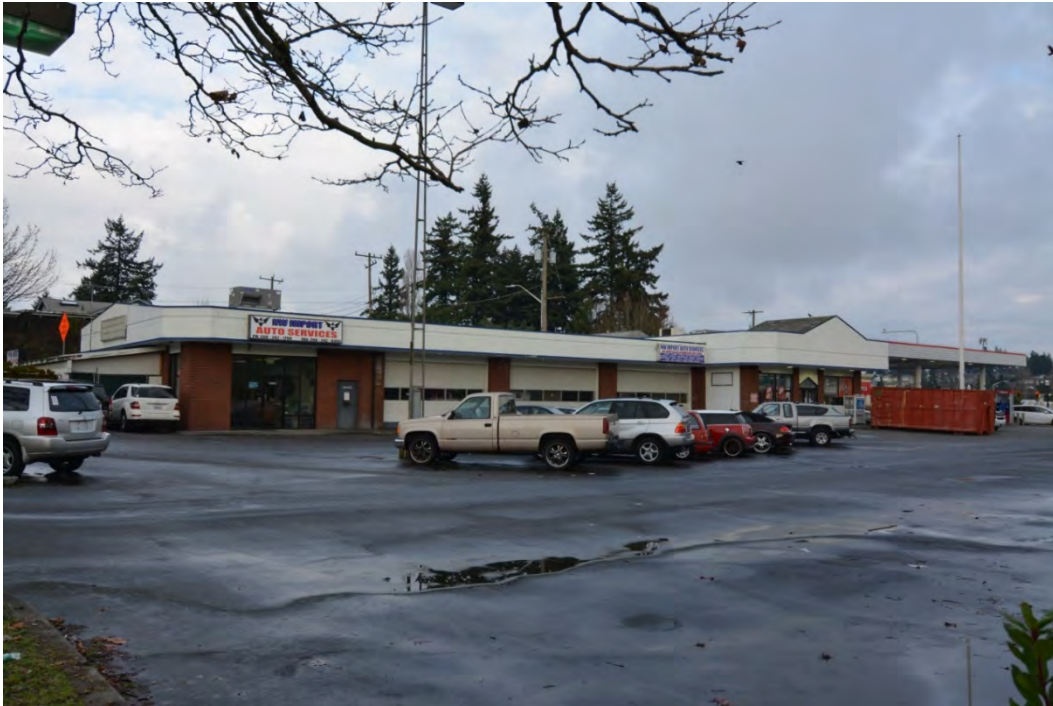
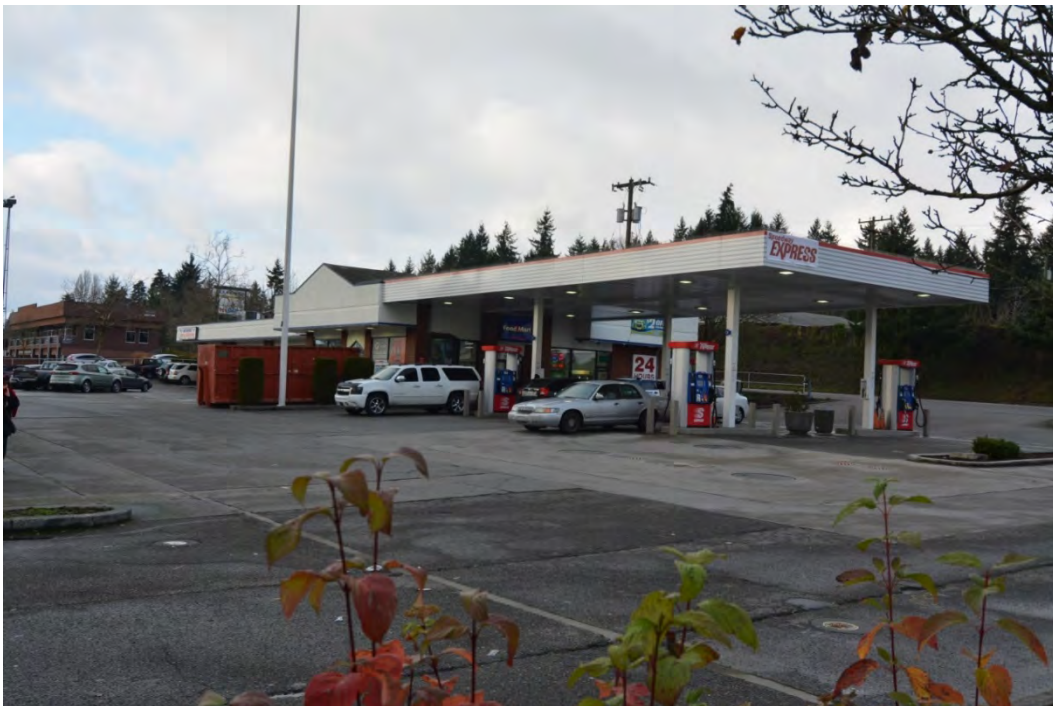
The building is essentially rectangular, with a central mass and two slightly off-set wings (**Figure 6-1** and **Figure 6-2**). The central mass measures 58 feet north-south by 35 feet east-west; the western wing measures 40 feet north-south by 85 feet east-west; the eastern wing measures 30 feet north-south by 66 feet east-west. The central portion houses a convenience store and is comprised of a series of plate-glass windows interrupted by brick columns. Double-glass doors are located on the southern and eastern façades. The western wing features three auto repair bays, with an office on the west end. The entrance to the auto repair office is located on the southern façade and features tall plate-glass windows flanked by sections of brick; a secondary personnel door is located to the right of the main entrance. The eastern wing covers two gas pump islands.

Figure 6-1 295 SW 148th Street, Burien; view to the northeast

Figure 6-2 295 SW 148th Street, Burien; view to the northwest

When constructed in 1966, the property had a flat roof with an 8-foot overhang and brackets. The western wing originally contained four auto repair bays; the repair office was clad in exposed aggregate. The eastern wing was not connected to the rest of the building. The 1989 remodel resulted in northern and southern additions to the eastern end, along with converting the easternmost repair bay, to form the convenience store. The roofline was changed to the current heavy entablature and connected to the eastern wing. The exposed aggregate was removed and replaced with the plate-glass windows.

For a property to be eligible for listing in the NRHP, it must be significant and possess integrity. This property is recommended not eligible for listing in the NRHP under any criteria and does not retain integrity.

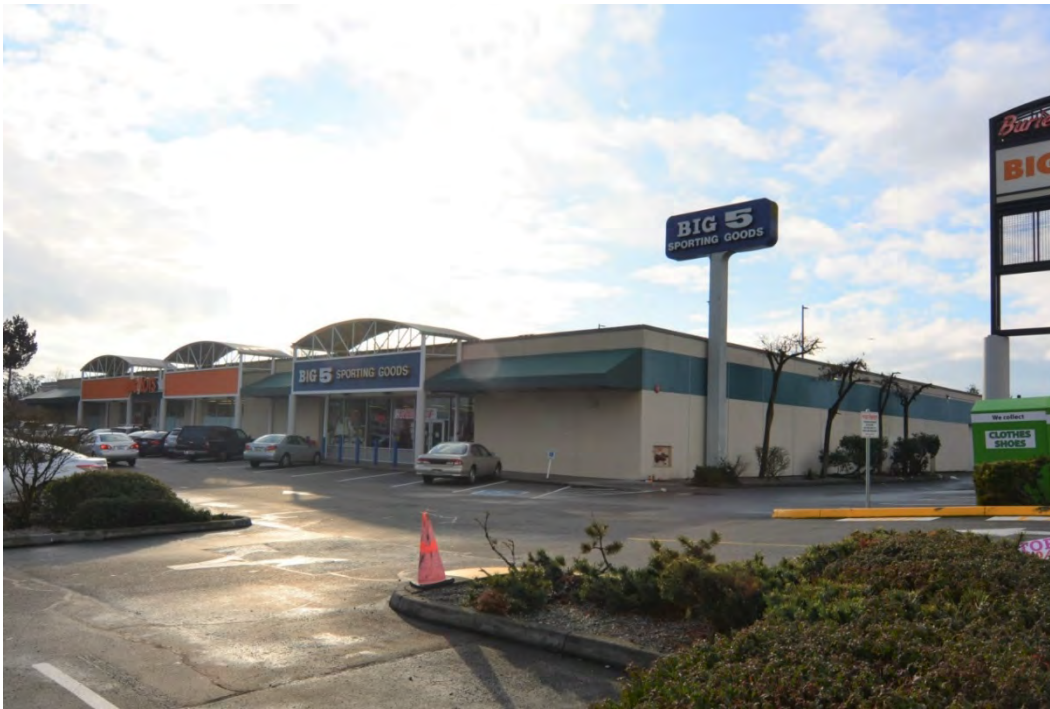
The 34,650-square-foot building is rectangular in plan with the shorter dimension parallel to SW 148th Street and the primary façade facing east (**Figure 6-3** and **Figure 6-4**). The primary façade of the building is comprised of a series of tall plate-glass windows interrupted by stucco panels. Three arched canopies over commercial signage space are meant to demarcate the entrances to three shops. However, the southern two shop bays have been combined into one store and, therefore, the commercial signage is located between the canopies.

Figure 6-3 125 A SW 148th Street, Burien; view to the southwest

Figure 6-4 125 A SW 148th Street, Burien; view to the north

When originally constructed, the building was clad in a combination exposed aggregate, marblecrete and structural clay research (SCR) brick. Shops were divided by large columns decorated with large, circular emblems. The building was remodeled in 1989, removing these details and adding the arched canopies and commercial signage space. The entrance to the middle shop was replaced by plate glass and a secondary set of doors was added to the southern shop.

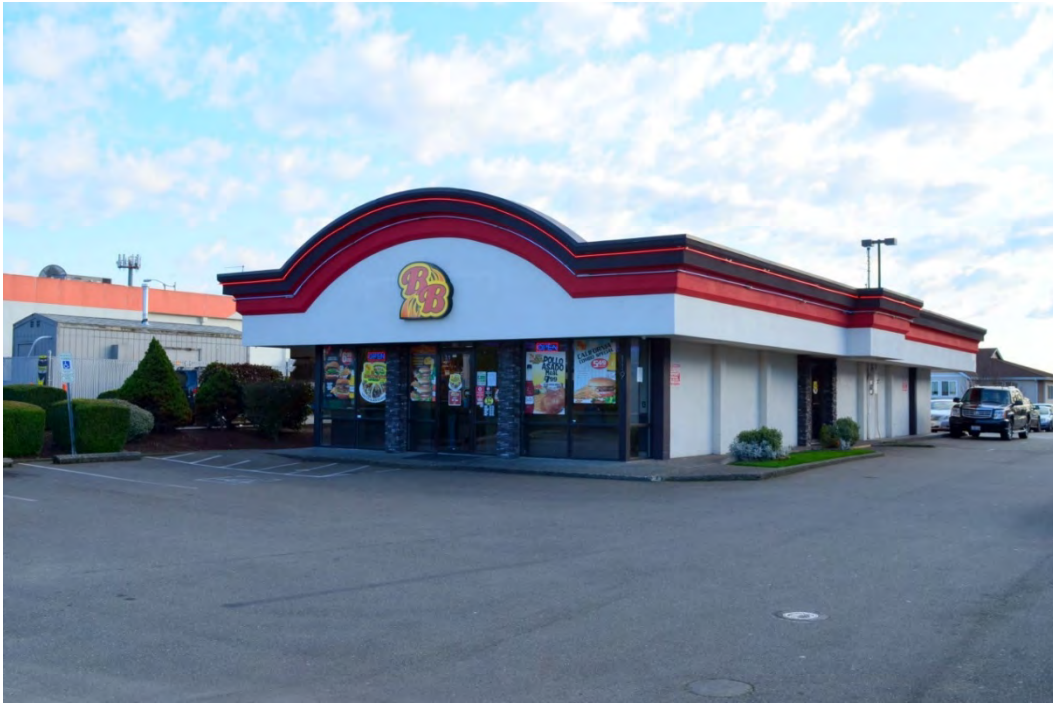
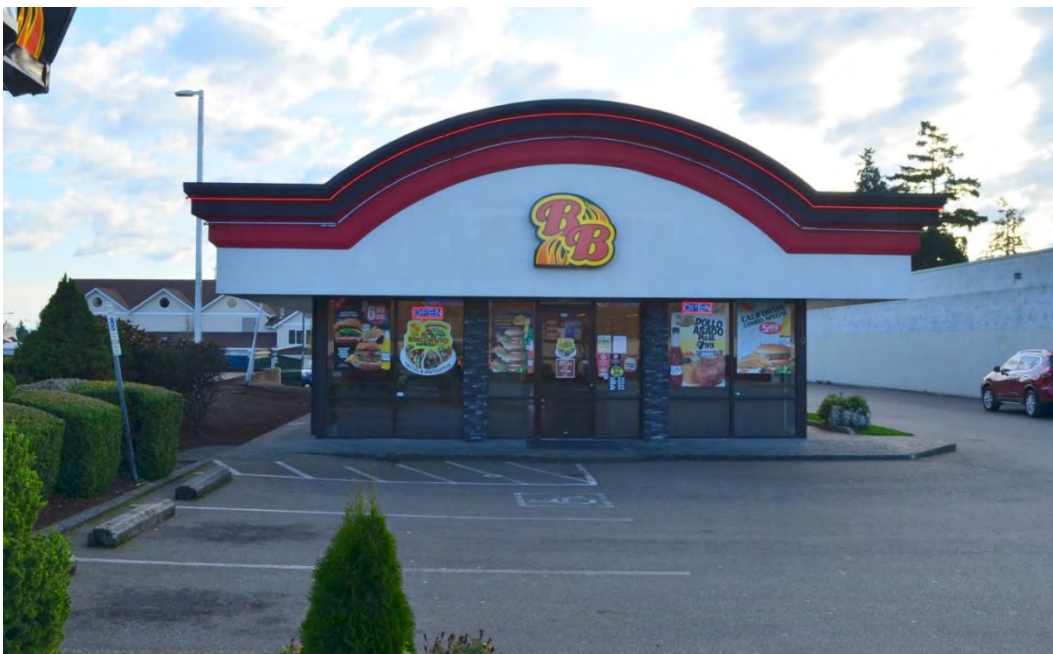
The building was originally constructed as a drive-in with an angled, Googie-style roofline. In 1974, it was remodeled into a seafood restaurant with a Mansard roof. An approximately 25-foot addition was constructed at the front of the building as well. The building was remodeled once again in 1990 to its current configuration.

Figure 6-5 119 SW 148th Street, Burien; view to the southeast

Figure 6-6 119 SW 148th Street, Burien; view to the south
