Bus Rapid Transit

I-405 corridor

Historic and Archaeological Resources Technical Memorandum

September 2020

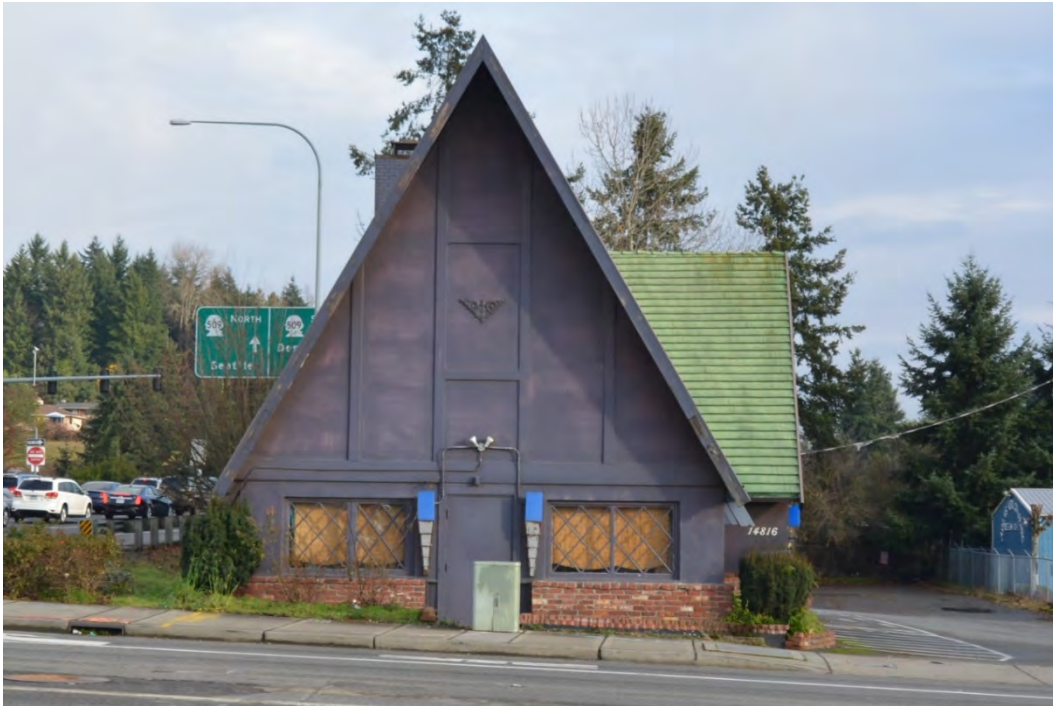
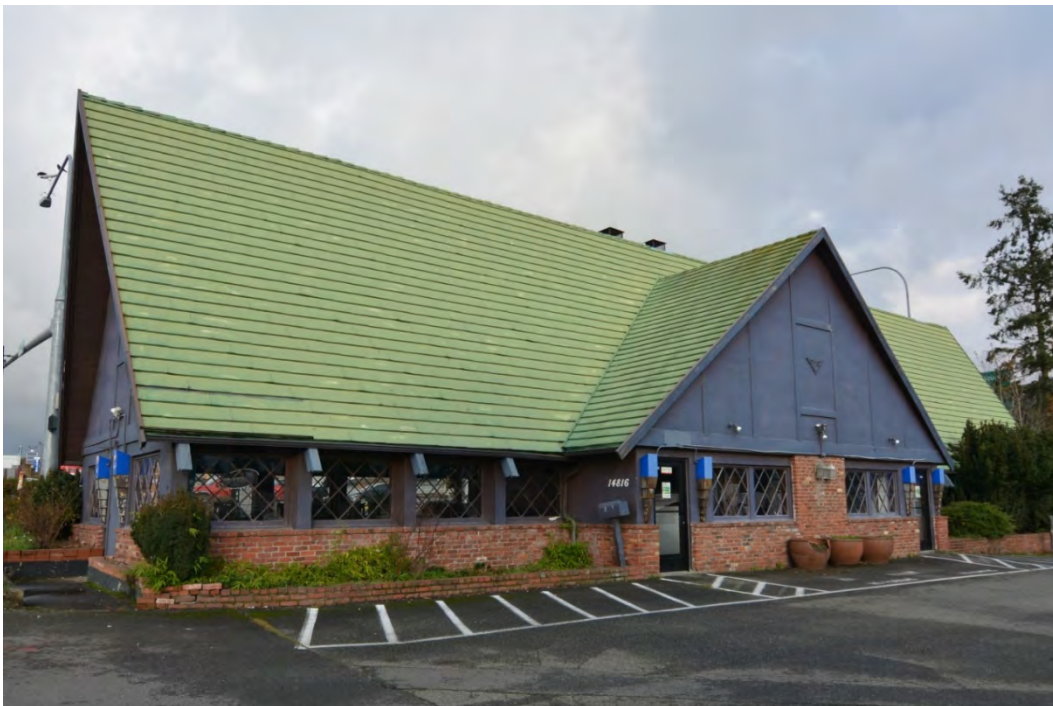
The building is rectangular in plan and has a footprint measuring 100 by 22 feet, with the shorter dimension parallel to 1st Avenue S (**Figure 6-7** and **Figure 6-8**). The one-and-a-half-story building features the characteristic steeply pitched cross-gable roof and exposed rafter tails iconic of the International House of Pancakes (IHOP) chain of restaurants. It is clad in applied brick veneer at the ground level to a faux water table, topped with stucco; decorative half-timbering is featured in the gables. An interior chimney is located on the northern slope. Fenestration on the north, south, and west façades consists of fixed windows with diamond grilles.

Figure 6-7 14816 1st Avenue S, Burien; view to the east

Figure 6-8 14816 1st Avenue S, Burien; view to the northeast

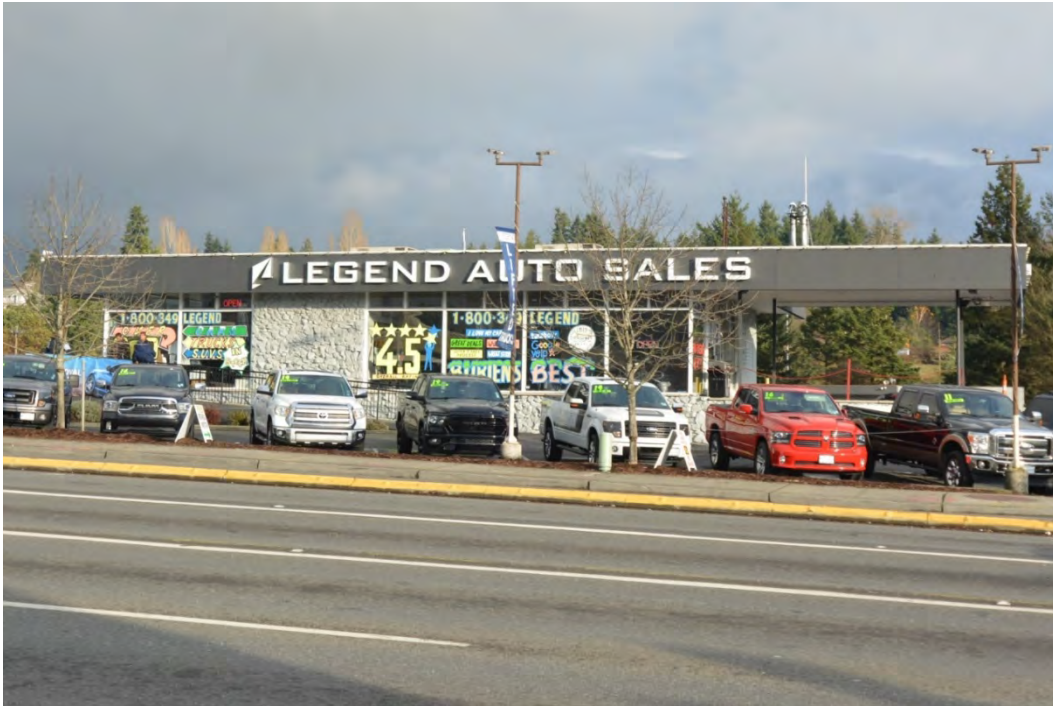
The building has a rectangular-shaped plan and has a footprint measuring 60 by 42 feet, with the longer dimension parallel to 1st Avenue S (**Figure 6-9** and **Figure 6-10**). The building has a flat roof with a 3-foot overhang; a 29-foot by 26-foot canopy supported by metal poles extends to the south. The western façade is comprised of a series of tall plate-glass windows with clerestory windows at the roofline; a decorative rock wall divides the series of plate glass. Double-glass doors are located on the southern façade. In addition to the plate-glass windows, the building is clad in T 1-11 siding. Window openings along the southern and eastern façades may have been altered and filled in with horizontal wood siding.

Figure 6-9 14650 1st Avenue S, Burien; view to the east

Figure 6-10 14650 1st Avenue S, Burien; view to the northeast

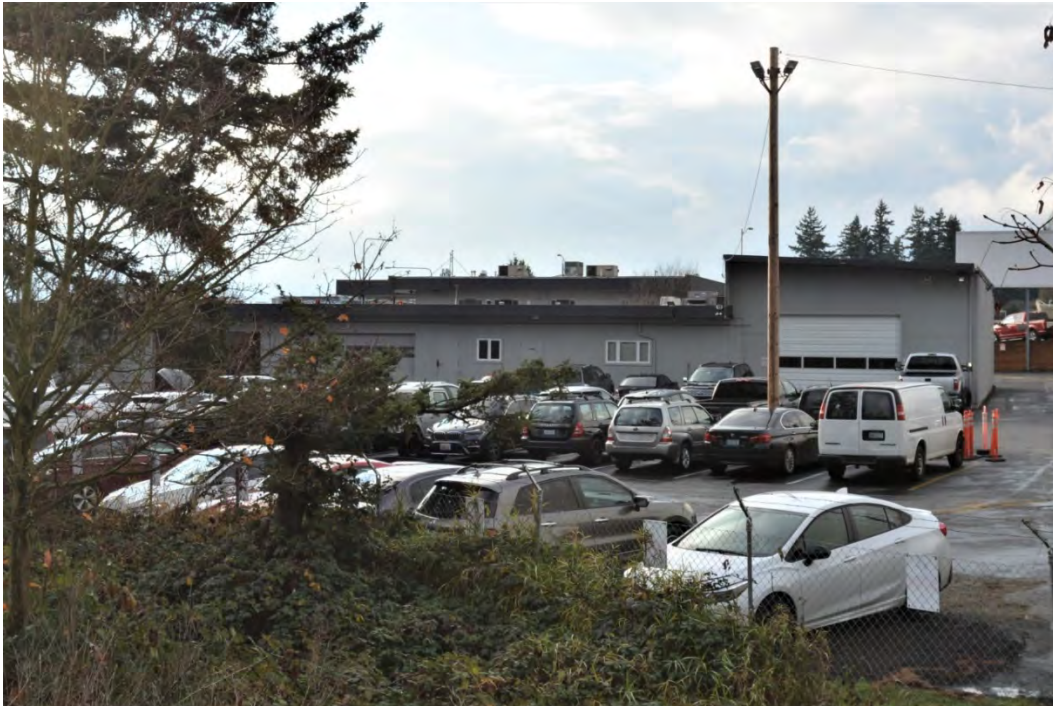
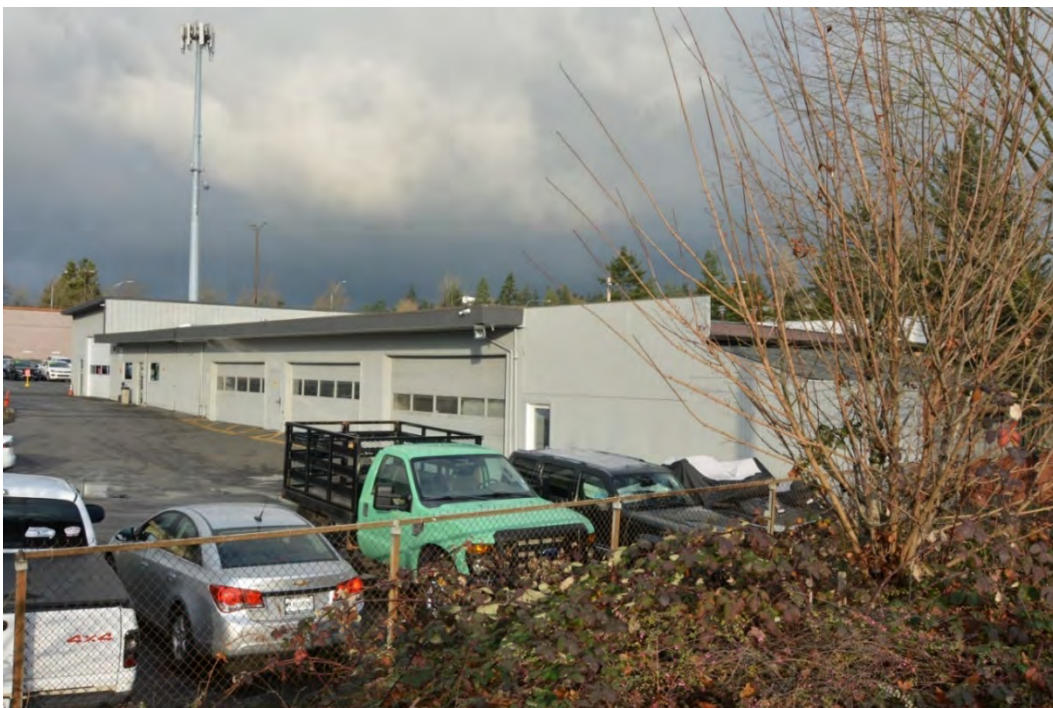
The building is rectangular in plan and has a footprint measuring 142 by 58 feet, with the longer dimension parallel to 1st Avenue S (**Figure 6-11** and **Figure 6-12**). The building has a flat roof, and the northern portion has a roofline that is approximately 5 feet higher than the rest of the building. The primary façade (west) features three auto repair bays with roll-up doors at the southern end and another roll-up door at the northern end. Four single personnel doors are located on the primary façade. The building is clad in T 1-11 siding.

Figure 6-11 14650 1st Avenue S, Burien; view to the southwest

Figure 6-12 14650 1st Avenue S, Burien; view to the northeast

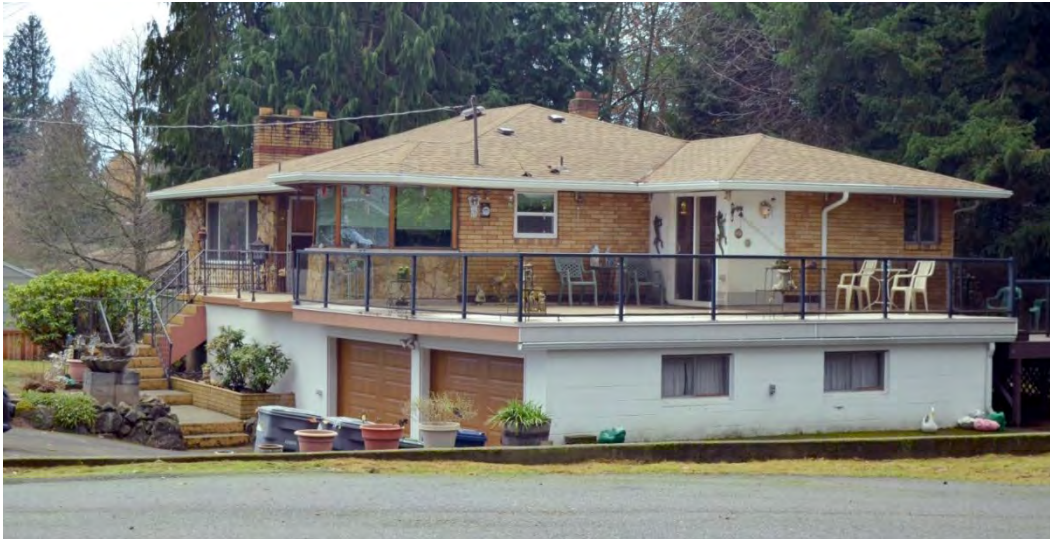
The building is a split-level ranch home with a hipped roof (**Figure 6-13**). The garage forms the base for a large deck that extends off the north side and wraps around to the front of the residence. The primary entrance is perpendicular to the primary façade and is accessed by an L-shaped set of concrete steps with a metal railing. The house has an octagonal room that protrudes from the northeast corner of the residence. Fenestration consists of aluminum-framed picture windows, rectangular panes, and sliding doors. Cladding is a mix of stone, brick veneer, and vertical board. The building does not appear to have been altered since the 2005 survey and evaluation.

Figure 6-13 14839 4th Avenue S, Burien; view to the southwest

The property was evaluated in 2005 and recommended eligible for listing in the NRHP under Criterion C:

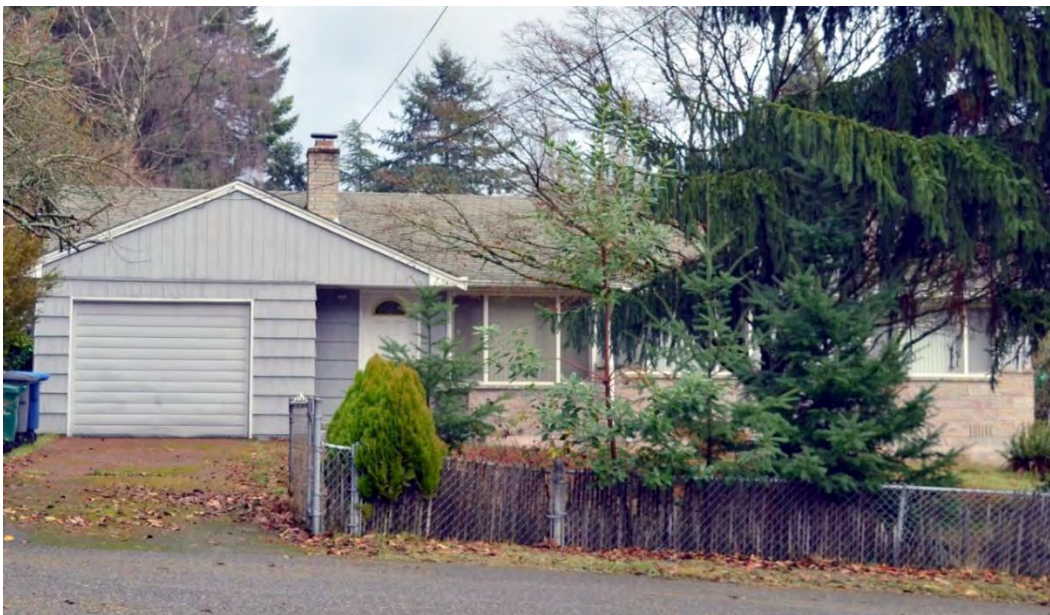
The building is a one-story ranch home with a cross-gabled roof and narrow eaves (**Figure 6-14**). It has a rectangular plan, with the garage in the base of the “L.” The primary entrance is located at the interior corner of the “L” and is flanked by a large picture pane on one side. The entry is under a corner porch created by the roof overhang, and the original door has been replaced with a paneled and partially glazed door. The cladding is stone veneer on the lower portion of the house (a 2005 survey and evaluation incorrectly described the cladding as brick veneer), which is likely a recent alteration, with asbestos shingle in the upper portion. The front gable over the garage is clad with vertical boards. The windows are aluminum sliding frames and have decorative brick sills. The building does not appear to have been altered since a 2005 survey and evaluation.

Figure 6-14 14832 4th Avenue S, Burien; view to the east

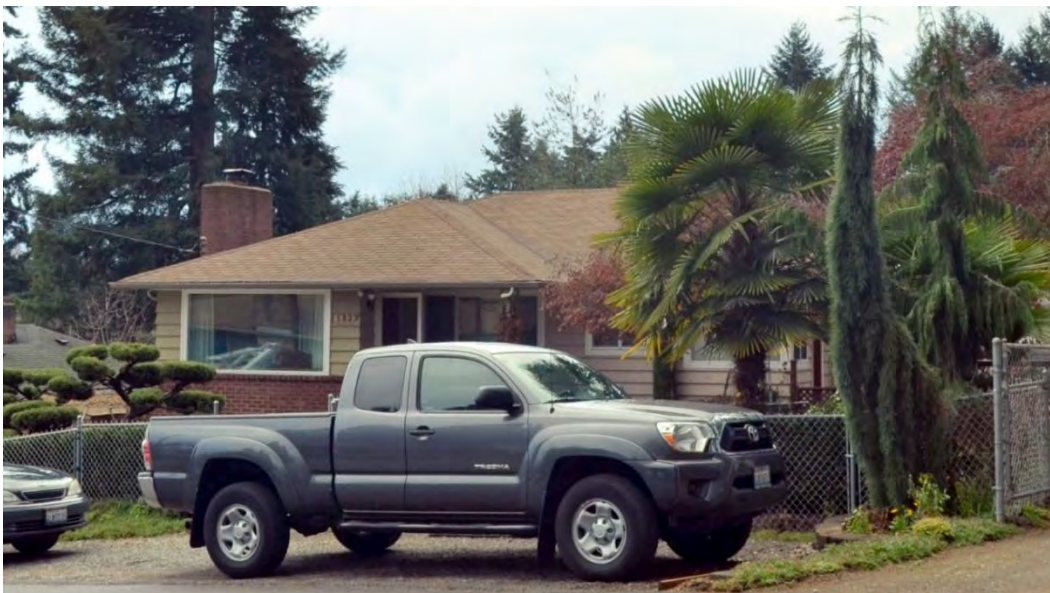
The building is a split-level ranch home with a rectangular plan and a cascading hipped roof (**Figure 6-15**). The primary entrance is located in the corner of the “L” under a recessed porch. One exterior brick chimney is located on the southern façade; a second brick chimney is in the northwest corner. Fenestration consists of replacement picture and sliding windows. Cladding is original wood clapboard and brick veneer. Some modification to cladding has occurred at the basement level. A single-car detached garage is located north of the building. The detached garage has a gabled roof and is clad in vertical wood siding.

Figure 6-15 14837 5th Avenue S, Burien; view to the southwest

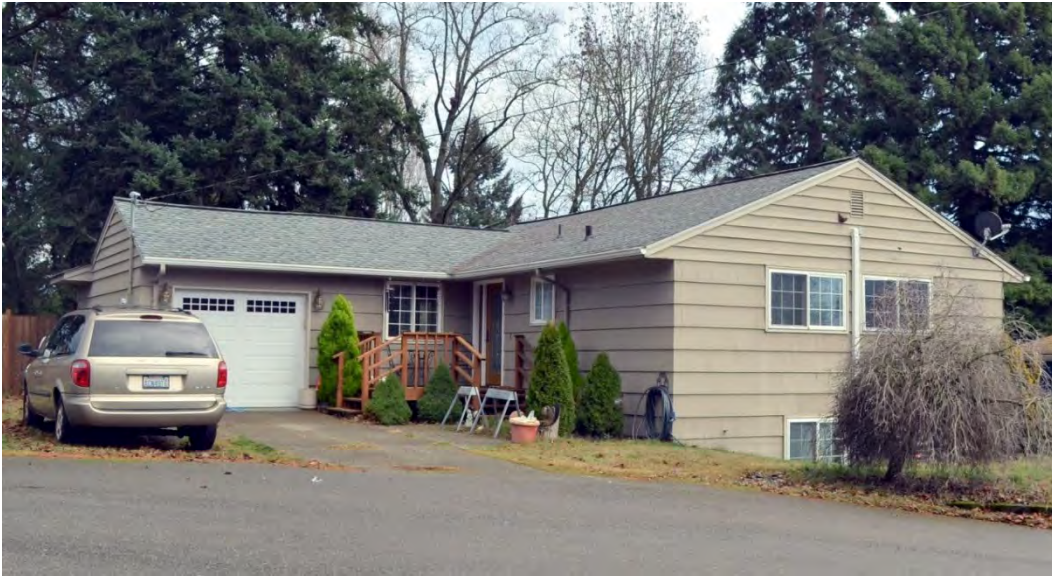
The building is a single-story, Ranch-style home with an "L"-shaped plan and cross-gabled roof (**Figure 6-16**). The primary entrance is located in the interior corner of the "L." The single-car garage is located in the base of the "L." Windows have been replaced throughout; window openings have been enlarged and another has been added to the basement level of the primary façade. The building is clad in asbestos shingle with wood clapboard in the gable. The building does not appear to have been altered since the 2005 survey and evaluation.

Figure 6-16 14838 5th Avenue S, Burien; view to the southeast

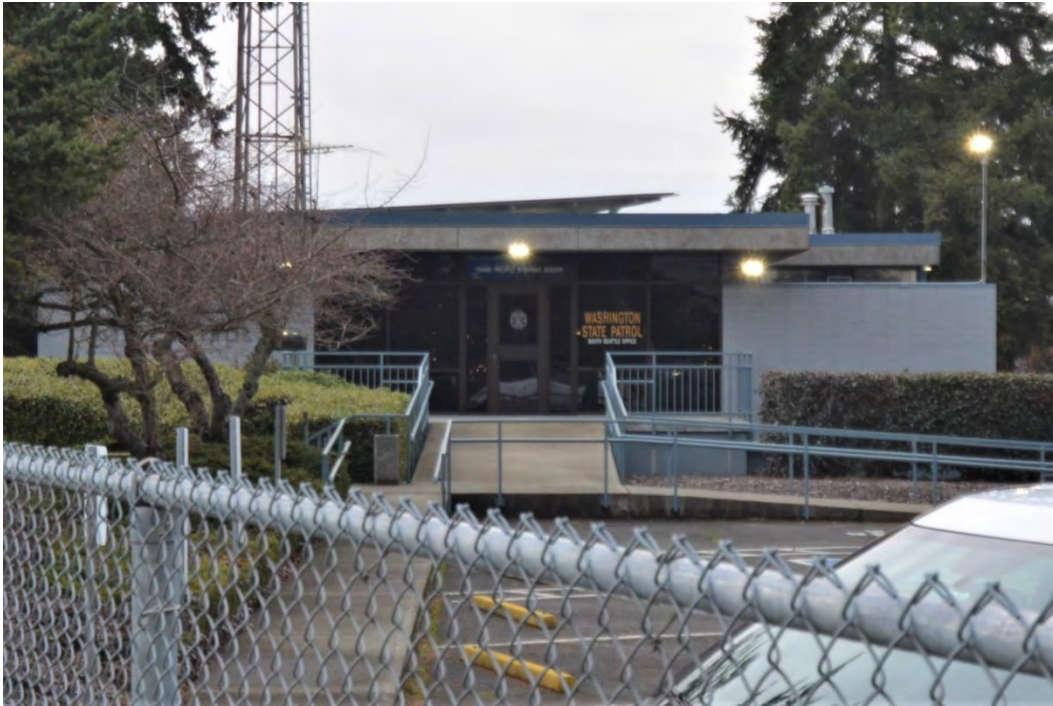
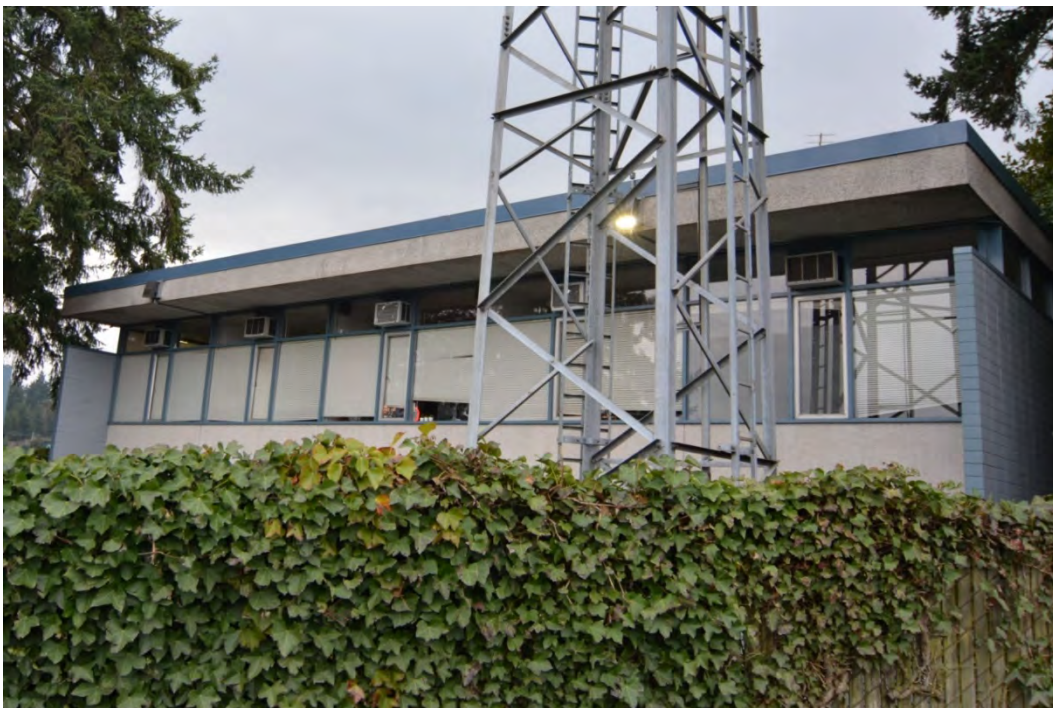
The one-story-over-basement building is T-shaped in plan with two enclosed courtyards on the southwest and southeast corners, creating a rectangular footprint measuring 51 by 53 feet (**Figure 6-17** and **Figure 6-18**). The primary façade faces southwest. The flat roof is cantilevered over the central portion of the primary façade, and the two courtyards that are enclosed by SCR brick walls in a stack bond do not have roofs. The primary façade of the building is comprised of a series of tall plate-glass windows with transoms; a single glazed pedestrian door is located in the center. The two side façades are clad in SCR brick in a stack bond, and clerestory windows are located below the roofline. The rear façade faces northeast, and the first floor is entirely glazed with a continuous series of fixed and sash windows and transoms.

The building appears to have undergone few alterations. When originally constructed in 1967, the primary façade featured a pair of glazed doors; these were replaced with a single glazed door at an unknown date.

Figure 6-17 15700 International Boulevard, Tukwila; view to the northeast

Figure 6-18 15700 International Boulevard, Tukwila; view to the southeast

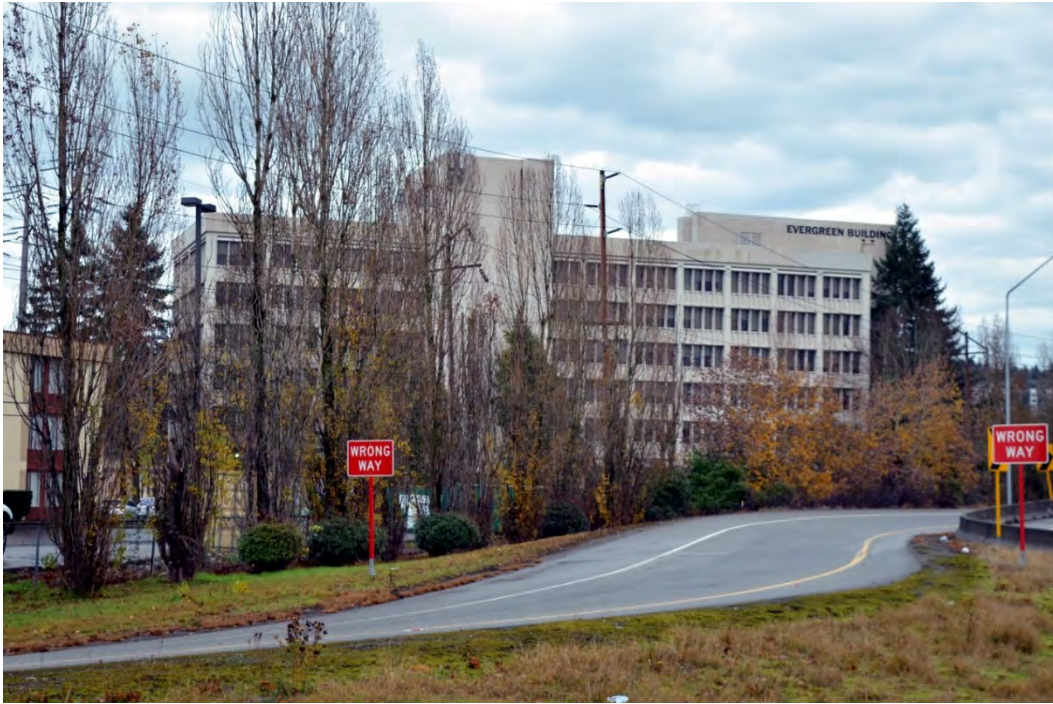
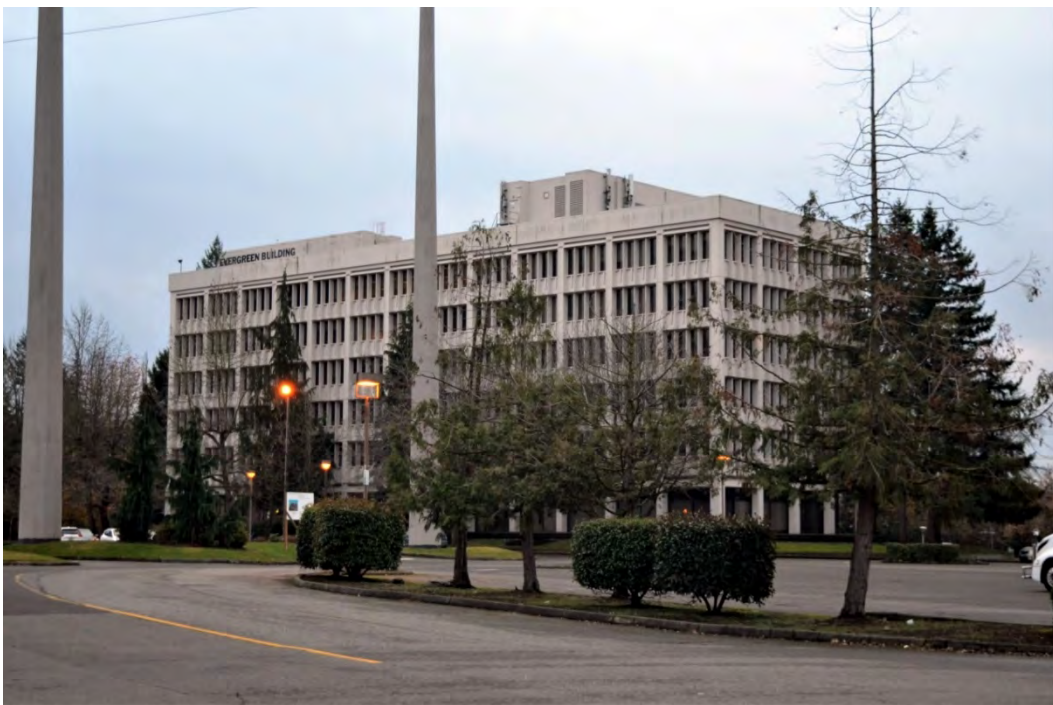
The six-story-over-basement commercial building features an irregular plan and has a footprint with maximum dimensions measuring 230 by 80 feet (**Figure 6-19** and **Figure 6-20**). It is clad primarily in concrete. The primary façade faces northeast toward a parking lot, and the recessed entrance composed of a pair of glazed pedestrian doors and fixed windows and transoms is accessed by concrete stairs. The façade is composed of 11 structural bays, each with fixed windows at each floor. The two side façades are composed of four structural bays, each with four fixed windows at each floor. Vertical circulation on the southeast façade is located in an enclosed stairwell that extends from the basement level to the sixth floor. The rear façade faces southwest and is composed of 11 structural bays, each with fixed windows at each floor. The four northernmost bays are separated from the other seven bays by a windowless vertical circulation feature that contains a combination stairwell/elevator shaft/lounge area that extends from the basement to the roof. The building is capped by a flat roof.

Figure 6-19 15 S Grady Way, Renton; view to the east

Figure 6-20 15 S Grady Way, Renton; view to the southwest

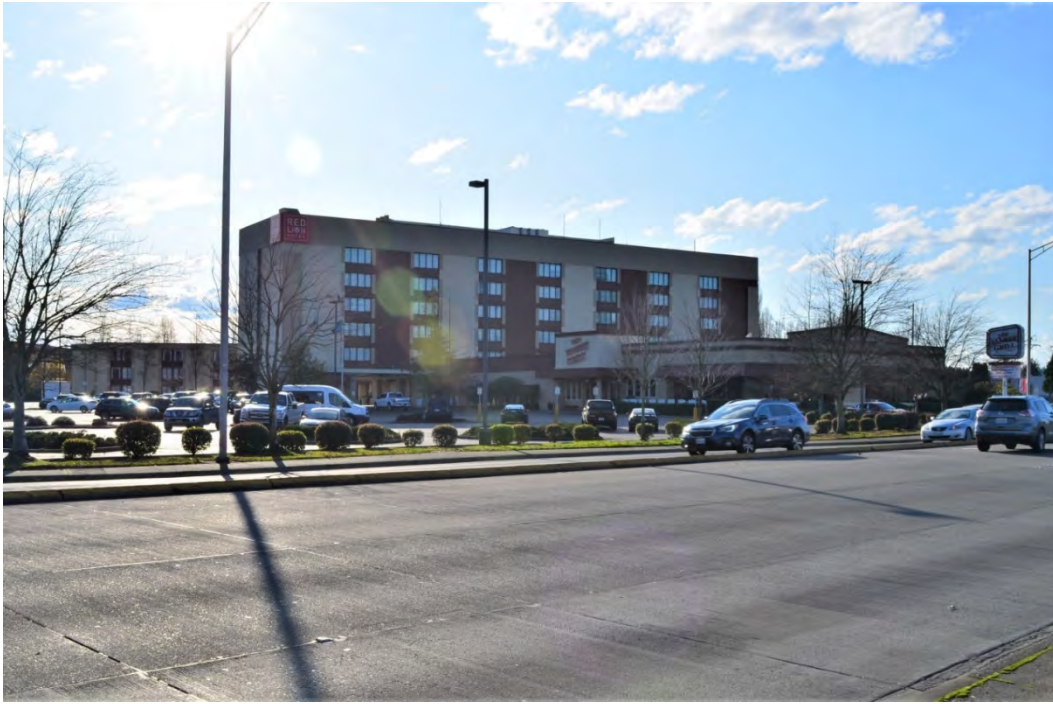
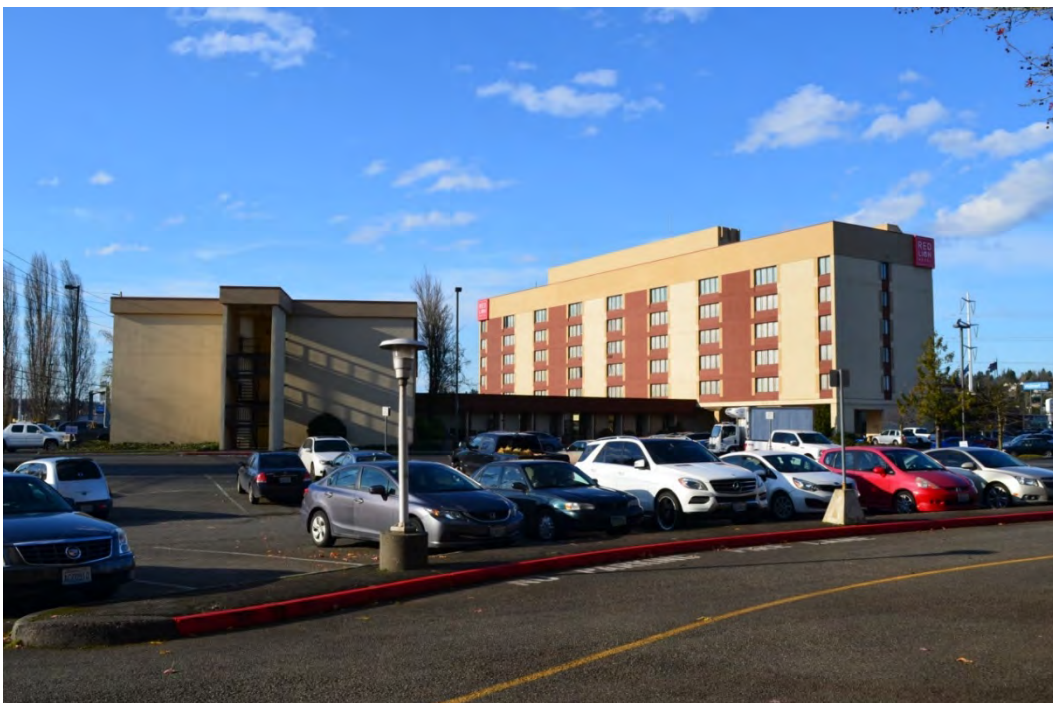
This property consists of a complex of three buildings attached by a covered walkway (**Figure 6-21** and **Figure 6-22**). The Central Building (Structure C) is six stories high, rectangular in plan with a flat roof. It is connected to the three-story, rectangular South Building (Structure A) with a flat roof and enclosed stairwells on the east and west by a fully enclosed arcade (Structure B). These two buildings converge toward one another forming a triangular plan with a central courtyard dominated by a swimming pool. The northern building (Structure C) extends east forming a covered driveway supported by six rectangular concrete piers. The third building (Structure D) is a one-story wing projecting north. The projecting north wing has a recessed covered entrance on the east supported by one concrete column, a flat roof with a parapet, and a projecting dropped awning on the east, north, and west elevations. The building does not appear to have been altered since the 2006 survey and evaluation.

Figure 6-21 1 S Grady Way, Renton; view to the southwest

Figure 6-22 1 S Grady Way, Renton; view to the northwest

Additional research has shown that the property has undergone numerous alterations. When originally constructed in 1965, the property consisted of the six-story Central Building and the restaurant. The three-story South Building and connecting arcade were additions constructed 1967. In 1980, the restaurant building was completely remodeled; the tiled Mansard roof was removed; exposed rafters were eliminated; and large metal awnings were added. In 1997, the partial sixth floor of the Central Building was demolished and replaced with a full sixth floor, which altered the roofline of the building, removing the Mansard roof and replacing it with a heavy entablature. Decorative rock cladding around the Central Building and restaurant were also removed at this time.

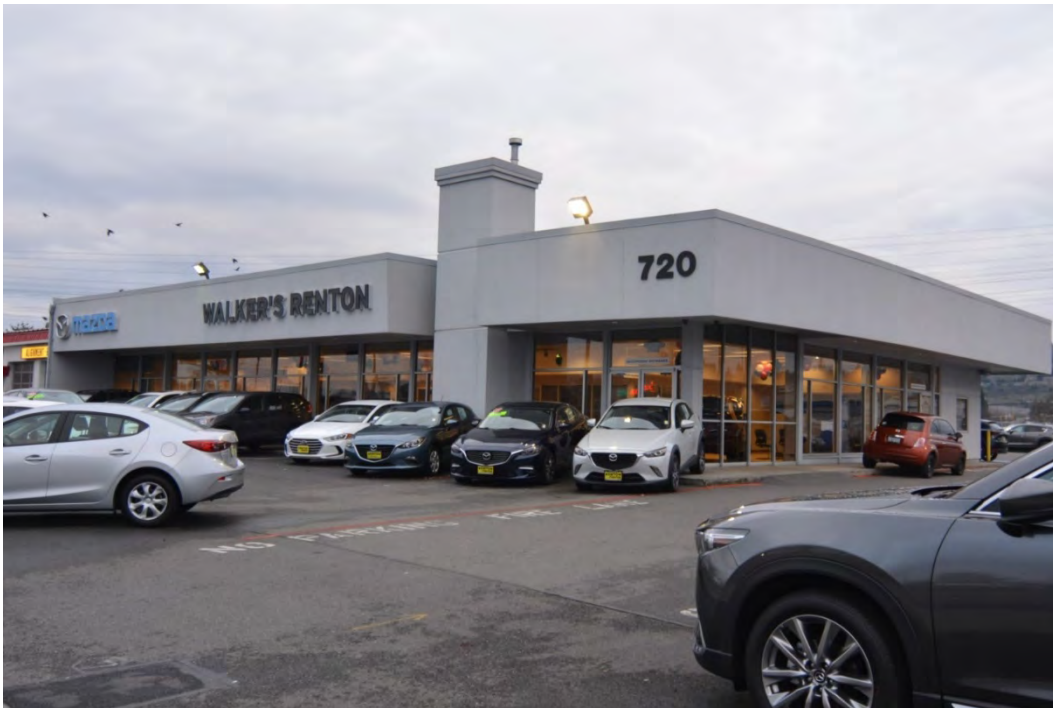
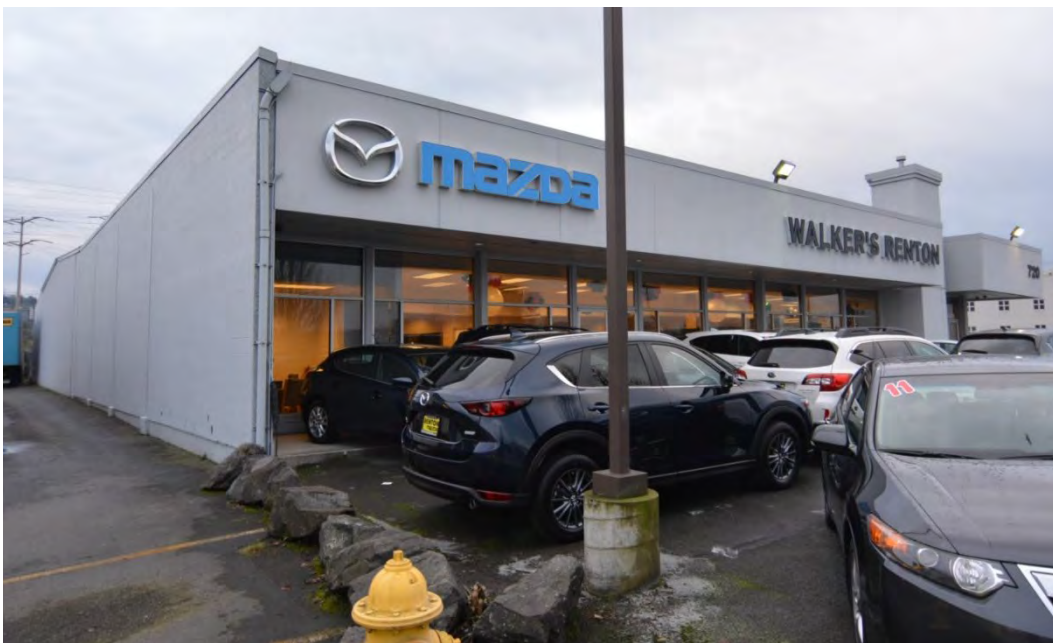
The building is rectangular in plan and has a footprint measuring 91 by 60 feet, with the shorter dimension parallel to 196th Street SW (**Figure 6-23** and **Figure 6-24**). The heavy entablature overhangs the western and southern façades of the building by 8 feet. The western and southern façades are comprised of a series of tall plate-glass windows with transoms. The western façade contains a slightly recessed concrete column, which mimics a large chimney. Two sets of double-glass doors are also located on the western façade.

The building has been altered since its 1965 construction; the materials and accents to the entablature were frequently changed. In 1972, a 25-by-30-foot canopy was constructed off of the western façade; it was removed between 2002 and 2006 (NetrOnline 2019). The faux-chimney was likely constructed in the 1990s; historic photos included in the property records do not show the feature in the 1980s; however, it is visible in 2004.

Figure 6-23 720 Rainier Avenue S, Renton; view to the northeast

Figure 6-24 720 Rainier Avenue S, Renton; view to the southeast

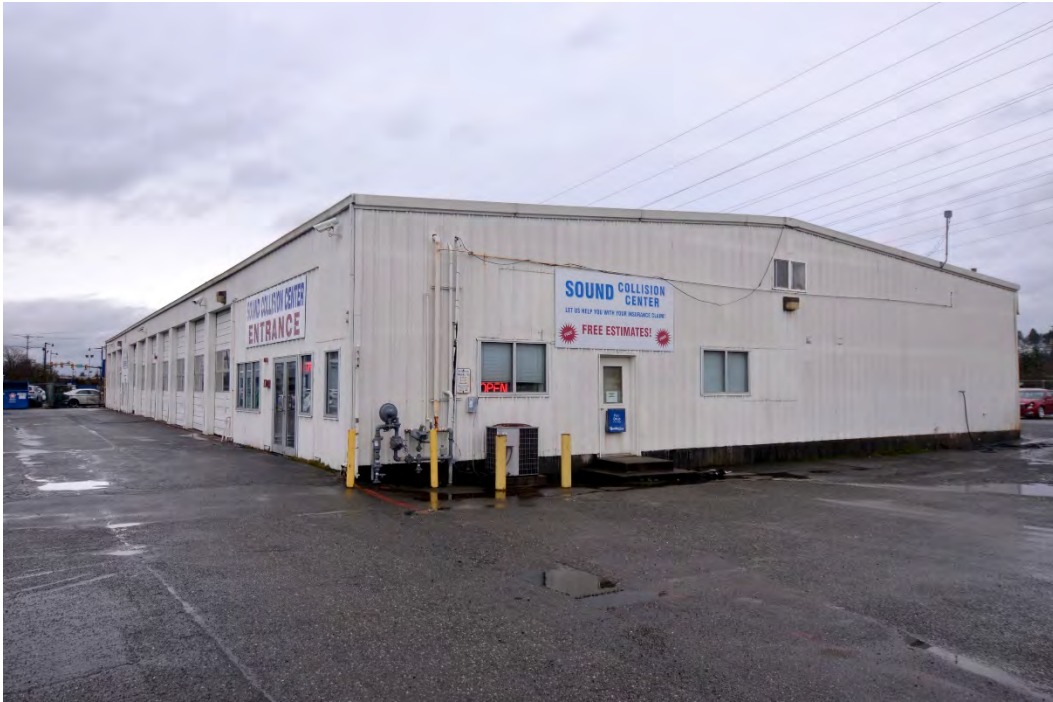
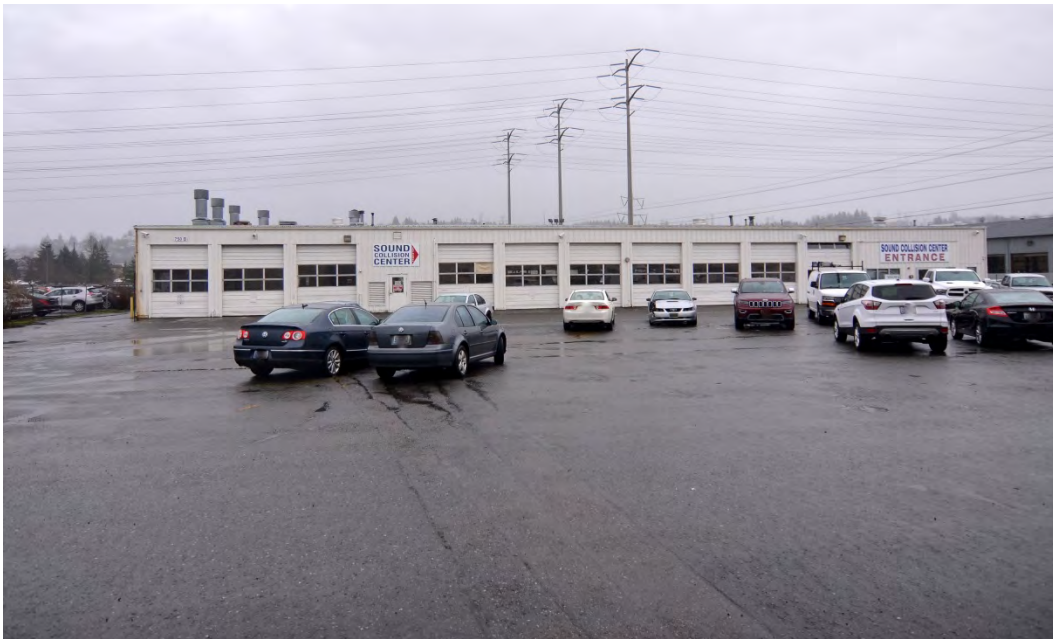
Building 2 at 720 Rainier Avenue S is directly behind building 1 which fronts Rainier Avenue S, located in Renton, King County (**Figure 6-25** and **Figure 6-26**). The one-story commercial building features an L-shaped plan and sits on a concrete foundation. It is of galvanized steel construction, clad in corrugated steel siding, and capped by a gabled roof covered with corrugated metal. The primary (west) façade is composed of 12 structural bays, which include 10 vehicular doors and two pedestrian doors. The rear (east) elevation features eight vehicular doors, one pedestrian door, and a paint shop. The only known alteration is the addition of the paint shop on the east elevation in ca. 2001.

Figure 6-25 720 Rainier Avenue S – Building 2, Renton; view to the northeast

Figure 6-26 720 Rainier Avenue S – Building 2, Renton; view to the east

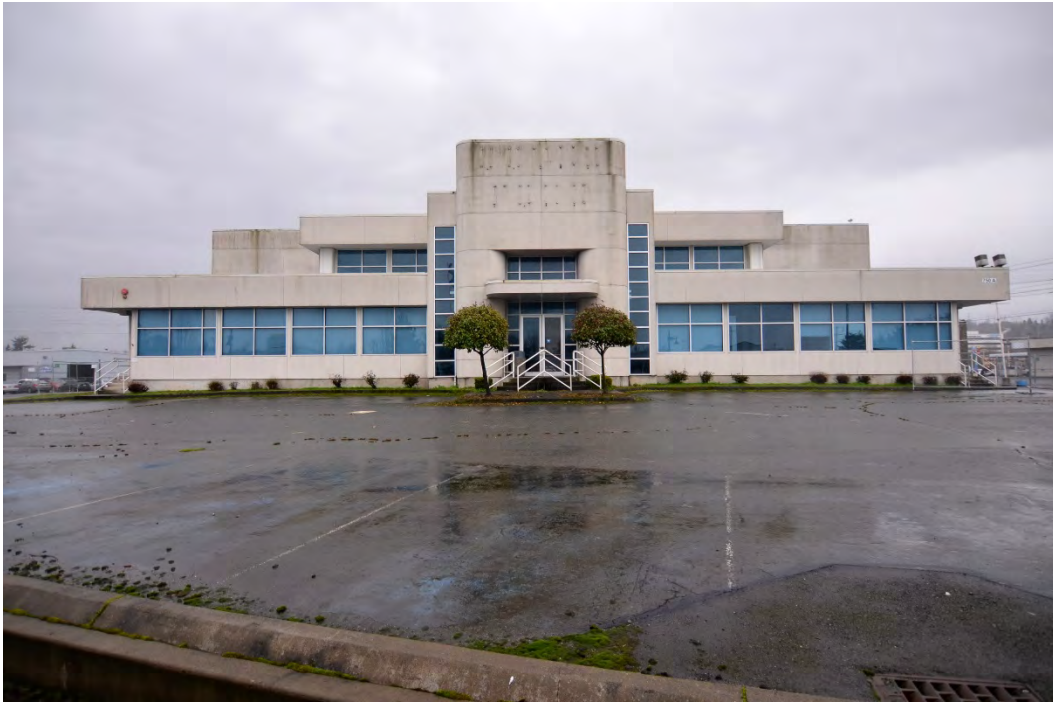
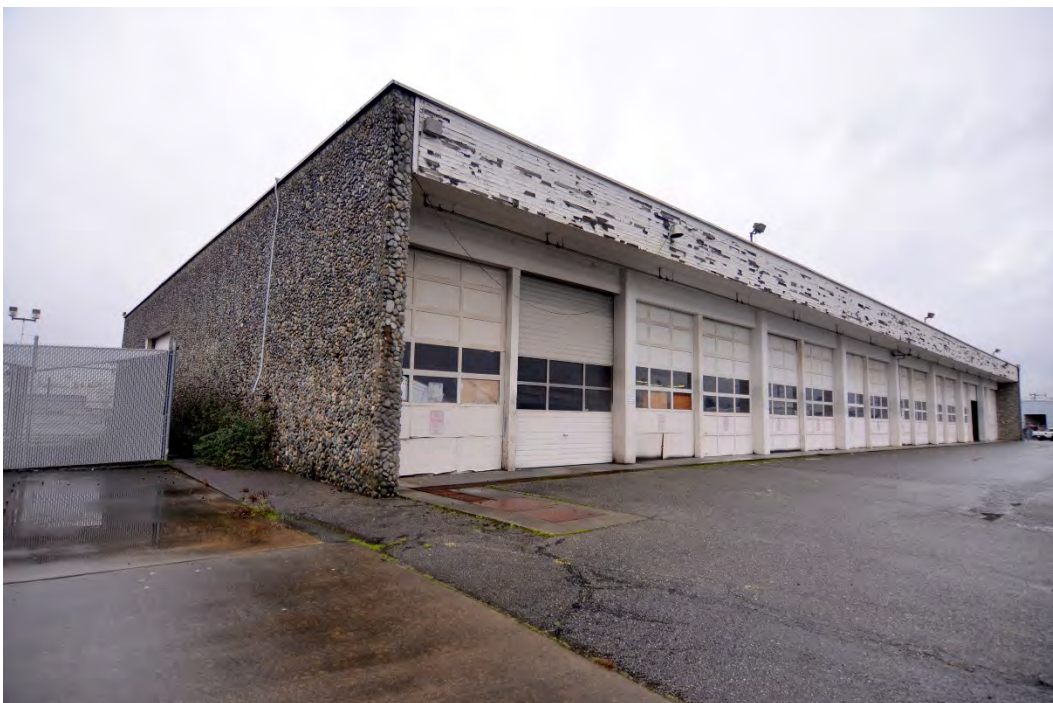
The building at 750 Rainier Avenue S. is located in Renton, King County (**Figure 6-27** and **Figure 6-28**). The two-story commercial building features an irregular plan and sits on a concrete foundation. The eastern half of the building (i.e., the original 1968 building) is constructed of tilt-up concrete walls, and the entire building is capped by a series of flat, built-up roofs. The primary (west) façade is clad in smooth, scored concrete and features fixed, aluminum-frame windows. The main entrance is centered on the façade and includes a pair of glazed aluminum-frame doors. The western portions of the north and south elevations are also clad in concrete, and the remainder of the building is clad in pebble dash, which is original to the 1968 design. The rear (east) elevation is composed of 16 structural bays, each with a vehicular door.

Figure 6-27 750 Rainier Avenue S, Renton; view to the east

Figure 6-28 750 Rainier Avenue S, Renton; view to the view to the northwest

Exterior alterations believed to have been made to the subject building in ca. 1991 were extensive, and the building no longer reflects its original Mid-Century Modern-style design. On the west (front) half of the building, the pebble dash cladding was replaced with smooth concrete; the original fenestration was removed and the fenestration pattern changed; and the massing, footprint, and roof forms were altered. The primary (west) façade was essentially redesigned in a faux-Streamline Moderne style.

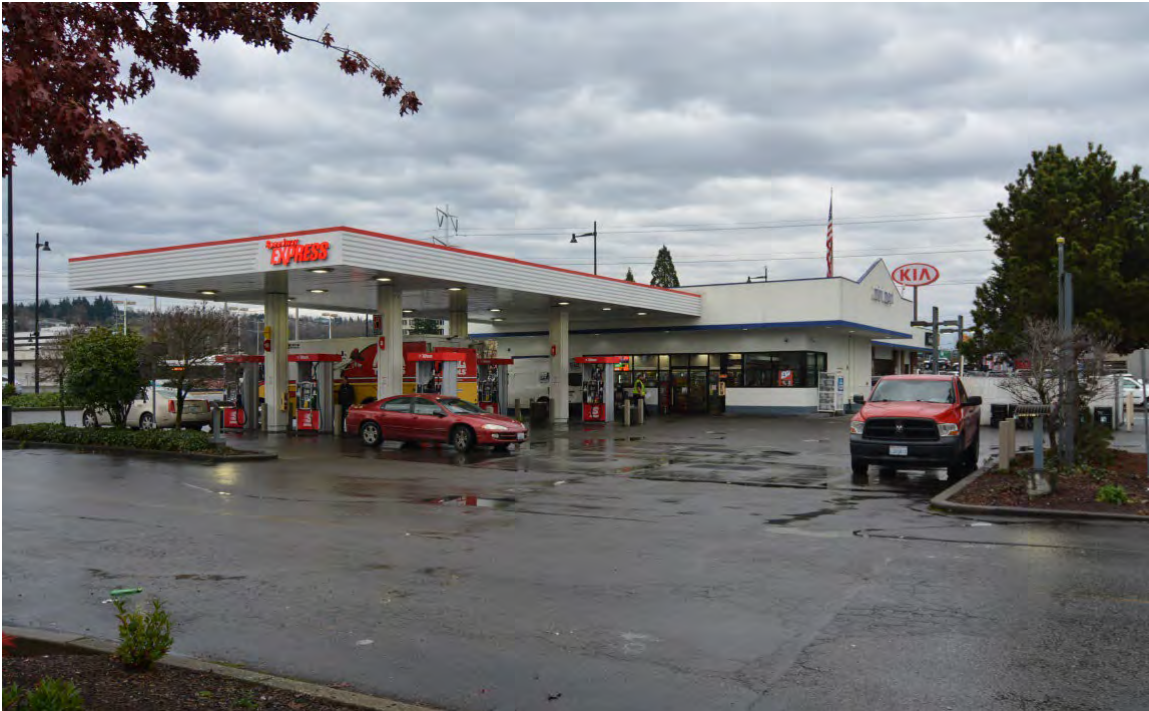
The building has a rectangular plan, measuring approximately 135 by 50 feet, with the longer dimension parallel to Rainier Avenue S; a small portion on the northern end of the western façade bumps out by approximately 8 feet (**Figure 6-29** and **Figure 6-30**). The roof is flat with gabled parapets on the eastern and western façades of the northern end. An awning covering two gas pump islands extends to the north and measures approximately 70 by 35 feet. The northern façade is comprised of a series of plate-glass windows and the double-glass doors that provide access to the convenience shop. The southern half of the building's western façade features three auto repair bays divided by brick columns, with an office on the southern end. The entrance to the auto repair office is located at the southern corner and features double-glass doors. The eastern and southern façades are clad in concrete blocks with geometric patterns.

According to the county assessor, the building was remodeled in 1985 (Artifacts Consulting 2011). An addition was constructed on the west façade in ca. 1990-98, according to review of historic aerial photographs. The roofline was likely altered at this time to its current appearance.

Figure 6-29 765 Rainier Avenue S, Renton; view to the southeast

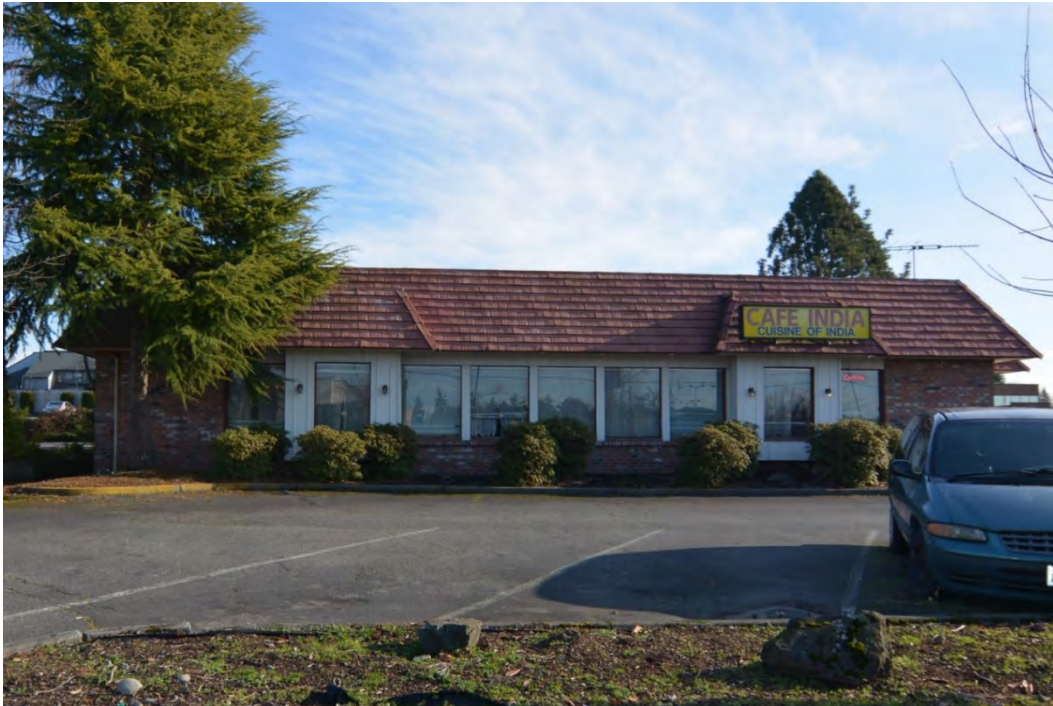
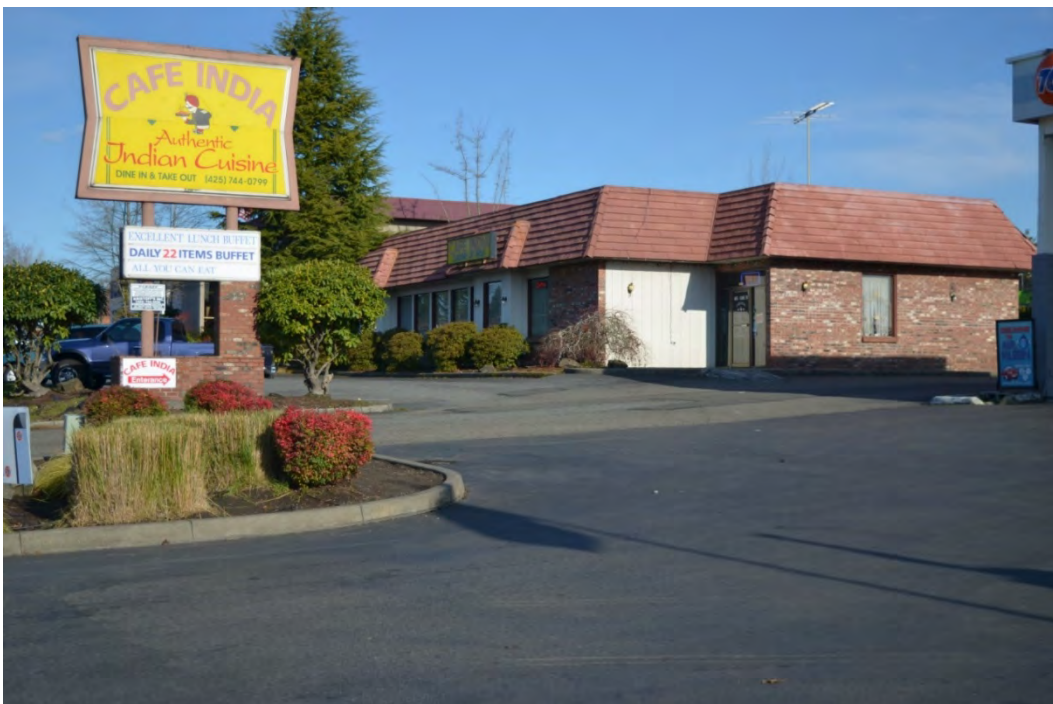
The building is essentially rectangular in plan, measuring 79 by 40 feet, with the longer dimension parallel to 44th Avenue W (**Figure 6-31** and **Figure 6-32**). The single-story building has a recessed area at the southwest corner, where the primary entrance is located, and a small bump out in the rear, northeast corner. The faux-mansard roof is covered with metal tiles. The entrance consists of a single-glass personnel door, flanked by tall panes of plate glass, and a transom window. Nine large, fixed windows are located on the primary façade. Cladding is a combination of brick and board and batten siding.

Figure 6-31 19817 44th Avenue W, Lynnwood; view to the east

Figure 6-32 19817 44th Avenue W, Lynnwood; view to the northeast
