Bus Rapid Transit

I-405 corridor

Historic and Archaeological Resources Technical Memorandum

September 2020

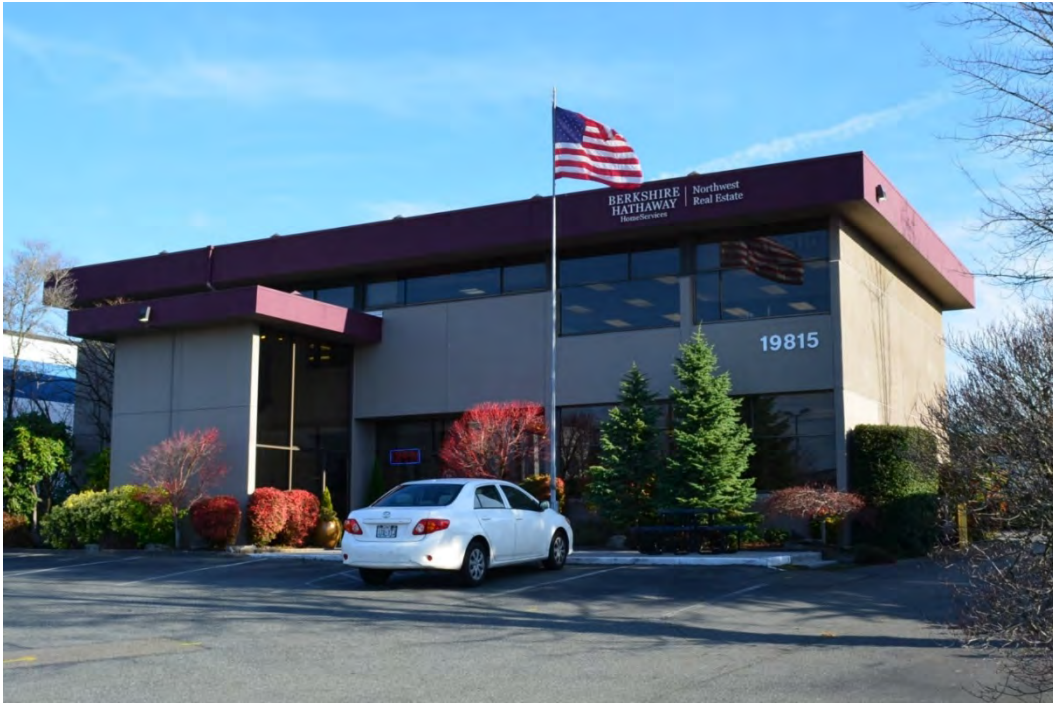
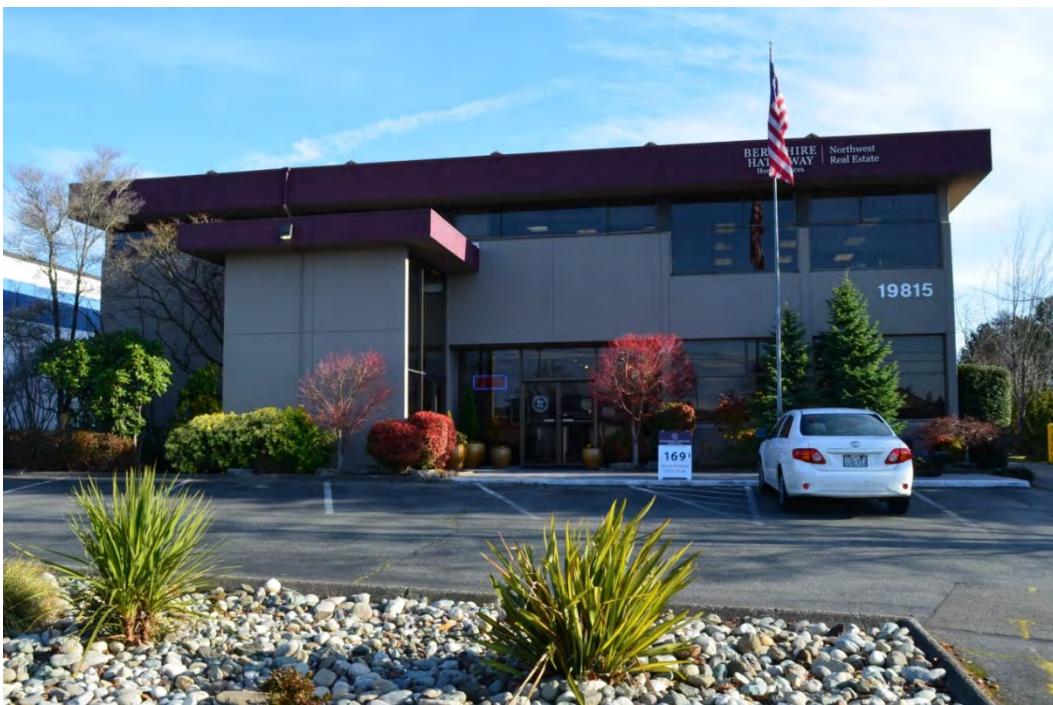
The two-story commercial building is T-shaped in plan and measures approximately 5,000 square feet (**Figure 6-33** and **Figure 6-34**). The primary façade faces west and is parallel to 44th Avenue W. The building is capped by a flat roof with a prominent fascia board, which overhangs on all sides. The primary entrance is composed of a pair of glazed doors near the center of the primary façade. Fixed, aluminum-frame windows are located on both floors. The two side façades feature no fenestration. The rear façade faces east toward a parking lot.

Figure 6-33 19815 44th Avenue W, Lynnwood; view to the northeast

Figure 6-34 19815 44th Avenue W, Lynnwood; view to the east

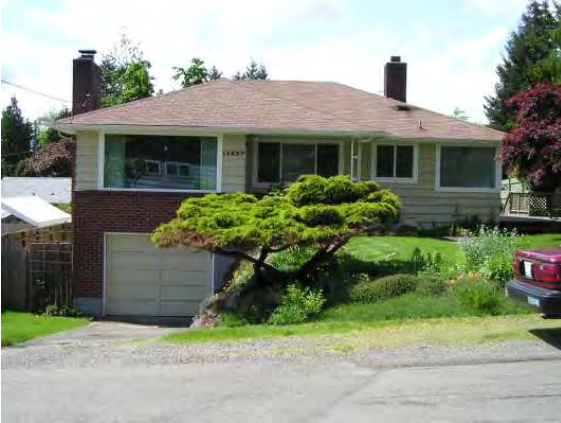
east elevation

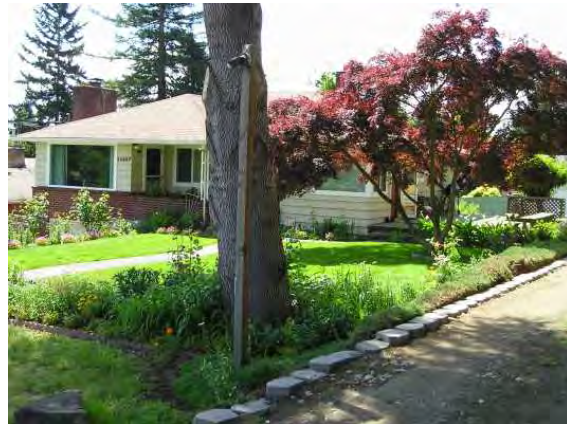
NE corner

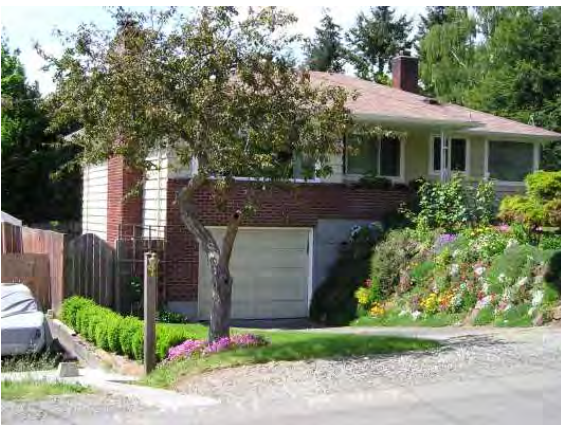
SE corner

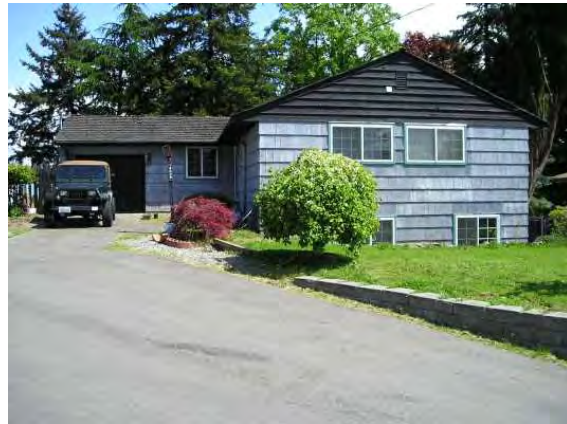
west elevation

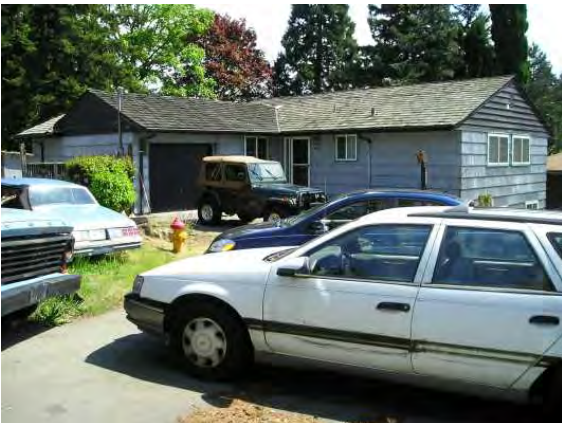
NW corner

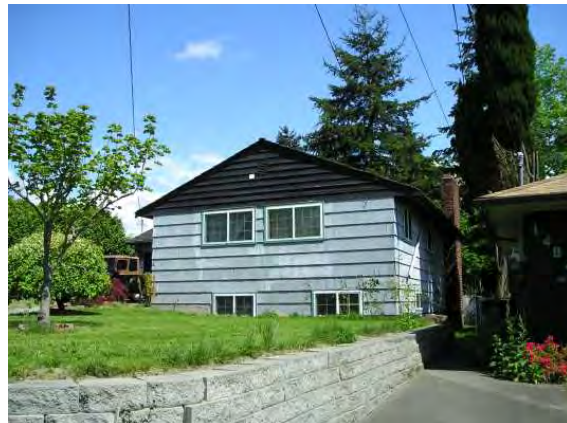
SW corner

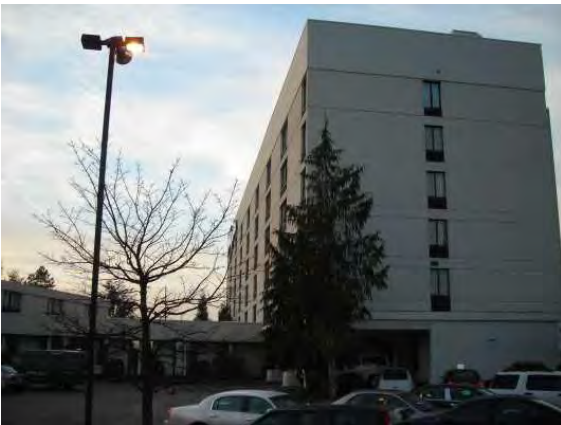
North Building-Center (Structure C)

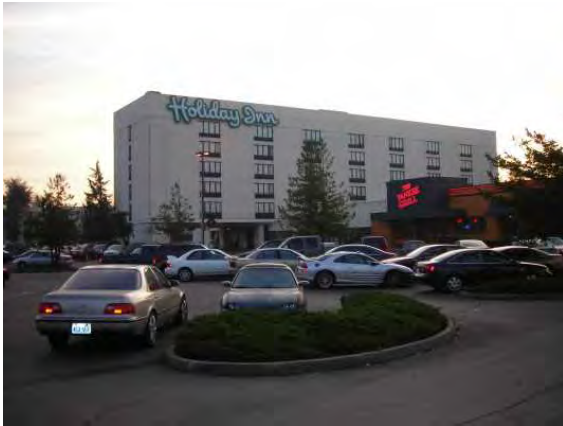
North and East Elevation

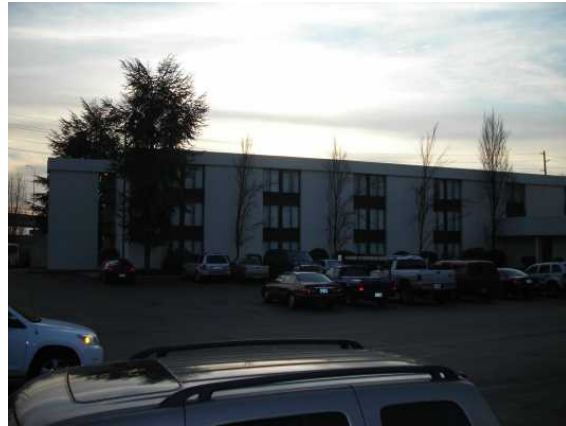
South Building-Far Left

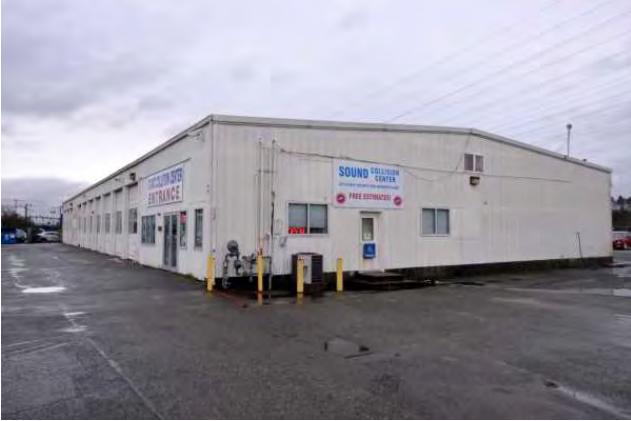
720 Rainier Ave S_Bldg 2__2020_NE.JPG

Physical description: Building 2 at 720 Rainier Avenue S is directly behind building 1 which fronts Rainier Avenue S, located in Renton, King County . The one-story commercial building features an L-shaped plan and sits on a concrete foundation. It is of galvanized steel construction, clad in corrugated steel siding, and capped by a gabled roof covered with corrugated metal. The primary (west) façade is composed of 12 structural bays, which include 10 vehicular doors and two pedestrian doors. The rear (east) elevation features eight vehicular doors, one pedestrian door, and a paint shop. The only known alteration is the addition of the paint shop on the east elevation in ca. 2001.

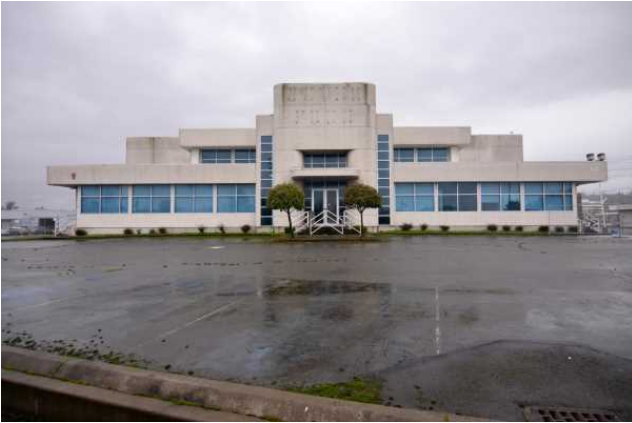
750 Rainier Ave S_2020_E.JPG.jpg

The building at 750 Rainier Avenue S. is located in Renton, King County. The two-story commercial building features an irregular plan and sits on a concrete foundation. The eastern half of the building (i.e., the original 1968 building) is constructed of tilt-up concrete walls, and the entire building is capped by a series of flat, built-up roofs. The primary (west) façade is clad in smooth, scored concrete and features fixed, aluminum-frame windows. The main entrance is centered on the façade and includes a pair of glazed aluminum-frame doors. The western portions of the north and south elevations are also clad in concrete, and the remainder of the building is clad in pebble dash, which is original to the 1968 design. The rear (east) elevation is composed of 16 structural bays, each with a vehicular door.

Exterior alterations believed to have been made to the subject building in ca. 1991 were extensive, and the building no longer reflects its original Mid-Century Modern-style design. On the west (front) half of the building, the pebble dash cladding was replaced with smooth concrete; the original fenestration was removed and the fenestration pattern changed; and the massing, footprint, and roof forms were altered. The primary (west) façade was essentially redesigned in a faux-Streamline Moderne style.
