**Environmental Assessment
and
Finding of No Significant Impact
for a
Debris-Containment Log Boom at Cochiti Lake,
Sandoval County, New Mexico**

U.S. Army Corps of Engineers
Albuquerque District
4101 Jefferson Plaza NE
Albuquerque, New Mexico 87109

August 2012

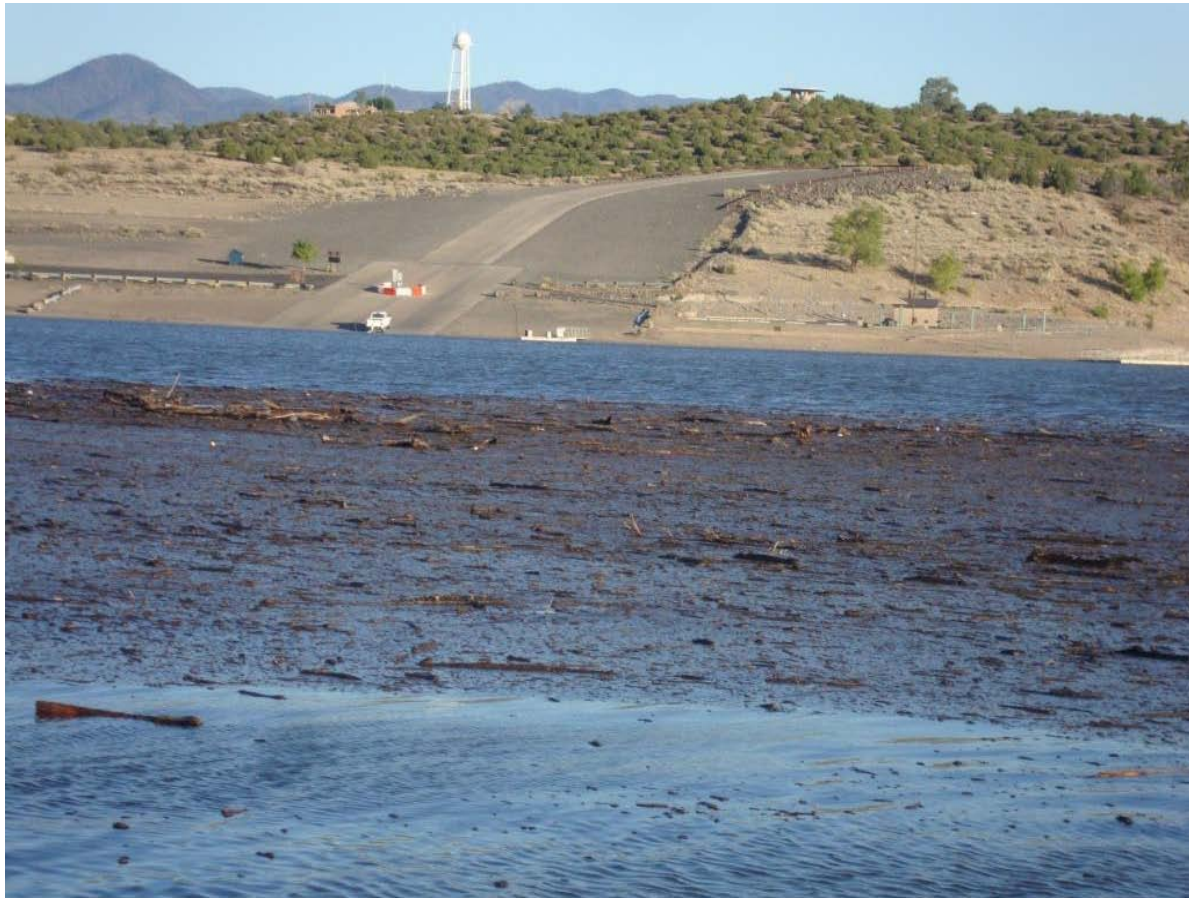
Figure 3: Debris and Debris Removal at Cochiti Lake, August 2011

a. Floating debris obstructing Tetilla Peak boat ramp

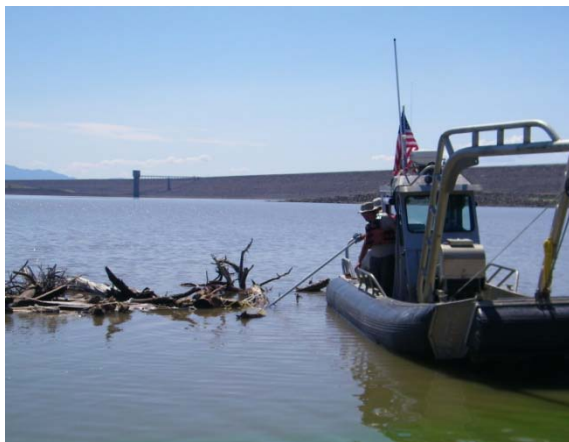
b. Towing debris to shore

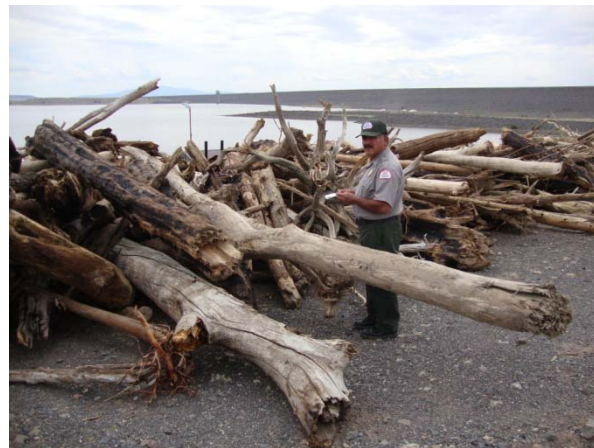
c. Stacked debris awaiting removal

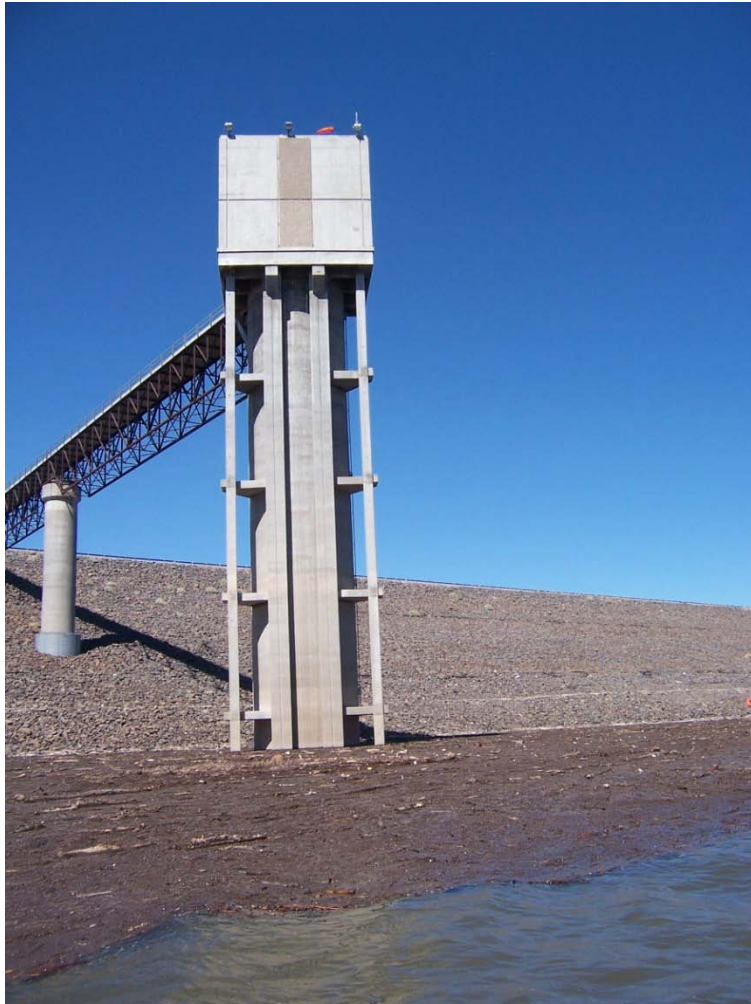
Figure 3, cont. Debris and Debris Removal at Cochiti Lake, August 2011

d. Cochiti Dam control tower. Outlet works below could be damaged if waterlogged debris enters.

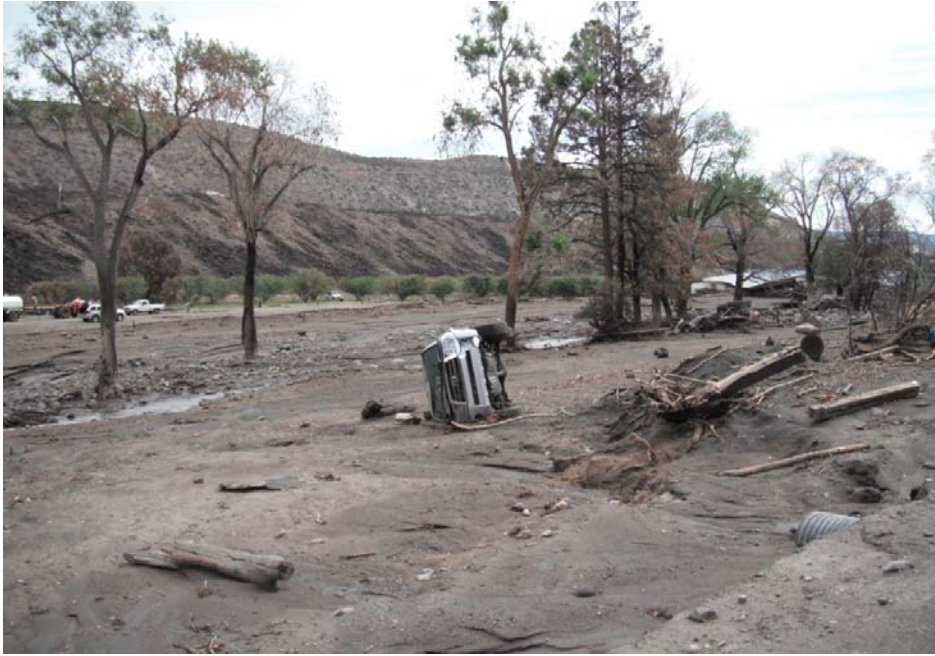
Figure 4: Post-fire flash flooding and debris flows, 2011

a. Aftermath of flooding in Cochiti Canyon at Dixon's Apple Orchard

The potential for destructive debris flows is a serious concern in the canyons upstream from Cochiti Lake. A debris flow is a mixture of water and solids (sediment, stones, boulders, timber) which flows downhill in channels. Debris flows have a high destructive potential, comparable with rockfall, avalanche and flood water, threatening the safety and property of people downstream. Post-fire debris flows occurred in several canyons during the fall of 2011. Examples of destructive post-fire flash floods and debris flows that occurred in 2011 include Cochiti Canyon, where Dixon's apple orchard was destroyed, and Medio Canyon (Figure 4).

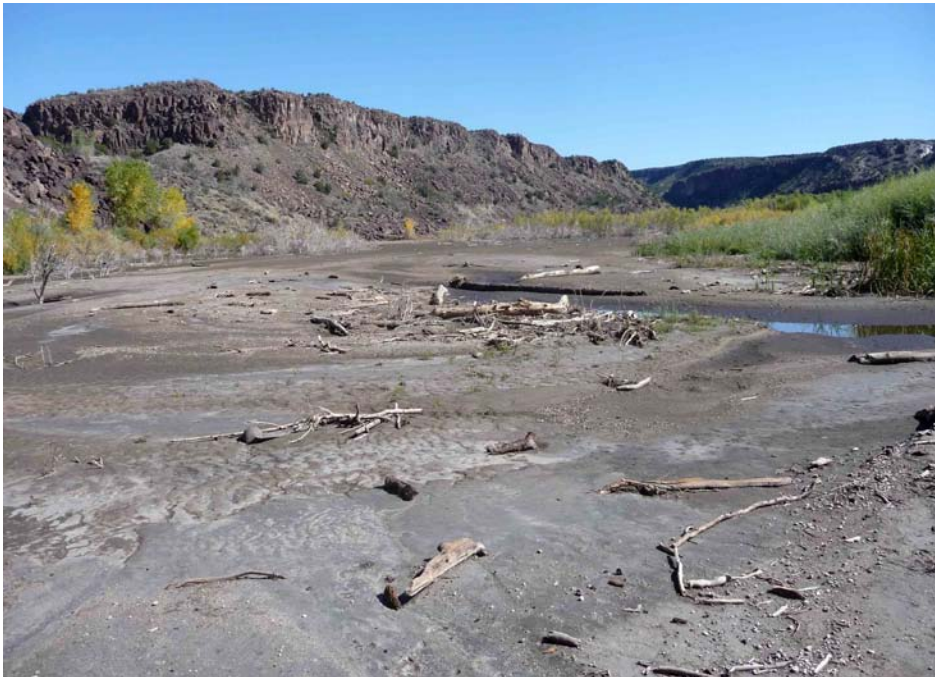
b. Debris Flow at the mouth of Medio Canyon, October 2011

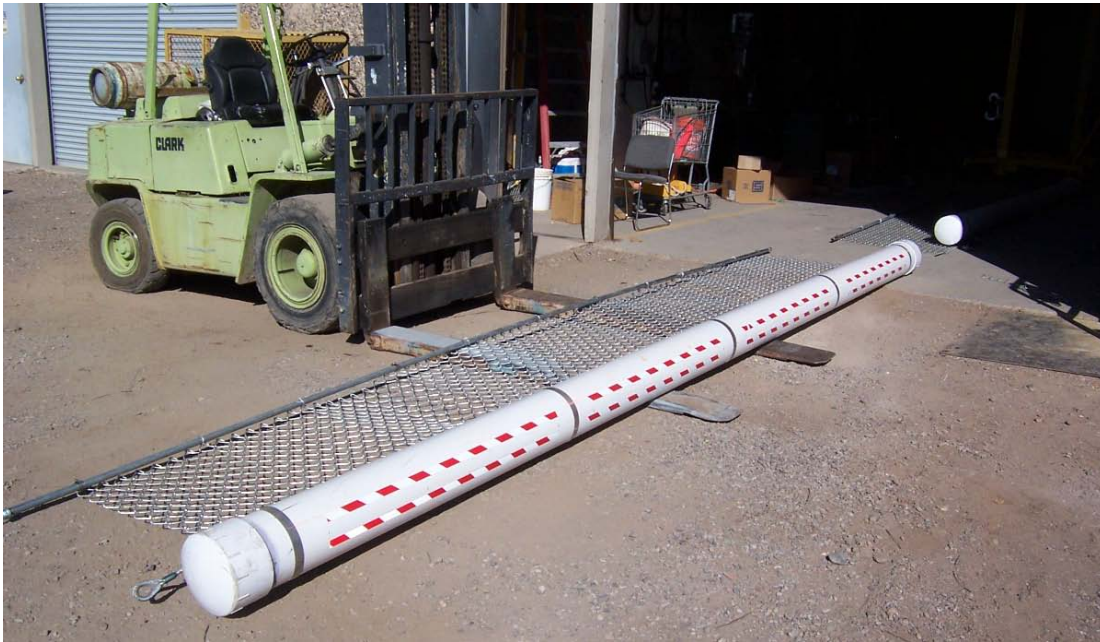
Figure 5: Log Boom Construction

a. Section of boom

The boom is constructed of 20-foot segments of 8" PVC pipe that are filled with flotation material and connected together with galvanized steel wire rope. It floats approximately 6" above the water line. Below the PVC pipe, sections of galvanized chain link are suspended to a depth of 3' to contain floating debris. The removable central segment of the boom curves downstream, forming a trap for debris, and will be detached and towed away to remove the debris. The boom is anchored with cable to the basalt cliffs on the left bank and boulders adjacent to the lake on the right bank. Anchor cables have been placed in low and high positions to accommodate changing water levels. Photos of the anchors are shown in Figure 5.

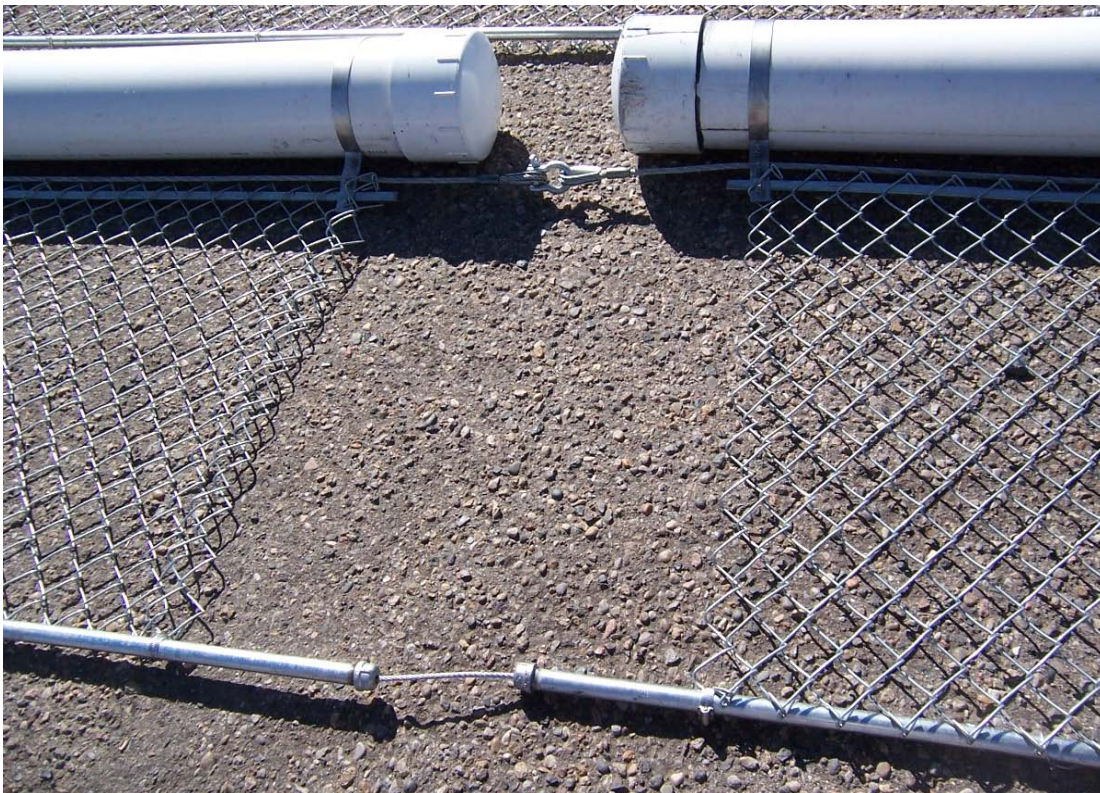
b. Connection between boom sections.

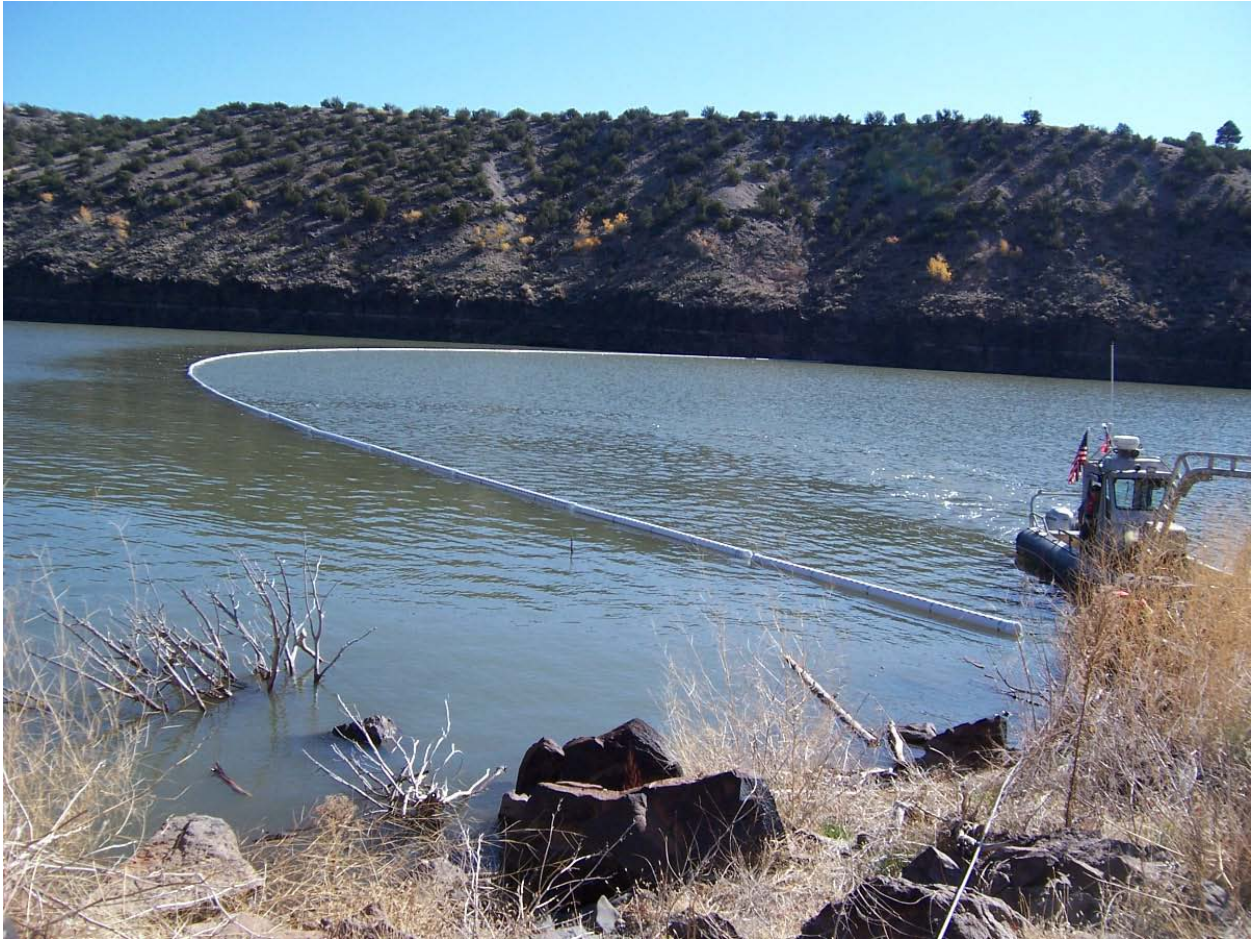
Figure 6: Log Boom Installation

a. Boom has been towed to site, ready to anchor to banks

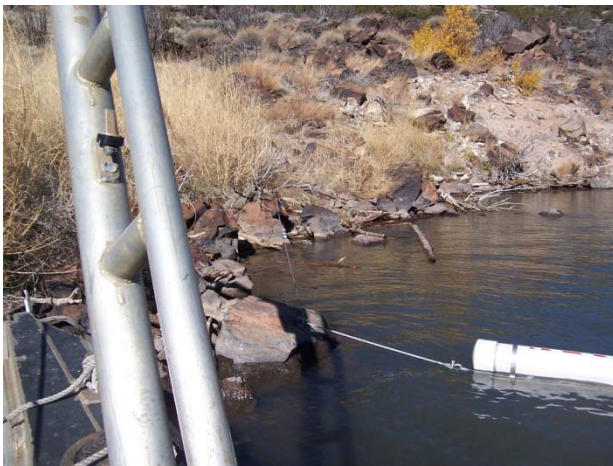
b. Right (west) bank anchor

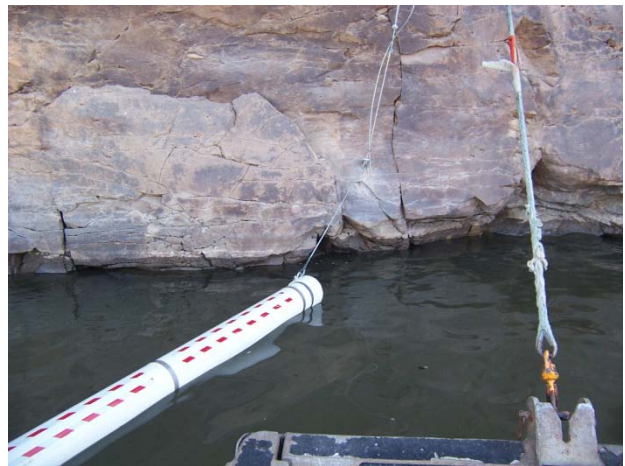
c. Left (east) bank anchor

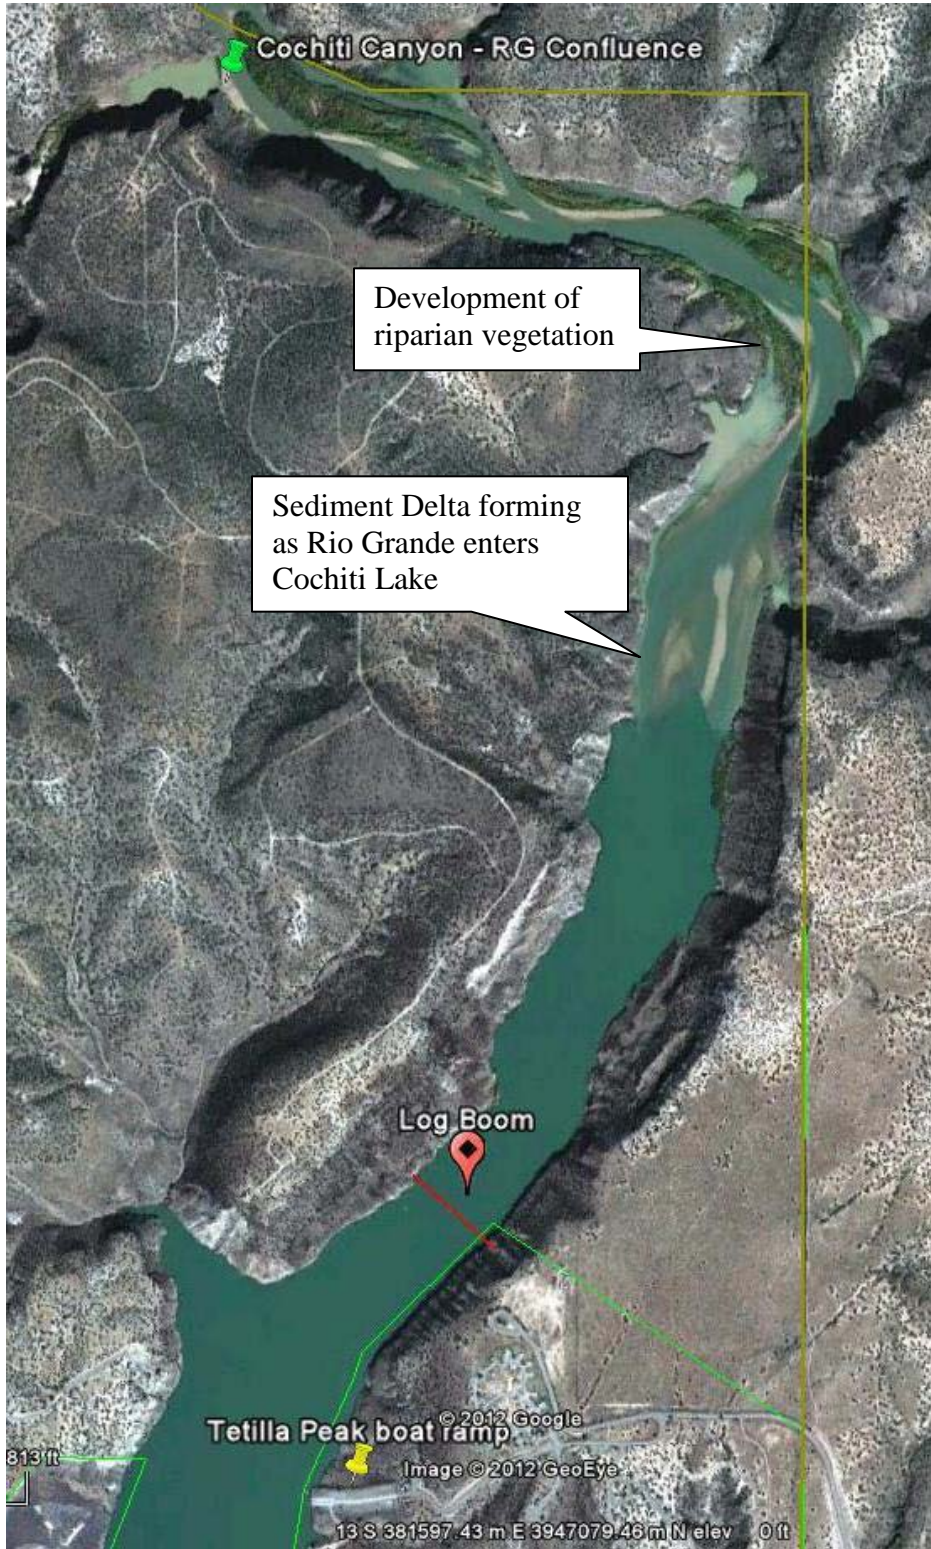
Figure 7: Lower White Rock Canyon and Upper Cochiti Lake, Showing Delta Formed by River Sediment Deposition and Development of Riparian Corridor
