CONSERVATION AREA MONITORING AND BIOMETRIC CONDITION ASSESSMENT

Southern Highlands Regional Shooting Complex
(Hill Top Conservation Area)

February 2022

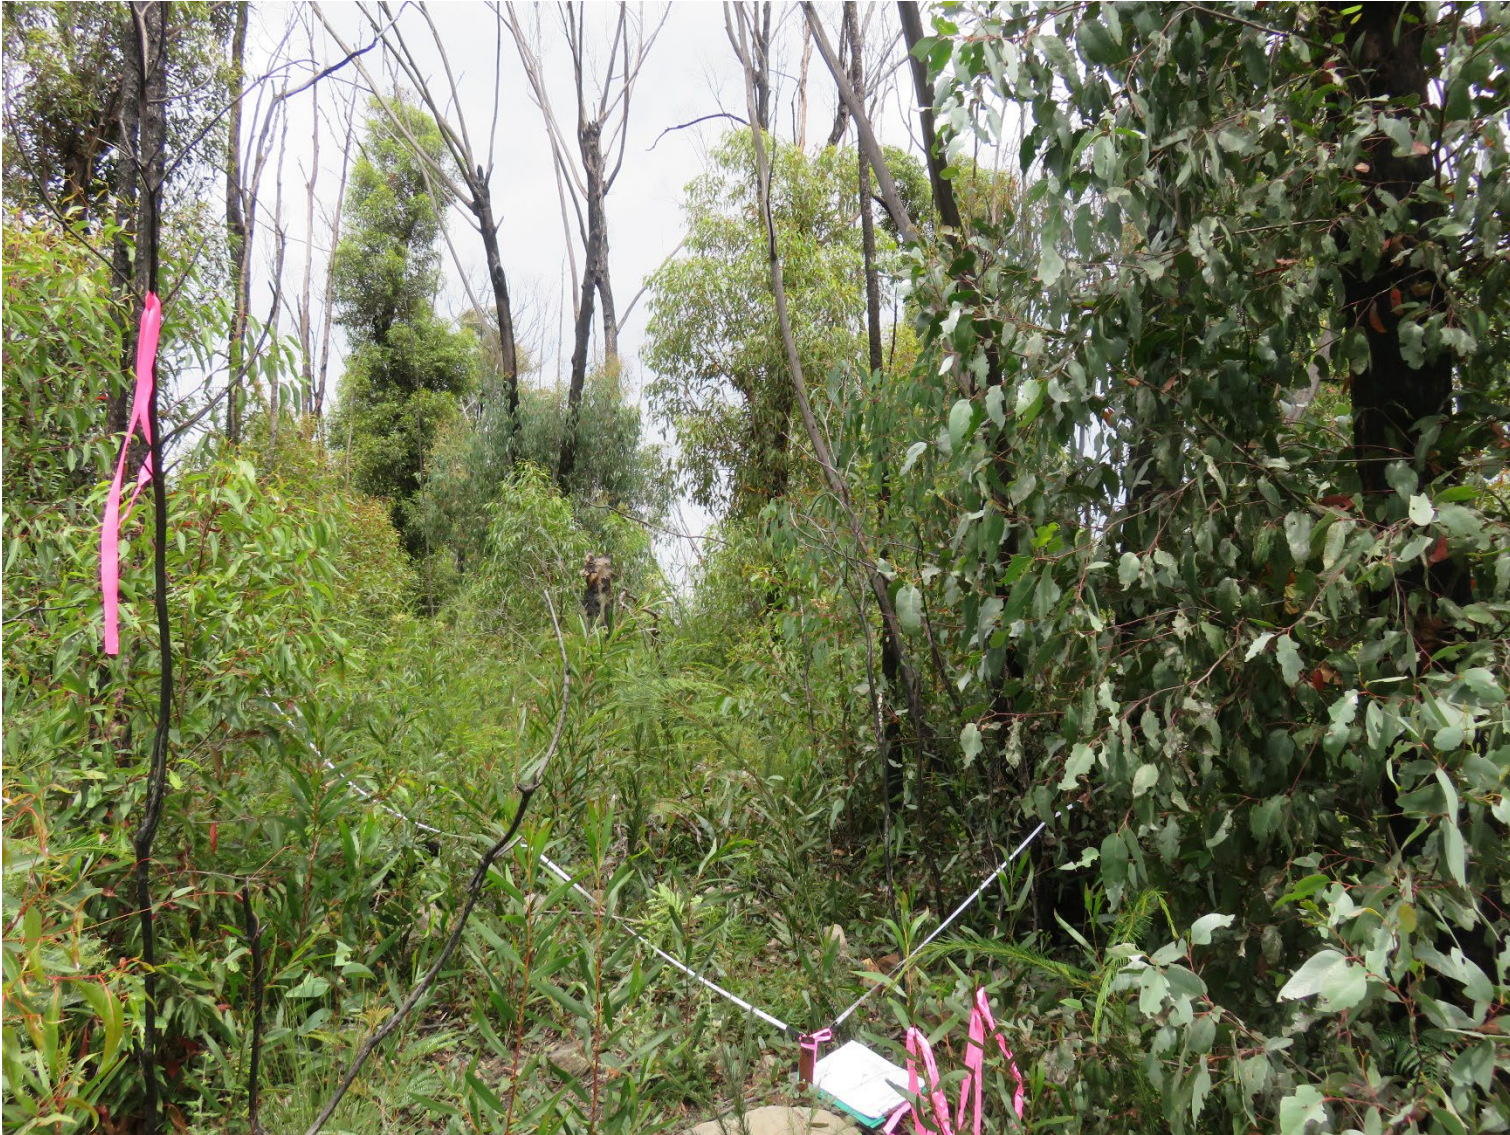
Plate 2. The character of the vegetation within Plot 2.

Feature	Y/N	Comment
Hollow-bearing trees	Y	Hollows with diameters 11-20 cm and >20 cm are present.
Rock outcrop	N	Some loose boulders.
Mistletoe	N	
Water body	N	
Threatened species	N	
Weeds	N	
Pest fauna	N	
Tree dieback	Y	Post fire dieback in canopy
Fire history	Y	Severe wildfire (Green Wattle Fire) December 2019. Effect on vegetation composition and structure evident. Some canopy trees have died and those surviving are dominated by epicormic growth. Shrub stratum now is the dominant stratum and will remain so for some years.
Erosion	N	
Other	N

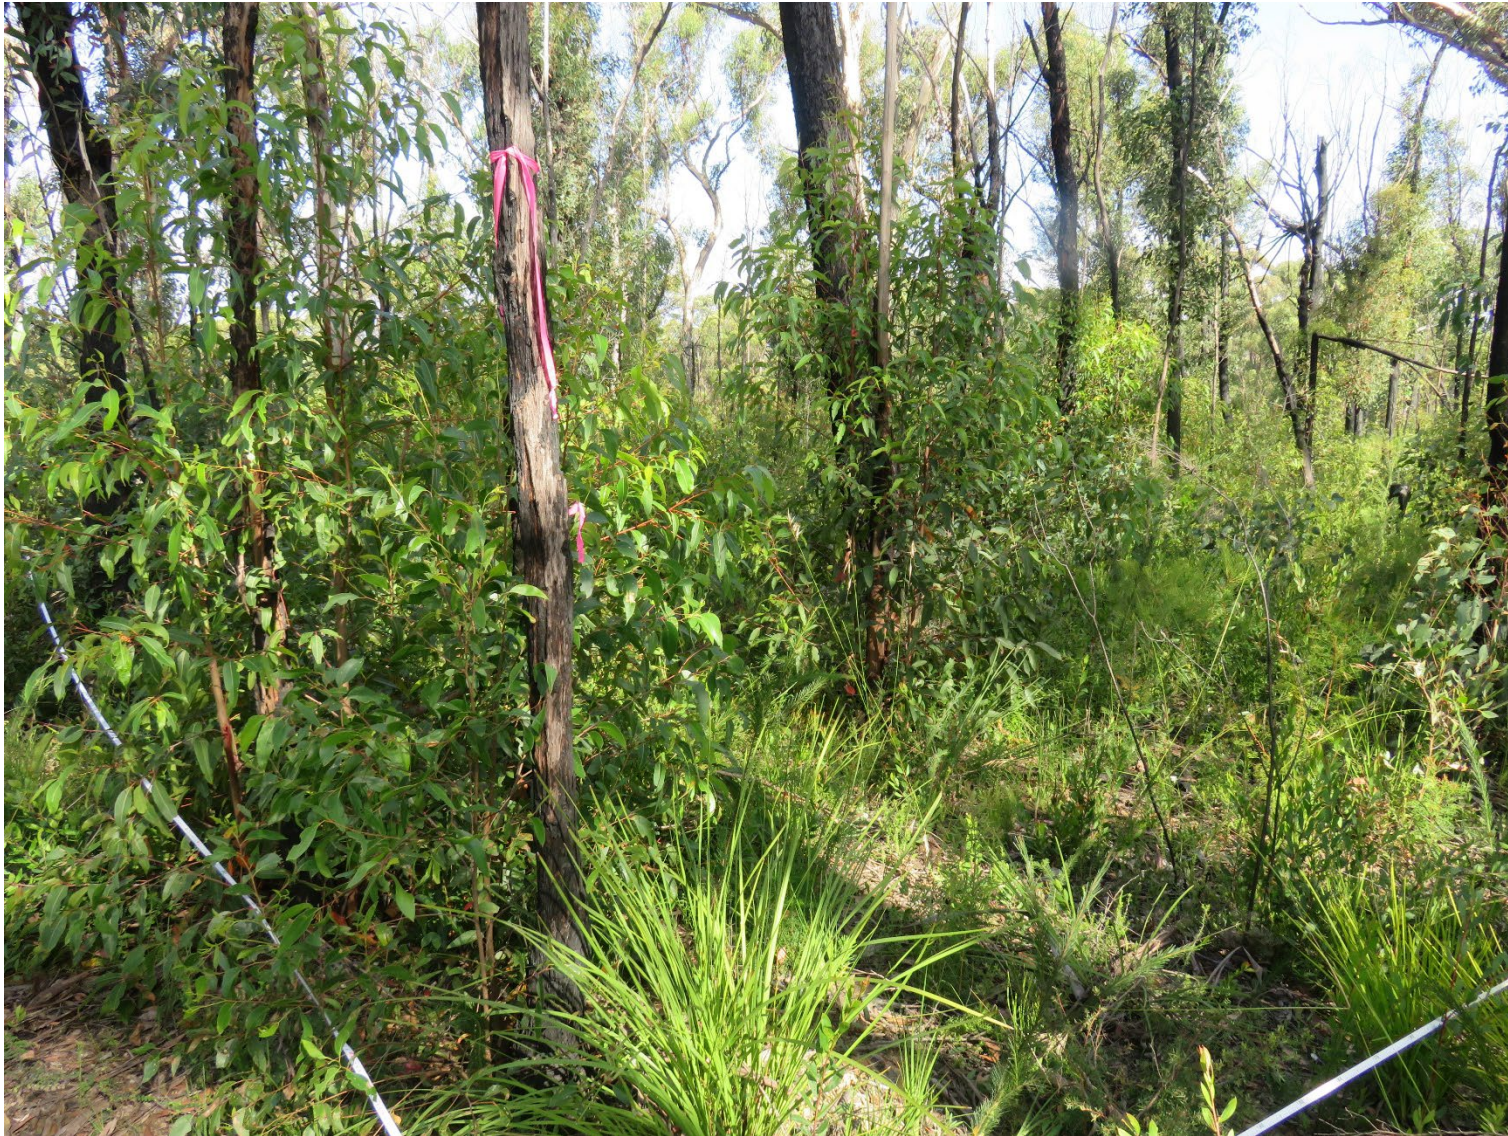
Feature	Y/N	Comment
Hollow-bearing trees	N	Not within the plot.
Rock outcrop	Y	Very minor amount.
Mistletoe	N	
Water body	N	
Threatened species	N	
Weeds	N	
Pest fauna	N	
Tree dieback	N	
Fire history	Y	Severe wildfire (Green Wattle Fire) Dec 2019. Crown not as heavily burnt as other plots. Shrub stratum regenerating and now dominant.
Erosion	Y	The track has a history of use and appears to still be used. The surface of the track is hard-set.
Other	N	Gate/fence is broken, permitting vehicle entry (previously noted).

Plate 3. The character of the vegetation within Plot 3.

Plot/Photo-point	Action
Plot	
1	No further action required.
2	No action required.
3	The wire strand fence beside fire trail gate requires repair.?
4	The discharge from the operational basins is spreading out across the rock platform and saturating a larger area of vegetation than necessary. This discharge point should be modified to control the water into a single alignment to a natural gully.
5	No action required.
6	No action required.
Photo-point	
1	No action required.
2	No action required.
3	No action required.
4	An erosion and sediment control strategy is required for the batter at the end of the 800m range to prevent ongoing erosion and prevent sediment transportation into the remnant vegetation where it is being deposited facilitating the establishment of weeds.
5	No action required
6	Rehabilitation proposed to be undertaken at this location and on the batter slopes should include native plant species of local provenance and/or those specified in Appendix G of the Ecological Management Plan (GHD 2010).

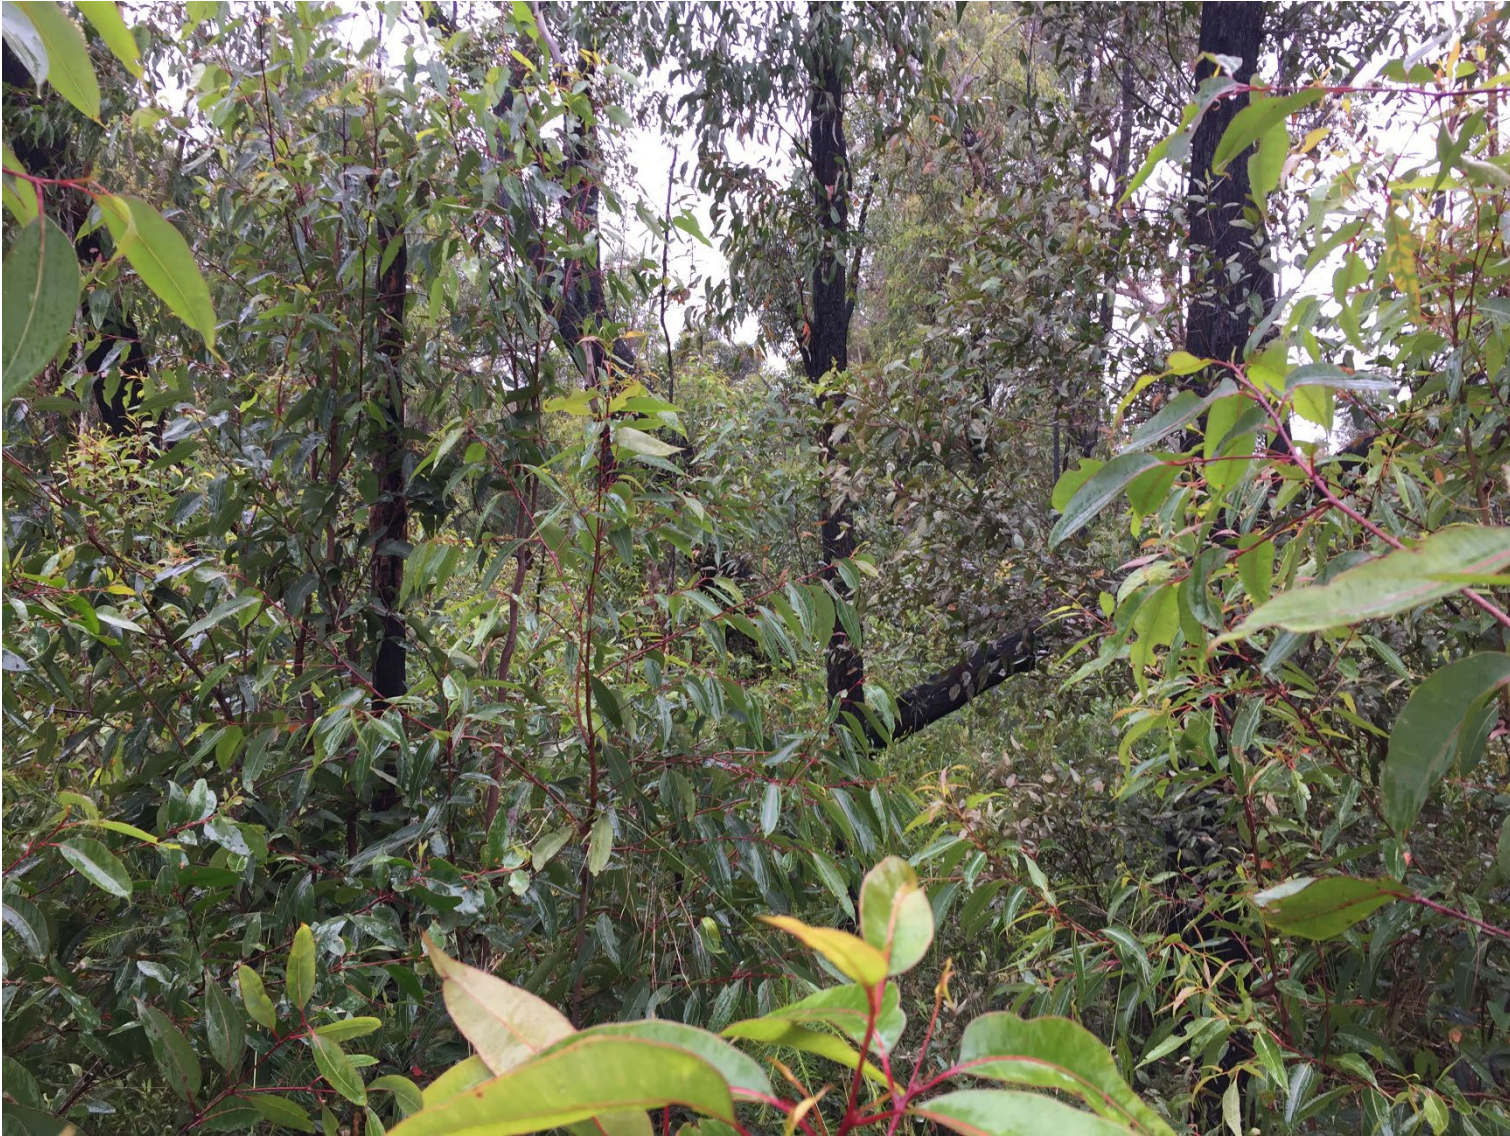
Plate 5. The character of the vegetation within Plot 5.

Stratum	Height (m)	% cover	Dominant species
Upper	15	15	<i>Eucalyptus sieberi</i> , <i>Corymbia gummifera</i> , <i>Eucalyptus agglomerata</i>
Mid-lower	2-2.5	25	Resprouting <i>Eucalyptus</i> spp. and <i>Corymbia gummifera</i>
Shrub	1.5	20	<i>Acacia</i> spp., <i>Bossiaea obcordata</i> , <i>Hakea dactyloides</i> , <i>Lomatia silaifolia</i> , <i>Pimelea linifolia</i> , <i>Pultenaea scabra</i>
Ground	0.5	30	<i>Hardenbergia violacea</i> , <i>Entolasia stricta</i> , <i>Austrostipa pubescens</i> , <i>Lomandra</i> spp., <i>Dampiera stricta</i> , <i>Goodenia bellidifolia</i> , <i>Goodenia hederacea</i> subsp. <i>hederacea</i> , <i>Opercularia hispida</i> , <i>Phyllanthus hirtellus</i> , <i>Platysace ericoides</i> , <i>Poranthera ericifolia</i> , <i>Scaevola ramosissima</i>

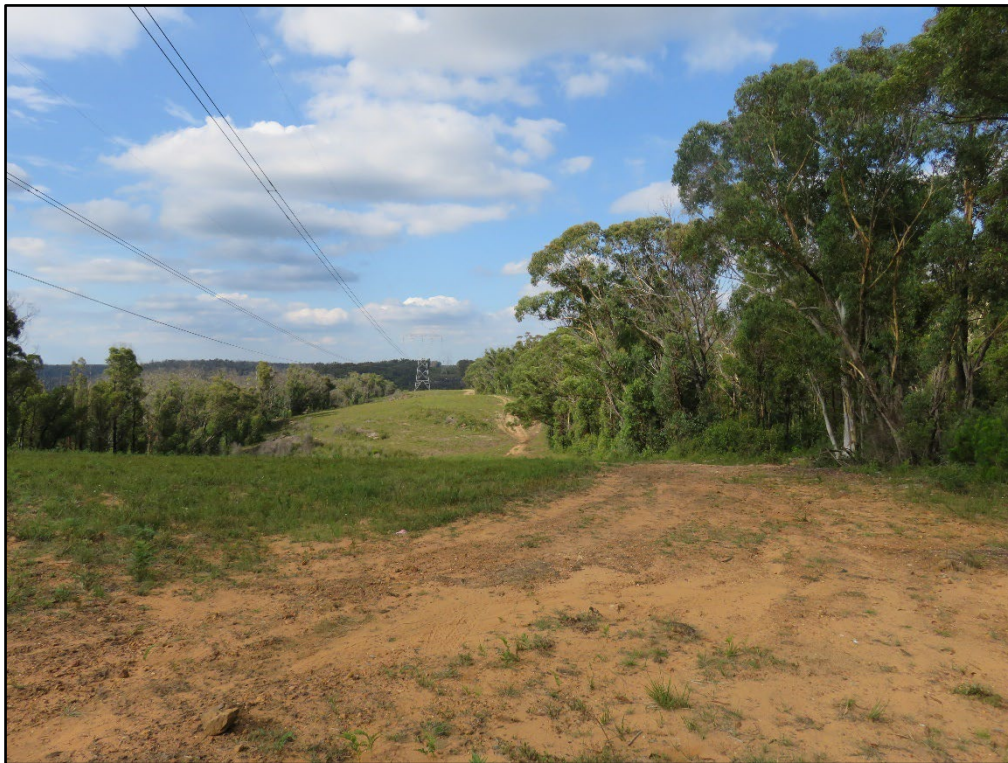
Plate 9a. Looking north-east with the conservation area evident to the west of the powerline easement (left of photo) (date taken: 28/01/2022).

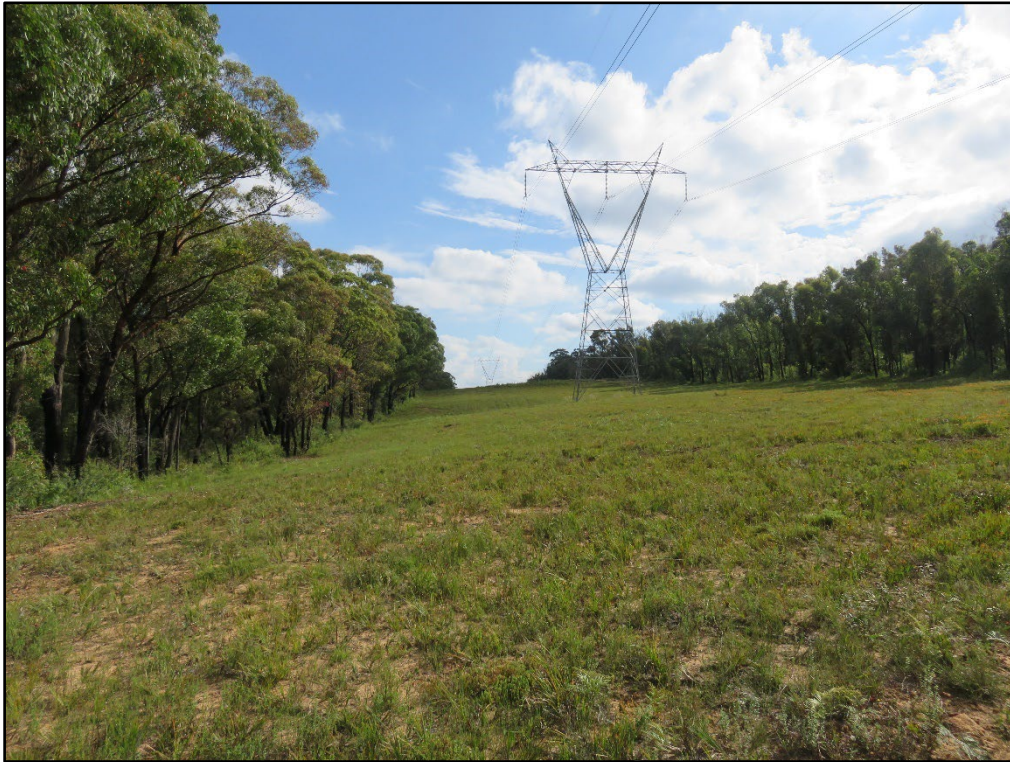
Plate 9c. Looking south-west with the conservation area to the west of the powerline easement (right of photograph) (date taken: 28/01/2022).

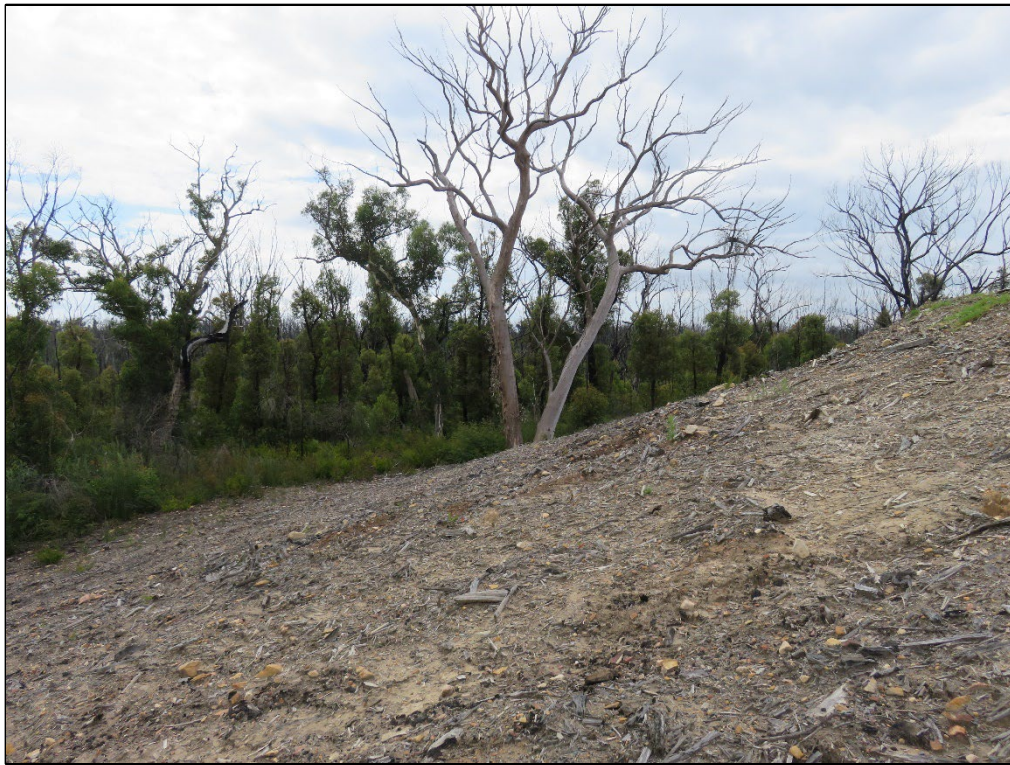
The batter at the back of the 800 m range is however unestablished. Mulch was applied to this area in as noted in the previous monitoring period, however without topsoil or revegetation actions there has been no native regeneration of the batter. This is allowing sediments to mobilise which are then uncontrolled before entering the remnant vegetation.

Plate 10a. The disturbed area at the southern end of the 800 m rifle range (date taken: 17/01/2022).

The recommendation is to discontinue Photopoint 4 as it does not reveal any vegetation changes of any significance (being the bare ground on the 800 m rifle range).

Whilst the 800 m range was not being used at the time of the monitoring study, shots were heard. From a personnel a Work Health and Safety perspective, the continued monitoring of this site is not recommended.

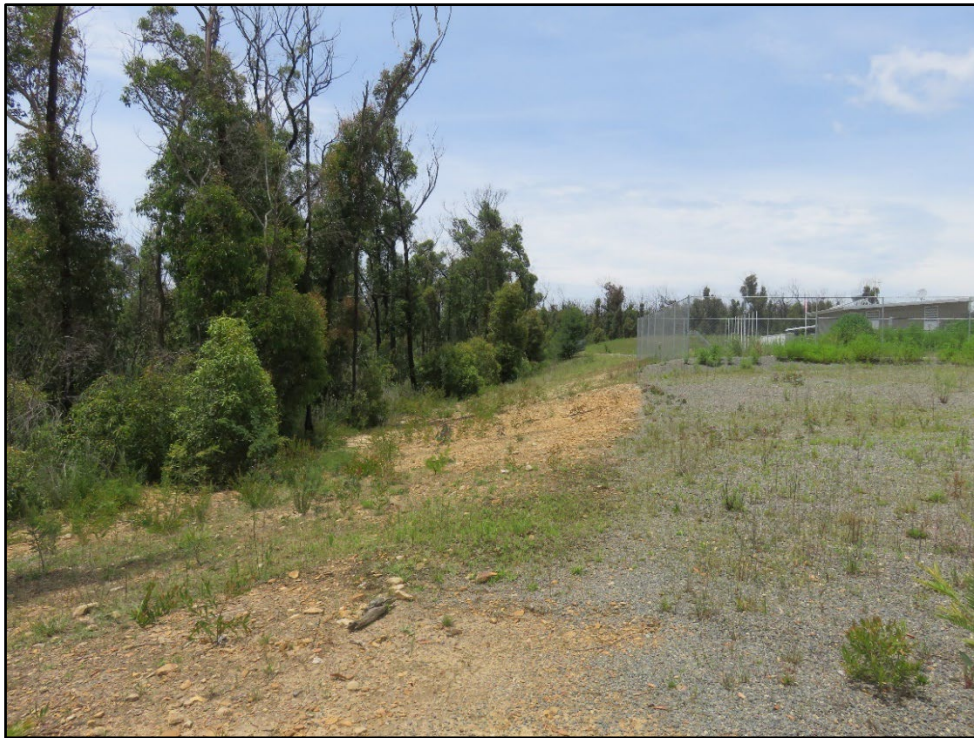
Weeds were observed along the drainage line that need removal, including: Nut Grass *Cyperus rotundus*, Scotch Thistle *Cirsium vulgare* and Purple Top *Verbena bonariensis*.

Plate 11. Looking east along the northern boundary of the 50m range (date taken: 17/01/2022).

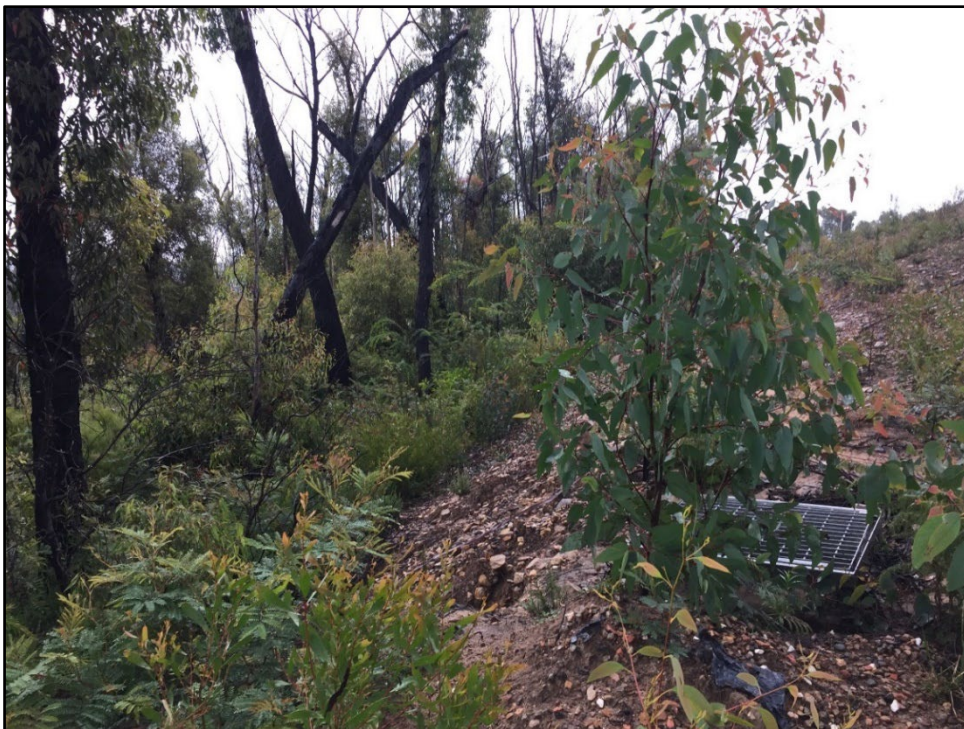
Plate 12. The character of the drainage pit and vegetation at the south-east corner of the 50m range (date taken: 18/01/22).

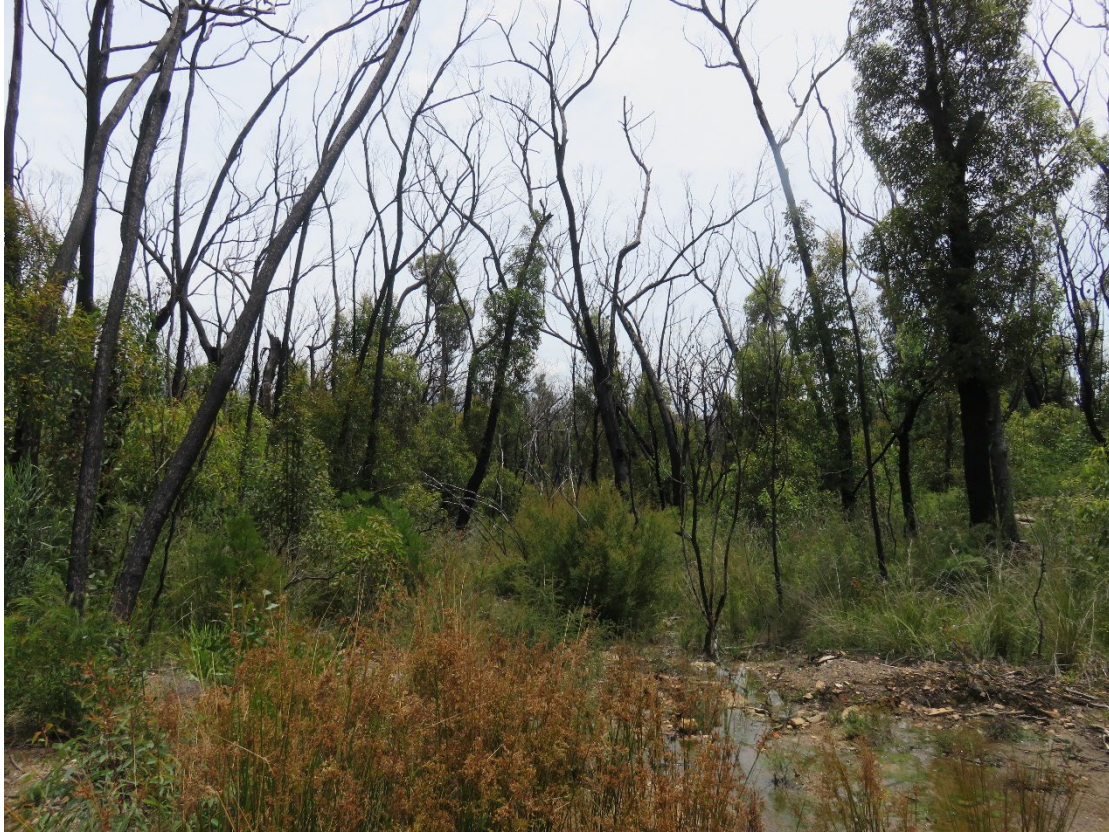
Runoff around the southern fence is bypassing the channels meant to divert it into the sediment control pond, so some earthworks are required to re-divert this surface flow. Sediment and water overflow is entering bushland at the western edge (as expected) but some weeds are establishing (Nut Grass, Thistles, Parramatta Grass, and Cudweeds) that need treatment.

Plate 13. The character of the sediment outbreak below Photo-point 7 (Photo taken 17/01/2022).
