Peatland Restoration Advice for the Norwegian Environment Agency

Author: Deborah Land

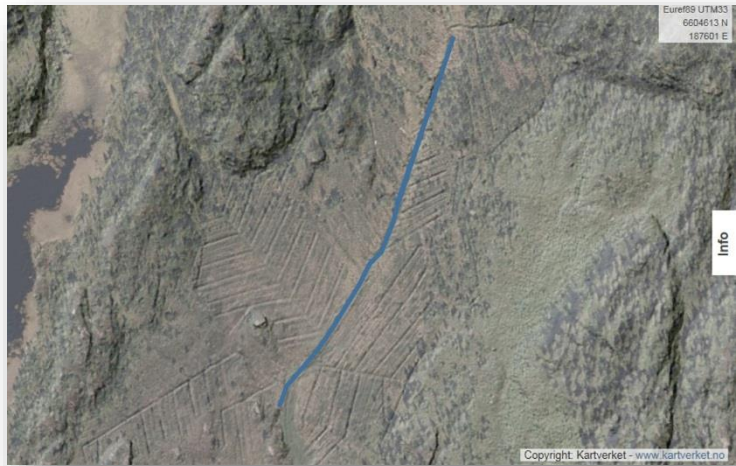
Figure 5 Aerial photograph of the upper mire detailing the modified stream and showing extensive herringbone ditches

- A.8 The upper mire system also has multiple ditches through the mire system many of which are channelling the water quickly through the mire to the central modified stream. Again, the network of herringbone drains need to be blocked, be it with peat or the glacial moraine material dependant on what the underlying material is available.

- A.9 There is also considerable areas of trees that have established in this upper area. Tree removal will be necessary where ditch blocking work is required, it would be necessary to remove these, but elsewhere it may be more sensitive to leave the trees and allow the raised water level post restoration to determine the natural extent of tree colonisation.

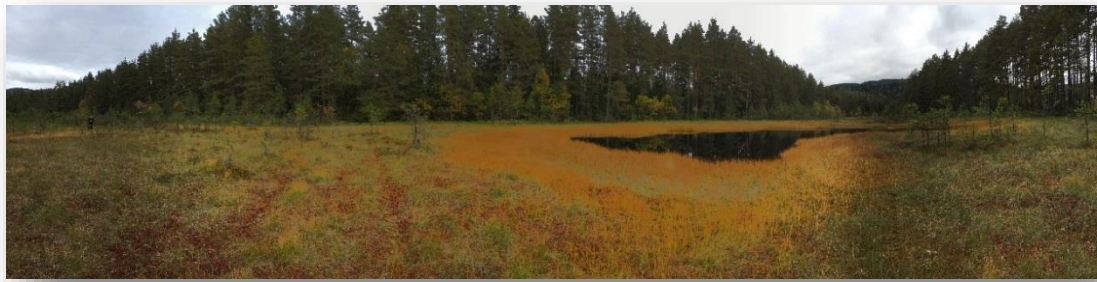
Figure 6 Panoramic view of the central area of Kringlemyr

B.3 Whilst the central part of the mire remains in good condition, the northern end is highly degraded. There is considerable peat slumping, drying and cracking. This has enabled trees to become established and grow to a considerable canopy.

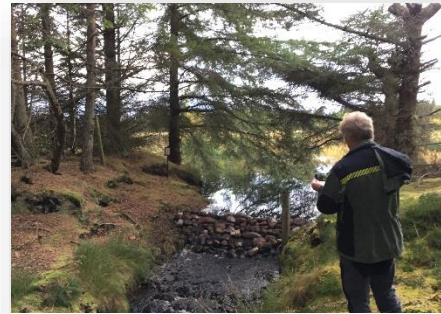
Figure 12. Small dam on the periphery of the reserve

D.5 On inspection, a small structure had been installed at the boundary of the site and was working satisfactorily, but a more robust structure would be more appropriate and easier to control the water levels. The installation of such a structure would negate any need for further peat removal whilst also increasing the desirability of the habitat for the bird assemblage.

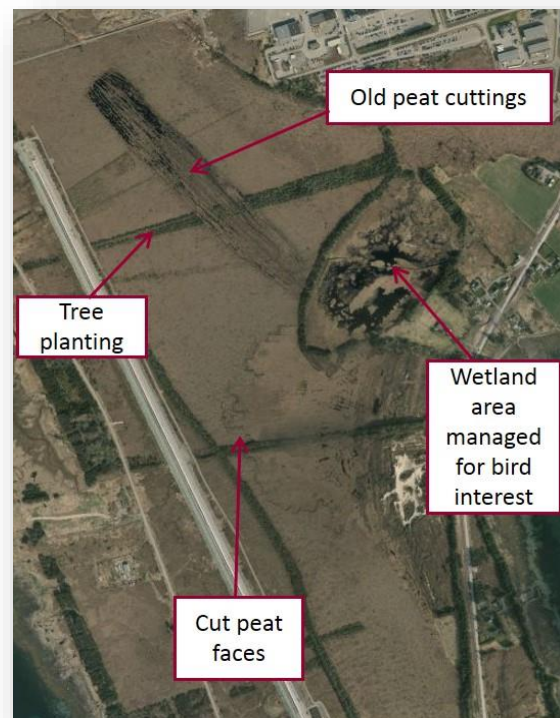
Figure 13 Aerial photograph showing the extent of damaged peat.

D.7 The cut peat faces form part of the boundary of the nature reserve. These are over 2m high in places and will be having a considerable impact upon the water table of the bog. They require considerable re-profiling as demonstrated in the video by the Cumbria Wildlife Trust (2015) together with the creation of cell bunding at the top and foot of the slope to assist with holding the water table close to the surface.

D.8 The methodology should follow the design for shallow bunding as described by OpenSpace (2015). It is acknowledged that restoration outside of the nature reserve boundary may present challenges to complete this part of the restoration.

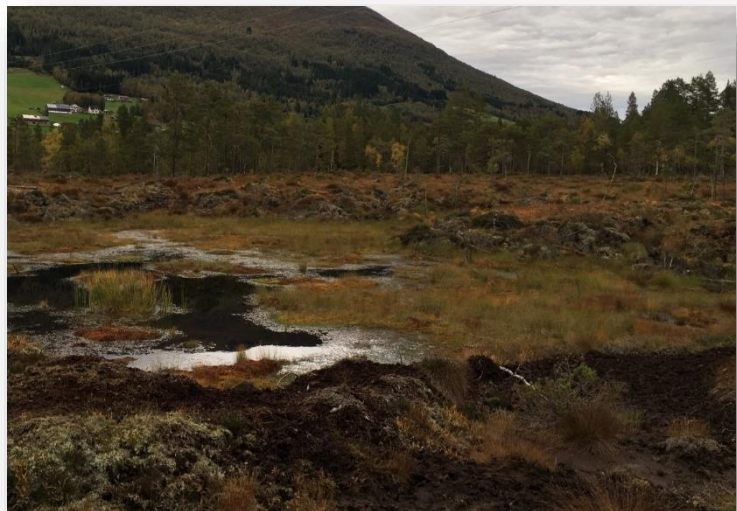
Figure 14 Eroded peat on Sætremyrane

- E.2 There are old abandoned peat workings and associated cuttings that can be clearly seen on the Lidar image. These date back to the early 1900s when peat was carried by railway across the bog. On reading the Management Plan for Sætremyrane, it is evident that there is a rich and diverse cultural history associated with the use of this bog; from peat cutting, to grazing, hunting and foraging.
- E.3 It is clear that the peat extraction has caused considerable damage to this mire, resulting in high dry baulks of peat with tree cover and wetter depressions where the peat was cut. There is also evidence of past management that may affect the water

- E.7 For the restoration of the bare peat areas, a series of small shallow bunds to slow the water flow in key locations will help to reduce the further loss of peat. The concern in this area is that the peat is already weak and fragile and the construction of large long contour bunds may hold too much water for the peat to hold and may result in a peat slide. Therefore a series of small strategic individual low bunds may be more appropriate.

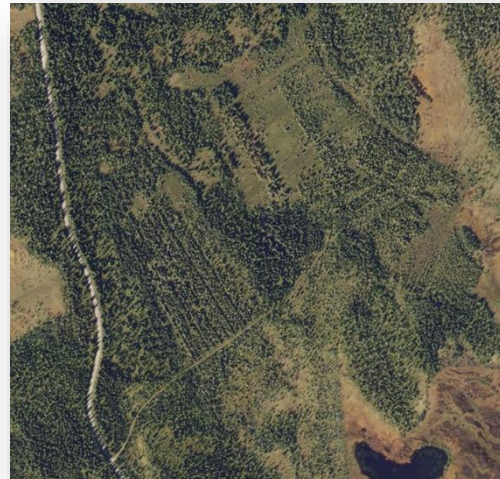
Figure 17 Aerial showing the extent of tree cover on peat

F.2 There has been considerable forestry development in the area, some of which is within the peat body of the mires. Forestry drainage has also impacted the reserve

F.3 In order to restore the hydrological functioning of these mires, all of the drains will need to be blocked using peat dams at regular intervals. It will be necessary to remove the trees from the bog surface where they occur on deep peat. This is not only necessary for the construction of the dams but also to ensure that there are no trees to intercept valuable rainwater to the mire.

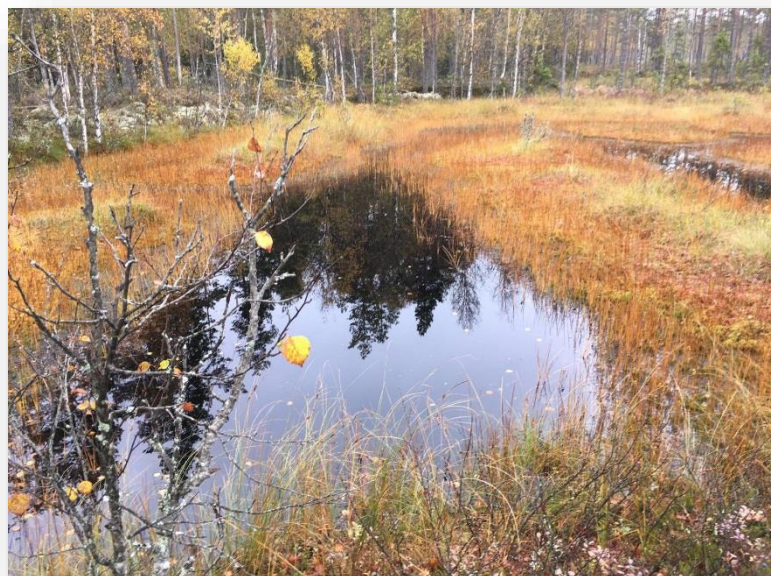
Figure 18 A view of the unique fan-shaped cuttings within the mire supporting rich fen vegetation.

G.2 There are two obvious episodes of modification to Ebrustormyra. The older modification to the peat body is curious. The peat has obviously been commercially extracted from the site in the past but the method of cutting is unlike anything encountered before. The series of fan-shaped cuttings are very deep and judging from the suite of species present, have connected the mire with the underlying groundwater.

G.3 In themselves, the fan-shaped cuttings do not present a negative impact upon the peatland and add to the ecological richness of the site. It is therefore advised that no restoration works are required to these cuttings.

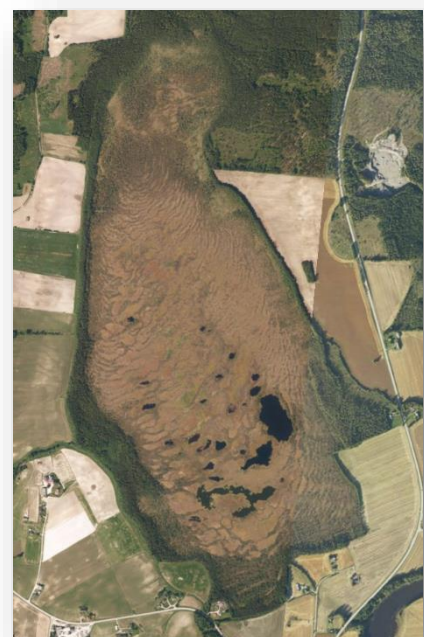
Figure 20 Aerial photo showing the eccentric patterning

H.2 The site has already received considerable restoration where in the 1970s, over 10,000m of ditches filled in in the northern area of the mire (Joosten, 1970). There is little evidence of this work when viewing the Lidar image, concluding that this has been successful.
