ENVIRONMENTAL ASSESSMENT, KARAAF WETLANDS

Report to Surf Coast Shire, by Doug Frood (Pathways Bushland and Environment, Marraweeney, Victoria), September 2022.

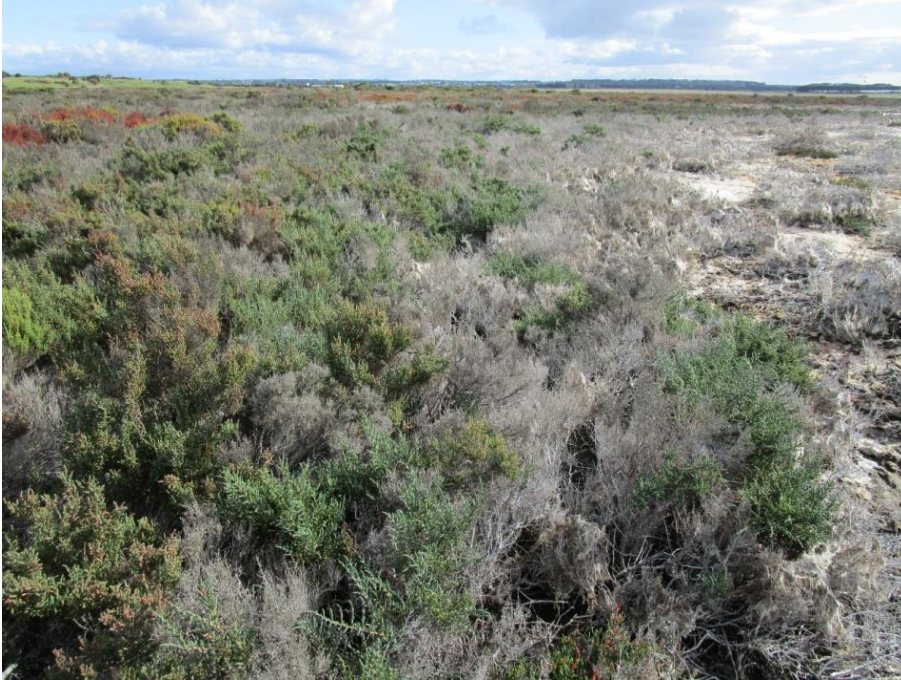
Coastal Hypersaline Saltmarsh codominated by Bellarine Glasswort and Shrubby Glasswort in a low-lying area within the broader saltmarsh vegetation. Note the dieback of glasswort shrubs to the right of the image, due to excessively prolonged inundation.

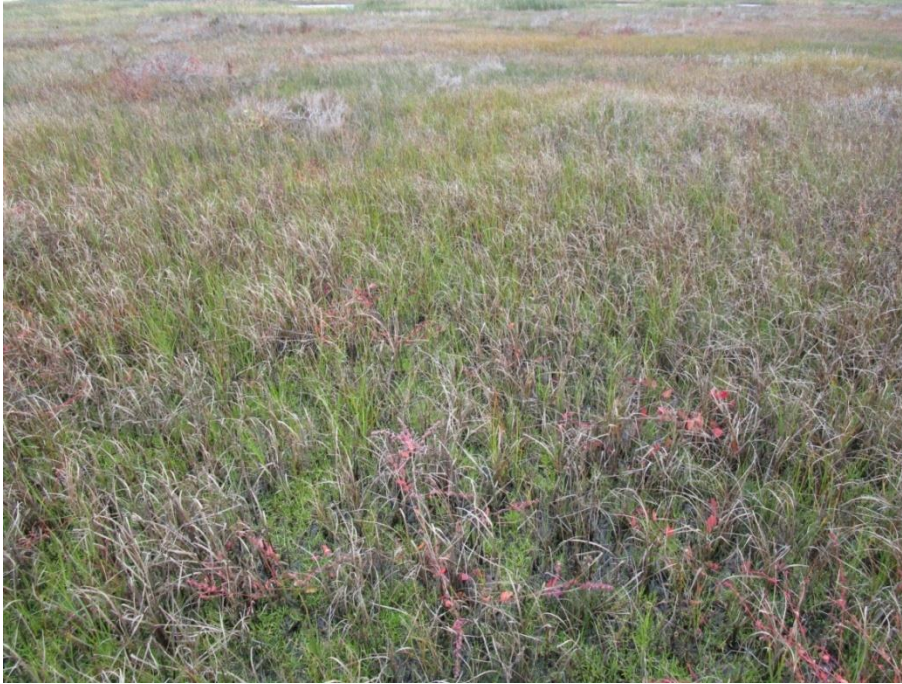
Adventive Brackish Wetland Aggregate with sparser culms of Salt Club-sedge near the western edge of the Karaaf wetlands.

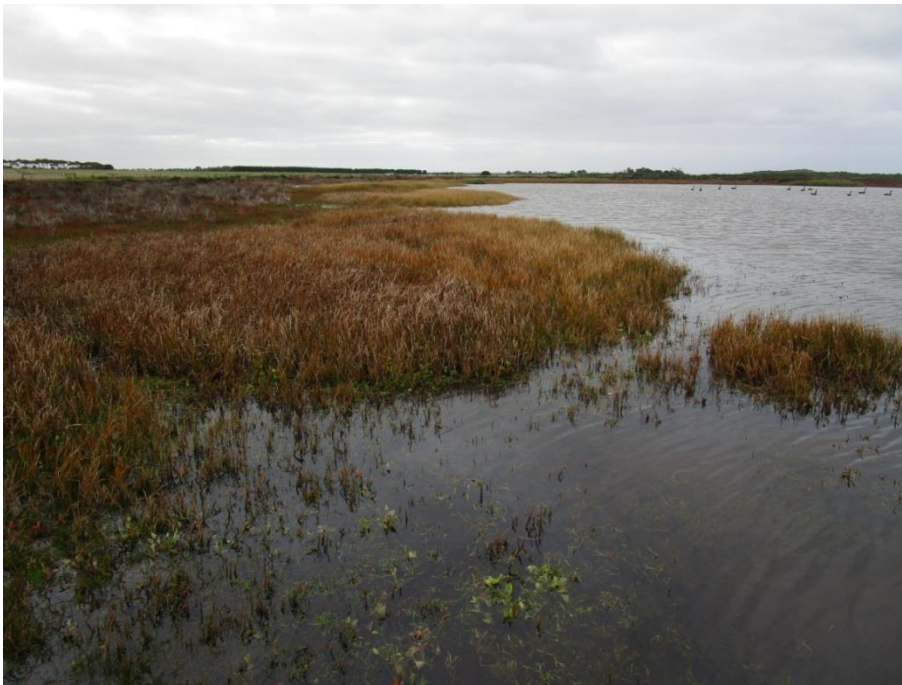
Brackish Sedgeland component of the Brackish Wetland Aggregate, dominated by Salt Club-sedge, developed on the margins of a shallow lagoon near the western margins of the Karaaf wetlands.

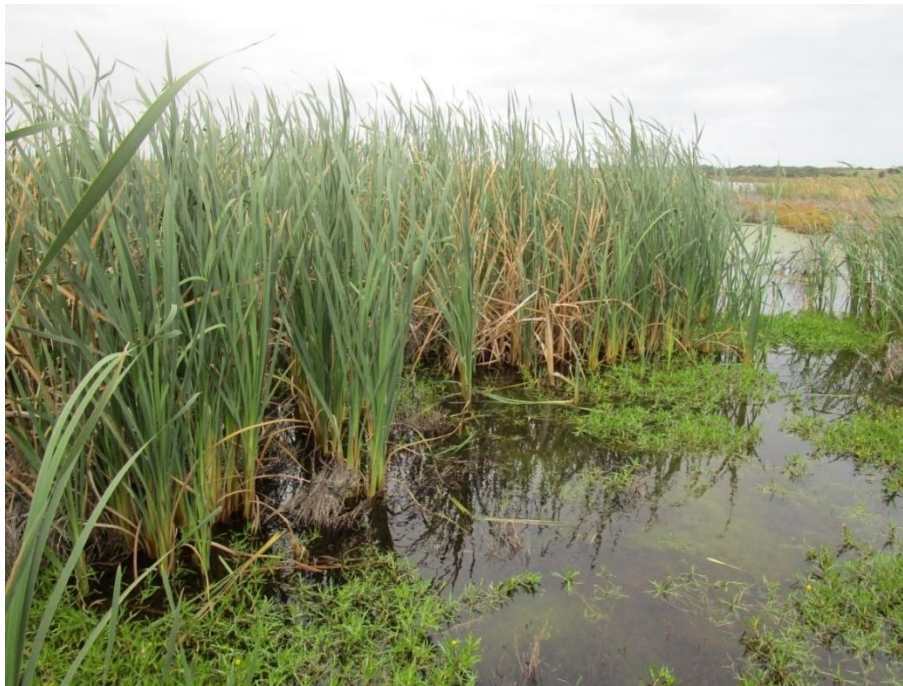
Opportunistic colonisation of Cumbungi around the verges of a shallow lagoon in the western portion of the Karaaf wetlands. The smaller mat-forming plant in the foreground is Water Buttons.

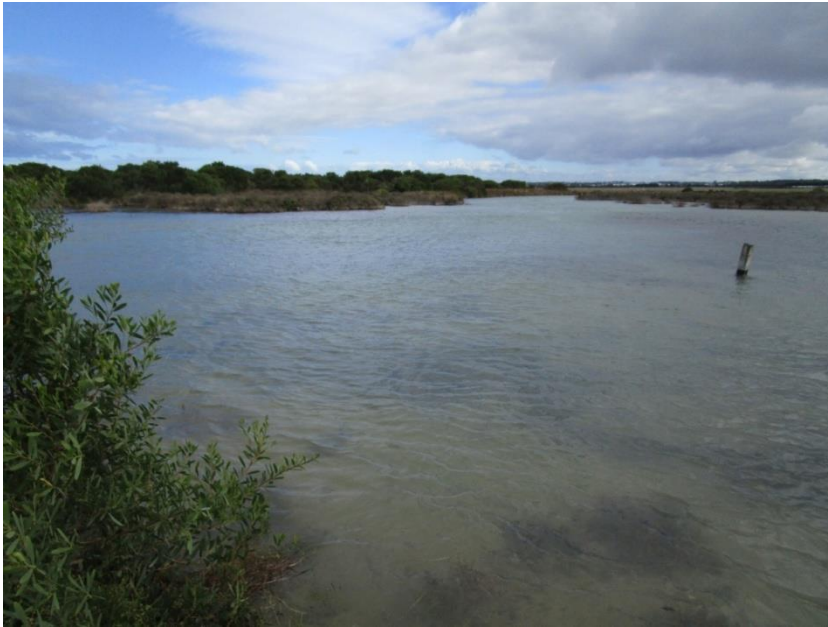
Mullet Creek looking west from the culverts along Point Impossible Road under conditions of very high tide. Tidal inundation restored to near natural conditions, with inundation extending deep into the saltmarsh when the entrance of Thompson Creek is open to the sea,

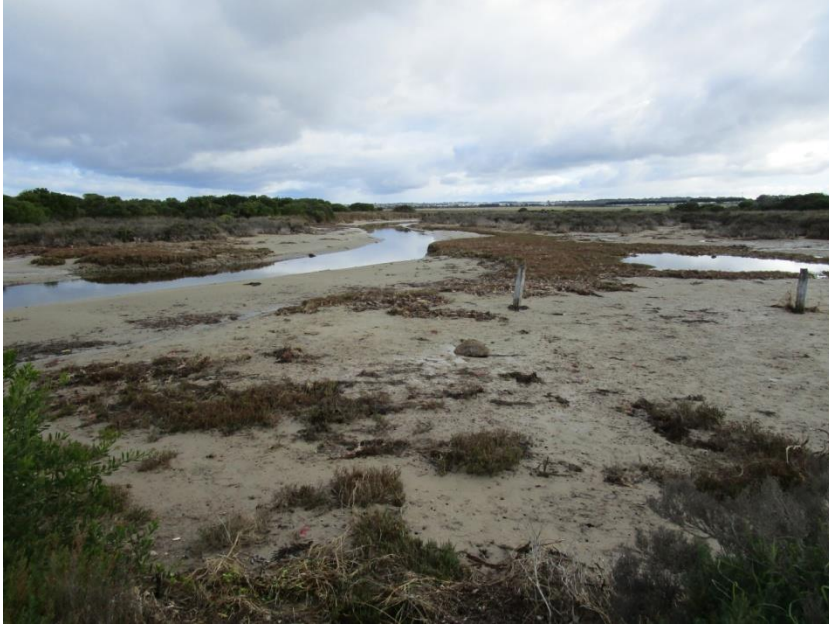
Mullet Creek west from the culverts along Point Impossible Road under conditions at low tide.

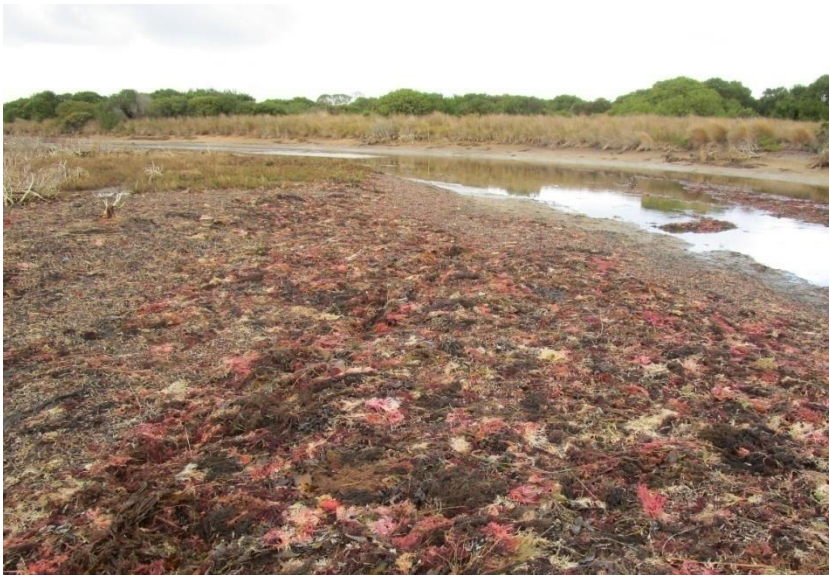
Accumulation of fragments of Sea Nymph and marine algae along the lower section of Mullet Creek.

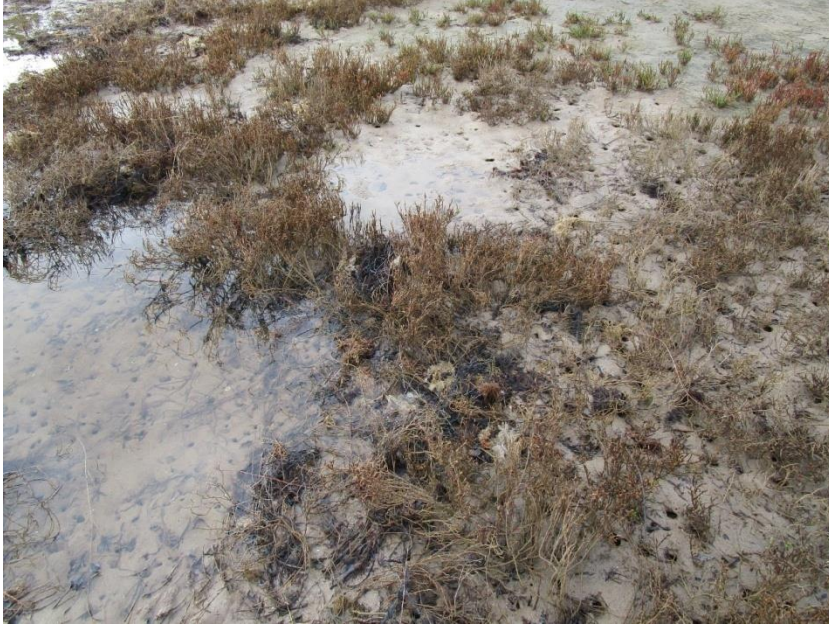
Stressed Beaded Glasswort at limits of tolerance near the Mullet Creek entrance

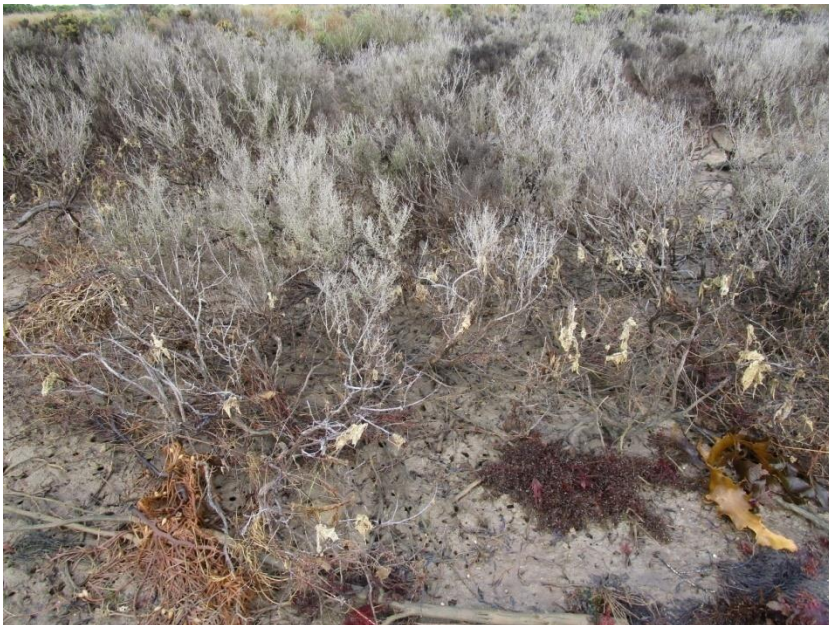
Dieback of Shrubby Glasswort adjacent to Mullet Creek, with remnants of filamentous algae hanging from stems and finer branches still attached, indicating relatively recent death of the plants.

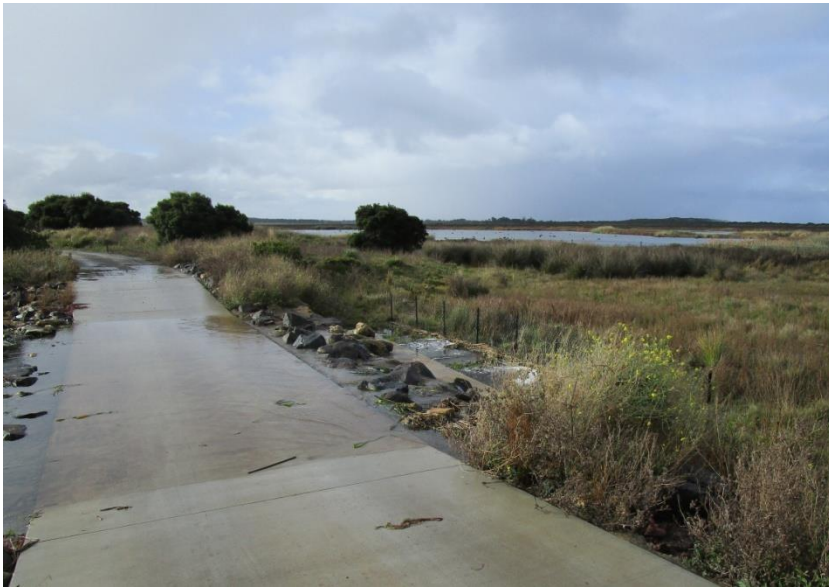
Stormwater flowing over the spillway between the stormwater treatment pond system and the Karaaf.

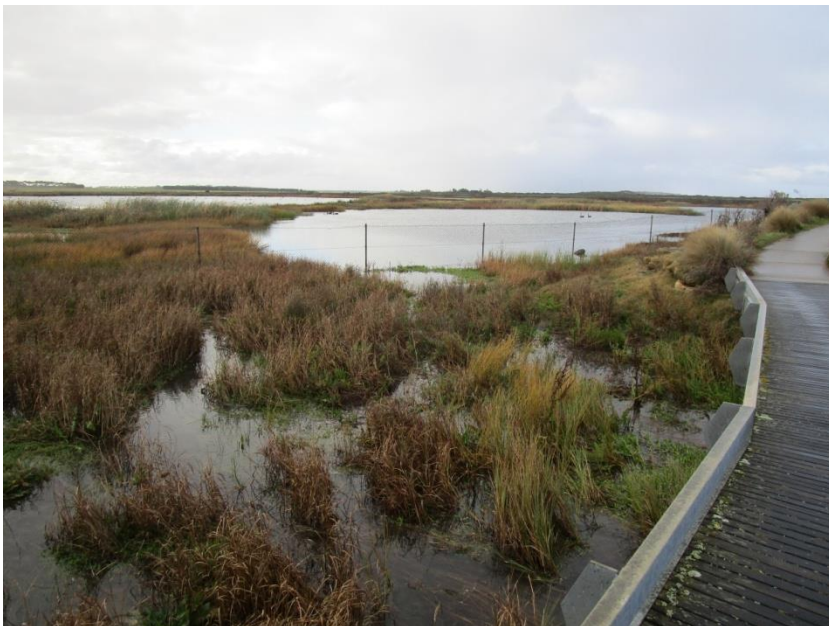
Stormwater overflowing into the wetlands at the south-western corner of the Karaaf.

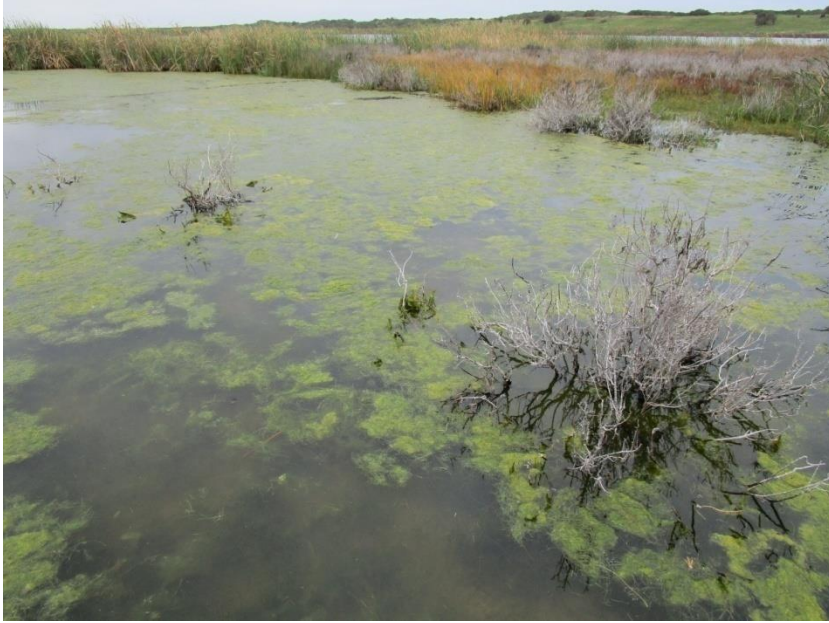
Filamentous green algae in shallow lake at the western end of the Karaaf, reflecting changed hydrology and elevated nutrients.

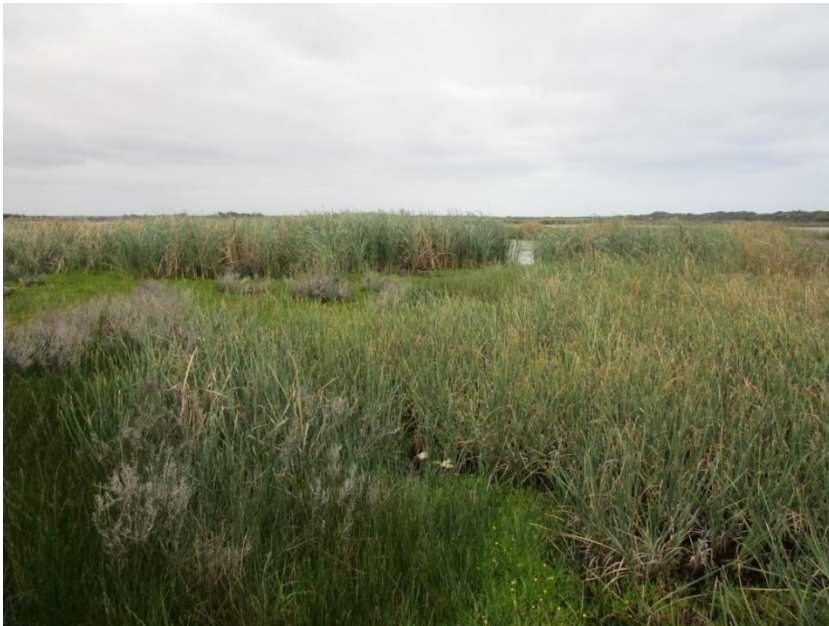
Colonization by Cumbungi due to freshwater inputs at the western boundary. Older plants are to the rear, with younger more recent colonization in the foreground.

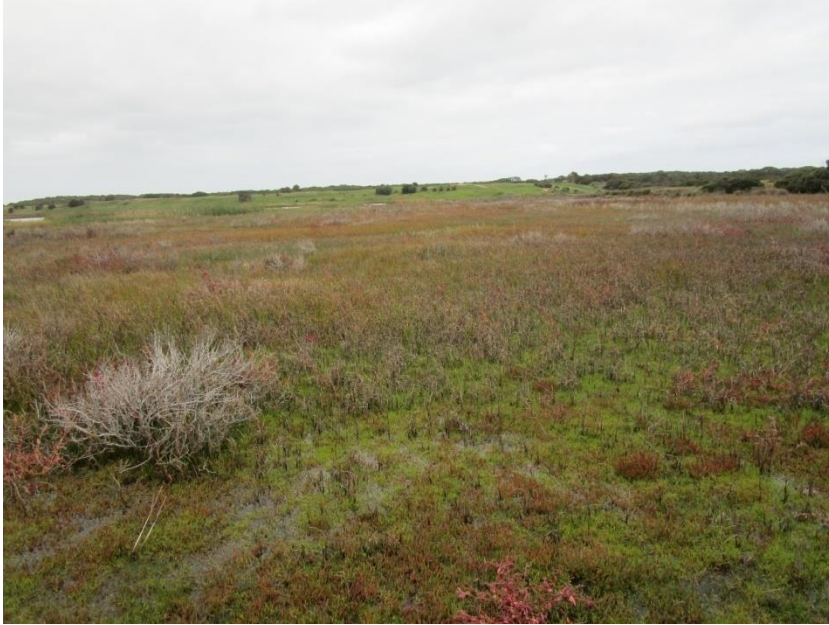
Extensive displacement of prior saltmarsh vegetation by adventive Brackish Wetland at the western end of the Karaaf.

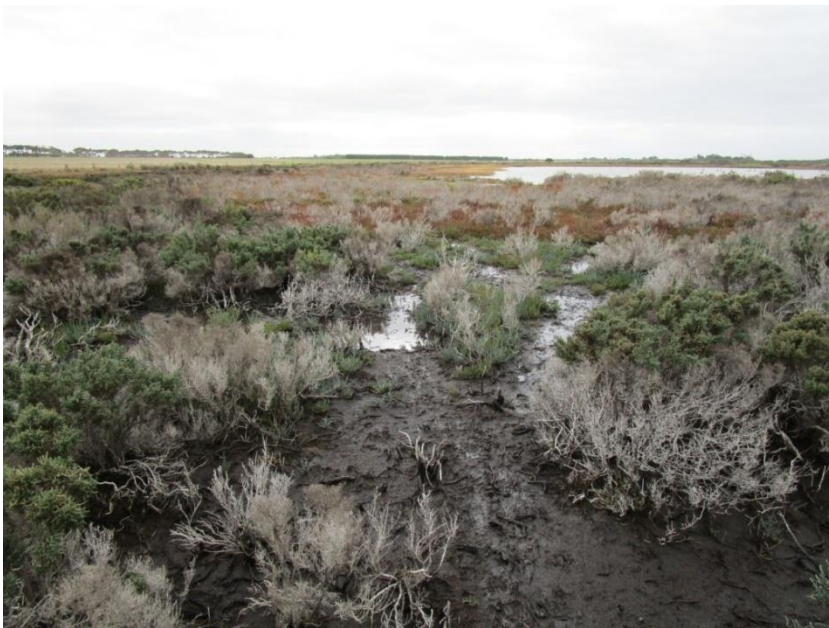
Progressive dieback of Bellarine Glasswort at the western end of the Karaaf, further from the major point of stormwater discharge (adjacent to the Brackish Wetland). Beaded Glasswort has increased in abundance in the wetter area fringing the lagoon to the rear, where the mortality of Bellarine Glasswort has been comprehensive.

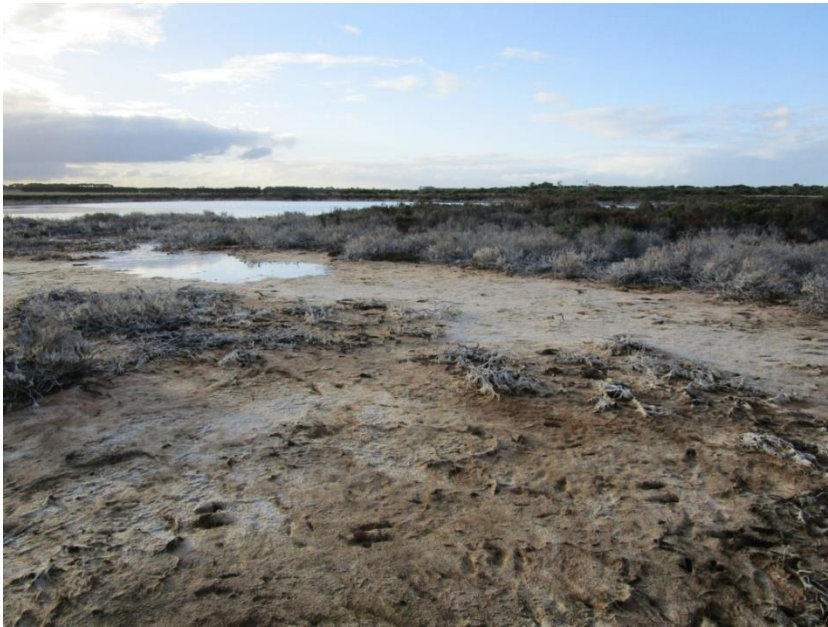
Extent of inundation during at a particularly high tidal event into shallow depression within the saltmarsh in the south-eastern section of the Karaaf.

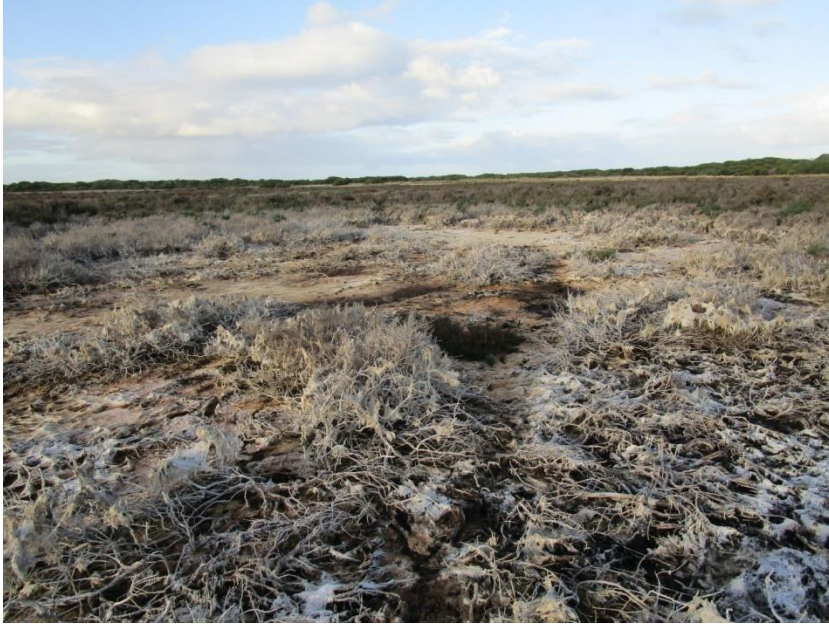
The vegetation surrounding the tidally influenced pond pictured in the previous image includes a mixture of Shrubby Glasswort and Bellarine Glasswort, indicating hypersaline conditions, and is above the usual range of tidal influence. Dieback of sections of this shrubland vegetation has occurred due to sustained inundation associated with the closure of the entrance of Thompson Creek. The white matting comprises the remains of a Stonewort or Charophyte, which is a salt-tolerant aquatic plant intermediate between algae and vascular plants. Shrub mortality in this area does not appear to be due to the direct impact of freshwater from stormwater inputs at the western end of the saltmarsh.

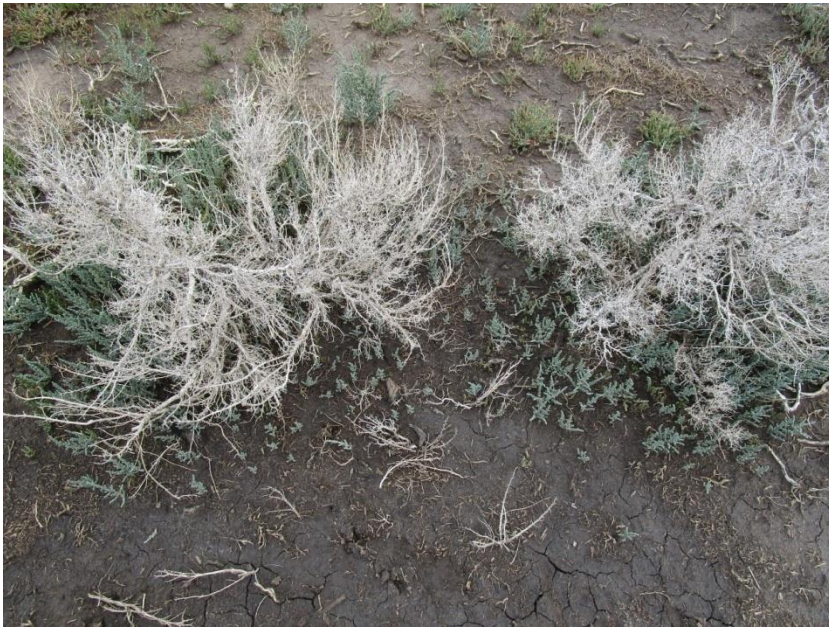
Vegetation dynamics: Regeneration of Bellarine Glasswort on the outer verges of impacted shrubland vegetation.

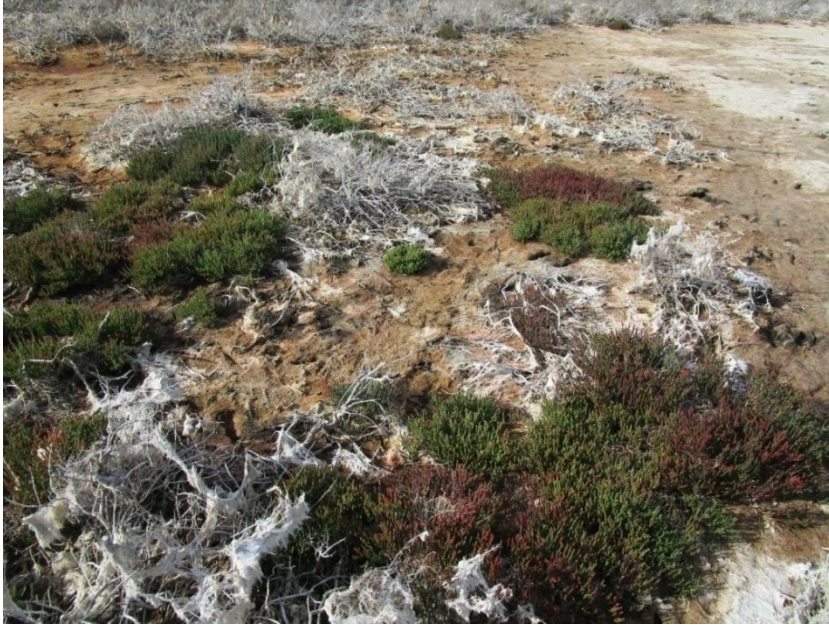
Vegetation dynamics: Recolonization of the herb Beaded Glasswort into impacted shrubland vegetation.

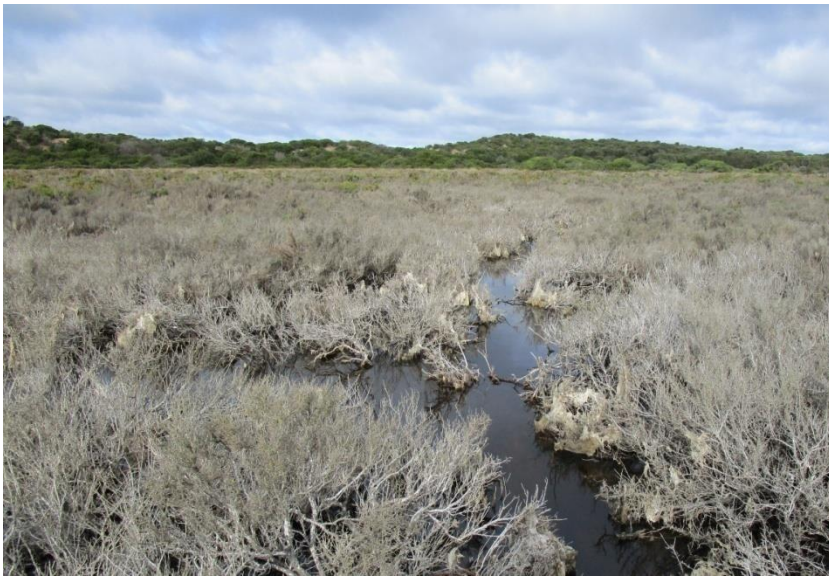
Broad-scale death of Shrubby Glasswort towards the western side of the Karaaf. Remnants of algae attached to the stems are indicative of a sustained inundation event.

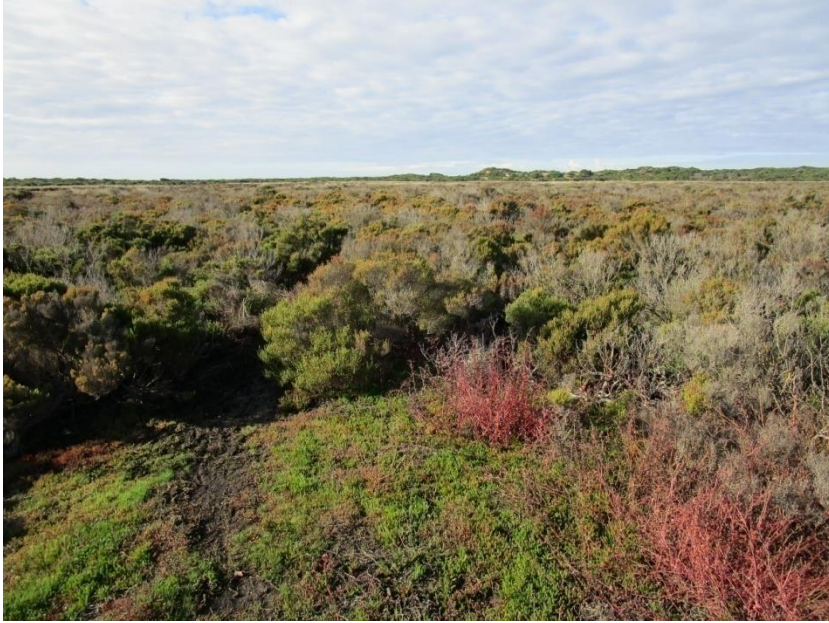
Shrubland of Shrubby Glasswort with relatively minor level of mortality in the south-central part of the Karaaf, in area less prone to excessive inundation.
