MITIGATION BANKING INSTRUMENT
COW ISLAND BAYOU MITIGATION BANK
LIBERTY COUNTY, TEXAS
SWG-2013-00223

SPONSOR: THIRD TEXAS RESOURCE, LLC
AGENT: RES

SUBMITTED FOR APPROVAL TO:
U.S. ARMY CORPS OF ENGINEERS
GALVESTON DISTRICT
AND
INTERAGENCY REVIEW TEAM

APRIL 15, 2019

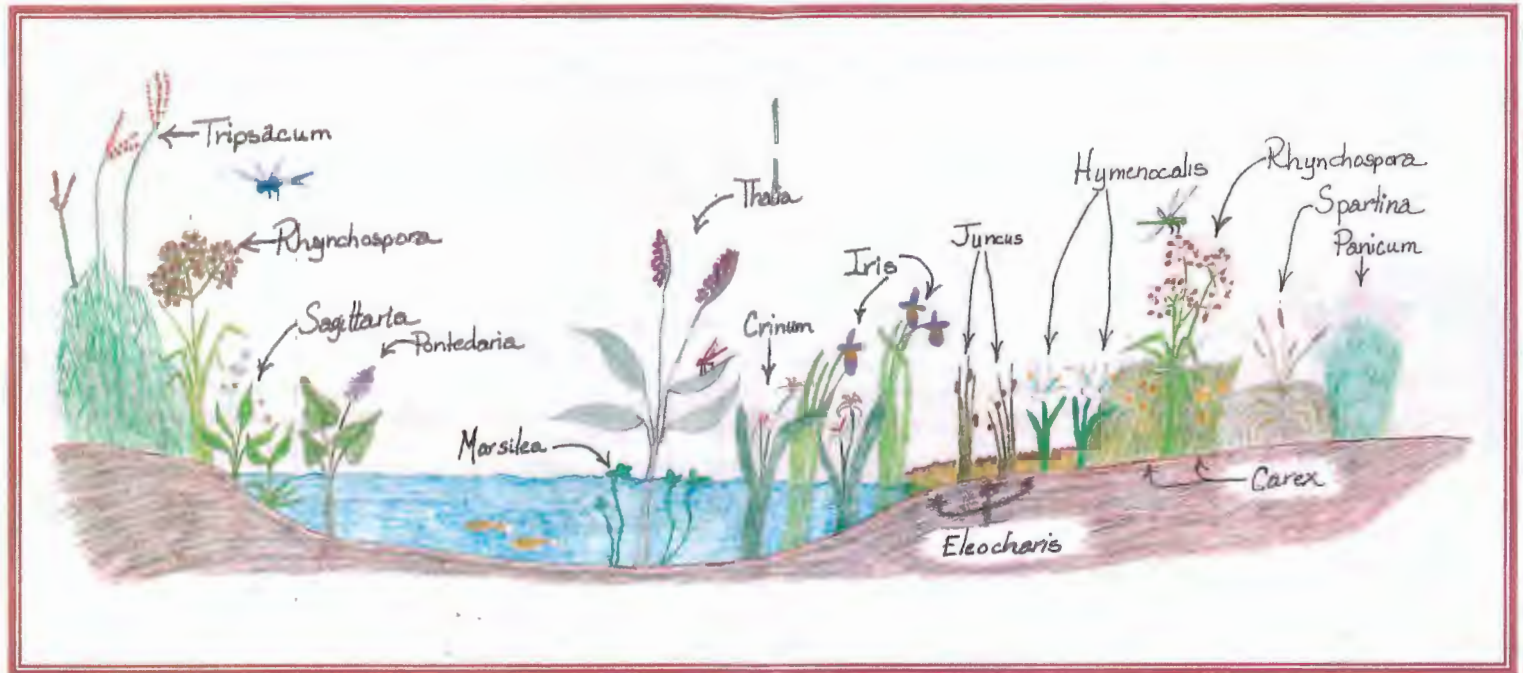
CROSS SECTION OF A GENERALIZED PRAIRIE WETLAND

Here at Sheldon Lake State Park, the original wetland basins were plowed and filled for agricultural purposes, leaving little or no “signatures” on the surface of where these basins once existed. To restore these critical wetlands, they were first identified and mapped, which allow for their re-excavation. Low levees were erected to hold water within the basins—mimicking the original hydrology of the area. The final step of planting the basins, completed the restoration. Six years later, vegetation monitoring showed the Sheldon-Sipocz method of re-excavating and restoring intact buried wetlands has proven to be a success.
