# Community Energy Action Plan

## Tanacross, AK

Tanana  
Chiefs  
Conference

February 2021

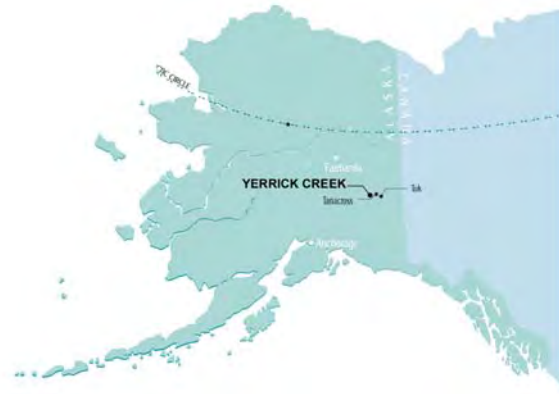
transmission infrastructure follows the highway right-of-way past the project site, this infrastructure (conductor) will need to be upgraded to handle the load from the project. Project capacity is expected to be 2-3 megawatts (MW). Project features would include a small diversion structure, an approximately 11,000 foot long penstock, powerhouse with a single impulse turbine (Pelton or Turgo) and generator, tailrace, small substation, and transmission line to and along the Alaska Highway, as shown in

Figure 1. The building season is short at this north latitude, so it will take two years to complete this project. This project not only will provide clean, renewable energy that will stabilize rates, but will provide a stable source of energy that can quickly come on line after power outages, which makes it one of the best renewable resources. The cost to maintain a hydro project is also significantly lower than diesel generation. The existing diesel generation plant in Tok will continue to supplement the grid as the hydro project is only expected to provide electricity for 100% of the load part of the year and down to approximately 10% of the load during low flow periods of the year, such as during the winter.

APC proposes to construct a run-of-river hydroelectric project that will interconnect with the grid supplying electricity to the communities of Tetlin, Tok, Dot Lake, and Tanacross. This grid is presently wholly reliant upon diesel generation. APC is the certified utility for this area along the Alaska Highway and is within the boundaries of APC's certificate from the Regulatory Commission of Alaska. This project is called the **Yerrick Creek Hydroelectric Project**. The project is located approximately 20 miles west of Tok on the Alaska Highway at Milepost 1339. Although APC's existing

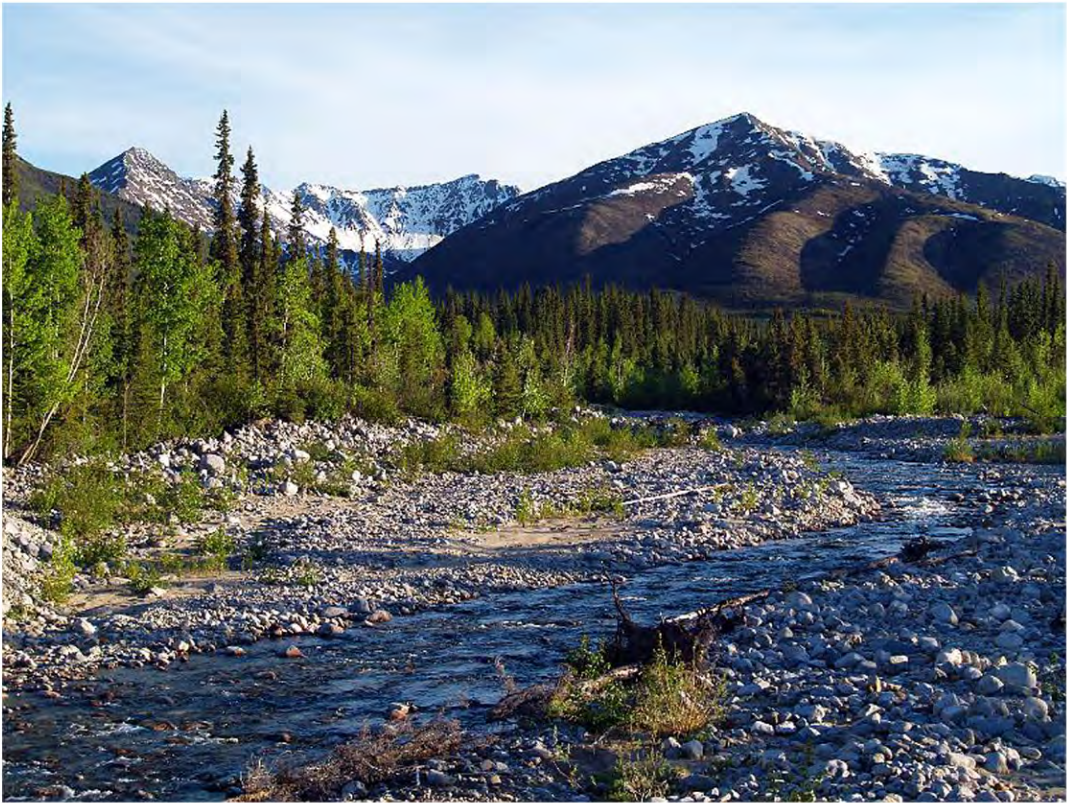
Above Photo: Looking up Yerrick Creek from Alaska Highway bridge.

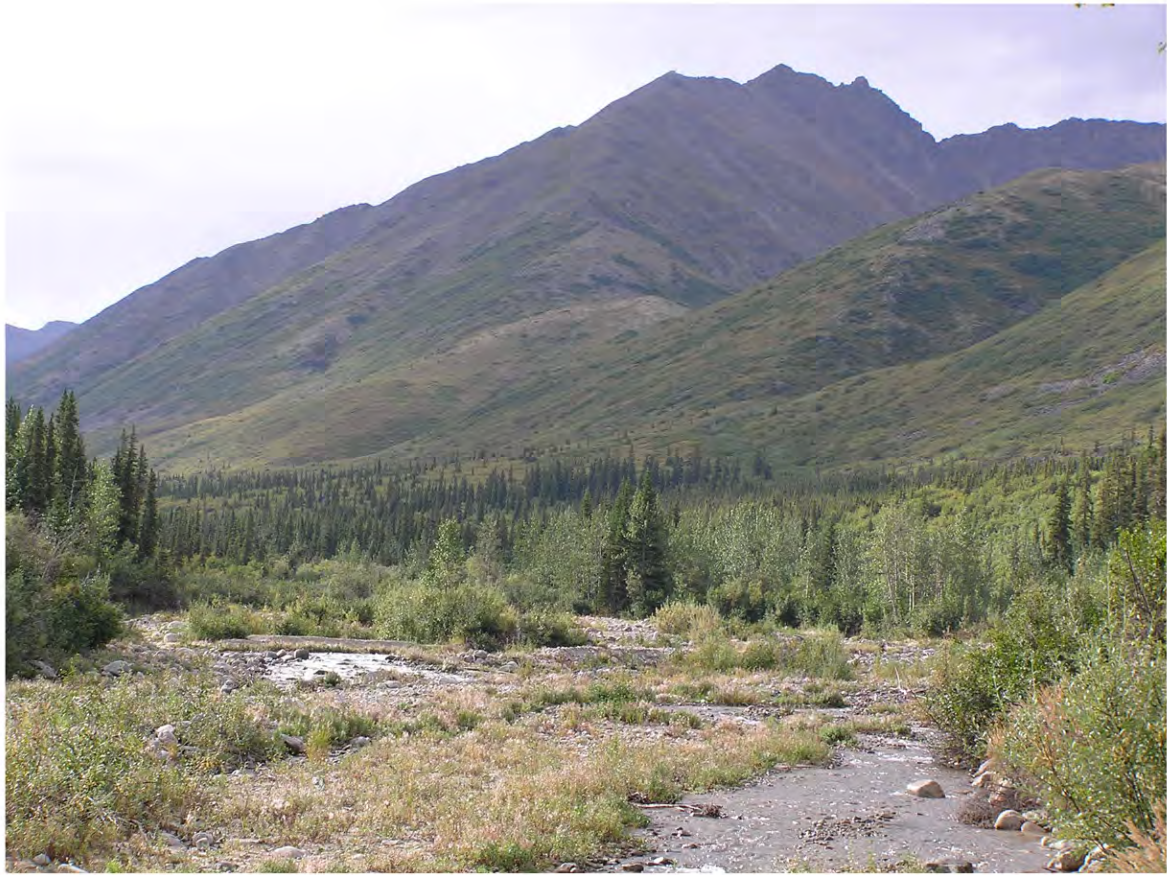
Above Photo: Yerrick Creek just above impoundment site

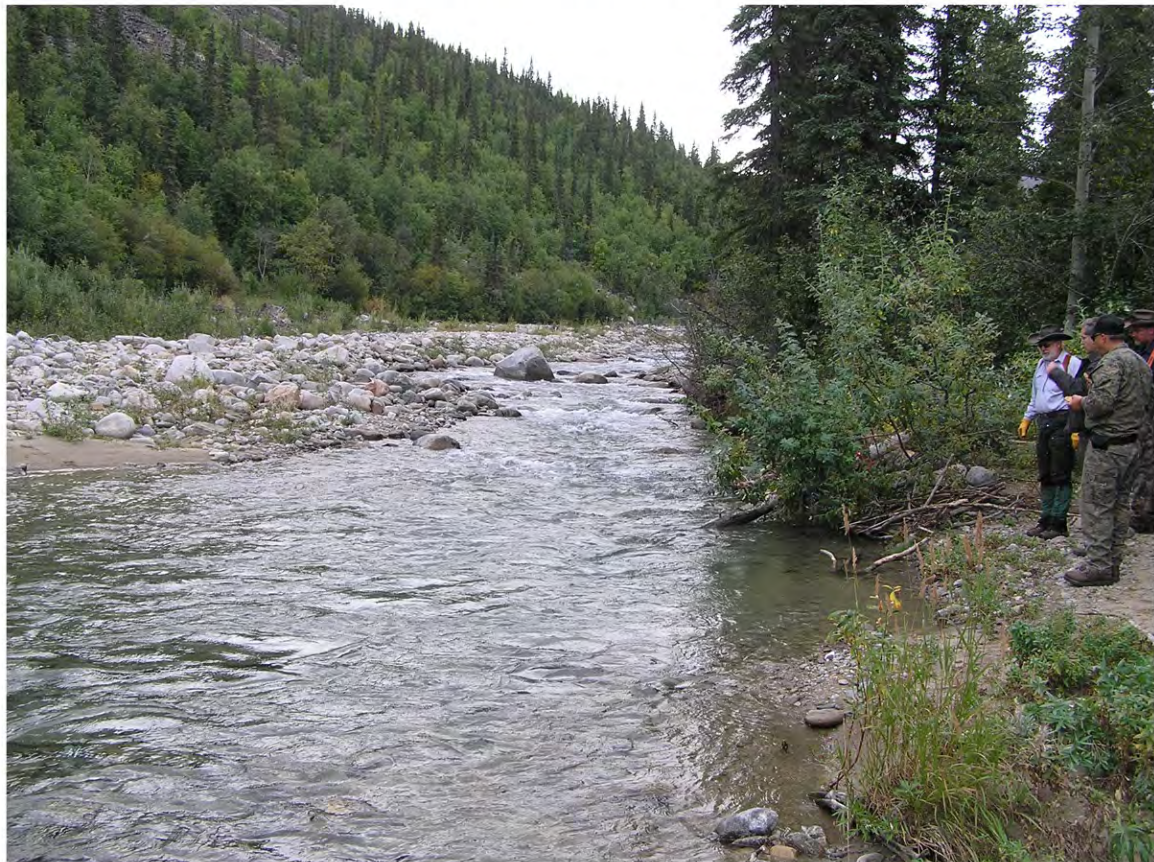
Above Photo: Yerrick Creek at gaging site.

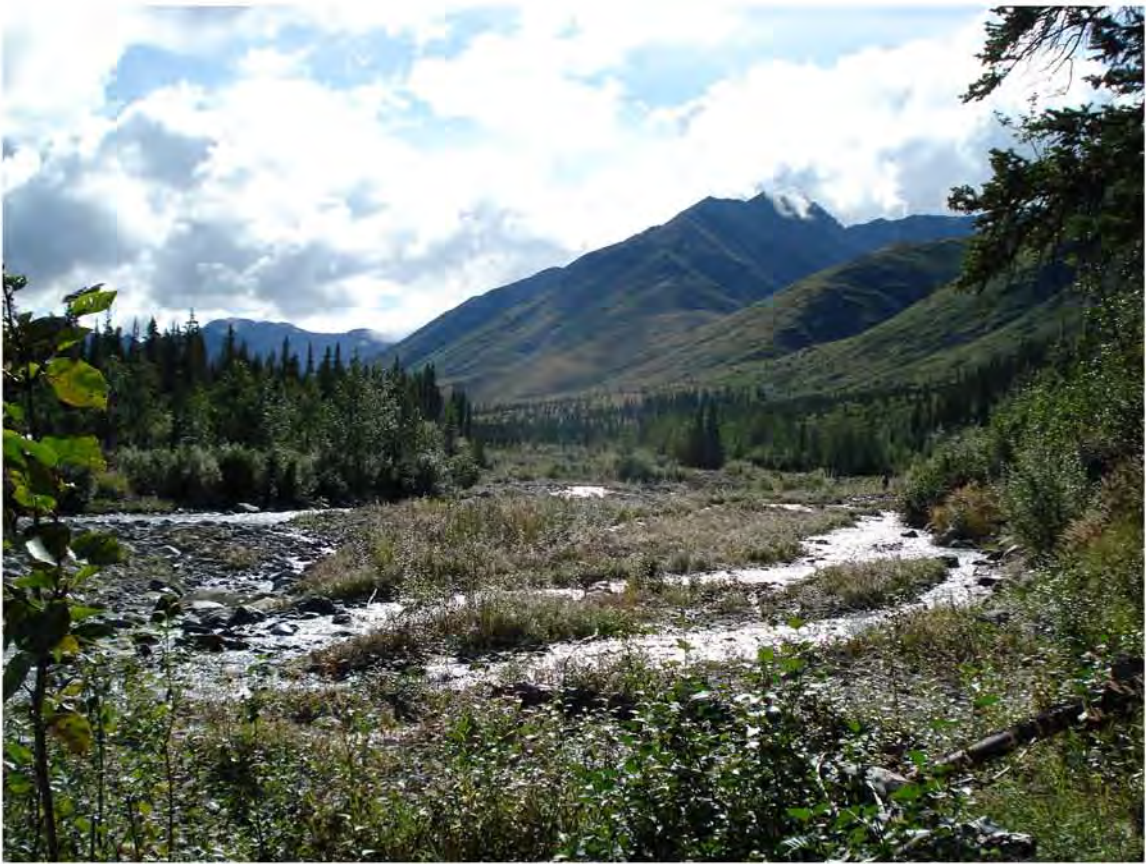
Above Photo: Yerrick Creek near impoundment site

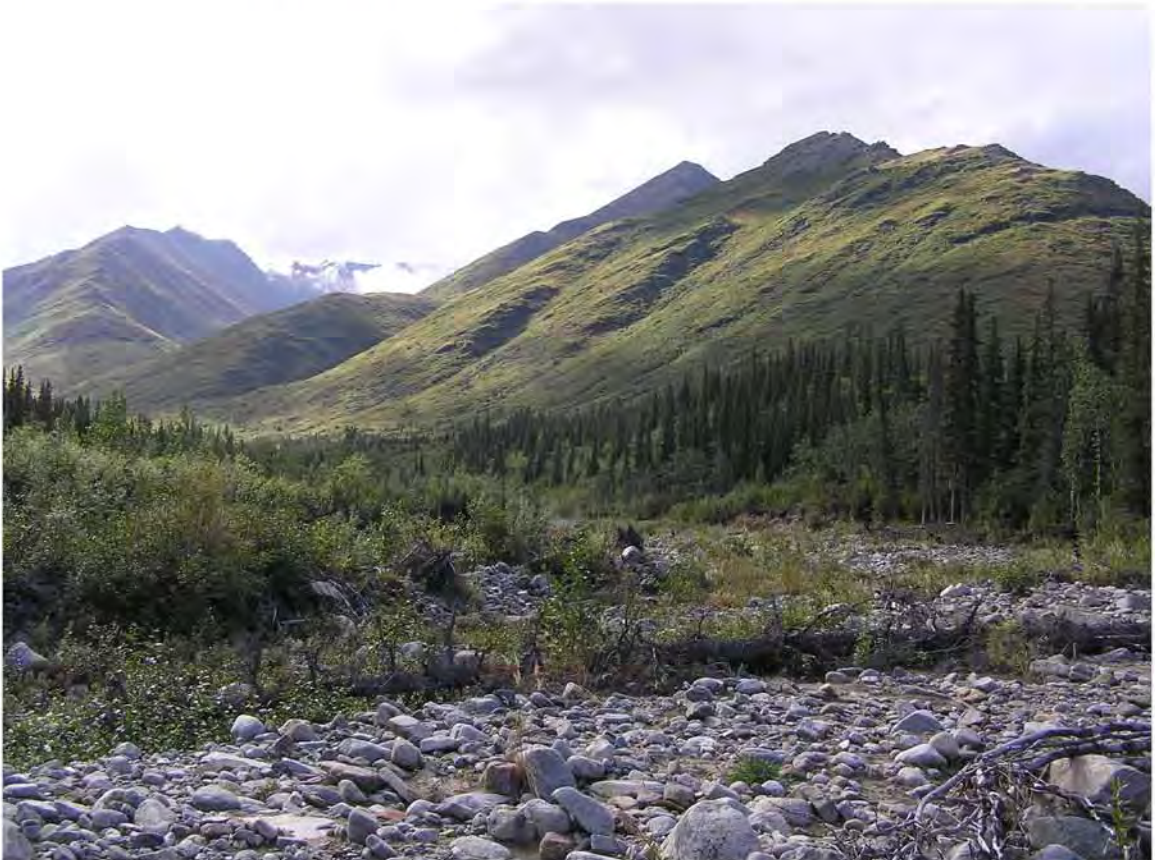
Above Photo: Yerrick Creek below impoundment site

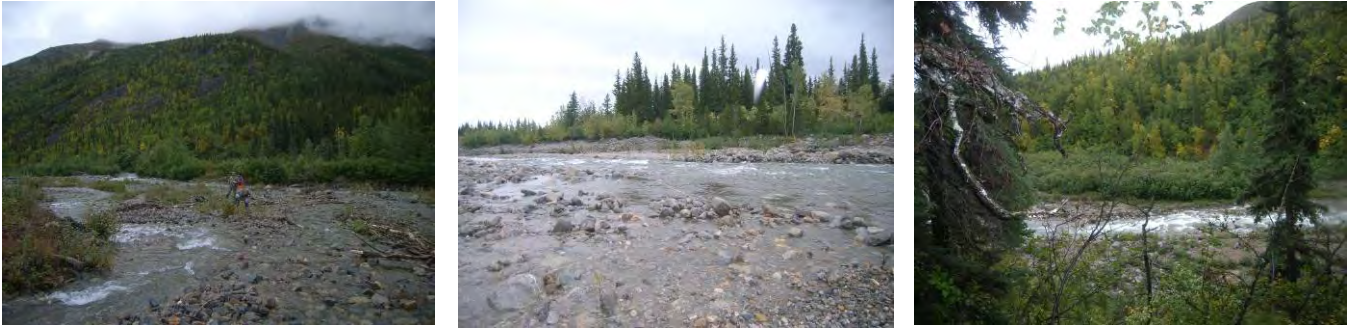
| <b>Parameter, units</b> | <b>Maximum</b> | <b>Minimum</b> | <b>Count</b> | <b>Mean</b> | <b>Median</b> |
|---|---|---|---|---|---|
| Silica, filtered, mg/L | 44 | 7.2 | 208 | 11.8 | 11 |

The project area is located along Yerrick Creek, a cobble-, gravel- and sand-substrate creek which crosses the Alaska Highway at approximately milepost 1339 (Figure 2). Most of the project area is undeveloped, with an open gravel waterway, adjacent forests, abandoned gravel side channels in various states of revegetation, and heavily forested banks (see images below). Specific legal and geographic descriptions for the property required for Preliminary Jurisdictional Determinations are included in Table 1.

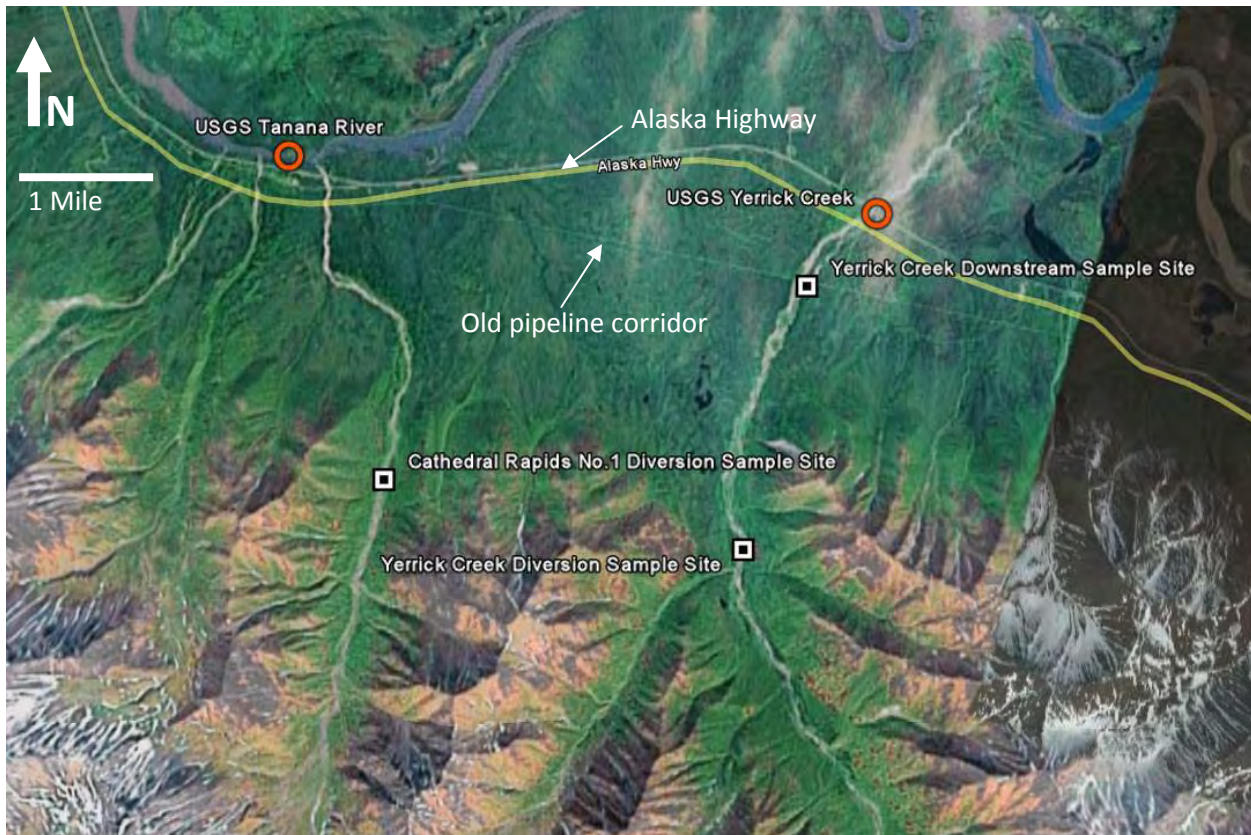
Figure 1.1. Sample locations on Yerrick Creek and Cathedral Rapids Creek No. 1 (Google Earth, 2008).

The hydroelectric project proposed by Alaska Power and Telephone (AP&T) will include an impoundment in Yerrick Creek just below the confluence of two tributaries with Yerrick Creek (Yerrick Creek Diversion Sample Site, Figure 1.1). A penstock will be constructed to carry water to a powerhouse to be constructed near the old pipeline corridor (Yerrick Creek Discharge Sample Site). A separate diversion and powerhouse system may be constructed on Cathedral Rapids Creek No. 1 as well. The impoundment would be in the approximate location of Cathedral Rapids No. 1 Diversion Sample Site (Figure 1.1). Power generated from the hydroelectric project would power Tok and surrounding communities during summer months and possibly supply some portion of the power supply for a larger portion of the year.

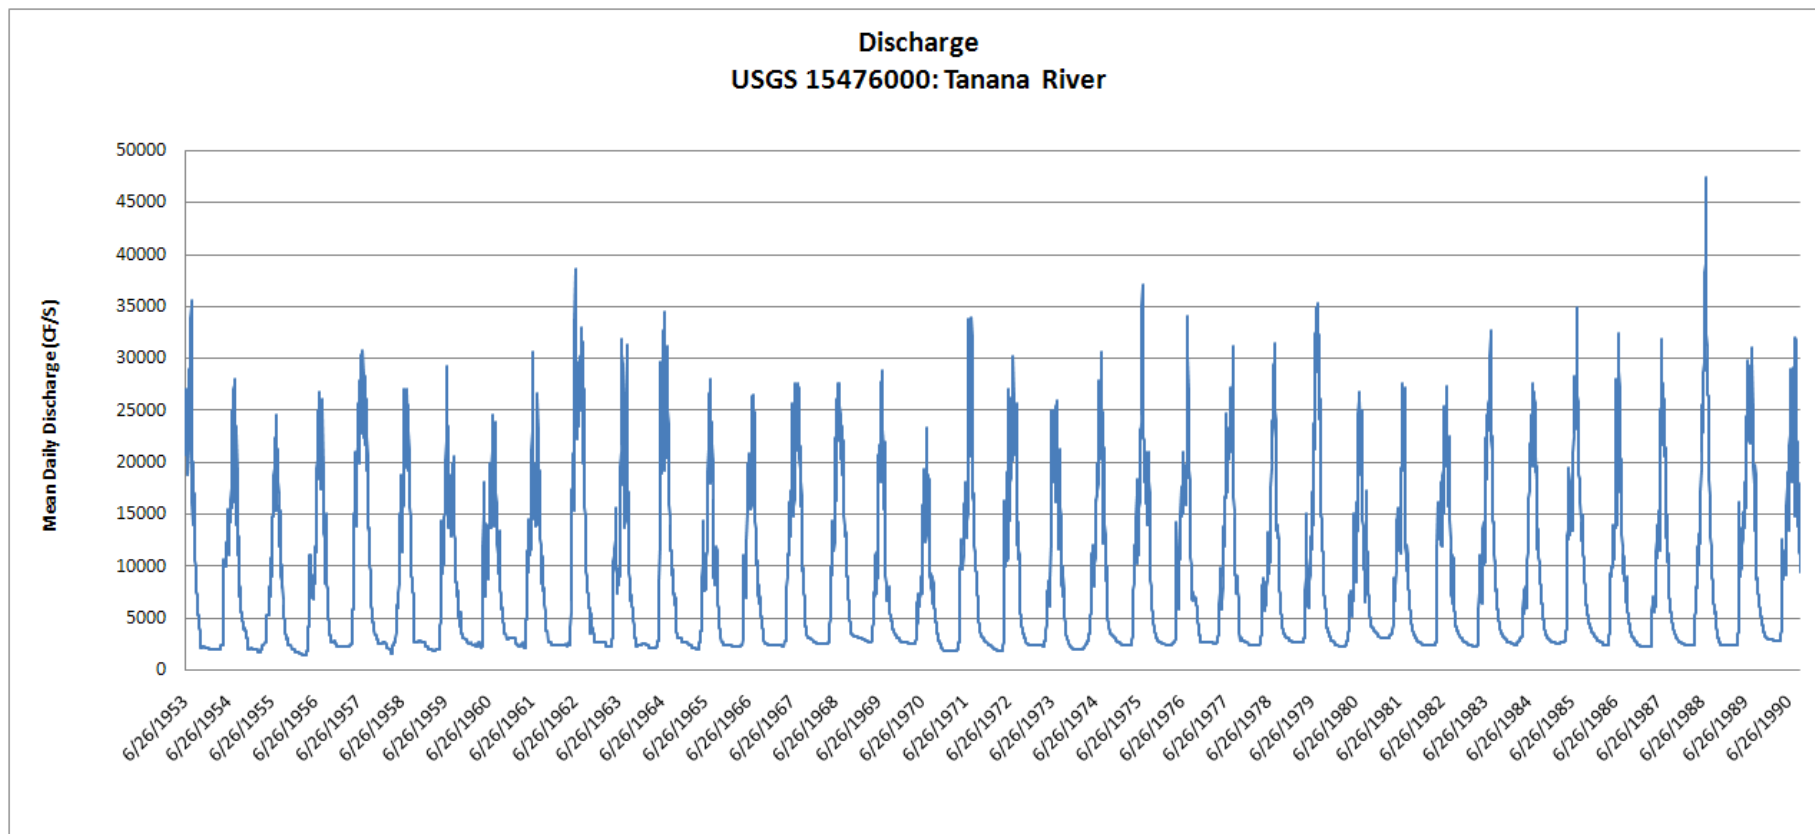
Figure 2.1. Tanana River mean daily discharge, 1953 through 1990 (USGS, 2008).

Nine of the ten highest daily discharge measurements for USGS 154760000 occurred between July 19<sup>th</sup> and 27<sup>th</sup> in 1988. Of the 50 highest daily discharge measurements, 27 occurred in July, 18 occurred in August, and 5 occurred in June, suggesting that summer rains cause the highest flows rather than snowmelt and breakup. If, however, the month of July 1988 is removed from the record, four of the top ten daily discharges occurred in August and three occurred in each June and July. Likewise, excepting July 1988, 29 of the 50 highest daily discharges occurred in August, 14 occurred in July, and 7 occurred in June.

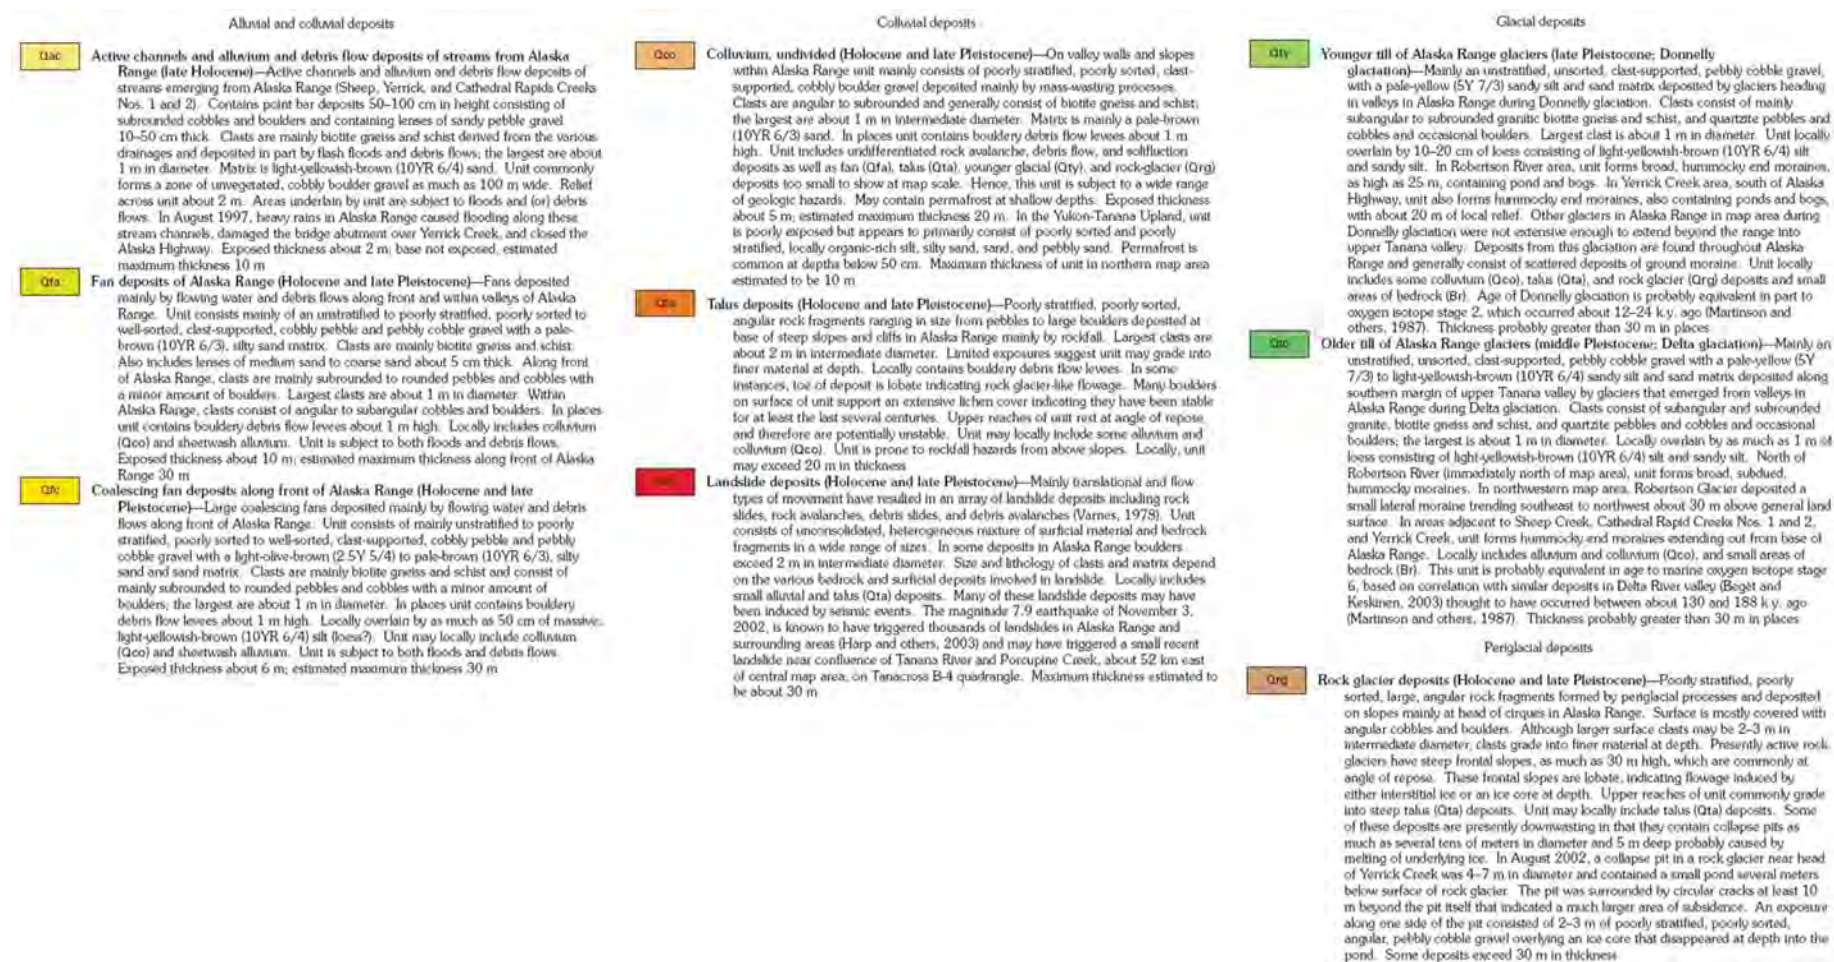
Figure 2.6. Key to geologic map (Figure 2.5).

According to Carrara (2004), the map units that occur in the Yerrick Creek drainage include Qac, Qco, Ata, Qfa, Qty, Qto, Qrg, and Qls (Figures 2.5, 2.6). Cathedral Rapids Creek #1 drains an area that includes map units Qac, Qfc, Qto, Qfa, Qrg, and Qta. These map units include alluvial, colluvial, glacial, and periglacial deposits. Biotite gneiss and schist are among the rock types found in the surface geology of the area.

Carrara (2004) notes that areas underlain by the Qac unit are subject to floods and debris flows. The Yerrick Creek bridge abutment was damaged by flooding in August 1997 (Carrara, 2004; Figure 2.6). With regards to map unit Qto, Carrara (2004) notes that in the Yerrick Creek and Cathedral Rapids Creek No. 1 areas the unit forms hummocky end moraines extending out from the base of the Alaska Range.

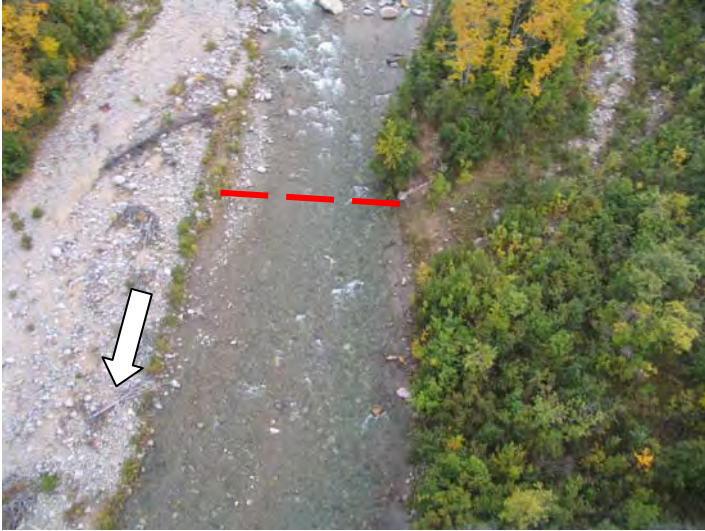
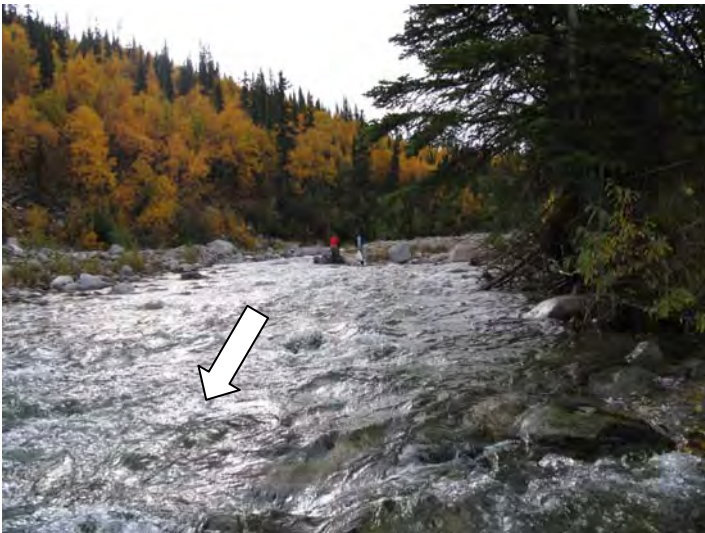
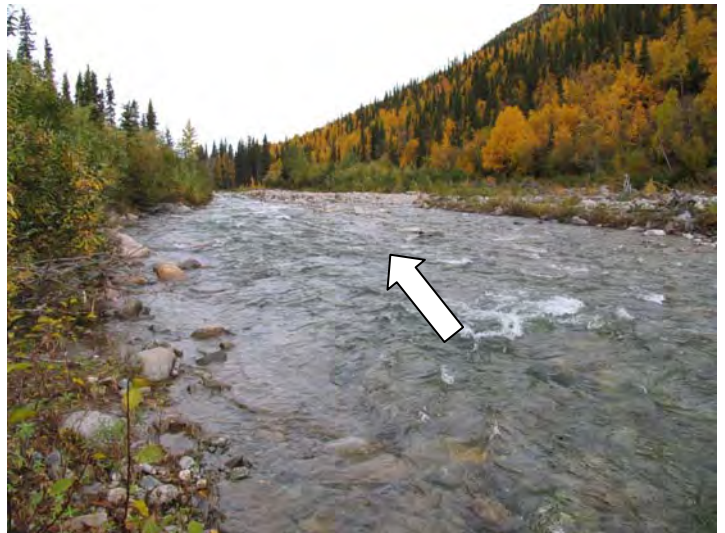
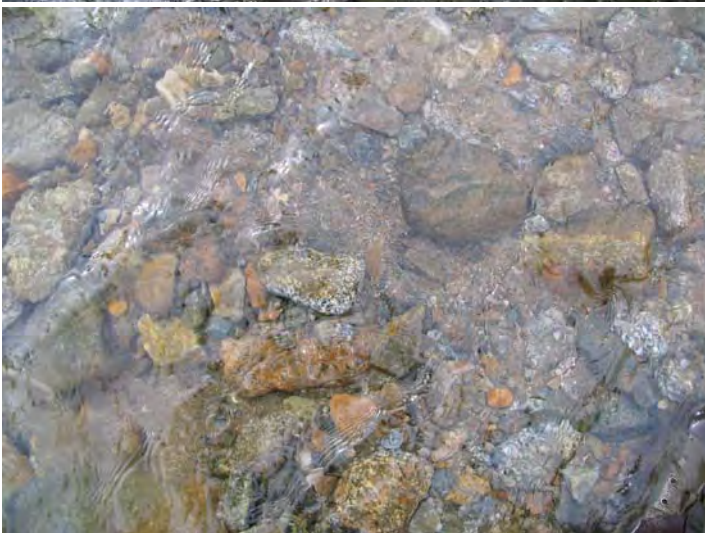
## Yerrick Creek Diversion Site Photos

Upper Left: aerial view  
Upper Right: site view  
Middle Left: upstream view  
Middle Right: downstream view  
Lower Left: sediment view

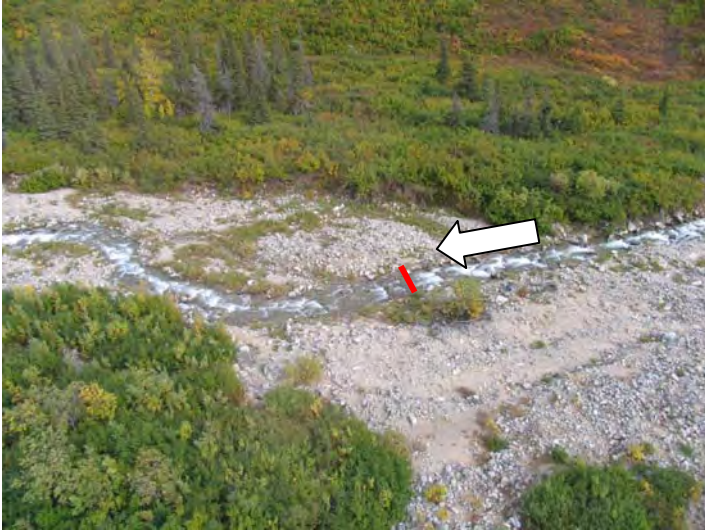
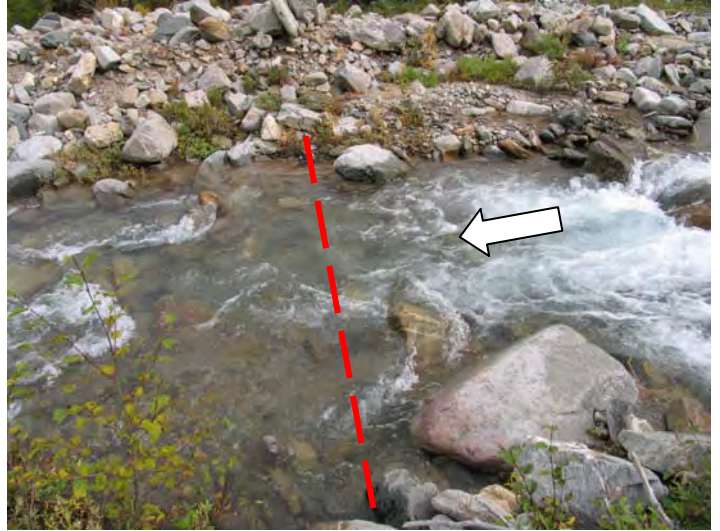
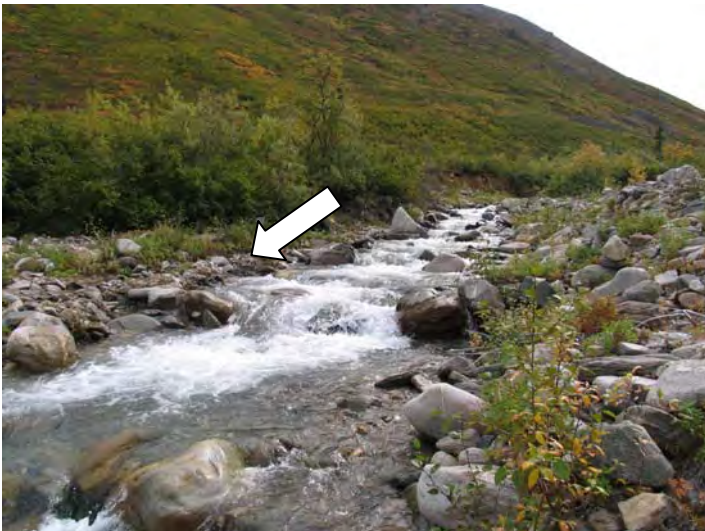
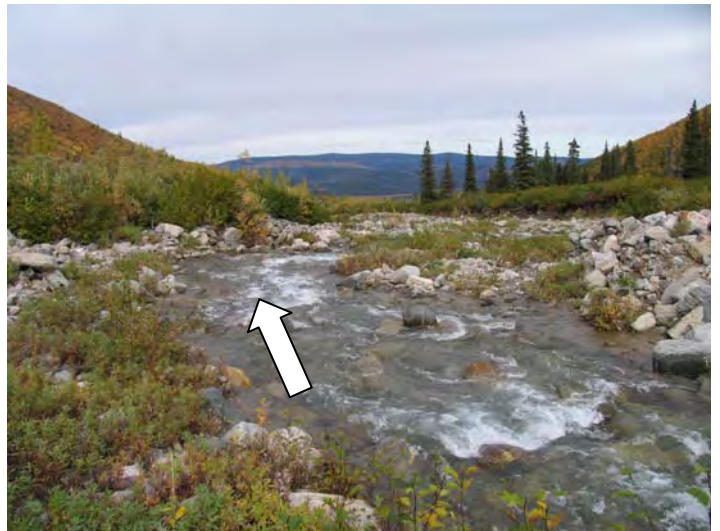
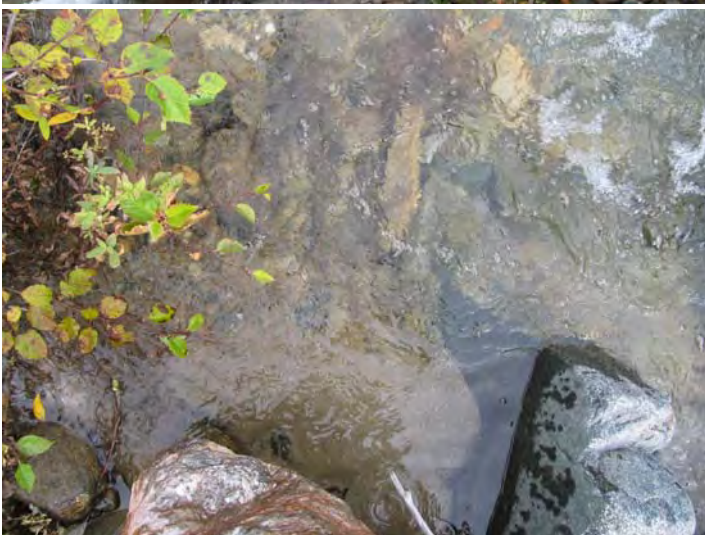
### Cathedral Rapids Creek No. 1 Site Photos

Upper Left: aerial view  
Upper Right: site view  
Middle Left: upstream view  
Middle Right: downstream view  
Lower Left: sediment view

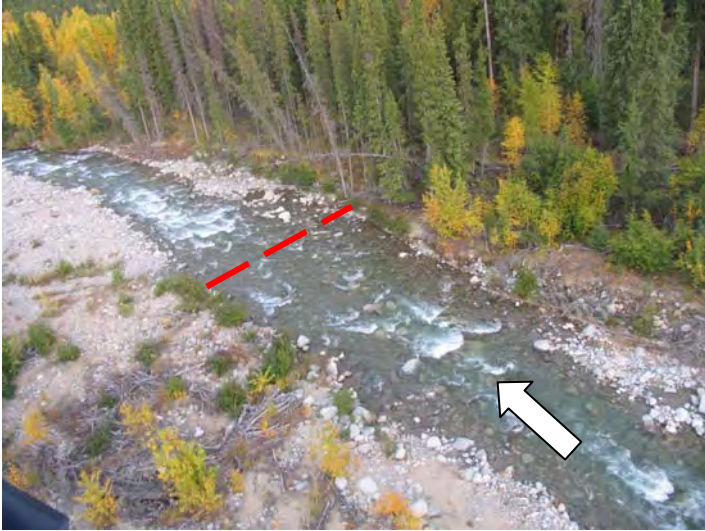
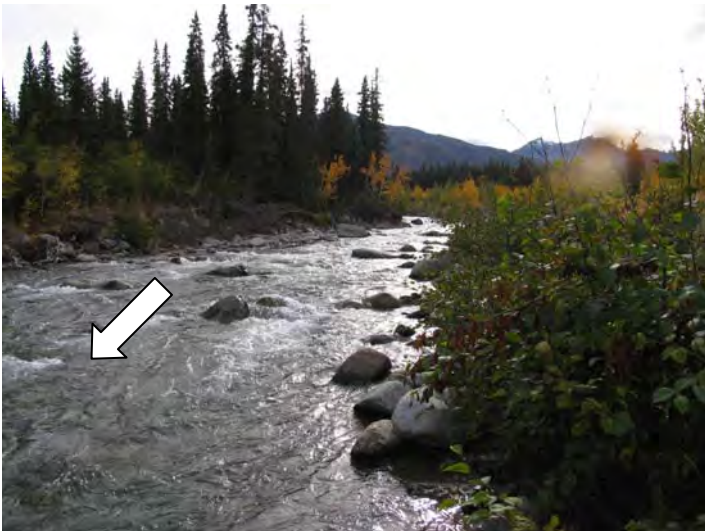
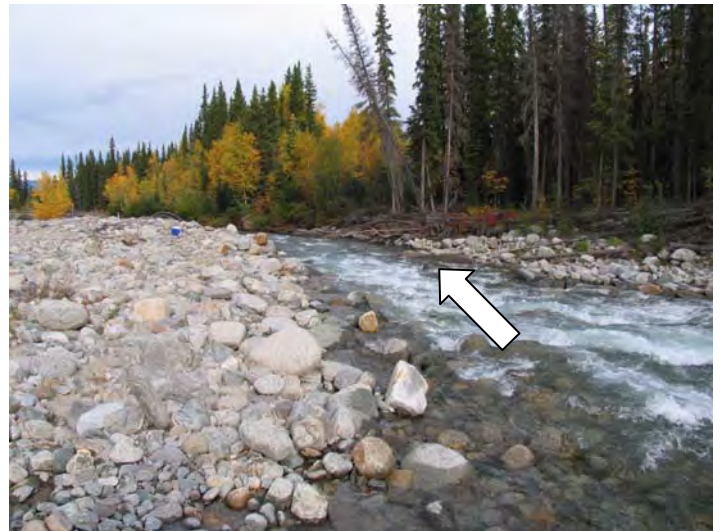
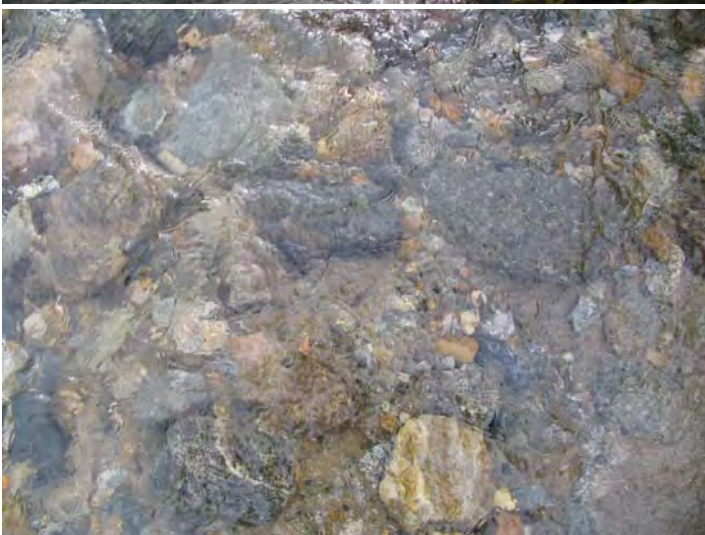
## Yerrick Creek Downstream Site Photos

Upper Left: aerial view  
Upper Right: site view  
Middle Left: upstream view  
Middle Right: downstream view  
Lower Left: sediment view
