# Thames Water Utilities Limited - Drought Permit Application 2022

Environmental Assessment of the Baunton (1) Drought Permit

Report for Thames Water Utilities Ltd

ED 13714 | Issue number 3 | Date 25/10/2022

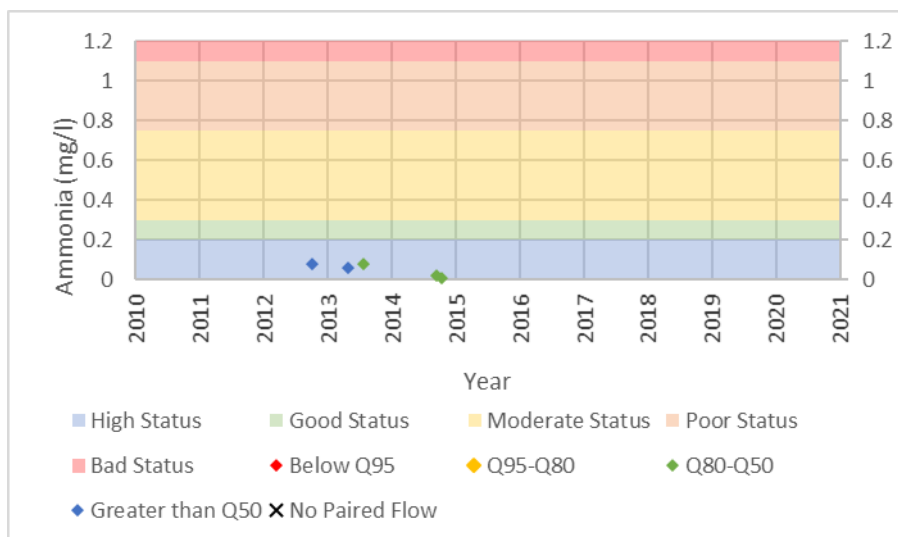
**Figure 4.6 Total Ammonia in River Churn (Churn at Perrot’s Brook), Incorporating Appropriate WFD Status Bands**

Total ammonia concentrations at Perrott’s Brook gauge were all consistent with the WFD standard to support Good status for fish and invertebrates (0.3mg/l) and show no association with differing flows.

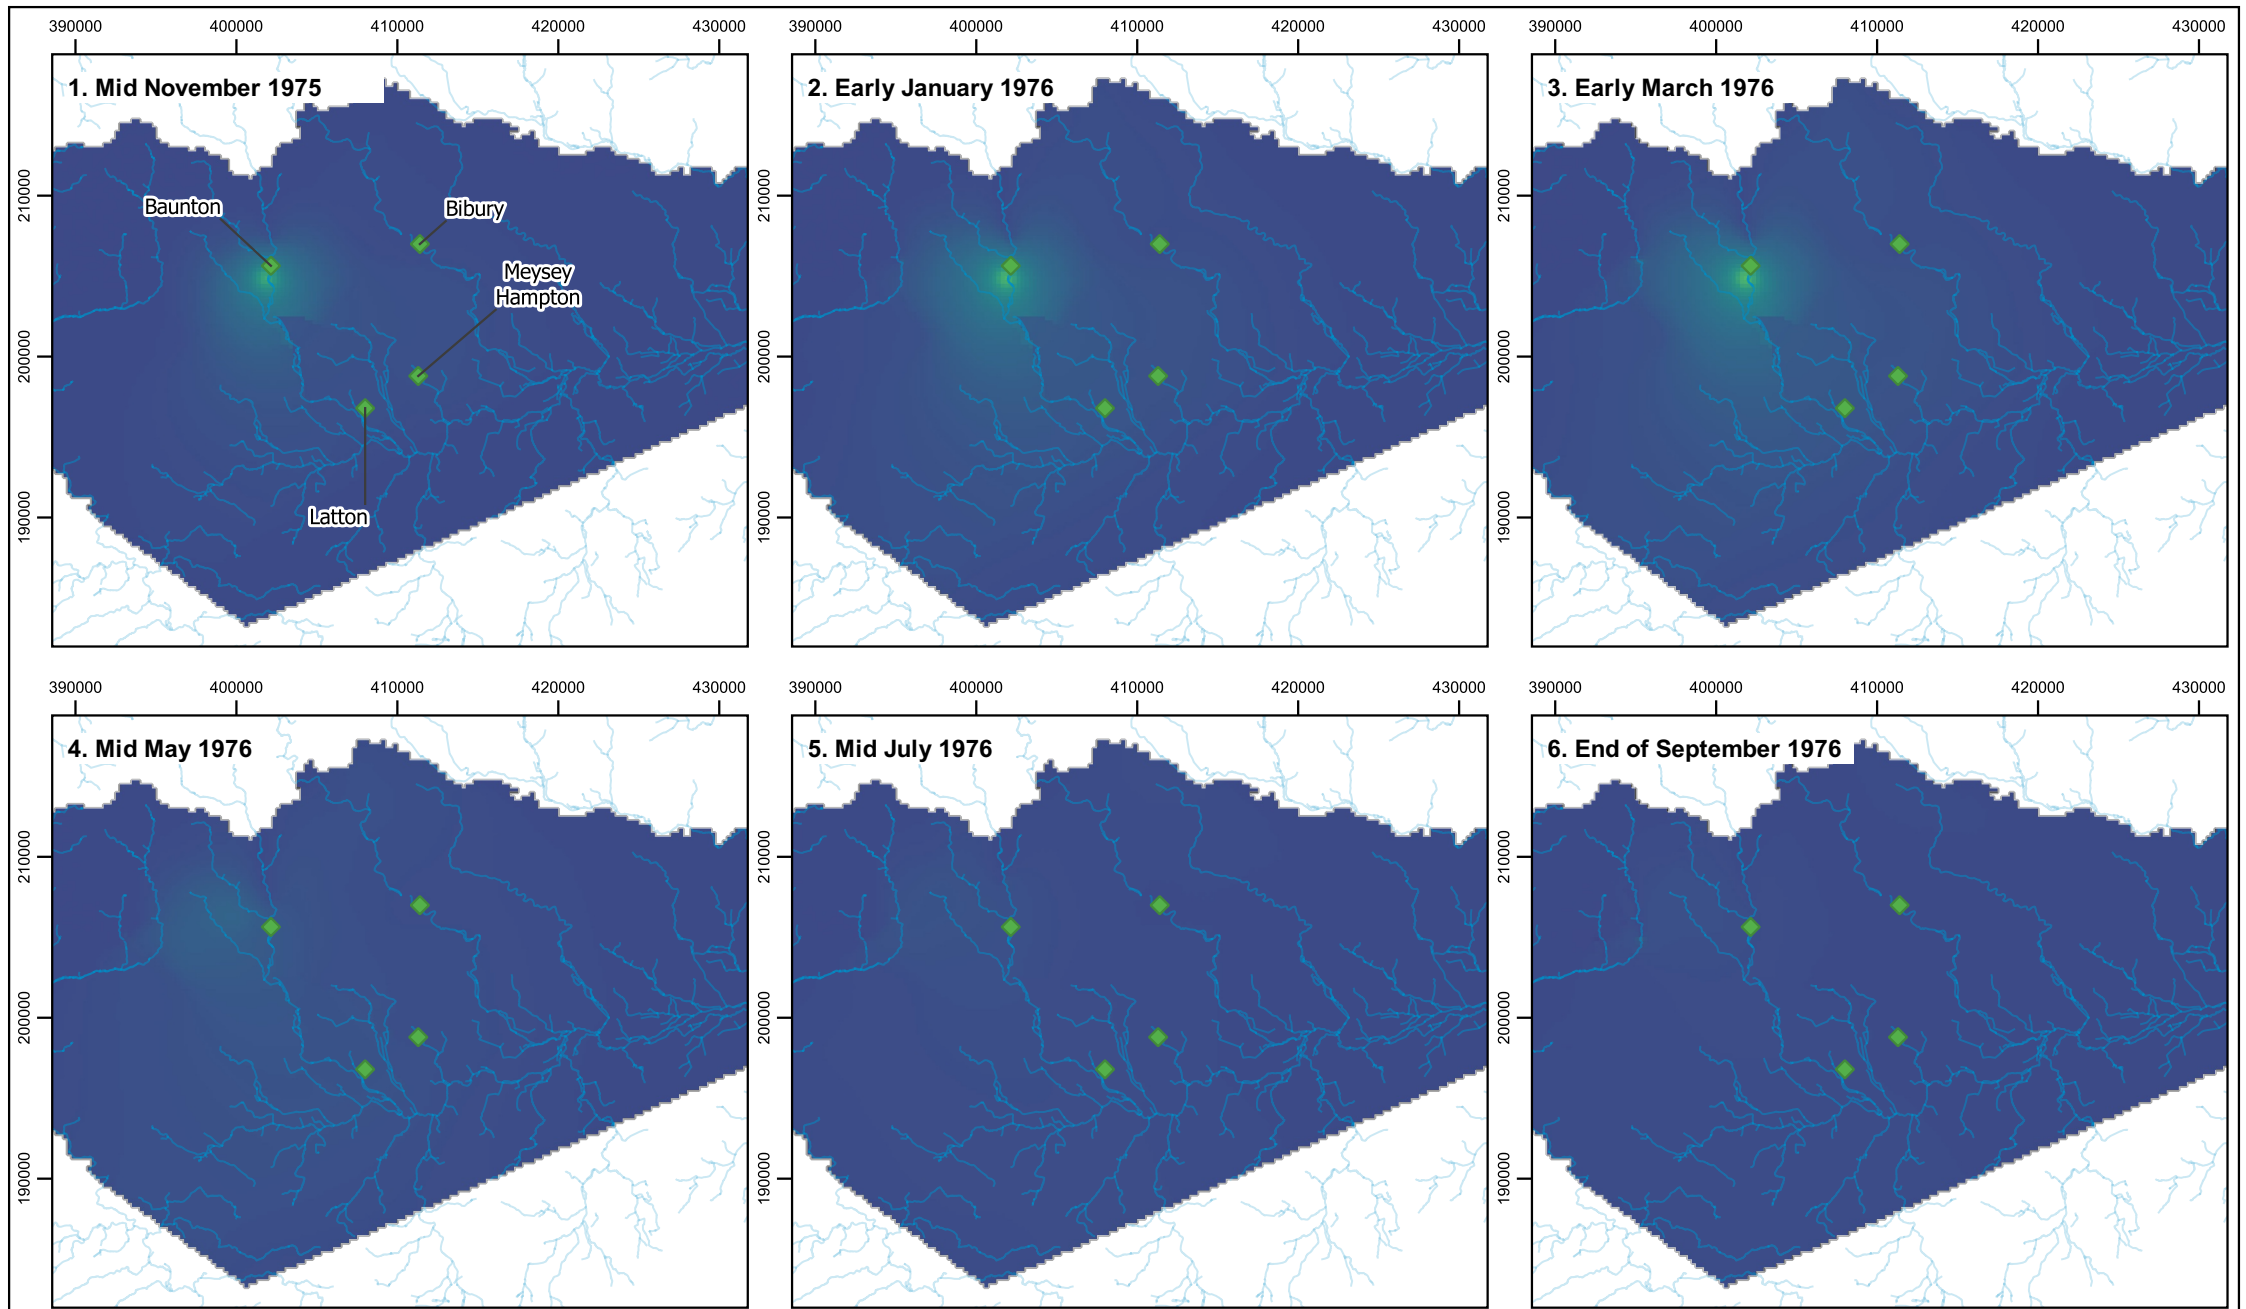
The groundwater modelling has been used to understand the increased extent of groundwater drawdown associated with the Baunton (1) drought permit. The difference in groundwater drawdown in the Inferior Oolite under baseline (without drought permit) conditions and Baunton (1) drought permit conditions is illustrated on **Figure 4.18** below.
