River Dee/ Afon Dyfrdwy SSSI Restoration Technical Report

March 2013

Project: River Dee SSSI Restoration Project No: B1867400
 Client: Environment Agency
 Document Title: Technical Report
 Ref. No: A02

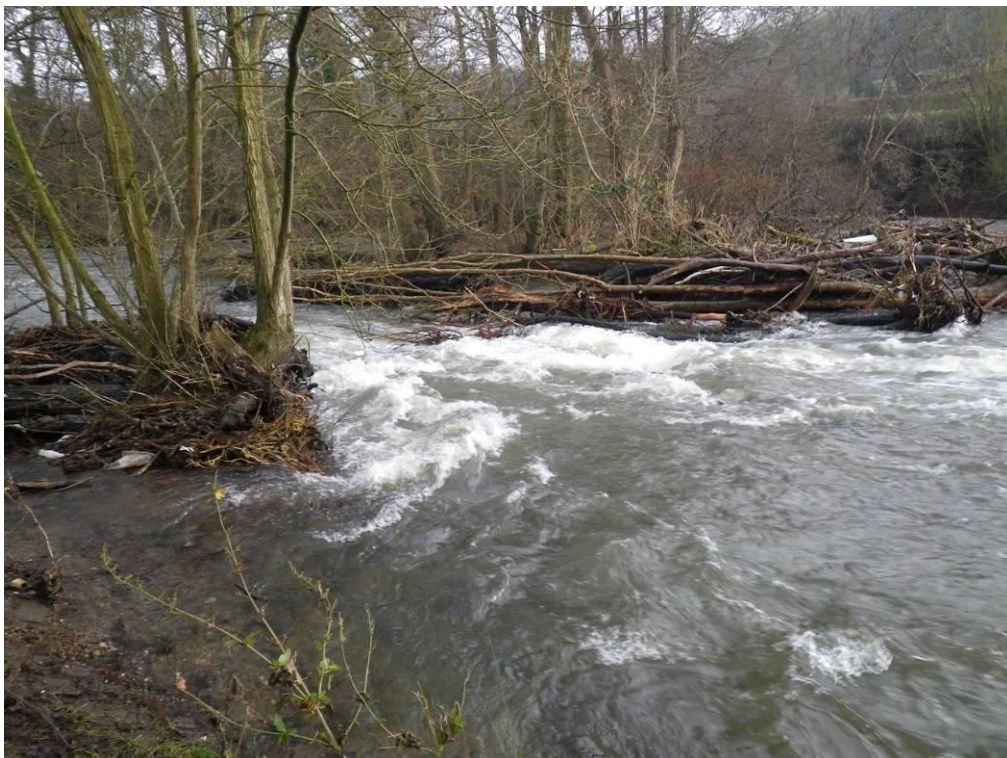
From approximately 2km upstream to the confluence of the Ceiriog and Dee there is evidence of increased deposition, including silt bars and over bank deposits (see Deposits Map, Appendix C). This suggests that this area acts as a sediment sink due to the flatter gradient coinciding with the main stem Dee floodplain. The lower gradient causes deposition of large amounts of cobble and fine material, which has resulted in mid-channel islands and secondary channels. This deposition of fine material may create suitable spawning and parr habitat for salmonids and optimum bullhead conditions. Ammocoete habitat would be expected in the slower flow marginal areas where silts are deposited. In particular, there are a high number of large woody debris accumulations which have resulted in alterations to flow types across the channel and increased deposition where these occur, forming these islands (Figures 5.2 and 5.3).

Figure 5.2 Large woody debris accumulations which have resulted in formation of chute flow and accumulation of sediment in front of and behind large woody debris, River Ceiriog

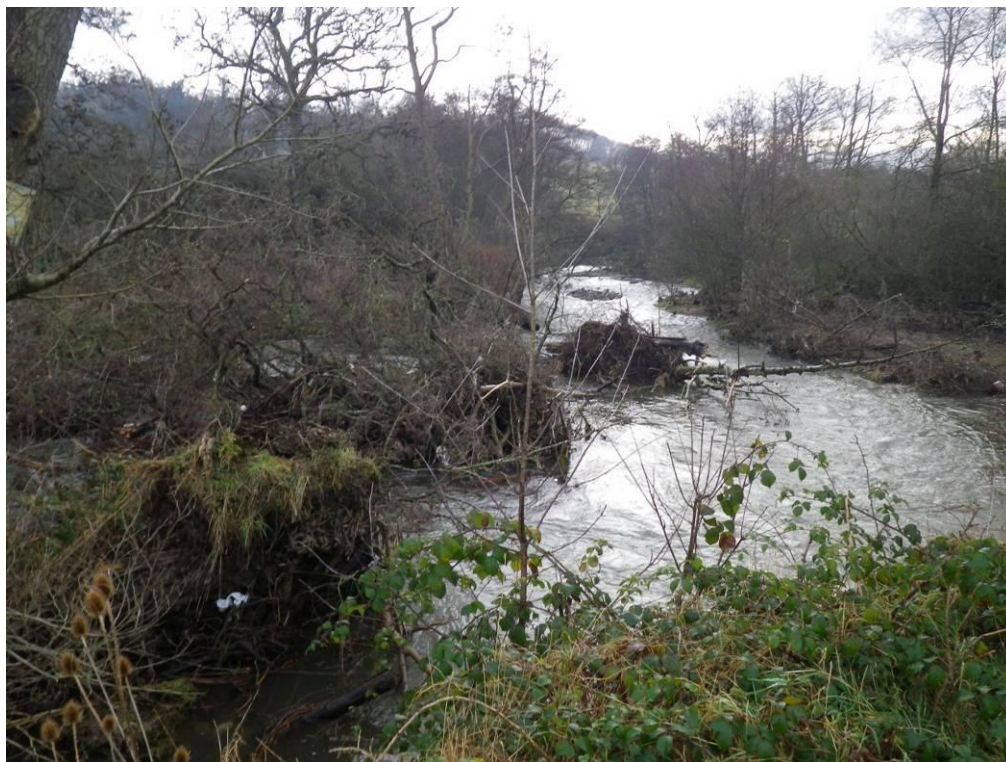
Figure 5.3 Islands and deposits forming as a result of large woody debris accumulations, River Ceiriog

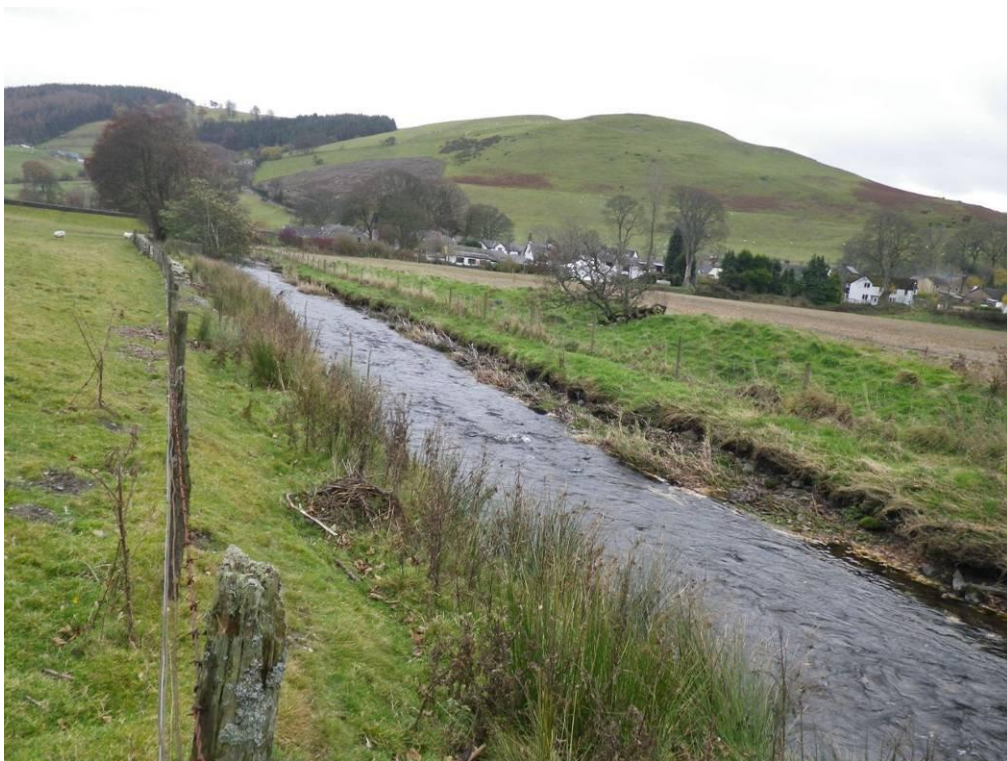
Figure 5.4 indicates an artificially straightened section in spot check CEI002SP, where incision appears to have occurred, limited by the development of an armoured cobble bed. It is likely that this channel was straightened to increase slope and stop gravels dropping out. This will be detrimental to all fish species as straightening reduces flow and bed substrate variation, depriving gravel deposition (important for spawning) and the loss of other important in-channel and riparian habitat necessary to support diverse fish assemblages.

Figure 5.4 Example of straightened section with incision in spot check CEI002SP, Afon Ceiriog

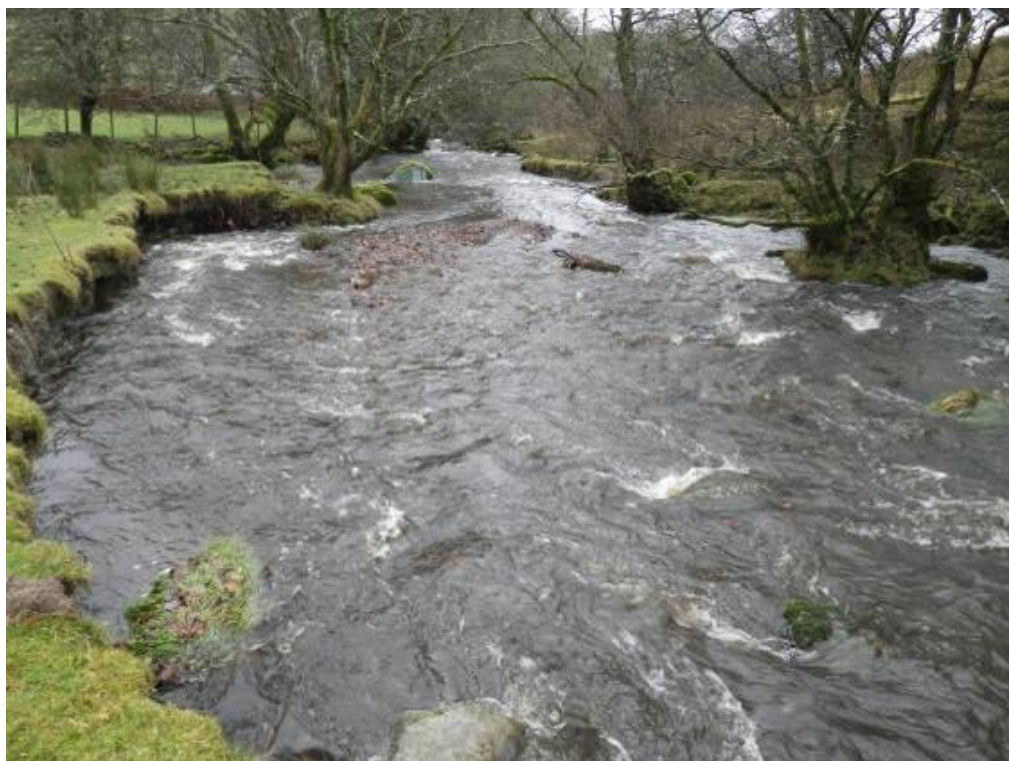
Figure 5.5 Active section with erosion and channel cut islands, Afon Mynach

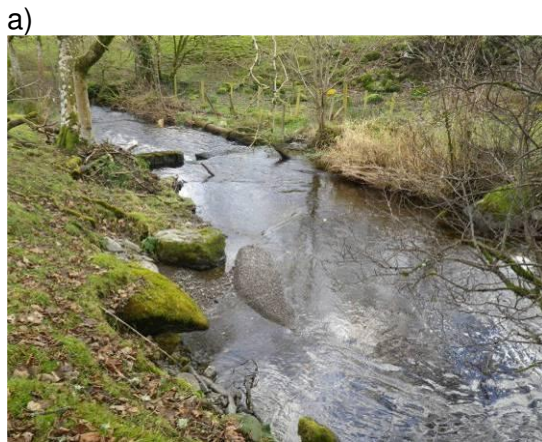
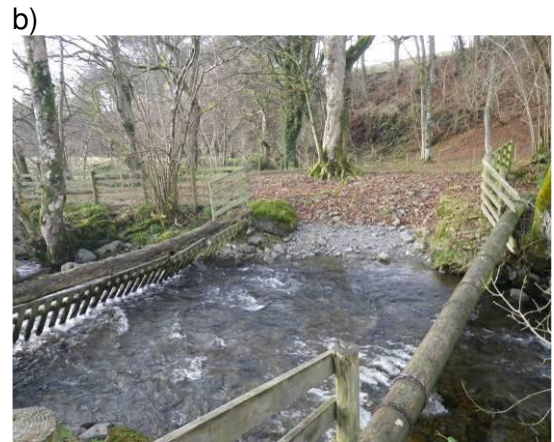
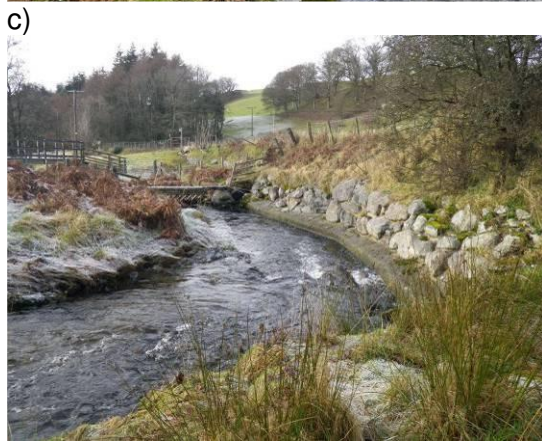
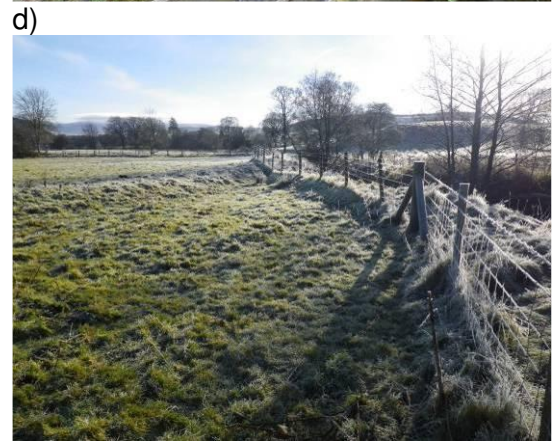
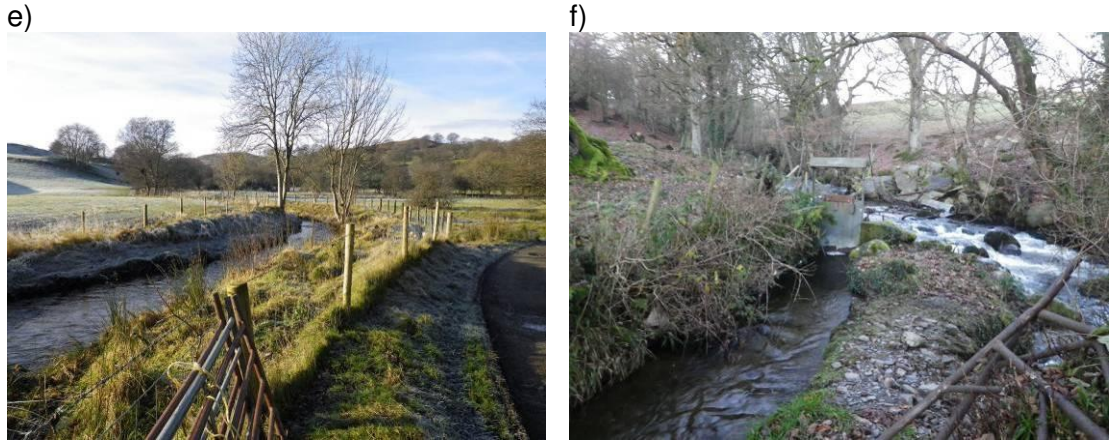
Figure 5.8 a) Weir for water supply; b) managed water access point for livestock; c) bank protection on outside of bend; d) straightened section; e) embanked section (probably using spoil taken from new course) and f) sluice for domestic hydropower scheme, Afon Meloch

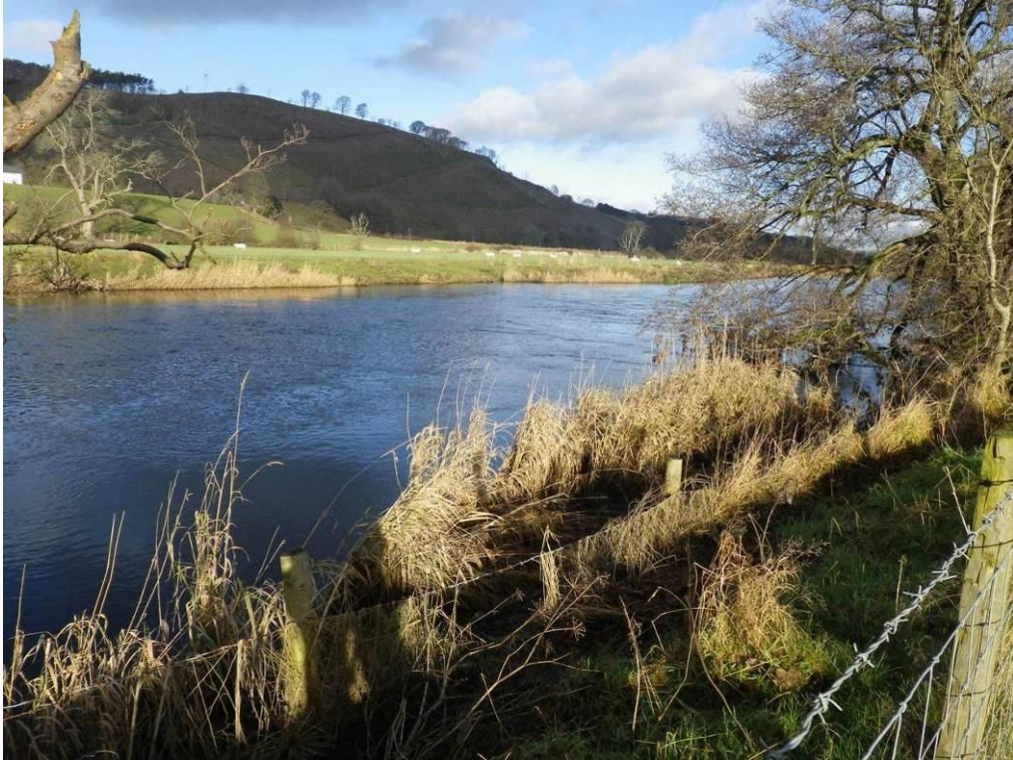
During the November/ December 2012 surveys the bed material was found to be obscured by the water depth but the observed bank material was earth (silt, sand and clay) with a mix of glacial till. The banks are mainly vegetated with grass, which corresponds to a predominant land use of rough pasture for livestock. The riparian zone is generally fragmented with patches of woodland, some thin tree lining or absence of trees entirely (Figure 5.9).

Figure 5.9 Typical section of Upper Dee with floodplain confined by steep valley sides

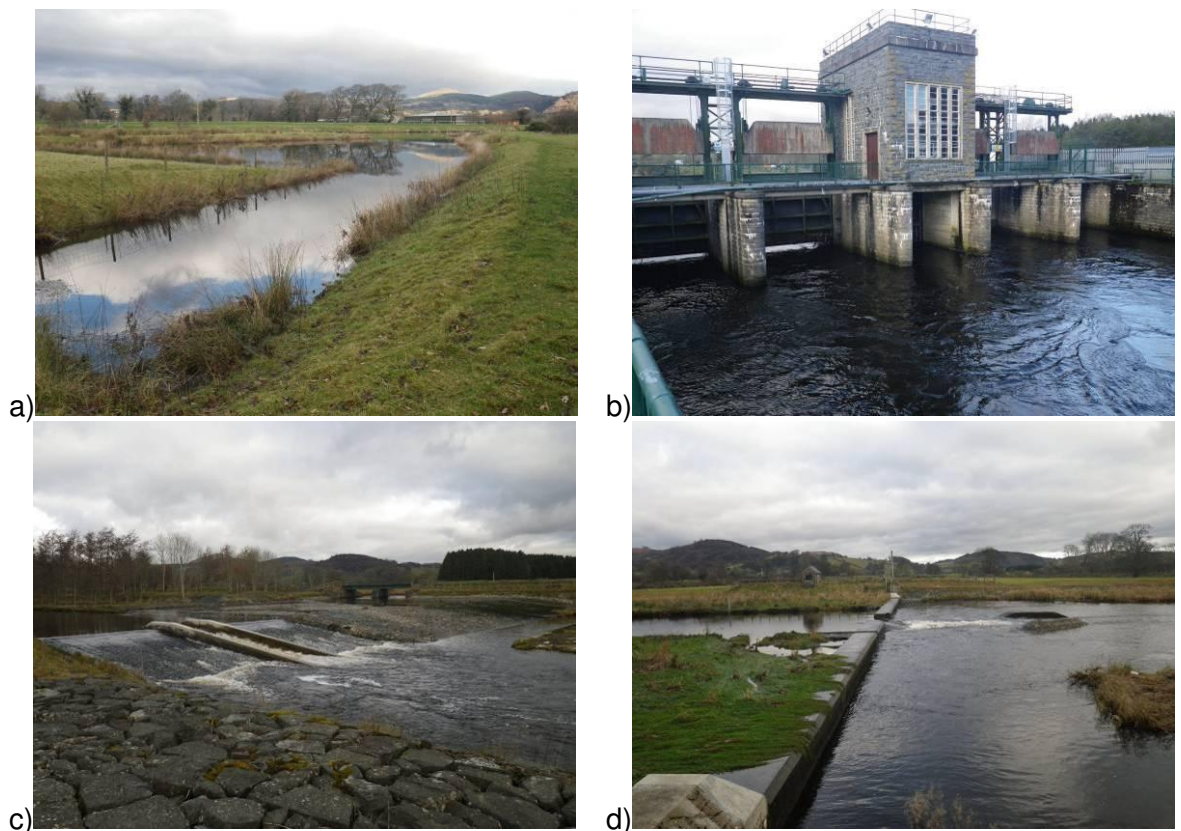
Major construction works have taken place on the Upper/Middle Dee associated with flow regulation. At the Bala Lake/ Llyn Tegid outfall there has been major channel straightening and realignment to accommodate the Bala Lake system for water regulation (Figure 5.11a-d). The Dee and Treweryn confluence was recorded as having a low conservation status because the channelisation works have created a uniform morphology and significantly affected the fluvial processes. At the Bala lake outlet there is a sluice gate (Figure 5.11b), salmon steps (Figure 5.11c), weir (Figure 5.11d) and access bridge. The sluice has five metal gates that can be operated independently. The concrete weir (Figure 5.11d) is circa 1.5m high and spans the width of the river which is approximately 25m wide upstream of the weir and 60m downstream. The river flow is restricted through a 5m section of the weir. The salmon steps (Figure 5.11c) are constructed from concrete and stone and are approximately 15m wide and 2m high. The salmon steps may restrict upstream migration of lamprey.

Figure 5.11 Structures at Treweryn confluence; a) Side channel right bank probably for flood storage, b) Sluice gate to control flow rate in Dee c) Salmon Steps and d) Weir by Bala Enterprise park

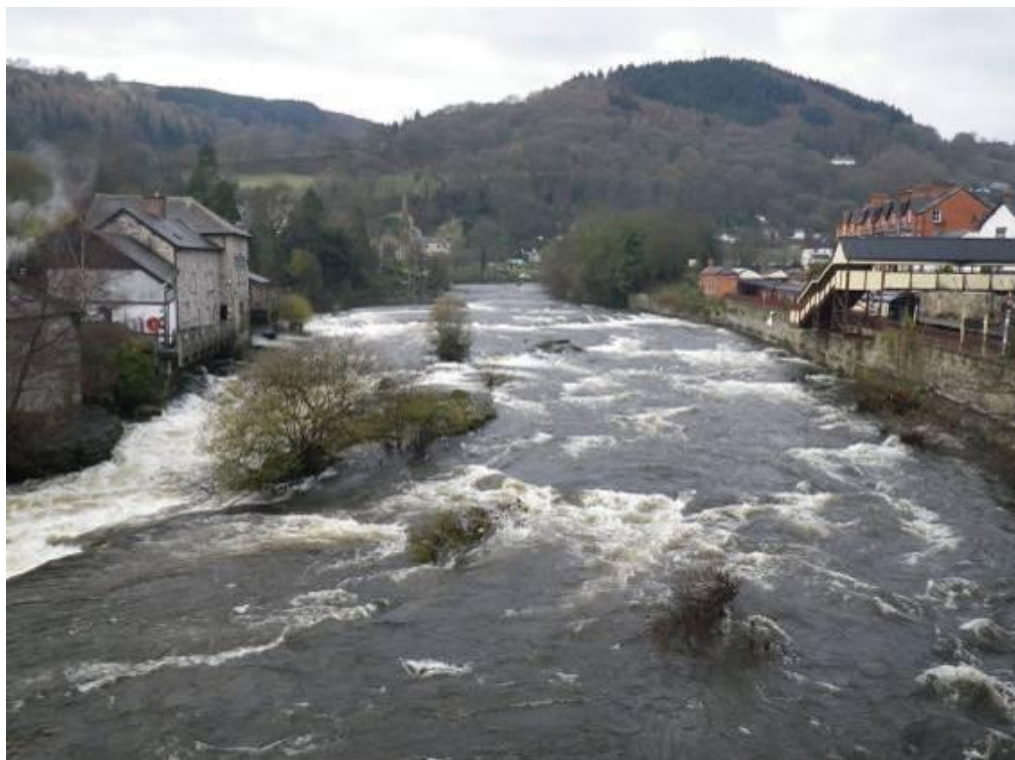
At Llangollen the Dee is constrained by bank protection, embankments or walls. However, there was evidence that some geomorphological processes are still occurring, with the presence of mid-channel silt and gravel deposits, some of which are vegetated (Figure 5.12). Diverse habitats were still present, although marginal habitats of value to juvenile fish and lampreys are generally absent in areas of reinforcement. Himalayan balsam was recorded along the upper reaches and along the banks within the town of Llangollen.

Figure 5.12 River Dee at Llangollen with vegetated mid-channel islands

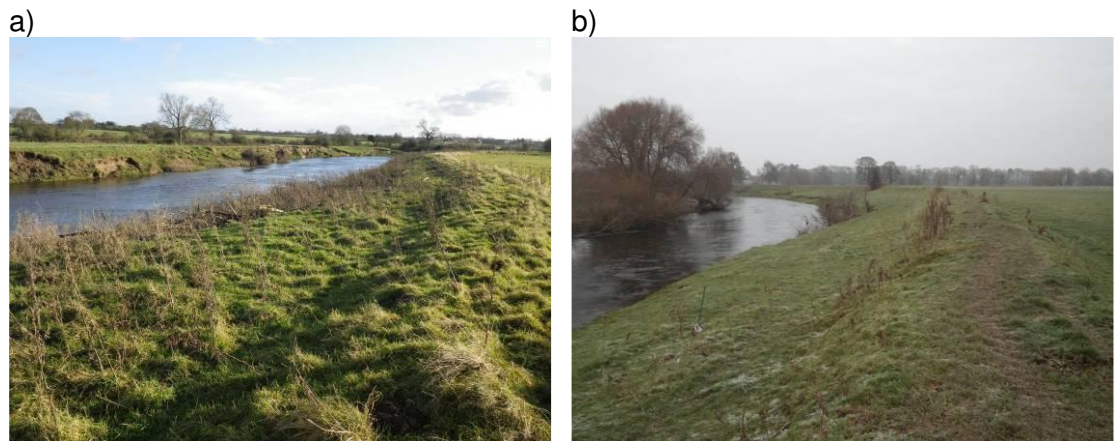
Analysis of aerial photographs also identified some straightened sections in the Lower Dee, mainly for settlements of Farndon and Chester. The Hill and Emery (2005) Fluvial Audit also identified an extensive section of concrete bank protection on the right bank as the river flows through Chester towards the Chester weir. Just upstream of the Chester weir, the river is completely confined on both banks by brick/laid stone (left bank) and concrete (right bank).

Figure 5.15 Embankment on Lower Dee with lack of trees; a) at the Dee meanders; and b) Downstream of Farndon

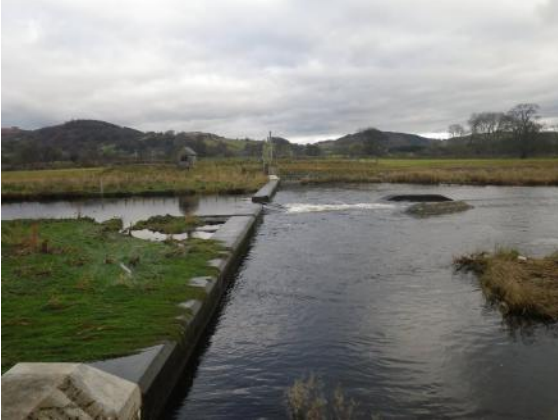
| Location | Photograph of weir | Description | Ecology |
|--|---|--|--|
| <p>Weir at Bala Lake scheme (SH931 359)</p> <p>Upper Dee – Tryweryn</p> <p>Management unit - 15</p> | | <p>Approximately 1.5m high, 3m wide. In low-moderate flows, flow is diverted through the 3m wide section and into deflectors. High flows will overtop weir</p> <p>Adjacent land use is rough pasture (left bank) and recreational walk (right bank)</p> <p>Weir is part of the Bala Lake Scheme</p> | <p>Unlikely to pose a significant obstruction to salmonid passage under most flow conditions due to water depth and weir height being suitable for all fish species to navigate</p> |

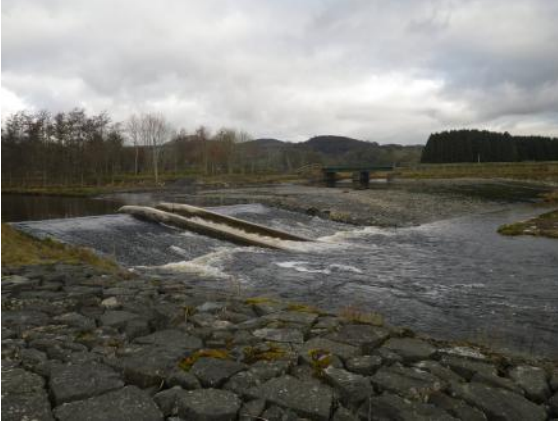
| Location | Photograph of weir | Description | Ecology |
|--|---|--|--|
| <p>Salmon Steps (SH932 356)</p> <p>Upper Dee – Tryweryn confluence</p> <p>Management unit – 2/15</p> | | <p>Approximately 2m high, 2m wide and 4m long section in the centre of the structure that is designed as a fish pass</p> <p>The sections flanking the fish pass are approximately 2m high, 7m wide and 4m long each</p> <p>Adjacent land use is Bala Lake Scheme works (left bank) recreational (right bank)</p> <p>Salmon steps accommodate fish passage through the Bala Lake Scheme</p> | <p>Fish pass will ensure fish passage under most flow conditions. Unlikely to be suitable for lamprey or bullhead passage due to the velocity of water over the fish pass, leading to use of sub-optimal spawning habitats and potentially a reduction or failure to spawn</p> |

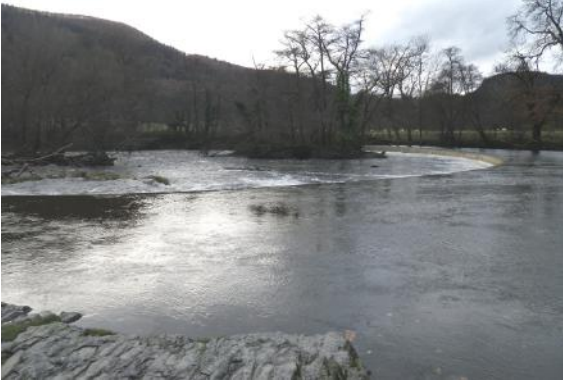
| Location | Photograph of weir | Description | Ecology |
|---|--|--|---|
| <p>Horseshoe Falls (SJ195 433)</p> <p>Middle Dee – Main stem Dee/ Afon Dyfrdwy</p> <p>Management unit – 5/6</p> | | <p>Approximately 1m high, 100m wide. Cuts diagonally across river channel. Glide flow type upstream of weir and cascades and runs downstream, suggesting that the weir is having a significant effect on upstream flows by levelling out the gradient</p> <p>Adjacent land use is rough pasture for grazing</p> <p>Weir is still used to divert and maintain water in the Llangollen Canal</p> | <p>Potential obstruction to salmonid migration due to the vertical steepness of the weir. However, it may be passable under higher flow conditions. Delays in migration and increased holding time beneath the structure may lead to increased concentration of fish, increase exploitation rates and lowering of water quality. This can cause a reduction of fish condition through disease and result in fish using sub-optimal habitats or failing to spawn at all if outside of the main run. Unlikely to allow lamprey and bullhead to ascend due to the vertical steepness of the weir</p> |

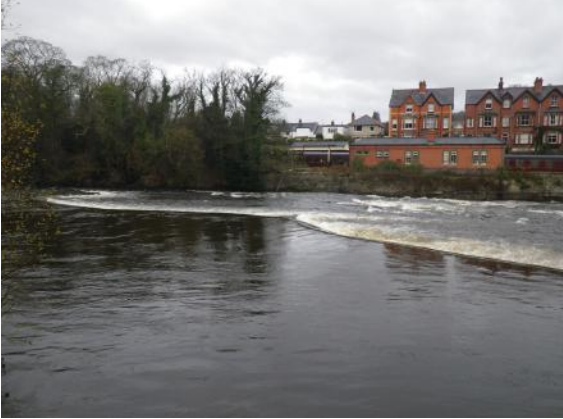
| Location | Photograph of weir | Description | Ecology |
|---|---|---|--|
| <p>Llangollen weir (upstream of road bridge) (SJ213 421)</p> <p>Middle Dee</p> <p>Management unit - 6</p> | | <p>Approximately 1m high and 100 metres wide. Cuts diagonally across the river channel. Due to the moderate/steep gradient of upstream channel, there is limited ponding effect and water cascades over the weir into a steeper, cascading section</p> <p>Adjacent land use is urban</p> <p>The weir was used in the past to divert water into a corn mill on the right bank, which is now a public house</p> | <p>Potential obstruction to salmonid migration due to flow rate, but passable under higher flow conditions. Delays in migration and increased holding time beneath the structure may lead to increased concentration of fish and lowering of water quality. This can cause a reduction of fish condition through disease and result in fish using sub-optimal habitats or failing to spawn at all if outside of the main run. Unlikely to allow lamprey and bullhead to ascend due to the steepness and fast flow of water over the weir at most times</p> |

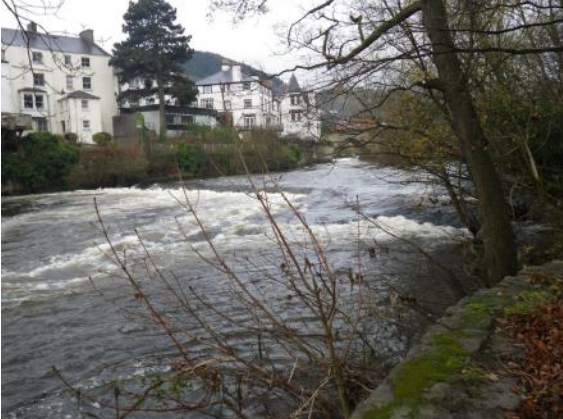
| Location | Photograph of weir | Description | Ecology |
|---|---|---|--|
| <p>Llangollen weir (downstream of road bridge) (SJ215 421)</p> <p>Middle Dee</p> <p>Management unit - 6</p> | | <p>Approximately 1m high and 33m wide. Due to the steep gradient and cascading flow upstream there is no ponding effect on this weir</p> <p>Adjacent land use is urban</p> | <p>Potential obstruction to salmonid migration, but passable under most flow conditions. However, delays in ascending multiple weirs through Llangollen reduce the time available after ascending the structures to find suitable spawning habitat leading to selection of sub-optimal spawning habitat. Unlikely to allow lamprey and bullhead to ascend due to fast flow of water over the weir</p> |

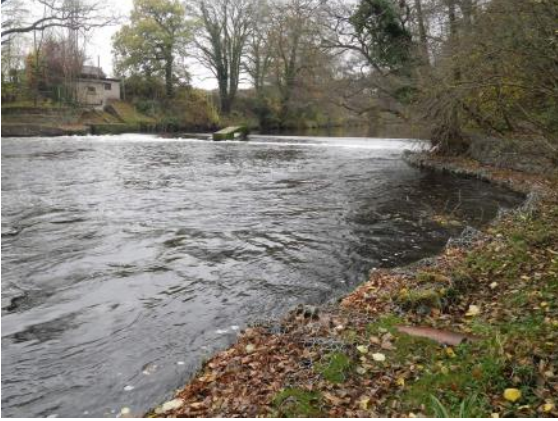
| Location | Photograph of weir | Description | Ecology |
|--|---|---|---|
| <p>Manley Hall gauging weir (SJ348 415)</p> <p>Middle Dee – Main stem River Dee/ Afon Dyfrdwy</p> <p>Management unit 8</p> | | <p>2 compound crump weirs approximately 1m high, 3m long, 15m and 20m wide. Used as a gauging weir, upstream flow type is a glide and downstream a run. Ponding and reducing flow velocities approximately 200m upstream</p> <p>Adjacent land use is rough pasture for grazing on both banks</p> <p>Gauging weir is still used for measuring river flow</p> | <p>Potential obstruction to salmonid migration, but passable under higher flow conditions. Delays in migration may increase concentration of fish below the structure, increase predation or exploitation, increase the chance of disease among fish leading to reduced fish condition and result in fish using sub-optimal habitats or failing to spawn at all. Unlikely to allow lamprey and bullhead to ascend</p> |

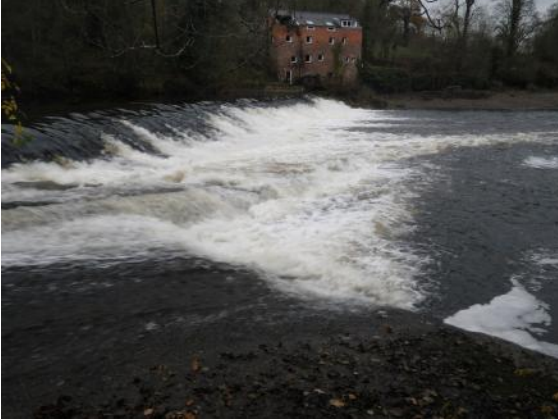
| Location | Photograph of weir | Description | Ecology |
|--|---|---|---|
| <p>Erbistock weir (SJ354 421)</p> <p>Middle/Lower Dee – Main stem River Dee/ Afon Dyfrdwy</p> <p>Management unit 8/9</p> | | <p>Approximately 2.5m high, 3m long and 65m wide (diagonally crosses channel which is approximately 52m across)</p> <p>There is a gentler sloping section of the weir at the right bank where fish were observed to be attempting to swim upstream</p> <p>Ponding effect and reduces flow velocities extended upstream for at least 200-300m</p> <p>Adjacent land use is rough pasture for grazing (both banks)</p> | <p>Potential obstruction to salmonid migration due to weir height, but passable under higher flow conditions. Delays in migration may reduce fish condition, increase concentration of fish below the structure and increase exploitation rates. Significant obstruction to lamprey migration due to flow velocity and weir height</p> |

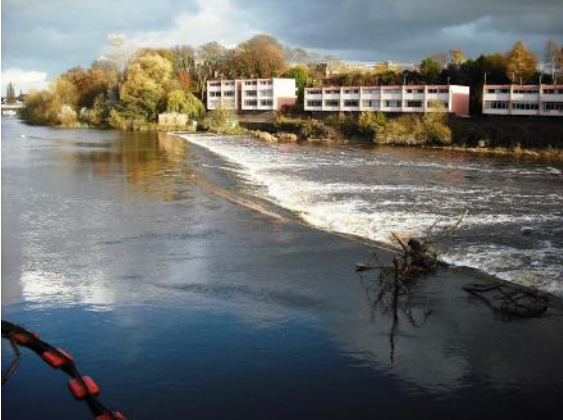
| Location | Photograph of weir | Description | Ecology |
|--|--|--|--|
| <p>Chester weir (SJ407 658)</p> <p>Lower/ Esturaine Dee</p> <p>Management unit – 13/14</p> | | <p>Approximately 9m high, 7-17m long, 153m wide (cross channel diagonally)</p> <p>Adjacent land use urban (Chester)</p> <p>Historic weir originally built to serve medieval mills and then restored for hydroelectric power in the early 20th century. Now used for abstractions and to prevent tidal ingress for all but highest tides</p> | <p>Fish pass will ensure fish passage under most flow conditions</p> |

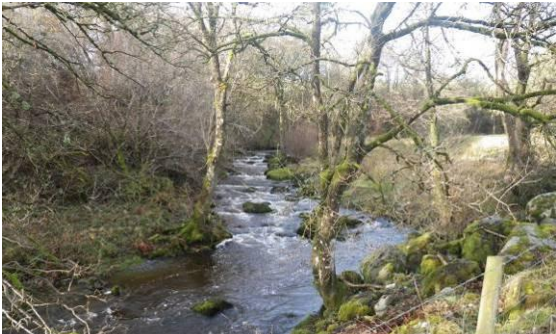
| Afon Mynach | CCW management unit - 16 |

| Afon Mynach | CCW management unit - 16 |
|--|---|
| <p>Geomorphological summary: Overview: This is a typical upland headwater tributary of a British river. Predominant river types alternate between relatively inactive tree-lined gravelly river, relatively inactive rock bound and an active braiding-like section with possible lateral adjustment. The river has confined irregular meanders in MYN001 and MYN002 then as it moves downstream it becomes relatively inactive, sinuous as it reaches a bedrock lined channel</p> <p>Key Characteristics: Flow types: Fast runs and cascades, step-pool sequences</p> <p>Bed and Bank Sediments: Bedrock to glacial deposits (including till and cobbles/boulders). Also a high variety of finer sediments ranging from discrete sand/silt deposits to fine and coarser gravel. MYN001 and MYN002 are active sections where erosion and deposition into side and point bars is frequent. Along these reaches farmers have instated bank protection in the form of fixed woody debris and boulders along these reaches</p> <p>Sediment transport characteristics: the upper reaches of the Mynach are predominantly exchange reaches, where both active erosion and sediment deposition are occurring within the same reach. The lower half of the river is predominantly a transfer zone with only localised deposition behind obstructions</p> <p>Planform: The upper reaches exhibit confined irregular meandering whilst in the lower reaches the river becomes sinuous, except where straightened in the lead up to the confluence. This sinuosity in the lower reaches is possibly inherited from former times when vegetation cover was lower and runoff higher. Evidence of secondary channels in MYN001 and MYN002 where the river is more active</p> <p>In-Channel Vegetation: Emergent reeds/sedges/rushes, exposed tree roots and large woody debris</p> <p>Bank vegetation: Trees which are possibly the last vestiges of a wooded post-glacial landscape and simple communities, consisting of grass and shrubs</p> | <p>Ecology/Habitat suitability:</p> <ul style="list-style-type: none"> • Extensive otter habitat for foraging and lay-up sites • Channel, substrate and flow diversity offer suitable spawning and juvenile habitats for salmonid fishes and deeper sections for adults. Optimum spawning habitat confined to lower reaches. Naturally constrained in upper catchment by high flows and steep gradients limiting optimal spawning habitat • Extensive habitat present suitable for <i>Ranunculus</i> communities • Bank side vegetation lacking in upper reaches, but increases downstream • Himalayan balsam present • No barriers to fish movement within Mynach catchment but obstructions are present on the main stem Dee (predominantly for all three lamprey species and bullhead) <p>Key issues:</p> <ul style="list-style-type: none"> • Poaching • Bank reinforcement (albeit soft reinforcement – wired fixed tree branches) • Straightened section • Bank reprofiling in MYN001 • Riparian zone degradation <p>Potential restoration options:</p> <ul style="list-style-type: none"> • Grazing management for riparian zone replenishment and to reduce poaching (particularly important for active reaches MYN001 and MYN002) • Manage livestock access points to water • Re-meander straightened section immediately upstream of Tryweryn confluence |
| | <p>Typical characteristics of the watercourse</p> |

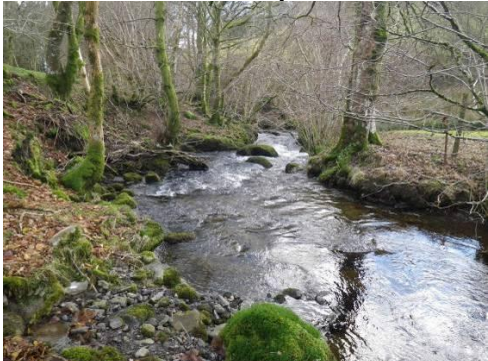
| Afon Meloch | CCW management unit - 17 |
|--|--|
| <p>Geomorphological summary: Overview: This is a typical upland headwater tributary of a British river. Predominant river types alternate between a relatively inactive rock bound and a relatively inactive tree-lined gravelly river</p> <p>Key Characteristics:</p> <p>Flow types: Step-pool and run-riffle sequences</p> <p>Bed and Bank Sediments: Bedrock to glacial deposits (including till and cobbles/boulders). Glacial deposits have formed terraces along significant lengths of the channel</p> <p>Sediment transport characteristics: it is predominantly a transfer zone, only localised deposition has occurred (obstructions)</p> <p>Planform: except where straightened the winding pattern has possibly been inherited from former times when vegetation cover was lower and runoff higher. Little evidence of secondary currents (i.e. few point bars and eroding bends except in middle reaches close to where straightening has occurred). In lower reach MEL006 mid channel bars are occurring</p> <p>In-Channel Vegetation: mosses and bryophytes</p> <p>Bank vegetation: Trees which are possibly the last vestiges of a wooded post-glacial landscape and simple communities, consisting of grass and shrubs</p> <p>Ecology/Habitat suitability:</p> <ul style="list-style-type: none"> • Very good otter habitat including exposed tree root systems, vegetated banks, presence of ash and sycamore, possible den sites • Channel, substrate and flow diversity offer suitable spawning and juvenile habitats for salmonid fishes and deeper sections for adults, particularly in the lower reaches • Extensive habitat present suitable for <i>Ranunculus</i> communities • Bankside vegetation is minimal where poaching by livestock is apparent • A small weir may restrict upstream migration of lamprey and bullhead. However lamprey are unlikely to reach the Meloch with significant barriers to migration on the main stem Dee. Very limited depositional features suitable for lamprey ammocoetes • Suitable bullhead habitat recorded • Straightened section offers minimal appeal to riparian species | <p>Key issues:</p> <ul style="list-style-type: none"> • Straightened section running through field in MEL004 with embankment probably constructed from spoil won when new channel dug. This could be relatively recent as fence appears to be less than 10 years old • Poaching, where livestock are able to access river, although this is not extensive • Bank reinforcement for infrastructure (i.e. roads, bridges) • Water abstraction for small, domestic, run-of-river hydropower scheme near Aerfen <p>Potential restoration options:</p> <ul style="list-style-type: none"> • There are no obvious restoration actions required for relatively inactive, stable stream channel types as modifications that are present along these reaches are having a minimal effect on geomorphology • For the straightened section, restoration actions could include re-meandering to the old course however this may re-activate the reach as a sediment trap. Obviously gravels deposited here could form (and possibly re-create) a useful habitat for spawning fish as the substrate in the straightened course contains larger grain sizes. A feasibility study would be required to look at all benefits and disbenefits • Grazing management and tree planting where riparian zone is degraded <p>Rock bound channel and exposed tree roots</p> |

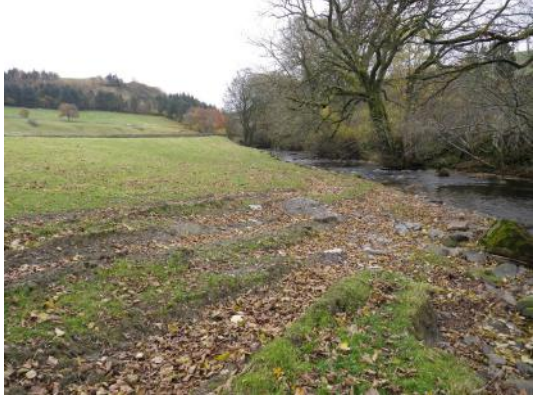
| Afon/River Ceiriog | CCW management units – 18 (upper Ceiriog) and 19 (lower Ceiriog) |
|--|--|
| <p>Geomorphological summary: Overview: Winding channel, confined by glacial valley sides. Channel alternates between active and relatively inactive sections and bed material is predominantly cobbles and boulders. There is a braided section just upstream of the confluence with the Dee (CEI007) where the slope is lower and wet woodland habitat exists</p> <p>Key Characteristics:</p> <p>Flow types: Run for the majority of the river, but with riffles and glides. There are also areas of rapids where there are large glacial boulders and bedrock outcrops in the channel</p> <p>Sediment transport characteristics: The upper reaches of the Ceiriog are predominantly transfer zones carrying sediment into the lower reaches, although cobble/gravel side and point bars are common. From Chimney Farm downstream, in the lower reaches of the Ceiriog there are a high proportion of deposits comprised of fine sediment such as sand and silts and a braided section with significant amounts of large woody debris</p> <p>Planform: Winding planform alternating between active and relatively inactive sections. Becomes braided in the lower reaches where fine sediment has been deposited and mid channel islands have formed, some with mature broadleaf trees</p> <p>In channel vegetation: Extensive exposed tree roots and large woody debris throughout. Moss and lichens also present in most parts</p> <p>Bank vegetation: Largely tree-lined or with wooded areas, mainly deciduous</p> <p>Ecology/Habitat suitability:</p> <ul style="list-style-type: none"> • Extensive habitats present suitable for otter (exposed roots, lay up sites, woodland/vegetated banks). Evidence of badger • Riffles and runs offer suitable spawning and juvenile habitat for salmon, predominantly in the lower reaches where there is greater flow and substrate diversity and habitats are well connected. Silt/sand substrate for larvae of lamprey species. Areas of protected refuges and overhanging vegetation • Some habitat present suitable for <i>Ranunculus</i> communities • Potential barriers to fish movements on the main stem of the Dee | <p>Key issues:</p> <ul style="list-style-type: none"> • Two major weirs: Brynkinalt weir (gauging weir) and weir upstream of fish hatchery (by Pont Faen) • Poaching • Straightening (CEI002SP) • Bank reinforcement through settlements • Invasive species (Rhododendron, Japanese Knotweed and Himalayan Balsam) <p>Potential restoration options:</p> <ul style="list-style-type: none"> • Weir removal, modification or fish pass installation (neither weir appeared to have a fish pass) • Grazing management to encourage riparian zone replenishment and address erosion caused by poaching • Re-meander straightened sections (to potentially re-create a sediment sink and spawning redds) • Remove bank protection that does not conflict with CFMP • Manage invasive species <p style="text-align: right;">Riparian zone degradation</p> |

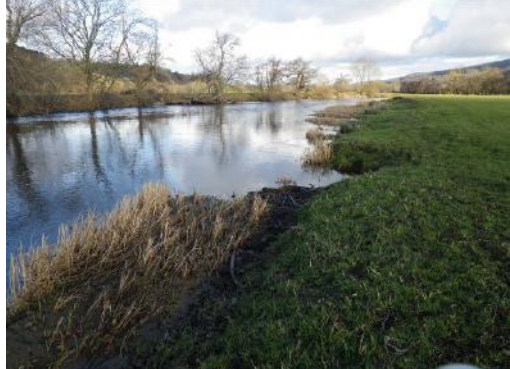
| Upper Dee / Middle Dee | CCW management units – 2, 3, 4, 5, 6, 7, upstream half of 8 and 15, |
|---|--|
| <p>Geomorphological summary: Overview: Confined meandering due to steep glacial valley sides of the Upper Dee</p> <p>Key Characteristics: Flow types: Glides and runs</p> <p>Sediment transport characteristics: Erosion (sediment sources) are more widespread than deposition. Erosion is mainly a function of fluvial action or geotechnical failure. Deposition occurs mainly at point locations and there are a few mid-channel bars that are vegetated. Difficult to ascertain bed material as river was relatively deep at time of survey. Likely to have cobble bed, however deposits comprised of mainly coarse gravel and bank material was observed to be mainly earth</p> <p>Planform: Confined meandering due to steep glacial valley sides of the Upper Dee</p> <p>In-channel vegetation: Marginal vegetation comprises of emergent reeds and grass. There is also the occasional mid-channel bar that is vegetated with grasses/reeds</p> <p>Bank vegetation: Mainly uniform with grass, however where there are trees, these form a thin tree-line along the river bank. Proportionally a very small riparian buffer strip, but they prevent livestock from entering channel and causing erosion through poaching</p> <p>Ecology/Habitat suitability:</p> <ul style="list-style-type: none"> • Bankside woodlands offer suitable habitats for riparian mammals, with suitable exposed root systems and cover • Salmonids observed in the river. Variation in channel habitats is suitable for fish species with runs, riffles and pools present in certain locations. Silt is present in pools and gravel/cobbles evident on inside of bends. Macrophytes offering fish refuges are present • Significant barriers to lamprey migration at Erbistock and Horseshoe Falls although these weirs are passable to salmon • Some habitat present suitable for <i>Ranunculus</i> communities, and for floating water plantain immediately below Bala Lake outlet where it is expected • Himalayan balsam present • Walls and riprap near Llangollen less suitable for riparian ecology | <p>Key issues:</p> <ul style="list-style-type: none"> • This survey area was strategically selected due to the extensive mapping of bank protection in the Hill and Emery (2005) Fluvial audit. Therefore the main issues in this area are the bank protection consisting predominantly of laid stone and/or large boulders which are altering the natural geomorphology processes that would be occurring if this was not present. There is also poaching along this surveyed area, however this is not extensive • Riparian zone is indefinite (sparse) along most of this surveyed section • Historic piers in one location are causing the build up of sediment between the structures, however this is fairly localised <p>Potential restoration options:</p> <ul style="list-style-type: none"> • This section of bank protection was selected as an example section to investigate the feasibility of bank protection removal. The main options along reaches similar to this are to remove bank protection completely to reinstate natural geomorphological processes and to plant trees along the bank • Grazing management and tree planting to encourage riparian zone replenishment <p>Marginal vegetation and single tree line on left bank</p> |

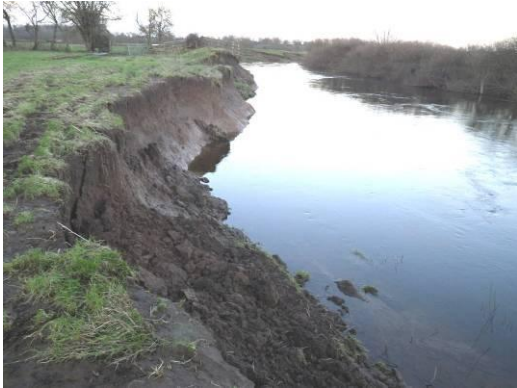
| Lower Dee | CCW management unit – Downstream sections of 8, 9, 10, 11, 12, 13 and 14 |
|---|---|
| <p>Geomorphological summary: Overview: Predominant river type is an unconfined channel with an extensive alluvial floodplain and evidence of historical migration of channels. Likely to locally be an active channel although the channel is unlikely to move freely and significantly across its floodplain in modern times as a result of flow regulation (i.e. reduced peak flows over time). Unmanaged lateral movement of meanders is occurring in some parts, where presumably recorded bank protection has been washed away, leading to erosion and/or failure of flood embankments</p> <p>Key characteristics:</p> <p>Flow types: alternating between shallow fast flowing sections (riffles and runs) and deep slow flowing sections (pools and glides). Also a highly regulated flow, leading to channel adjustment through narrowing with berm formation</p> <p>Sediment transport characteristics: transport appears to be predominantly clay, silt and fine sand (in suspension) although there may be some limited gravel bedload transport. However this reach is a sediment sink. River under natural conditions would deposit overbank on the adjacent floodplain. Due to regulation fine sediment also drops out to accelerate the formation of berms and may also obscure gravel substrate</p> <p>Planform: meandering planform with potential to migrate laterally, although with regulation such channel adjustments are now likely to be very localised and occur much less frequently</p> <p>In channel vegetation: Locally reeds and rushes colonising the berms. Occasional mid-channel islands with trees</p> <p>Bank vegetation: would be trees and woody debris in the channel (historically removed as part of maintenance programmes)</p> <p>Ecology/Habitat suitability:</p> <ul style="list-style-type: none"> • Habitat suitable for riparian mammals is generally lacking except in areas of woodland. High prevalence of badger along the course of the meanders • The form of the river creates a range of substrate and flow conditions suitable for adult salmon and lamprey ammocoetes. Side pools offer refuge areas for fish. Limited opportunity for spawning on key species due to a lack of coarse substrates • Limited habitat present suitable for both <i>Ranunculus</i> communities • Bank side vegetation generally lacking. Himalayan balsam present • No barriers to fish movements recorded | <p>Key issues:</p> <ul style="list-style-type: none"> • Historic bank reinforcement that was instated to stabilise meanders appears to have been washed out, however there are still patches of laid stone present that will affect local geomorphology processes • There is a lack of tree-line or riparian zone along these meanders as trees and shrub growth would have been historically removed to prevent embankments from failing through mechanical erosion from tree root growth <p>Potential restoration options:</p> <ul style="list-style-type: none"> • Assist natural recovery by allowing unmanaged retreat of meanders into embankments • Plant bands and clumps of trees and introduce grazing management to encourage riparian zone regrowth which would both improve connectivity along the river corridor and provide shading for the channel, thus improving in-channel habitats <p style="text-align: right;">Erosion of embankments</p> |
