ROWES BAY / PALLARENDA SHORELINE EROSION MANAGEMENT PLAN

**prepared for
Townsville City Council**

March 2010

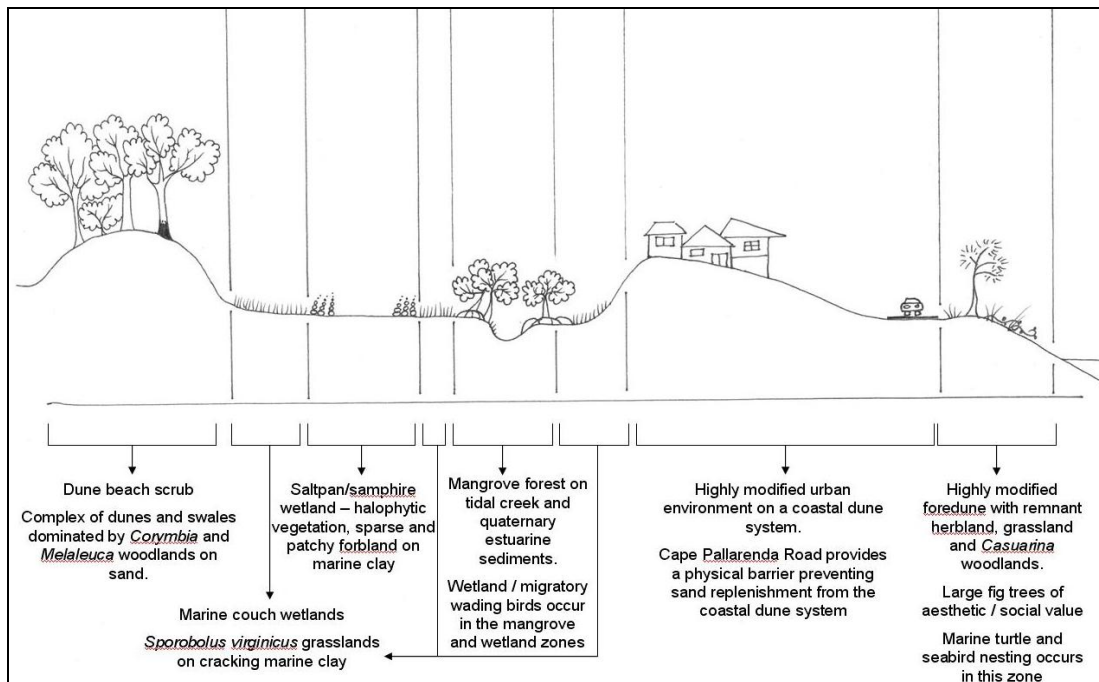
Figure 2.2 : Extent and types of local terrestrial vegetation

Figure 2.2 illustrates the nature and extent of the terrestrial values of the local foreshore.

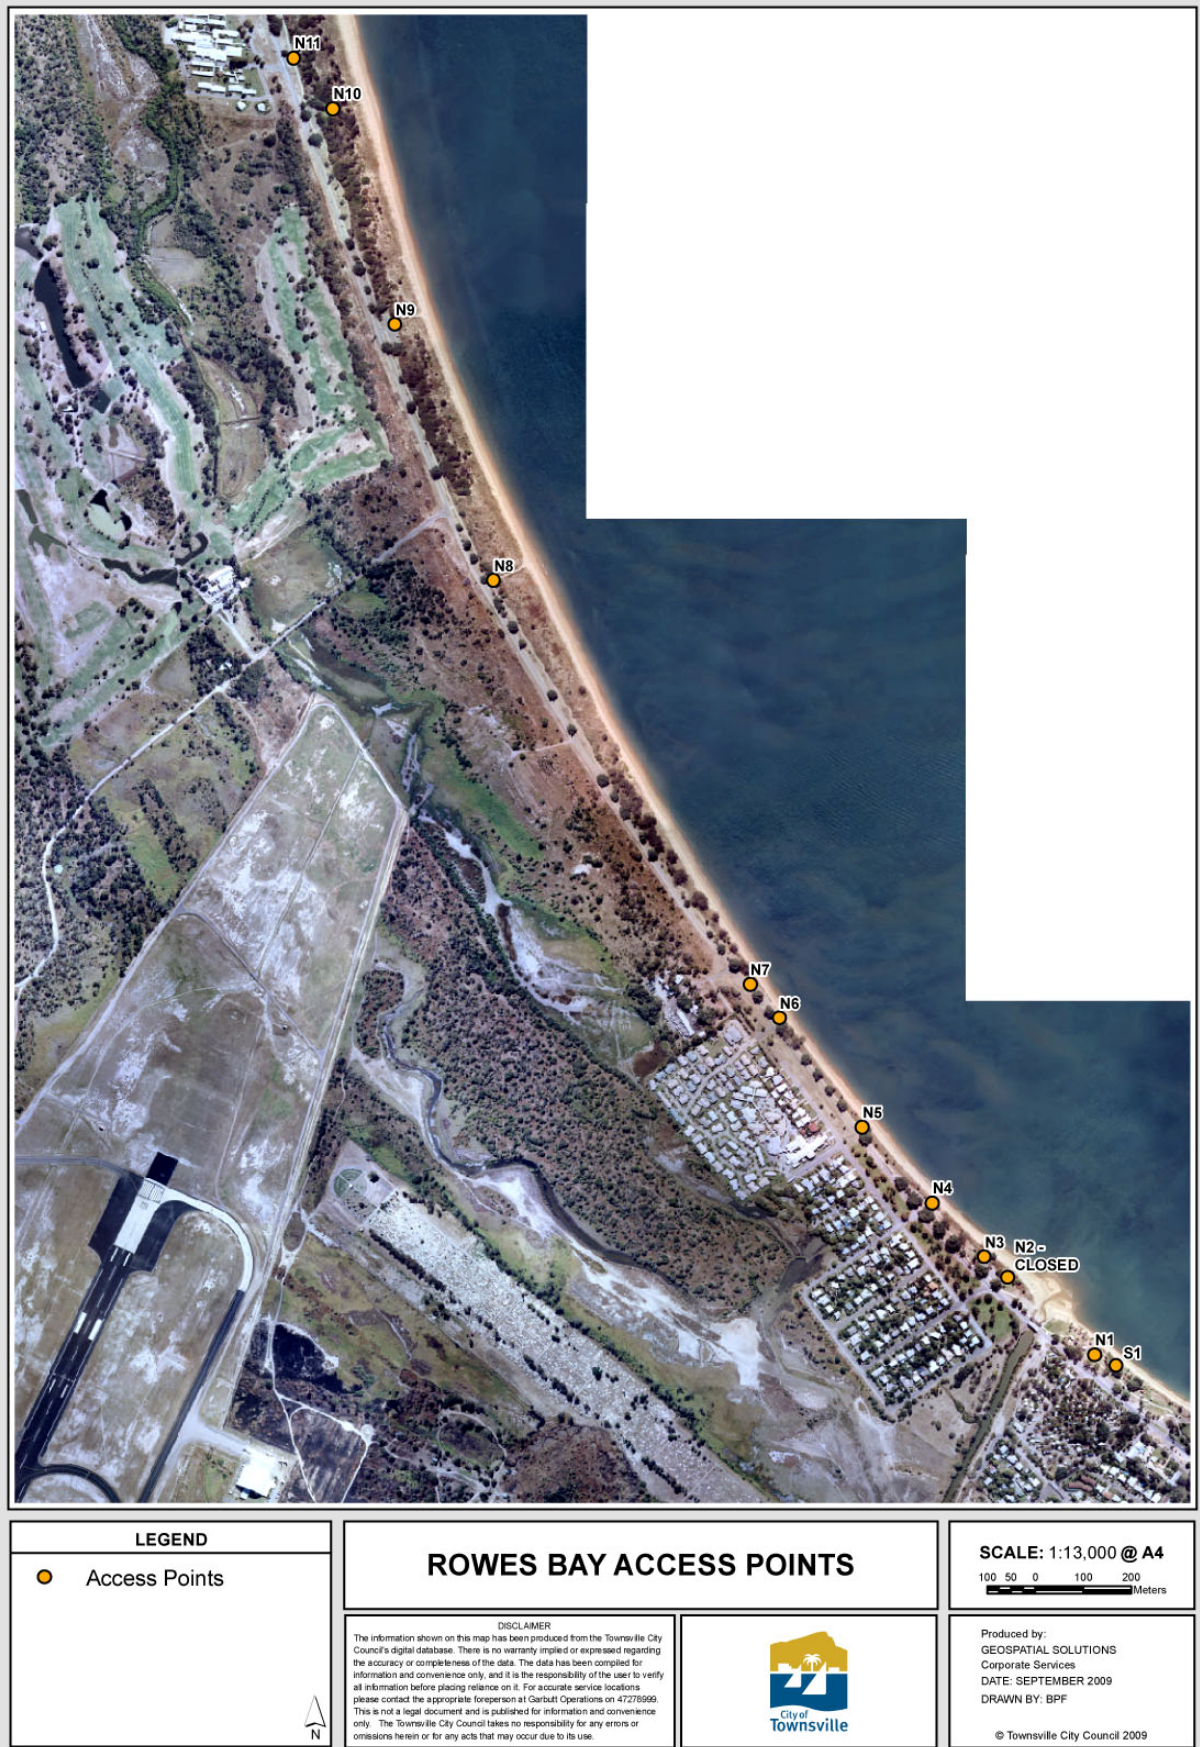
Figure 2.3 : Location of Beach Access Points on Southern Shores of the Study Area

A coastal walking path shaded by large banyan fig trees follows much of the bay foreshore between Soroptimist Park and Cape Pallarenda. Numerous small car-parks are located at some of the twenty-two formal beach access points; these Beach Accesses are shown on Figure 2.3 and Figure 2.4. A section of foreshore provides one of only two beaches in the city that are designated as off-leash areas for Townsville residents to exercise their dogs.

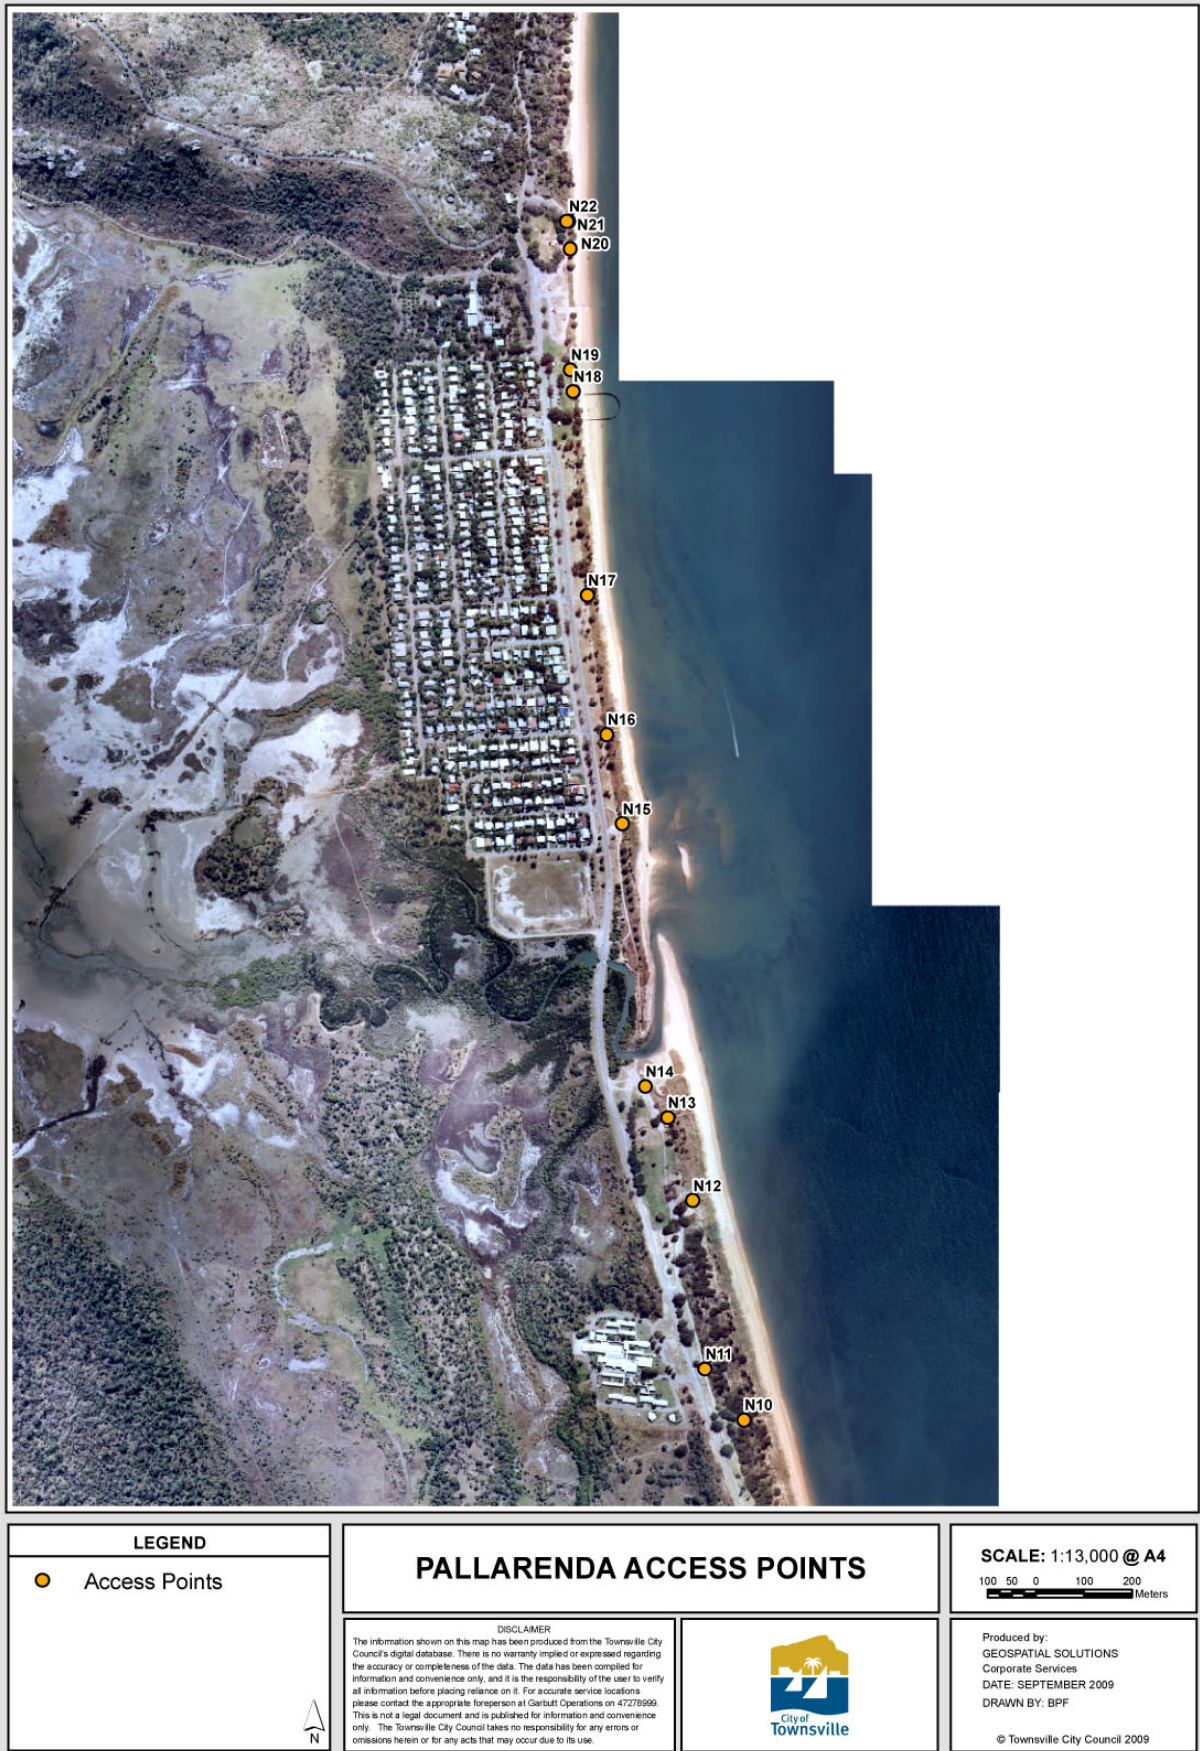
Figure 2.4 : Location of Beach Access Points on Northern Shores of the Study Area

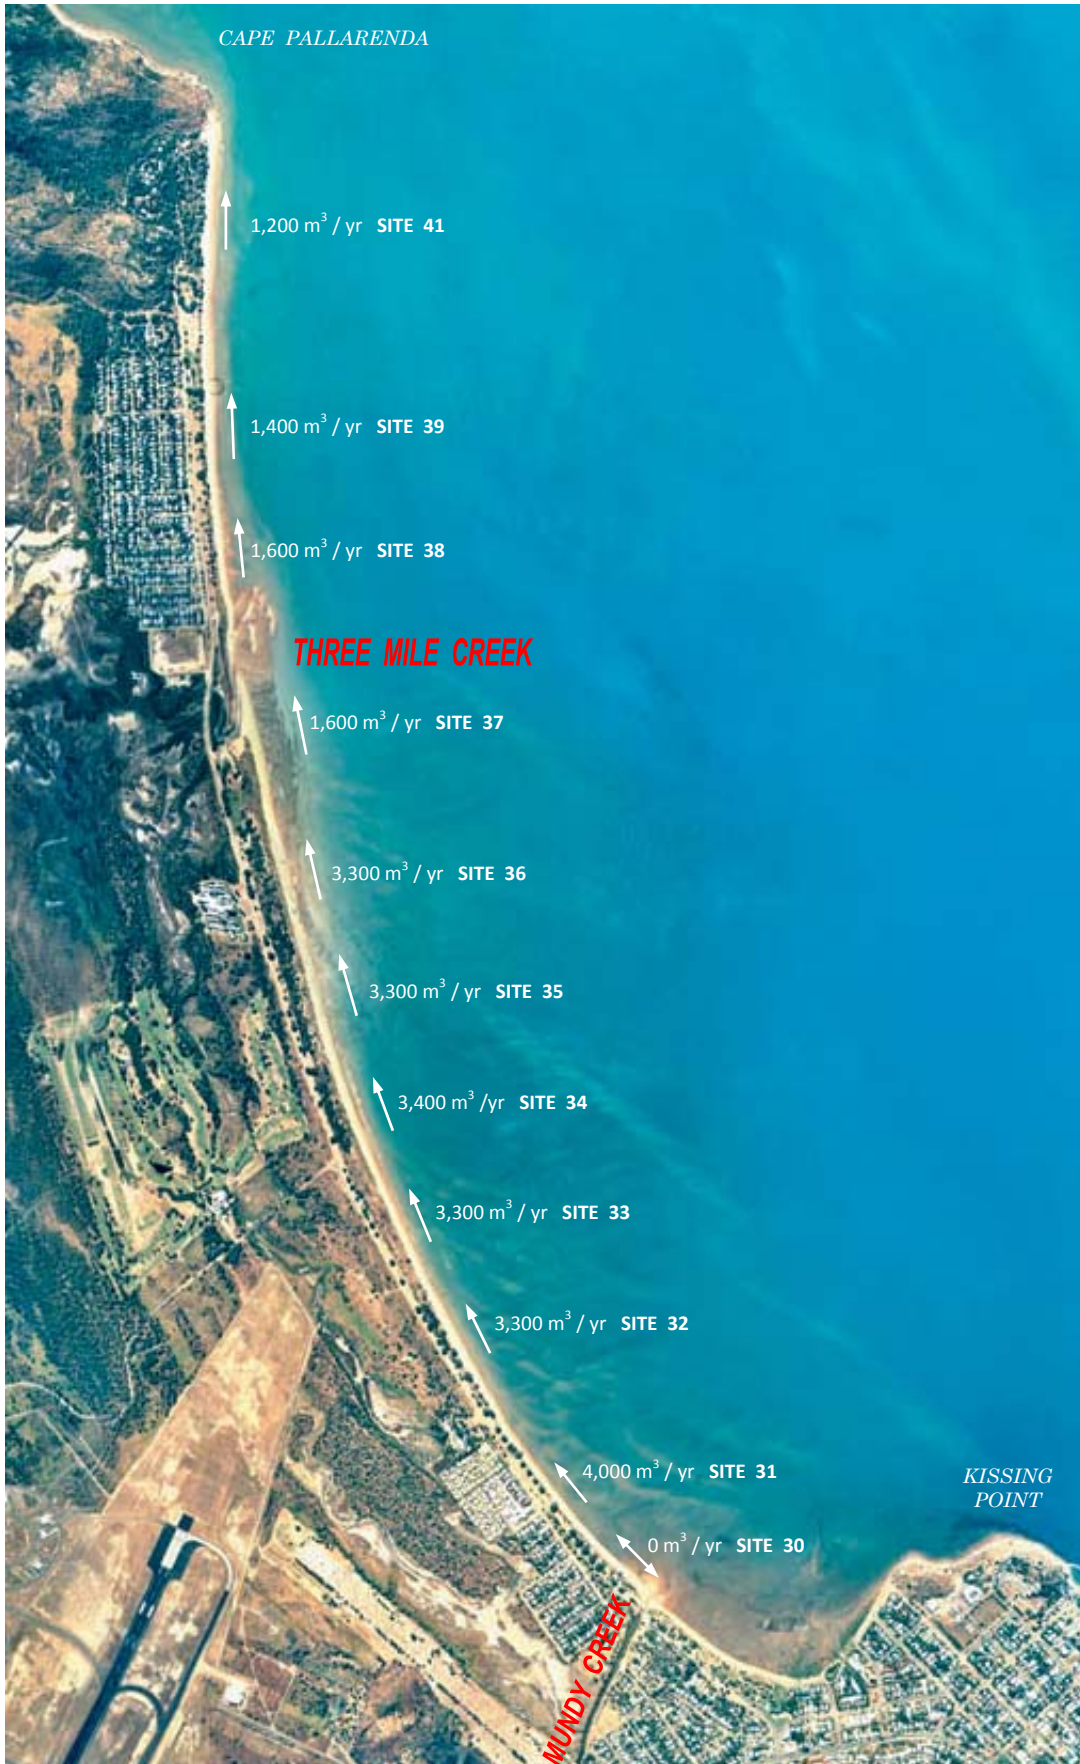
Figure 3.4 : Summary of Modelling Results for Annual Longshore Sand Transport

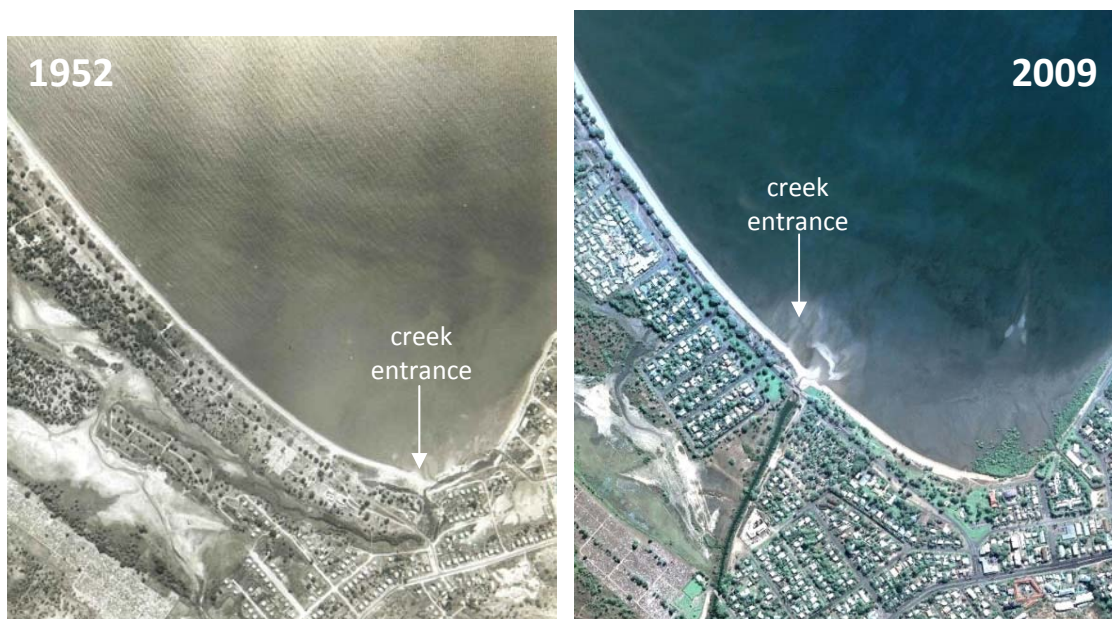
Figure 3.6 : Historical Changes to the Ocean Entrance of Mundy Creek

Originally the mouth of Mundy Creek was further south than it is at present. Figure 3.6 shows that historically the lower reaches of the creek meandered southward through what is now Soroptimist Park, exiting through the foreshore at the western end of The Esplanade, against the northern flank of Kissing Point.

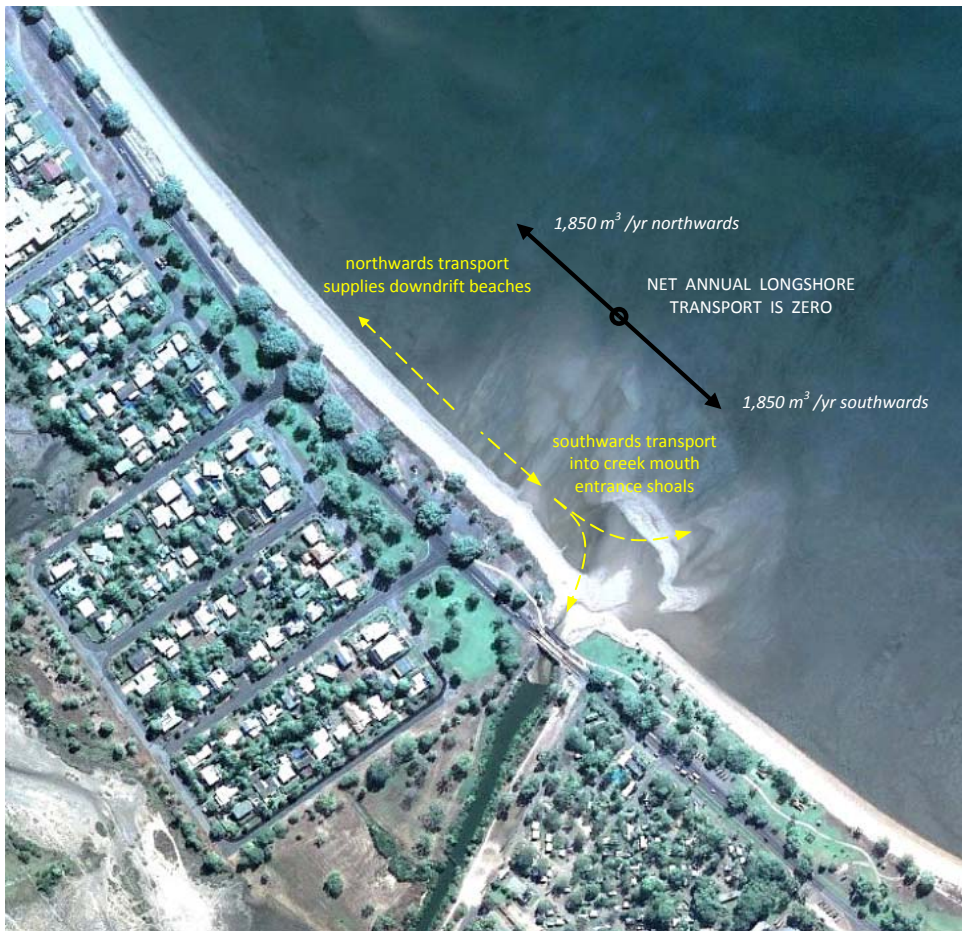
Figure 3.7 : Sand Transport Mechanisms at Mundy Creek Entrance

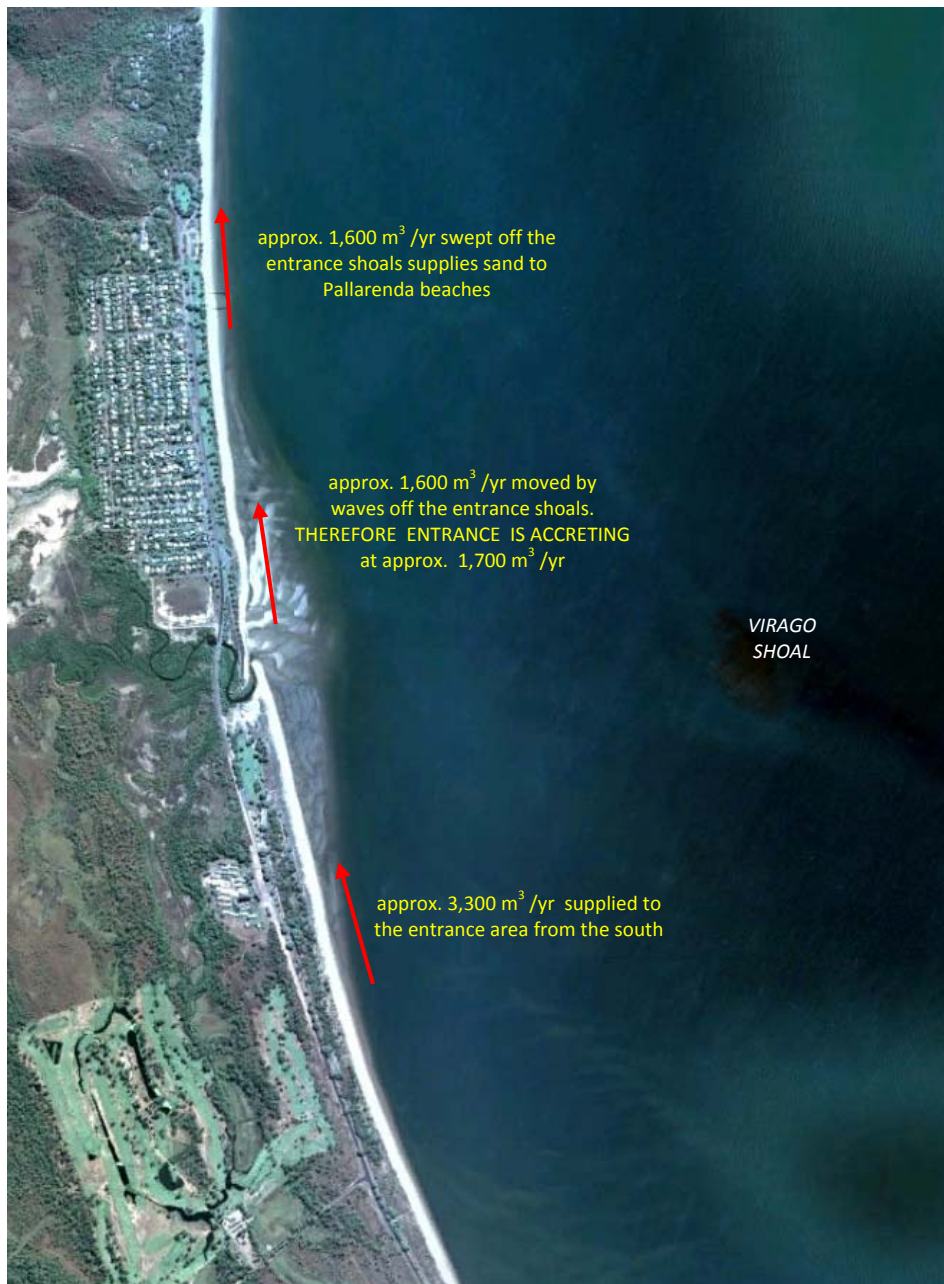
Figure 3.8 : Sand Transport Mechanisms at Three Mile Creek Entrance

Figure 3.8 presents a conceptual representation of sediment transport processes in the vicinity of the Three Mile Creek entrance.

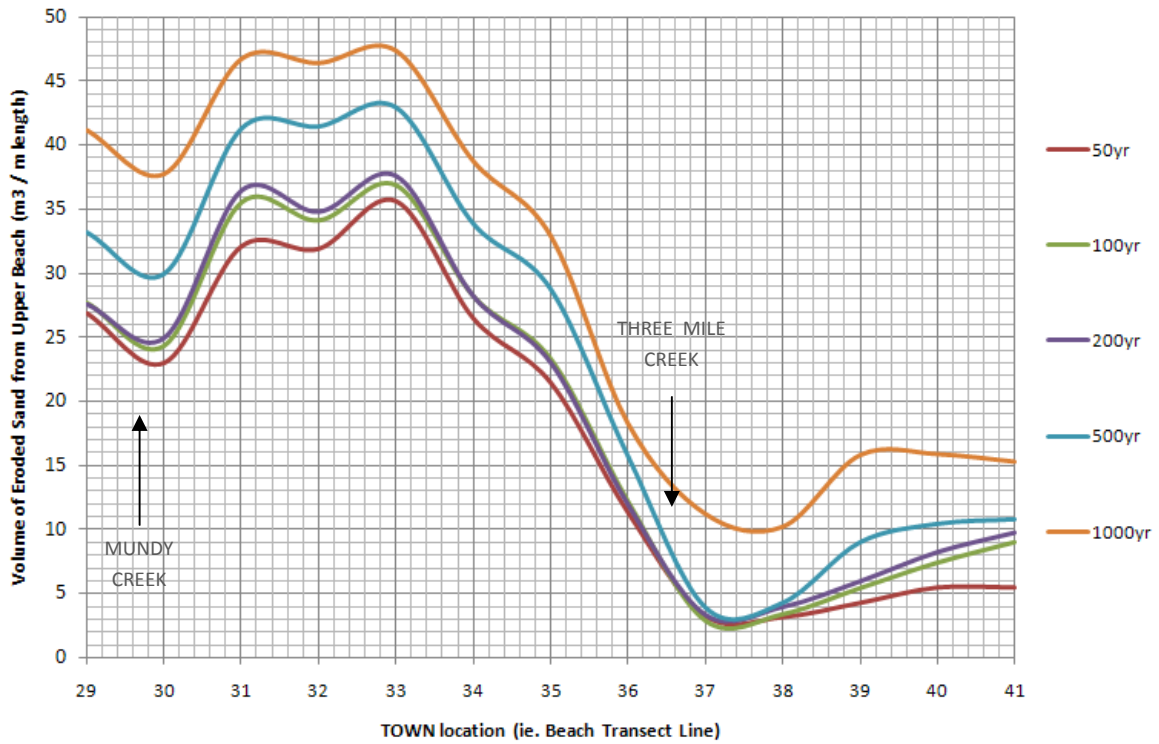
Figure 3.10 : Predicted Cyclone Erosion Volumes for Various ARI Cyclone Events

The volume of sand removed from the upper beach by various cyclone scenarios is presented in Figure 3.10 - whereas the distance that the shoreline recedes as a consequence of these same cyclones is shown in Figure 3.11.

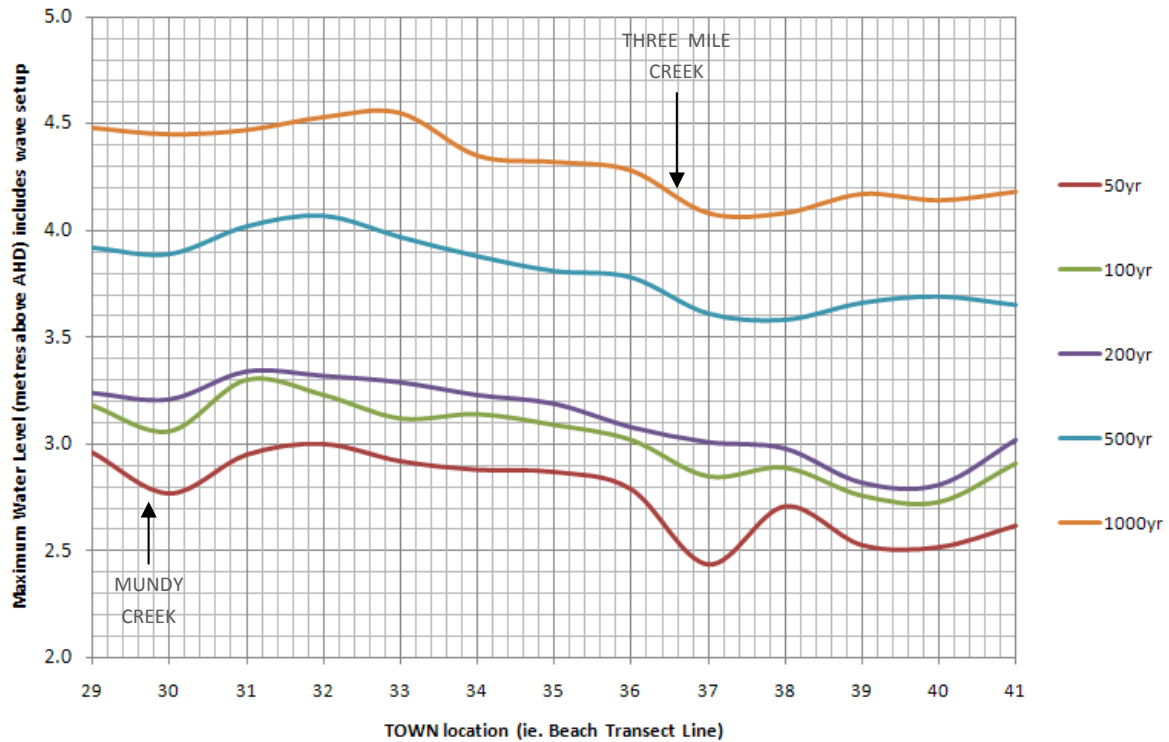
Figure 3.12 : Predicted Wave & Surge Influences for Various ARI Cyclone Events

As can be seen from this figure, the levels vary along the shoreline. This is primarily due to the variation in wave setup that occurs on the slightly different seabed approaches at each location. Typically wave and surge influences have the greatest impact on the southern shores - peaking between approximately TOWN30 and TOWN33 (ie. from the Mundy Creek entrance north to almost Beach Access N8).

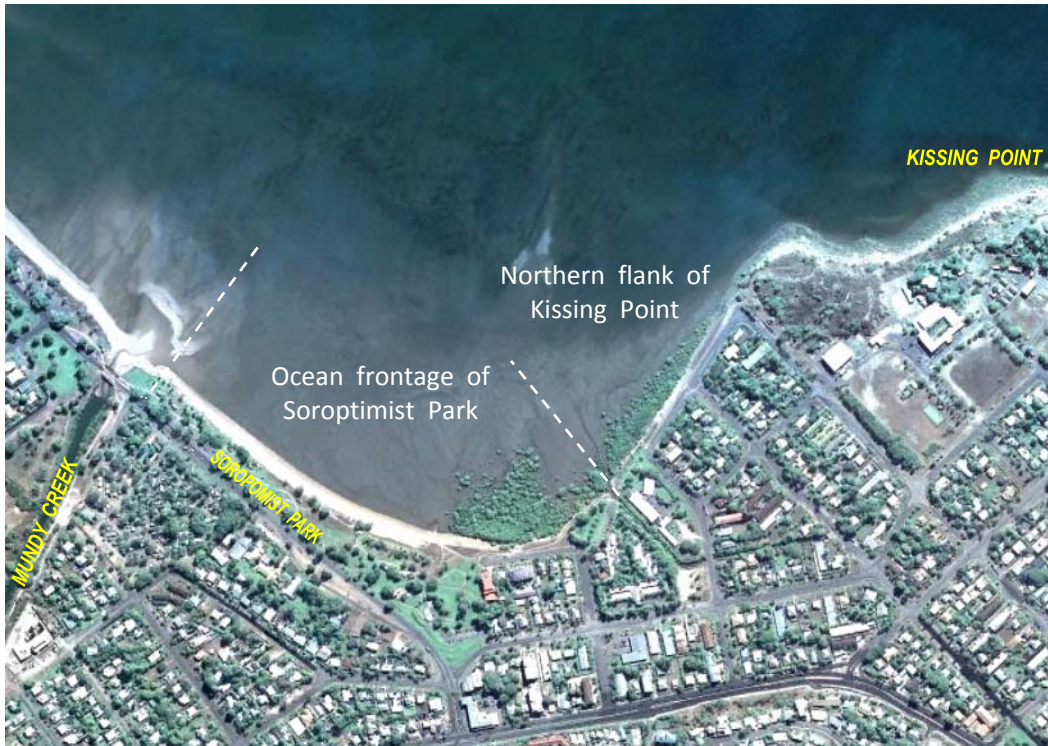
Figure 5.1 : Southern Reach of Rows Bay / Pallarenda Shoreline

The southern reach of the Rowes Bay / Pallarenda shoreline nominated for inclusion in this Shoreline Erosion Management Plan extends from the seaward tip of Kissing Point to the Mundy Creek entrance. As shown in Figure 5.1, this can be further subdivided into two smaller precincts:

This section of the shoreline is adequately protected from erosion by an existing rock armoured seawall. Inspections of this structure indicate that it is of apparently sound structural integrity and is expected to fulfil its function of mitigating erosion - both in the short-term and long-term.

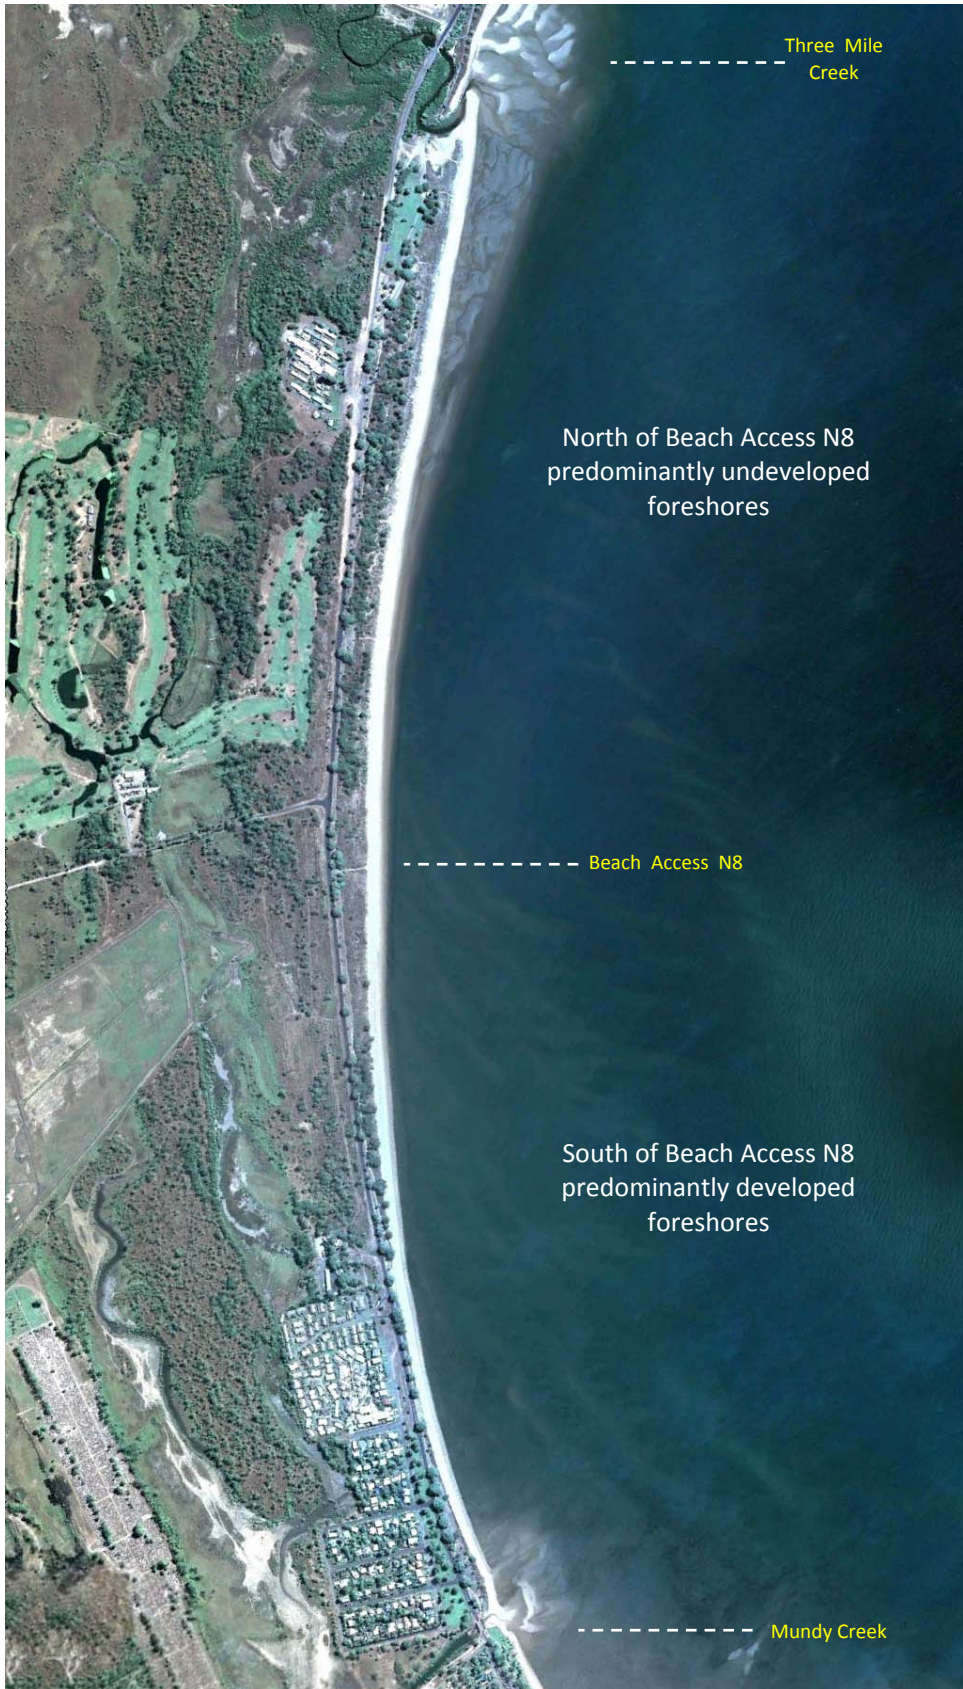
Figure 5.2 : Central Reach of Rows Bay / Pallarenda Shoreline

The central reach of the Rows Bay / Pallarenda shoreline extends from the entrance of Mundy Creek northward to the Three Mile Creek entrance. For the purposes of developing an appropriate management strategy, the entrances of these waterways are included within this central coastal precinct. As shown in Figure 5.2, this central reach can be further subdivided into two smaller precincts:

However it is evident (from historical surveys in conjunction with the modelling of local coastal processes) that during periods of southerly transport, sand can be ingested into the Mundy Creek entrance and swept onto the creek's entrance shoals. This has the dual effect of inhibiting creek flows and removing a significant volume of sand from the active beach face. Consequently whilst being effective, previous beach nourishment activities have had to be supplemented with more frequent renourishment than might otherwise be the case.

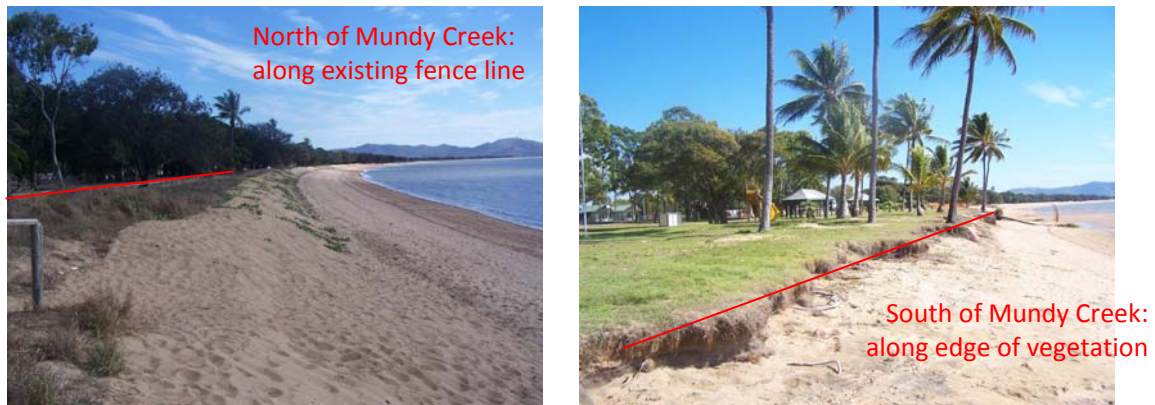
Figure 6.2 : Assumed Location of the Coastal Defence Line at Rows Bay

As discussed, the long-term erosion on the southern shores of Rows Bay caused by the deficit in sand being supplied from the south is expected to continue. This means that the erosion buffers created by the initial sand nourishment will gradually be depleted - thereby diminishing the protection that they afford.

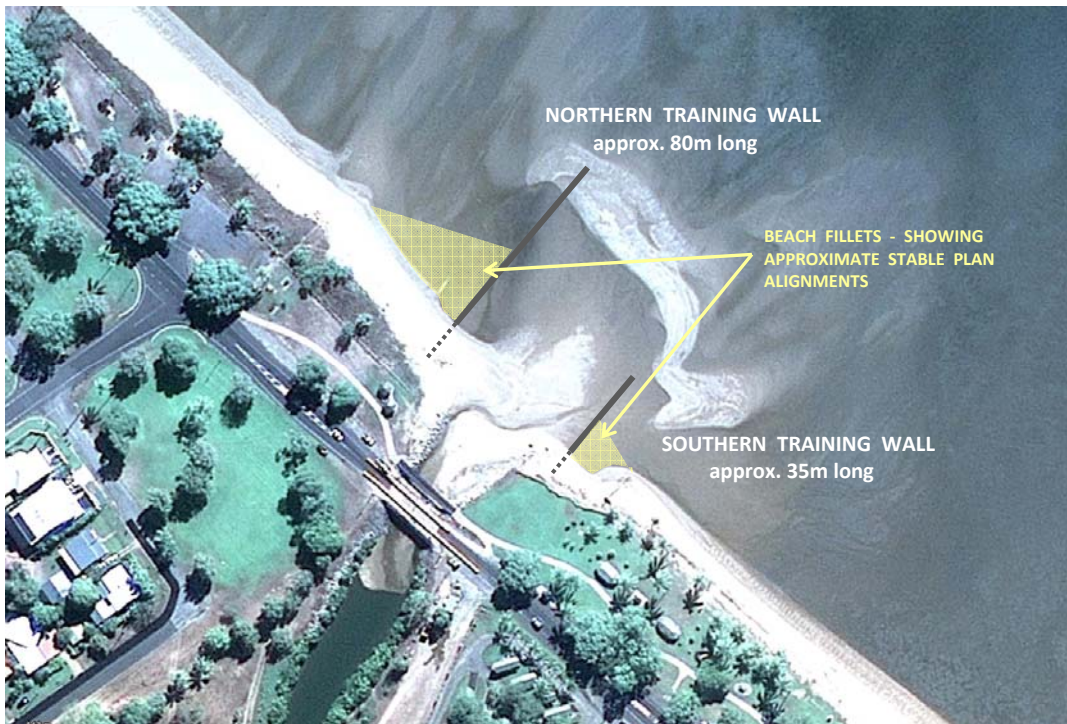
Figure 6.3 : Conceptual Layout of Entrance Training Works at Mundy Creek

It is therefore recommended that the entrance to Mundy Creek should be better controlled through the construction of training walls. The concept is illustrated in Figure 6.3.

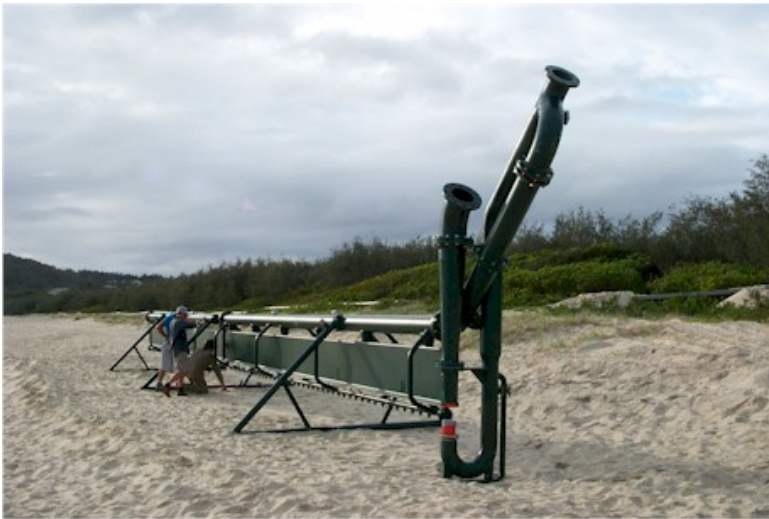
sand shifter unit:
on the beach prior to deployment at the
extraction site

Figure 6.5 : Images of Sand Shifters Used for Sand Backpassing Operations

The self-burying sand shifter unit would be placed parallel to the shore between the high water and low water line off the beach. The concept is illustrated in the images presented in Figure 6.5 - which are of existing backpassing operations larger than would be required for Rowes Bay / Pallarenda.

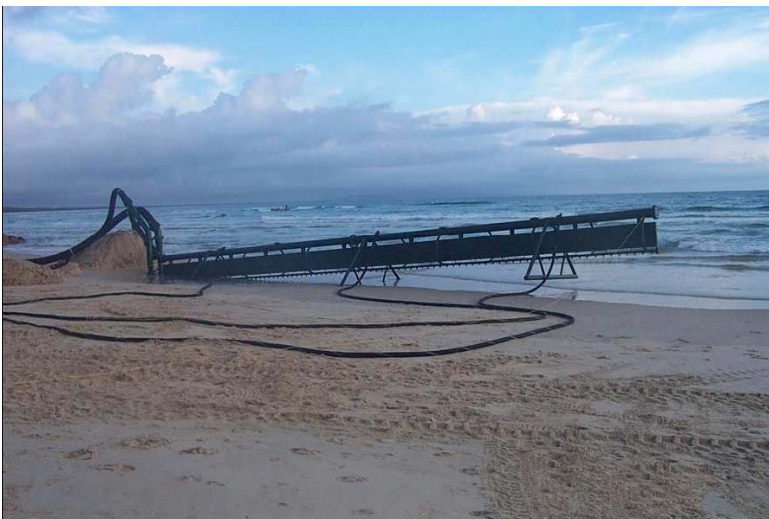
sand shifter unit:
in the process of self submerging at the
selected sourcing site

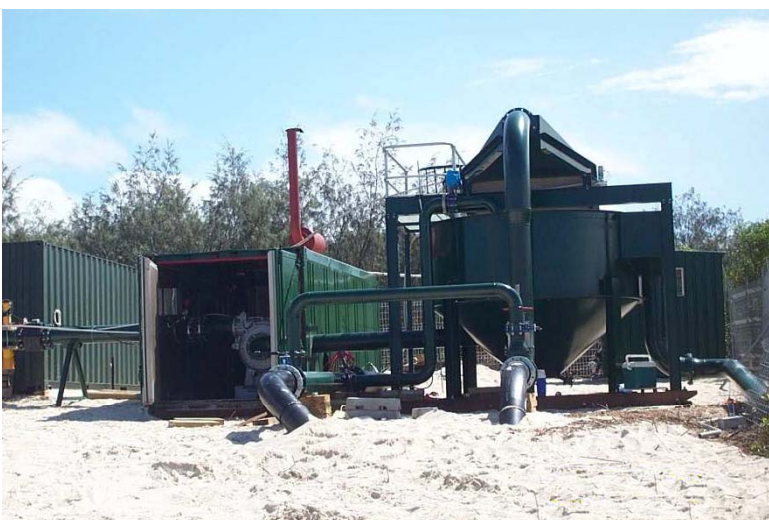
temporary onshore pump and slurry systems
for transfer of extracted sand to the
foreshore requiring renourishment.

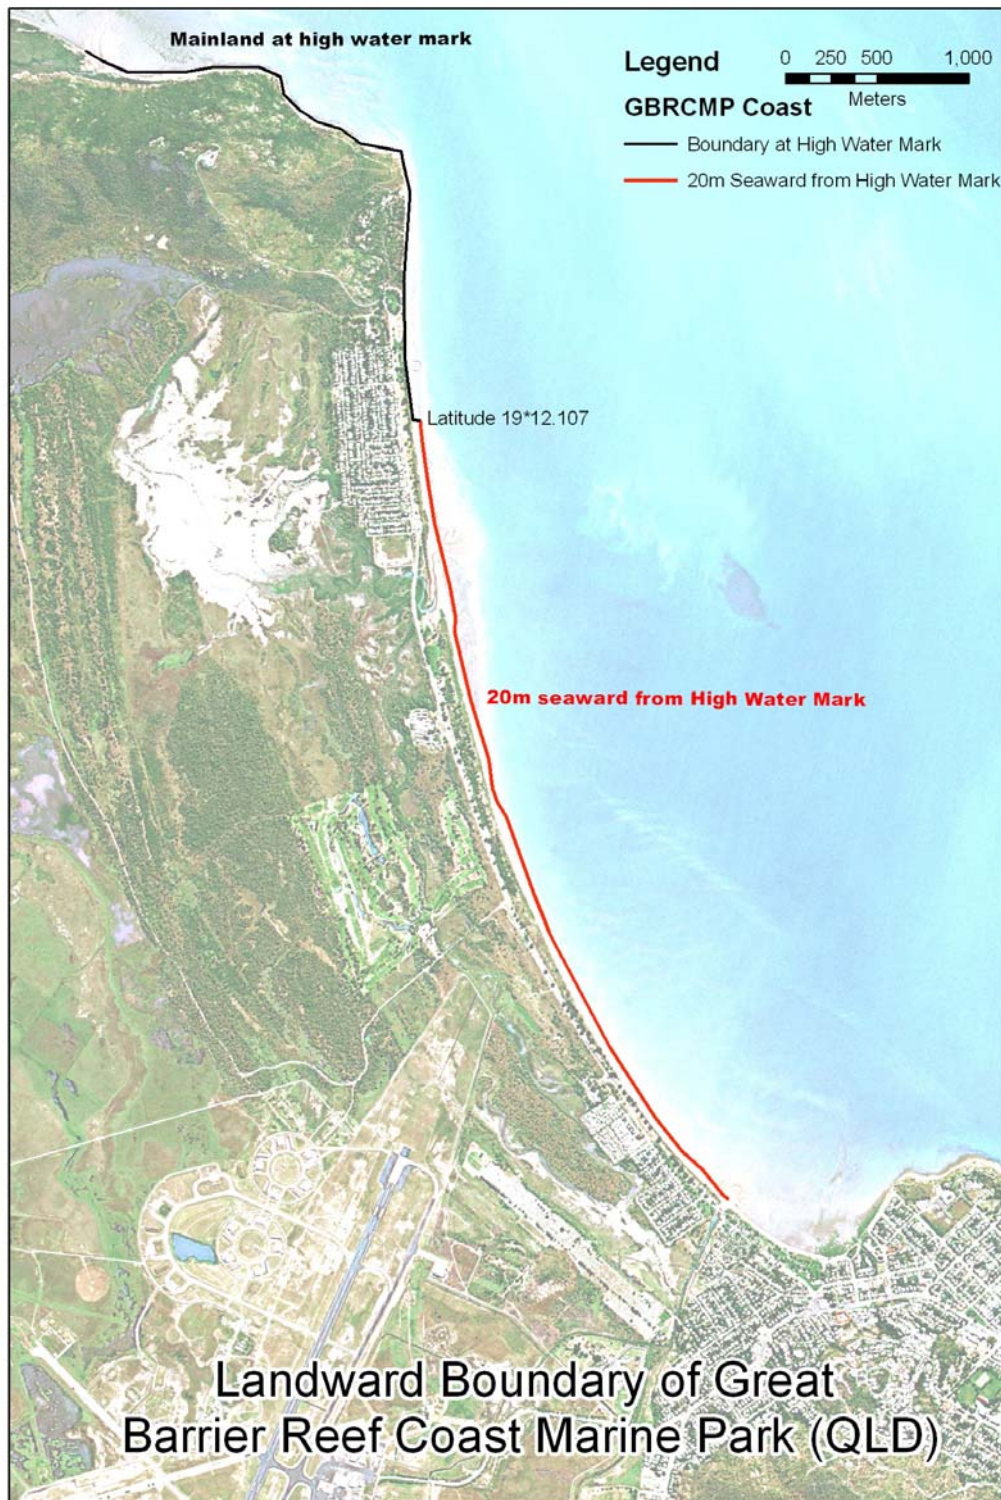
Figure 4. Landward boundary of Great Barrier Reef Coast Marine Park as defined under the *Marine Parks (Declaration) Regulation 2006*.

The Great Barrier Reef Coast Marine Park boundaries relevant to the Rowes Bay study area are defined by the *Marine Parks (Declaration) Regulation 2006* (the Regulation). The Regulation defines the landward boundary of the marine park as (Figure 4):

- From where longitude 146°47.465' east intersects the coastal 20m line around the mainland
- then northerly along the coastal 20m line around the mainland to where it intersects latitude 19°12.107' south
- then west along latitude 19°12.107' south to where it intersects the mainland at high water
- then generally northerly and westerly along the mainland at high water to where it intersects longitude 146°45.465' east

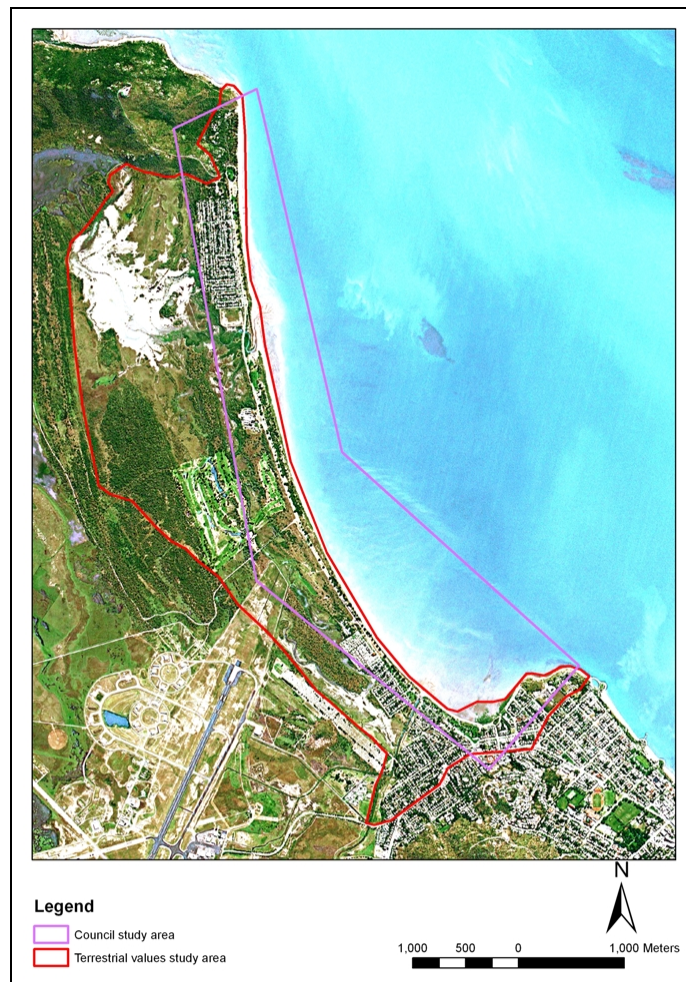
Figure 3: Rowes Bay terrestrial values study area, overlaid onto the original Rowes Bay study area plan.

The terrestrial values study area has been expanded to include terrestrial environments which may be impacted by coastal erosion processes (Figure 3). Land zones 1 and 2 include mangroves, salt pans, tidal flats and tidal beaches, coastal dunes and beach ridges, sand plains and swales, lakes and swamps enclosed by dunes. Land zone 3 comprises alluvial systems, including floodplains, alluvial plains, alluvial fans, terraces, levees, swamps, channels, closed depressions and fine textured palaeo-estuarine deposits. The terrestrial environment extends approximately 2km inland from the Rowes Bay foreshore. A total of seven regional ecosystems occur within this area (Table 4).
