Appendix 15.1 Cultural Heritage

Desk Based Survey

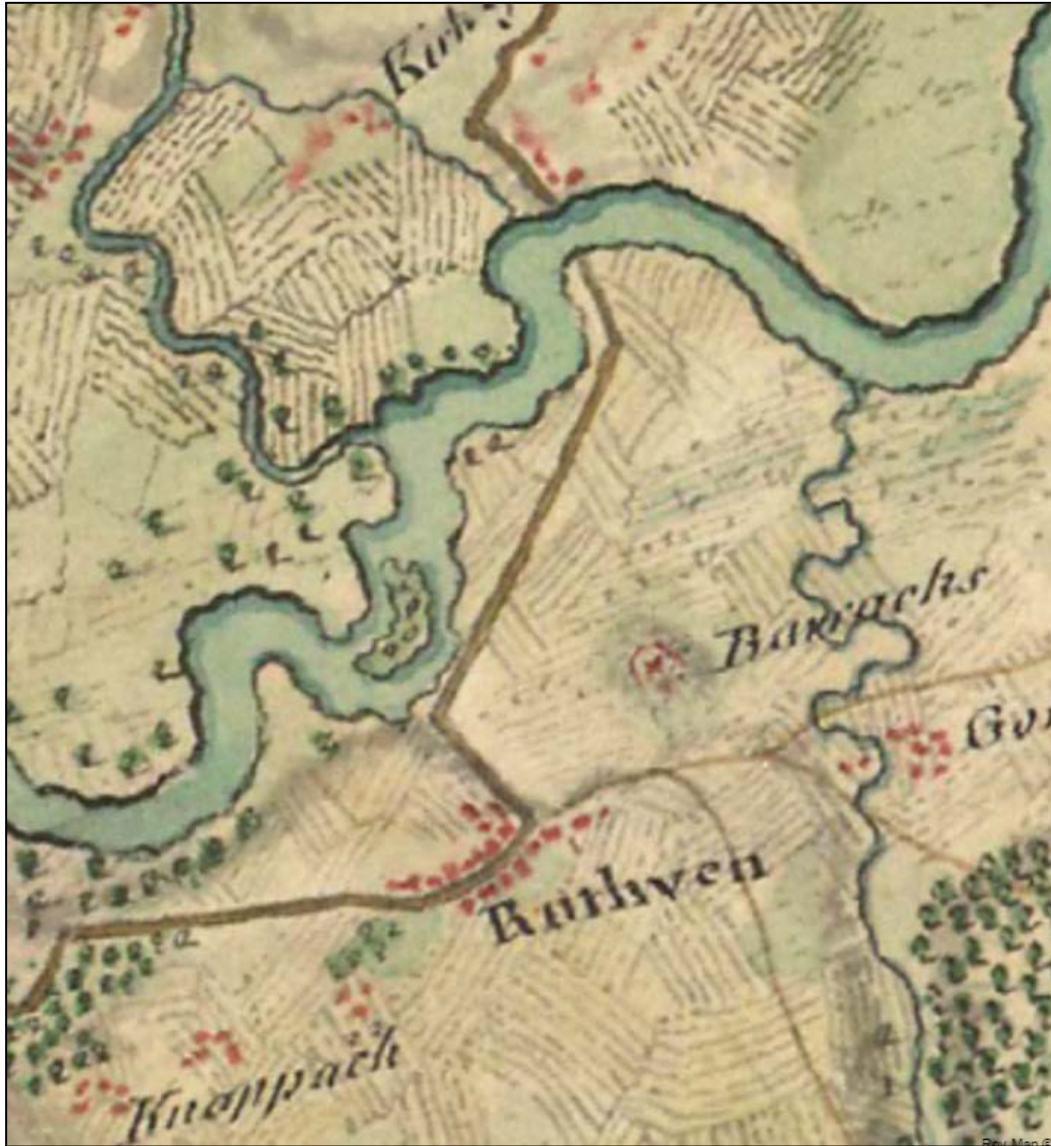
Figure 6-1: Roy Highlands 1747-52: Ruthven Area

- 6.1.1 Ruthven Barracks can be seen in the centre of the map, with General Wade’s Military Road crossing the Spey to the north. The settlements of Knappach and Ruthven can be seen to the south.

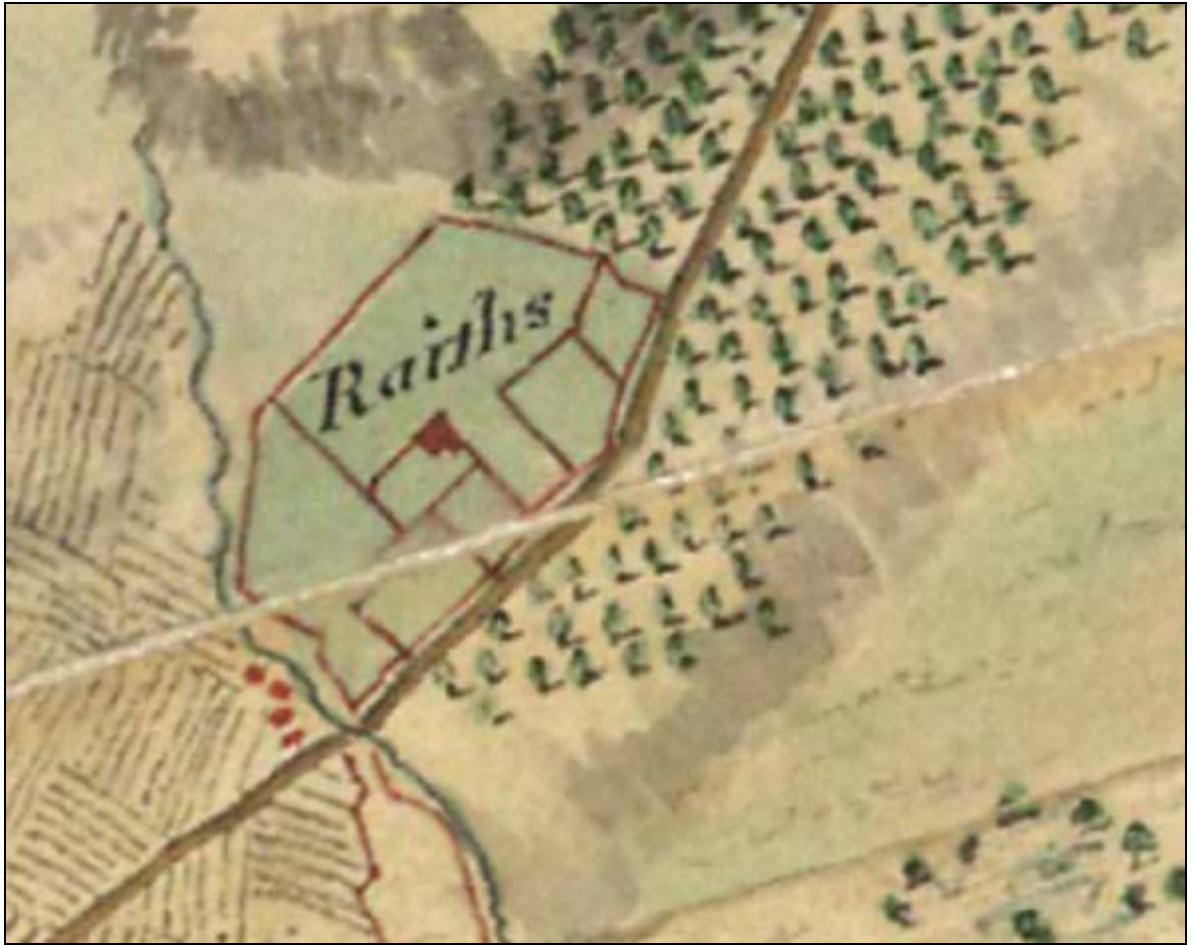
Figure 6-2: Roy Highlands 1747-52: Raitts

- 6.1.2 Raitts Cave is likely to be shown as the infilled red box below *Raiths*. Field systems are evident, as are a number of buildings to the south-west.

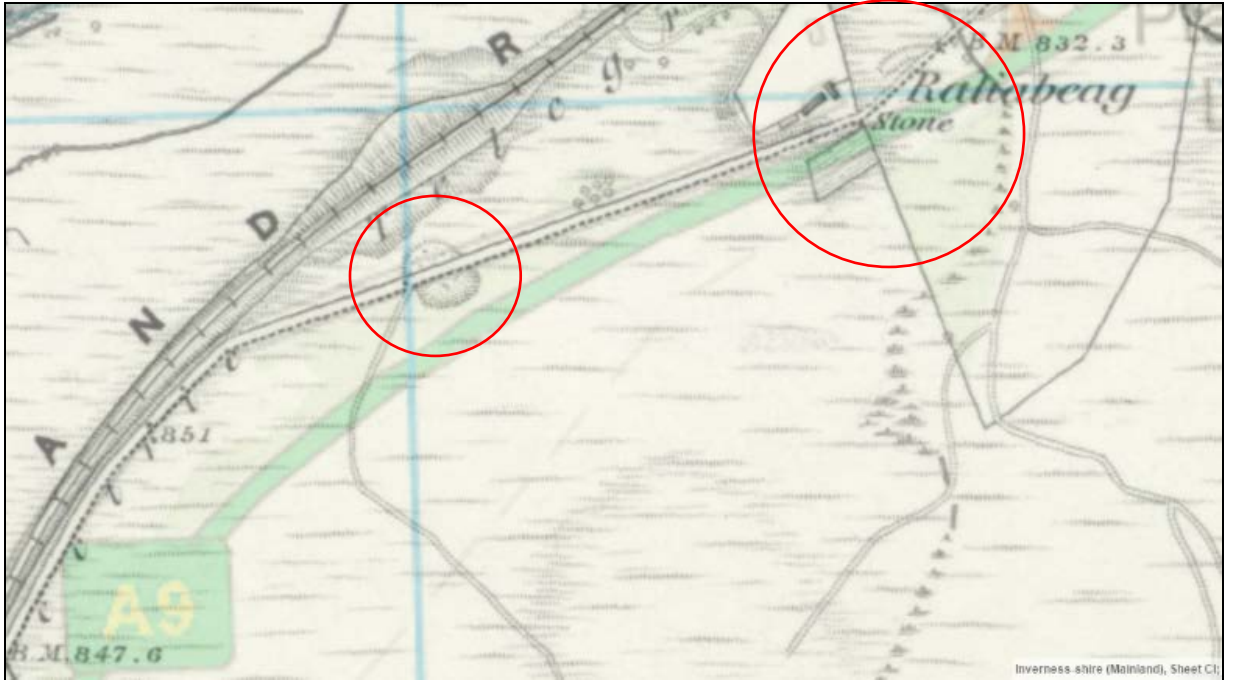
Figure 6-3: OS 6" 1843-1882: Raliabeg

6.1.3 The small settlement at Raliabeg can be seen, with the location of a ‘Stone’ shown on the line of the current A9. A small quarry scoop can be seen close to where the present day Ralia Café is located.

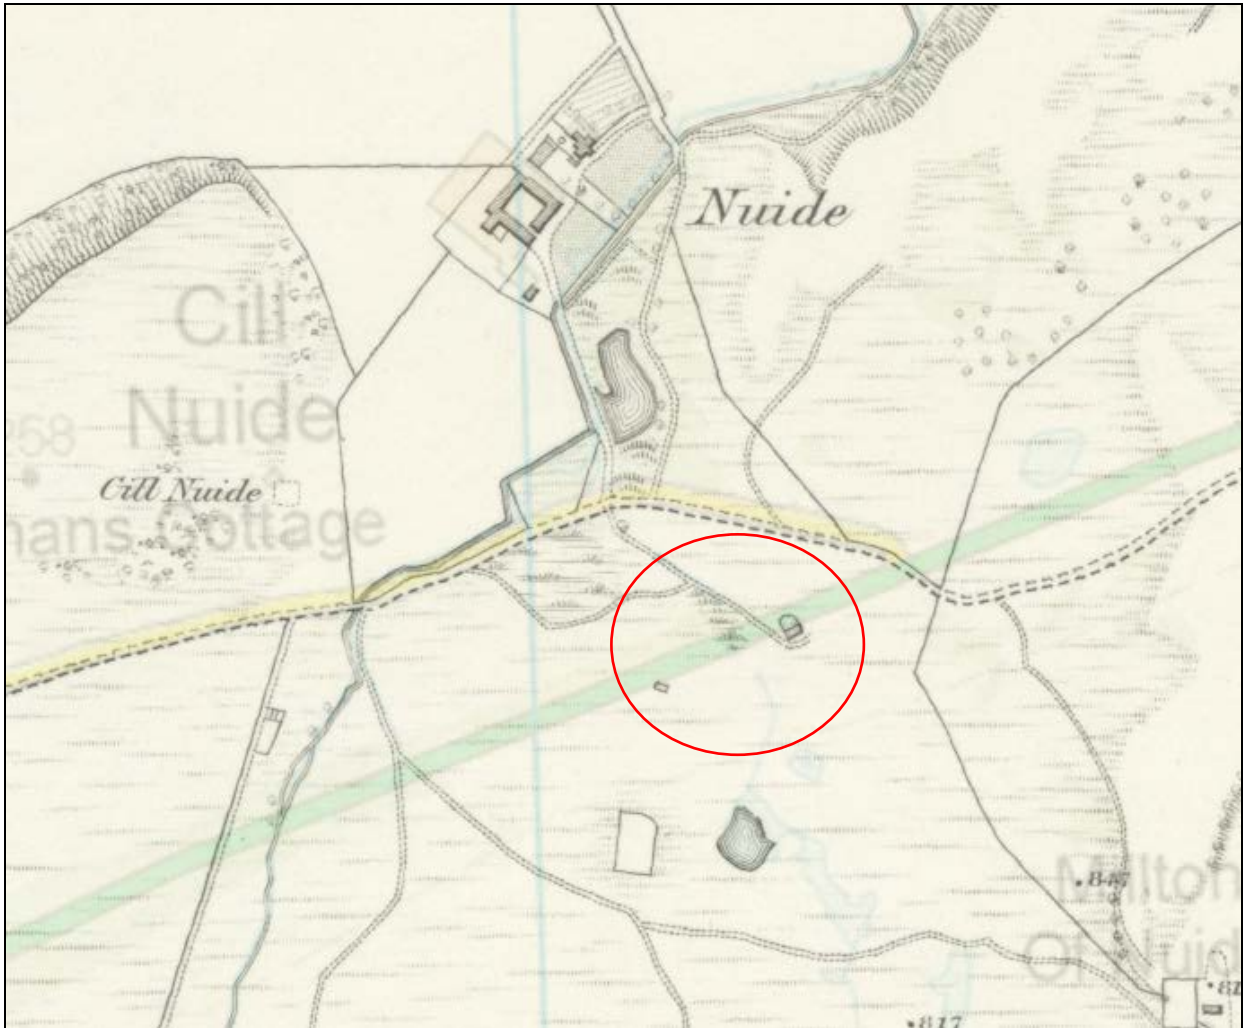
Figure 6-4: OS 6" 1843-1882: Nuide

6.1.4 Two small buildings are shown on the line of the current A9.

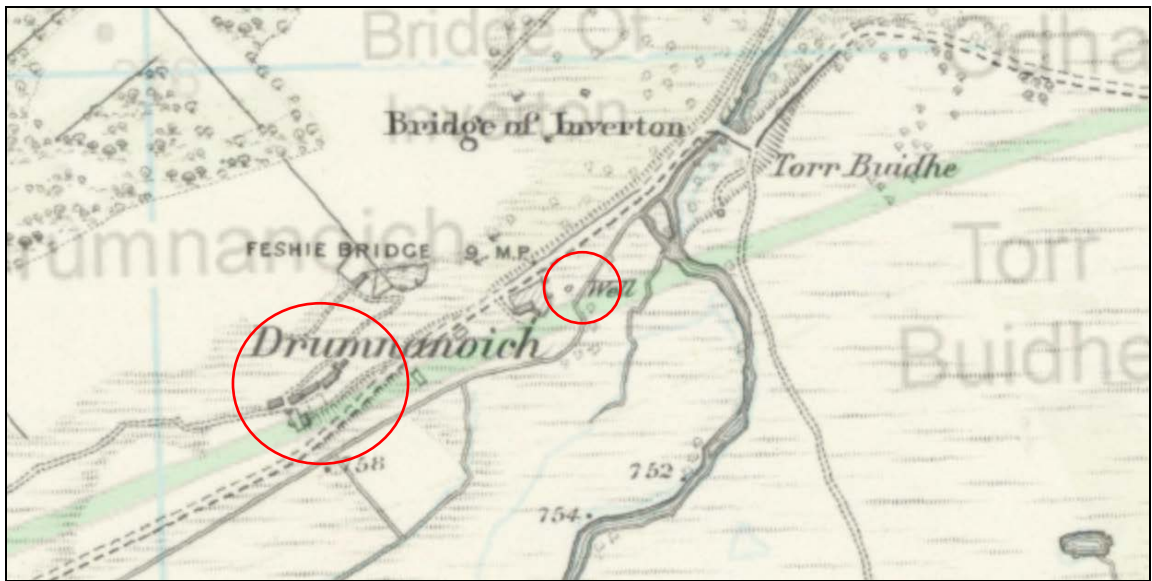
Figure 6-5: OS 6" 1843-1882: Drumnanoich

6.1.5 Several buildings and a well can be seen on the line of the current A9.

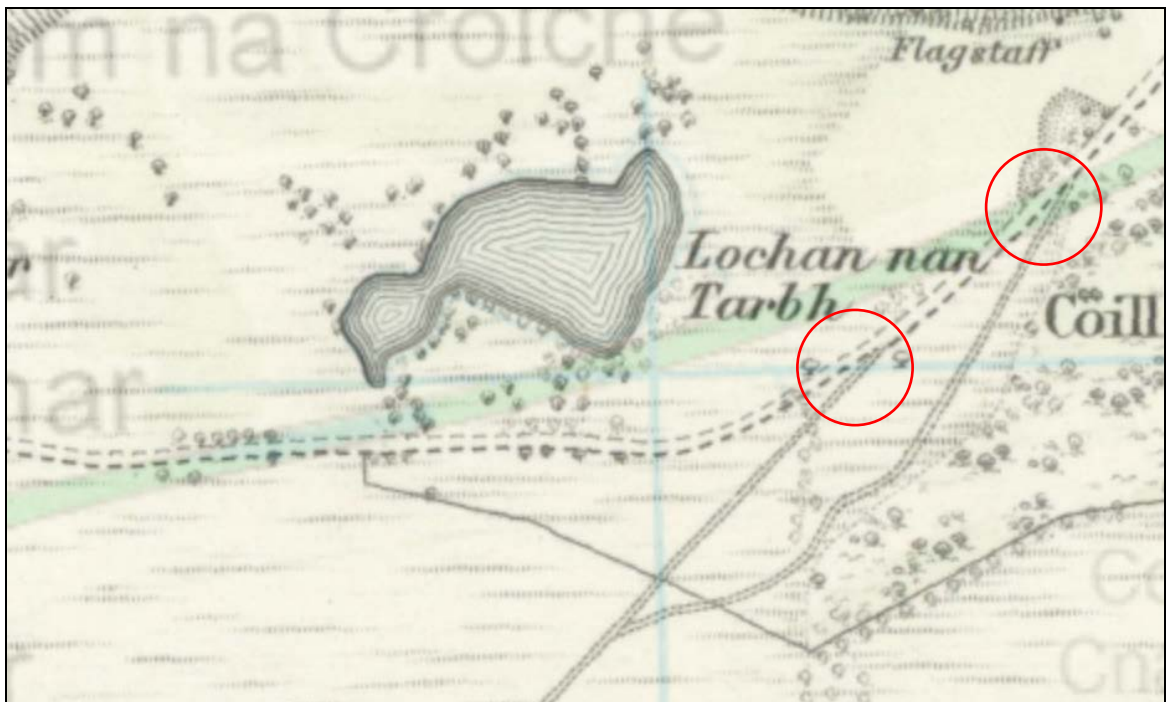
Figure 6-6: OS 6" 1843-1882: Lochan nan Tarbh

6.1.6 General Wade's Military Road can be seen to cross the A9 at two locations.

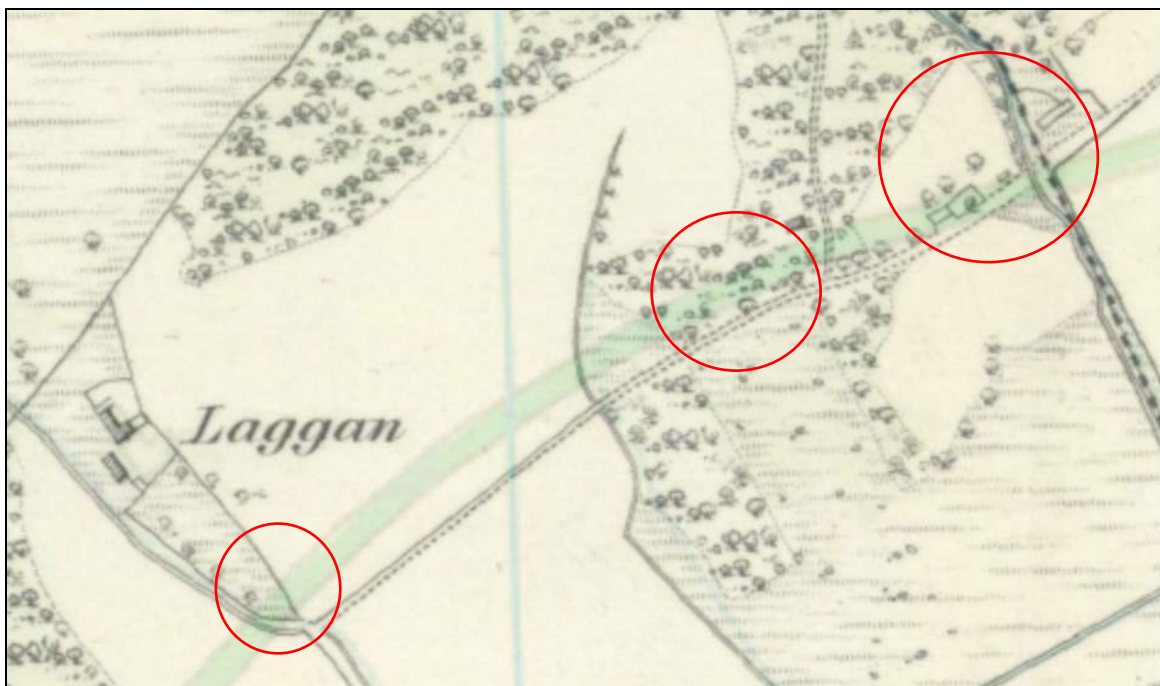
Figure 6-7: OS 6" 1888 – 1913: Laggan

6.1.7 Buildings and enclosures can be seen to the east of Laggan

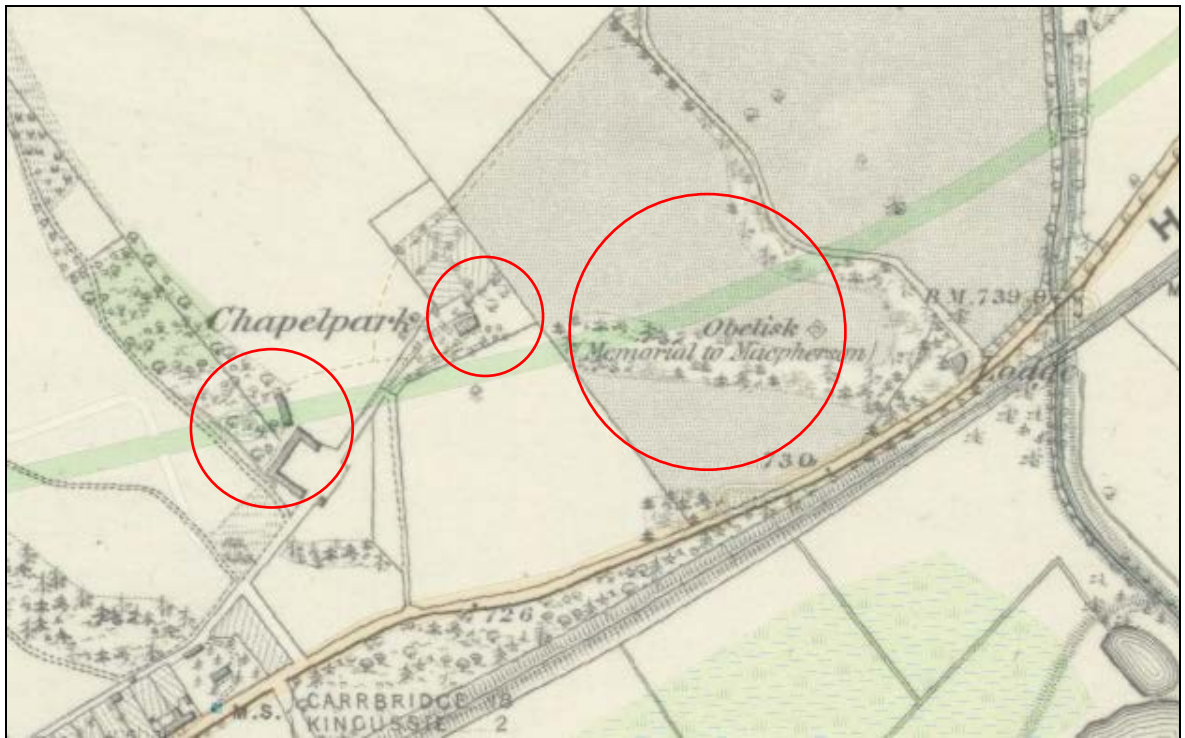
Figure 6-8: OS 6" 1888 – 1913: Chapelpark

- 6.1.8 Buildings at Chapelpark can be seen, these were removed by the construction of the A9. The Macpherson obelisk and burial ground, and West Lodge can be seen
