BEAR CREEK WATERSHED ASSESSMENT

PLACER COUNTY, CALIFORNIA

February 16, 2018

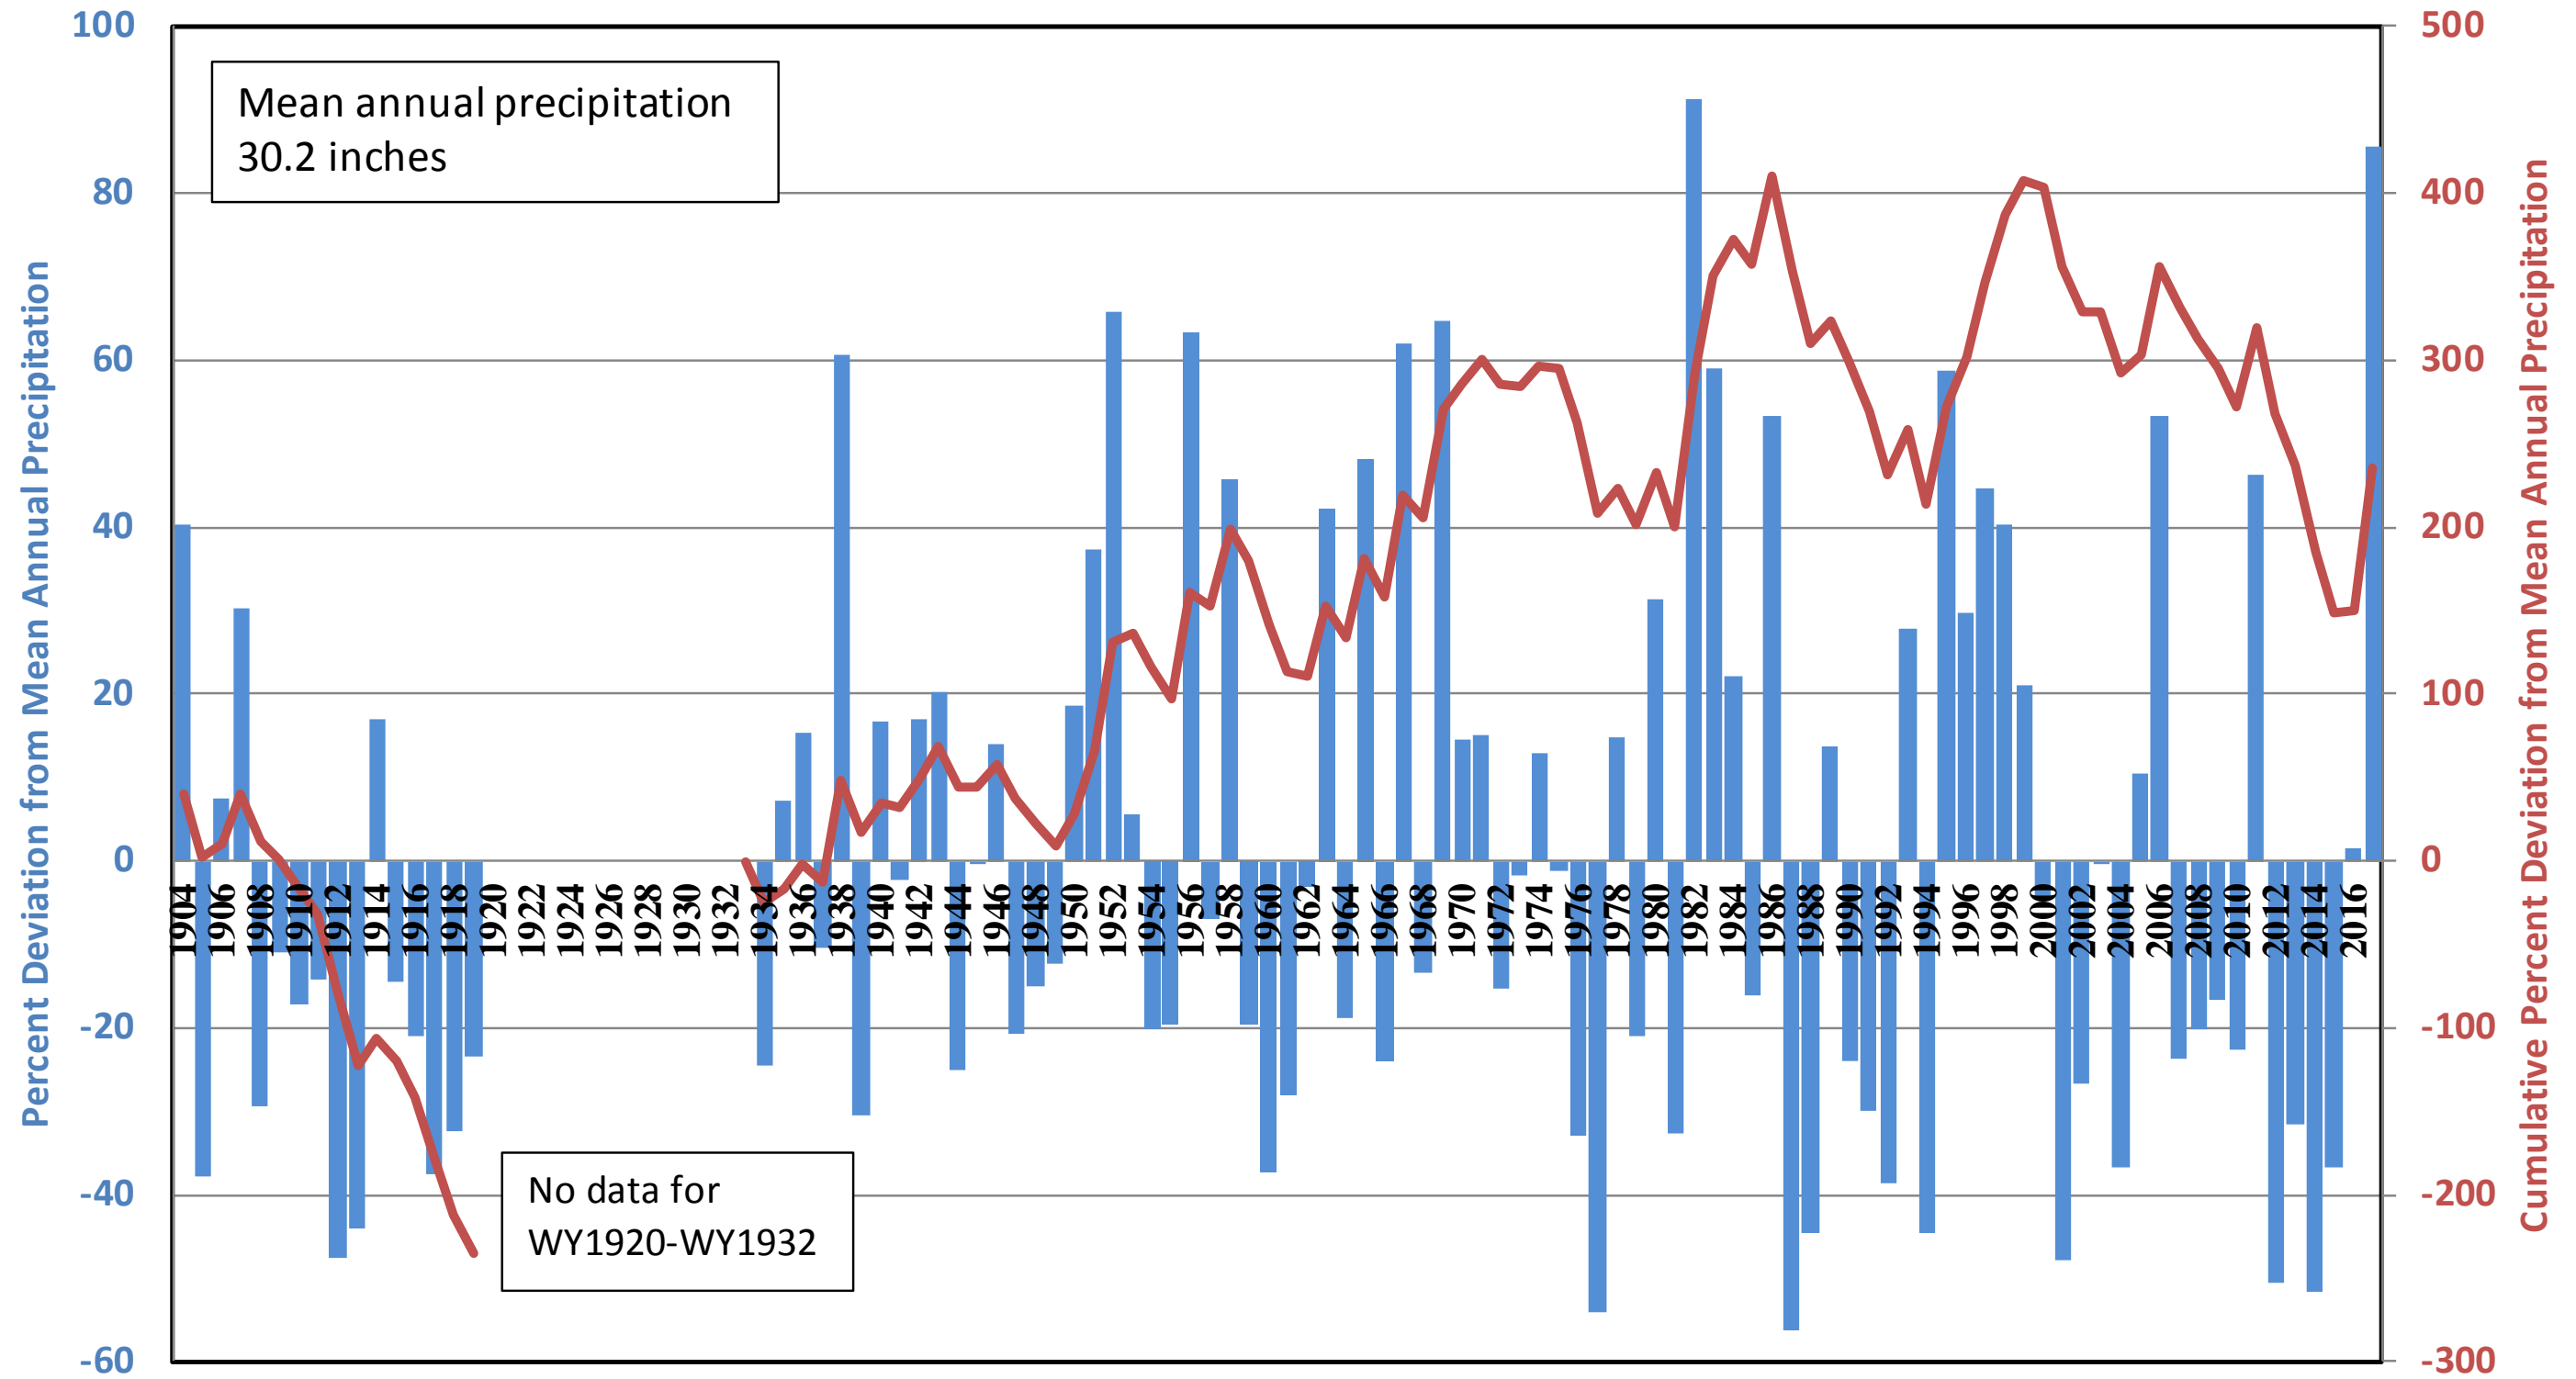
Sources: station TKE(Truckee), US Forest Service, 6,020 feet elevation, California Data Exchange Center (CDEC)

Figure 3-5 illustrates year-to-year precipitation variability. It shows the annual percent deviation and cumulative percent deviation from mean annual precipitation for Truckee Ranger Station, Truckee, California (station TKE, NRCS). This station is used for its long period of record (WY1904-current), and along with **Table 3-1**, provides context for interpretation of historical conditions, aerial photography and field investigations carried out as part of this assessment.

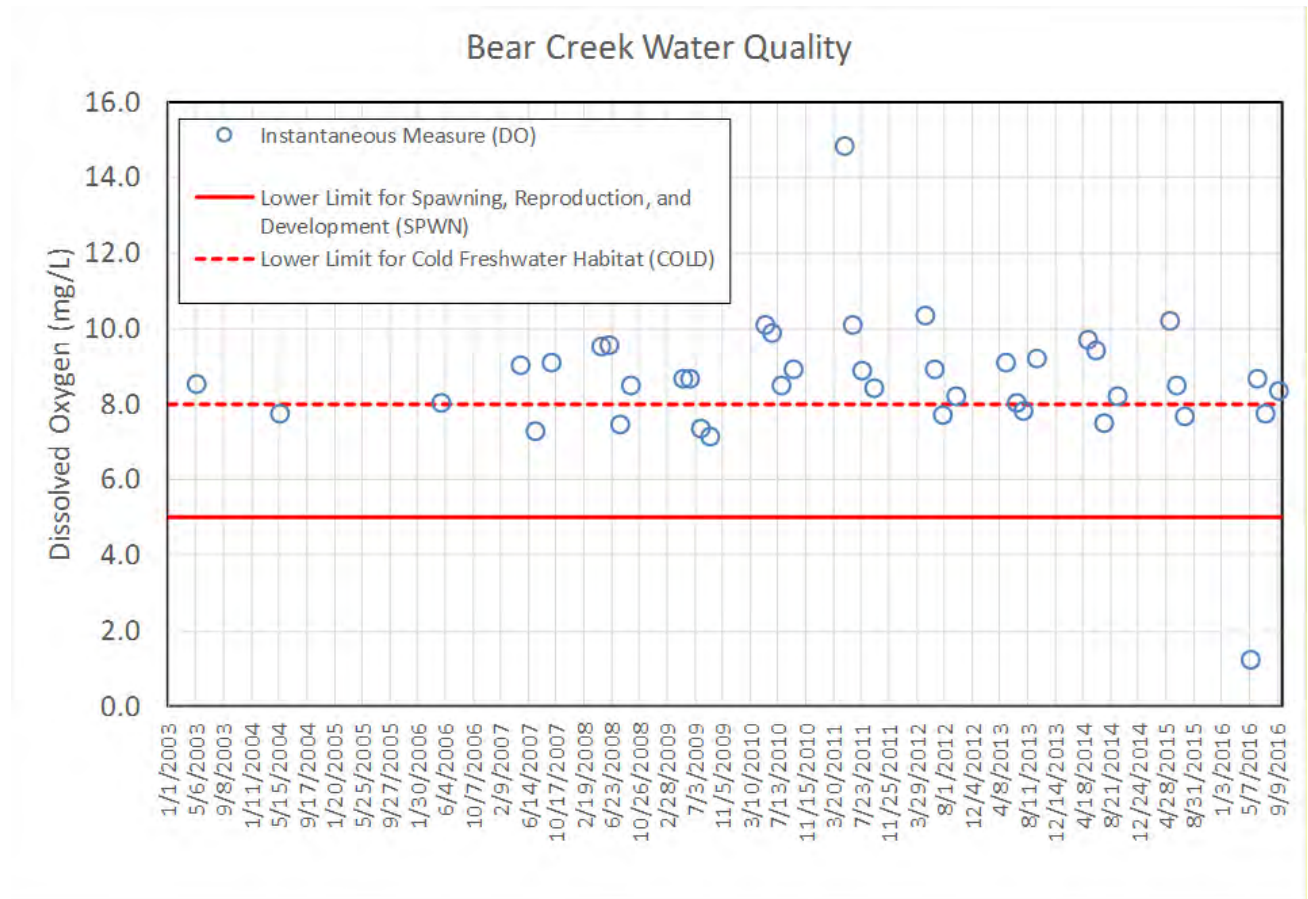
Dissolved oxygen (DO) has been measured periodically to fall below the 1-day minimum limit for supporting the beneficial use of cold freshwater habitat (8.0 mg/L; LRWQCB, 1995). Most measurements of DO have ranged above 8.0 mg/L; however, a handful of measurements over the years have recorded DO values less than this standard.

Figure 3-8 Instantaneous dissolved oxygen values in Bear Creek (Reach A), WY2003-WY2016, Placer County, California.

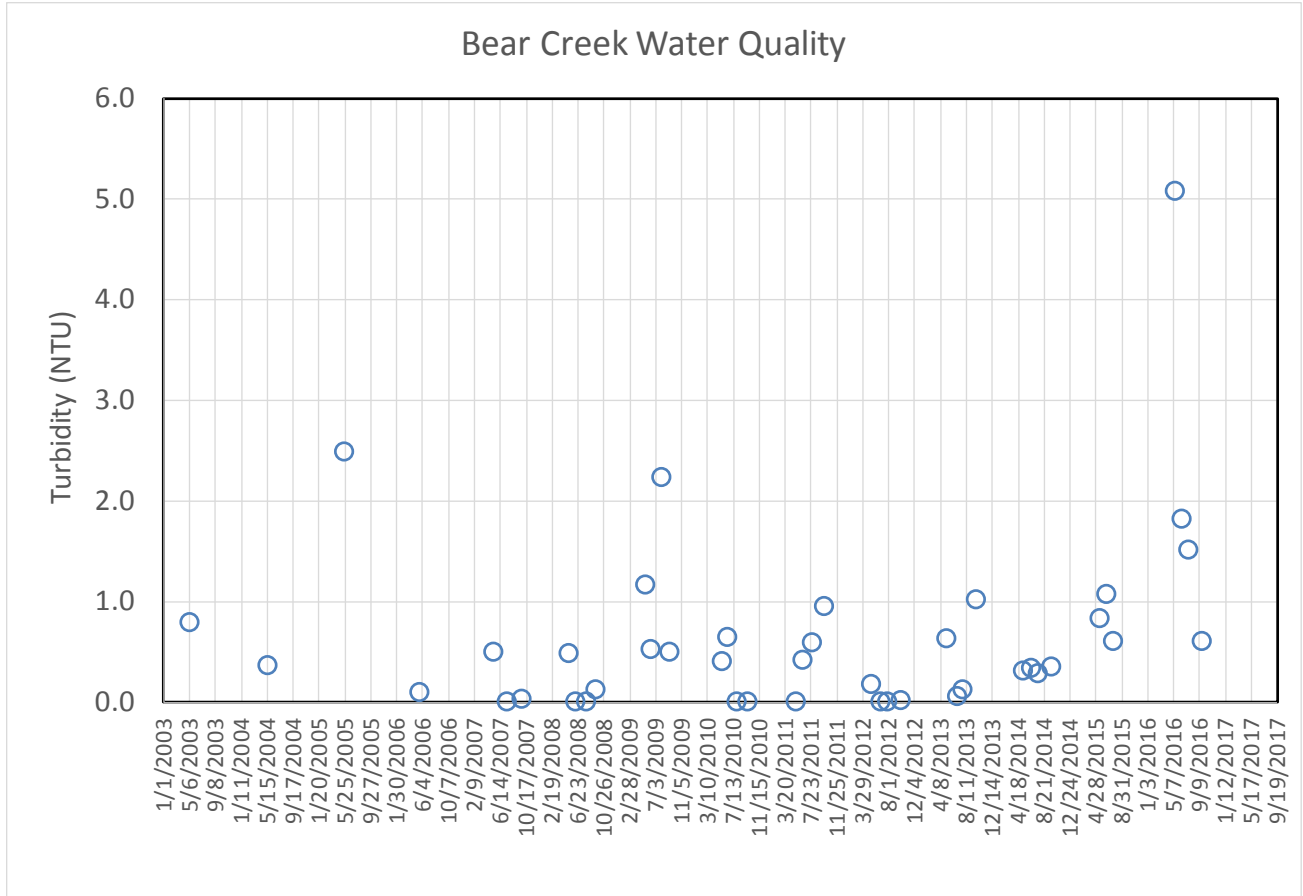
Turbidity values have ranged between 0 and 5.1 Nephelometric Units (NTU), representing generally clear water conditions. However, most samples were collected during non-rain events or after the peak snowmelt runoff period.

Figure 3-9 Instantaneous turbidity values in Bear Creek (Reach A), partial WY2003-WY2016, Placer County, California.

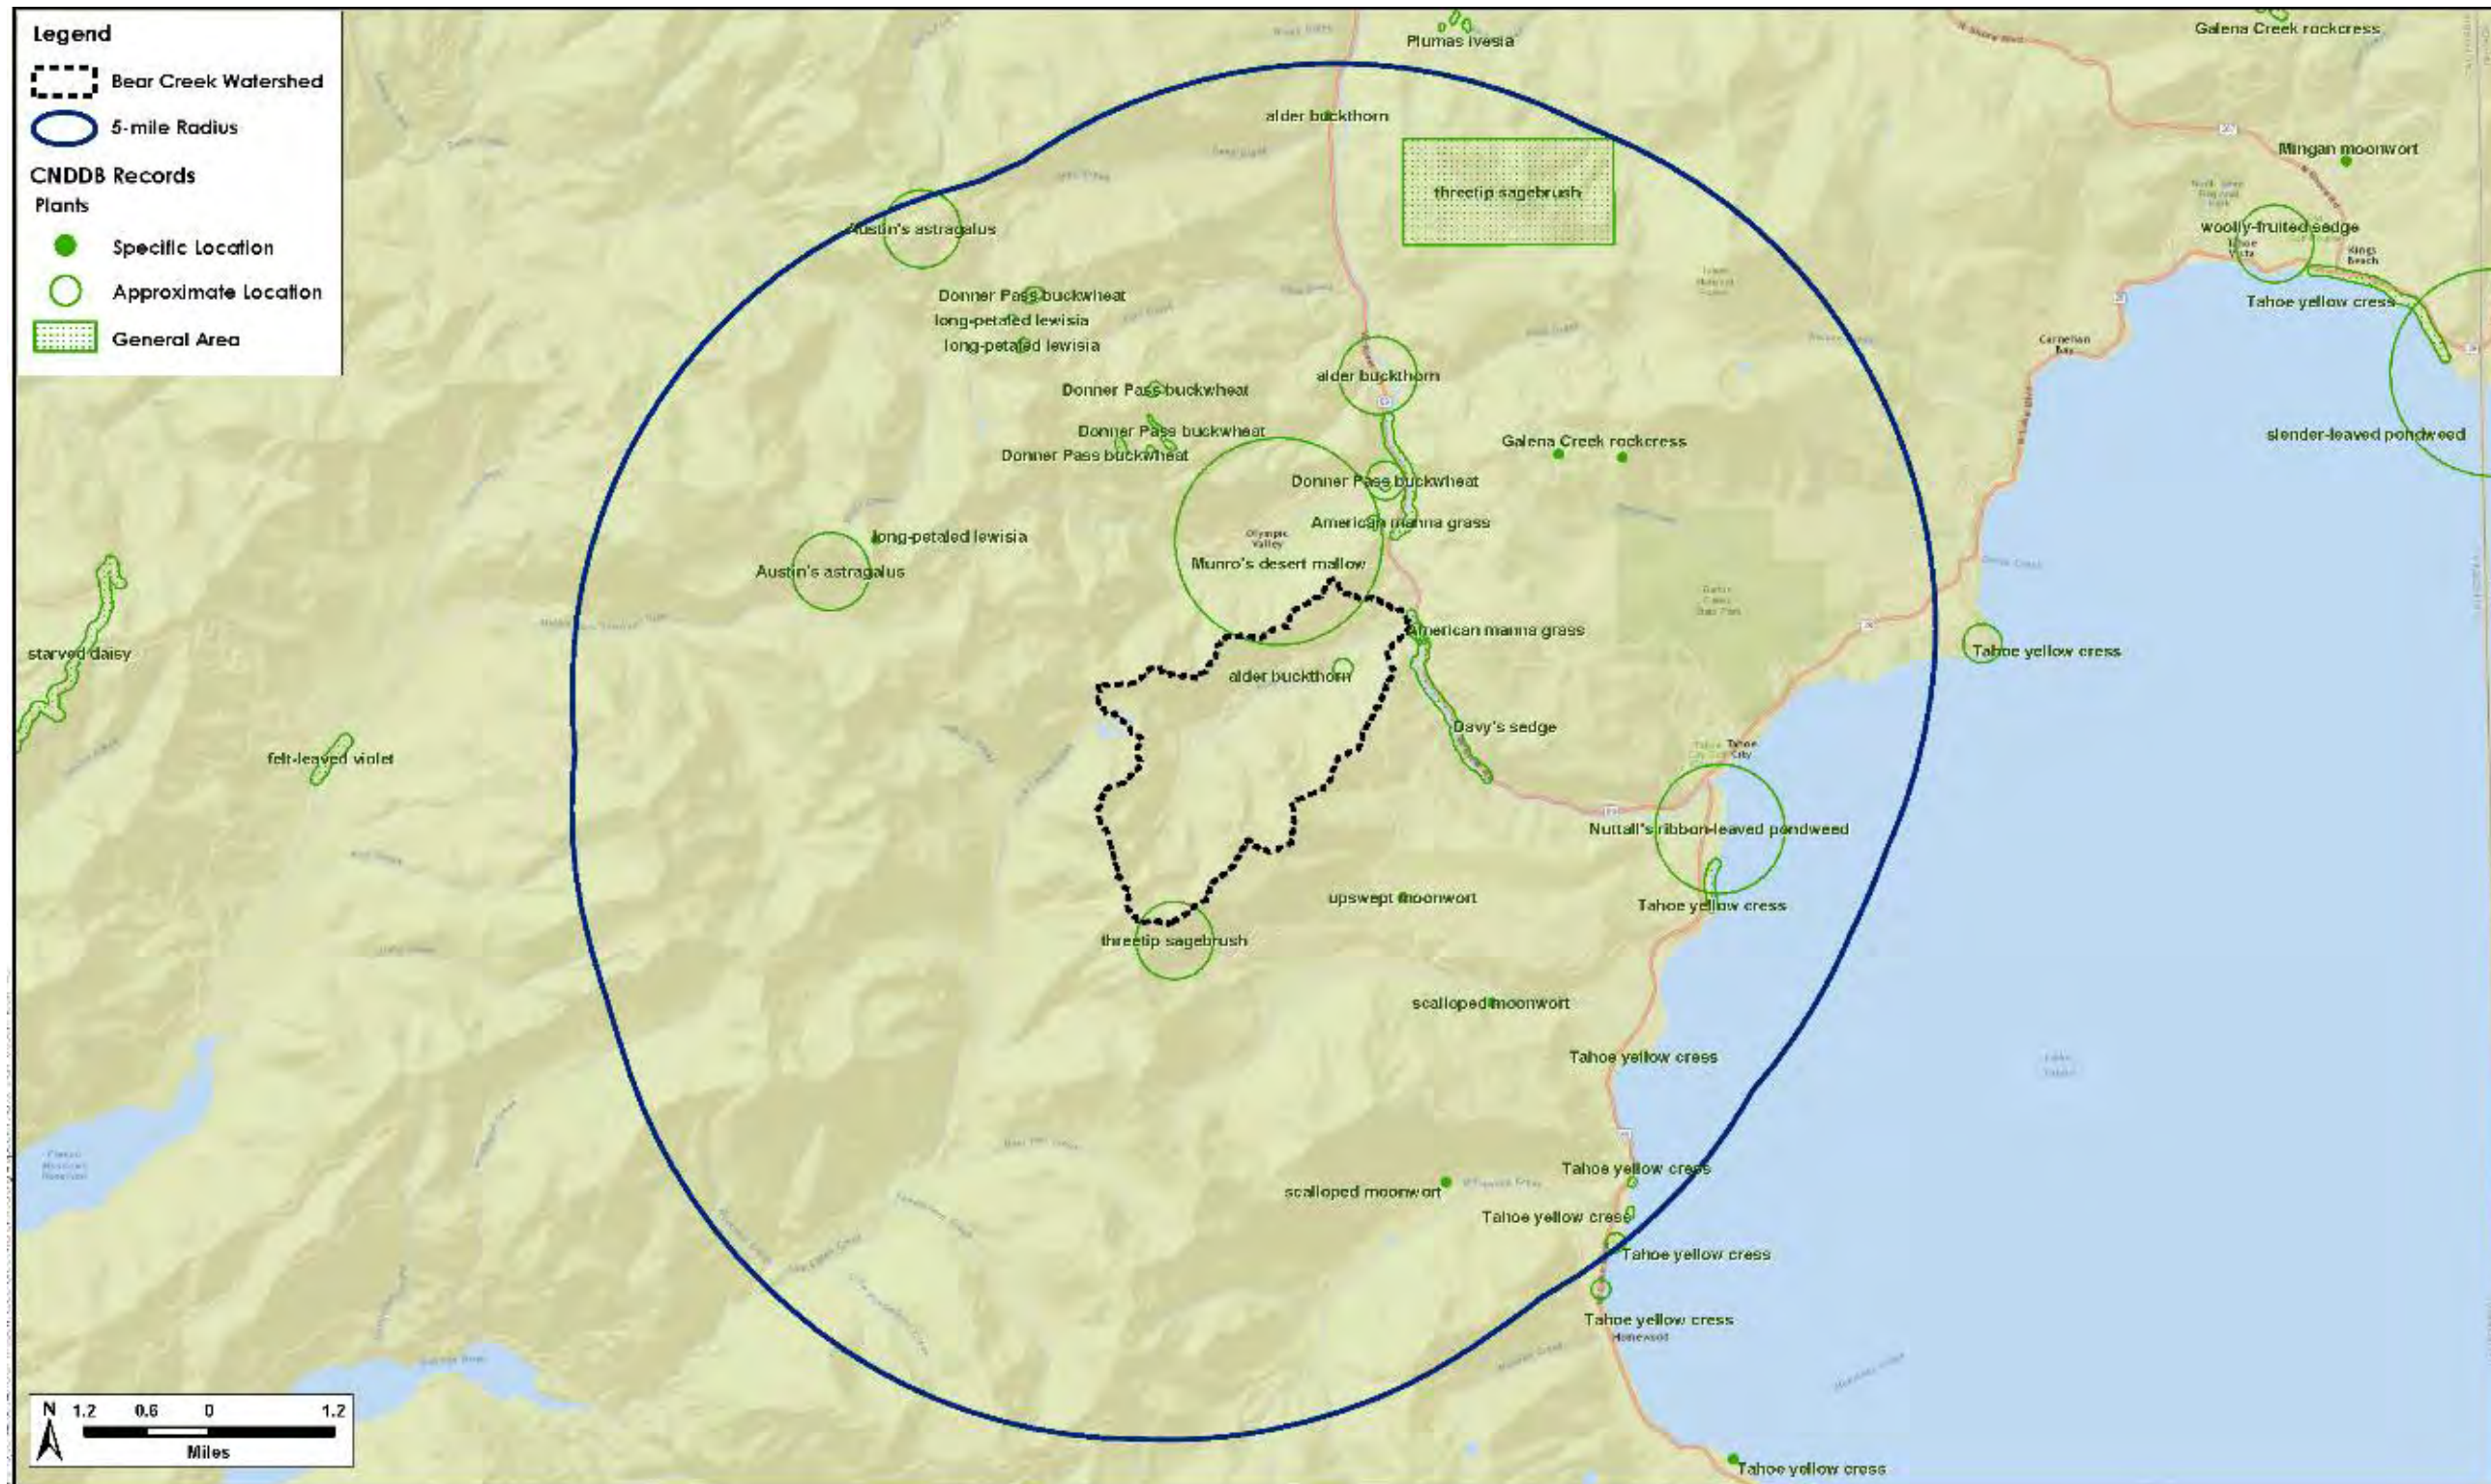
Figure 3-14 Special-status plant occurrences, Bear Creek watershed, Placer County, California.

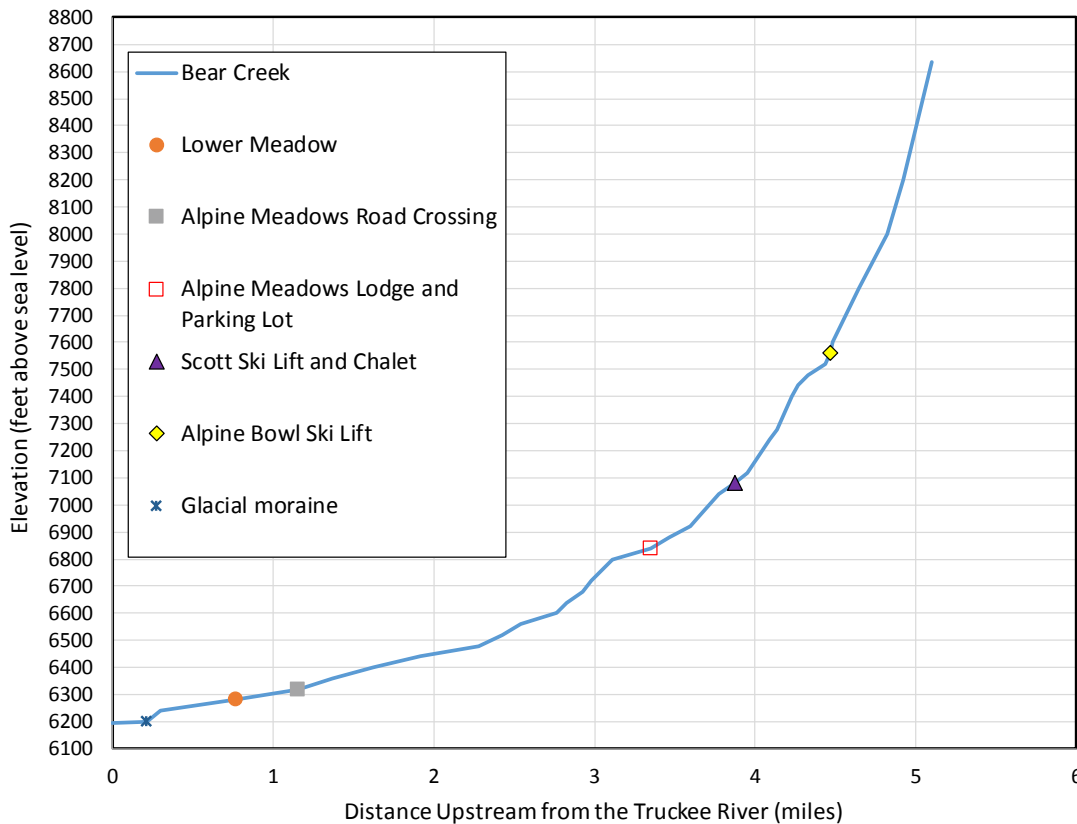
Figure 4-2 Longitudinal Profile of Bear Creek, Placer County, California.

Smaller, steeper tributaries (not shown) in the upper zone of a watershed function to erode and transport sediment, while the larger, shallower mainstem channel in the lower zone of a watershed tends to accumulate or deposit sediment. Watershed management strategies should differ where sediment transport processes differ. It is also important to recognize that these zones are not static, and sediment transport processes may change in a particular location following large floods, wildfires, or during extreme droughts.

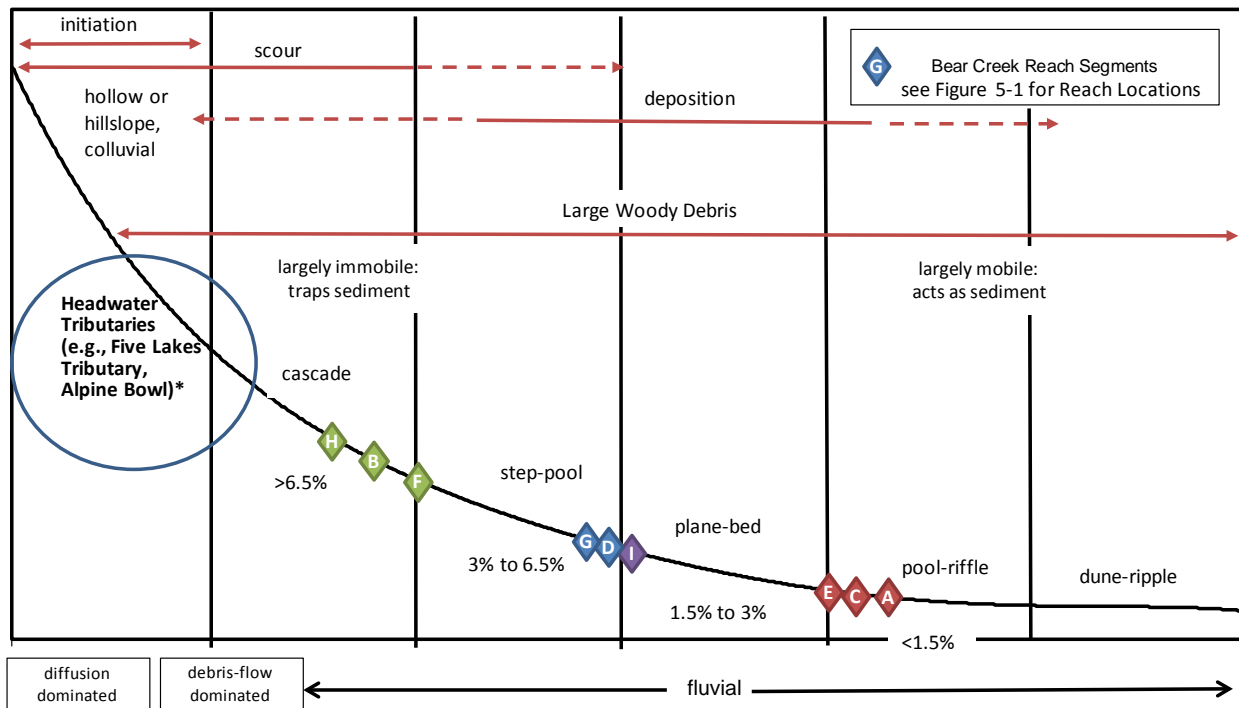
* Headwater stream slopes vary and support intermittent, lower-gradient, meadow systems

In **Figure 4-3**, we plot Bear Creek by reach based on slopes measured from topographic maps and as compared to the general distribution of alluvial channel types presented by Montgomery and Buffington (1997). Processes such as scour, deposition, and function of large woody debris can be inferred from the graph and applied toward channel restoration planning in specific areas. Alluvial reaches exhibit pool-riffle type morphology, whereas, bedrock controlled reaches typically express cascade and/or step-pool morphology. The predicted channel morphology generally conforms to our observations in the field. Their classifications also help to define future design concepts to maintain geomorphic form and function.

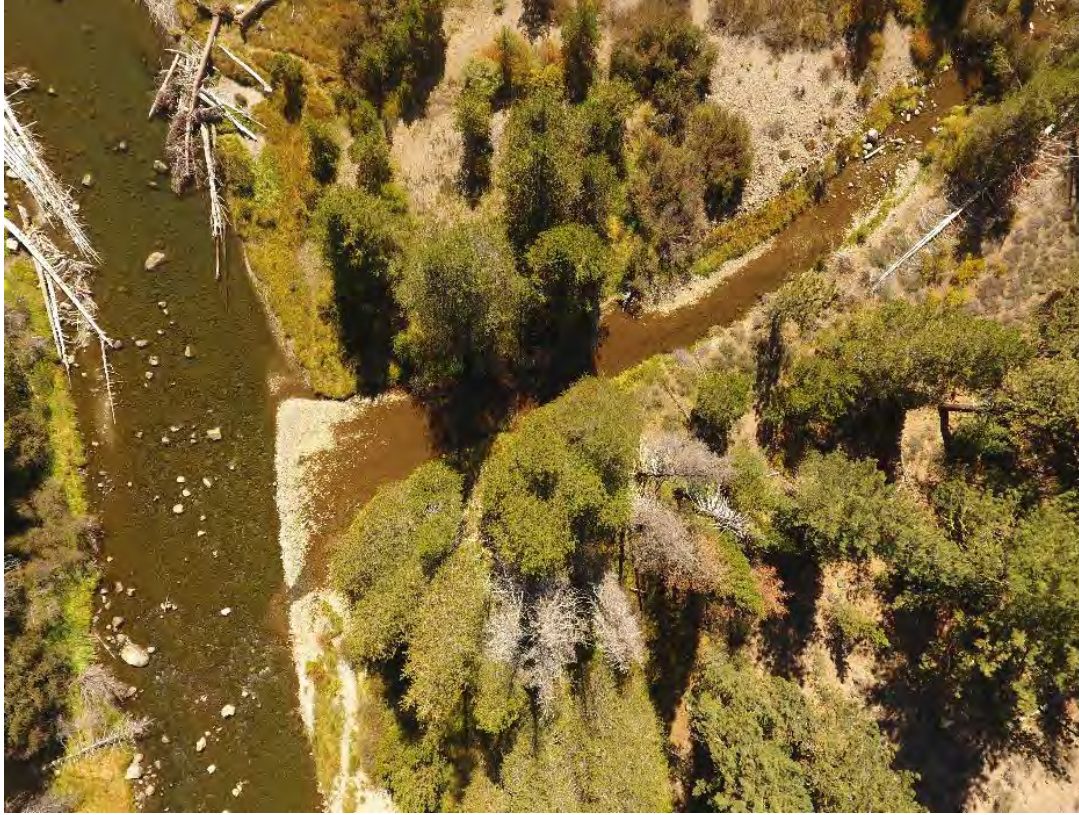
Reach A forms a deltaic type landform, where Bear Creek encounters a fluctuating base level of the regulated Truckee River. The change in base level and energy forms a depositional zone with dynamic distributary channels, similar to a delta (**Figure 4-19**). Sediment deposition, transported by the steeper Bear Creek, changes location relative to the stage of the Truckee River. For example, during times of reduced Truckee River flow releases from the Tahoe City dam, sediment from Bear Creek actively deposits in the active channel of the Truckee River. In contrast, higher flows in the Truckee River promote overbank deposits and bar development within Bear Creek within this reach.

Figure 4-4 Reach A showing confluence with Truckee River and wet meadow complex, Bear Creek, Placer County, California.

No restoration actions are recommended for this reach.

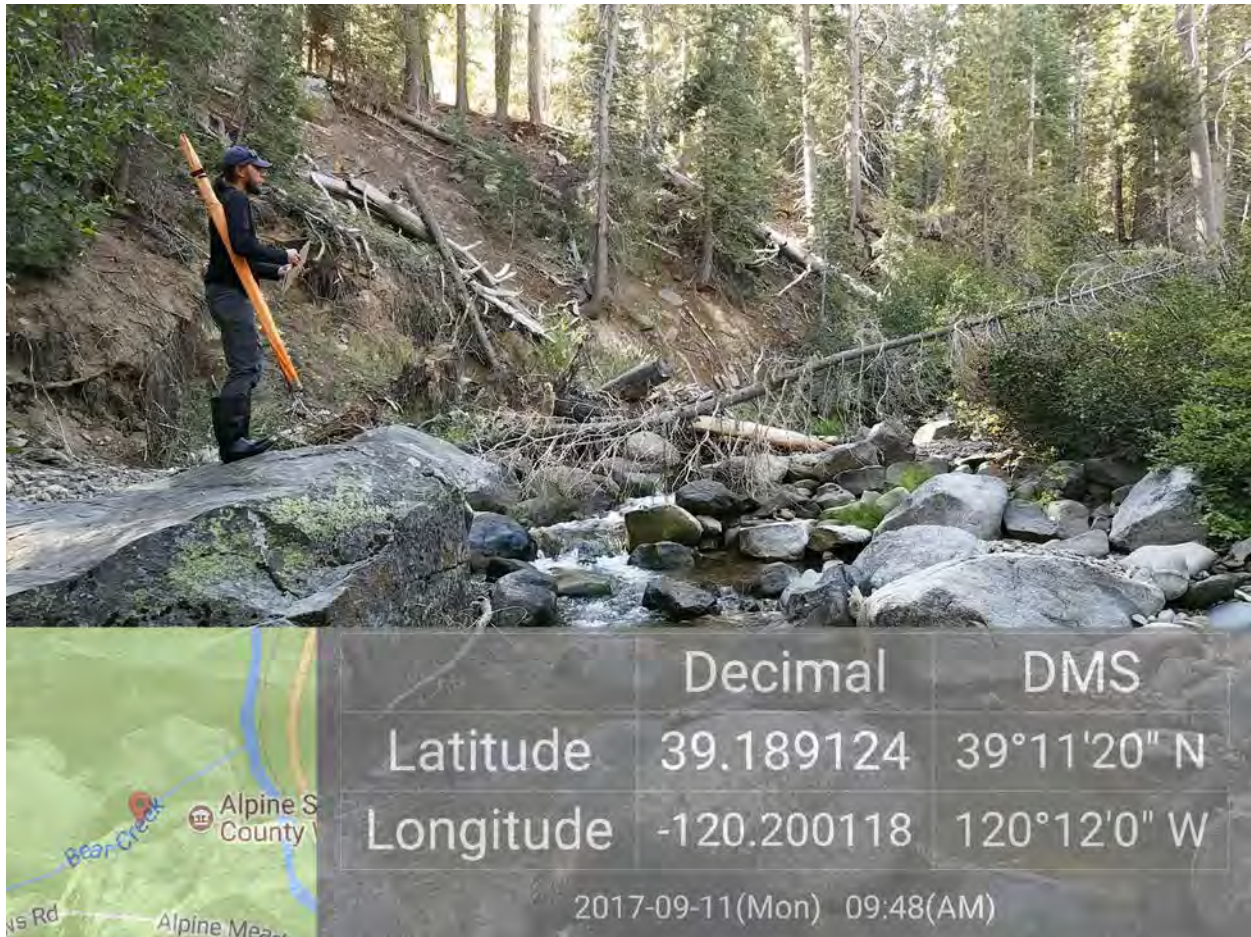
Figure 4-5 Reach B showing boulder-dominated step-pool morphology and steep sideslopes of a channel cutting through a glacial moraine, Bear Creek, Placer County, California.

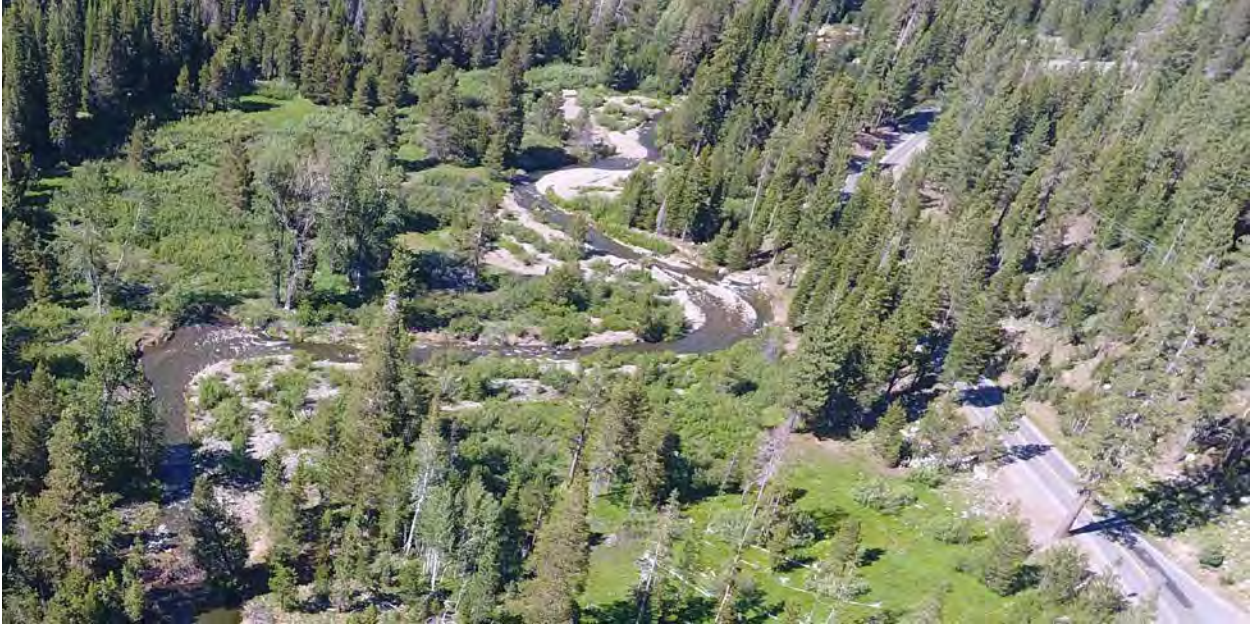
Reach C is defined by alluvial valley fill, a lower gradient system influenced by the downstream moraine and possibly structural geology (fault trace). Bear Creek in this reach is a dynamic, meandering channel with active bank erosion and in-channel bar formation with pool-riffle morphology (**Figure 4-6**).

Figure 4-6 Reach C showing a meandering alluvial channel and wet meadow complex, Bear Creek, Placer County, California.

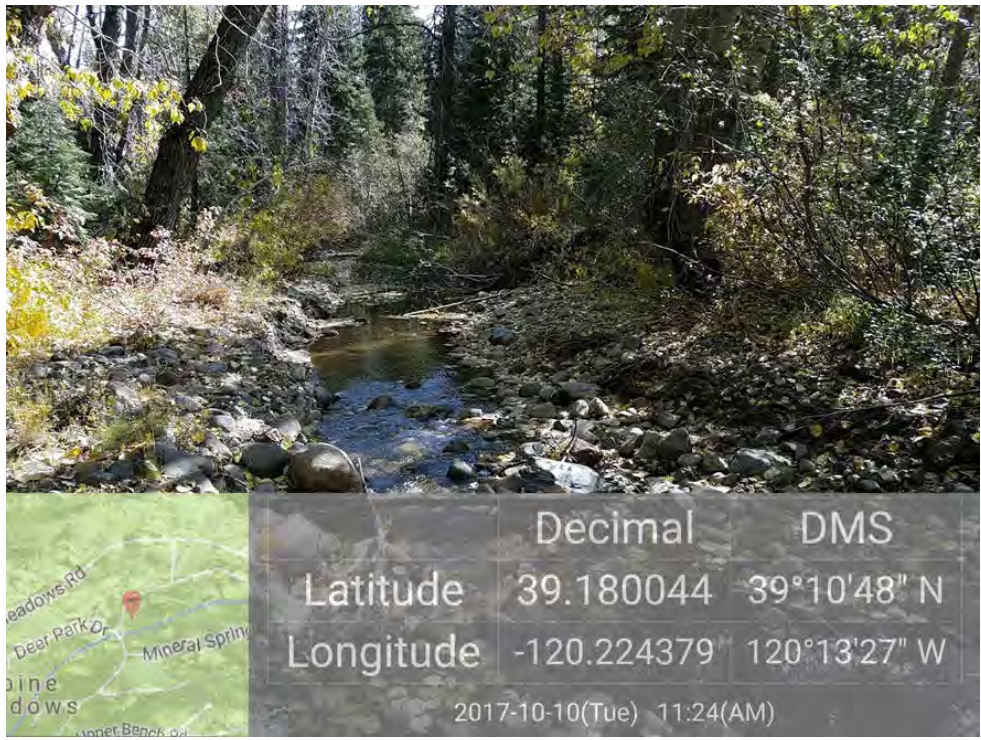
Reach E includes the Lower John Scott Trail crossing at Bear Creek and a confluence with several tributaries including the Five Lakes trailhead tributary. This reach is confined within a narrow canyon, but includes segments of alluvial fill where channel and floodplain features are present. Channel characteristics include pool-riffle morphology with gravels and cobbles dominant (**Figure 4-11**). The channel exhibits active widening and some incision. The coarse texture of the bed provides some resilience to these instabilities. Road traction sand observed in pools and along floodplains is evidence of stormwater runoff and source of possible hydromodification effects. A review of Placer County stormwater culvert locations and flow paths suggest that this reach receives runoff from a significant portion of Alpine Meadows Road and neighborhood streets.

Figure 4-11 Reach E, Bear Creek, Placer County, California.

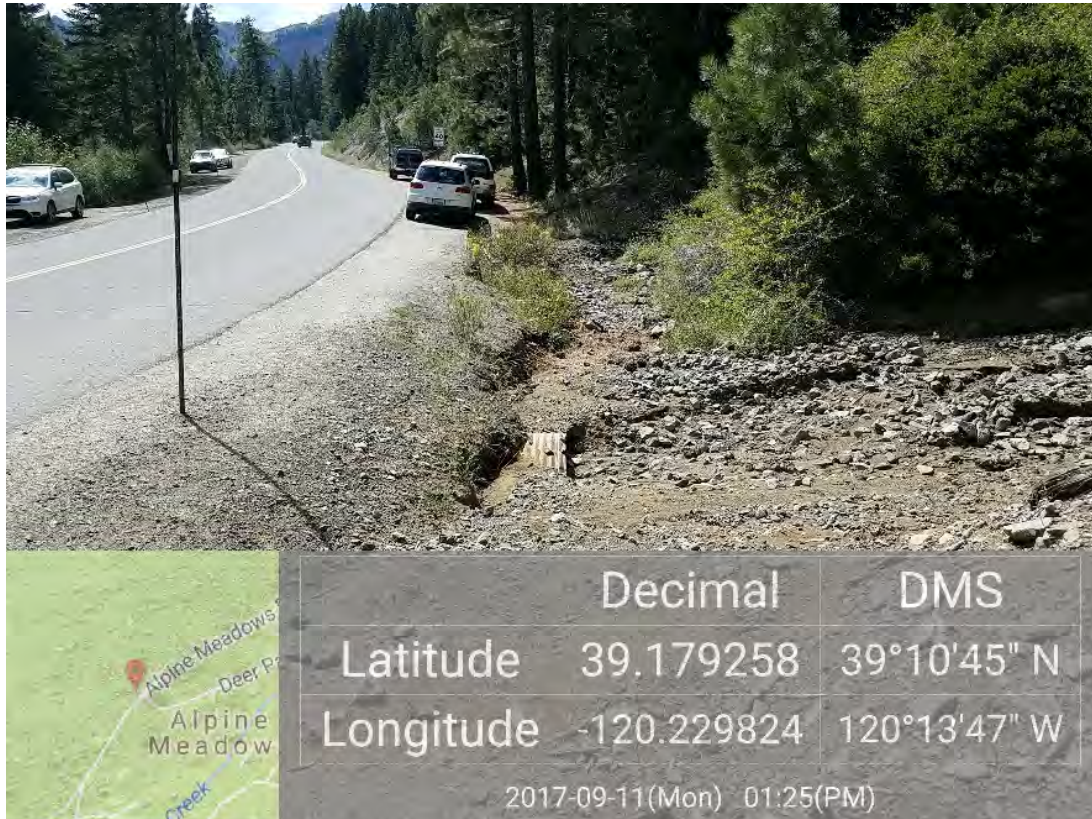
Stormwater impacts in this reach can be traced up the Five Lakes tributary. This tributary funnels a significant portion of runoff from Alpine Meadows Road. Furthermore, tributaries along this portion of the watershed drain highly erosive geology and in some events, can trigger significant sediment transport to Bear Creek. Frequent culvert plugging from sediment was reported by Placer County under Alpine Meadows Road at the Five Lakes Trailhead. These occurrences have forced stormwater and sediment onto the road and onto private property (Boyer, T., pers. comm., 2017) **Figure 4-12**.

Figure 4-12 Sediment plugged culvert inlet, Alpine Meadows Road at Five Lakes Trailhead, Placer County, California.

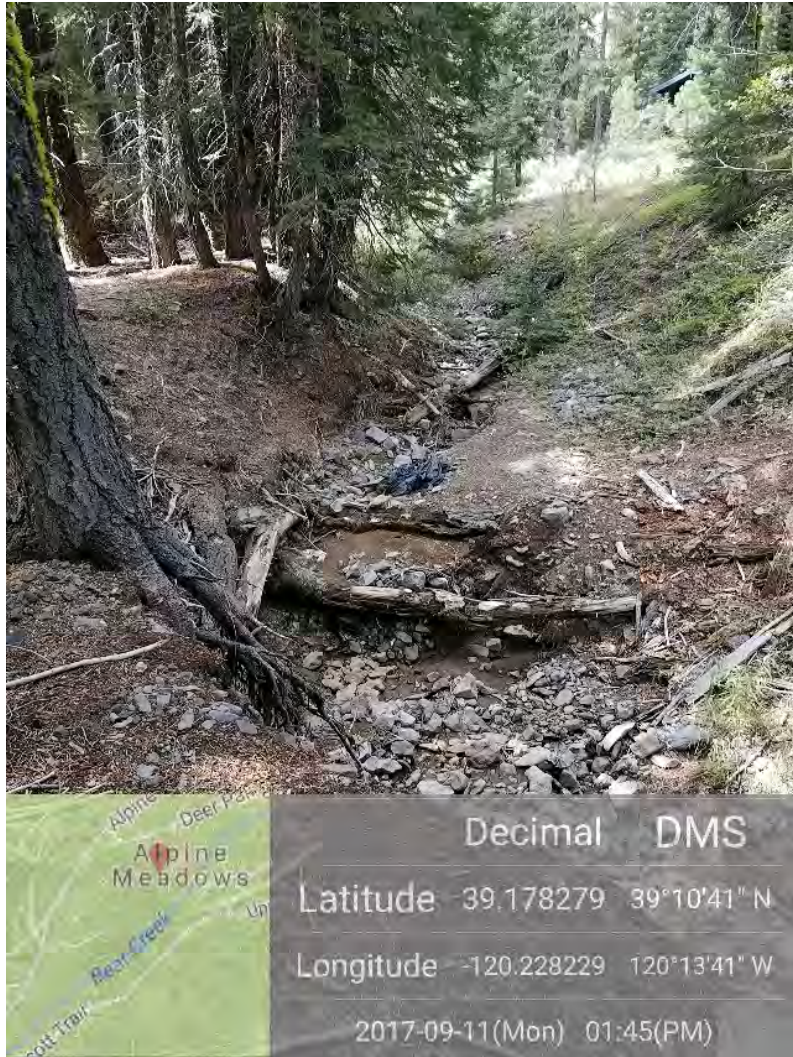
Two undersized culverts at the Five Lakes Trailhead conveys runoff from multiple drainages and an inboard ditch under Alpine Meadows Road and discharge to a steep tributary and Bear Creek. The excess stormwater runoff results in channel scour and bank erosion and is a likely sediment source to Bear Creek (**Figure 4-13**).

Figure 4-13 Active channel and bank erosion downstream from Five Lakes Trailhead, Tributary to Reach E, Bear Creek, Placer County, California.

-No restoration opportunities were identified in this reach.

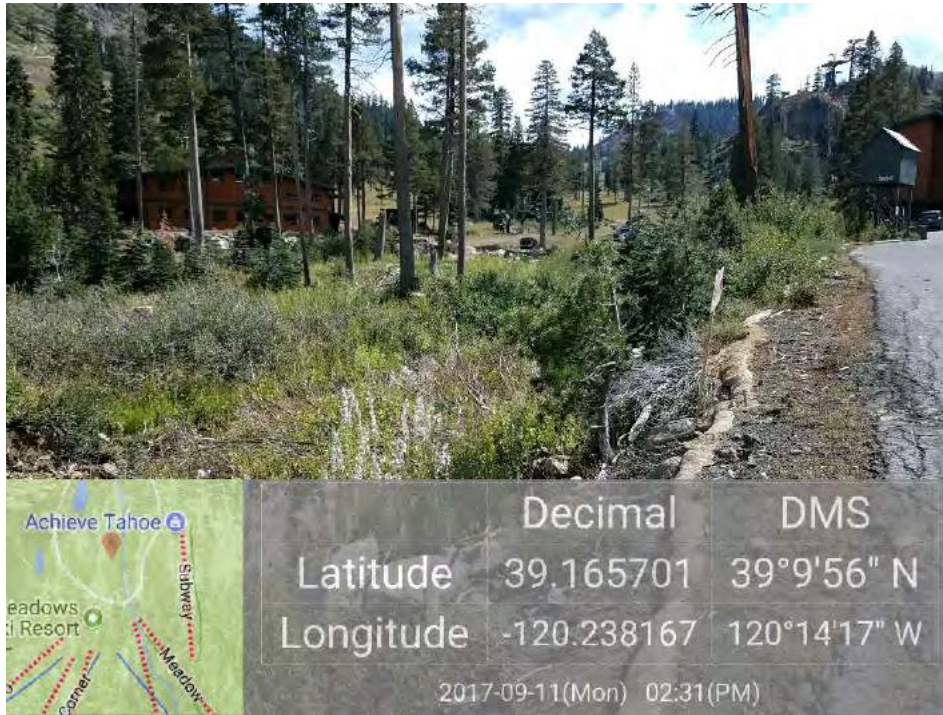
Figure 4-18 Riparian mortality from snow storage, Bear Creek (Reach I), Placer County, California.

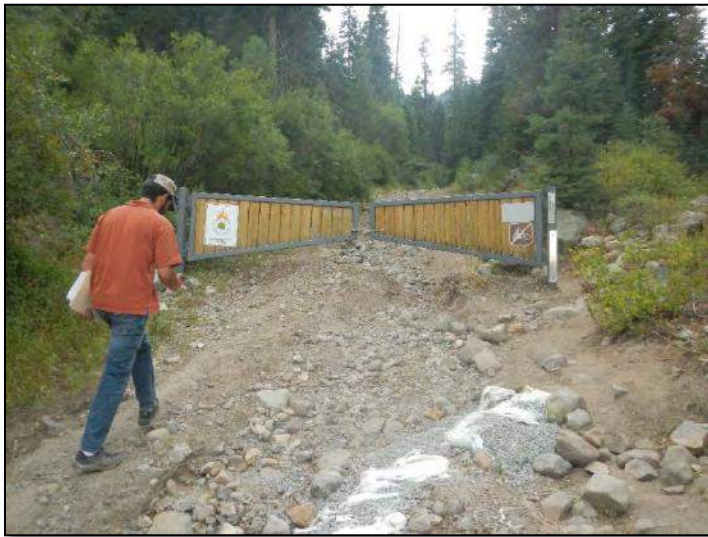
Figure 4-20 Stream capture from private/USFS road, Road Area #2 (USFS, 2016), Placer County, California.

The USFS (2016) identified plugged culverts and stream capture on a dirt road on the south side of the watershed. The road has since scoured and generated measurable runoff and sediment to neighborhood streets and the urban storm drain system (**Figure 4-20**). In **Figure 4-19** and **Figure 4-20**, the flow accumulation analysis shows clearly where the stream is captured by road segments (green circle) and diverts several other smaller drainages into the urban storm drain system.

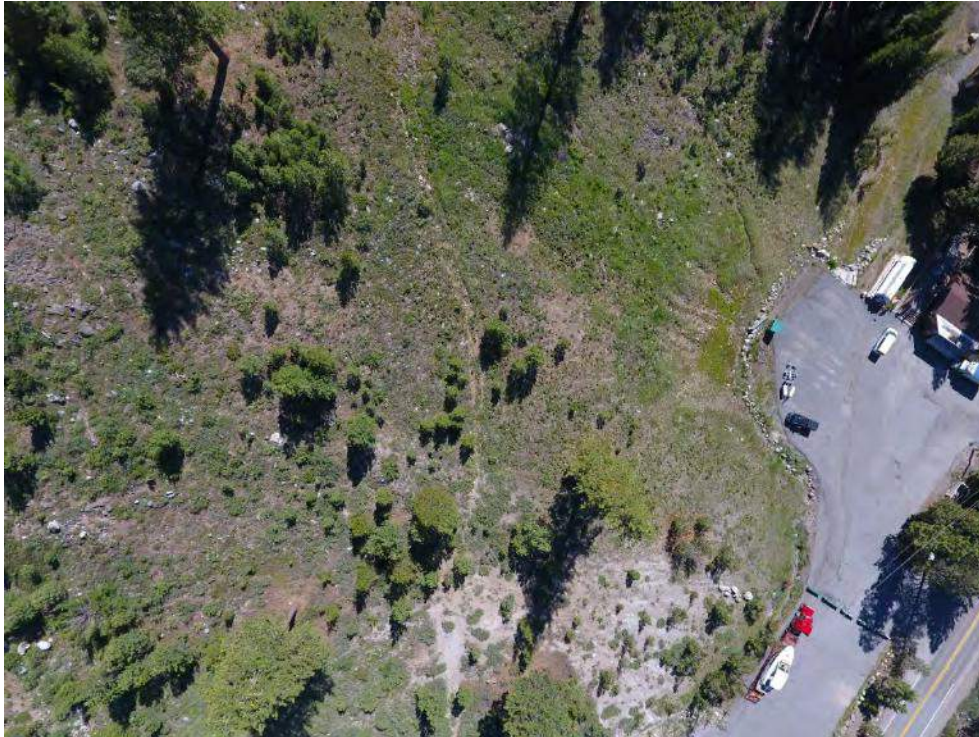
Figure 4-22 Aerial view of former Deer Park Ski Area, showing areas lacking vegetation, hillside rilling, and stormwater ditch, Bear Creek watershed, Placer County, California.

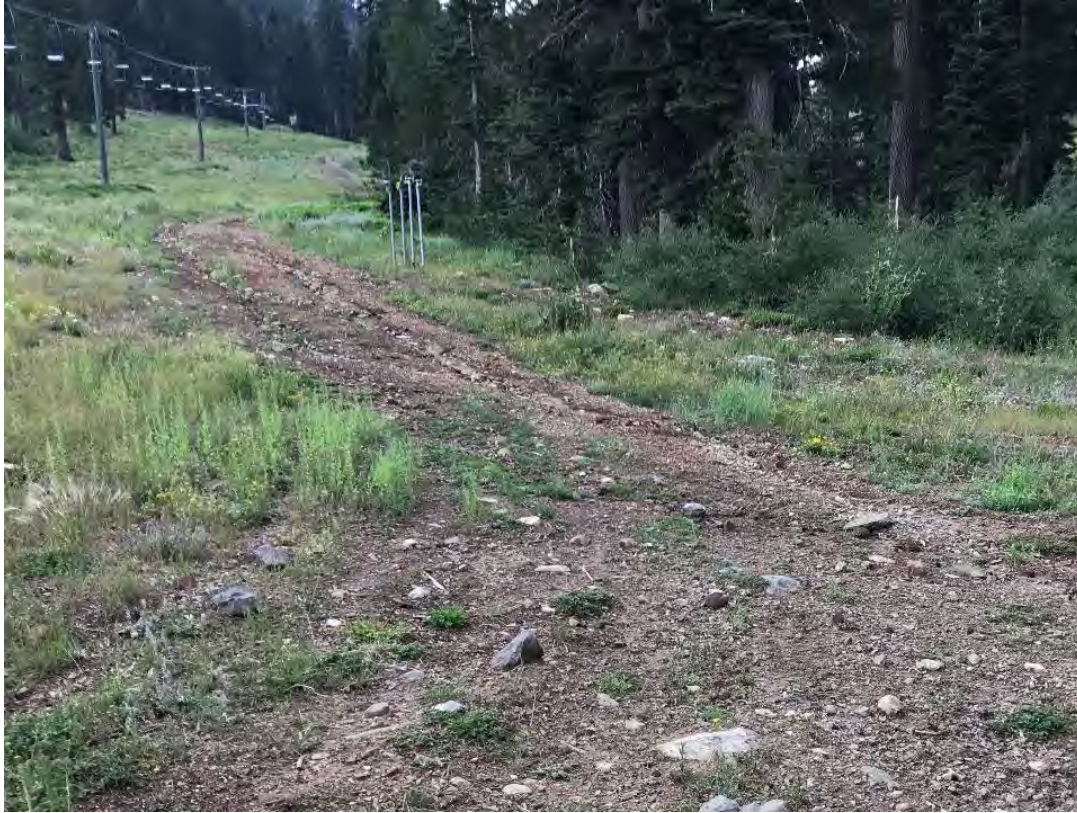
Figure 4-24 Erosion along water lines, adjacent to Meadow Chair, Alpine Meadows Ski Area, Tahoe National Forest, Placer County, California.

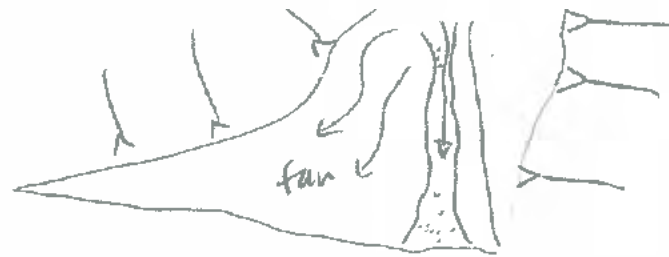
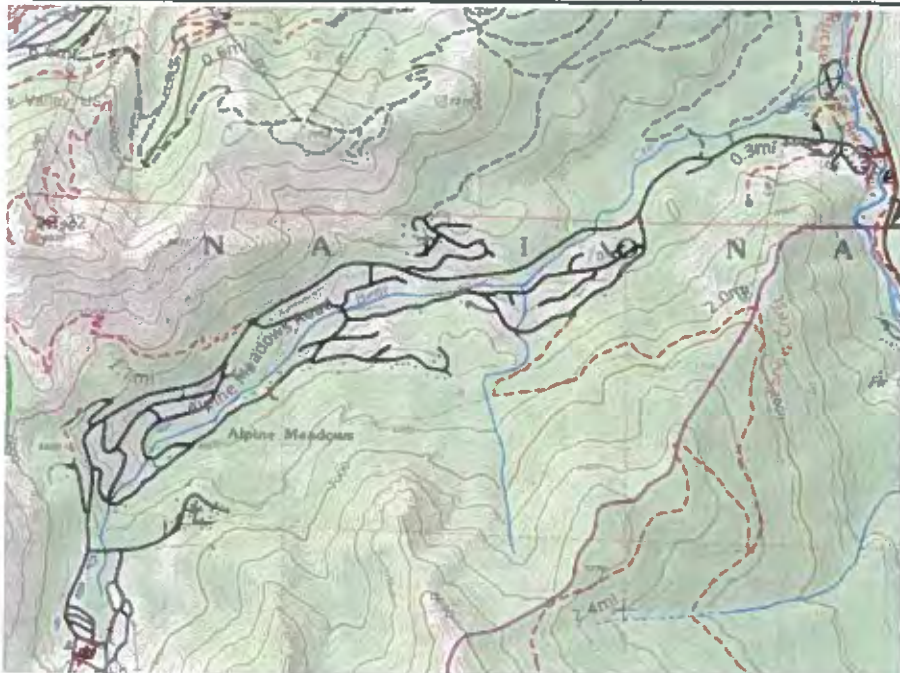
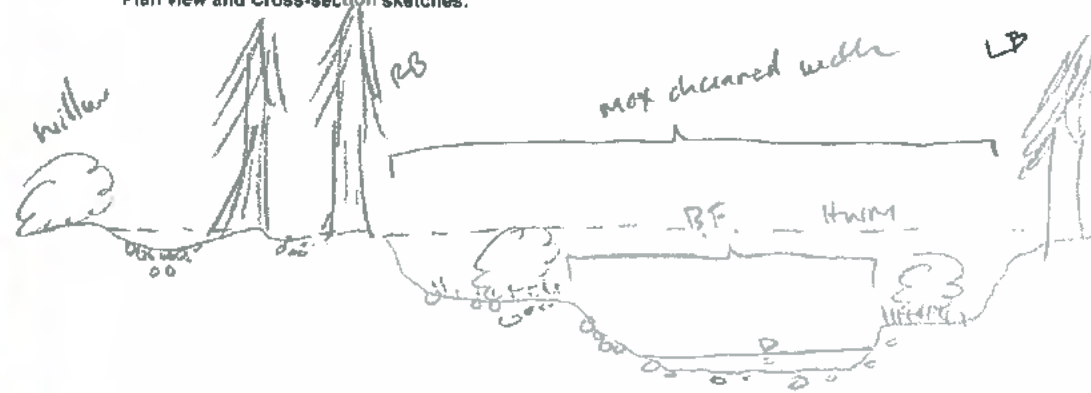
Reach A - 100' up of mouth

beaver activity; channel appears locked in w/ old pines 3' D BH
bed conditions rich in algae even though scoured this winter

HWM = Jan 8, 2017?

possible backwatering from TR
