BEAR CREEK WATERSHED ASSESSMENT

PLACER COUNTY, CALIFORNIA

February 16, 2018

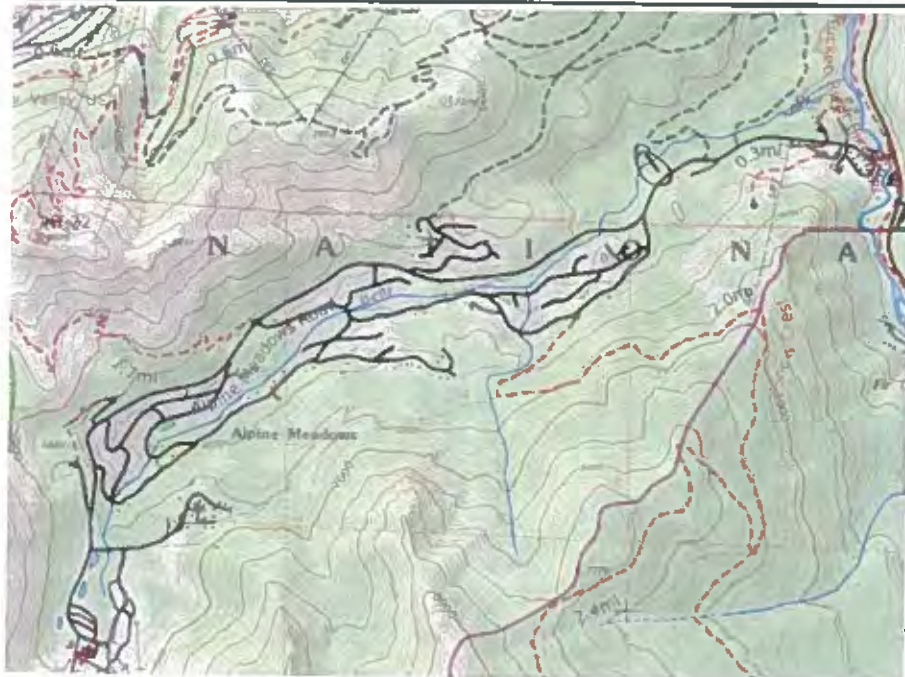
historically braided, today incised
 definitely need to evaluate meadow stressors → stormwater? Evaluate historical aerial, oral accounts. → Susan?

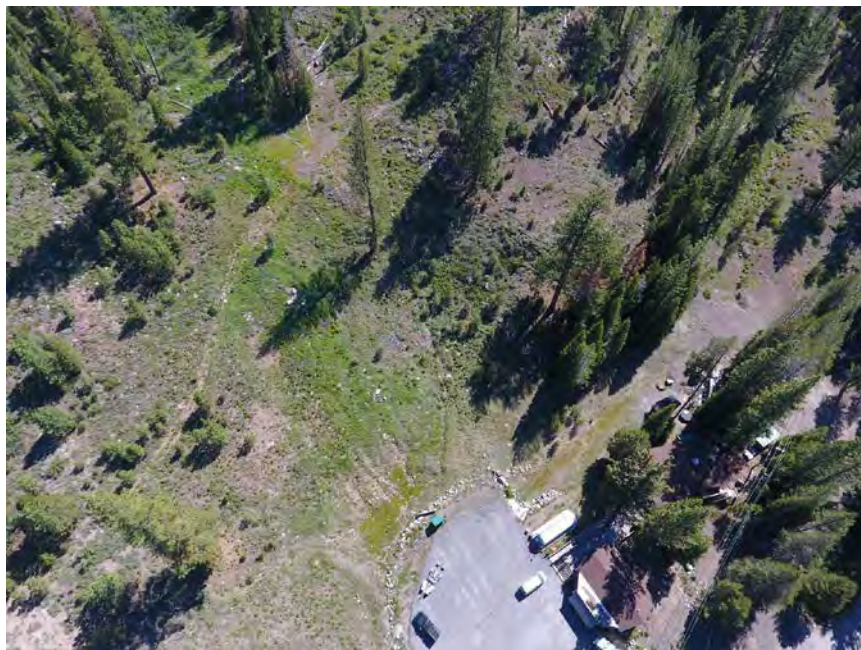
Aerial image showing active rilling, sparse vegetation, and an old road that captures and concentrates hillside runoff.

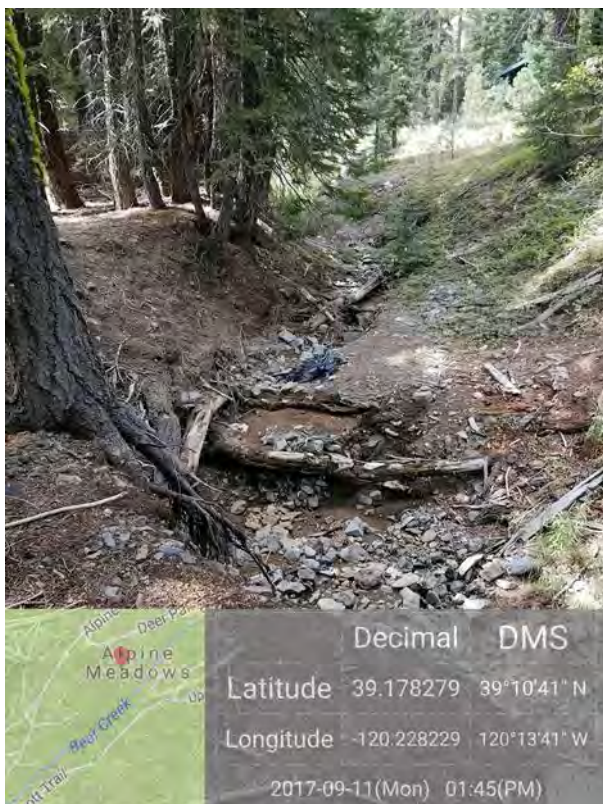
Eroded tributary channel below Alpine Meadows Road

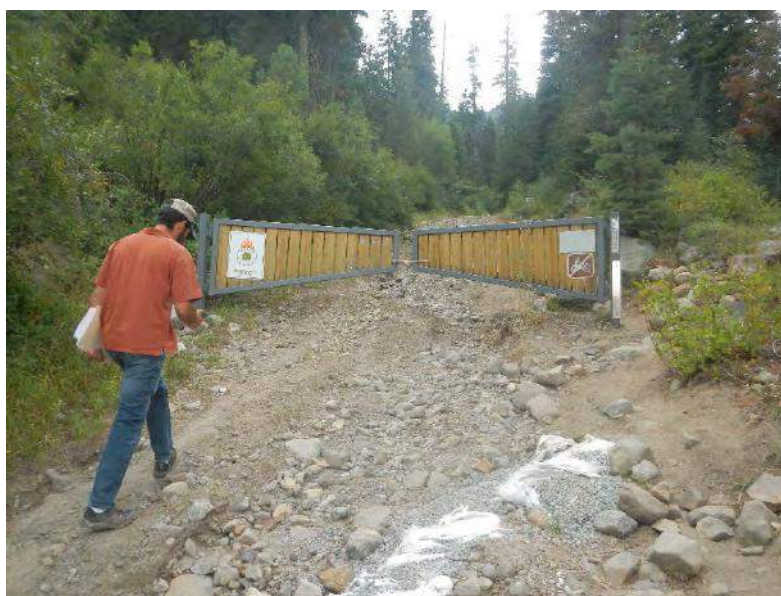
Goal(s)	Sources of degradation	Objectives to achieve goal(s)
Reduce sediment to Bear Creek; Improve drainage to maintain road	Ineffective drainage; road grading	Restore drainage flow direction; Introduction of water bars/dips; re-contouring some roads with out sloping surfaces; armoring drainage crossings

Drainage improvements could be completed to restore drainage flow direction into existing natural channels. Reduction of road runoff can be alleviated by out sloping the road and/or introducing additional dips. Where natural channels cross the road, 'Arizona crossings' (rock-lined water dips) or additional culverts can be installed to replace undersized or sediment plugged culverts. The USFS assessment (2016) provide additional options and details. Additional considerations of downslope drainage and property flooding require evaluation.

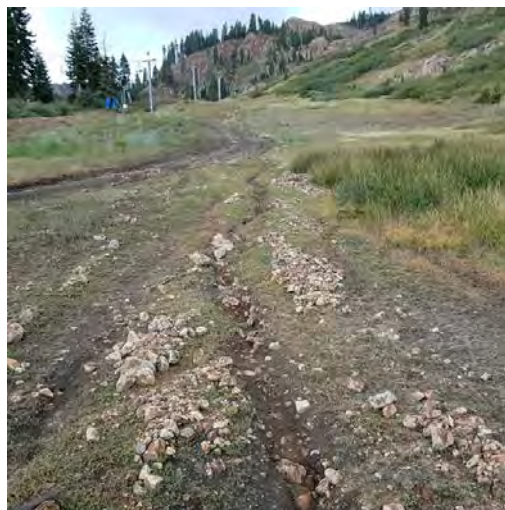
Hillside seepage from relocated tributary and hillside erosion along maintenance road

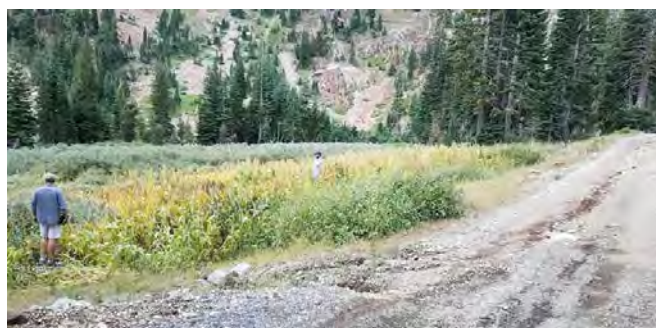
Meadow sedimentation from road runoff and erosion.

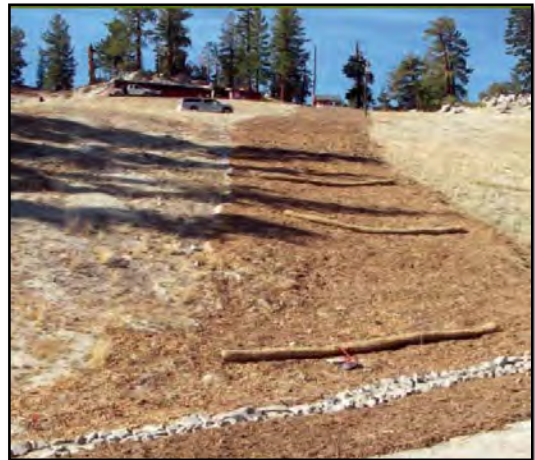
Restoration treatment following installation of a water line (IERS, 2009)

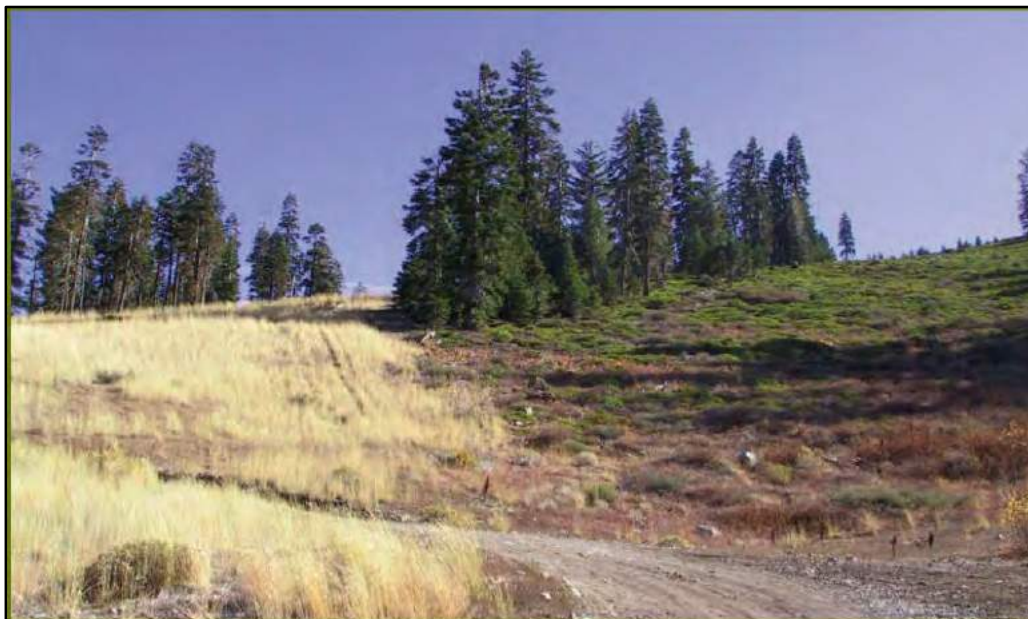
The ski run on the left was graded, while the ski run on the right was cleared (IERS, 2009).

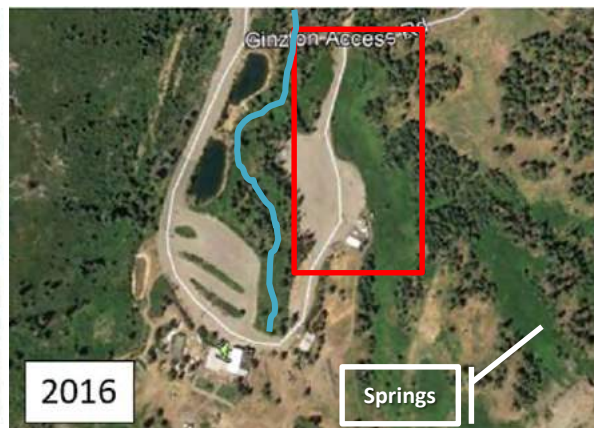
Historical aerial photography illustrating the dissection of a large wet-meadow complex in the Upper Bear Creek Watershed. Red box approximates the same area in both photographs.
