UNITED WATER CONSERVATION DISTRICT

**Fish Passage Monitoring and Studies, Vern
Freeman Diversion Facility, Santa Clara River,
Ventura County, California**

**Annual Report
2011 Monitoring Season**

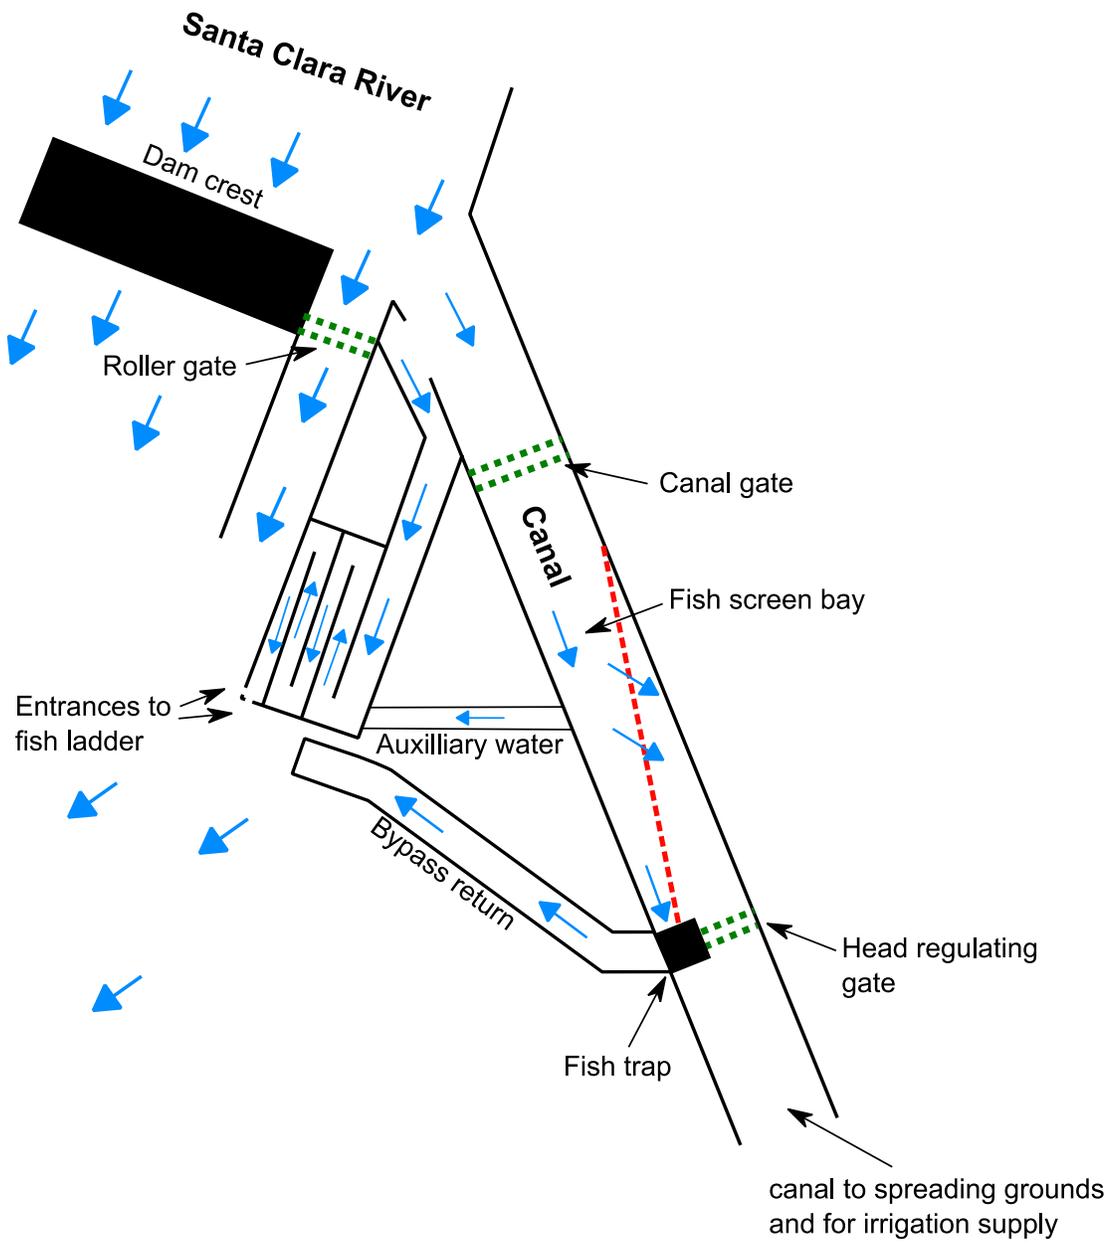
Figure 1. Schematic of Freeman Diversion Facility

The Freeman Diversion Facility was constructed in 1991 and is located approximately 10.7 miles upstream from the Pacific Ocean. The main purpose of the facility is to divert surface water from the Santa Clara River to conserve groundwater resources in the Oxnard plain through percolation to the groundwater aquifer. The facility is comprised of a concrete dam, a denil fishway (fish ladder), a fish screen bay, a downstream migrant trap, and various canals and spreading grounds (Figure 1, Appendix A). The concrete dam is a complete barrier to steelhead and Pacific lamprey upstream migration. The fish ladder was constructed to facilitate anadromous migration over the Freeman Diversion Dam. The fish screen bay is located directly downstream of where flow enters the facility and its function is to keep fish out of the canals and spreading grounds and to direct fish to the downstream migrant trap. A fish bypass pipe is located at the end of the fish screen bay that can be used to direct fish back to the river when there is sufficient flow to allow for volitional migration to the estuary.

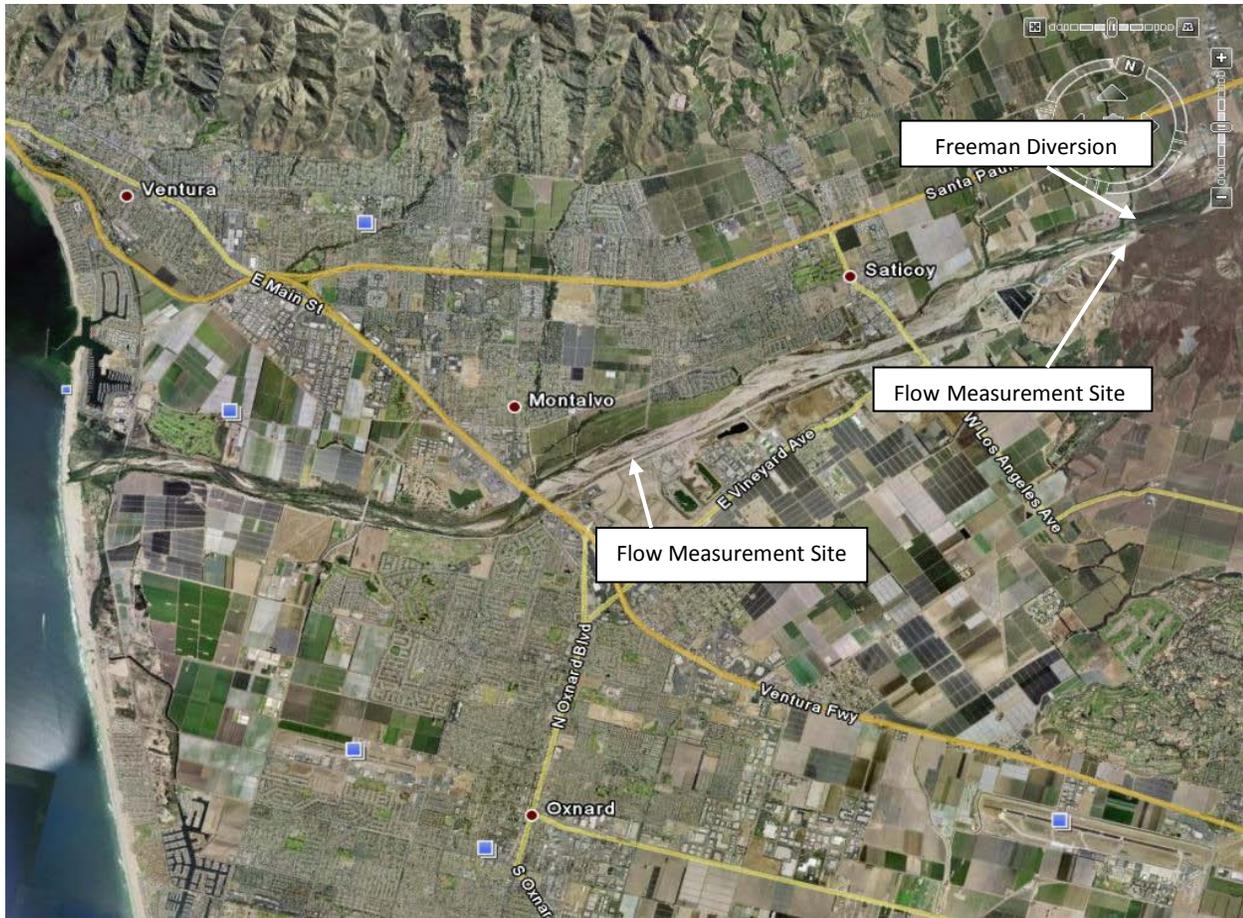
Figure 6. Freeman bypass flow monitoring sites below the Freeman Diversion

personal observations) to be the critical habitat type (migration bottlenecks and delay) regarding velocity and depth for steelhead migration in the Santa Clara River. The actual critical riffles (typical area to measure shallow conditions) have narrower active channels (wetted width) than glide habitats resulting in deeper conditions compared to the wide, sandy glides.

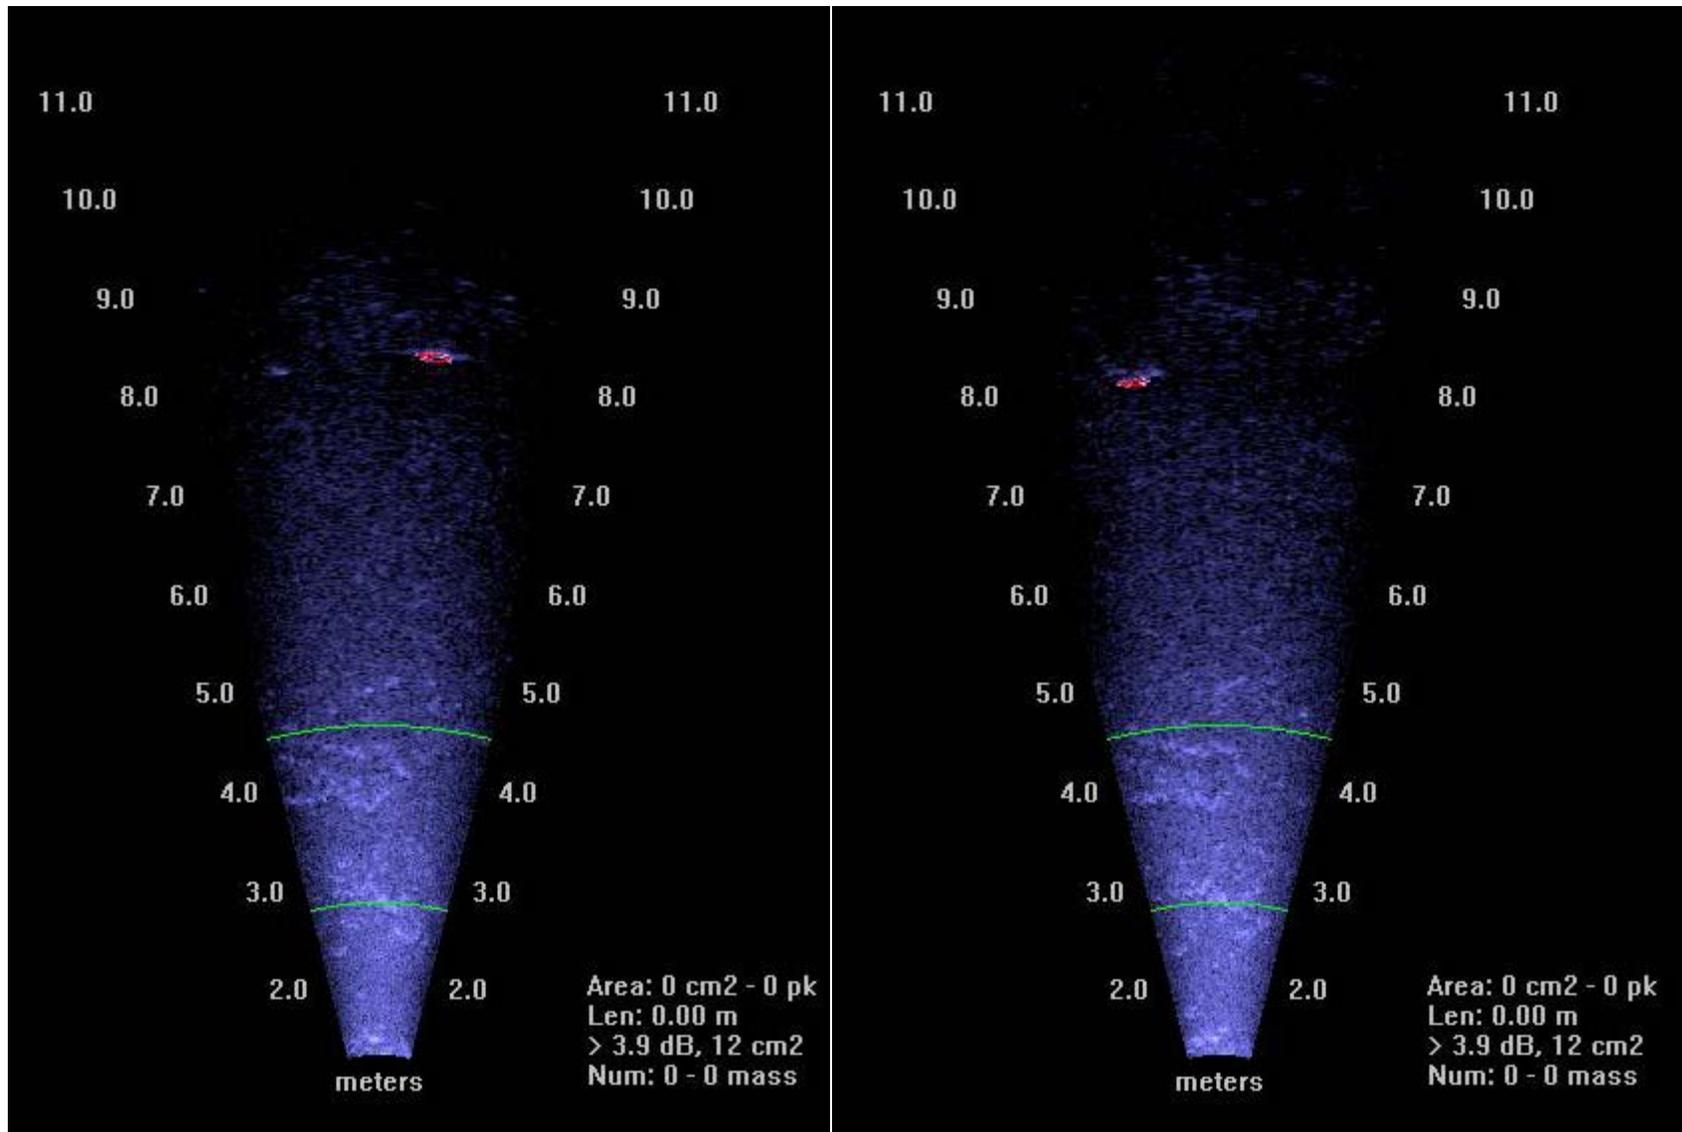
Figure 7. DIDSON images from April 28 (left) depicting a 426 mm fish moving upstream and May 13 (right), a 548 mm fish moving downstream. The body of the fish is indicated in red.

The DIDSON camera detected both upstream and downstream movement of fish at the monitoring site located directly below the Freeman Diversion Dam (Figure 7, Appendix A). Fish species identification is difficult with this technology and was not possible (upstream migrants) from data collected during the first year of monitoring. Large fish (>300 mm) observed in DIDSON video were either steelhead or common carp. We observed large schools of carp in isolated pools directly downstream of the dam and in the lower river following the end of the bypass flow releases. There are large numbers of common carp in the Santa Clara River Estuary and these fish potentially could have migrated up river during the extended bypass flow releases in 2011. At this time, we cannot distinguish between these species in the DIDSON images. Smolts were identified by their downstream swimming behavior while still pointing upstream. Size estimates were computed using the DIDSON software and appear to be repeatable within 50 mm.

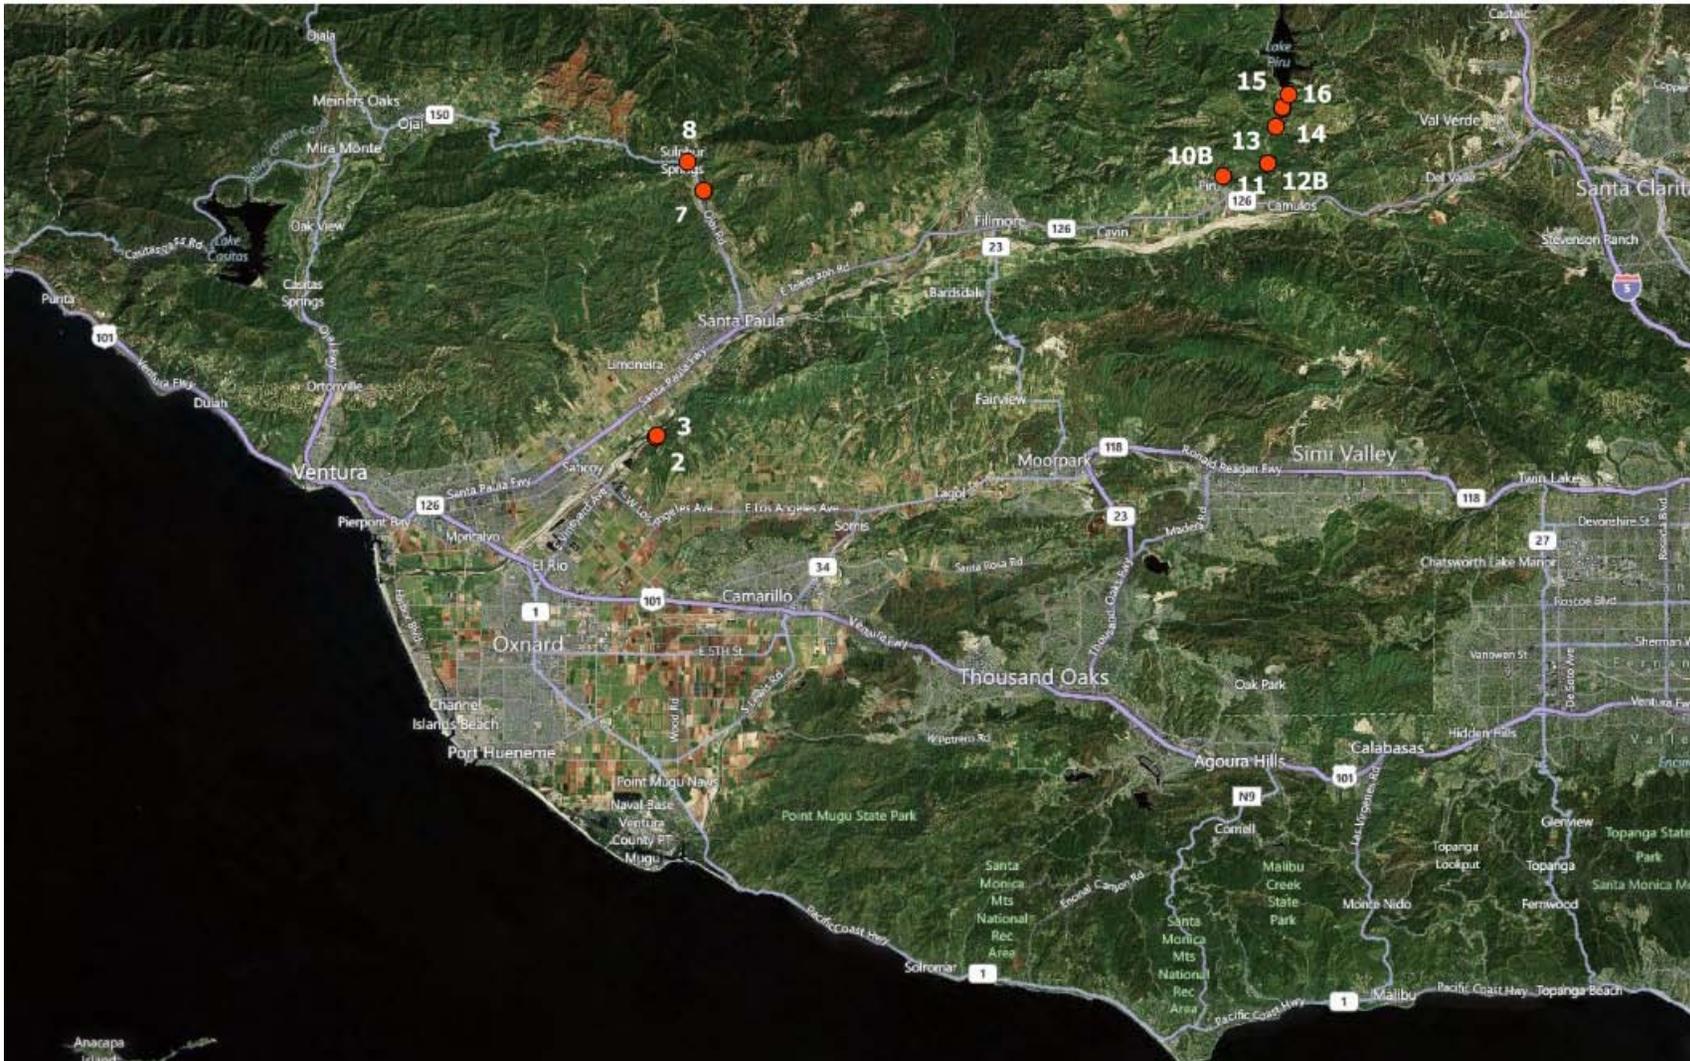
Figure 8. Water temperature monitoring sites within the Santa Clara River watershed.

A map identifying each monitoring site can be found in Figure 8, Appendix A. Graphs depicting data at these eleven sites are in Figures 9-19, Appendix A. Specific information regarding each site can be found in Table 10, Appendix A. Additional temperature loggers were installed in the Santa Clara River Estuary, Santa Clara River at the VCWPD project, and Santa Paula Creek upstream of the Harvey Diversion, but these loggers were lost during high flow events. Loggers will be replaced during 2012.

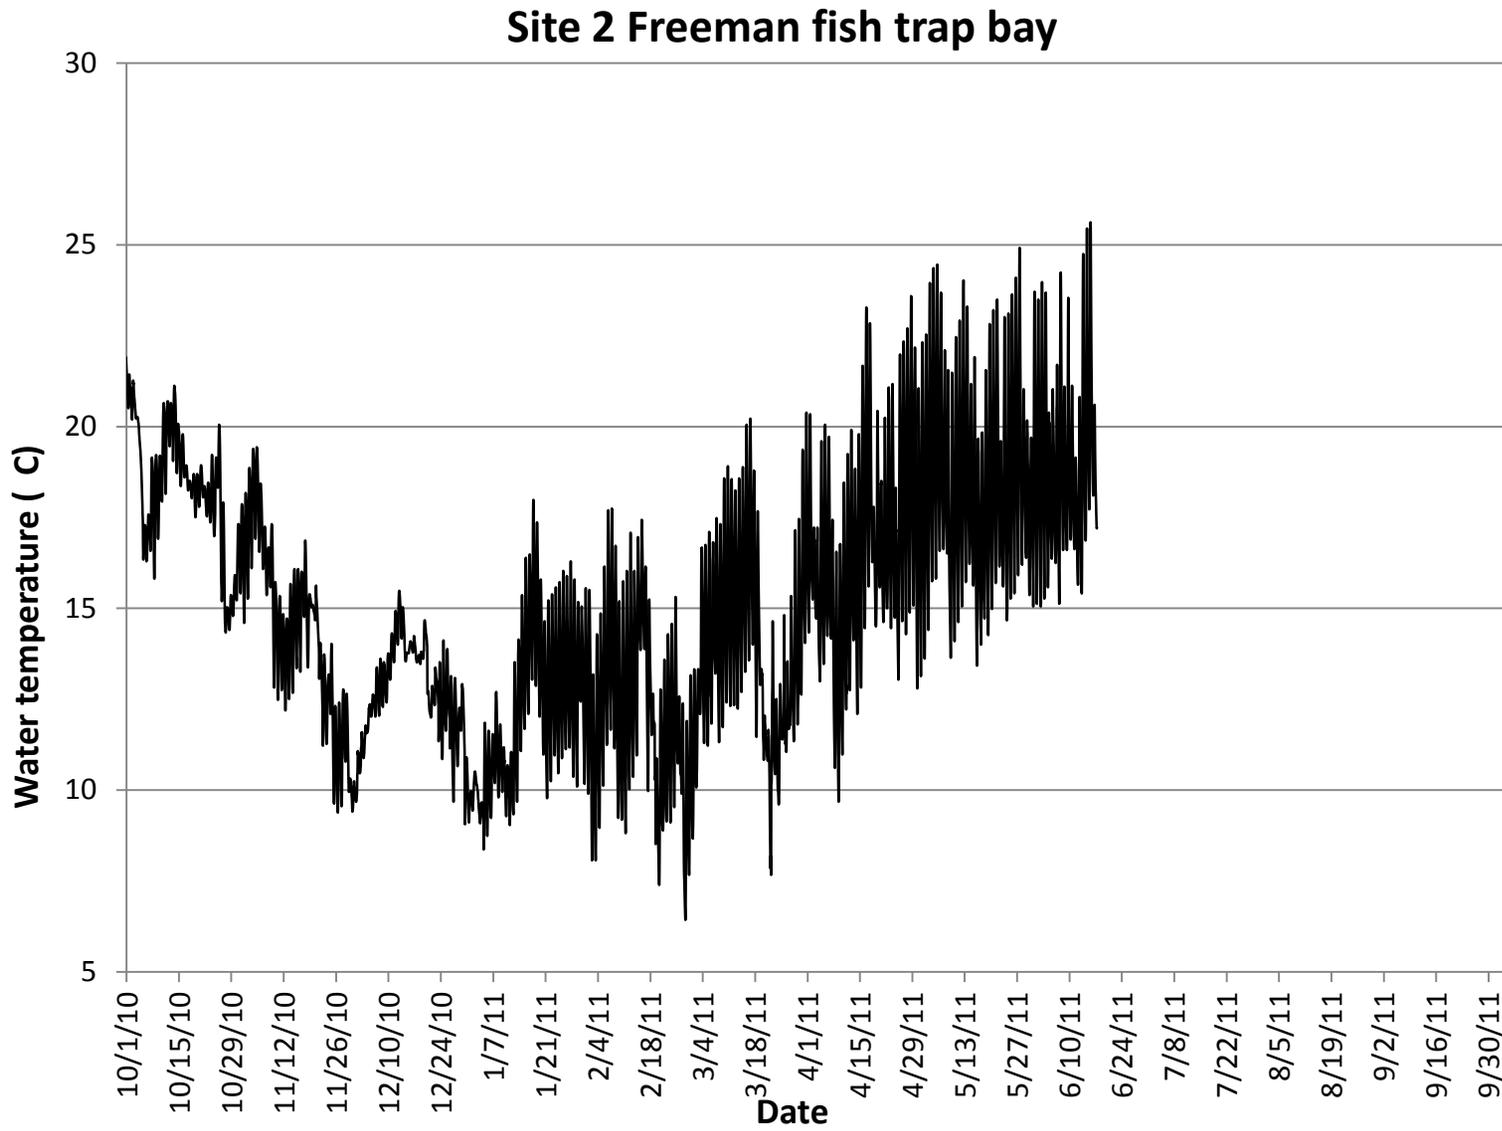
Figure 9. Freeman fish trap bay water temperature

Location	Max Temp (°C)	Date Max Temp	Min Temp (°C)	Date Min Temp	Mean Temp (°C)
Freeman Fish Trap Bay	25.6	6/15/11	6.3	2/27/11	15.5
Freeman Fish Screen Bay	28.5	8/24/10	5.3	3/22/11	16.0
Santa Paula Creek at Steckel Park	20.7	8/29/11	6.8	2/27/11	14.7
Santa Paula Creek directly downstream of Sisar Creek confluence	20.5	6/23/11	6.8	2/27/11	12.9
Piru Creek upstream of Temescal property line	27.7	7/4/11	6.0	2/3/11	16.1
Piru Creek downstream of the Old USGS gauge Site	26.1	5/3/11	5.9	2/27/11	16.3
Piru Creek at the old USGS gauge Site	28.7	8/26/10	5.4	2/3/11	16.0
Piru Creek at second bridge	25.2	7/6/11	5.6	2/3/11	14.5
Piru Creek downstream of spill and release channel confluence #1	19.3	4/17/11	7.0	2/2/11	12.7
Piru Creek downstream of spill and release channel confluence #2	19.9	10/28/11	7.0	2/2/11	13.2
Piru Creek at the USGS Gauge directly downstream of Santa Felicia Dam	18.9	10/24/11	8.0	2/2/11	12.8

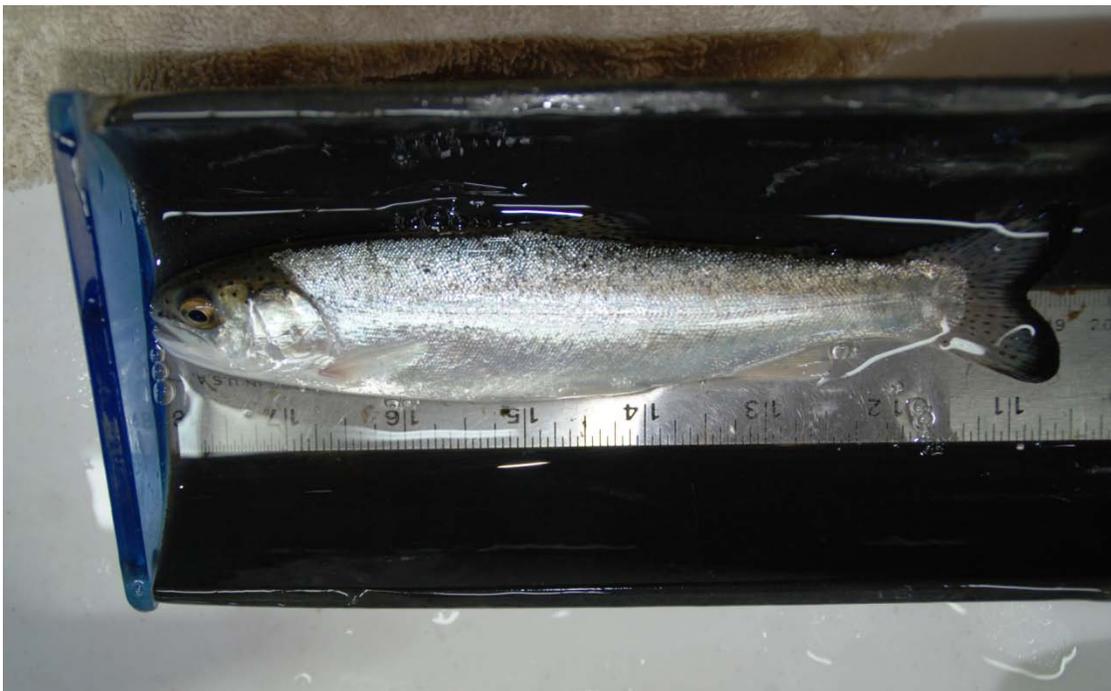
Photo 6 – Santa Clara River Steelhead Smolt Length Measurement

Trapped smolts were measured to fork length (Photo 6, Appendix A). Lengths were measured by placing the fish in a fish measurement cradle for no more than 10 seconds. The fish were not sedated. If an individual fish could not be measured in less than 10 seconds, the fish was placed back in an aerated cooler and not measured again.

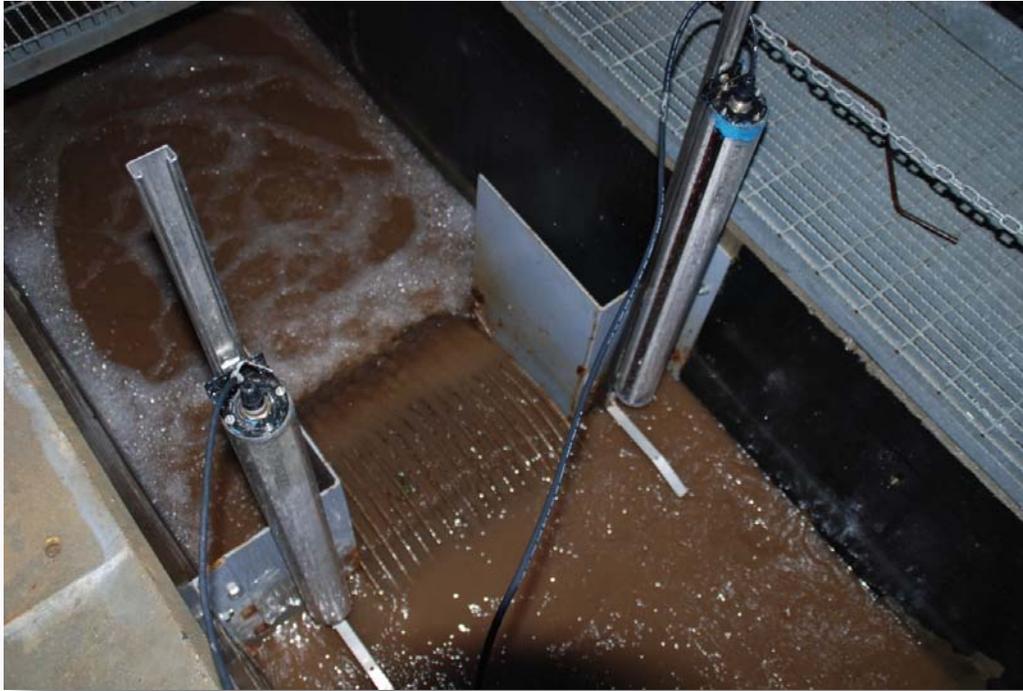
Photo 9 - Upstream Migration Monitoring Infrared Scanners

The IR scanner device was equipped with sensors on both sides of the false weir with multiple closely-spaced infrared beams. When the beams are broken by a fish jumping over the weir, the IR scanner signals the surveillance system to record the event.

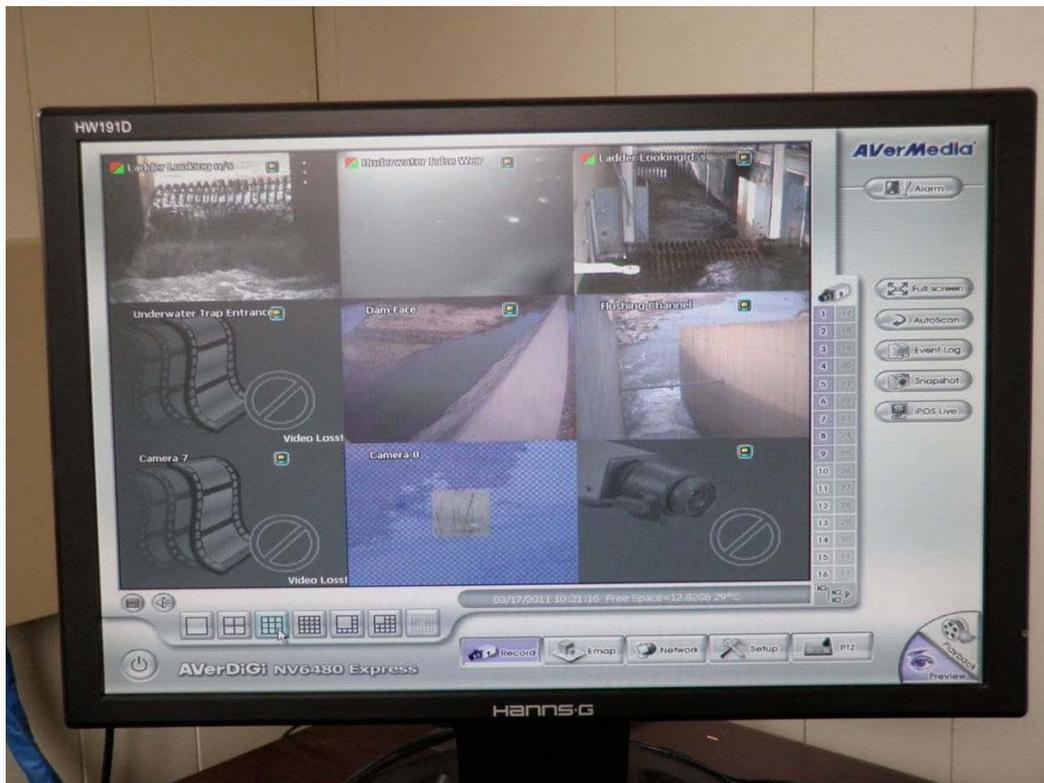
Photo 10 – Upstream Migration Monitoring Surveillance System

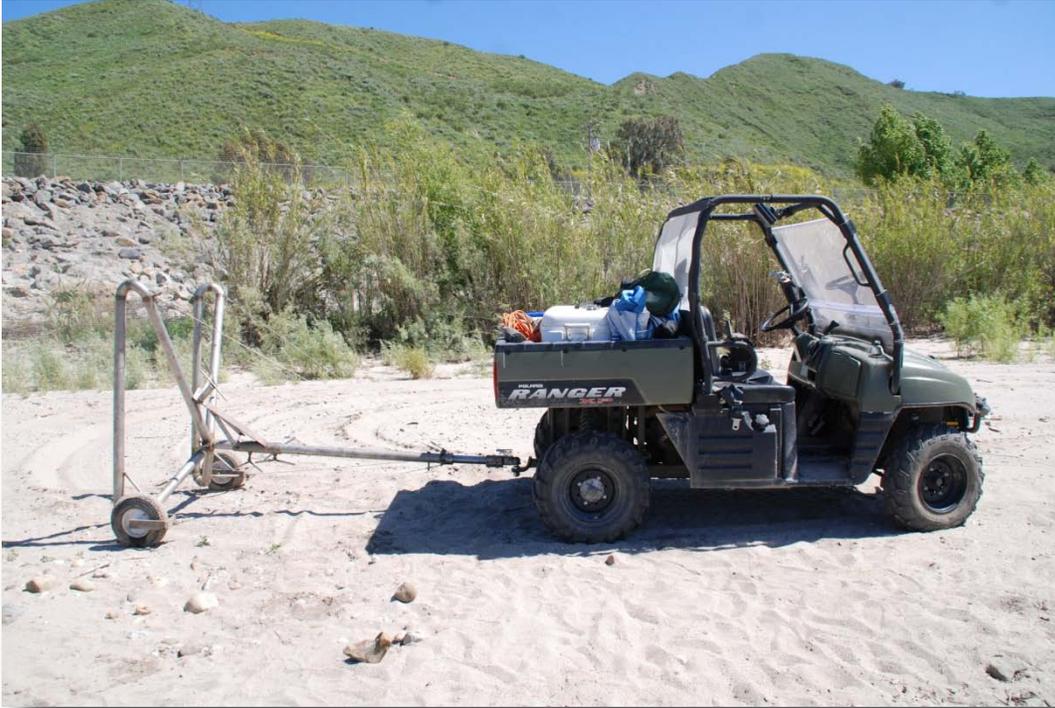
Photo 11 – DIDSON Trailer Mount with ATV

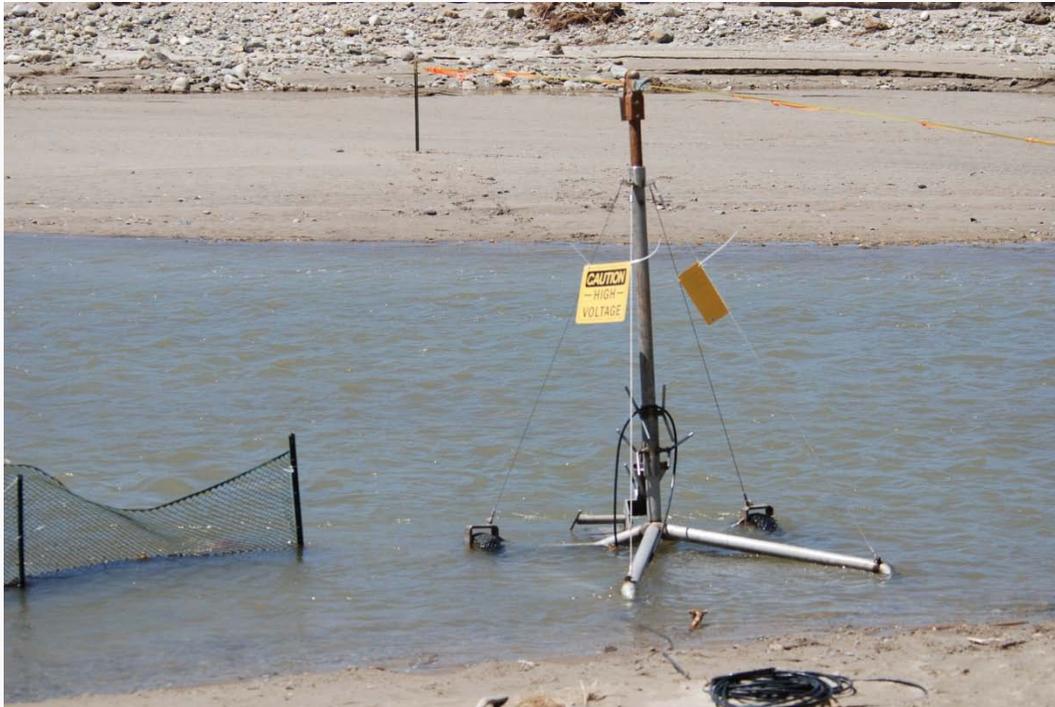
Photo 12 – DIDSON Deployed Below Freeman Diversion Dam

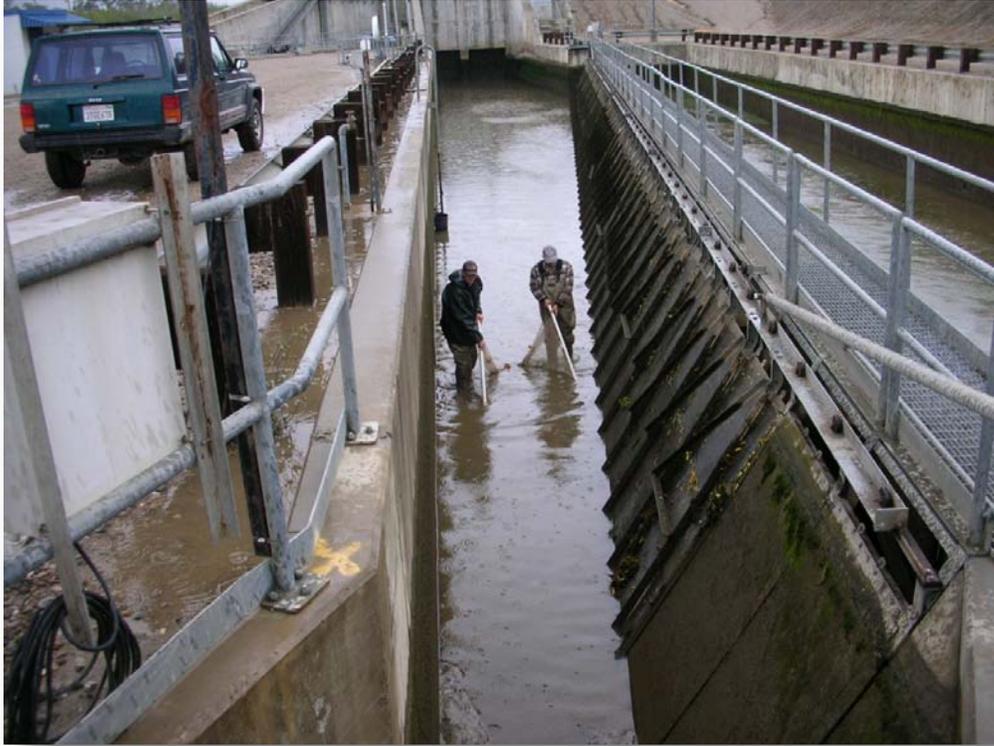
Photo 13 – Fish Screen Bay Stranding Survey

The primary objective of fish stranding surveys is to rescue any fish that become stranded when diversion operations cause river flow to rapidly diminish downstream of the Freeman Diversion in the Santa Clara River and within the fish screen bay and fish ladder during dewatering operations.
