# *ARUNDO DONAX* IN THE SALINAS RIVER

## VIRTUAL WORKSHOP

# Salinas River Watershed *Arundo* Eradication Programs

# Salinas River Arundo Control Program: Progress and Lessons Learned

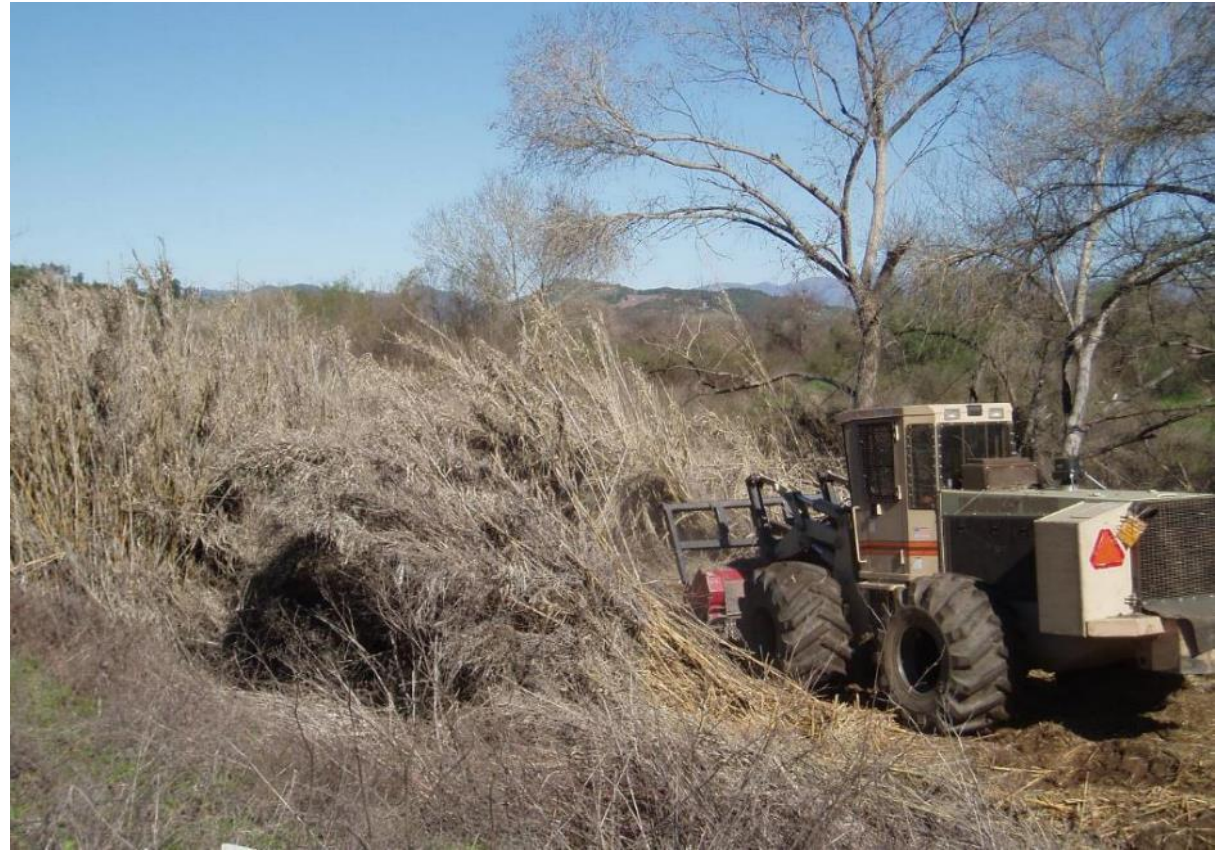
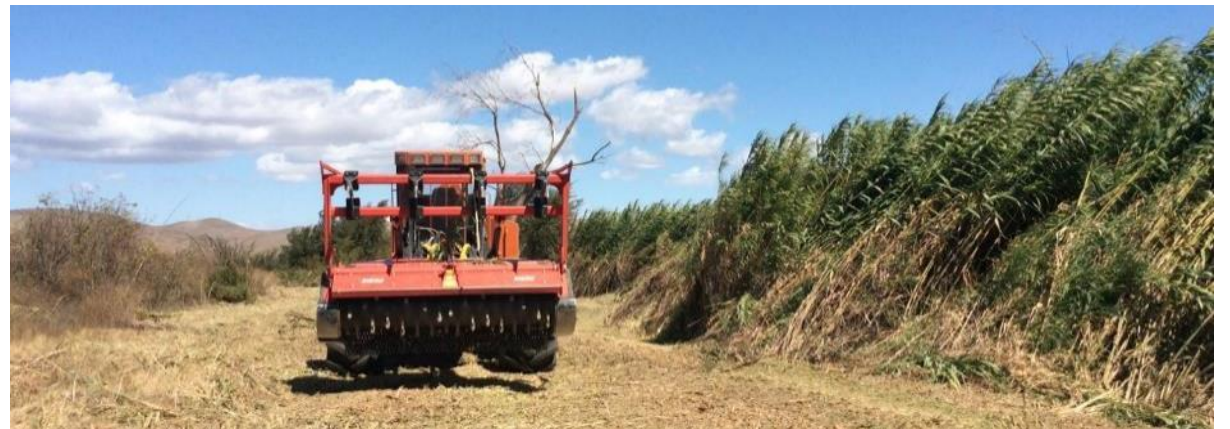
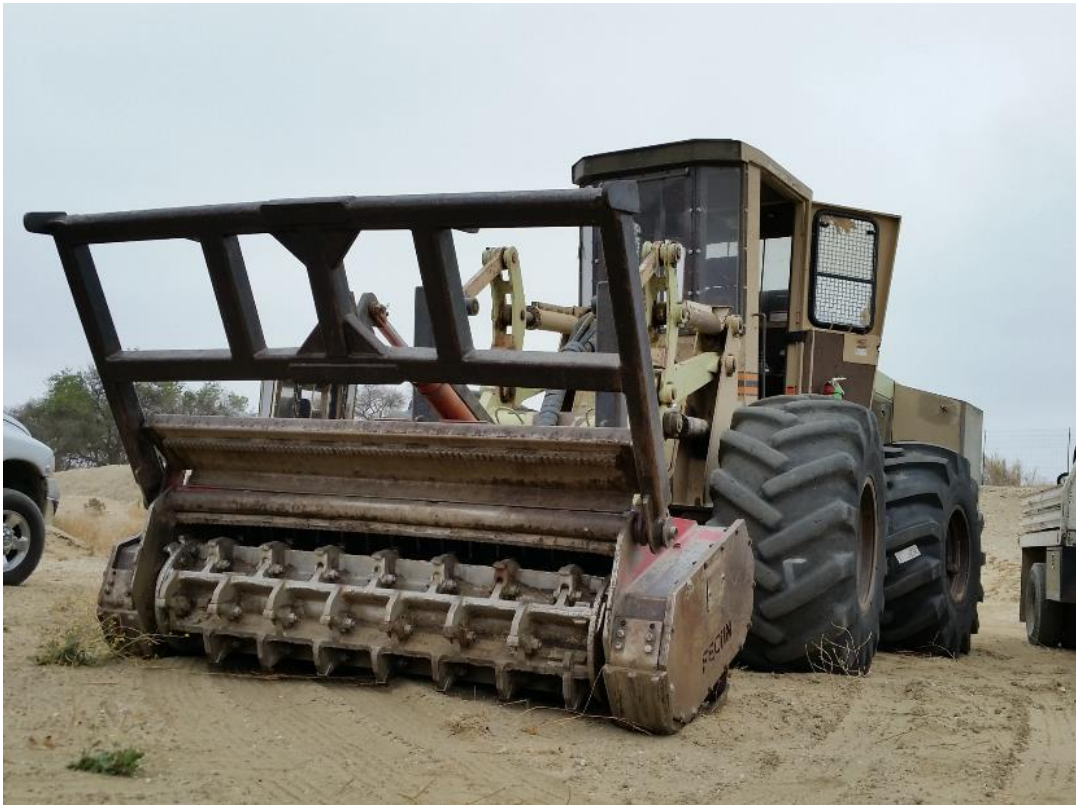
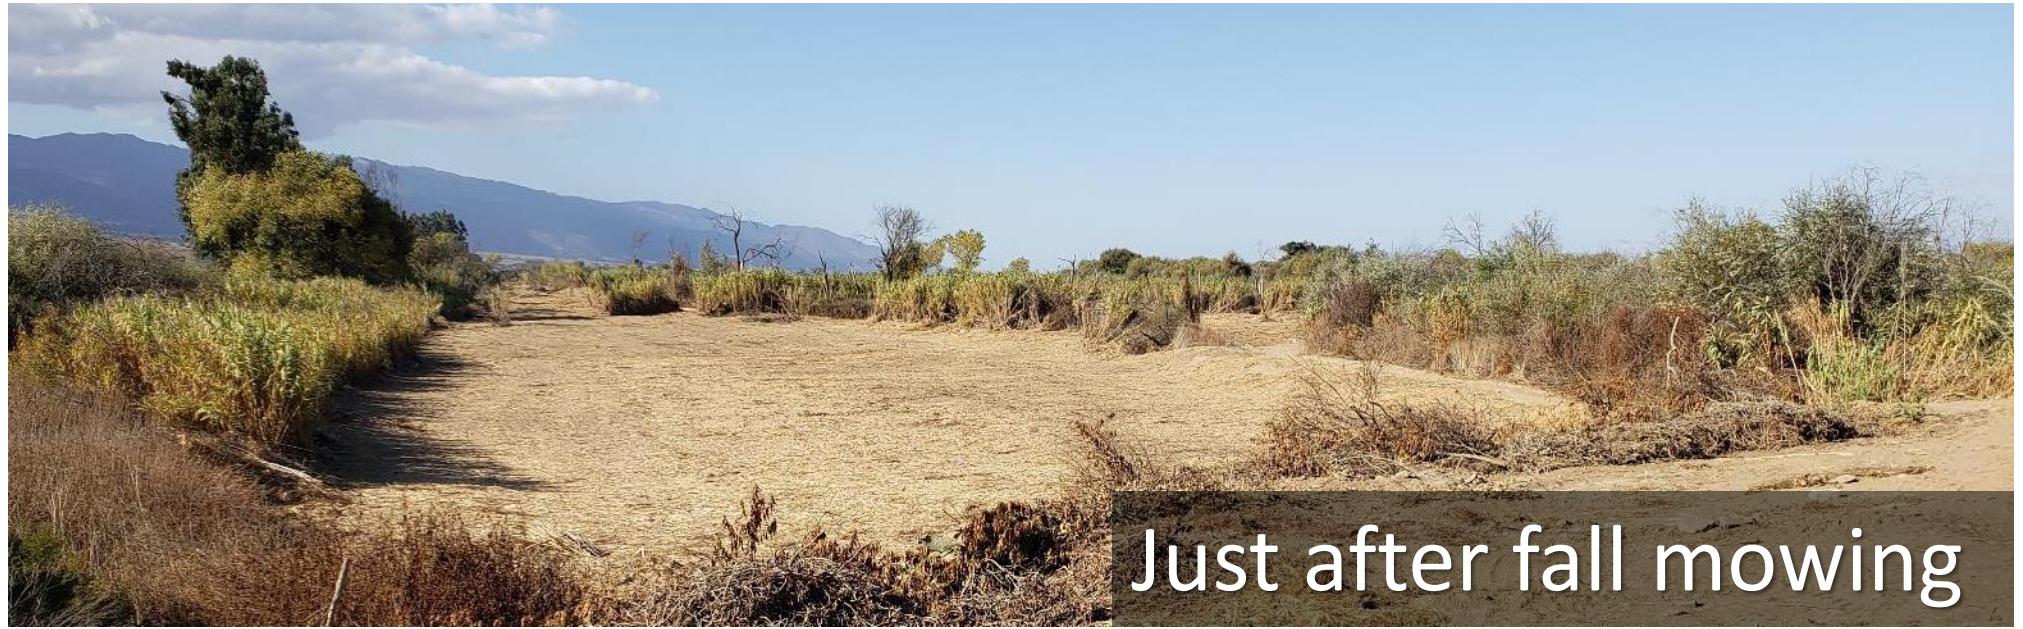
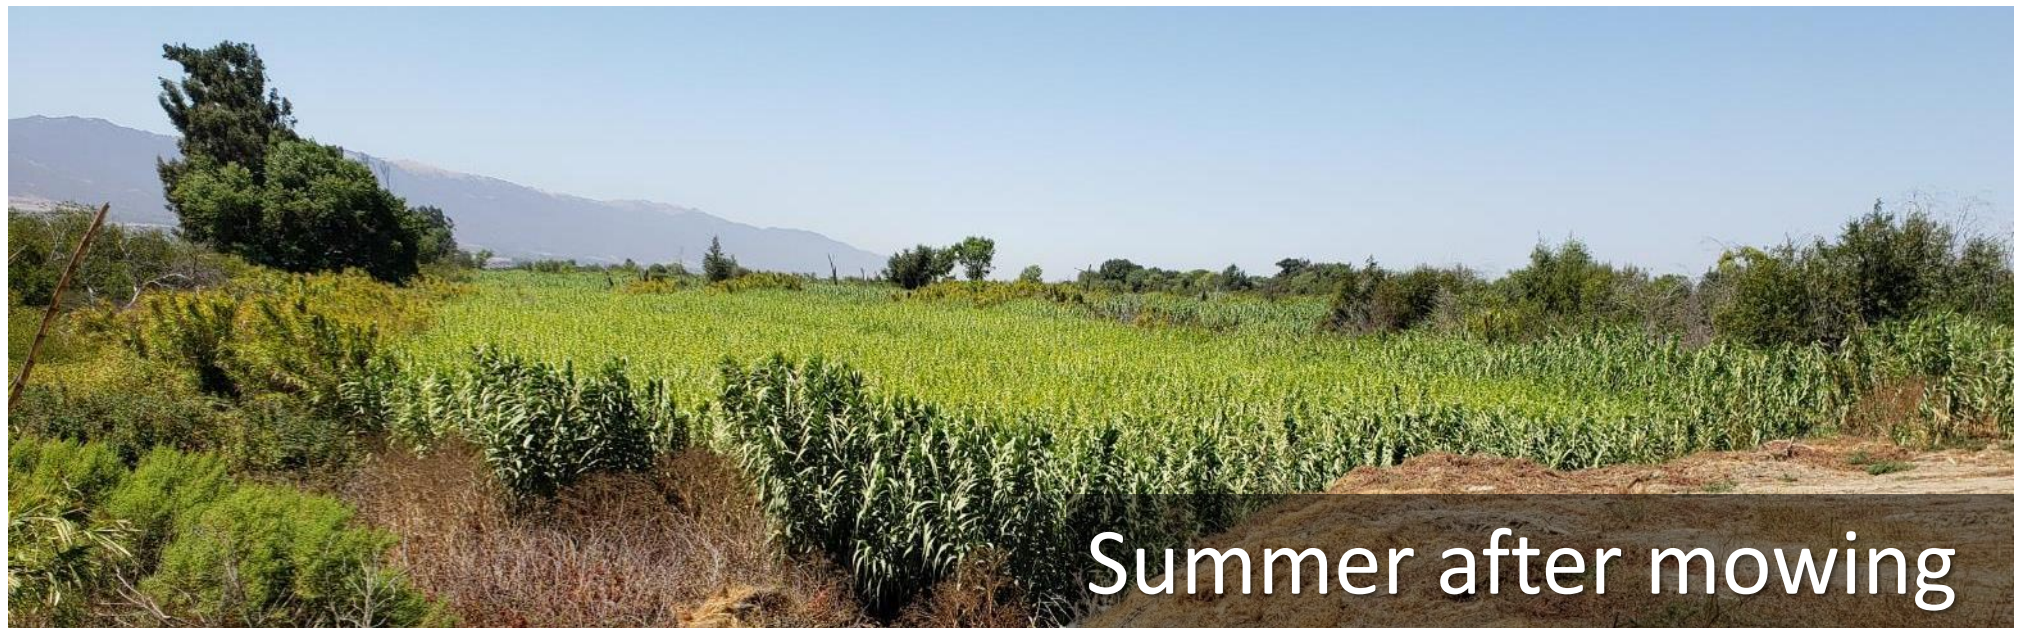
# Biomass Reduction Mow in Year 1 (fall)

- Upstream to downstream treatment
- Mow large stands to reduce biomass
- Small stands – spray only
- Treat with herbicide for multiple years

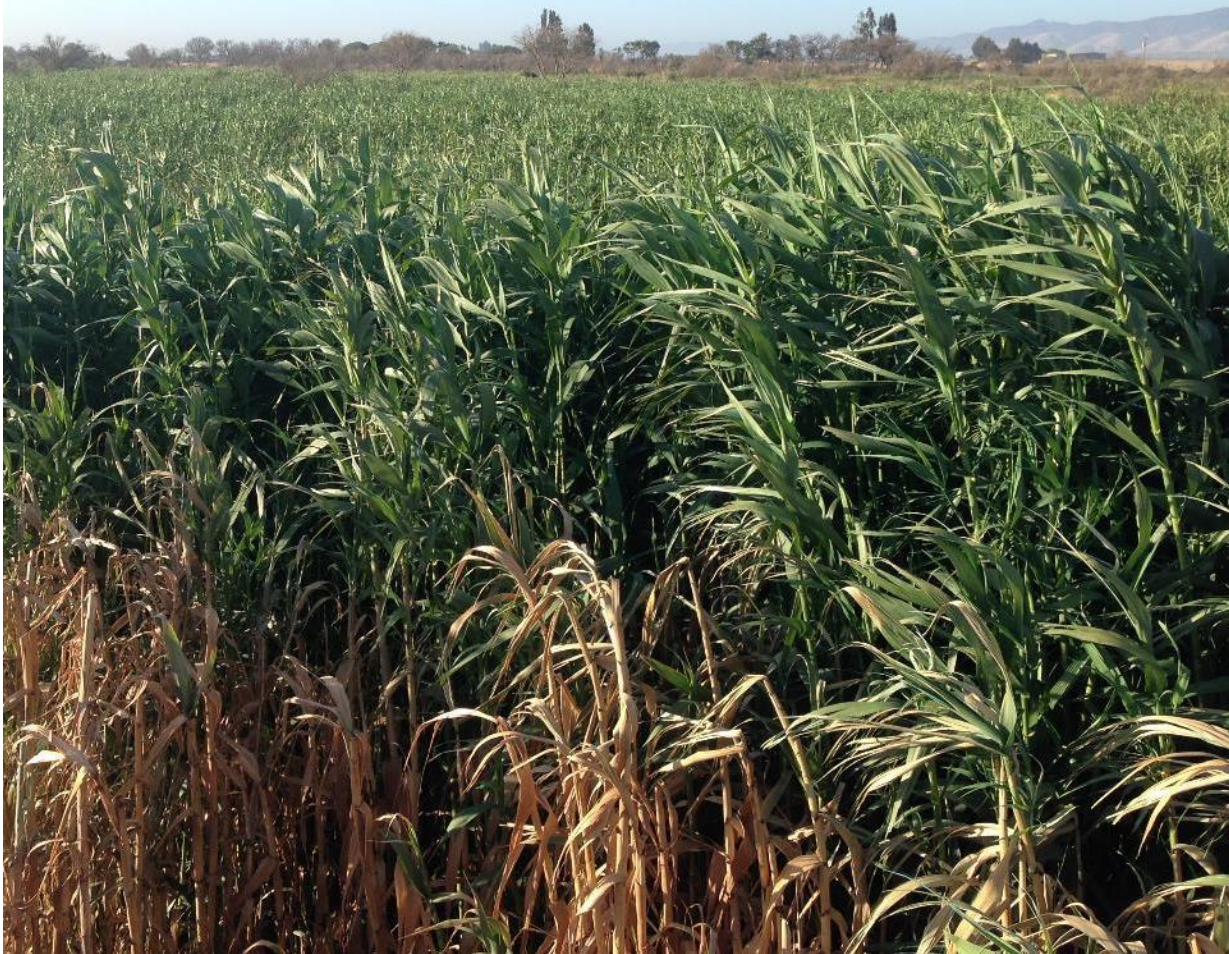
Before initial spray

- Glyphosate (aquatic approved)

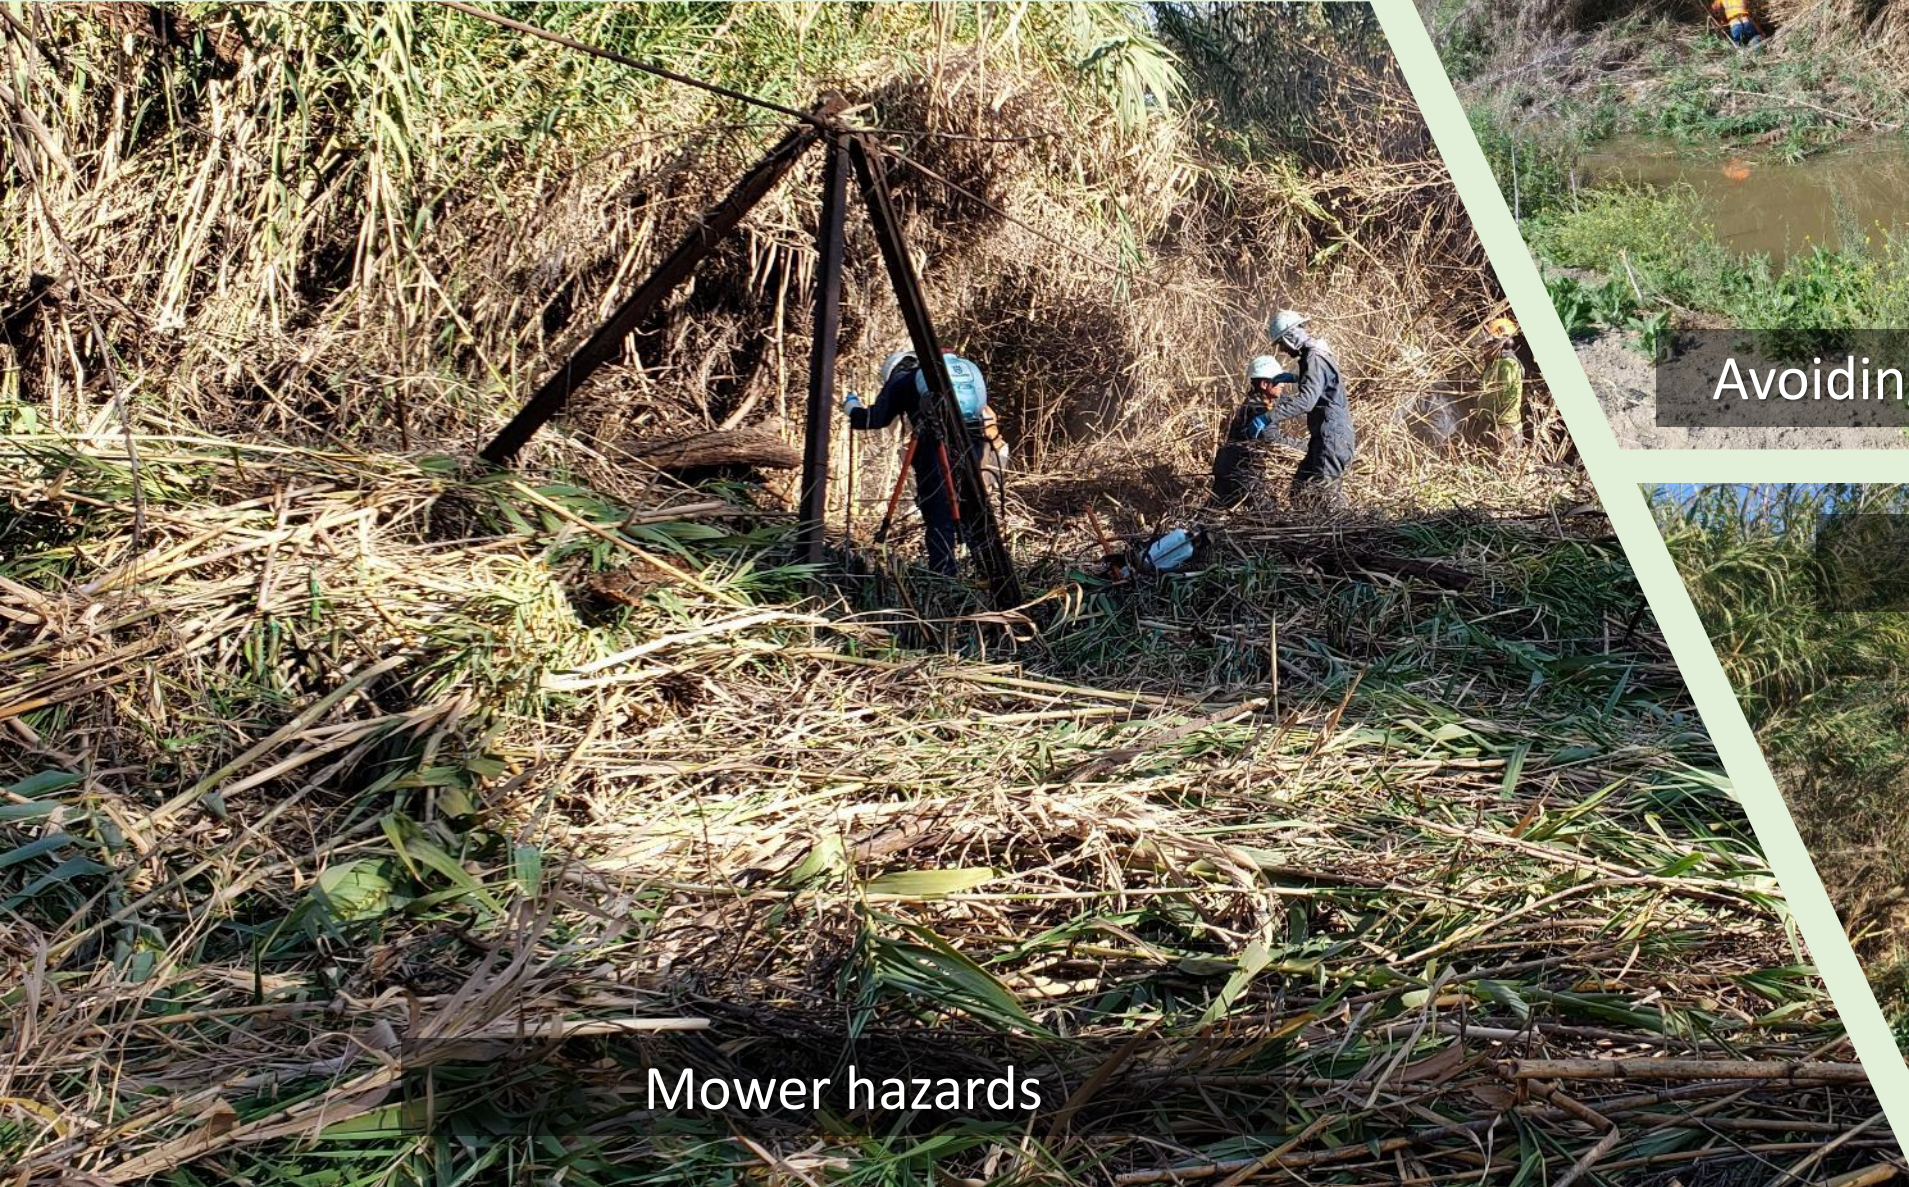
# Cut stump treatment

- Needed in limited cases

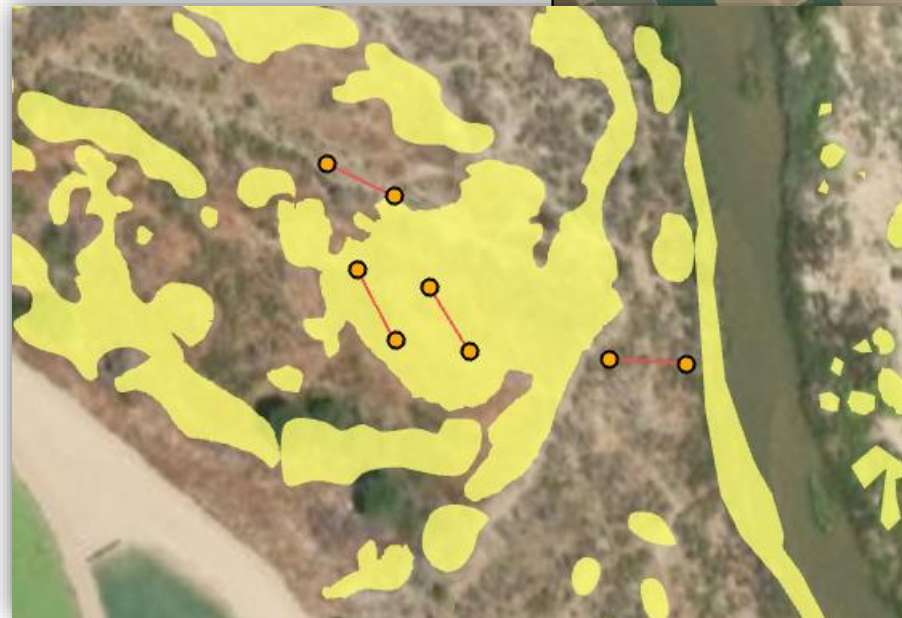
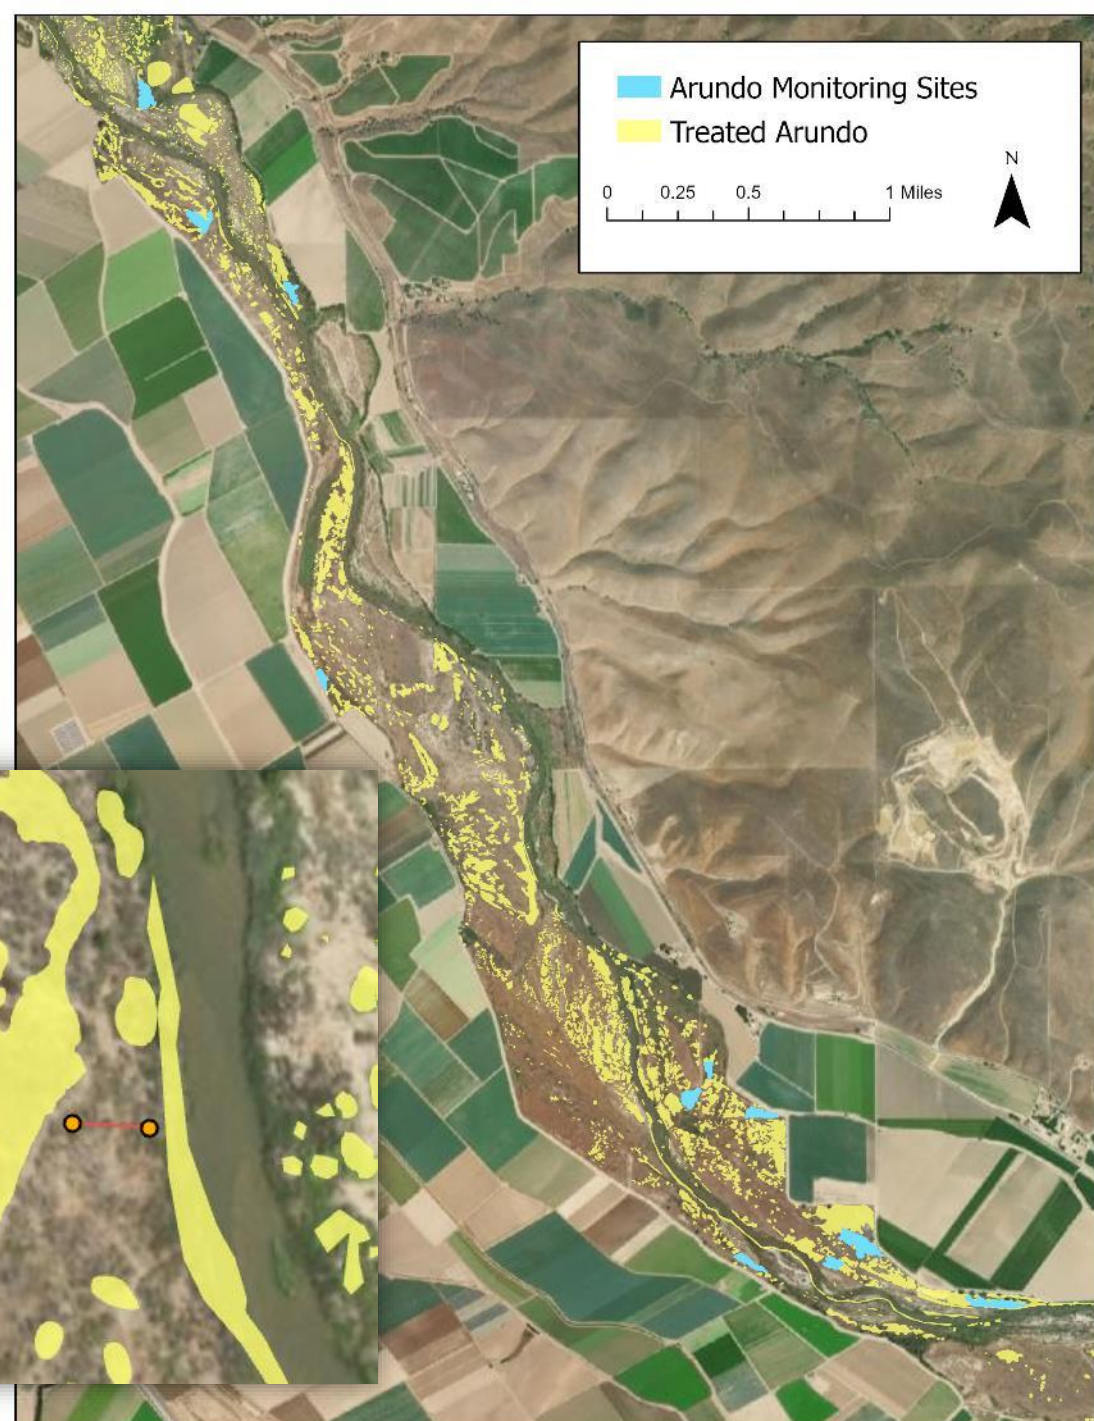
# Plant community survey methods

- Selected 11 large arundo patches mowed fall 2016
- Each patch:
  - Two transects in arundo stand (“arundo transects”) and two outside of arundo stand (“control transects”)
  - Arundo cane density
  - Species presence
  - Data on percent cover
    - Herbaceous
    - Woody
    - Graminoids (grasses)

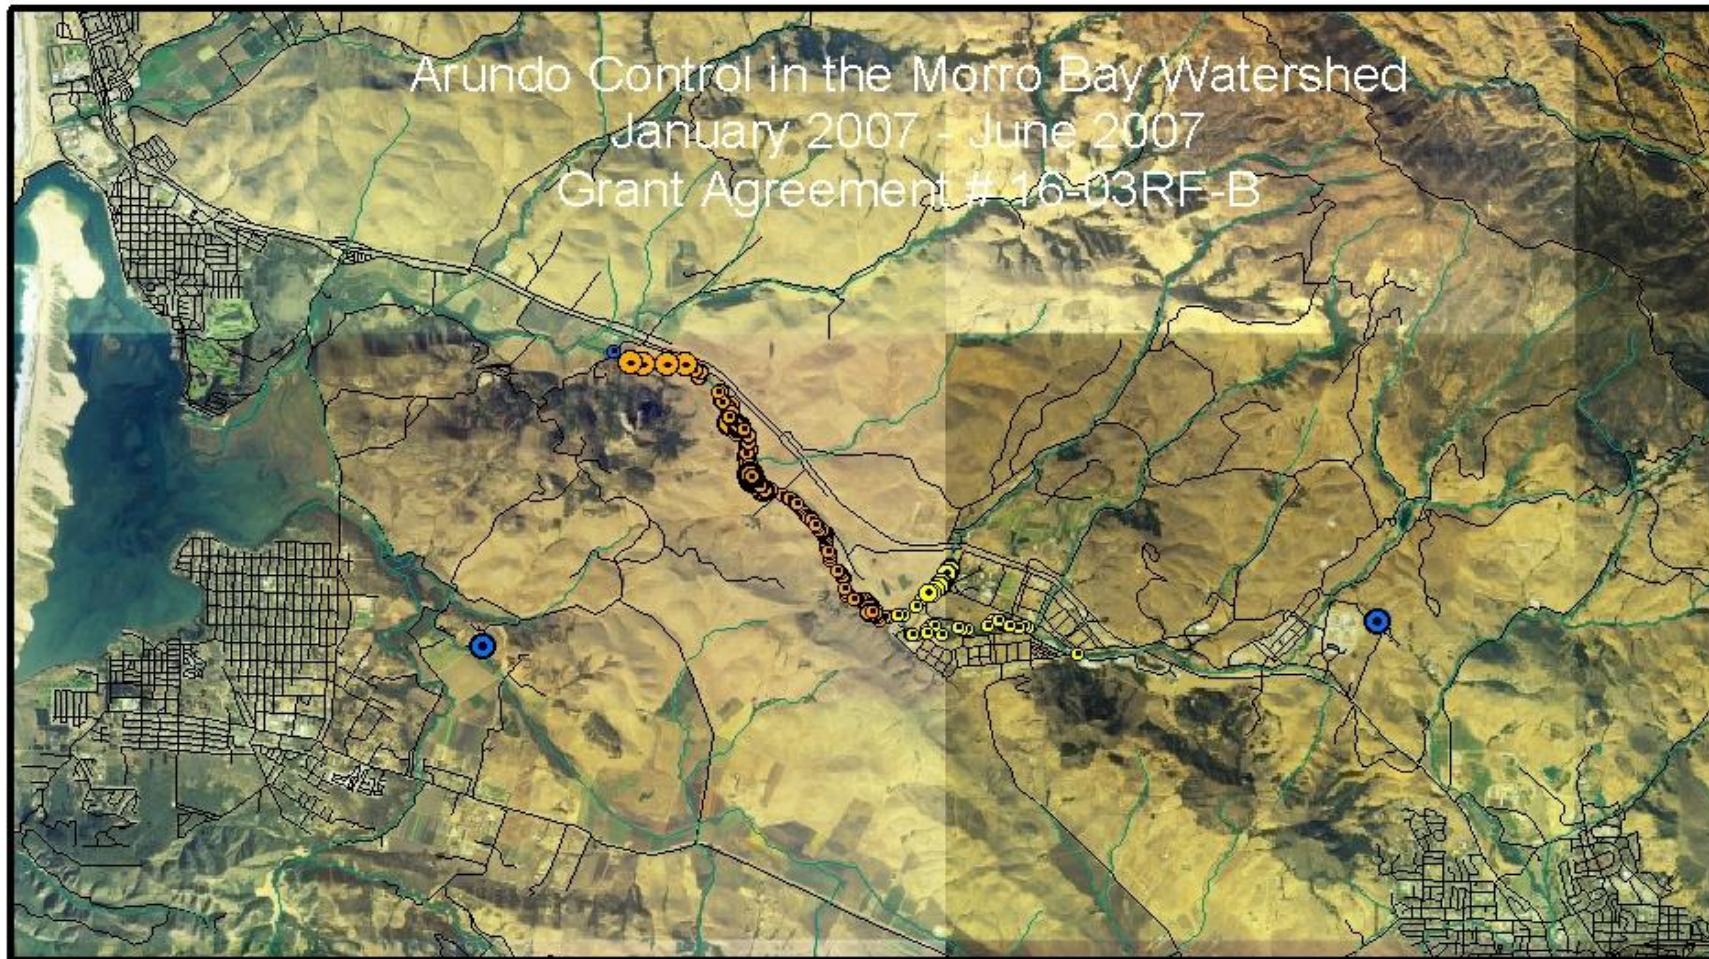
Arundo Control in the Morro Bay Watershed  
 January 2007 - June 2007  
 Grant Agreement # 16-03RF-B

**Arundo Clumps Initially Treated in 2007**

- 1 - 5 ft clump diameter
- 6 - 15 ft clump diameter
- 16 - 25 ft clump diameter
- 26 - 50 ft clump diameter
- over 50 ft clump diameter
- Arundo Clumps Retreated in 2007 - MBNEP Funds
- Arundo Clumps Surveyed and Retreated (in-kind funds)

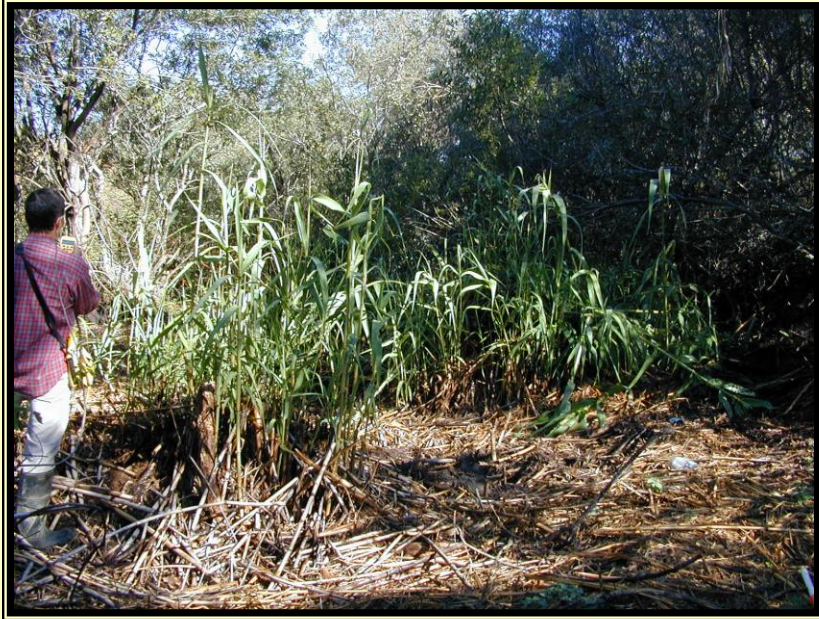
# Arundo Herbicide Treatment

- Cut stump method is logistically difficult for larger clumps
- Foliar applications of glyphosate to uniform regrowth have proven very effective, especially when conducted in early fall

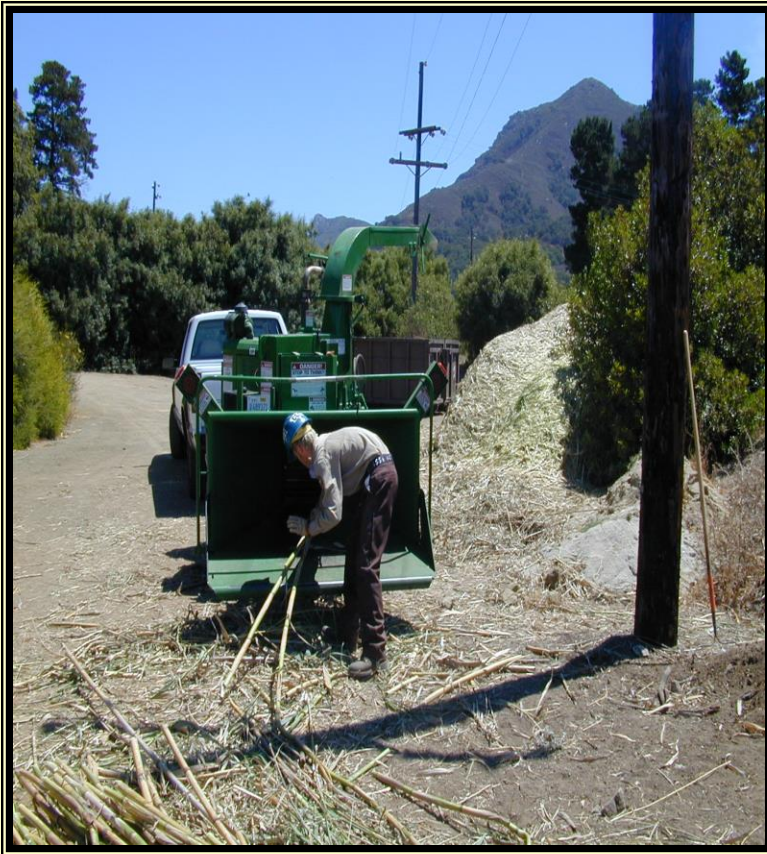
# Arundo Disposal

- When our efforts began, many arundo control projects were either burning arundo biomass (very limited) or hauling it to local landfills
- Arundo canes can be removed from the riparian area, or chipped on-site
- Chipping freshly cut canes is better than allowing the canes to dry out
