# STRUCTURE PLAN

MCLACHLAN RIDGE

SPN-0010M-2

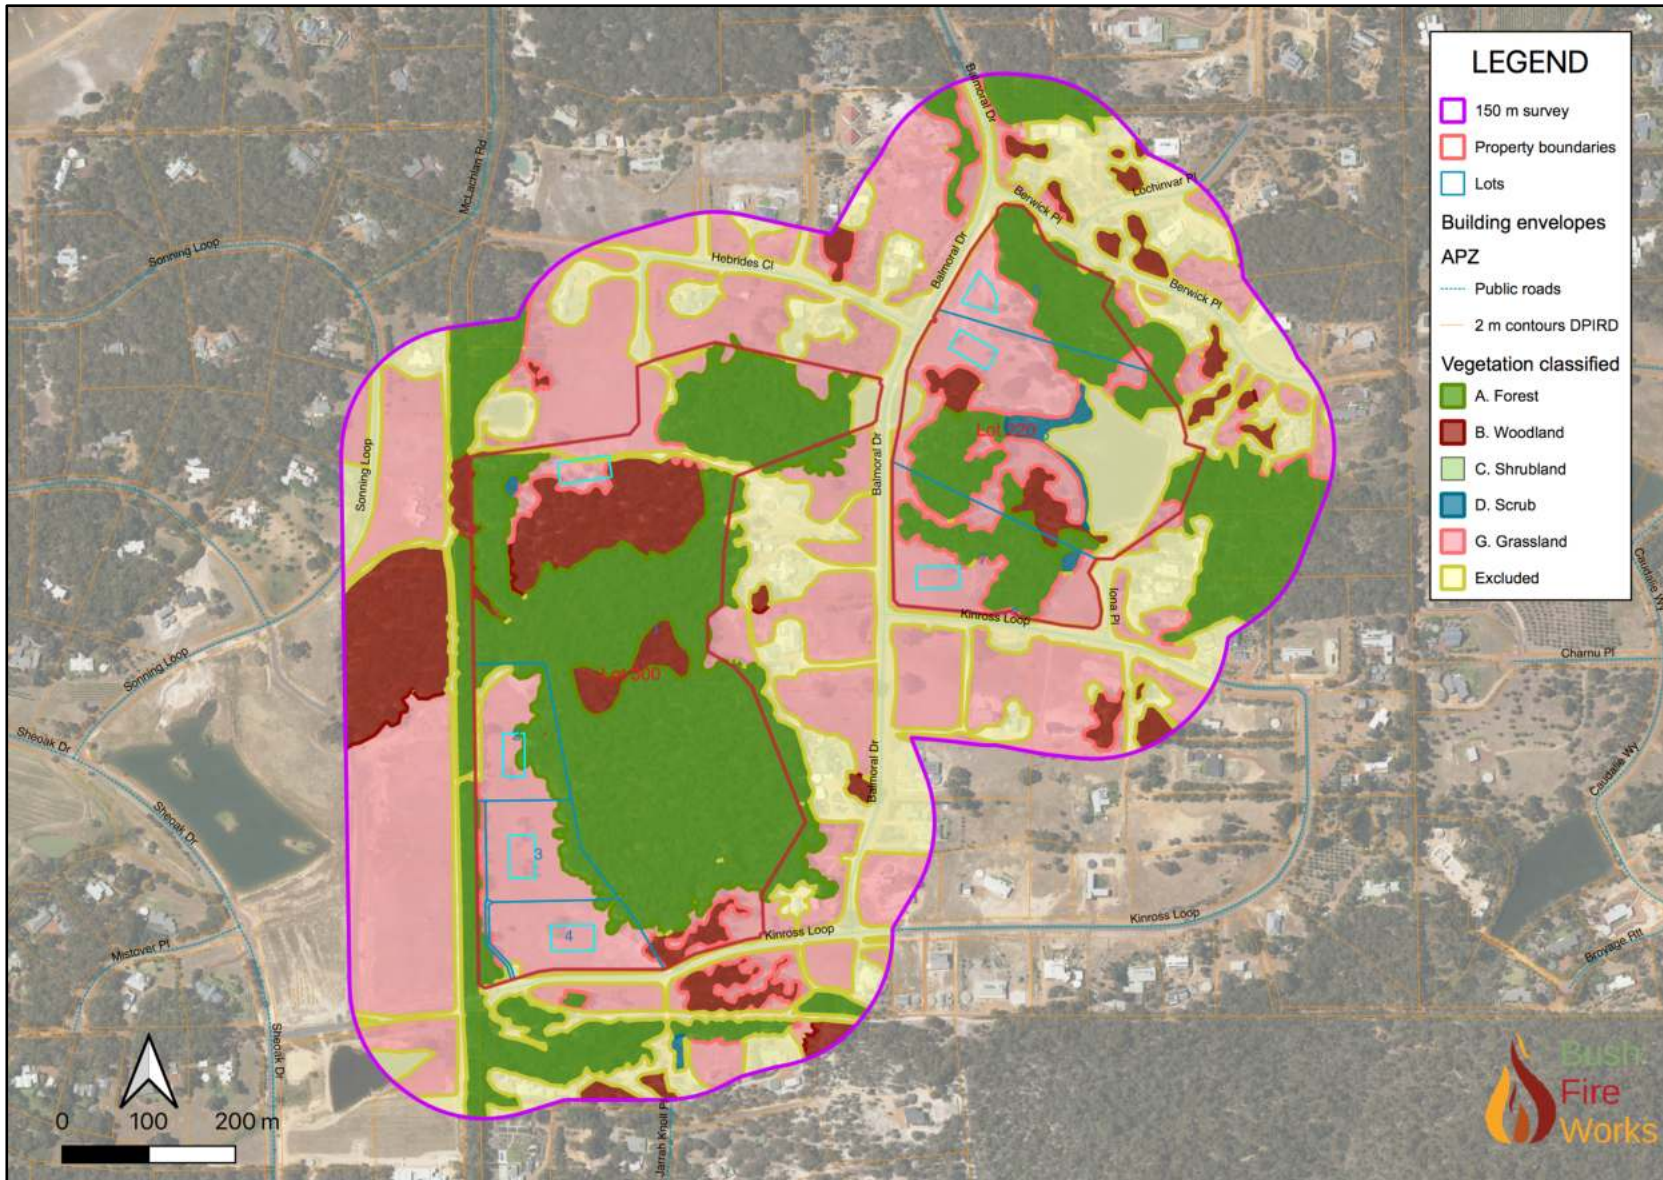
Figure 3 Vegetation classified existing

The existing vegetation observed on site was classified according to the methodology specified in AS3959:2018 (Figure 3).

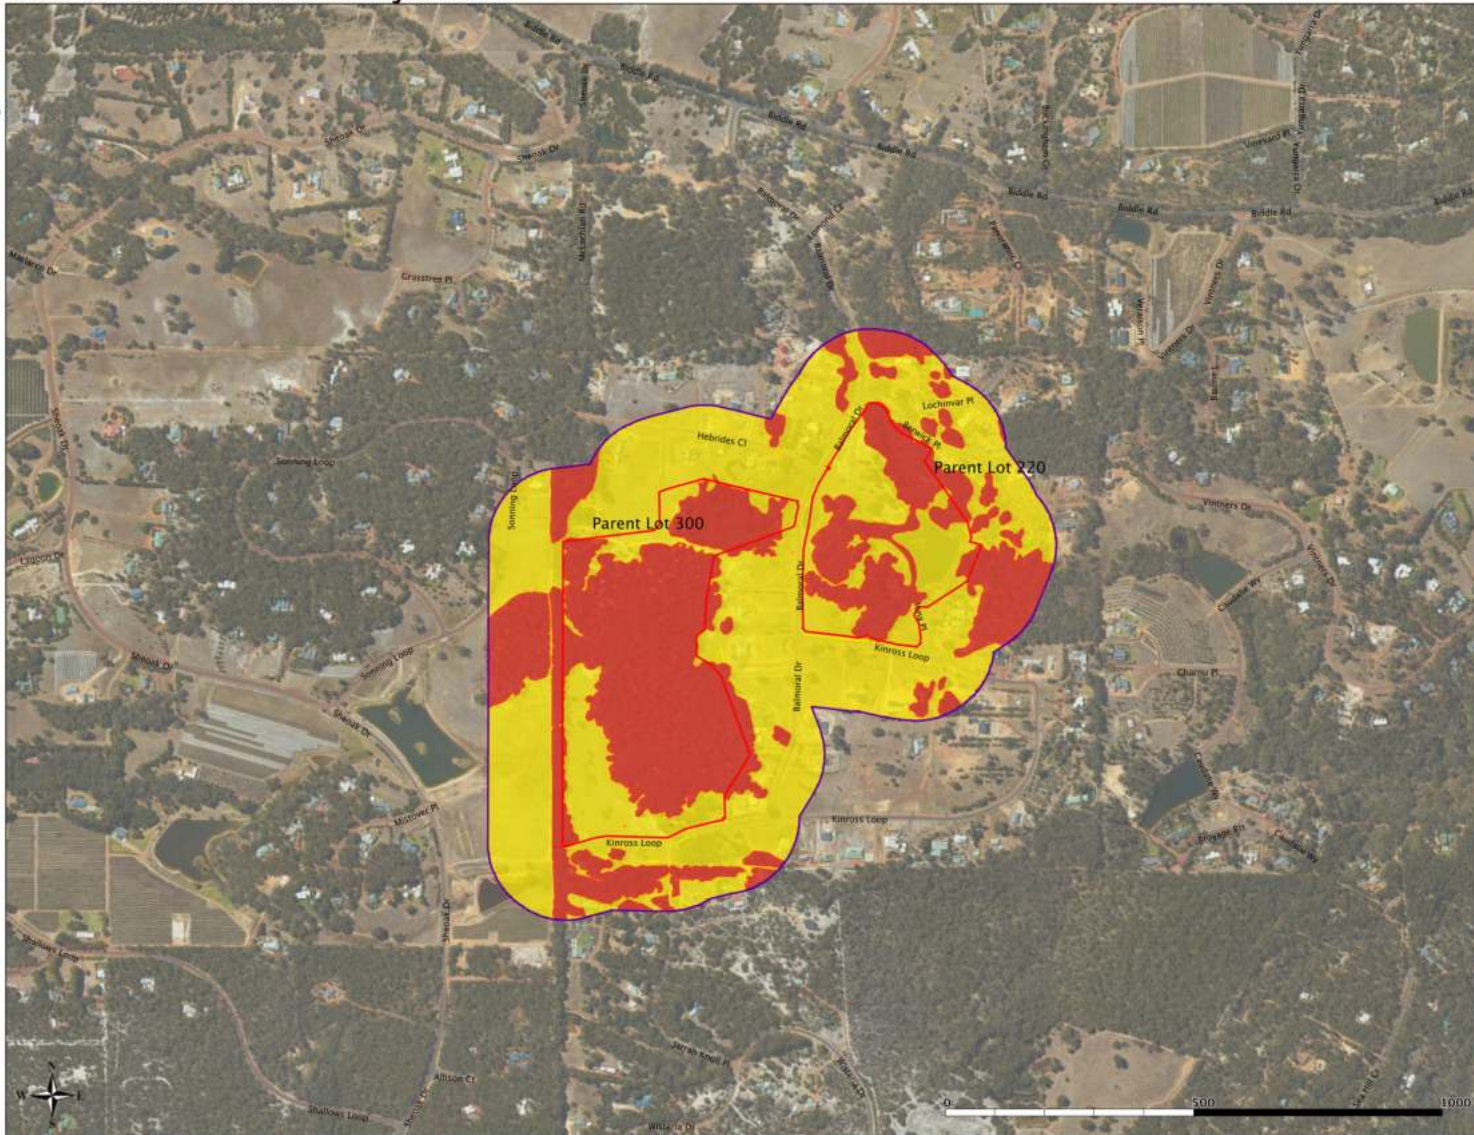
Figure 10 Bushfire hazard level (BHL) assessment showing surrounding areas of original vegetation

A BHL assessment (Figure 10), confirms the 'Extreme' hazard levels within and adjoining the subject Lots caused in most part by the extensive stands of original Class A Forest and Class B Woodland. The 'yellow' or 'Moderate' BHL areas are associated with previously-cleared unmanaged Class G Grassland.

A broader assessment of the regional extent of the original vegetation that constitutes a regional-scale 'Extreme' bushfire hazard can be clearly seen in Figure 10.

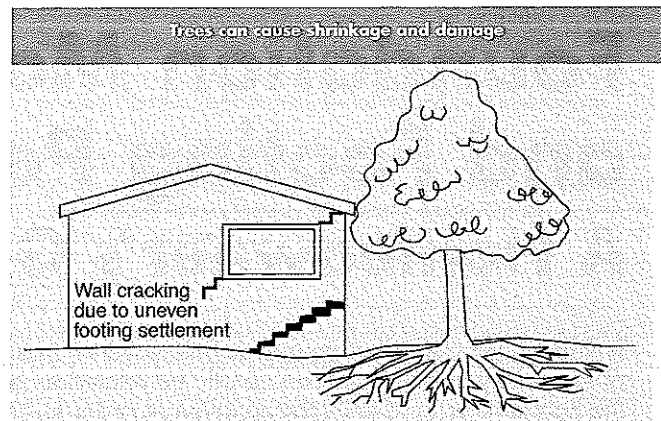
As the moisture absorption process completes its journey to the innermost areas of the building, the internal footings will rise. If the spread of moisture is roughly even, it may be that the symptoms will temporarily disappear, but it is more likely that swelling will be uneven, creating a difference rather than a disappearance in symptoms. In buildings with timber flooring supported by bearers and joists, the isolated piers will rise more easily than the strip footings or piers under walls, creating noticeable doming of flooring.

As the weather pattern changes and the soil begins to dry out, the external footings will be first affected, beginning with the locations where the sun's effect is strongest. This has the effect of lowering the external footings. The doming is accentuated and cracking reduces or disappears where it occurred because of dishing, but other cracks open up. The roof lines may become convex.

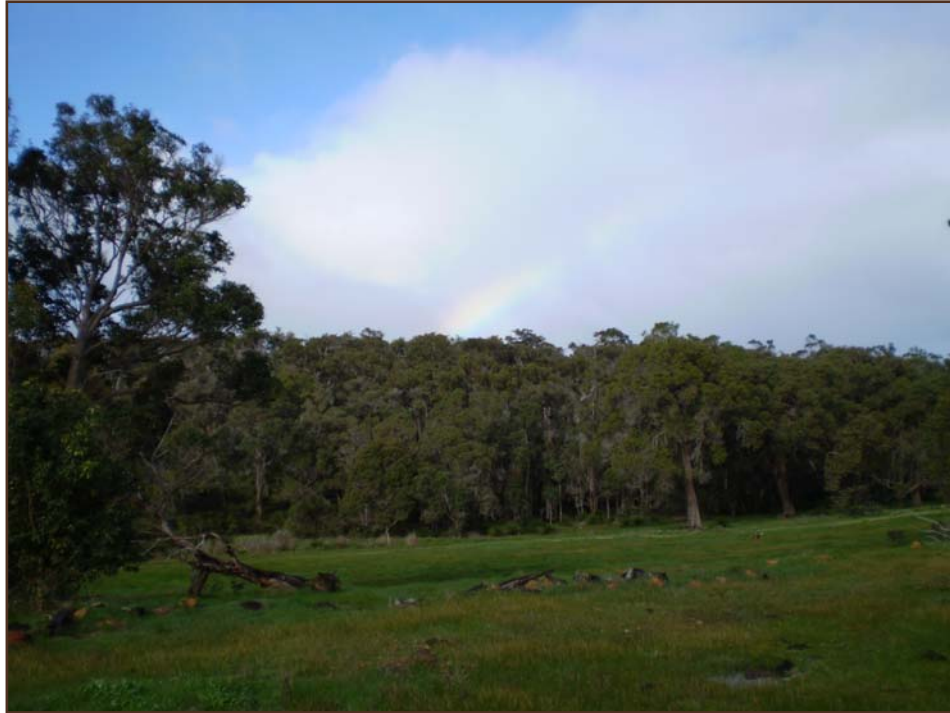
Plate 5: Looking east across waterlogged section in the central western area of the site.

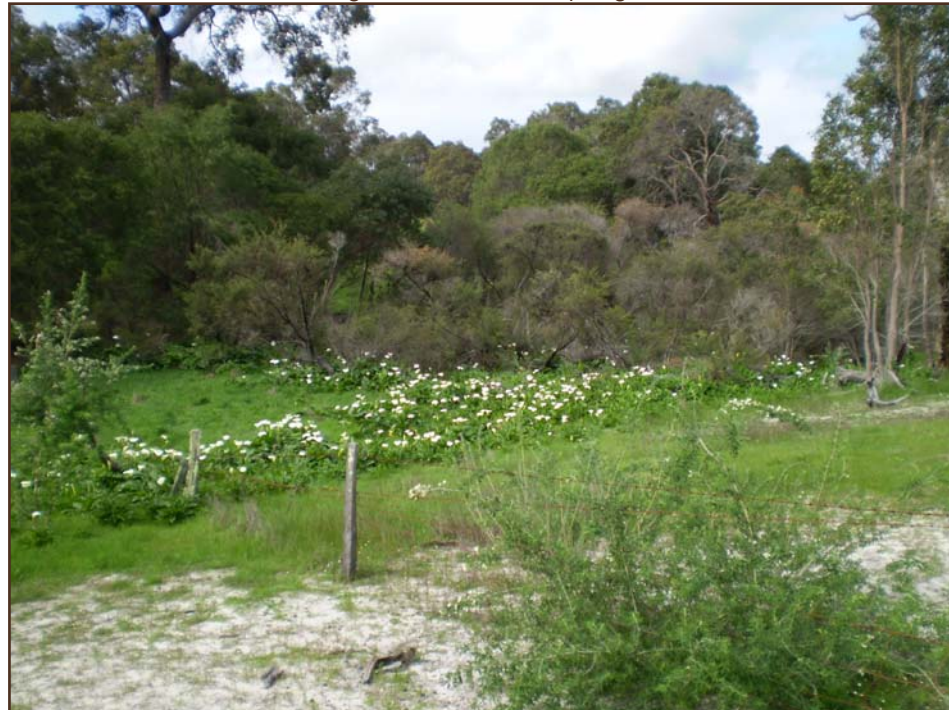
Plate 8: View of main natural drainage line. Looking south-east from sampling location Y11.
