# FORESHORE AND CHANNEL ASSESSMENT OF SPENCERS BROOK

WATER AND RIVERS COMMISSION  
REPORT NO. WRM 28  
2002

The Spencers Brook catchment drains part of the western portion of the Shire of Northam into the Avon River. Foreshore and channel assessments along Spencers Brook were undertaken between April and May 2001.

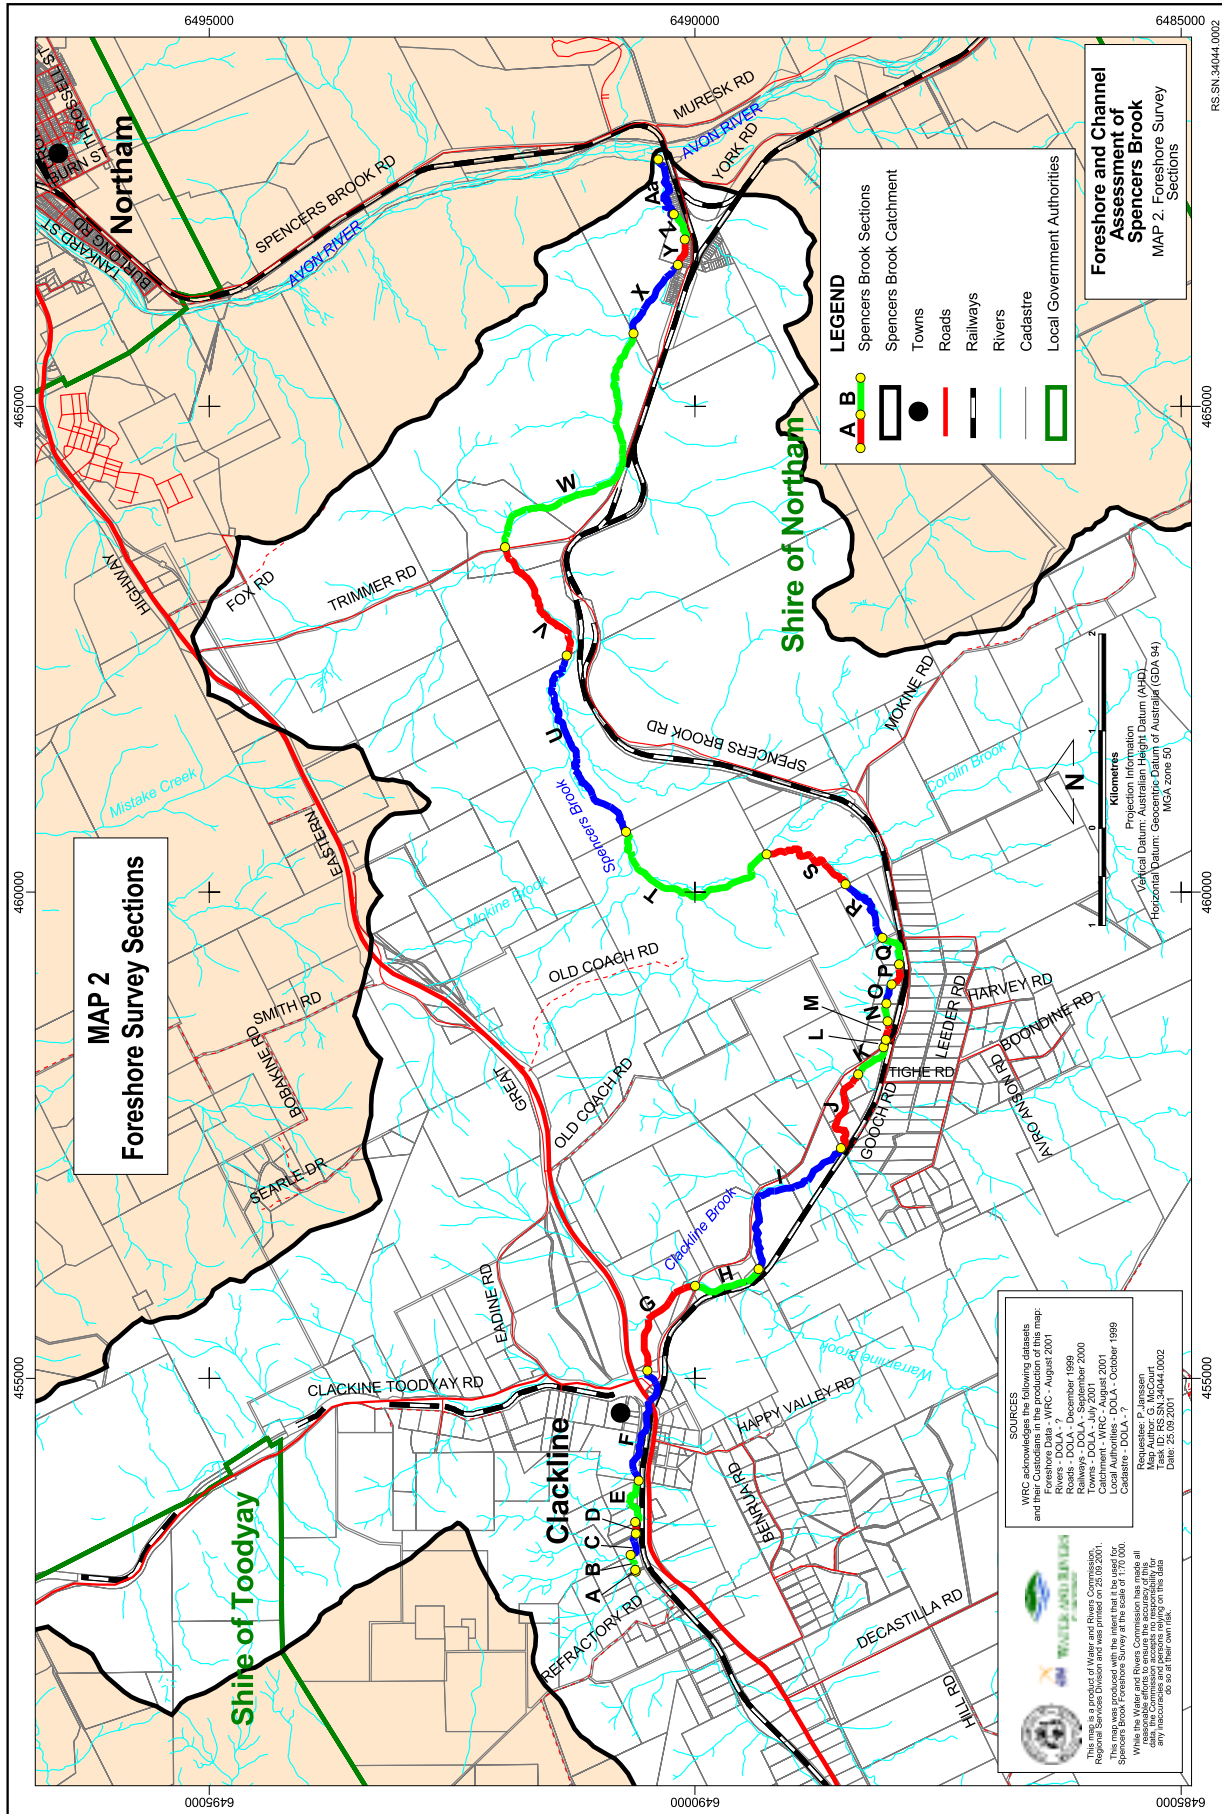
Map 2. Foreshore survey sections

Map 1 depicts the size of the Spencers Brook catchment and also shows the location of the brook and the extent of the Clackline Brook incorporated into this study. Map 2 shows the boundaries of each of the 27 sections that the waterway was broken into for the purpose of this assessment.

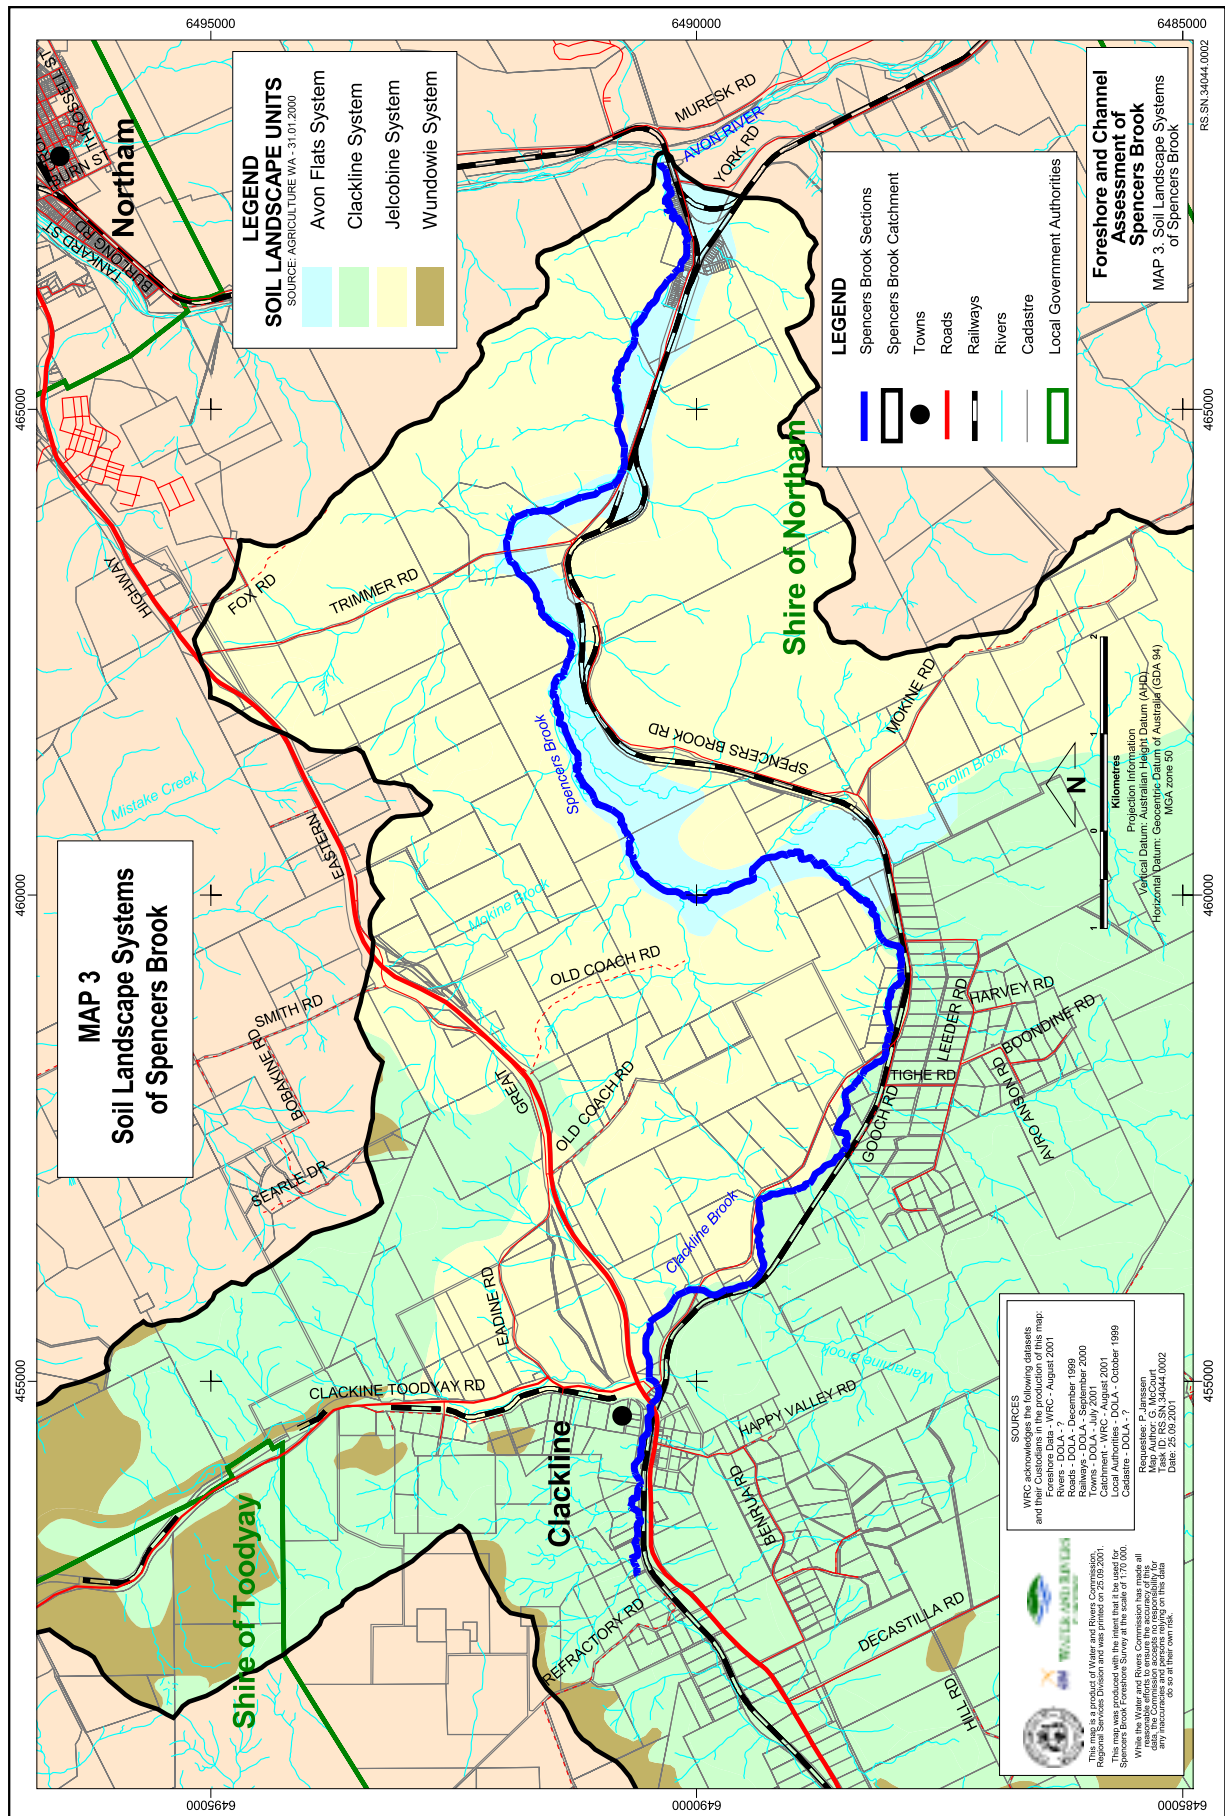
Map 3. Soil landscape systems

The Avon Flats system is characterised by brown loamy earths, grey non-cracking clays, and deep brown sands. This system is commonly found along alluvial terraces and flats (Agriculture Western Australia, 1999).

The Clackline soil system is located along the lower, mid and upper slopes of the surrounding catchment area and is characterised by shallow grey sandy duplexes, duplex sandy gravels, loamy gravels, shallow pale sands and red loamy duplexes. It is often limited to moderately dissected areas with gravelly slopes and ridges (Lantzke and Fulton, 1992).

The Jelcobine system is located on the hill slopes but is defined by deep red and shallow sandy and loamy duplexes, deep grey sandy duplexes, bare rock and cracking and non-cracking clays (Lantzke and Fulton, 1992 and Agriculture Western Australia, 1999).

The Wundowie unit is defined by deep sandy gravels, duplex sandy gravels and shallow gravels. It is found in the higher areas of the catchment where lateritic plateaus with rocky outcrops are common (Agriculture Western Australia, 1999).

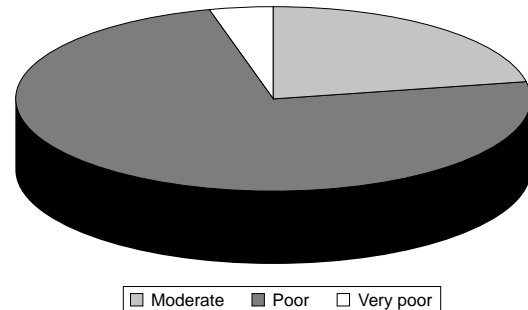
*Figure 1. Bank stability and sedimentation ratings for Spencers Brook.*

Bank stability and erosion were rated as moderate in 22% of sections (Figure 1). The majority of sections, 74%, were classified as poor and 4% as very poor (artificial bank stabilisation techniques were utilised in 22% of sections). Techniques such as log and rock walling have been employed along the banks to protect degraded areas from further erosion and undercutting. There were also some locations (ie. road bridges) where channel stabilisation had been undertaken as part of engineering structures for safety reasons and to support the construction of such features, not for protection of the waterway.

Sedimentation was another prominent component of degradation recorded along the brook with 4% of the sites recorded as minimal, 52% as localised, 40% as significant and 4% as severe. 55% of sites were recorded as having sand slugs.

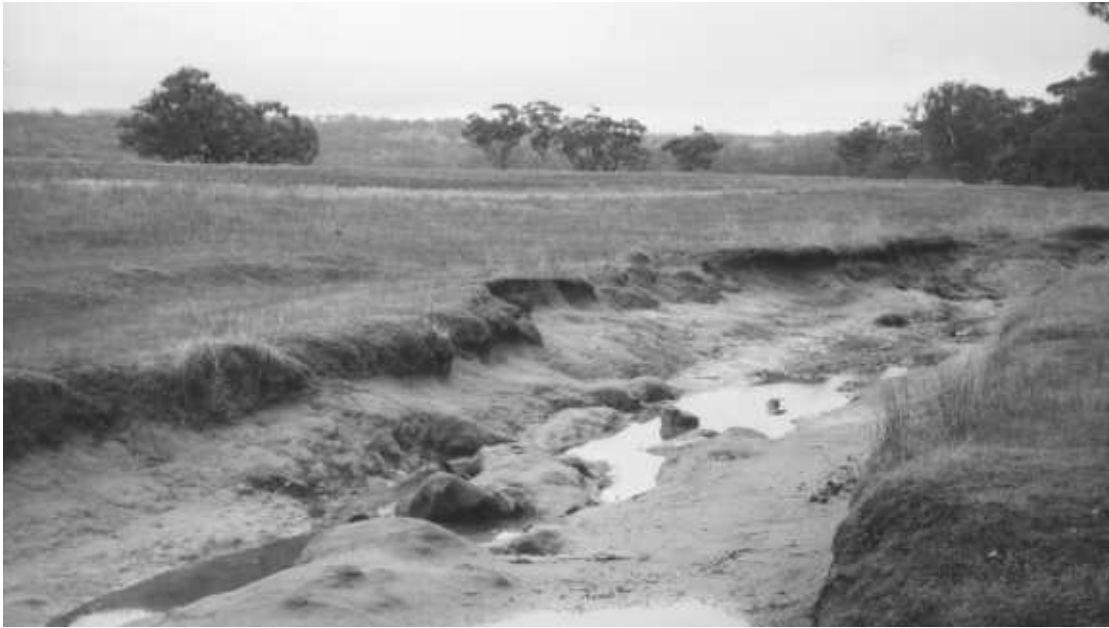
*A section along Spencers Brook showing characteristics of an eroded bed and D-grade foreshore.*

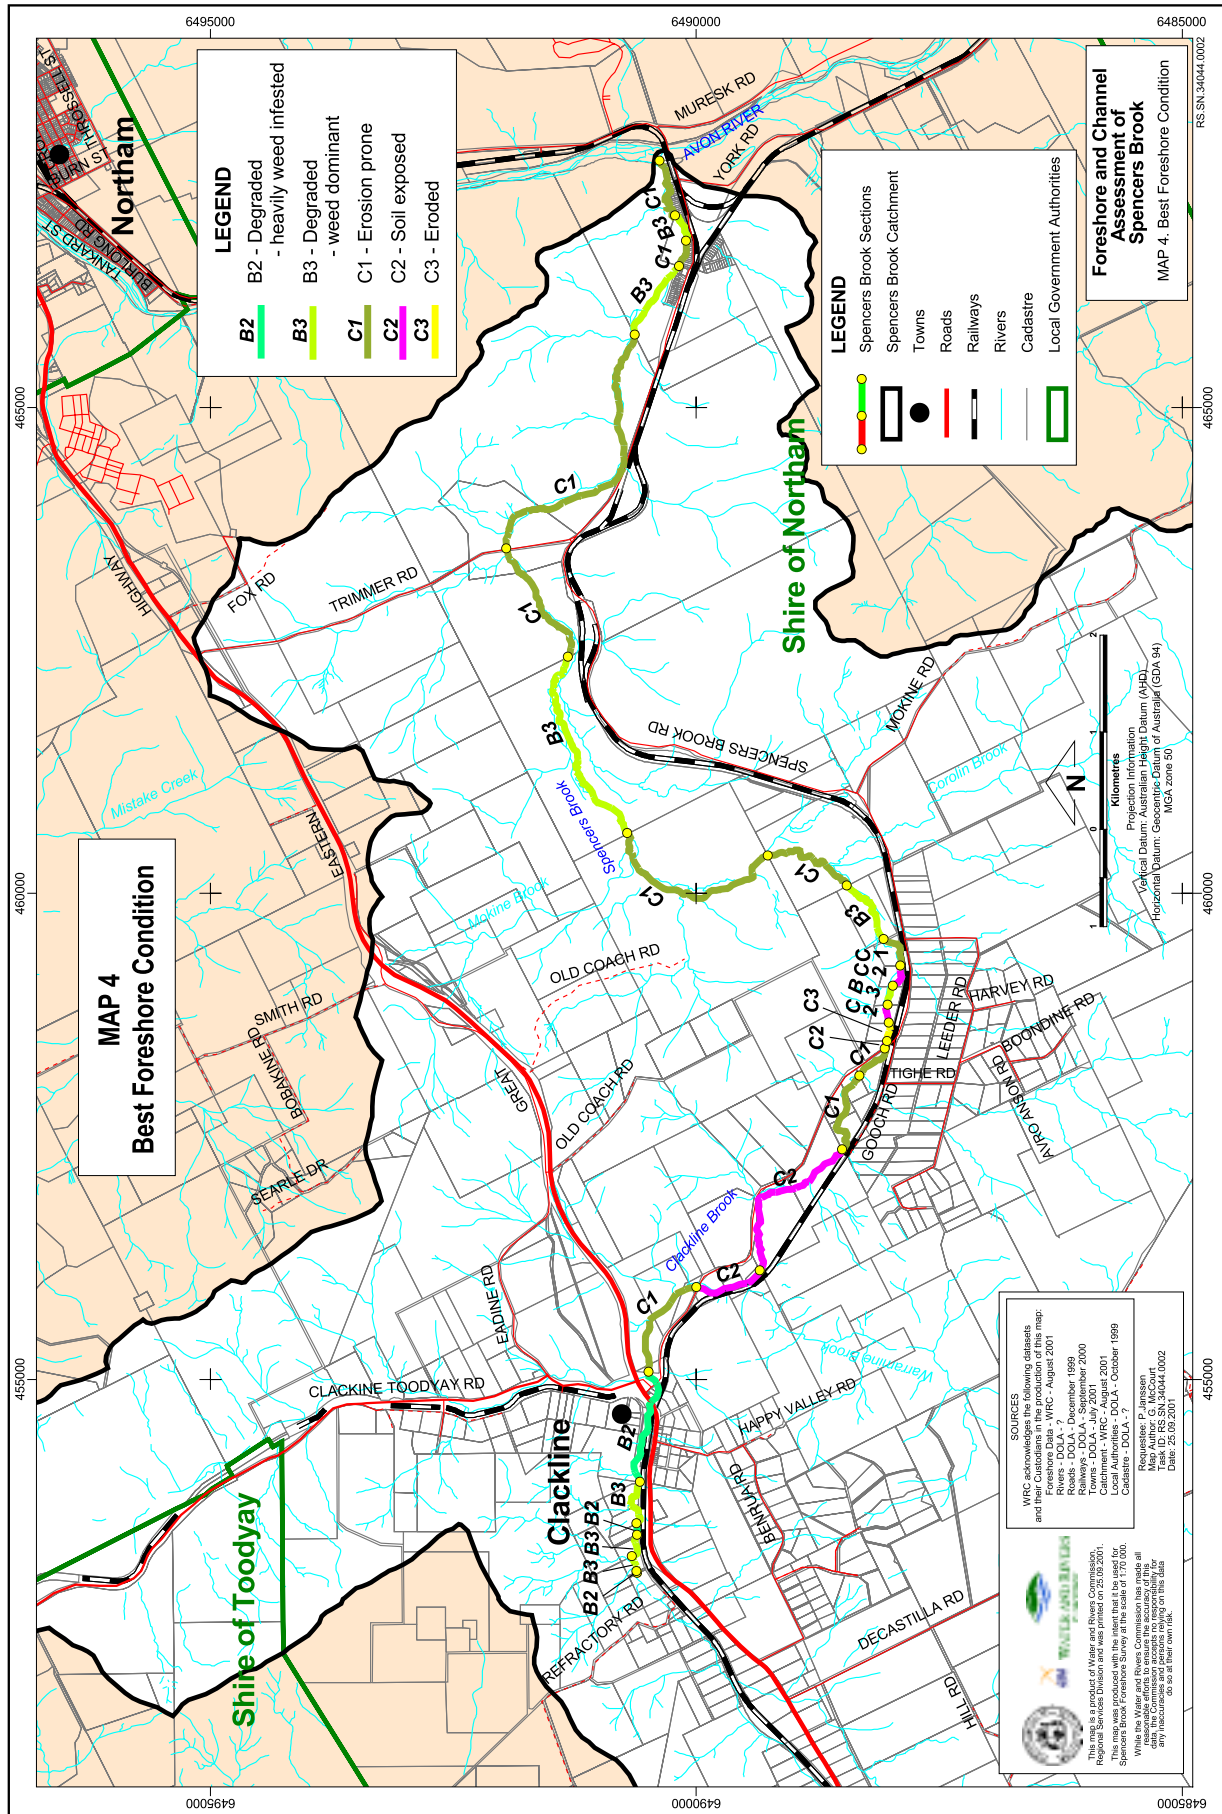
Map 4. Best foreshore condition

The best foreshore condition recorded along each section varied greatly with 11% of the sites rated as B2, 29% as B3, 41% as C1, 15% as C2 and 4% as C3-grade (Map 4).

Results indicate that there was no distinct pattern and foreshore condition was largely related to past and current landuses throughout the catchment.

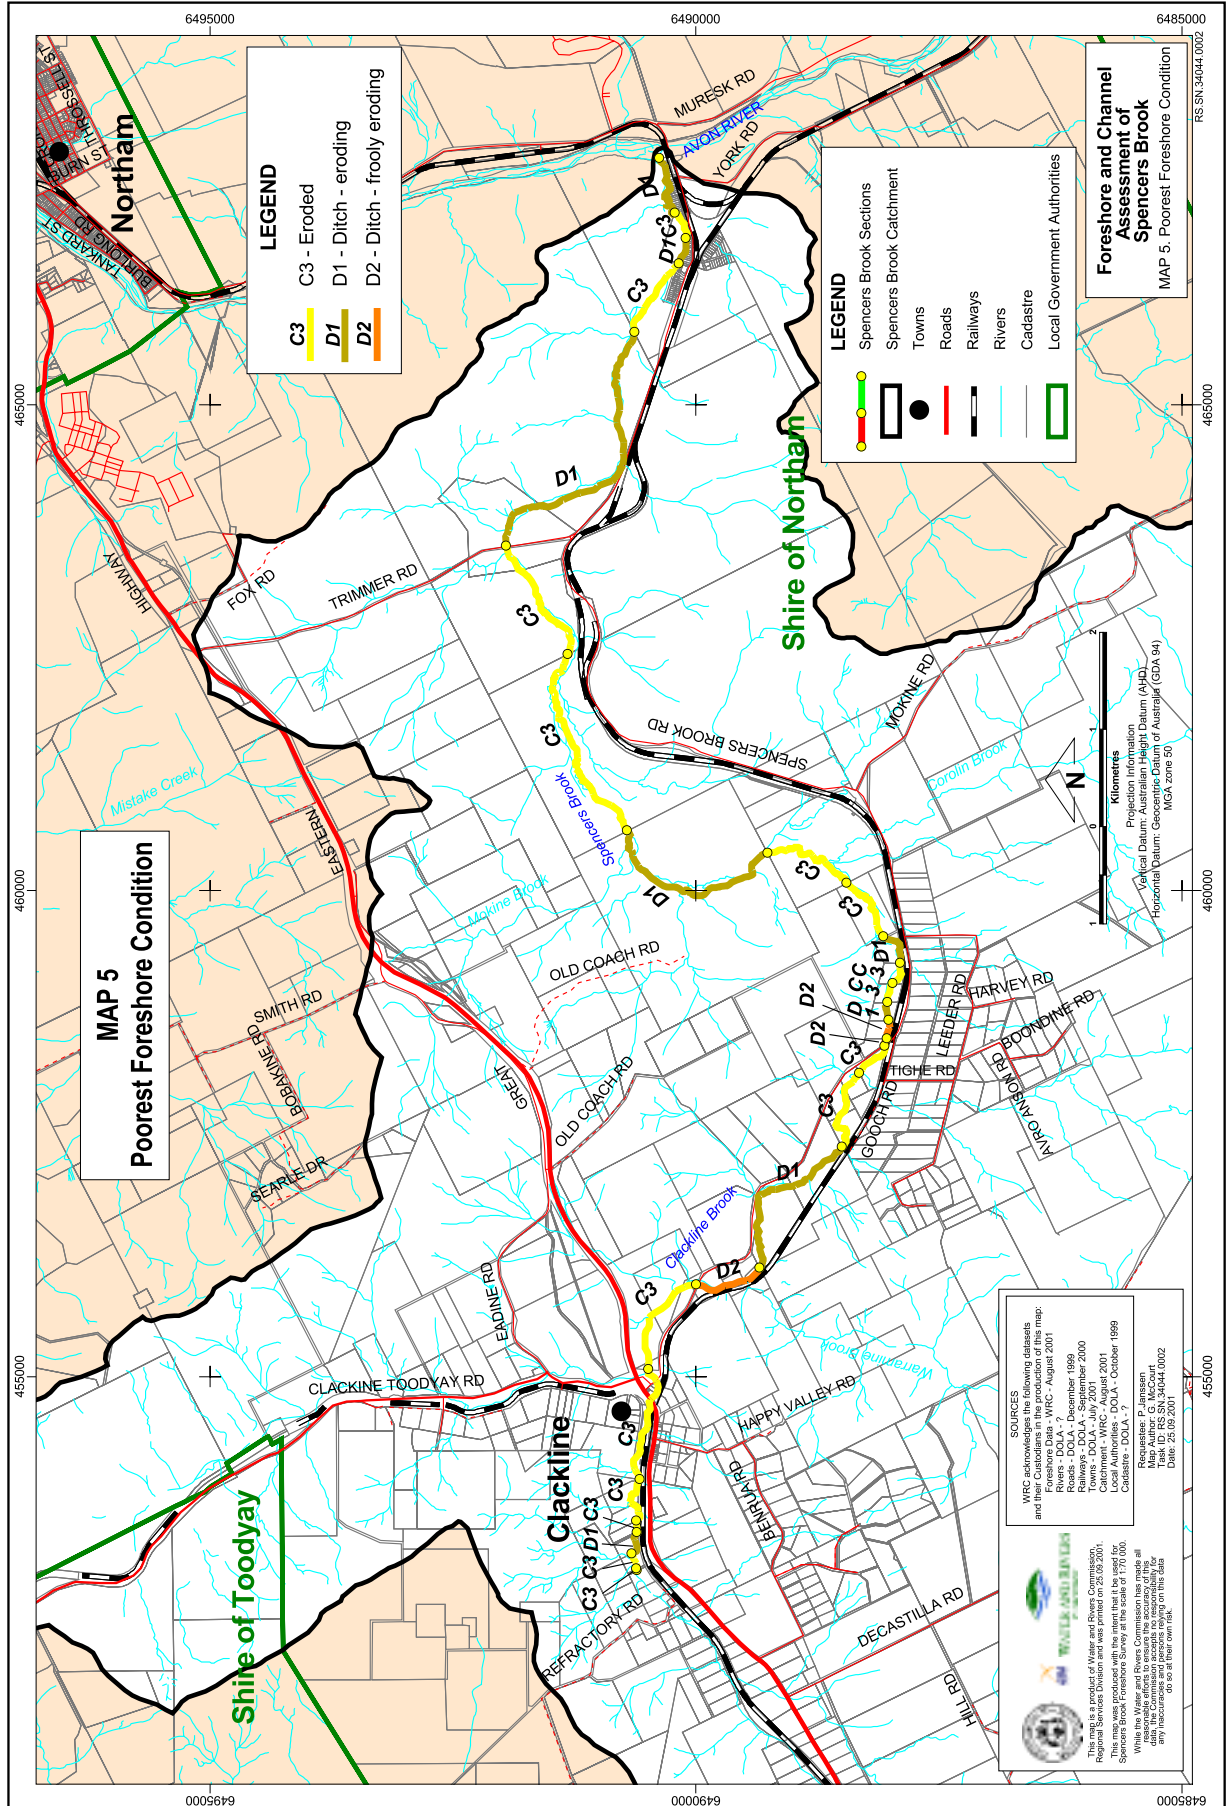
Map 5. Poorest foreshore condition

Map 5 depicts the poorest foreshore conditions recorded in each section surveyed along Spencers Brook. The map indicates that there was less variation recorded in the poorest foreshore condition classifications with 59% of surveyed sections rating as C3, 30% as D1 and 11% as D2-grade.

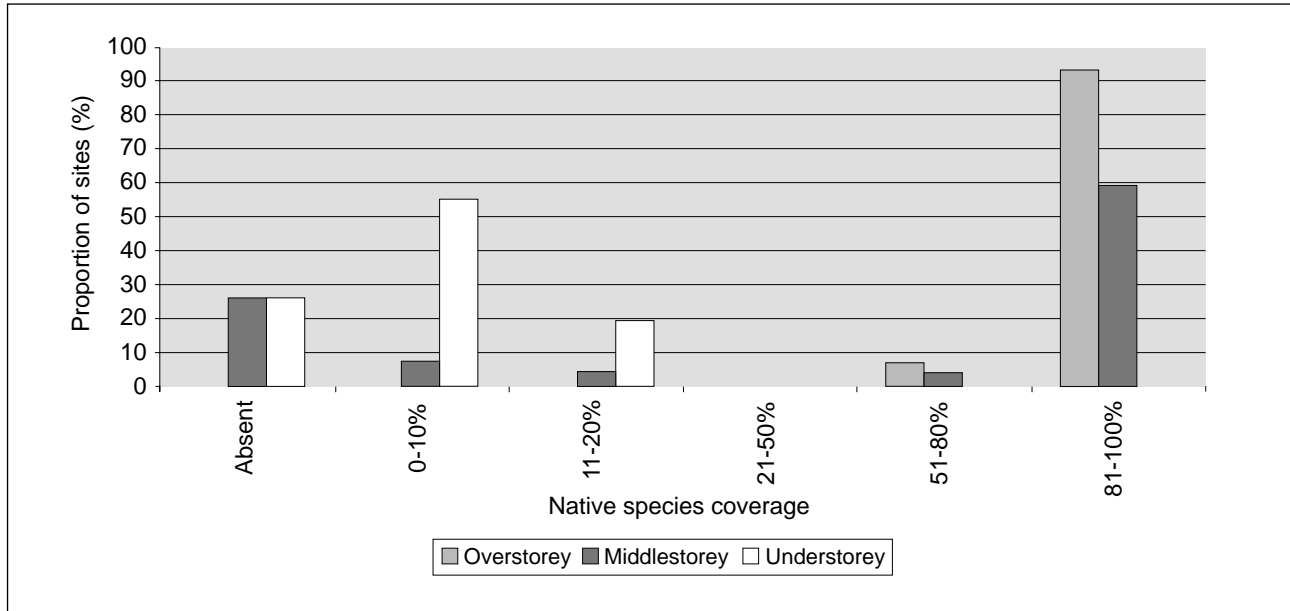
Figure 2. Proportion of native species in each vegetation layer

Figure 2 shows that the majority of native species occurred in the overstorey and middlestorey with 93% of surveyed sections recorded as being comprised of between 81-100% native vegetation in their tree layer.

Of middle storey species present (shrubs and small trees), 59% of sites were recorded as having between 81-100% native vegetation. Ground cover (ie. grasses) was predominantly weed species with 55% of sites recording a cover of between 0-10% native species. Native understorey and middlestorey species were found to be absent in 26% of sections.

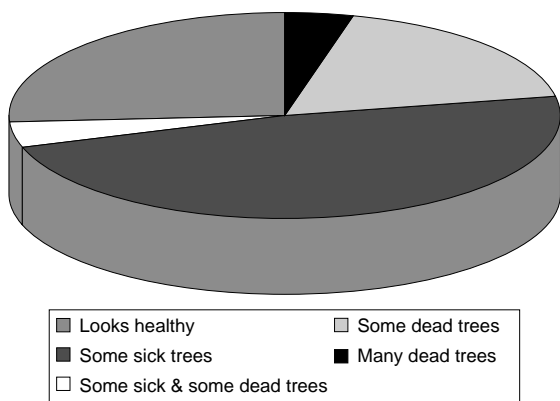
Figure 3. Vegetation health

Vegetation health was determined to be moderate along most of Spencers Brook and tree death was obvious in many areas. As described above, there was a lack of middle storey plants in most areas and the ground cover was dominated in most instances by weed species.

Figure 3 shows that 48% of surveyed sections recorded some sick trees among the foreshore vegetation, while 18% of sites had some dead trees. Only 26% of sites were recorded as having healthy looking vegetation (ie. lots of leaves, natural regeneration of native species, lack of weeds, diversity of native species and a low level of disease and insects).

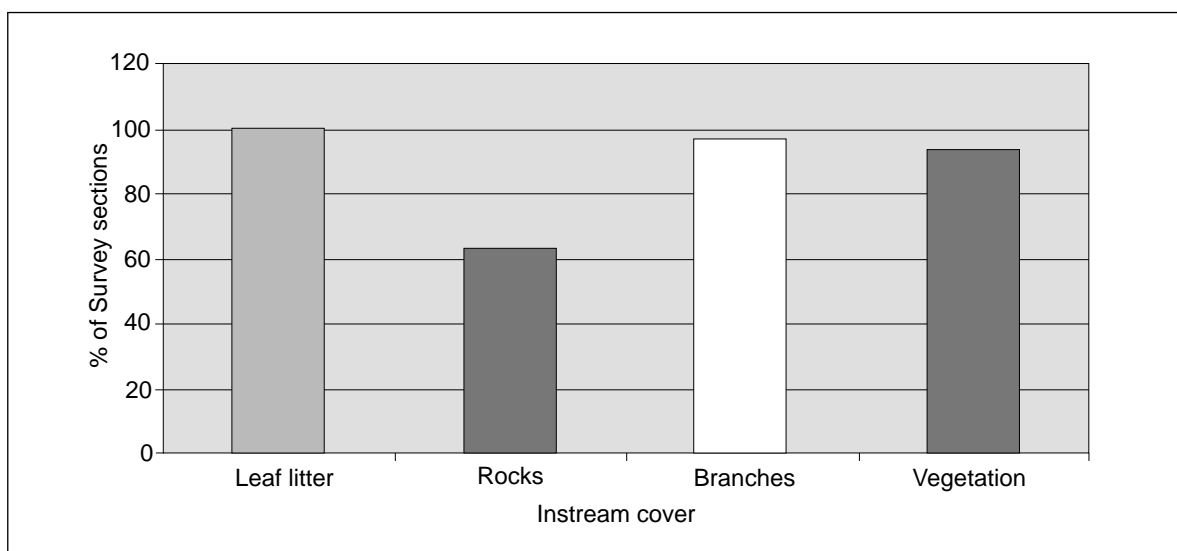
Figure 4. Proportion of instream cover

Instream cover was moderate in 78% of sections when determined as part of the overall stream environmental health rating. There was often a mixture of leaf litter, rocks, branches and vegetation. Figure 4 shows the proportion of sections that had instream cover and that leaf litter was the most common instream cover and habitat type (at 100% of sites), followed by branches, occurring at 96% of sections.

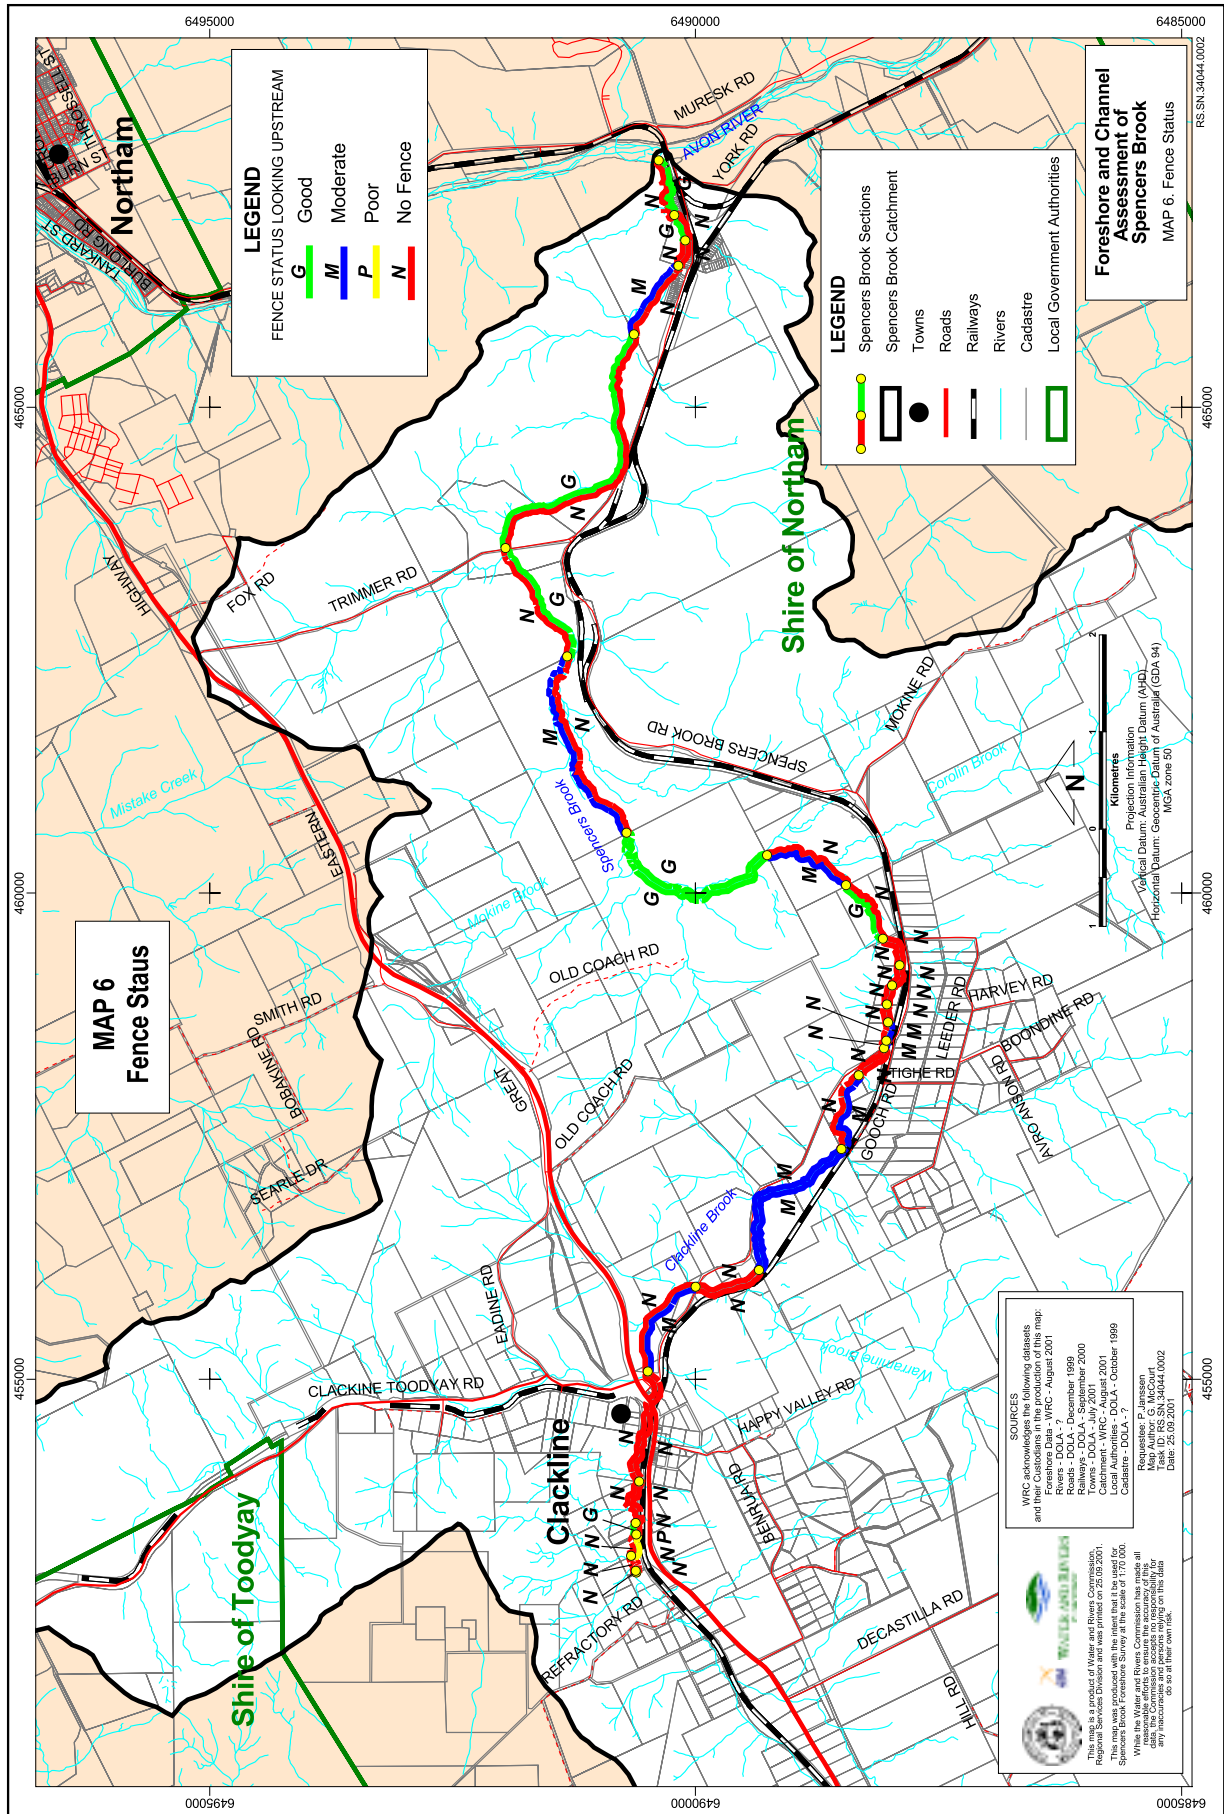
Map 6. Fence status

Of those areas that were fenced, 44% was in good condition, 50% was in moderate condition and 6% was in poor condition. Of the fencing style used along the fenced sections 12% were plain wire, 16% barbed wire, 6% electrified, 6% a combination of fabricated and electrified, 31% a combination of fabricated and barbed, 12% plain wire and electrified, and 17% plain with barbed wire. Appendix 9 provides a definition of each fencing style and examples of fence condition.

The position of the fence was also determined, with an approximation given for the distance of the fence line (left and right bank) from the bank of the waterway. Table 5 shows that the majority of fenced sections were fenced within 30 metres of the riverbank along the left bank, whereas only 11% of fenced sections along the right bank were fenced within 30m of the riverbank.

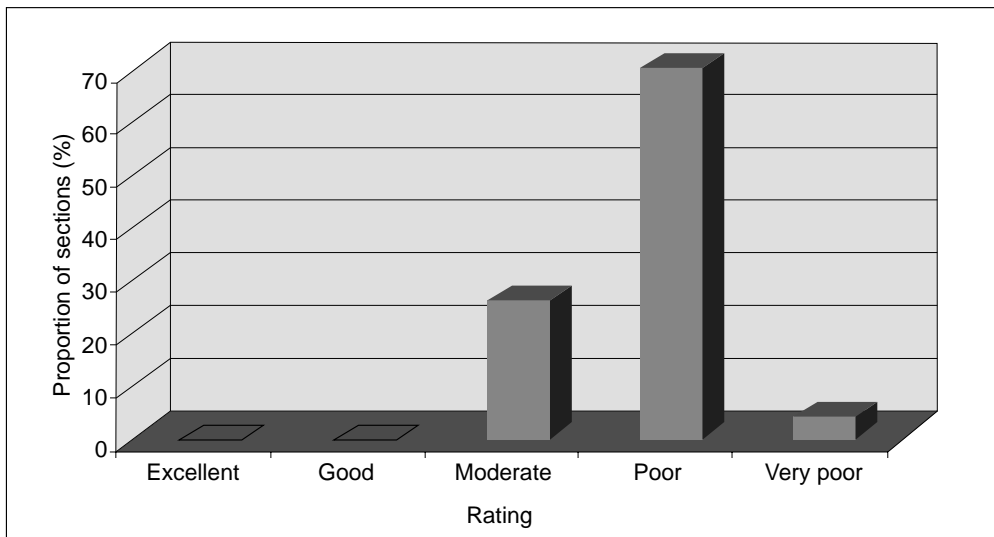
Figure 5. Overall stream environmental health ratings

The results in Figure 5 show that only 26% of the surveyed sections were classified as having a moderate stream health, 70% as poor and 4% as having very poor stream health. The dominantly poor health rating of the brook was mainly due to poor ratings in all categories with the exception of stream cover and habitat diversity of which 78% and 81% of sites respectively were rated as moderate, as shown in Table 6. Appendix 6 provides a description of each factor at each level of health.

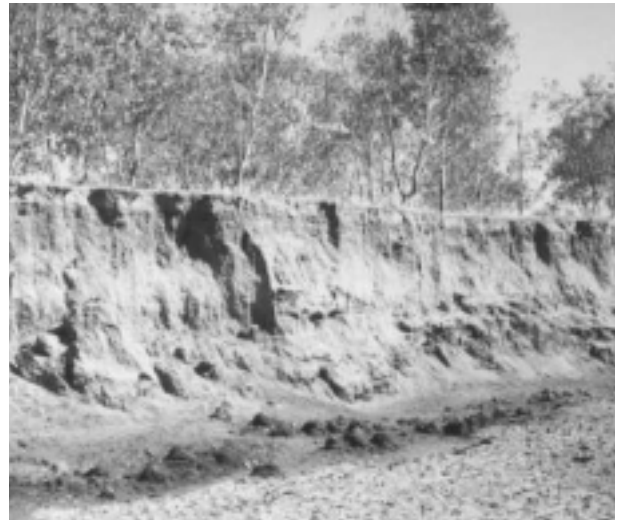
Historically an unstable system, the stability of the channel, banks and floodplain has declined as a result of pressure from a mixture of past and present landuse practices. Stock access to the riparian zone has led to foreshore areas becoming devoid of vegetation that plays a role in channel stabilisation. Its intricate root

*An example of severe bank erosion along Spencers Brook*

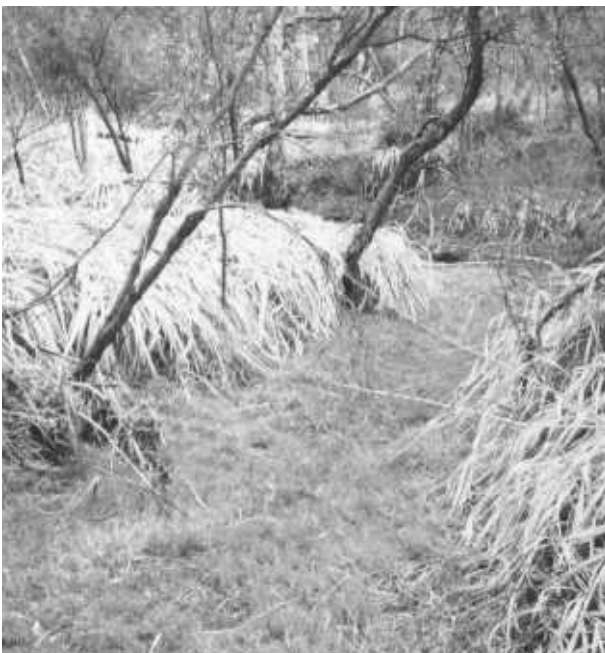
*Watsonia and Couch are becoming invasive along many sections of Spencers Brook*

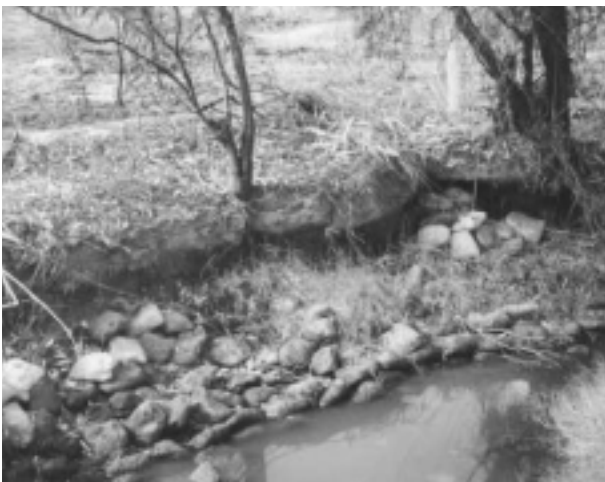
*Rocks can be used to stabilise the toes of banks to limit erosion*

A riffle can either be natural (comprised of rocks and branches) or man-made (an engineer-designed low rock bar, or some other form of engineered structure). An engineered structure is usually located across the river at a strategic point with the aim of slowing river velocity. These structures can also become places where coarse sediments will be deposited and can later be removed.

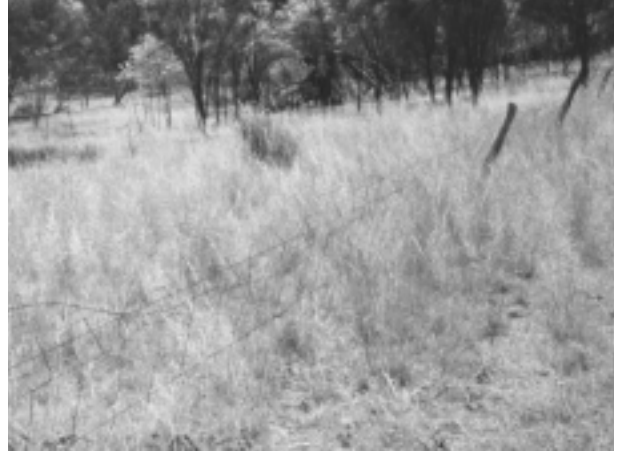
*Fence condition: POOR*

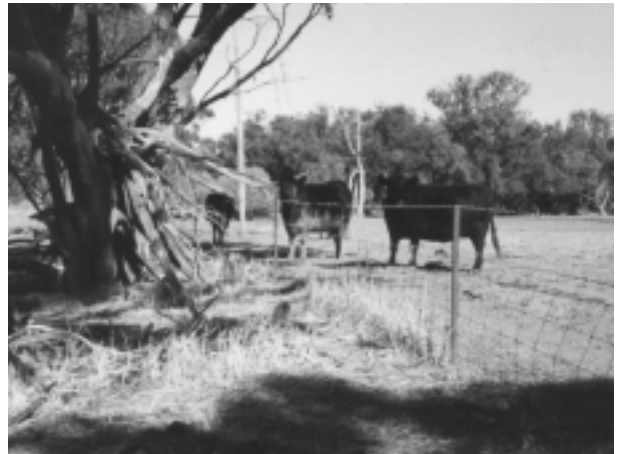
*Fence condition: MODERATE*

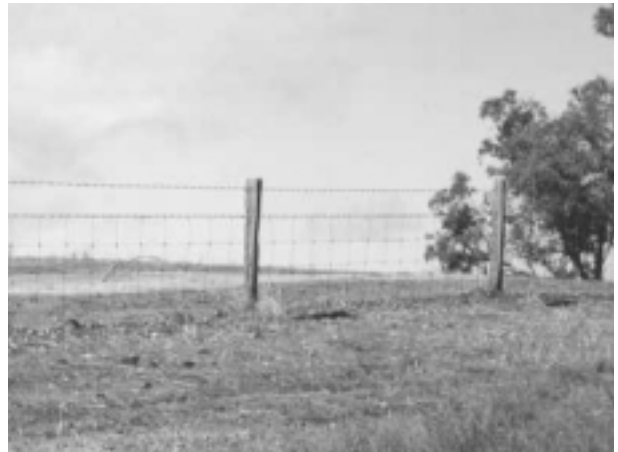
*Fence condition: GOOD*

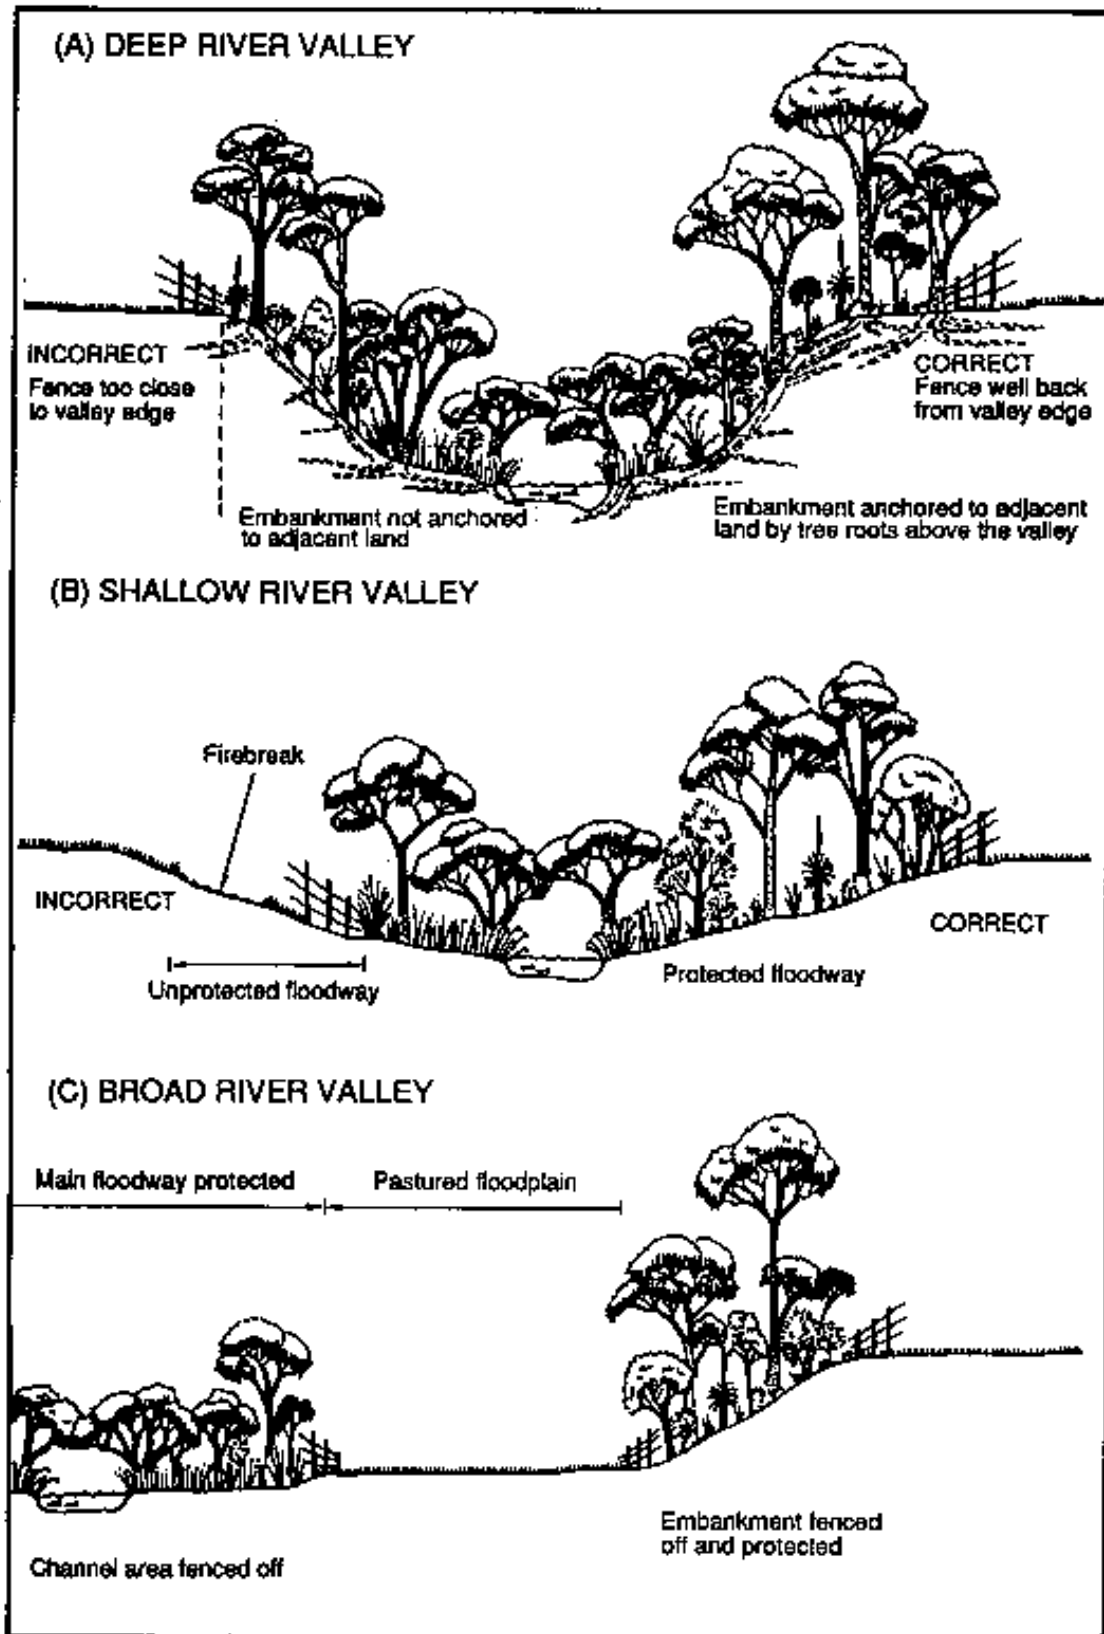
The correct and incorrect placement of fences in relation to the river valley
