Neds Corner Environmental Water Management Plan

Mallee CMA (2016) Neds Corner Environmental Water Management Plan, Mallee CMA, Mildura Victoria

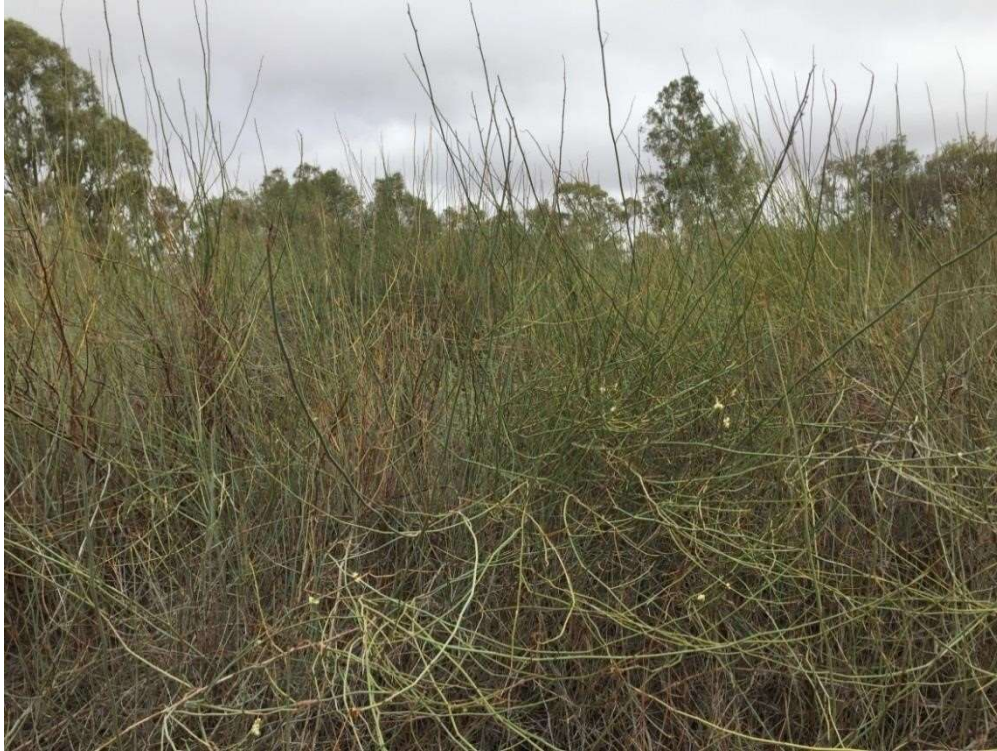
Significant vegetation response was evident after the 2015 event, with a flourish of strong growth exhibited by *Lignum* located in the north of the Neds East target area (Figure 10).

Figure 10. Strong growth occurred at Neds East after the 2015 watering event. This image captured 11 April 2016.

Neds East has responded well to several years of environmental water delivery. Lignum stands have exhibited strong growth (Figure 10, page 18). Tree canopies and the wetland bed has showed signs of positive vegetative response within the woodland and herbland EVCs, with good coverage of herbs and forbs that dry off over the summer (cover image; Figure 17).

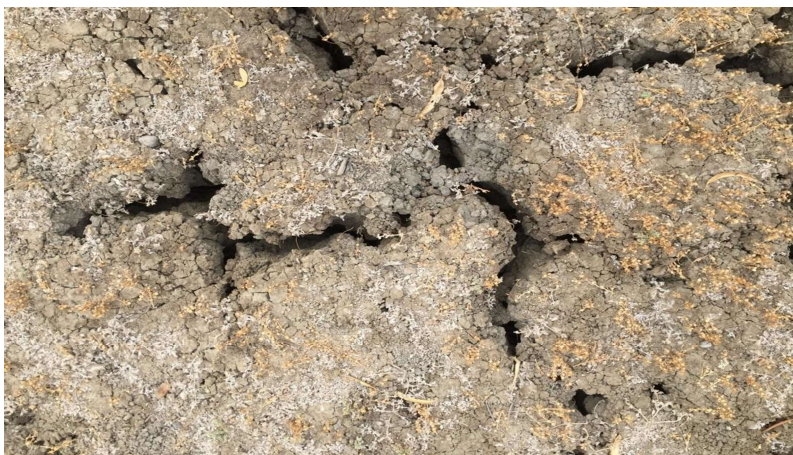
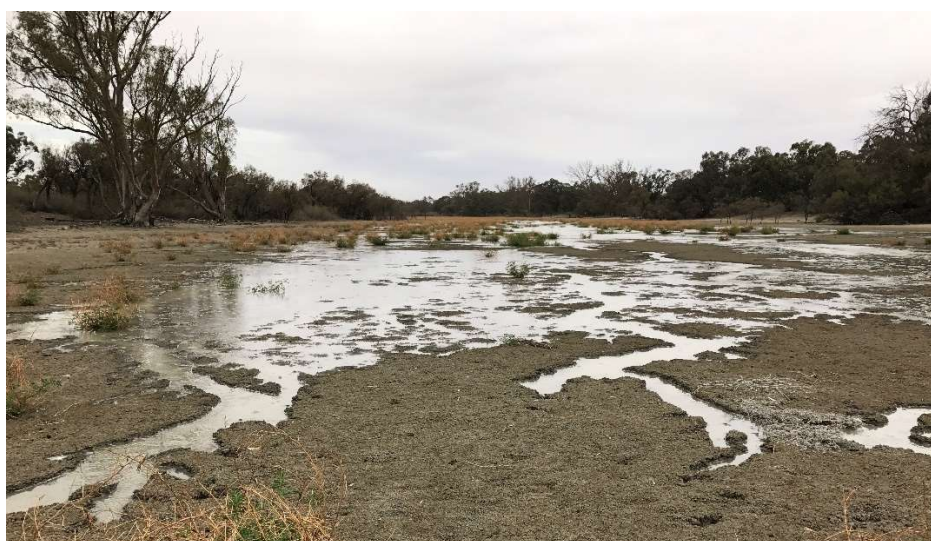
Figures 12a/b. The soils in parts of Neds East exhibit significant shrink-swell characteristics, as evidenced in the top image, captured April 2016, with some cracks measuring 50 mm across. Water movement along these cracks was demonstrated, bottom image, during delivery at Neds East in Oct 2019. These soils may provide habitat for the near threatened Giles Planigale and the critically endangered De Vis' Banded Snake recorded at Neds Corner.

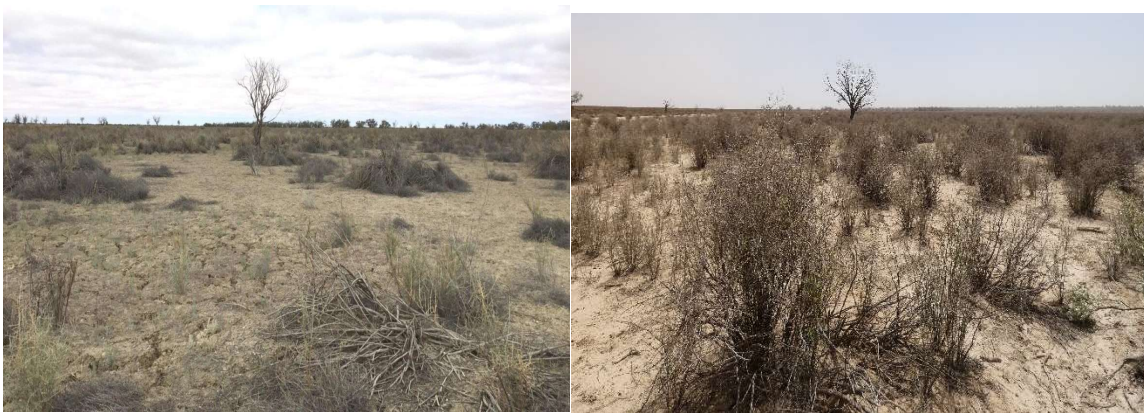
Lignum dieback was apparent across the floodplain of Neds Central, with loss of some overstorey in 2016 (Figure 19a). This vegetation has shown marked improvement after several years of environmental water delivery and natural floods (Figure 19b). Grey cracking soils were evident in this location and herbs and forbs were also noted. Areas situated high on the floodplain continue to exhibit signs of drought impact, with nearby Black Box overstorey in very poor health.

Figure 19a/b. Lignum at Neds Central had suffered severely when observed in 2016 (left), but was exhibiting a strong evidence of growth in response to several years of environmental water delivery and natural floods (right).
