PROGRAMMING & ADVANCED PLANNING SUBMITTAL

SCO No.: 13-10964-01-WCU

- 4. PRE-DESIGN DRAWINGS
- E. PRELIMINARY PROJECT SCHEDULE
- F. FACILITIES CONDITION ASSESSMENT PROGRAM
 - 1. FCAP REPORT
 - 2. DESIGN STRATEGIES TO ADDRESS FCAP ISSUES

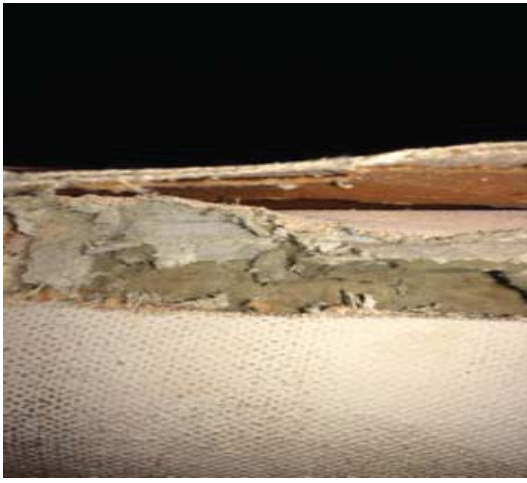
Pipe insulation with multiple layers of non-asbestos paper and 1 layer of ACM

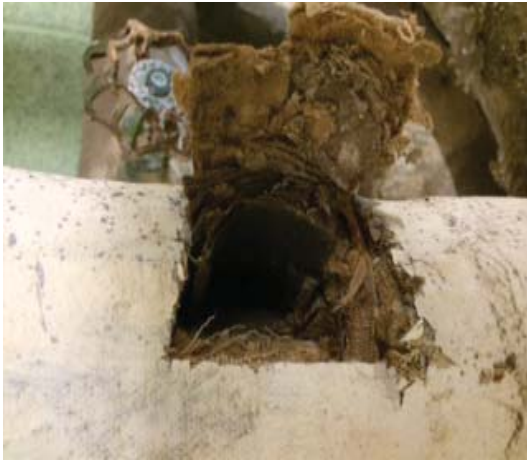
Pipe insulation with multiple layers of paper (no ACM)

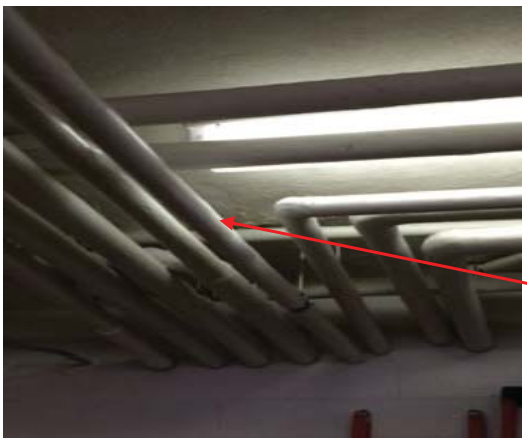
Pipe in Bulk Storage
ACM Pipe Insulation (paper with one ACM layer)
All fittings (elbows) in photo contain asbestos

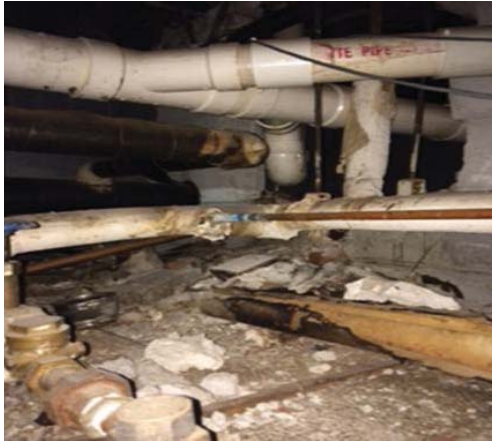
Over ceiling in Can Wash (room adjacent to dishwashing)

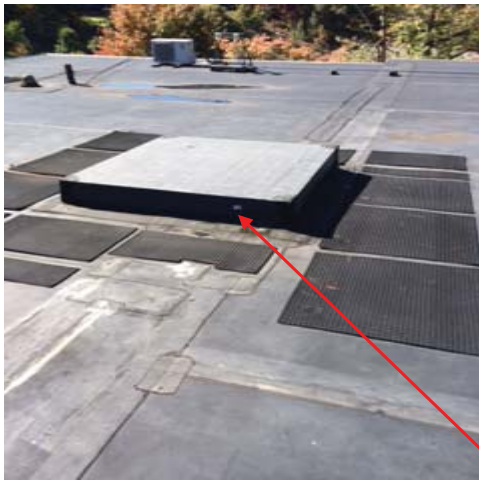
Area where ACM tar was identified (under rubber membrane)

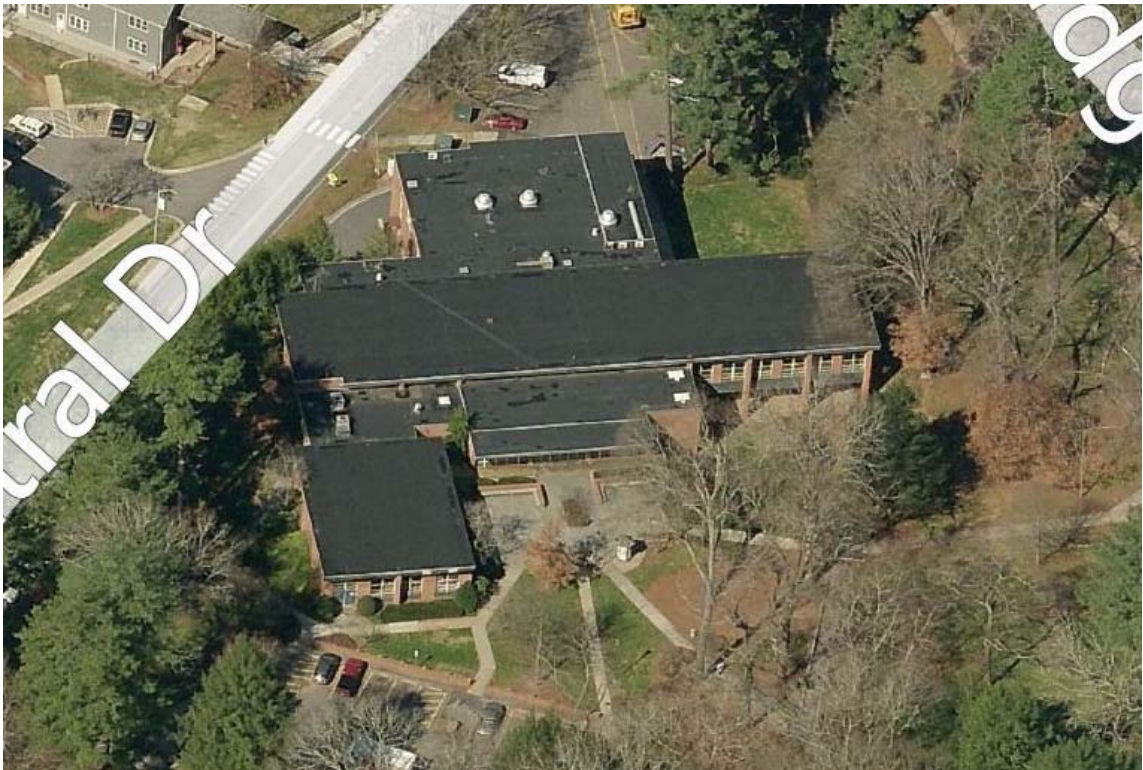
(Fig 1) Existing Brown Roof Photo)

EXISTING ROOF: The roof is a 2 inch gypsum roof deck, sheetrock formboard and rigid insulation with a built-up roof. At some point in time, the built up roof has been covered by an EPDM membrane.

Repair/Renovation: Existing roof will be removed (see abatement report for locations of hazardous materials) with a complete rip and replace of the entire roof system down to the deck. New roof will be a 20 year warranted three ply modified bitumen roof membrane system to match the new addition. There will be a minimum of 5 inches (average) of rigid insulation with cover board on top of the roof for an R-30. The cap sheet shall be a white granular surfaced product. Roof scuttles, vents, drains, overflows, coping and penetrations will all be removed and replaced.

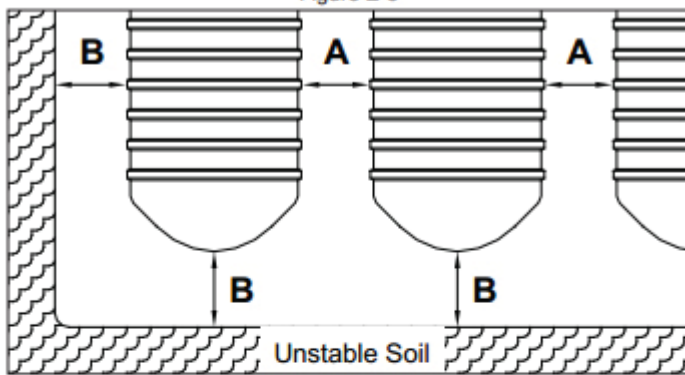
Figure E-3

- 12' tanks need a minimum cover of 48" backfill or 36" backfill plus 6" reinforced concrete.

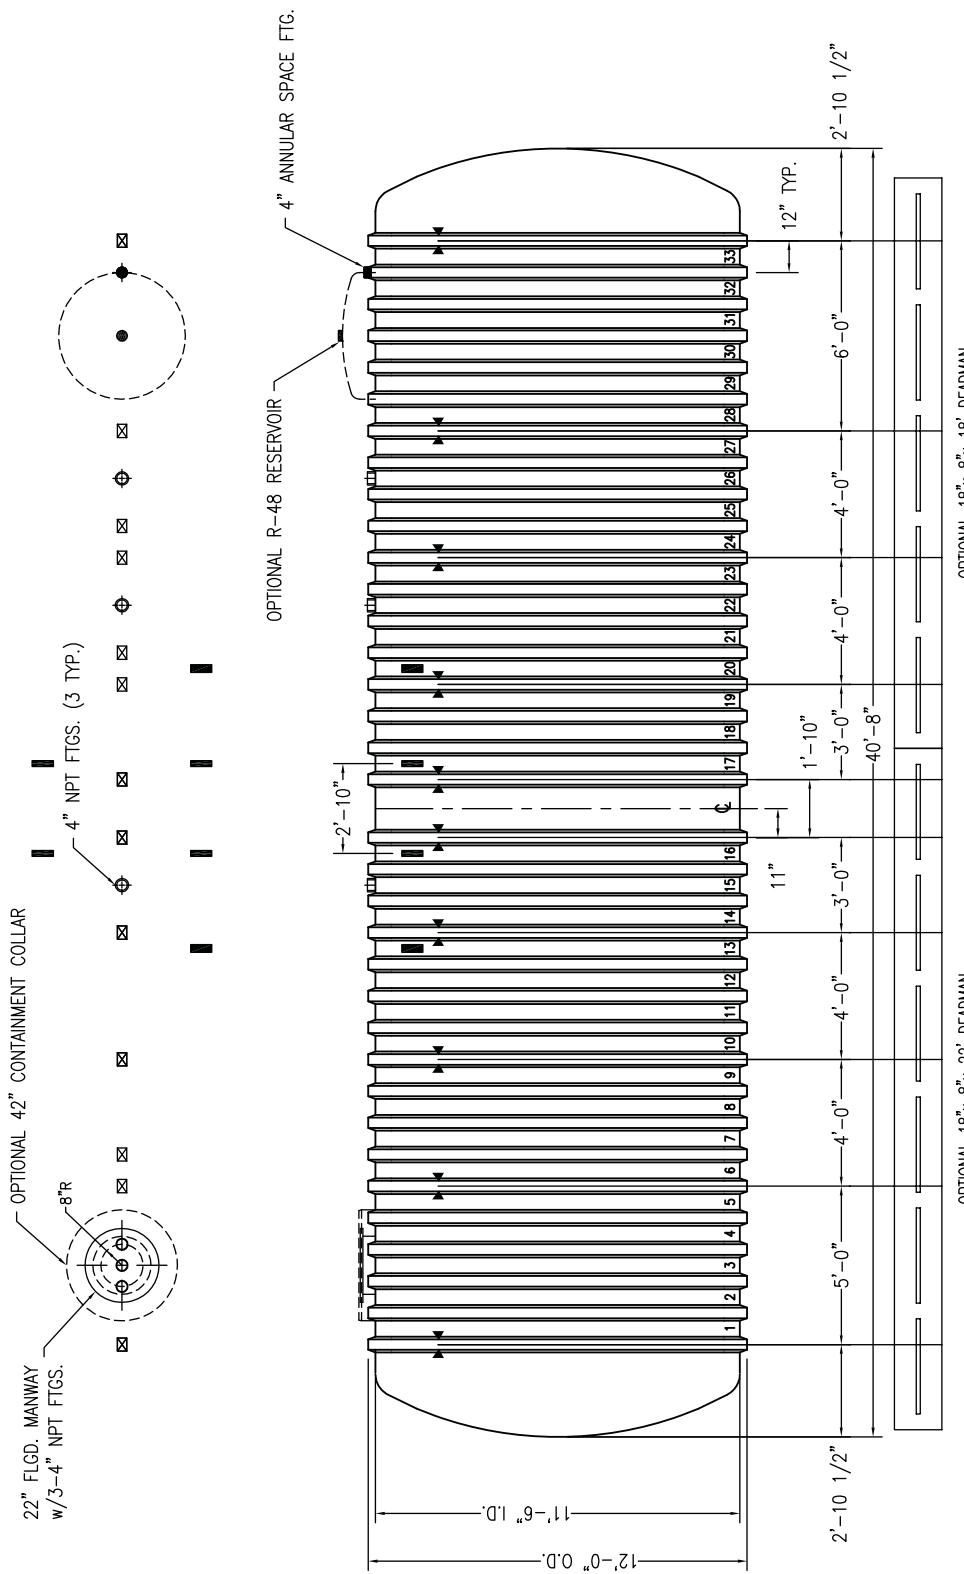
DWT 6 (12')-30000	DATE: 1/1/2014
	DRAWN BY: R.OXNER
	REVISED:
CONTAINMENT SOLUTIONS	CAPACITY: 30,147
	WEIGHT: DRY/WET: 22800/30350
	DWG. NUMBER: 12-30DW6S

Underground dual wall fuel oil storage tank(s) will be provided for fuel oil storage with submersible fuel oil pumps (2 per tank), dual wall containment underground fuel oil piping, and leak detection/monitoring system will be provided. A fuel polishing system will also be provided. Base bid will be a 30,000 gallon tank with an alternate for (2) 25,000 gallon tanks.
