**Caistor Conservation Area  
Appraisal**

## 1 Introduction

Caistor is a rural historic Market Town located 15 miles south west of Grimsby, 26 miles north east of Lincoln. Caistor was first designated in January 1970 as an area of 'special architectural or historic interest' under section 277 of the Town and Country Planning Act 1971 and an appraisal was completed in 1977. The purpose of this reviewed appraisal document is to give an up to date character appraisal.

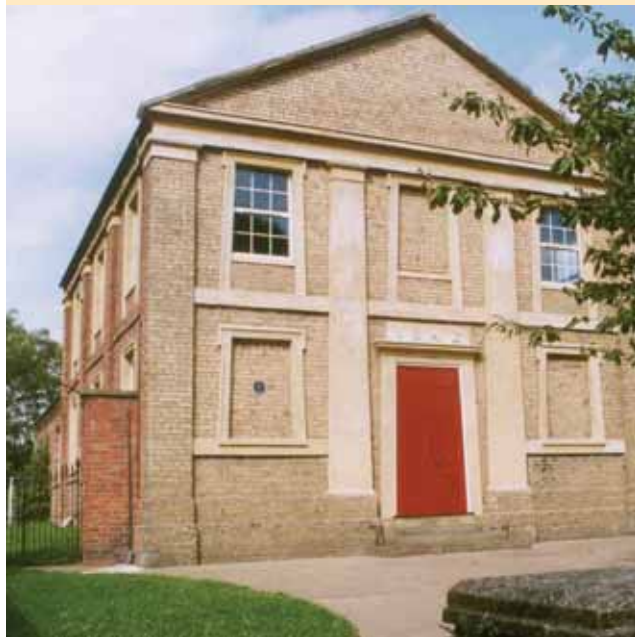
[1] Use of architectural classical orders - pilasters

- Horizontal emphasis in the form of string courses, dentilated brick eaves and box cornice gutters
- Tall retaining walls in brick or stone  
Use of architectural classical orders - for example, in pilasters.<sup>[1]</sup>

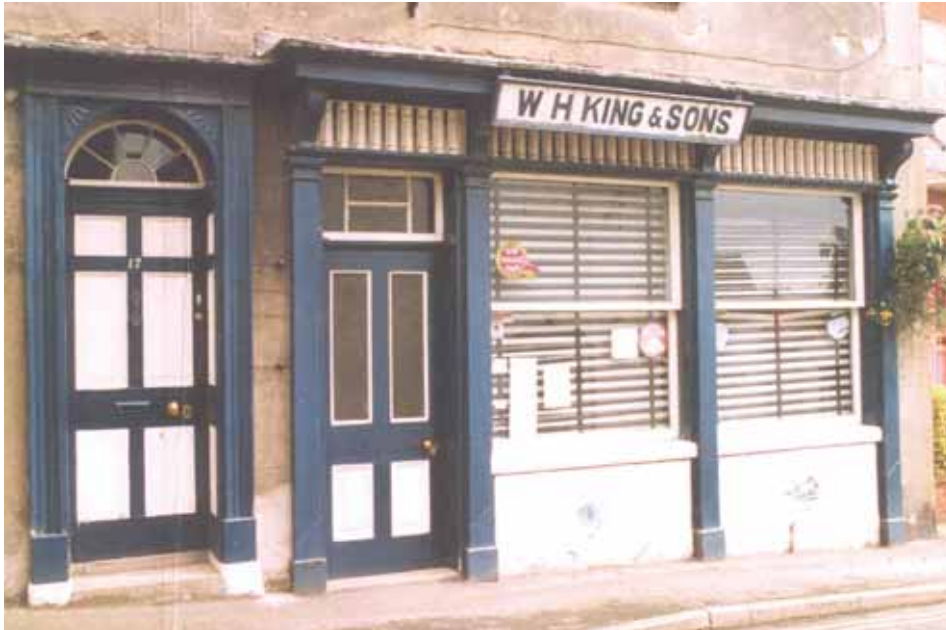
[2] Butcher's shopfront - South Street

- There are many original and particularly fine shop fronts. Examples from different eras and design are found in and around the town centre adding charm and character. It is unusual to see so many early shop fronts within one settlement and they are an important reminder to Caistor's past prosperity.<sup>[2]</sup>
- Caistor has a superb collection of door surrounds in the classical style. Their style reflects national trends in architecture, which were copied from Builder's Pattern Books, produced from about 1735 onwards.<sup>[3]</sup>
- Window head detail is also of a high quality in the town, and is another distinctive architectural feature which should be preserved.

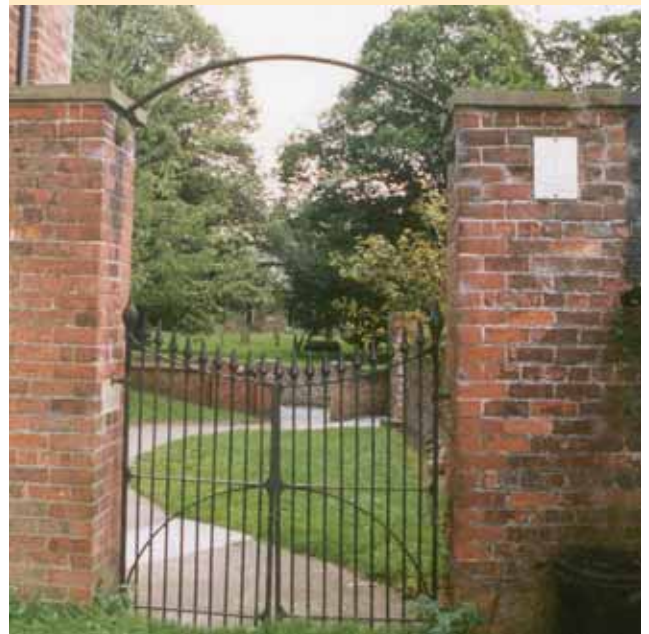
[4] Example of decorative ironwork

- Decorative ironwork - A notable example is the listed town pump in the Market Place, cast in 1897 to mark Queen Victoria's Silver Jubilee. Additionally there are several examples of decorative iron railings and boot scrapers.<sup>[4]</sup>

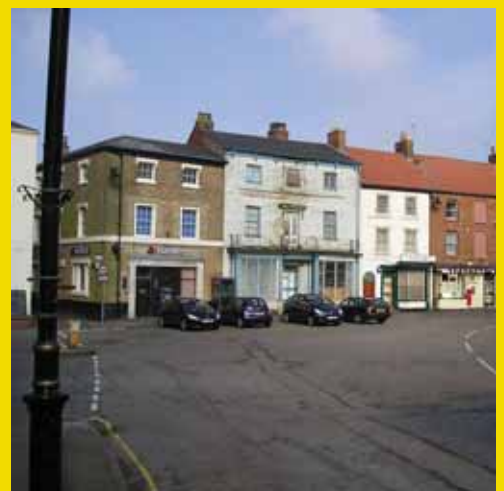
[5] View to the west of the Market Place

The Town Hall building forms an effective and decorative view stop to the north of Market Place, on High Street with the former Red Lion Hotel as an important corner building to the entrance of the Market Place. To the West, leading towards this view stop there is a strong building frontage of three storey buildings, punctuated by a small single track entrance into Bank Lane.<sup>[5]</sup>

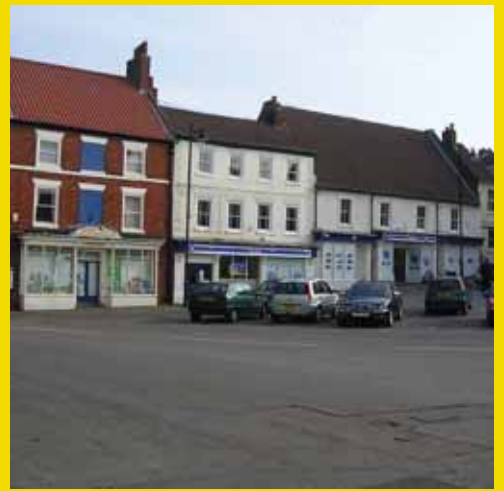
[6] View to the north of the Market Place

The northern boundary of the Market Place is enclosed by 17<sup>th</sup> and 18<sup>th</sup> century buildings, which now form retail units. These are much altered with modern shop fronts and concrete tiled roofs. Only no. 1 retains its original features.<sup>[6]</sup>

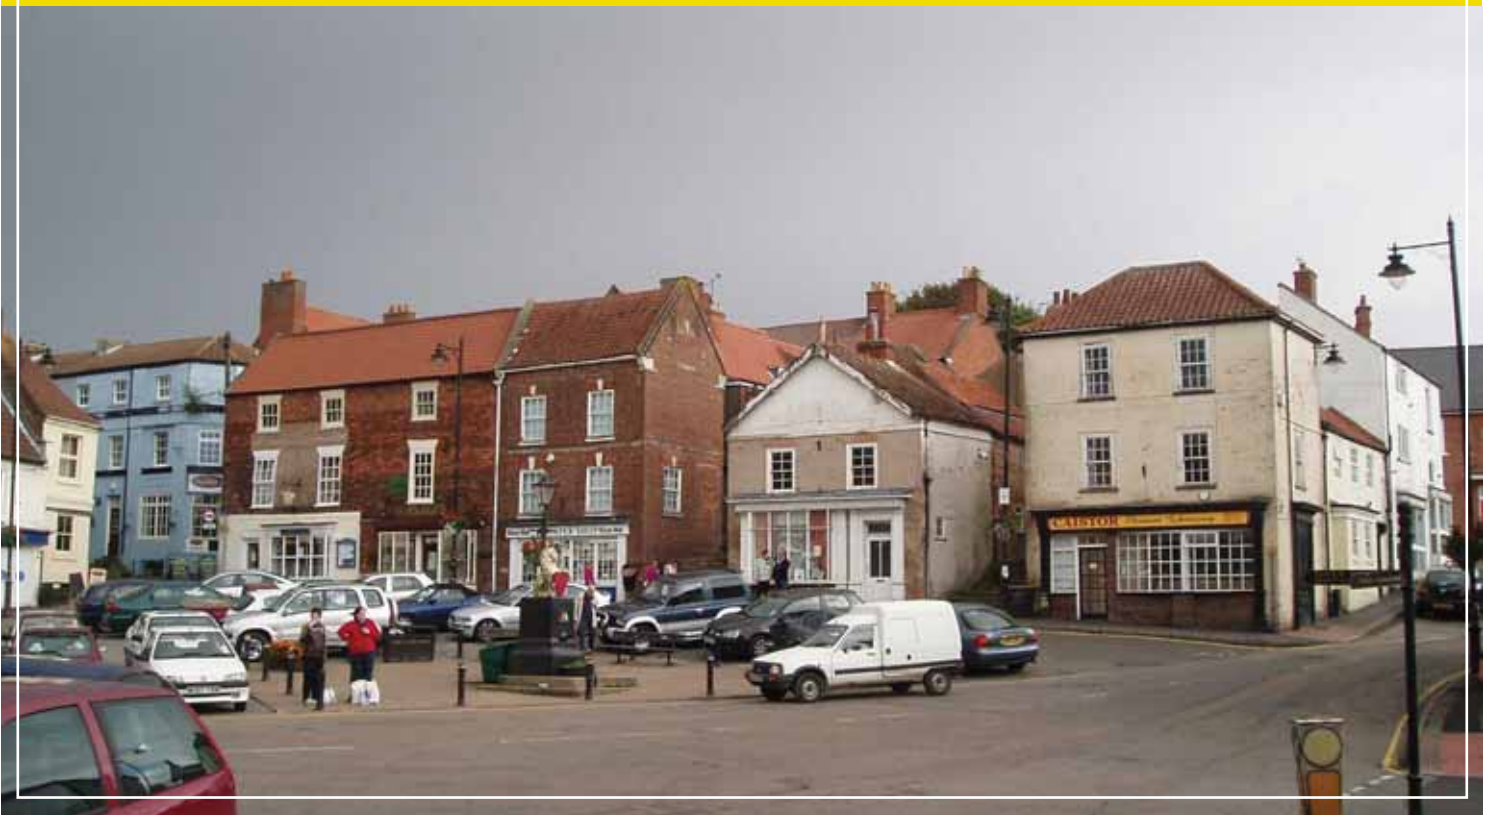
[7] View to the east of the Market Place

To the east, no. 11 is one of the few buildings with a gable fronting the market place, however, a photograph of 1910 shows that this was originally a three-storey building with a roofline reversed to match its neighbours. This alteration detracts

from the building line and is a weak element.<sup>[7]</sup> The south of the Market Place is more open with two major junctions reducing the sense of enclosure. The South Street junction leads directly on to the Buttermarket, as an open area.

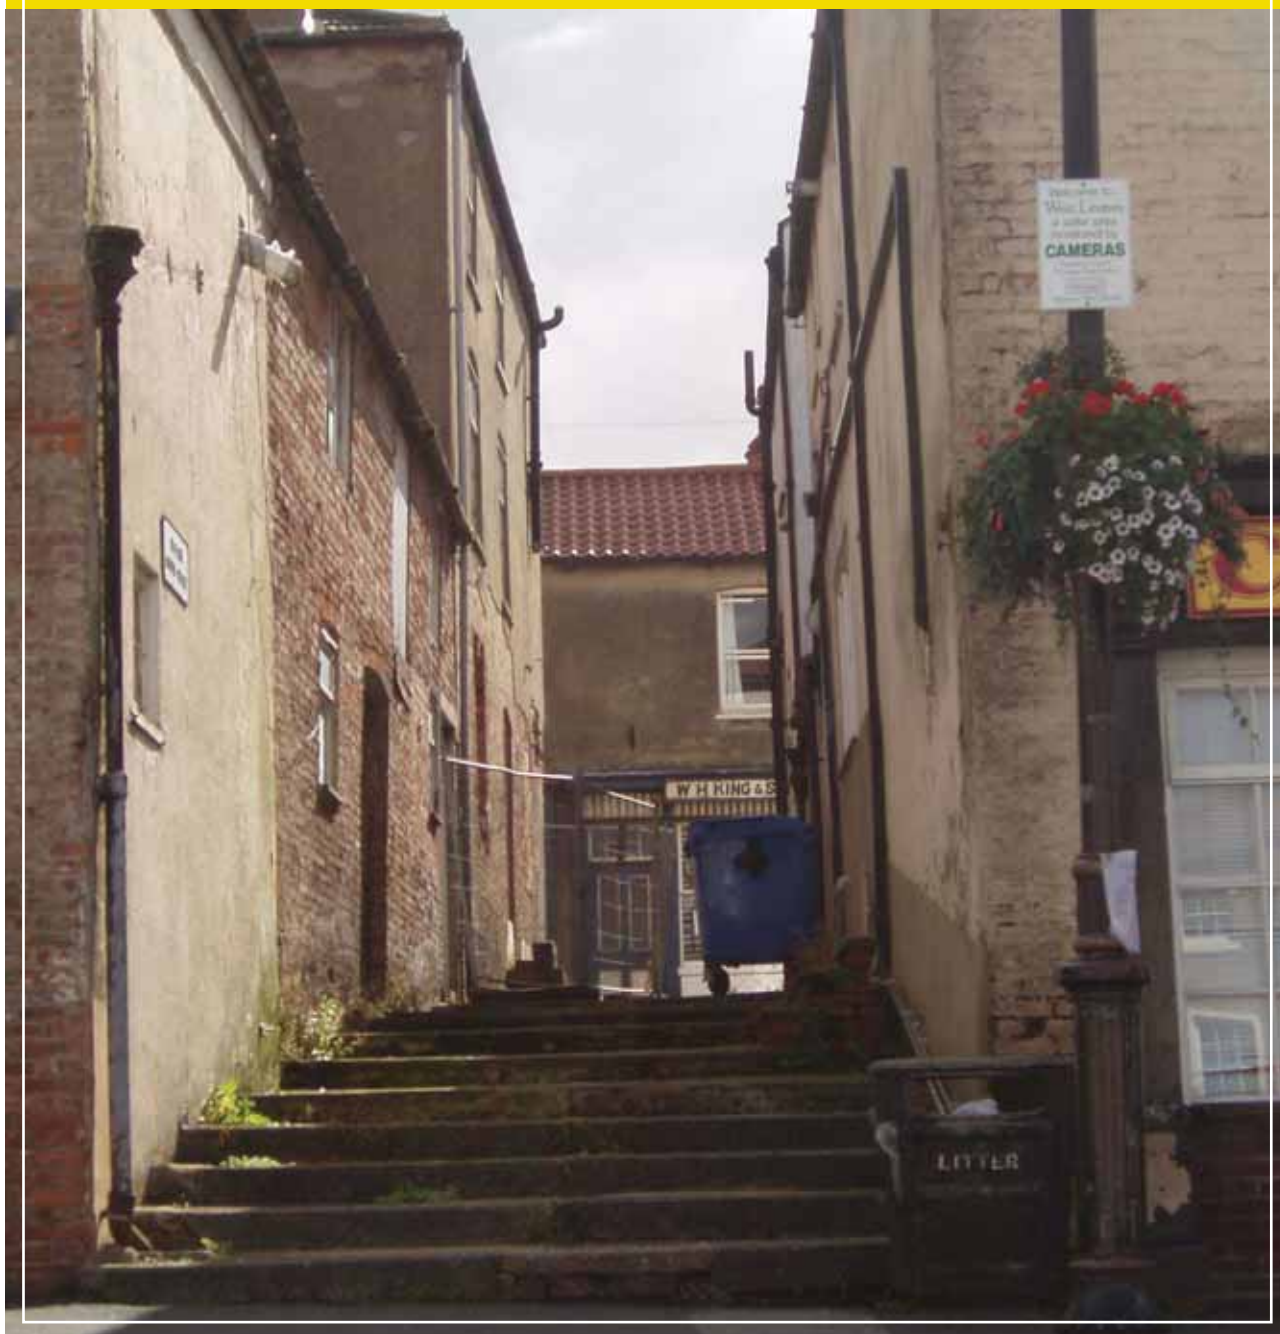
[8] Steps leading from the Market Place to South Street

There has been some erosion of character in the Market Place due to the installation of incongruous modern shop fronts into historic facades. A portion of the roofscape has been altered by the use of concrete pantiles. The use of corporate

signage and replacement windows has also detracted from Caistor's individuality. The stepped passageways leading to South Street from the Market Place are also of poor quality and a number of buildings in this area are in a state of dilapidation.<sup>[8]</sup>

Caistor has little in the way of original street surfaces. One of the sets of steps which lead from the Market Place to South Street are the only known survivors of York stone paving. Most street surfaces are of a poor quality and could be improved with a sensitive scheme.

- Consider rationalising highway signage in the Conservation Area.
- As noted above, the quality of street surfaces could be improved.

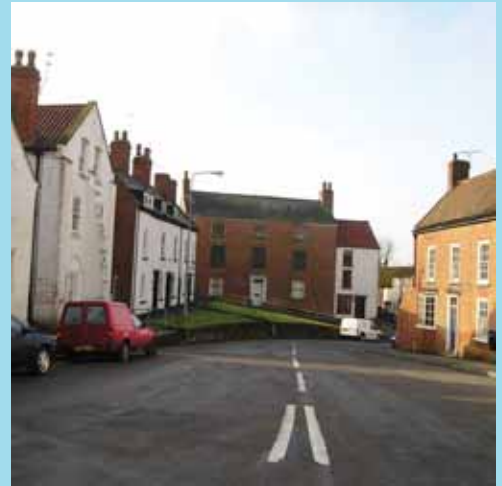
[9] View to Plough Hill showing grass bank

Plough Hill is a wide street that leads from the southern Market Place and connects via a steep hill to the Horse market. A deflected view from the Market Place is aided effectively by the grassed 'L'-shaped embankment following the curve of the sharp bend into Plough Hill topped by nos 1, 3, 5 and 7 Plough Hill which sit to the back of the steeply grassed bank.<sup>[9]</sup>

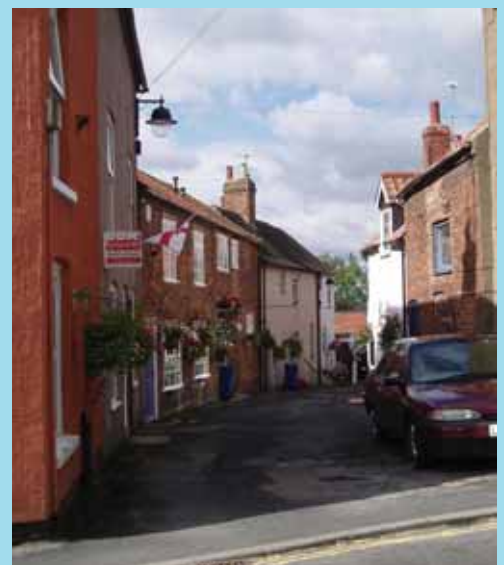
[10] Bob's Lane

Bobs Lane is an interconnecting pedestrian lane between Plough Hill and South Street. Many smaller red brick buildings, some of them outbuildings, exist here. Most now have seriously eroded character having suffered from many alterations over the last 30 years. Modern materials and incorrectly styled details have been used, especially windows. The street surface is poor for a historic pedestrian lane.<sup>[10]</sup>

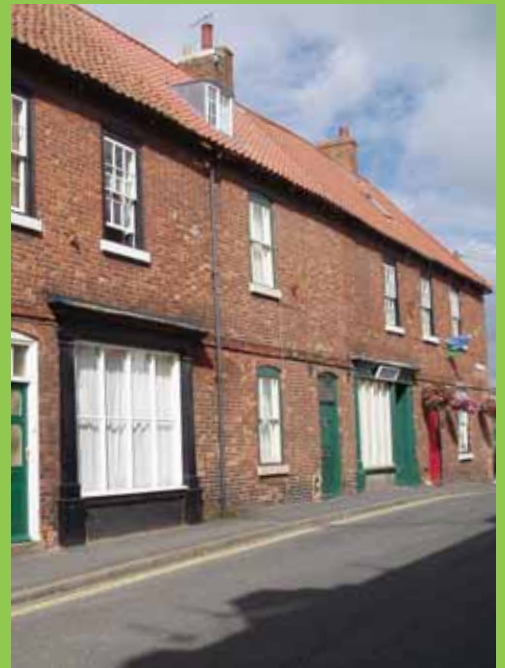
[11] South Street

South Street is a long curving narrow road interspersed with two squares, the Butter Market and the Cornhill. The remainder of the street is almost continuously lined with Georgian buildings closely built up to the back of pavement, giving a strong feeling of containment. The buildings are a mixture of two and three storey developments. <sup>[11 and 12]</sup>

South Street, beyond the White Hart/ Butter Market has suffered some loss of character with poorly altered shop fronts that are now redundant. Satellite dishes and plastic windows are also a problem at both ends of the street.

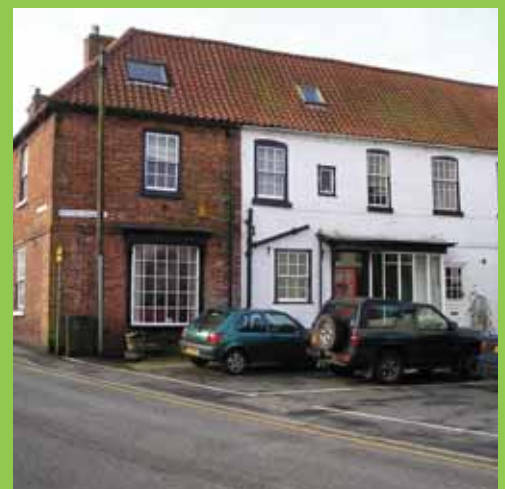
[13] View into the Buttermarket

The Butter Market is likely to have been created by historic encroachment on the south-eastern corner of the original Market Square. This is a small square, enclosed on three sides, that is dissected in a similar fashion to the Market Place. <sup>[13]</sup>

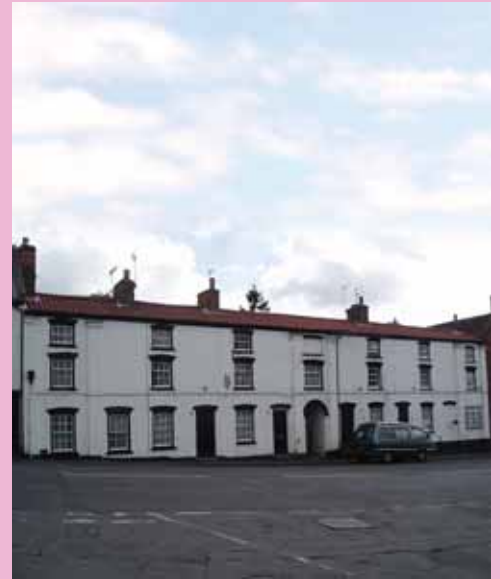
[14] Nos 1 - 11 Horsemarket

The Horsemarket is a set in a hollow, probably created by quarrying during the Roman period, where a wide space between buildings denotes the space once used for the famous fairs held at Caistor. There are small, relatively humble two storey dwellings to the west of Horsemarket some of which have suffered loss of historic joinery details. The eastern side is dominated by the elegant three storey façade of the late Georgian terrace known as no's 1 -11 Horsemarket with giant pilasters and a central carriage arch.<sup>[14]</sup>

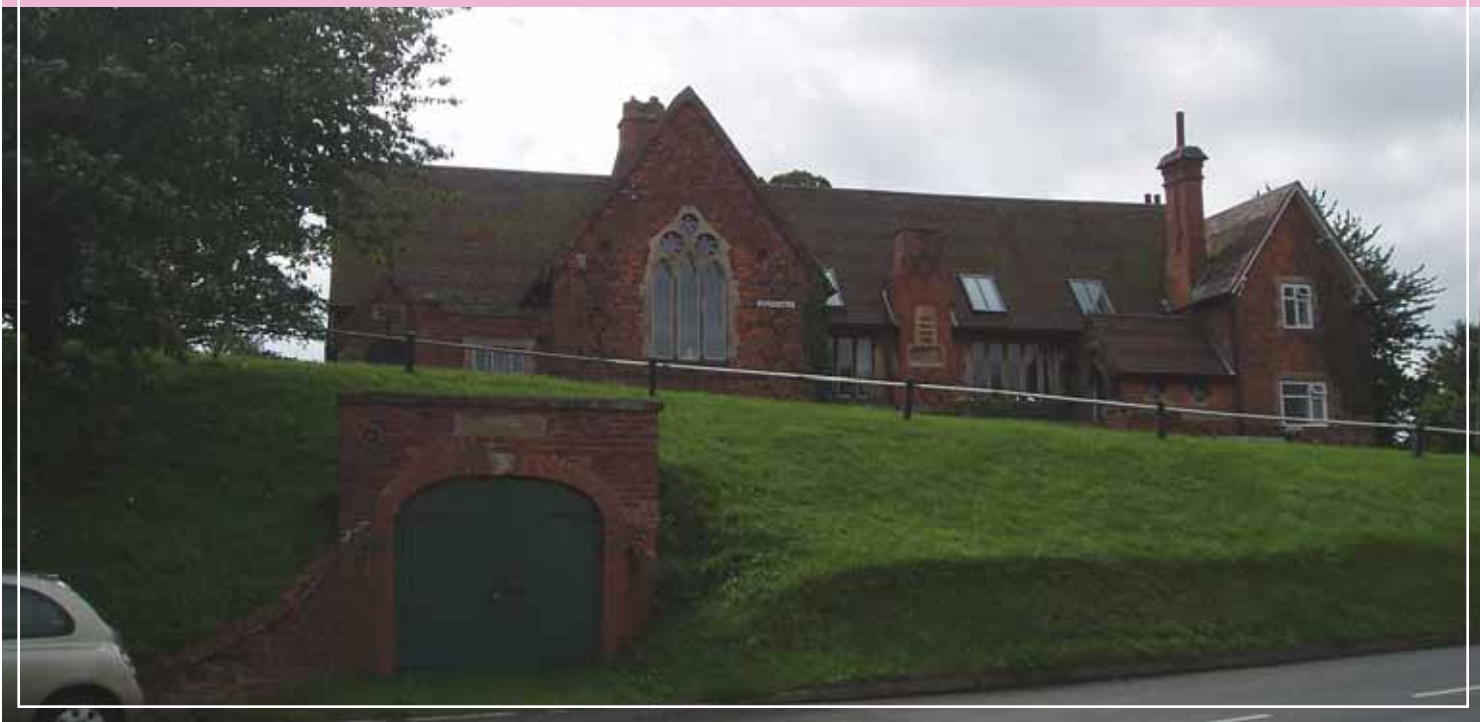
The southern end of Horsemarket is effectively contained by a steep grass bank. The Old Fire Station constructed in 1869 is unusually built in the form of a tunnel into

the hillside with Pigeon Spring just to the left. The Victorian School House above the elevated bank provides a view stop.<sup>[15]</sup>

[15] Southern end of Horsemarket showing schoolhouse above the elevated bank which provides a viewstop

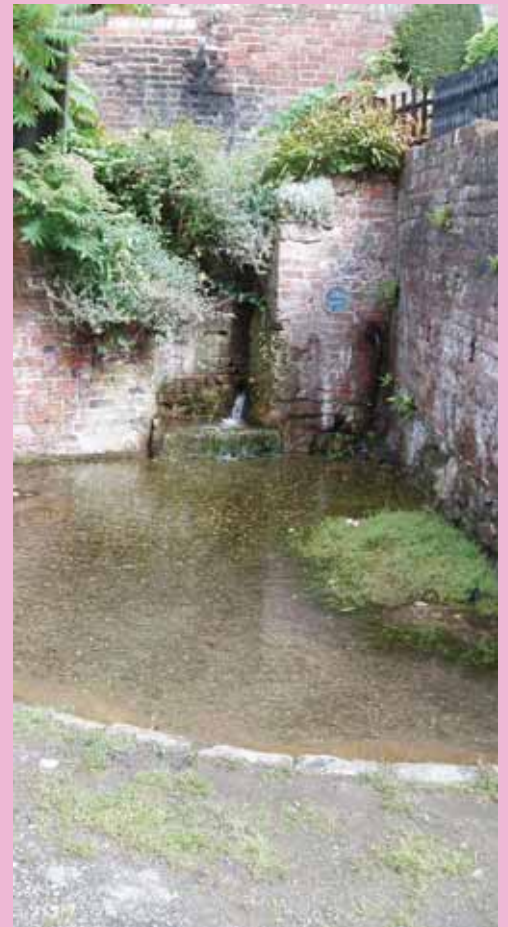
[16] Syfer Spring a natural water source

Fountain Street leads from the Horsemarket, at the bottom of Plough Hill. This narrow lane is bounded by mainly whitewashed brick buildings to the south. The northern side has individual buildings sited up on a high banking and has a more open character. Many of these buildings have historic origin but are generally now heavily disguised by more modern interventions. Both the Syfer Spring and Fountain Springs are sited close together in this street.<sup>[16]</sup> The greenery of the churchyard area is clearly viewed from the top of Fountain Street.

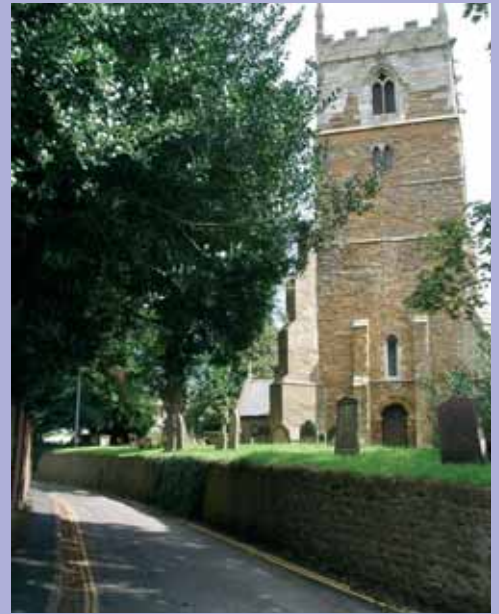
[17] St Peters and Paul's Church showing the raised green

Church Square is on a raised green enclosed by a stone retaining wall. The collections of tall mature trees within the grounds are a key element of the character of the area.<sup>[17]</sup> The area around the church is a large roughly squared space given a distinct sense of enclosure by the grammar school buildings and its associated buildings. Much of the interest in this part of the Conservation Area is to be found in the detailing of the different boundary treatments, including tall red brick walls and low boundary wall treatments often topped with railings or hedges.

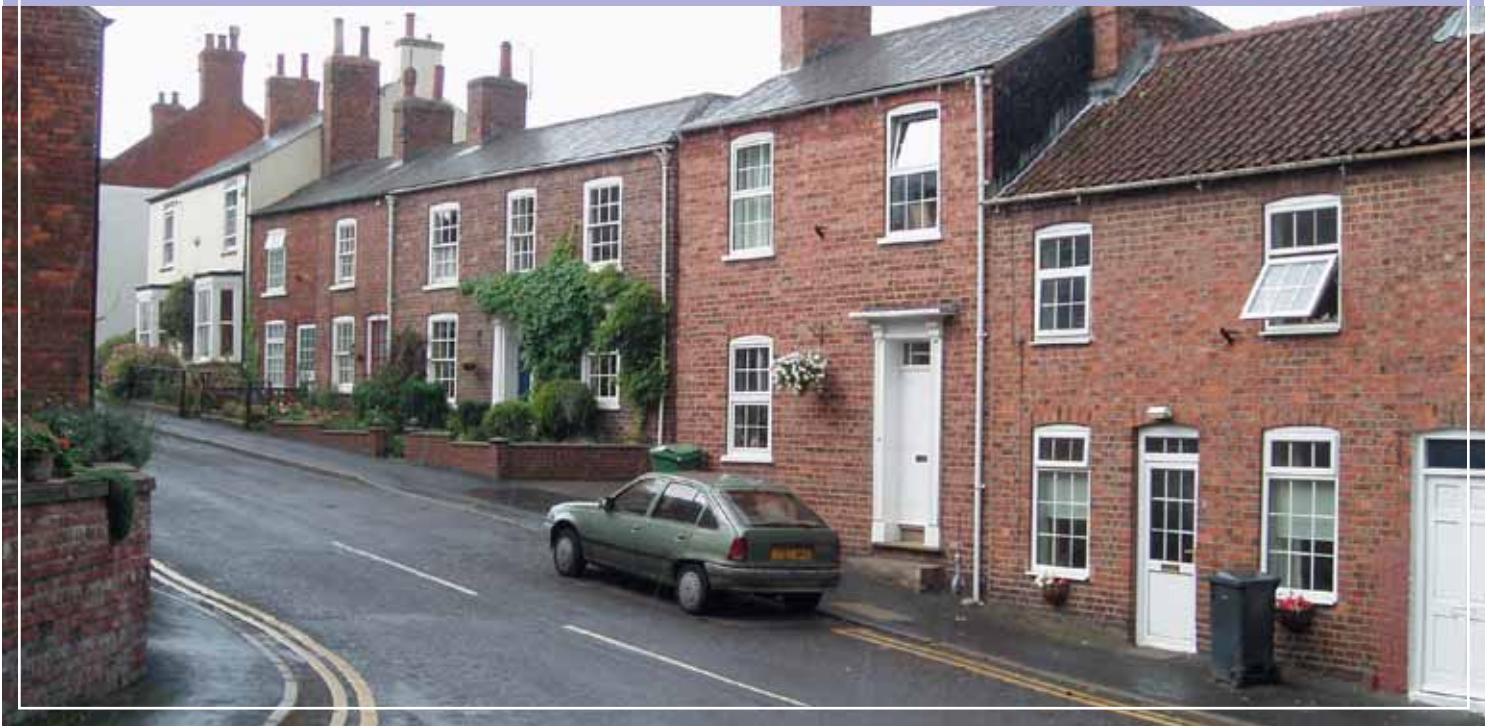
[18] Chapel Street, fine examples of brick built terraces

Architecturally there is a combination of fine examples of brick town housing in terraces or as neatly spaced buildings. Private front gardens contribute to the sense of open space.<sup>[18]</sup>

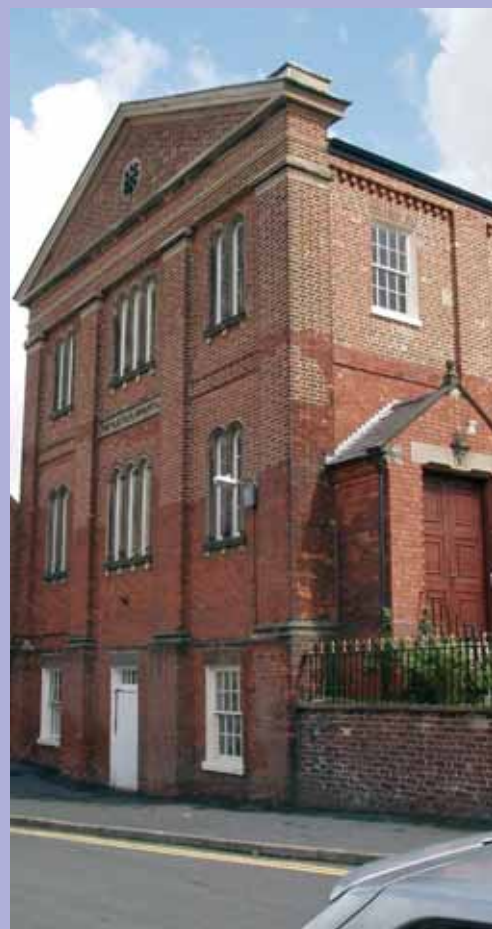
[19] Chapel Street, fine examples of brick built terraces

Chapel Street is dominated by the large Italianate Chapel of 1841, which placed on a slightly elevated site, dominates the street being of a much larger scale than anything around it <sup>[19]</sup>. A building belonging to the Grammar School is sited in Castle Hill. This building has a very poorly altered elevation facing directly into the street which detracts from this area of Caistor. There are some 20<sup>th</sup> century developments, but these are considered to be neutral elements in the conservation area, and have been softened by the retention of trees to the front boundary.

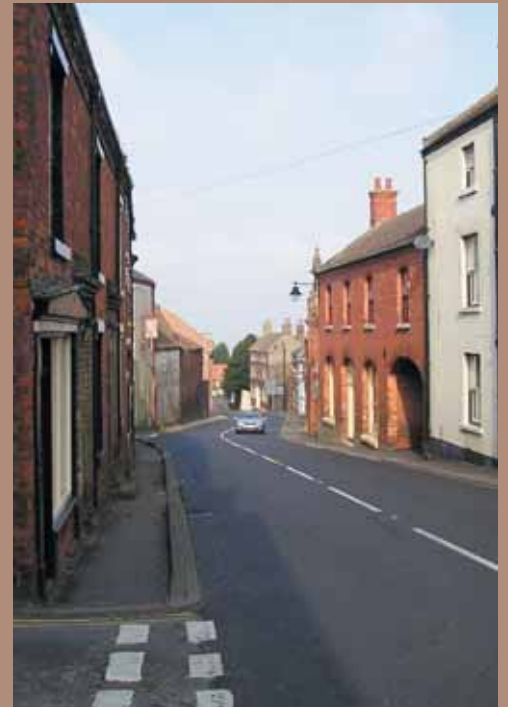
[20] View into the High Street

The High Street is lined with buildings of differing periods from the early 18<sup>th</sup> to the early 20<sup>th</sup> century, primarily constructed from red brick with pantile roofs.<sup>[20]</sup> There are some small shop fronts, many of which are presently empty and in poor repair. At either end of the High Street are two fine examples of 18<sup>th</sup> and early 19<sup>th</sup> century buildings; at the western end Holly House with steps up to its fine door surround whilst to the east is Tower House. At the junction with the Market Place, the Red Lion, a former coaching inn and public house has a distinctive curved corner which forms an important feature in the High Street.

Neglected buildings in the High Street jointly contribute to a strong sense of

detraction in terms of streetscape quality.

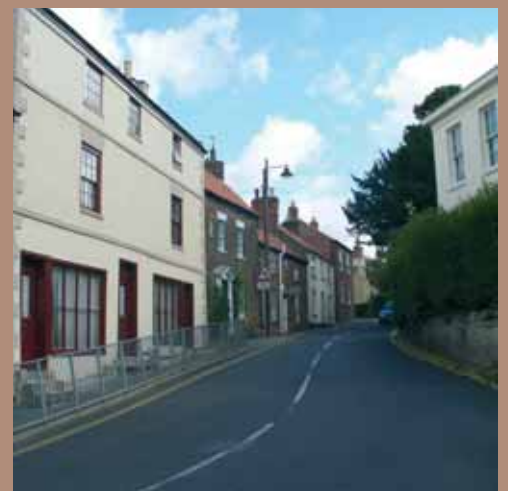
Grimsby Road continues with back edge of pavement development on its north side with mainly listed buildings. No's 3-5, have two replica shop fronts installed. Recent pedestrian safety barriers have been installed immediately to the front of this building, which detracts from the setting.<sup>[21]</sup>

[21] View up Grimsby Road showing typical back edge of pavement development

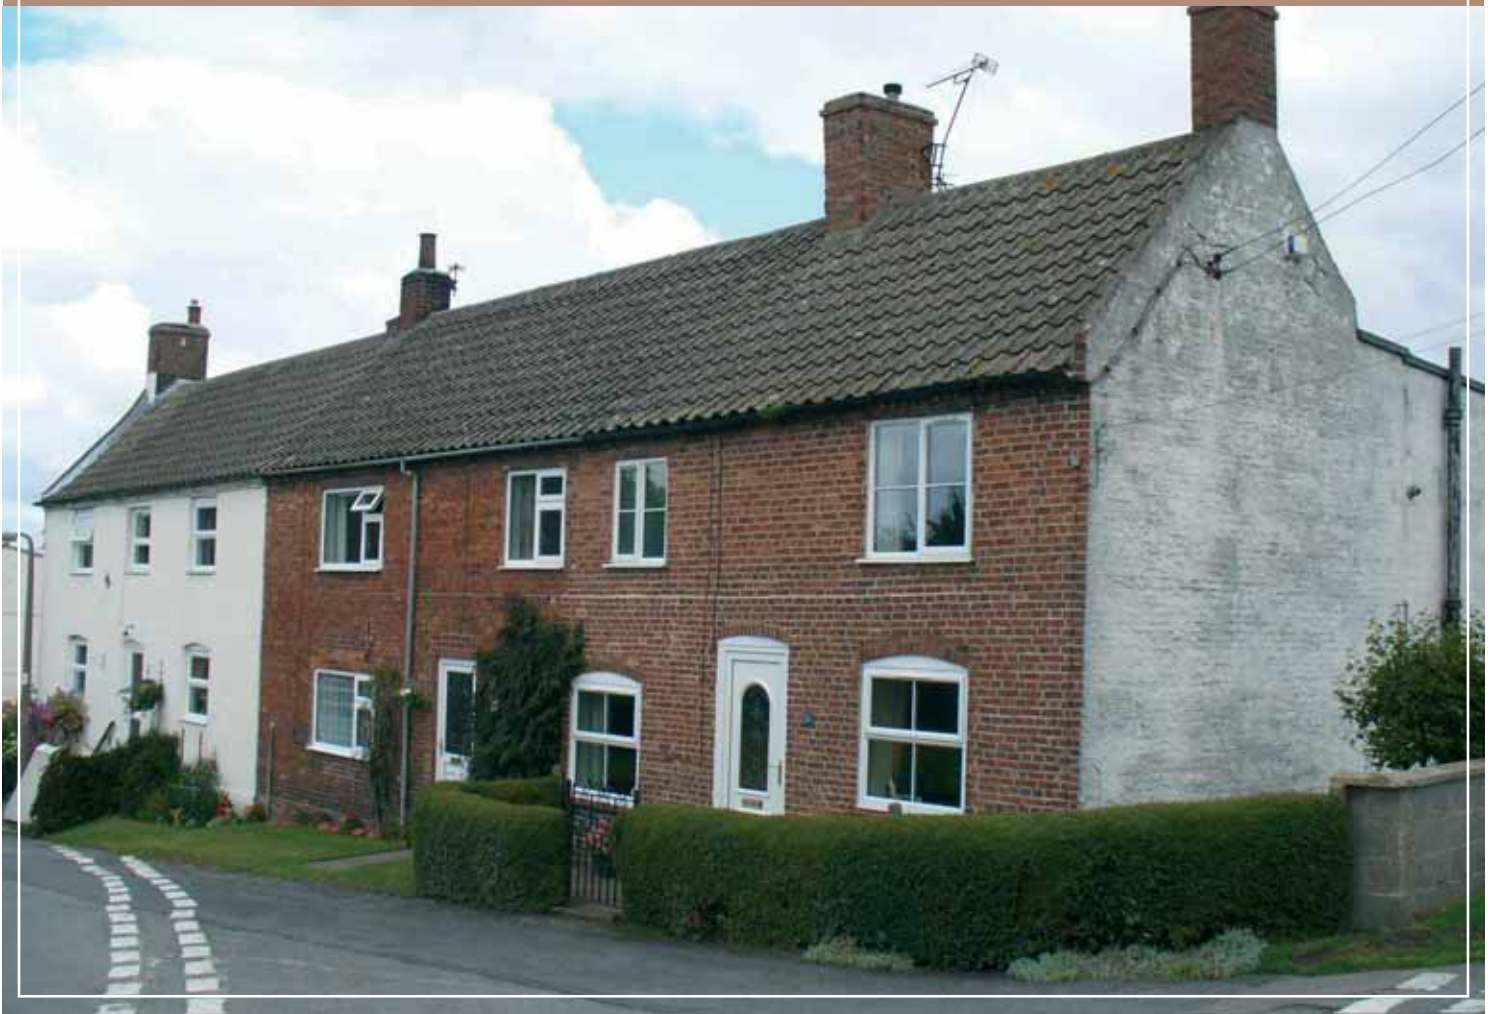
North Street runs on a steep incline and is approximately parallel with the High Street and Grimsby Road. This street has some modest 18<sup>th</sup> and 19<sup>th</sup> century terraces and cottages in pairs or groups of 3 <sup>[22]</sup>. Many of these have suffered from poor quality interventions and historic character has been eroded. As with other areas of Caistor, there

is a stepped appearance as the building line follows the topography. There are unsightly gaps in the frontage, notably on the south side of the street; however, a sense of enclosure is created by a long section of very tall walled garden belonging to the rear of Holly House. There are a number of modern bungalows on the street but their impact is minimal.

[22] North Street showing typically modest group of terraces

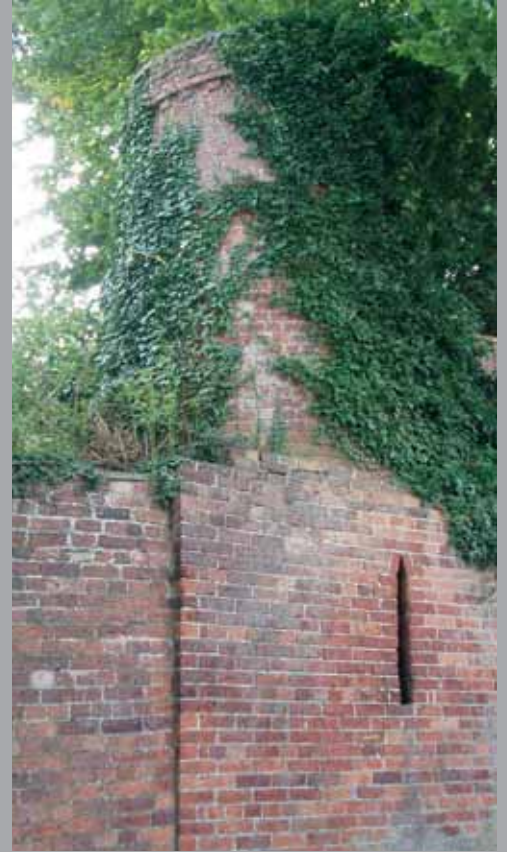
[23] The Tower,  
Mill Lane

Mill Lane is a narrow street that meanders over the hillside on the eastern boundary of the conservation area. The entrance is formed of tall flanking curved brick walls which form the boundary treatment to Tower House, and the wall of a castellated garden folly known as The Tower <sup>[23]</sup>. The road begins on a short steep incline, levelling out to give views over the pantile roof tops of Caistor and the back gardens of South Street. Many of these show clearly the long thin plots associated with the medieval burgage system of land division.

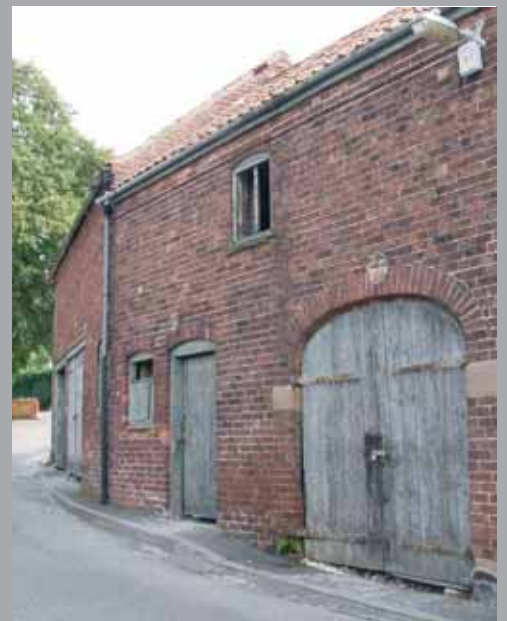
On both sides there are a variety of 19<sup>th</sup> century outbuildings which are unlisted but of historic merit <sup>[24]</sup> and also a Stonemasons yard lining the left side of Mill Lane. The southern end of Mill Lane travels downhill to meet with South Street. No.11 Mill Lane is small red brick traditional 3 bay fronted house with its gable end to the street. Beyond is the private garden space stretching down to meet the play area at the edge of the conservation area boundary.

[24] 19<sup>th</sup>  
Century  
outbuildings
