*The Gardens of the
National Palace of Queluz
Conservation Intervention*

The Gardens of the National Palace of Queluz: Conservation Intervention

© 2012 Associação World Monuments Fund Portugal and World Monuments Fund

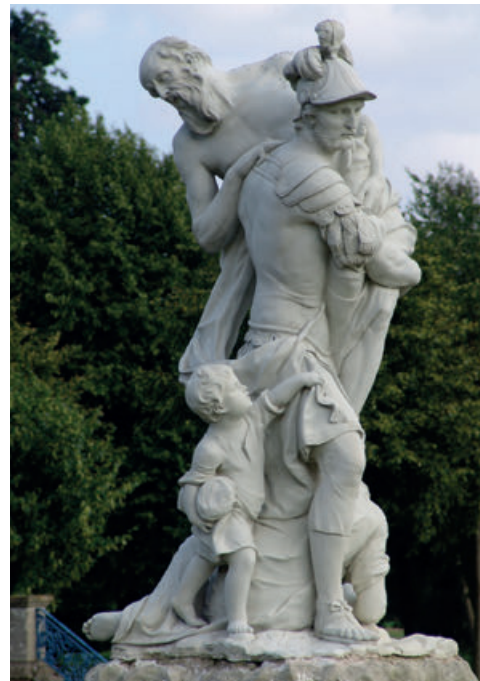
Figure 1. An example of Cheere's *Aeneas and Anchises* at Wrest Park (English Heritage), whose paint has been restored to its original finish to resemble stone.

Weaver’s opinion is still held by many today, and the natural patina of untreated lead is prized. Though the practice of restoring original surface treatment such as the lead groups at Wrest Park, which have been repainted in their original finish to resemble white stone (Figure 1), is acceptable to the modern eye, the polychroming of, for example, the rustic figures is harder for us to accept, particularly when the paint is freshly maintained and unweathered. Though mid-nineteenth-century awareness of historic polychrome liberated sculptors of the time (Luke 1996), it seems not to be a fact that is readily remembered or celebrated, and responses ranging from fascination to discomfort to outright horror have been noted to the recent examinations of the original polychrome exteriors of medieval cathedrals and of classical sculptures themselves, as researched by Prof. Dr. Vinzenz Brinkmann for example, and displayed in a touring exhibition (Brinkmann and Scholl, 2010). One might term this reaction “the shock of the old;” however there are subtle ways to approach the restoration of coloring that would perhaps more accurately reflect the appearance original

Several parts of this sculpture were found to be missing or damaged beyond repair. Molds were taken from another Cheere cast of the sculpture at Wrest Park, (Figure 1), with the kind permission of English Heritage, and the missing pieces were cast in lead and attached to the sculpture. Damaged areas were then repaired by lead-burning and a new stain-

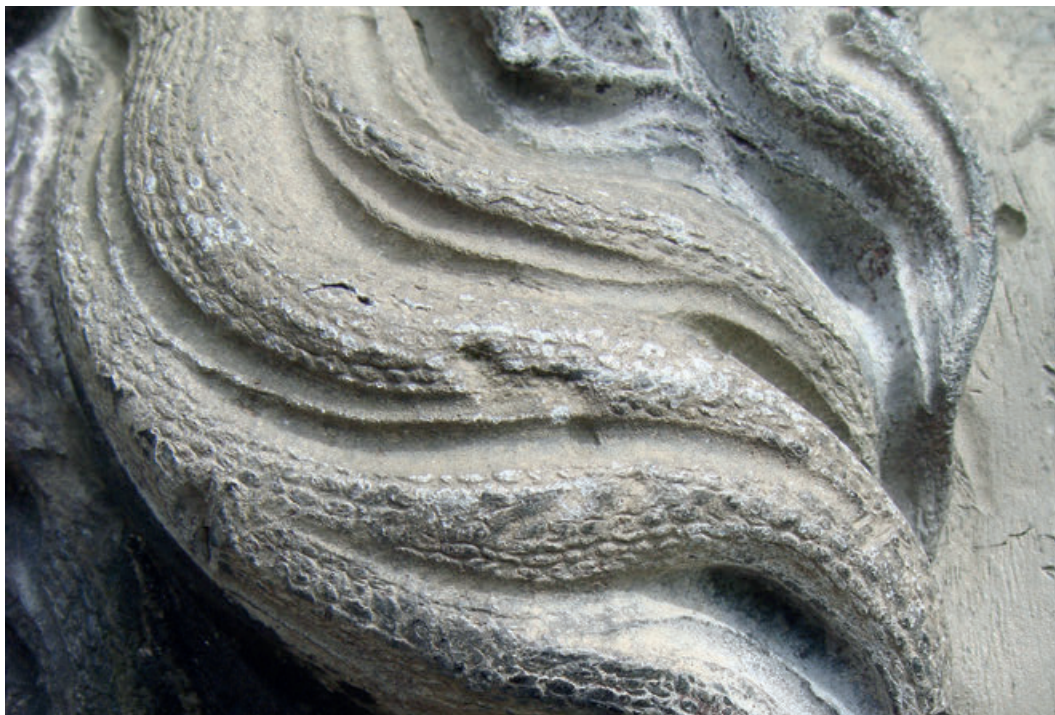
Figure 4. Example of Cheere's typical chasing technique.

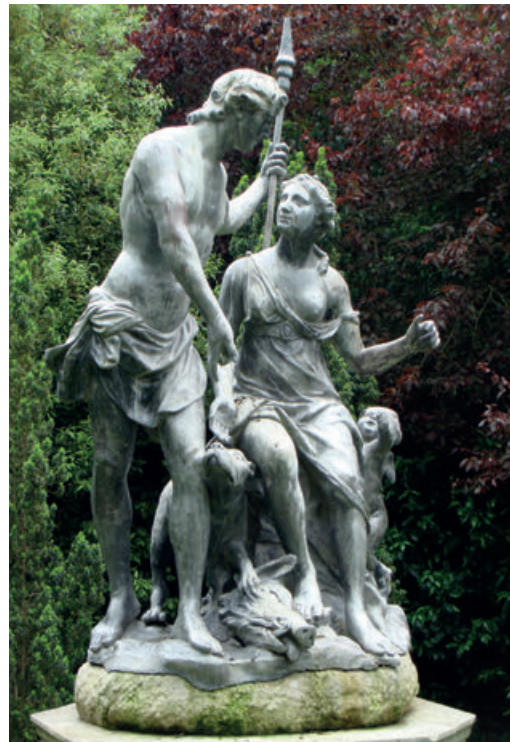
Figure 6. Natural patina on the same model as Queluz’s *Meleager and Atalanta* at Anglesey Abbey (National Trust), which is known there as *The Olympian Courtship*.

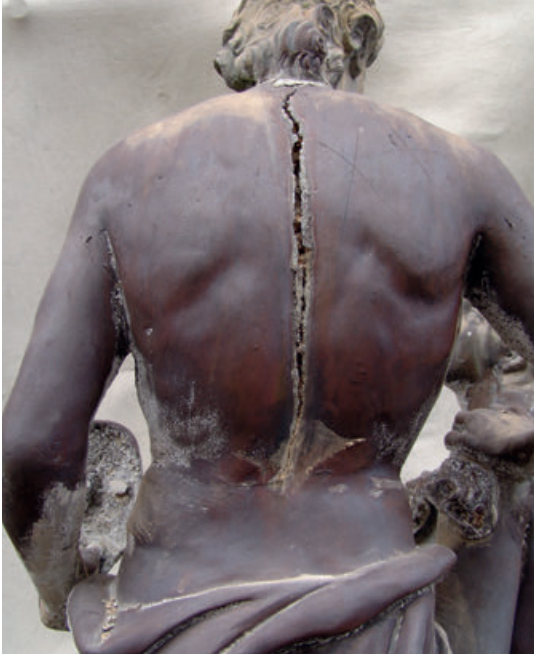
When we first examined the collection of Cheeres at Queluz in 2003, their condition was varied. Most had suffered from damage such as slumping and splitting caused by their failing, expanding iron armatures (Figure 7). Others had more dramatic physical damage such as suffered by *The Rape of Proserpine* (Figure 8), and *Venus and Adonis* (which had been struck by a falling tree branch, see Figure 2 in Chapter 9.2). Others, such as *Diana*, were missing attributes (Figure 9), though her quiver was held in storage at the palace, and some were missing parts, such as the drapery on *Aeneas*.

Figure 7. Crack in the back of *Vertumnus*, caused by expansion of internal iron armature.

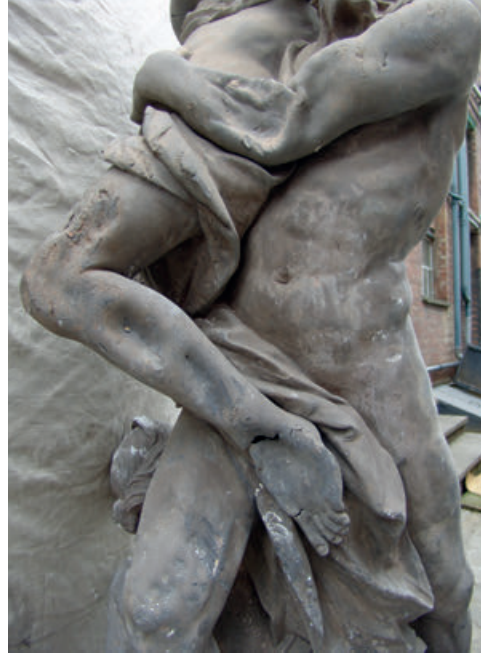
Figure 8. *The Rape of Proserpine*, showing severe distortion from impact damage suffered in the past.

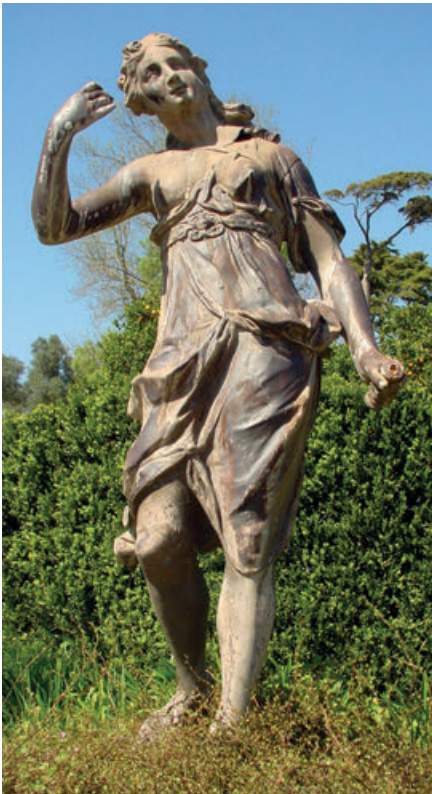
Figure 9. *Diana*, missing attributes of arrow and bow.

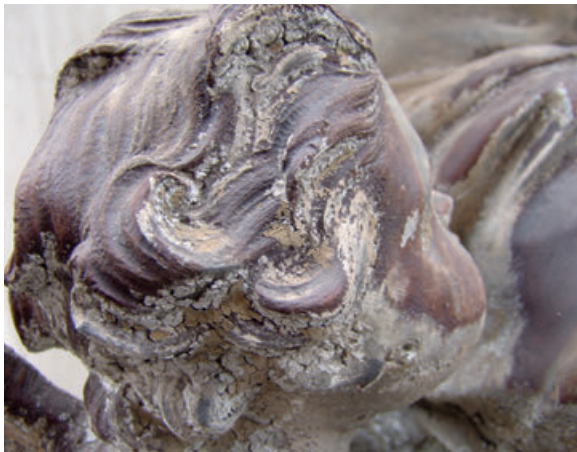
Figure 11. Remains of original paint on the putto of the *Vertumnus and Pomona* group.

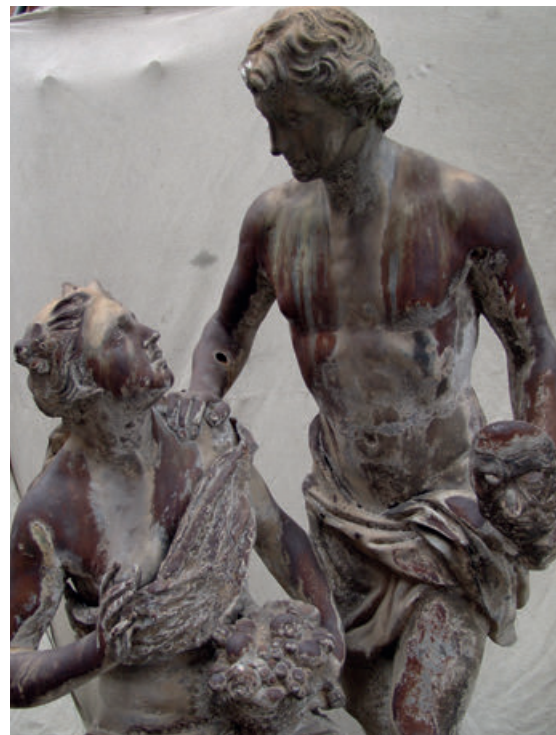
Where no original surface coatings exist, the naturally formed light to dark gray patina found on the leads was typical of that found on most lead sculpture exposed to the atmosphere, however many also exhibited a dark brown discoloration of their surface (lead dioxide formation), some in localized areas but others were heavily discolored (such as *Vertumnus and Pomona* and the Neptune Fountain). The presence of this discoloration was visually disruptive to the sculptural form of the compositions and, as such, it was considered undesirable on aesthetic grounds alone (Figure 12). Research into this phenomenon is in its

Figure 12. Intrusive dark brown discoloration on *Vertumno and Pomona*.

early stages; as part of this project a decision was made to carry out further research, which is dealt with in Chapter 6 of this publication.

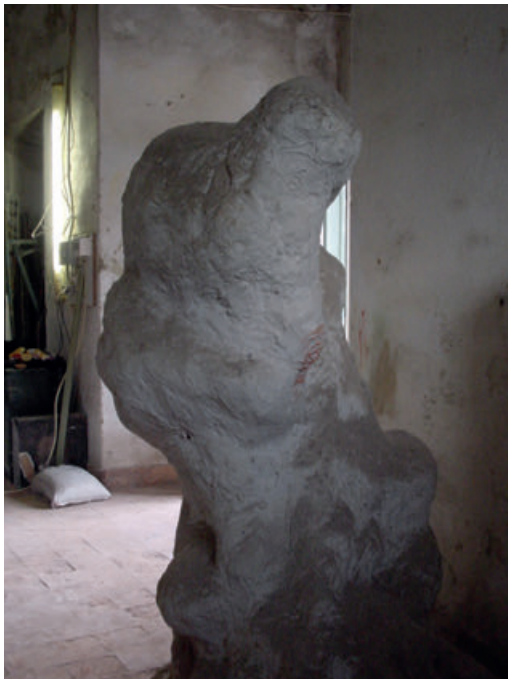
At the time of our first inspections, two of the sculpture groups were an unknown quantity, as at some time in the past they had been removed from the gardens into storage and covered in a mixture of plaster of Paris, horsehair, and supporting wooden battens (Figure 13), presumably in an attempt to stabilize them until restoration could be undertaken.

Figure 13. A figure group later revealed to be *Aeneas and Anchises*.

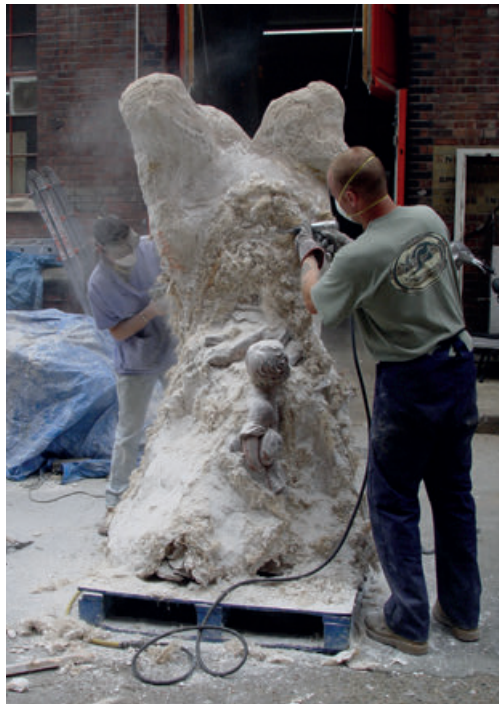
These two sculptures were the first to be treated at our studios in London where careful removal of the plaster covering revealed them to be life-size groups depicting *The Rape of Proserpine*, and *Aeneas and Anchises* (Figure 14).

Figure 14. Revealing *Aeneas and Anchises*.

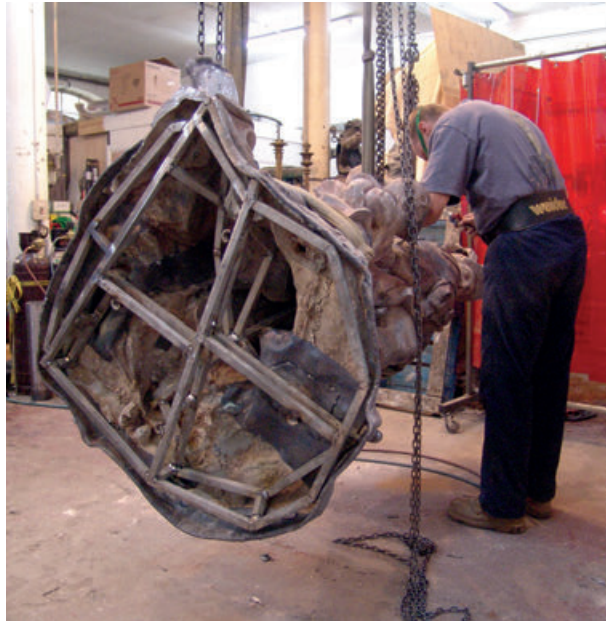
Figure 16. New stainless steel armature constructed to support the base.

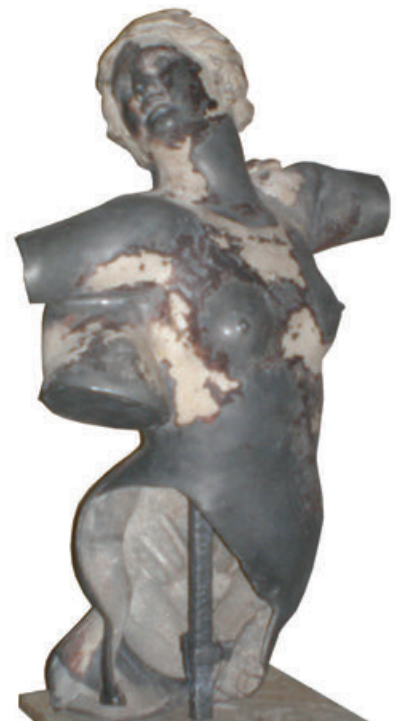
Figure 2. Remaining torso from the *Rape of the Sabines* group, exhibited in the interior of the palace.

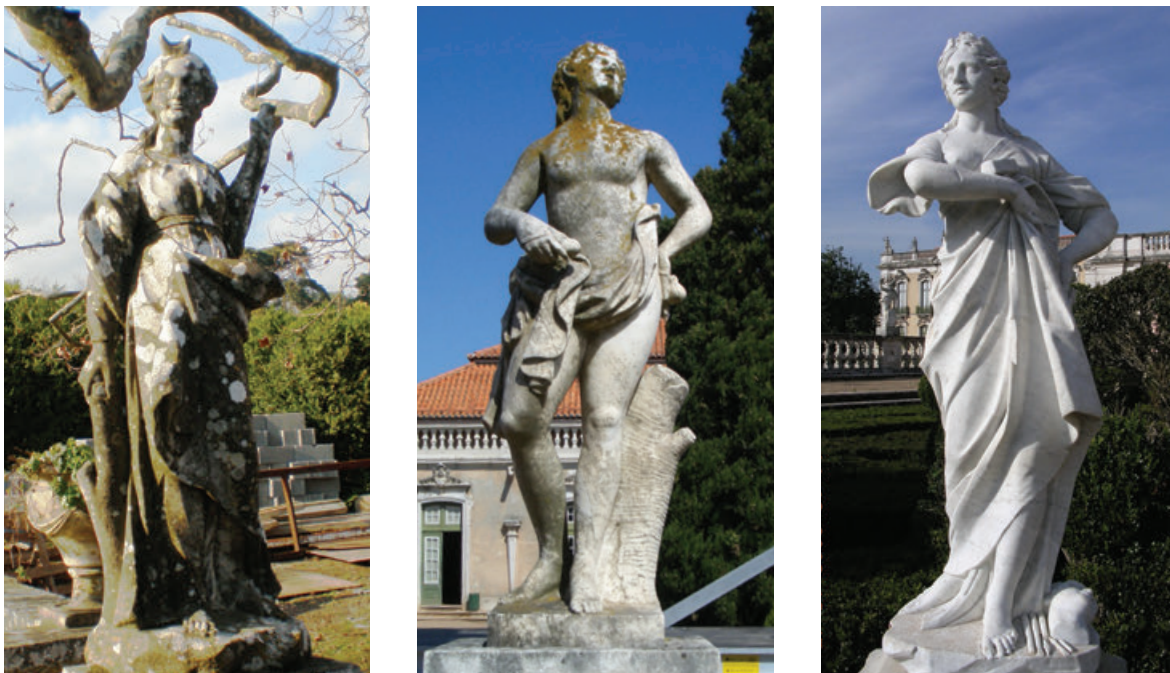
Figure 2. Statues presented various degrees of colonization or cleaning that reflected erratic maintenance.

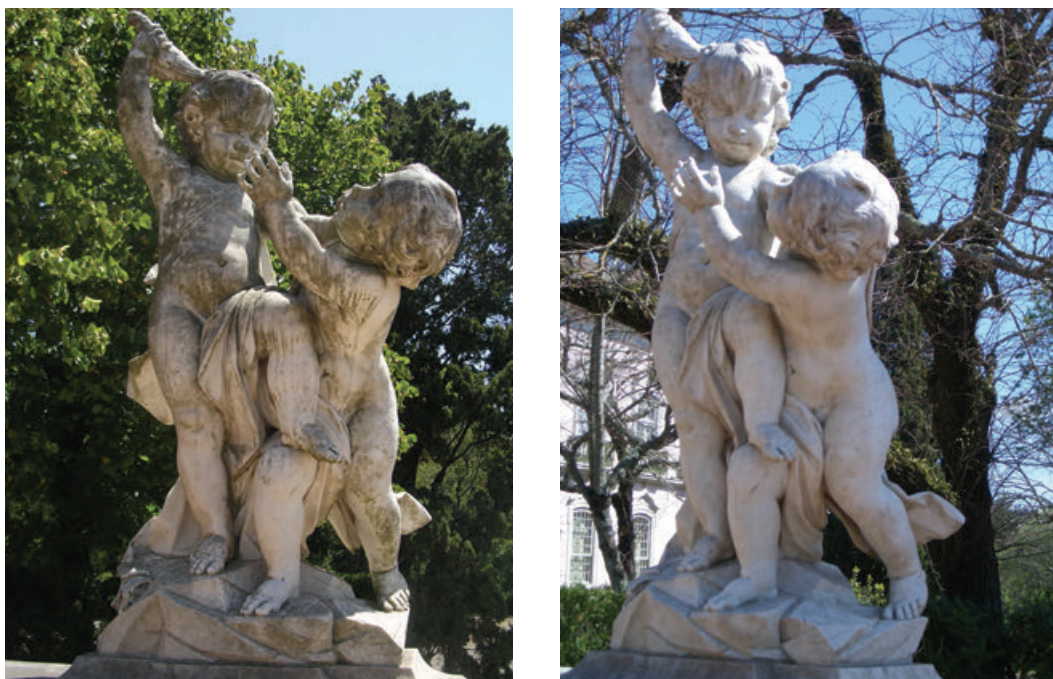
Figure 3. One of the putti groups that were treated during the workshops. Left: prior to treatment in September 2006. Right: six months later, March 2007. No mechanical removal was carried out.

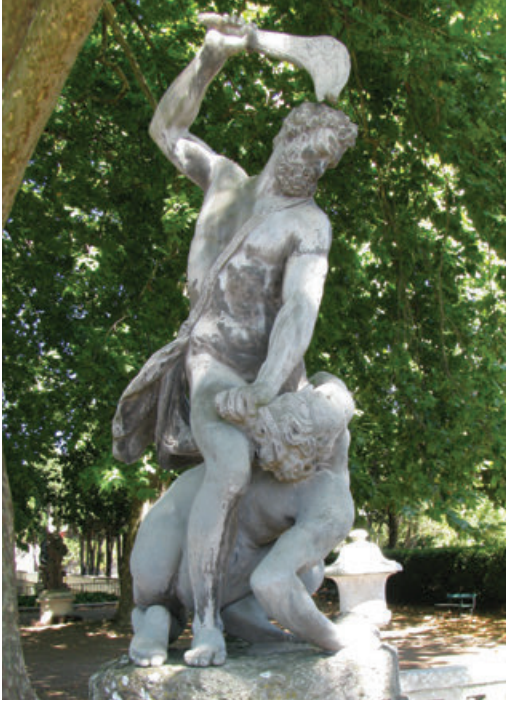
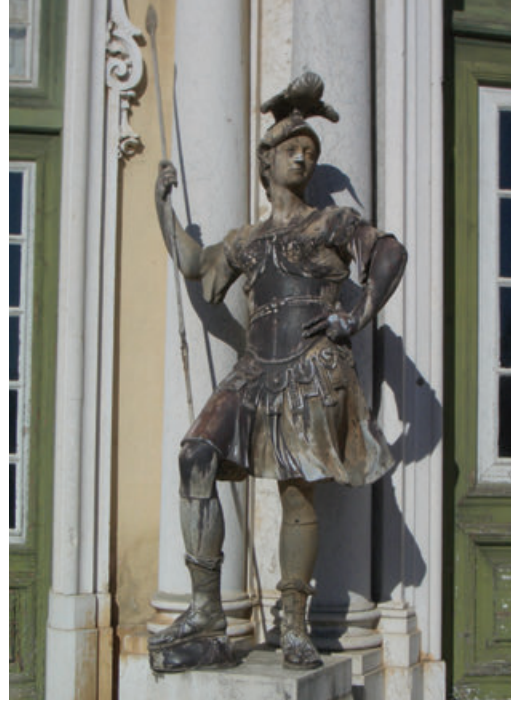
Figure 4. Lead sculptures in distinct visual conditions. Left: *Cain and Abel* group that still retains its gray appearance. Right: *Minerva* showing the black patina developed on the more exposed areas. This statue still retains traces of original paint.

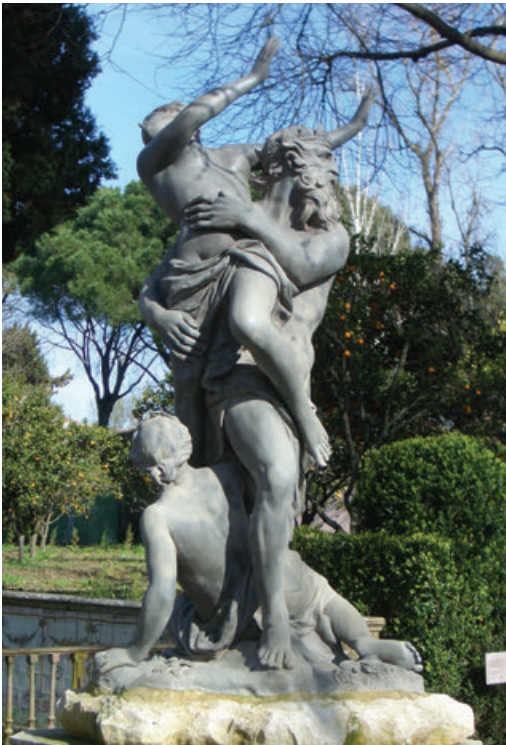
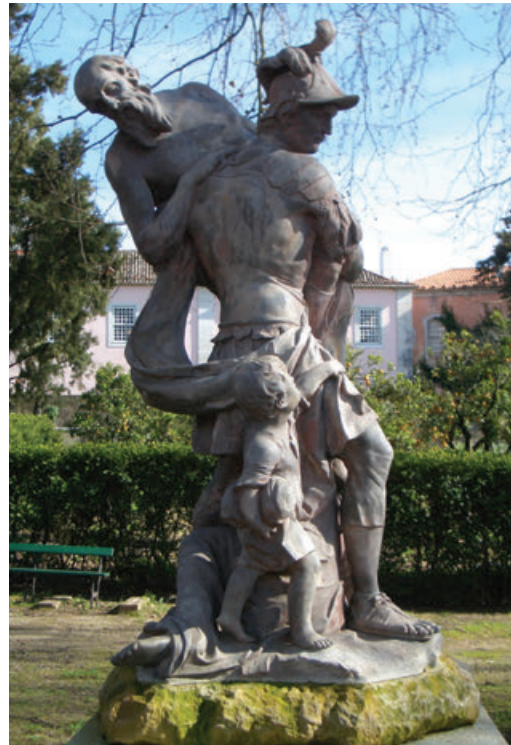
Figure 5. The two lead groups that were installed on the *Sycamore Plaza*. Left: *Rape of Proserpine*. Right: *Aeneas and Anchises*.

and *Aeneas and Anchises*. These were located in the Sycamore Plaza beyond the *Cain and Abel* group (Figure 5), as historical documentation indicated that the statues had been located there at some time in the past.

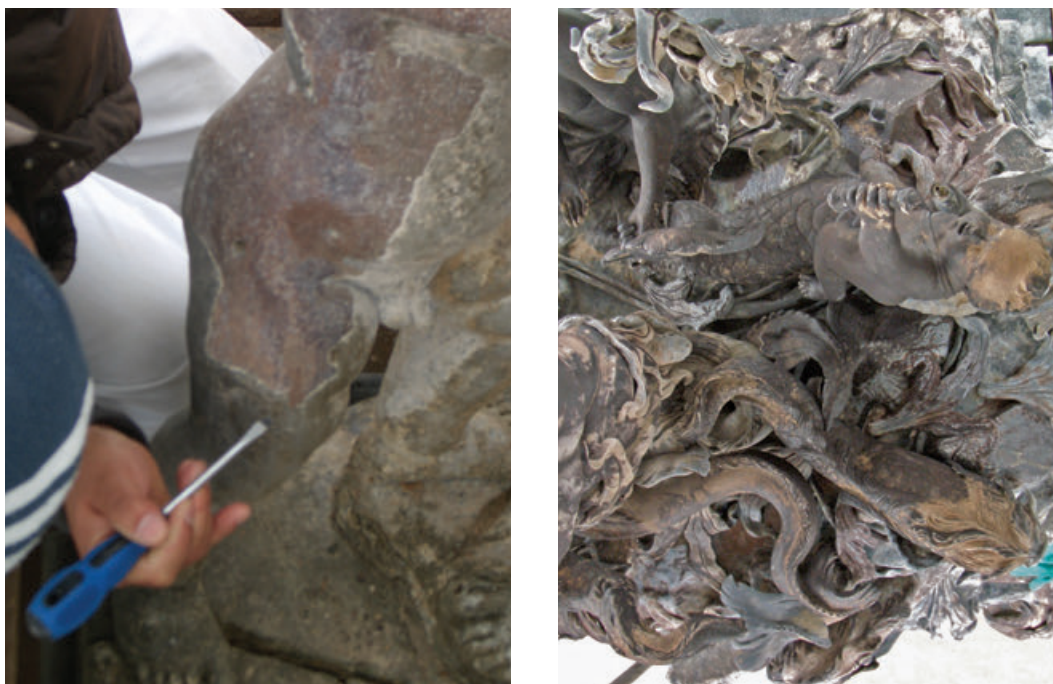
Figure 7. Concretions and patinas in the lead sculptures. Left: detail of the mechanical removal of the whitish concretion that covers the reddish patina formed on the dolphin of the Malta Fountain. Right: detail of the complex decoration of the central block of the Neptune Fountain showing the wide variation in color acquired by the lead surfaces, ranging from gray through reddish to nearly black areas, depending on the water flow over them, apart from the evident concretions on the most exposed parts.

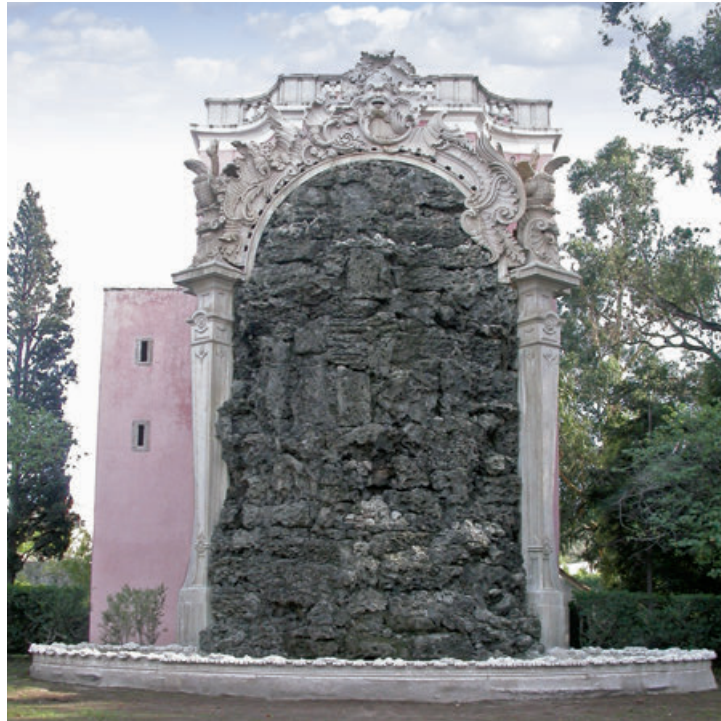
Figure 8. The Great Cascade after intervention. The water runs down the rugged stones that have been left with their acquired patina resulting from years of water circulation over them. Note that the basin has a thicker rim at its base that marks the level to which it should be buried.

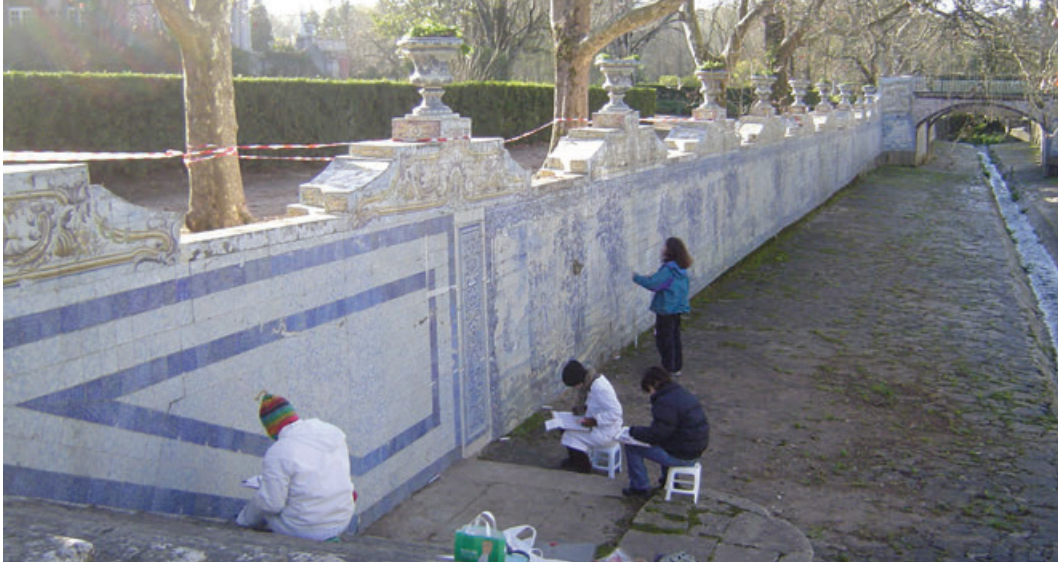
Figure 9. Condition survey of the canal. Note how close the sycamores were planted to the canal walls.

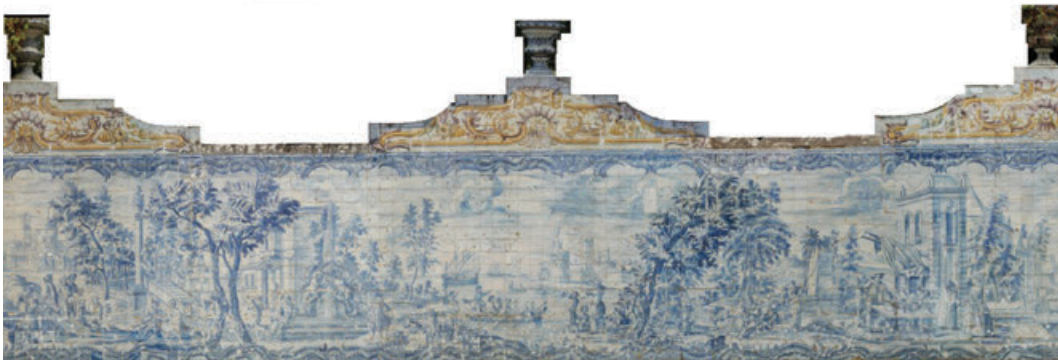
Figure 10a. Example of a section of the canal as photographically documented and superimposed on the digital laser scanning map.

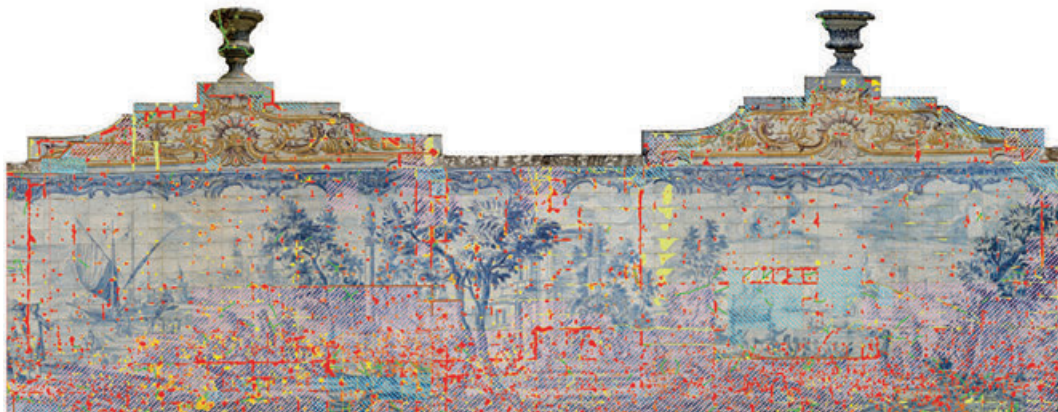
Figure 10b. Example of the condition survey of tiled canal. This survey was carried out on the maps obtained by laser scanning. Note that the major concentration of deterioration is found at the bottom of the panels, the sections that would be more frequently in touch with water during any flooding.

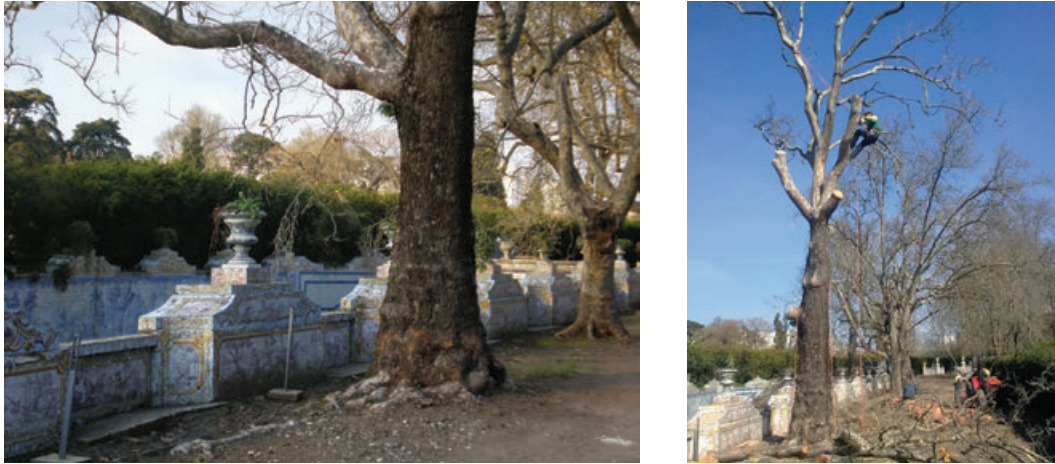
Figure 11. View of the sycamores just prior to and during their felling in January 2009.

over the canal, the possibility of any one of them falling into it during a storm was considered a serious threat that prompted the decision to have them felled. This was carried out during the winter of 2008–2009 (Figure 11).

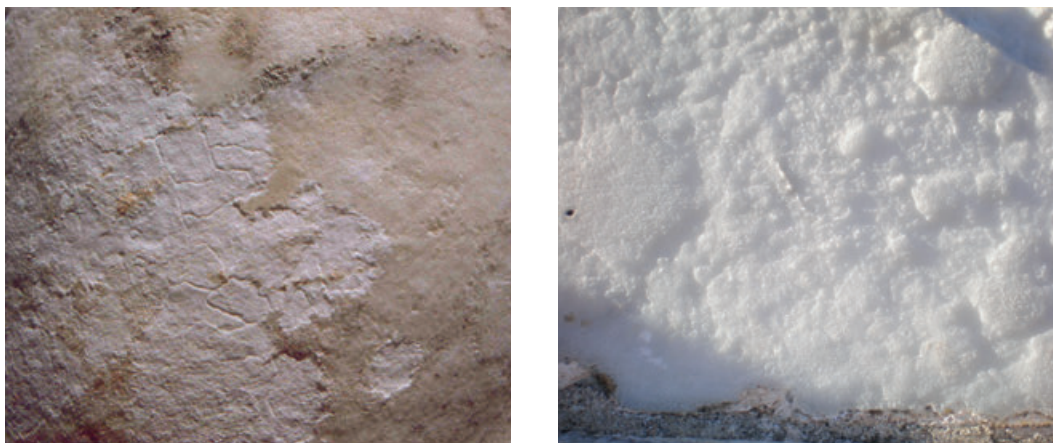
Figure 1. Surface conditions left by two different cleaning methods. Left: application of a biocide and soft brushing (area is about 30 by 40 centimeters). Right: aggressive grit blasting (area approximately 10 by 8 centimeters). Note the overall smoother surface of the stone resulting from the significant loss of original finish.

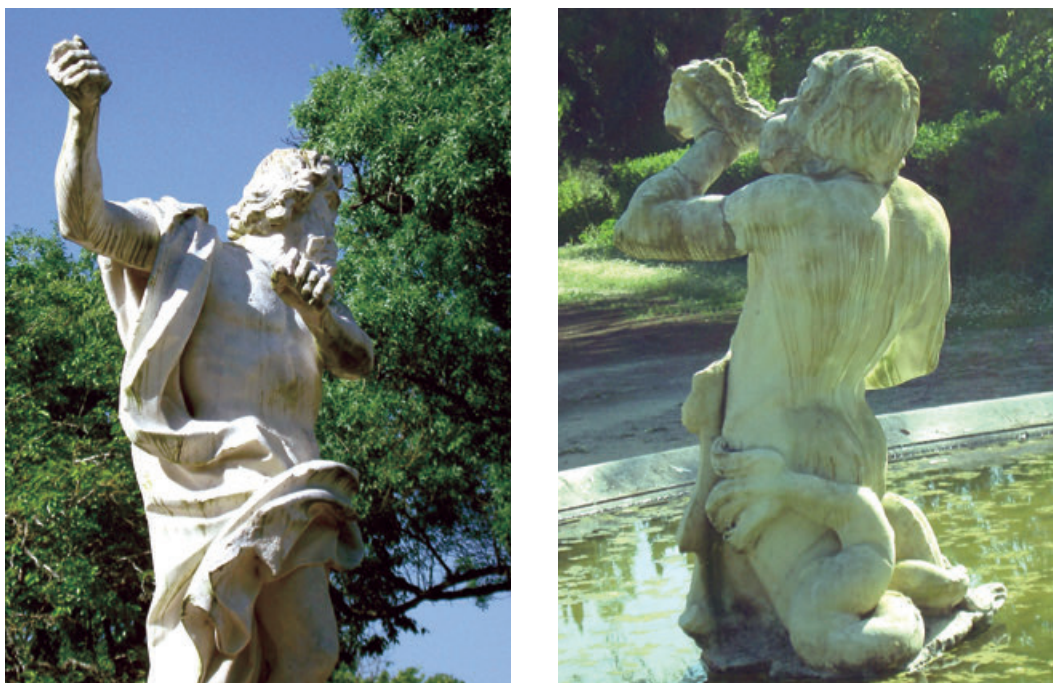
Figure 2. Recolonization pattern on sculptures treated with a water repellent after a restoration intervention (1999). The disfiguring green stripes appear soon after treatment, illustrating that the water repellents do not provide sufficient protection against biocolonization. The photographs show the intense biocolonization that developed after five years (photos 2004).

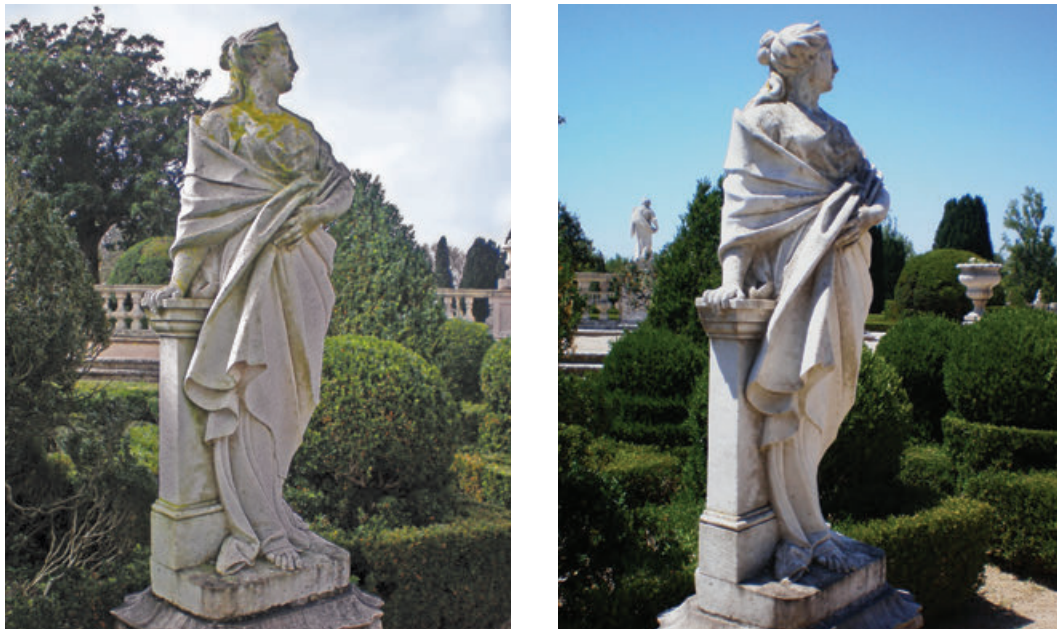
Figure 4. *Architecture* sculpture before a single application of Preventol 1.5% (June 2010) and two months after application. The spontaneous detachment of the colonizing lichens, particularly on head and bust has left the statue with an acceptably clean appearance.

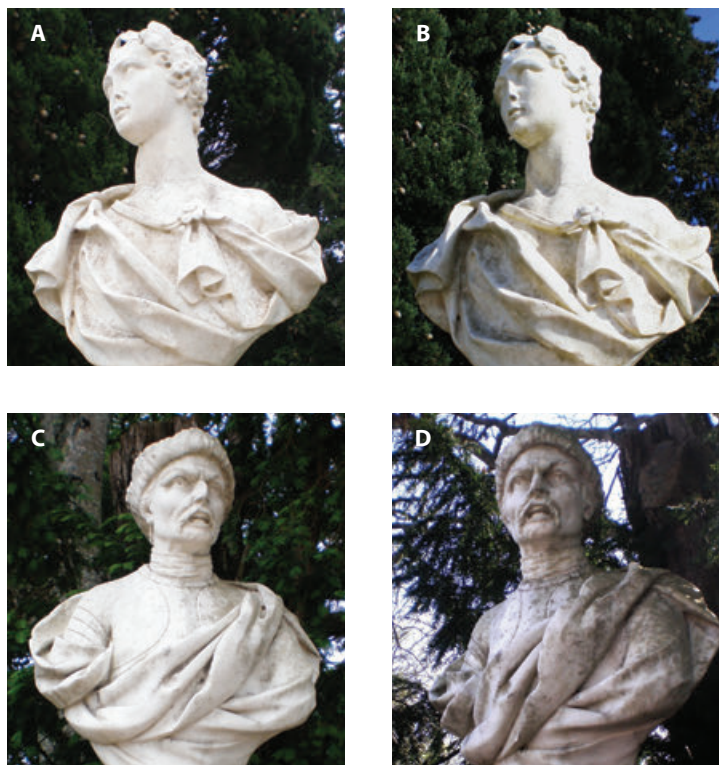
Figure 5. A and C busts shortly after being cleaned and reinstalled in the garden (June 2010). B and D appearance after eight months of exposure (February 2011). A and B bust in an exposed area with no direct cover. C and D bust shaded by trees. The faster recolonization suffered by objects in shaded conditions is clearly evident.

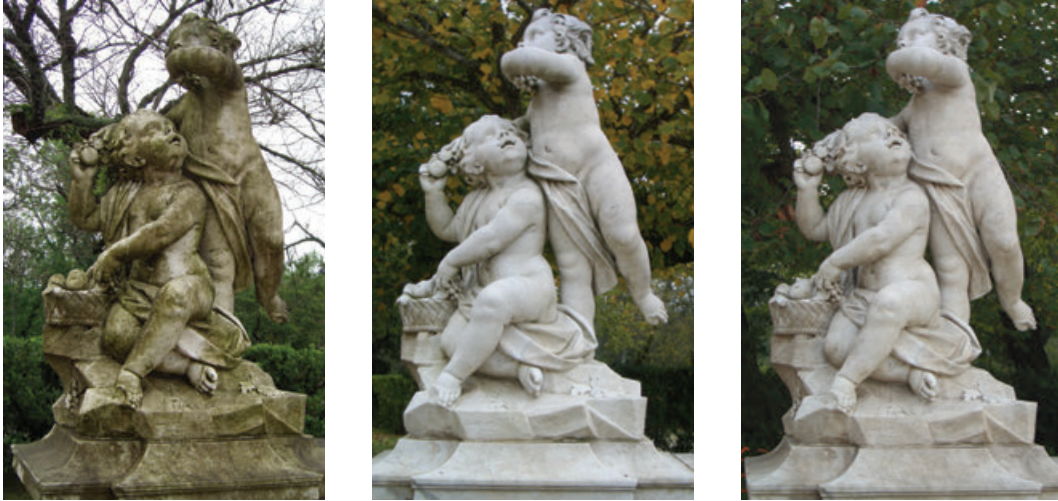
Figure 6. Left: a group of putti before treatment (2006). Center: one year after treatment (2007). Right: five years later (2011).

Figure 6 shows a pair of putti before treatment, nearly a year after the application of the biocide carried out in 2006, and then five years later.

From the above example it is evident that the developed approach is effective, and that recolonization for objects that are not in too shaded an area is still at an acceptable level five years after treatment.

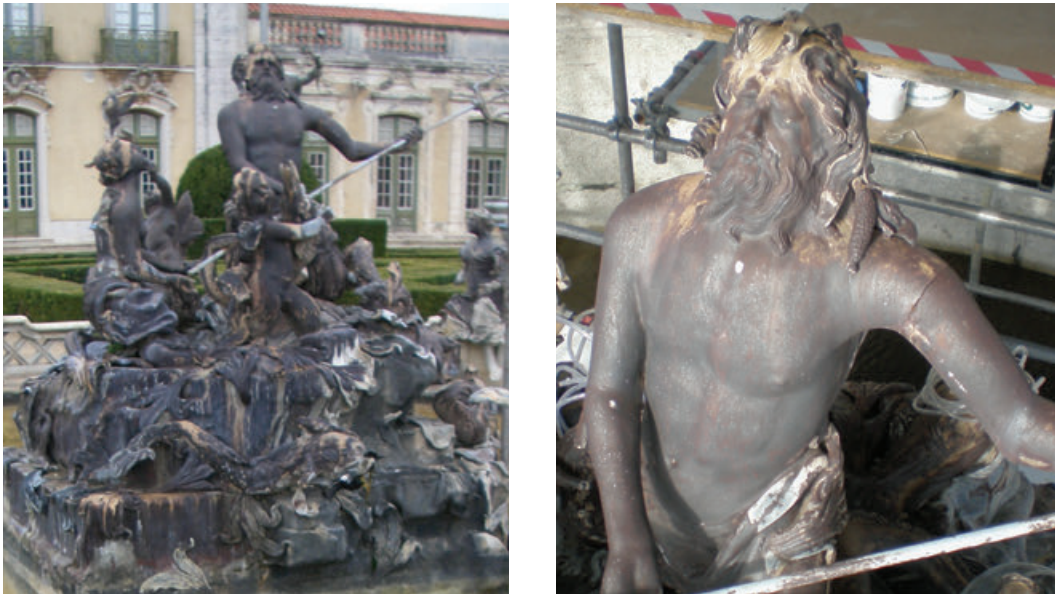
Figure 1. Appearance of the central block of the Neptune fountain. Note the dark brown-black color of the figures in this block. Different lighting affects the color hue, as seen in the above figures taken in summer (left) and winter (right).

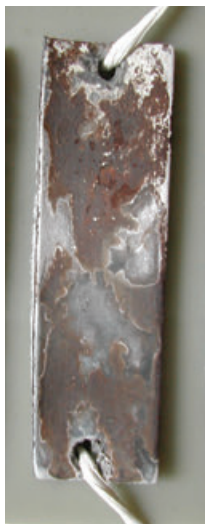
Figure 4. Appearance of a sensitized sample B after a 15-month exposure to an outdoor “severe” environment.

Regarding the role played by the initial surface condition, it was evident that the sensitization, as resulting from pretreatment with acetic acid, induced a more rapid development of the reddish-brown product, which started underlying the initial white carbonate layer and ended by replacing it almost completely. On the other hand, passivated samples, such as those treated with sulfuric acid, present a slower appearance of the reddish-brown product, and the polished samples did not show any changes, except turning matte at the end of the tests.

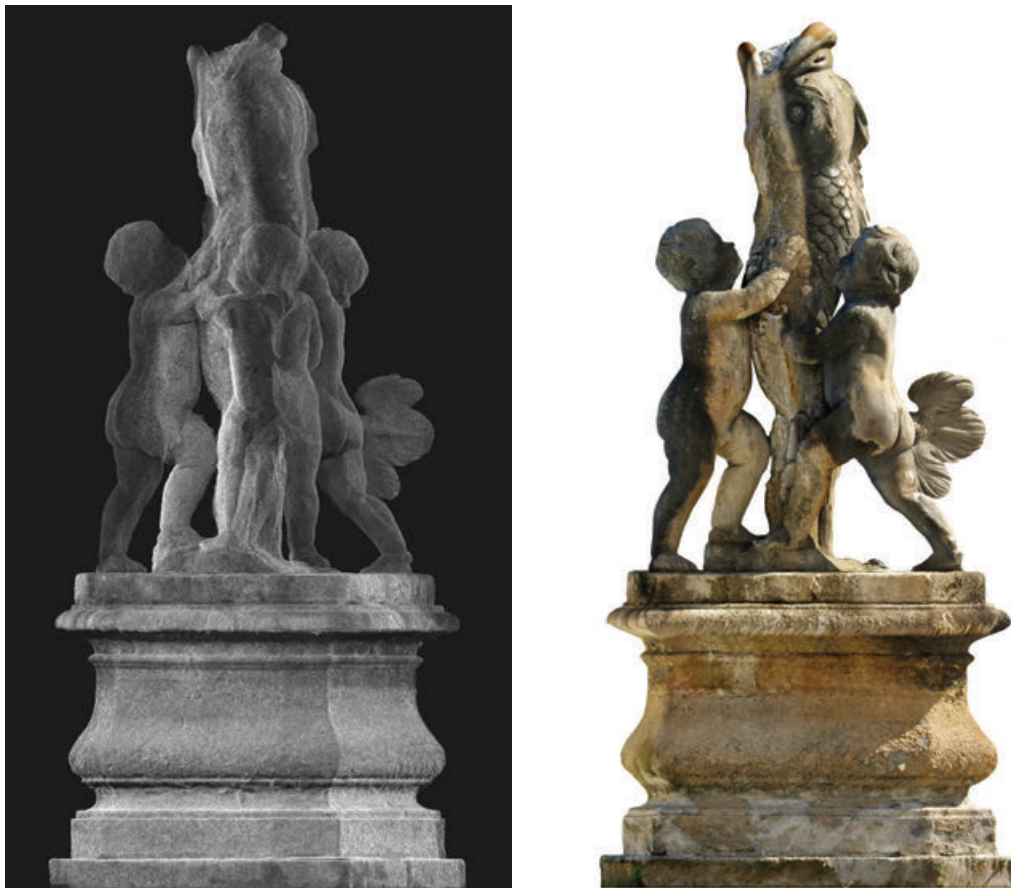
Figure 2. Laser scanning survey of the sculpture group in the Malta Fountain. Left: cloud point image. Right: 3-D rendering.

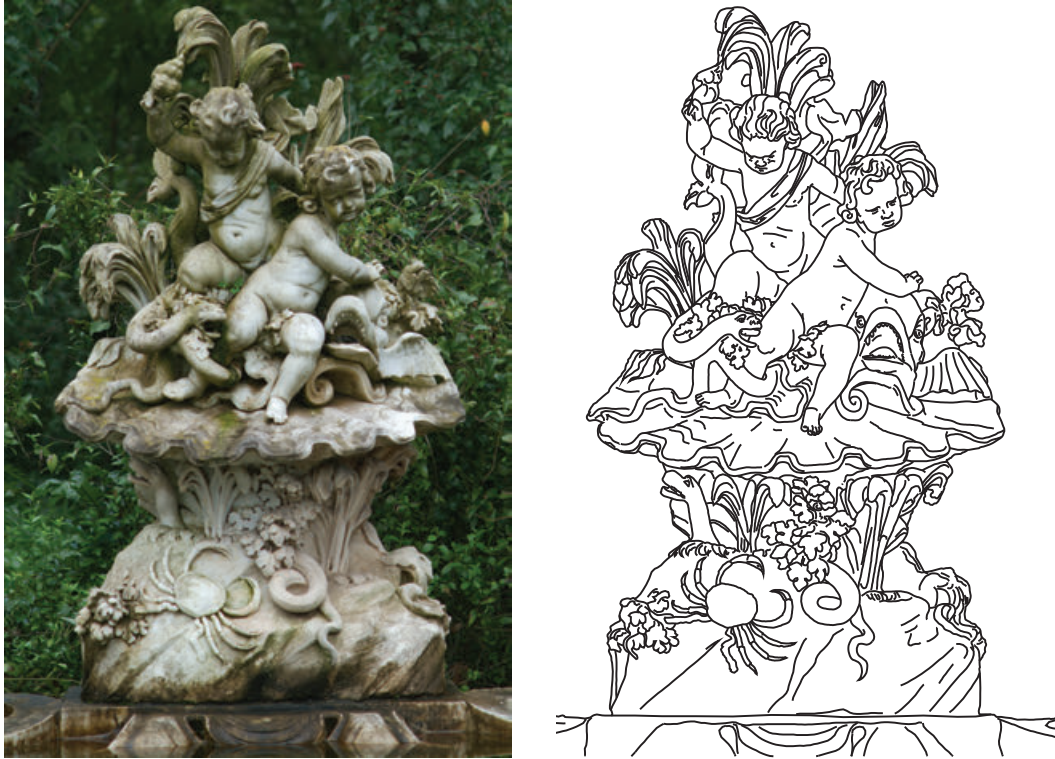
Figure 3. Survey of the sculpture group of one of the Shell Fountains. Left: regular photography. Right: 2-D rendering (© Luca Fabiani).

Independently of the usual written and photographic documentation on the various phases of the work carried out, a scaled survey of both the architectural and sculptural elements (Figure 3) produced an important document to record the various objects. This set of documents will hopefully serve as the basis for future graphic documentation, such as the state of conservation, undertaken conservation/restoration measures, and maintenance operations.

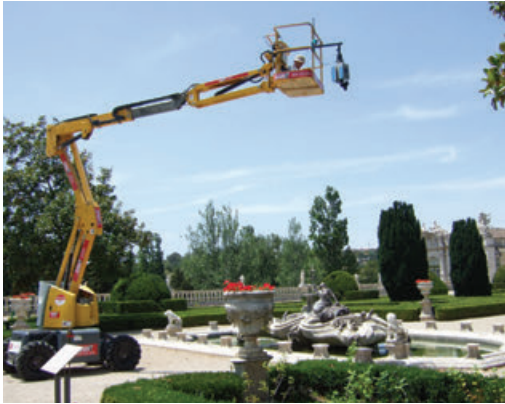
Figure 4. Laser scanning of the Nereid Fountain.

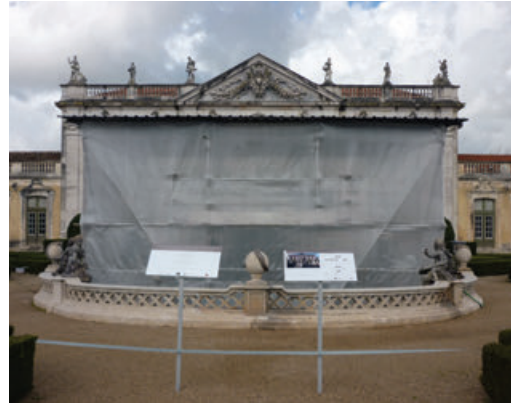
Figure 5. Scaffolding and didactic panels located at the edge of the restricted area by the Neptune Fountain.

Although visitors were allowed to view the progress during the restoration and conservation work carried out at the fountains—with due precautions for the safety of the visitors—in some cases, scaffoldings had to be installed because of the length or height of the surfaces to be treated, e.g., the Nereid and the Neptune fountains (Figures 4 and 5). In these cases, two didactic panels were installed by the protective barriers, where an explanation of the approach and methodologies used was given. This compensated in part for the fact that the fountain was not visible while providing information about the needs and objectives of the intervention.

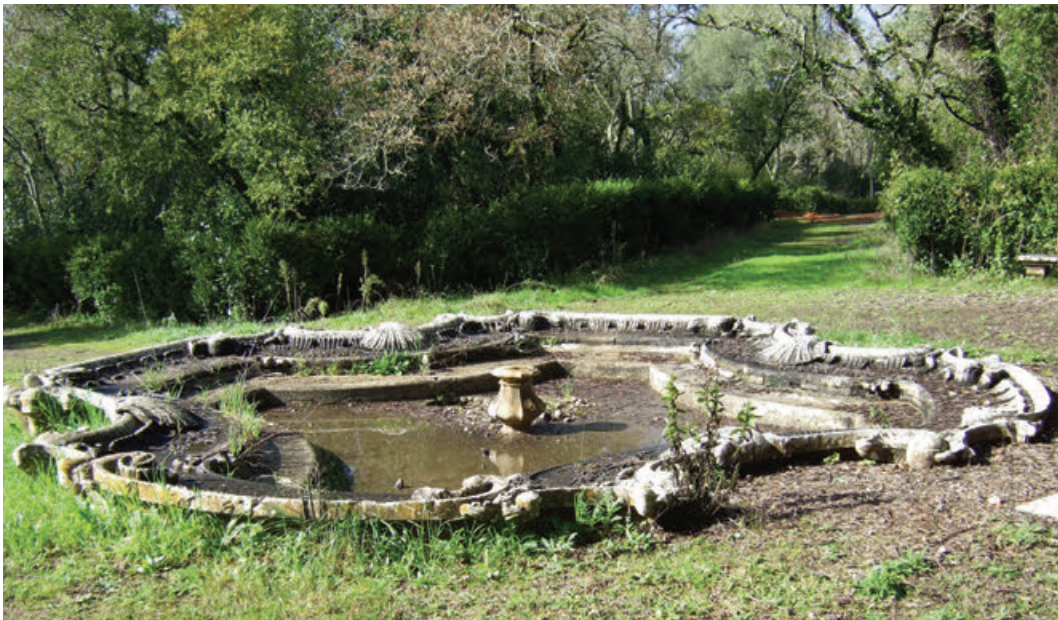
Figure 6. Condition of one of the Shell fountains prior to the conservation and restoration intervention.

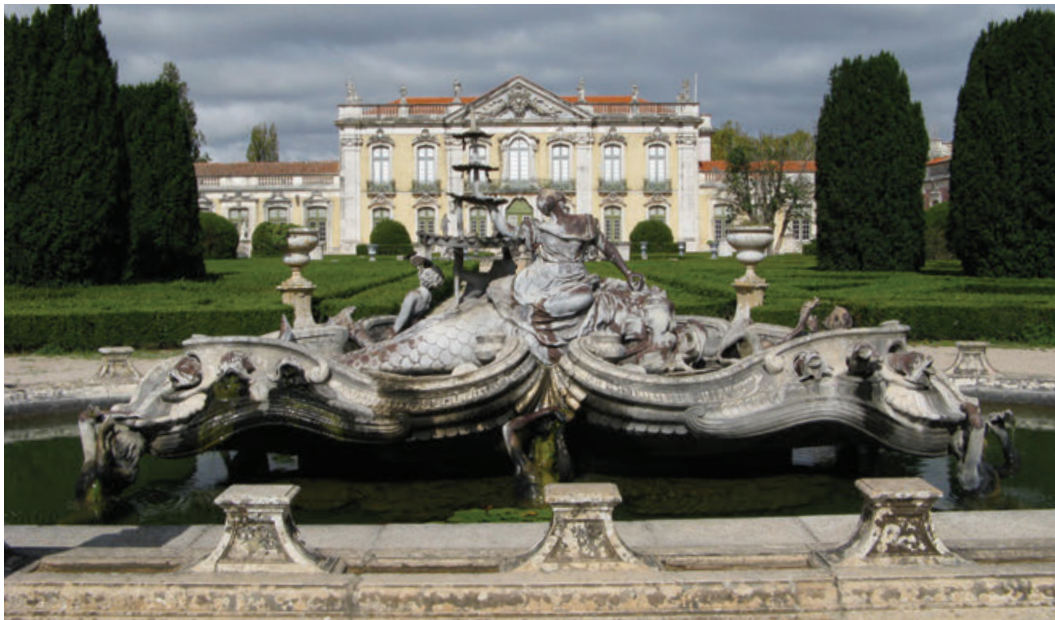
Figure 7. Condition of the Nereid Fountain where calcareous concretions were found on the lead objects.

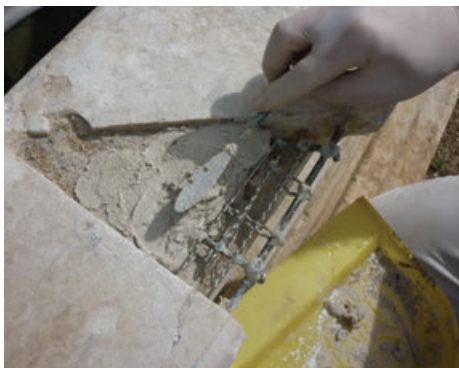
Figure 10. Filling in missing areas in the balustrade of the Neptune Fountain in the Hanging Garden.

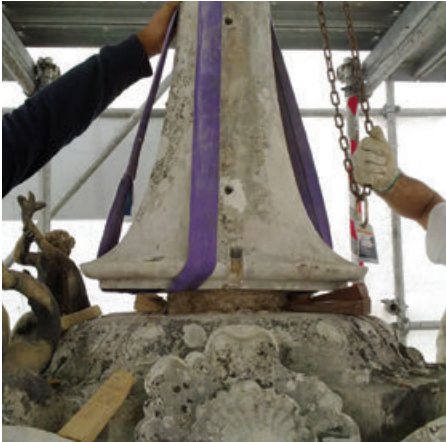
Figure 12. Removing the central block of the Medallions' Fountain to access the water distribution circuit.

- Removal of unstable elements within sculpture groups and their reinstallation, particularly on decorative elements as well as on the basins' moldings, such as those on Medallions' Fountain (Figure 12), the Dragons Fountain (Figure 13), and the marble Neptune Fountain.

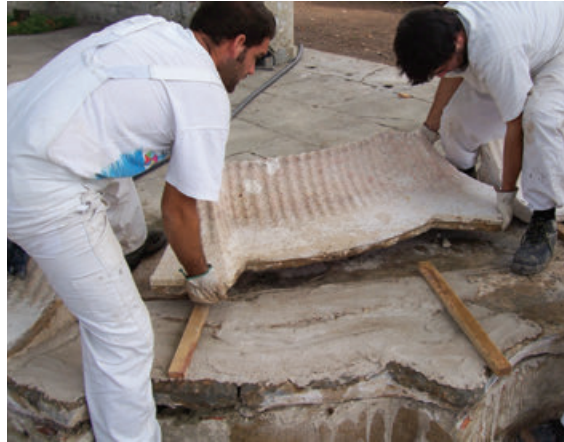
Figure 13. Resetting the decorative edge of the Dragons' Fountain by the Sycamore plaza after cleaning it, clearing out roots and debris, and leveling the base.

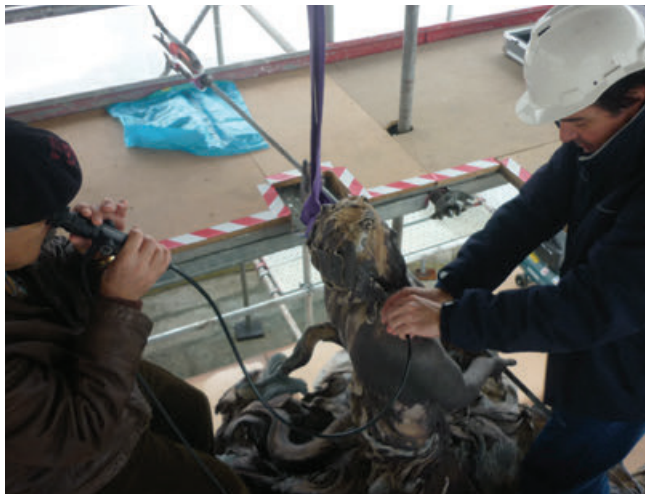
Figure 14. Endoscopy carried out to evaluate the interior condition of the Neptune lead statue.

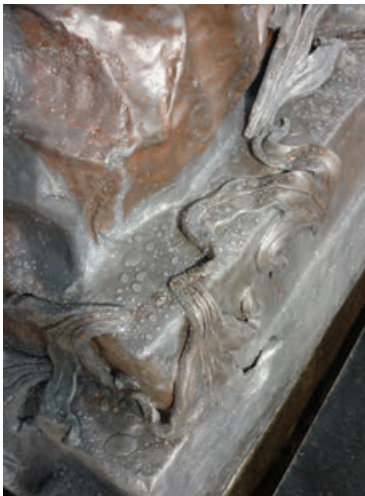
Figure 16. Detail of lead surfaces on the Neptune Fountain after applying the multilayer protective coating.

Once these operations were completed, any chromatic differences resulting from soldering were adjusted by in-painting, and then the whole group was treated with a final multilayer protective coating of acrylic resins and microcrystalline wax (Figure 16).

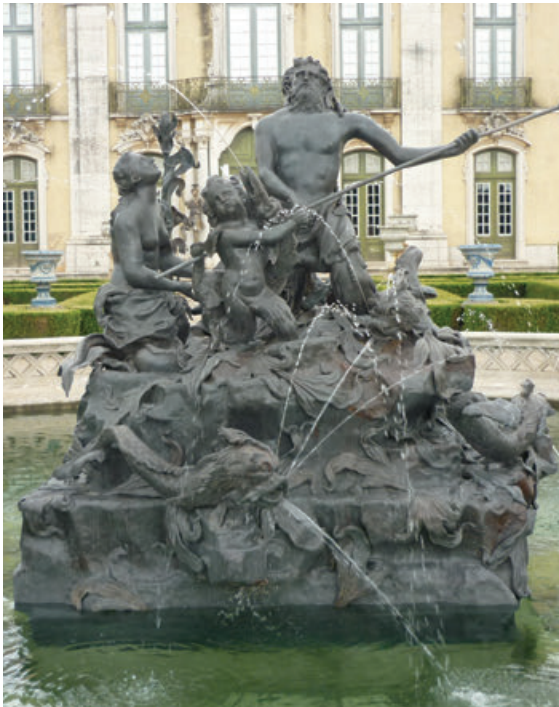
Figure 18. Neptune Fountain in the Hanging Garden showing the water jets in action after the intervention.

The completion of the described intervention achieved yet another objective of the conservation project of the gardens of the National Palace of Queluz. It served to restore some of the most important fountains (Figures 18, 19, and 20)—key elements of the architectural and landscaping objective of this site—bringing back to the gardens at least part of its past brilliance and splendor.
