*The Gardens of the
National Palace of Queluz
Conservation Intervention*

The Gardens of the National Palace of Queluz: Conservation Intervention

© 2012 Associação World Monuments Fund Portugal and World Monuments Fund

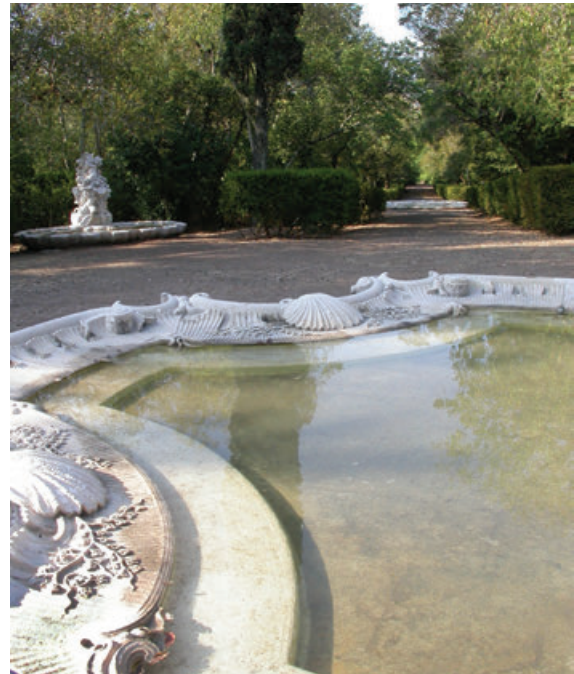
Figure 19. The east Shell fountain on the Cascade lane in the foreground, and the west Shell fountain (upper left corner) after the restoration and conservation intervention.

The completion of the described intervention achieved yet another objective of the conservation project of the gardens of the National Palace of Queluz. It served to restore some of the most important fountains (Figures 18, 19, and 20)—key elements of the architectural and landscaping objective of this site—bringing back to the gardens at least part of its past brilliance and splendor.

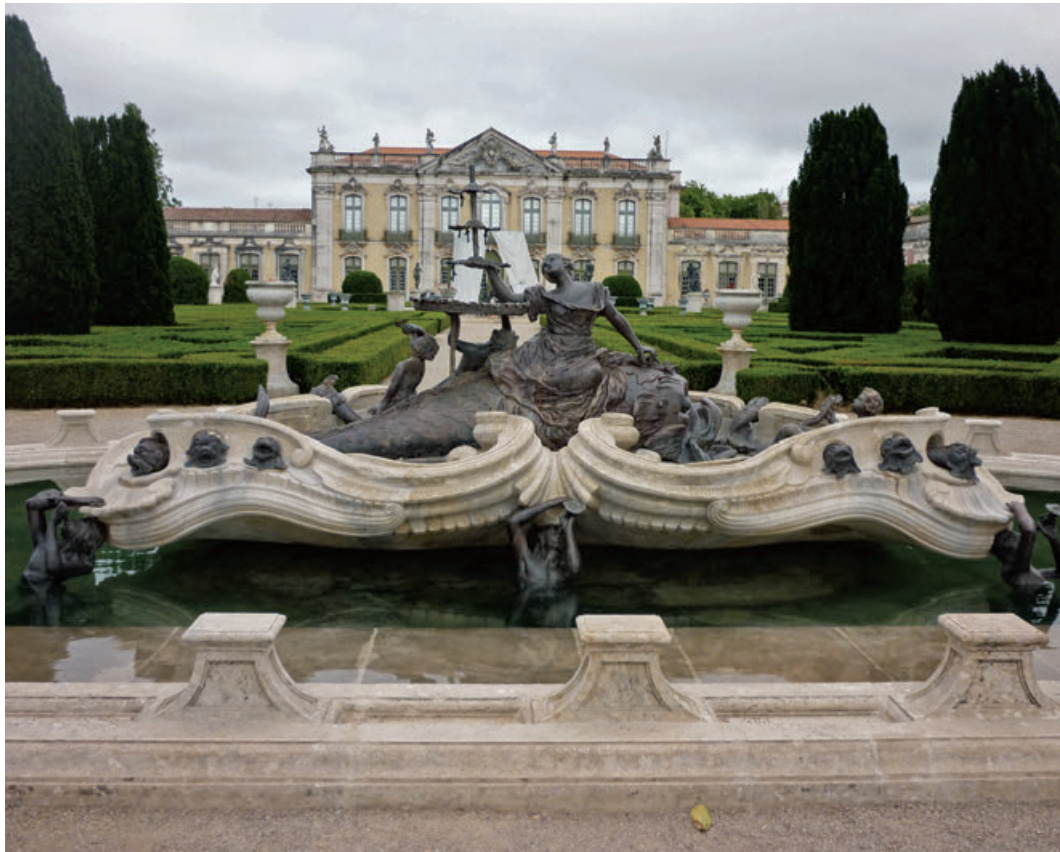
Figure 20. The central sculpture group in the Nereid Fountain, after the restoration and conservation intervention.

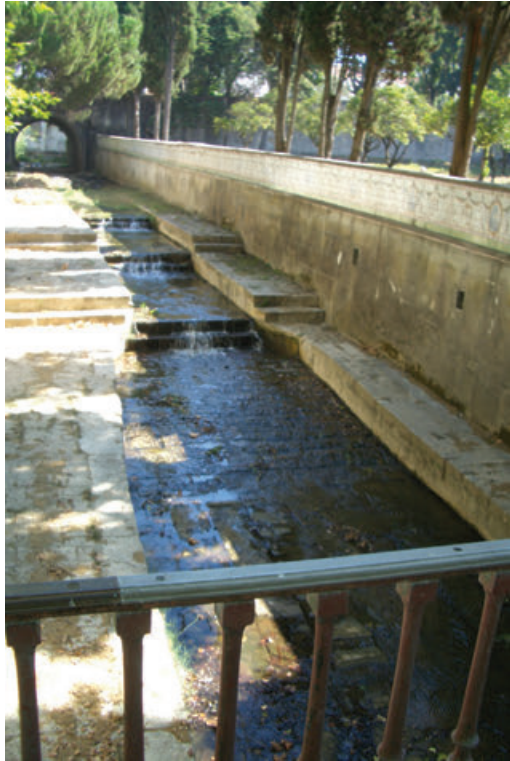
Figure 2. View of the Jamor River when it enters the gardens of the palace. Note that even this modest canal section was embellished with a band of elegantly decorated azulejos.

The Jamor River was channelled many years before the property passed into possession of the royal family in the first half of the eighteenth century (Pereira and Luckhurst, 2005). It enters the palace property in an open canal usually referred to as the entry canal (Figure 2). Then it flows underground until it passes the Sycamore Plaza, where it resurfaces as it runs into the Canal de Azulejos proper.

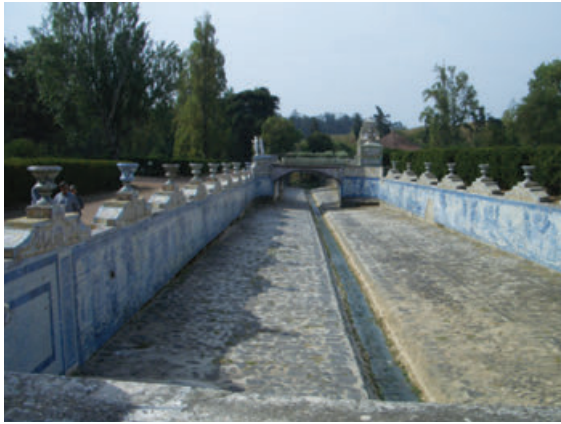
Figure 3a. The beginning of the Canal de Azulejos proper. In the distance, the center block. Note that the azulejo cover starts right at the floor of the canal and, as this slopes down, the undecorated wall becomes evident as can be seen in the center block.

The floor of the canal was originally far deeper, so that when the canal was filled the water would barely reach the azulejo decoration. In the 1940s, the floor of the canal was raised, presumably because of structural problems, so it is now practically at the level of the lowest row of tiles at the beginning of the canal (Figure 3a) and progressively departs from it toward the south, reaching a distance of about one meter at the end of the decorated section (Figure 3b). The

floor of the canal is paved with stone masonry to protect it from erosion, and is sloped toward a deeper center trench that is sufficient to carry all the water during the dry seasons (Figure 3a). As mentioned, the overall flow is north to south.

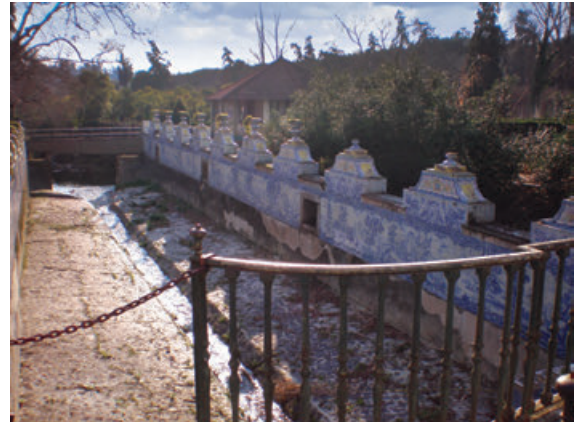
Figure 3b. End of the decorated structure adapted from an early-twentieth-century conservatory. Below the bridge, at the end of the canal, the flood gate was installed. Note that the azulejo decoration is over one meter from the floor.

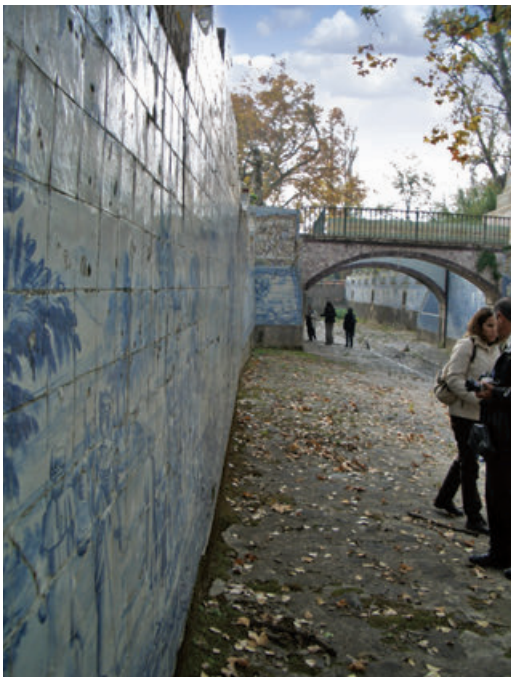
Figure 5. Rebuilt section after the 1967 flood, showing the buckling of the azulejos. The bridge over the canal corresponds to that of the center block.

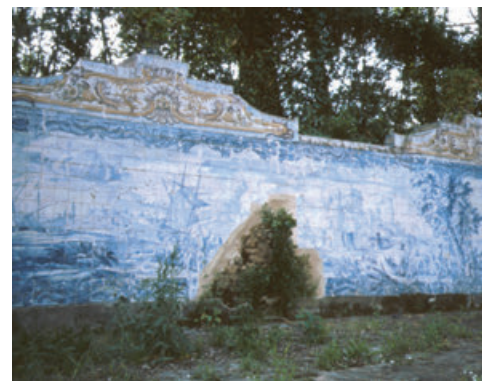
Figure 6. View of the inner west wall of the canal showing an area with azulejo loss (compare with Figure 12 in Chapter 4) partly due to the root growth of larger trees, such as poplars growing on the west bank that were propagating into the canal bed (May 2004).

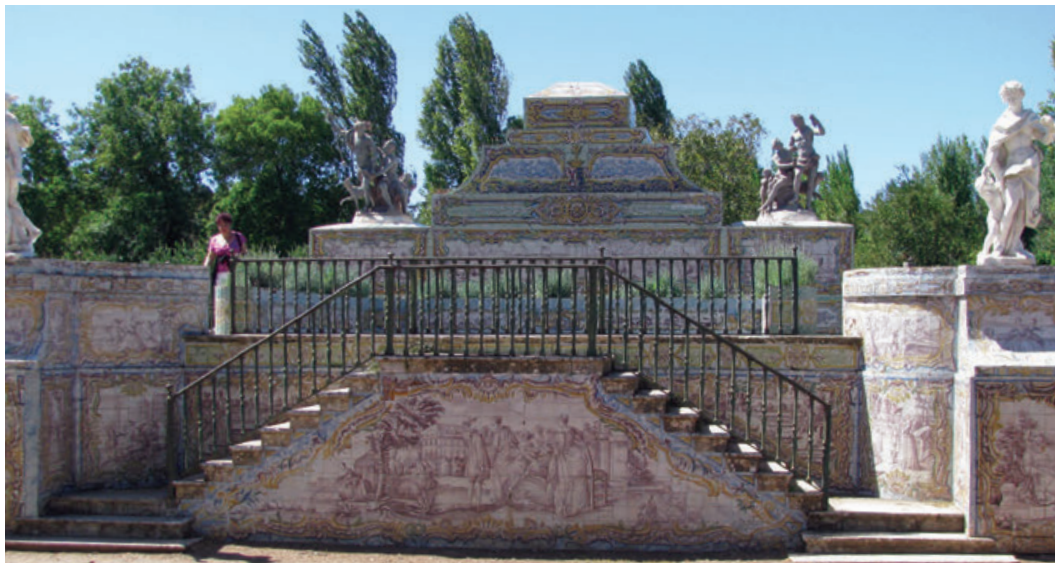
Figure 7. The center block of the canal, where the music stand was installed, as seen from the palace side after completion of the project (2010).

The Canal de Azulejos proper extends from the Sycamore Plaza to where the floodgate used to be and where it is joined by the tributary creek. While the inner walls of the canal are covered with eighteenth-century azulejos, those in the center block are more recent (Figure 7). Historic studies have shown them to be from the early twentieth century following the alterations introduced during the nineteenth century (Sequeira and Vale, 2004).

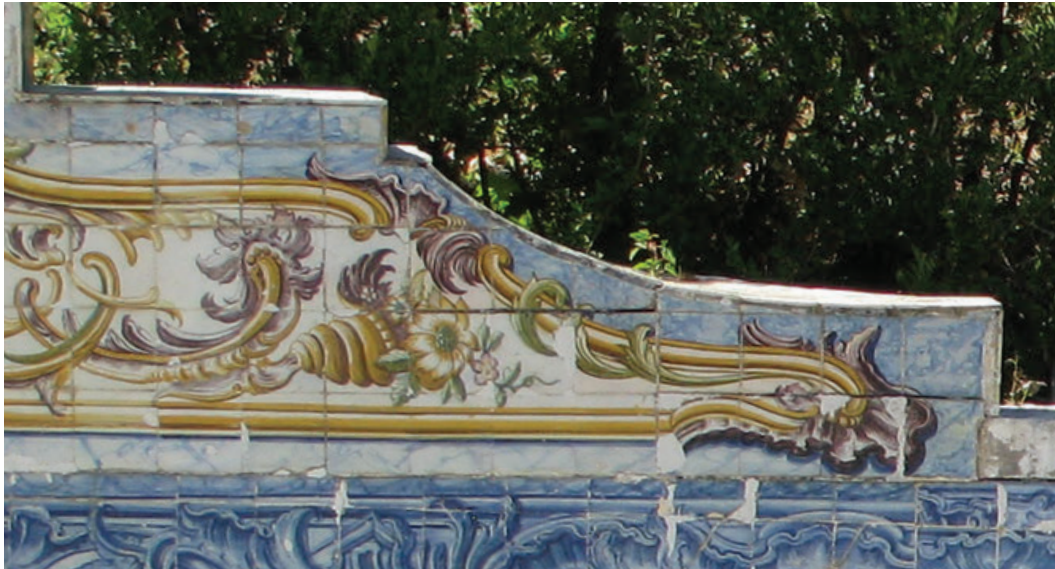
Figure 8. Decorations details typical of the rococo style.

There are about 50,000 azulejos lining the interior sides of the canal, not including those of the center block. The stylized bat wings and shell-like features, typical components of the rococo style, are abundantly used on the exterior decoration of the canal walls and on the decorative mounts on top of the wall, where glazed ceramic vases are installed (Figure 8). Some preliminary studies on the composition of the *chacotte* and the glazing of these azulejos were carried out at the IPT (Polytechnic Institute of Tomar (Ferreira, 2007).

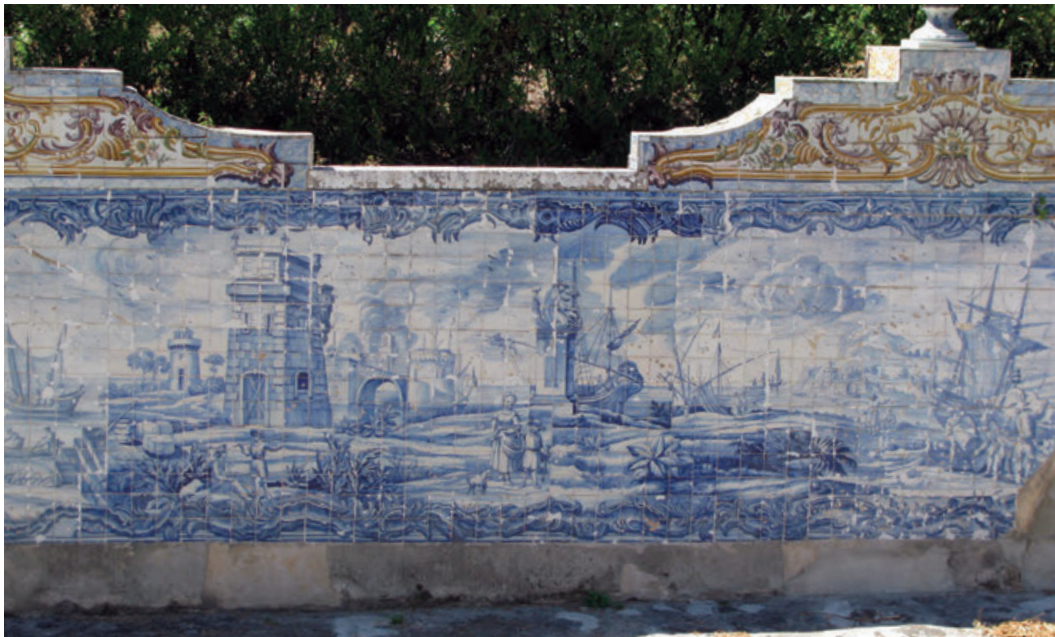
Figure 9. Example of an azulejo-decorated panel. Notice the exquisite quality of the drawing and the use of half-tones of blue to accentuate the 3-D illusion. Note the colors used on the decorative mounts that support the glazed ceramic vases. At this point the separation of the azulejo cover from the canal bed is about 50 centimeters (assuming the azulejos are about 14 centimeters square).

The tiles used for the inner decoration of the canal are mostly traditional blue-and-white azulejos of exquisite design and manufacturing quality. The panels are finely drawn, incorporating painting details to highlight a three dimensional illusion created by their composition and the use of halftones of blue and of white brush strokes as shown in Figure 9.

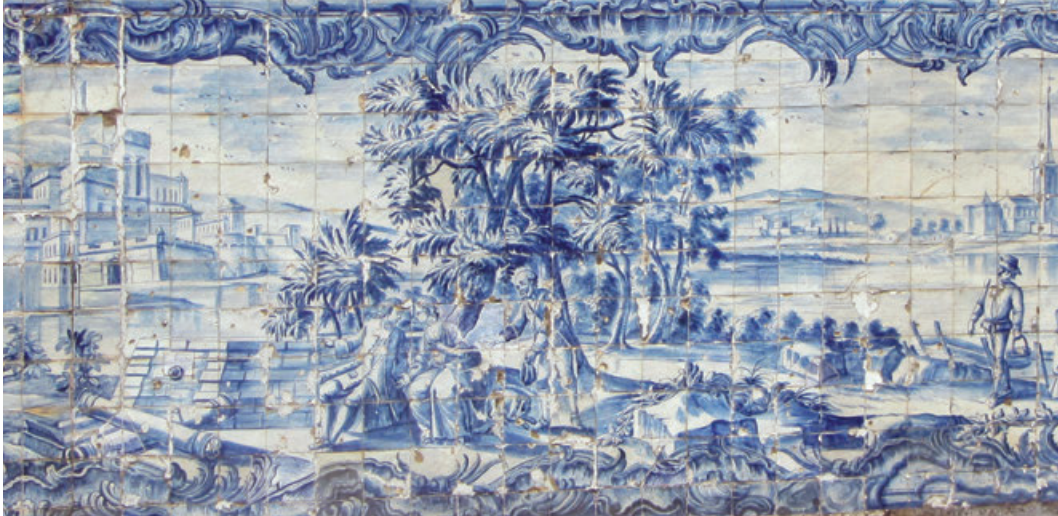
Figure 10. A closer detail of another section showing the high manufacturing quality of the tiles. The photograph also shows that many of the tiles are deteriorated and that some have been replaced, identifiable by their lesser design quality.

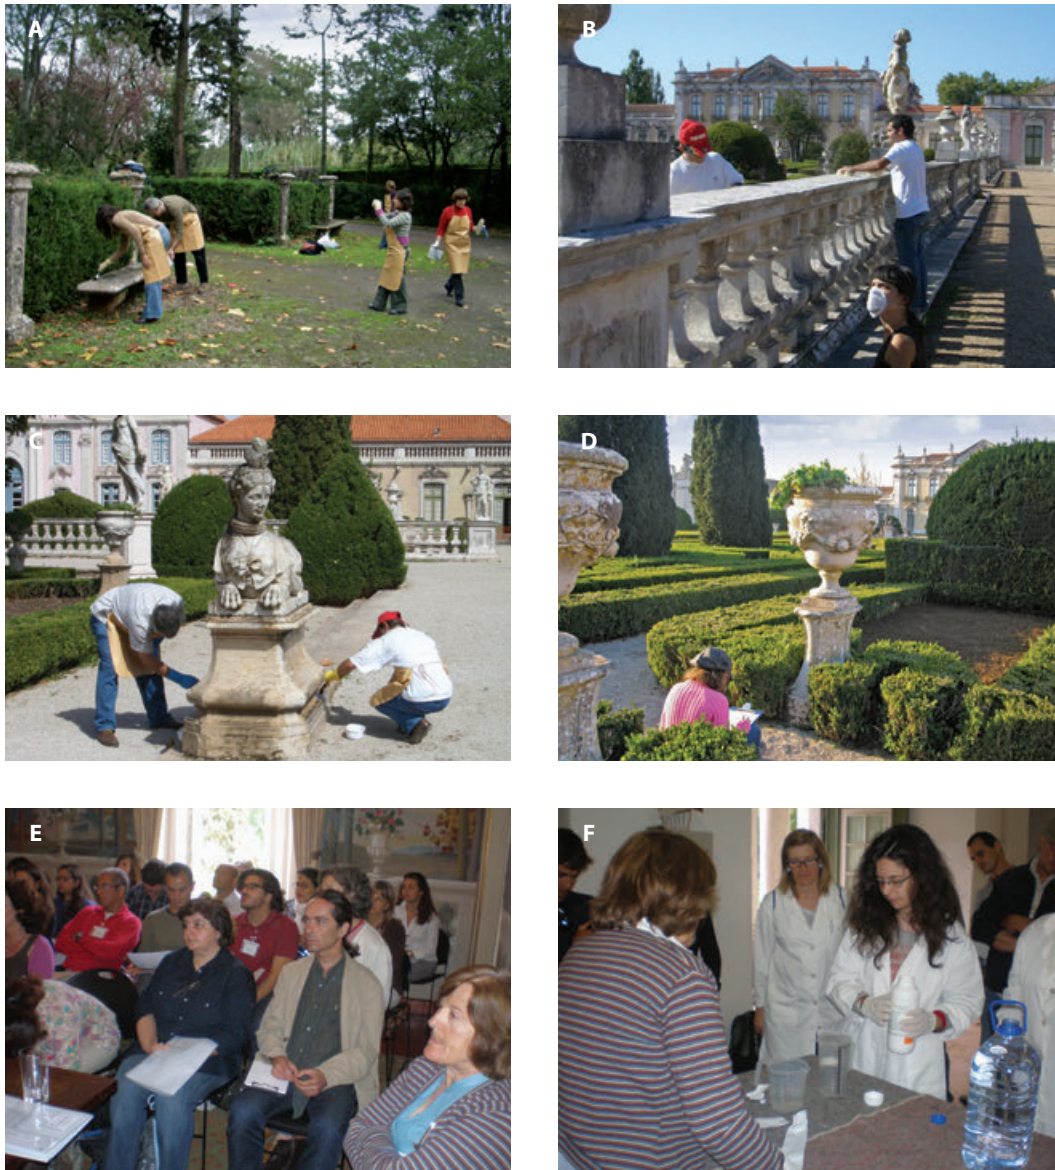
Figure 1. Participants working during the stone workshops: **A** photographic documentation and biocide application (first workshop); **B** and **C** biocide application (third and fifth workshop); **D** condition survey of a vase (sixth workshop); **E** lecture session; **F** preparation of biocide solutions (both ninth workshop).

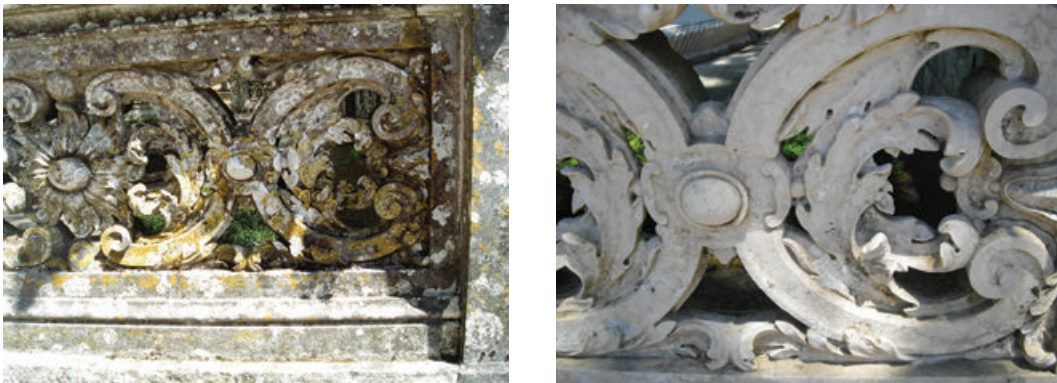
Figure 1. Balustrade of the Sycamore Plaza. Left: detail of the biological colonization prior to the application of the biocide (April 2006). Right: appearance after four years (June 2010).

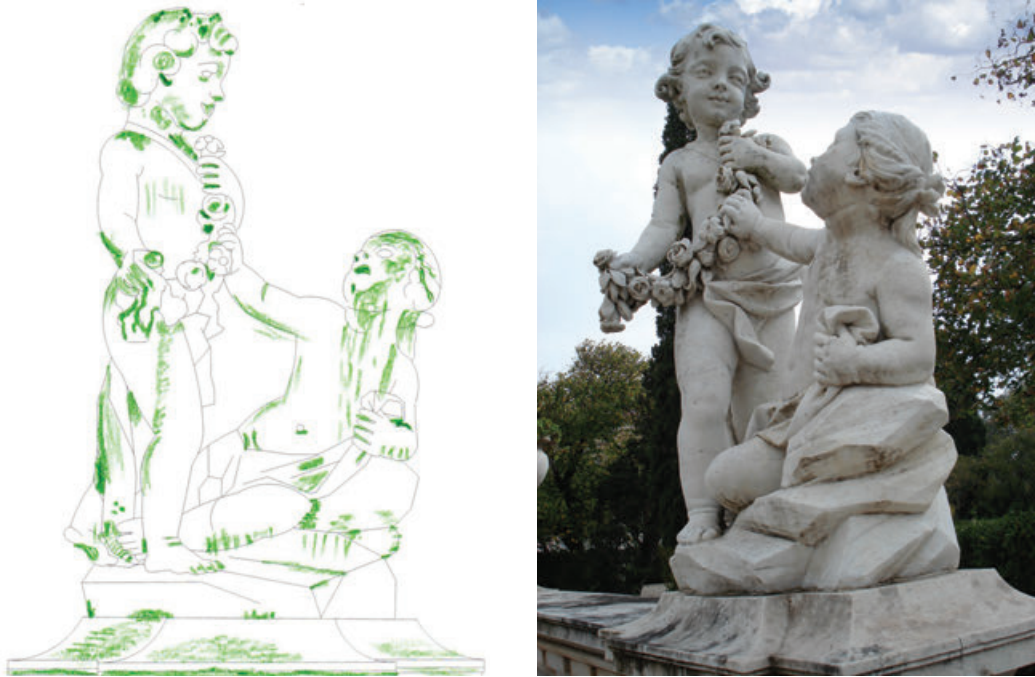
Figure 2. Putti. Left: Condition survey mapping prior to the biocide application (September 2006). Right: General appearance after two years of the biocide application (October 2006).

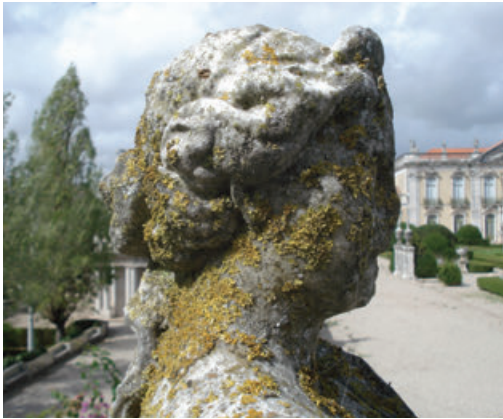
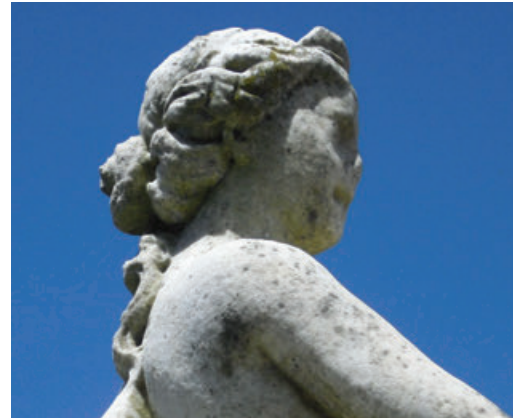
After approximately three years of the biocide application the stone nearly recovered its original appearance through the loss of most of the biocolonization. However, in some areas, such as the lower part of the arms or under the chin where water may collect, recolonization is already occurring.

Figure 3. *Ceres*, the goddess of agriculture. Left: detail of the face colonized by various lichens prior to the application of the biocide (October 2007). Right: appearance after three years (June 2010).

Figures 3 and 4 show two marble statues, mounted on the west balustrade of the Hanging Garden, that were treated with a 3% biocide solution during the fifth workshop carried out in October 2007.

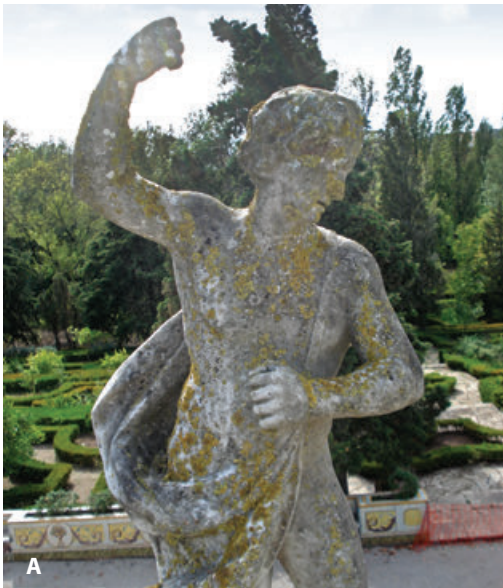
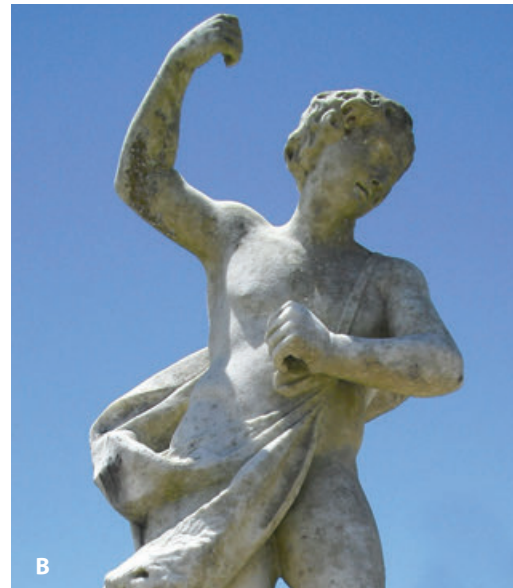
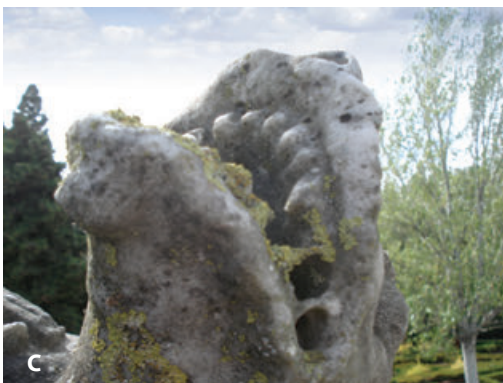
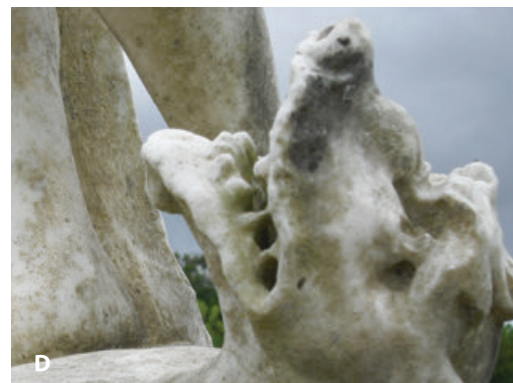
Figure 4. *Hercules and the Lernean Hydra*. **A** detail of the face, arm and right hand showing various biological communities prior to the biocide application (October 2007); **B** appearance after three years (June 2010). **C** detail of the hydra head prior to treatment; **D** after three years.

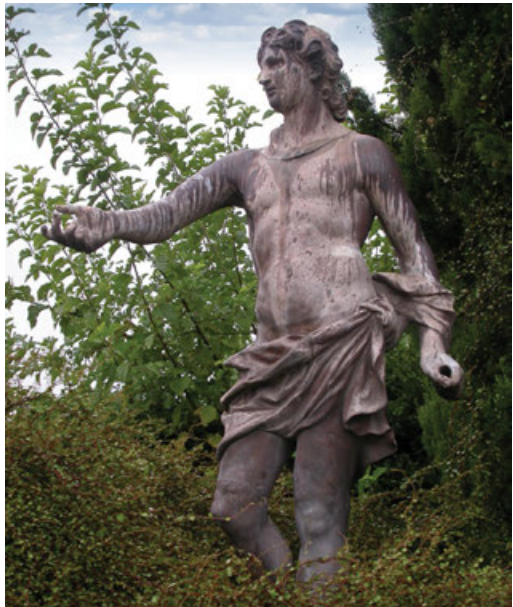
Figure 1. Discoloration (brownish lead dioxide) and fissures detected on the *Apollo* statue.

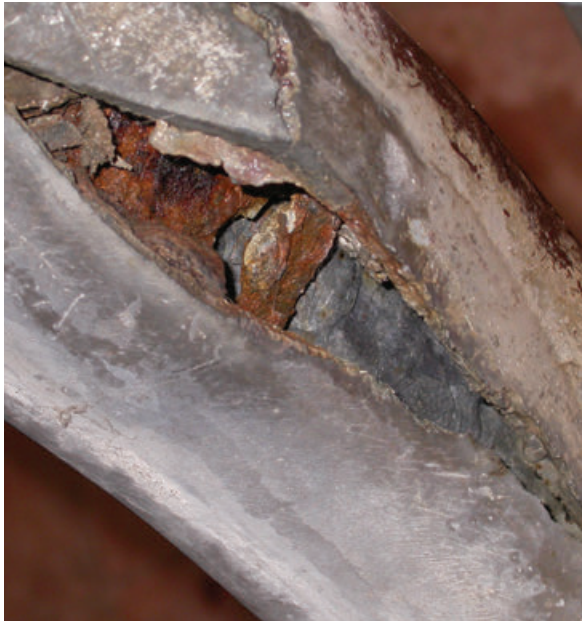
Figure 3. Fissure in *Autumn*'s leg, through which it is possible to see the severe corrosion of the iron inner structure.

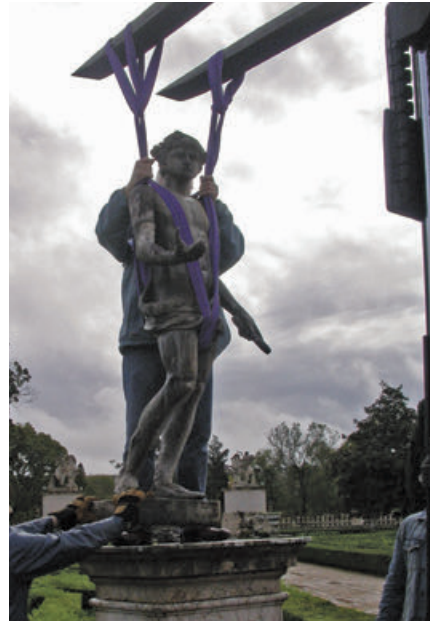
Figure 4. Lifting *Autumn* from its stone pedestal.

Following visual analysis, a careful photographic record was made. As the major deterioration was related to the poor condition of the old inner iron armatures, it was decided to remove and replace them with new ones. For this purpose, it was important to mark the lead where it was to be cut and draw lines to make sure that the separated parts could return to their original position, maintaining the statue's original shape.

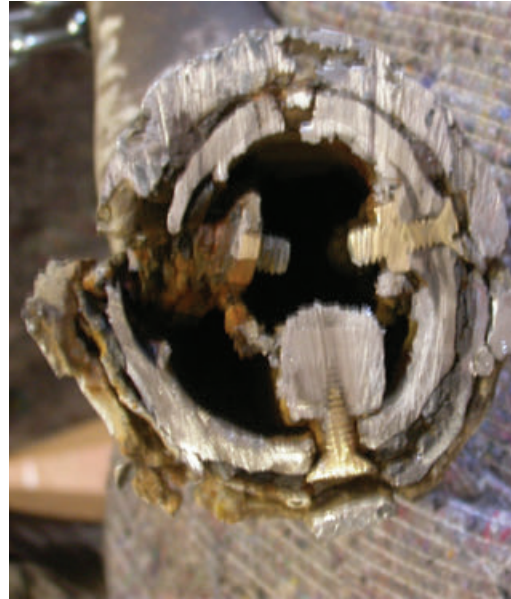
Figure 6. Set of screws found in the arm of *Autumn*, presumably from former repairs.

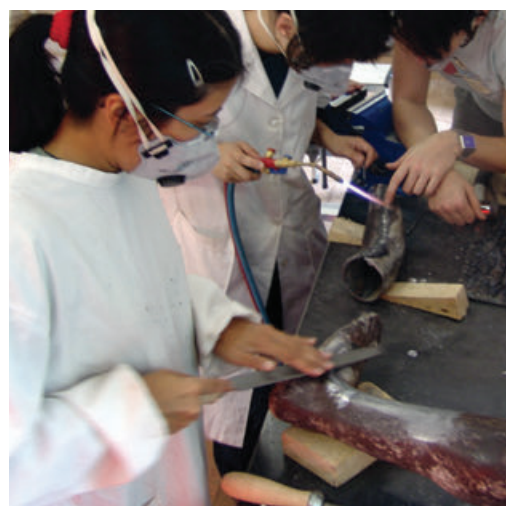
Figure 10. Finishing lead burned surfaces.

Finishing activities basically consist of mechanically removing the excess material at lead burned joints (Figure 10). Finer tools (from rasps to shaves and files) were sequentially used as the material was taken off and the repaired area smoothed with fine-grain sandpaper. For a better reintegration of the decorated parts, punch detail instruments were used as well.
