# **Macedon Gas Development Ministerial Statement 844 2023 Compliance Assessment Report**

Woodside Energy Global Pty Ltd

January 2024

# Macedon Gas Pipeline Rehabilitation Survey 2023

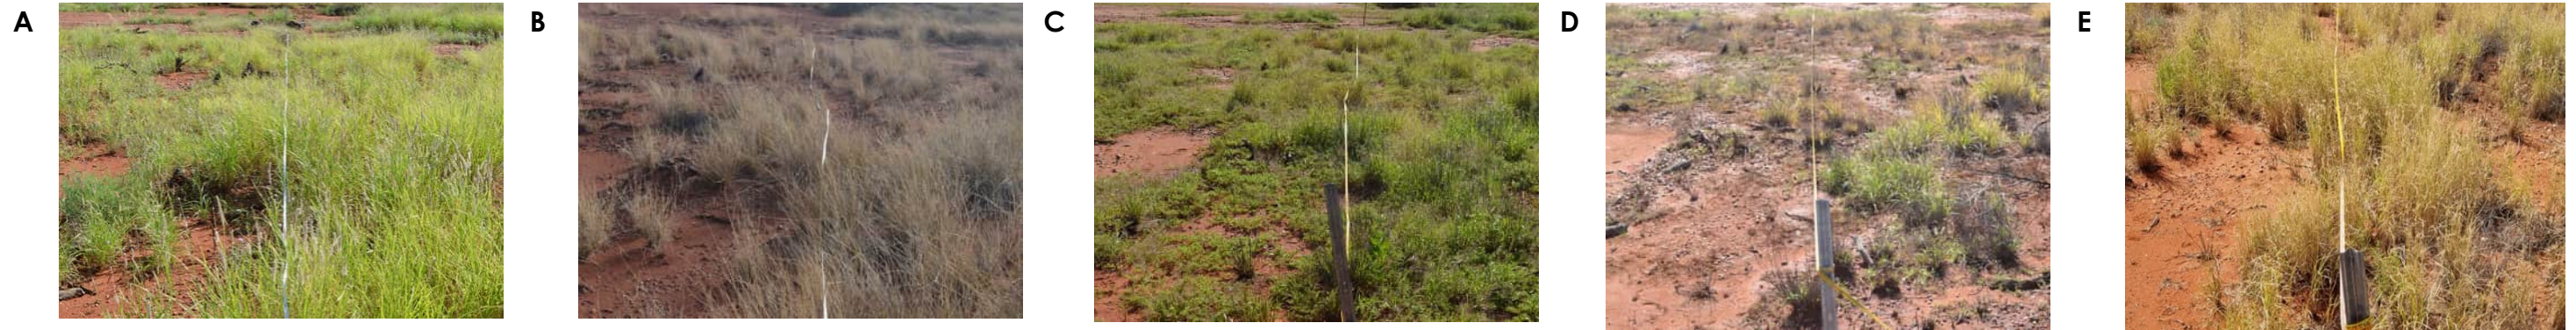
In 2019, *\*Cenchrus ciliaris* was recorded from analogue site BHPPA-29 at which it was previously recorded; it was also recorded in the strip transect only at BHPPA-30 for the first time. The percentage cover of *\*Cenchrus ciliaris* at analogue transect BHPPA-29 showed an increase of 7.2% from 2017. In terms of the rehabilitation transects, *\*Cenchrus* spp. were recorded from all transects from which they had previously been recorded, except for BHPPD-23 where it was absent in 2019. *\*Cenchrus setiger* co-occurred with *\*C. ciliaris* along the line transect at BHPPD-31.

From 2017 to 2019, the cover of *\*Cenchrus* spp. decreased at four of the rehabilitation sites, including at BHPPD-28 where *\*Cenchrus* was no longer recorded along the line transect but only in the strip transect, and at BHPPA-23 where *\*C. ciliaris* and *\*C. setiger* were no longer recorded in the strip-transect. Substantial decreases in cover were observed at BHPPD-29 and BHPPD-31 following herbicide treatment (see Plate 5.1, Plate 5.3). There was essentially no change in *\*Cenchrus* cover at the remaining site (BHPPD-30; Plate 5.2). The cover of *\*Cenchrus* species along the line transects at four rehabilitation sites was greater than that of pre-cleared levels, with all four situated in the Mt Minnie conservation area (BHPPD-28 to BHPPD-31).

Plate 5.1: \**Cenchrus* at site BHPPD-29 in 2017 (A); 2019 (B); 2021 (C); 2022 (D); and 2023 (E).

Rehabilitation monitoring is ongoing on a yearly basis, with no additional actions required to improve species diversity. Annual weed spraying will continue to target areas identified in the 2023 monitoring report, post wet season. Additional weed spraying to be implemented in 2024 based on consultant recommendations.

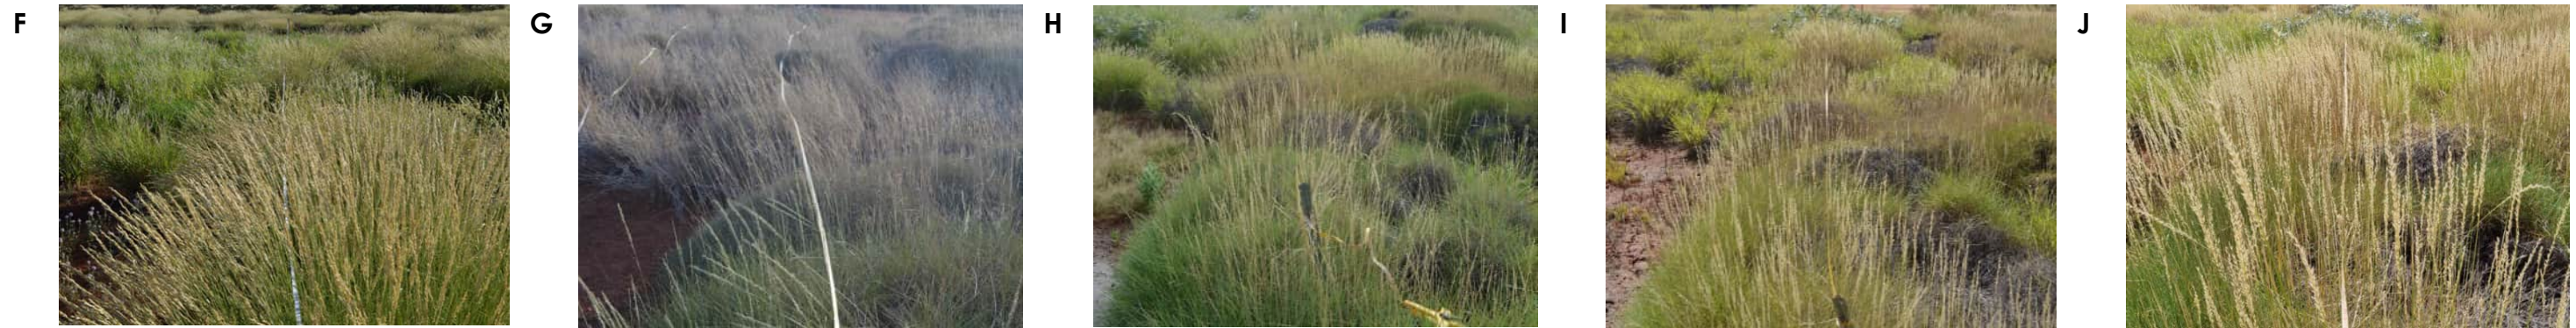
Plate 5.2: \**Cenchrus* at site BHPPD-30 in 2017 (F); 2019 (G); 2021 (H); 2022 (I); and 2023 (J).

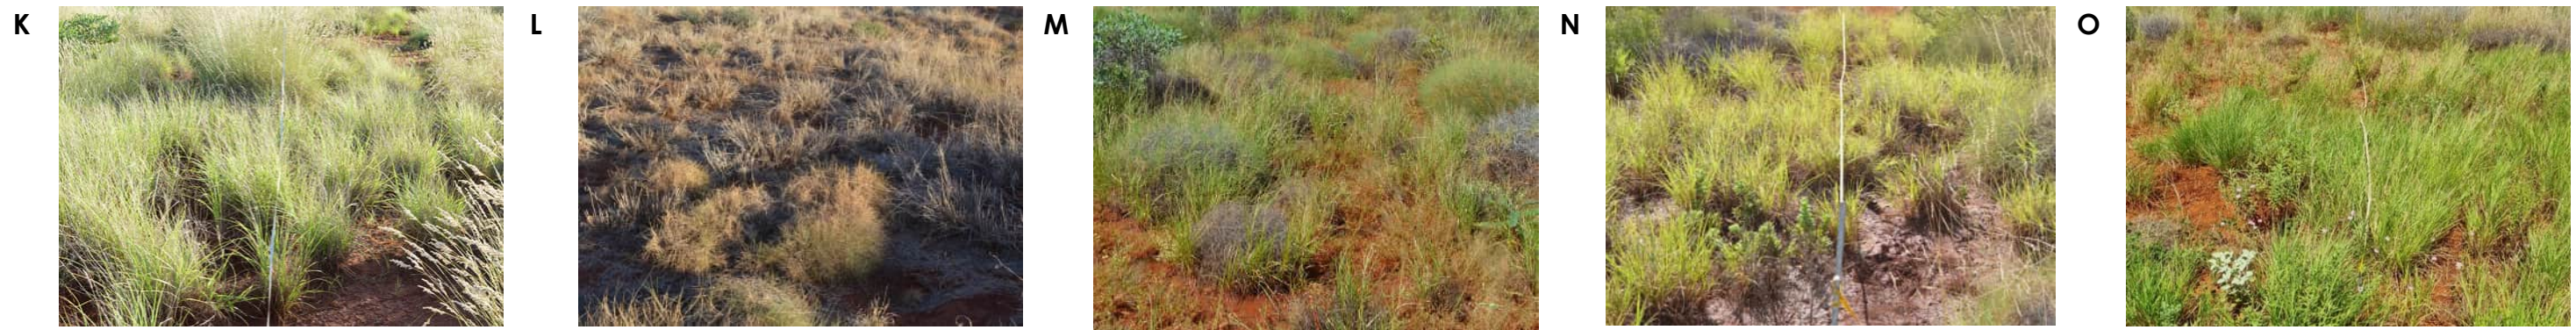
Plate 5.3: \**Cenchrus* at site BHPPD-31 in 2017 (K); 2019 (L); 2021 (M); 2022 (N); and 2023 (O).

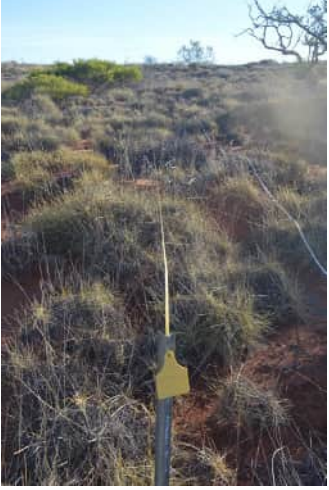
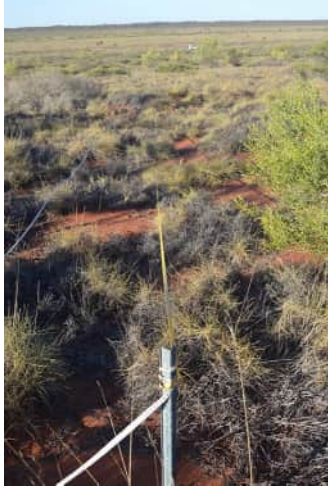
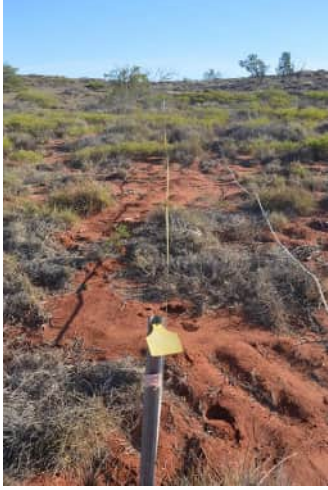
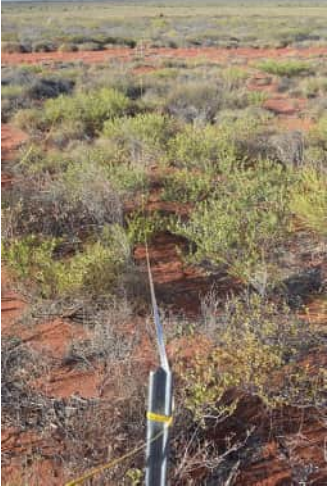
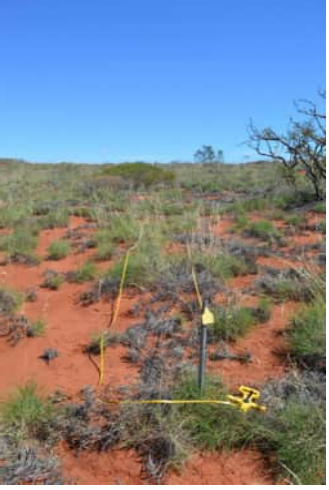
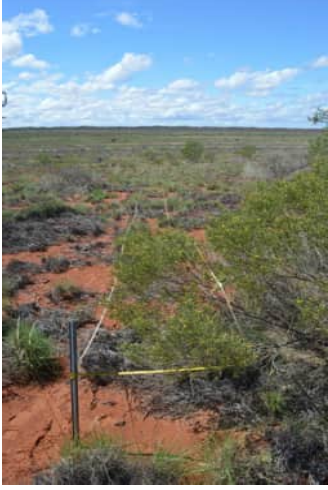
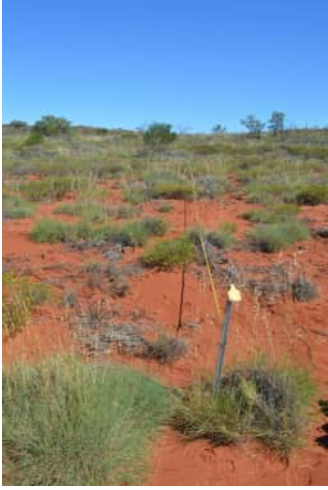
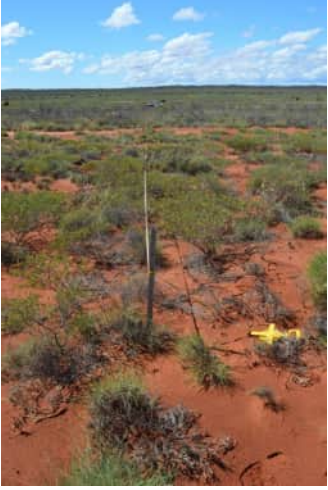
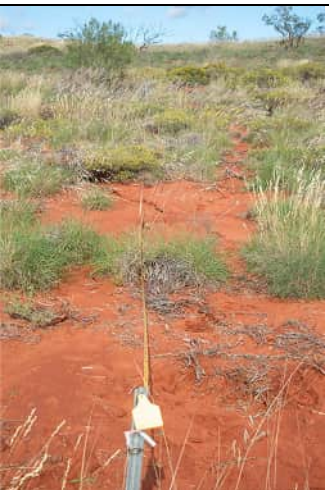
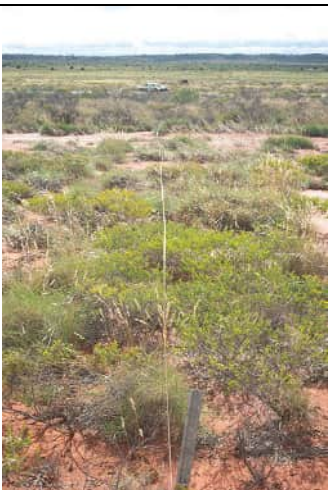
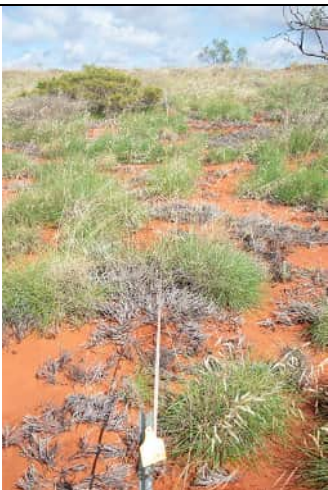
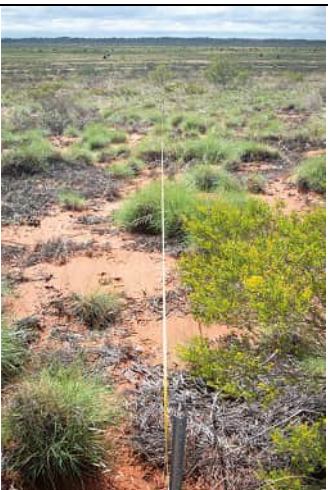
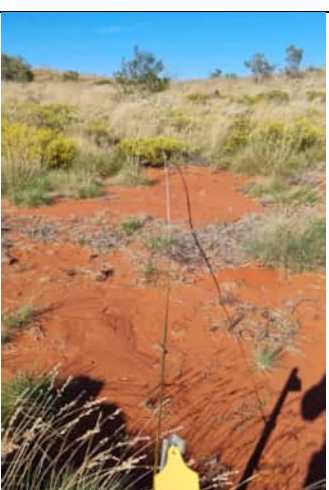
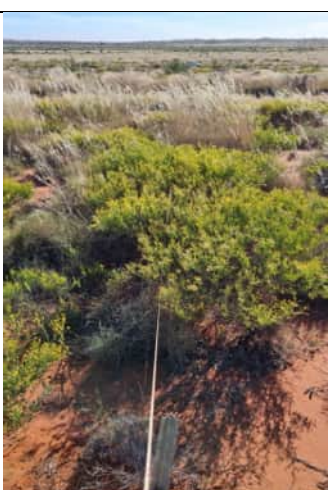
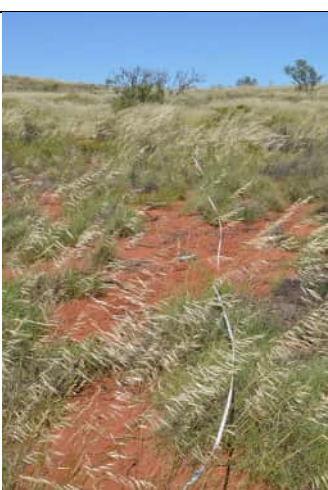
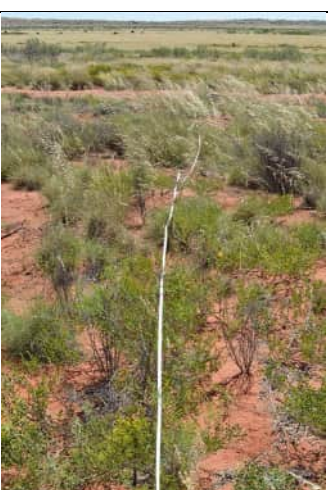
Site 22 (Mt Minnie conservation area)

Analogue Transect BHPPA-22		Rehabilitation Transect BHPPD-22

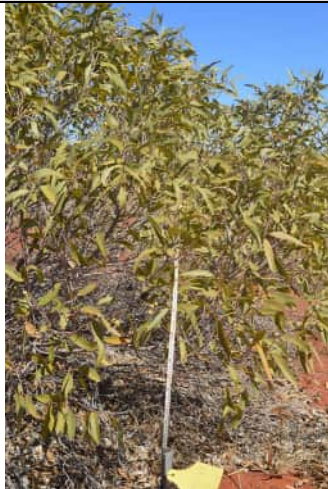
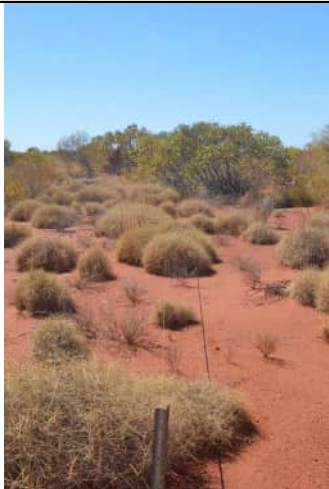
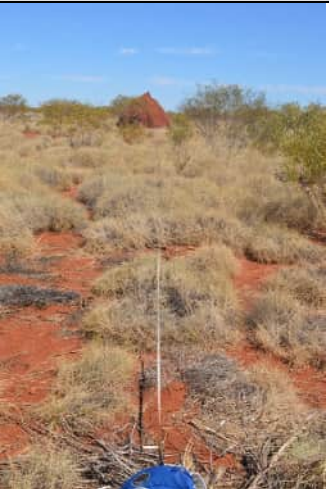
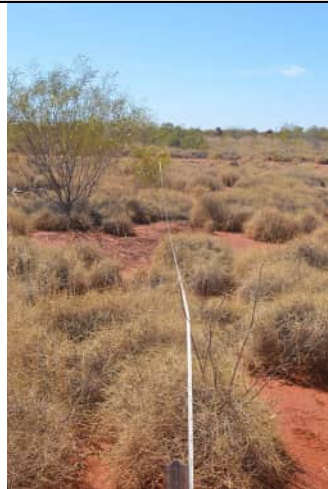
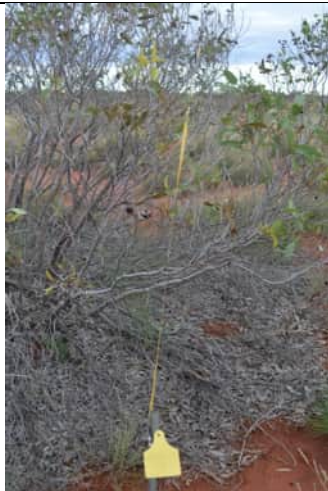
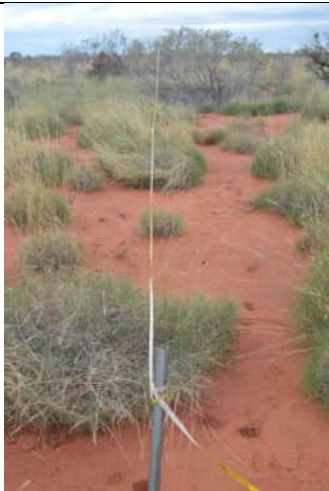
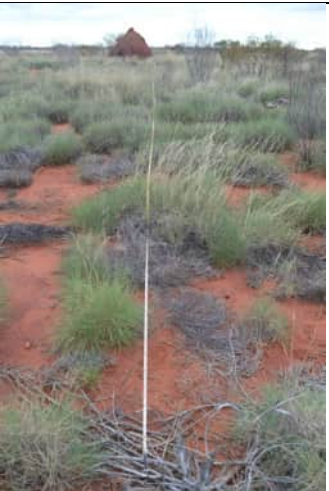
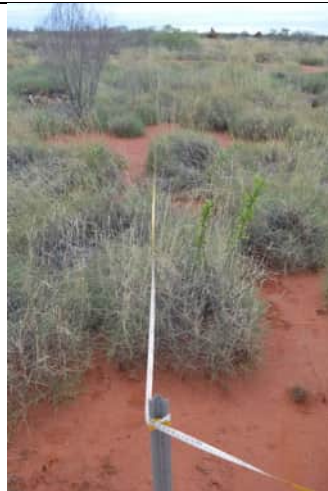
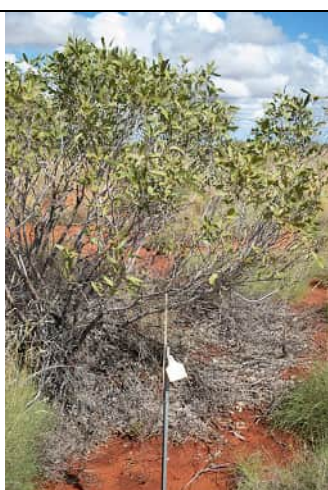
Site 24 (Mt Minnie conservation area)

Analogue Transect BHPPA-24		Rehabilitation Transect BHPPD-24

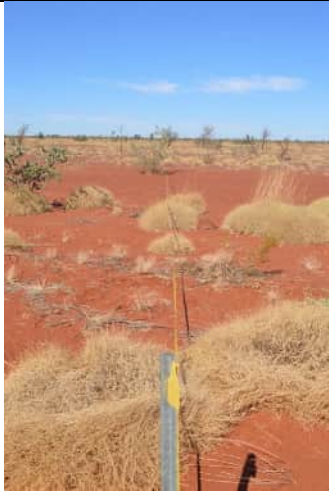
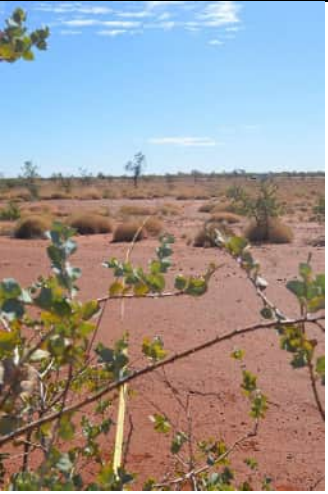
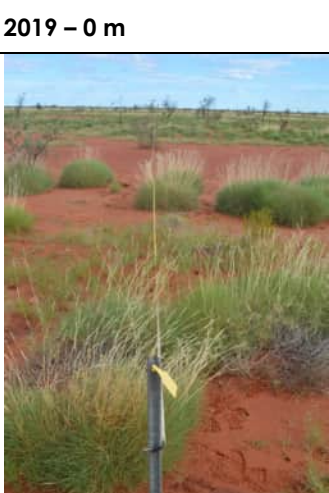
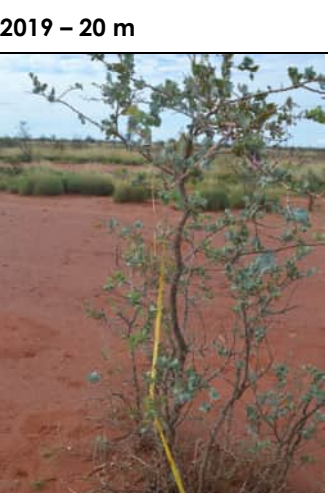
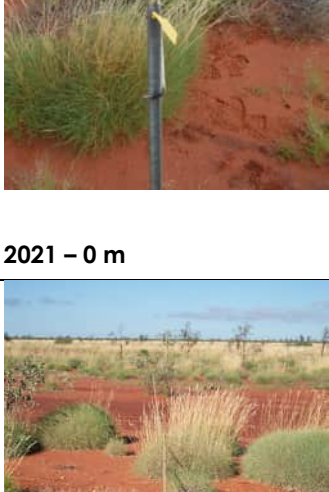
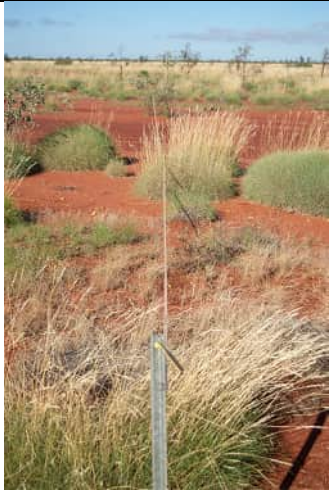
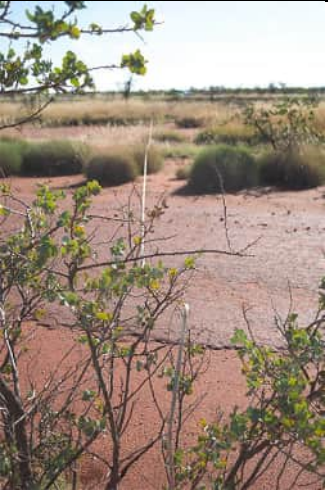
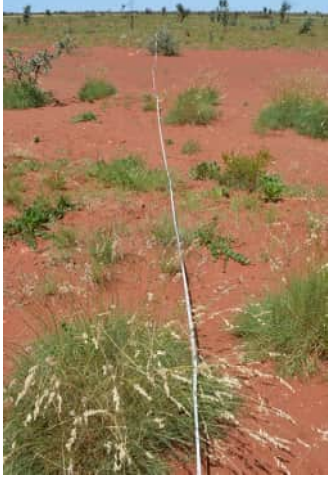
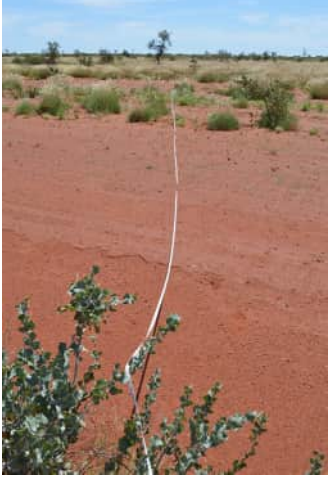
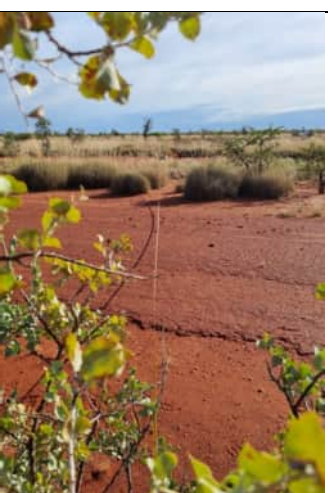
Rehabilitation Transect BHPPD-27

Rehabilitation has remained as good condition in 2023; spinifex cover has seen a decrease in 2023 to 10.15% which now represent only a quarter of pre-clearing levels. Overall there is positive indication that vegetation structure is tending towards its natural state, and would likely be evident in further phases of monitoring given appropriate rainfall; there has also been a decrease in annual grasses like *Aristida contorta* and *Paspalidium clementii*; no weeds were recorded within the sites or in the surrounding vegetation.

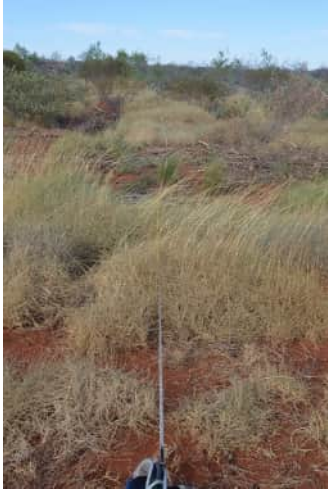
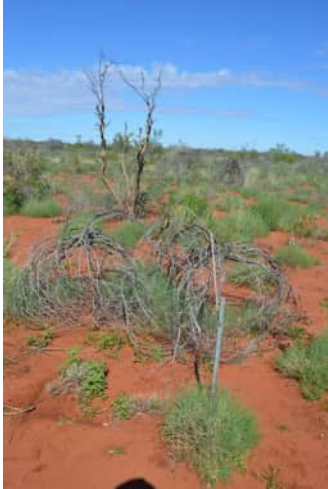
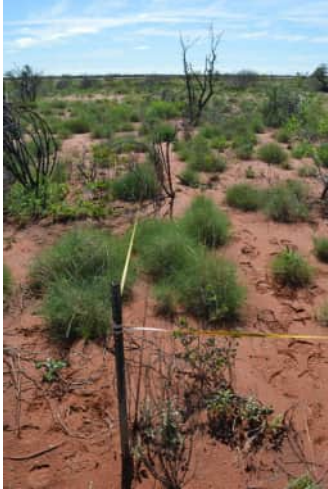
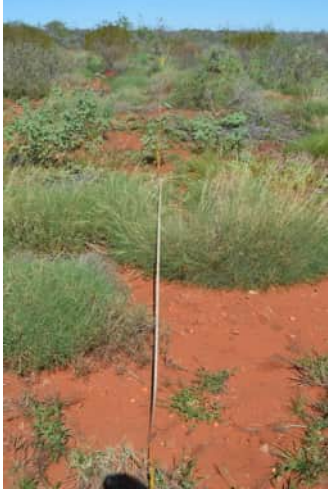
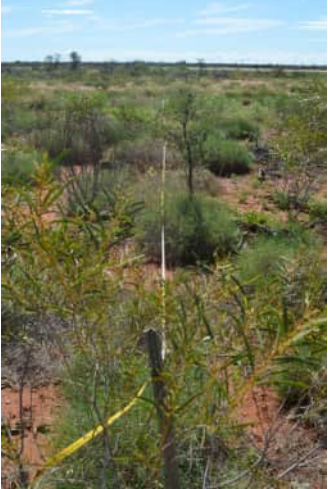
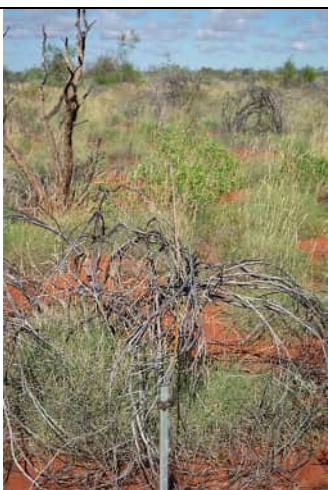
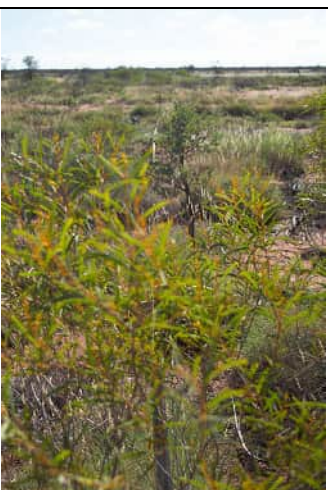
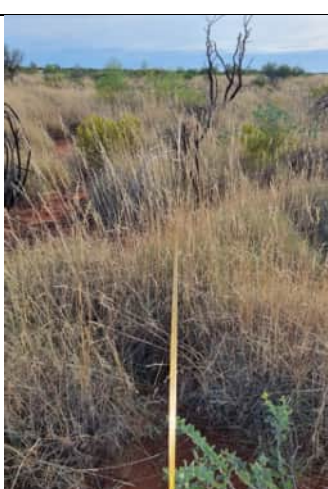
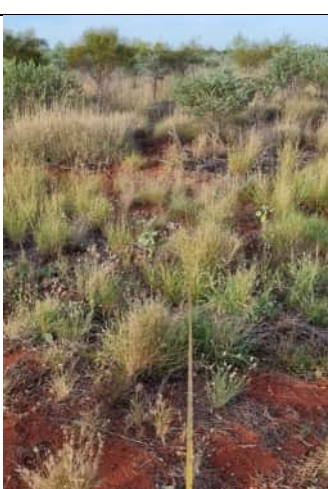
Site 28 (Mt Minnie conservation area)

Rehabilitation is again in very good condition in 2023; spinifex cover has again decreased since 2019 and is at approximately half that of pre-clearing levels in 2023; cover of *Acacia* spp. shrubs is still low compared to pre-clearing with mature *Acacia ancistrocarpa* and *A. bivenosa* reaching 200cm in height and *Senna artemisioides* subsp. *oligophylla* reaching 150cm in the surrounding non-cleared vegetation; less mature *Acacia*'s appear to be present over the clearing footprint; a sharp increase in the cover of *Cenchrus* was recorded 7.5% along the line-intercept and the cover in the surrounding rehabilitated area has increased somewhat.

Species diversity is slightly less in both the Rehabilitation and Analogue transects in 2023 which is most likely due to seasonal conditions. Spinifex cover has again increased in 2023 within the Analogue site to pre-clearing levels.
