PHILCO

# PHILCO HOME RADIO MODELS

D-592, D-593, D-595, D-598, D-727,  
D-728, D-730 and D-736

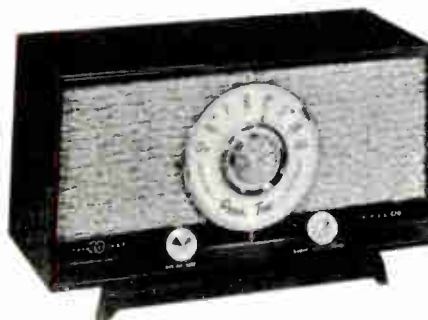
PHILCO MODEL D-598

Cabinet .....D-592, D-593, D-595, D-727,  
D-728 and D-730 — molded  
plastic; D-598 and D-736 —  
wood table model.

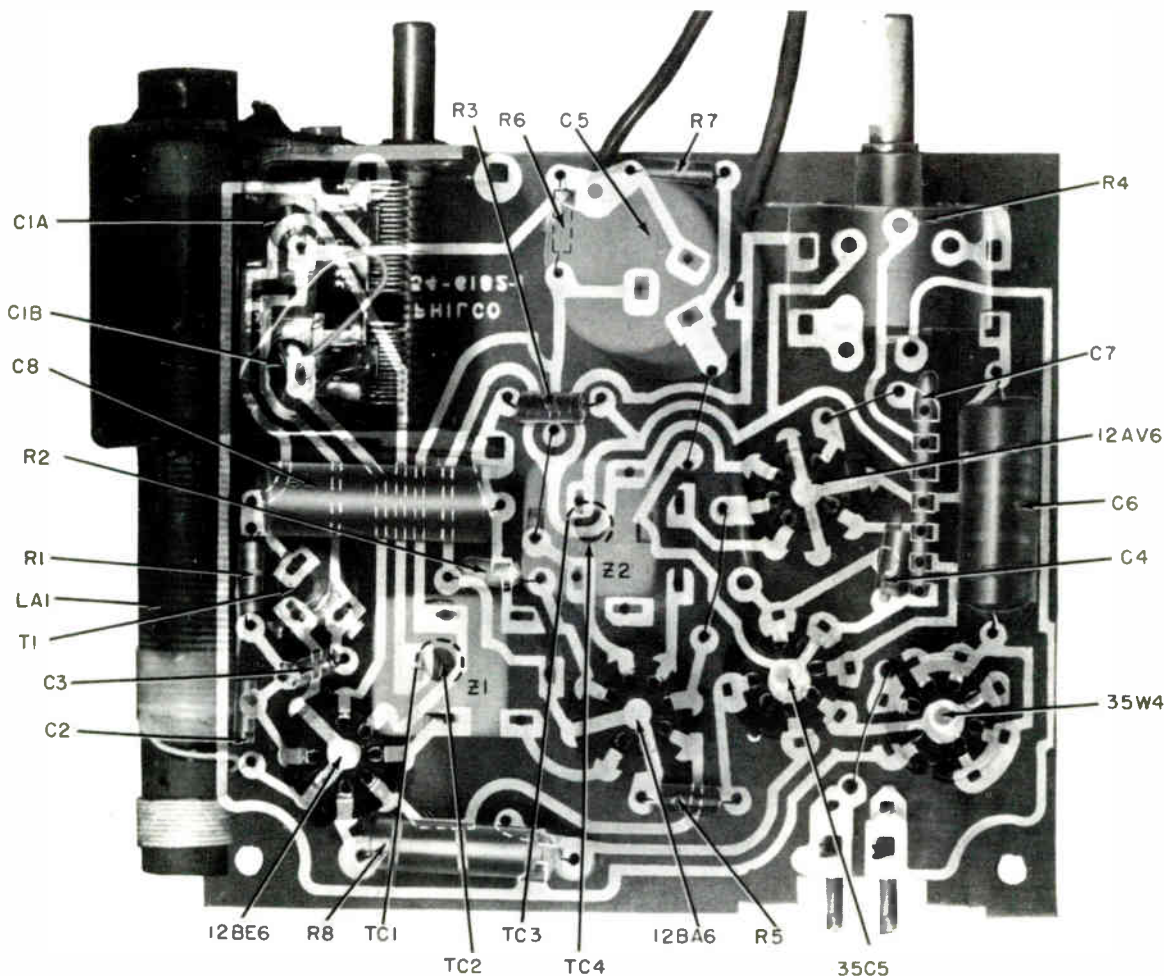
*Composite Photo of Printed Panel Showing Parts Layout*

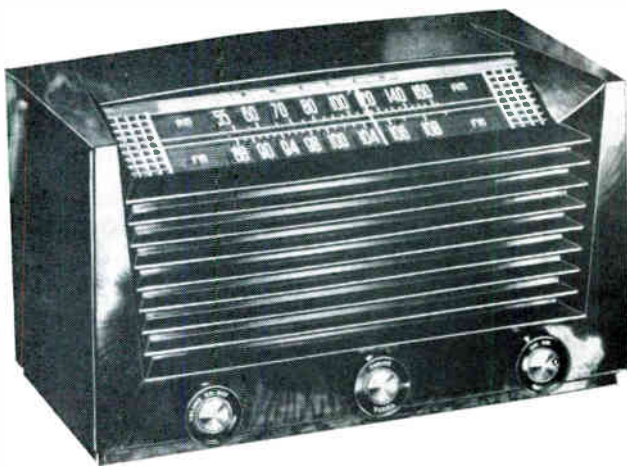
FIGURE 1. Philco Radio Model 52-944

Philco has just announced a new table model AM-FM receiver, Model 52-944 (Figure 1) that has several new quality features. In keeping with our policy of continual leadership, this new set has been considerably improved sensitivity wise. The new models sensitivity is two microvolts better than the preceding comparable model. This will be of particular advantage to fringe area users. However, the big advantage of this set is that the radiation from the FM local oscillator has been kept at an exceedingly low level. While this radiation can be measured with laboratory equipment, for all practical purposes this set does not radiate. It causes no interference to television reception nor to any of the other radio services. The radiation is well within the limits, proposed by the Federal Communications Commission, covering the allowable local oscillator radiation of receiving equipment.

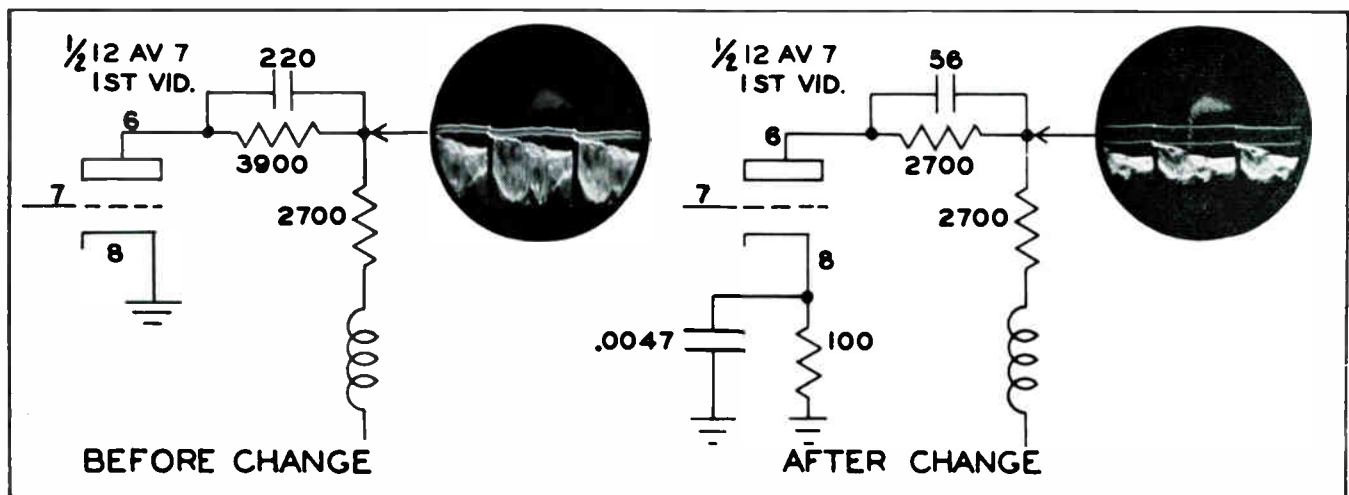
FIGURE 6

It was also found that even though the signal at the video detector output was normal, the first video amplifier might become overloaded under strong signal conditions. In order to correct this condition cathode bias was added by means of a 100 ohm resistor bypassed by a 4700 mmfd. condenser. The plate voltage was increased by changing one of the plate load resistors to 2700 ohms, and the shunting capacity was changed from 220 mfd. to 56 mfd. to improve the high frequency response. See Figure 6.

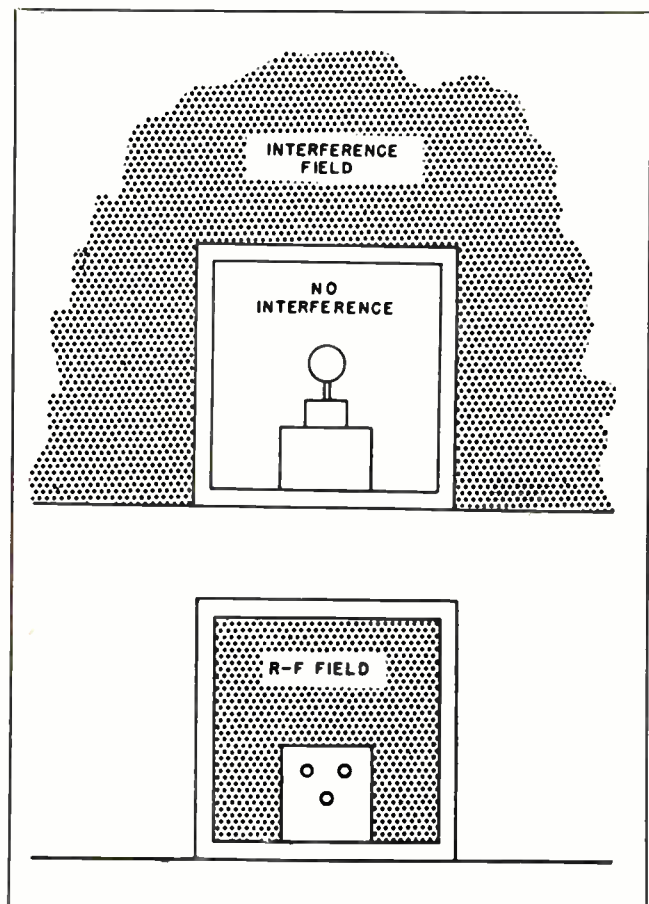
**FIGURE ONE—Shielded Room Provides an Interference-Free Area for Performing Tests, or Confines an R-F Field**

Maximum attenuation results if the two shields are not connected at any point. Since it is generally necessary to provide a duct through which power lines can be run into the room, the next best condition is obtained if connection between the shields is limited to this one point. Connecting the two shields at more

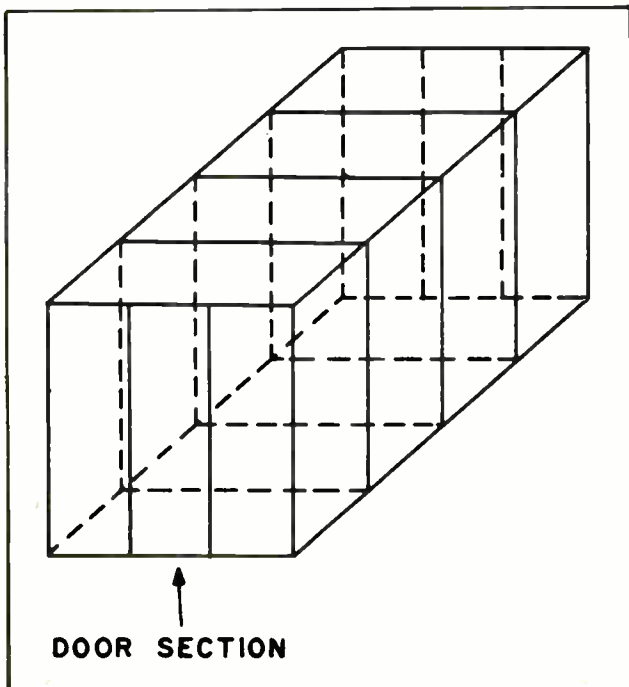
FIGURE TWO—Diagram showing how cells make up a Shielded Room

The use of foil or of solid metal plate for shielding complicates the lighting and ventilation factors; for this reason, copper screen is the most commonly used material. When selecting the screen to be used, a mesh should be selected which is small compared to the thickness of the metal surrounding the hole. An electromagnetic field sets up currents which flow in parallel lines on the surface of the metal. If the mesh is large, the holes will interrupt the current flow, and cause it to flow around the surface of the break to the other face of the screen, where a new field will be set up by re-radiation. This, of course, reduces the effectiveness of the room. A screen between a 16-mesh and a 22-mesh will give good results; a 22-mesh screen is preferred.

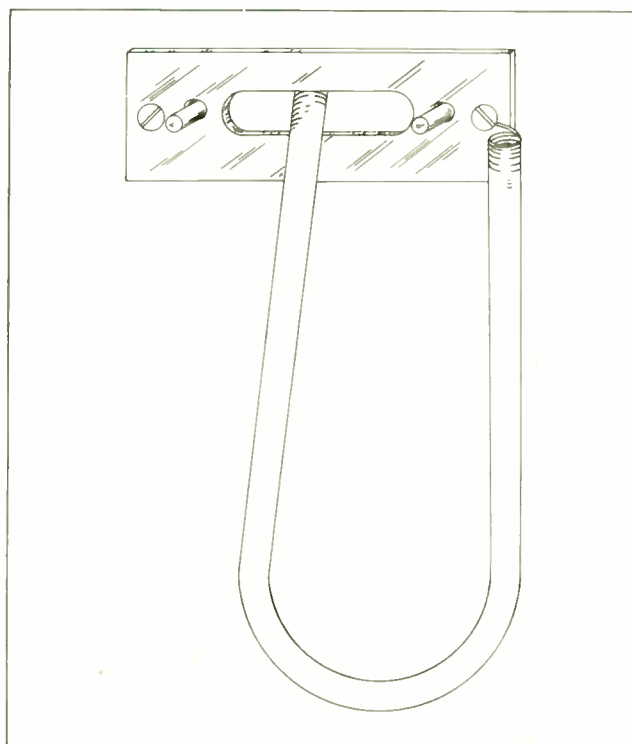
**FIGURE TWO—Proper Alignment of Jiffy Griddle Spring Sheath**

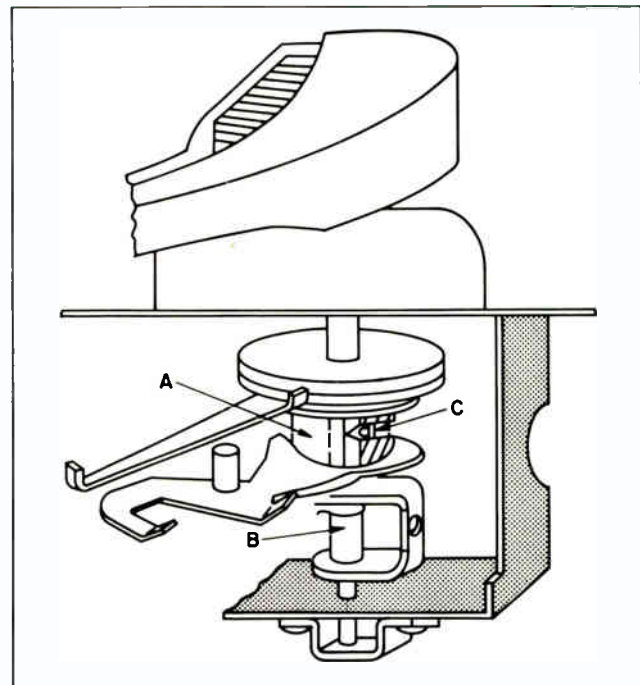
Figure 6

Of all the parts assembled on the tone arm shaft, figure 6, only the stop plate assembly (A) is securely fastened to the shaft (B), by using a set screw (C). Therefore, any up or down or lateral movement of the stop plate is transferred to the tone arm. All the other parts assembled

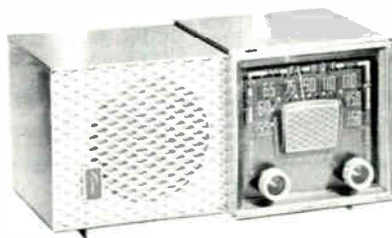
MODEL 53-950

<b>Cabinet</b>		<b>Audio Output</b> .....	1 watt
Model 53-950 .....	Phenolic, brown or ivory	<b>Operating Voltage</b> .....	105—120 volts, a.c. or d.c.
Model 53-952 .....	Phenolic, brown	<b>Power Consumption</b> .....	30 watts
Model 53-954 .....	Wood, mahogany or blond	<b>Antenna</b> .....	Built-in, high-impedance loop
<b>Circuit</b> .....	Five-tube superheterodyne (plus rectifier)	<b>Intermediate Frequency</b> .....	455 kc.
<b>Frequency Range</b>		<b>Philco Tubes</b> .....	6BJ6 r-f ampl.; 12BE6 converter; 6BJ6 i-f ampl.; 6AQ6 det., a.v.c., 1st audio; 35C5 output; 35W4 rectifier
Broadcast .....	540—1620 kc.		
Special Services .....	1700—3400 kc.
