Cameby Downs Continued Operations Project

Aquatic Ecology Assessment

Cameby Downs Continued Operations Project -
Aquatic Ecology Assessment

June 2018

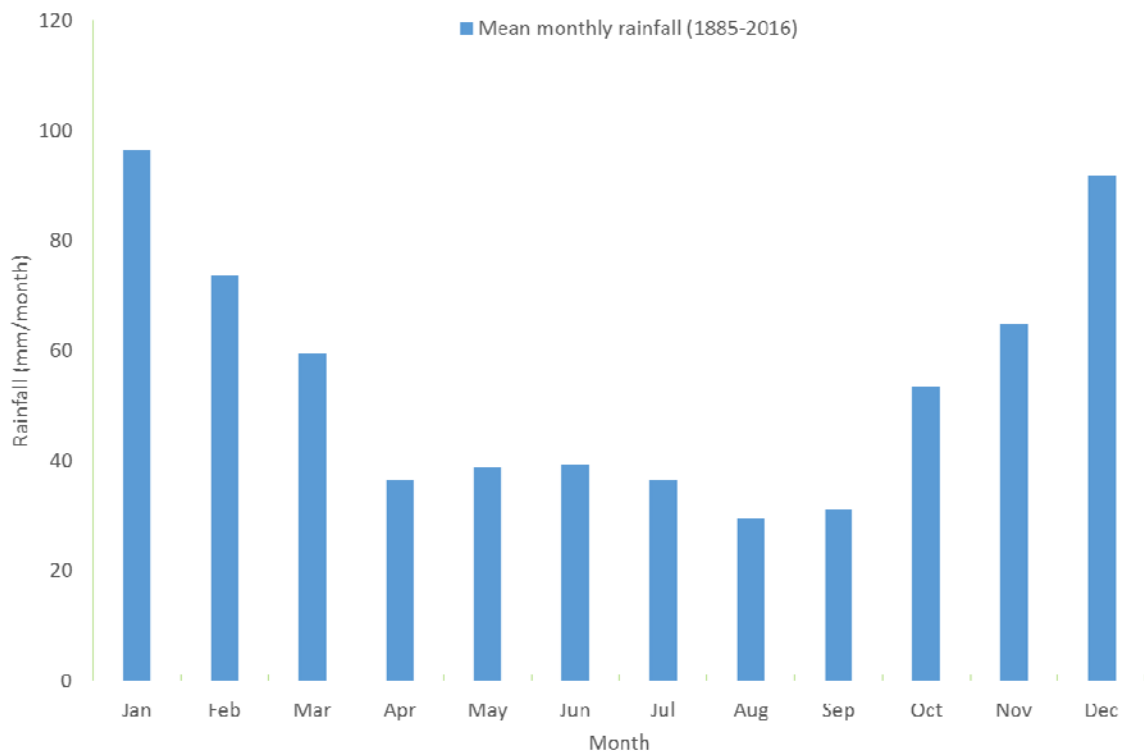
Figure 3 Historical rainfall at Miles Post Office meteorological station 42023 (BoM 2016)

The waterways of the Study area are subject to seasonality, which can be broadly categorised as either dry season or wet season. Rainfall across the Study area is expected to be greatest in mid-summer, with the lowest rainfall expected to occur in late winter, as inferred from data collected at the Miles Post Office monitoring station 42023 (BoM 2016) (Figure 3), located approximately 14 km west of the Study area.

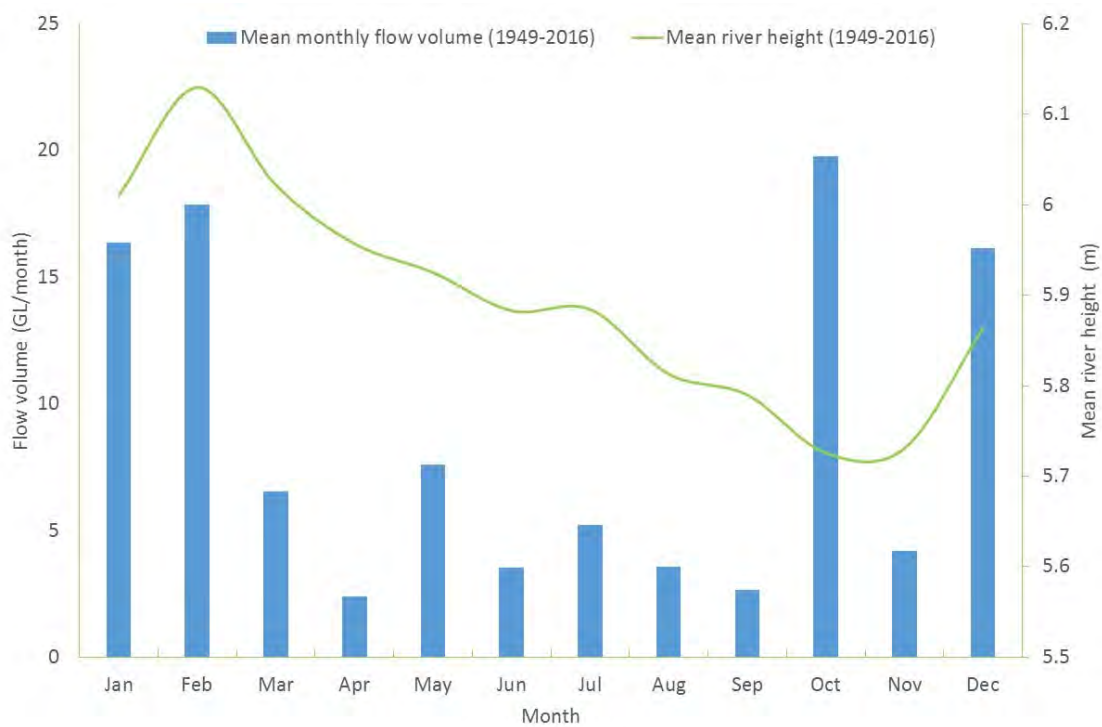
Figure 4 Flow volume and river height for Dogwood Creek at Gilweir (DNRM station 422202B, located approximately 5 km south of Miles)

Historical flow and river height monitoring data (1949-2016) for Dogwood Creek at Gilweir (DNRM monitoring station 422202B), located approximately 5 km south of Miles, provides an indication of the local flow regime. It is noted that although Dogwood Creek receives runoff from Study area, the gauging station is upstream of the confluence with Drainage Line 1, which drains the majority of the Study area. However, historical flow and river height data for this monitoring station suggests that waterways of the broader area are likely to incur reduced flows between March and September (Figure 4) (DNRM 2016).

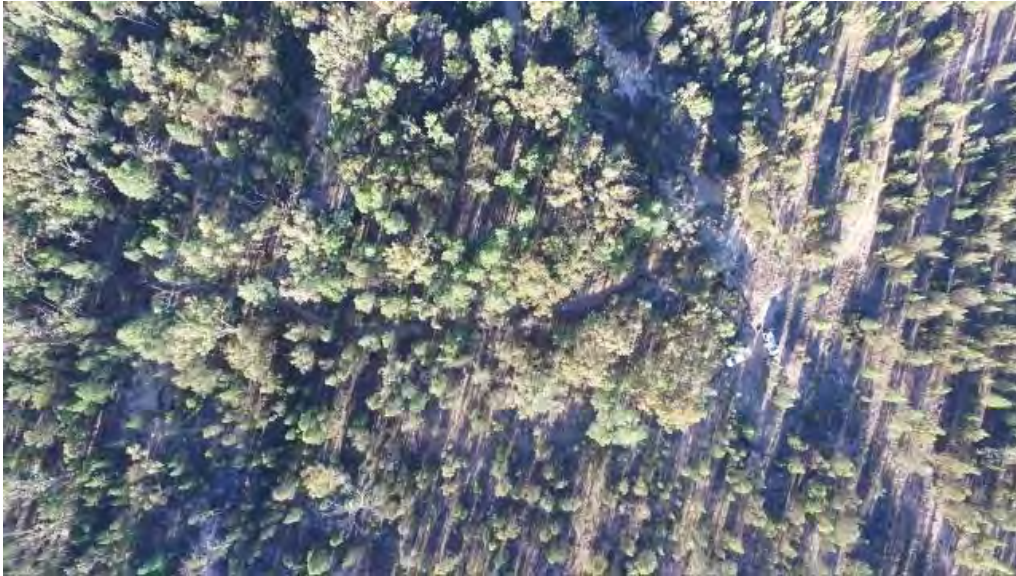
Plate 1 Drainage Line 2 (R1), stream order 2, 27/07/2016

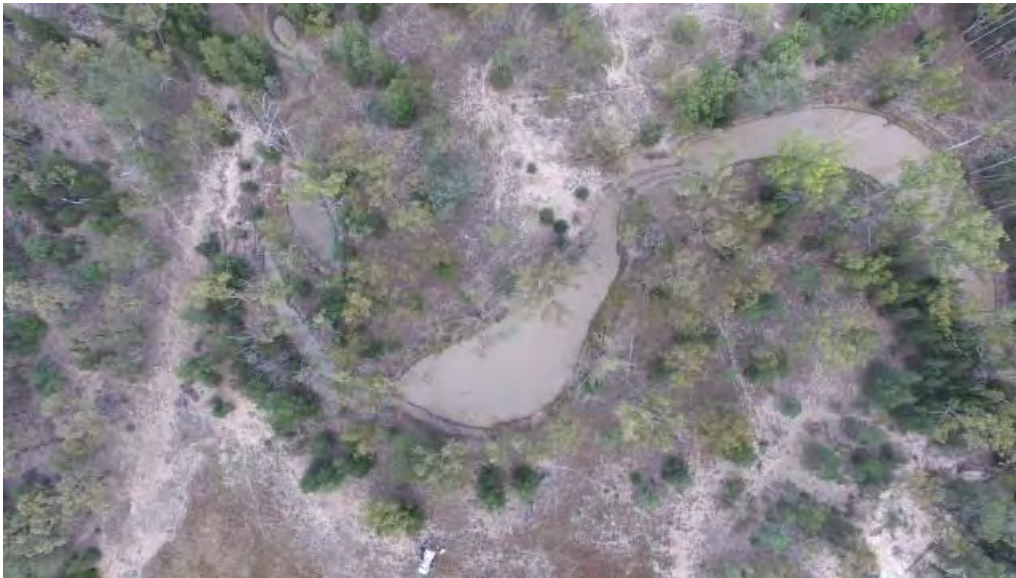
Plate 2 Drainage Line 1 (R2), stream order 3, 25/07/2016

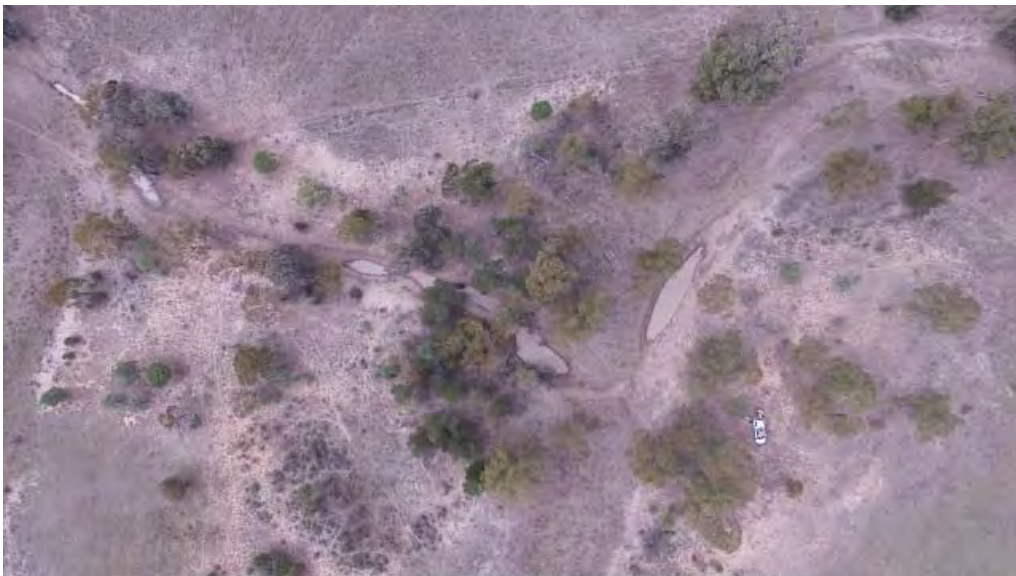
Plate 3 Drainage Line 1 (R3), stream order 1, 25/07/2016

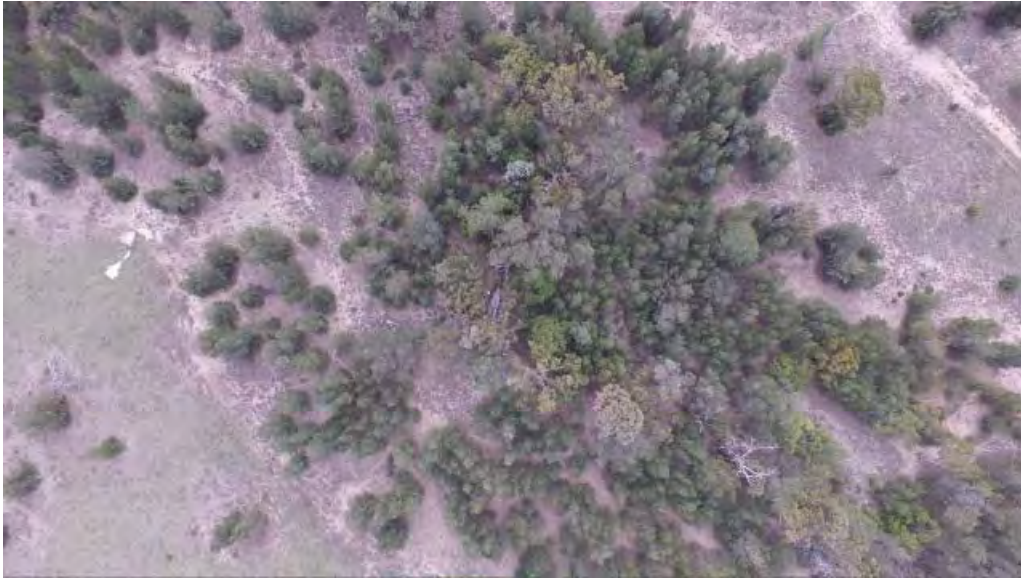
Plate 4 Drainage Line 1 (R4), stream order 2, 27/07/2016

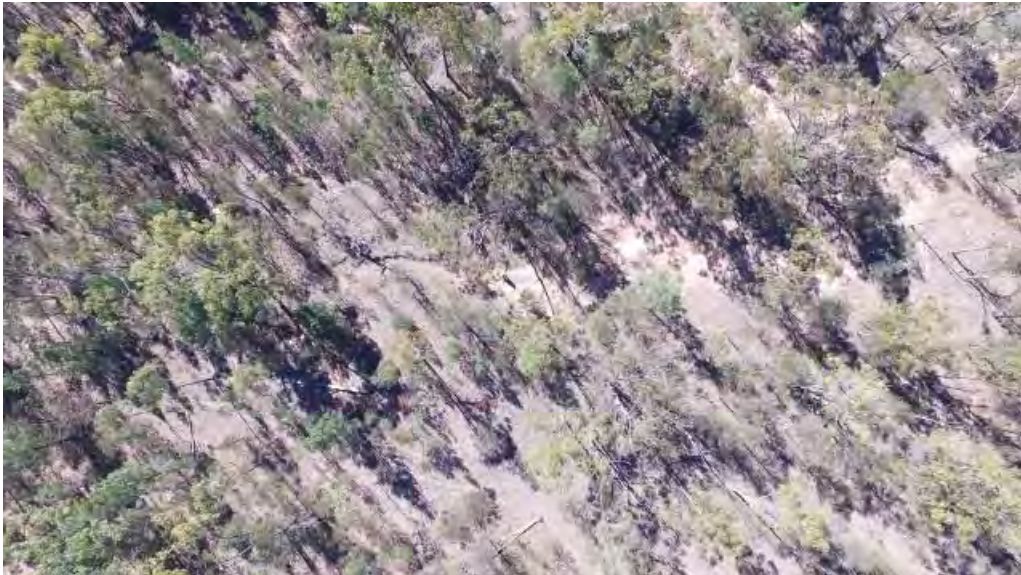
Plate 5 Minor Drainage Feature of Drainage Line 5 (R5), stream order 2, 28/07/2016

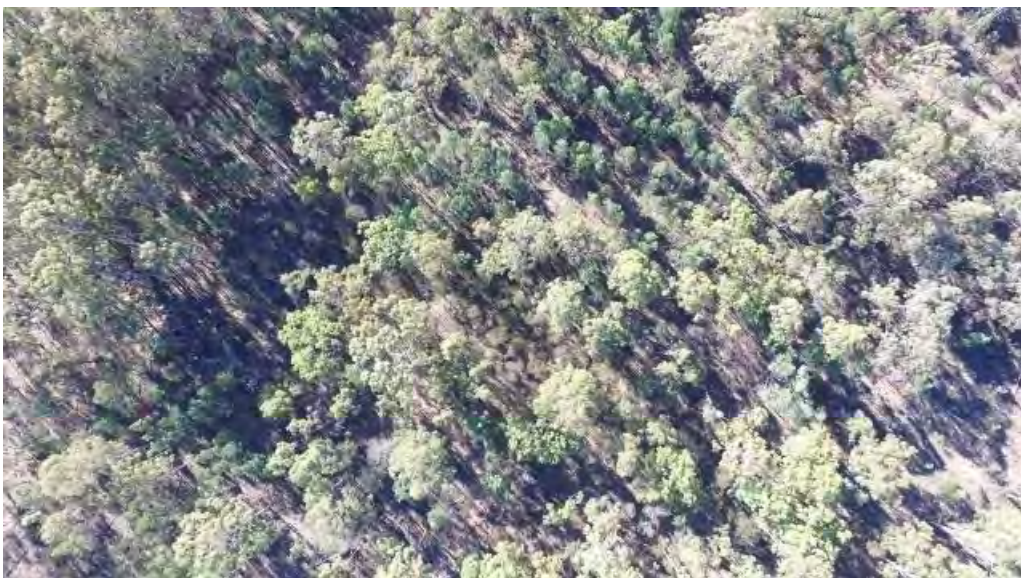
Plate 6 Minor Drainage Feature of Drainage Line 6 (R6), stream order 1, 28/07/2016

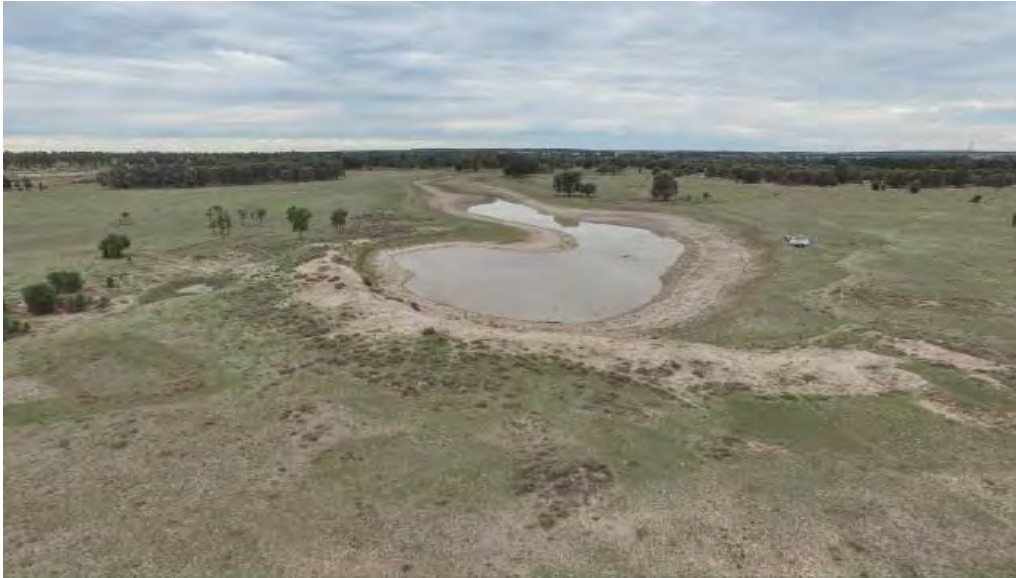
Plate 7 Constructed dam (L1) mapped as lacustrine waterbody, 26/07/2016

No natural lacustrine waterbodies or wetlands were detected within the Study area as each of the 11 mapped lacustrine waterbodies were ground-truthed as being either farm dams or mine water dams during the site visit conducted 25-29 July 2016. Photographs of each waterbody are presented in Plates 7 to 15, along with a location reference corresponding with Figure 7.

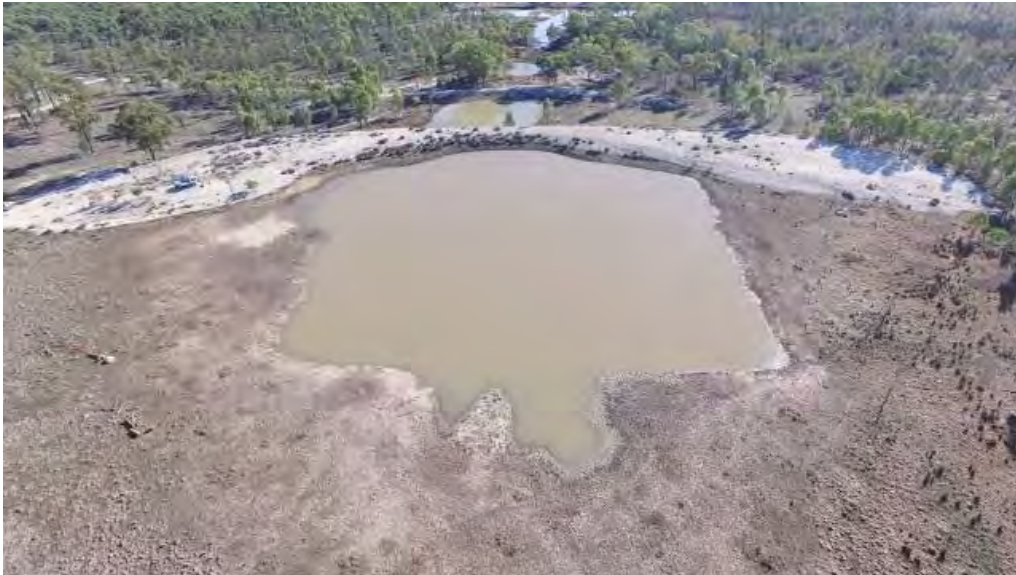
Plate 8 Constructed dam (L2) mapped as lacustrine waterbody, 29/07/2016

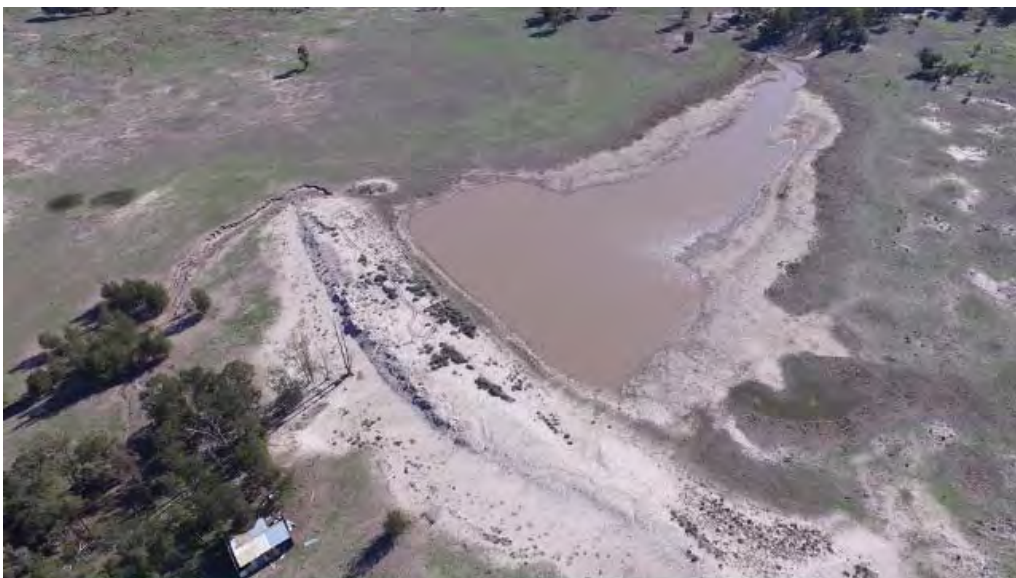
Plate 9 Constructed dam (L3) mapped as lacustrine waterbody, 27/08/2016

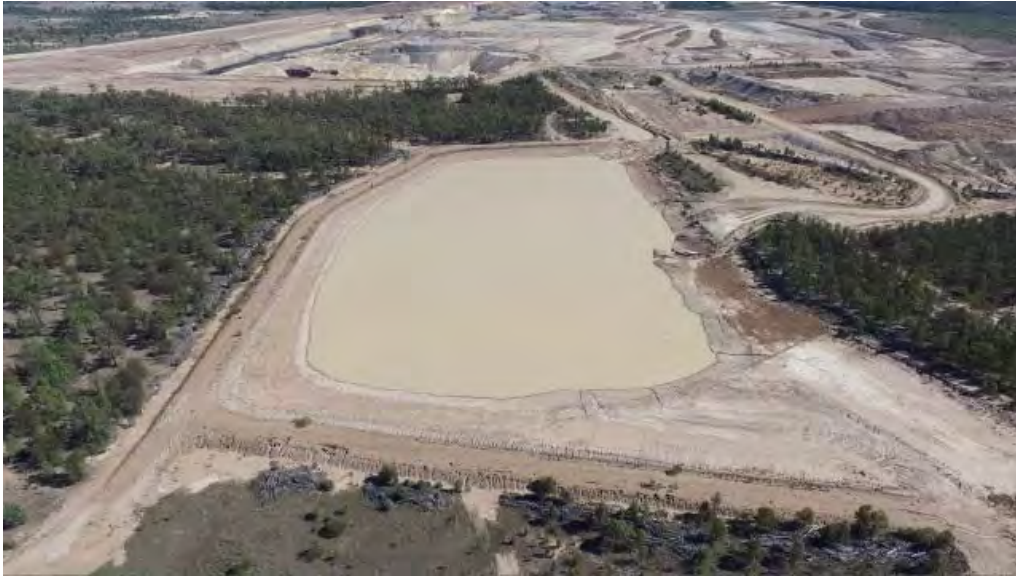
Plate 10 Constructed dam (L4) mapped as lacustrine waterbody, 28/07/2016

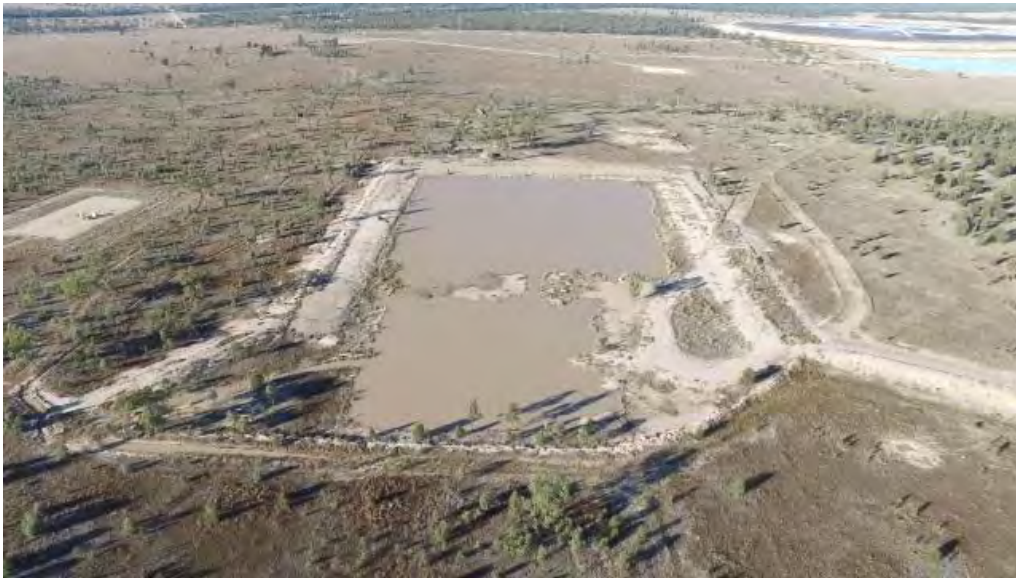
Plate 11 Constructed dam (L5) mapped as lacustrine waterbody, 29/07/2016

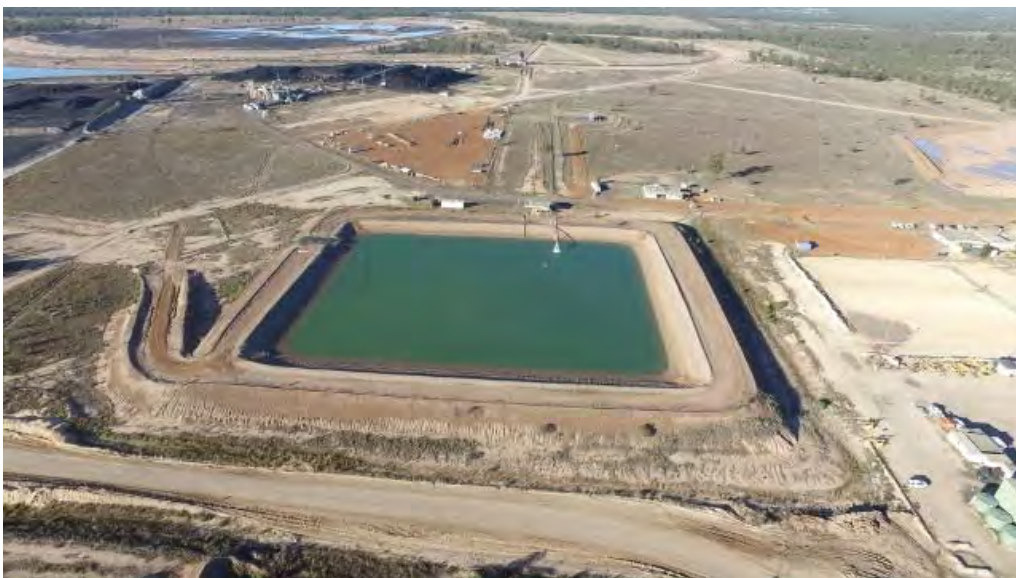
Plate 12 Constructed dam (L6) mapped as lacustrine waterbody, 29/07/2016

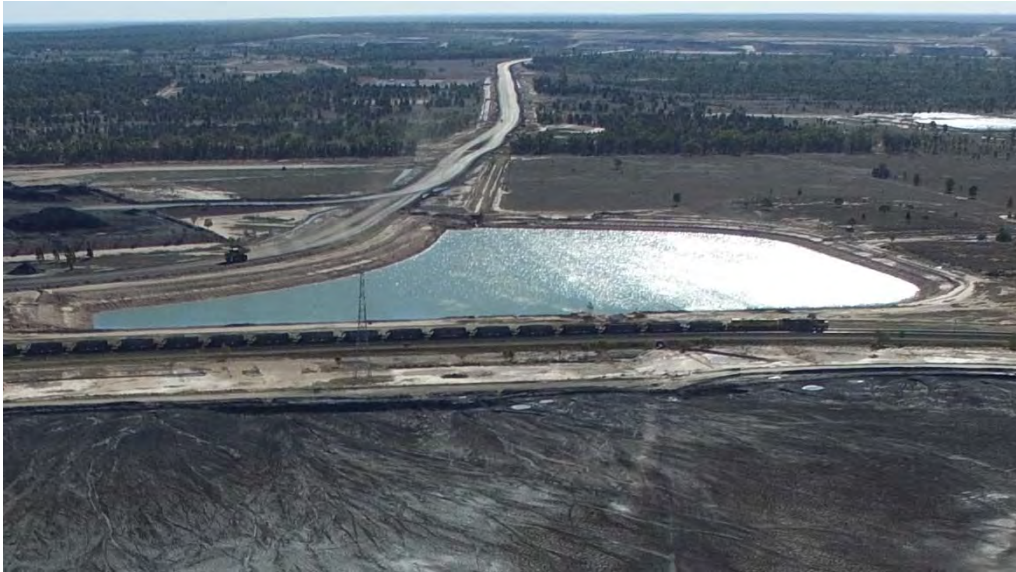
Plate 13 Constructed dam (L7) mapped as lacustrine waterbody, 28/07/2016

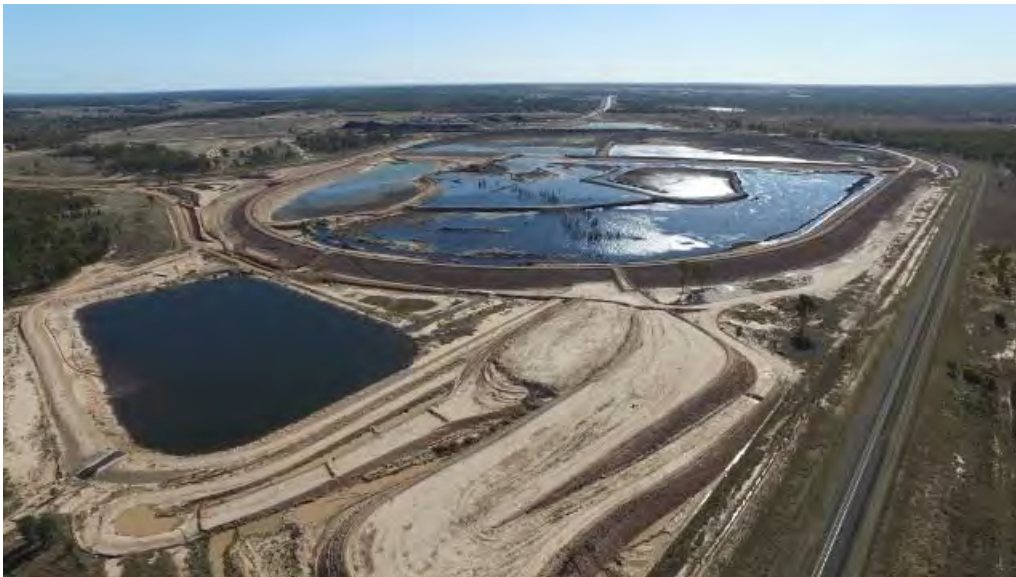
Plate 14 Constructed dams (L8 [top right], L9 [middle] and L10 [left]) mapped as lacustrine waterbodies, 28/07/2016

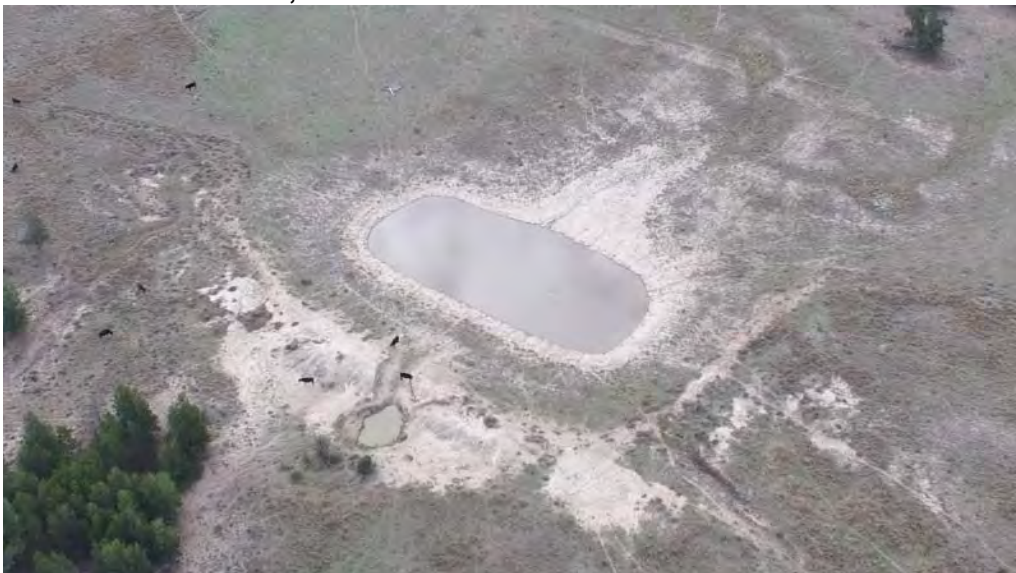
Plate 15 Constructed dam (L11) mapped as lacustrine waterbody, 26/07/2016

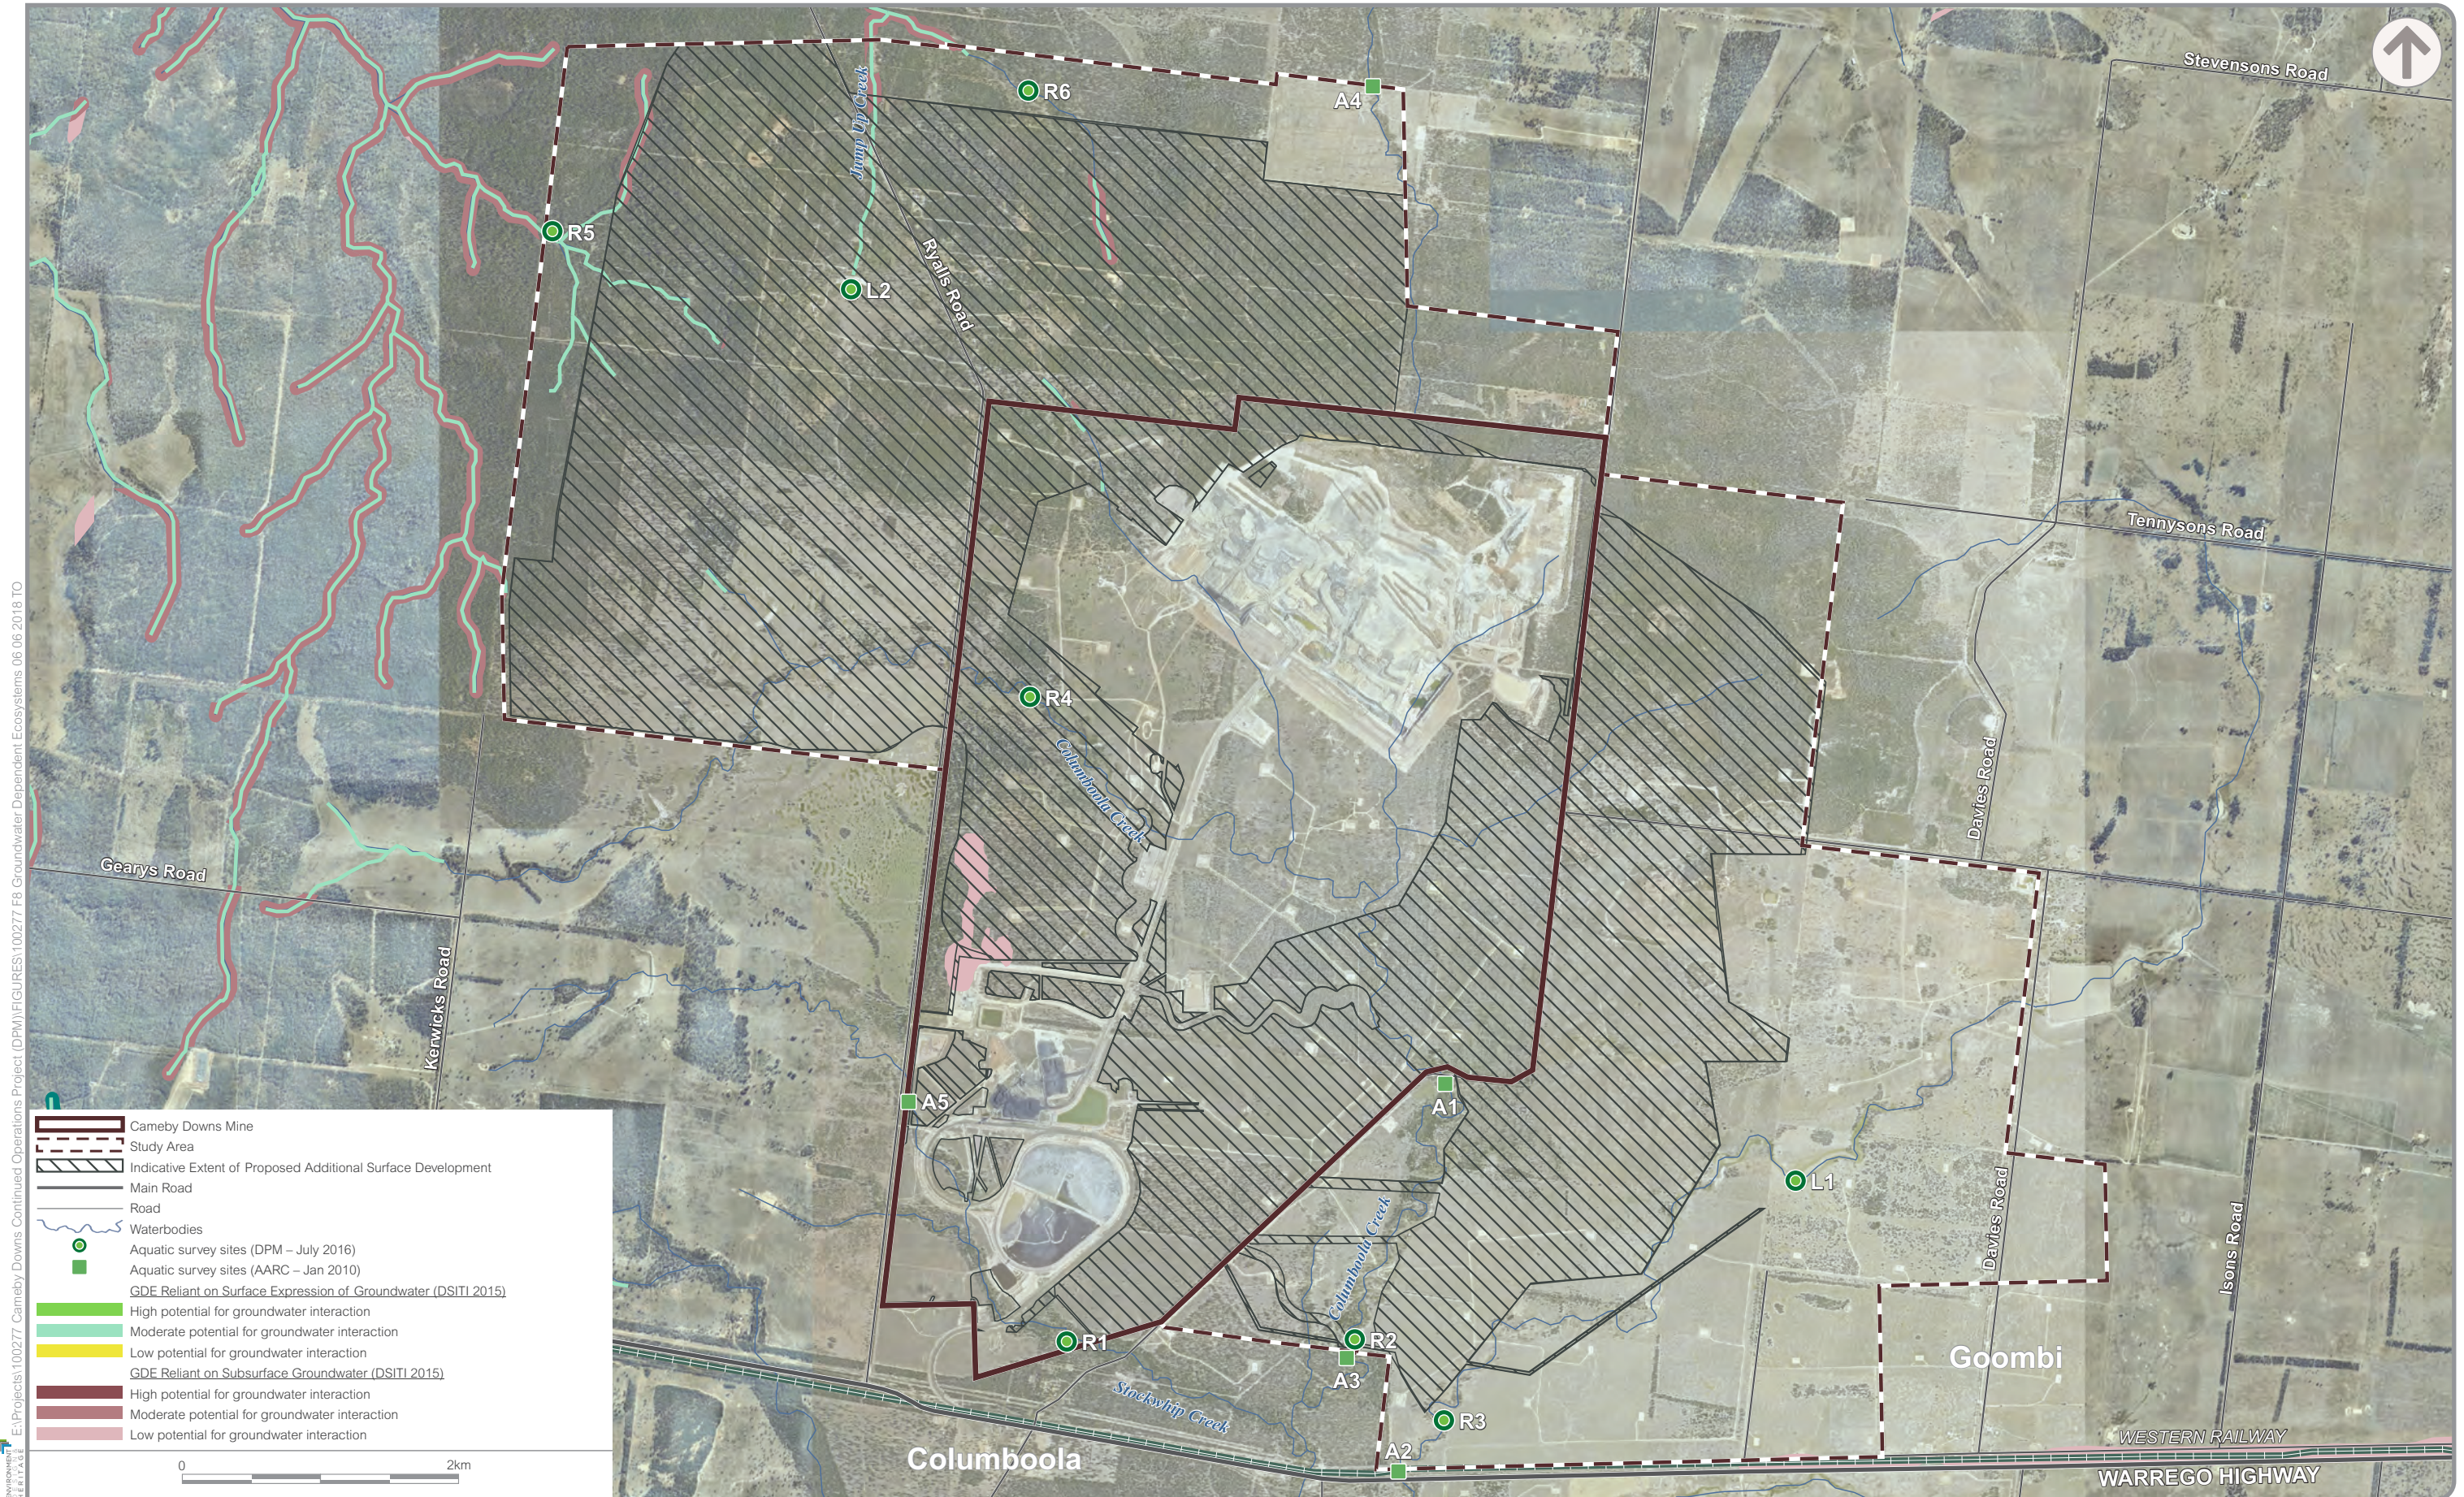
E:\Projects\100277_Cameby Downs Continued Operations Project (DPM)\FIGURES\100277_F8_Groundwater Dependent Ecosystems 06.06.2018.T0

- The patch of terrestrial vegetation in ML 50233 (mapped as RE 11.5.1) is not likely to be dependent on groundwater because the occurrence of this regional ecosystem is dominated by Ironbark Woodlands and comprises tree species that are more widely distributed across the landscape and not restricted to areas where the vegetation could potentially access groundwater (Ecosure 2018).

- There are no other drainage lines, watercourses, wetlands or springs surrounding the Project in the maximum drawdown zone (including those patches of terrestrial vegetation south of ML 50233) that are likely to support GDEs which are connected to the regional groundwater system and subject to any predicted drawdown impacts by the Project (AGE 2018).
