Central Térmica de Temane Project - Terrestrial Ecology Impact Assessment

Moz Power Invest, S.A. and Sasol New Energy Holdings (Pty) Ltd

18103533-320312-1

April 2019

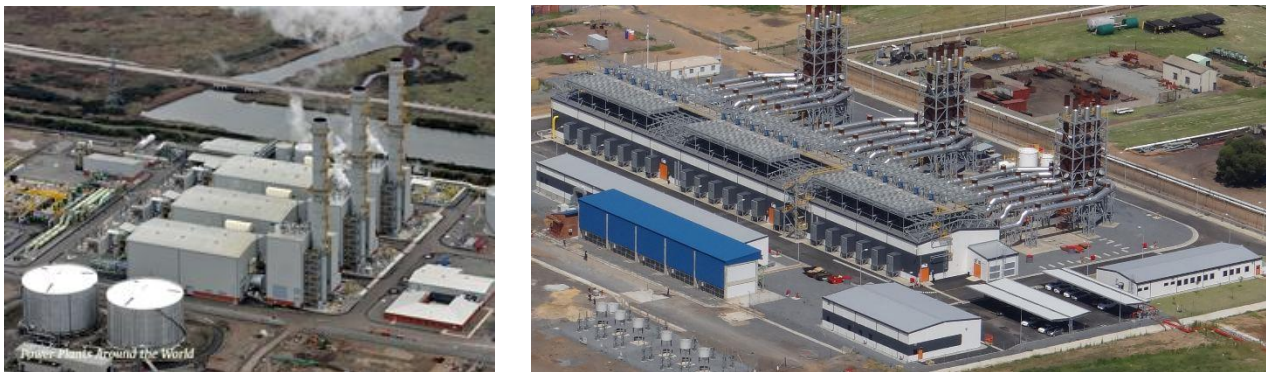
Figure 2: Examples of gas to power plant sites (source: www.industcards.com and www.wartsila.com)

- Gas to Power Plant with generation capacity of 450 MW (examples are shown in Figure 2);
- Gas pipeline (± 2 km) that will feed the Power Plant with natural gas from the CPF;

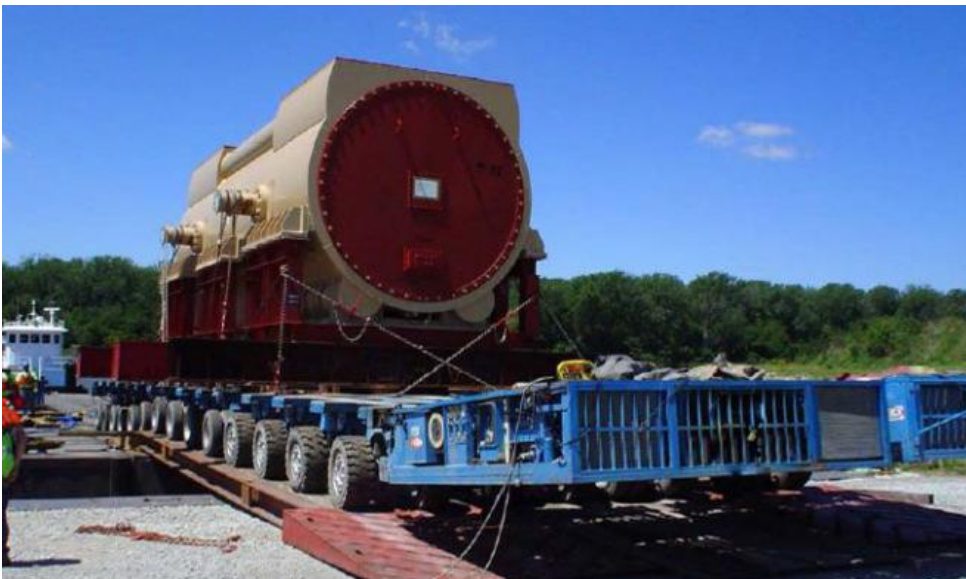
Figure 5: Example of large equipment being offloaded from a barge (Note the levels of the ramp, the barge and the jetty (source: SUBTECH))

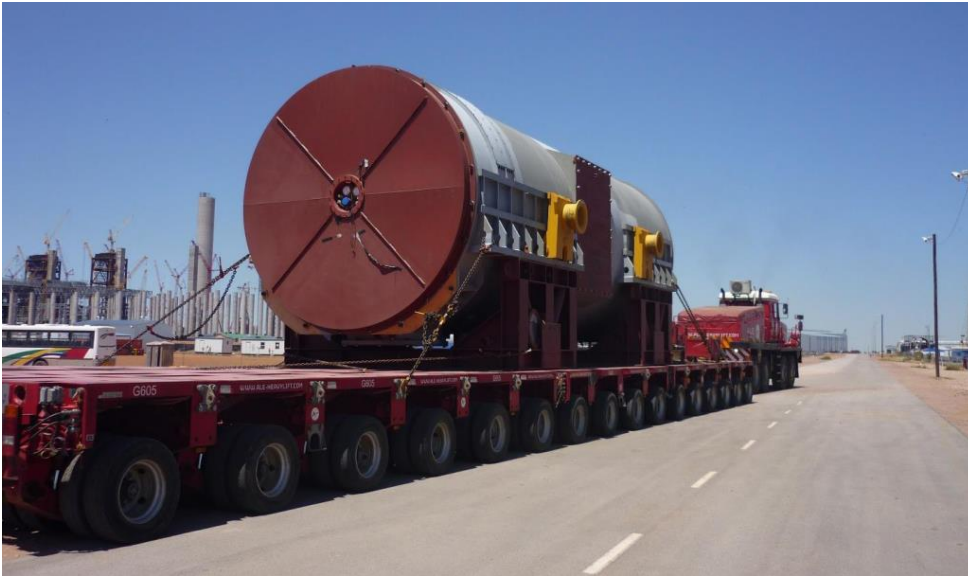
Figure 6: Heavy haulage truck with 16-axle hydraulic trailer transporting a 360 ton generator (source: ALE)

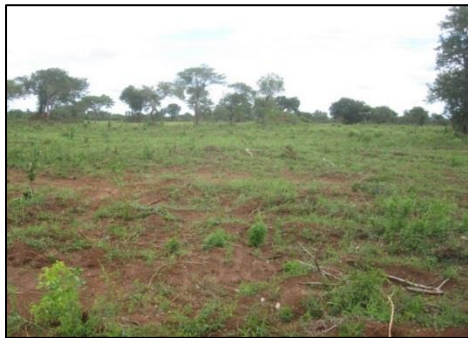
Figure 13: Interior of the Power Plant Site

The proposed Power Plant site is approximately 40 ha in extent and located 500 m south of the existing CPF. As part of demining activities, the site was largely cleared of vegetation prior to the February 2015 field visit. At the time, vegetation thus comprised only scattered large trees, isolated thickets associated with termitaria, as well as pioneer herbaceous regrowth throughout (see Figure 13 and Figure 14). Recorded large trees included *inter alia*; *Senegalia burkei*, *Vachellia nilotica*, *Bolasantus speciosus*, *Combretum imberbe*, *Diospyros mesepiliformis*, *Sclerocarya birrea*, *Spirostachys africana*, with *Dichrostachys cinerea*, *Flueggia virosa* and *Ziziphus mucronata* common as smaller shrubby plants (Golder, 2015b).

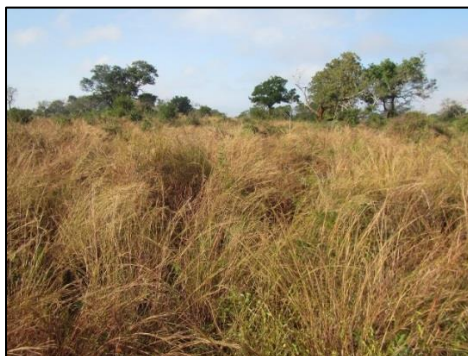
Figure 15: Interior of the Power Plant Site

During the 2018 field survey it was evident that vegetation at the site is recovering, with significant regeneration of the herbaceous component. As expected, ruderal species were dominant, with the pioneer grass *Heteropogon contortus* and various *Hyparrhenia* species particularly abundant and often forming dense swards (Figure 15). Other common pioneer species in the herbaceous layer herbs included *Waltheria indica* and *Lippia javanica*. The emergence of woody shrubs amongst the grass was also noted, with several species present including *inter alia*; *Dichrostachys cinerea*, *Flueggia virosa*, *Grewia micrantha*, *Hyphaene coriacea*, *Phyllanthus reticulatus*, *Sclerocarya birrea* subsp. *caffra* and *Strychnos madagascariensis* (Figure 16).

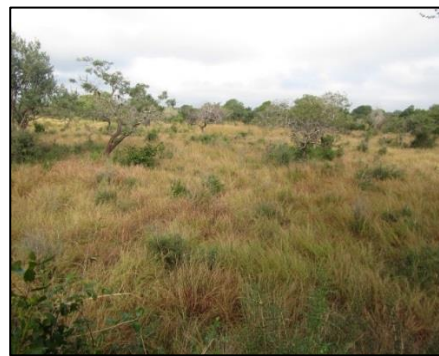
Figure 16: Power Plant Site, note emergence of scattered woody plants

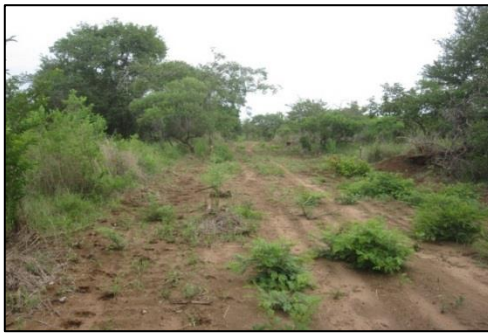
Figure 17: Cleared powerline corridor through woodland

Like the proposed Power Plant site, vegetation in the powerline corridor had been cleared during 2015, and as a result at the time of the 2015 field visit it was characterised by only emergent grasses and herbs, and a few woody plants - see Figure 17 and Figure 18 (Golder, 2015b).

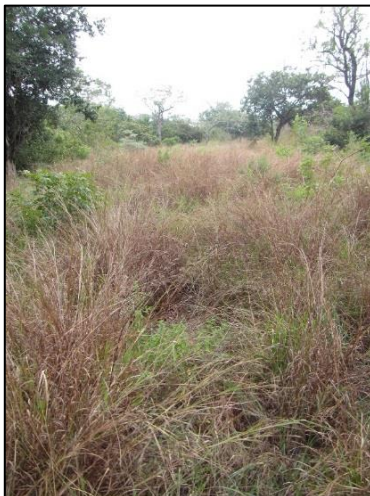
Figure 19: Relatively open powerline corridor, dominated by grasses

During the 2018 field survey, it was noted that vegetation had re-established substantially, and unlike in the 2015, it was not possible to drive along on the old vehicle track the runs the length of the corridor. Along most portions of the corridor, grasses are the most abundant re-coloniser - *Heteropogon contortus* and tall *Hyparrhenia* species are typically dominant, while other taxa such as *Digitaria eriantha*, *Melinis repens*, *Panicum maximum* and *Urochloa mossambicensis* were also noted. Along grass-dominated portions, the corridor is readily distinguished from adjacent vegetation, as shown in Figure 19. Along other portions however, woody vegetation has established well and colonised the cleared footprint.

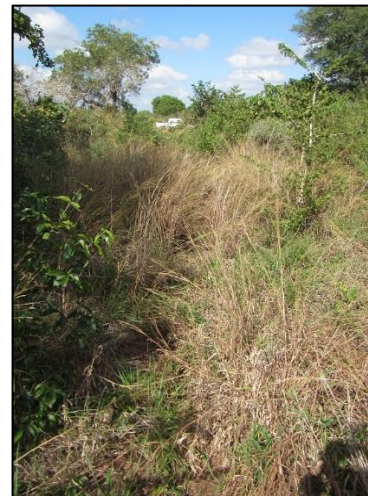
Figure 20: Densely re-vegetated portion of the powerline corridor. Note establishment of woody taxa

In these areas, it was often difficult to even discern where the corridor bisected the various gravel roads that are used to gain access to it (Figure 20). Common woody colonisers include species such as *inter alia*; *Dichrostachys cinerea*, *Ptilostigma thonningii*, *Phoenix reclinata*, *Ormocarpum trichocarpum* and *Terminalia sericea*.

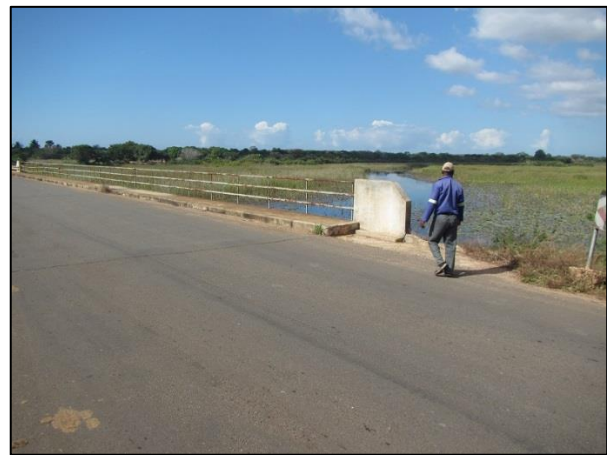
Figure 22: The double lane R241 Inhassoro road as it crosses the Govuro River in 2018

The R241 road servitude from Inhassoro is about 10 m wide (Figure 22). The tarred portion of the road has been widened since the 2015 and it is now a full two-lane road. In terms of floristic composition and species dominance, the terrestrial vegetation adjacent to the road differs markedly on either side of the Govuro River. The dominant vegetation community along the R241 is Open and Closed Woodland. To the east, woodland trees comprises mostly *Julbernardia* and *Brachystegia* species (De Castro and Brits, 2014). The land adjacent to the road along its entire length is heavily disturbed by current or historic cultivation, with only small patches of natural vegetation remaining. In the vicinity of Inhassoro, human habitation increases and the adjacent land is completely transformed.

The R241 road crosses the Govuro River approximately 10 km west of from Inhassoro. Although at the bridge crossing, the river channel is relatively narrow, both immediately up and down stream of the bridge, the river is characterised by a broad, open floodplain comprising hydrophytic grasses, sedges and rushes. The Govuro River Floodplain is considered to have high biodiversity value (Golder, 2017), and is therefore an important and sensitive habitat.

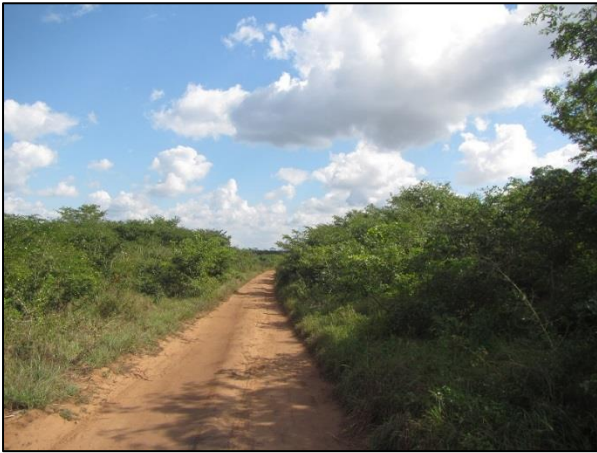
Figure 23: Vehicle track running through *Julbernardia-Brachystegia* Short Woodland (2018)

The vehicle track crosses a dry ephemeral drainage line, which drains into an adjacent inland depression/pan. The drainage line is grass dominated and fringed by *Julbernardia* and *Brachystegia* trees. The track also bypasses an inland depression/pan. Like the Govuro River, these wetland features are considered high biodiversity value, and are therefore both important and sensitive (Golder, 2017).

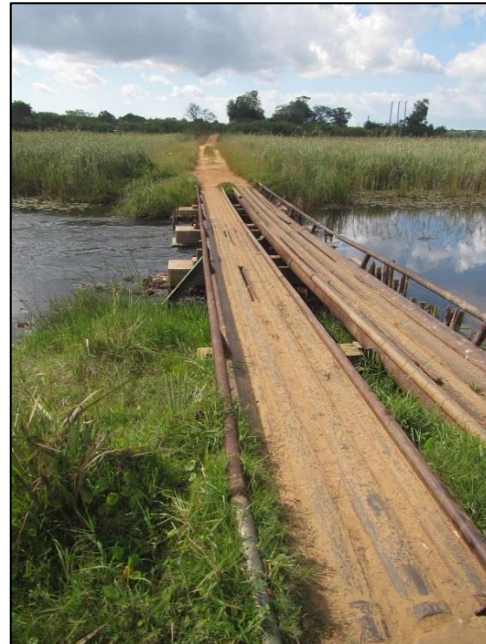
Figure 24: Vehicle track as it crosses the Govuro River (2018)

The vehicle track also crosses the Govuro River at a point where the river is characterised by a broad floodplain, with a reed-dominated channel (see Figure 24).

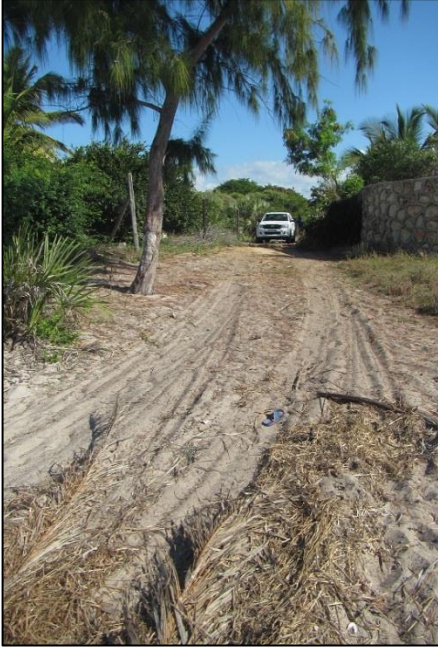
<p data-bbox="606 983 1005 1084">Figure 30: View from the beach toward the Briza Mar access point -2018</p>	<p data-bbox="1061 331 1436 846">The approach to this beach landing is narrow and bordered on either side by tourist lodges. Flora species recorded include the grass <i>Cyndoon dactylon</i> and <i>Panicum maximum</i>, and at the entrance onto the beach the woody <i>Hyphaene coriacea</i>. Several alien invasive species were noted including <i>Casuarina equisetifolia</i>, <i>Leucaena leoucephala</i>, <i>Senna</i> sp. and <i>Ziziphus mauritiana</i>.</p> <p data-bbox="1061 857 1436 1032">Vehicle tracks suggest that this approach is frequently used, probably by adjacent tourist lodges, to launch boats or gain access to the beach.</p> <p data-bbox="1061 1043 1380 1176">There is no evidence of significant change in the ecological character of this site.</p>

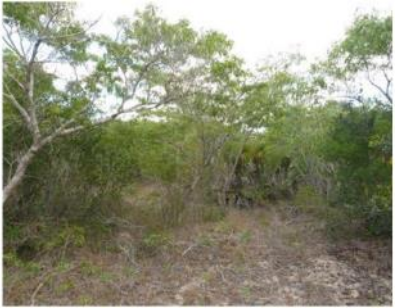
<p><i>Julbernardia globiflora</i> Low Thicket</p>	<ul style="list-style-type: none"> ■ Landscape Unit: Western Plains, Southern Coastal Plain; ■ Terrain Features: Level to undulating plains; ■ Soil Types: Deep, white Aeolian sands; and ■ Vegetation Structure: Low thicket, sometimes merging with Low closed woodland. Canopy cover 80 - 100%. Canopy height 2 - 5 m. 	<ul style="list-style-type: none"> ■ Dominant Species: <i>Julbernardia globiflora</i>; and ■ Species of conservation concern: <i>Xylia mendoncae</i> (VU). <p>Numerous protected species.</p>

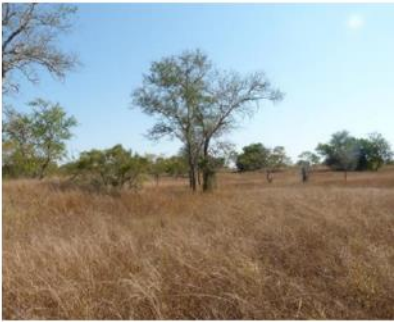
Vegetation Communities	Key Characteristics	Dominant Species and Species of Conservation Concern	Photographs	Biodiversity Value
<p><i>Acacia nigrescens</i> - <i>Acacia robusta</i> Tall Open Woodland</p>	<ul style="list-style-type: none"> ■ Landscape Unit: Save River Valley, Low Plateau, Western Plains; ■ Terrain Features: Level terrain with scattered termitaria; ■ Soil Types: Dark to light grey-brown clay loam or loamy sand with clay patches; and ■ Vegetation Structure: Tall open woodland. Canopy cover 20 - 40%. Canopy height 5 – 8 m. 	<ul style="list-style-type: none"> ■ Dominant Species: <i>Acacia nigrescens</i>, <i>Acacia robusta</i> subsp. <i>usambarensis</i>, and <i>Combretum imberbe</i>; and ■ Species of conservation concern: <i>Dalbergia melanoxylon</i> (NT). Numerous protected species.

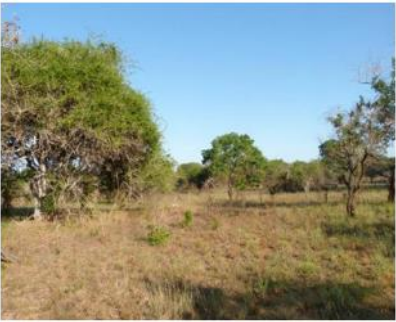
<p>Medium</p>
<p>Tall Mixed Broad-leaved Woodland</p>	<ul style="list-style-type: none"> ■ Landscape Unit: Save River Valley, Low Plateau, Western Plains; ■ Terrain Features: Level terrain with numerous large termitaria; ■ Soil Types: Light grey-brown to reddish brown sandy loam to moderately deep reddish brown sand; and ■ Vegetation Structure: Tall mid-dense to closed woodland. Canopy cover 40 - 80%. Canopy height 5 - 8 m. 	<ul style="list-style-type: none"> ■ Dominant Species: <i>Sclerocarya birrea</i>, <i>Xeroderris stuhlmanni</i>, <i>Pseudolachnostylis maprouneifolia</i>, <i>Terminalia sericea</i>, <i>Acacia nigrescens</i>, <i>Acacia robusta</i> subsp. <i>Usambarensis</i>; and ■ Species of conservation concern: <i>Dalbergia melanoxylon</i> (NT), <i>Pterocarpus angolensis</i> (NT). Numerous protected species.

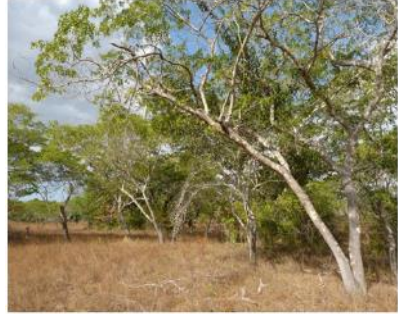
Vegetation Communities	Key Characteristics	Dominant Species and Species of Conservation Concern	Photographs	Biodiversity Value
<p><i>Julbernardia globifera</i> - <i>Brachystegia spiciformis</i> Low to Tall Closed Woodland</p>	<ul style="list-style-type: none"> ■ Landscape Unit: Western Plains. Southern Coastal Plain; ■ Terrain Features: Undulating to level plains with scattered, large <i>termitaria</i>; ■ Soil Types: Deep white to light brown sands; and ■ Vegetation Structure: Low to tall closed woodland. Canopy cover 60 -80%. Canopy height 4 - 7m. 	<ul style="list-style-type: none"> ■ Dominant Species: <i>Julbernardia globifera</i>, <i>Brachystegia spiciformis</i>; and ■ Species of conservation concern: A number of protected species.

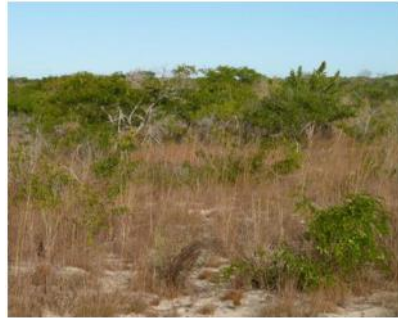
<p>Medium</p>
<p><i>Julbernardia globifera</i> - <i>Garcinia livingstonei</i> - <i>Hyphaene coriacea</i> Low Mid-dense Woodland</p>	<ul style="list-style-type: none"> ■ Landscape Unit: Western Plains. Southern Coastal Plain; ■ Terrain Features: Undulating to level plains with scattered, large <i>termitaria</i> and moist depressions; ■ Soil Types: Deep white to light brown sands; and ■ Vegetation Structure: Low open to mid-dense woodland. Canopy cover 40 - 60%. Canopy height 3 – 7 m. 	<ul style="list-style-type: none"> ■ Dominant Species: <i>Julbernardia globifera</i>, <i>Garcinia livingstonei</i>, <i>Hyphaene coriacea</i>; and ■ Species of conservation concern: <i>Pterocarpus angolensis</i> (NT). Numerous protected species.

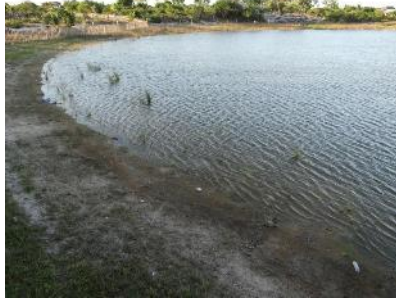
Vegetation Communities	Key Characteristics	Dominant Species and Species of Conservation Concern	Photographs	Biodiversity Value
<p>Permanently to Seasonally Wet Coastal Depressions</p>	<ul style="list-style-type: none"> ■ Landscape Unit: Southern Coastal Plain; ■ Terrain Features: Relatively shallow basins on level plains; groundwater-fed systems; ■ Soil Types: Coarse white sands; and ■ Vegetation Structure: Sparse cover of emergent hydrophytes in permanently inundated zone; low density grass/sedge cover in seasonally inundated zone. 	<ul style="list-style-type: none"> ■ Dominant Species: <i>Eleocharis spp.</i>, <i>Schoenoplectus spp.</i>, <i>Cyperus spp.</i>; and ■ Species of Conservation Concern: None recorded.

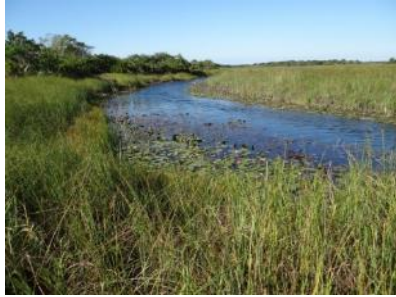
<p>High</p>
<p>Permanently to Seasonally Wet Floodplains (Govuro River)</p>	<ul style="list-style-type: none"> ■ Landscape Unit: Govuro Floodplain; ■ Terrain Features: Level floodplain on either side of river; ■ Soil Types: Sandy soils with leached E-horizons; and ■ Vegetation Structure: Various vegetation zones depending on frequency and duration of inundation. 	<ul style="list-style-type: none"> ■ Dominant Species: <i>Cladium mariscus</i>, <i>Phragmites australis</i>, <i>Cyperus spp.</i>; and ■ Species of Conservation Concern: Unique ecotype of <i>Chrysopogon serrulatus</i>.

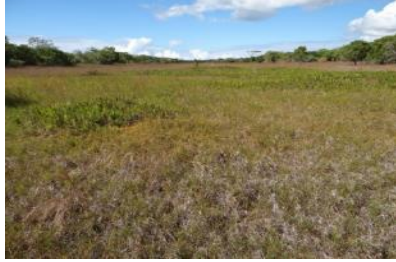
<p>Seasonally to Intermittently Wet Drainage Lines</p>	<ul style="list-style-type: none"> ■ Landscape Unit: Southern and Northern Coastal Plain; ■ Terrain Features: Moderately broad to narrow drainage lines on plains; ■ Soil Types: Sandy soils; and ■ Vegetation Structure: Grass meadows with limited sedges. 	<ul style="list-style-type: none"> ■ Dominant Species: <i>Imperata cylindrica</i>, <i>Andropogon eucomus</i>, <i>Phragmites australis</i>; and ■ Species of Conservation Concern: None recorded.
