**DUN FHINN
KILDALTON, ISLAY
AN ARCHAEOLOGICAL SURVEY**

**DATA STRUCTURE REPORT
May 2017
Roderick Regan**

ISLAY HERITAGE
DUALCHAS ÌLE

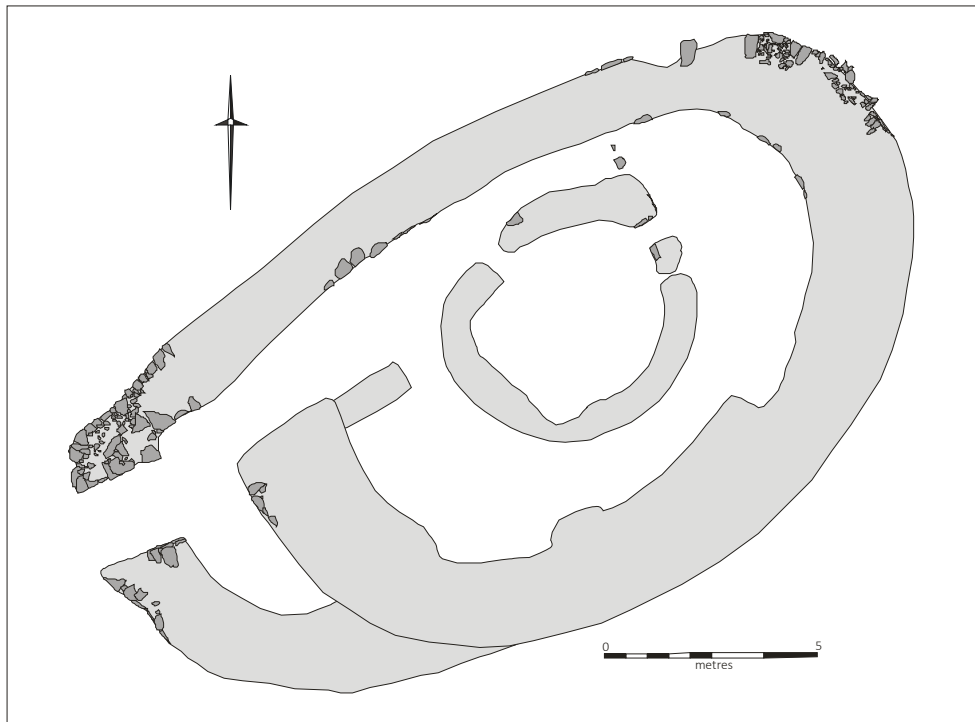
Figure 4: Plan of Dun Fhinn

debris covers the SE flank of the knoll in a scree-like spread. At the SW end there is a particularly heavy spread of jumbled stones, and while without excavation it is not possible to be sure, it seems most likely that, as indicated on the plan, the wall split into two sections; the inner section followed the margin of the summit to complete the dun wall, while the outer section branched down towards the foot of the knoll, through a drop of about 3m, to form a curving outwork. The entrance through the outwork is 2.7m in average width, and a short length of each of the side-walls of the passage is exposed. The entrance through the inner wall is obscured by debris. Within the interior there is a later intrusive enclosure formed by a wall 1m thick with an entrance facing NE' (RCAHMS 1984).

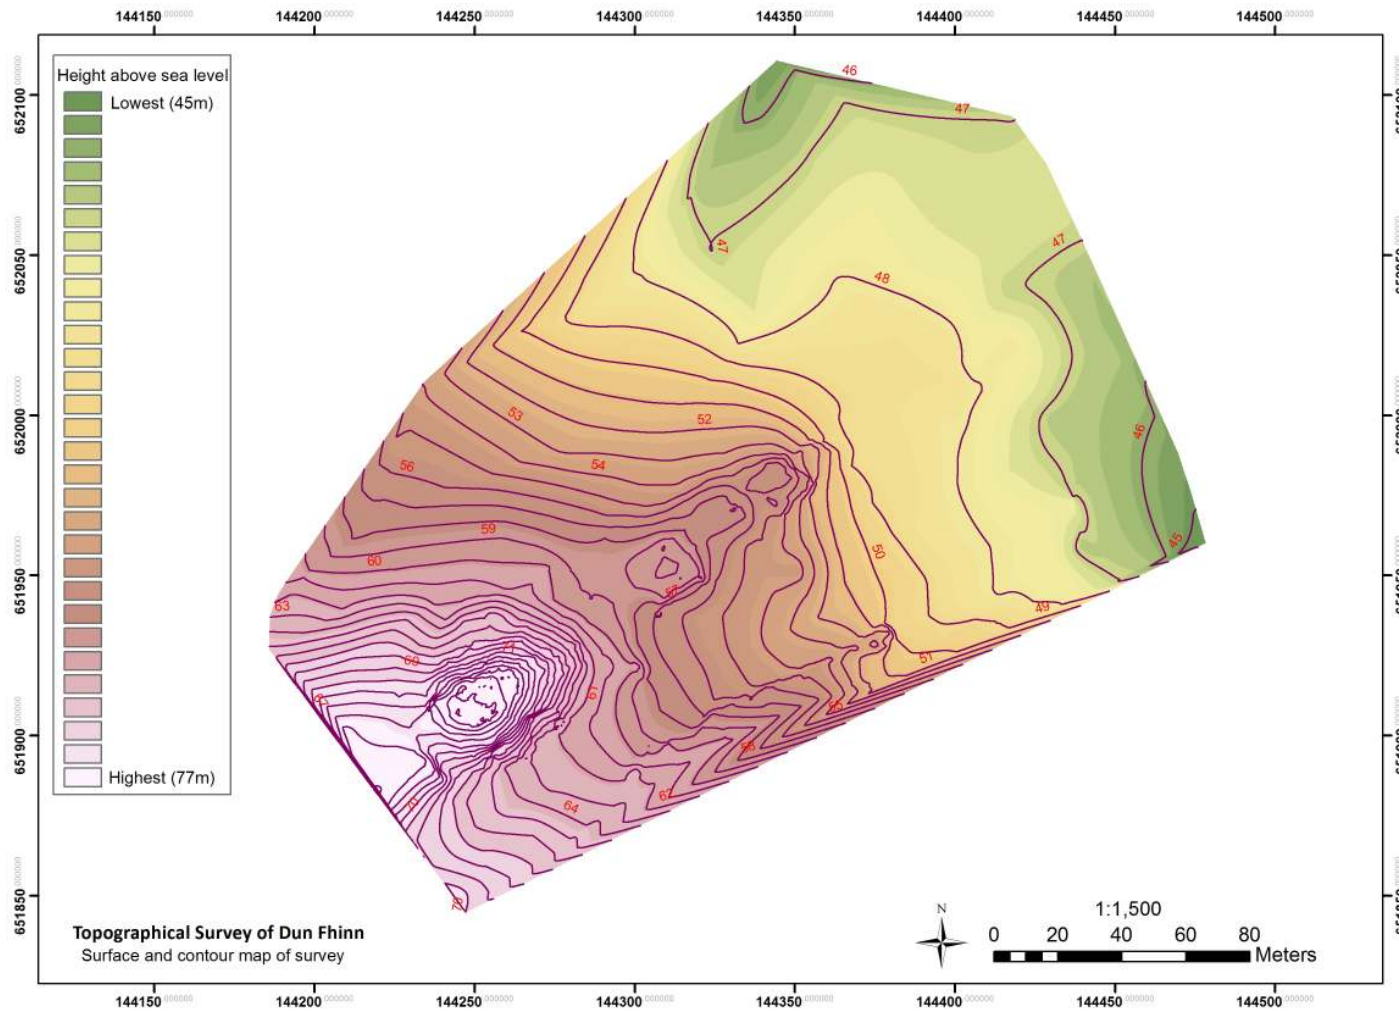
Figure 5: Topographical survey of Dun Fhinn and surrounding area

The topographic survey of Dun Fhinn was conducted using a Leica GS09/CS09 GNSS SmartNet system, which is able to record X, Y, and height (Z) location data to within 2cm accuracy. The system collects satellite data which is corrected in real-time, from a known base station on the mainland via an internet link. The survey took three days, over which 3000 data points were collected within the local landscape of the Dun. This included the survey of the Dun itself, and the surrounding landscape in which it sits. Over and close to the mound of the Dun itself, the spatial resolution of the survey is approximately 2m. The broader landscape survey was surveyed to approximately 10m resolution (Figure 5). A micro-topographical survey across the plateau of the Dun was also undertaken (Figures 6 & 7), with a survey resolution of approximately 0.5m, so that finer detail of the topography and upstanding archaeology within this area could be further understood. The data are downloaded into a GIS package where the data points were converted into surface layers (via a Natural Neighbour interpolation algorithm) and height contours. The data can also be imported and manipulated into a 3D workspace for further analysis and visualisation

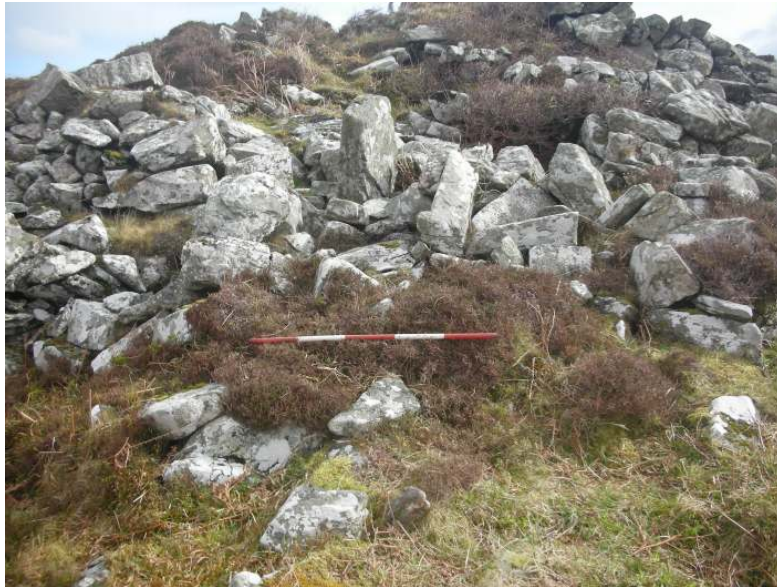
The rubble filled lower entrance through the dun outwork

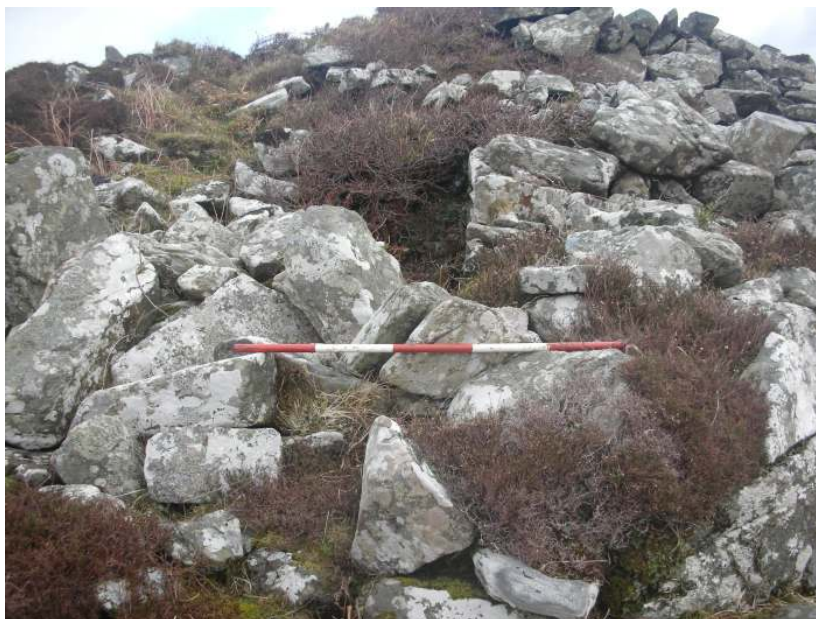
The eastern side of the entrance

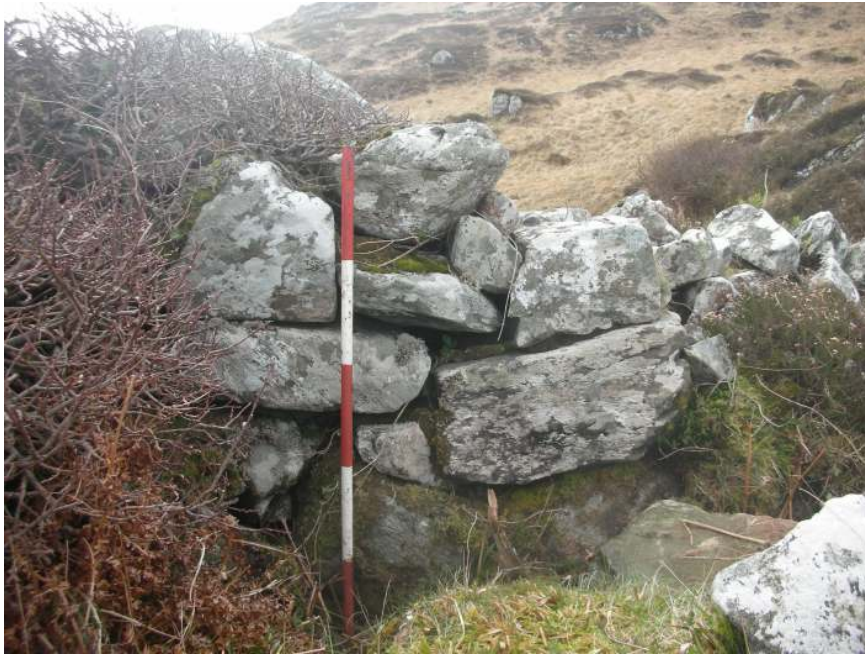
Facing stones of the eastern side of the entrance

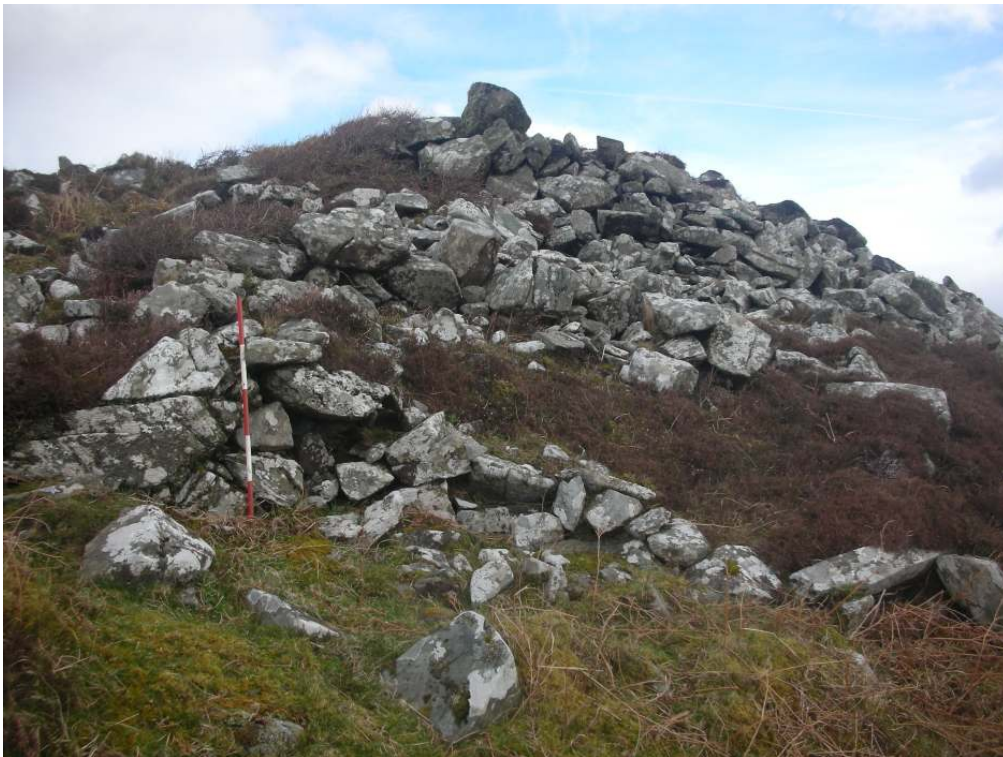
The lower out-work facing stones with the distorted facing stones of the dun wall above

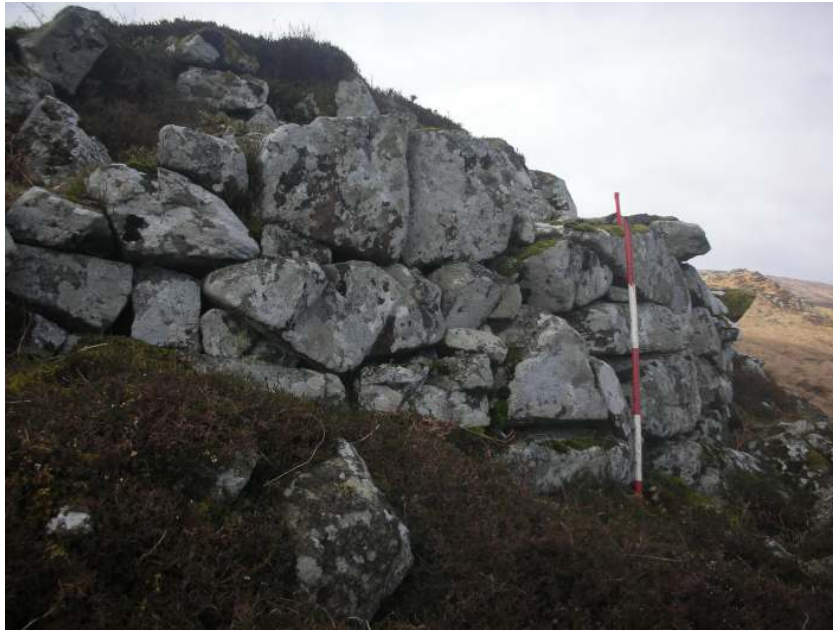
The facing stones on the NW side of the dun

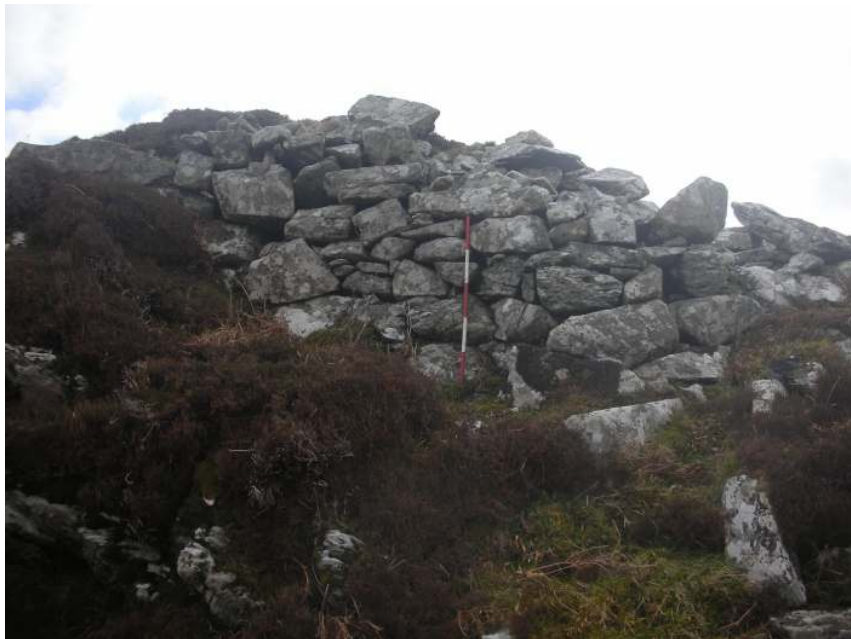
The facing stones on the SW side of the dun

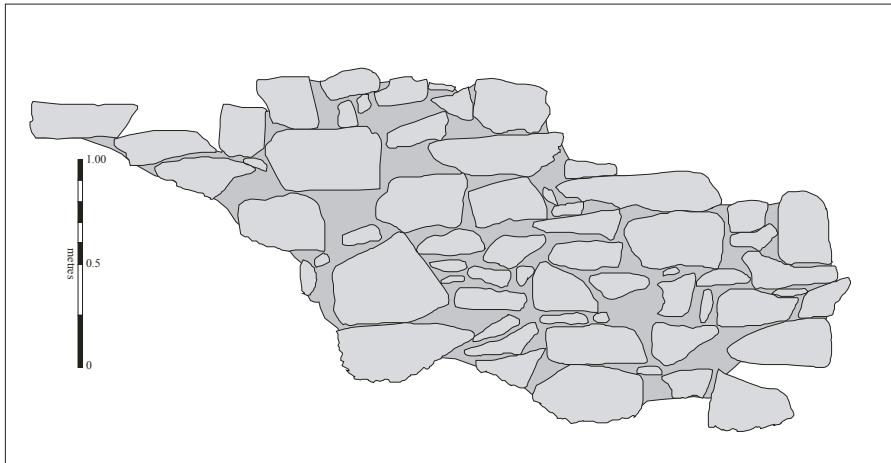
Figure 8: Section of the SW wall

The near circular structure within the dun measures between 6.0-6.40m in internal diameter with walls up to 1.20m thick and standing up to 0.60m above the present ground surface. The RCAHMS entry in the inventory states that this circular enclosure is a later addition to the original dun and while this may be so, elsewhere this structure would have been recorded as a hut circle or 'homestead' and there seems no reason why this is not also the case here. Without the surrounding dun walls this structure is decidedly exposed when compared to other potentially later buildings recorded during the survey such as sheilings which have been constructed in relatively sheltered positions and are smaller than the structure within the dun. Such a structure lies below the dun on the NE side (Site 8 below) and while this might represent a sheiling structure it might also be related to evidence of nearby quarrying. Hollows and uneven ground on the outside the dun entrance on the SW side might also suggest the presence of other structures here. Remnants of a circular or sub circular structures can also be found within the forts of Creagan an Ceardaich Mor, Dun Beag and Loch Nan Clach.

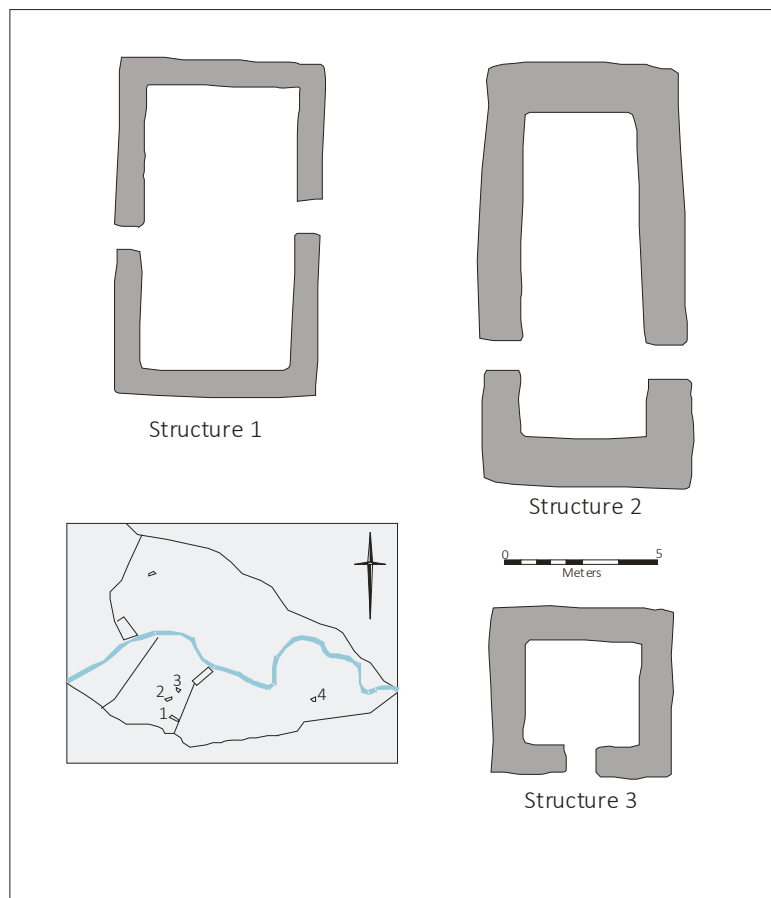
Figure 11: Staoin Structures

The area south of the river was bounded by a turf and earthen dyke with some internal divisions. Most of the ear enclosed within the surrounding dyke shows signs of extensive rig and furrow cultivation. The remains of 5 structures were recorded (Structures 1-5) along with three rectilinear enclosures.

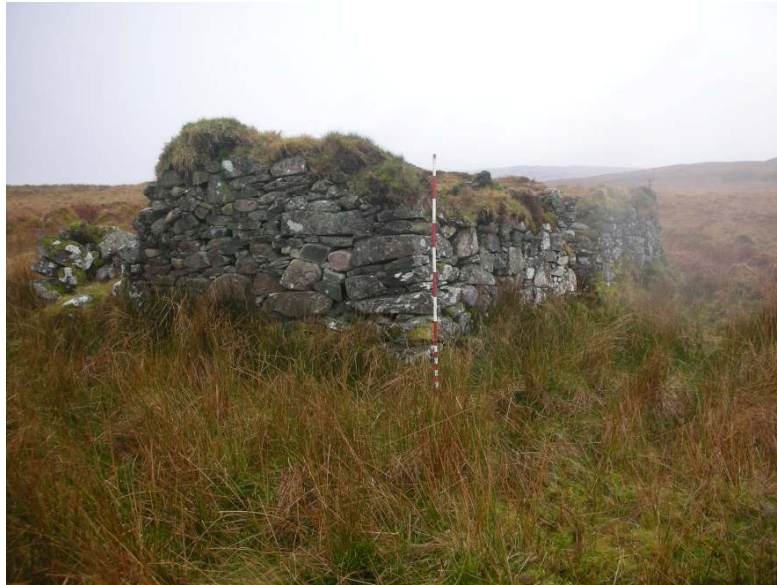
Staoin, Structure 1

Rectangular rubble built structure oriented NS and measuring 10.80m long and 6.6m wide externally. The walls in part stand to probable full height up to 2.1m. The building has two opposed entrances although the one on the side has been blocked. There is evidence of clay and sand mortar/packing within the walls.

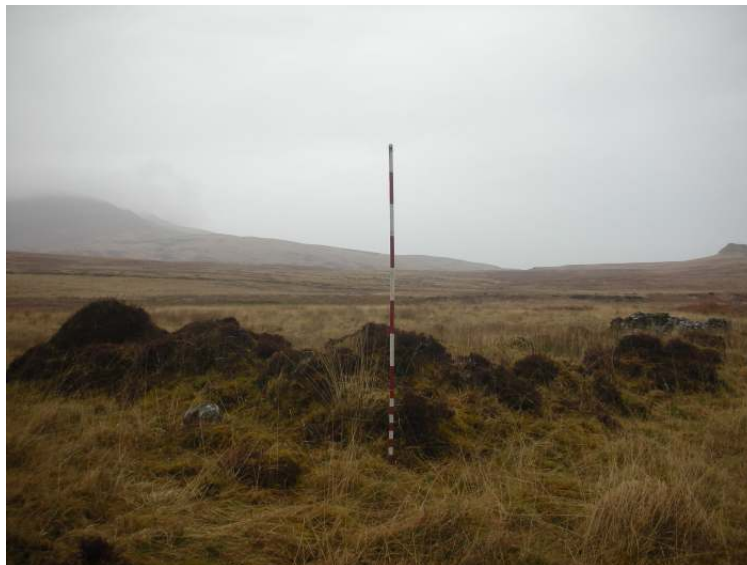
Staoin, Structure 2

Rectangular rubble built structure oriented EW and measuring 13.8m long and 7m wide externally. The denuded/robbed walls stand up to 0.60m in height. The building has two opposing entrances within the W end of the structure.

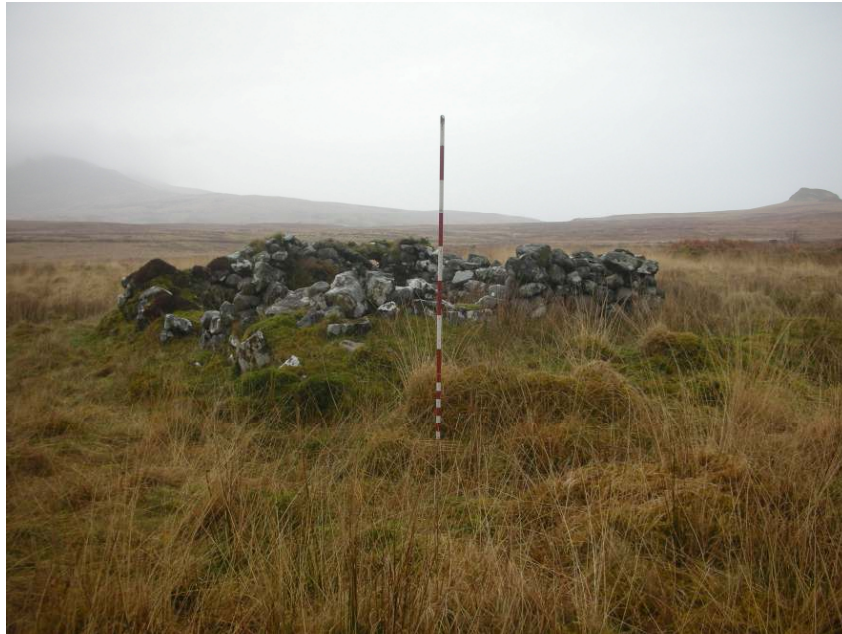
Stoain, Structure 3

Rectangular rubble built structure oriented NW/SE measuring 6.0m long and 5.40m wide externally. The walls stand up to 1.50m in height. The building has an entrance on the SE side. The building appears to have been shortened as footings of what may be an earlier version of the building extend 2m to the NW.

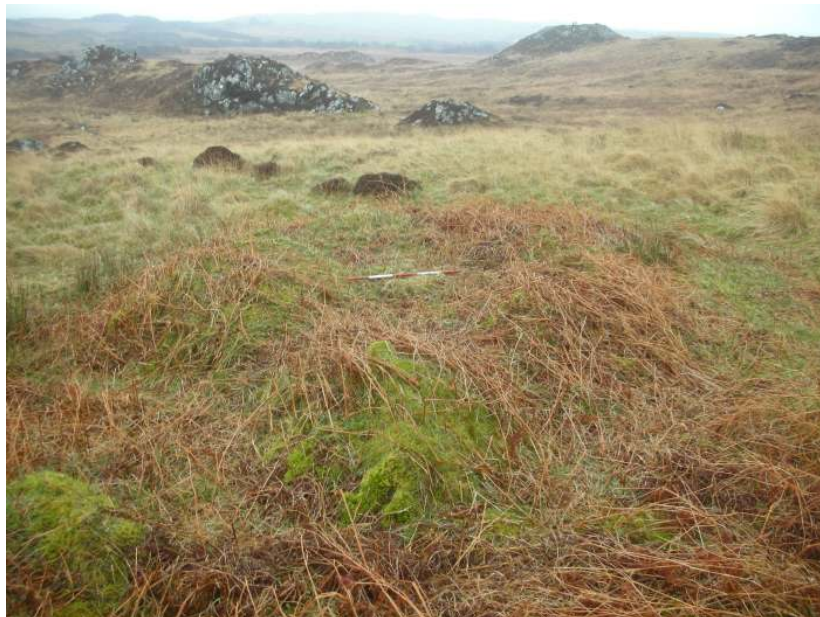
Stoain, Structure 4

Spread of rubble representing remains of oval? structure oriented NW/SE measuring c8.30m by 6.10m.

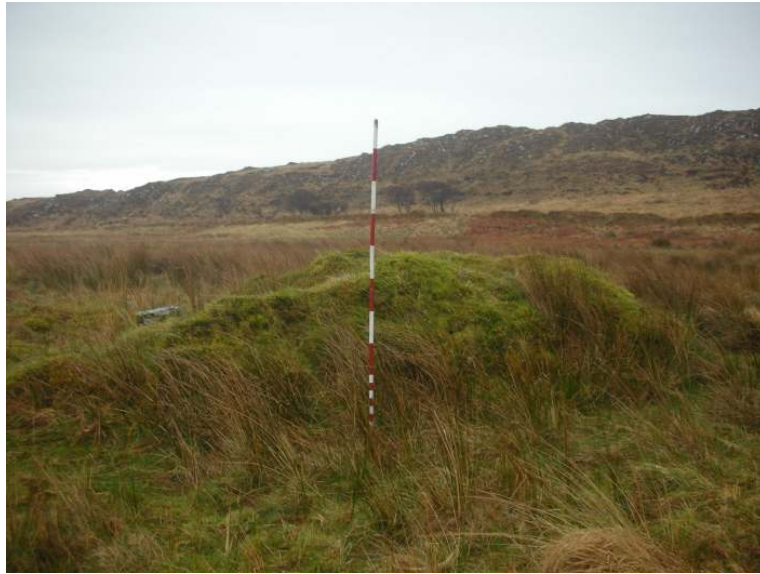
Staoin, Kiln

Overall the structure measures 7m by 5m but the main oval kiln measures 5m by 4m standing up to 1.30m in height with a flue entrance on the E side. Footings of a sub-square structure or earlier kiln extend to the W and contain a smaller sub square arrangement of stones.

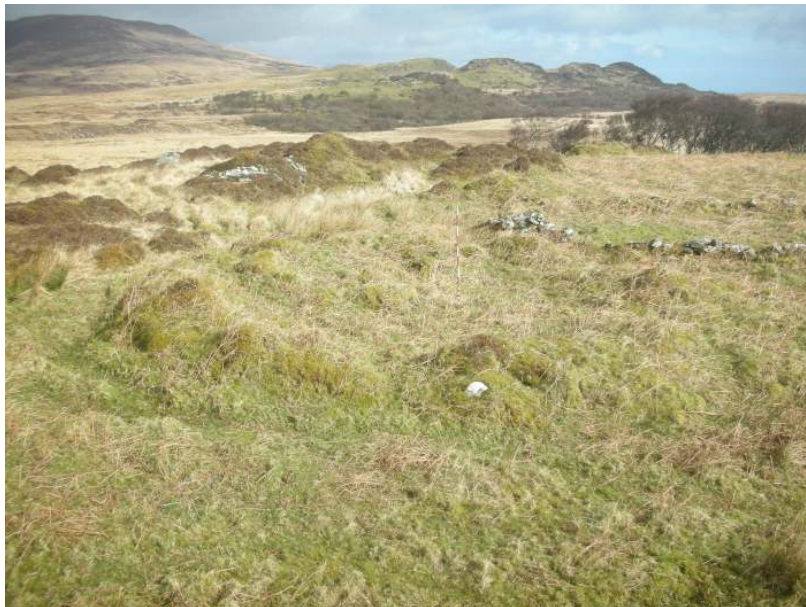
Site 14, Structure 1

Sub circular enclosure or structure measuring 12m by 11m externally with turf covered walls standing up to 0.6m high. The walls appear eroded and vary in width although 1.0m appears to be the most consistent. A gap on the SE east side suggests an entrance.

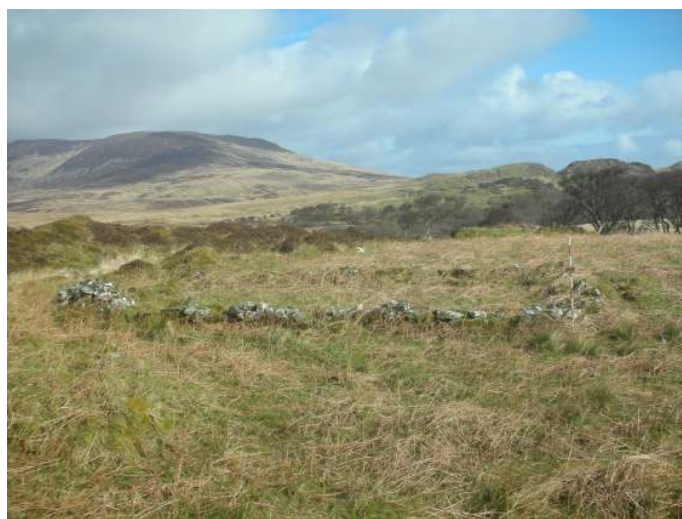
Site 14, Structure 2

Sub rectangular enclosure measuring 13m by 8.4m externally with walls generally 0.8m wide and standing up to 0.9m high with an entrance gap on its W side, although this may be due to robbing to construct a small twinning pen at the SW.

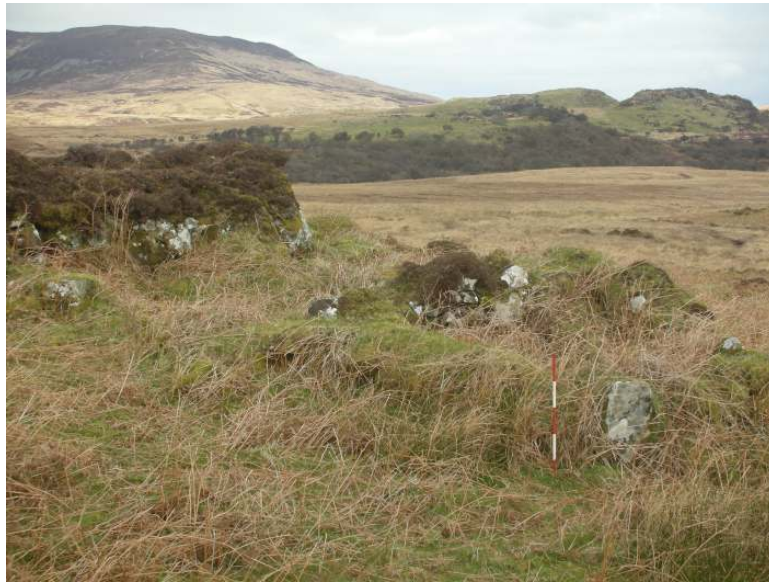
Site 14, Structure 3

Rectangular building constructed against a natural scarp which forms its NW side. The structure measures 9.8m by 4m externally with walls up to 1.2m wide and standing up to 1.8m. The building is divided into two parts by a cross wall with entrance gaps in the SW and SE sides.

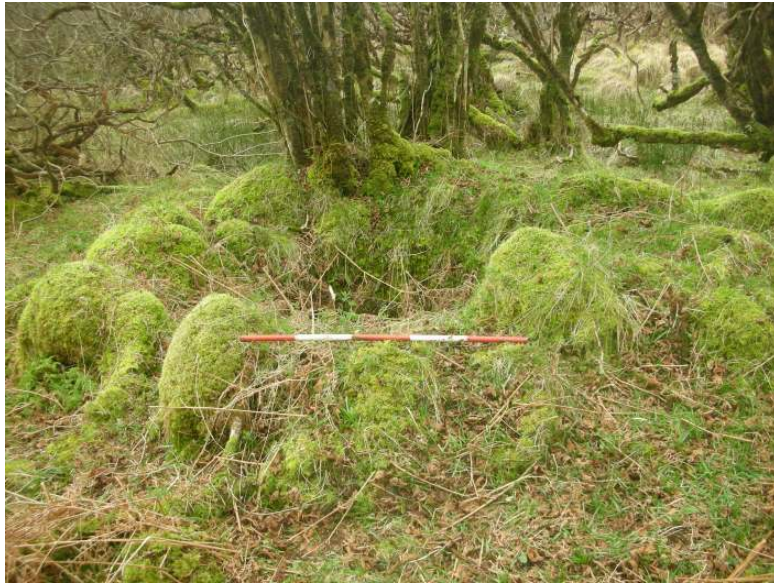
Site 15, Well

Circular stone lined well structure measuring 2m by 2m externally with walls standing up to 1.60m.

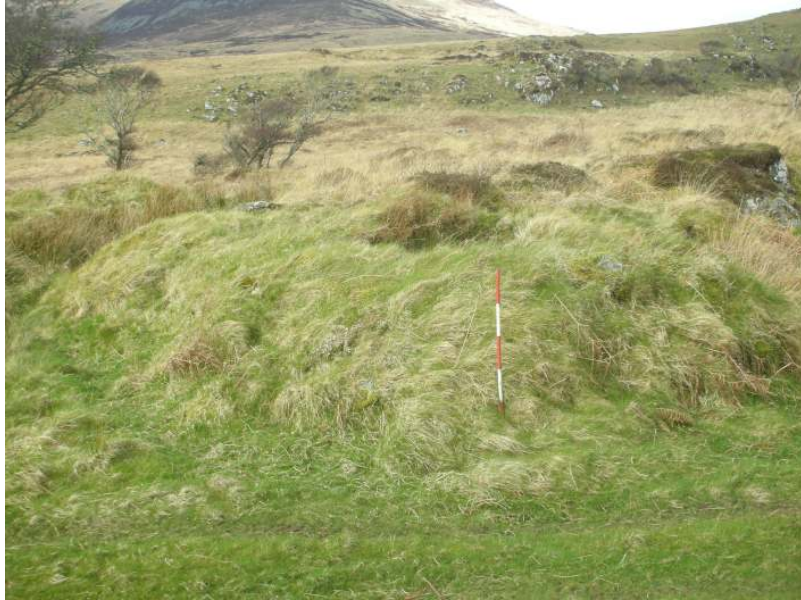
Site 16, Structure 1

Possible recessed platform or small enclosure with turf and stone walls sides. Measures 7m by 6m internally with walls standing up to 0.4m in height.

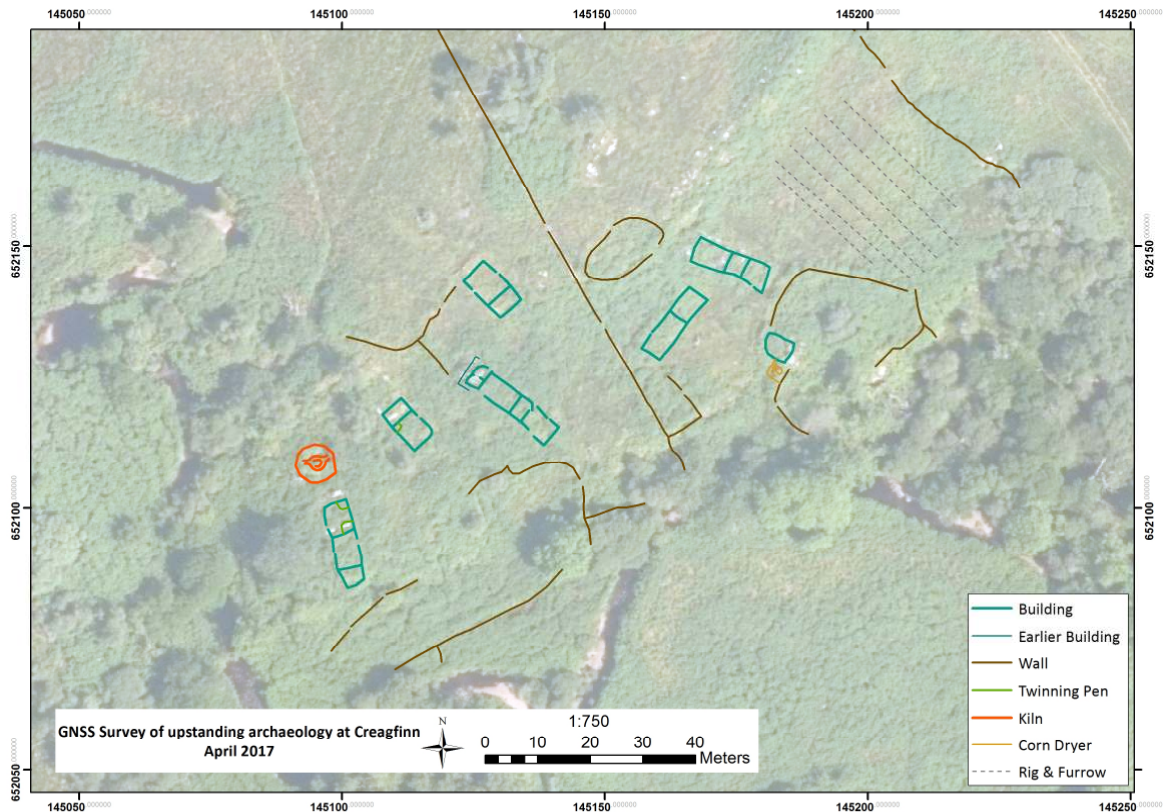
Figure 15: Survey of upstanding structures at Craighinn

A GNSS survey of the upstanding archaeology at Craighinn was undertaken over a single day (Figure 15). This was conducted using a Leica GS09/CS09 GNSS SmartNet system, which is able to record X, Y, and height (Z) location data to within 2cm accuracy. Where archaeological remains were identified, they were logged within the GNSS system and subsequently plotted within a GIS system to compliment the hand-drawn archaeological record of this site.

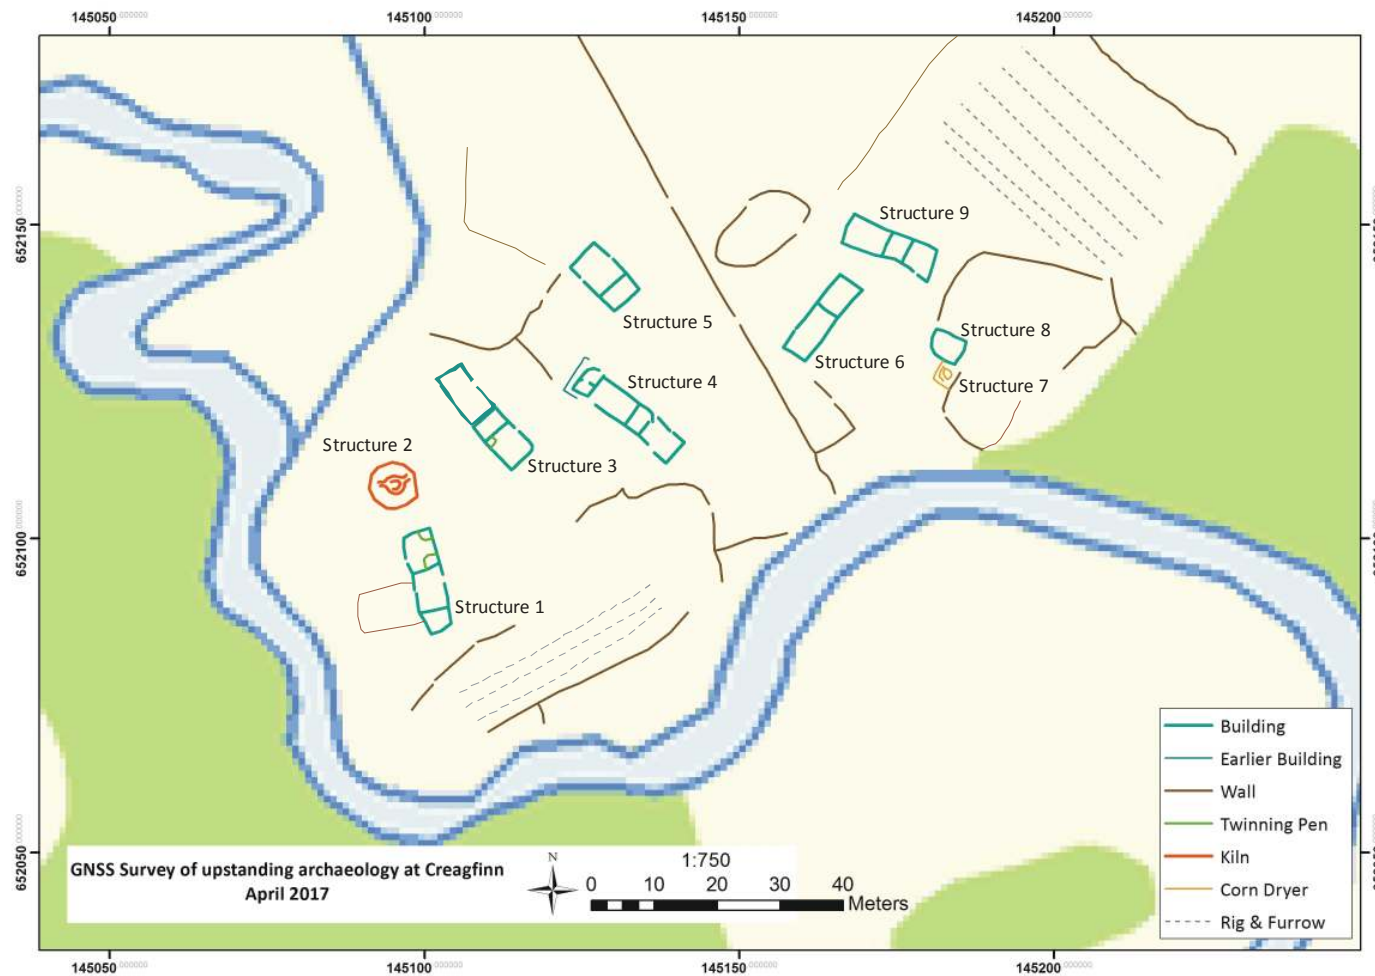
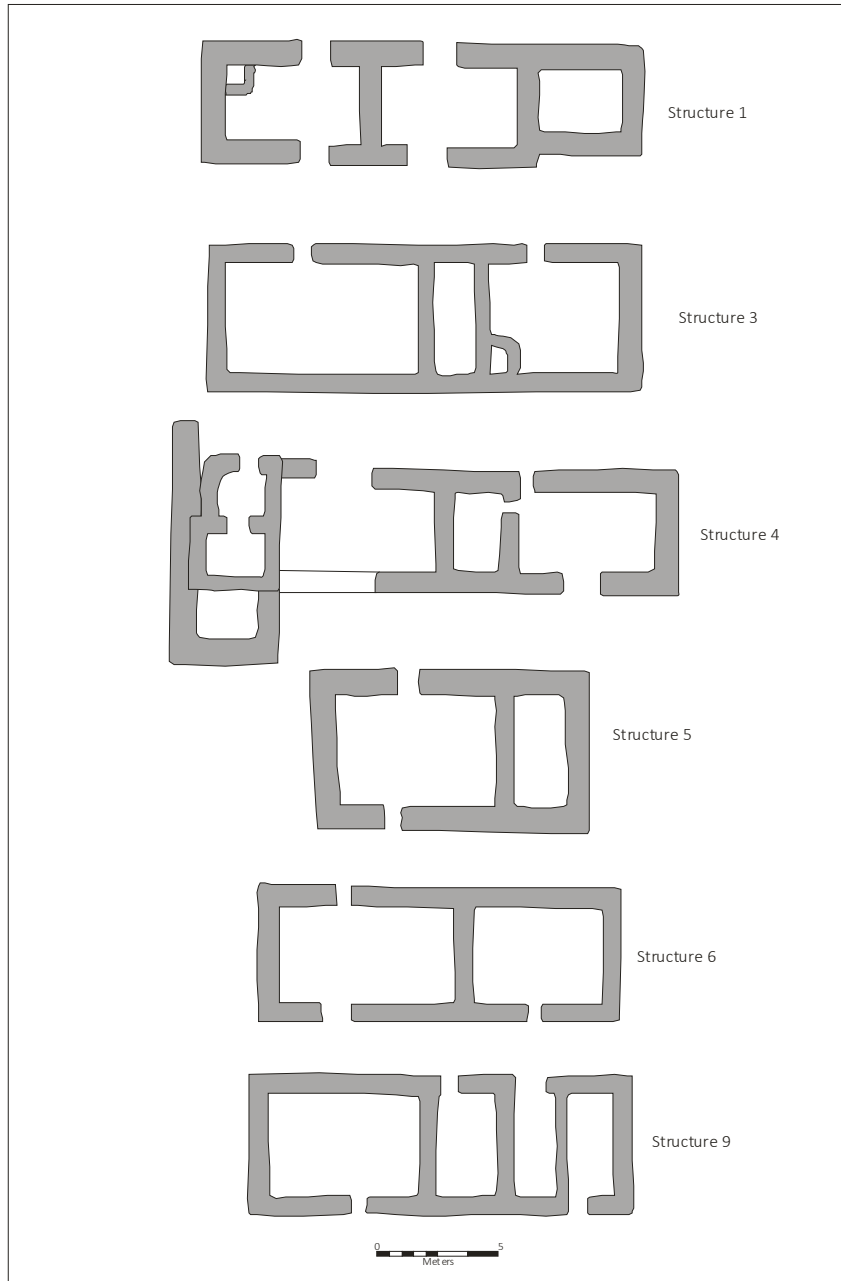
Figure 16: Creagfinn

The settlement consists of 6 rectangular buildings (Figures 16 and 17, Structures 1, 3, 4, 5 and 9) and a seventh irregular building (Structure 8) along with two kilns (Structures 2 and 7). These are situated on a bend in the Kintour River and surrounded by a series of enclosures some of which contain evidence of rig and furrow cultivation. Structure 9 is depicted as roofed on the 1st Edition Ordnance Survey map suggesting this was the last occupied structure in the settlement.

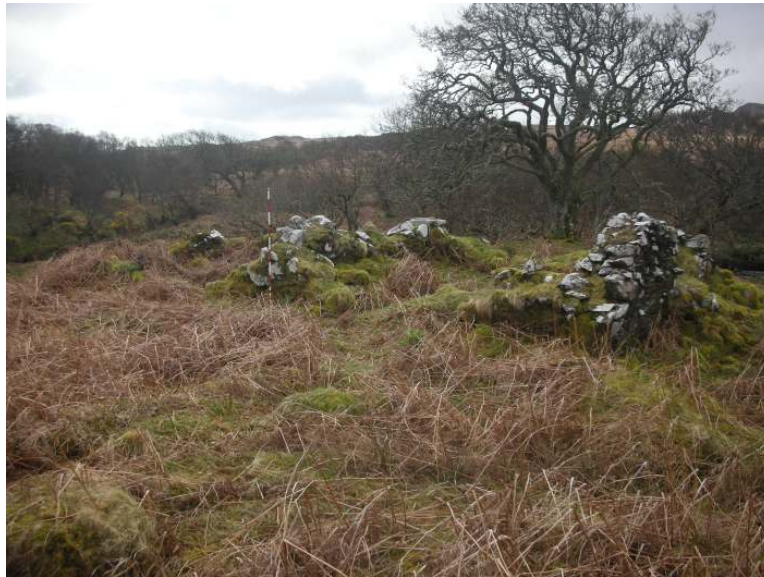
Creagfinn, Structure 1

Rectangular NW/SE oriented rubble built structure and measures 18m long and 6m wide externally with walls 0.60m wide and standing up to 1.7m in height. The building is divided into three parts with opposing entrances in the two northern most divisions. Traces of an attached enclosed area 10m wide lies on the western side of the structure. Two twinning pens have been constructed within the northern room. The northern wall is best preserved and suggests a gable ended building.

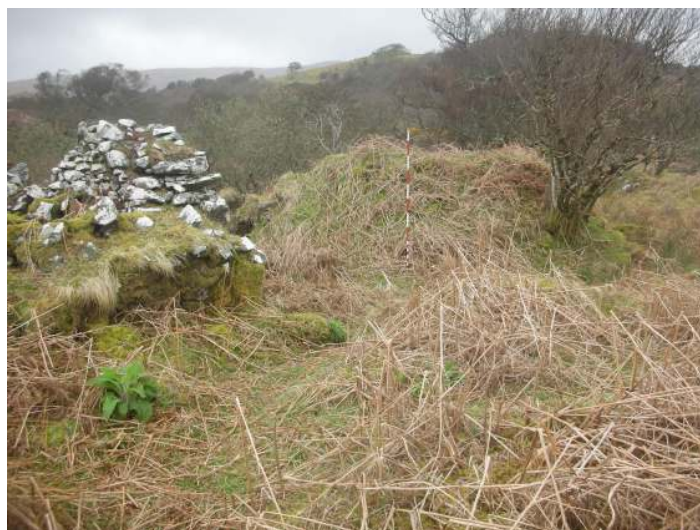
This kiln structure is sub circular in shape measuring 5.5 by 5m and stands to a height up to 2.40m above present ground level. The walls measured up to 1.40m thick around a central chamber, which was likely accessed on the SW side.

Creagfinn, Structure 2, Kiln lying NE of Structure 1

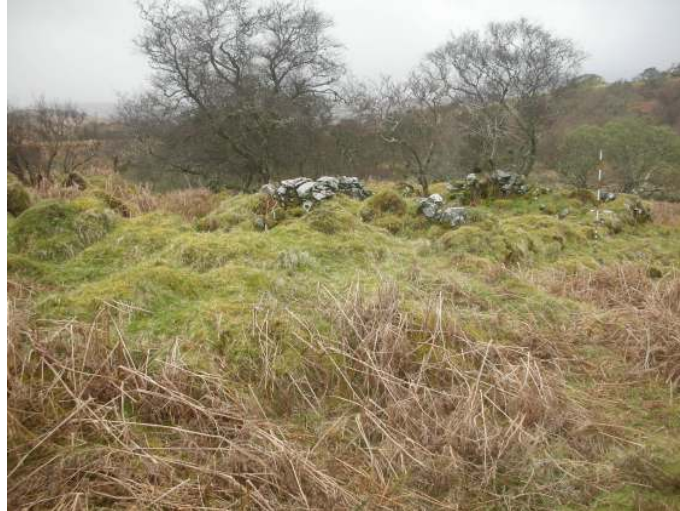
Creagfinn, Structure 3

Rectangular NW/SE oriented rubble built structure measuring long 17.7m in length by and 6m wide externally with walls 0.70m wide standing in 0.70m in height. The building is divide into three parts with two entrances on the NE side. A twinning pen has been constructed in the corner of the southern room.

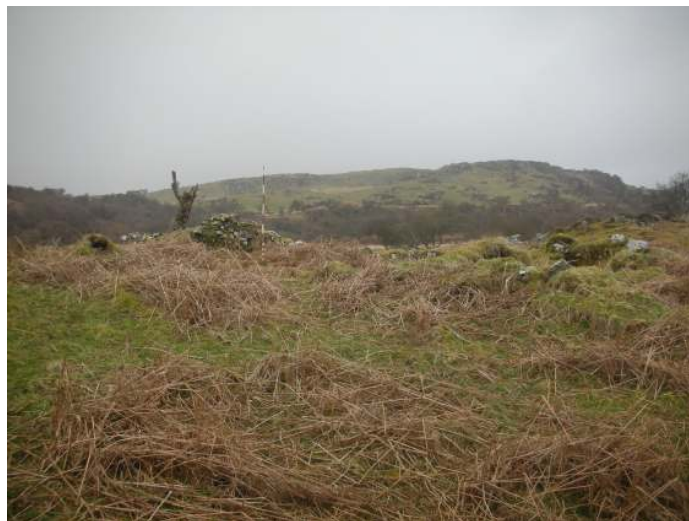
Creagfinn, Structure 4

This building in its original form may have been T shaped. At the W end are the footings of a SW/NE oriented rectangular building measuring 9.8m by 5.20m externally with walls standing 0.50m high. Over this has been built a smaller structure measuring 5.4m by 3.30m externally with walls up to 1.50m in height. This smaller structure is divided two parts or rooms the northern most with a distinctly curving N wall. To the SE of these is what was likely an attached rectangular range which is oriented NW/SE measuring 16m long by 6.1m wide externally and divided into three parts.

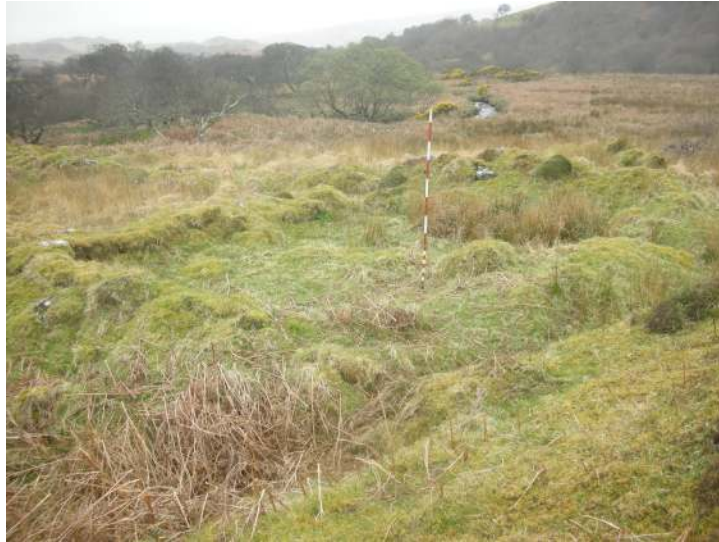
Creagfinn, Structure 5

Rectangular NW/SE oriented rubble built structure measuring long 11.30 long by 6.50m wide with walls 0.70m wide and standing up to 0.80m in height. The building is divided into two parts with opposed entrances in the northern room.

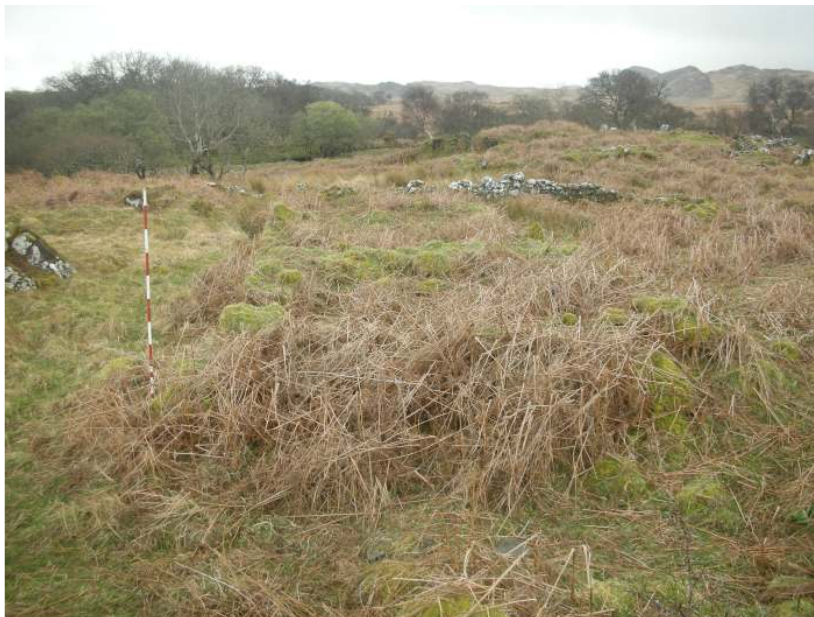
Creagfinn, Structure 6

Rectangular SW/NE oriented rubble built structure measuring 15m long and wide 5.50m wide with walls 0.70m wide and standing in up to 0.60m height. The building is divided into two parts with opposing entrances in the southern room and a single entrance in the SE wall of the northern room.

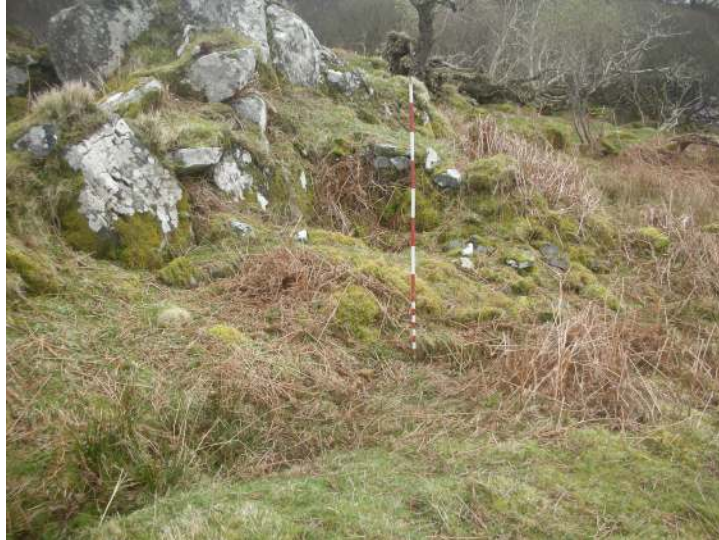
Creagfinn, Structure 7

This kiln structure was constructed against a natural scarp at the north and a enclosure wall on the east. The structure measured 4.0m by 2.70m with walls measuring 0.80m wide and standing up to 1.00m high.

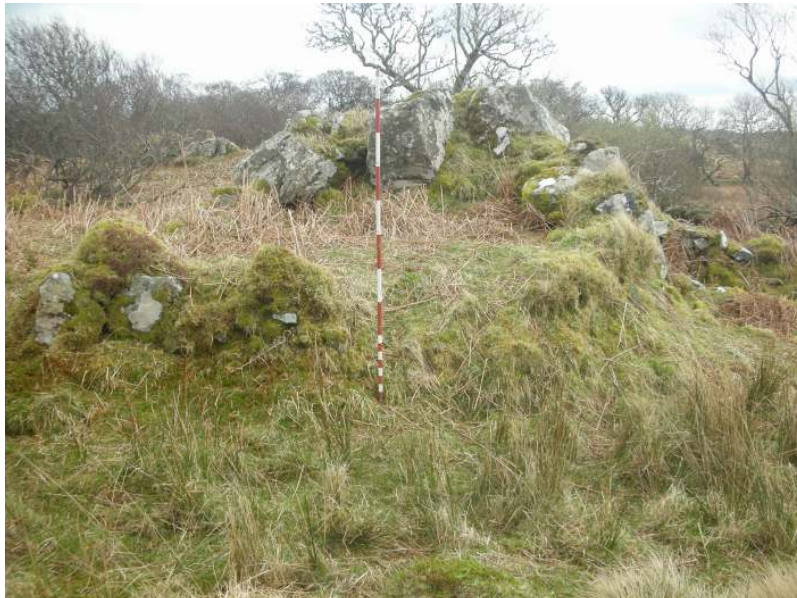
Creagfinn, Structure 8

This could be the remains of an irregular structure or a small enclosure measuring 10m by 8m with walls 0.60m wide and standing up to 0.45m high.

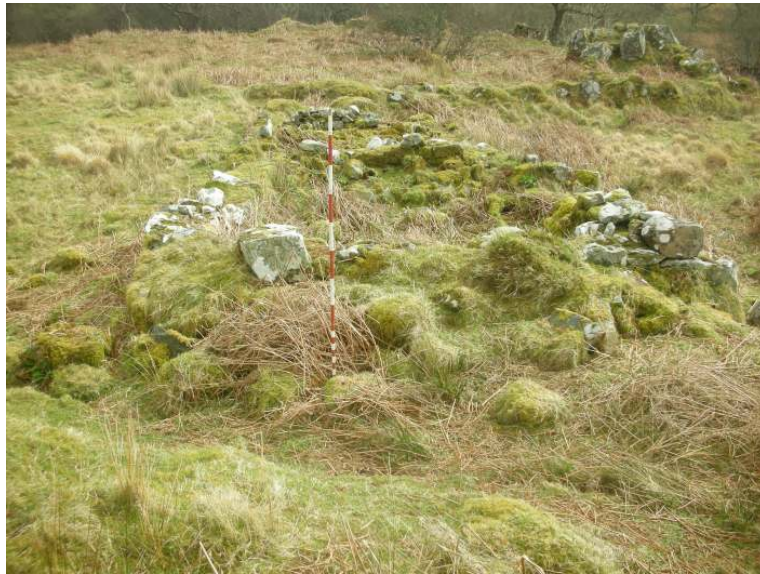
Creagfinn, Structure 9

Rectangular NW/SE oriented rubble built structure measuring 15.60m long and 5.80m wide externally with walls 0.80m wide and standing up to 1.15m in height. The building is divided into three parts (although what may be the remains of a later wall suggest a fourth division). Two entrances on the south side of the building give access to the eastern and western rooms, while a now blocked entrance on the north side gives access to the central room or bay.

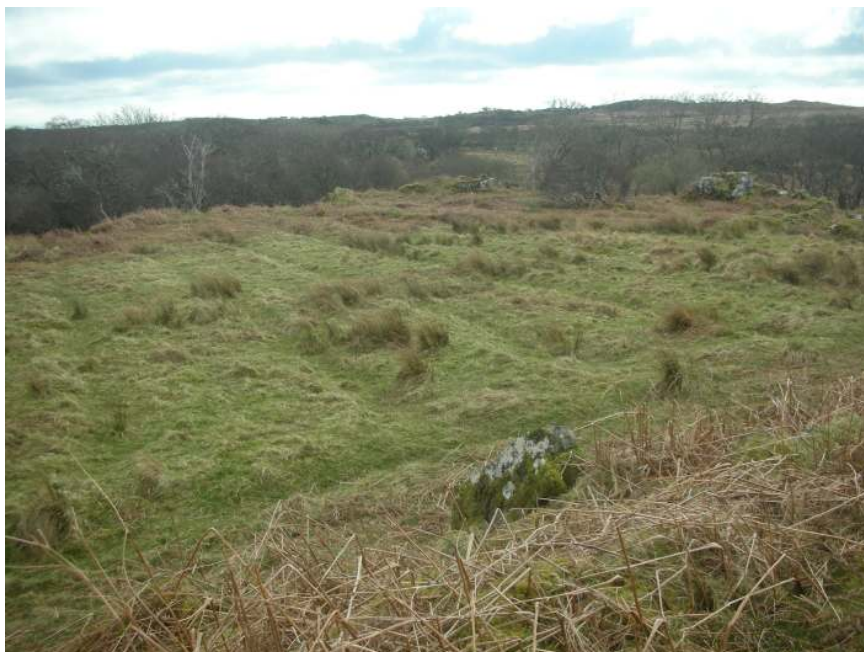
Rig and furrow cultivation at Creagfinn

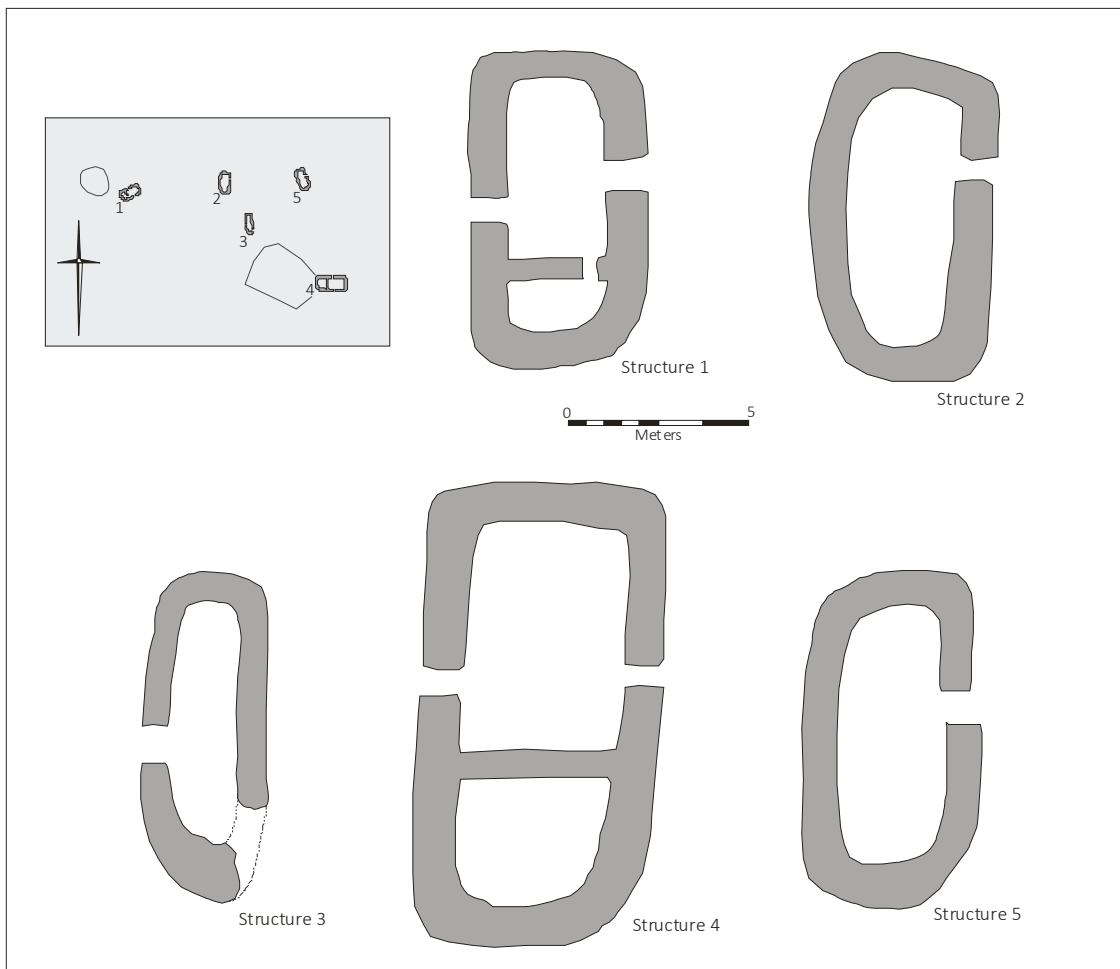
Figure 18: Ballore Structures

Located east of Creagfinn and located on the next prominent rise were the remains of Ballore, which had previously been described in Canmore (Appendix 2, Site 21). The settlement consisted of five definite structures (and 1 possible) along with two enclosures.
