**DUN FHINN
KILDALTON, ISLAY
AN ARCHAEOLOGICAL SURVEY**

**DATA STRUCTURE REPORT
May 2017
Roderick Regan**

ISLAY HERITAGE
DUALCHAS ÌLE

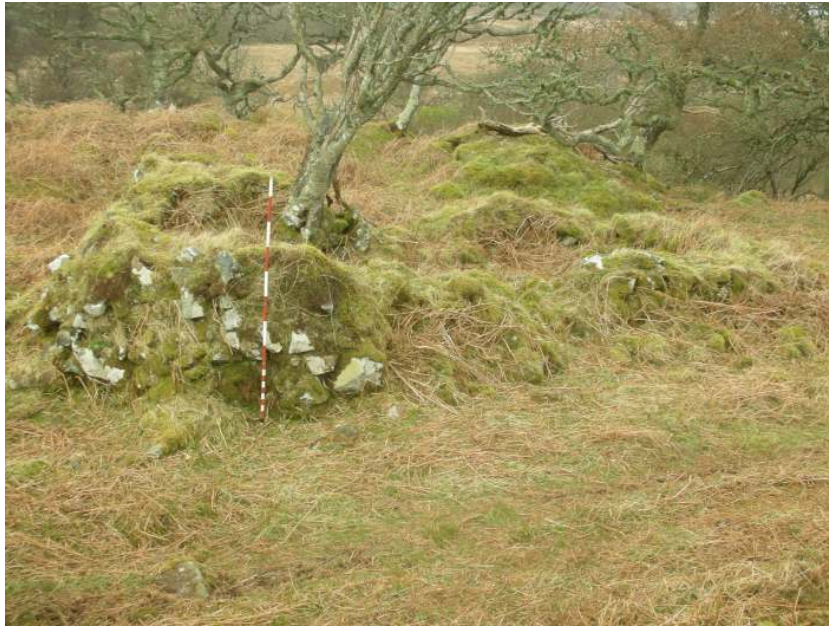
Ballore, Structure 1

Oval E/W oriented rubble built structure with rounded ends measuring 7.80m long by 4.9m wide externally with walls standing up to 1.70m in height. The building has two entrances on either long side and is divided into two parts.

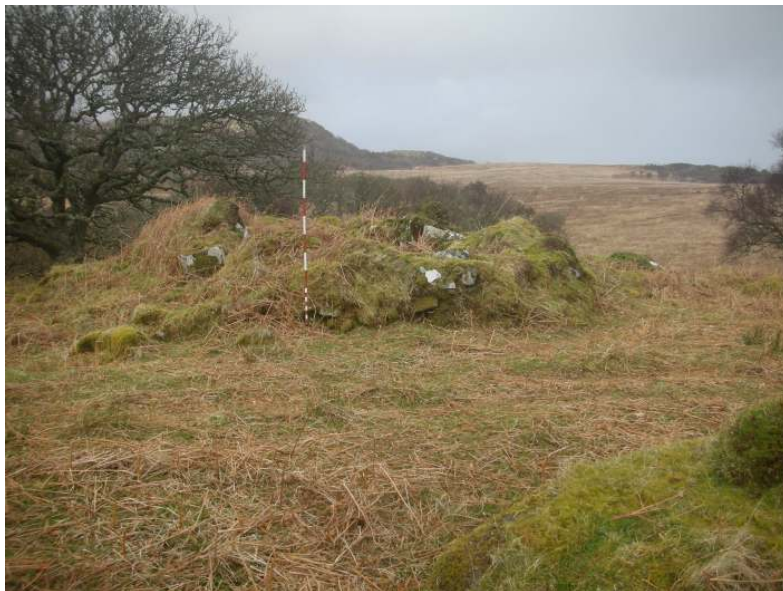
Ballore, Structure 2

Oval SW/NE oriented rubble built structure with rounded ends measuring 8.70m long by 5.0m wide externally with walls standing up to 1.60m in height. The building has an entrance on the SE side.

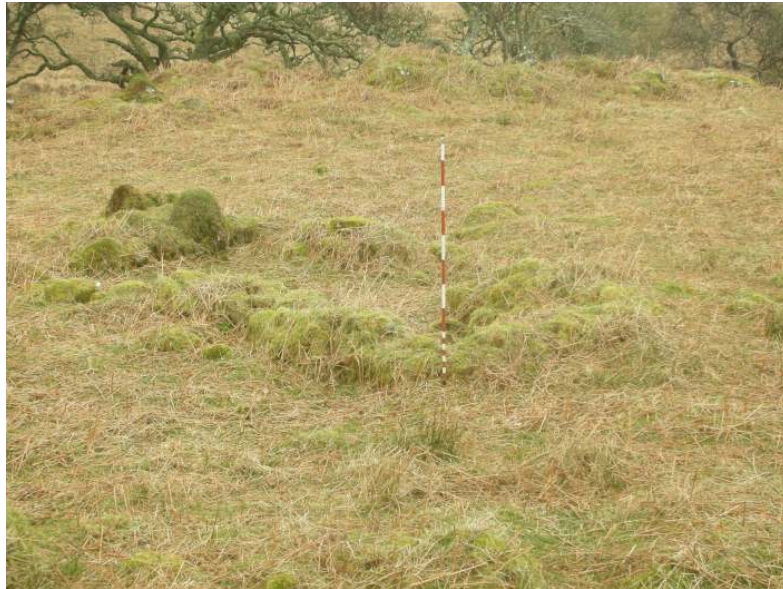
Ballore, Structure 3

Badly disturbed remains of an oval SW/NE oriented rubble built structure with rounded ends measuring 9.5m long and 3.20m wide externally with walls standing 0.60m in height. The building is with an entrance on the SE side.

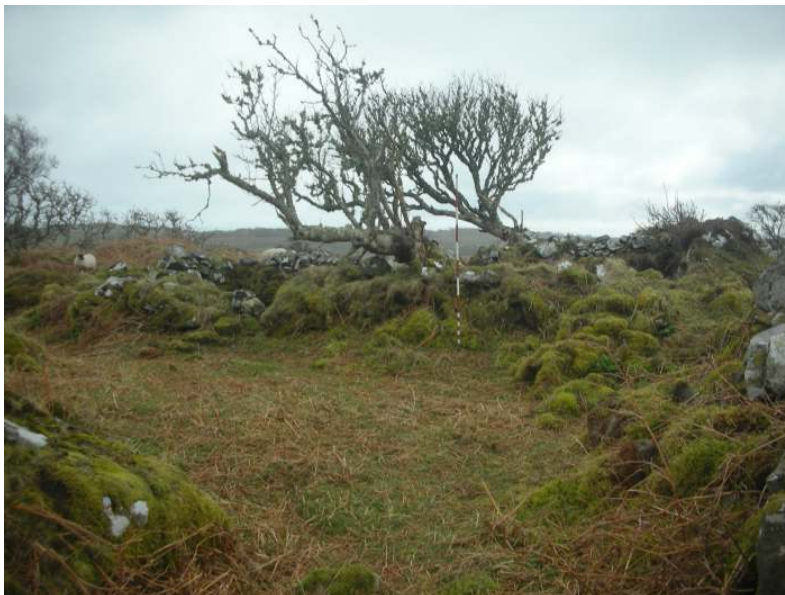
Ballore, Structure 4

Oval E/W oriented rubble built structure with rounded ends measuring 12.4m long and 6.7m wide externally with walls standing up to 1.90m in height. The building divided into two parts by a later? cross-wall and has opposed entrances on the long sides.

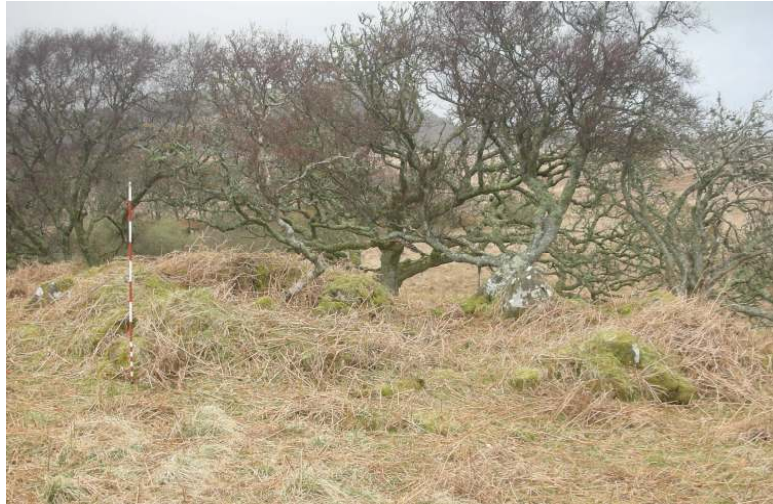
Ballore, Structure 5

Oval SW/NE oriented rubble built structure with rounded ends measuring 9.0m long by 5.0m wide externally with walls standing up to 1.10m in height. The building has an entrance on the SE side.

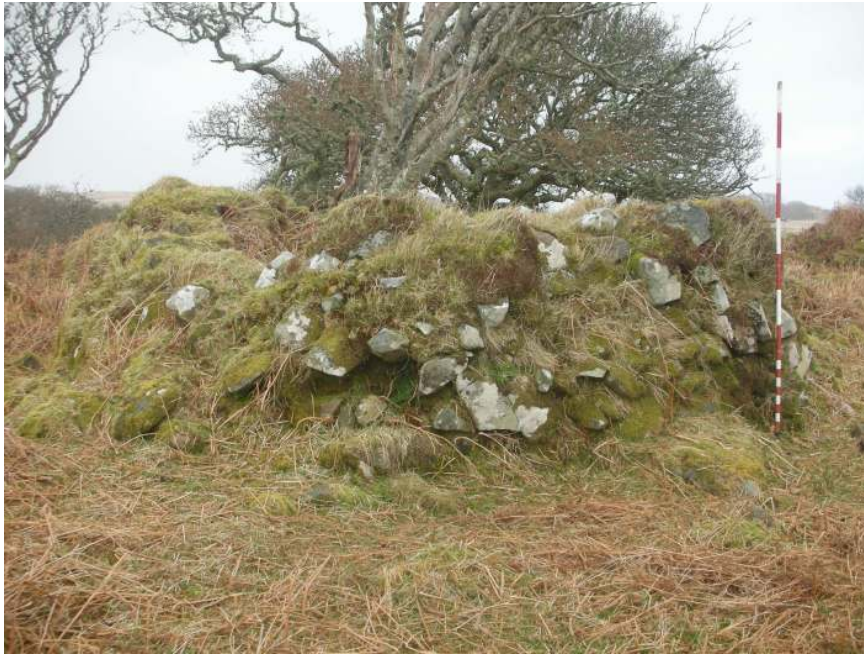
Well preserved round-ended structure at Ballore
