King Family Home Martin Luther King, Jr. National Historical Park Cultural Landscape Report

King Family Home

Cultural Landscape Report

January 2022
Prepared by:
WLA Studio

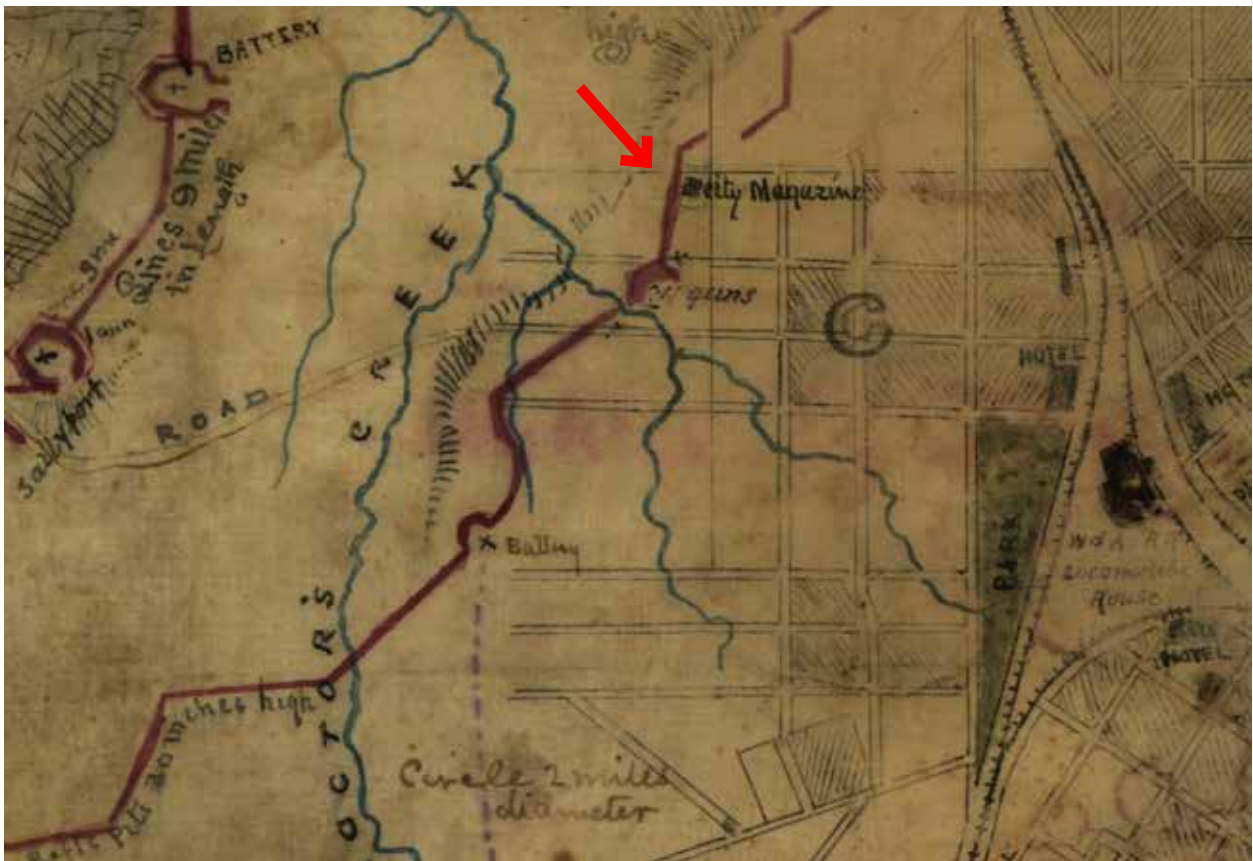
Figure 2.3. 1864 map of west side of Atlanta showing Proctor's Creek, Confederate fortifications, and the city magazine (indicated with a red arrow). (Source: Library of Congress Prints and Photographs Division <https://www.loc.gov/item/gvhs01.vhs00311/>.)

In the years before the Civil War, much of the area on the west side of downtown Atlanta was rural farmland owned by a few large landholders. James Alston Jett (1796-1876) owned Land Lot 110, a portion of which was outside the city limits. Jett's original farm was located on "Land Lot 109 near the present intersection of Martin Luther King, Jr. Drive and James P. Brawley Drive."⁸³ Mapping indicates that Jett's heirs kept ownership of the portions of Land Lot 110 into the 1870s (Figure 2.2). The city street grid had extended east of Land Lot 110 to Land Lot 83, and the area contained a city powder magazine as early as 1855.⁸⁴ As Atlanta prepared for an attack from United States Army (US Army) forces during the Civil War, Confederate forces constructed fortifications around the powder magazine (Figure 2.3).

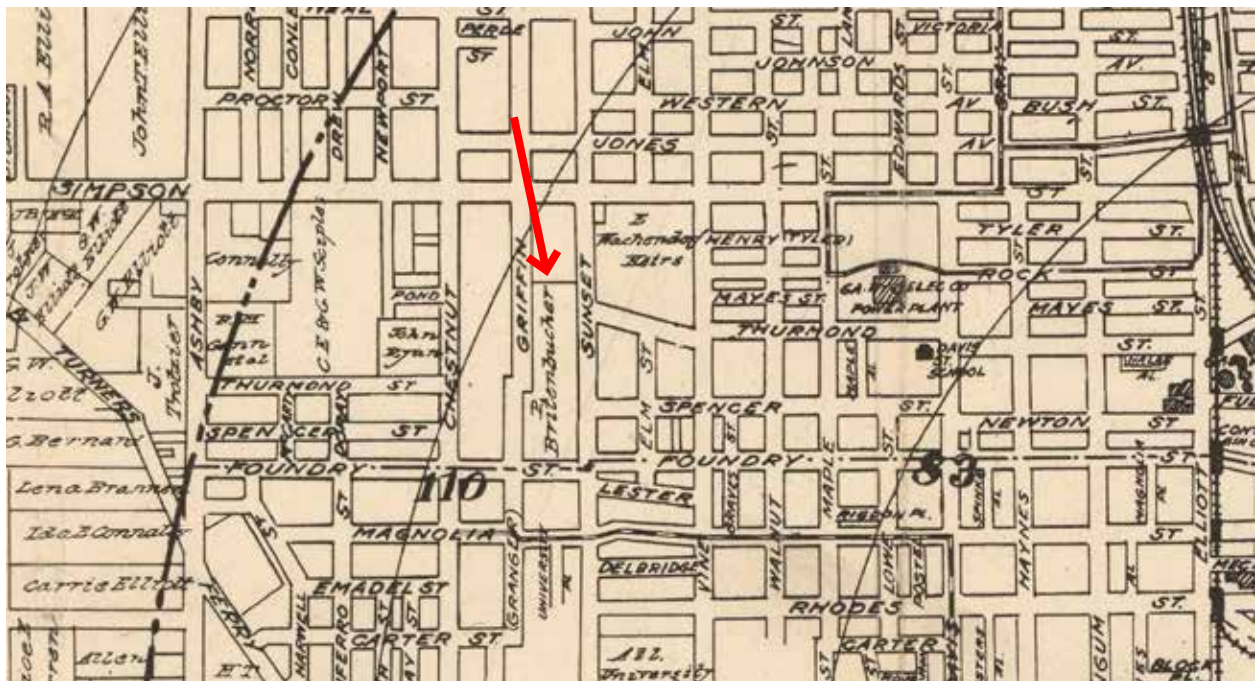
Figure 2.10. 1906 map showing ownership of property around Sunset Avenue. Note Philip Breitenbucher and Wachendorff Brothers as large landholders. (Source: Kauffman's Map of the City of Atlanta, 1906, Emory University, <http://disc.library.emory.edu/atlantamaps/1906-atlanta-city-map/>.)

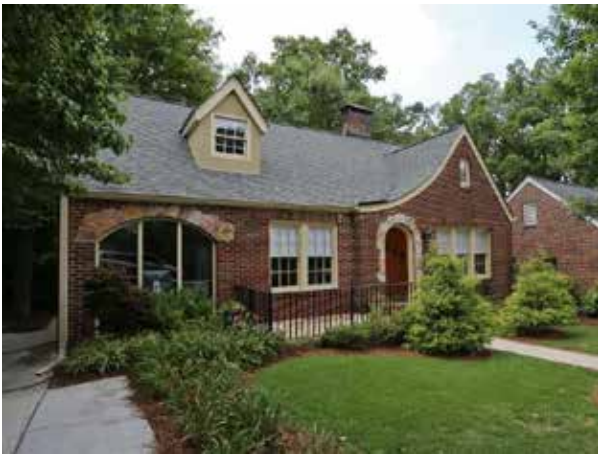
Figure 2.23. Chester R. Elliott House (1935), 911 Highland Terrace NE, Atlanta. The right-hand three bays appear to be a close match to the King Family Home's original appearance. (Source: Realtor.com, 2019.)

While no twin houses of the same design have been located to date, several existing English Cottages in Atlanta appear to be remarkably similar to the house's original appearance (Figure 2.23 and Figure 2.24). The house's design and architectural expression appear to have been unusual in the Vine City area.

Five unequal bays appear to have divided the façade of the original house. The wider north bay projected forward and contained a bank of three windows. The south bay contained a window or door opening, with a projecting exterior chimney in the next bay. There was a pair of two windows in the bay north of the chimney. The front entrance was placed between this bay and the projecting north bay. The door may have been sheltered by a small porch or an enclosed vestibule flush with the face of the north bay. The main roof was side-gabled, with a front gable over the projecting north bay and a hipped roof over the rear wing. Smaller side-gabled extensions of the main roof projected from the east part of each gable, aligning with the east face of the roof. The south extension sheltered the end of the living room, while the north extension covered a porch opening off the dining room. The front gable on the façade and the south gable over the living room both appear to have had concave extensions to one side, a common feature of English Vernacular Revival houses. The front gable's extension sheltered the main entrance, while that of the south gable covered a small room west of the living room. In addition to the chimney on the front elevation, the house featured three interior chimneys, one in the kitchen and the other two in the walls of the three bedrooms.

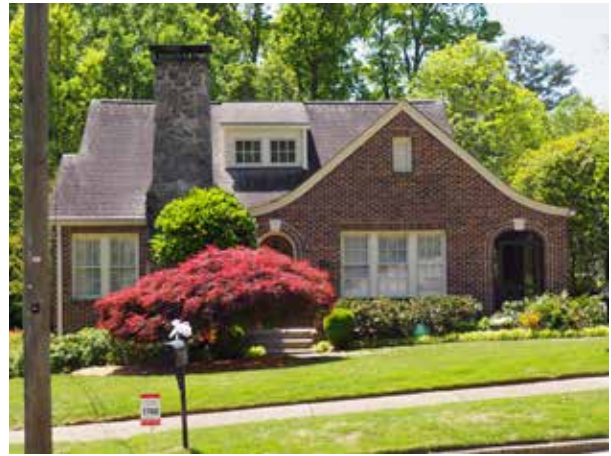
Figure 2.24. W. C. Hodnett House (1929), 1740 N. Pelham Road NE, Atlanta. (Source: WLA Studio, April 2020.)

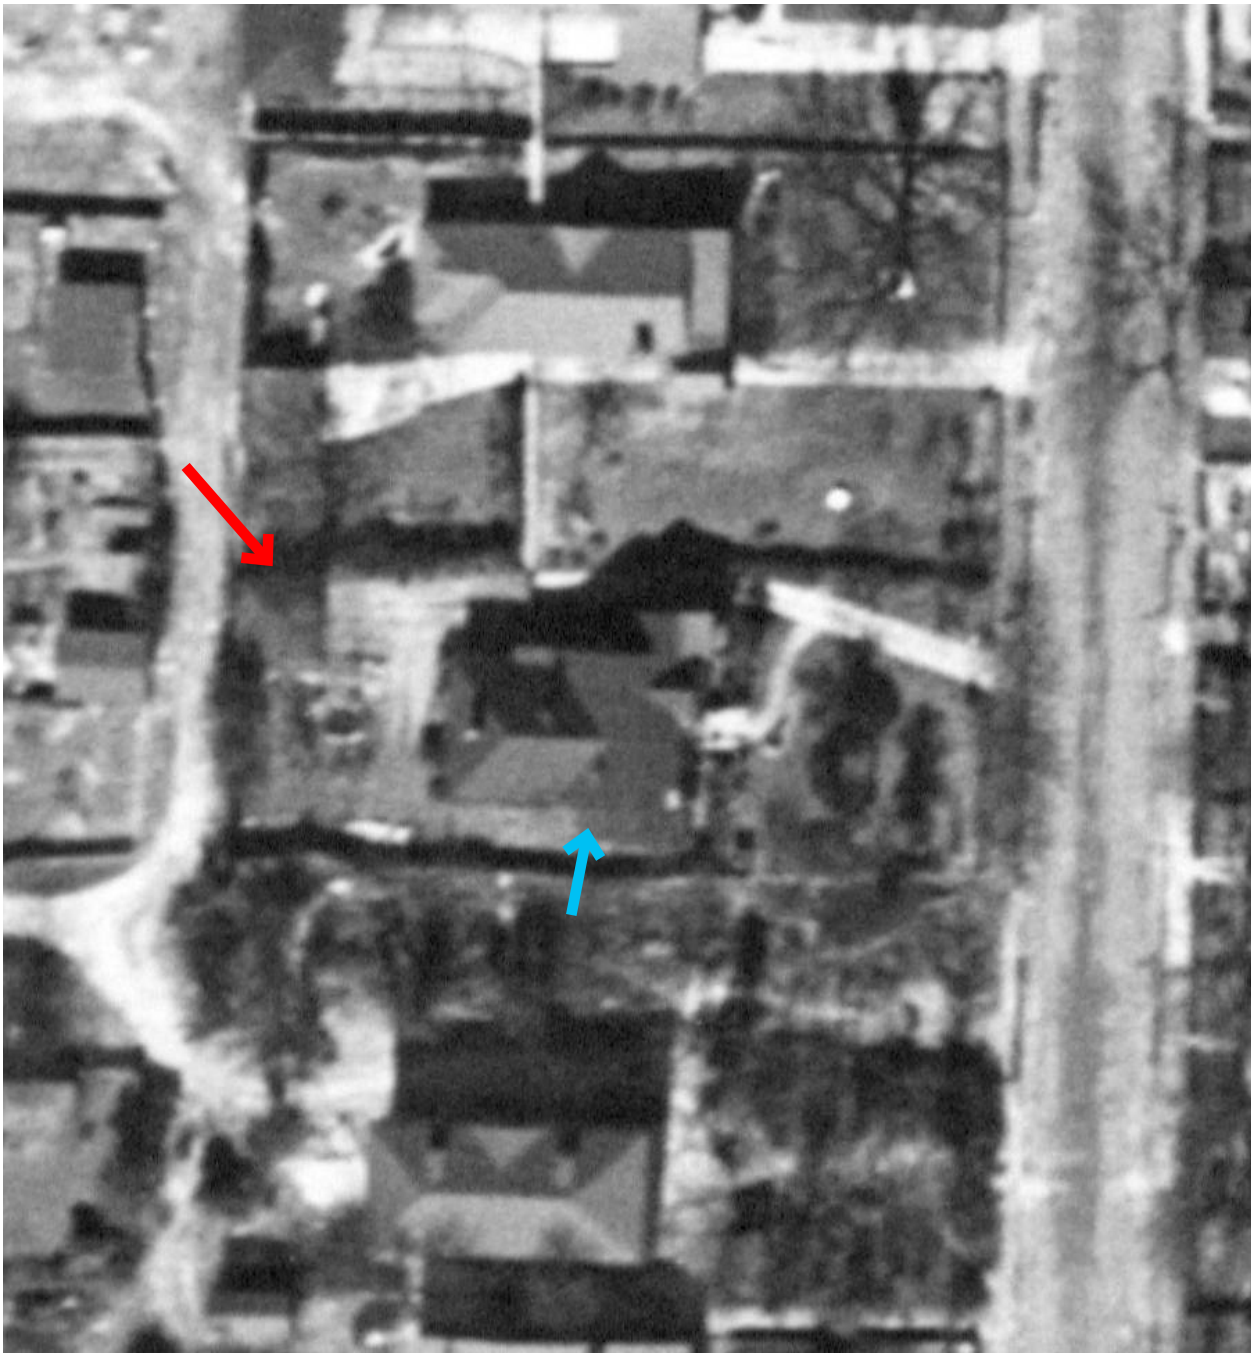
Figure 2.27. 1949 aerial view of the house located at 234 Sunset Avenue, with a detached garage (red arrow) and possible terrace (blue arrow). (Source: Planning Atlanta - A New City in the Making, 1949 Aerial Mosaic and Photographs, Georgia State University Library, asa043l.)

Aerial photographs and a Works Progress Administration map depict the site at 234 Sunset Avenue during the Cowan's occupation (Figure 2.26 and Figure 2.27). The house at 234 Sunset Avenue did not feature any recorded hedges or other property boundary markers, but there was a fence located along the rear of the property. Dunkirk Street, located south of the property, was unpaved with no walk or curb. The Works Progress Administration Map shows the features located in the city right of way as well as property and fence lines. The sidewalk paralleling the street is paved with brick and had a granite curb by 1938. Sunset Avenue is paved. Dunkirk Street is noted as unpaved and the alley is not depicted on the map. A fence line exists on the west property line. Figure 2.28 depicts an approximate layout of the first floor of the house.

The Cowan family commissioned the construction of a solarium, sunroom, or sun porch addition along the south side of the house sometime between 1952 and 1955. A 1949 aerial photograph may show signs of a terrace at this location (Figure 2.27). Two 1952 aerial photographs have low resolution; one appears to show this area the same color as the back yard, while the other registers it as a lighter color like that of the driveway, in contrast with the dark roof of the house. A low resolution 1955 aerial appears to show the existing shed roof of the addition.²⁰⁵ The January 1957 realty listings for the house describe the room as a “beautiful solarium.”²⁰⁶ The Cowans appear to have accessed the solarium from a door in the west wall of the living room (Figure 2.28). This door opened into a small space under the west extension of the south gable. This space may have originally been an enclosed room or an exterior porch. Spaces of this type became common during the first half of the twentieth century, providing a sunny living space that could be enjoyed in cooler weather. The east wall is clad in notched vertical board siding, a treatment not documented elsewhere on the house. There is no photographic evidence of what the solarium looked like. Its construction may

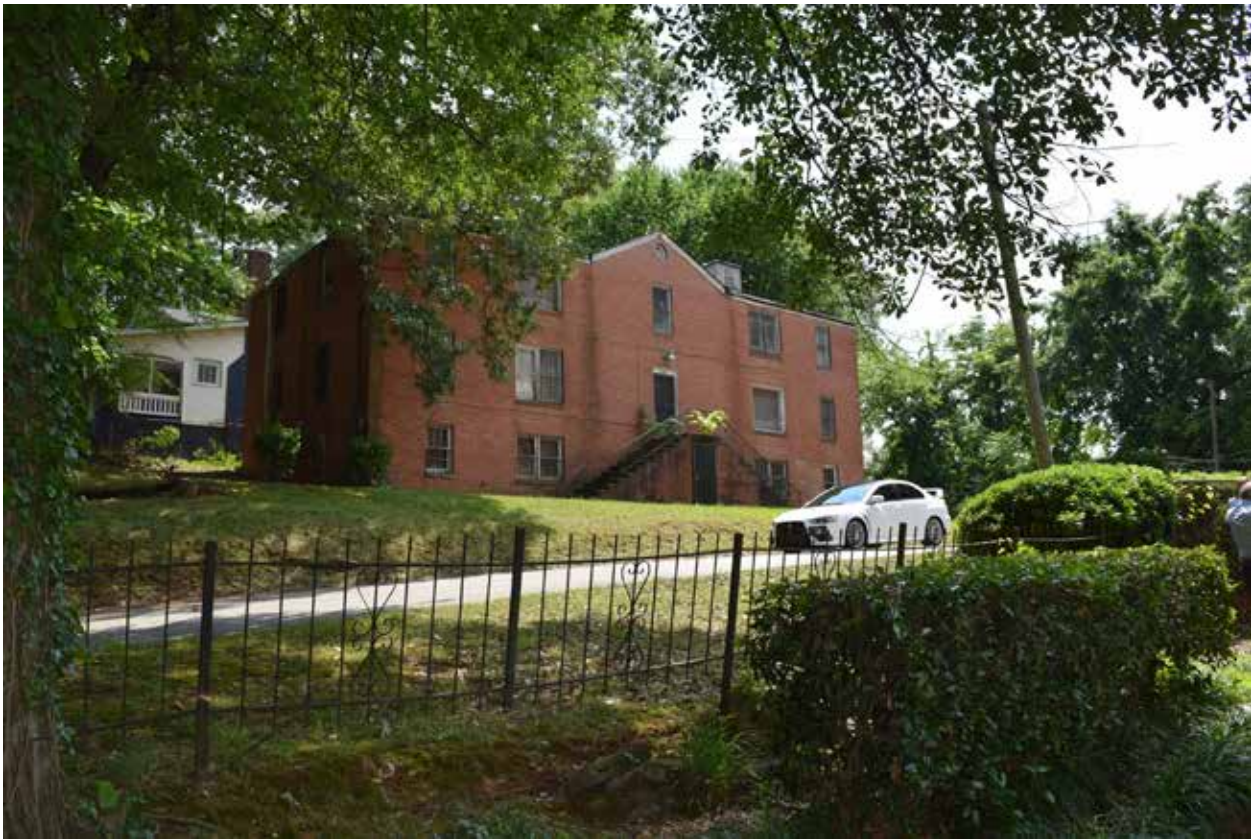
Figure 2.29. Jackson Apartments (1949), 220 Sunset Avenue NW. (Source: WLA Studio, April 2020.)

and pastor Rev. Maynard Holbrook Jackson, Sr. constructed a three-story apartment building at 220 Sunset Avenue in 1949 (Figure 2.29). The Jackson Apartments reflect the stripped-down aesthetics of the late-1940s and early-1950s.¹⁹⁹ Rev. Jackson was the pastor of Friendship Baptist Church, "Atlanta's oldest autonomous black church," which was associated with the founding of Atlanta University, Morehouse College, and Spelman College.²⁰⁰ Rev. Maynard Jackson and his wife Dr. Irene Dobbs Jackson were key figures in Atlanta's early civil rights movement of the 1930s through 1950s. The couple lived on the second floor of the building with their six children, and the income produced from renting the remaining portions of the building helped support their income.²⁰¹ Maynard Holbrook Jackson, Jr. was one of the Jackson children; he later became

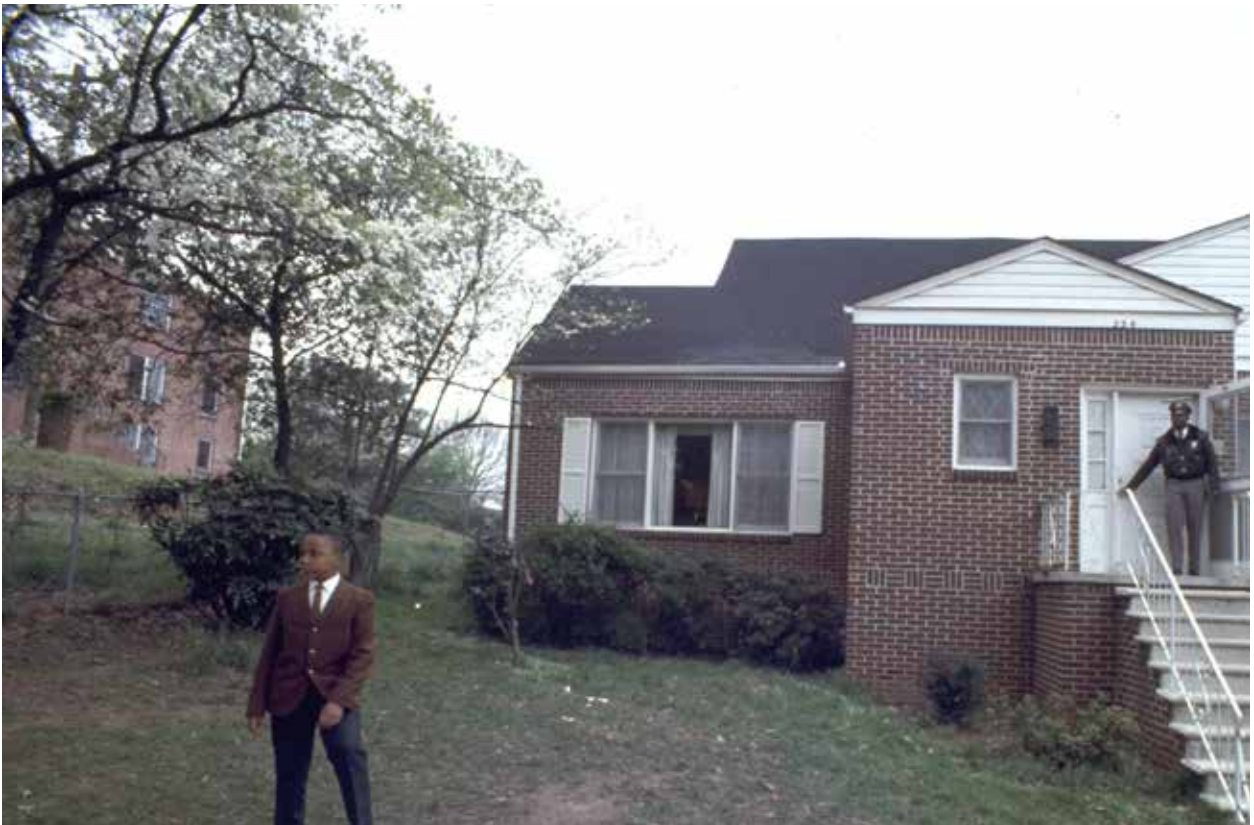
Figure 2.45. Image of Martin Luther King III and a police officer standing in front of the King Family Home, April 1968. This photo shows the established dogwood trees along the south property border and large shrub, which may be a mahonia located off the southeastern corner of the house. Police officers may have taken advantage of the view from the front entry stair for surveillance / security purposes. (Source: © Flip Schulke.)

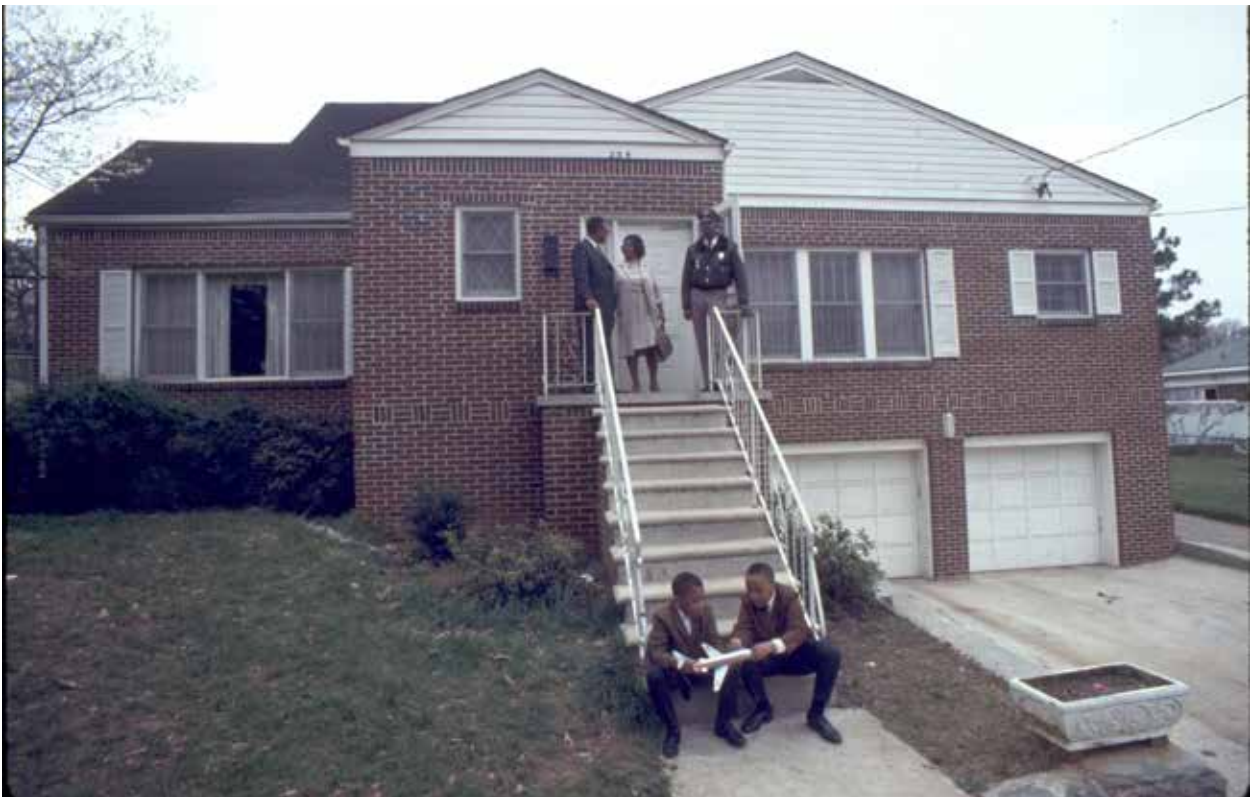
Figure 2.46. Image of Martin Luther King III and Dexter King sitting on the front steps of the King Family Home, April 1968. This photo shows what appears to be a rock border in the front of the house in between the shrub plantings. The photo also shows the concrete rainwater diverter that separates the grade of the driveway into the garage from the grade of the driveway that skirts the north property line. (Source: © Flip Schulke.)

Flip Schulke and Bob Fitch were allowed inside the residence. Photos show Yolanda signing for flowers on the front steps of the house (Figure 2.44), lines of visitors in the living room, and Coretta Scott King receiving visitors in her bedroom. An image captures Martin Luther King III and Dexter King sitting on the front steps of the house with a police officer standing guard (Figure 2.46). Film coverage and images captured Robert and Ethel Kennedy as they arrived at the house to pay their respects.³³⁸

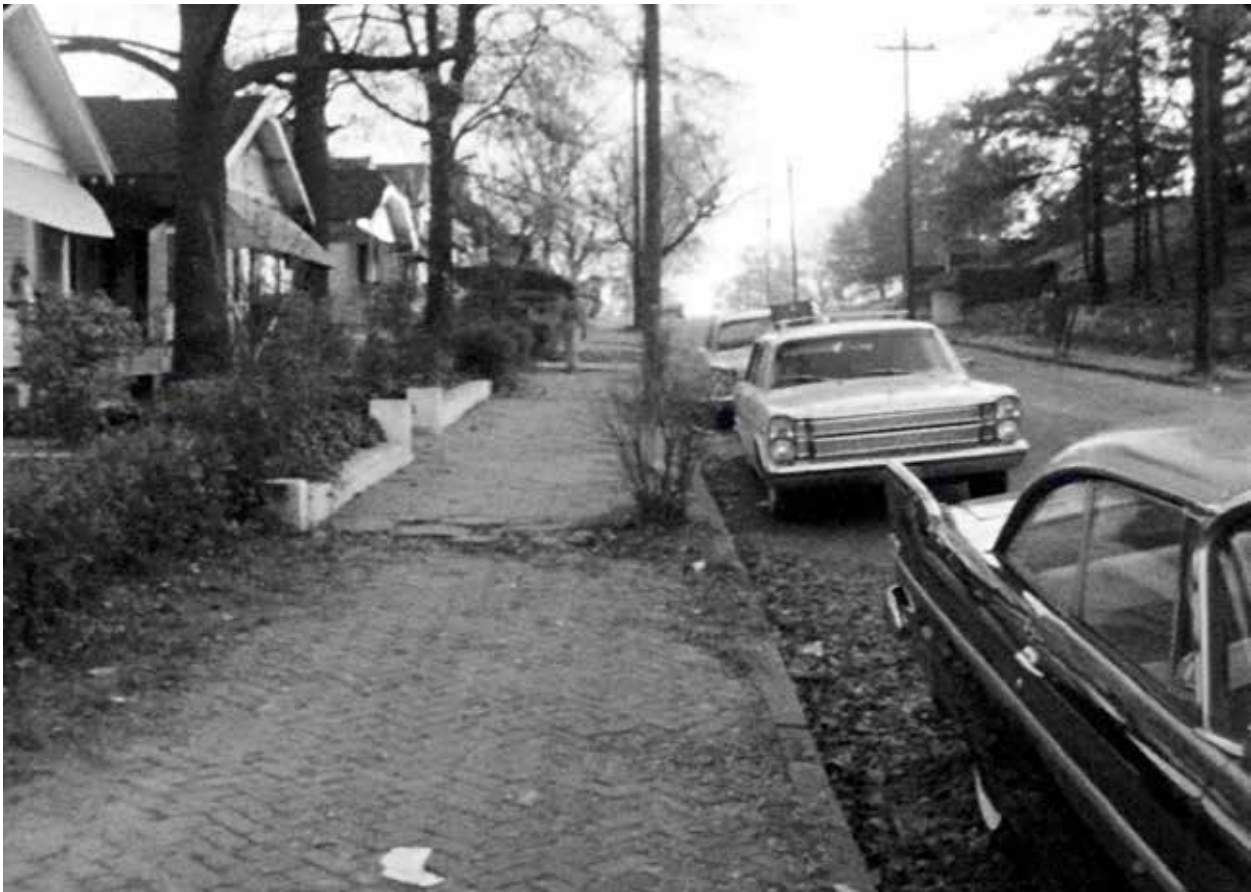
Figure 2.50. December 1965 view facing south on Sunset Avenue. Image is across the street from the King Family Home. Note herringbone sidewalks, on street parking, and large street trees in front yards. The houses on the east side of the street have a smaller setback than those on the west side of Sunset Avenue and there is no planting strip between the curb and sidewalk. (Source: MLK and Arnold Michaelis Interview, Raw Footage Reel 8, University of Georgia, Peabody Archives.)

Dr. King moved to Chicago in the winter of 1965 and 1966, while Coretta Scott King and the children stayed behind in Atlanta, “where Yoki and Marty were now enrolled in a desegregated public school – one of the best in Atlanta; Coretta had seen to that.”³²³ Dr. King traveled back and forth between Chicago and Atlanta frequently that winter, with his travel and home life documented by crews who accompanied journalist Arnold Michaelis in December 1965. Raw footage from these interviews show Sunset Avenue and the surrounding Vine City neighborhood, the children playing in the front yard with numerous neighbors and friends, including the son of Ralph Abernathy, the children inside the house interacting with Ms. Patricia Latimore, and Yolanda playing the piano.³²⁴ This footage captured many site features in the front yard as well as in the interior of the house. Footage shows the setting of Sunset Avenue, a neighborhood with single-family homes, herringbone brick sidewalks, granite curbs, on-street parking, and street trees (Figure 2.50 and Figure 2.51). Electrical utilities are aboveground.

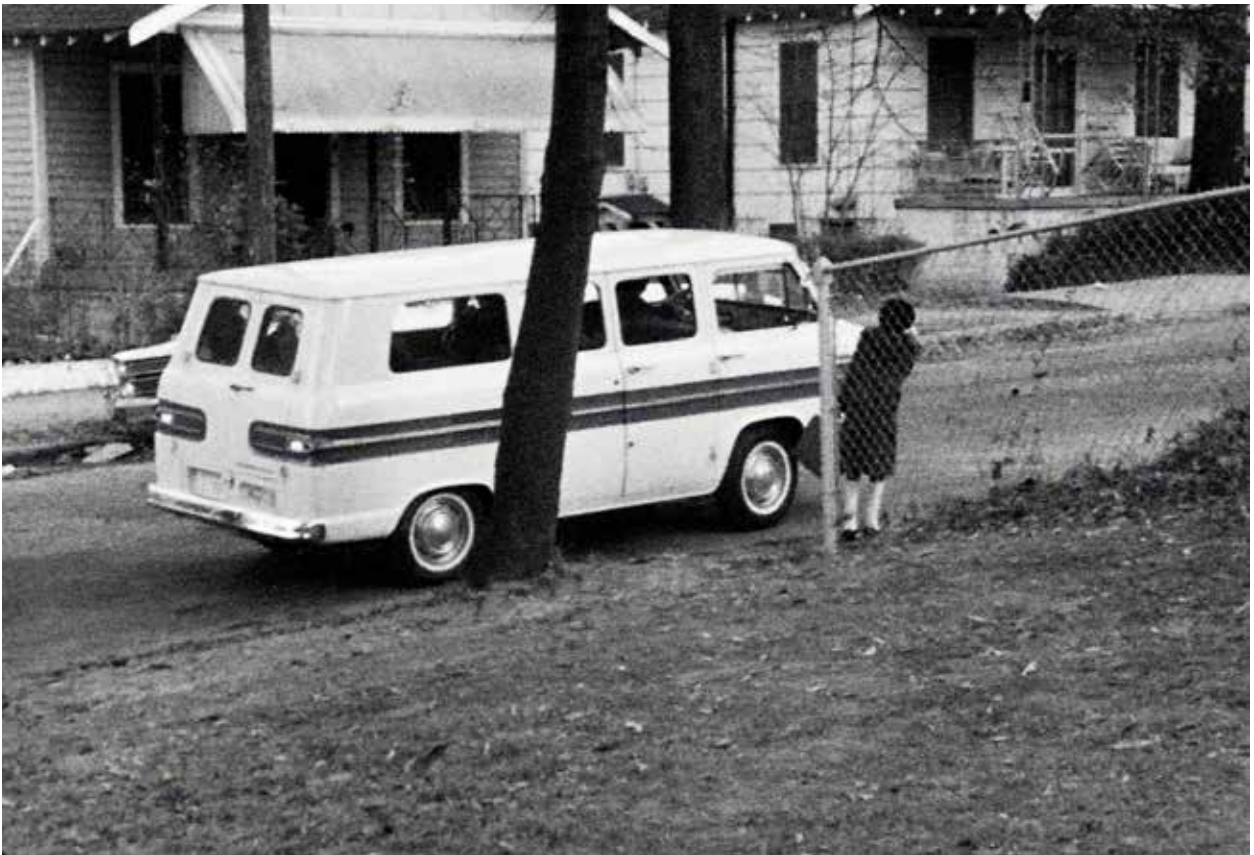
Figure 2.52. December 1965 view of southeast property corner, showing terminus of new chain link fence. (Source: MLK and Arnold Michaelis Interview, Raw Footage Reel 8, University of Georgia, Peabody Archives.)

The footage shows the front yard and its vegetation, small-scale features, and the house's front façade. Details such as the chain-link fence on the south property line are visible in the footage. The fence line stops close to the southeast property corner, adjacent to the sidewalk along Sunset Avenue (Figure 2.52 and Figure 2.53). The front yard contains a turf grass area, evergreen foundation plantings, a pine tree, and a lamp post. The retaining wall lining the driveway is stepped down on its eastern end near the sidewalk. The retaining wall extends west to the house façade, with a break to allow for the steps up to the entry walkway (Figure 2.54). The lamp appears to be a coach lamp type post top luminaire on a four-foot-high post (Figure 2.55 and Figure 2.56). These types of fixtures were readily available in the 1960s from outlets such as Sears, Roebuck and Co.³²⁵ The front yard contains an established pine tree that is also visible in the film footage (Figure 2.57). The northern edge of the driveway

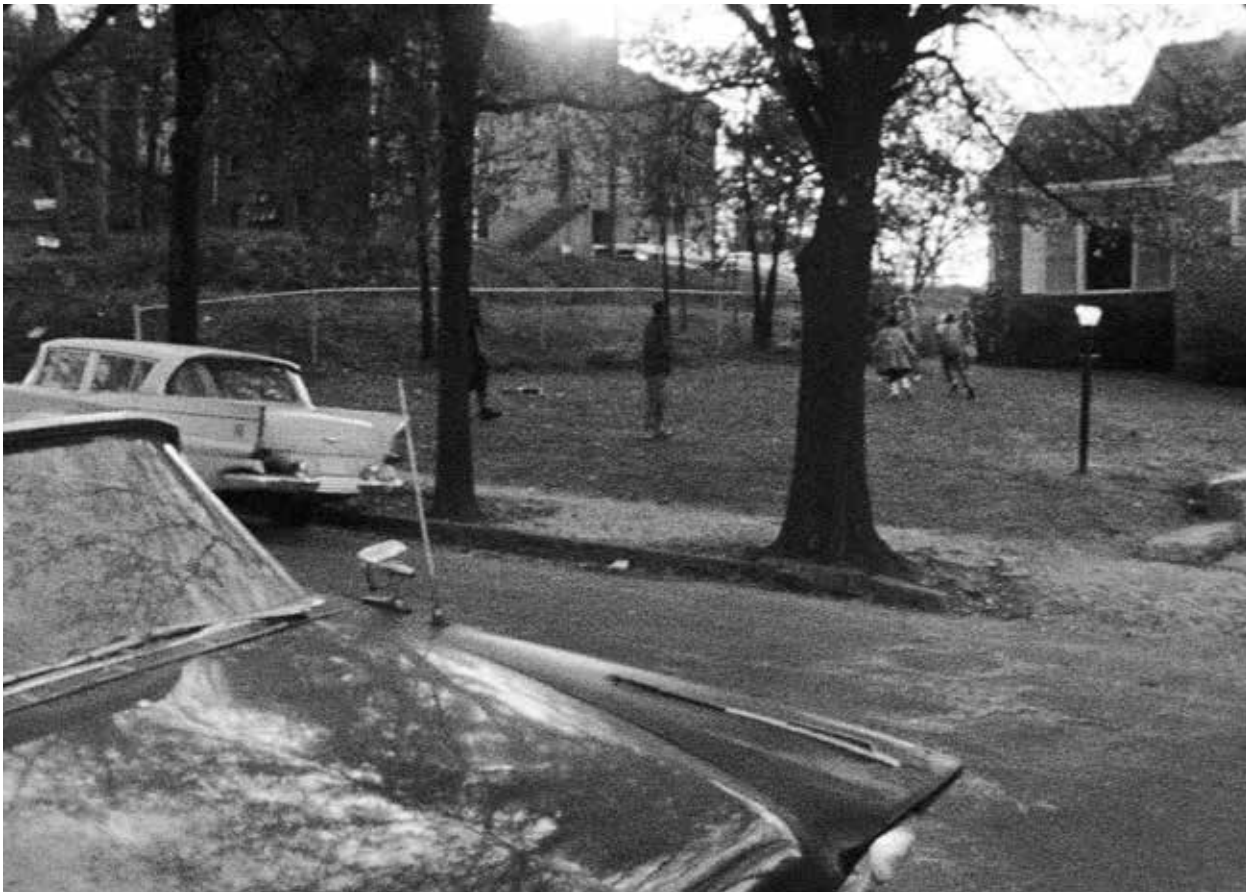
Figure 2.53. December 1965 view toward southern property border from across Sunset Avenue. Property line trees are apparent. Street trees are present between the curb and brick sidewalk. It appears that there is a section of brick or worn dirt between the two trees in this image. (Source: MLK and Arnold Michaelis Interview, Raw Footage Reel 8, University of Georgia, Peabody Archives.)

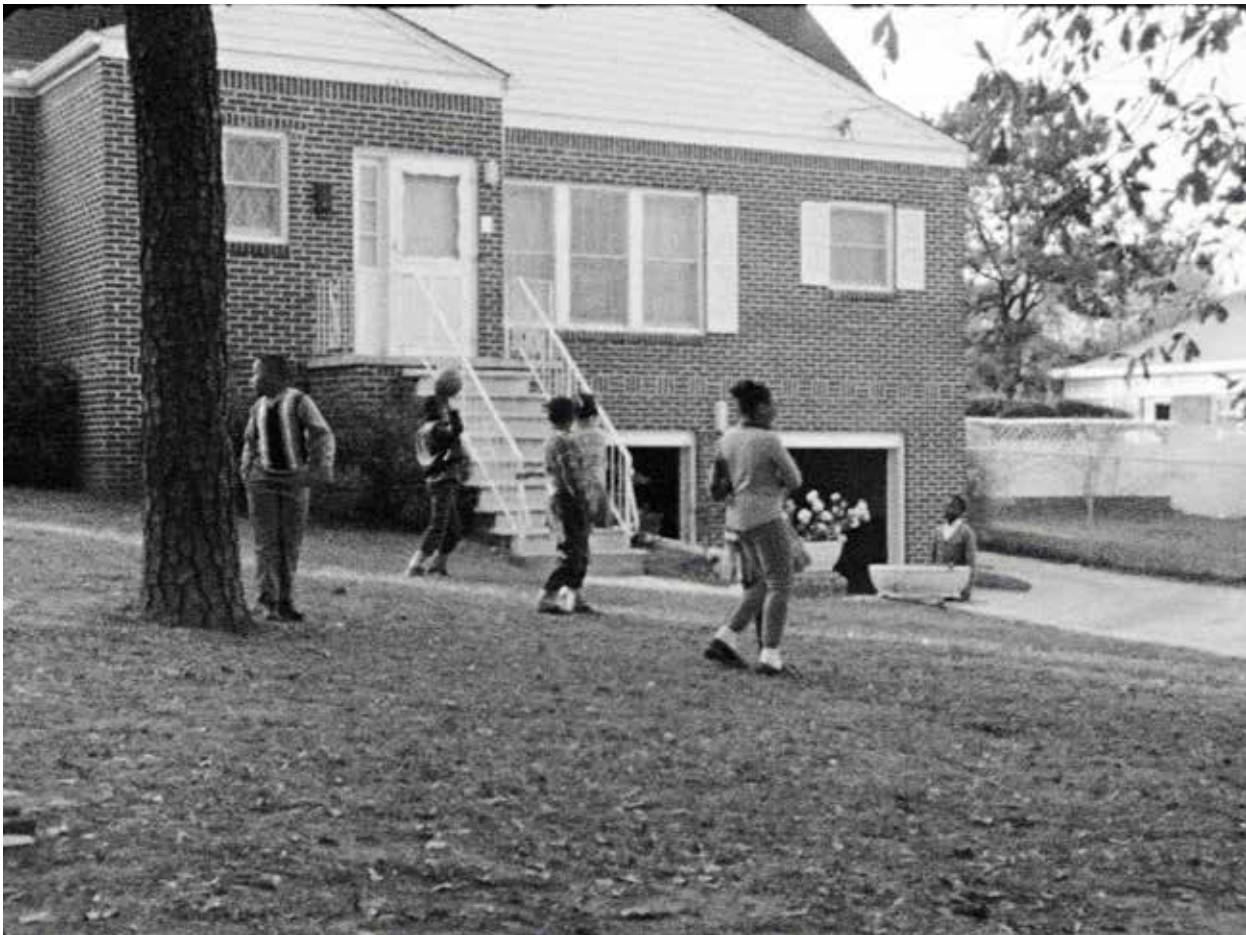
Figure 2.59. December 1965 view looking northwest from the sidewalk. Note two concrete planters on retaining wall, one planted with mums. The adjacent side yard has a wood privacy fence with lattice along the top. (Source: MLK and Arnold Michaelis Interview, Raw Footage Reel 8, University of Georgia, Peabody Archives.)

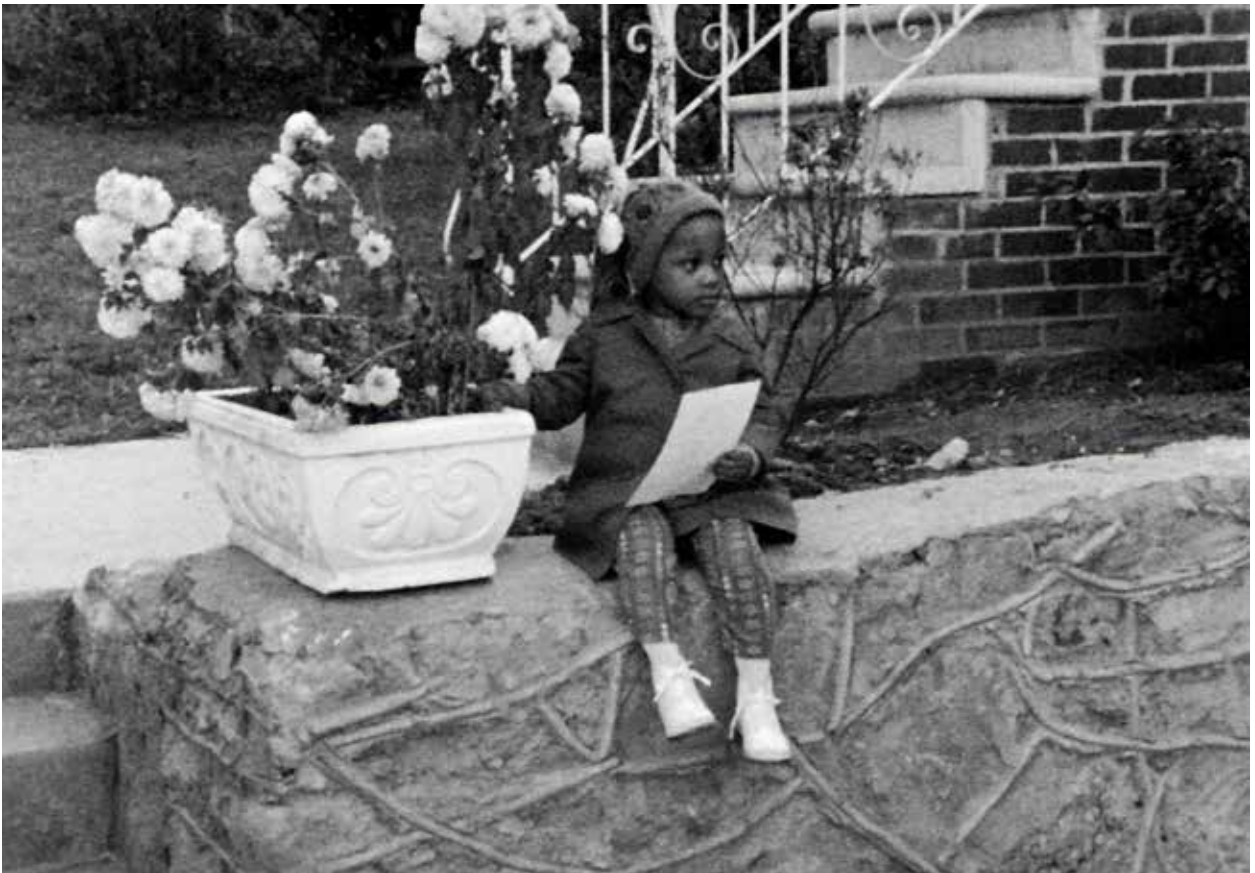
Figure 2.60. December 1965 still image of Bernice King sitting on the stone retaining wall next to the concrete planter. The retaining wall may be painted with grey paint or skim coated with concrete. (Source: MLK and Arnold Michaelis Interview, Raw Footage Reel 8, University of Georgia, Peabody Archives.)

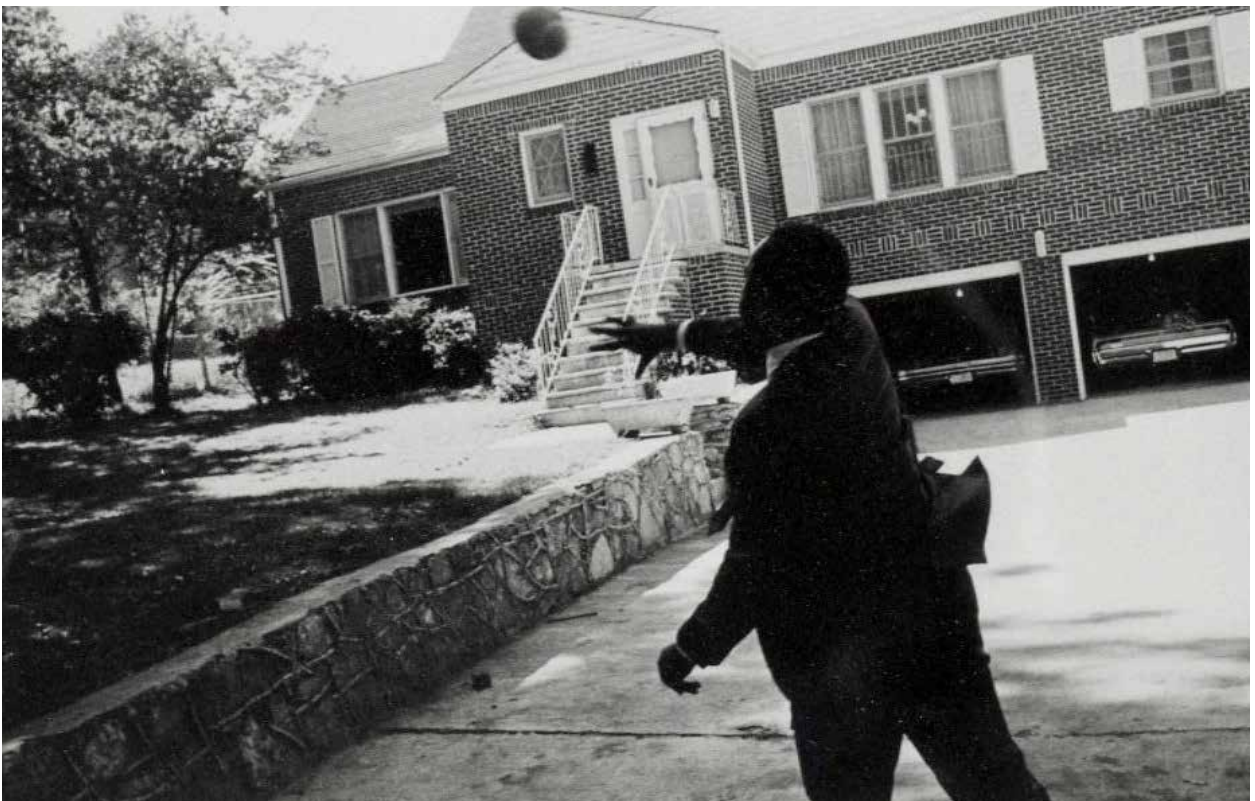
Figure 2.61. Undated photograph of Martin Luther King, Jr. in front of the King Family Home. View of the retaining wall and expansion joint in the driveway concrete. Evergreen shrubs are located at foundation. Unidentified trees are visible along the southern property line. (Source: MALU Archives.)

is lined by a brick border, with the bricks placed on a diagonal. Several bricks are missing from the border, and some bricks are askew (Figure 2.58). It is unknown if this was an existing border prior to the 1965 installation of the driveway. Plantings include evergreen shrubs, including possibly southern Indica azaleas (*Rhododendron indicum*), between the front entry stair and the retaining wall and mums in one of the concrete planters that flanked the steps to the entry walkway (Figure 2.59). Closeup footage of the retaining wall does not reveal if the wall is painted a light grey color or if a skim coat of concrete covers some of its stone. Raised beaded joints are apparent in the wall construction (Figure 2.60). An undated photo of the front yard shows the full length of the retaining wall, the variation in stone color in the wall construction is apparent in this photo (Figure 2.61).

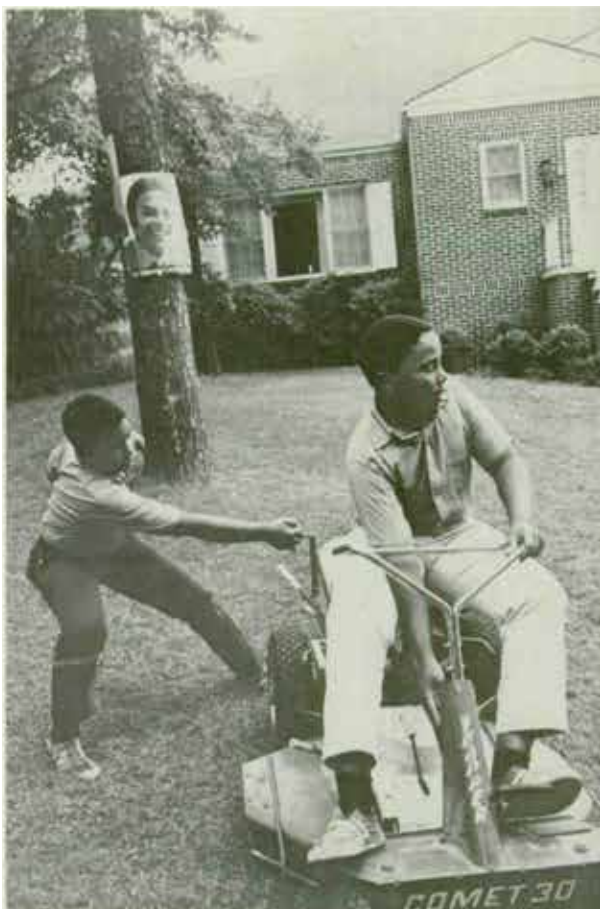
Figure 2.65. Martin Luther King III (on mower) and Dexter (starting mower) in front yard, 1970. Note the evergreen foundation plantings are still present in front of the house, and vegetation has increased near the southeast corner of the house. (Source: *Ebony* – permission pending, see Appendix E.)

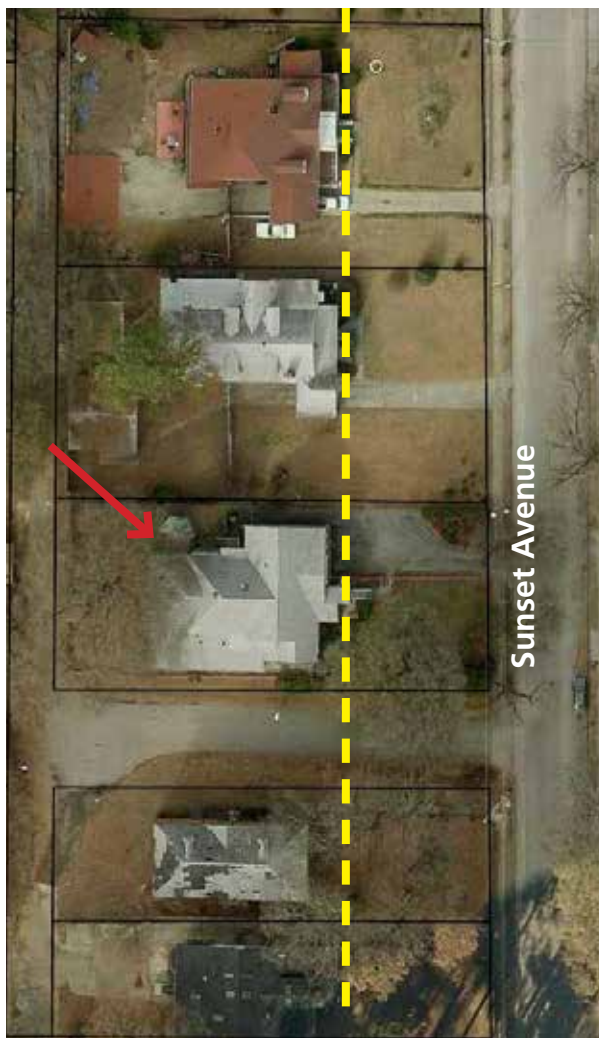
Figure 3.2. Aerial view of the King Family Home showing setback from Sunset Avenue. (Source: ESRI, City of Atlanta.)

The spatial organization of the King Family Home site is defined by the residential building centered on the site, with fence lines designating the property boundaries on the north, west, and south. The house is aligned with its narrower elevation facing Sunset Avenue. The house setback is similar to that of other single-family residential buildings on the west side of the street, approximately seventy-five feet from the face of curb (Figure 3.2).

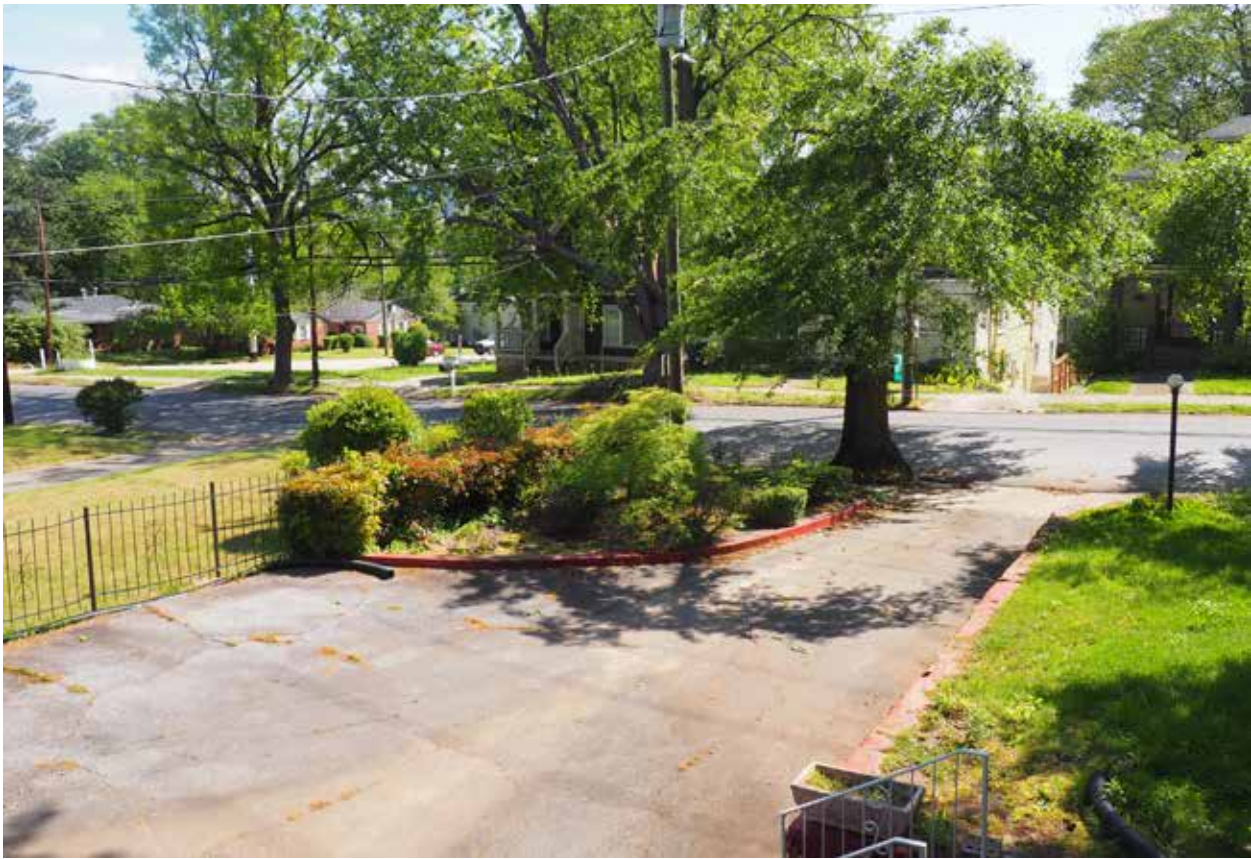
Figure 3.3. The asphalt driveway north of the front yard, facing northeast. A smaller landscape bed is visible in the northeast corner of the property. (Source: WLA Studio, June 2020.)

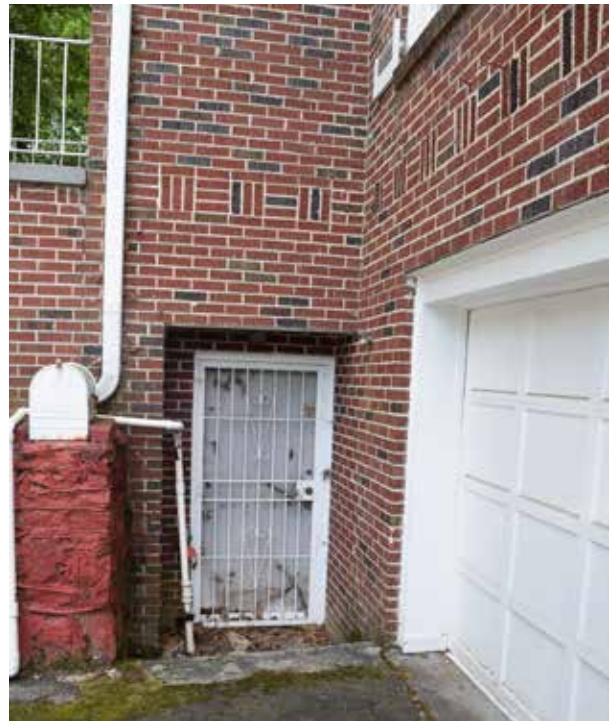
Figure 3.6. The lower floor of the residence can be accessed through the garage door (right) or the exterior door (center). The door is accessible by a single concrete step to a lower concrete platform from the driveway. Photo facing south. (Source: WLA Studio, October 2019.)

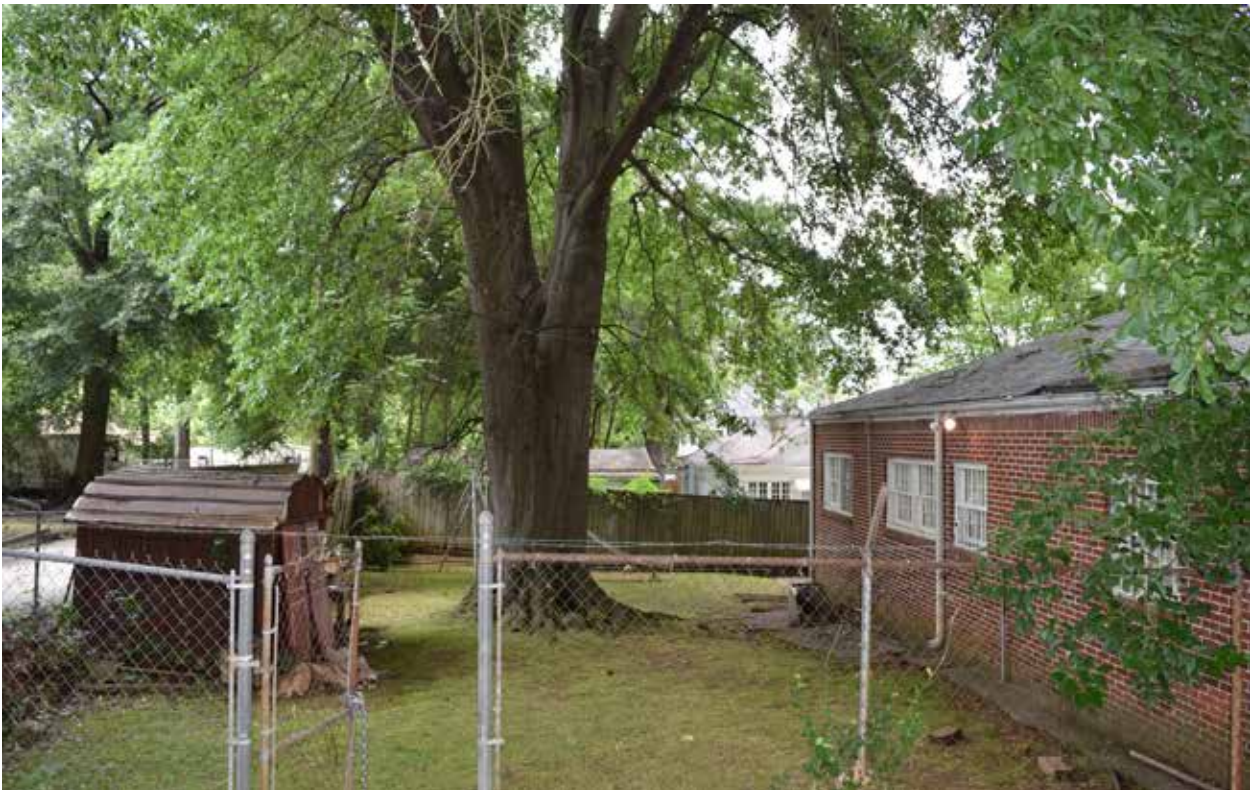
Figure 3.7. The back yard of the residence is mostly turf grass areas and hardscape. A mature oak provides canopy cover over much of the back yard. A chain link fence runs along the southern property line. Barbed wire installed atop the fence is in poor condition and missing in areas. Photo facing north. (Source: WLA Studio, June 2020.)

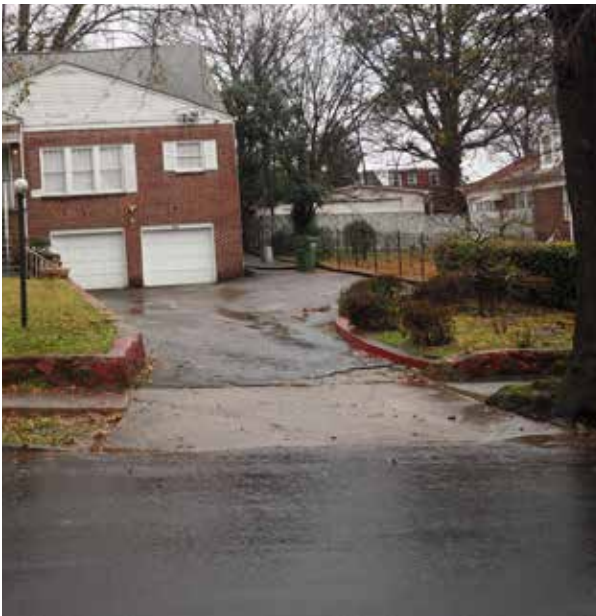
Figure 3.12. View of the asphalt driveway on the northeast section of the property, facing west. The driveway is lined by the stone retaining wall on the south and a concrete curb on the north. The apron leading from Sunset Avenue is concrete. (Source: WLA Studio, June 2020.)

Vehicles enter the asphalt driveway from a curb cut on Sunset Avenue. The driveway can accommodate three to four vehicles at once when double-parked. The driveway is the primary access point for vehicular or pedestrian activity on the site, and it is located in the northeast portion of the site (Figure 3.12 and Figure 3.13). The irregularly shaped paved area spans approximately thirty feet north to south at its widest point. The southern edge of the paved area is straight and parallels a stone retaining wall. The northern edge is partially curved and has a landscape bed along its edge. The driveway extends sixty-eight feet west toward the two-car attached garage. A drive continues another thirty-five feet
