King Family Home Martin Luther King, Jr. National Historical Park Cultural Landscape Report

King Family Home

Cultural Landscape Report

January 2022
Prepared by:
WLA Studio

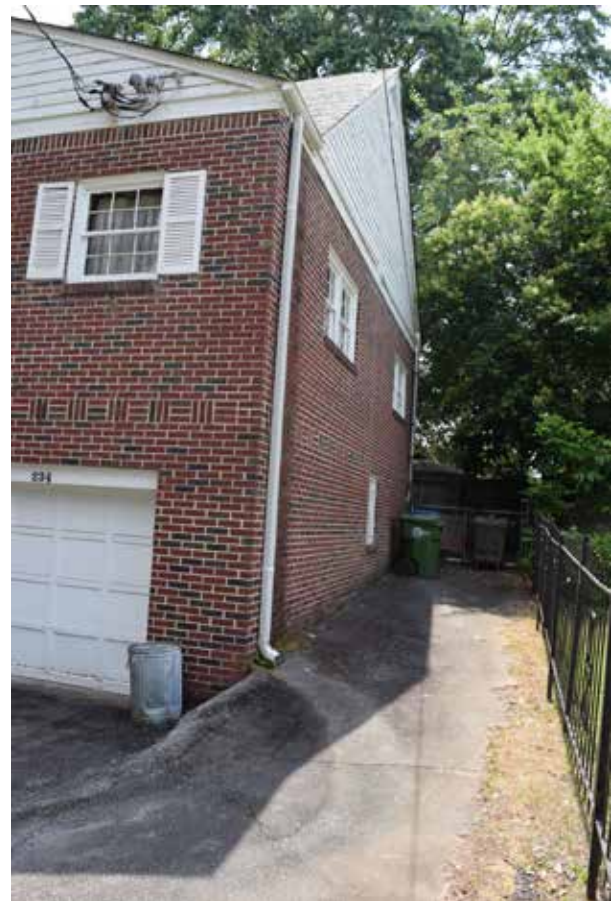
Figure 3.13. View of the driveway as it continues to the north side of the residence, facing west. Utility lines cross the driveway and enter the residence from the front gable (left). (Source: WLA Studio, June 2020.)

along the north elevation of the house before ending near the side entry into the north side of the house. The northern section of the driveway past the northeast corner of the house is eight feet wide. The driveway on the east side of the house is bounded by the retaining wall to the south and a metal pike fence to the north. A concrete curb edge is the boundary between the northeast portion of the driveway and a planting bed. A section of the asphalt pavement on the north side of the house is fenced. It is bounded on the west by a section of wood privacy fence, on the north by the metal pike fence, and on the east by chain-link gate. The asphalt driveway shows signs of deterioration including cracking. In addition, the asphalt surface has negative drainage, which directs water toward the garage doors and basement entry area. There are no drains built into the driveway. There is a small area of raised asphalt near the northeast corner of the house, presumably installed to direct drainage away from this corner of the building.

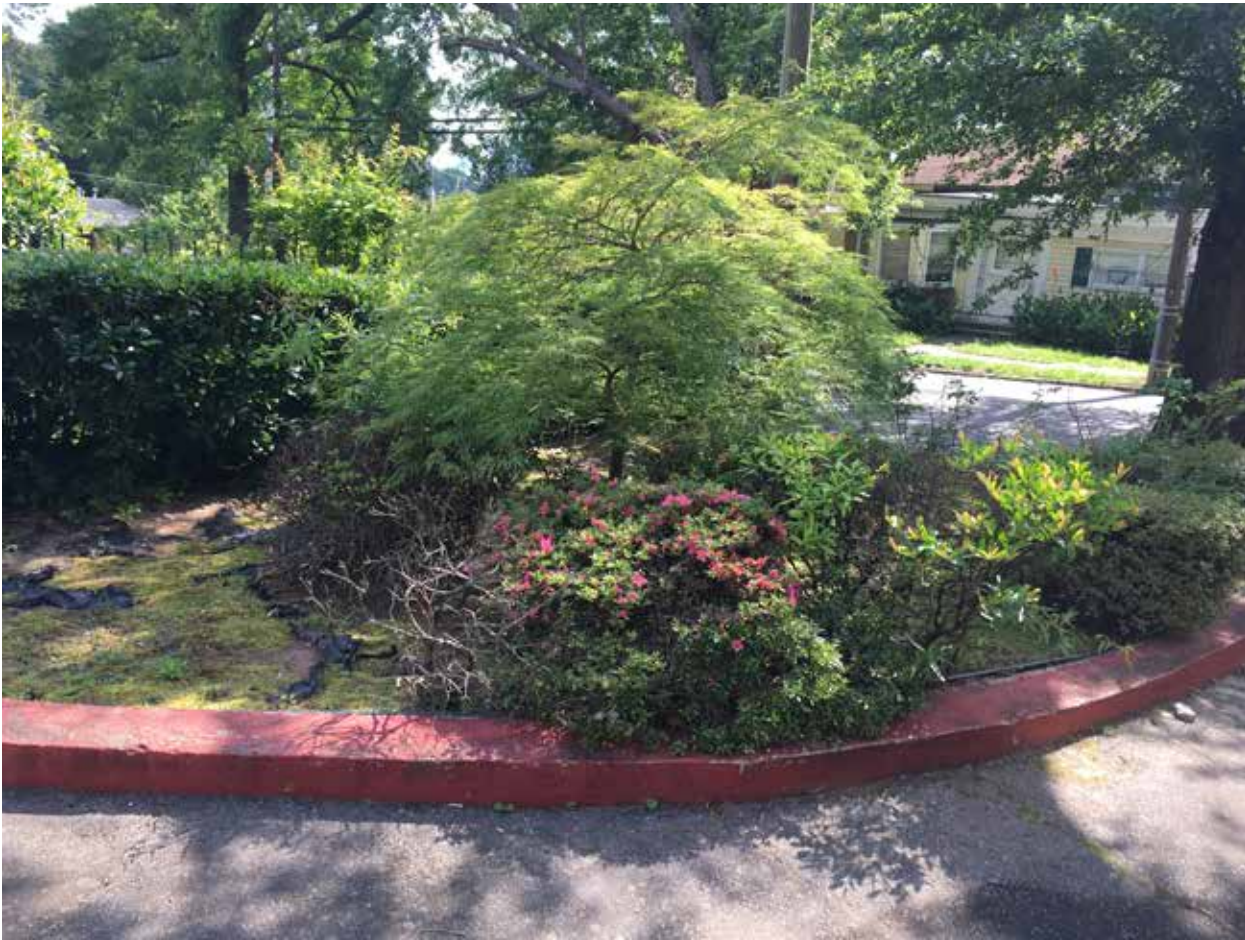
Figure 3.14. View of the concrete curb along edge of driveway, facing northeast. (Source: WLA Studio, June 2020.)

A raised, painted curved concrete curb encloses the landscape bed on the northeast corner of the site. It meets a stone wall at the entrance of the driveway (Figure 3.14). This feature is approximately thirty-six linear feet long, eight and one-half inches wide, and five inches high. The curb begins at the northern property line and terminates at the northern portion of the stone retaining wall paralleling Sunset Avenue, north of the driveway. The concrete is painted red, with peeling and chipping paint.

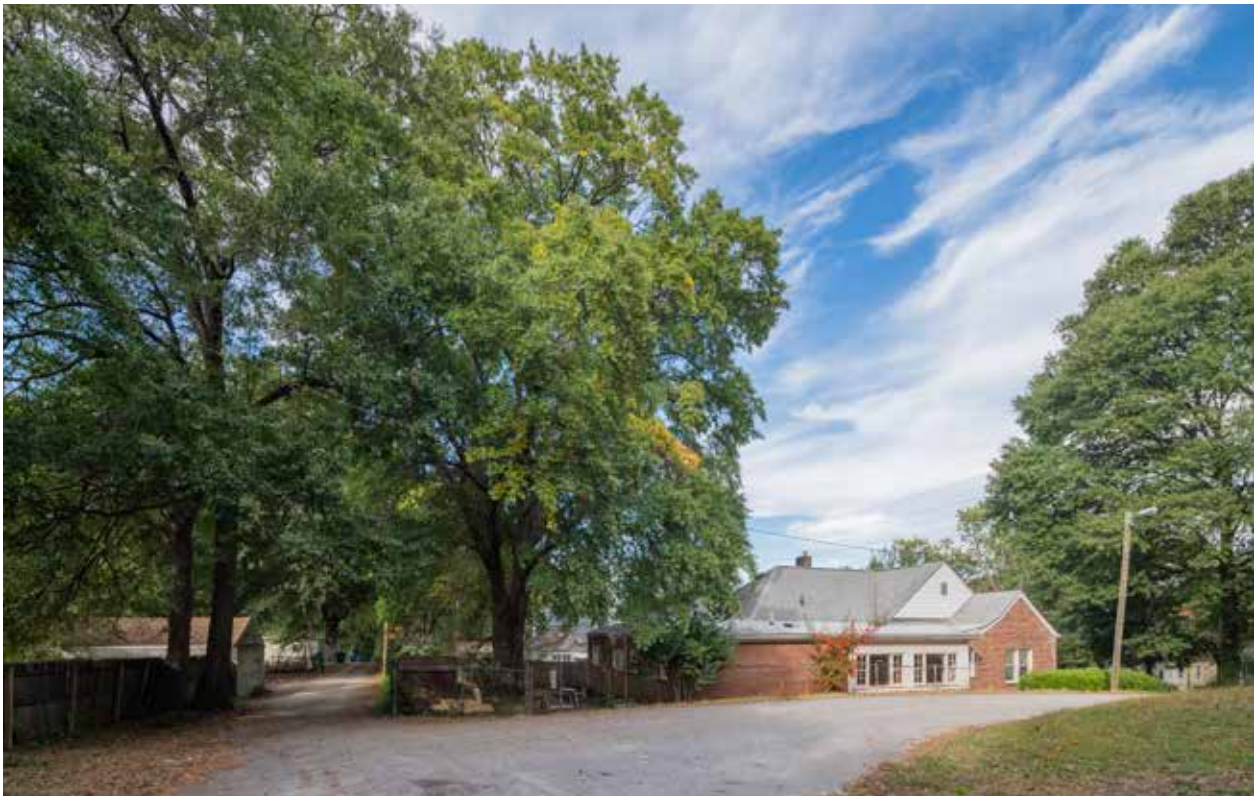
Figure 3.15. View of Dunkirk Street, located south of the property, and the alley, located west of the property, facing northeast. (Source: HABS_GA-199-7, 2020.)

Dunkirk Street runs along the southern property line (Figure 3.15). The label “Dunkirk Street” does not appear on current city maps, but it was the historic name of this access road. The road is paved with asphalt and has no curb. The approximate width of the street is eighteen feet with the asphalt flaring to forty feet wide where the street meets an alley on the west side of the parcel. There is a

There is an alley located along the western property border of the King Family Home (Figure 3.15). The alley is paved with gravel and provides access behind addresses 216 to 266 Sunset Avenue and 209 to 267 Griffin Street. The alley is eight to nine feet wide.

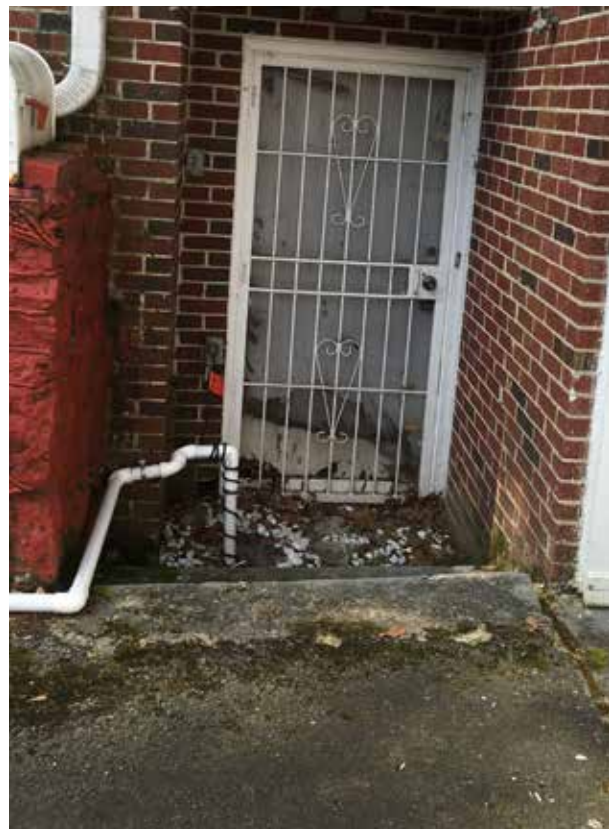
Figure 3.16. Concrete step leading to basement entry door, facing south. (Source: WLA Studio, June 2020.)

A single concrete step connects the asphalt driveway to the basement-level entry door located underneath the front entry stair (Figure 3.16). Contractors constructed this step by removing a portion of the adjacent retaining wall and turning

it back toward the house. The step is coated in chipping grey paint. The chipping paint provides evidence that the step was previously painted black. This feature dates to the 1968 renovation of the basement.

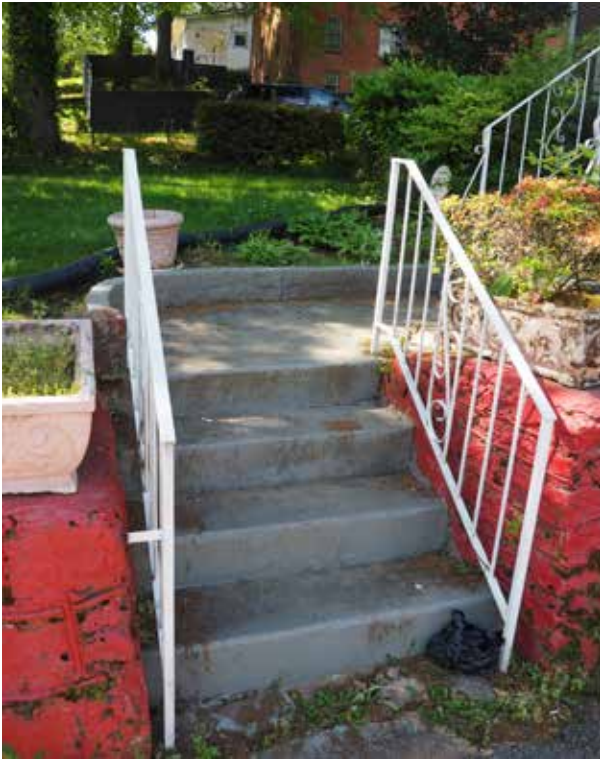
Figure 3.17. Three concrete risers with decorative metal handrails connect to a concrete walkway, facing south. (Source: WLA Studio, June 2020).

A curved concrete walkway and set of steps connect the asphalt driveway to the primary entrance of the residence (Figure 3.17 and Figure 3.18). The steps intersect the stone retaining wall on the south side of the driveway. Three risers transition pedestrians from the driveway level to the top of the retaining wall. From there, the concrete walkway curves west and continues to the stair leading to the front entrance of the house. The curved portion of the walk is bounded by a mortared brick edge, which is painted grey.

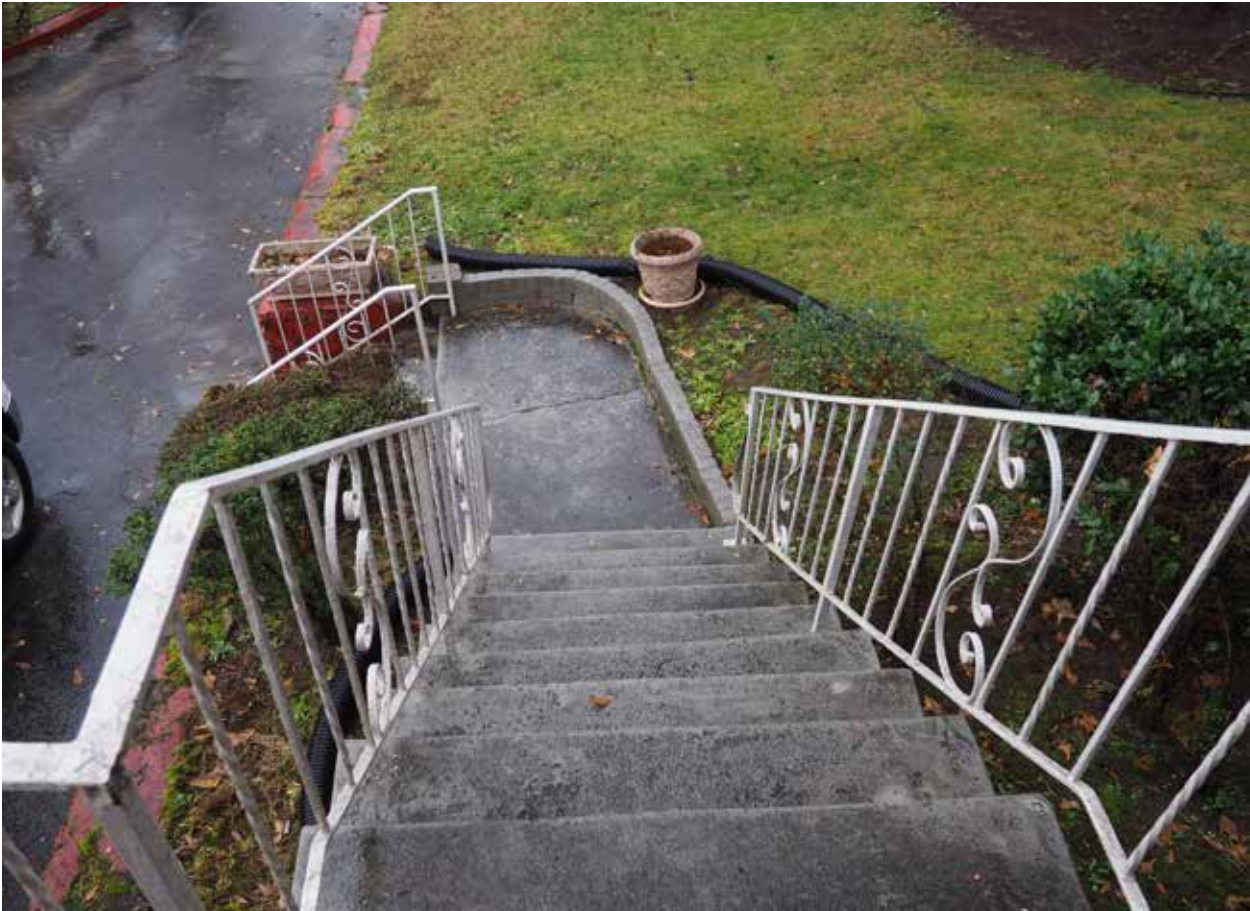
Figure 3.18. View of the curved concrete walkway from the front landing. The walkway is separated from the front turf grass area by a mortared brick edging (Source: WLA Studio, June 2020).

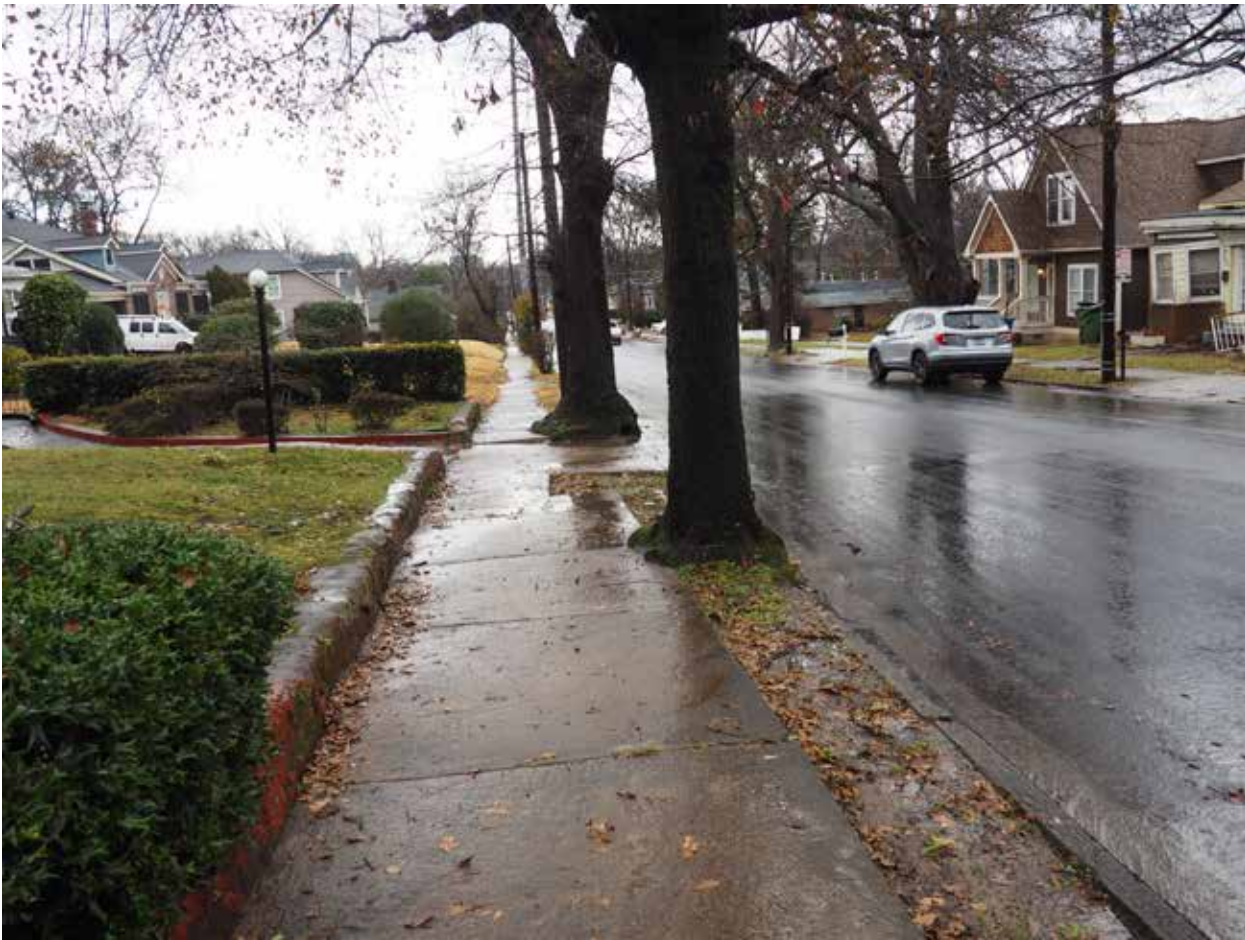
Figure 3.20. View facing north along Sunset Avenue at the intersection with Dunkirk Street. The property is located on the left side of the photo. (Source: WLA Studio, June 2020.)

The city-owned sidewalk is located outside the property boundaries. It crosses the eastern edge of the property parallel to Sunset Avenue. The concrete sidewalk is six feet wide. The sidewalk provides pedestrian access to the site via the driveway (Figure 3.20) The sidewalk is in fair condition, with some areas of erosion and undermining and some cracking. Where the asphalt driveway meets the sidewalk, there is a concrete apron transitioning grade to the street from curb level. There is a landscape strip between the sidewalk and Sunset Avenue. A six-inch concrete curb with a twelve-inch gutter separates the landscape strip from Sunset Avenue, which is paved with asphalt.

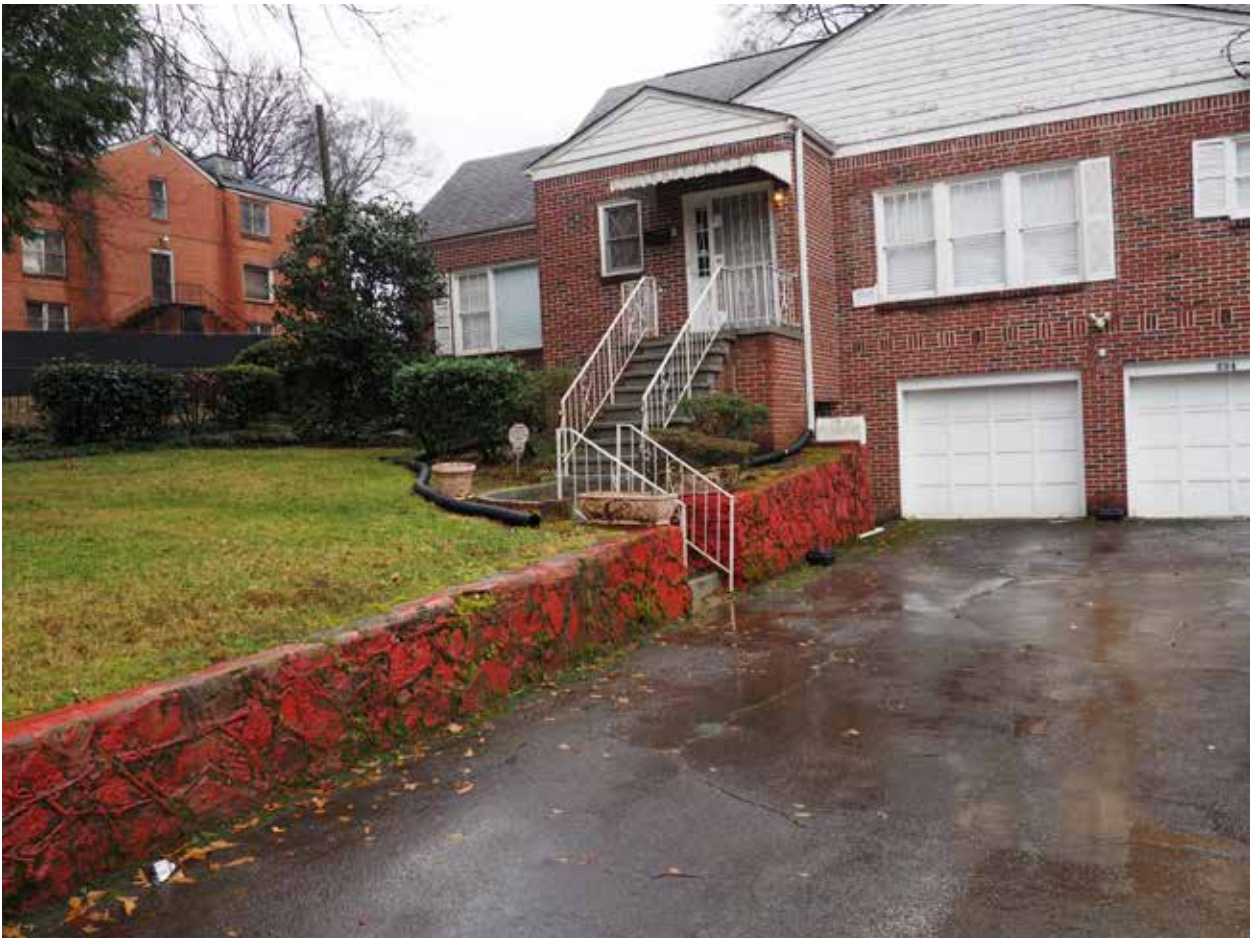
Figure 3.21. View facing southwest showing how the natural grade has been excavated to accommodate the asphalt driveway and residence. Concrete staircase and walkway connect the driveway to the main entry of the King Family Home. (Source: WLA Studio, June 2020.)

There is significant topographic variation at the King Family Home site. The entirety of the site slopes to the northeast at approximately 7.7 percent, following the natural grade. The natural grade has been modified by the excavation for the foundation of the residential building and for the asphalt driveway (Figure 3.21). The house is located at an elevation of approximately 990 feet above sea level. There is a two- to three-foot change in topography from the south side of the front yard to the asphalt driveway on the northern side of the property. Retaining walls maintain grades along the driveway to provide access to the garage. Closest to the street, there is a fifteen-inch grade change from the top of the retaining wall to the asphalt driveway. The retaining wall gradually increases to a height of forty-nine inches as it nears the residence (Figure 3.22). Retaining walls also hold the grade at the eastern boundary of the site, with thirteen to fifteen inches of grade change

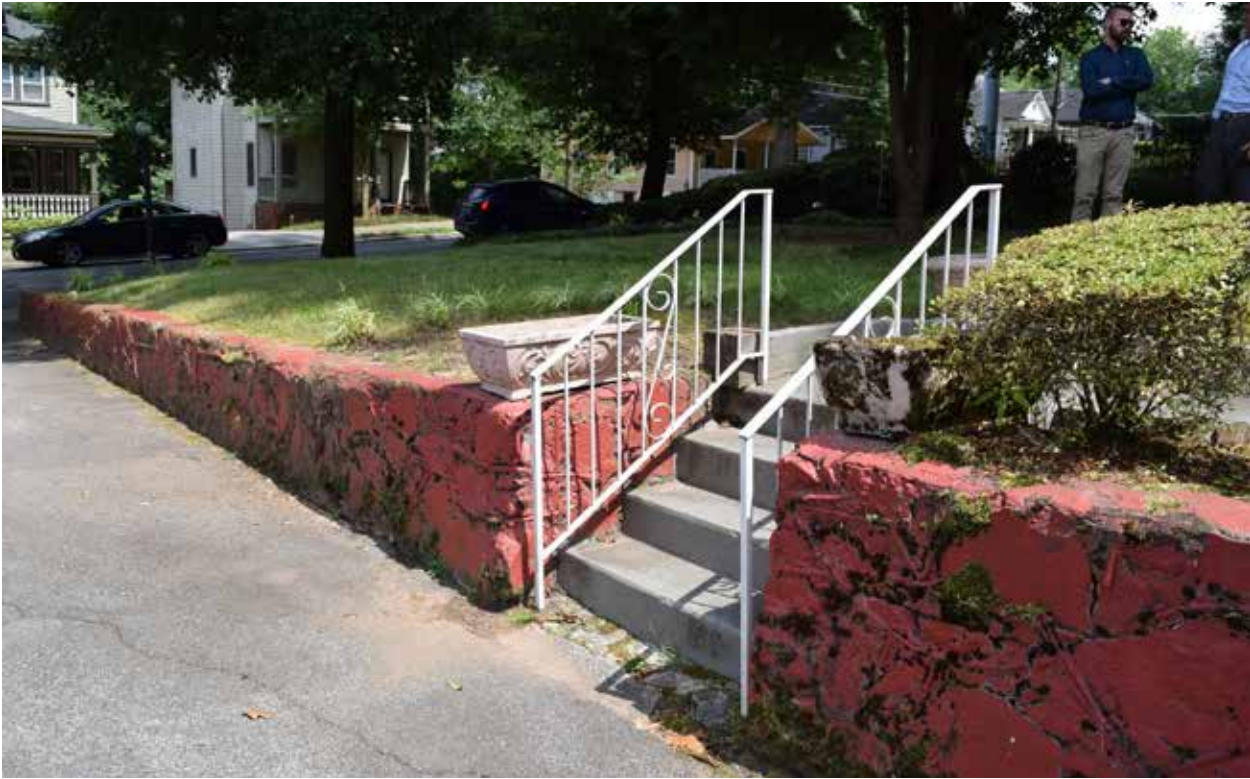
Figure 3.22. View facing southeast of the stone retaining wall, which holds the grade between front turf grass area and driveway. The wall terminates into the grade on either side of the staircase. (Source: WLA Studio, June 2020.)

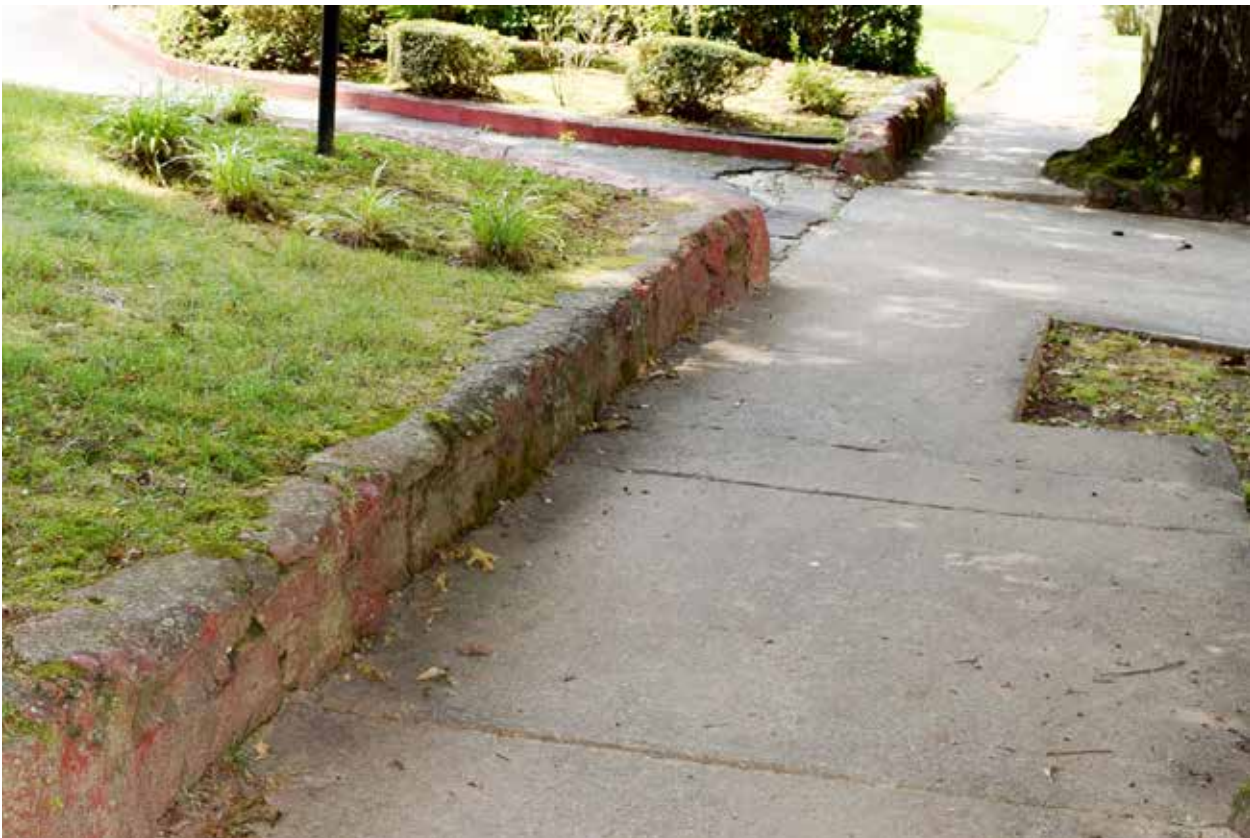
Figure 3.23. View facing north of the stone retaining wall, which holds the grade between front turf grass area and sidewalk. The stone wall turns ninety degrees at the eastern edge of the driveway. The wall is present on both the north and south sides of the driveway. The concrete sidewalk is six feet wide in most areas. (Source: WLA Studio, June 2019.)

between the eastern property boundary and the sidewalk right-of-way (Figure 3.23).

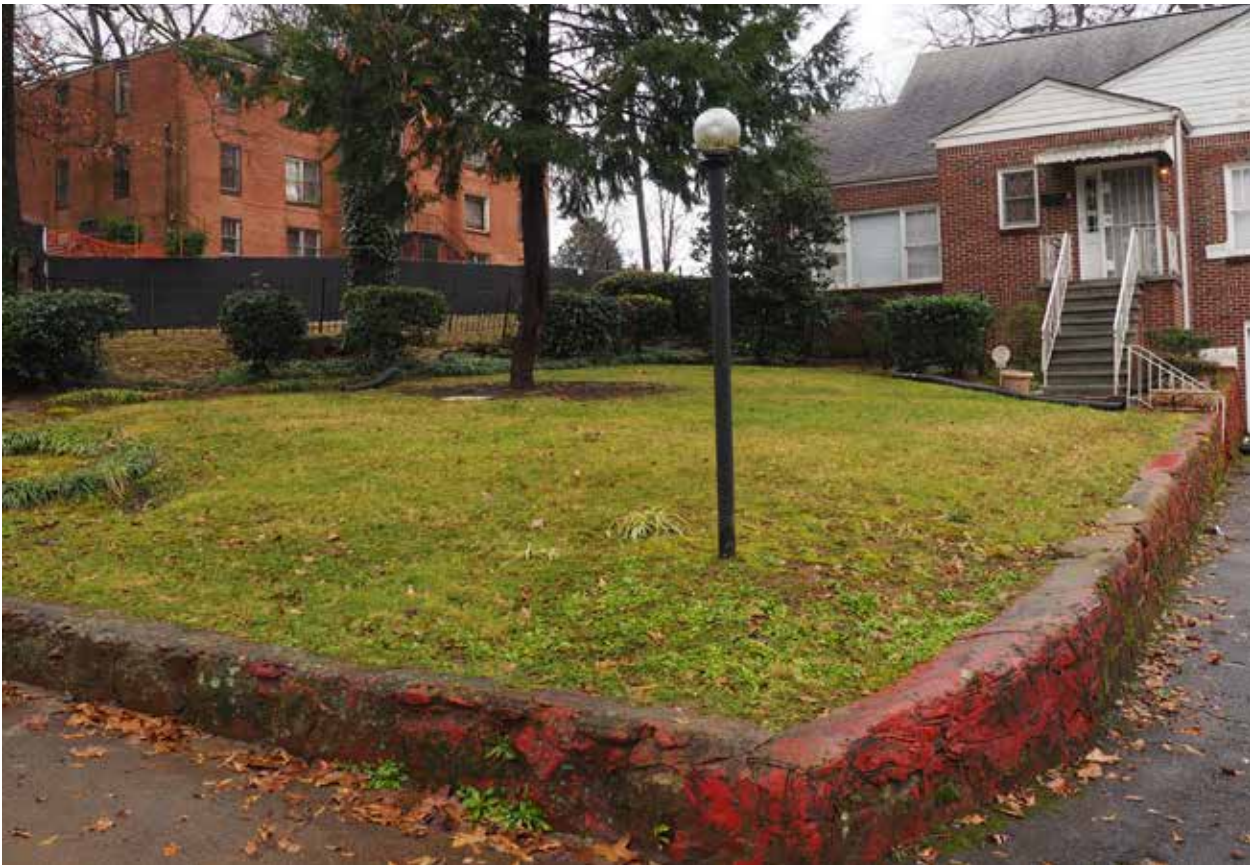
Figure 3.24. Turf grass is planted between landscape beds in the front yard. The front turf grass area includes patches of moss and bare areas. Photo facing southwest. (Source: WLA Studio, June 2019.)

The turf grass areas, comprised of grass (*Cynodon dactylon*), clover (*Trifolium repens*), and moss (*Bryopsida* spp.) groundcover, exist between landscape beds in both the front and back yards (Figure 3.24). The turf grass area in the front yard is fairly healthy with some bare areas in heavy shade near southern property line. The turf grass area in the rear yard is less vigorous, with swaths of weedy vegetation and bare areas in zones with heavy shade.

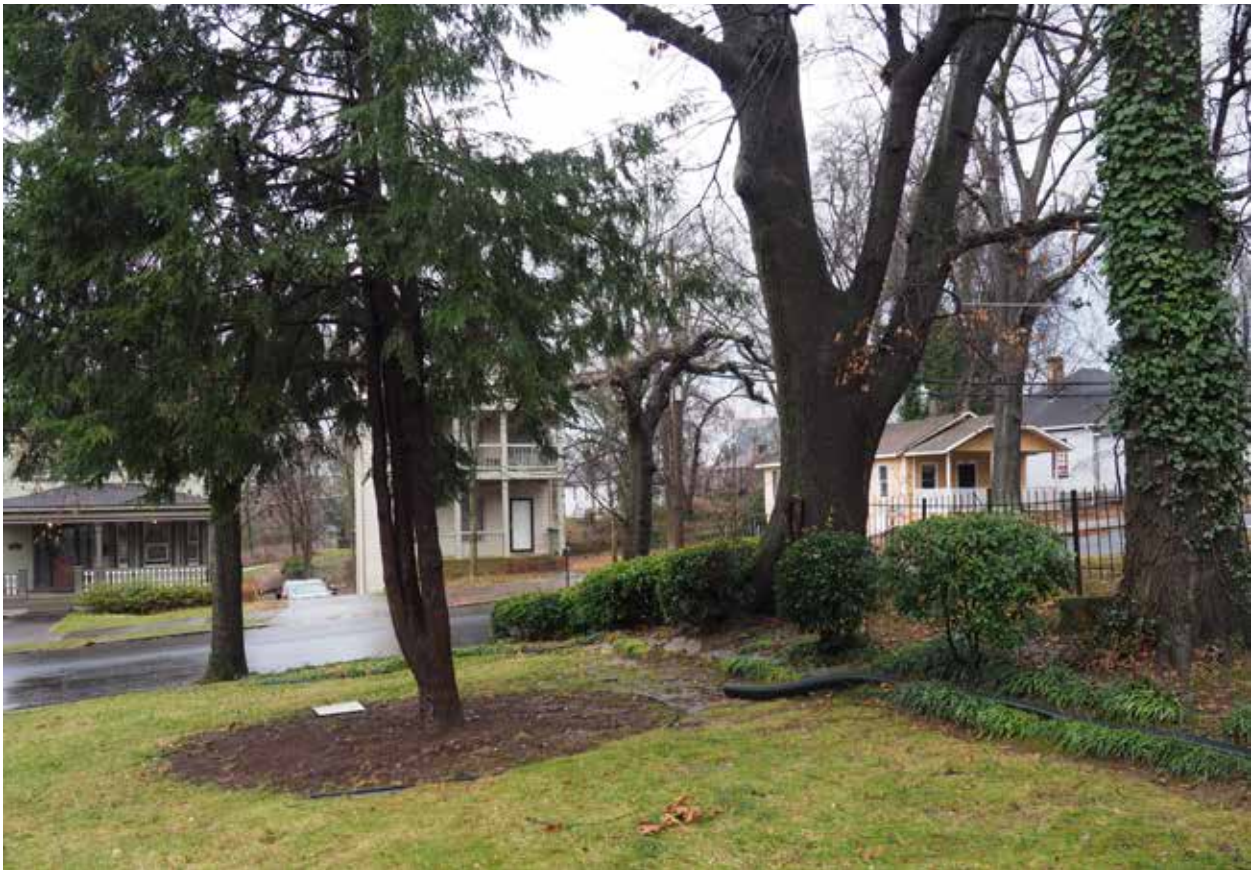
Figure 3.25. The Canadian hemlock is centrally located in the front yard (foreground). View is from the front steps of the house, facing southeast. Mature trees line the southern perimeter and Sunset Avenue. (Source: WLA Studio, June 2019.)

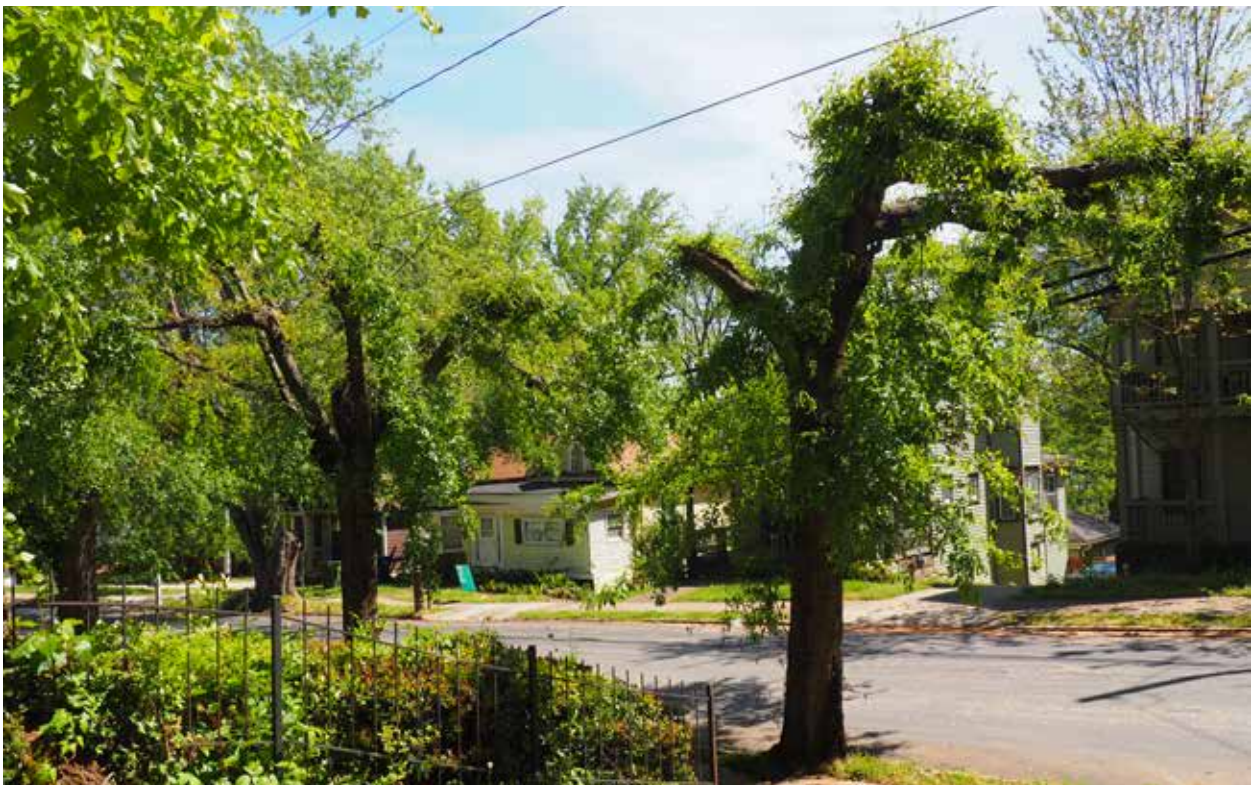
Figure 3.26. Water oaks in front of the property, located in the right-of-way on Sunset Ave. View is from Dunkirk Street, facing northeast. The trees have been aggressively pruned to accommodate overhead power lines and are in very poor health. (Source: WLA Studio, June 2020.)

Trees on the property include several large canopy trees lining the southern edge of the front yard and one large tree in the central area of the back yard. The trees on site include water oaks (*Quercus nigra*), a hybridized red oak (*Quercus spp.*), cherry laurel (*Prunus caroliniana*), black cherry (*Prunus serotina*), Japanese maple (*Acer palmatum*), and Canadian hemlock (*Tsuga canadensis*) (Figure 3.25). The trees in the right-of-way along Sunset Avenue are in poor condition (Figure 3.26). Power company crews have pruned them to accommodate overhead utilities, resulting in massive deformation of the tree crowns. The trees on the southern property border are in fair condition. Impacts include the adjacent pavement, located within these trees' dripline and poison ivy (*Toxicodendron radicans*) and English ivy (*Hedera helix*) growing on two of the trees (Figure 3.27). The Canadian hemlock in the front yard and the Japanese maple in the front planting bed are in good condition. Arborists assessed the water oak in the rear yard in March 2019 (see Appendix C). According to this tree assessment, this oak creates site issues including surface roots that are pushing up the concrete apron located at the

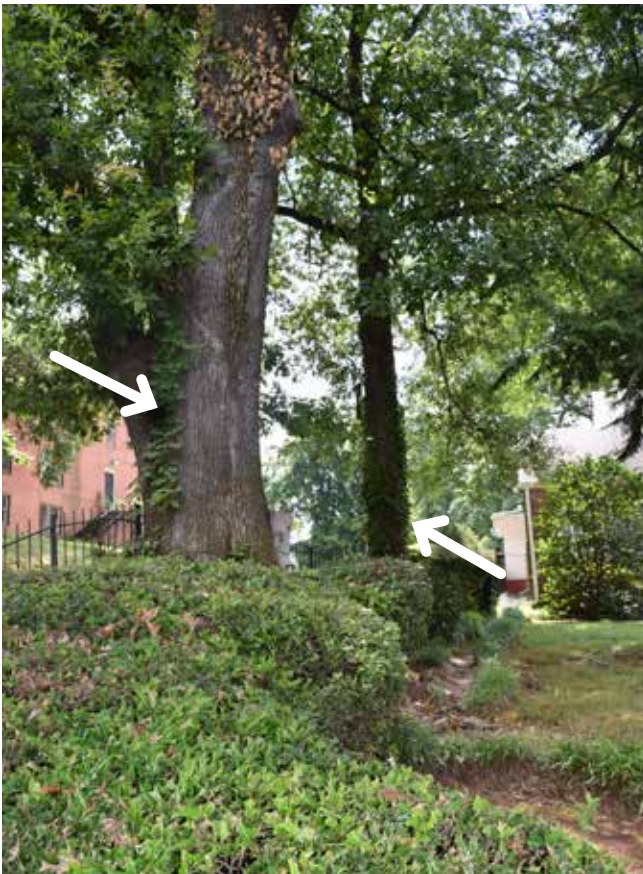
Figure 3.27. View of trees along southern property boundary with poison ivy and English ivy growing on two of the trees (indicated), facing west. (Source: WLA Studio, June 2019.)

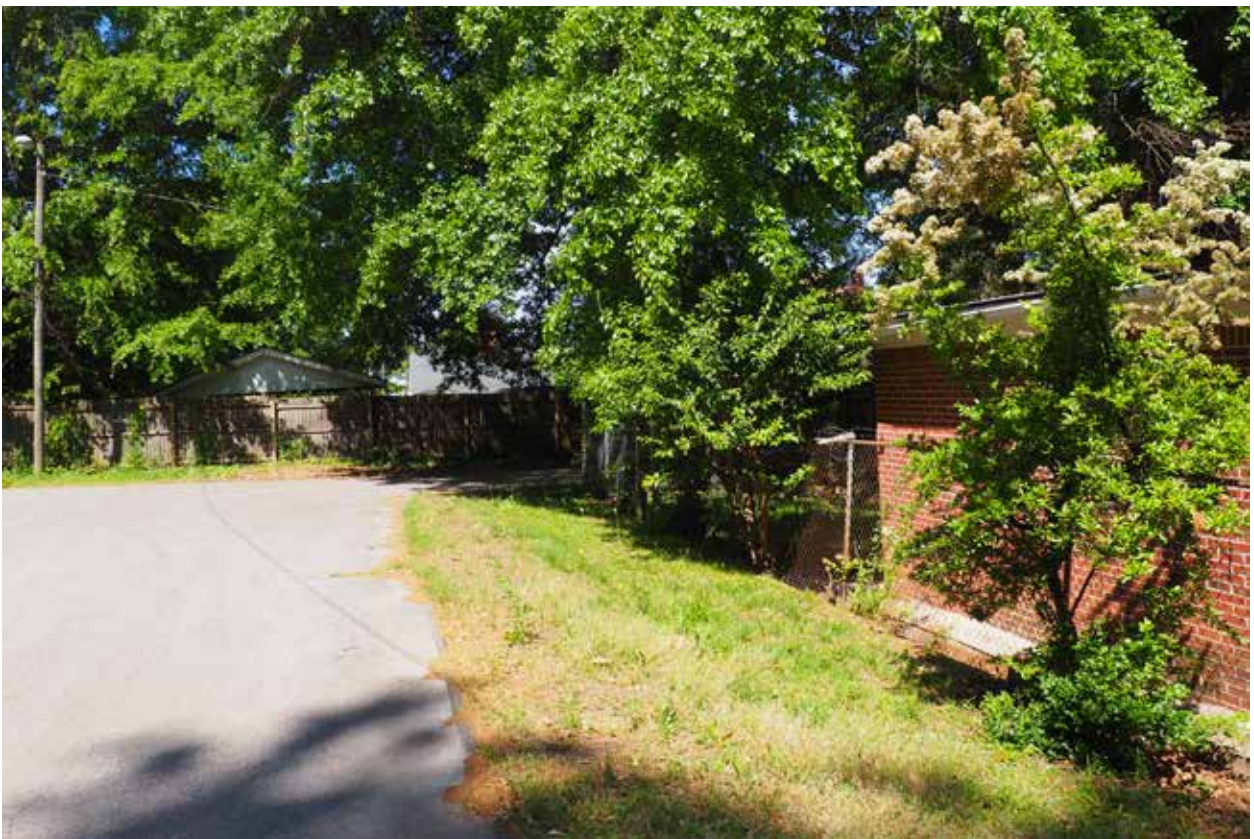
Figure 3.28. Pyracantha (foreground) and wax leaf privet (background, against fence) on the southern fence line of the property. View is from Dunkirk Street, facing north. (Source: WLA Studio, June 2020.)

The landscape beds contain mostly woody perennial shrubs. Shrubs along the southern property line include wax leaf privet (*Ligustrum lucidum*), scarlet firethorn (*Pyracantha coccinea*), Chinese holly (*Ilex cornuta*), Japanese ternstroemia (*Ternstroemia gymnanthera*), and cherry laurel (Figure 3.28). The Chinese holly (*Ilex cornuta*) at the southeast corner of the site may be a variety such as 'Carissa', which has reverted to 'Rotunda'. The east (front) foundation includes a variety of evergreen shrubs including a Sasanqua camellia (*Camellia sasanqua*), cherry laurel, convex Japanese holly (*Ilex crenata* 'Convexa'), and a mass that includes Japanese privet (*Ligustrum japonicum*), Chinese privet (*Ligustrum sinense*), and another unidentifiable weedy seedling (Figure 3.29 and Figure 3.30). The area north of the entry stair includes convex Japanese holly and an azalea (Kurume hybrid) (*Rhododendron ponticum*) (Figure 3.31 and Figure 3.33). The rear yard includes a clump of liriopé along the north property boundary and three Japanese andromeda along the west property boundary (*Pieris japonica*) (Figure 3.32).

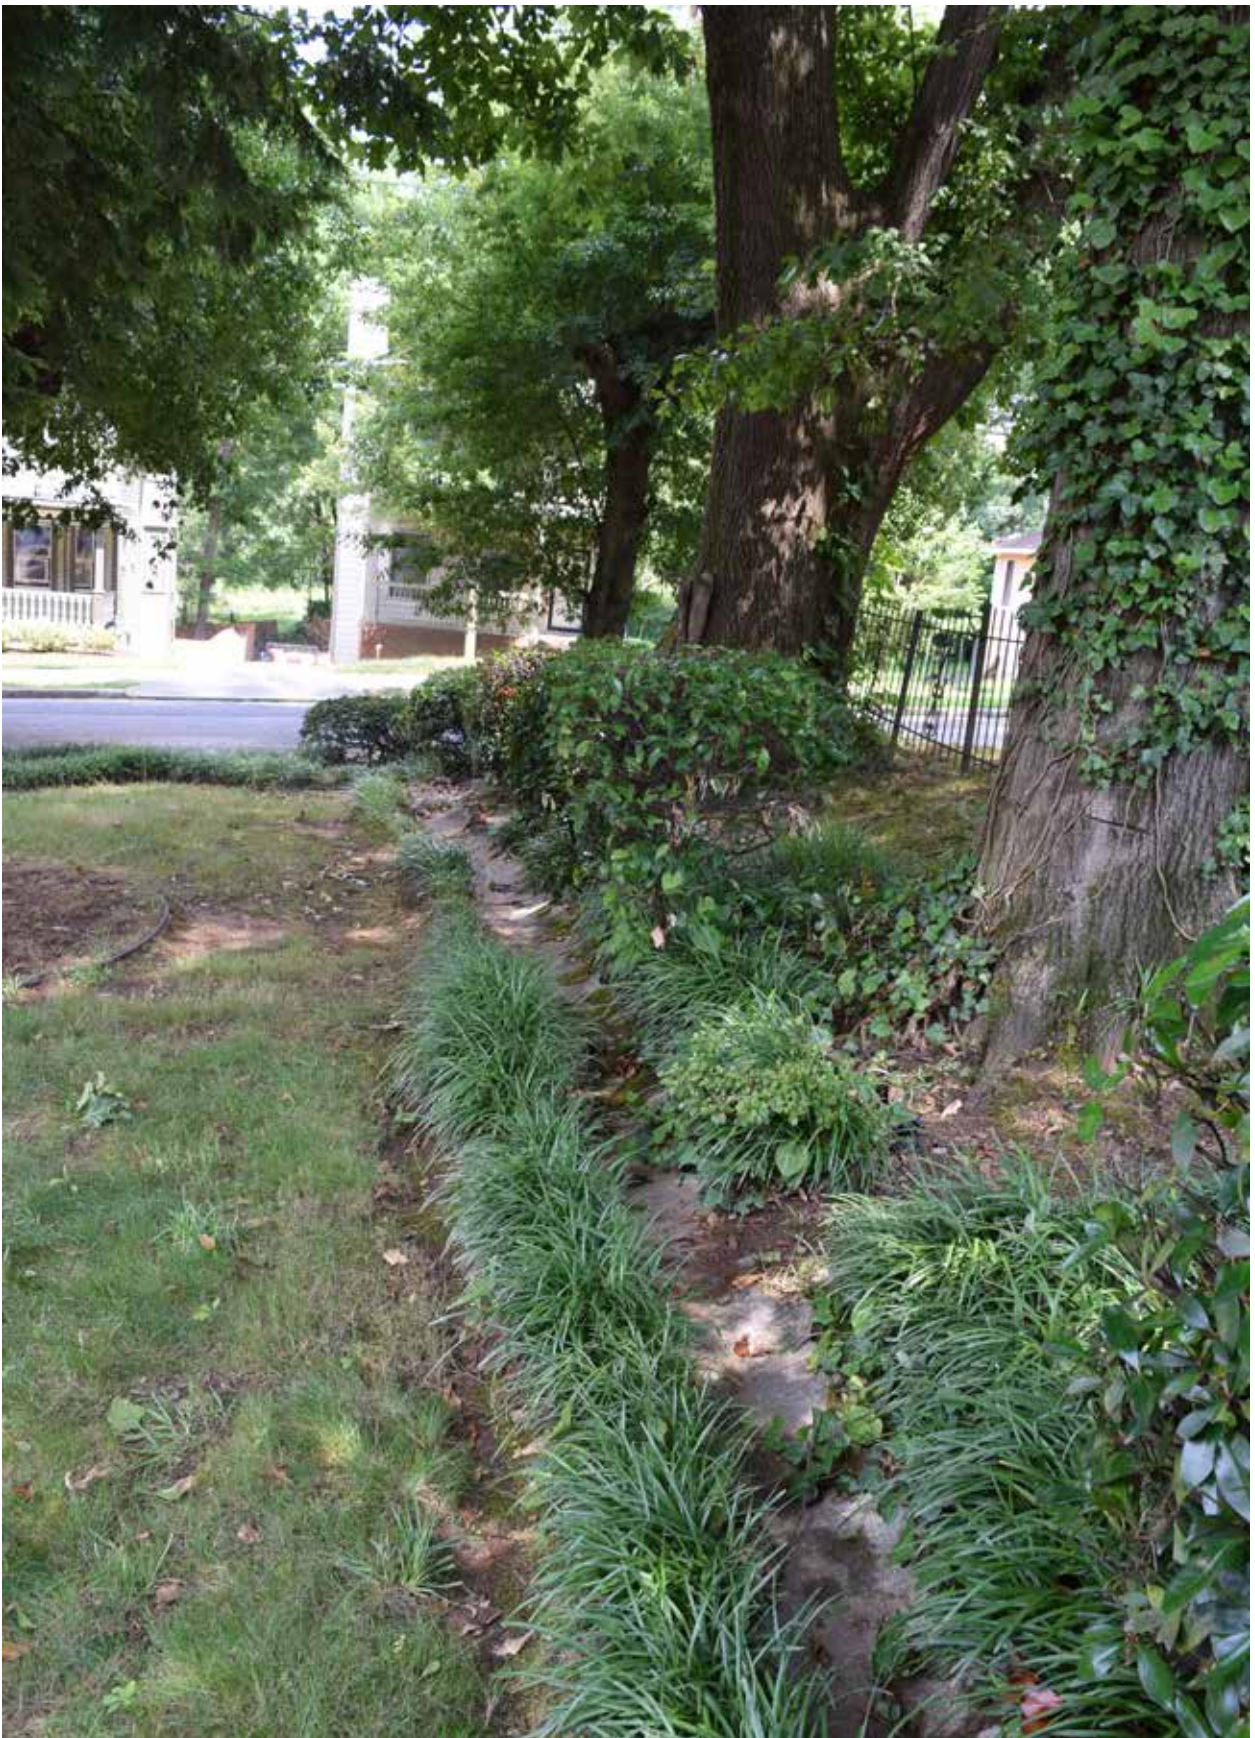
Figure 3.34. View facing east of liriope, which lines the landscape beds in many areas of the front yard (center). Evergreen shrubs occupy the bed space (right). A concrete swale directs water through the landscape bed. (Source: WLA Studio, June 2020.)

Herbaceous species at the site include liriopé (*Liriope muscari*), which lines many of the planting beds in the front yard along the south property line (Figure 3.34). There is a line of liriopé along the north property line in the rear yard. Another line of liriopé extends north into the front yard, forming a ring near the front retaining wall. There are individual liriopé planted around the base of the light pole in the front yard as well as the foliage of some unidentified bulbs, likely tulip (*Tulipa* cvs.) (Figure 3.35). There are hostas (*Hosta* sp.) planted near the front entry walkway and around the base of the light pole near the front sidewalk (Figure 3.36).

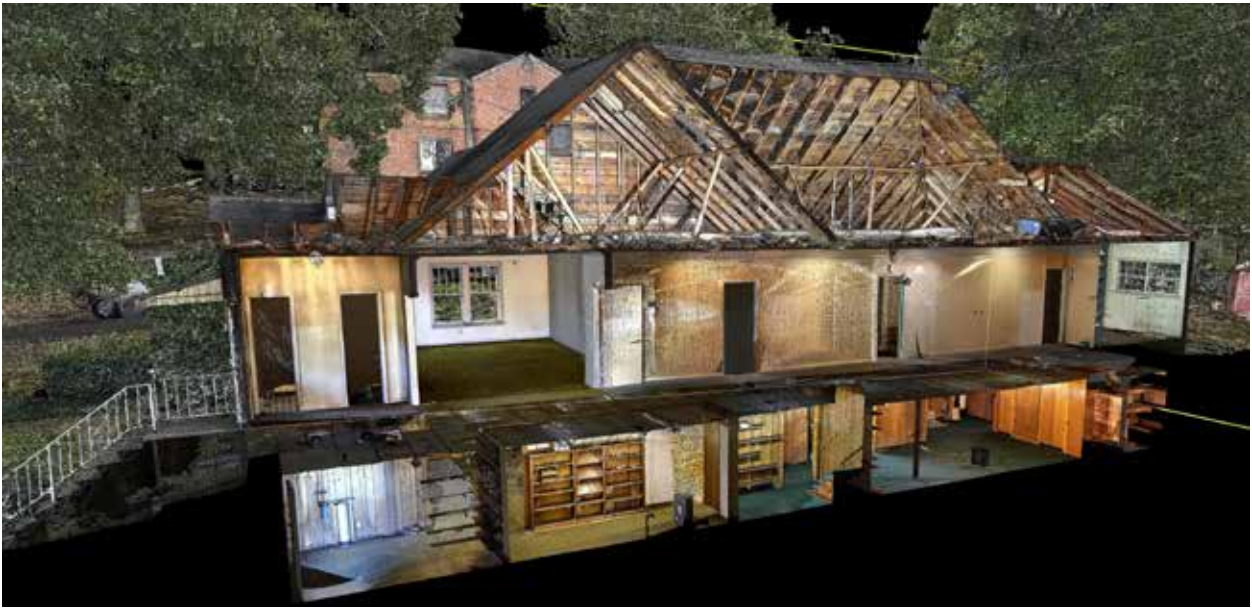
Figure 3.38. Longitudinal perspective section cut through house from front to rear, showing complex roof structure construction and general organization of linear interior spaces along a central corridor on the first floor and a room-to-room pattern in the basement areas. Section facing south. (Source: HABS October 2019.)

The King Family Home, initially constructed around 1933, had major modifications completed in 1965 and again in 1968 under the direction Atlanta architect Joseph W. Robinson, Sr., AIA. The building has been documented in a 2021 historic structure report and by a Historic American Building Survey (HABS) report (GA-199). The first renovation project extensively altered the outside appearance of the house. Following the Kings' acquisition of the house and their subsequent renovations, the house appears to retain many of its mid-to-late 1960s character defining features. The building is one story built on a raised basement. The main block of the house is a series of cross gables with an asphalt shingled roof. A shed roof covers an addition to the south and several hipped roofs cover extensions to the rear of the house. The building has a brick foundation, brick-veneer and wood-clad façades, and wood-sided gables. The approximately 3,600-square-foot house is built into a hillside, exposing the basement level on the east and north sides (Figure 3.38). Two

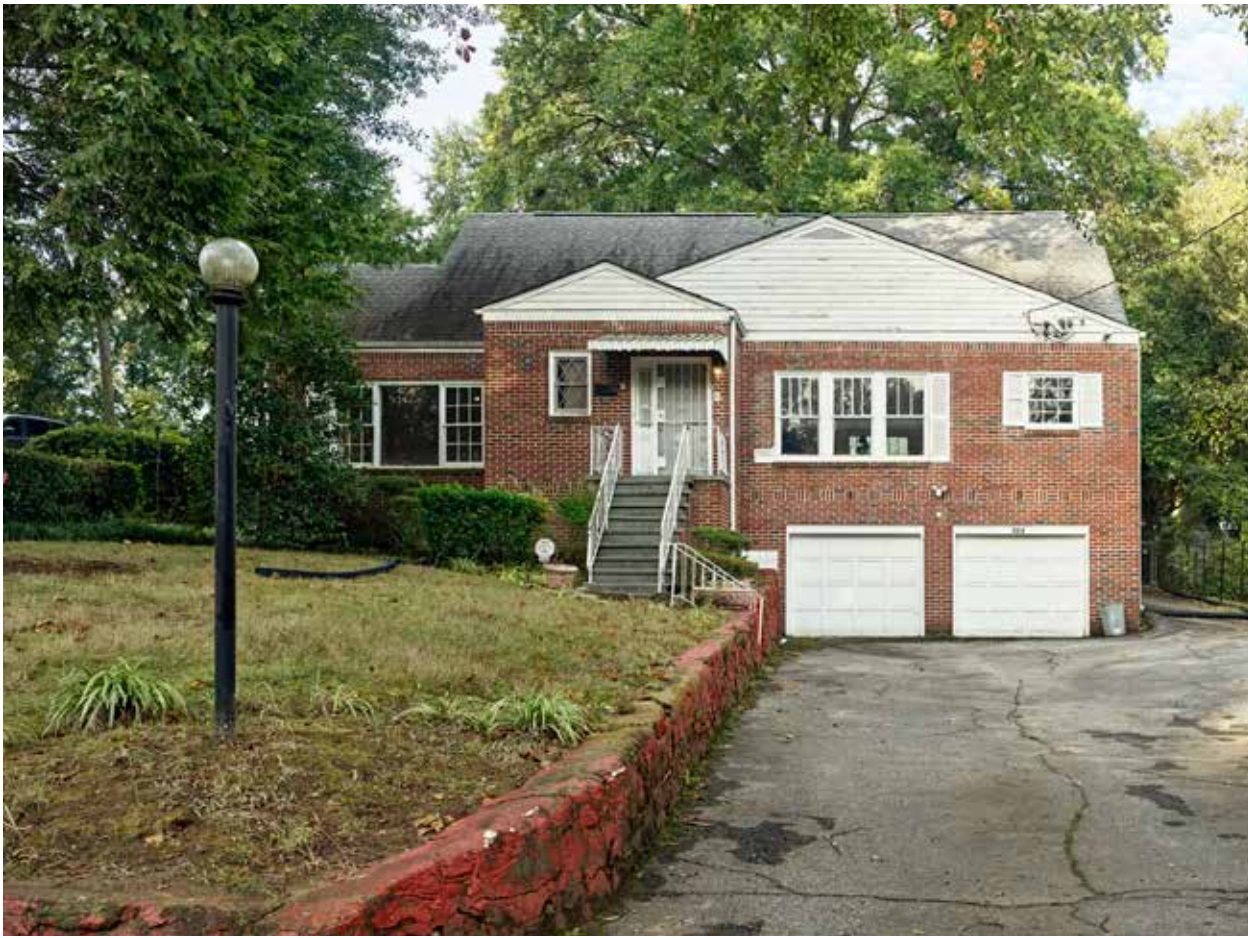
Figure 3.39. Façade of the house, facing west. (Source: HABS_GA-199-2, 2020.)

The façade is asymmetrical, three rooms and fifty-five feet wide and one story on a raised basement with a prominent front facing wood clapboard gable (Figure 3.39). The south bay contains a large triple sash picture window. The protruding south central bay contains a single window and wood recessed panel door with an exterior metal grill storm door and sidelight. A metal awning shelters the front entry. A group of three double-hung windows are in the north central bay. A single window is in the north bay. Louvered shutters flank the windows. Two paneled garage doors are located at the basement level. A triangular attic vent is located at the top of the horizontal clapboard front gable.

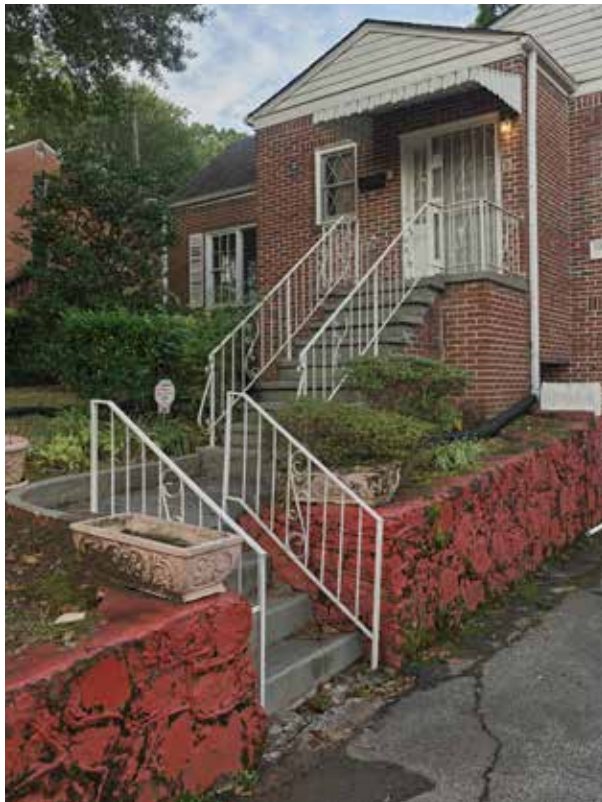
Figure 3.40. View facing southwest of the nine concrete risers with decorative metal railing that lead to a concrete landing at the main entrance of the residence. (Source: HABS_GA-199-3.)

Contractors constructed the front porch during the 1965 renovation (Figure 3.40). The porch consists of a concrete pad set on brick walls that extend out from the house. The brick pattern matches that of the primary building. There is a vertical crack at the juncture of the front porch and the house. Nine concrete treads that have been painted grey span between brick stringer walls. White painted

wrought iron handrails and balustrades run along the stairs. The railings are constructed in panels supported on one-inch square tubular posts. The rails have vertical pickets. In the center of each panel, there is a decorative combined “S”-shaped motif, which is supported by two pickets. Decorative wrought iron balustrades continue around the concrete platform on the porch.
