King Family Home Martin Luther King, Jr. National Historical Park Cultural Landscape Report

King Family Home

Cultural Landscape Report

January 2022
Prepared by:
WLA Studio

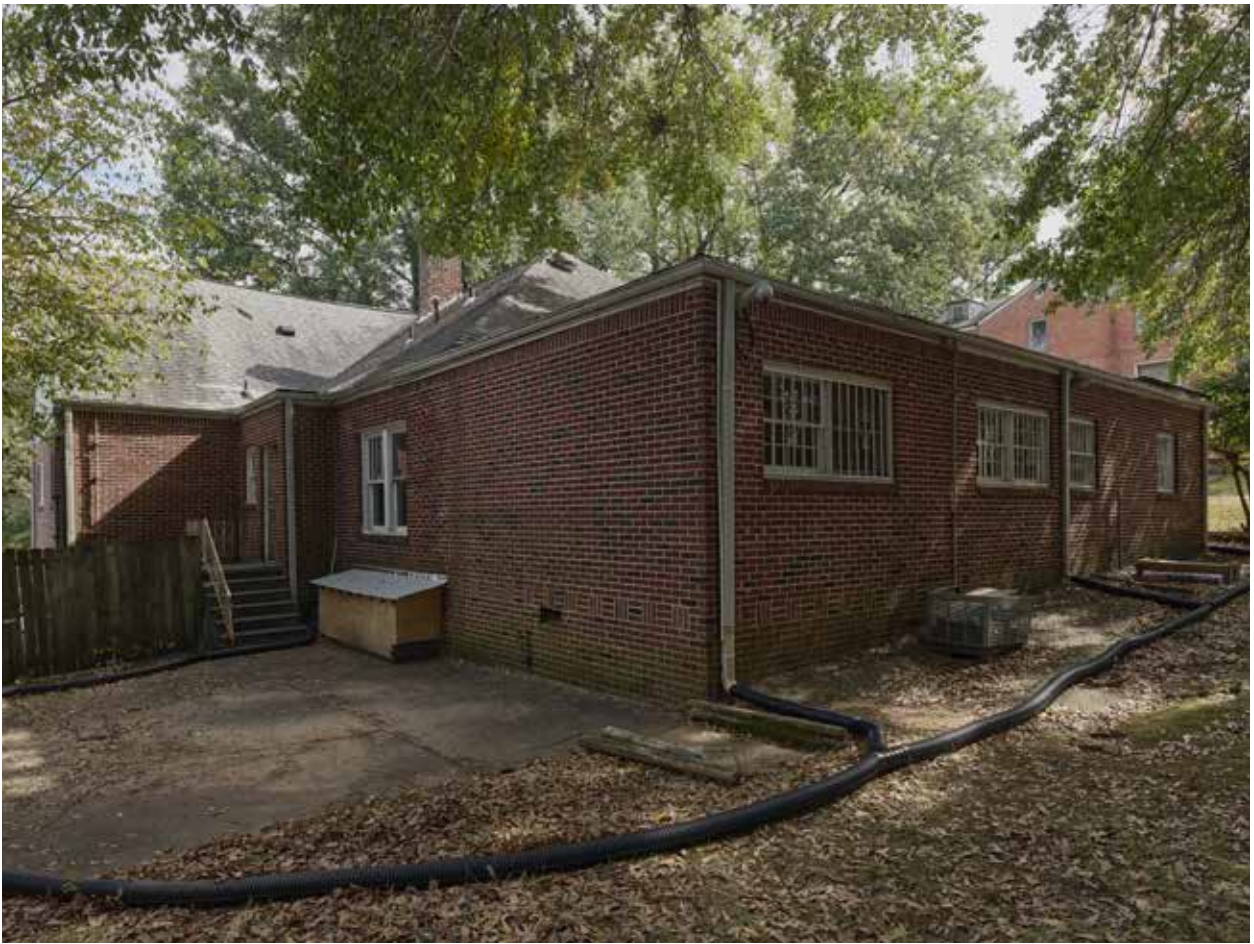
Figure 3.41. North and west elevations, facing southeast from rear yard. (Source HABS 199-8, October 2019.)

The north elevation is asymmetrical (Figure 3.41). The basement level is exposed on this elevation on the east side. Most of this elevation is composed of the thirty-three-foot-wide east bay. The east bay consists of two double windows at the first level and one opening at the basement (garage) level. The central bay is recessed nine feet, seven inches from the east bay, and it contains a side porch raised on a brick foundation. The central bay contains one window and a door at the first level. The west bay of the north elevation is recessed from the central bay. This bay contains one double window at the east side. Toward the rear of the building, the grade raises and conceals the basement level. At the west bay, two windows are located at basement level with a light well. A moderate hipped roof covers the central and west bays of the north elevation.

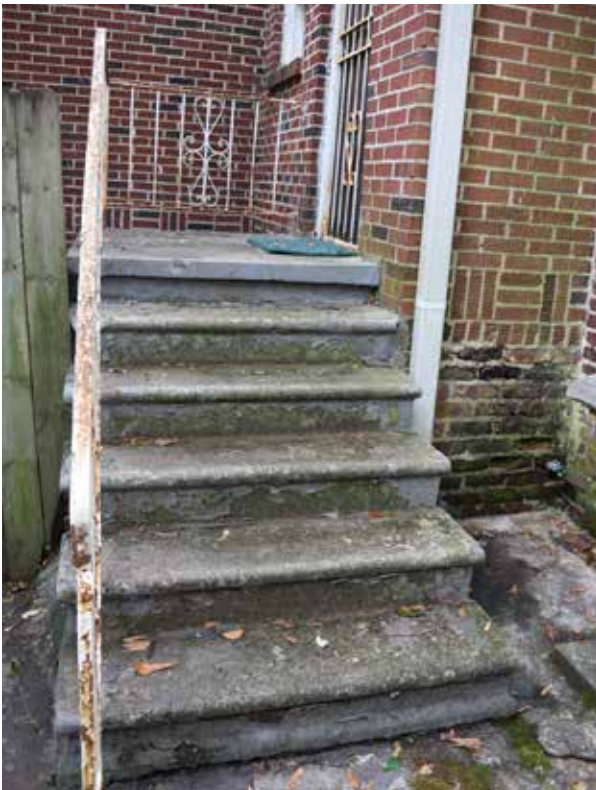
Figure 3.42. View facing east of the brick and concrete staircase located on the north side entrance of the residence. Five concrete risers with a decorative metal handrail lead to a landing. (Source: WLA Studio, October 2020.)

The porch located on the north elevation has a five-tread stair that is a straight run from the concrete pad in the back of the house to the kitchen door / utility room entrance on the north side of the house (Figure 3.42). The porch railing is “L” shaped as it follows the outer edges of the porch deck. It is attached to the porch deck on either side of the stair. The rails, pickets, and decorative motifs match the railings on the front porch.

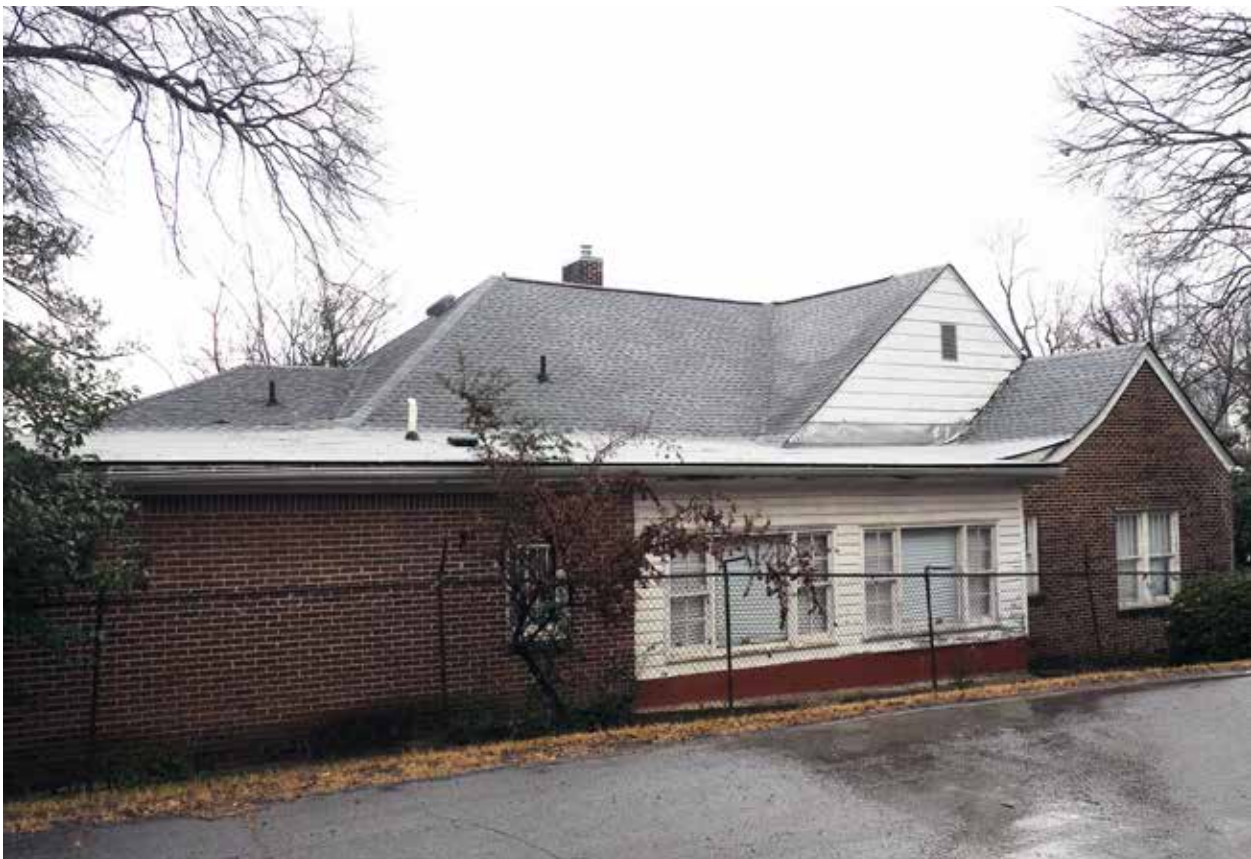
Figure 3.44. View facing northeast of the south elevation showing cross-gable roof of main house rising above the south elevation one-story low slope extension. (Source: WLA Studio, January 2021.)

The south elevation is asymmetrical (Figure 3.44). Stairs with brick foundation lead up to the front entry on the east side. A brick gable dominates the eastern front section of this elevation. A larger wood-sided gable is recessed. This elevation reveals the remnants of the curved beam/ swept roof detail from the early 1930s construction. The gabled section contains one double window and one single window. The center section is wood sided framed construction over concrete block foundation. It contains two large picture windows. This section is believed to have been constructed as an enclosed porch, later converted to a solarium. It was later renovated into a playroom for the King family and then into an extension of the boys’ and girls’ bedrooms. The west section of the south elevation is brick with one single window covered by a decorative metal grille. A low shed roof covers the west and central sections of this elevation. A single masonry chimney is located at the ridge of the hipped roof in the center of the house.

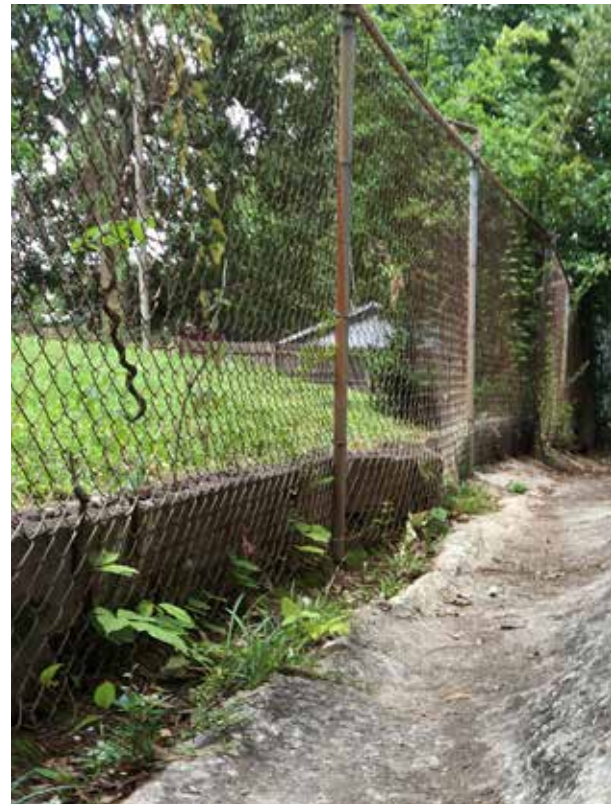
Figure 3.48. Concrete apron/swale on the south side of the house, facing west. Concrete block wall is located south of the swale. Portions of the wall are failing and are being held up by the chain link fence. (Source: WLA Studio June 2020.)

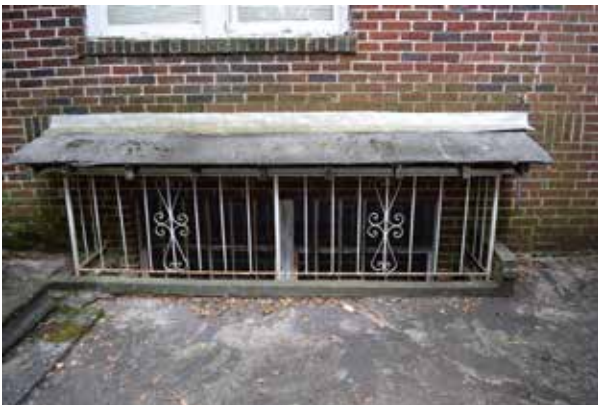
Figure 3.49. A small roofed projection prevents water from entering the garden level window well on the north elevation of the residence. The window well is surrounded by decorative bars that provide security. View facing south. (Source: WLA Studio, June 2019.)

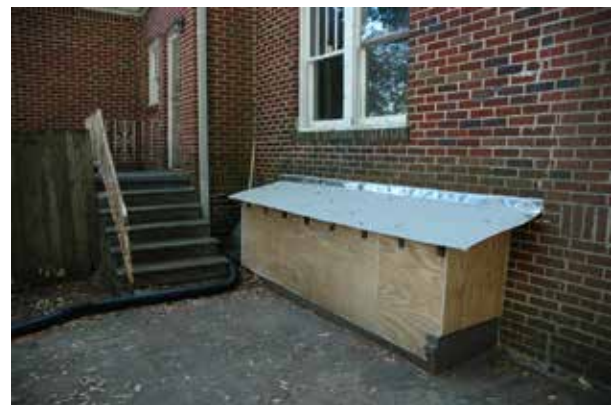
Figure 3.50. Window was enclosed with plywood and flashing between June and October 2019 to reduce the amount of water ingress to the basement and the window well area. View facing east. (Source: HPTC October 2019.)

in 2019 to prevent water from entering the windows in the basement. The enclosure obscures the decorative metal railing of the window well, which matches the adjacent concrete stairs (Figure 3.49 and Figure 3.50).

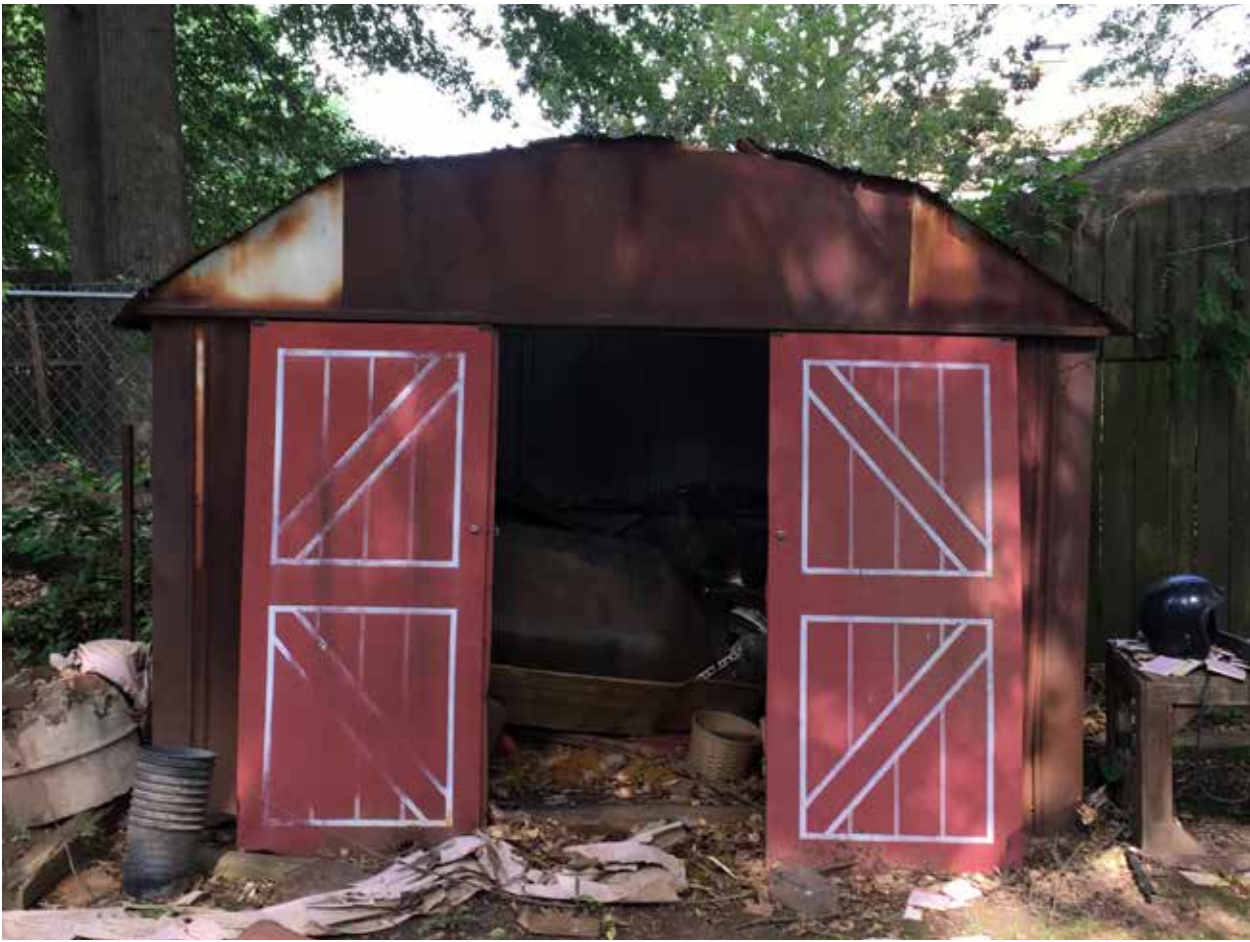
Figure 3.51. Metal sided shed in rear yard. View facing west. (Source: WLA Studio June 2020.)

A small metal sided utility shed structure is located on the western edge of the back yard, abutting the chain-link fence (Figure 3.51). The structure is approximately seven feet long by ten feet wide and sixty-five inches tall. The shed is sheathed in red-painted sheet metal, with a rounded roof. The structure was produced by the Sears Roebuck & Co., Model No.696-60097. The structure appears to be in poor condition. It approximately dates to the early 1970s.

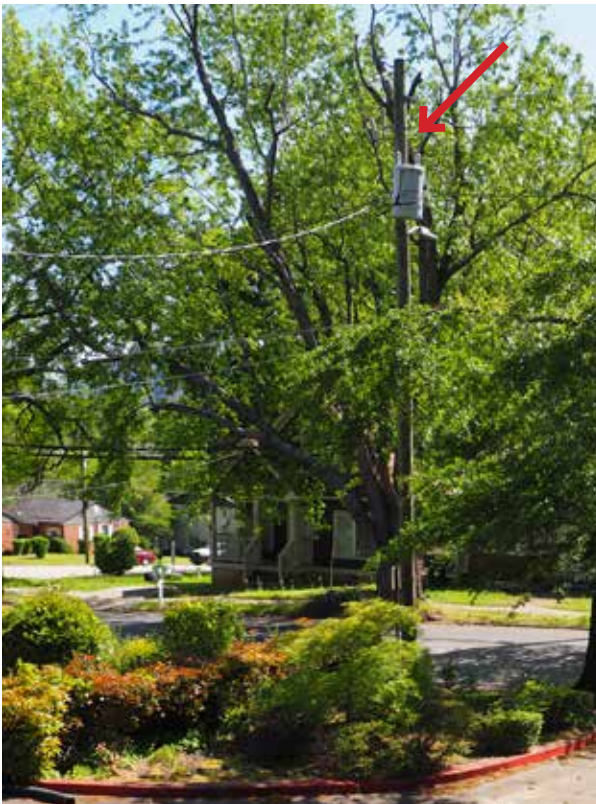
Figure 3.52. View facing northeast of the power pole and overhead residential electrical service in the northeast corner of the site. (Source: WLA Studio, June 2020.)

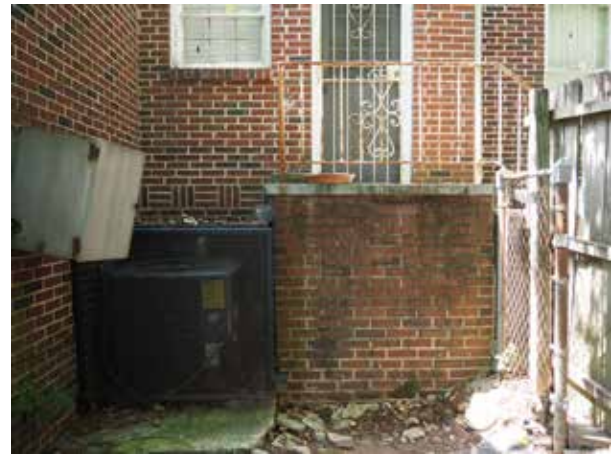
Figure 3.53. HVAC Unit located inside cage structure on north elevation. (Source: WLA Studio June 2020.)

HVAC equipment exists on the north side of the site, just inside the chain link gate near the terminus of the driveway. A gas-powered forced air heating system supplies heat to the house. Air conditioning is electric powered. The unit is housed inside a locked cage structure (Figure 3.53). There is a non-functioning HVAC unit located near the west elevation of the house (Figure 3.54).

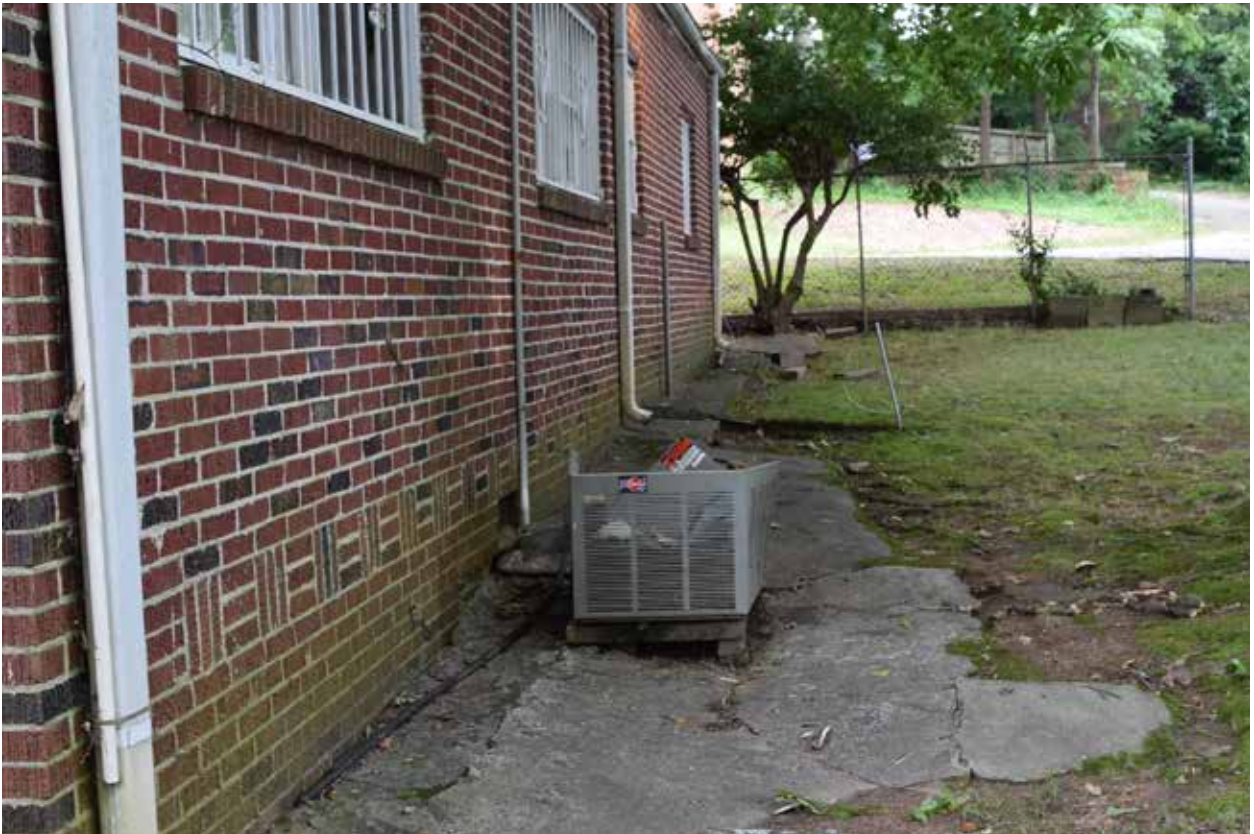
Figure 3.54. Nonfunctioning HVAC unit located in rear yard, facing south. (Source WLA Studio June 2020.)

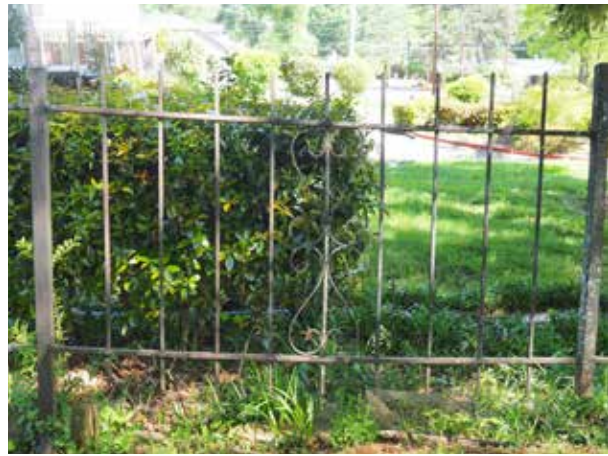
Figure 3.59. Decorative detail of the anodized aluminum pike fence lining the north and south sides of the front yard, facing north. (Source: WLA Studio, 2020.)

A decorative anodized aluminum pike fence marks the property boundary on the north and south sides of the front yard, east of the residence (Figure 3.59 and Figure 3.60). Both sections have five-foot-tall fence panels, which are black. The fence totals 188 linear feet. The fences terminate at the sidewalk on Sunset Avenue. The fence is stable, but there are sections that are no longer plumb. The fence is missing decorative scroll work in several locations, and the finish has patinaed to a dull finish. Vegetation has overgrown the fence in some locations.

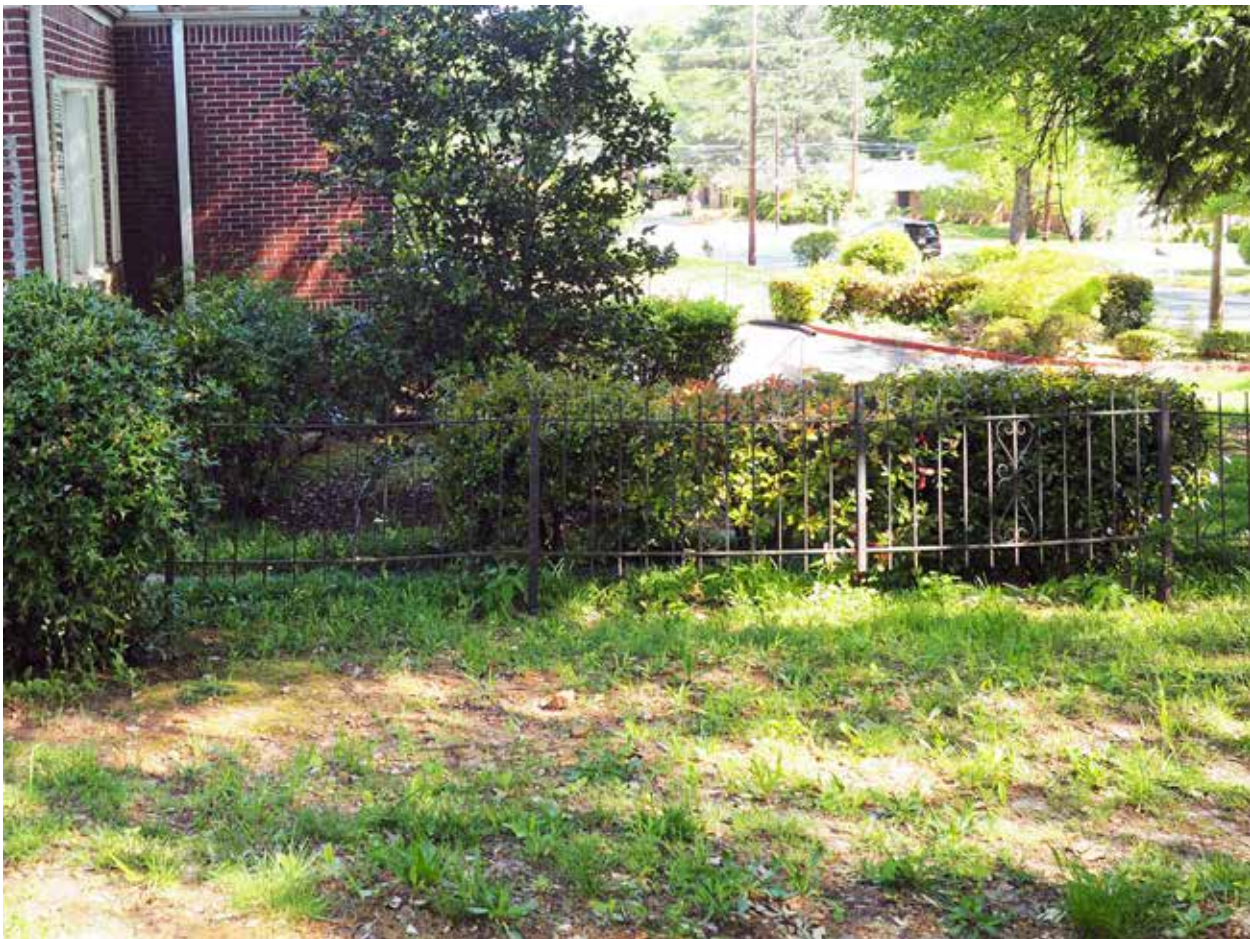
Figure 3.60. Anodized aluminum pike fence on the south side of the front yard, facing north. (Source: WLA Studio, 2020.)

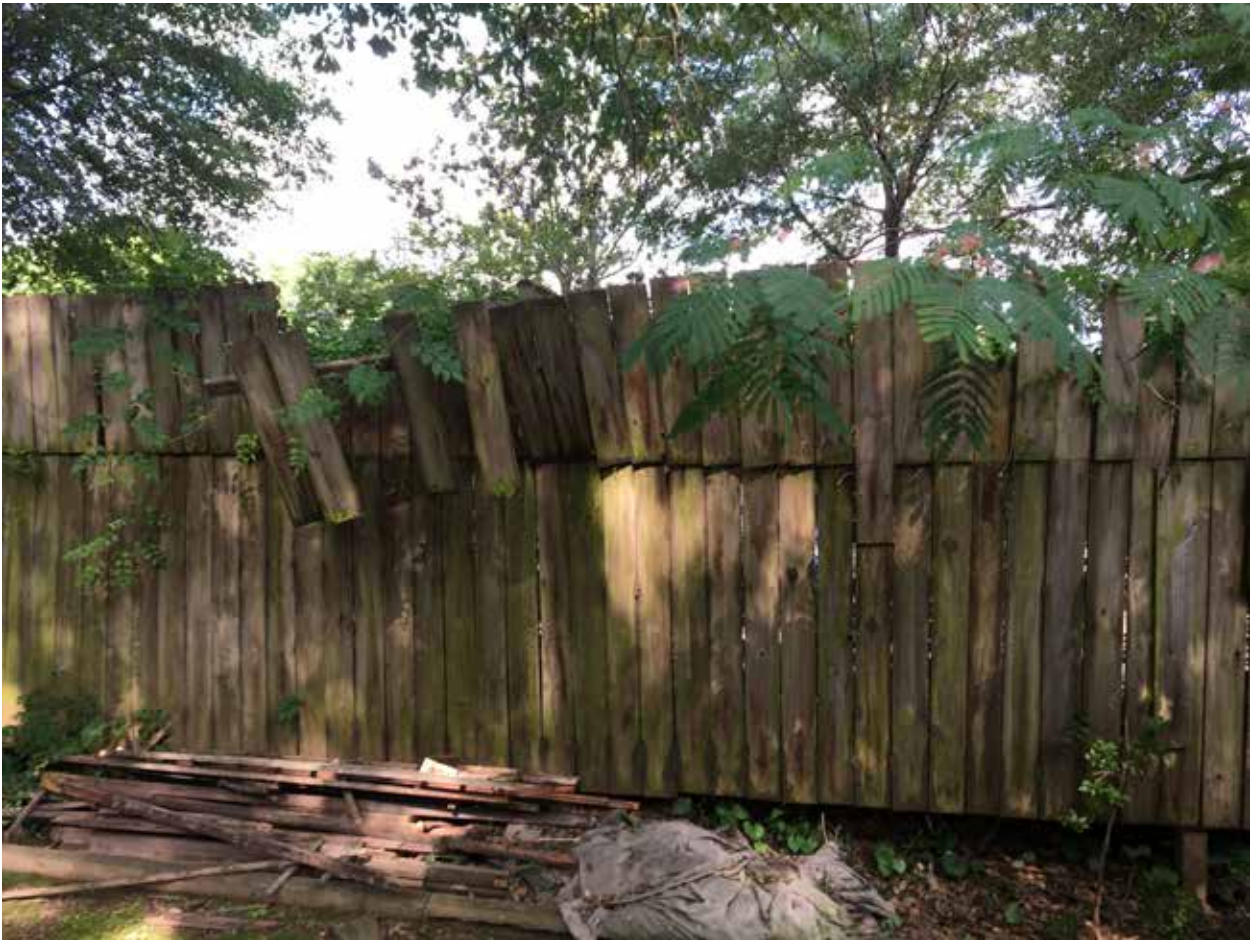
Figure 3.61. Wood privacy fence in the back yard has been modified, likely for privacy or security, on the western boundary of the property, facing west. (Source: WLA Studio, June 2019.)

A wood privacy fence encloses a portion of the property on the northwest corner of the site and a concrete patio area on the north side of the residence (Figure 3.61). The four sections of fence total approximately 141 linear feet. The fence style is a common pressure treated pine dog-ear panel. This style is composed of six-inch-wide pine pickets tightly abutted with a blunt chamfered top, sold commercially in preassembled six-foot-wide panels. The fence is in disrepair with extreme weathering and damage, and it has evidence of previous modifications. There are missing and broken vertical boards, and the panels are no longer plumb. The hinged section at the terminus of the driveway is no longer functional. In most areas the fence panels are six feet high. Someone modified the fence height on the western edge of the property by layering sections of fence panels for a total height of eighty-six inches. This change was likely done to increase security or privacy in the rear yard.

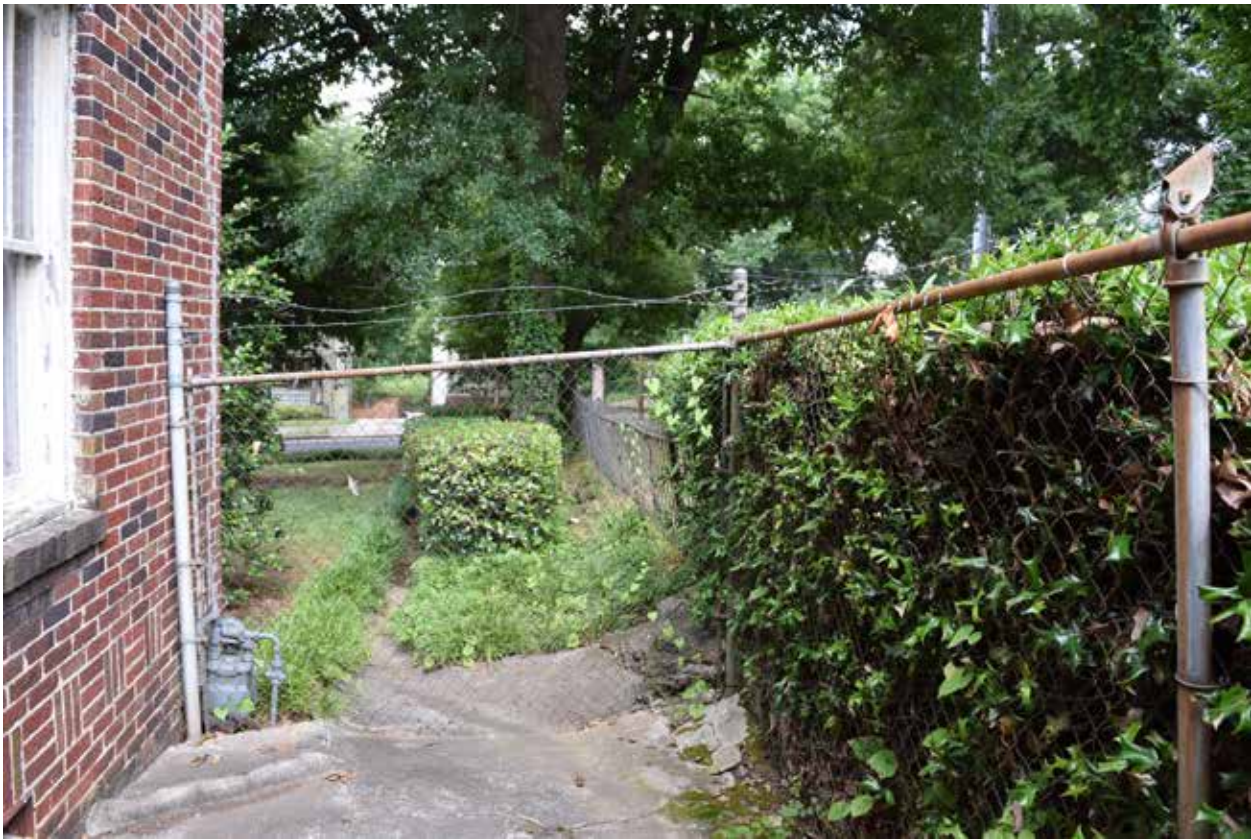
Figure 3.62. Chain link fence along south side of the property, facing east. (Source: WLA Studio, June 2020.)

A chain link fence encloses the property on the south and west sides (Figure 3.62 and Figure 3.63). There are two gates, one near the southwest corner of the property that opens from the back yard to Dunkirk Street, which is secured with a chain and lock, and another on the north side of the residence that opens to a small enclosed area between the front and back yards. The chain link overlaps with the wooden fence on a portion of the western boundary of the property. The seventy-inch-tall chain link fence is approximately 176 linear feet, including the length of the two chain-link gates. Barbed wire installed on the top of the fence increases the fence height to approximately eighty-two inches. The barbed wire is in disrepair and missing in areas. The fence is generally plumb and solid. Most of the panels along the southern property line have a corroded finish. The barbed wire stingers at the top of the fence in the rear yard are deteriorated, and vegetation has overgrown the fence in certain areas.

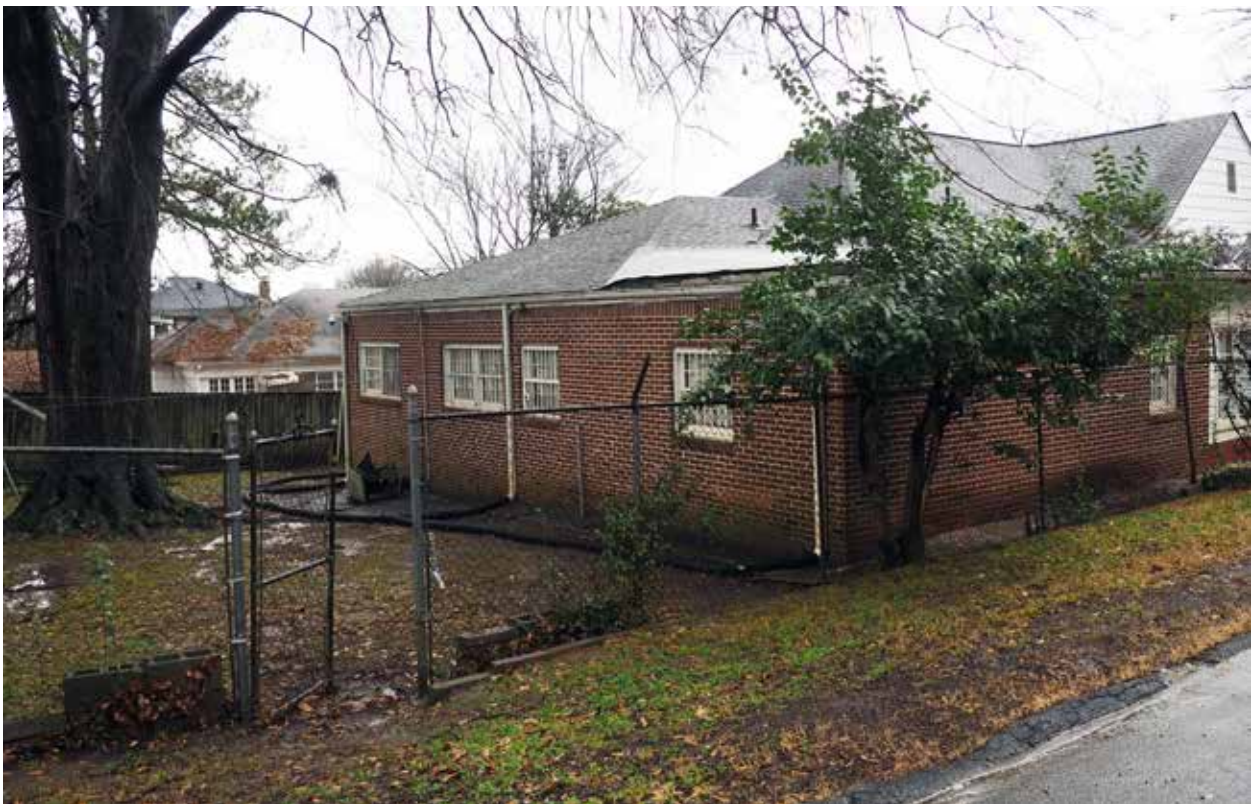
Figure 3.63. View of the chain link fence near the southwest property corner, facing northeast. (Source: WLA Studio, April 2020.)

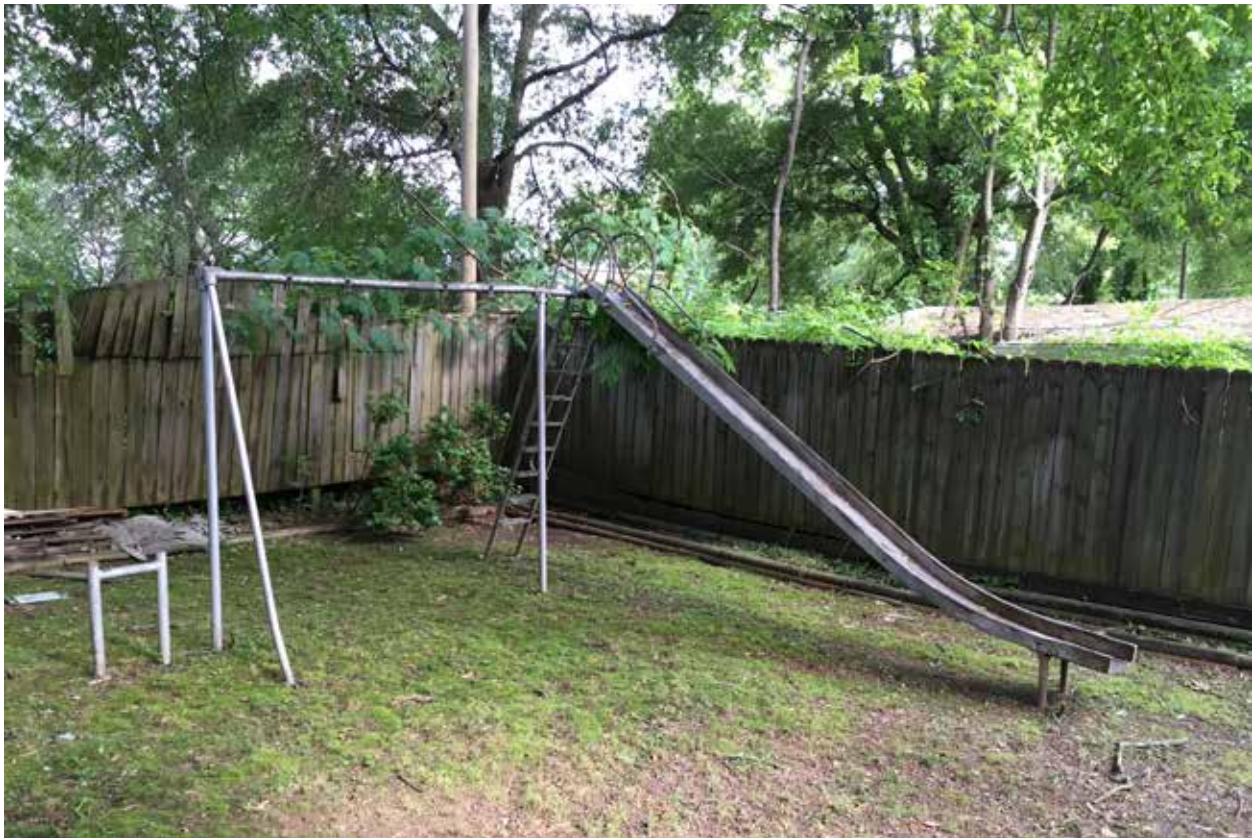
Figure 3.64. Metal play set in the back yard originally held two swings and a seesaw, now missing. (Source: WLA Studio, June 2020.)

A steel play set is located on the northwest corner of the property, in the back yard behind the residential structure (Figure 3.64). The set is approximately seven feet, nine inches high and over twelve feet wide. The play set originally had two swings and a slide with a ladder, as well as a separate seesaw. The ladder and slide are intact. The ladder has nine steps leading to a top landing. The steps are spaced fourteen and a half inches apart with handrails on two sides. The brand “AMERICAN” is cast in the step tread with a slip-resistant surface etch treatment. The slide, oriented to the east, has visible rust. There is hardware remaining for two swings that are no longer present. The structure is supported by three steel posts and is missing a fourth support post. The steel fulcrum adjacent to the slide set is all that remains of the seesaw. The fulcrum is just over two feet high and seventeen and a half inches wide. This play set, produced by the American Playground company, dates to the mid-1960s, as confirmed by the manufacturer.

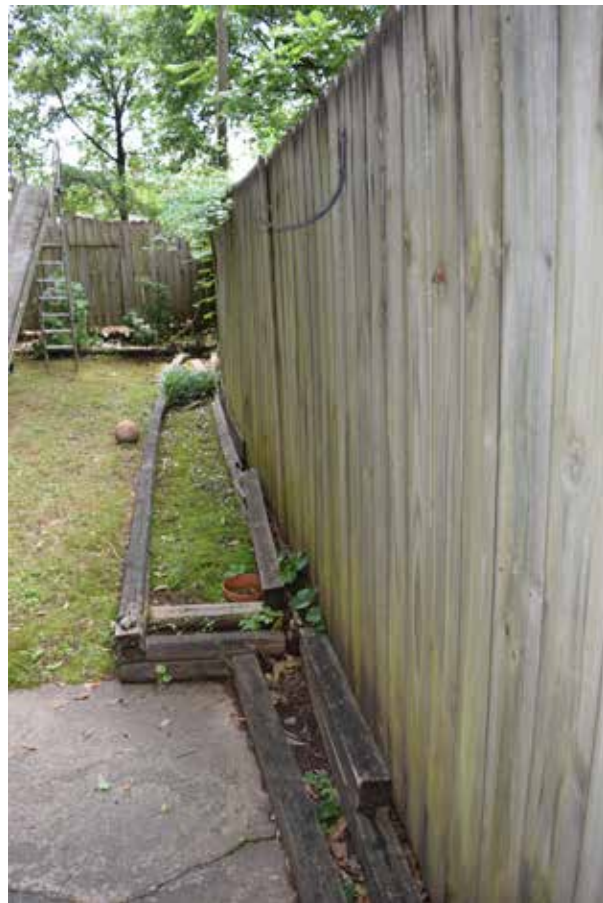
Figure 3.65. Raised landscape beds constructed from landscape timbers in the back yard. (Source: WLA Studio, June 2020.)

Landscape timbers create planting beds in the northwest corner of the site. Though varied in width, the approximately twenty-nine-inch-wide by eight-inch-high raised-bed style planting beds are approximately thirty-six linear feet in length. The planter is enclosed by stacked, commercially produced pressure-treated pine landscape timbers. The landscape timbers are eight feet long with rounded sides (Figure 3.65). Much of the planter is in disrepair, and the few remaining plants include liriopie and Japanese andromeda.

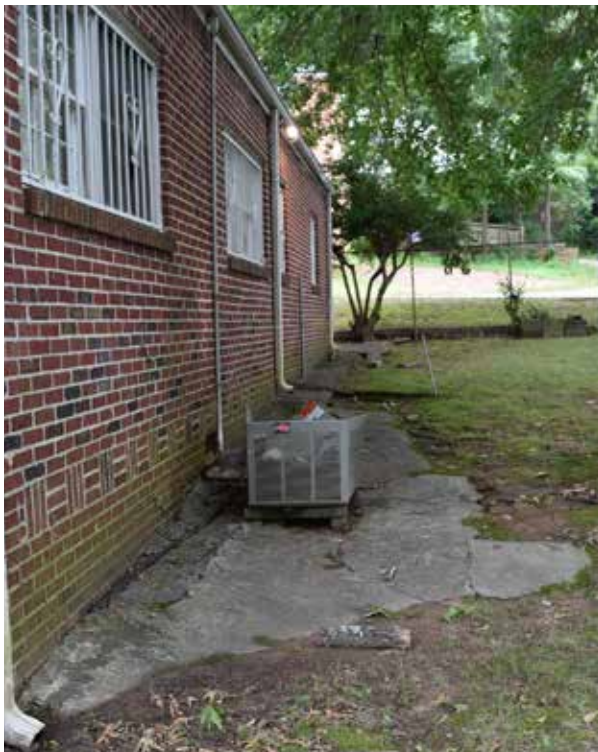
Figure 3.66. Concrete apron on west side of the house (rear yard), facing south. (Source: WLA Studio, June 2019.)

According to Bernice King and Pat Latimore, Hal Horton installed a concrete apron around the entire house in the 1980s to direct water away from the foundation of the residence (Figure 3.66 - Figure 3.69). There are cracks in the concrete and some areas are undermined and eroded, allowing water to infiltrate the foundation and basement. Because it is damaged, it is likely that the concrete on the south side of the house actually directs water toward the unwaterproofed foundation walls. The concrete apron is widest on the west side of the house, where it ranges in width from two feet, six inches to nearly seven feet wide.

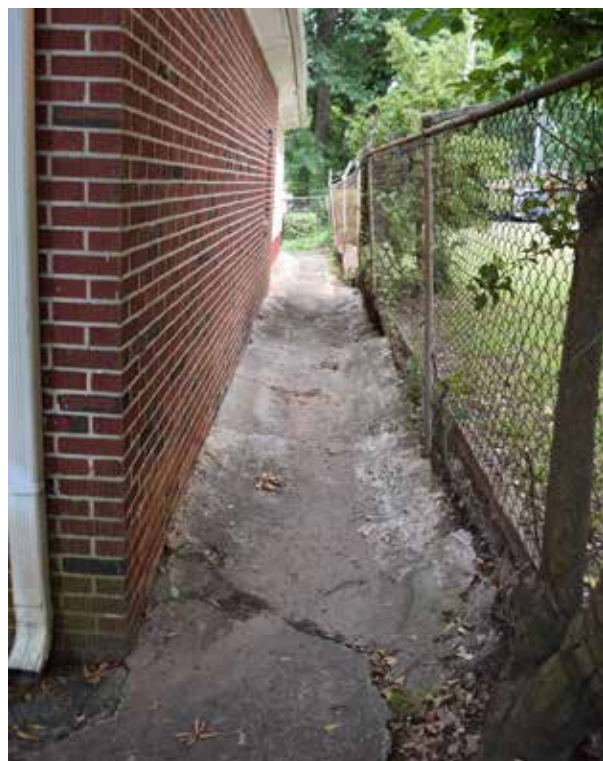
Figure 3.67. View of the concrete apron on south side of the house, facing east. (Source: WLA Studio June 2019.)

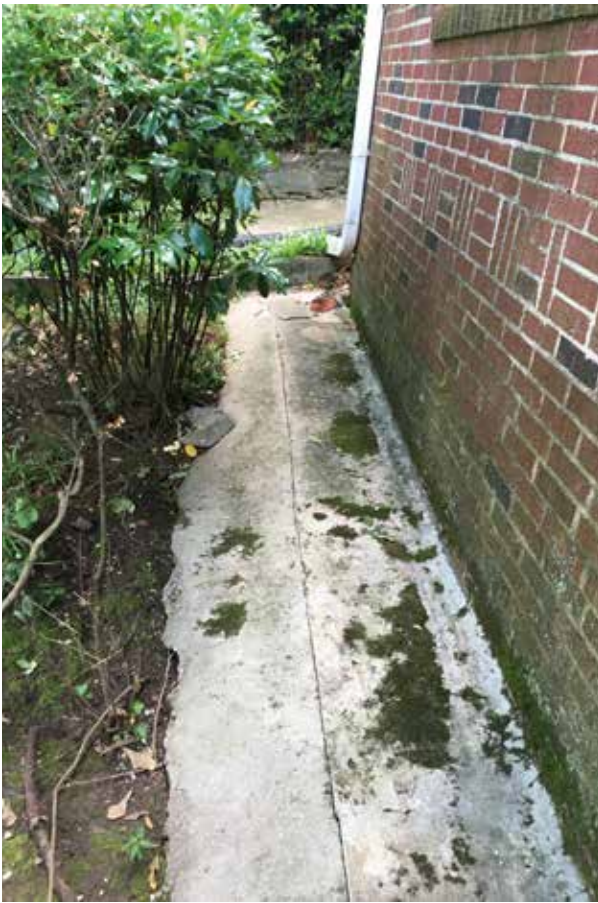
Figure 3.68. View of the concrete apron on the east (front) side of the house, facing south. (Source: WLA Studio June 2019.)

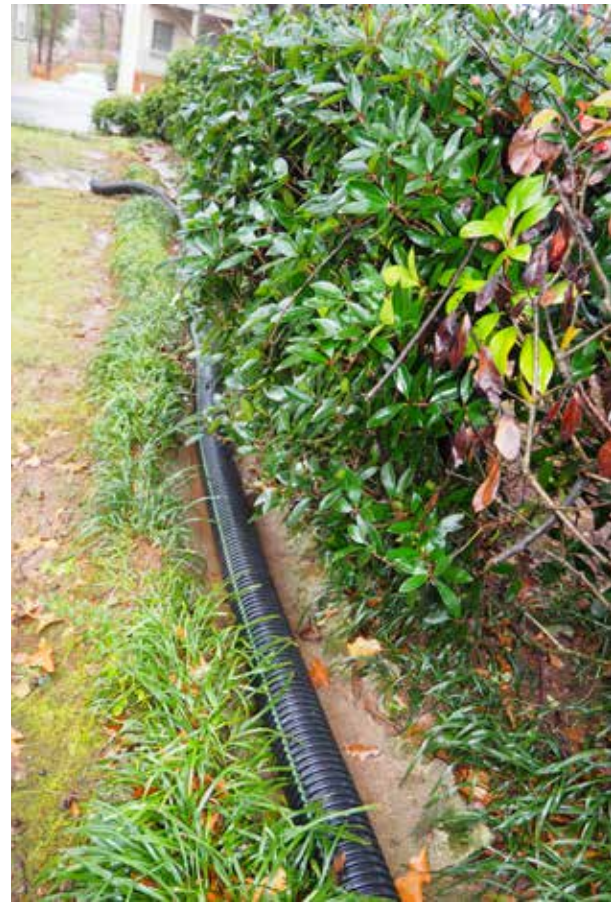
Figure 3.69. View of the concrete swale in the front yard, which now contains a temporary drainage pipe. (Source: WLA Studio, April 2020.)

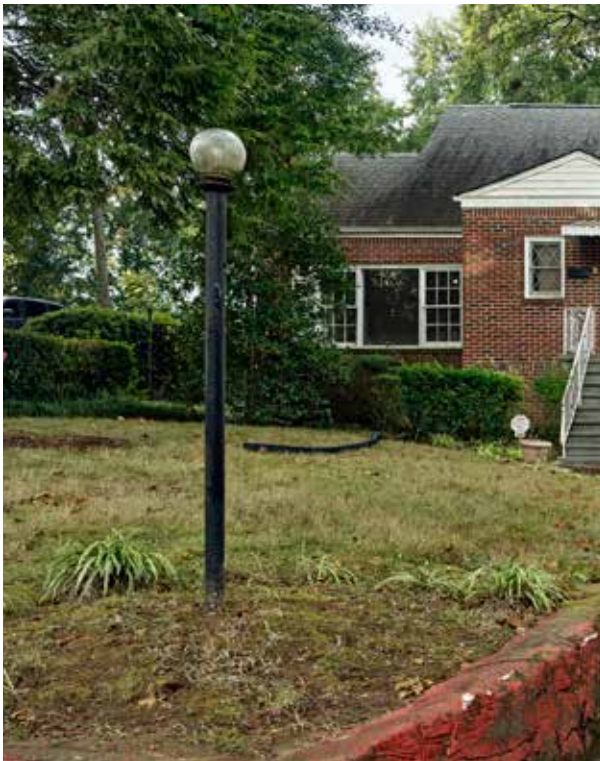
Figure 3.70. Lamp post in the front yard is located west of the stone retaining wall. (Source: HABS GA-199-1.)

There are several fixed small-scale features on the site. A small lamp post with a glass globe is installed in the turf grass area on the south side of the driveway entrance (Figure 3.70). Landscape edging materials delineate landscape beds in several areas of the front yard, including pieces of brick and plastic edging (Figure 3.71). There is a group of stones or dislodged pieces of the stone retaining wall located at the southeast corner of the site where the stone retaining wall terminates at the anodized aluminum fence (Figure 3.72). The stones are located within a mass of Chinese holly. A white mailbox is installed on top of the stone retaining wall at the southwest corner of the driveway (Figure 3.73). The NPS installed a sump pump just outside the entry stair to the basement in 2019. The pump has rigid PVC piping attached to it, which outlets onto the driveway (Figure 3.73).

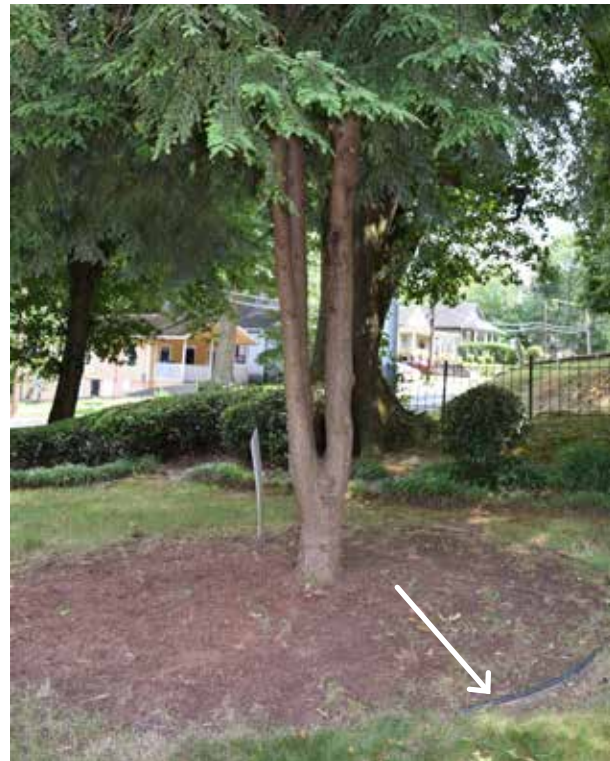
Figure 3.71. Plastic landscape edging in the front yard (indicated). (Source: WLA Studio, April 2020.)

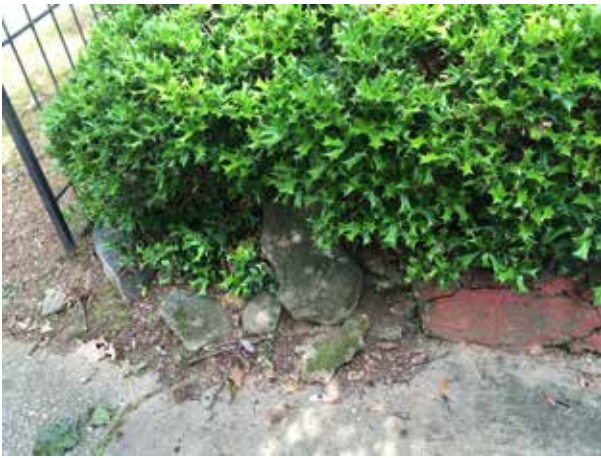
Figure 3.72. Group of stones at terminus of stone retaining wall near southeast property corner. These may be pieces of broken retaining wall. (Source: WLA Studio, April 2020.)

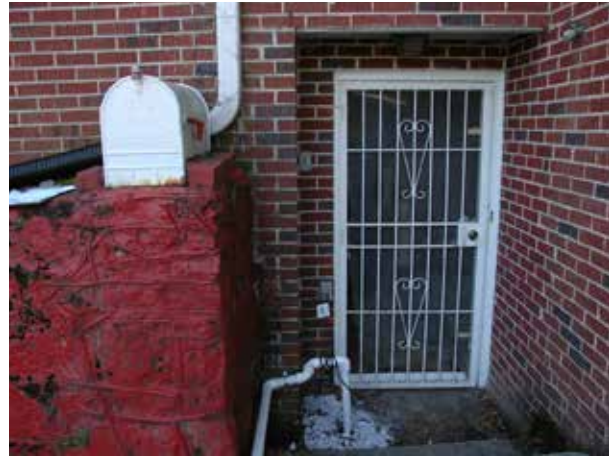
Figure 3.73. View of the sump pump and mailbox at the basement entry door. The sump pump alleviates moisture at the basement level of the house. (Source: HPTC, October 2019.)

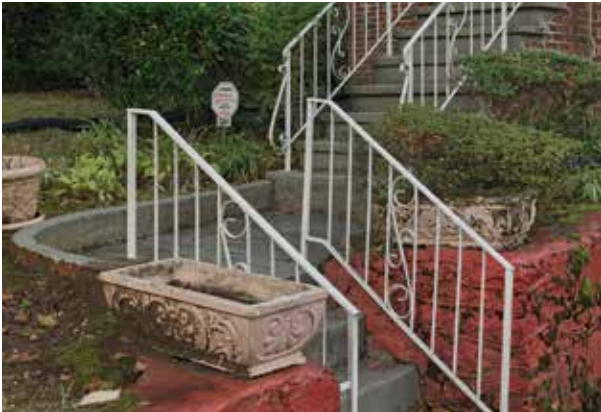
Figure 3.74. Cast concrete planters placed on the stone retaining wall near the steps to the driveway. (Source: HABS GA-199-3.)

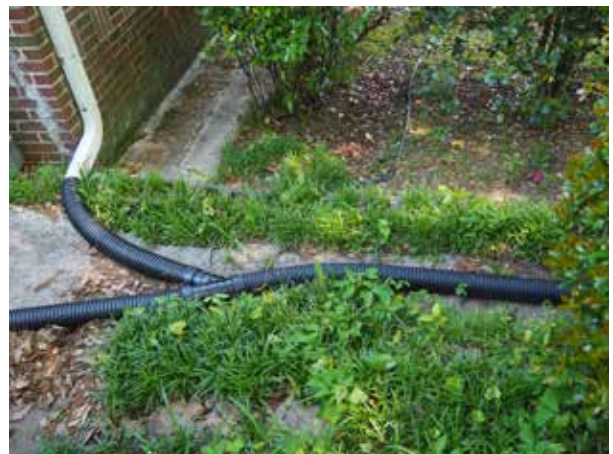
Figure 3.77. Because concrete apron and swale no longer direct water away from the house foundation, the NPS has added drain pipes to direct water toward Sunset Avenue. (Source: WLA Studio, June 2020.)

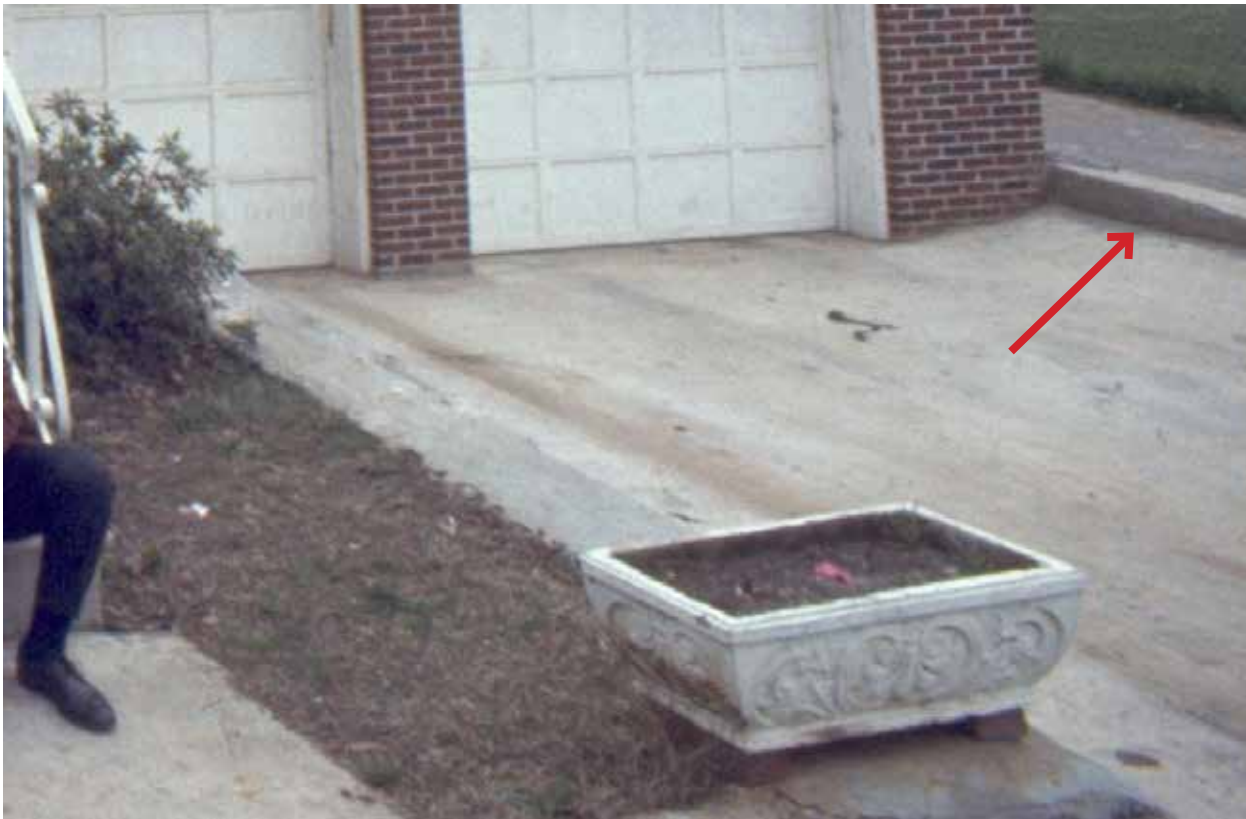
Figure 4.3. Enlargement of a portion of a 1968 photo showing the concrete curb located at the northeast corner of the house and an asphalt walk leading to the rear yard. (Source: © Flip Schulke.)

especially at the intersection with the driveway.⁴³⁹ There was an asphalt path along the north side of the house with a concrete curb separating the asphalt from the concrete driveway (Figure 4.3).
