King Family Home Martin Luther King, Jr. National Historical Park Cultural Landscape Report

King Family Home

Cultural Landscape Report

January 2022
Prepared by:
WLA Studio

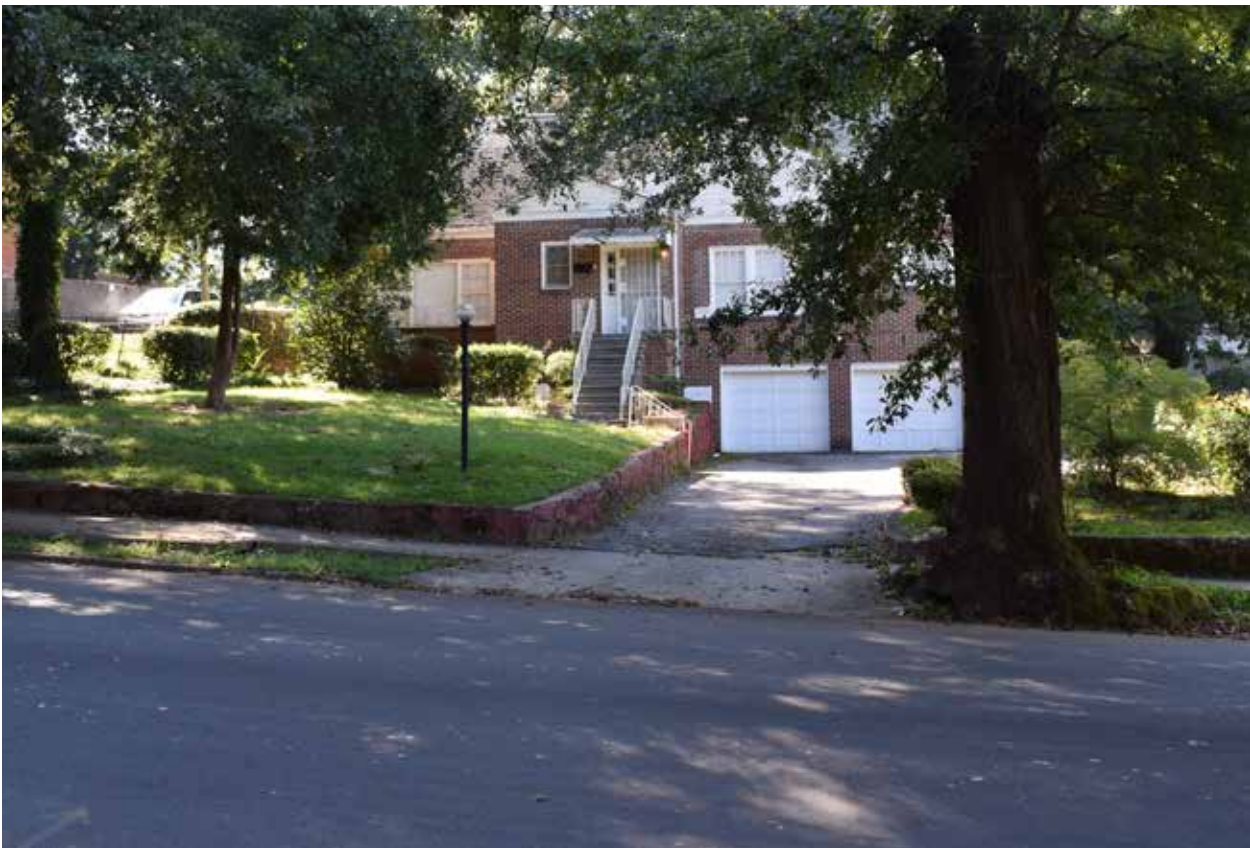
Figure 4.10. The house and retaining wall are intact at the site. The top photo is from 1965 and shows the retaining wall as constructed during the first house renovation. The lower photo is from 2020, and shows the later (1968) wall addition, which runs parallel to Sunset Avenue. (Source: MLK and Arnold Michaelis Interview, Raw Footage Reel 8, University of Georgia, Peabody Archives and WLA Studio, June 2020.)

Exterior structural alterations to the house appear to have been limited to the creation of the new basement office entrance and the cutting of a new window for the recreation room, along with the construction of a window well, on the north elevation. The new basement entry door required a modification to the stone retaining wall. Contractors turned the wall back toward the front entry stair to create an opening for the basement entry door and a step down to the entry door level. Additionally, contractors added a section of low retaining wall paralleling the sidewalk on Sunset Avenue. This work may have corresponded with city installation of new sidewalks and a drive apron in December 1968 (Figure 4.10). At some point prior to 2007, the King family painted the stone retaining wall red.

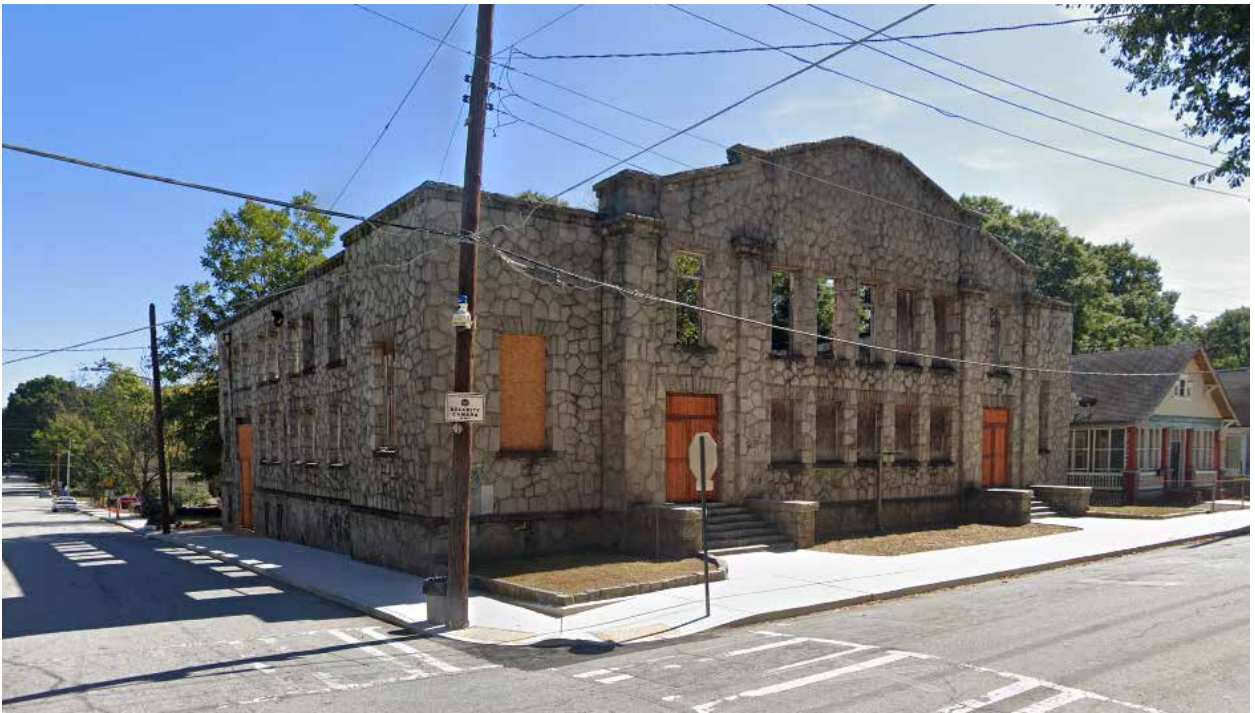
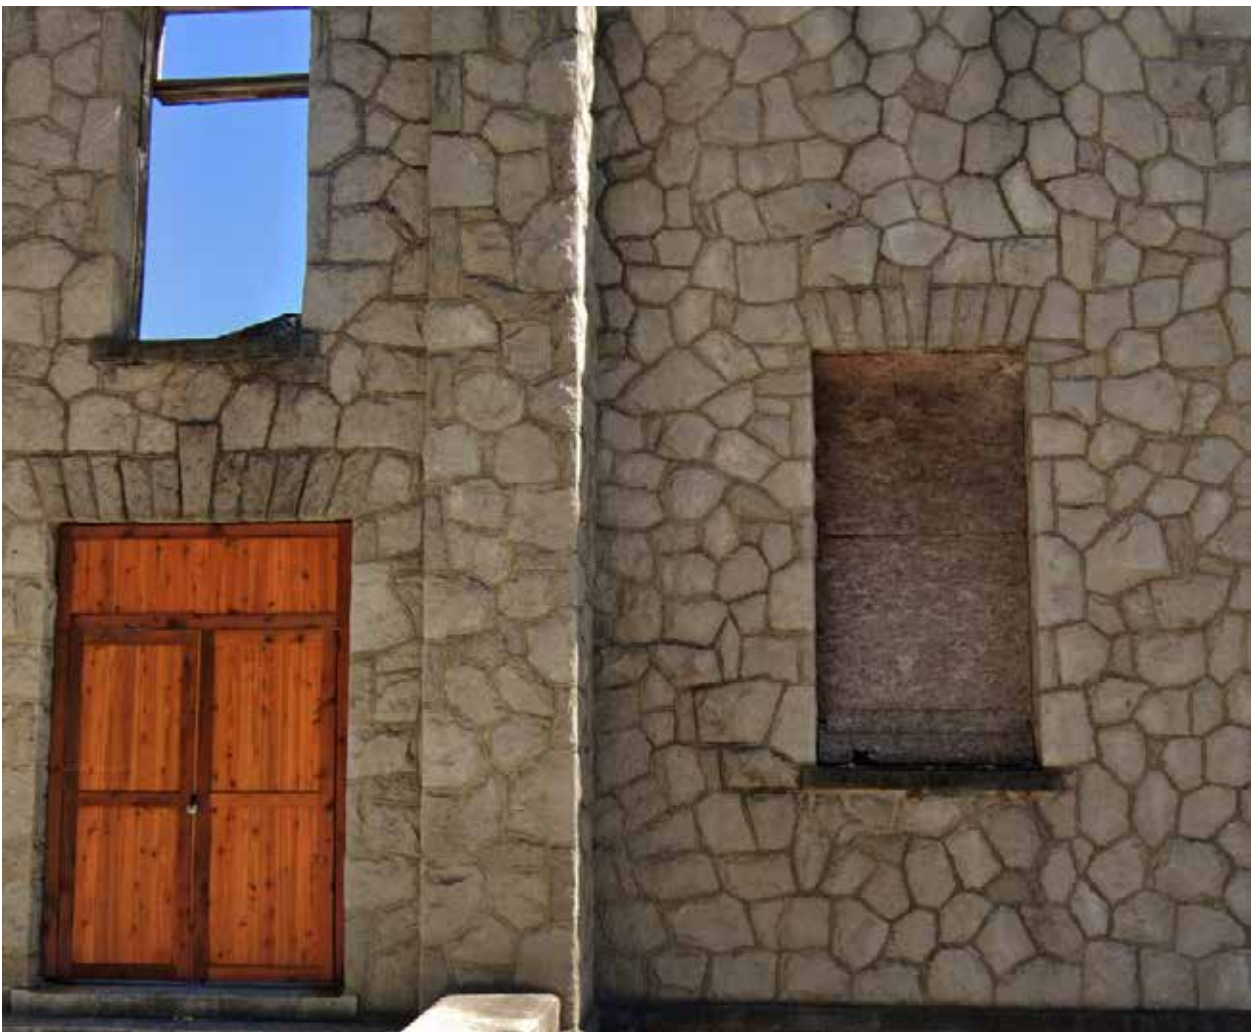
Figure 4.11. Example of similar wall construction at the ruins of First St. Mark A.M.E. Church, located in the English Avenue neighborhood, just north of Vine City. North elevation and closeup of stonework. (Source: Google, 2020.)

The 1965 and 1968 construction of the retaining wall at the King Family Home reflects typical stonework patterns in the neighborhood. Granite rubble walls, with stones of various sizes and colors are present throughout the neighborhood. Several reflect the construction method of this stone retaining wall with an irregular pattern and raised beaded joints. There is another stone retaining wall on the 200 block of Sunset Avenue (216 Sunset Avenue) that has this same type of joint work. The stone mason is unknown for both walls. Another local example of similar stone workmanship former church walls located at First St. Mark A.M.E. Church at the corner of Chestnut Street and Cameron Madison Alexander Boulevard. This church construction displays similar stone and mortar work with raised beaded joints (Figure 4.11). According to masonry expert Harley McKee, "the irregular pattern and thickness of joint in rubble [walls] called for varied treatment with the trowel. Sometimes stones projected irregularly beyond the face of a flat surface of mortar."⁴⁴³

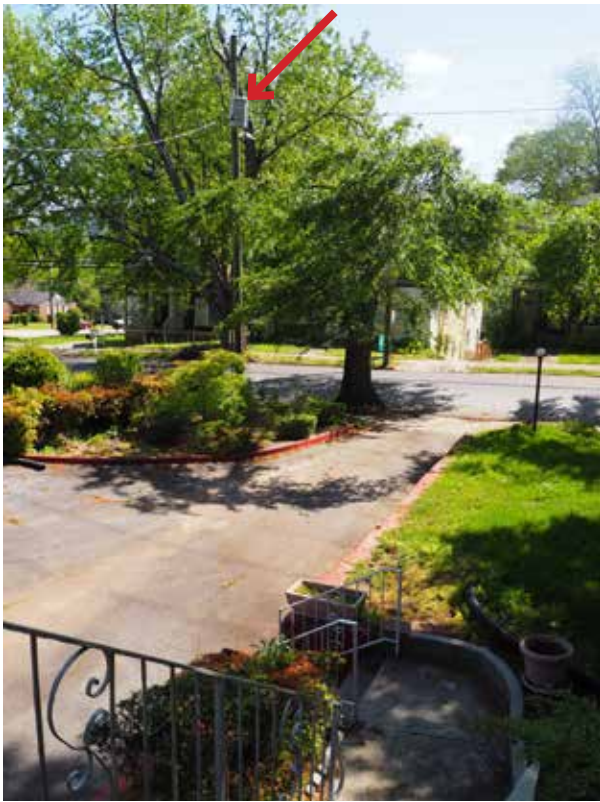
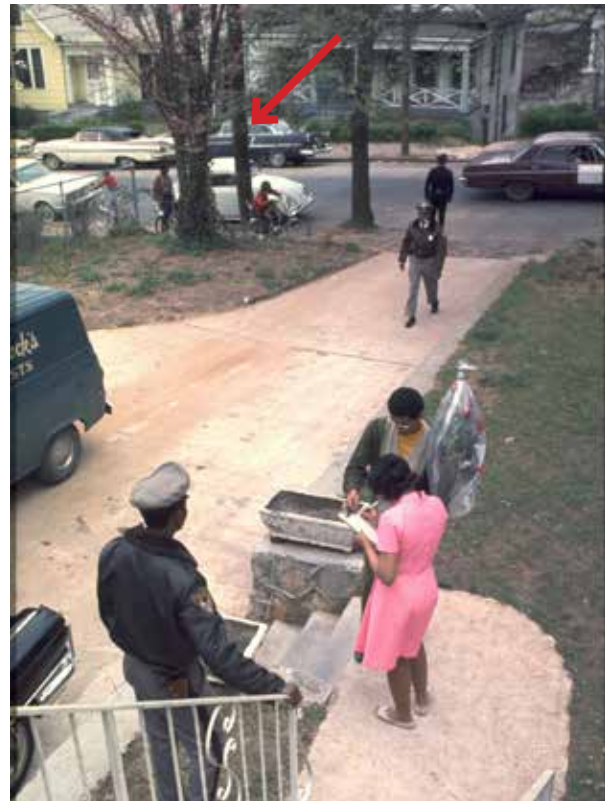
Figure 4.12. Portion of a photo from April 1968 and current view of above ground power line servicing the house. Vegetation obscures the power pole in the current view. (Source: © Flip Schulke and WLA Studio, April 2020.)

After Coretta Scott King moved out of the King Family Home, her estate performed general maintenance and upkeep on the house from 2004 to 2019, preserving it much as it appeared in the period of significance. Improvements to the house included a new roof, a new hot water heater, and an upgraded HVAC system. The metal sided utility shed in the rear yard is in poor condition and shows signs of deterioration including rust. The doors have fallen off their tracks (they are still located at the site), and the roof shows signs of impact, perhaps from branches of the nearby water oak. Above ground power lines continue to service the house (Figure 4.12). The NPS modified the

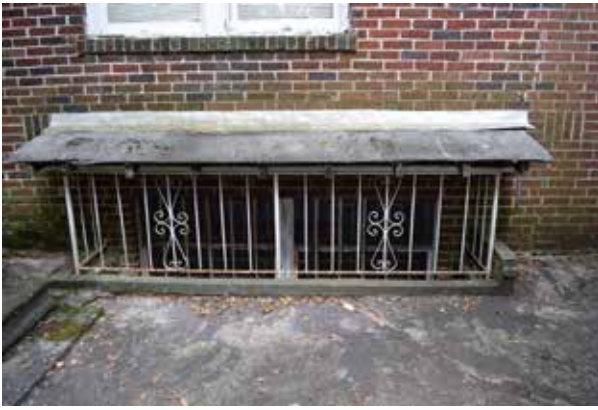
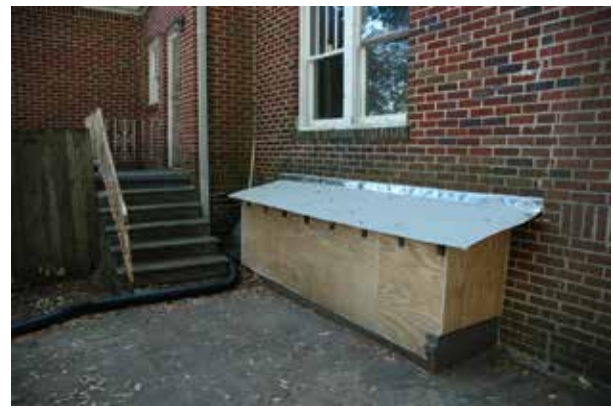
Figure 4.13. View of window well prior to plywood structure construction. Window was enclosed with plywood and flashing between June and October 2019 to reduce the amount of water ingress to the basement and the window well area. (Source: HPTC, October 2019 and WLA Studio, June 2019.)

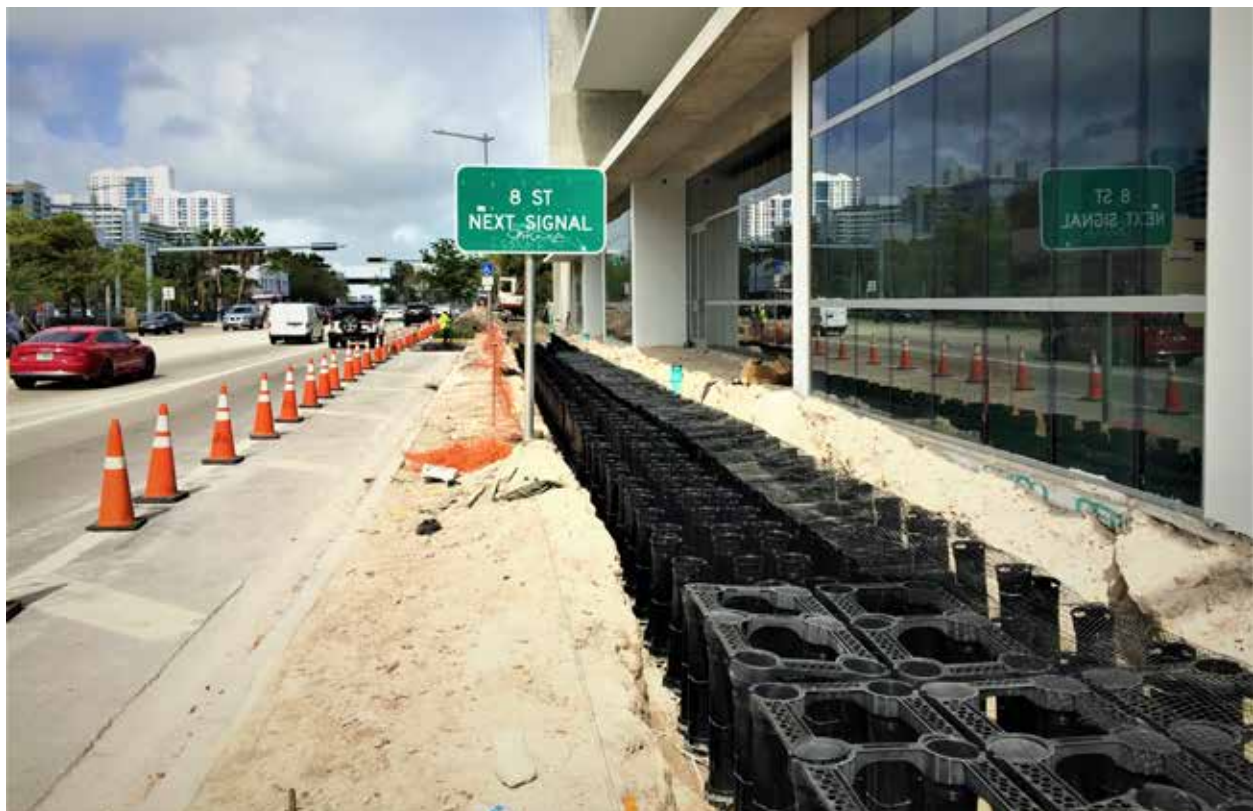
Figure 5.2. View of installation of a modular suspended pavement system. (Source: © 2021 Deeprout, deeprout.com.)

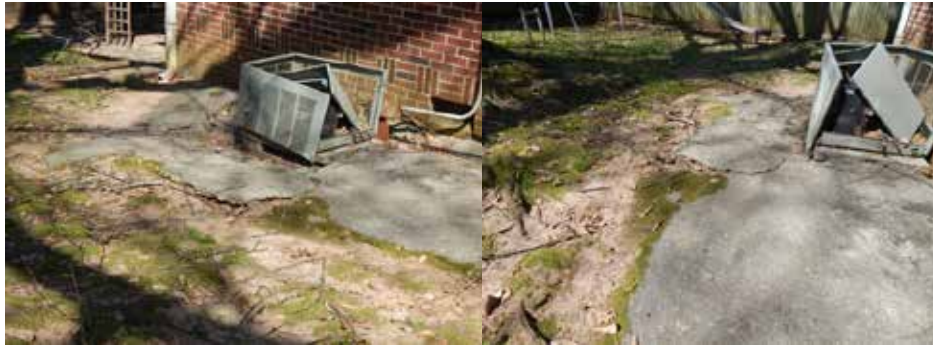
The surface roots are pushing up the asphalt walkway in the rear of the house, possible impacting the foundation as well (above).

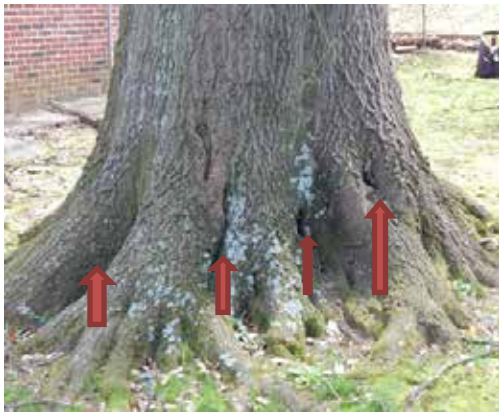
There are several cavities in sinuses at the root flare (above).

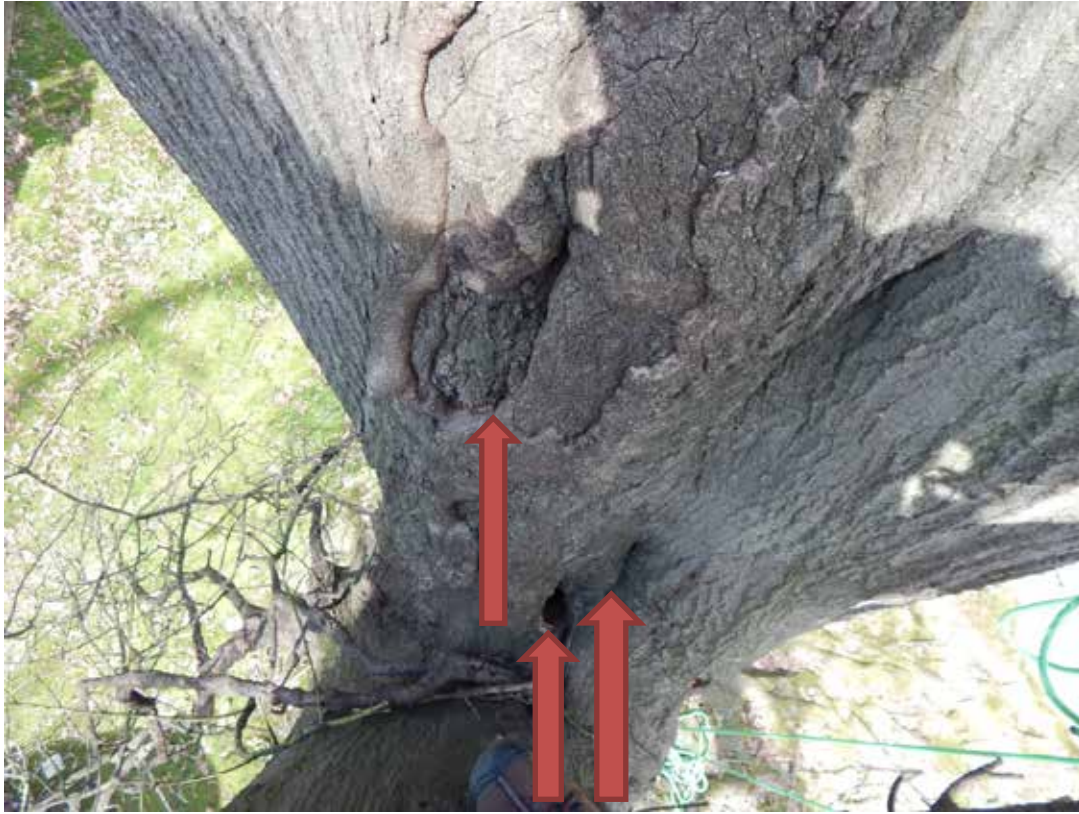
There are cavities higher up, mostly on the side of the tree away from the house. There are two large (12-14 inch) branches that extend horizontally over the house approximately forty feet. There was no foliage to examine at this time of year. The tree does not have any discernable lean. Little pest evidence was found, which would be normal for this time of the year. Several witches' brooms are forming on some of the lower horizontal branches. Witches' brooms are possible indicators that the tree is stressed. (see below).

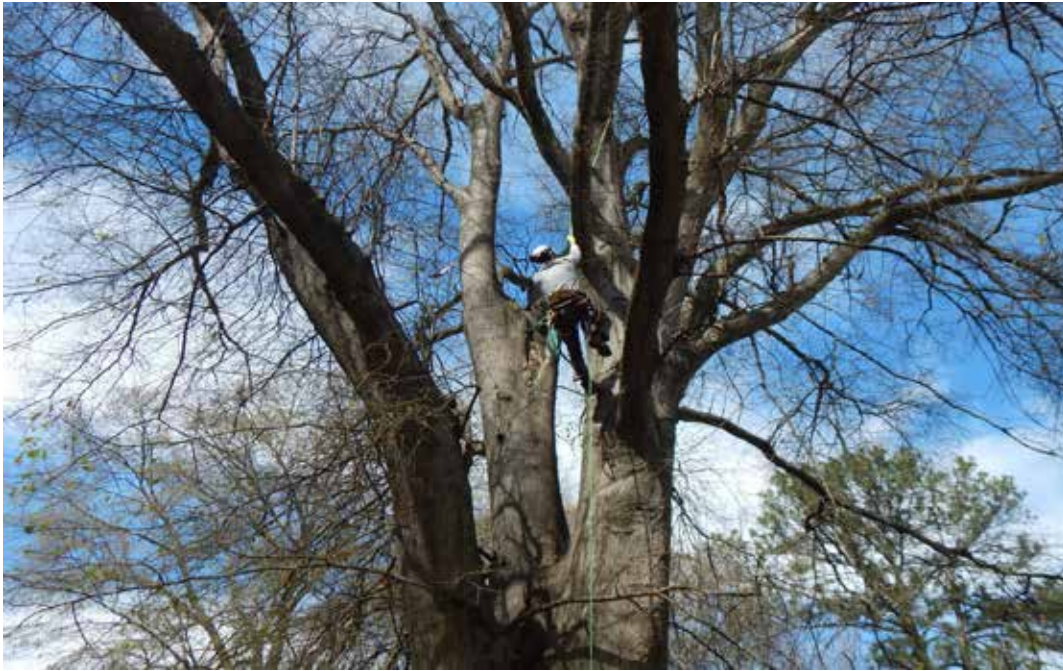
Shawn Dawson is climbing the tree for aerial inspection. Note the size of the co-dominate leaders.
