THE OLD VICARAGE,
KILBURN
NORTH YORKSHIRE
YO61 4AH

APPLICATION FOR PLANNING PERMISSION TO PARTIALLY TAKE DOWN EXISTING
ANCILLARY BUILDING AND ASSOCIATED MODERN TIMBER SHEDS AND REFORM
NEW ANCILLARY BUILDING ON LARGER FOOTPRINT AND ASSOCIATED
LANDSCAPING WORKS AND NEW DRIVE ENTRANCE GATES

DESIGN & ACCESS STATEMENT &
HERITAGE IMPACT ASSESSMENT

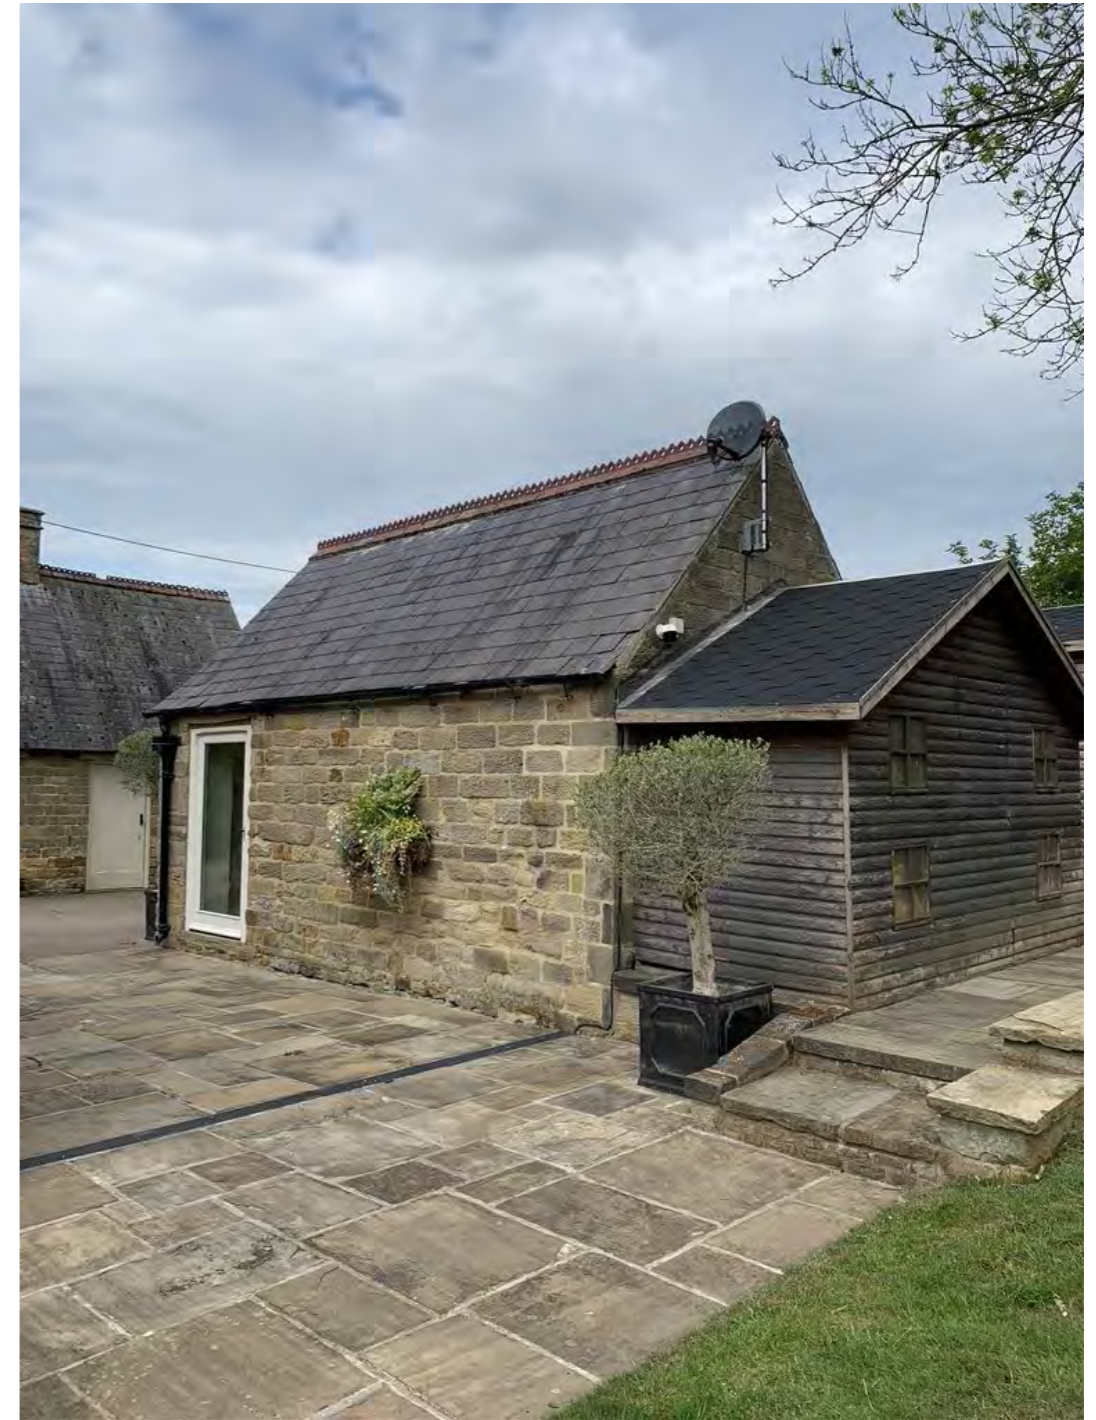
c) view of the south & north east elevations of the existing ancillary building currently being used as a gym. Proposal to retain the south wall and build new building and extend to the right hand side and back

The design of the proposed new ancillary building retains the exiting southern wall of the existing ancillary building and the south west corner remain as existing. The new building stretches back to the boundary line. There is a two metre plus grass verge between the proposed new building line and the edge of the footpath.

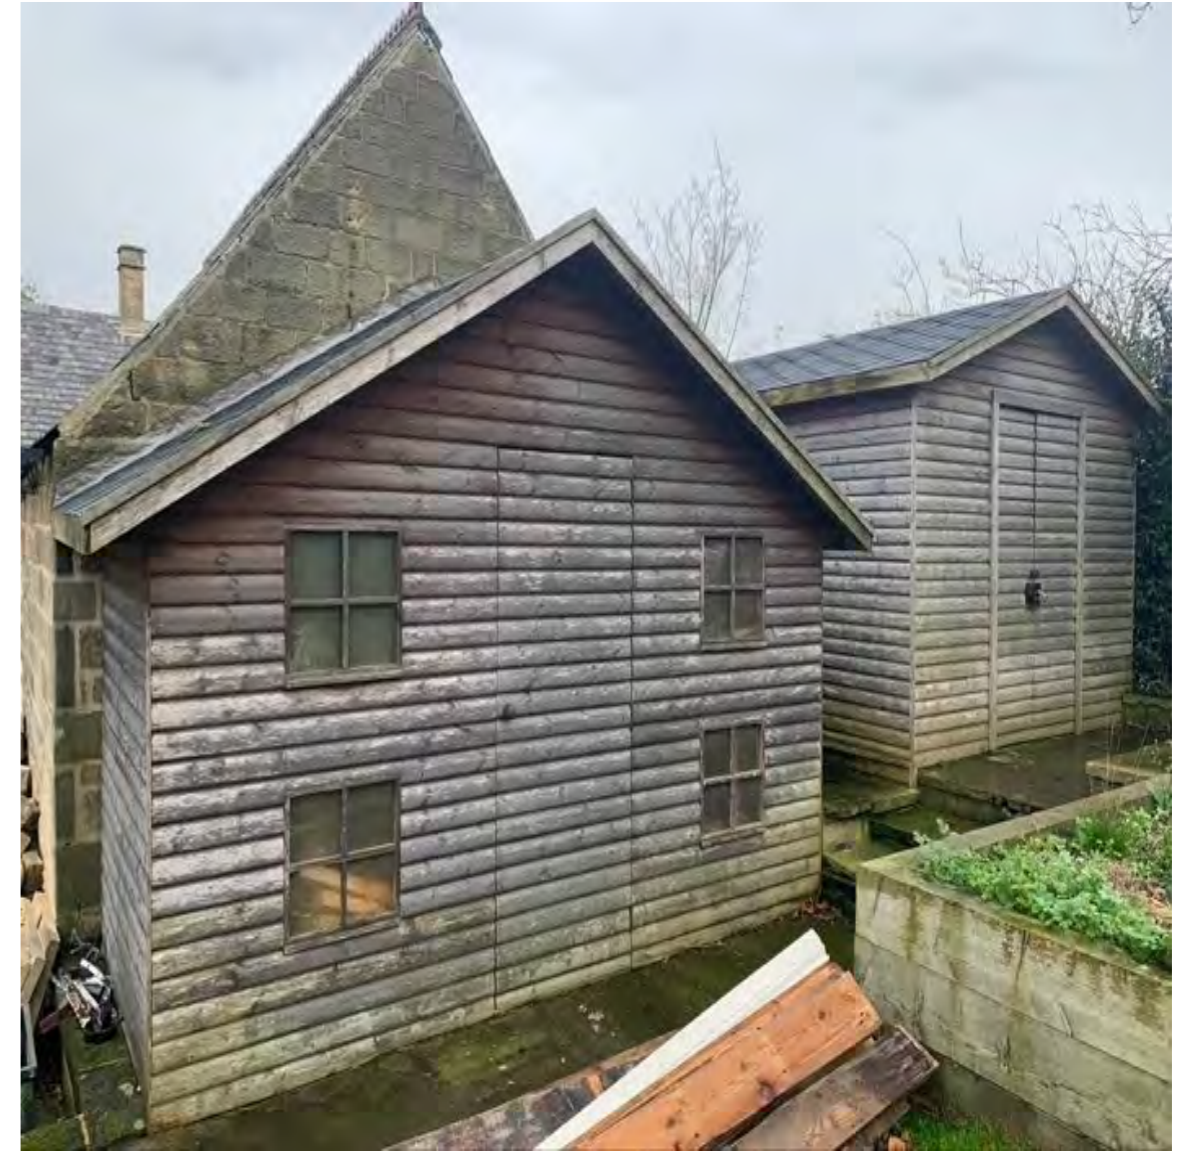
e) view of the north east elevation of the existing ancillary and modern timber extension – showing the freestanding timber building to the north

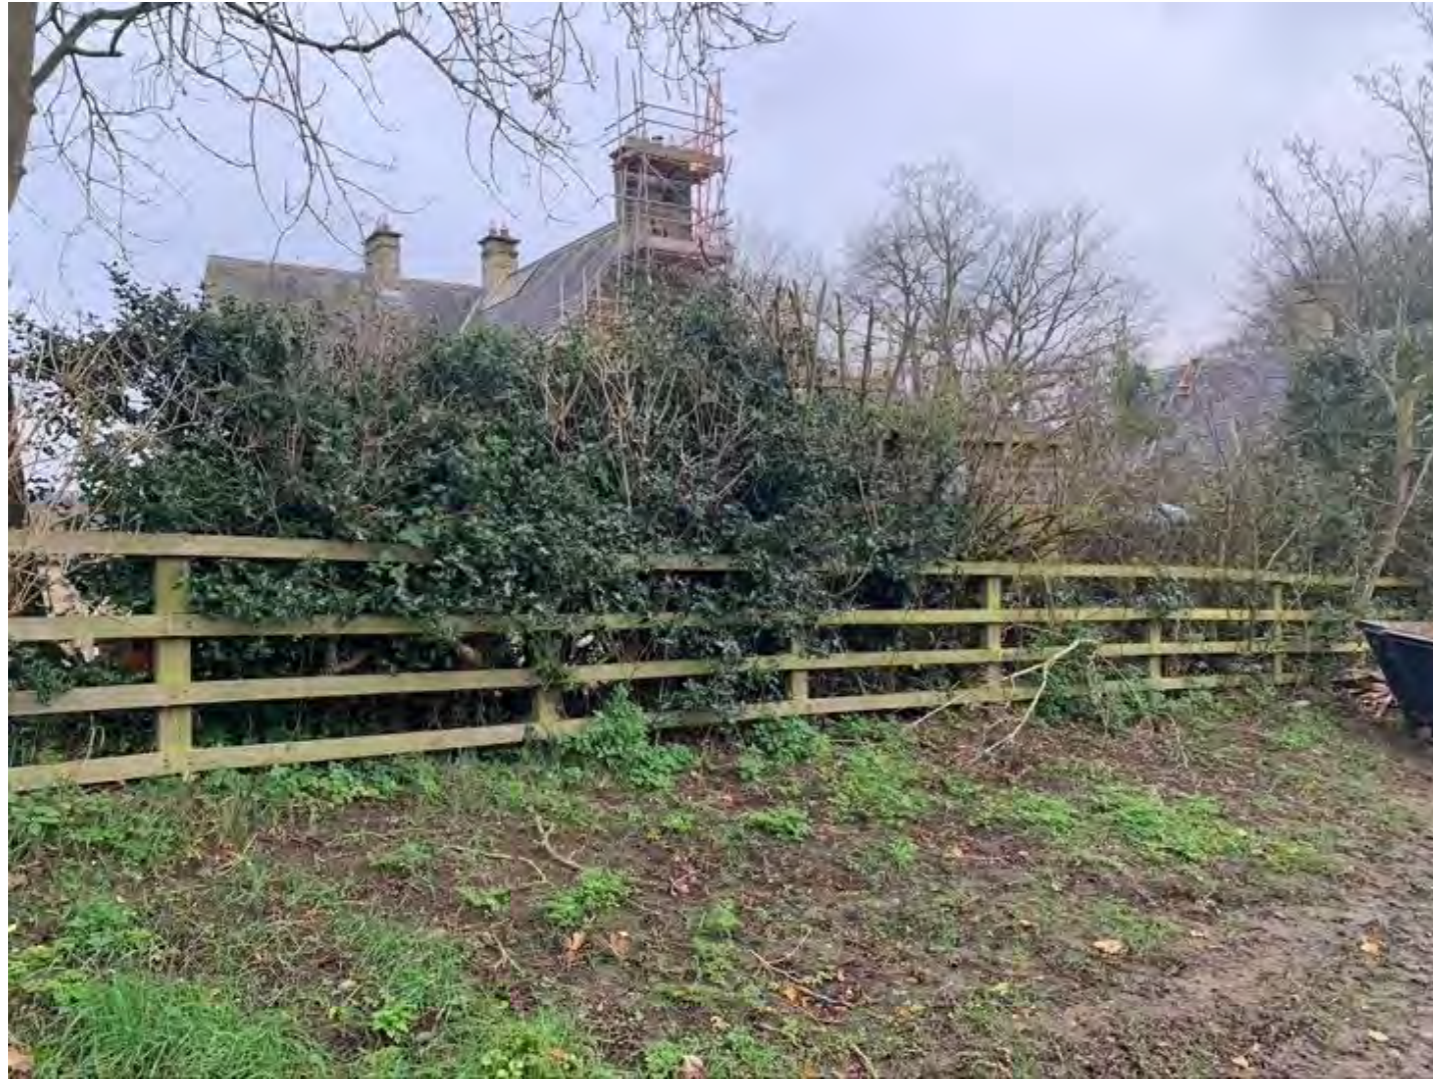
g) View of the proposed location of the enlarged building from the public foot path to the north, showing the timber post and rail boundary treatment and scrappy hedge.

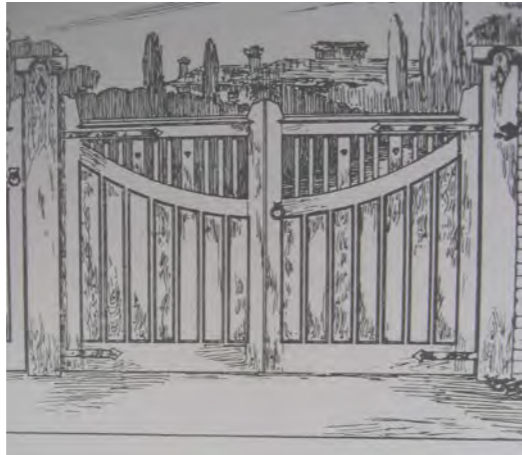
bespoke pair of double hung
hardwood gates formed to
traditional design - natural
finish allowed to 'silver' with time

solid timber gate posts
with lead capping for
weatehr protection

The proposal is for a hard wood gate built to a traditional design, in natural hardwood, which will be left untreated and allowed to 'silver' with age. The lower section will be solid.

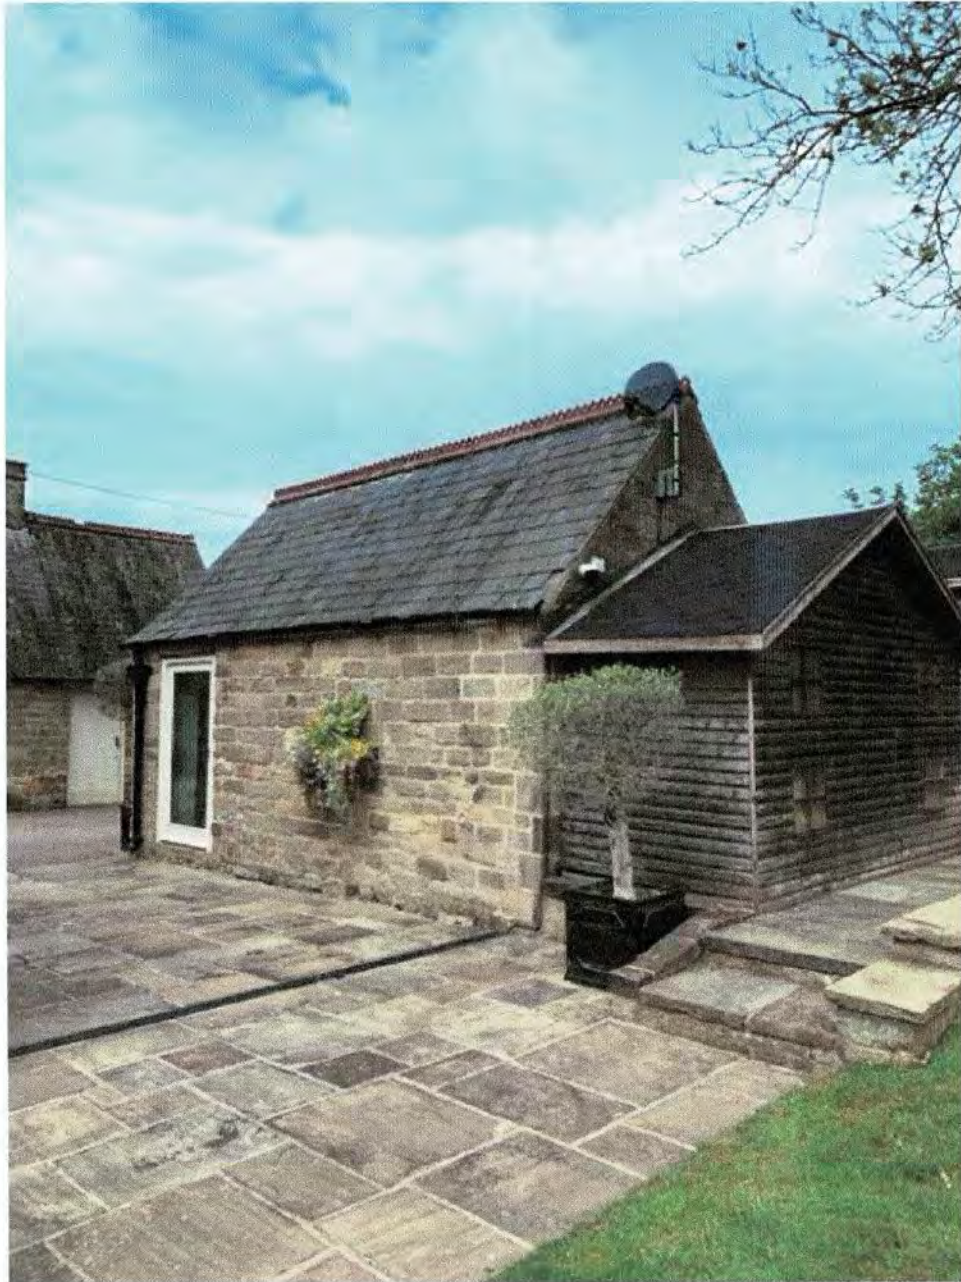
Image 1. Existing 'Gym' Building
From South East Corner

NB. Picture taken from Emergence/
Re-entry Survey Point 'X'

4.2.2 The building. The current structure is stone built with a pitched slate roof (Image 1). It is in an excellent state of repair internally and externally. No roof tiles are damaged or disturbed, all mortar seals are good and the guttering, window and door frames are all intact. There is a negligible risk of bat roosting and no sign of any other bat activity.

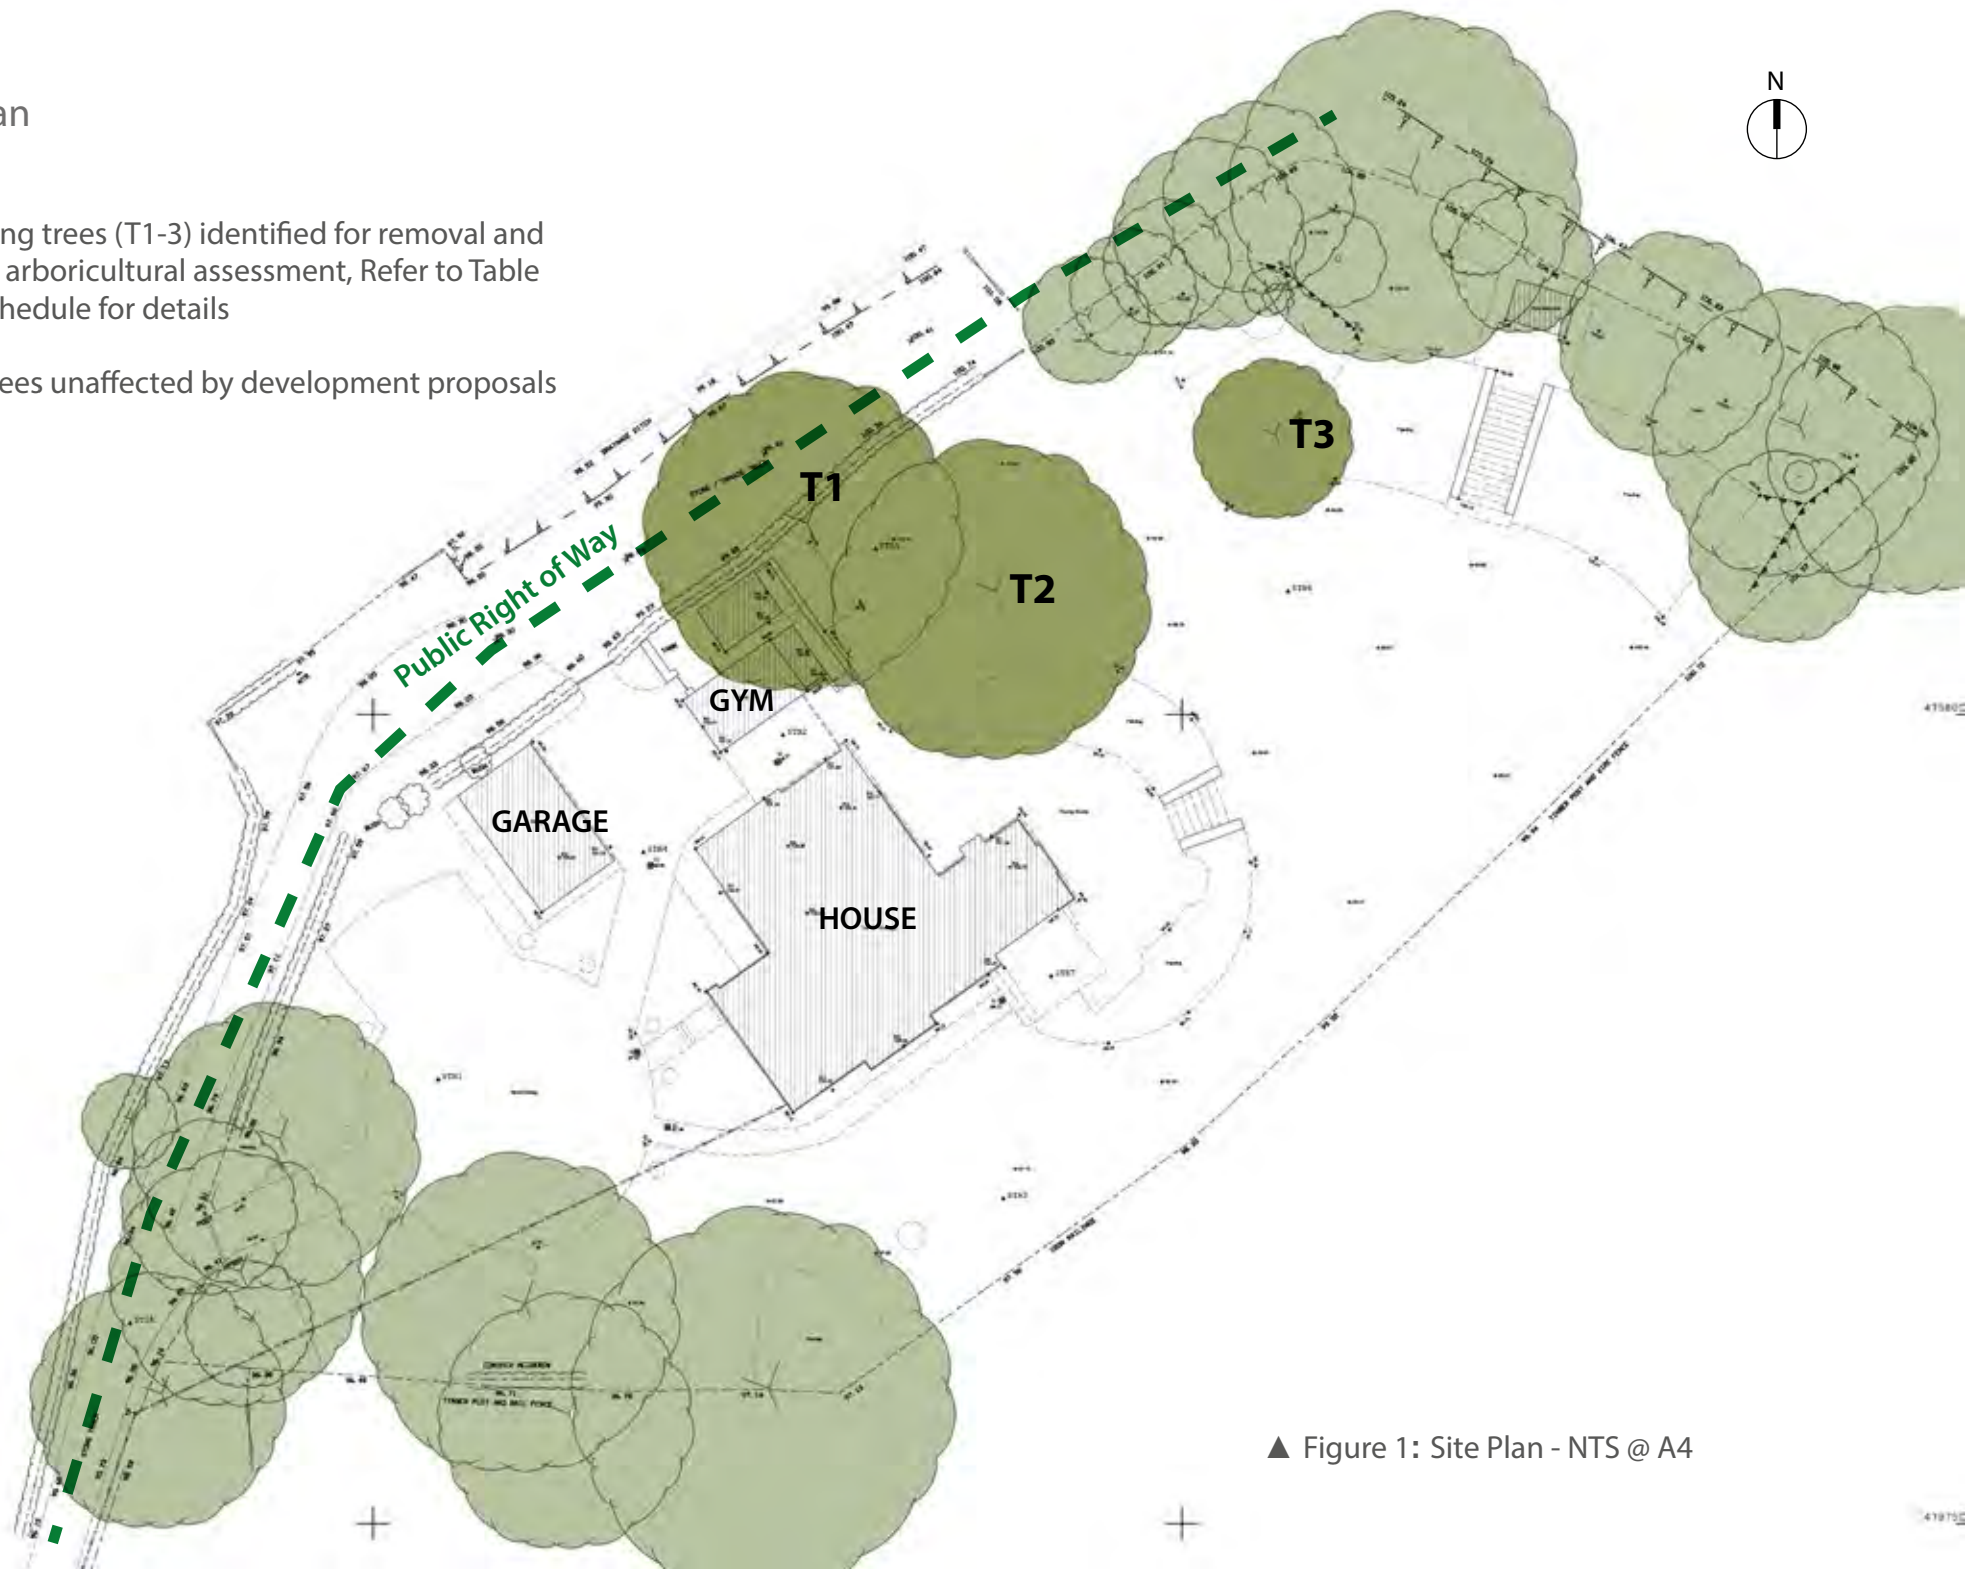
▲ Figure 1: Site Plan - NTS @ A4

- 3no. Existing trees (T1-3) identified for removal and subject to arboricultural assessment, Refer to Table 1 - Tree Schedule for details
- Existing trees unaffected by development proposals

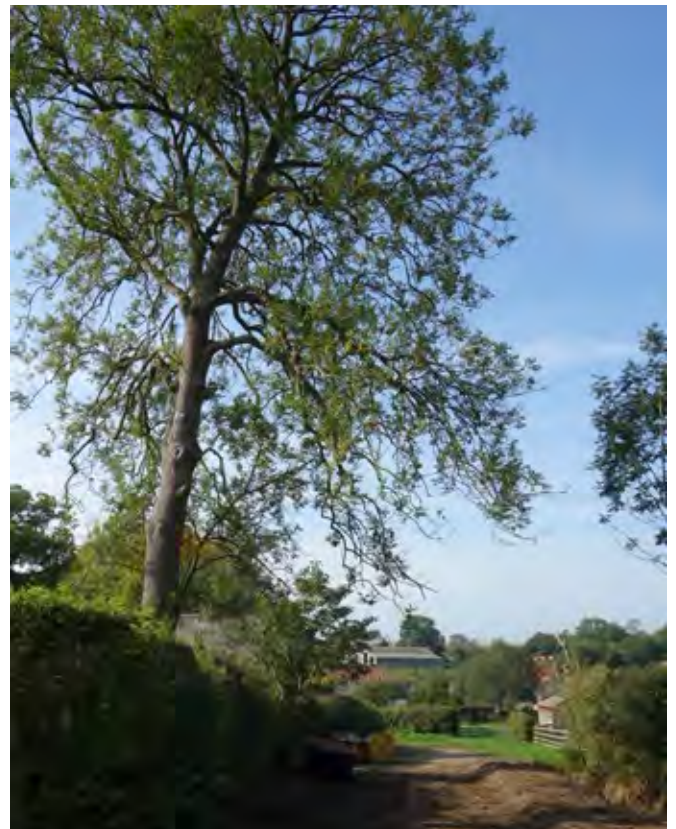
▲ T1 - Ash (*Fraxinus excelsior*) overhanging adjacent Public Right of Way to north western boundary

Ref. No.	Species	Height (m)	Av. Crown Spread (m)	D.B.H (mm)	Life Stage	Phys. Condition	SULE	Structural Condition & Notes
T1	Ash <i>Fraxinus excelsior</i>	22	15	740	M	Poor	<10 yrs	<ul style="list-style-type: none"> Reduced vitality with visible signs of Ash dieback (<i>Hymenoscyphus fraxineus</i>) on shoots throughout the crown High volume of minor deadwood Stem bi-forked at circa.5/6m with good tension union Moderate basal condition Limited prospects given Ash Dieback infection and current state of crown condition Safe retention likely to be limited to a maximum of 5 years due to it's location overhanging a Public Right of Way and increasing risk of harm to public and home owners from falling deadwood and branch tear outs
T2	Lime <i>Tilia europaea</i>	12	5	840	M	Poor	10-20 yrs	<ul style="list-style-type: none"> Poor form and low levels of vitality Recently subjected to heavy crown reduction/ pollard (50% reduction) and responding with low levels of vigour Epicormic shoots developing on stems and branches along with basal epicormics Co-dominant stems with included bark union at 3m Sounding hammer indicates internal decay within lower stem Dead girdled root Dead bark/ decay in upper stems Limited longer term prospects Safe longer term retention only possible with further remedial work (pollarding)

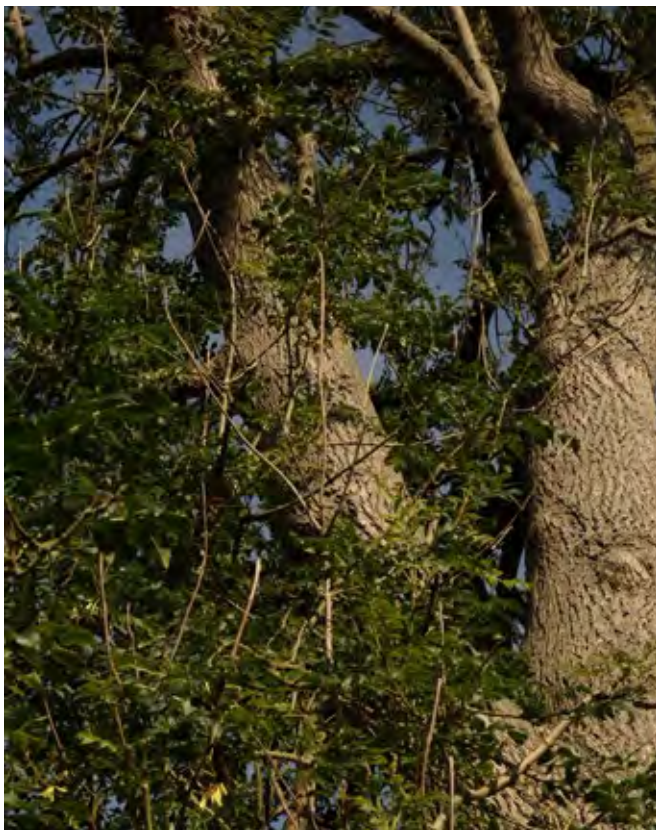
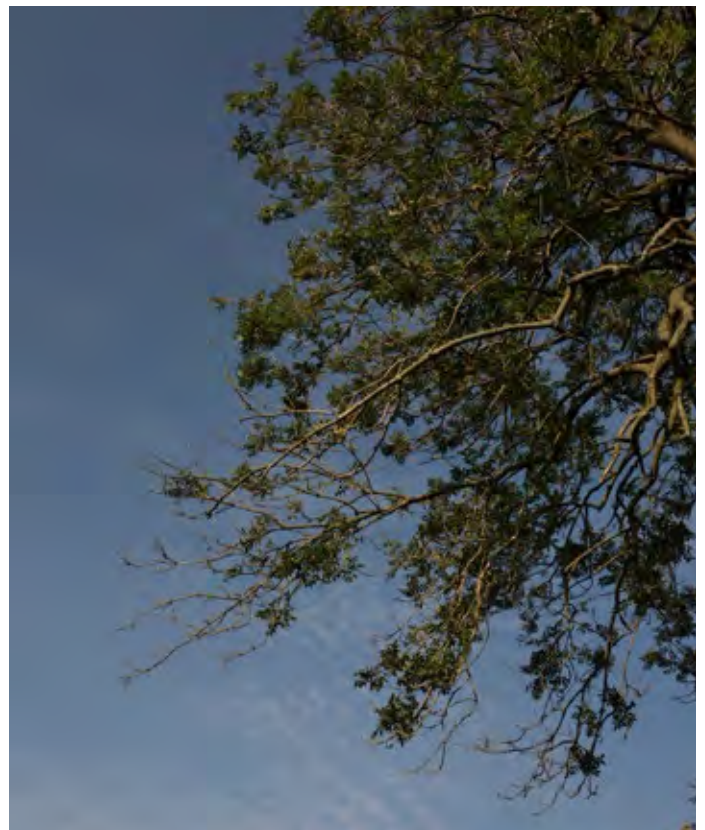
▲ T1 - Ash (*Fraxinus excelsior*) signs of Ash Dieback

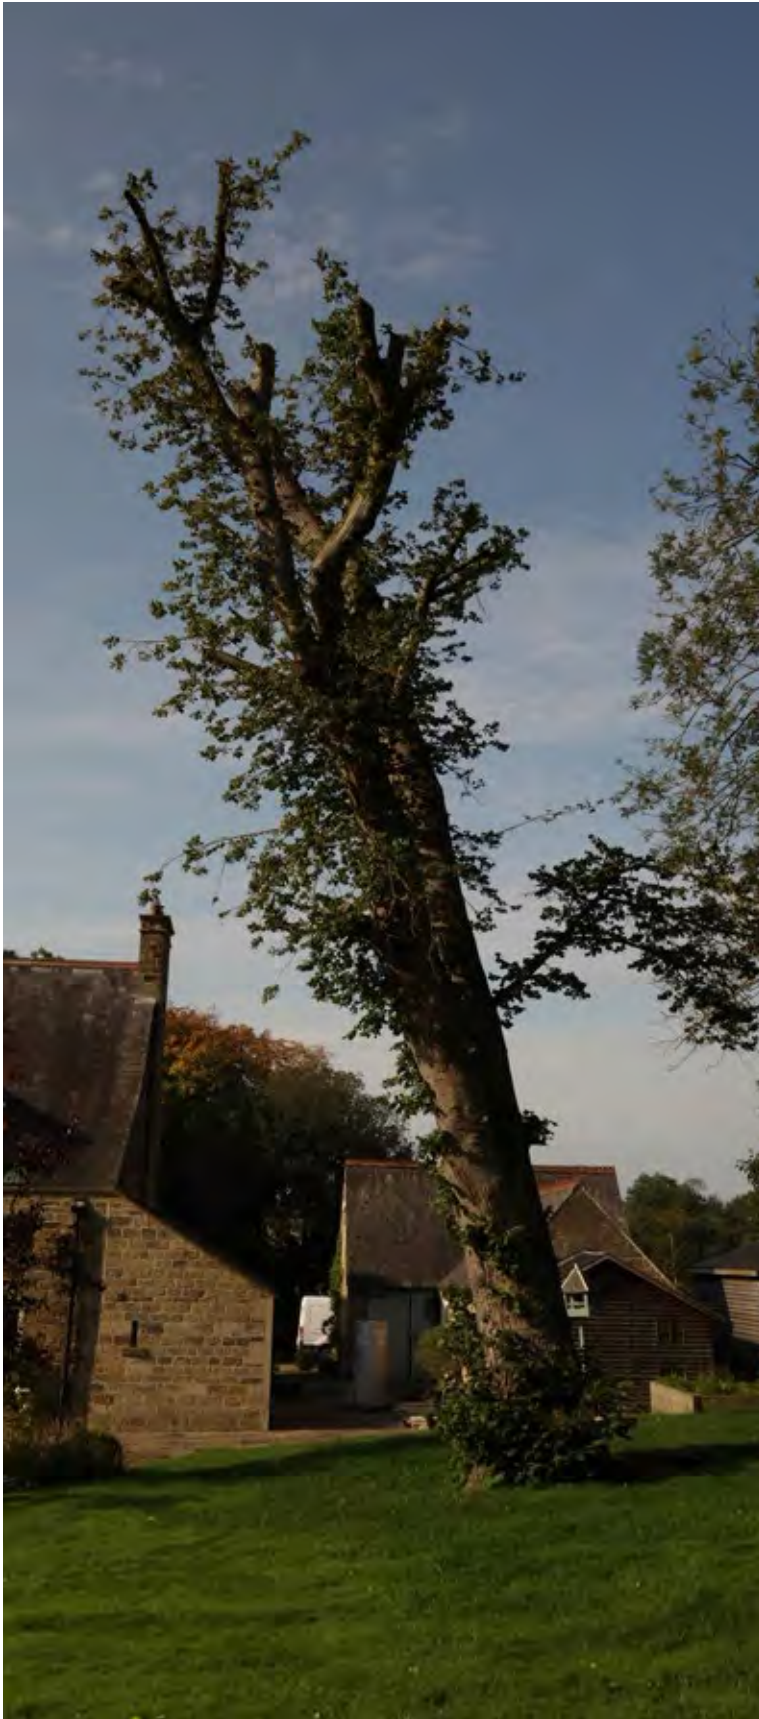
▲ T2 - Lime (*Tilia europaea*) - Recently heavily pollarded and responding with low levels of vigour

The tree has not responded well to the recent remedial work (pollarding) which has left the tree with an unsightly appearance. As root and basal decay continue to progress the tree will present an increasing level of risk.

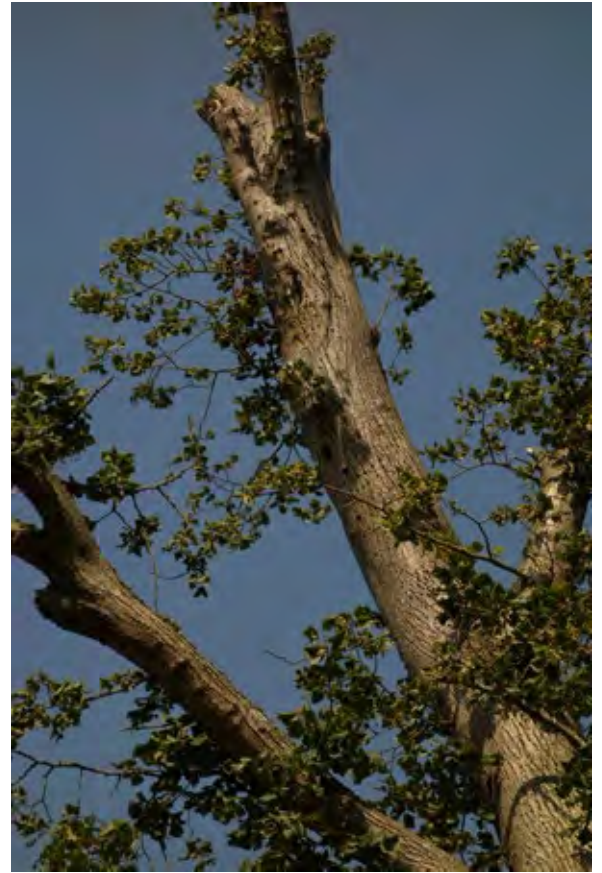
▲ T2 - Lime (*Tilia europaea*) - Low crown density and dead/necrotic bark

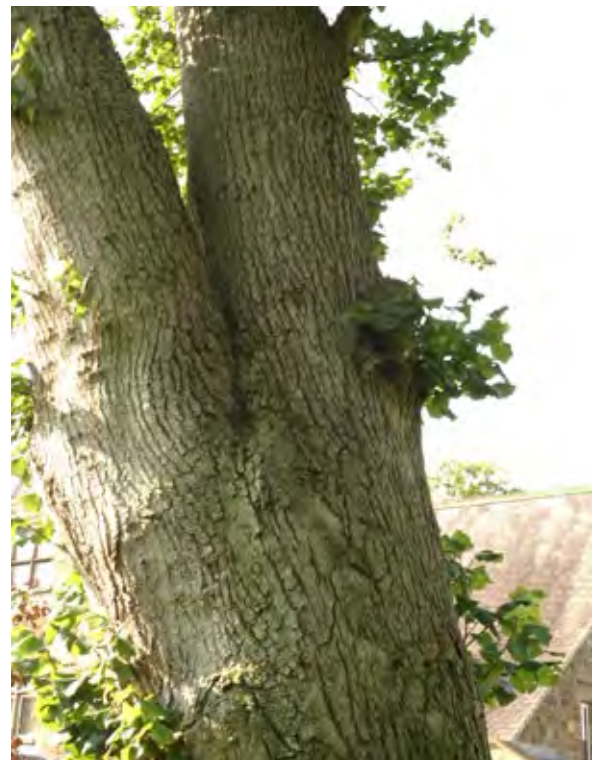
▲ T2 - Lime (*Tilia europaea*) - included bark union

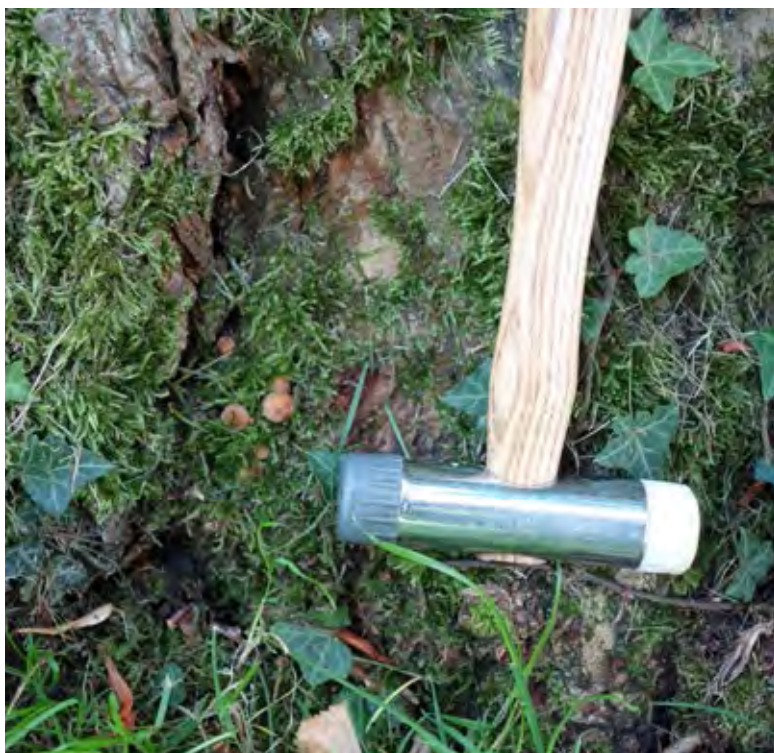
▲ T2 - Lime (*Tilia europaea*) - small emerging *Armillaria mellea* fruiting bodies indicating root decay

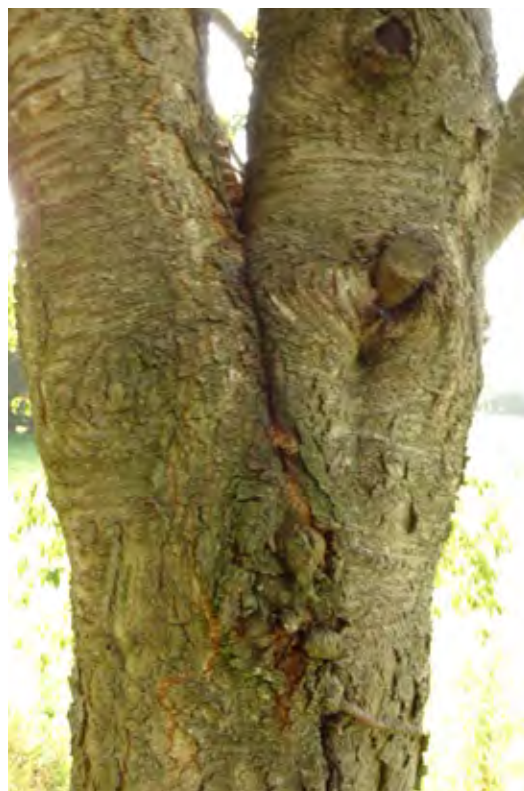
▲ T3 - Cherry (*Prunus*) - Included bark union

T3	Cherry <i>Prunus sp.</i>	11	11	460	M	Fair	>40yrs	<ul style="list-style-type: none"> Average vitality Poor form - weak union with co-dominant stems with included bark union at 2m. Spreading crown with limited natural bracing - increasing probability of failure over time (may require remedial action, i.e. cable bracing to limit probability of failure at defect union) Currently located in a relatively low target setting Minor deadwood Good basal condition Light mower damage to surface roots Light shot-holing of leaves indicative of bacterial canker infection

Although physiologically the trees condition is satisfactory, structurally it features a significant defect which is likely to require remedial work in the future to reduce the risk of a stem failure.
