Project				
<p>An assessment of the ecological impact on the Dawn River arising from diversion of part of the river channel within the Dawn Meats Facility at Carroll's Cross, Co. Waterford.</p>				
Client Dawn Meats Ireland				
Project ref	Report no	Client ref		
1329	1329			
<p>DixonBrosnan The Cedars, Bridewood, Ovens, Co Cork Tel 086 851 1437 carl@dixonbrosnan.com www.dixonbrosnan.com</p>				
Date	Rev	Status	Prepared by	
20/06/13	0	Issue to client	Carl Dixon M.Sc.	
<p>This report and its contents are copyright of DixonBrosnan. It may not be reproduced without permission. The report is to be used only for its intended purpose. The report is confidential to the client, and is personal and non-assignable. No liability is admitted to third parties. ©DixonBrosnan 2013.</p>				
v180907

1. Introduction

Appendix 2. Proposed works on bank slopes along a section of the Dawn River at Dawn Meats, Carrolls Cross, Co. Waterford

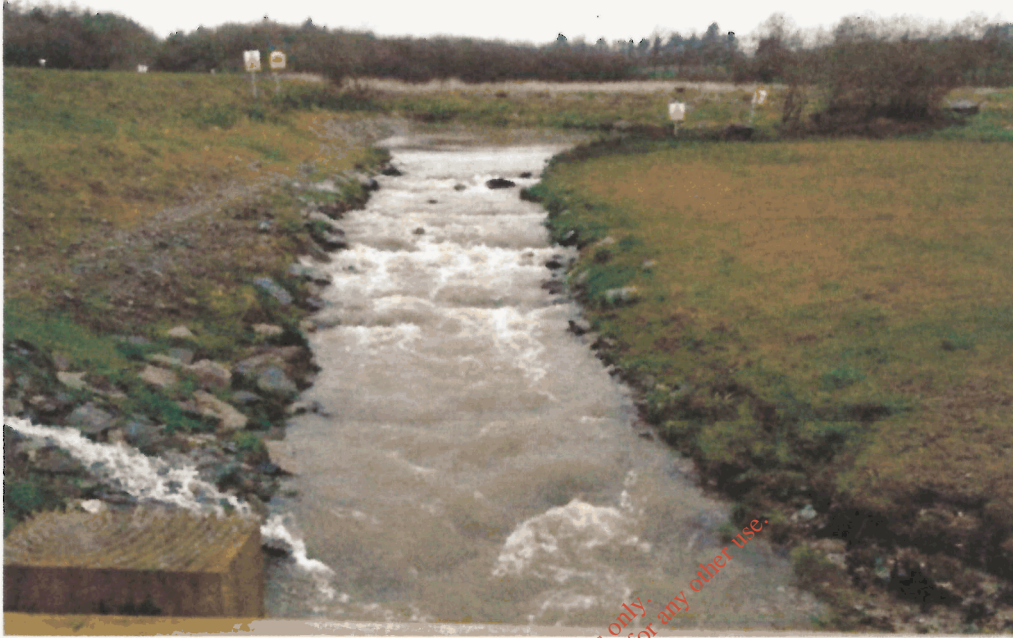
Photo 1 Riffle habitat during period of high flow

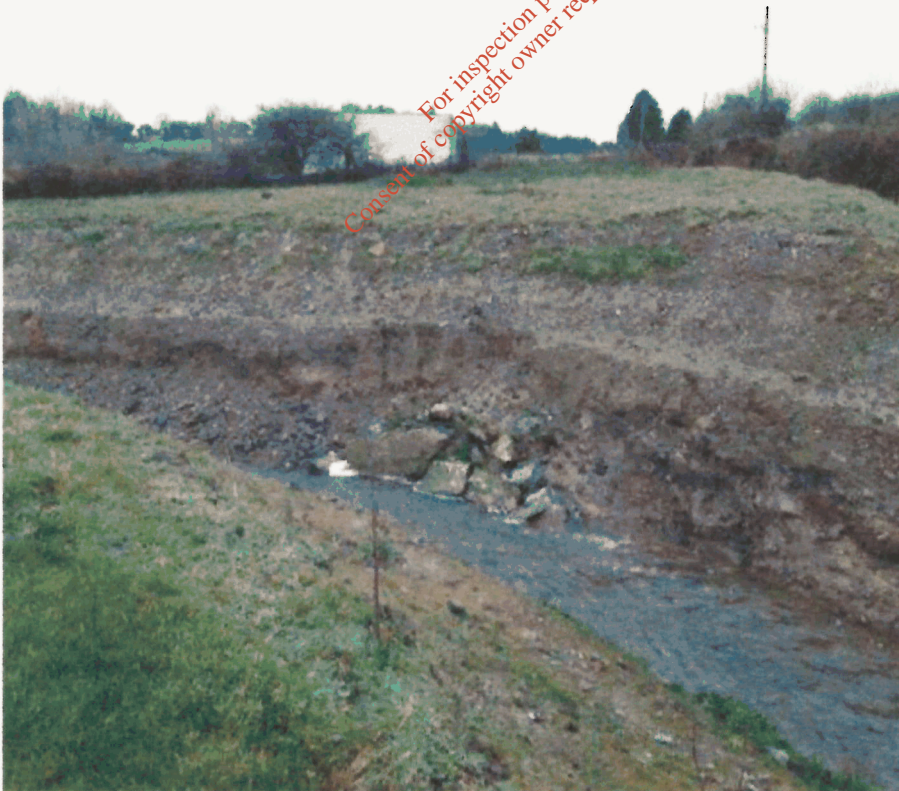
Overall, the morphology of the new section of river channel is probably not dissimilar to that which previously existed, with a mixture of glide and riffle habitat. However following completion of the works some erosion of the newly constructed banks has occurred in places. This is particularly evident in the downstream section of the channel where there is an acute angle and in the absence of mitigation there is the potential for quite large volumes of solids to reach the watercourse. This

has the potential to impact on the ecological value of the river. Thus work is required to stabilise eroding river banks via rock armour and appropriate planting.

Photo 2. Eroding river bank on new channel

The new section of river channel and ICW are already complete. However additional works will be required to stabilise river banks which are eroding. A brief outline of the proposed works, which will be carried out in consultation with Inland Fisheries Ireland, in the period from July to September 2013 is included as **Appendix 2** of this report. Works will have the following characteristics:

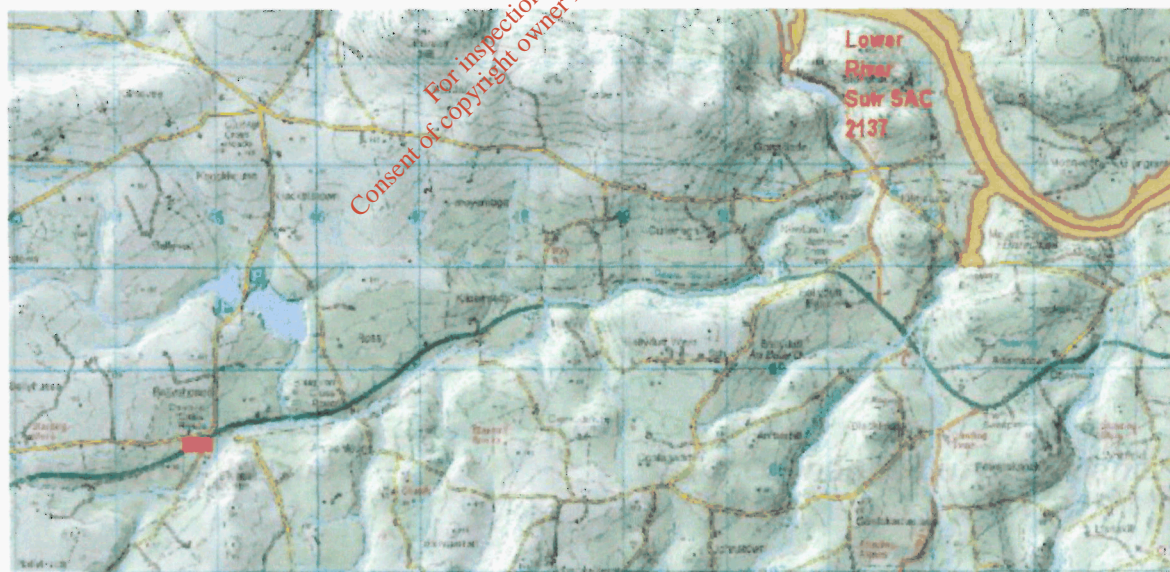
Figure 1. The proposed development area, under the red square, in relation the Lower River Suir SAC (shaded orange).

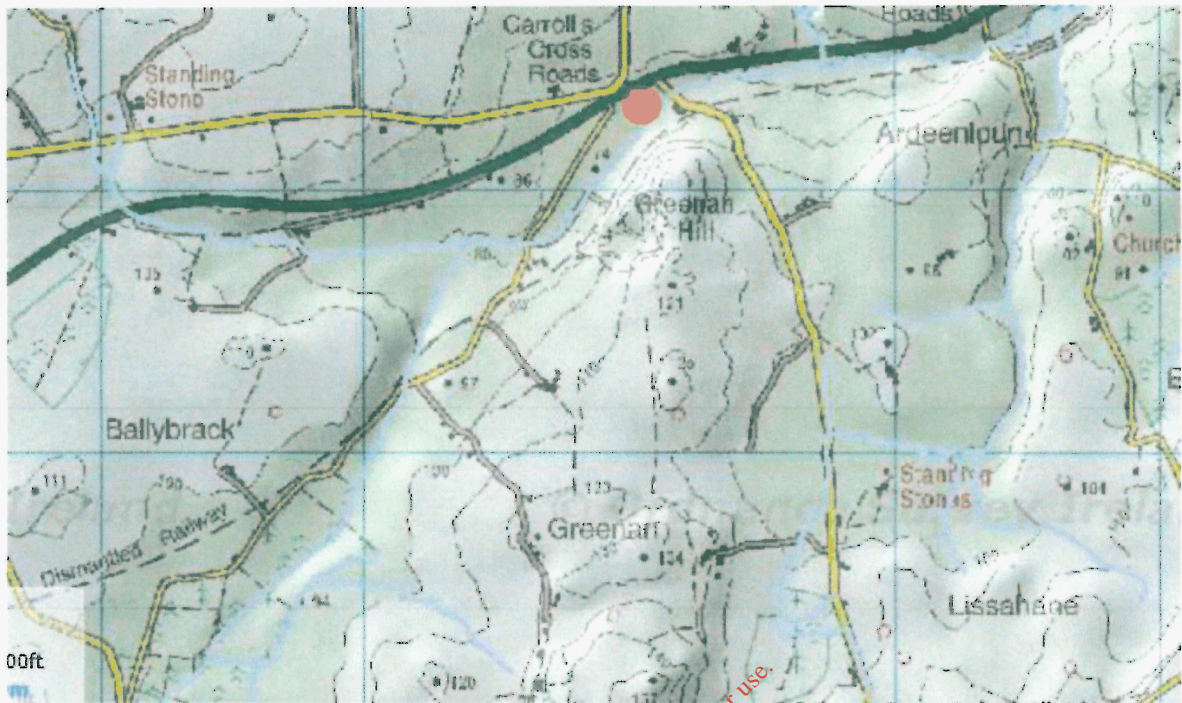
The Dawn River is a small river which rises approximately 2.7km south west of the Dawn Meats facility. The facility is therefore located in the upper reaches of the catchment. Land in the upper reaches is consists of low to moderate quality pasture with planted blocks of coniferous forestry. An overview of the upper catchment is shown in **Figures 2 and 3** below.

Figure 2. Upper catchment Dawn River south of N25. Location of facility marked in red.

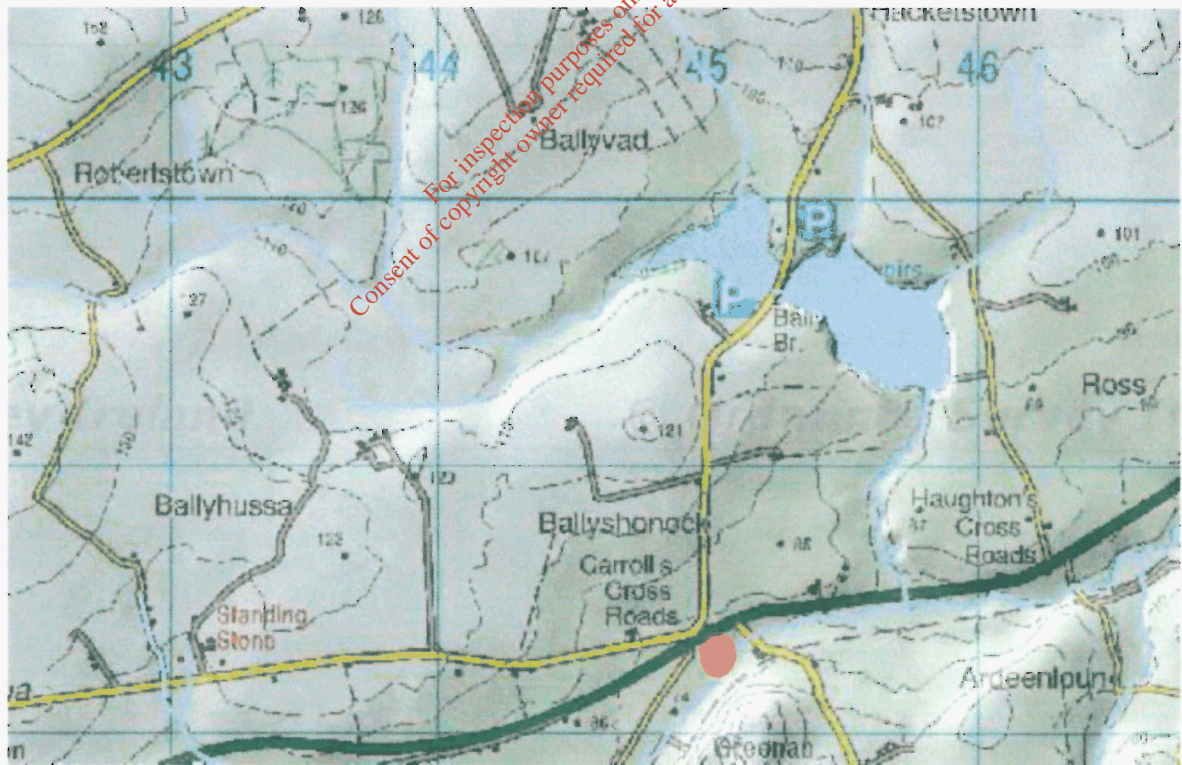
Figure 3. Upper catchment Dawn River north of N25. Location of facility marked in red.

Upstream of the Dawn facility there is a large Roadstone Quarry which has not been used for several years. The Dawn River crosses under a minor road and is then culverted into the quarry. It is possible that the pipe which passes under the minor road is blocked which may prevent connectivity with the upper catchment. The river emerges from the quarry directly onto the Dawn Meats site. A visual inspection of the Dawn River as it enters the Dawn Meats site shows that it has a reactively small flow and the levels of silt and algal are indicative of some nutrient enrichment.

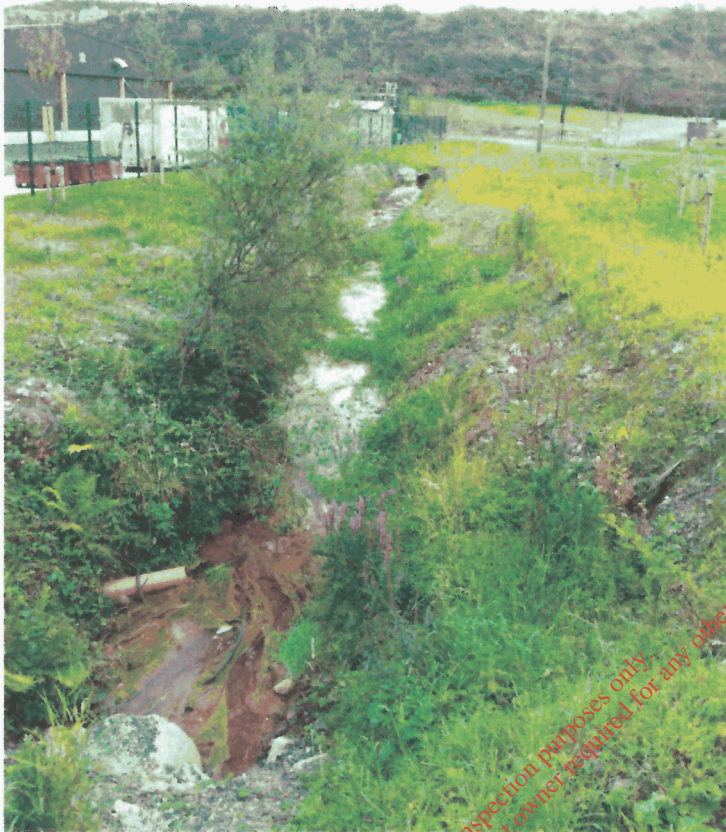
Within the Dawn Meats site there are two discharges to the river. The wetland system consists of 14 cells which discharge to the river. The system is designed to treat 80m³/day and provides a high quality effluent. Within the Dawn Meats site there is also an open channel which takes surface water run-off from the N25 road. A visual inspection of this channel indicates high levels of iron and the dense growth of algae and macrophytes which is indicative of nutrient enrichment (**Photo 3**).

Photo 3. Showing discharge from N25 with high iron and nutrient levels

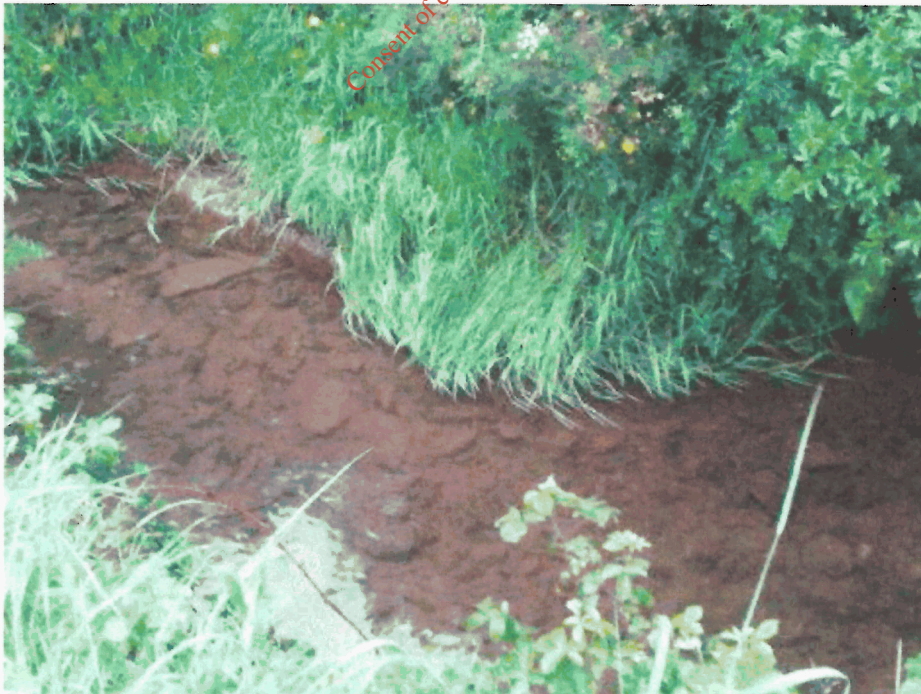
Downstream of the new section of channel and downstream of the Dawn Meats site, there is high levels of silt on the bed of the river (**Photo 4**). Silt levels begin to drop approximately 450m downstream of the site. This section of the river is relatively uniform with some smaller areas of faster flowing water. The silt impacts on small areas of gravel that could function as spawning/nursery habitat for trout and is probably suppressing macro-invertebrate populations.

Photo 4. Silt on riverbed downstream of the Dawn Meats Facility.

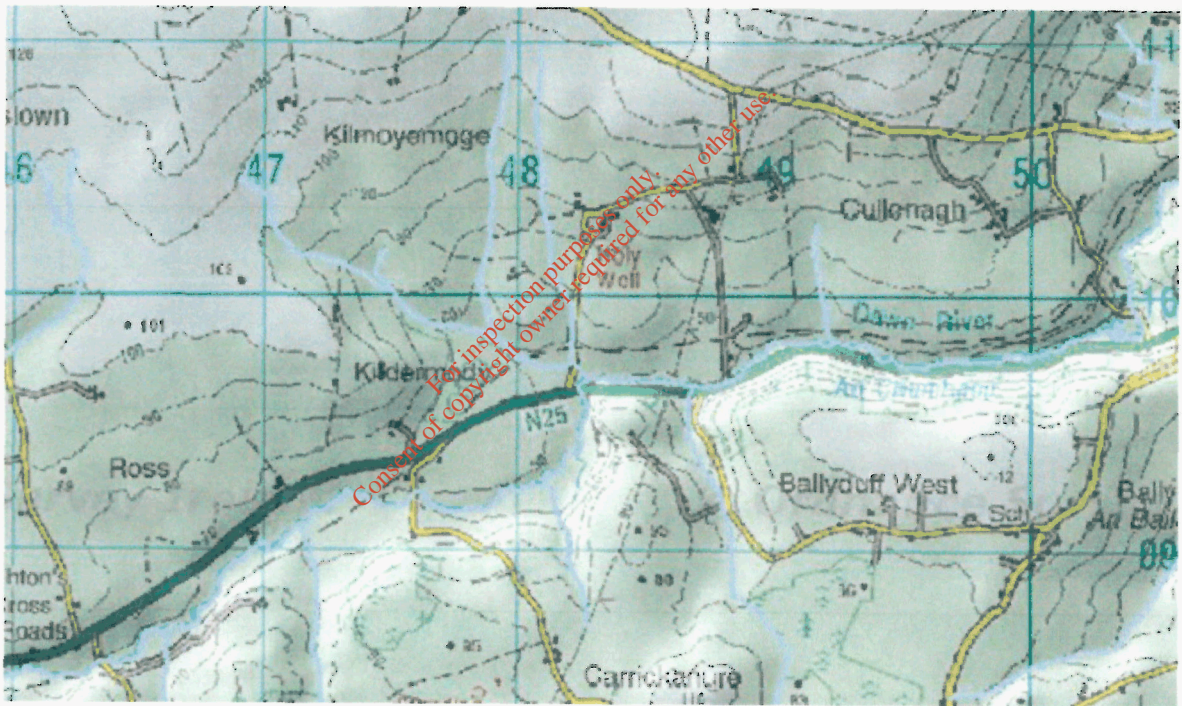
The middle section of the river is characterized by better quality farmland; however the average field size remains relatively small and pasture remains the dominant agricultural activity. There are large amounts of mature trees in the landscape and the banks of the river is wooded where for long sections where it runs through a steep valley adjoining the N25. There are some small areas of conifers. An overview of the middle catchment is shown in **Figure 4** below.

Figure 4. Middle catchment Dawn River.

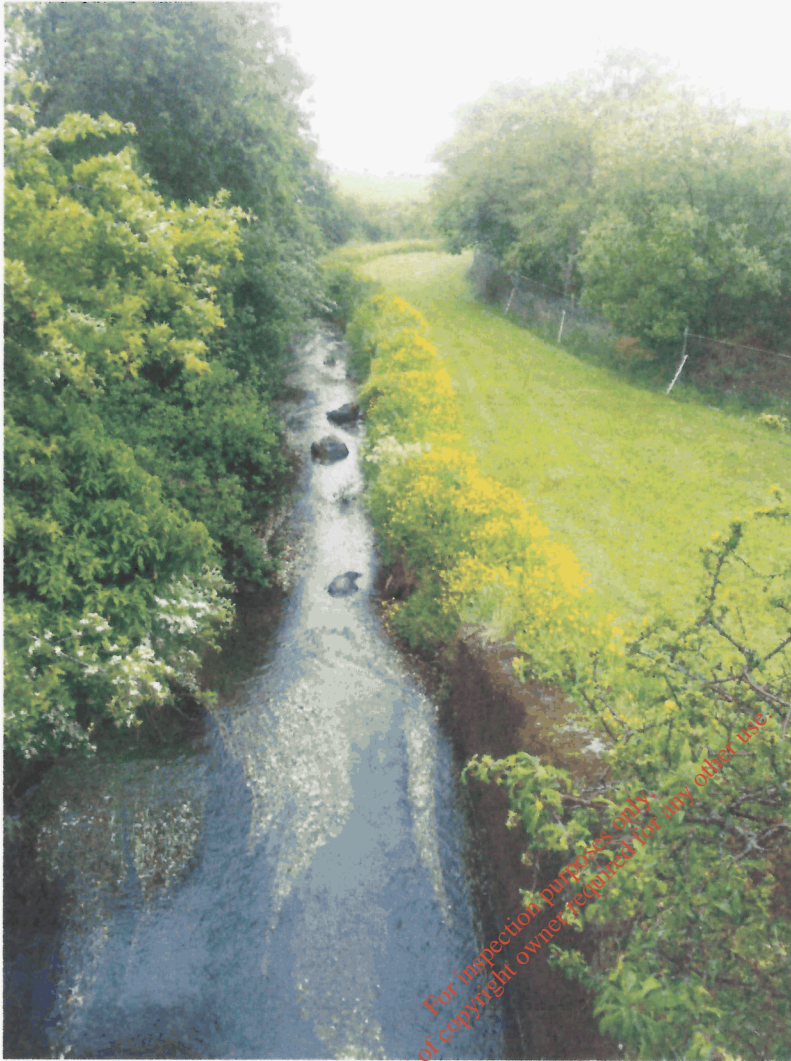
Photo 5 Moderate quality habitat with dense growth of water crowfoot.

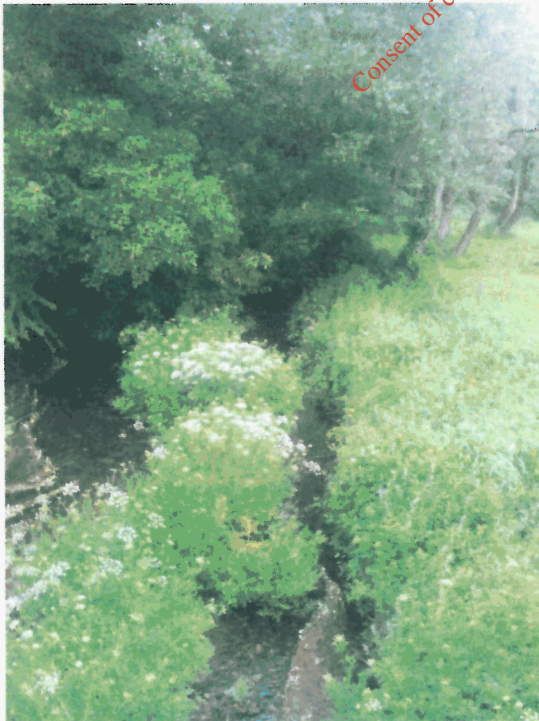
Photo 6. High quality habitat with clean gravels.

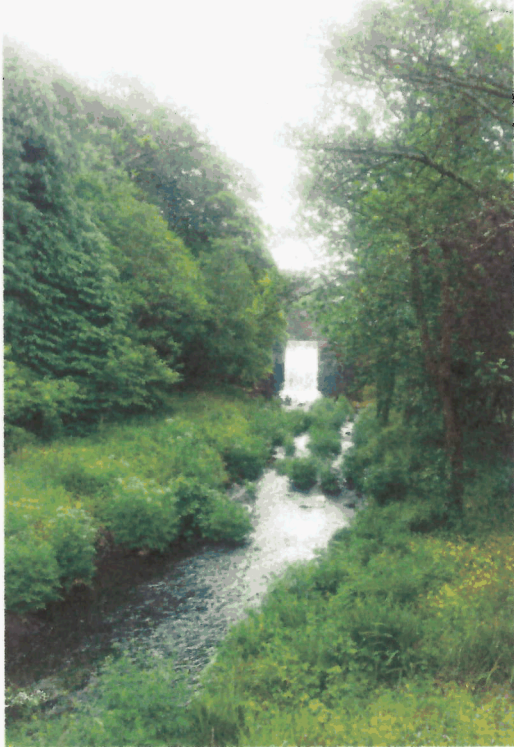
small hydroelectric scheme. The outflows from the lake would appear to create an insurmountable barrier for migratory fish such as salmon, sea trout and sea lamprey. Eels however should still be able to migrate upstream.

Photo 7. Waterfall outflow from the lake associated with Poulgrew House which appears to create an impassable barrier for migratory fish.

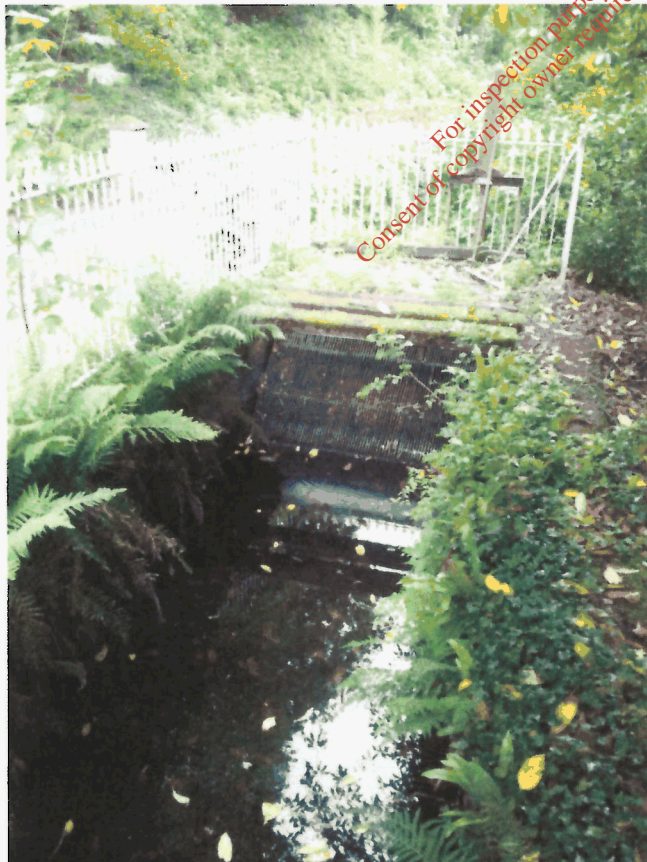
From Pouldrew Bridge downstream to the River Suir the channel appears tidal with high silt levels along either bank. Upstream of the bridge there is good quality salmonid habitat with riffle and pools (**Photo 6**). The dominant feature in the lower catchment however is the large lake associated with Pouldrew House into which the Dawn River flows. This is an artificial lake once associated with a historical mill which is reputed to hold pike and brown trout and the outflow from this lake falls vertically approximately 20 feet over a man-made, stone-wall dam (**Photo 7**). Alternatively, water exits the lake via a channel with a screen and sluice gate (**Photo 8**) and then is piped as part of a

Photo 8. Screen and sluice on the lake outflow channel.

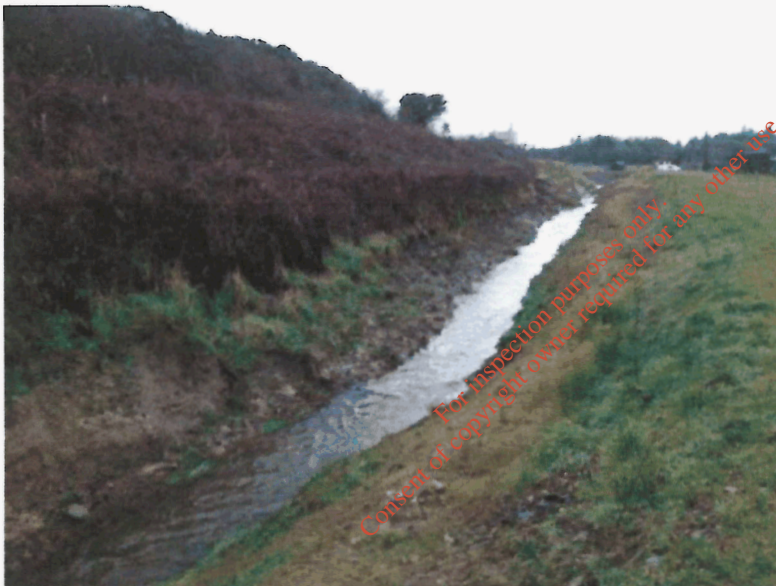
The Dawn River flows north east to the rear of the Dawn Meats facility at Carroll's Cross. Sections of the River have experienced some subsidence on the eastern bank slope of the Dawn River. Remediation works are proposed to stabilise the banks slopes and to minimize any further movement of the bank down into the river channel. The section of the river that has been identified as requiring some remediation works is between the bridge (244987,108153) and to the point at which the river exists the Dawn Meats site (245126,108329). These works will primarily include the placement of rock armour along the affected bank slopes, as well as vegetation establishment. These works are being proposed in a manner that will have minimum impact upon the Dawn River channel, water quality and habitat.

Dawn River proposed works along eastern bank (left)

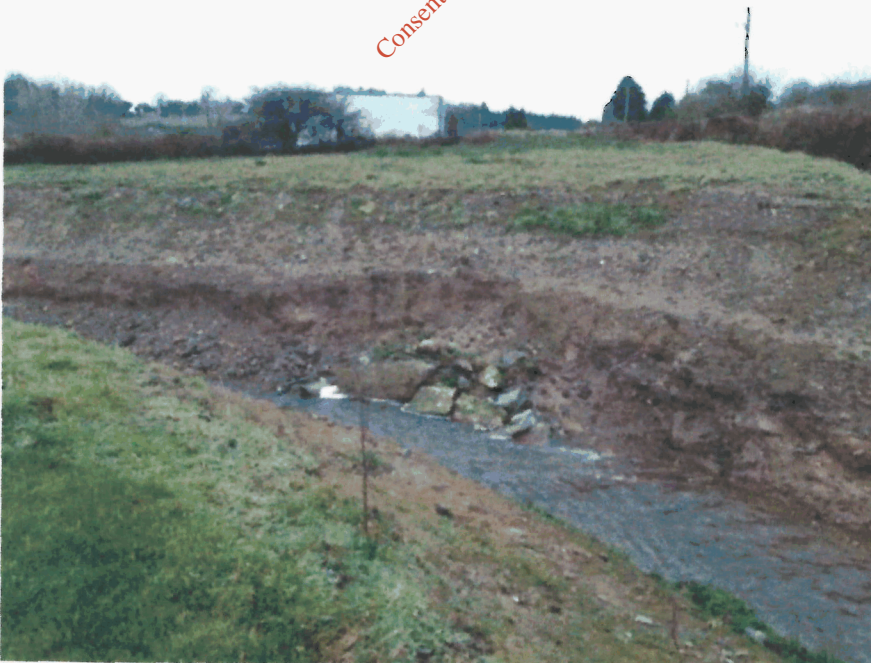
The areas of work will include the areas where the bank slope has collapsed, as seen in the image below. These sections are to be placed with large stone (500-1200mm) sourced from the Roadstone Quarry in Kilmacow. The type of stone used, where possible, will be similar to that found locally.

Figure 1. Collapse of bank slope

The large stone will be strategically positioned to ensure that they are not undercut or that they do not collapse down into the river channel. This will be achieved by submerging the lower boulders (up to one third of their depth) below the bed level and battering them into final position.
