# Northeast Aquatic Research

## 2019 Monitoring Report

Article 409 Nuisance Plant Monitoring of Lakes;  
Candlewood, Lillinonah, and Zoar

Prepared for FirstLight Power Resources  
November 29<sup>th</sup>, 2019

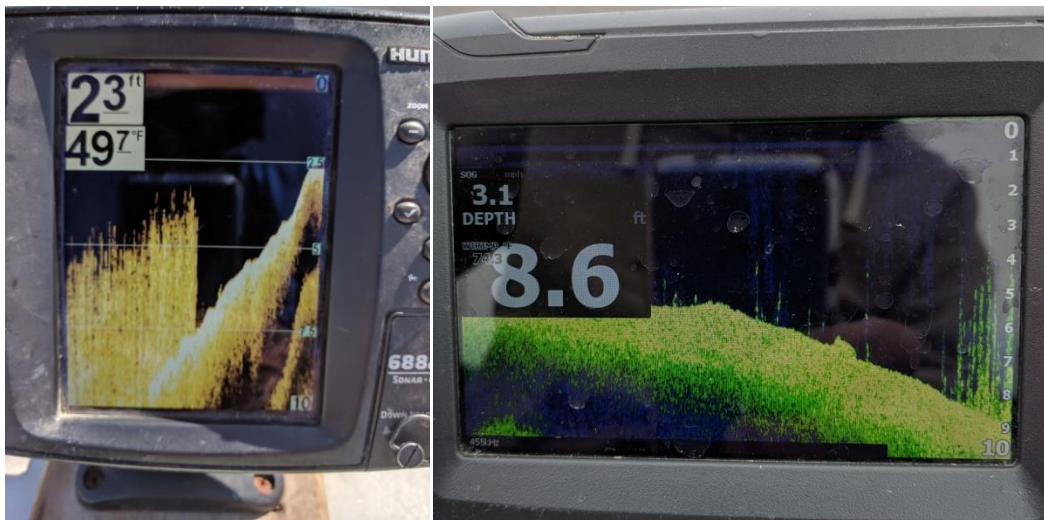
The second way to estimate percent cover of vegetation is to use down-imaging SONAR, which shows a detailed image of the plants as the boat passes above (**Photo 1**). SONAR imaging is used to corroborate visual percent cover estimates in areas where plants can be seen from the surface. In areas where plants cannot be seen from the surface, the SONAR image becomes the primary way to 'see' coverage. SONAR and visual estimates are then corroborated by weed-rake tosses. Rake tosses involve stopping the boat and throwing a 30ft line to tow through plant beds. Plants retrieved by the rake are estimated semi quantitatively as a percent cover:

The down-imaging SONAR device is also used to estimate plant height in the water column, as well as the water depth (**Photo 1**). In almost all cases in Candlewood Lake, Eurasian milfoil reached to only 1-2ft from the surface. Survey methods involve a number scale of 1 to 5 in estimating plant height in the water column.

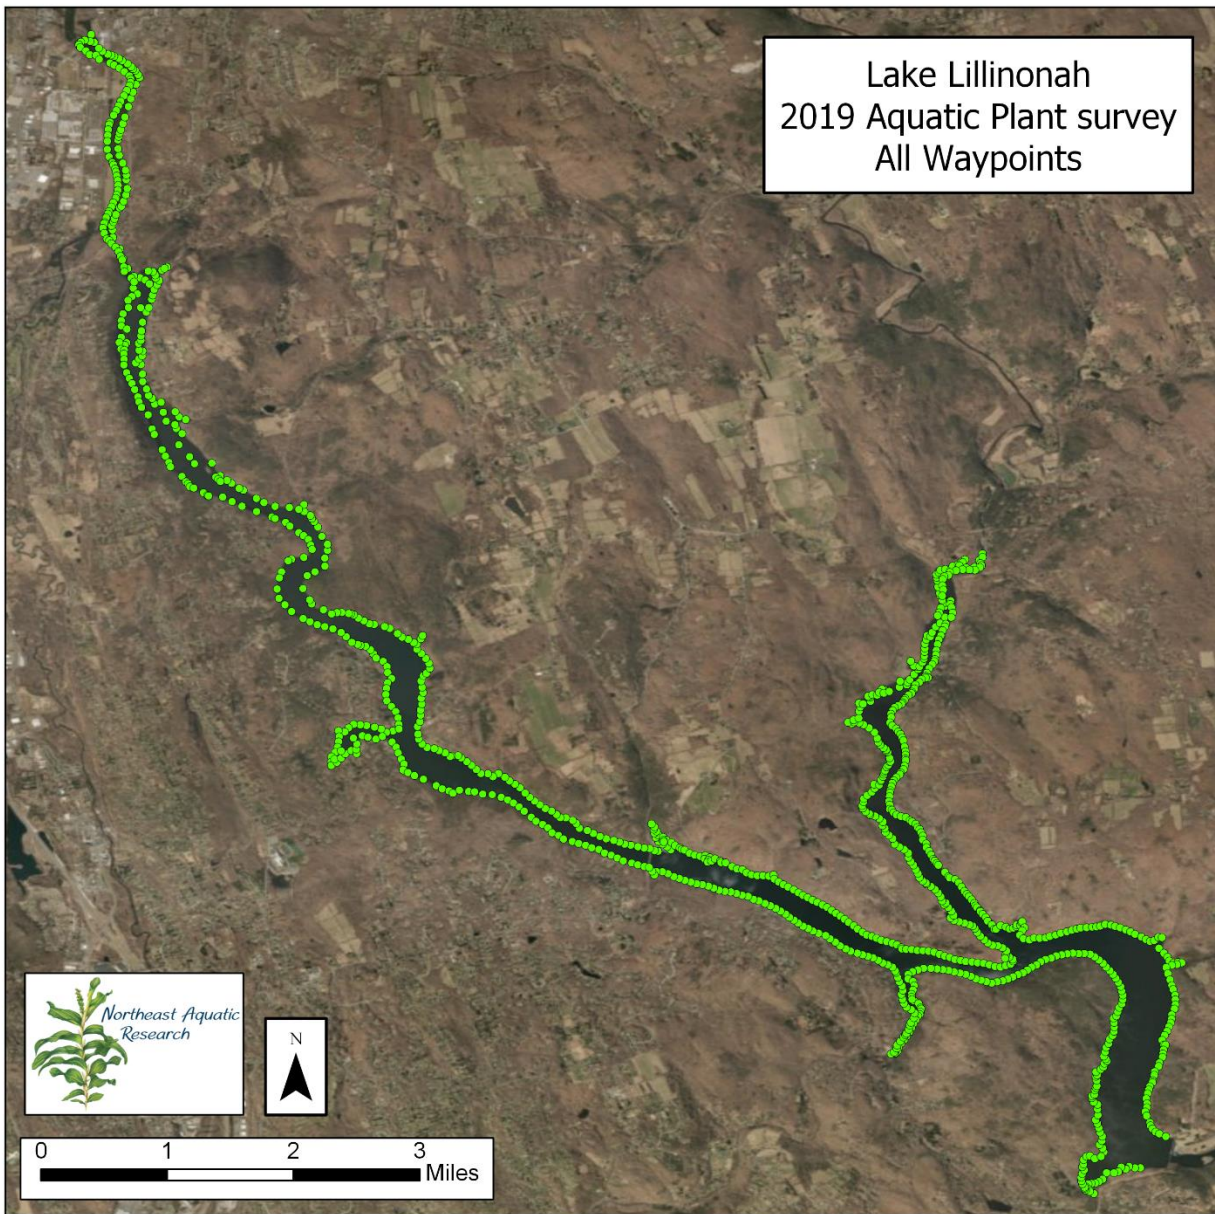
**Map 15** Waypoints (green dots) made in Lake Lillinonah during NEAR 2019 survey

Lake Lillinonah was surveyed over six days between July 30<sup>th</sup> and August 15<sup>th</sup>. In total, approximately 134 acres of milfoil was found in the lake. The invasive species Water chestnut, which is not present in Candlewood Lake or Squantz Pond, was found at 34 waypoints in Lake Lillinonah (**Maps 16-19**). Three other invasive species were found in Lillinonah: *Najas minor*, *Potamogeton crispus* and *Trapa natans*. Respective total acreages or number of sites are listed in the table below.
