←———— Kishacoquillas Valley —————→
Watershed Assessment and
←———— Restoration Plan —————→

Prepared by:
Mifflin County Conservation District
20 Windmill Hill #4
Burnham, PA 17009
June 2003

Kishacoquillas Valley Watershed Assessment and Restoration Plan

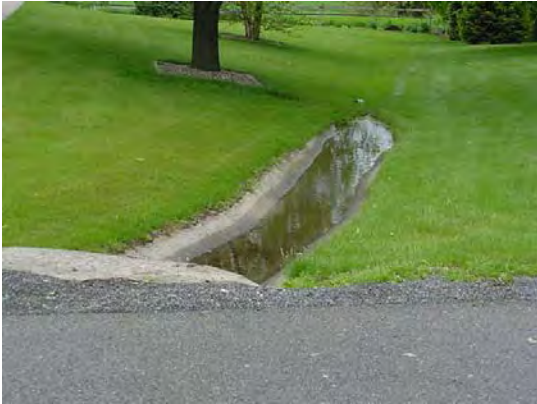
Figure 11 Comparisons of Hydrographs before and after urbanization.

macadam surfaces and hard packed dirt. During a rain event, rain should be infiltrating into the ground and percolating to the groundwater table. Streams rise slowly because the increase in water is coming from the increase in ground water, not discharge from the storm event itself. Figure 11, pg. 19 illustrates water runoff rates are higher post urbanization. When rain falls on a road, roof, or other impervious surface, it can not infiltrate and so it is no longer available to recharge that groundwater aquifer. Along roadways, stormwater is often directed to a storm drain which outlets into a stream. When stormwater flows over surfaces such as roads, it picks up pollutants such as highway salts, oils and other car related fluids. The artificially increased volume not only burdens the stream, but contaminates it as well.

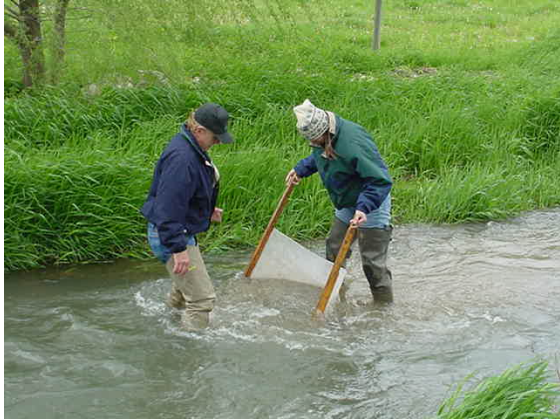
Benthic macroinvertebrates were collected from riffle habitats using a 1 meter x 1 meter kick seine held downstream with the lower edge in the bottom substrate of a riffle.

An individual upstream disturbed the stream bottom by vigorously shuffling their feet as they walked toward the seine. An area only as wide as the seine was disturbed. Bottom disturbance occurred for approximately one minute. Rocks in the sample area were rubbed by hand to collect additional organisms potentially not found in the bottom substrate. The seine was raised bottom first out of the water and spread in a flat portion of the bank to collect the organisms off the seine. This procedure (referred to as a “kick”) was done twice at each sample location in two separate riffles. The
