Little Mill of Clinterty

Bat Survey

Survey Dates: 22nd June & 11th July 2016

Ref: LMC-1607-BS

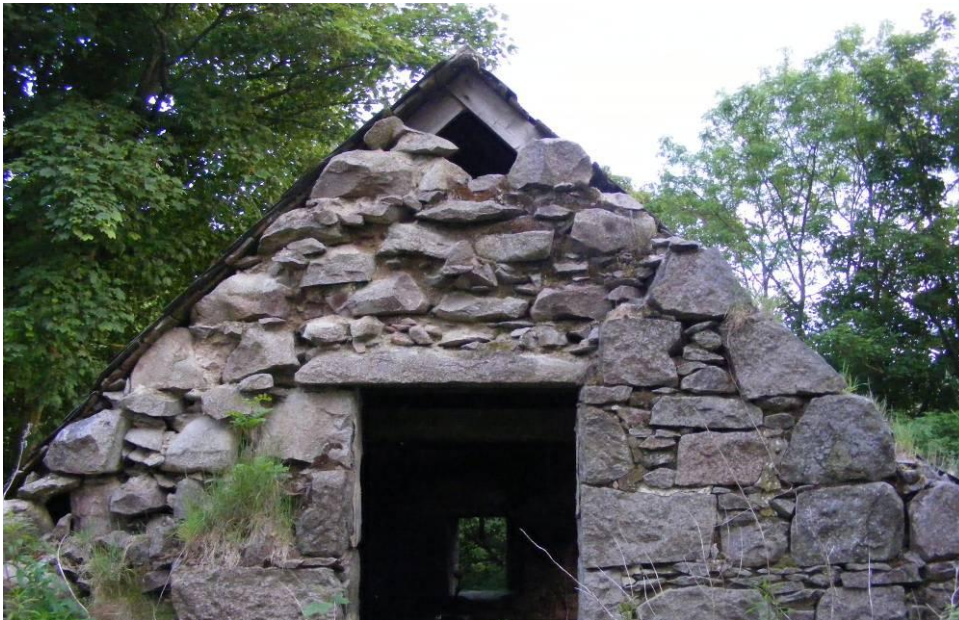
Photo 4: North elevation. Wall in poor condition, with large gap at the ridge. Large cracks are shallow and offer no bat roost potential. No evidence of bats.

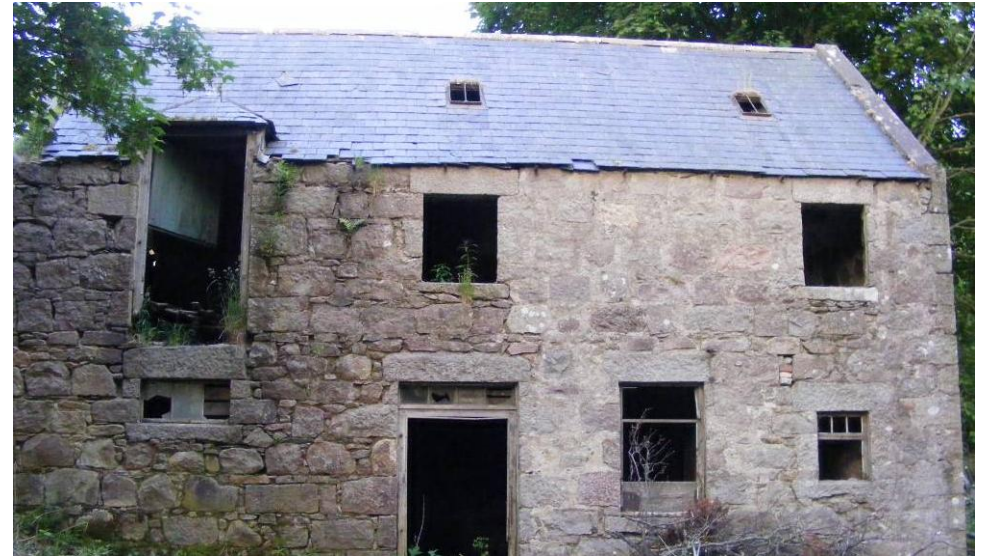
Photo 5: West elevation of mill. Plants are growing from cracks in places show wall is damp. Some loose and missing slates on roof provide limited bat roost potential. No evidence of bats found.

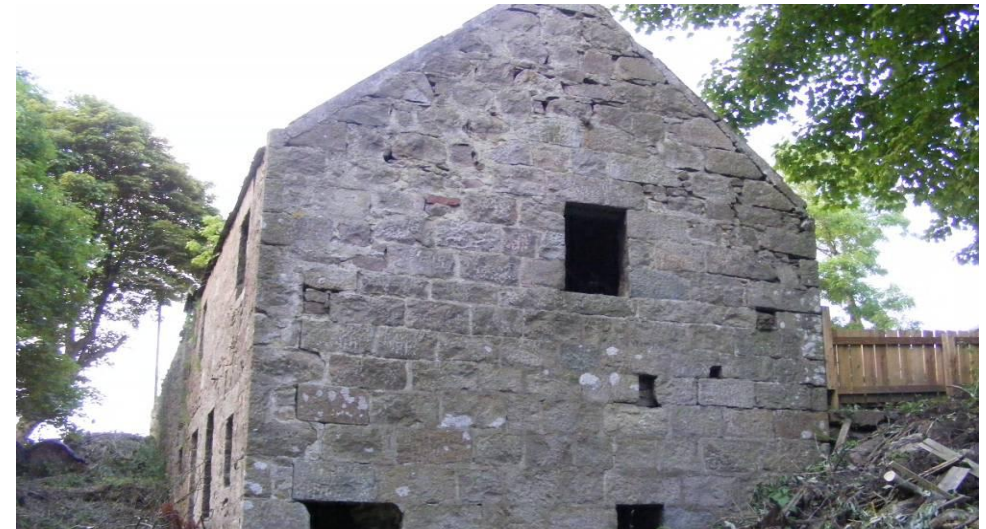
Photo 7: South elevation of mill. Some large holes in wall which had some cracks, however, no evidence of bats were found. Small, shallow cracks near top of mill could provide limited roosting potential. No evidence of bats was found.

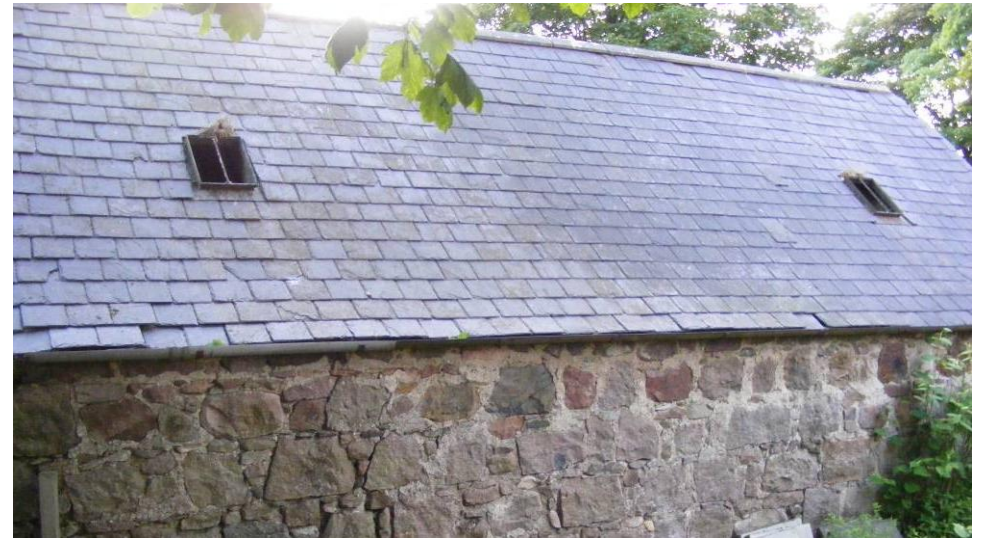
Photo 10: Eastern elevation of Mill building. Roof has several missing slates but is mainly in good condition. Windows are broken allowing water inside contributing to the damp. Ridge appears intact.

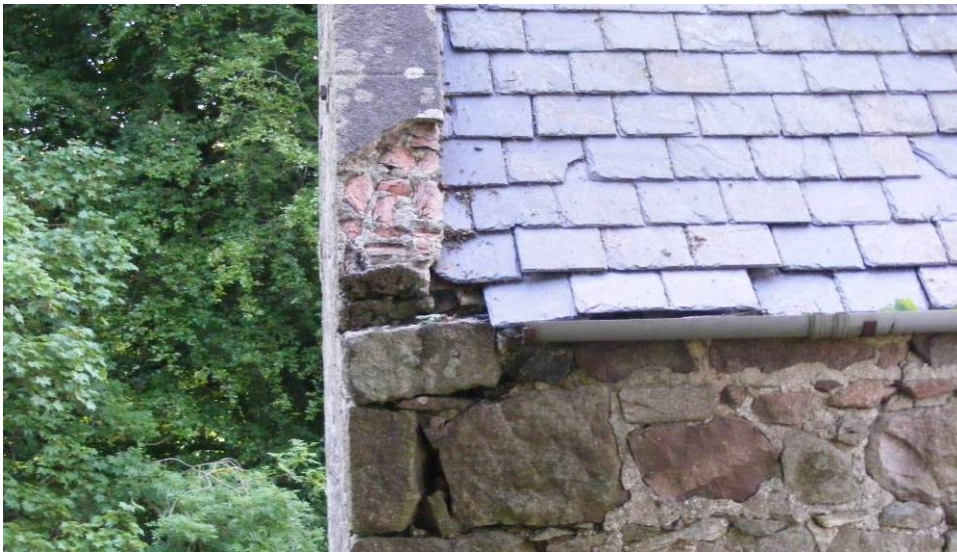
Photo 9: Southeast corner of building. Damage to wall and a missing slate has caused a large crack to form. This has no bat roosting potential and no evidence of bats was found.

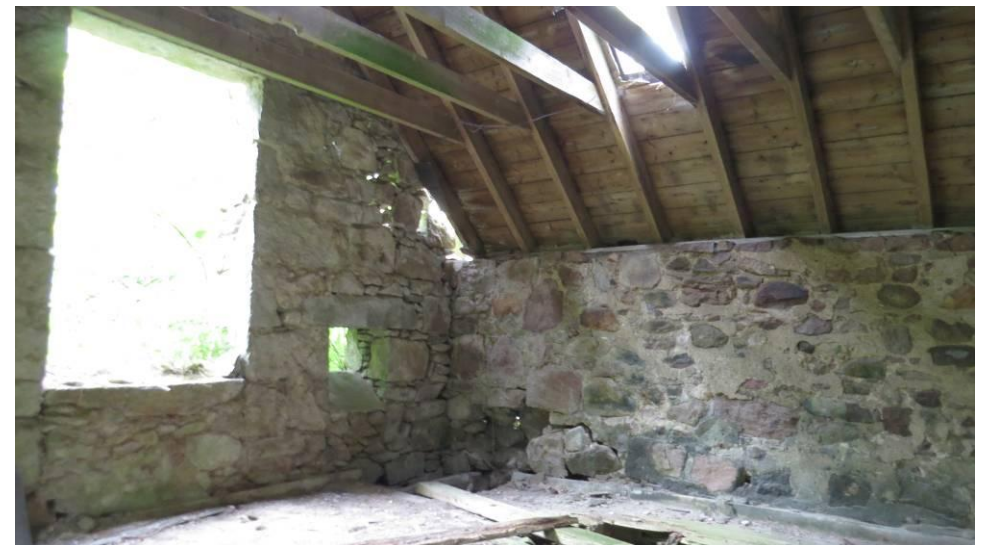
Photo 11: North gable. Large hole in northeast corner of the wall. Roof and floor rotten in places. The building is in poor condition and becoming dangerous.

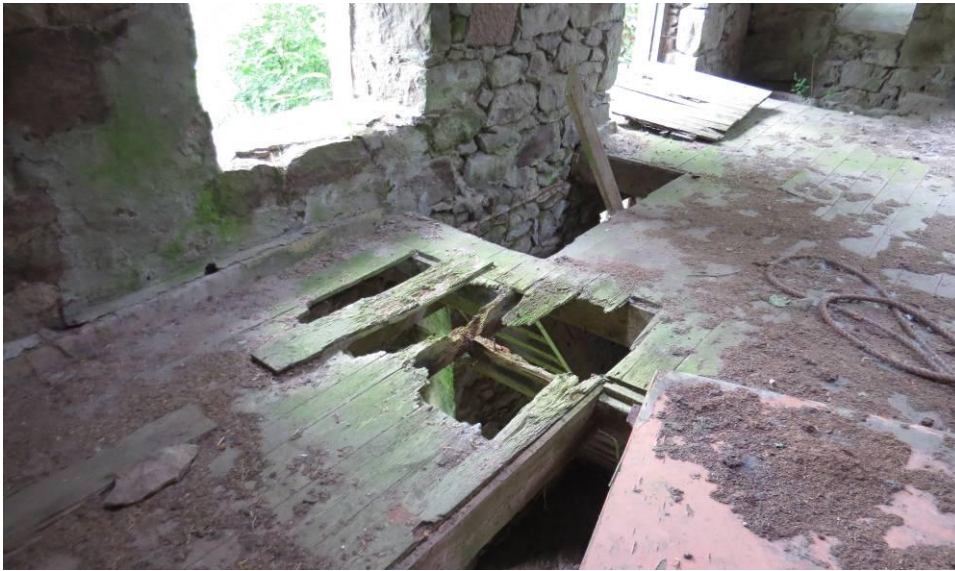
Photo 12: View of staircase from ground floor to lower ground floor. Area is dangerous with rotten floorboards and some joists are not attached to the wall.

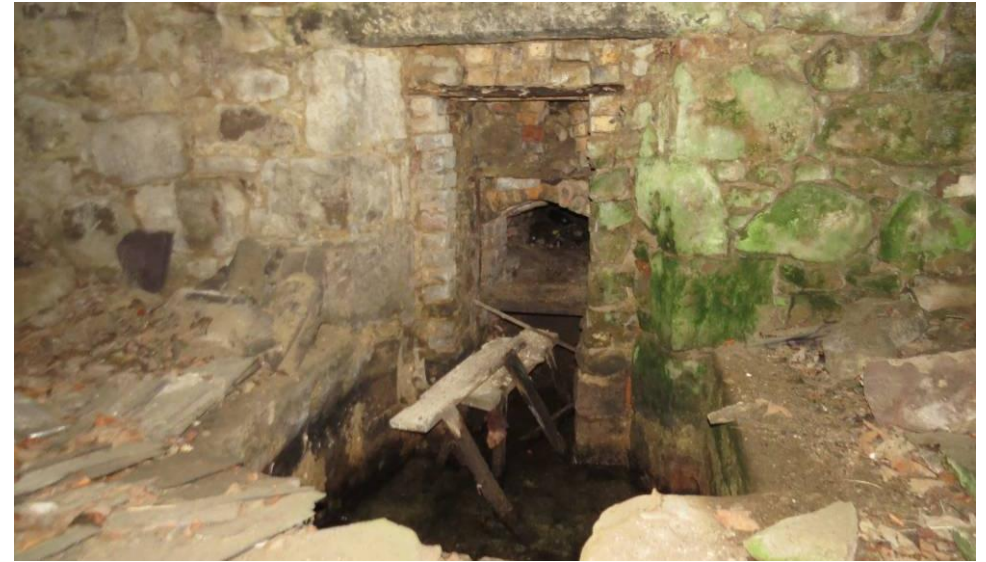
There was some standing water on the lower floor where the grain drying kiln has collapsed. The tunnel formed by the fire chamber for the old kiln had potential to be used by hibernating bats. This area was inspected and no faecal pellets or evidence of bats was found. (See photo 14).

Photo 14: Lower floor, north gable of main building. Grain drying kiln floor has fallen in. The walls are damp and have no cracks. The grain kiln has a collapsed chimney. Inspection showed no evidence of bats

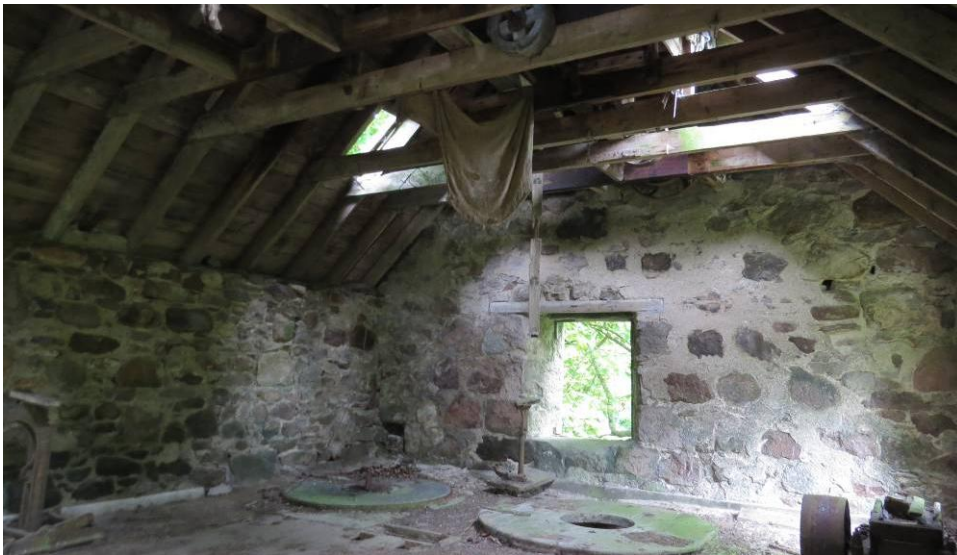
Photo 13: South gable. Roof rotten and collapsing in places. Algae on floor and walls are further evidence of damp with rainwater entering the building. There is no enclosed roof space and limited bat roost potential.

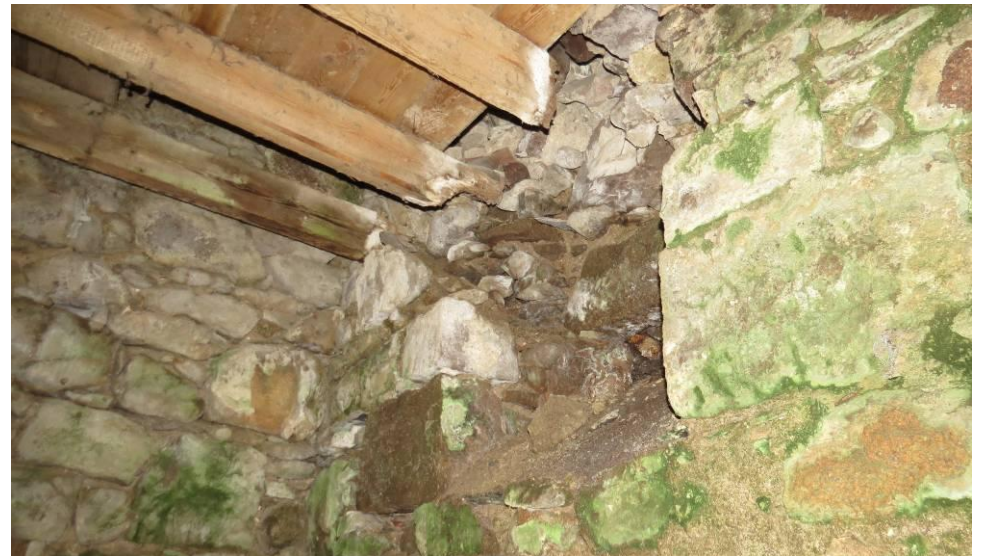
Photo 15: Lower floor ceiling beams rotten and dangerous. The wall is very damp with no bat roost potential.
