Adfreeze strength of Wooden Piles in Warm Permafrost Soil

Keywords: Adfreeze strength, permafrost, strain rate, temperature, wooden piles

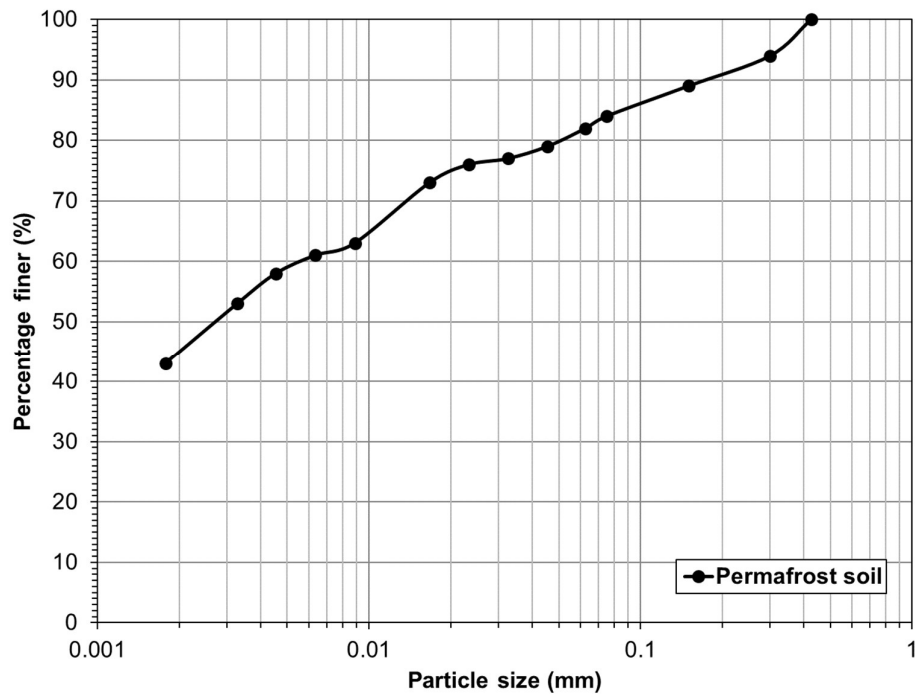
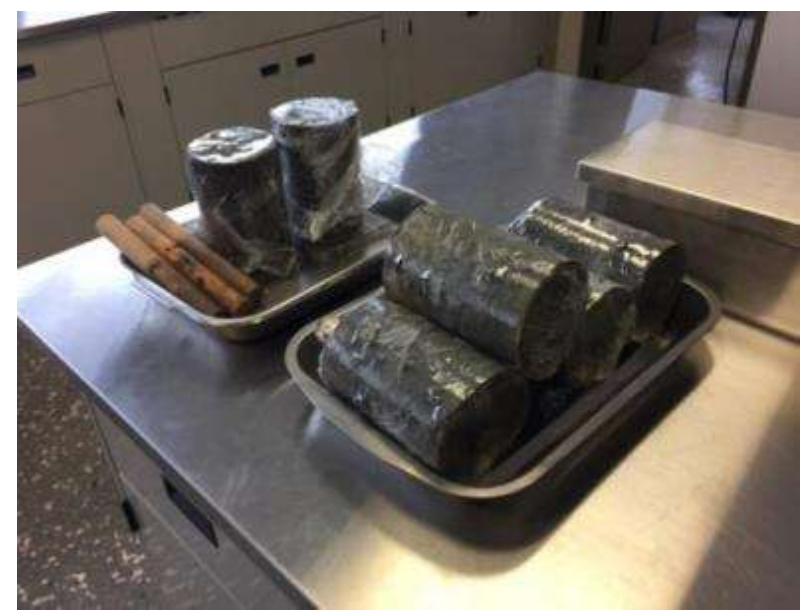
(a) (b)
Fig. 2. Soil details a) grain size distribution of soil and b) soil samples ready for freezing.

Representative samples of typical northern Canadian permafrost soil were prepared by combining various regional clays found across Quebec. The field moisture content of the soil varied between 25% and 30%. According to USCS classification, the soil used in the investigation was a low plastic silty clay with traces of fine sand (CL) which had a liquid limit of 44% and a plasticity index of 19. Fig. 2 depicts the grain size distribution of soil determined in accordance with ASTM D 422 (2003).

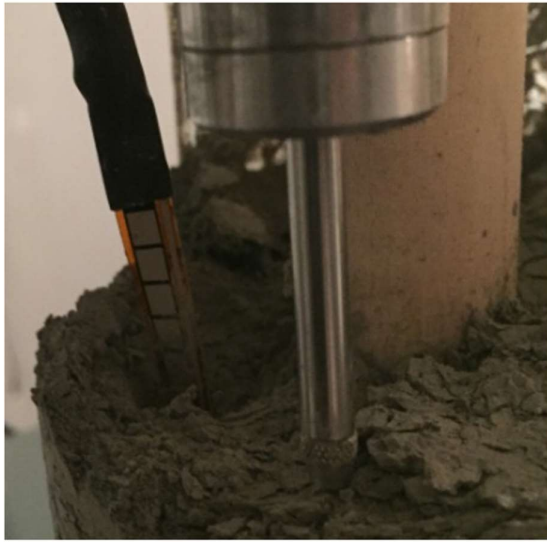
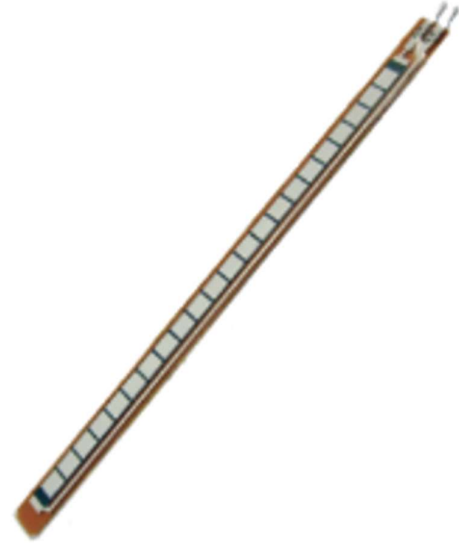
τ_a - Adfreeze strength
 P - Axial load

K - Type of sensor
 Ω - Deflection sensor

Fig. 4. a) Photos of the bending sensor (right) and its placement in the soil (left). b) Position of sensors (left) and the zones of influence using bending gauges (right).

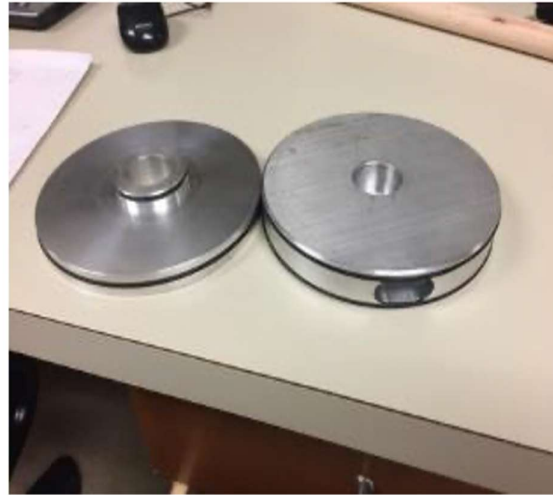
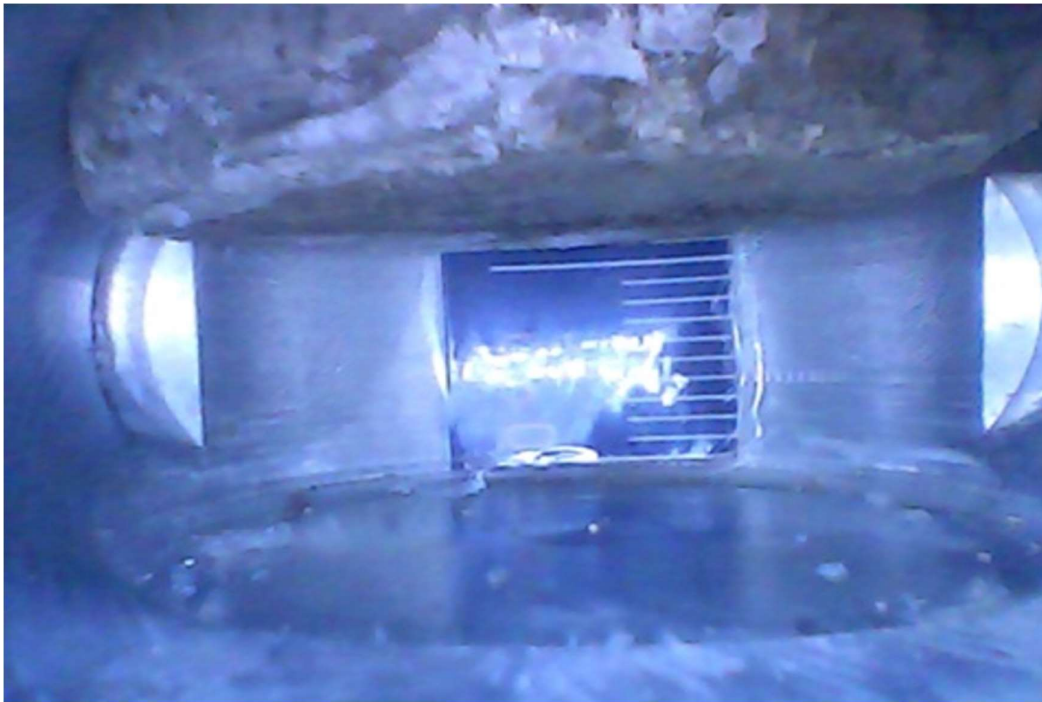
Fig. 5. a) Modified plate for carrying out the test. b) Image of the pile head camera window.

Simple axial compression tests were carried out in the laboratory of the atmospheric icing center at the Université du Québec à Chicoutimi. This laboratory allows air temperatures to vary between $-6\text{ }^{\circ}\text{C}$ and $0\text{ }^{\circ}\text{C}$. For the testing, an *MTS 810* machine fitted with a 25 KN loading cell (Model 661.20E-01) was used. A plate placed on top of the pile was designed to ignore resistance at the pile head and measure only axial shear within the sample. The plate design prevented the pile head from producing any resistance during the test (Fig. 5a). The plate also contained a lateral opening for inserting a 7 mm micro-endoscopic camera (Fig. 5b) to visually record the alignment and displacement of the pile. This visual record ensured that any observed friction was not produced by the friction of the pile with the seat plate, and it allowed for verifying that pile travel was sufficient.

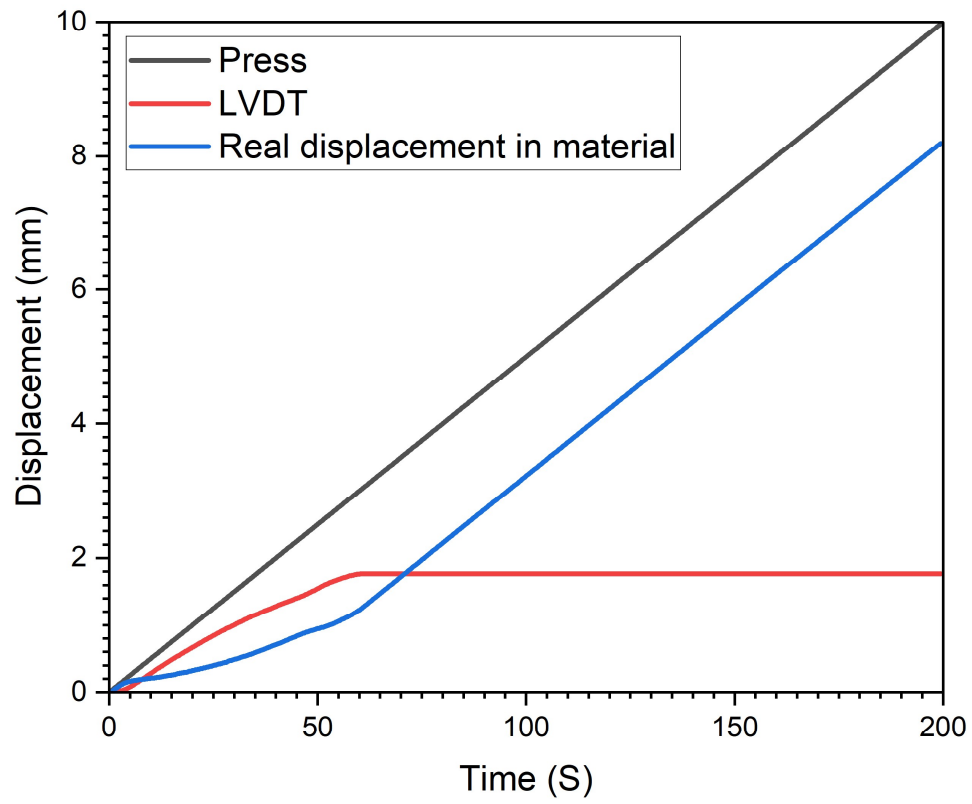
Fig. 6. Displacement between the pile and the clay over time.

The axial compression tests were performed for several loads at $1\text{ }^{\circ}\text{C}$ intervals between -1 and $-5\text{ }^{\circ}\text{C}$ (note that the tests carried out at $-6\text{ }^{\circ}\text{C}$ caused the breakage of the piles). A deviation of around $\pm 0.3\text{ }^{\circ}\text{C}$ was observed during testing in the cold room chamber for a specified test temperature. For each temperature, tests were performed at three deformation rates: 0.01, 0.1, and 0.5 mm/s, and all tests were repeated three times. The axial stresses and strains were measured during the tests. A linear variable differential transformer (LVDT) sensor was installed to determine the displacement of the monolithic soil. The axial displacement of the acquisition head and the LVDT sensor ($\pm 0.05\text{ mm}$) differed by 0.002 mm. This displacement is attributed to the seating of the material and not to the displacement of the pile in the clay. Therefore, this displacement is disregarded in the interpretation of the results. Displacement was determined as

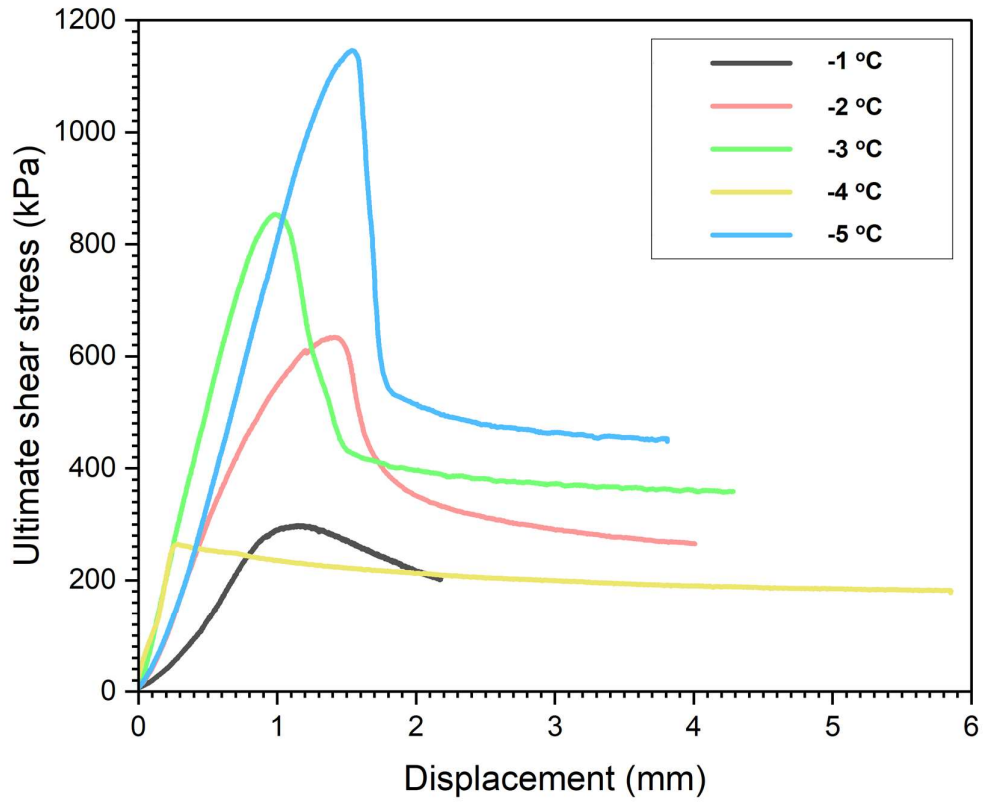
Fig. 7. Shear stress-displacement curves at various temperatures under strain rate of 0.01 mm/s

The results of the axial compression tests at varying temperatures and strain rate of 0.01 mm/s are shown in Fig. 7. The ultimate shear stress (which is obtained by dividing the axial load by the surface area of pile in contact with permafrost) is assigned to the vertical axis and the axial displacement is plotted on the horizontal axis. The ultimate shear stress-displacement curves for all the tests on piles at other deformation rates with various temperatures ranging between 0 to -5 °C are depicted in Figs. 8-9. From Fig. 7, it was found that, at a strain rate of 0.01 mm/s and -1 °C, the adfreeze strength was about 297 kPa. The adfreeze strength increased to about 634 kPa and 854 kPa at -2 °C and -3 °C respectively, whereas it decreased to about 258 kPa at -4 °C. At -5 °C, the adfreeze strength again increased to about 1146 kPa. It was observed that the adfreeze strength at -5 °C was almost 4 times at -1 °C. Even at strain rates 0.05 and 0.1 mm/s (Figs. 8-9), adfreeze strength increased as temperatures cooled from -1 to -3 °C. At -4 °C, the adfreeze strength was lower than that for -1 to -3 °C but then increased to reach a maximum value at -5 °C. At -4 °C test temperature, the soil-pile model failed in a plastic manner with a comparatively smaller difference between peak and residual shear stress. At all remaining test temperatures, the soil-pile model exhibited brittle failure with a pronounced difference between peak and residual shear stress. The decrease of adfreeze strength of wooden piles between -3 °C and -5 °C for all three deformation rates seemed anomalous. Tests were conducted between -3 °C and -4 °C temperatures to establish the decrease in adfreeze strength

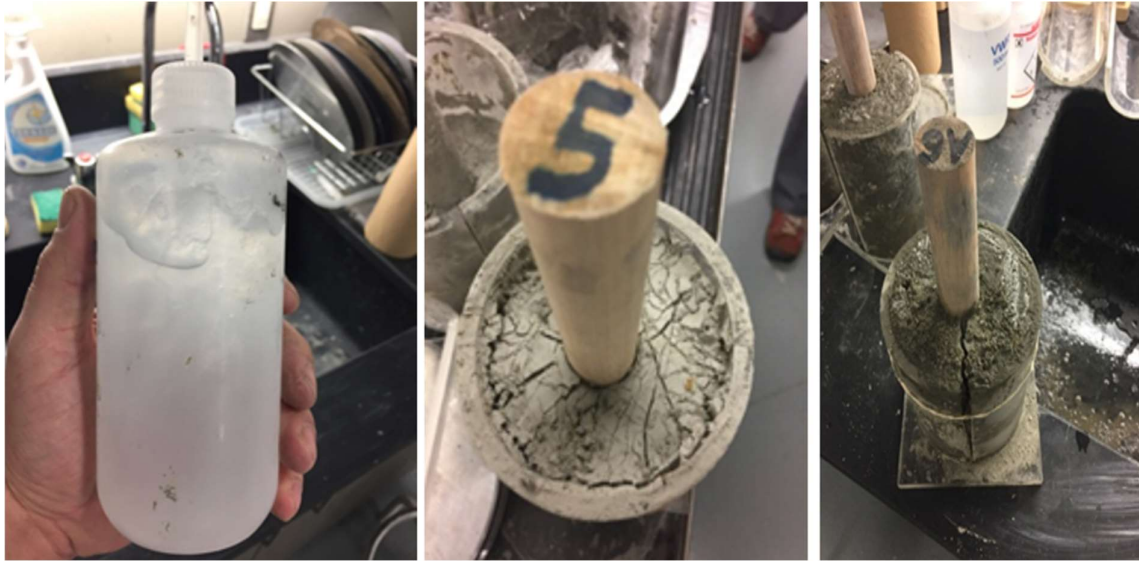
(a) (b)
Fig. 12. a) Water at $-1\text{ }^{\circ}\text{C}$ with the presence of liquid. b) Apparent significant cracking for tests at $-5\text{ }^{\circ}\text{C}$ (center) and $-4\text{ }^{\circ}\text{C}$ (right).

Furthermore, in most cases, the failure was observed in the wooden piles rather than frozen soil (Fig 12b). Following cracking, the stress is taken up entirely by adfreezing, testifying that the admissible lateral shear strength of a pile is equal to that of the adfreeze strength. At $-6\text{ }^{\circ}\text{C}$, the destruction of the wooden piles was observed with stresses exceeding 2200 kPa. Ice strength exceeding 2000 kPa at temperatures less than $-5\text{ }^{\circ}\text{C}$ was also reported by Farid et al. (2016); this stress provoked the failure of wooden piles rather than the frozen soil. Ladanyi and Theriault (1990) also highlighted the poor structural capacity of wooden piles though these piles exhibit good insulation properties and relatively high bond strength. The adfreeze strength computed in the present study was considerably higher than that reported by Aldaeef and Rayhani (2018) and lower than that found by Tang et al. (2019) for the same temperature range. These discrepancies may be attributed to differences in testing conditions.
