DUNMORE HERITAGE AUDIT

COUNTY GALWAY

2020/2021

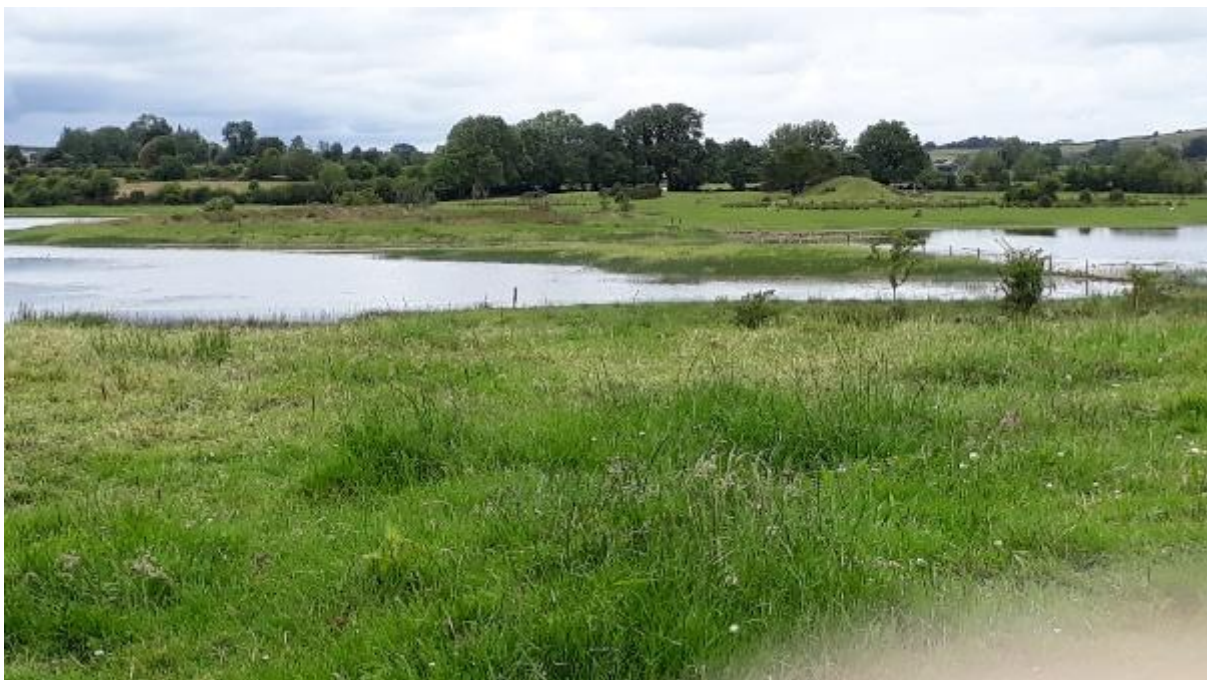
Curragh Lough is similar in many ways and is in hydraulic continuity with Polleagh. As the water level lowers during drier periods small hummocks of glacial material are revealed. A very good viewing point is from the Dunmore-Ballymoe Road where a small hill of glacial till is visible to the north--west.

Photograph 1: View across Curragh Lough from Dunmore-Ballymoe Road north-westwards towards Beagh

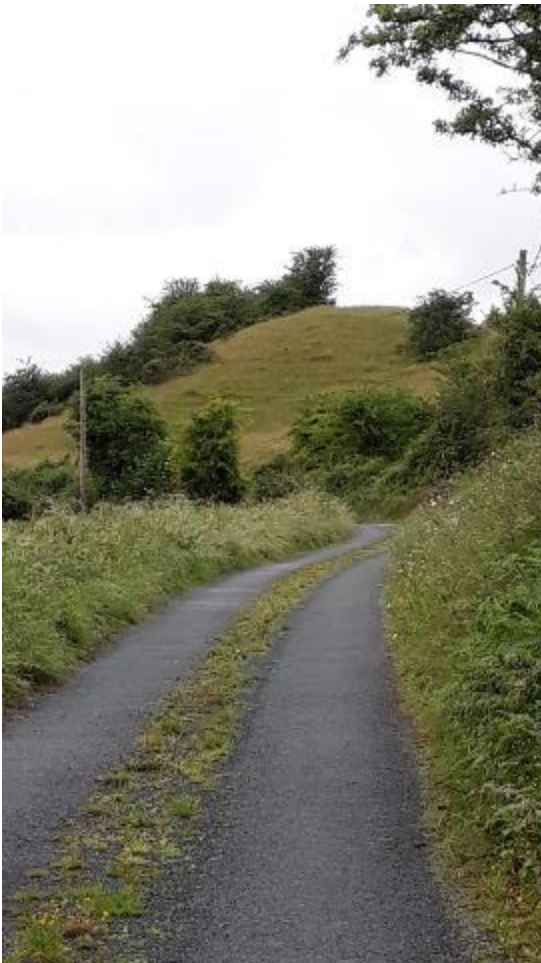
A section runs from the south-west to the north-east of the study area, through the townlands of Flaskagh More, Flaskagh Beg, Drumbane, Shrule, Quarter, Ballagh East, Ballagh West, Ballymoney South, Menus Park, Pollaphuca, Menus, Knockaunnagat, Roy, Kilnaslieve, Gardenfield, Graigueachullaire, Grange and Lenamore.

Photograph 2: View of esker ridge from road in Flaskagh More townland

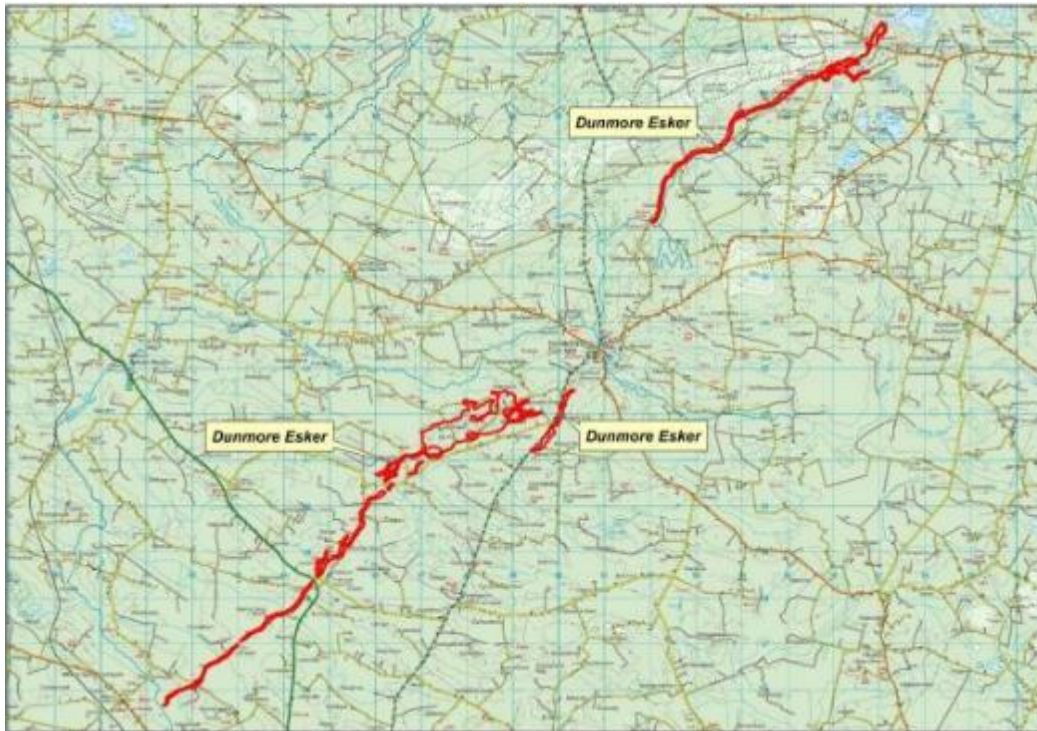
During the last Ice Age, three major melt water systems drained the melting ice sheet in the western portion of the Irish Midlands. The Dunmore-Ballyhaunis esker system is the westernmost of those subglacial systems. It extends through Galway, Mayo and Roscommon and is recognised as one of the finest examples of a long, wide tunnel-deposited esker in Ireland.

Map 10: Indicative line of the Dunmore Esker

The Dunmore Esker is one of Ireland's best examples of a tunnel-deposited esker and is an impressive, high, striking example of a dry sand and gravel ridge. It has been designated as a County Geological Site and may be recommended for designation as a Geological Natural Heritage Area (NHA).

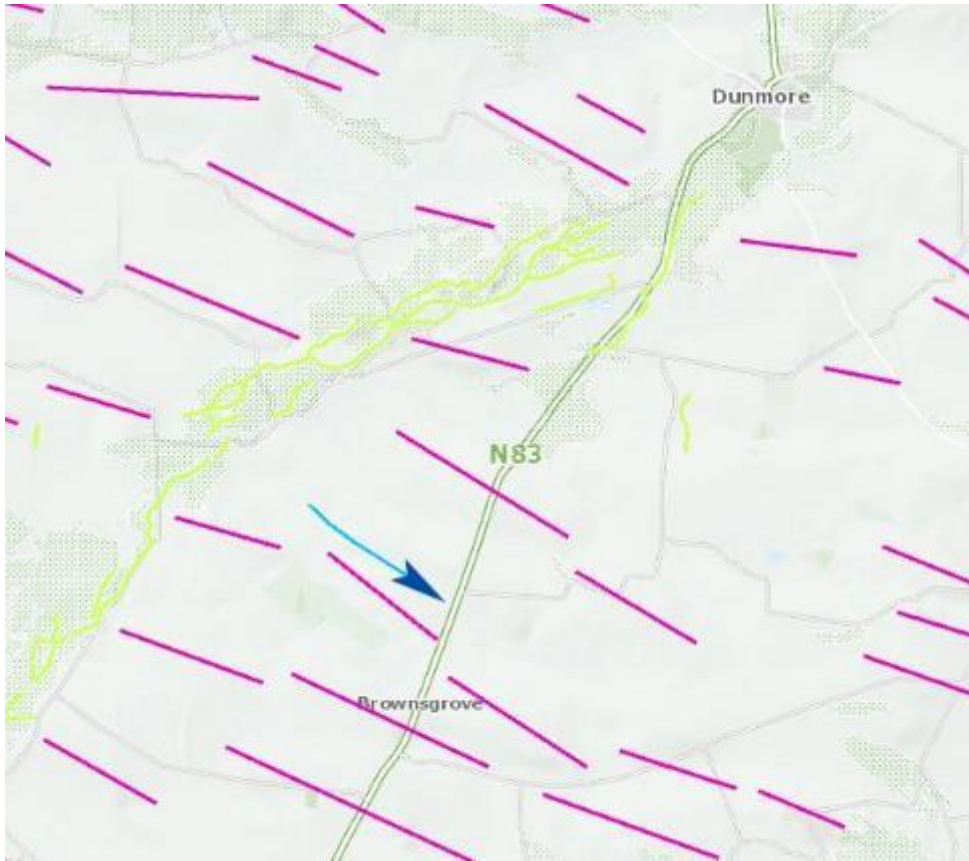
Map 12: Esker ridge to the Southwest of Dunmore town (denoted by yellow lines) 'Data from the GSI.ie Geology database accessed through the Heritage Maps Viewer at www.heritagemaps.ie, [5-5-2020]'.

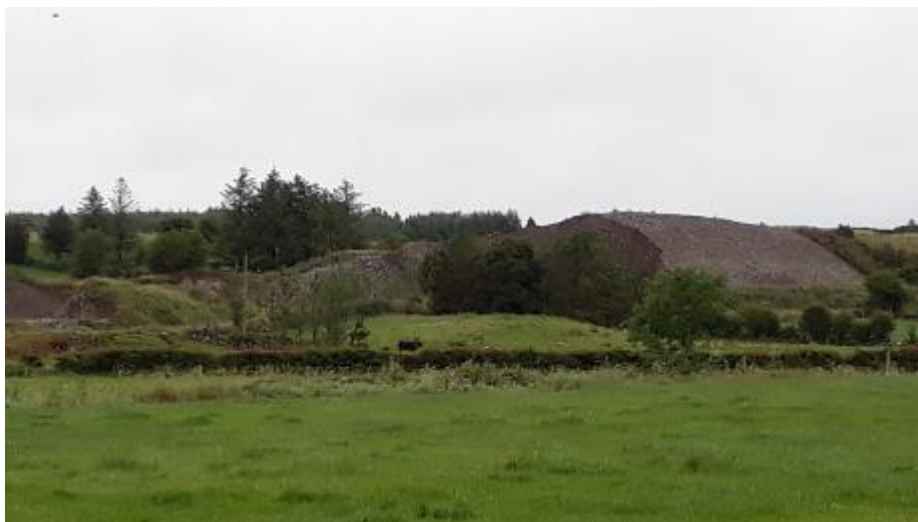
Gravel pits have been cut into a number of the drumlins and the esker ridges in the study area for the extraction of sand and gravel over the centuries. There are active cuttings in Flaskagh More and Flaskagh Beg, with the most exploited area to the south-west of Dunmore in the townlands around Menus. There are a number of quarries currently operating in this area, the largest of which are operated by CmC Quarries Ltd. and Finnigans Sand Ltd. Other active quarries are found south of Dunblaney in the south east of the study area.

Photograph 3: Quarry in Esker in Flaskagh More

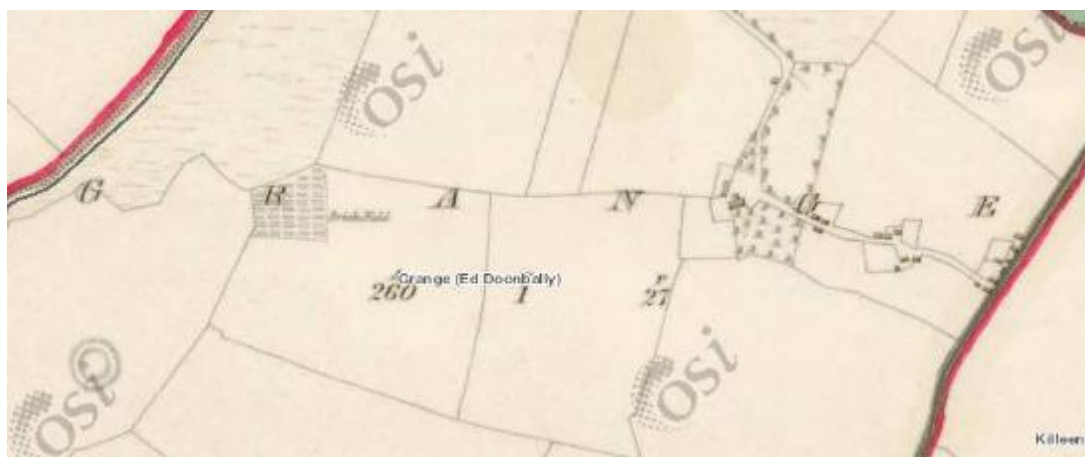
The Geological Survey of Ireland mapping system indicates the presence of clay brick in the townland of Grange in the south-west of the study area. The Ordnance Survey first edition 6-inch map c.1840 shows that this resource was being exploited, with a brickfield illustrated in Grange. Griffiths Valuation c.1855 shows the land was being leased from Sir George Shee Bart. by George Reilly at this time.

Map 15: First Edition Ordnance Survey 6-inch map (c.1840) with Brick Field indicated. 'Data from the base maps gallery accessed through the Heritage Maps Viewer at www.heritagemaps.ie, [7-5-2020]'.

The general process for small, local brick fields in the mid-19th century was that the clay would be dug out during the drier months of the year (generally April to September) and left for a few days to dry (or 'sour'). Stones were picked out by hand and the clay was then worked to the right consistency by watering and trampling underfoot. This was known as 'tempering'. The clay was then spread into wooden moulds which were shod with iron and brought to a drying ground, where it was emptied out of the moulds and left to harden. After this stage of drying, the bricks were arranged in small stacks and traditionally fired in a clamp kiln. The fuel for the kiln was most likely turf in this area, taken from the local bog at Grange.

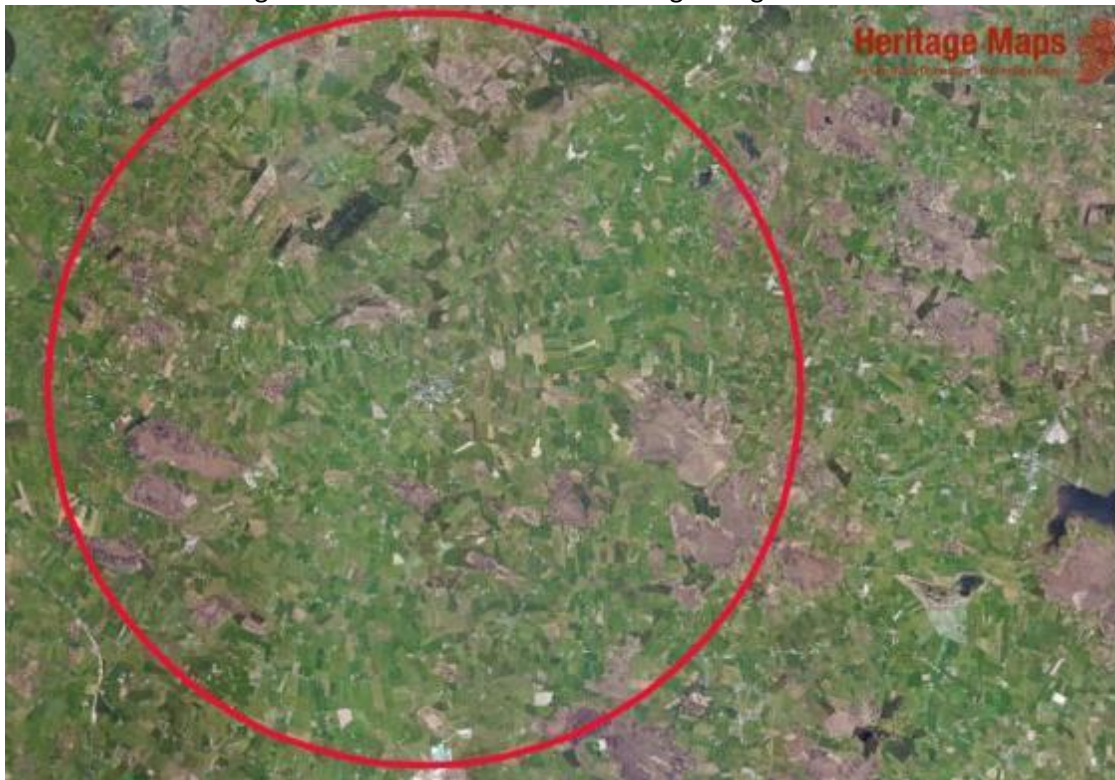
Map 17: Areas of grassland (green) and bog land (brown) in study area (red circle). 'Data from the base maps gallery accessed through the Heritage Maps Viewer at www.heritagemaps.ie, [18-6-2020]'.

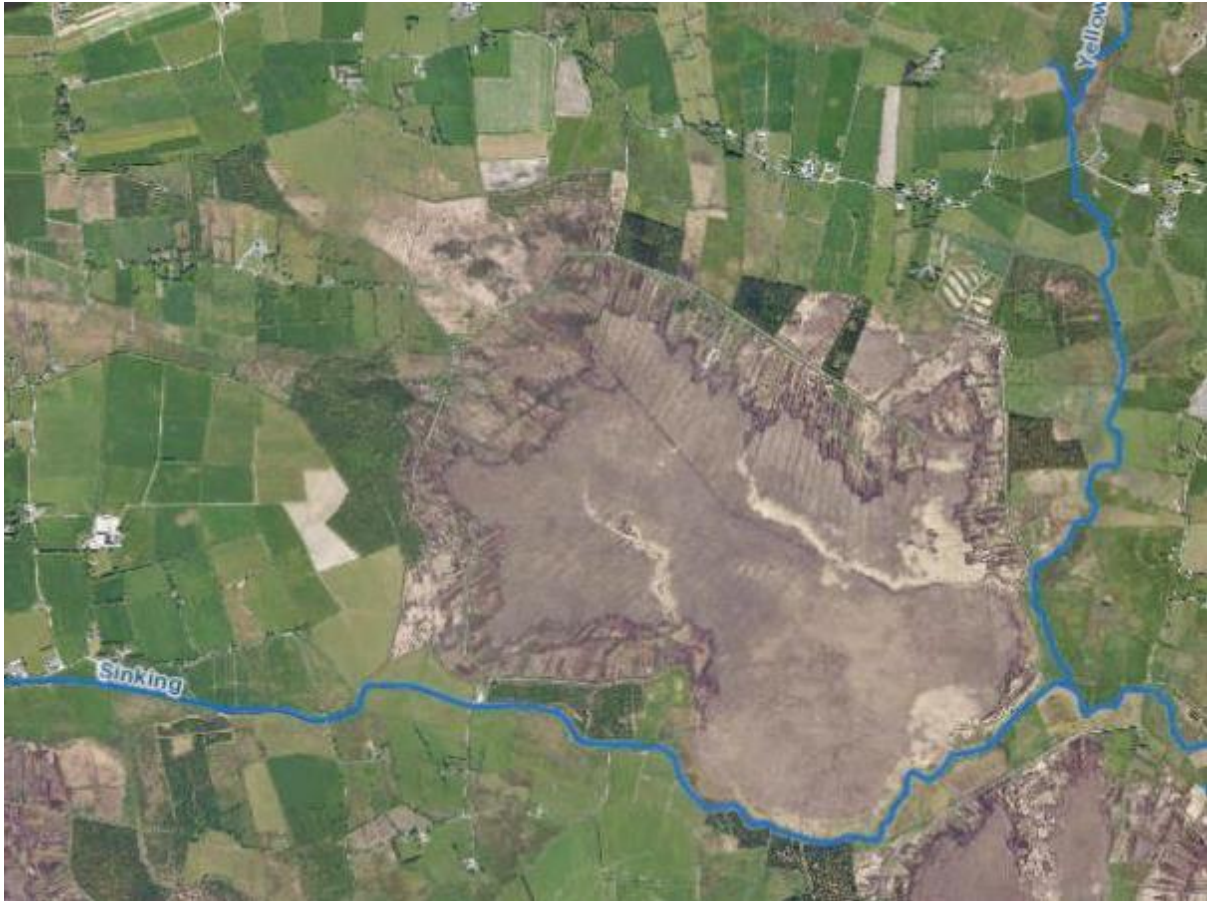
It consists of one dome of sloping bog, associated with subsidence caused by drainage, and an intact dome to the south-east. Cutover bog occurs all around the margins of the high bog except where the bog slopes down to the river where the edge is semi-natural. The south and east margins of the site are bounded by the Sinking (Yellow) River, the northern and western sections by roads.

Map 18: Aerial view of Slieve Bog showing cutover areas around the margins of the high bog with Sinking River to south and east. 'Data from the base maps gallery accessed through the Heritage Maps Viewer at www.heritagemaps.ie, [18-6-2020]'.

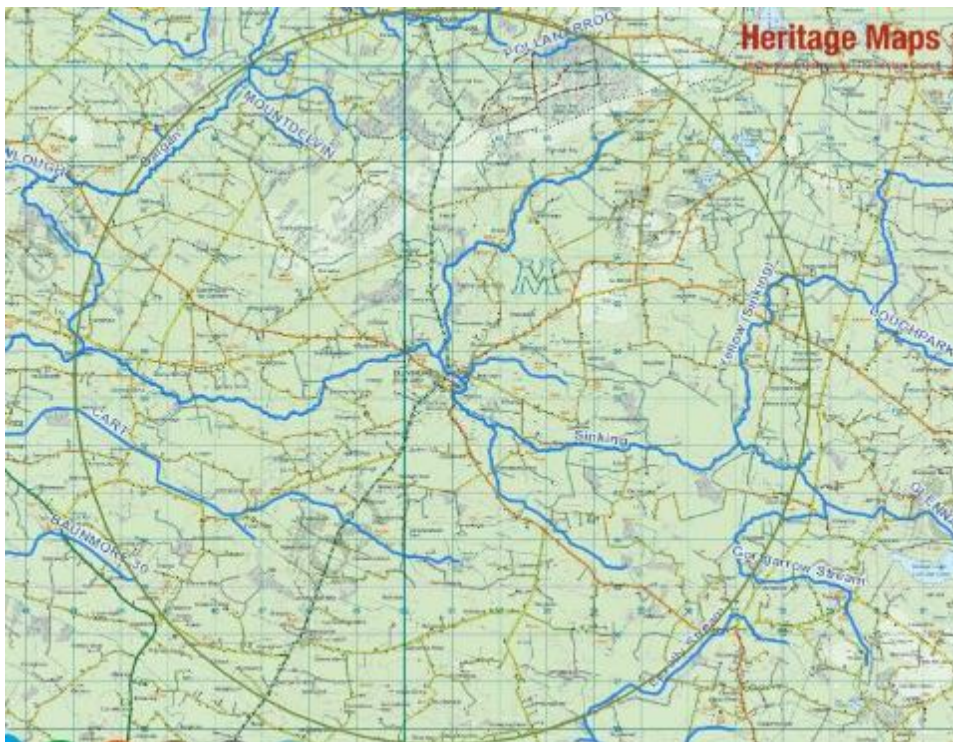
Map 19: Rivers in the Study Area 'Data from the Rivers and Streams database accessed through the Heritage Maps Viewer at www.heritagemaps.ie. [20-6-2020]'.

The river which has its source in Tobernara Spring (the water of which flows underground from Coolcam Turlough) flows from the north east of the study area in a south-westerly direction before joining with the Sinking River at Abbeyland North. The Yellow River enters the study area at Gortagany and flows south to meet the Sinking River on the east side of Slieve Bog. The Sinking River flows from Lisheenaheltia through Dunmore Town to leave the study area just to the west of

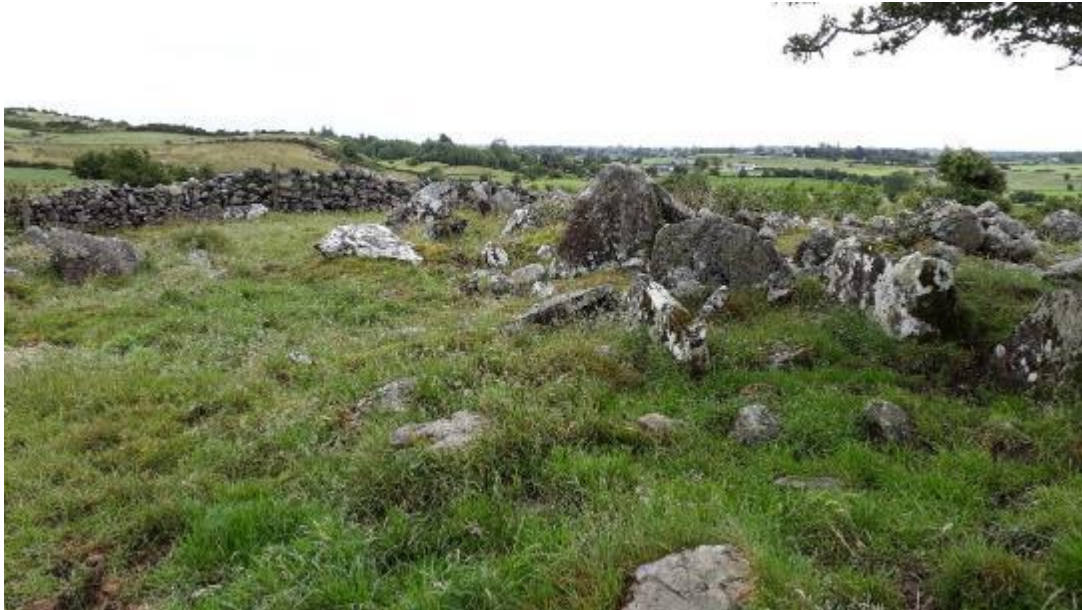
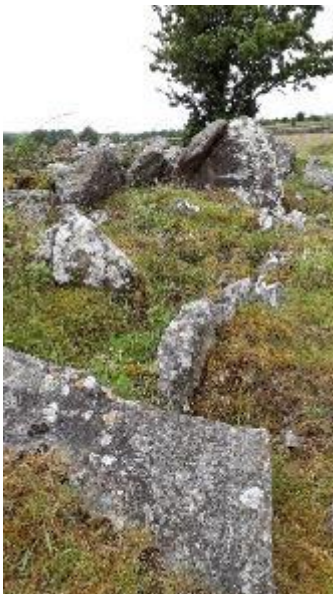
Photograph 5: Flaskagh More court tomb view from north-west towards Ballycostello.

The tomb consist of a pair of galleries set back to back and 1.75m apart. The main long axis runs from east to west. The eastern gallery consists of 2 chambers with a small ante-chamber to the front and the barely discernible remains of a court. The west gallery is not as well preserved and only the eastern end survives. No court is visible at this end.

To the south of the galleries there is quite an amount of cairn material. On the north side it is less obvious. There has been considerable disturbance.

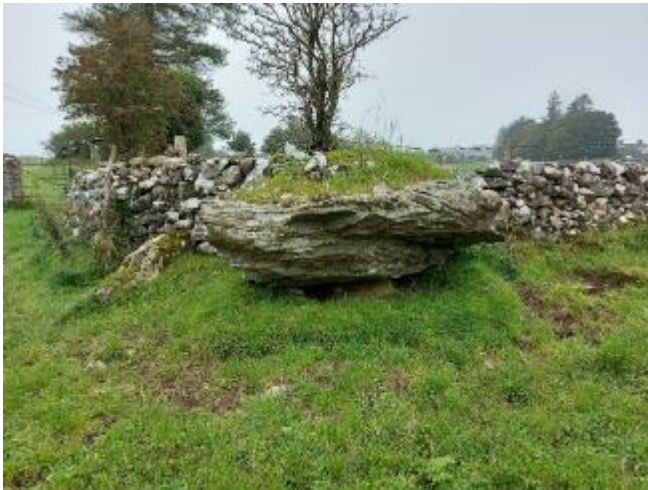
Megalithic structure Lissyconor

Located in the adjoining field, to the north of the private avenue to Rabbits house at Lissyconor, this monument consists of a large rectangular boulder with its long axis running NE-SW. A boundary wall between Rabbits and Moran's land lies over it on the north side. The boulder rests on a smaller boulder at its south end and there is a possible side stone on its west side. This monument is locally believed to be a grave, but due to its condition, the type of megalithic structure present has not been classified by the National Monuments Service (NMS).

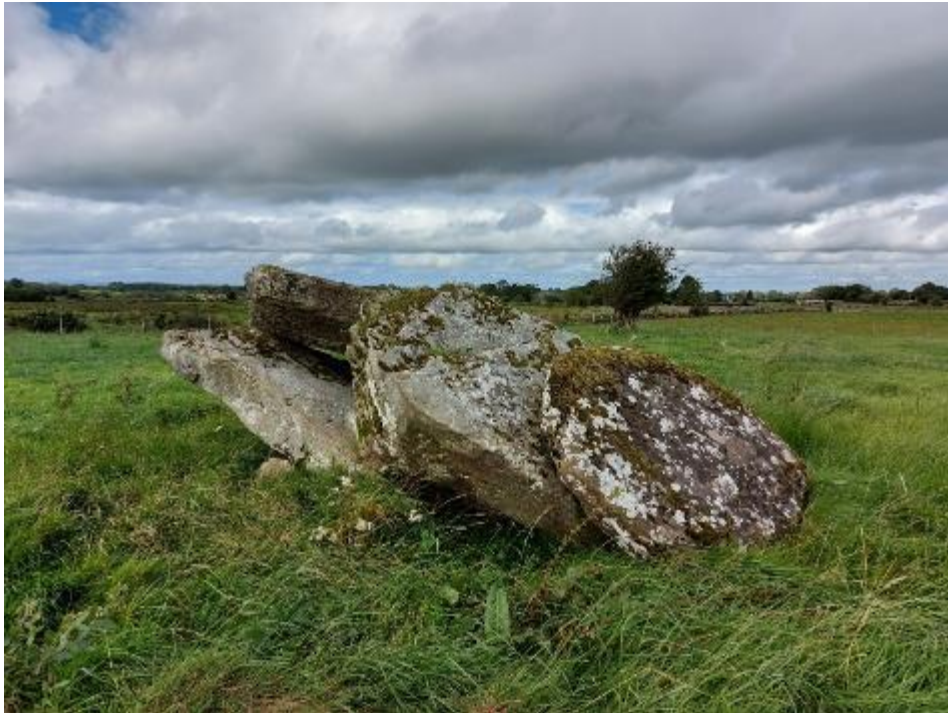
Located on John Keavney's land in Garrafrauns, this grouping of large stones is known locally as a 'Dolmen'. The six large stones rest on top of each other on a rise in the ground which may be a stone cairn. They were described in 1972 by de Valera and Ó Nualláin as *'Six large superimposed stones resting in an inclined position and forming no recognizable arrangement'*. Due to their current positioning the National Monuments Service came to the following conclusion *'the nature of the site is uncertain and it may, in fact, be entirely natural'*. The site however is currently a recorded monument on the Sites and Monuments Record compiled by the National Monuments Service where it is referred to as 'Anomalous stone group'.

Photograph 8: Possible megalithic structure at Garrafrauns.

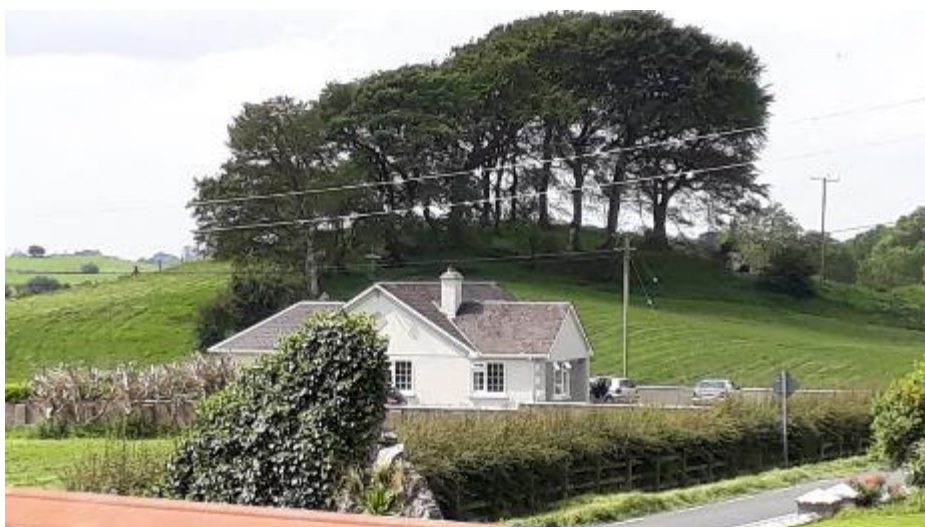
It consists of a poorly preserved almost circular enclosure defined by a low bank surrounding the base of a raised mound on a natural hillock. This mound is labelled 'Rathcoll' on the OS 6-inch historic maps and is known locally as 'Fairy Hill'. The sub-townland name in the area in which it is located is Knockmannanan. The blind poet Cormac Dall O'Comán claimed that Dún Mór was actually Dún Móire, after the daughter of Mananáin Mac Lir and this sub townland name refers to him (Greaney, J. 1984)

Photograph 9: 'Rathcoll' - Possible Burial Mound in Knockatee East.

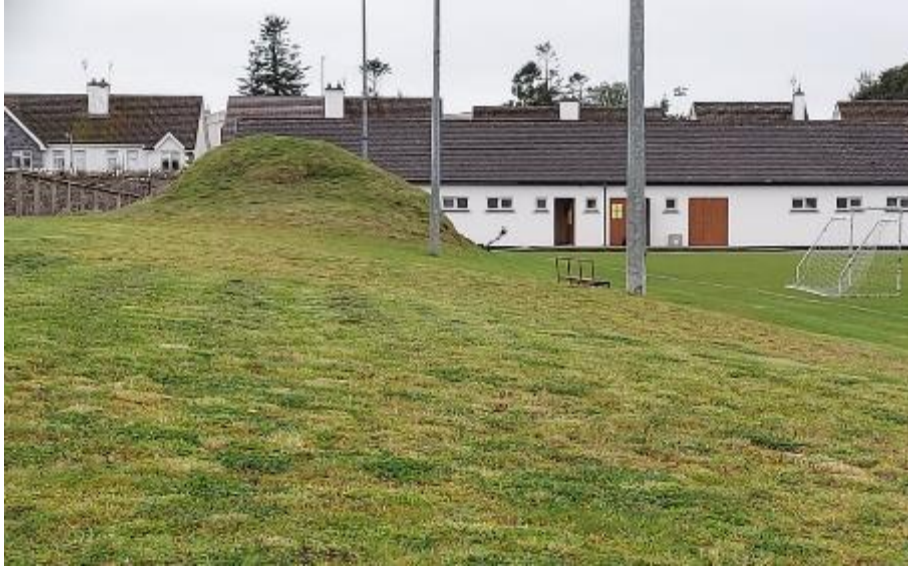
In **Abbeylands South townland (Dunmore Town)** at the east end of the Soccer playing pitch is a small well-preserved mound, roughly circular in plan and conical in profile. Traces of a low linear bank and shallow fosse are visible running along the ridge summit to the south-east. The NMS label this monument as an 'unclassified barrow'.

Photograph 10: Unclassified barrow in Abbeylands South townland

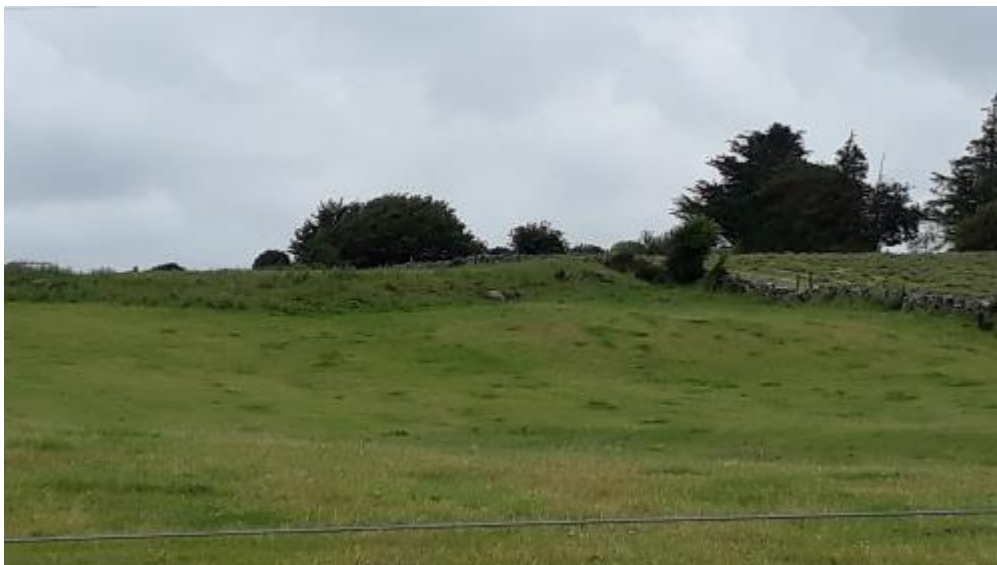
In a field to the west of the road between Kiltivna and Ballycostello is a roughly sub circular grassed-over cairn of earth and stone. On the summit is a slight rectangular depression, possibly stone-lined. This cairn has been classified by the NMS as a recorded monument with the proviso that *'though the whole mound could be the result of field clearance, the presence of the latter feature (i.e. the summit depression) suggests that it is of some antiquity'*.

Photograph 11: Cairn in Flaskagh More

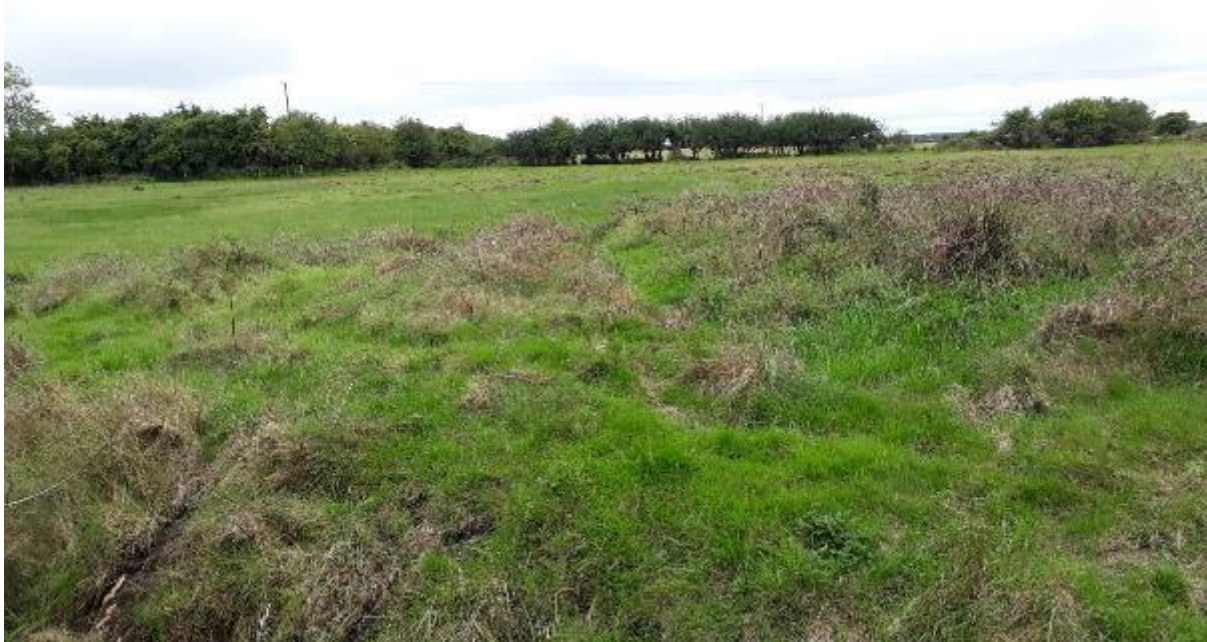
The second example is located in a low-lying field just inside the roadside boundary and is visible from the roadside. It is a well preserved horse –shoe shaped grass and briar-covered mound. The NMS record that it consists of earth and stone.

Photograph 12 : Fulacht Fiadh (GA00745) in Killuney townland.

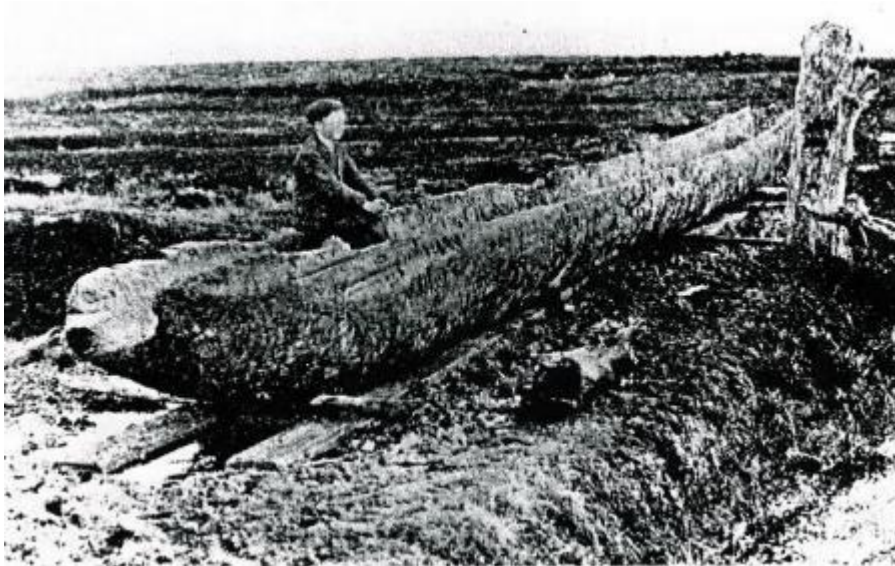
Photograph 13: Lurgan dugout boat shortly after discovery

The largest of Europe's surviving dugout boats was recovered from the raised bog in Lurgan townland in 1902. While digging a drain workmen uncovered two pieces of timber a short distance from each other. They cut away enough of the timber to make the bottom of the drain level. Later that year Mr Pat Coen, the bog owner was deepening the drain and when he uncovered more of the timber, he thought it was part of a coffin. He reported his find and Fr Kelly of Milltown contacted Sir Thos. Esmoncle, who investigated and purchased the boat for the Royal Irish Academy from Mr. Coen for £25. The boat was removed from the bog and brought to Milltown Railway Station, a process that took three weeks. From Tuam station it was brought to Dublin on three large railway wagons. It was then housed in the National Museum where conservation work was undertaken. (<https://milltown.galwaycommunityheritage.org/content/townlands/the-lurgan-dugout-boat-2>) The drain digging had damaged parts of the boat, but these were later remodelled in plaster after conservation treatment.

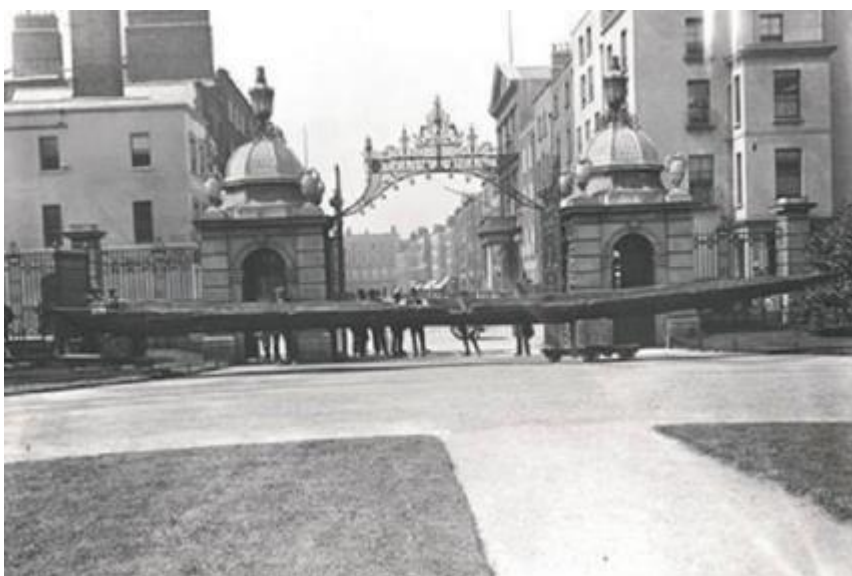
Photograph 14: Lurgan boat at gate of National Museum of Ireland – on arrival. (NMI photo)

Unfortunately, the exact location of the find was never recorded. Found at a depth of 2.4m, it measures 15.24m long, 1.11m wide and is 0.77m in depth at its widest point. Radiocarbon dating indicated that it was carved around 4,400 years ago (c.2400 BC).

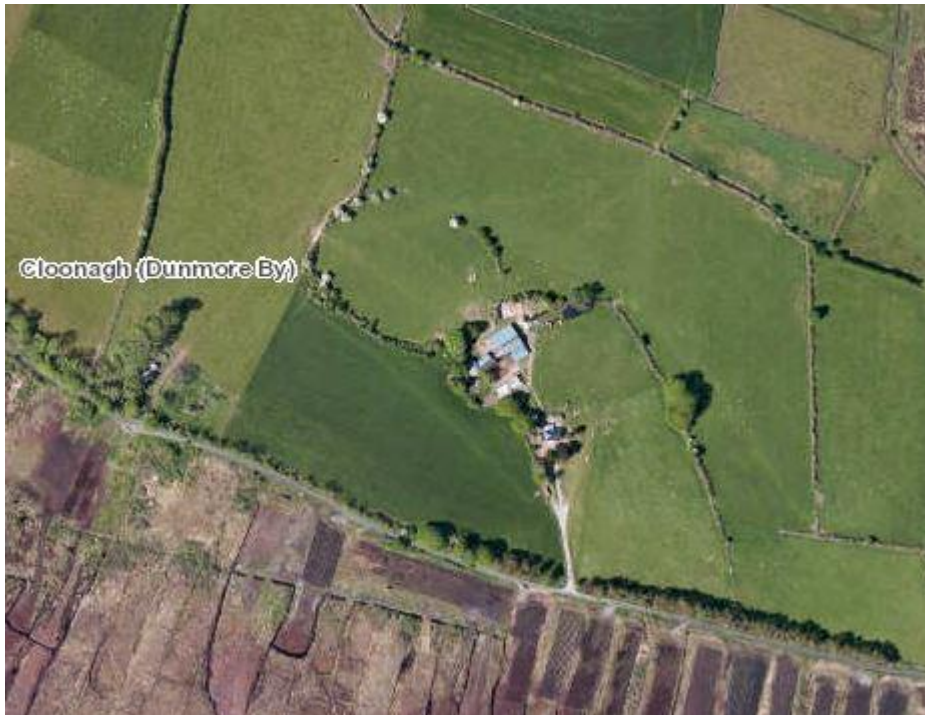
Photograph 16: Aerial view of the hilltop enclosure in Cloonagh townland. 'Data from the base maps gallery accessed through the Heritage Maps Viewer at www.heritagemaps.ie, [9-8-2020]'

Cloonagh hilltop enclosure is located on a low hill on the north side of the road from Ardclon to Knockaunnagat with a view over Lurgan bog to the south. It is oval in shape and classified as being in fair condition by the NMS. It measures 112m from east to west and 95m from north to south. It is enclosed by two banks and an intervening fosse. The inner bank is in poor condition while a modern field boundary forms part of the outer bank on the west and a farmyard encroaches on the east.

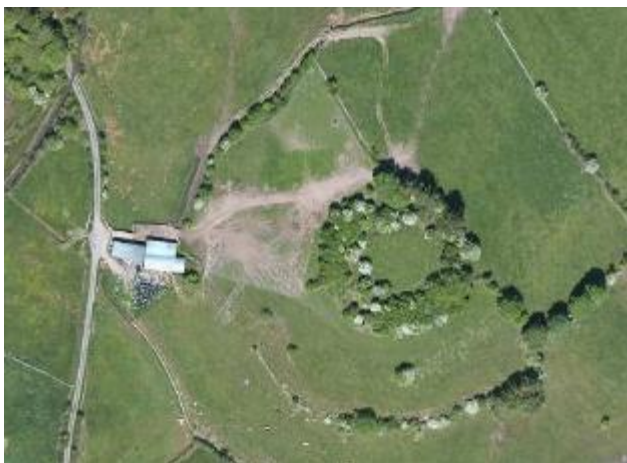
Located on the summit of a hill, it consists of a well-preserved circular rath with a diameter of c.30m. Three earthen stone-lined banks and two intervening fosses enclose the lios. There is a well-defined entrance on the north-east side.

There is a probable souterrain in the north-west section as an L-shaped hollow is visible in the ground. A large limestone upright is locally believed to mark the entrance to the souterrain (Alcock et al 1999)

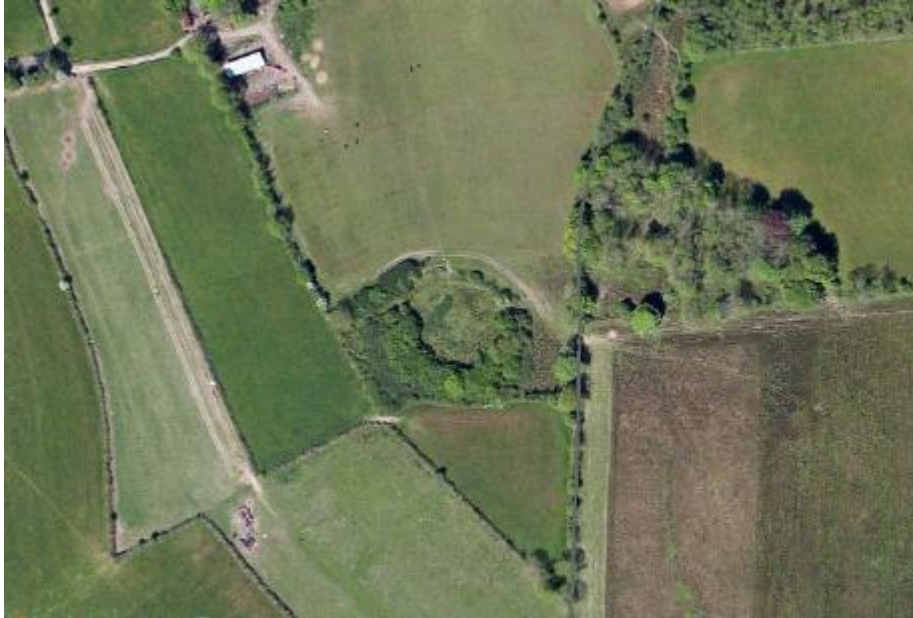
Marked 'Lisnadreeglee' on the historic Ordnance Survey maps, Neary (1914) called this fort 'Lisnatreeblee' and describes it as '*a massive, circular, earthen rath much ravelled on the E side*'. He also states that traditionally it is known as 'the Fort of the Three Shouts' because a gigantic Dane gave three shouts in the morning, at noon and at sunset from the rampart of the rath. The fort consists of an inner scarp, two banks and two intervening fosses with an entrance at the north. Quarrying has encroached on the south and north-west sides.

Photograph 18: Aerial View of the 'Fort of the Three Shouts' Carrowpadeen East 'Data from the base maps gallery accessed through the Heritage Maps Viewer at www.heritagemaps.ie, [20-6-2020]'.

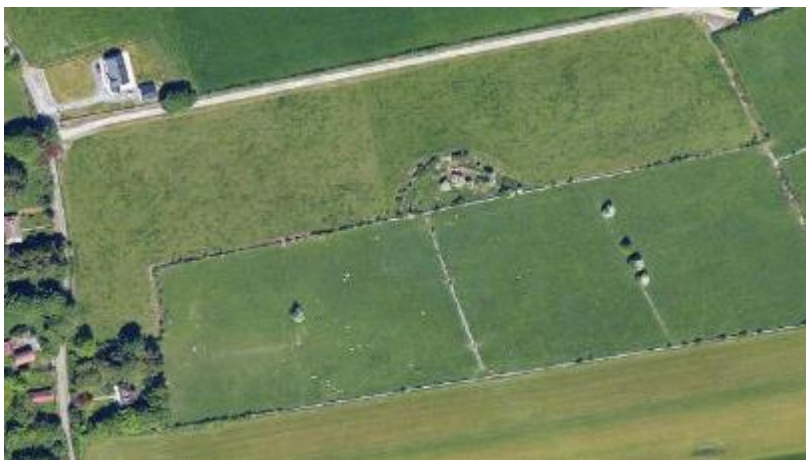
Photograph 19: Aerial view of the remains of the triple bank ringfort in Bellwell. 'Data from the base maps gallery accessed through the Heritage Maps Viewer at www.heritagemaps.ie, [20-6-2020]'.

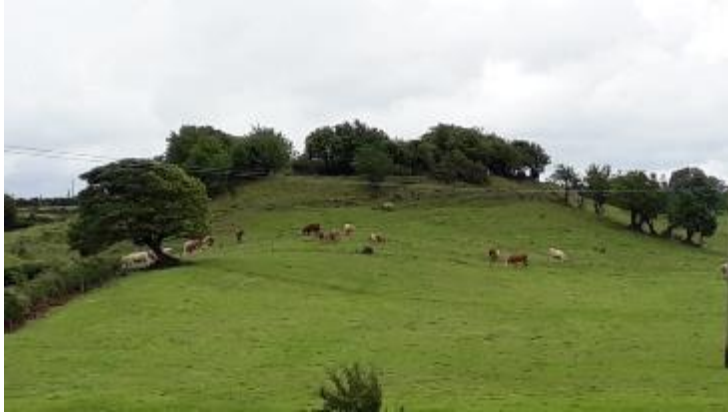
The most numerous form of ringfort found in the study area is the **bivallate**, with several well preserved examples. 'Lios a Roc' ringfort is a typical example. It is sited on the summit of an esker ridge in Flaskagh More townland. This well-preserved monument is enclosed by two banks with an entrance gap in the south west. It is visible from the roadway. However the majority of the ringforts in the area are not visible from public roads and require permission from the landowner to access.

Photograph 20: 'Lios a Roc' fort in Flaskagh More townland

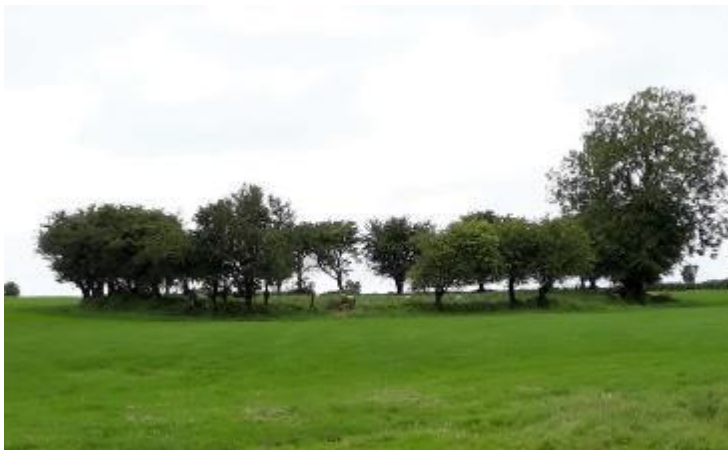
Photograph 21: Univallate ringfort in Carrowroe West townland. The bank is overlain with a stone wall.

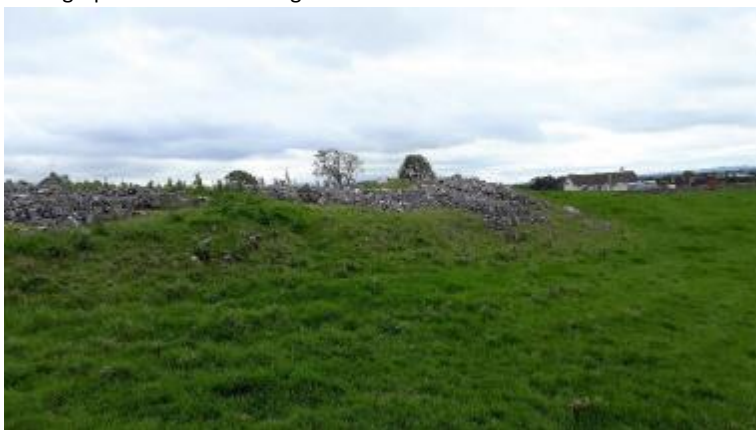
Photograph 22: Drumbulcaun Cashel with surrounding dry stone wall.

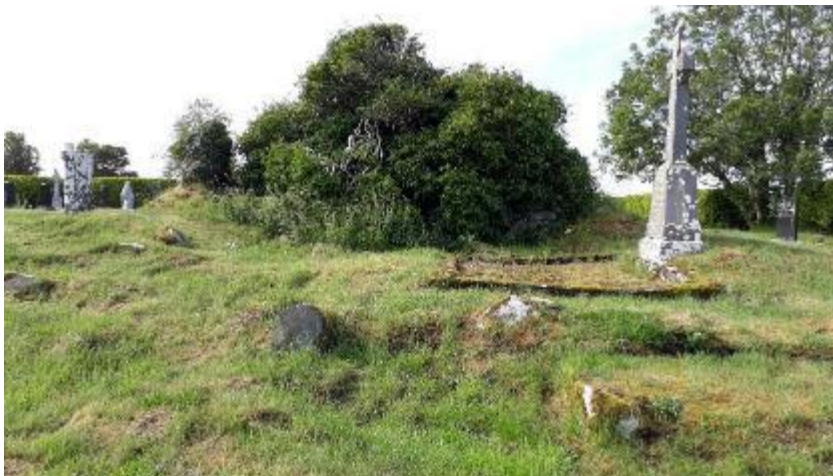
Photograph 23: Ruin of medieval church in graveyard at Kiltivna

In the north-west corner of the modern graveyard in Kiltivna are the foundations of a rectangular building believed to be the remains of a church. The low boundary of a circular enclosure are visible in the field to the west – but only a slight scarp is visible within the graveyard. The 'church' is located in the north-east corner of the enclosure on the highest piece of ground. All that remains is a section of the north wall, part of the east and the low foundation of the remaining walls. The standing wall sections are ivy-covered. The church ruin is surrounded by a burial ground of low stone markers arranged in north-south rows which is believed to be a children's burial ground. From this area, later burials have spread out with the oldest in the northern section of the graveyard and the more recent extending to the south along the eastern boundary.

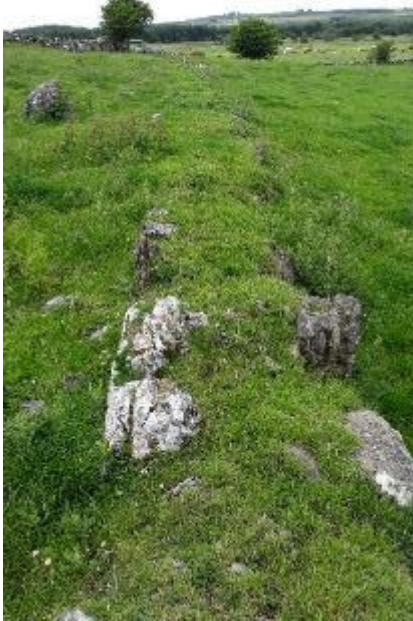
Photograph 25: Part of enclosing wall at Carrownseer

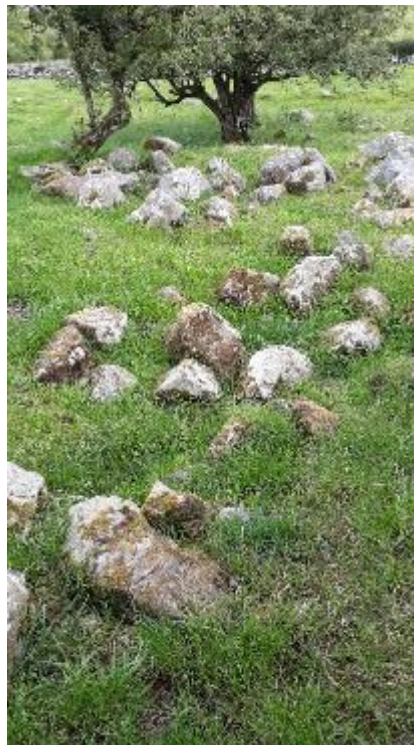
Photograph 26: Footings of church at Carrownseer

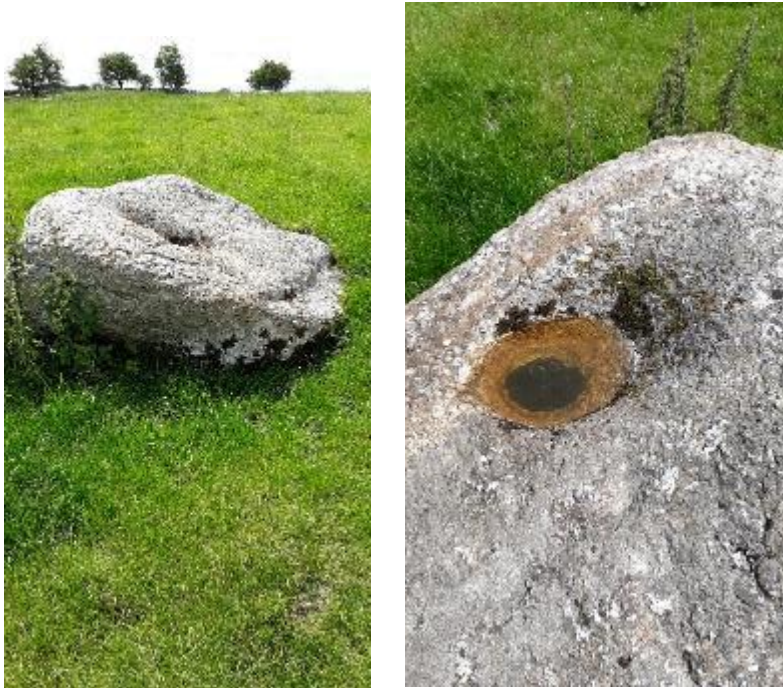
Photographs 27 and 28: 'St Patrick's Stone' Carrownseer North townland

Approximately 60m to the north-north-east of the enclosure, is the very large bullaun stone known locally as 'St Patrick's Stone' - the bowl of which is said to be the imprint of his knee (O'Donovan's Letters).

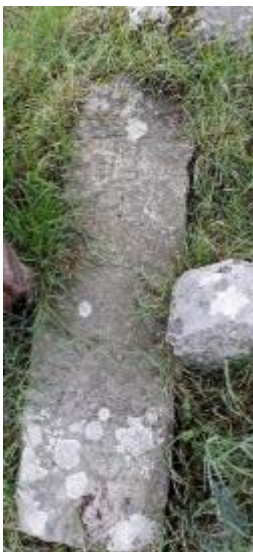
The inscribed cross-slab (GA005-035005) is located beneath a hawthorn tree. It consists of a rectangular piece of limestone inscribed with a simple outline cross. Jim Higgins in his work *'The Early Christian Cross Slabs, Pillar Stones and Related Monuments of County Galway Ireland'* (1987) identifies the cross as 'Greek form' created by the pocking out of broad grooves with a point. He records that the stone was standing upright until about the 1950s when it was re-used to cover the last child's burial at this site.

Photograph 29: Inscribed cross-slab at Carrownaseer

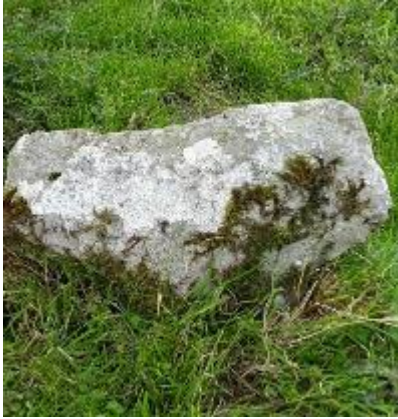
The roughly worked and undecorated tau-shaped cross of sandstone is the only such example recorded in Co. Galway (GA005-035006-) (Higgins, J. 1987). Positioned at the head of a grave, which is covered by a flat recumbent stone, the cross appears to have been set upright in the ground to act as a grave marker.

Photograph 30: Tau-shaped cross Carrownaseer

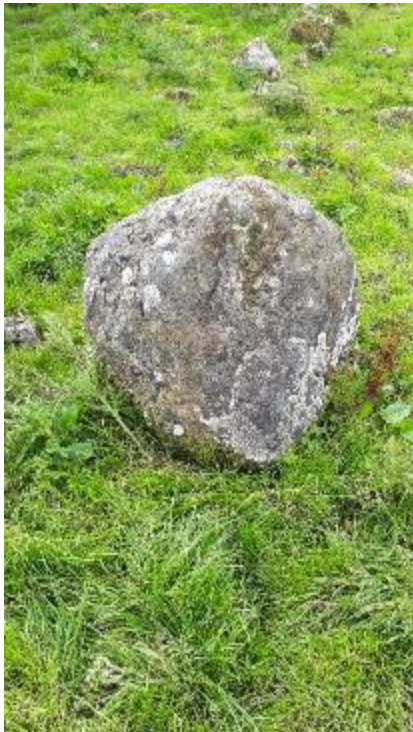
Possible ogham markings have been identified on a stone in the graveyard. However these have yet to be confirmed (pers. com Dr Christy Cunniffe)

Photograph 31: Possible ogham stone at Carrownaseer

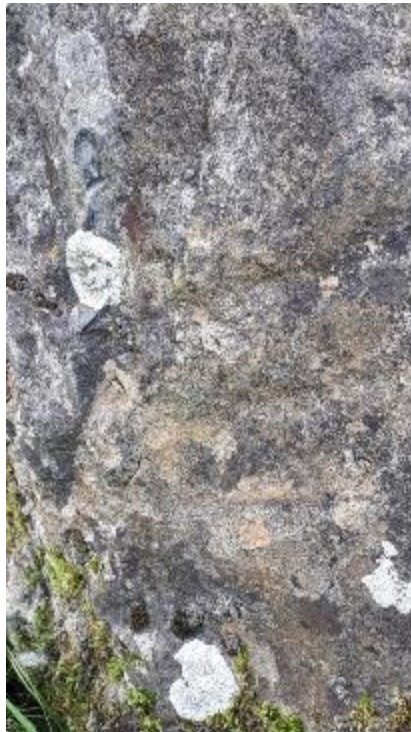
Photograph 32: Possible ogham markings on stone

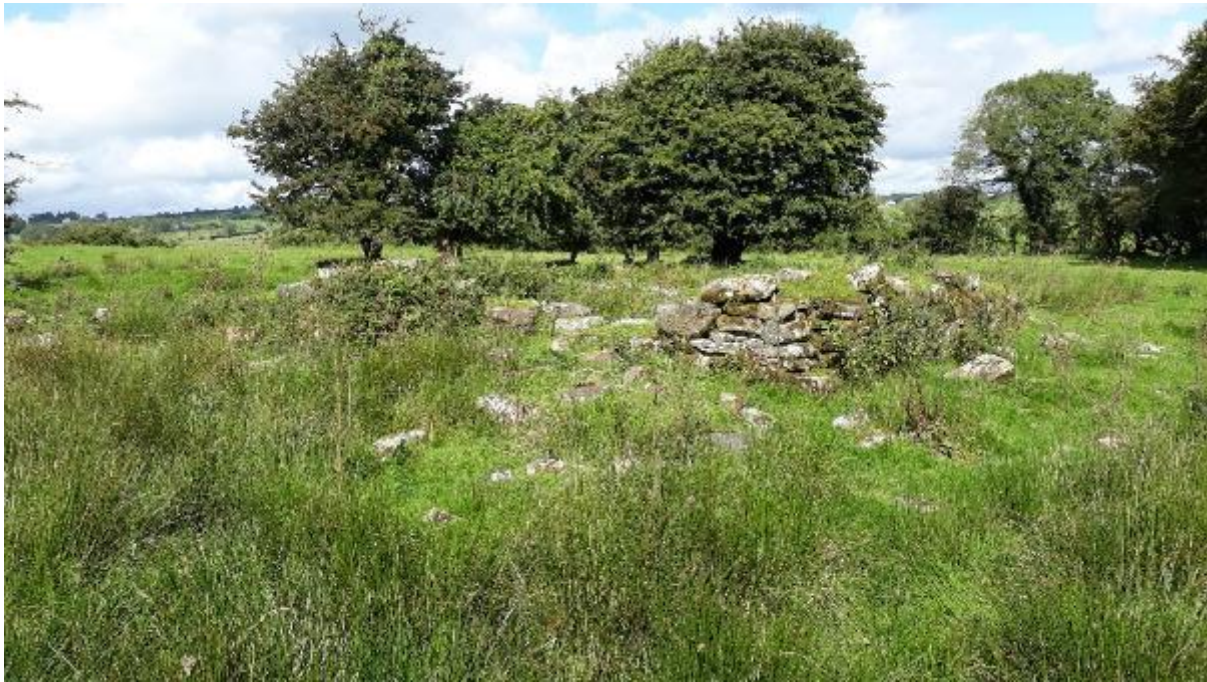
Photograph 33: Remains of Church and Graveyard in Cloondergan townland

On the south side of the church is a small area enclosed by an earthen bank. Some small set grave marker stones are visible in the interior. According to local information, this graveyard is believed to be a children's burial ground, though some adult human bones were noticed during bulldozing. (Alcock et al. 1999)

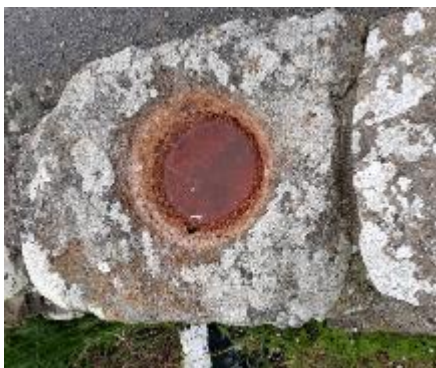
The bullaun stone is set into the graveyard wall to the left of the entrance stile. This may have functioned as a holy water font in the original church. When the remains of the church were demolished in the 1960s, this and other stones from the church were used in the construction of Dalgin Bridge (Greaney, J. 1984) – it has since been returned to Carrowntomush graveyard.
