DUNMORE HERITAGE AUDIT

COUNTY GALWAY

2020/2021

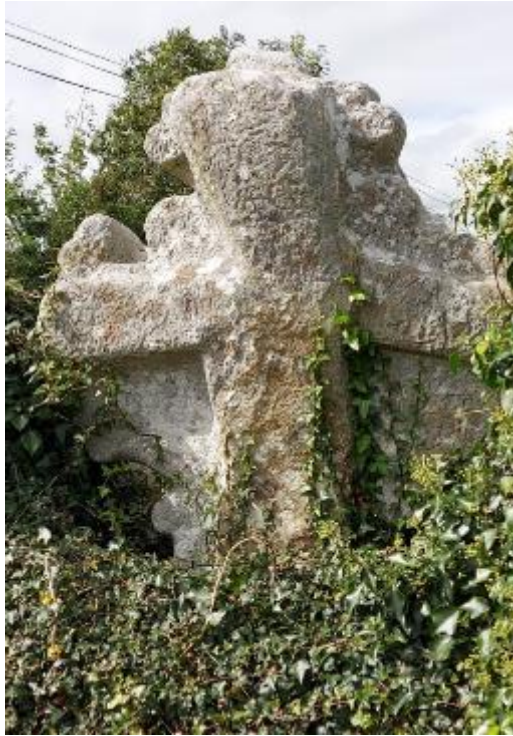
Photograph 36: Medieval Cross Head set into boundary wall in Addergoole Graveyard

The unfinished head of a sandstone medieval cross, depicting the Crucifixion, appears to have moved position several times. The original site appears to have been on the summit of a hillock in the adjoining field 65m west of the graveyard. (Historic OS 6-inch maps). Neary (1914) wrote 'A rudely-sculptured cross stands in an adjoining field'. Local tradition states that it functioned as a market cross in this location, but it could also have functioned as a termon or boundary cross of the early ecclesiastical monastic site.

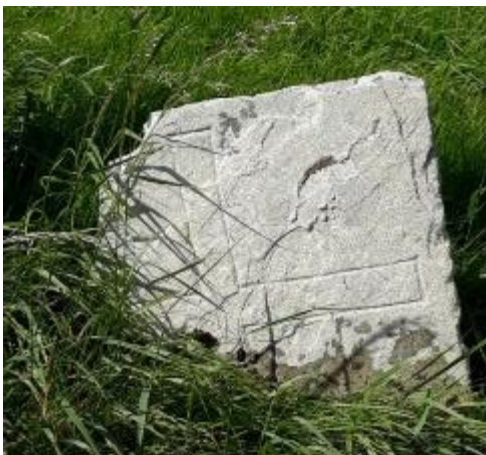
The only cross slab identified by Higgins which was located in the graveyard during this audit, consists of a large sandstone slab (H 0.85m; Wth 0.71m; T 0.06m) inscribed with a two-line Latin cross with simple straight-ended terminals. The upper left-hand corner and bottom part of the slab are missing.

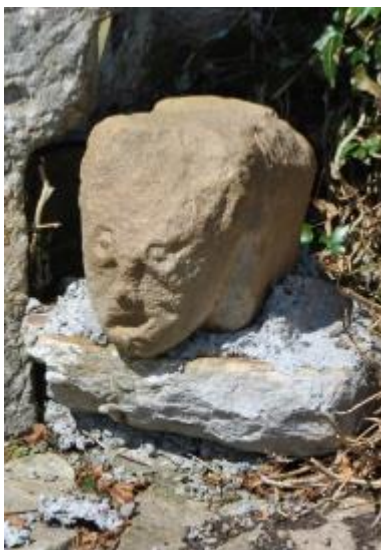
A small carved sandstone head, of medieval date was set on the same plinth as the large 12th-century cross but in recent years this head has been removed and is now housed in Milltown Museum. Dr Christy Cunniffe has identified its purpose as a decorative stop or label from a window or door.

Photograph 42: Medieval sandstone head when it was set in wall of Addergoole graveyard (courtesy of Dr Christy Cunniffe)

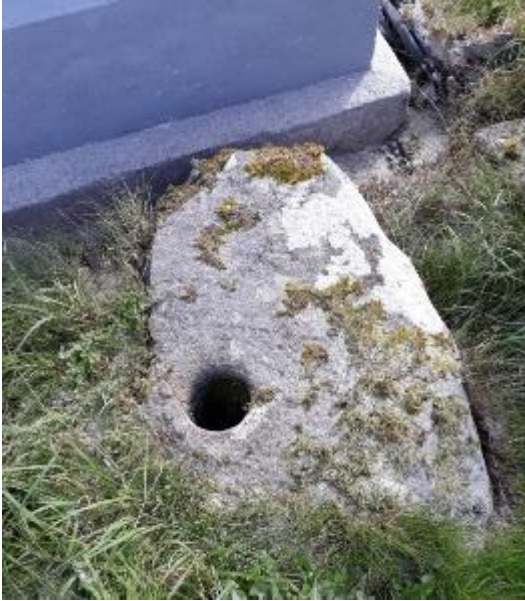
Close to the summit of the hill on which the graveyard is located, a holed stone is partially hidden in the grass. This has been mistakenly identified as a bullaun stone in the past, but is in fact a broken mill stone. Its origin is unknown and it may have been used as a grave marker.

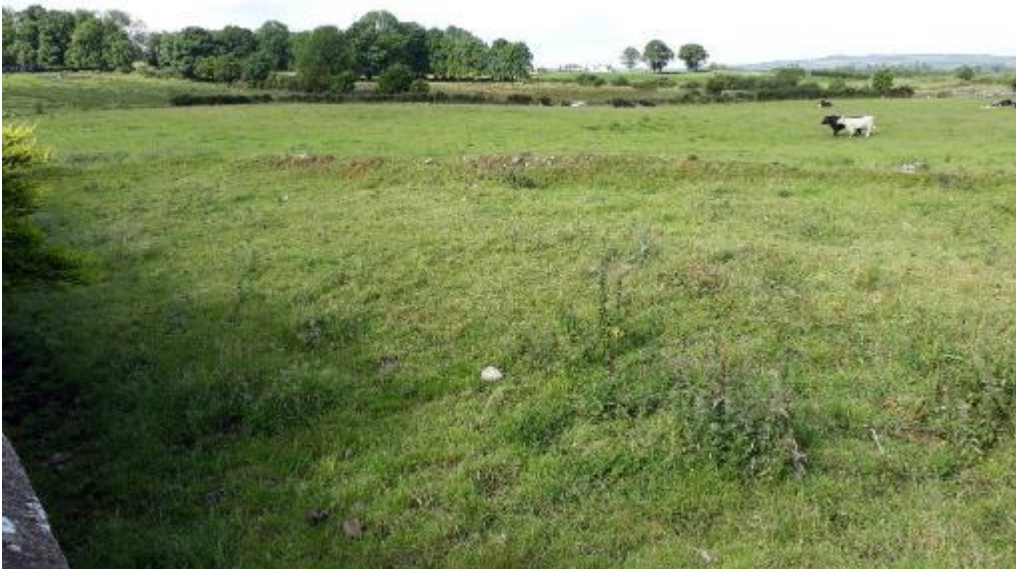
This poorly preserved site is located on the slope of a low hill close to the Sinking River on land owned by Kay Jennings of Tuam. It consists of a low circular enclosure marked by a low earth and stone boundary, the interior of which is divided in two by a modern field wall. The grassed over foundations of a rectangular church are set within a smaller enclosure in the interior and a more recent children's burial ground (CBG) is found to the south of the church site. The CBG has several closely set stone markers and a number of upright markers. Higgins (1987) recorded an inscribed cross slab at this site and it was mentioned in the Archaeological Survey of County Galway in 1985. In 1996, it was recorded by the National Museum of Ireland (NMI), reference number: IA/87/1996.

Photograph 44: Remains of ecclesiastical enclosure in Addergoole More townland

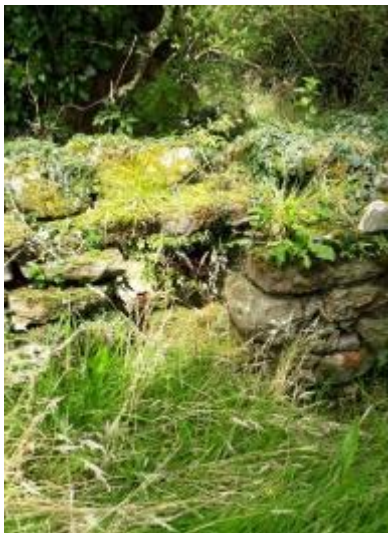
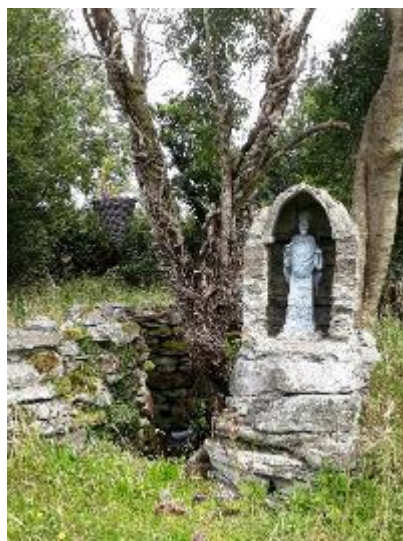
Photographs 46-47: Holy wells at Cappagh

One of the holy wells consists of a spring enclosed by a rectangular mortared stone wall which opens to the south-east through a water channel. Above this opening is a small rectangular alcove in the interior wall, which may have been used in the past for the deposition of votive offerings.

The second well is enclosed by a dry stone wall on three sides with an opening on the south side where a single step gives access down to the water. A grotto containing a statue of St Patrick has been erected on top of the east wall.

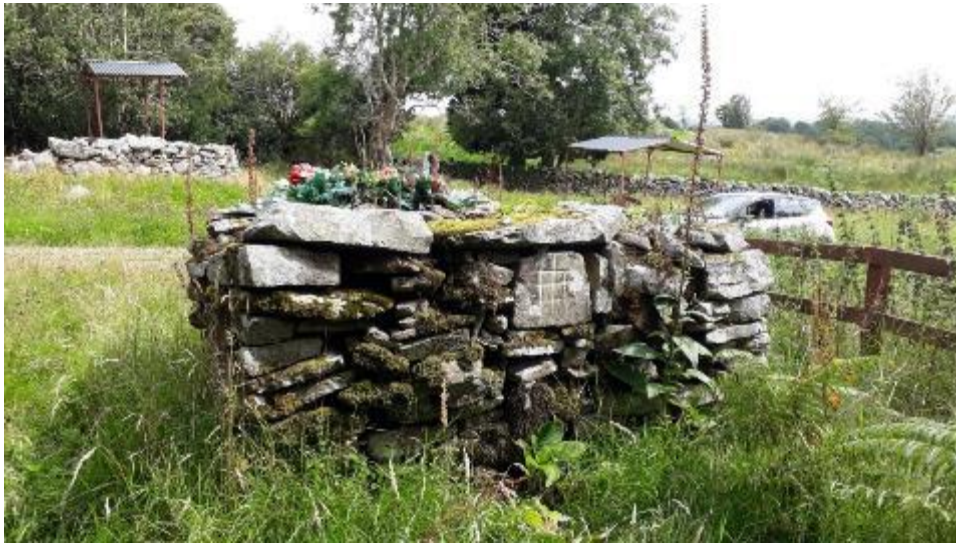
Photograph 48: Altar or 'leacht' at Cappagh

An Altar or leacht is located on the opposite (west) side of the boreen from the wells. It consists of a square, dry stone table – like structure with a cross slab in its east face. The cross slab was described by Higgins (1987, ii, 313, no. 39) as a limestone slab bearing *'three one-line Latin crosses, one large one and two smaller ones'*. The two smaller crosses extend from beneath the arms of the larger one. Traditionally pilgrims trace the outline of the crosses with a stone while performing the pattern of rounds at the site. It is this cross inscribed slab that gives the site its name 'Tobar na Croise'. It is also known locally as the 'Dean's Grave' (pers comm Hubert Birmingham).

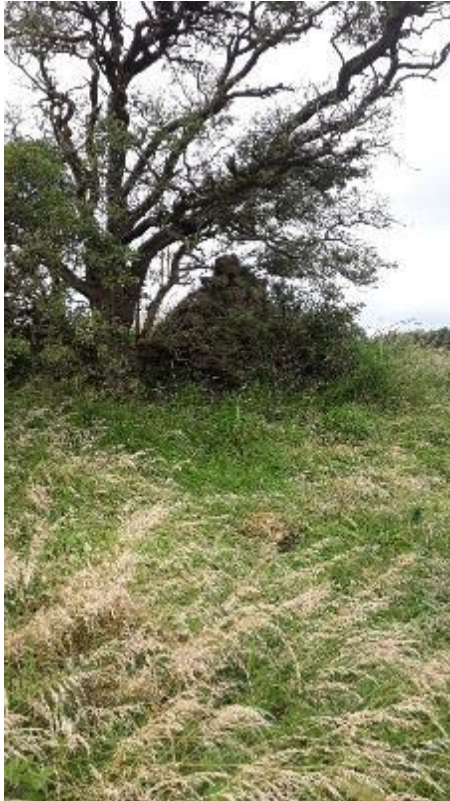
Photograph 52: Remains of north wall of Clocmakeeran church

In more recent times a stone wall was built to enclose the graveyard which surrounds the remains of a medieval parish church known locally as 'Clocmakeeran Church'. Neary described the church in 1914 as '*its foundations [could] be plainly traced*' and it measured '*70 ft. [21.35m] E. to W., by 26 ft. [7.9m] N. to S. [with] walls ... 3 ft [0.9m] thick, and the foundation of a cross wall, 24 ft. [7.3m] from the E., seem[ing] to mark the division of nave and chancel*'. Today all that is visible is the outline of the chancel to foundation level with the exception of the north wall which survives to a height of 1.4m.

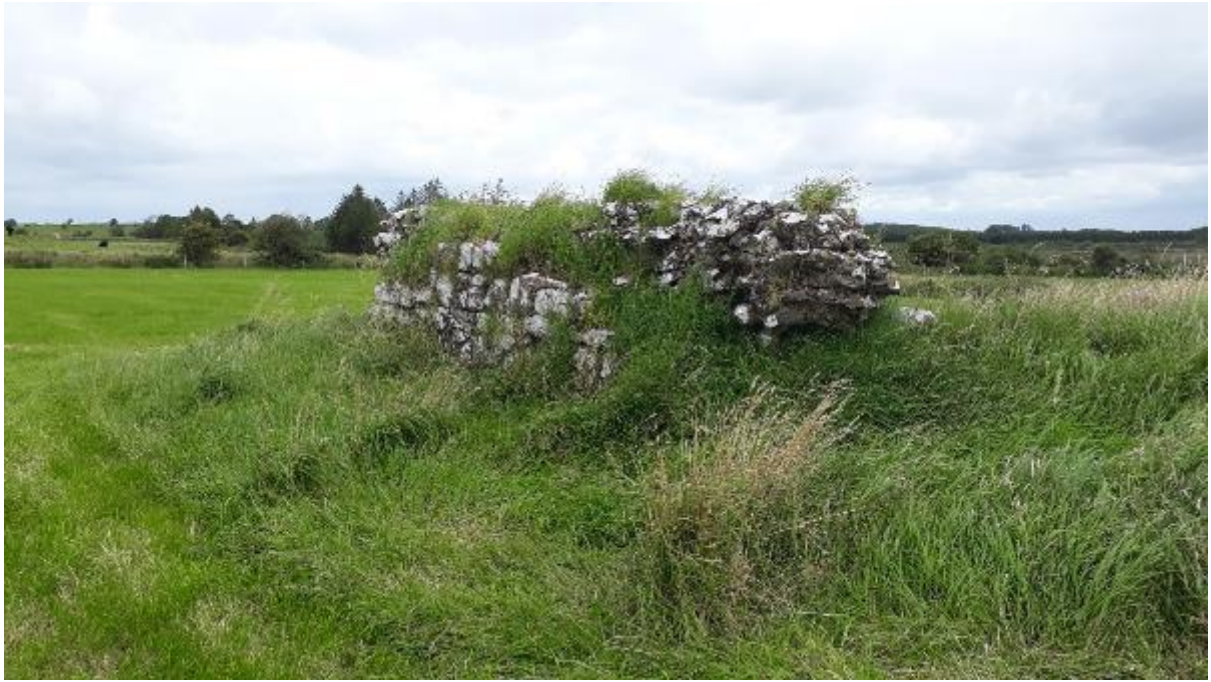
Photograph 54: Remains of Medieval Church at Kilmurry

All that remains today are the overgrown foundations of a rectangular building and piles of rubble in an agricultural field overlooking bogland to the east. The site is located on the south side of a breen which leads down to bog. The west gable is the best preserved section and the interior floor area is at a much lower level than the exterior. In the field on the opposite side of the approach breen to the site is a curved scarp which is likely the remains of a circular enclosure which originally surrounded the site. Neary (1914) records the remains of '*a segment of the old cashel wall or bank*' 70 yards to the north-west.

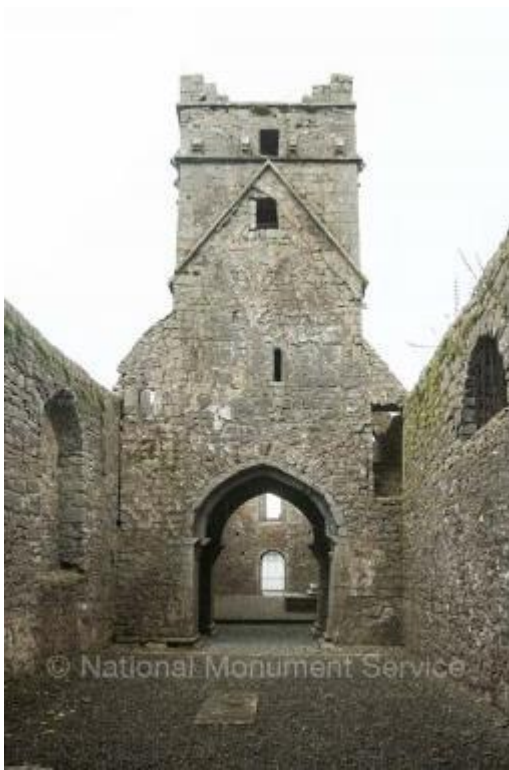
Photograph 55: Dunmore Friary Crossing Tower

A three storey crossing tower was inserted in the 16th century over the pointed chancel arch. Some of the original plaster and wicker-centring survives on the underside of its vault and a small carved head is visible on its south-east pier (<https://webgis.archaeology.ie/historicenvironment>).

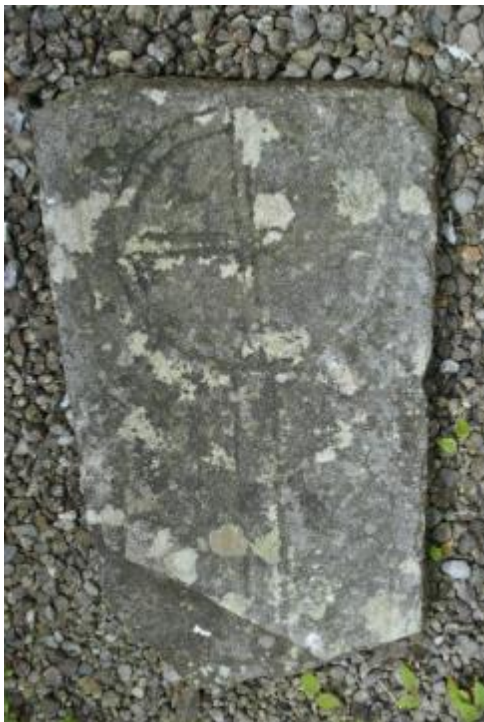
A cross-slab (GA017-005004-) found within the Abbey was described by Higgins (1987, 361, no. 83) as a sub-rectangular, weathered slab of limestone measuring 95cm long, tapering from 52.4cm to 49 cm wide and between 14 and 16cm in thickness. The tapered slab is broken with the lower end missing. The upper section is incised with a two-line Greek ringed cross on a long shaft, enclosed in what was probably originally a single-line rectangle.

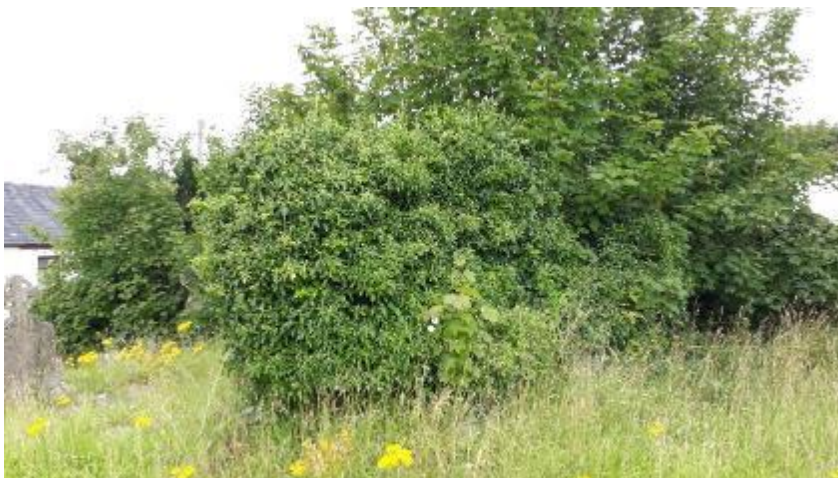
Photograph 58: Remaining section of west gable of the Medieval Parish Church of Dunmore

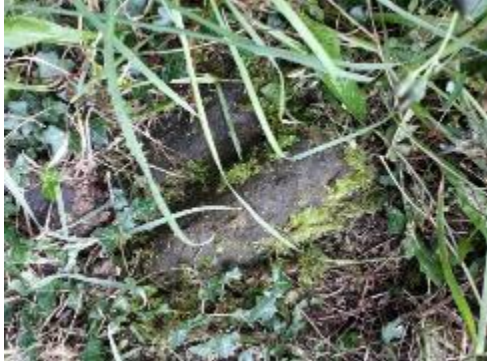
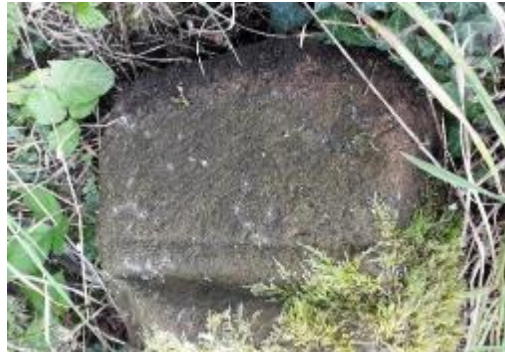
Photographs 59-60: 11th-13th architectural fragments in St. Nicholas graveyard, Chapel St. Dunmore

Hidden in the undergrowth within the 'church' site are two moulded sandstone architectural fragments which were likely to have been part of a window. They have evidence of diagonal tooling on the dressed face and have been dated between the 11th-13th centuries by Dr Christy Cunniffe as part of this audit. This indicates that the foundation of the building that stood here very likely dated back to this period.

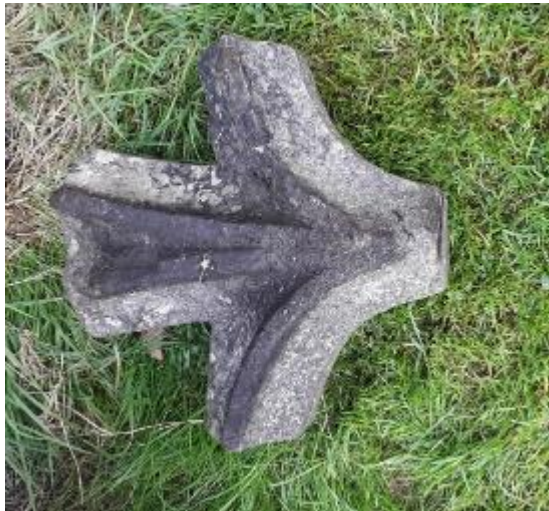
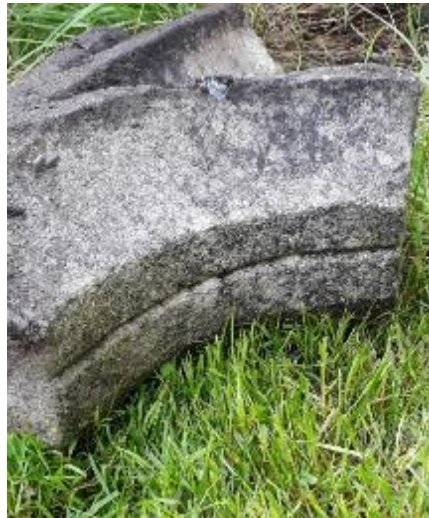
Photographs 61-62: 15th century Window fragment possibly from the medieval parish church of Dunmore. Photograph on right shows glazing grooves.

An additional architectural fragment is in Hubert Birmingham's safe keeping. It consists of part of a 15th century window. The tracery shows a division for two lights, but the window is likely to have been larger and may even have been the east window of a church. Glazing grooves visible on the fragment show that glass was used.

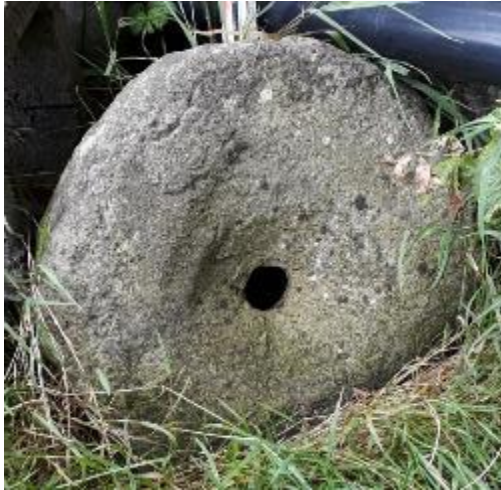
Photograph 63: Quernstone found in St Nicholas Graveyard, Church St. Dunmore.

Also in Hubert Birmingham's possession is a quernstone which was found in the graveyard. It has a hollowed out area surrounding the central hole and could possibly have been reused as a door stop or cross base.

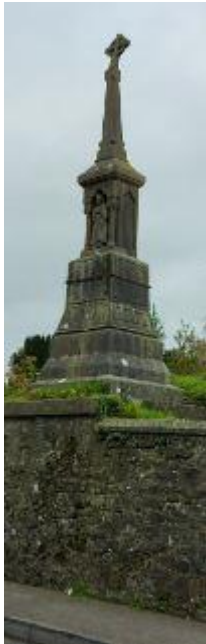
Photograph 76: Delaney Memorial, St Nicholas Graveyard, Chapel St., Dunmore

The most noticeable memorial stone in the graveyard towers high above the boundary wall overlooking Chapel St. It was erected to the memory of '*Peter Delaney, Irish Patriot who died March 9 1895 aged 55 years*' and was sculpted by Hawthorne

The memorial is a tapering pedestal set on a stepped cut limestone base and topped with a cornered obelisk and a carved ringed cross.

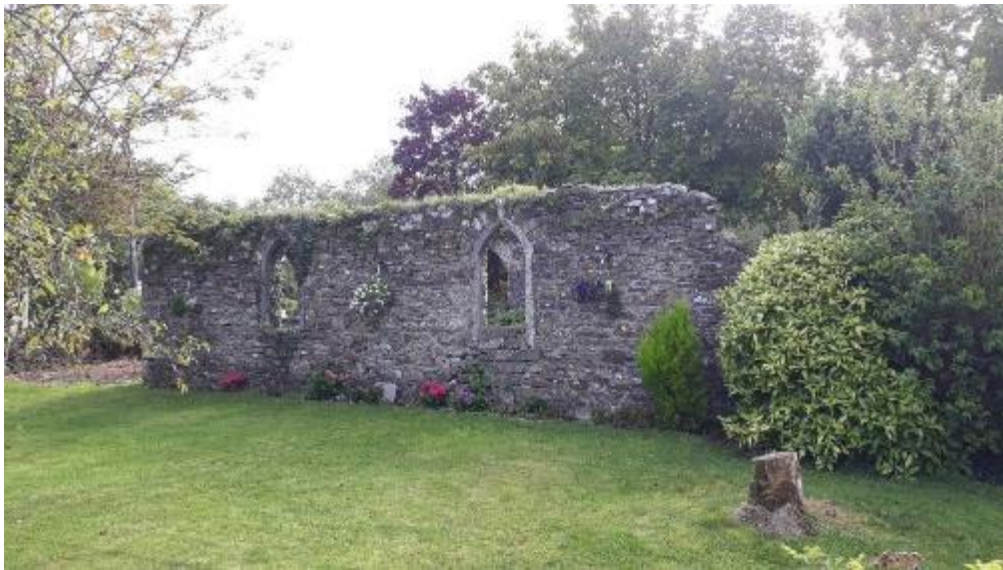
Photograph 78: South wall of St Patricks Chapel Garrafrauns

The ruins of the chapel are located opposite the present day St Patricks RC Church in Garrafrauns village. Aligned east –west, the west gable and both side walls are still standing while a concrete built shop was inserted into the east end of the building around 1963/64 (pers. comm. Pat Slattery)

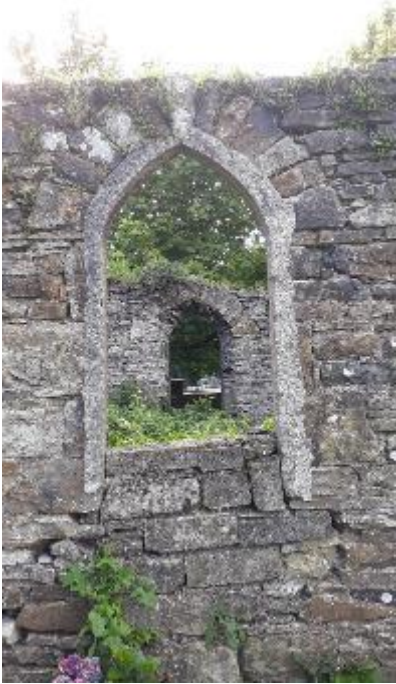
Photograph 80: View through window opening in north wall St Patricks RC Chapel, Garrafrauns

The chapel was a substantial single cell building with opposing Gothic style pointed arch windows in each side wall. A pointed arch doorway, of similar style to the windows, is located in the centre of the west gable. There is evidence of a lower roofline on the west gable and this may indicate the presence of a former outer porch and that the doorway that survives was an inner door, leading from the porch into the nave. The building today is roofless and the interior is overgrown and filled with rubble.

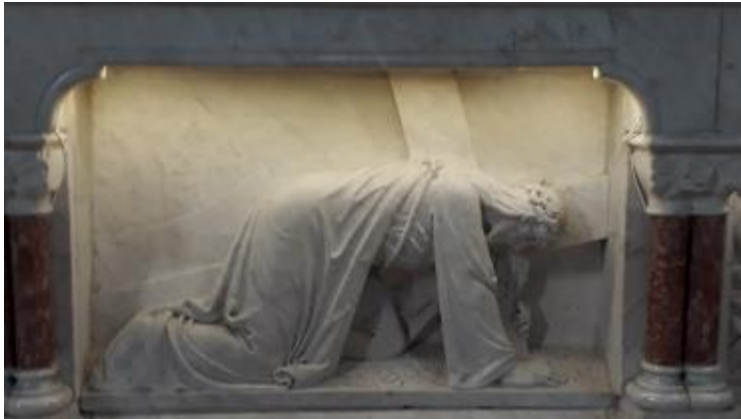
Photograph 83: Altar in St Patricks Church Garrafrauns.

Thomas McHugh, Tuam, sculpted the altars from Carrara and Connemara marble. As a result of changes to church law after the Second Vatican Council in the 1960s the main altar was restructured to face the congregation, the two side altars were removed and the altar rails were reinstated to the front of the gallery. The main altar which survives is carved with a full depiction of 'The Fall of Christ'. The altar is similar to those found in the Church of St Joseph Kilkerrin and the Church of Our Lady of the Mount Carmel, Clonberne (Hoctor, Z. Cunniffe, C. 2020).

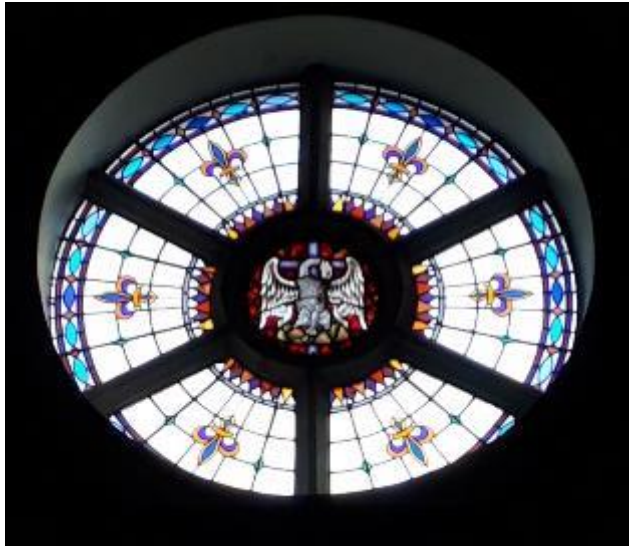
Photograph 85: Round window in north gable St Patricks Church Garrafrauns

The Church was completed in 1913 and was consecrated by Archbishop Healy assisted by Dean Macken P.P. on October 5th 1913. A round window was added to the north gable c.1920. It has limestone between the glazing giving a wheel pattern and the stained glass in the central hub bears a depiction of the 'Pelican in Piety'. The sections between the spokes are decorated with a 'fleur-de-lys' motif.

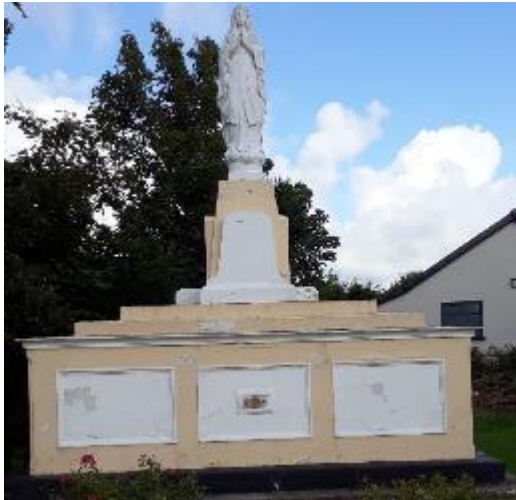
Photograph 86: Flemings Grotto in grounds of St Patricks Church, Garrafrauns

In 1938, a grotto dedicated to Our Lady was erected in the Church Grounds in memory of John and Catherine Fleming, Corohan.

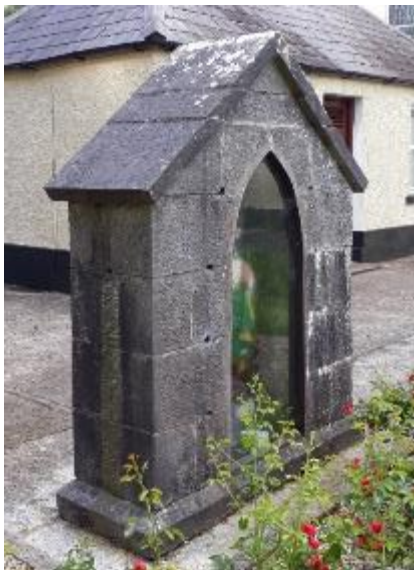
Photograph 87: Former bell housing, St Patricks Church, Garrafrauns

In 1974 the bell and housing were removed from the church and the bell was transported to a parish in Africa. The housing was placed in the church grounds and now contains a statue of St. Patrick.

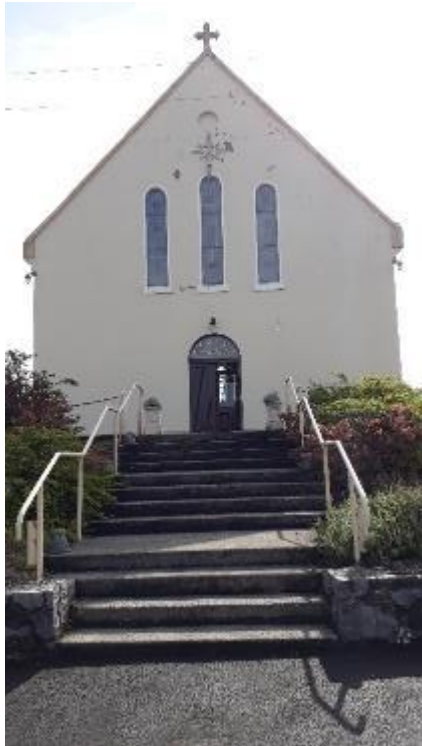
Photograph 88: Front elevation of Kiltivna Church

Built c. 1850 this barn style church stands on an elevated site in Kiltivna village. The church has a seven bay nave, a lower single-bay chancel and a later flat-roofed sacristy on the south-east corner.

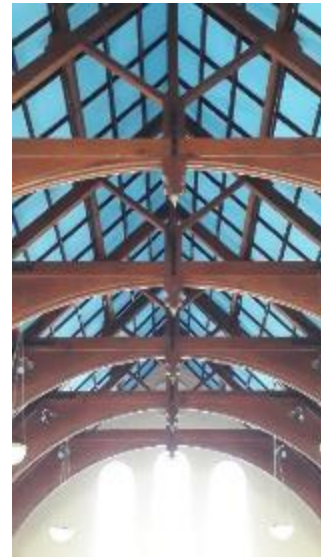
Photograph 89: Interior roof, Kiltivna Church

The interior of the church has the original mid-nineteenth-century open timber kingpost truss roof with perforated trefoil and drop details. It is supported on limestone corbels.

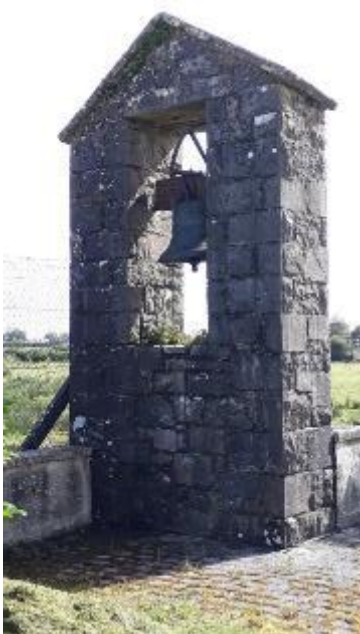
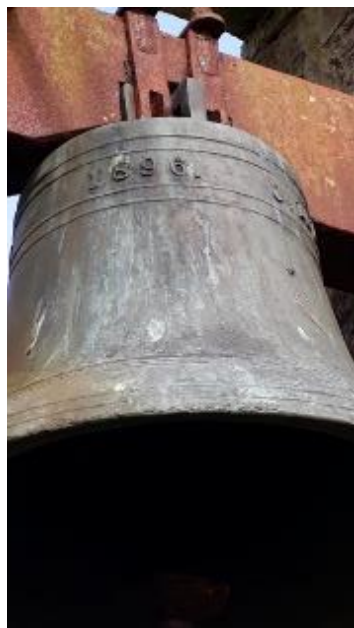
Photograph 90-91: Belfry and bell Kiltivna Church

To the rear of the church is a freestanding belfry built of limestone with a square-headed arch into which a bronze bell is hung. The bell bears the date 1896 and the makers name "J. Murphy Foundry Dublin 1896" – some letters are missing.

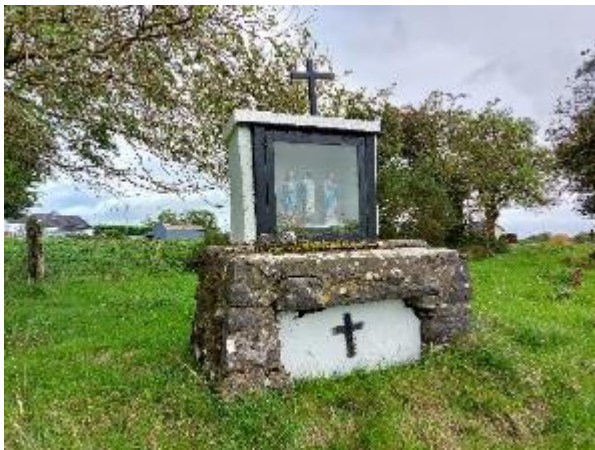
Photograph 100: Well house at Beagh well

'The Blessed Well is situated in the middle of a field of rushes. A woman named Sarah Hoblan, Beagh, is supposed to have seen the Blessed Virgin at the well. She has a small stone, slated house with one window erected as a memorial on the spot, where she saw the vision about thirty years ago. There are three medium-sized statues, the B. Virgin, Saint Joseph, and St. Anthony inside the window, and on the broad window-sill outside, there are a few flower-vases which are kept well-filled all summer. There is a certain kind of station to be done at it. Crowds of people are there every Sunday in the Summer. To do the station one must come three Sundays to the well. One has to go ten times around the well praying, sometimes walking and sometimes on ones knees. The way the people reckon the number of rounds is to pick ten pebbles and to drop on at each round until none remain. The last Sunday of the three, each person ties a red ribbon on the tree by the well and long before the summer is over, the tree is well decorated in red.'

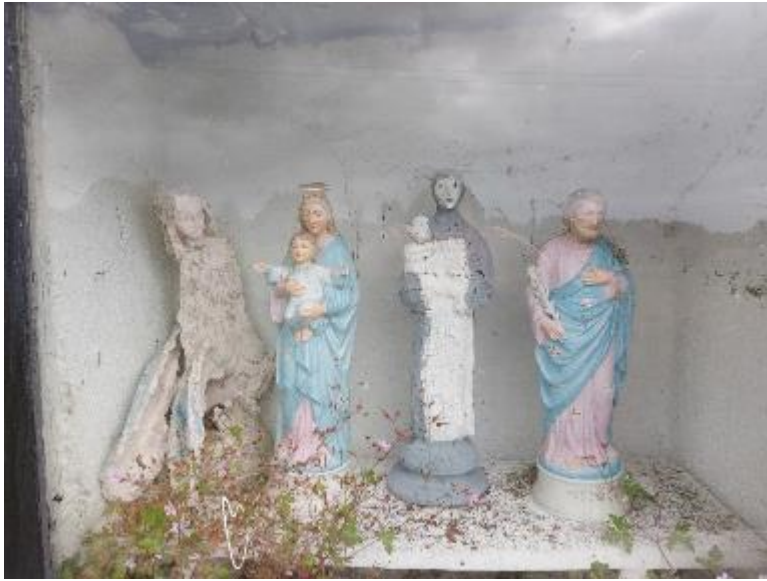
Photograph 102: Statues encased on the altar at Beagh Holy Well.

The area today consists of wet grassland which would appear to have an underground spring. Adjacent to the area is a stone built table like structure with a flat stone on its south-west face which has a black painted cross on a white background. Mounted on top of the stone structure is a white and black painted stone box with a glass door. A cross is placed on the top of the box. Four statues have been placed within the box – two of which are modern, while the other two may date back to the original construction of the altar in the early 1900s. The statues are of a naïve vernacular style and may have been made locally. They appear to be constructed from a clay type material. One depicts the Virgin Mary holding the Child Jesus while the other is of a hooded lady – possibly the Virgin Mary. The two modern statues were sent from England in recent times by a relative of the family (pers comm. Tom Barrett). To the south-east of the altar is a hawthorn tree which is reputed to be the original rag tree associated with the well and pattern at this site. Visits to this site are rare today.

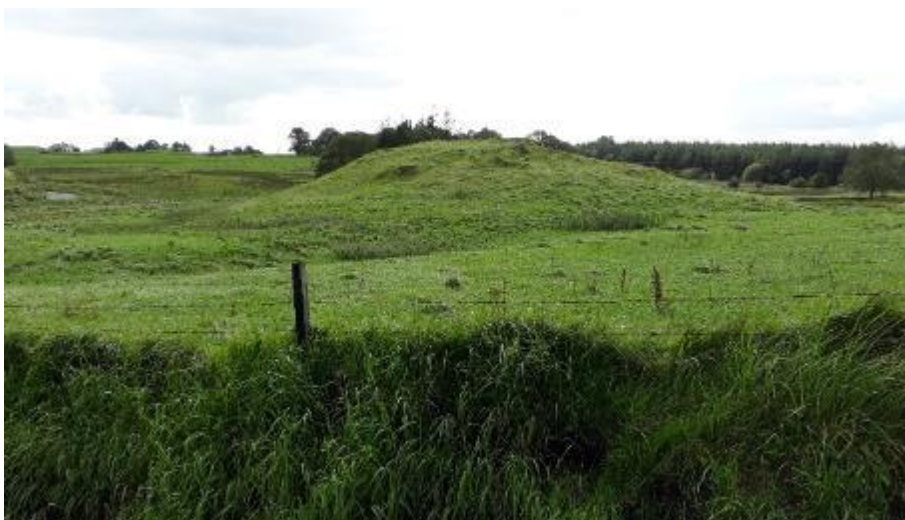
Photograph 103: View of Motte and Bailey in Graigueachullaire townland, from the east.

An existing hill, which is part of the Dunmore Esker, was used for the construction of the motte and bailey in Graigueachullaire townland. It is likely that this fortification was built during the initial conquest of this area shortly after 1235 when Richard De Burgh invaded Connacht. At a later stage a stone castle, 'Doonbally' was built on the summit. Its date of construction is unknown but it was in the possession of 'Thomas Balve' in 1574 (JGAHS 1 (1900-1)). Neary in 1914 described the ruin as *'nine huge blocks of masonry strewn around and upwards of ten tons each, have kept together with wonderful cohesion'* and he surmises from the state of the ruin that it was blown up.

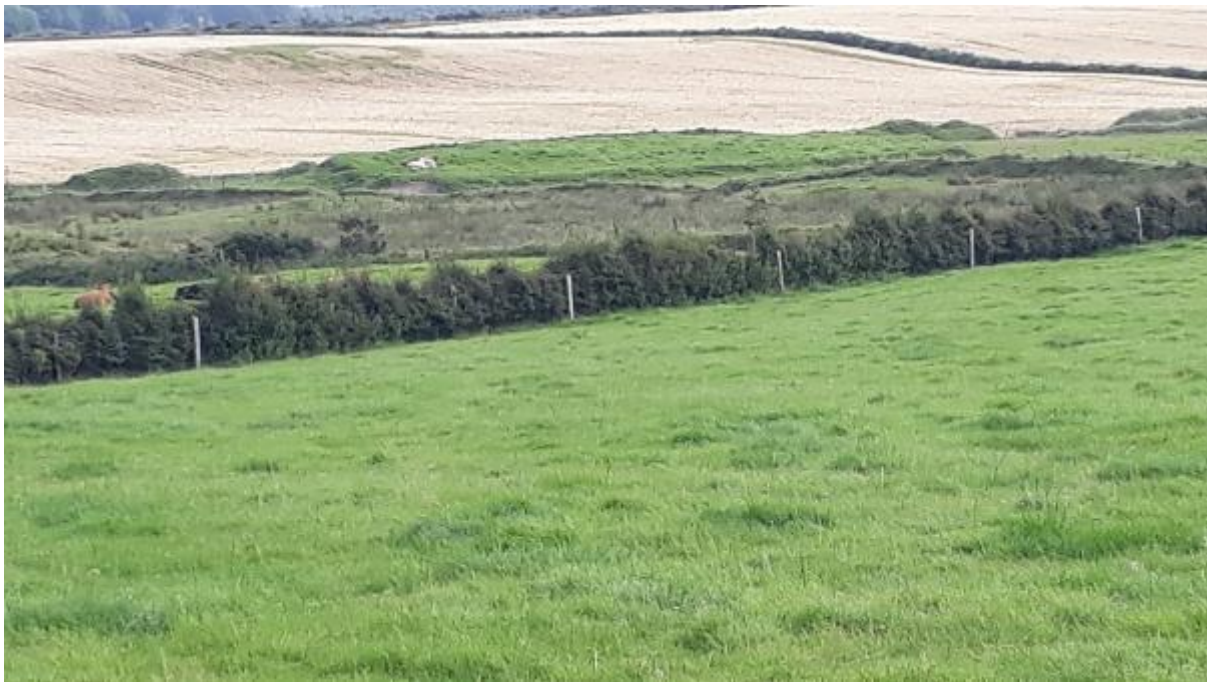
Photograph 105: View of conjoined moated site, in Carrowmunniagh townland, from north.

The largest example within the study area is found in Carrowmunniagh townland and it is classified as a 'well preserved conjoined moated site' by the NMS. It is labelled 'Lisduff' on the OS 6-inch historic maps. It consists of a rectangular enclosure and an adjoining D-Shaped enclosure, both enclosed by two banks and an intervening fosse (or moat). It is sited in a shallow valley, on the south bank of a stream, with traces of dried up channels visible on the east and north-west side which would have allowed water to be diverted from the stream into the moat. In the interior of the D-Shaped enclosure is a grassed over structure of earth and stone which may be the remains of a house. <https://webgis.archaeology.ie/historicenvironment>

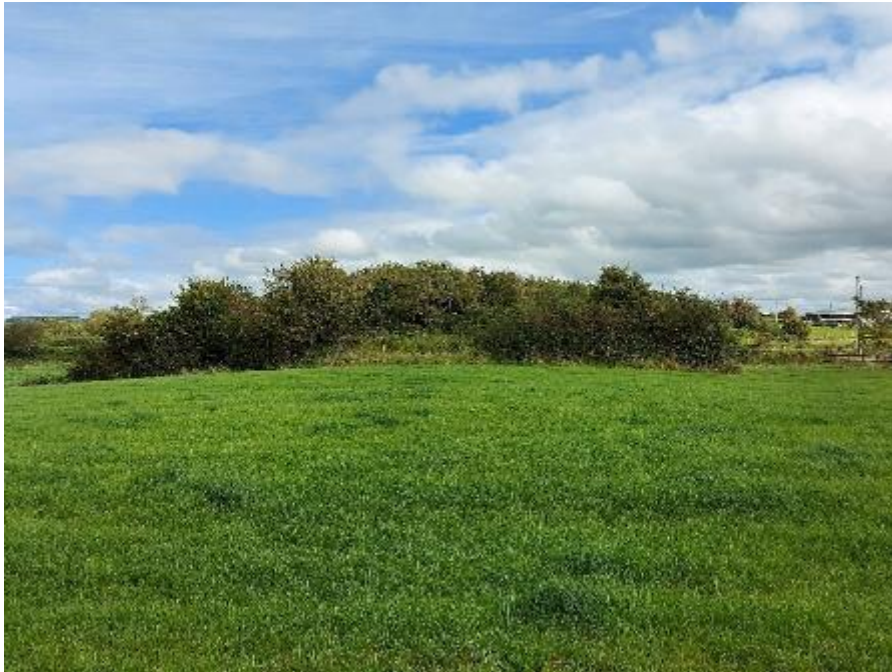
Photograph 106: View of Moated Site in Darry North townland, from the west

A second moated site is located in Darry North townland. It is poorly preserved and overgrown and access is difficult. The interior is enclosed by a scarp, fosse and outer bank, but these do not survive on the east side, and the outer bank on the north is now in use as a field boundary.

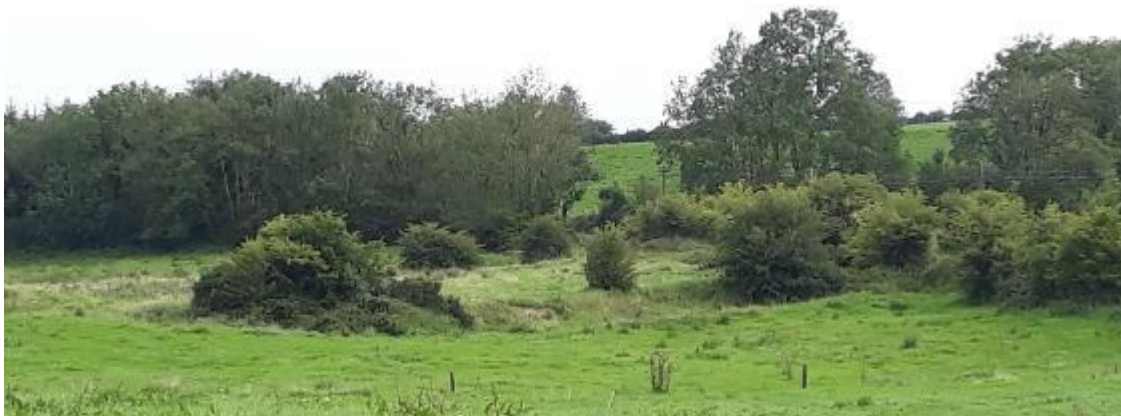
Photograph 107: View of Moated site, in Graigue townland, from the south-west.

A third example is found in Graigue townland, just behind the field boundary immediately west of the Tuam-Dunmore road. This well preserved example is defined by two banks and fosse, but the outer bank does not survive on the north and east sides. There is a possible house site on the inner bank in the south-south-west.

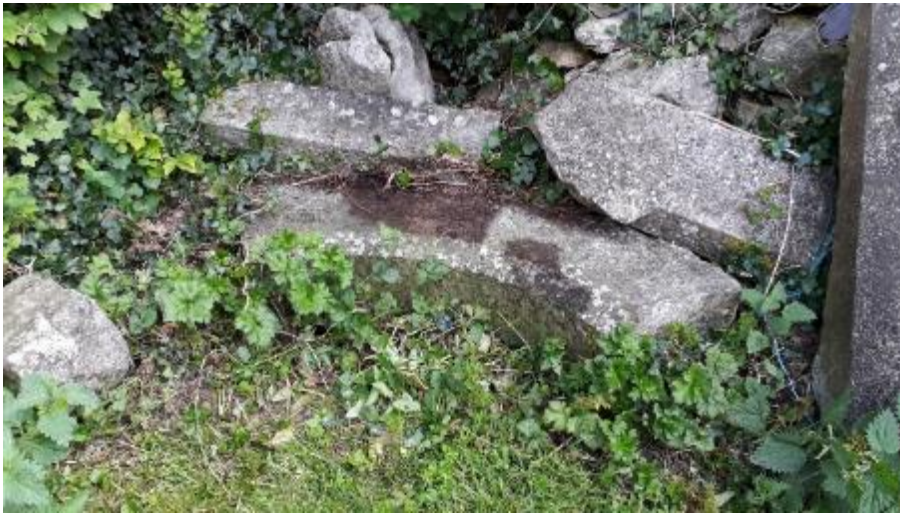
Photograph 109: Fragment of arch stone inscribed with initials

In the adjoining garden on the south side of the castle there are a number of architectural fragments which may have been part of the 13th century hall house (pers. comm. Dr. Christy Cunniffe). These include an arch fragment. Carved on the arch, in relief, are two sets of initials EB and MB. These,

very likely, relate to members of the Birmingham family. When initials were carved together like this on a medieval building they usually signify a marriage between the two individuals concerned.

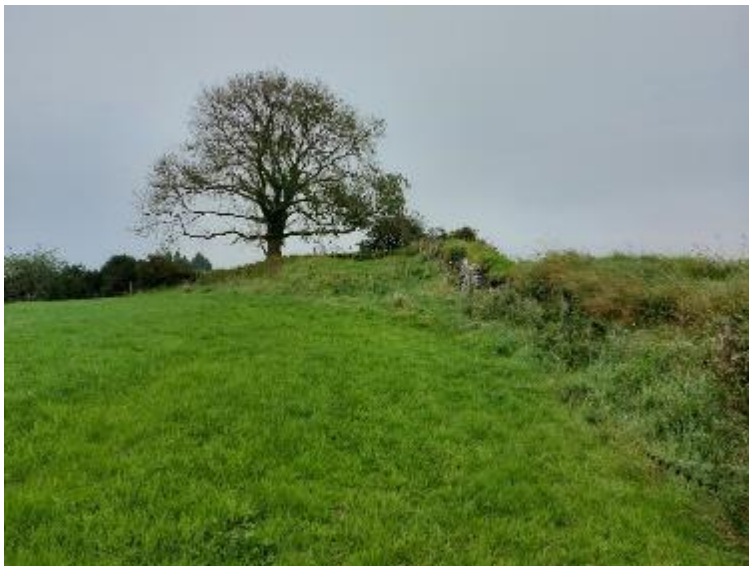
Photograph 113: 'Unclassified Castle' site in Castle Townland

In Castle townland, in the east of the study area, is a grassed-over mound of earth and stone. The site is known locally as 'Caislean Beg or Little Castle'. The antiquarian, Neary described it in 1914 as a 'small square castle ... long a quarry, and only the foundation remains, 24 ft. [7.3m] square in plan, walls 4 ft. [1.2m] thick'. When the NMS surveyed the site in 1998 they described the surviving elements as follows

Neary had also recorded the 'openings of two souterrains ... in the centre of the castle ruin', but the NMS found no trace of these and surmised that they were possibly cellars but unlikely to be souterrains.

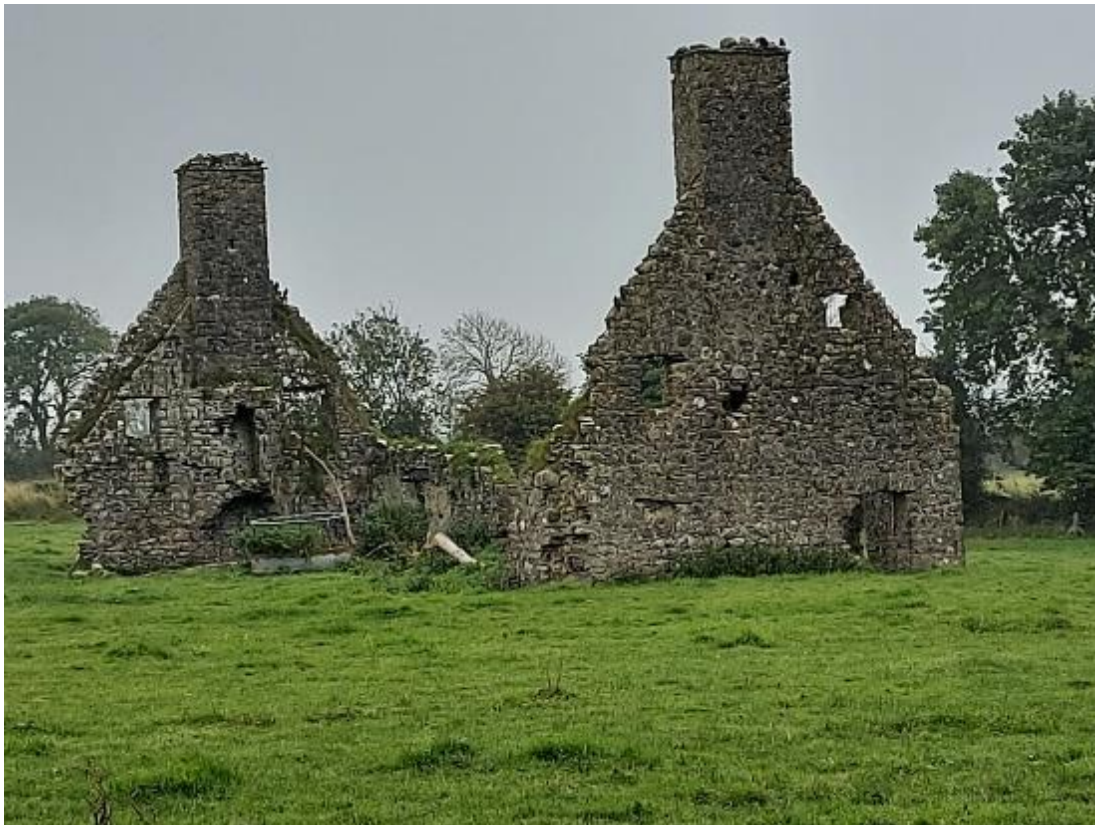
Photograph 114: Remains of a late 17th /early 18th century house in Lissyconor.

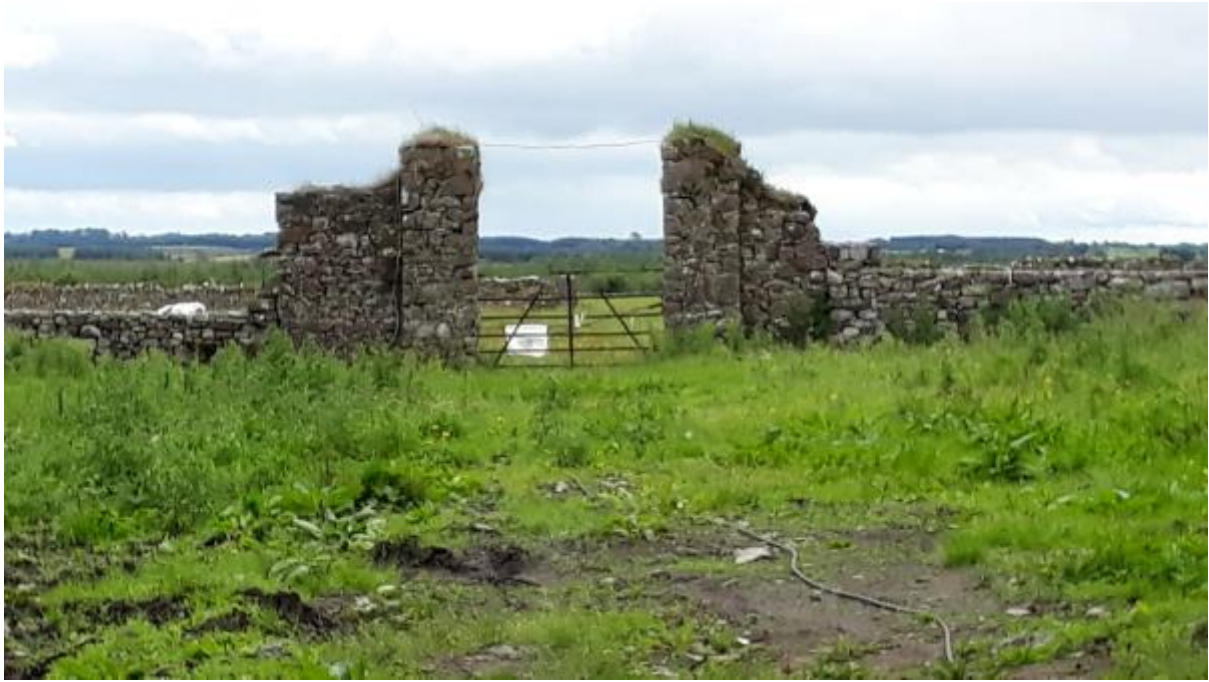
Photograph 116: Remains of boundary walls and gateway at former Woodfield House.

All that remains today at Woodfield are the courtyard boundary walls and some outhouses. A more recent house which stands in the grounds is currently under reconstruction.

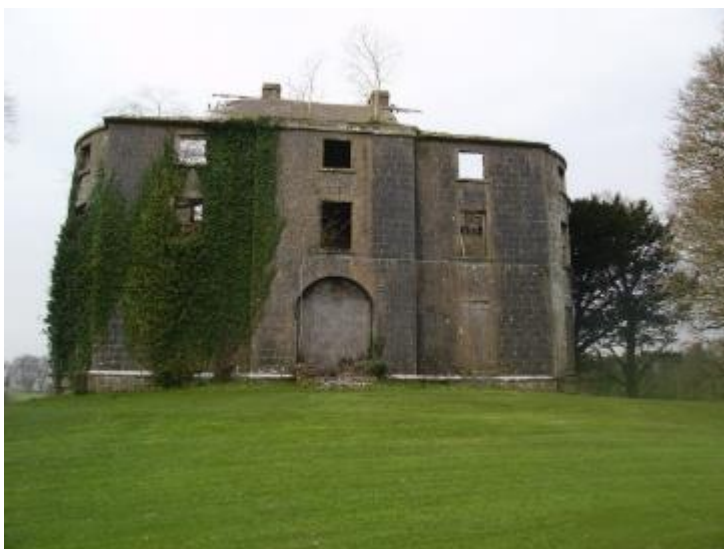
Photograph 118: Dunmore House today

The ruin of Dunmore house is surrounded today by the grounds of Dunmore Golf Course. It was a three-bay three-storey over half-basement house with bowed ends and a shallow entrance breakfront. It had a hipped slate roof and two centrally placed cut limestone chimneystacks. The front of the house was ashlar limestone. The round headed front door was accessed by a series of stone steps.

The house is a protected recorded structure under the National Inventory of Architectural Heritage (NIAH Reg. No. 30330014)

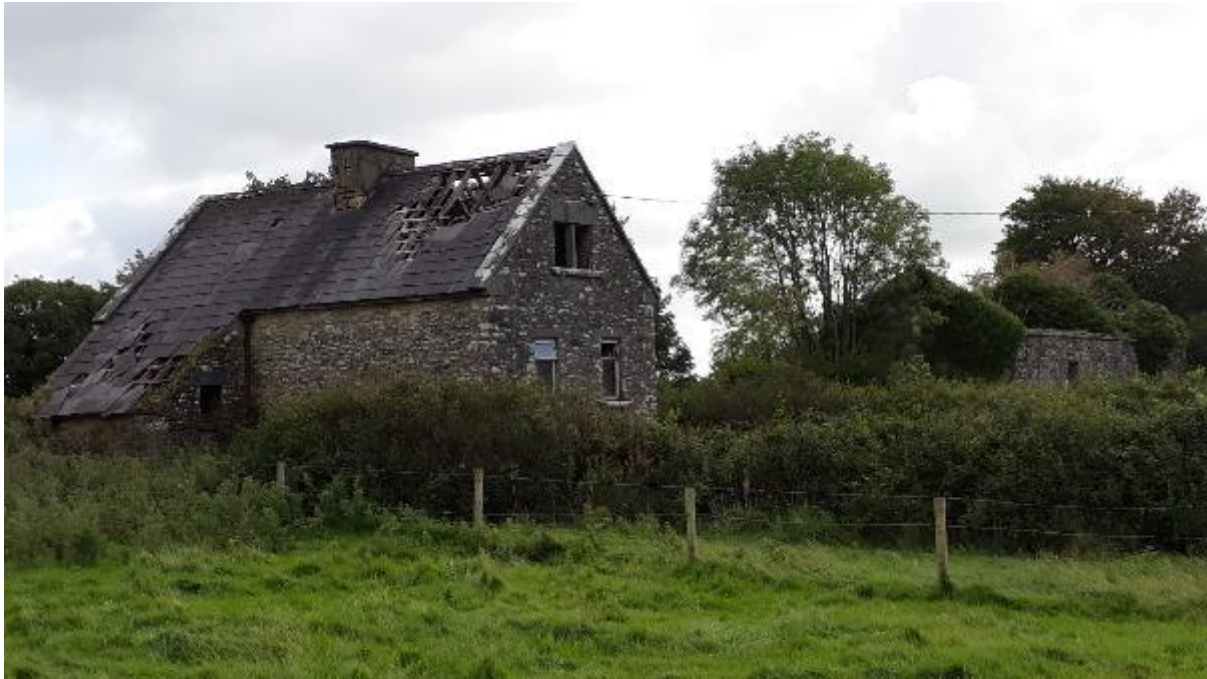
Photograph 121: House and stable block at Curraghaun

A detached, three bay single storey house with dormer attic and cut limestone detail is located in Curraghaun townland. It is part of a complex consisting of the house, an outhouse, a large stable block (on the opposite side of the road), a freestanding stone arch and the remains of a formal garden feature.

The house, outhouse and stable block all have inscribed cut limestone date stones. The inscription on the stable block identifies that this building and very likely the house (due to the cut limestone detail present) were constructed from stone from the former Curraghaun House (which was a Kirwan House) over a period of 2 years (1864 – 1866).

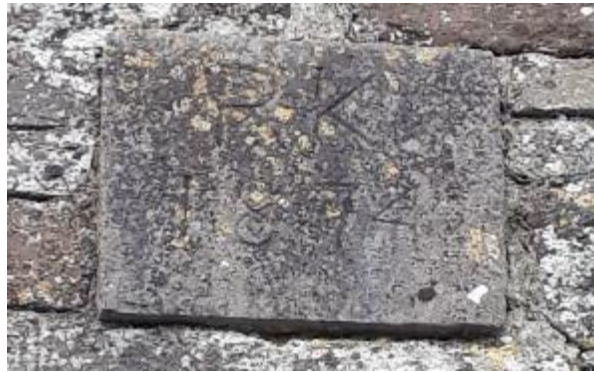
Photograph 124: Date stone (RK 1874) on outhouse.

The outhouse is referred to as the 'high barn' and is believed to be where tenants came twice-yearly to pay their rents on 'Gale Days' (www.garrafrauns.ie). A free standing stone arch to the rear of the herd's house and the outhouse may have been connected to this practice.

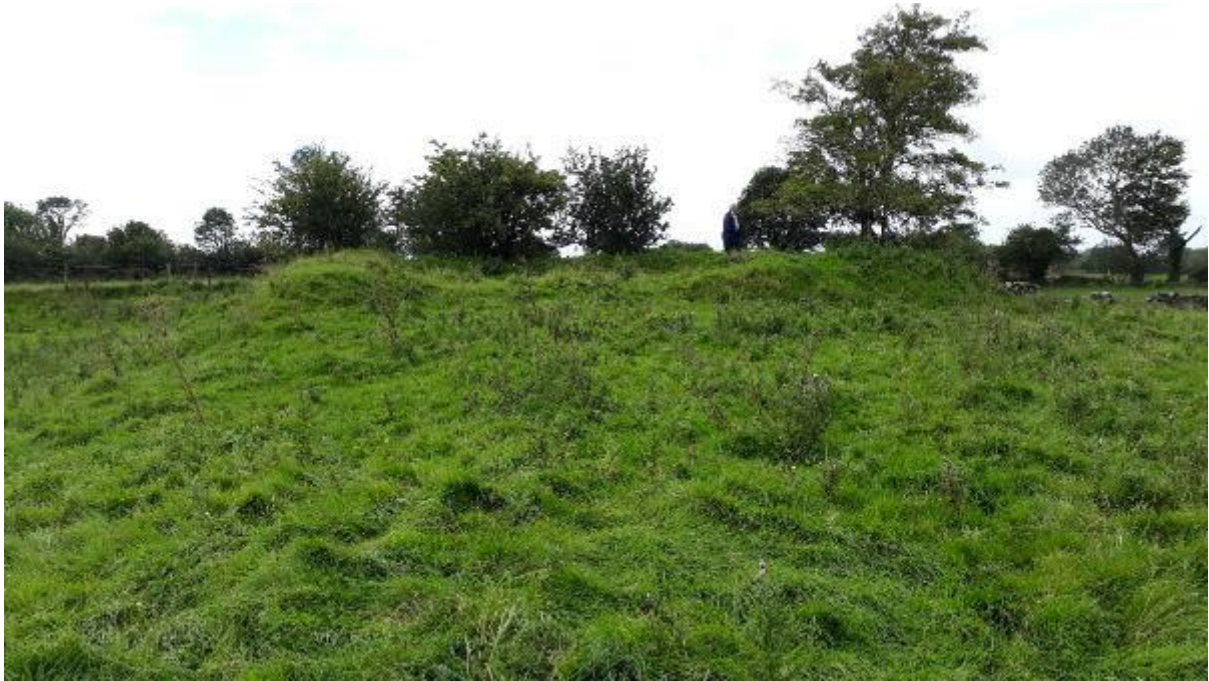
Photograph 126: Remains of late 18th/ early 19th century formal garden feature Curraghaun.

A feature that survives of the formal garden is shown on the 1st edition OS 6-inch map. It is an almost rectangular enclosed platform to the south of the herd's house. The platform is enclosed by an approximately 1metre high earth and stone bank. A modern house has been constructed between the herd's house and the feature.
