DUNMORE HERITAGE AUDIT

COUNTY GALWAY

2020/2021

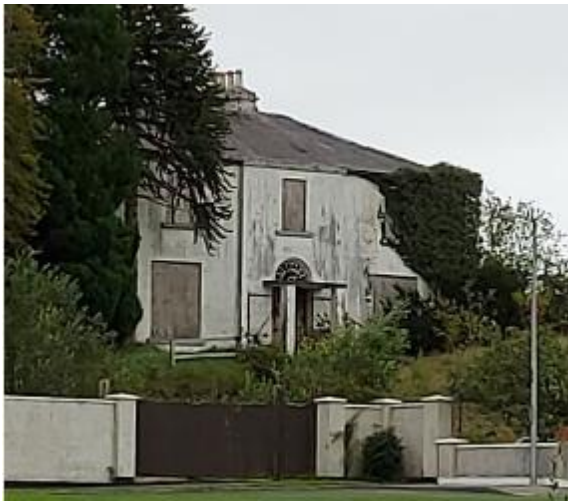
Photograph 129: Sion Hill (The Glebe) 2020

This Georgian detached three-bay two-storey over basement house was built in 1828 for Sir George Shee (info from Renate Cooke). It was the residence of a number of Church of Ireland Ministers whose church was at that time part of the Augustinian Friary. Church of Ireland services were held in the house in 1865 as renovations were taking place to the church in the Friary. There is allegedly a tunnel linking the house to the Abbey under the river (pers. comm. Joan Walkin) The Black and Tan soldiers occupied the house for a while. It was bought by Dr John Cooke from the Bank of Ireland c.1931 and the Cooke family remained in residence until 2002.

There are single-storey, rubble stone outbuildings to the rear of the house. The house is now derelict and the square-headed windows are boarded up. The house is a listed protected structure on the National Inventory of Architectural Heritage (NIAH Reg. No. 30330006).

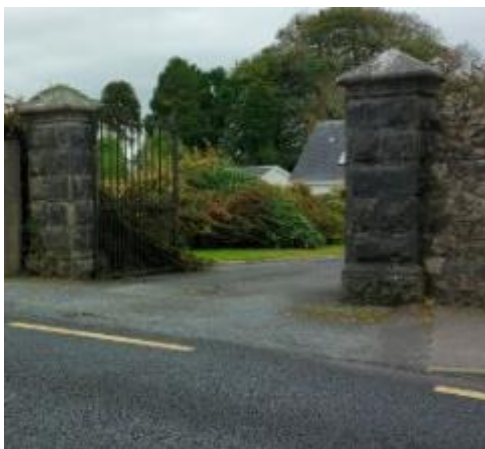
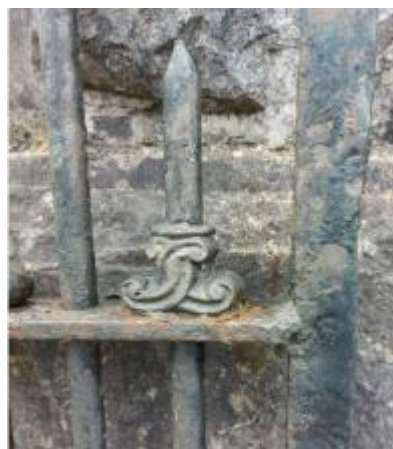
Photographs 130-131: Back entrance cast iron gates and stone pillars to the former Sion Hill House (The Glebe)

The set of stone piers and cast iron gates on Sion Hill opposite the National School, mark the original back entrance way to the house. They are not original to the house but were purchased from a Convent in Ballyhaunis Co. Mayo in the 1970s. (Information from Renate Cooke to Joan Walkin). The main entrance to the house was located close to the present day entrance to Friars Walk housing estate.

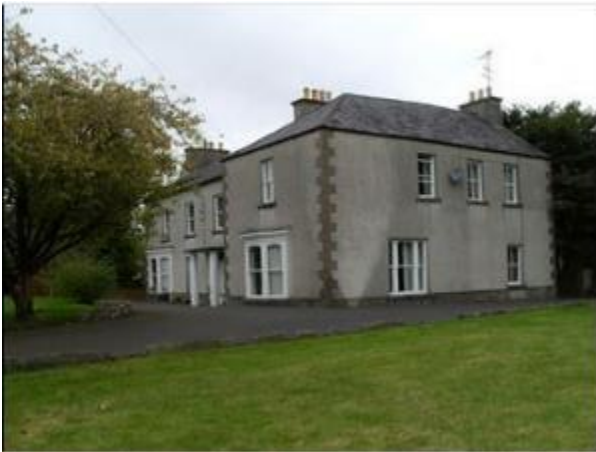
Photograph 132: St Mary's House Dunmore

Set in its own grounds this simple Georgian style house is composed of a detached four-bay two-storey block built c.1810 and a three-bay additional block added c.1830 to the side. Two Victorian-style canted-bay windows were added to the front of the house c.1880. The grounds are enclosed by rendered walls and metal gates.

The house is a protected structure listed on the NIAH (Reg. No.: 30330003) and on the RPS.

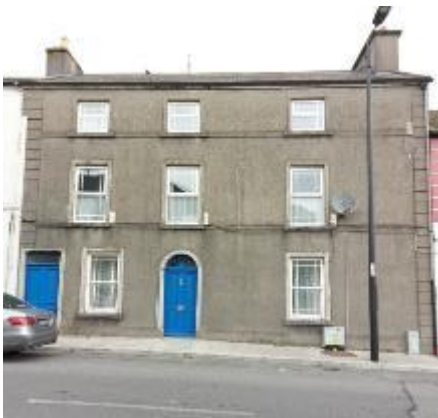
Photograph 133: House on High St., Dunmore

The terraced three storey house in High St. was built c.1820 and retains its original proportions and use. It has a four-bay ground floor and three-bay upper floors. The walls are cement ruled and lined with probable rubble stone beneath. The square-headed windows have raised moulded cement surrounds and limestone sills. The ground floor windows are the original margined timber sliding sash one-over-one pane but the upper floors have replacement uPVC windows. There are two doorways at ground level. The round-headed doorway has a spoked timber fanlight, while the square-headed doorway has an overhead. Both have 19th century timber panelled doors. The house is a protected structure listed on the NIAH (Reg. No.: 30330010) and the RPS.

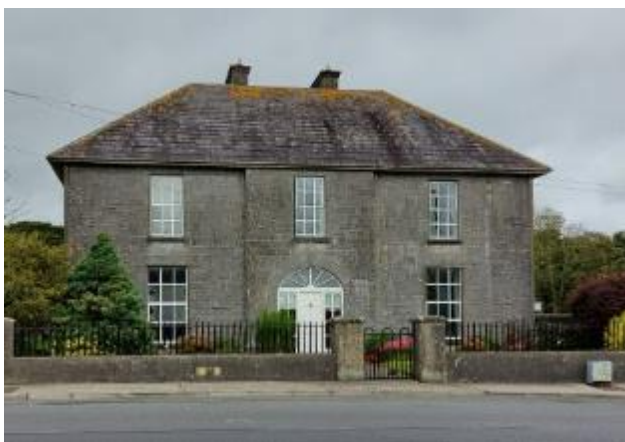
Photograph 134: Parochial House, Dunmore

The Parochial House on High St is a detached three-bay two-storey L-plan house which was built c.1820. On the 1890 OS 6-inch map, it is labelled as 'Merton House'. It is placed in a strategic position facing down the street opposite and is set back from the street with wrought-iron railings on a rendered plinth wall and a decorative wrought-iron pedestrian gate set between a pair of limestone piers with caps.

The rendered chimneystacks are set behind the roof ridge. A shallow entrance breakfront has a wide segmental-headed doorway with a replacement timber door and fanlight. The tall square-headed windows have limestone sills and replacement uPVC glazing. The house is a protected structure listed on the NIAH (Reg. No.: 30330013) but it is not included on the RPS.

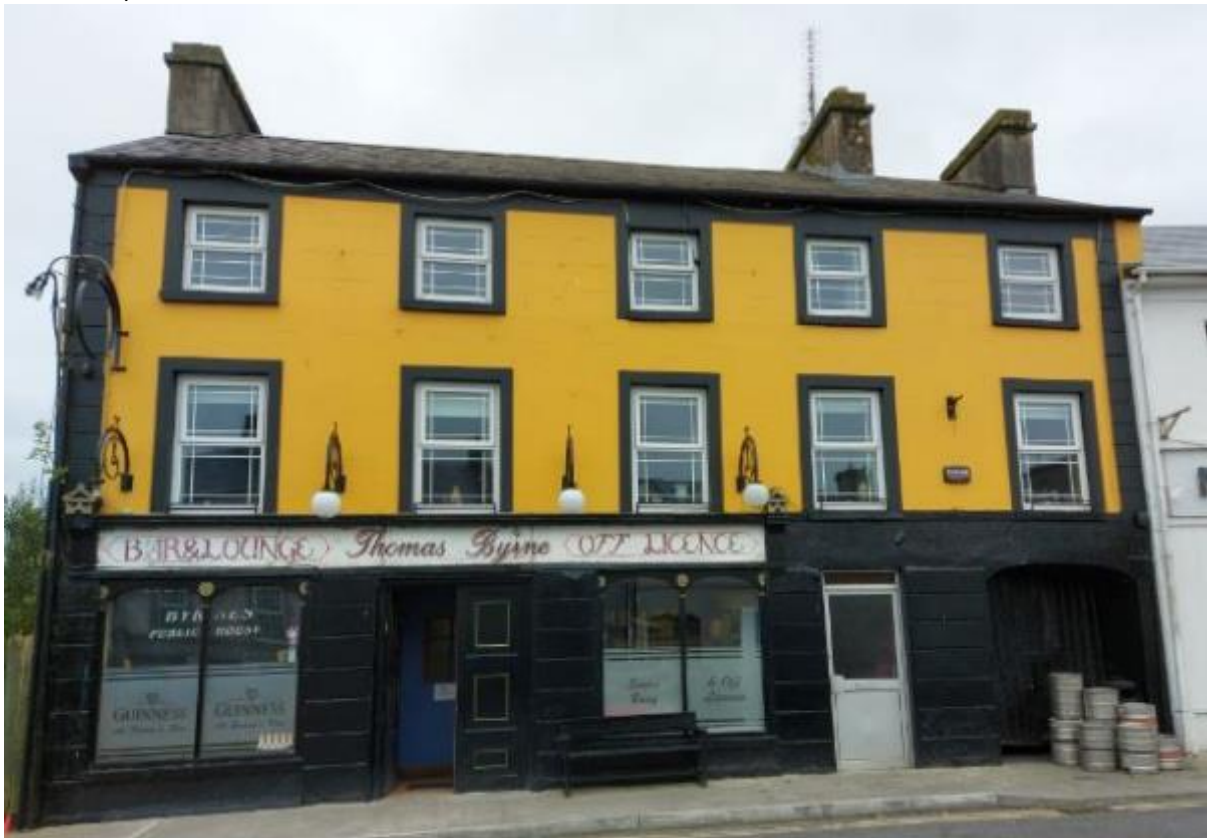
Photograph 135: Thomas Byrne Bar and Lounge, Dunmore.

The building has a low pitched natural slate roof with three rendered chimneystacks. The rubble limestone walls are rendered and painted, ruled and lined on the upper floor and channelled on the ground floor. The square-headed window openings on the upper floors have stone sills and raised render surrounds. They are replacement uPVC windows.

The shopfront is defined by decorative pedimented brackets, a plain fascia with a moulded cornice and painted lettering. A central double-leaf panelled timber door is flanked by two display windows divided by a central mullion. The building is listed as a protected structure on the NIAH (Reg. No. 30330012) and also on the RPS.

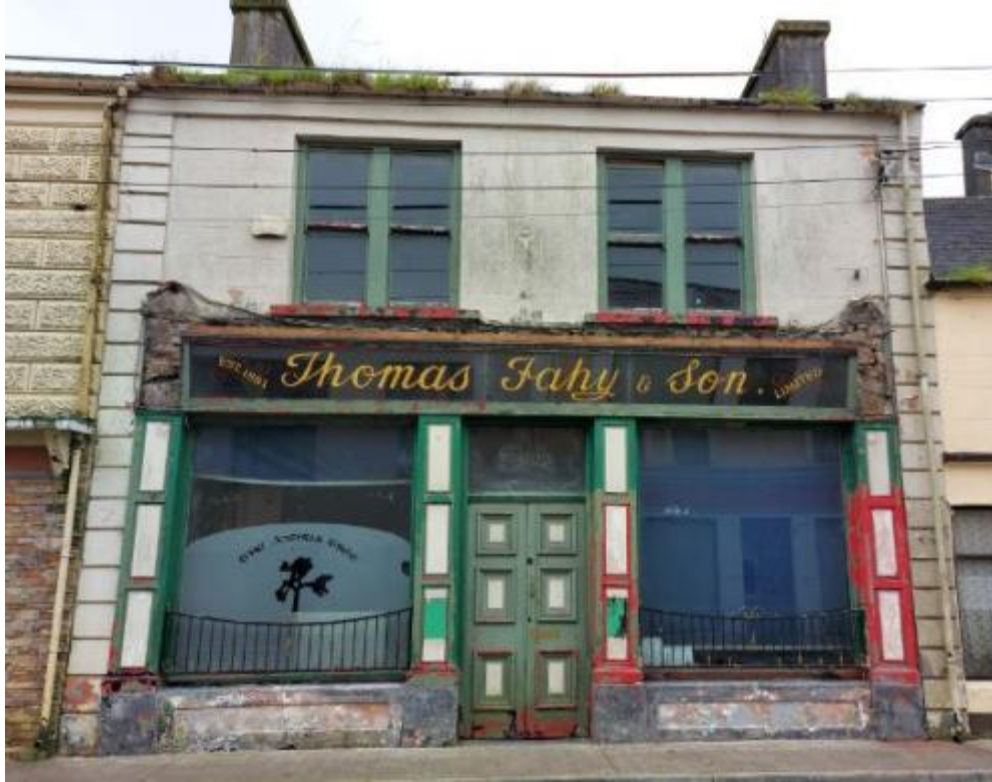
Photograph 136: Thomas Fahy & Son Public House 2020.

This terraced two-bay two-storey house was built c.1830 and a public house front was added c.1881 to the ground floor. The building was remodelled c.1910. There has been a marked dilapidation of the building and shopfront since it was recorded for the NIAH inventory in 2009. In 2009, the NIAH described it as *'the fine render shopfront is one of the best in Dunmore and the incorporation of mirrors into the brackets is unusual and decorative'*.

It has a pitched slated roof with rendered chimneystacks and the walls are rendered and painted with parallel, raised quoins. The shopfront has panelled pilasters with plinths and brackets which were recorded as incorporating mirrors by the NIAH. The double-leaf timber panelled entrance door has a rectangular overhead. The display windows are protected by wrought-iron railings. The building is listed on the NIAH (Reg. No.: 30330008) and on the RPS.

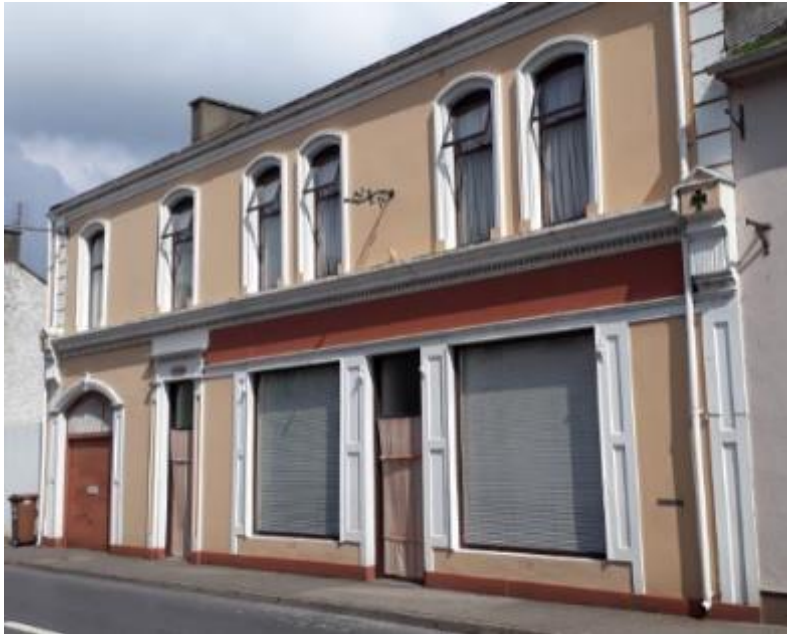
Photograph 137: Former shopfront, Castle Street

This early twentieth-century shop and house are a noteworthy part of Castle Street. The range of well-maintained mouldings and plasterwork sets the building apart from its neighbours and adds to the architectural variety of the town.

The carriage arch at the north end is flanked by panelled pilasters and topped with a moulded arch with a fluted keystone. The first floor windows openings are camber-headed with moulded architraves and replacement timber casement windows. They are grouped in two pairs to the south end.

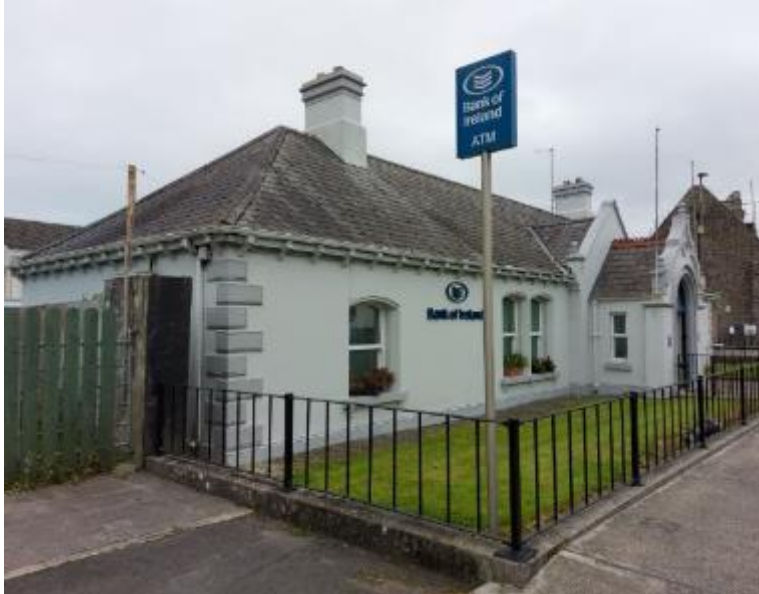
Photograph 138: Bank of Ireland Dunmore

The building that currently houses the Bank of Ireland, though typical in detailing of a late Victorian bank building, is unusually single storey. It is sited on Barrack St and has a small grass area to the front enclosed by metal railings on a rendered plinth.

The building is listed on the NIAH (Reg. No.: 30330009) and on the RPS. The Bank of Ireland in Dunmore is scheduled for closure in September 2021.

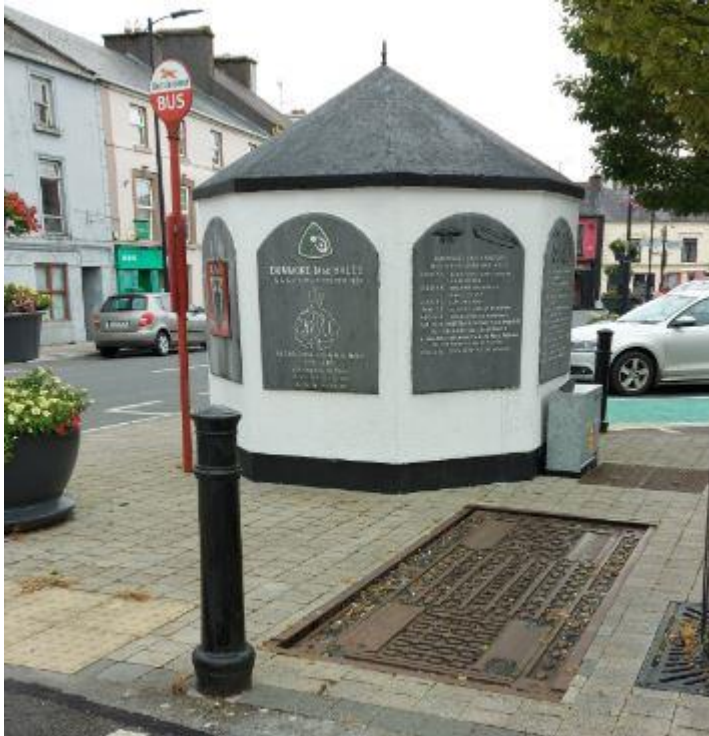
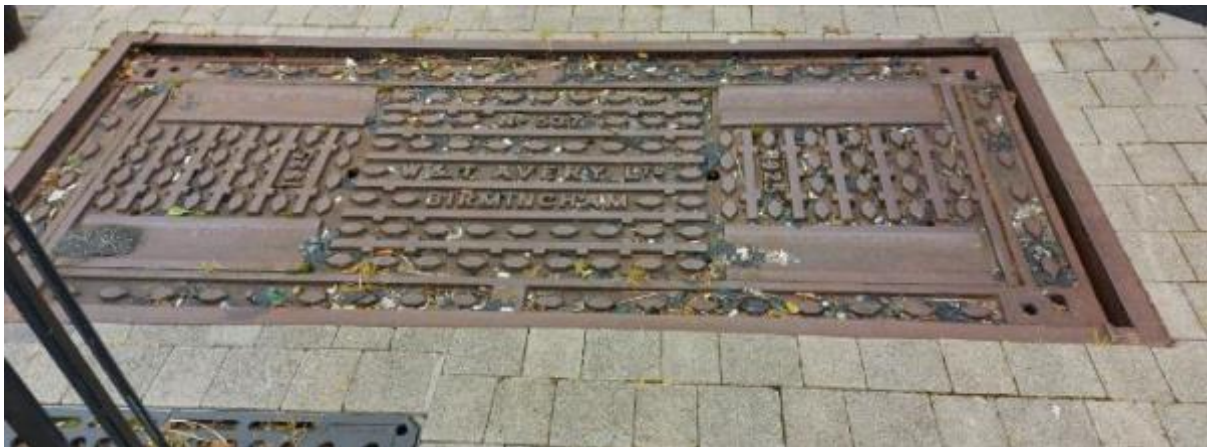
Photographs 139-140: Weighbridge and House, the Square, Dunmore

The weighbridge and house located in the Town Square is a notable and unique feature of the architecture of Dunmore and its history as a market town. Once a common feature in market towns most have been removed.

The octagonal-plan single-storey weigh-house has a conical roof and rendered painted walls. A square-headed doorway is located on the north side. Limestone plaques commemorating local history and events have been inserted around the exterior walls.

The decorative cast-iron weighbridge is located on the south-east side of the house. There are four wheel channels at the corners. The makers name and date 'W&T Avery Ltd Birmingham 1925 No. 537' are inscribed in raised lettering and decorative motifs give a very attractive pattern. The house and weighbridge are listed on the NIAH (Reg. No.: 30330011) and on the RPS.

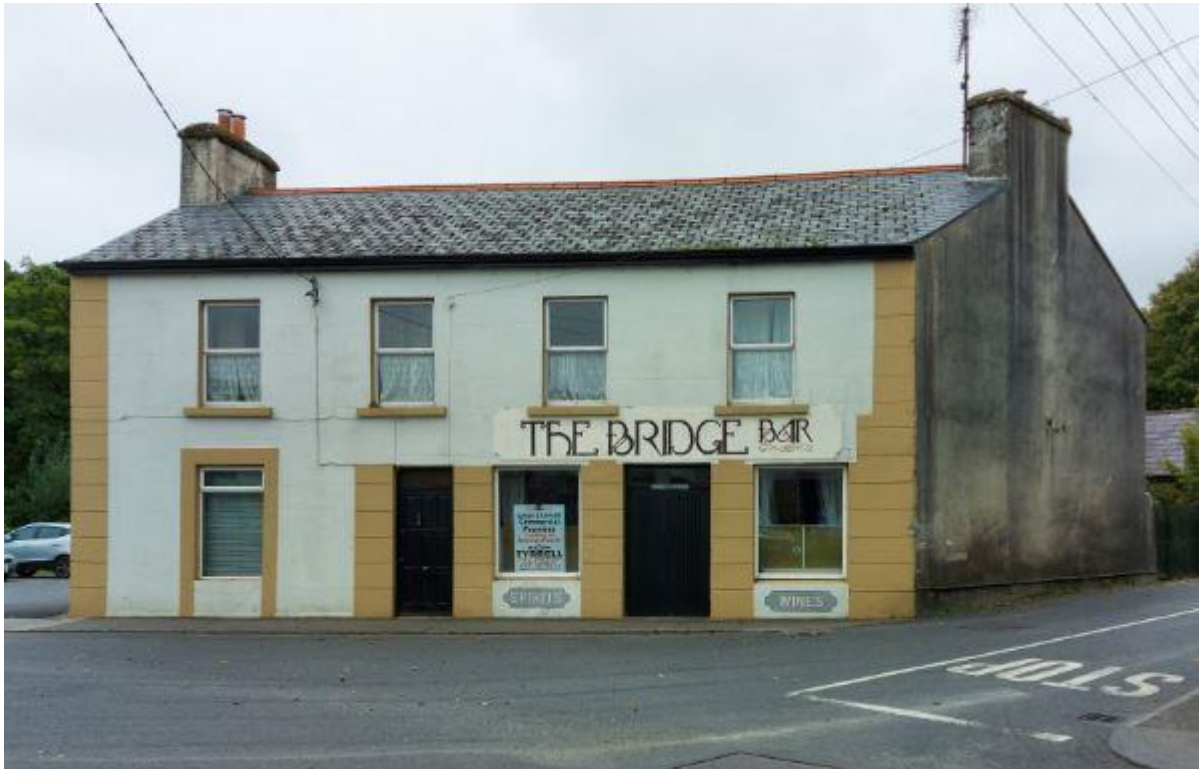
Photograph 141: The Bridge Bar, Dunmore

This building dating to the late 1800s was designed to fit into the layout of the earlier, possibly medieval street plan. John Loftus, the owner of the Bridge Bar built a Handball Alley to the rear of the building. The back wall of the alley is still standing. (Information from Hubert Birmingham).

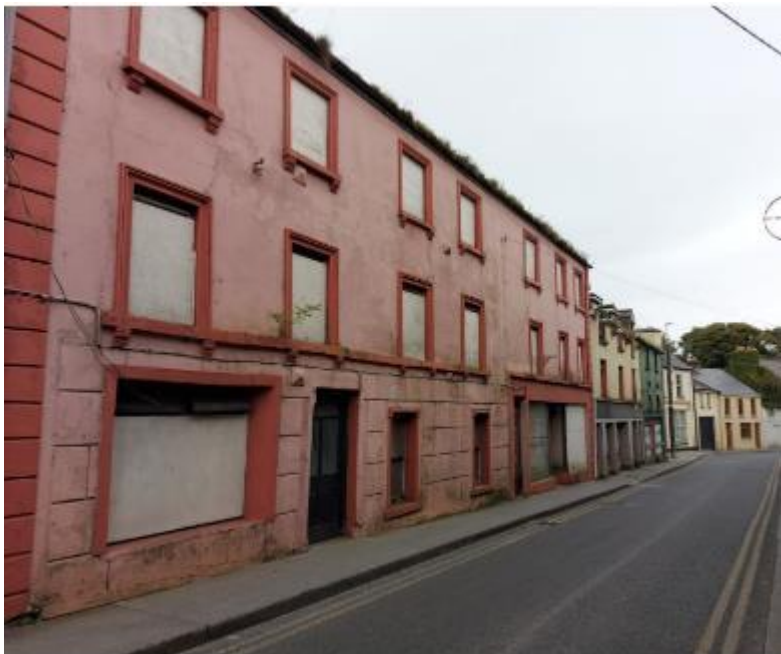
Photograph 142: Former McDonnells Department Store, Bridge St., Dunmore

This derelict building on Bridge St. exhibits many of the architectural features common in the town including square headed windows with moulded surrounds set on brackets, a continuous sill course to the first floor and a shopfront inserted into the ground floor. The recessed entrance doorway is

tilled with a very attractive mosaic pattern inscribed with the owner's name. This was once the entrance to a large department store owned by Martin McDonnell, a merchant from Roscommon who prospered significantly in the mid-1800s. He later opened branches in Tuam, Milltown, Mountbellew, Ballyhaunis and Cloonfad. He held eight townlands in the parish of Boyounagh, one in the parish of Tuam and one in the parish of Dunmore at the time of Griffith's Valuation. He bought almost 6,000 acres of Lord Fitzgerald's estate in the vicinity of Dunmore in the early 1850s. By the 1870s he owned over 9,000 acres in county Galway, 2,940 acres in county Roscommon and three acres in county Mayo. (<http://landedestates.nuigalway.ie/>) His life and times are detailed in the book 'The Life and Times of Martin McDonnell, Merchant, Landlord and Poor Law Guardian' by William Keaveney. (Information from Joan Walkin)

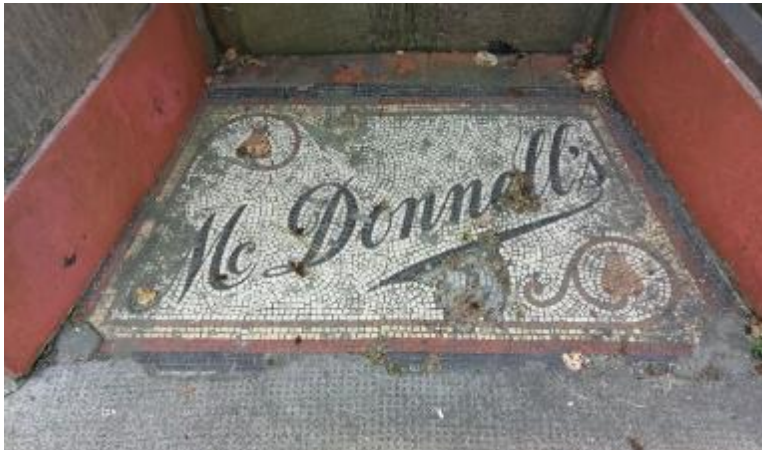
Photograph 143: Mosaic tiled entrance door step Bridge St., Dunmore

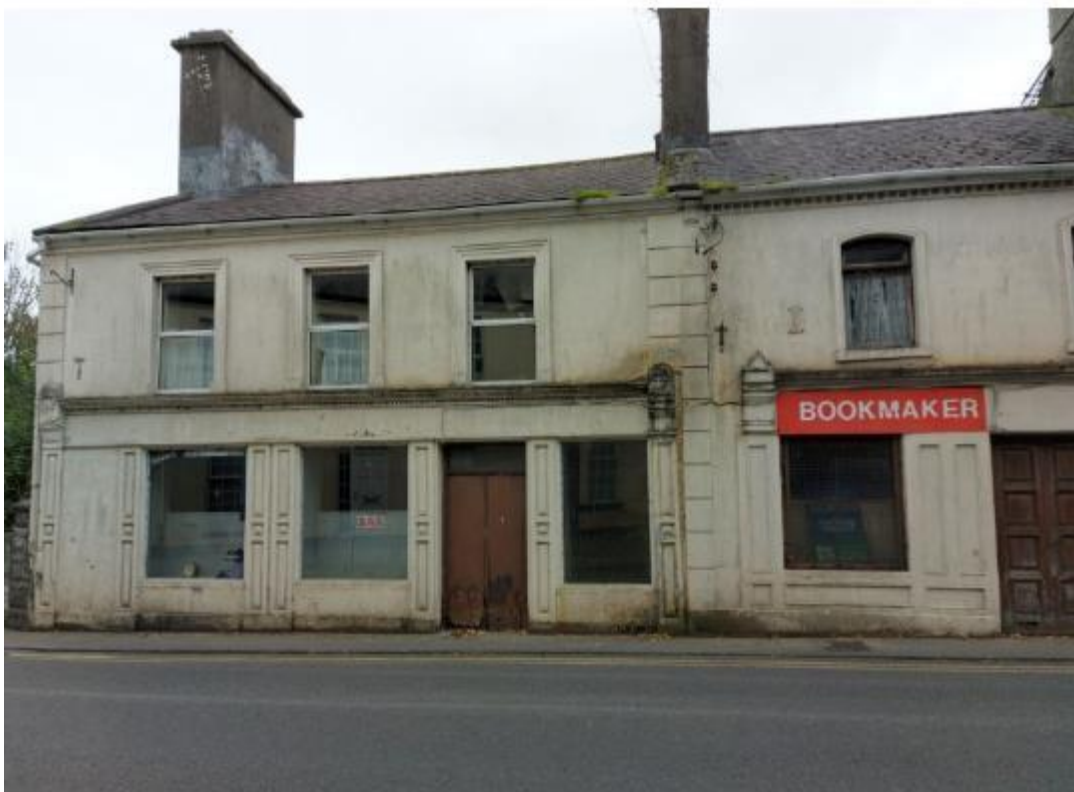
Photograph 144: Former houses with integral shopfronts, Bridge St., Dunmore

A number of derelict houses with integral vernacular shopfronts are located on Bridge St. A noticeable feature of these buildings are the high chimneystacks. The buildings on the east side of Bridge St. are due for demolition under the Dunmore Rural Regeneration Scheme which is underway by Galway County Council. <http://www.galway.ie/en/services/roads/roadsprojects/dunmore/> The purpose of the project is to improve the centre of Dunmore to enable regeneration within the town, improve the usability of Bridge Street and encourage use of the Square. A feasibility study was completed with public consultation in 2020 with five route options presented to alleviate traffic flow problems in the town. Option 2 has been selected and is currently being forwarded for planning.

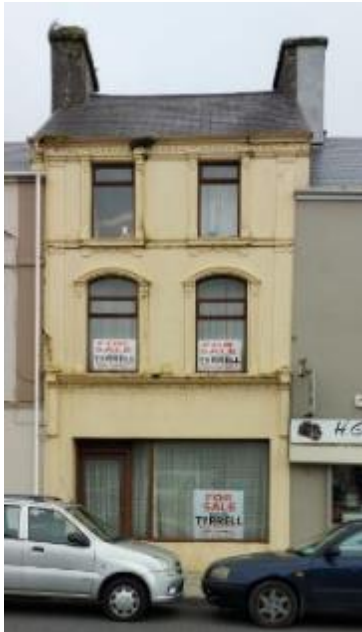
Photograph145: An unusually narrow three storey, two bay building with integral shopfront, the Square, Dunmore

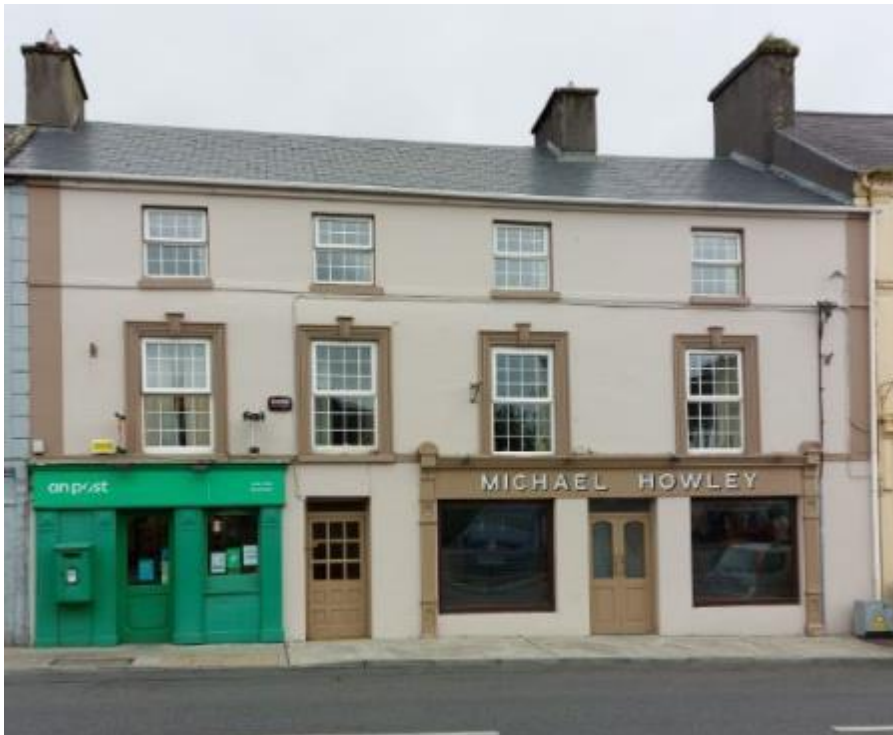
Photograph 146: Traditional shopfront with hand painted name plate and modern post office shopfront set into ground floor of house. Second floor windows with decorative channelled architrave with central pediment.

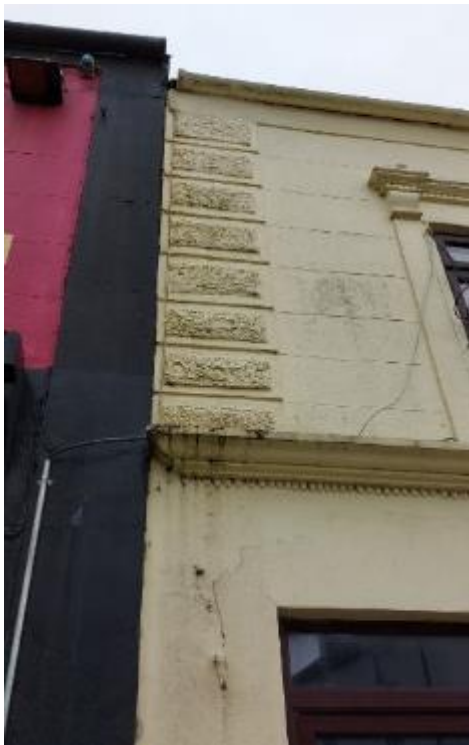
Photograph 148: Plaster decoration on quoin stones of building in The Square.

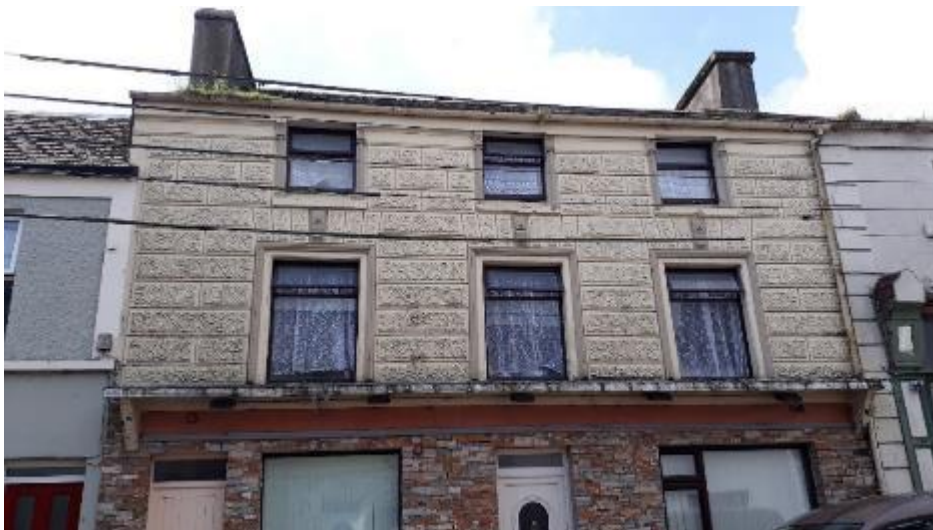
Photograph 149: Plaster decoration on lined and rendered façade of upper floors of house in Castle St. with remains of fascia of a traditional shopfront over ground floor.

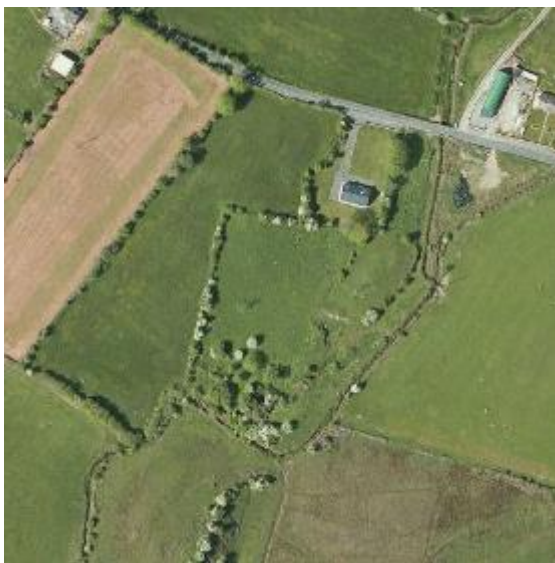
Photograph 150: Ruins of Millers House at Garrafrauns mill site

The mill was built in 1842 by Daniel Heverin on the site of an earlier mill. Daniel was a member of a family of mill wrights who lived in Lavallyroe, near Cloonfad.

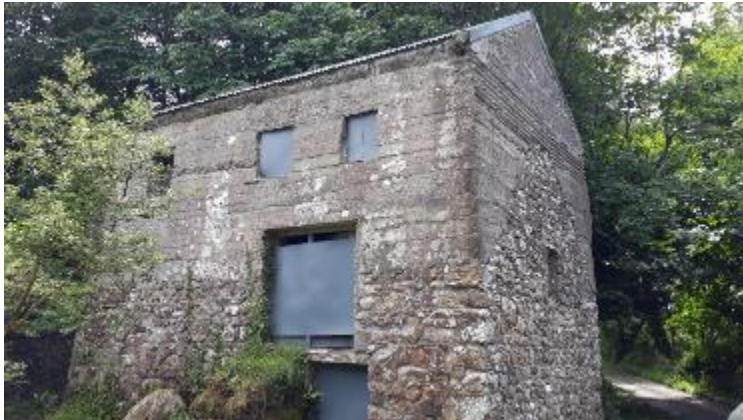
Photograph 152: Drumbane mill

One of the millstones of the Drumbane mill lies against the exterior wall. A second stone from this mill is currently located outside the entrance to a newly built nearby house. An extra storey was added to the existing two storey mill in 1928 and the mill ceased operation in the 1960s. The tuck mill is a one-storey building on the opposite side of the mill race to the corn mill. Both mills operated

from the one wheel and the wooden shaft of the wheel is still in place in the mill race between the two mills. A chaff house for collecting the husk from the oats is attached to the rear of the mill. The chaff was used as fertiliser on the adjoining land (information from Steven Corcoran)

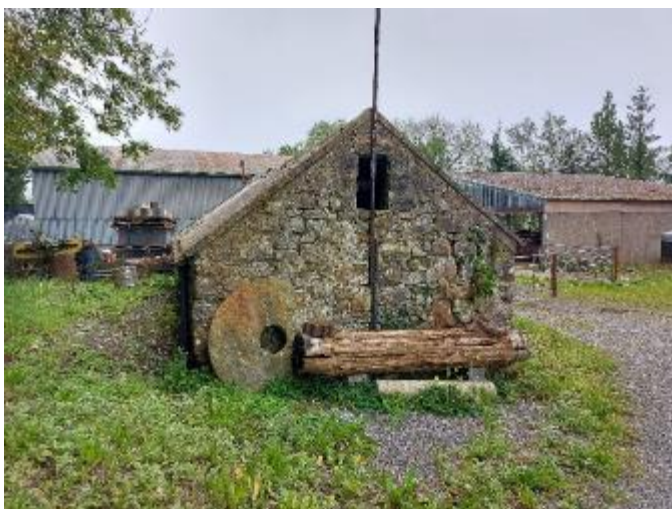
Photograph 154: Surviving storage shed, mill stone, wheel shaft, rynd and cog at Woodfield

The mill at Woodfield was always operated by the Comer Family, members of whom still live here. The corn mill was demolished in the late 1960s and a modern agricultural shed stands on the site today. A rubble stone, one-storey with attic out building survives. This would appear to have been a storage barn for the grain. One of the mill stones is placed against the side wall of this building along with the original wooden shaft of the mill wheel, a rynd from a stone and a cog.

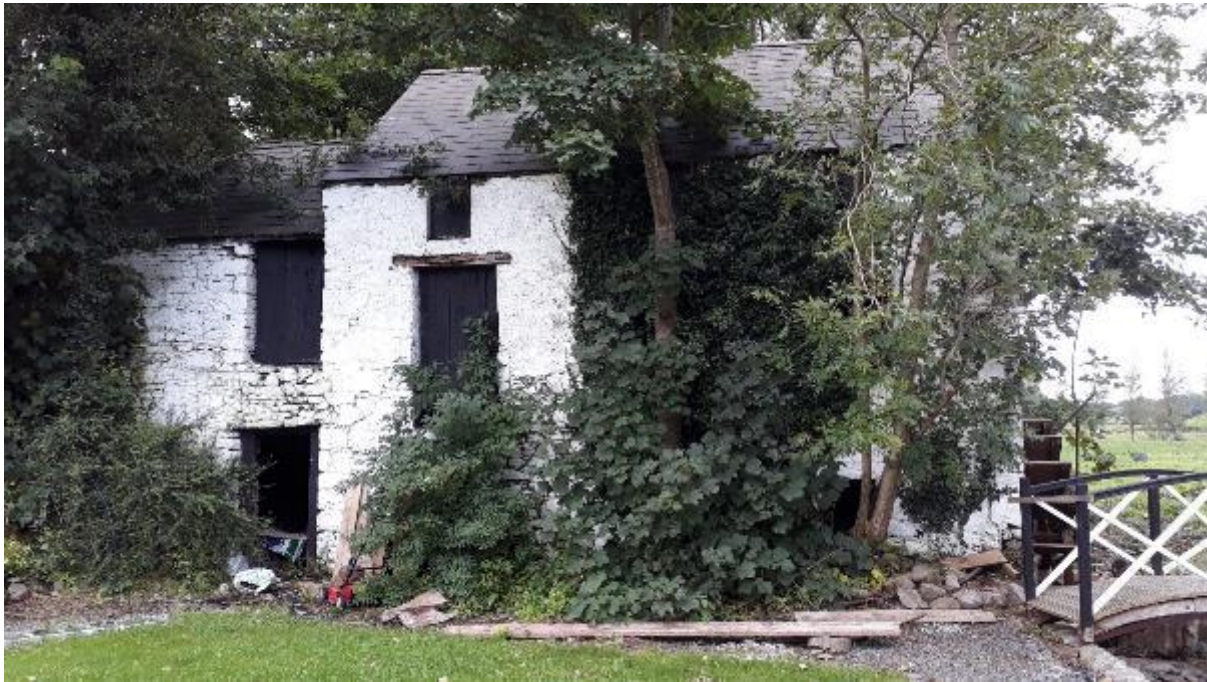
Photograph 156: Clooneen Mill

An important group of mill buildings are set back from the road on the south side of the Sinking River in Clooneen townland. The main mill building is three storeys and was built c.1760. Attached to it on the south is a two storey building with a one storey return to the rear, which is the former kiln with the perforated floor and fireplace still visible. Tom Byrne, the current owner, carried out some restoration work on the buildings in recent years, reconstructing the mill wheel and repairing the walls of the mill race. The interior of the mill is in a collapsed state, but the iron shafts, cogs and millstones are still present.

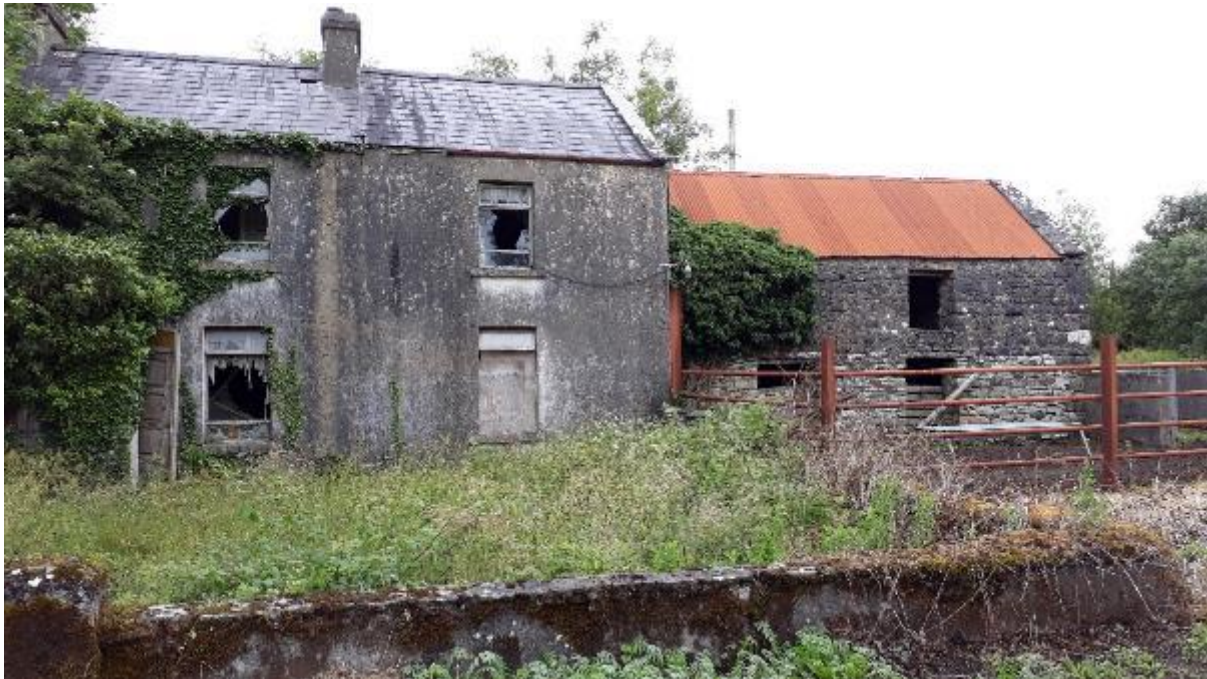
Photograph 157: Attiflynn Mill

In Attiflynn, the existing buildings consist of the ruin of a two storey house (which appears to have been occupied in more recent times) and an adjoining outhouse to the east. On the west side, where the mill race ran there is the ruin of a one storey building where the mill workings would have been. On the opposite side of the road is a large rubble stone building which may have been a grain store and possible kiln. A millstone from this mill is now located nearby, outside Eddie O'Loughlins house.

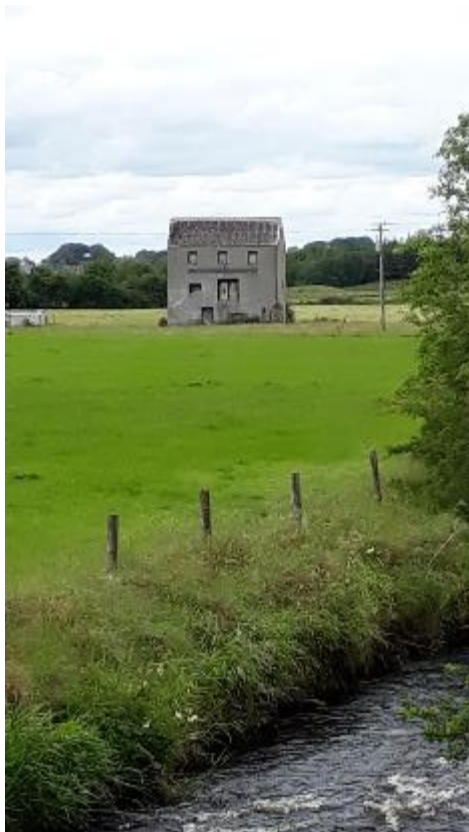
Photograph 159: Addergoolemore Mill

The remains of Corcoran's Mill at Addergoolemore consists of a three storey rectangular mill building. The mill race and wheel are no longer in evidence. A millstone from this mill is currently found outside Dunmore Friary. It was installed here to commemorate the twinning of Dunmore with Quierrien.

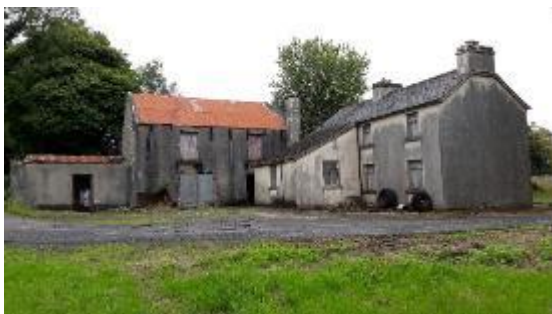
Photograph 160: Remaining two storey storage shed at Gortaganny Mill

The remains of Connells mill at Gortaganny consist of a two storey storage shed. The mill has been demolished and the mill pond and mill race removed.

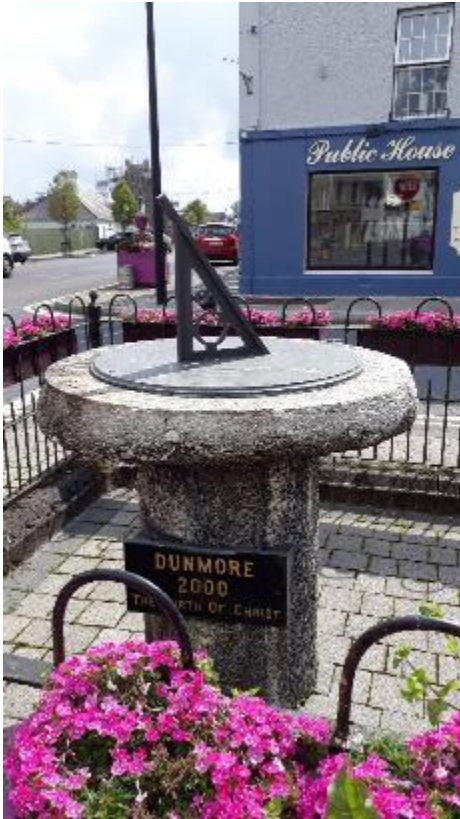
The Dunmore Millennium Sundial in the town square is mounted on a millstone set on a stone pillar. The sundial is based on a 19th century sundial which was made for Black Rock Lighthouse, Co. Sligo and bought by local man, Tommy Keaveney in 1948. Tommy had the vision of enlarging the 12-inch sundial into a 30-inch version to be placed in Dunmore. In conjunction with Dunmore Tidy Towns Committee the project was brought to fruition in 2000 AD. Seamus Kilgarriff Engineering, Dunmore made the brass disc and Jimmy Mullins Engineering, Stonepark prepared the base. The dial is mounted on a mill stone which was originally part of Gannons mill in Cloonarkin, near Cloonfad.

Johnny Glennon, Kiltivna made the concrete plinth and Paul Murphy, stonecutter made the commemorative plaque and cut the Latitude and Local Apparent time into the millstone base. (Information taken from an article by David Burke, Tuam Herald, 30 December, 2000)

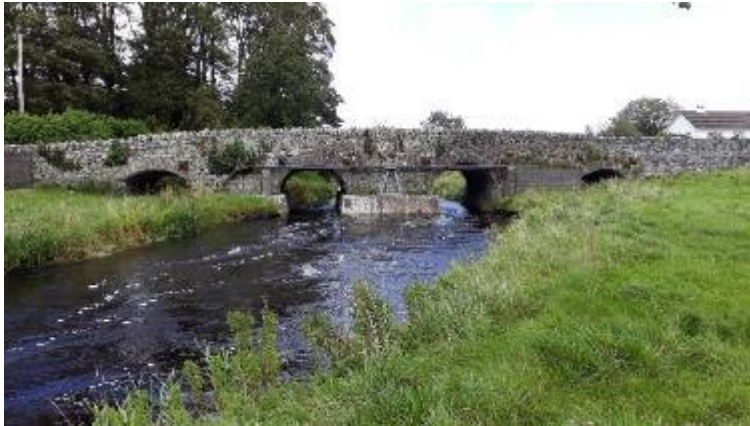
arch and flat-fronted concrete cutwaters between the arches. A section of the parapet to the south-west has been replaced with concrete block and flat coping and concrete block work supports pipework on the south-west elevation. Due to its historical and architectural importance the bridge is listed on the NIAH (Reg. No.: 3033001) and on the RPS.

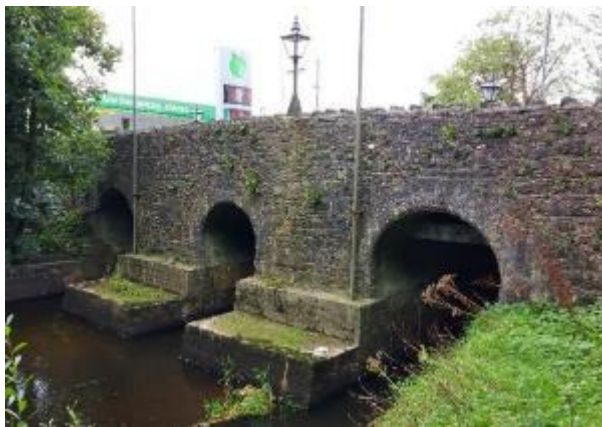
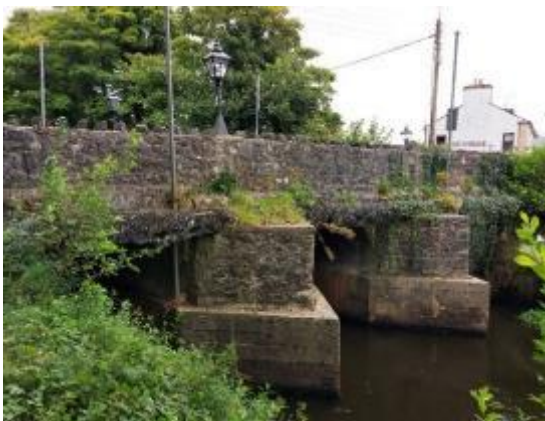
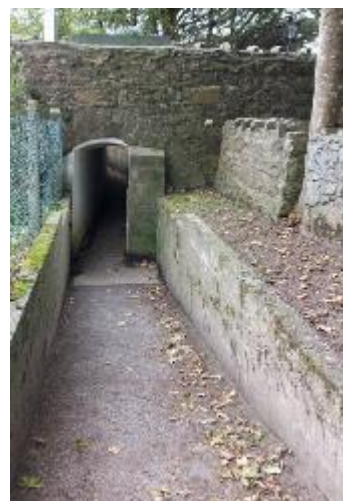
Further upstream is the bridge in Dunmore town. Built of rubble limestone, it has roughly hewn copings and cut limestone detail to the arches. The most southern arch has been converted into a public walkway. Large cutwaters protect the structure from floodwater flow on the upstream side.

Photographs 163-165: Views of bridge in Dunmore Town

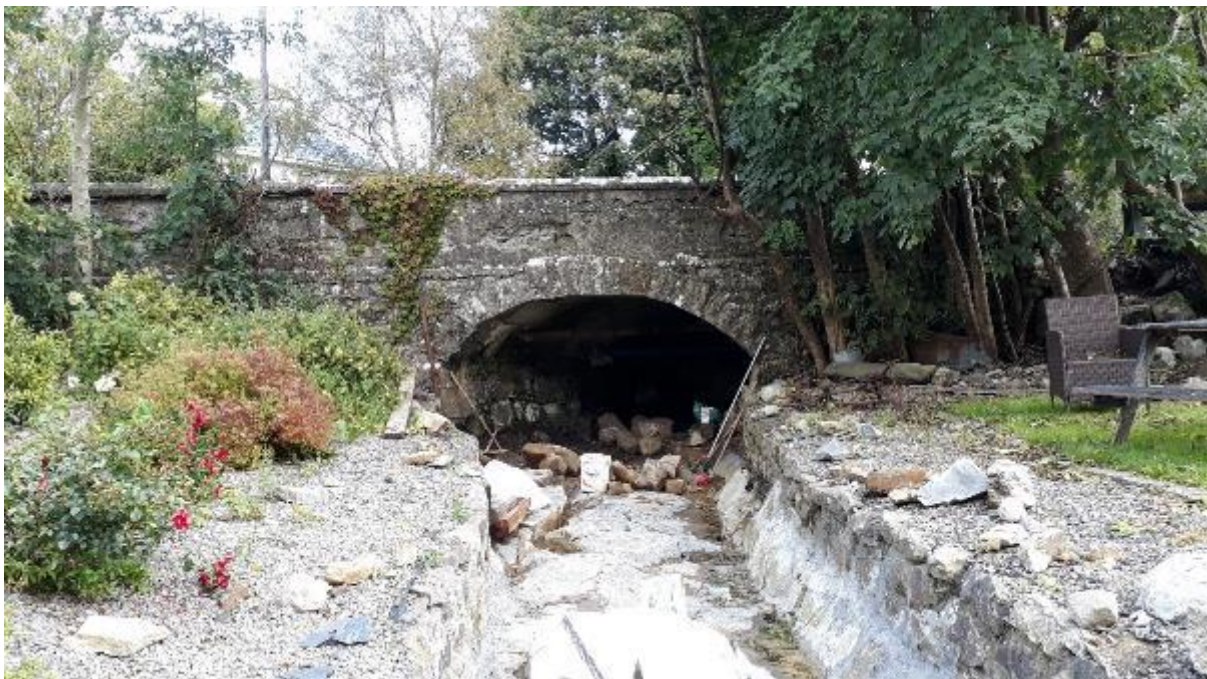
Photograph 169: Clooneen Mill Race Bridge

The beautifully constructed, small, one-arch bridge at Clooneen mill, at the edge of Dunmore Town, originally crossed the mill race that fed the mill wheel. Built from rubble limestone, the parapet and arch voussoirs are of cut stone. Today the mill race channel is dry and the limestone bedrock is exposed, allowing a good view of the underside of this bridge.

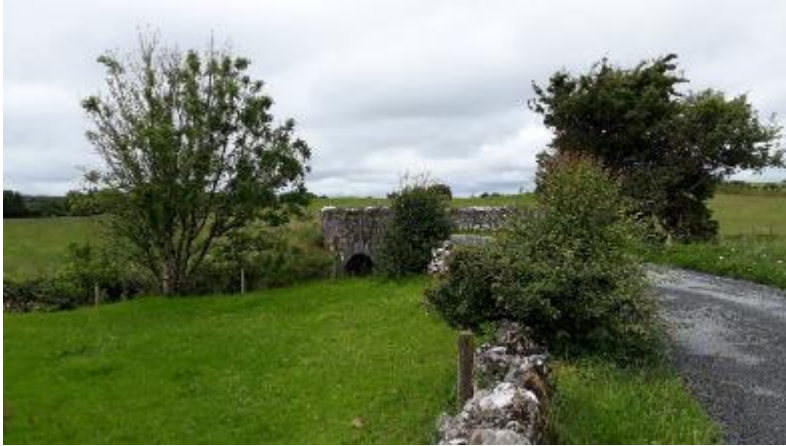
A small hump backed, single arch rubble stone bridge with cut stone arch detail is found in Woodfield townland. It may have been constructed as part of the Kirwan's Woodfield estate.

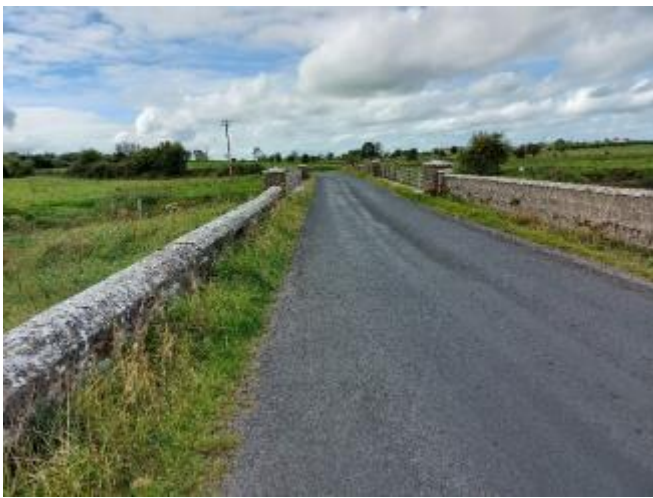
In more recent years, concrete bridges have been constructed such as that at Cloonmore and Cloonaghgarve. The bridge at Cloonaghgarve was built as part of the River Corrib Drainage Scheme which began in 1954.

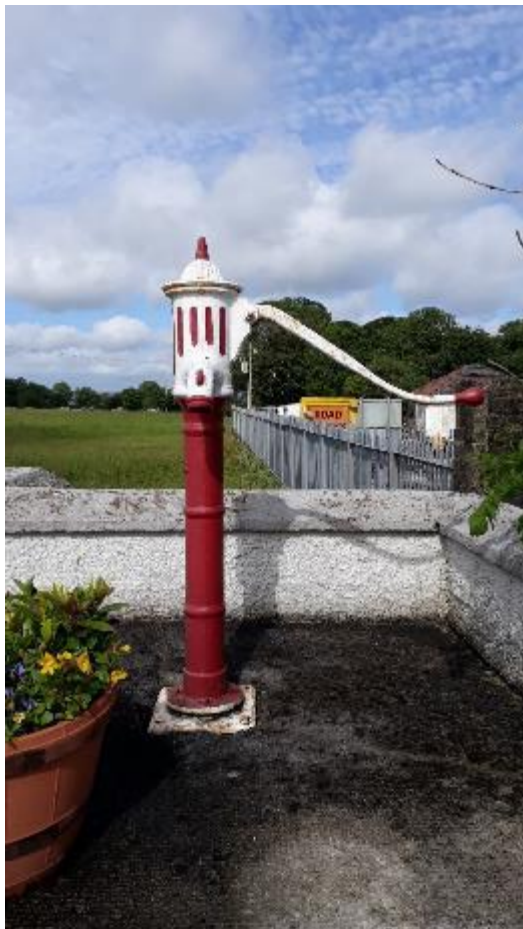
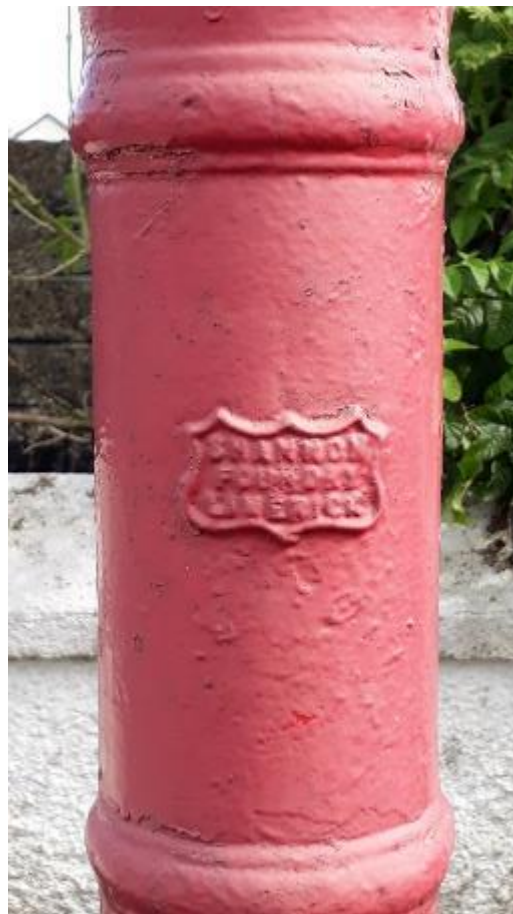
Photographs 173-174: Kiltivna pump and makers stamp.

The water pump was a vital utility in daily rural life in the past. The most common type that survives in the study area is the typical freestanding cast-iron pump with a fluted cylindrical shaft, spout with fluted neck and plain bucket grip, and a cow's tail pumping arm, fluted upper part topped with fluted domed cap with pointed finial. The pump is generally set on a concrete plinth with a protective wall to the sides and rear and it is accessed by a flight of concrete steps. There are a number of these pumps surviving in good condition, maintained by the local community and painted in a variety of colours. A selection are shown in the accompanying photographs. The general date for this type of pump is the late 1800s. Many were made in Shannon Foundry Limerick, as is stamped on the pump in Kiltivna village.

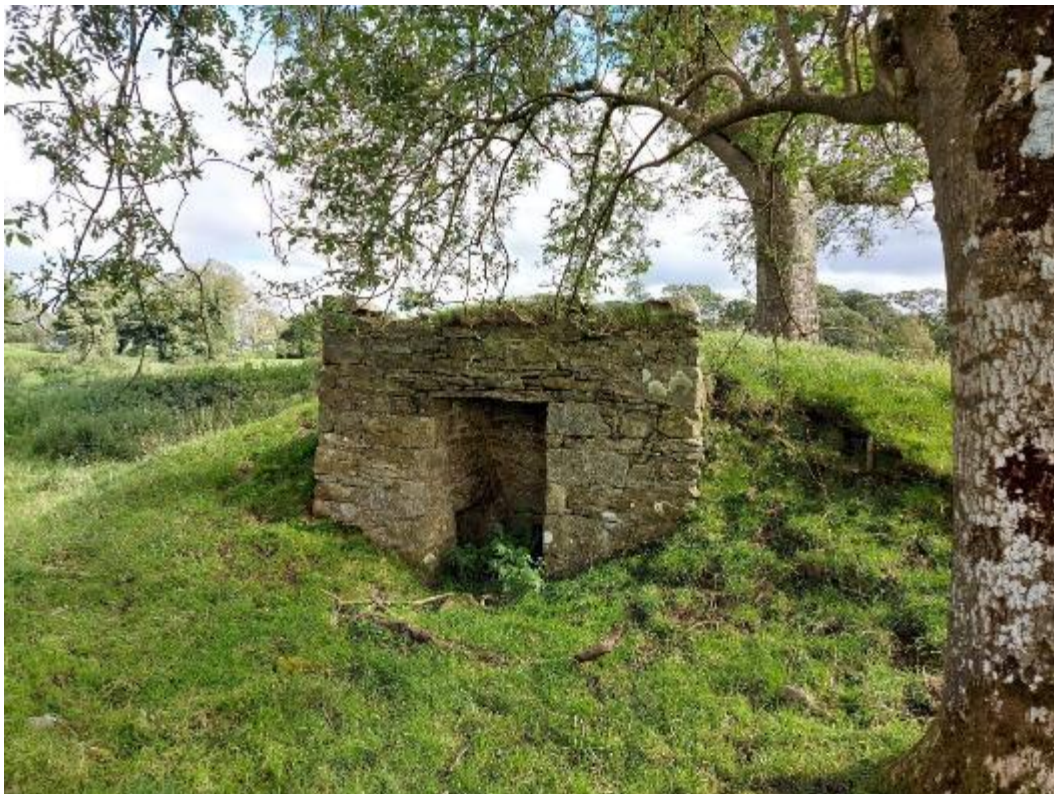
Photograph 179 : Cloonfane Lime kiln

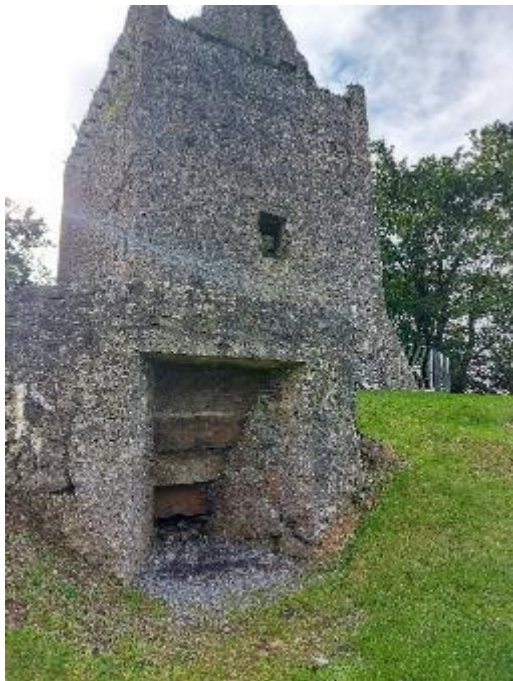
Photograph 180: Lime Kiln at Dunmore Castle

There were three lime kilns in the vicinity of Dunmore Castle, one of which is still very evident today adjacent to the laneway beneath the Castle. A 19th century photograph shows people working the kilns and very likely using stone from the castle walls, the lower sections which appear ‘robbed out’.
