DUNMORE HERITAGE AUDIT

COUNTY GALWAY

2020/2021

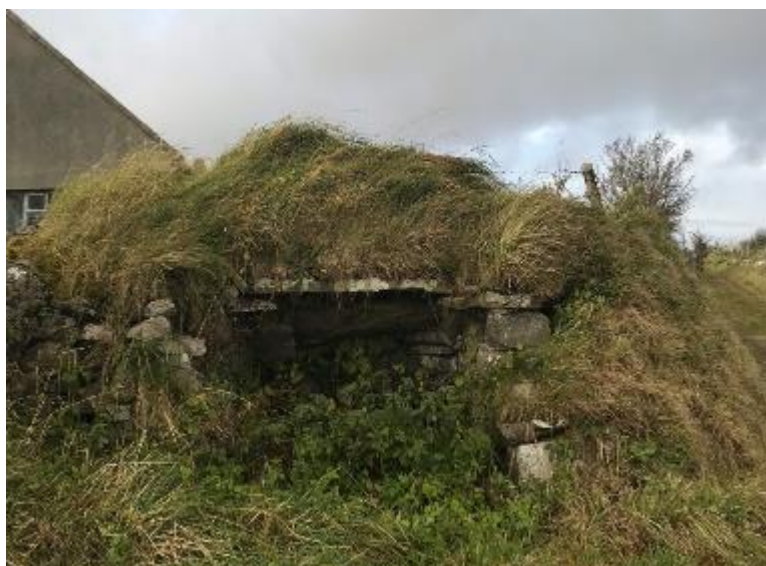
Photograph 182: Lime Kiln on the Bog Road at Dunmore (courtesy of Sara Slattery)

Other examples can be seen in the study area, including on the Bog road walking route and in Gurteen townland.

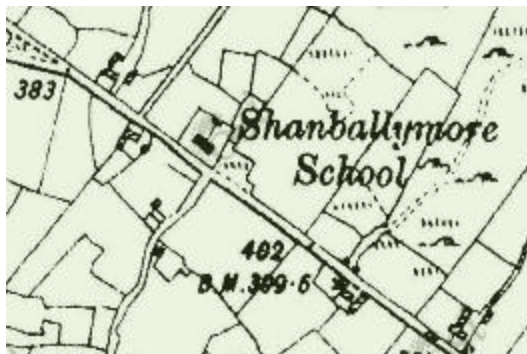
Map 41: Location of Shanballymore School built in 1906 (map dates to c.1930) 'Data from the base maps gallery database accessed through the Heritage Maps Viewer at www.heritagemaps.ie, [8-8-2020]'

The location of the most recent Shanballymore School (date stone 1906) was just to the north-west of the late 19th century school. It was originally a two teacher school but with an enrolment of 122 pupils by 1916, a third teacher was employed. By 1975 the number of pupils had decreased to 21 and the school was closed and amalgamated with Garrafrauns School. The ruin of the early 20th century Shanballymore School survives today.

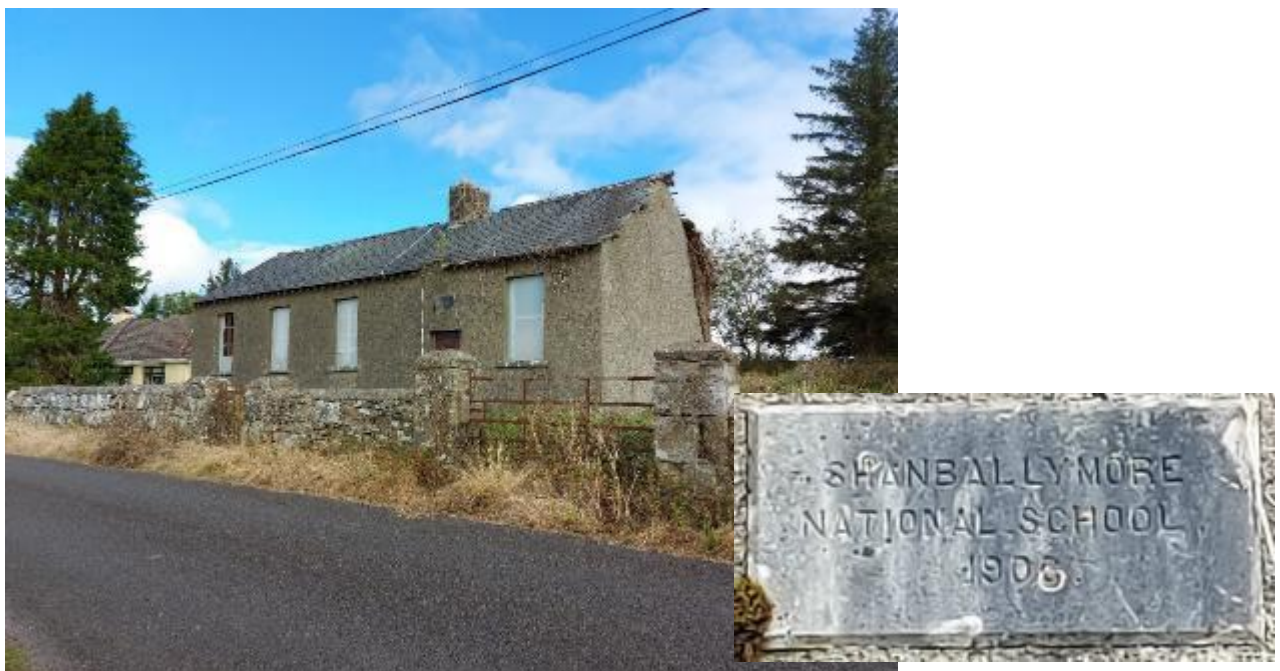
Photograph 184: The ruin of Shanballymore School (2020) Inset: Date stone over entrance doorway

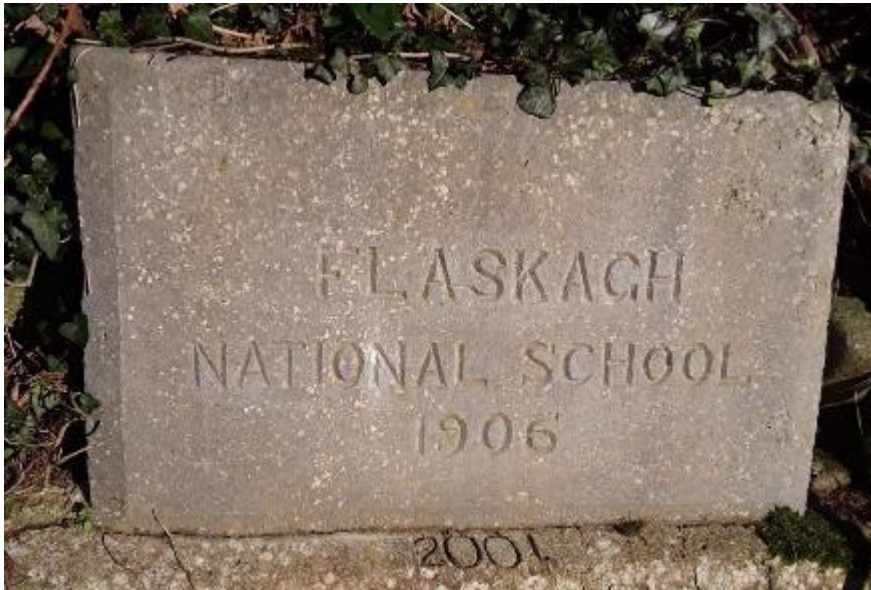
Flaskagh School was built in 1906 and is marked on the third edition OS 6-inch maps dated to c.1930. It closed in 1958. All that remains is the date stone, which is now located in a local residents garden. In 1955 a 'new' school was opened in Flaskagh. It closed in 1981 and was amalgamated with Scoil Níoclás Naofa in Dunmore. (Information courtesy of Pat Slattery)

Photograph 185: 1906 Date stone of Flaskagh School (Photograph courtesy of Diane Mahon)

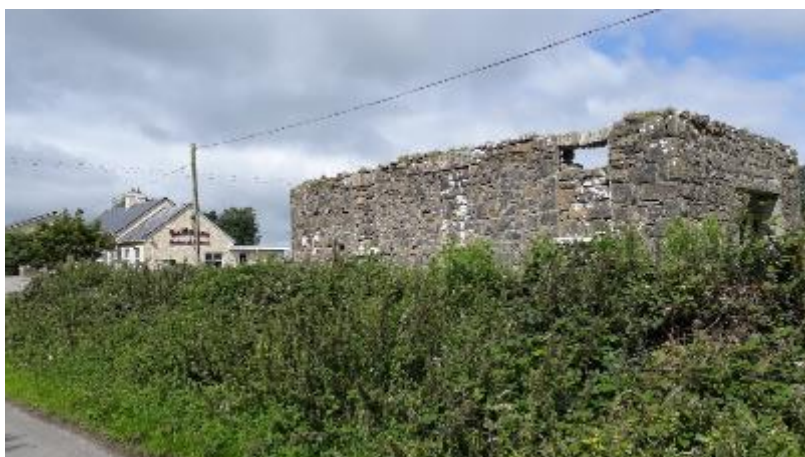
On the 1890 OS map Ballinlass School is located on the opposite side of the road from the present day school. The ruin of a stone and mortar building still exists on this site.

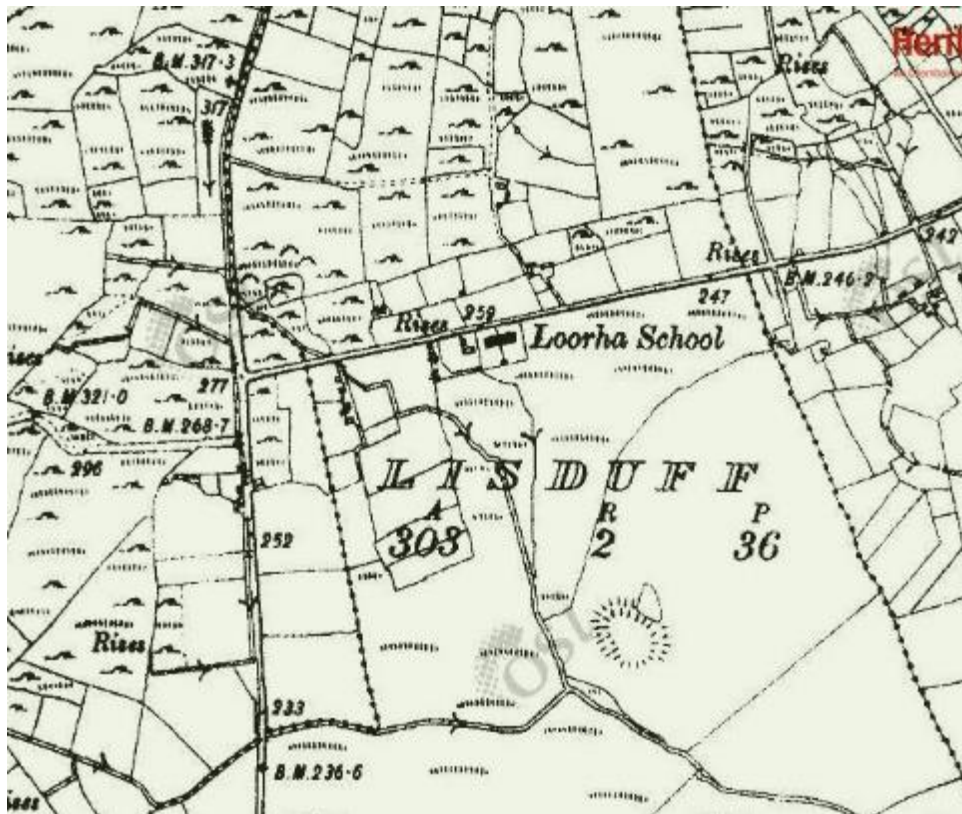
Map 42: Loorha School in Lisduff townland c.1930 'Data from the base maps gallery database accessed through the Heritage Maps Viewer at www.heritagemaps.ie, [8-8-2020]'.

Loorha School was located in Lisduff townland to the east of the Dunmore-Cloonfad road. It was built in 1898 and closed in 1948. No buildings survive today.

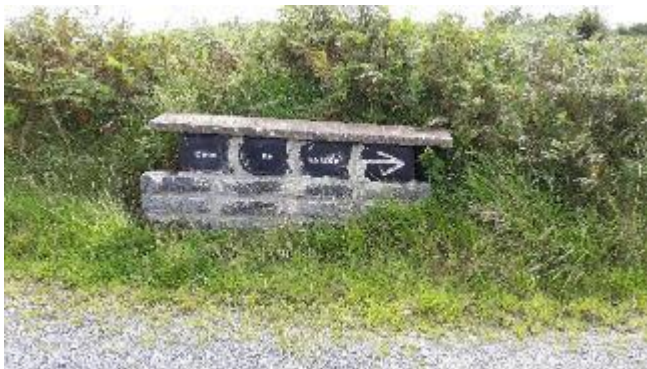
The mosaic of fen, reedmarsh, remaining open water of former Lough Agar and the cutaway of the former Drumbulcaun raised bog, set within a backdrop of drumlins, in the south of the study area, is visible from a community developed walking route along a metalled road. A number of hand painted signs highlight local features such as 'Cnoc na hAltor' but no further information or direction is provided.

Photograph 188: Seat at Lough Agar/Drumbulcaun Bog with directional sign for 'Cnoc na hAltor'

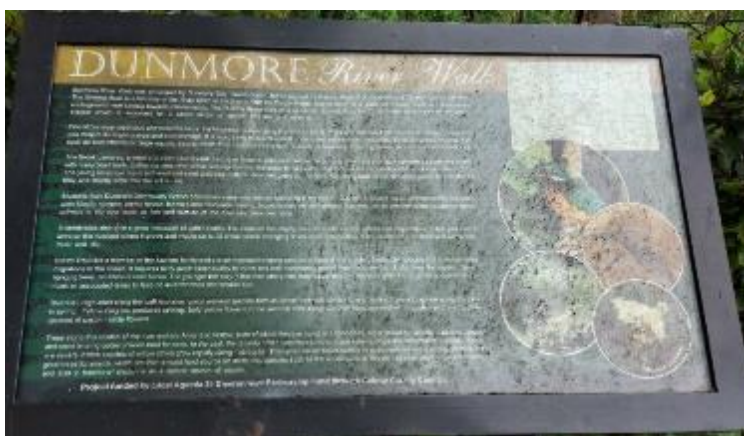
Towns, is located on the bank of the River in Dunmore town to the rear of the Eurospar Centre. It provides information about the river name and flow pattern, the kingfisher, the brook lamprey, an invertebrate sampling project by the local school, brown trout and the riverside vegetation. However, the river walk is not signposted and visitors to the town may be unaware of its existence.

Photograph 189: River Walk Interpretive Board
