# SALMON RIVER WATERSHED MANAGEMENT PLAN

## Phase I

Prepared by Franklin County Soil and Water Conservation District

# Watershed Assessment for the Salmon River, Franklin County, NY

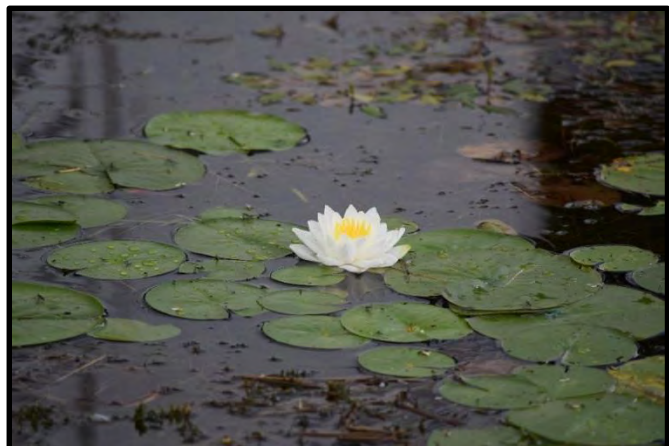
lake plain region of the Saint Lawrence Valley. The Salmon River Watershed is broken into two Hydrologic Unit Codes(HUC), the Salmon River and the Headwaters of the Salmon River. There are 15 HUC 12 sub-basins in the Salmon River Watershed (Figure 4).

**Sub-Watershed Delineation:** A hydrologic unit code is a sequence of numbers or letters that identify a hydrological feature like a river, river reach, lake, or area like a drainage basin. These numbers are created by the United States Geologic Society. New York State is divided into 17 watersheds, or drainage basins, which are the basis for management, monitoring, and assessment activities. The Salmon River watershed is found in the Saint Lawrence River Watershed. The Saint Lawrence Watershed lies at the border of New York State and Canada. The Saint Lawrence River serves as the gateway between the North Atlantic and the Great Lakes. At its most downstream point in the United States the Saint Lawrence drains an area of nearly 300,000 square miles. Within New York State the watershed drains the northern and western Adirondack Mountains and the

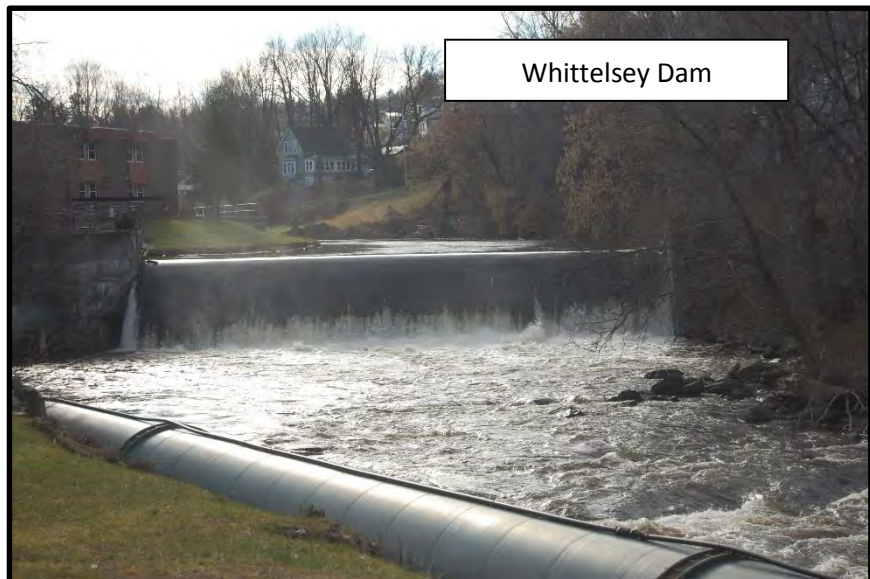
Trash racks reduce impingement through the turbines. Whittelsey is a run-of-river operation. The impoundment behind the dam is unnamed, less than 2 acres in size, and has a storage capacity of 10 acre-feet. Recently the dam was sold to a private organization in hopes to re-open the dam for local power production and local business support.

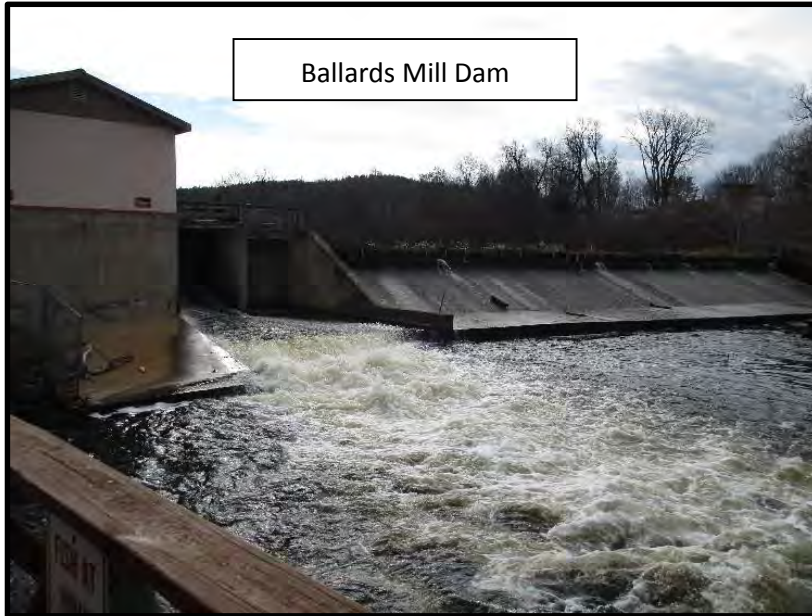
are owned and operated by Mr. Frank Christie. Ballards Mill has a generating capacity of 275 kilowatts. The dam is a concrete-capped timber crib that is 8 feet in height with a 110 foot spillway. FERC license 3267 specifies that two foot high flashboards can be added to the crest. Ballards Mill was originally a textile mill constructed in 1901. The old mill buildings on the eastern bank of the Salmon River were converted from powerhouse duties to a community theater in the mid-1990's. A new powerhouse was constructed

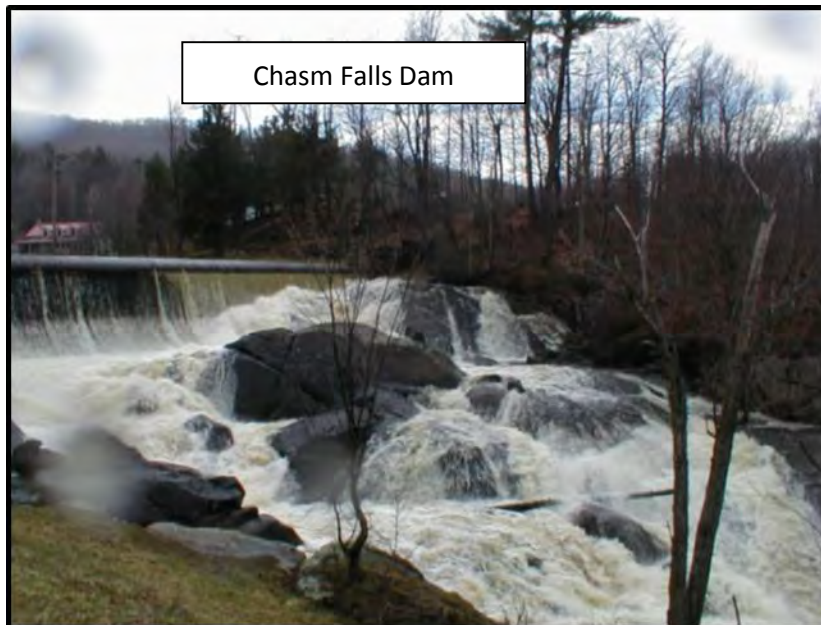
location is maintained by Brookfield Power. The Chasm Falls hydroelectric project was put in operation in 1983 and consists of two turbine/generator sets with a combined installed capacity of 1,600 kW, a 1931-built stone constructed powerhouse, two synchronous generators, an intake structure, and a concrete gravity dam, FREC license 7320.

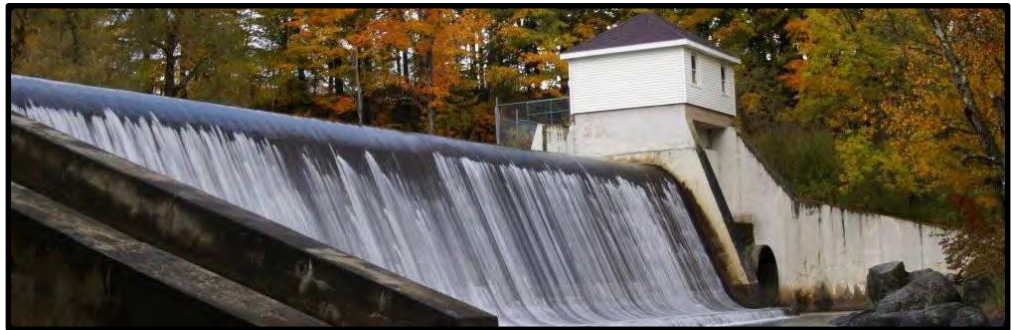
serve as gates at the gate house location. The length of dam, it is 56.3' plus gate house 20'. The width of the double planked crest of dam is 7.2'. These pipes were replaced with a concrete gate house containing two manual metal slide valves in the mid 1990s when sheet steel piling was driven down into the river bed in front of the dam as a method to control the leakage at the base of the dam. While the dam has had several owners since its origin it is now owned by the Town of Belmont. This dam is classified as a Class "A" Hazard. The town's Planning Committee is investigating the use of hydropower at this location currently.

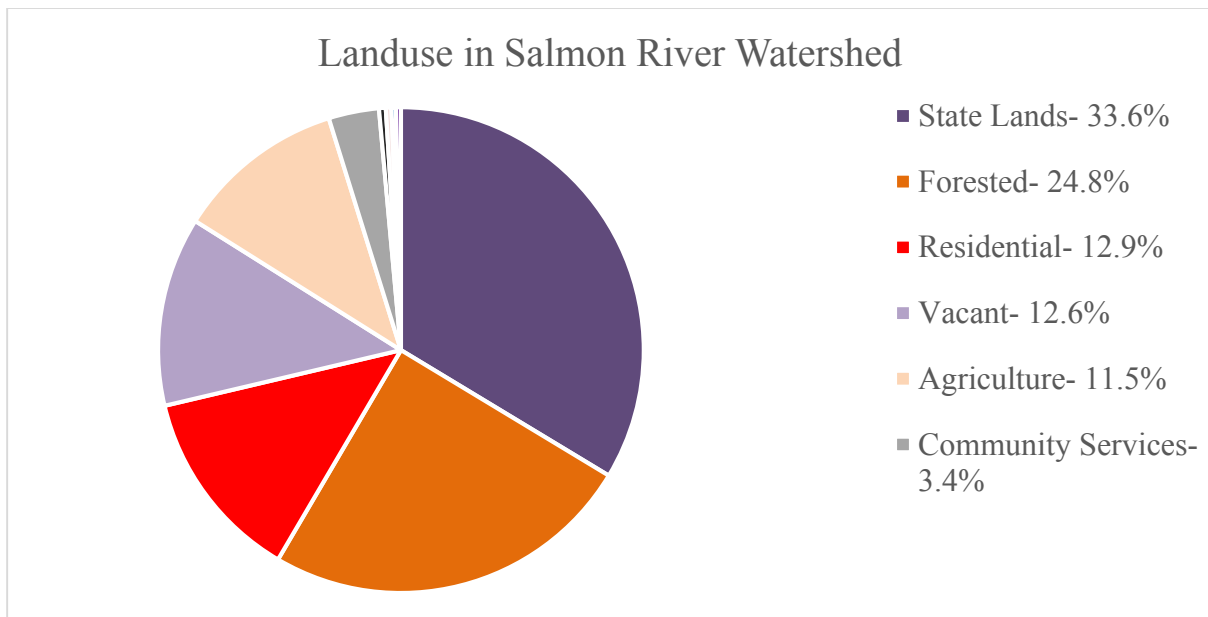
This table indicates that a majority of the land area in the Salmon River Watershed is state lands (33.6%) followed by forested (24.8%), residential (12.9%), vacant (12.6%), agriculture (11.5%), and community services (3.4%). State lands include state owned forest lands, conservation lands/easements and public parks. Forested land is the privately owned forest land, private hunting and fishing clubs. Residential include one family, two family and three family year round residential properties, seasonal residences, mobile homes and multiple residences. Vacant land is property that is not in use, is in temporary use or lacks permanent improvement. Agriculture includes property used for the production of crops or livestock. Community services include property used for the wellbeing of the community. Public services is property used to provide services to the general public. Commercial properties are used for the sale of goods and/or services. Recreation includes recreation and entertainment used by groups for recreation, amusement or entertainment. Industrial is for property that is used for the production of and fabrication of durable and nondurable man-made goods (NYS Office of Real property Services, 2006).

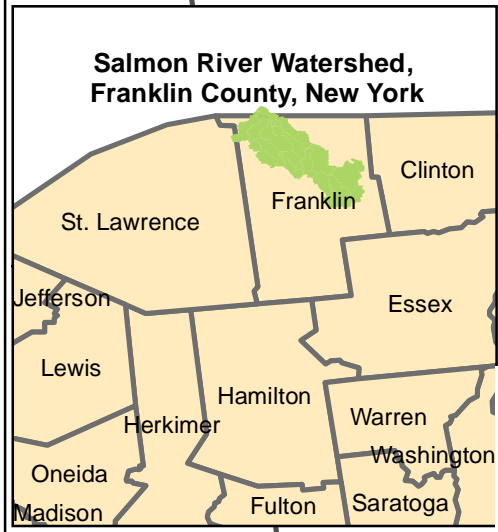
Figure 2

The Salmon River as well as several streams and brooks are designated as trout habitat by the New York State Department of Environmental Conservation (NYSDEC) (Figure 2). Most of the river is classified as a class C(T) and C(TS) stream. NYSDEC classifies water bodies as AA, A, B, or C for the purposes of establishing standards for water quality and stream management. Class AA and A waters are regulated to standards suitable for water supply, swimming and fishing. Class B waters are regulated to standards suitable for swimming and fishing. Class C waters are regulated to standards suitable for fishing only. Such watercourses are classified with a (T) which indicates the ability to support a trout population or a (TS) which indicates the ability to support a trout population and trout spawning.

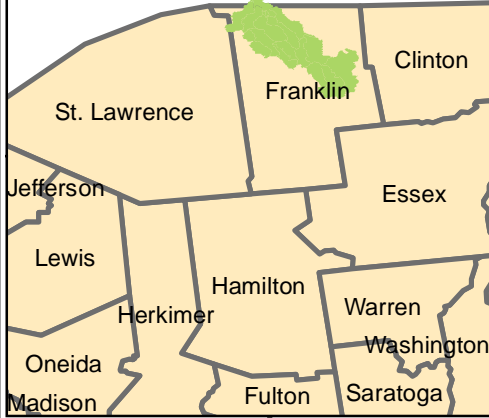
Nitrogen in the ground water is a concern in over 50% of the watersheds that support vegetables and livestock, based on a Cornell University study. See Figure 5 for regional soils.

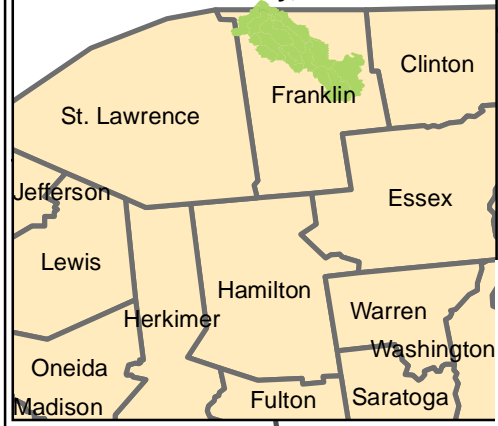
Figure 7

See Figure 7- Wetlands

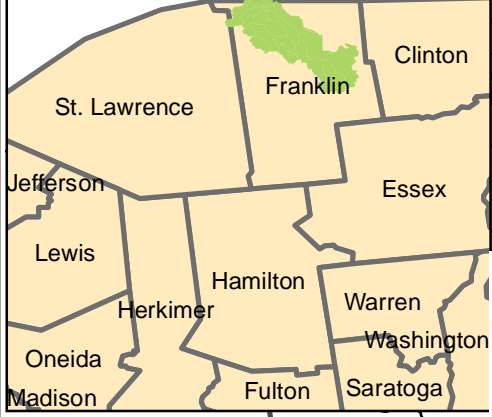
Figure 8

Recently a section of the Salmon River was designated for catch and release. The section of the Salmon River is from the Flat Rock Road Bridge to 200 yards downstream of the Cargin Road Bridge (Figure 8). The catch and release program is for trout all year long.
