Caplich Wind Farm

Environmental Statement

Volume Two: Main Report

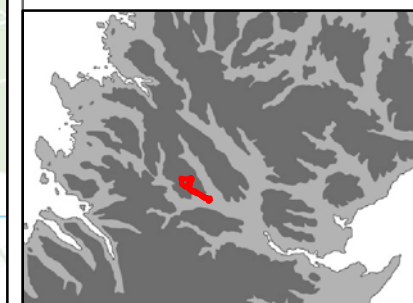
Figures 9.1: Location of Caplich with heritage assets within 1 km

Each heritage asset, including archaeological or historical sites, monuments or buildings, referred to in the text is plotted on the location maps (**Figures 9.1 and 9.2**) at the end of the report, using the assigned Site Nos. The proposed development site is outlined in red.

All known heritage assets located within a 1 km radius from the edge of the proposed Wind Farm development area have been included in the assessment. The aim of this is to help predict whether any similar hitherto unknown archaeological remains are likely to be impacted by the development. In addition, Scheduled Monuments, Listed Buildings, Conservation Areas, Inventory Gardens and Designed Landscapes, Inventory Battlefields and non-statutory monuments of national importance (as identified by the Highland Council HER) at distances up to 5 km away, which might be subject to impacts upon their settings, have also been identified. Figure 9.1 records archaeological remains and cultural heritage assets located within a 1 km assessment area surrounding the development site, while **Figure 9.2** shows designated heritage assets within 5 km of the proposed Wind Farm.

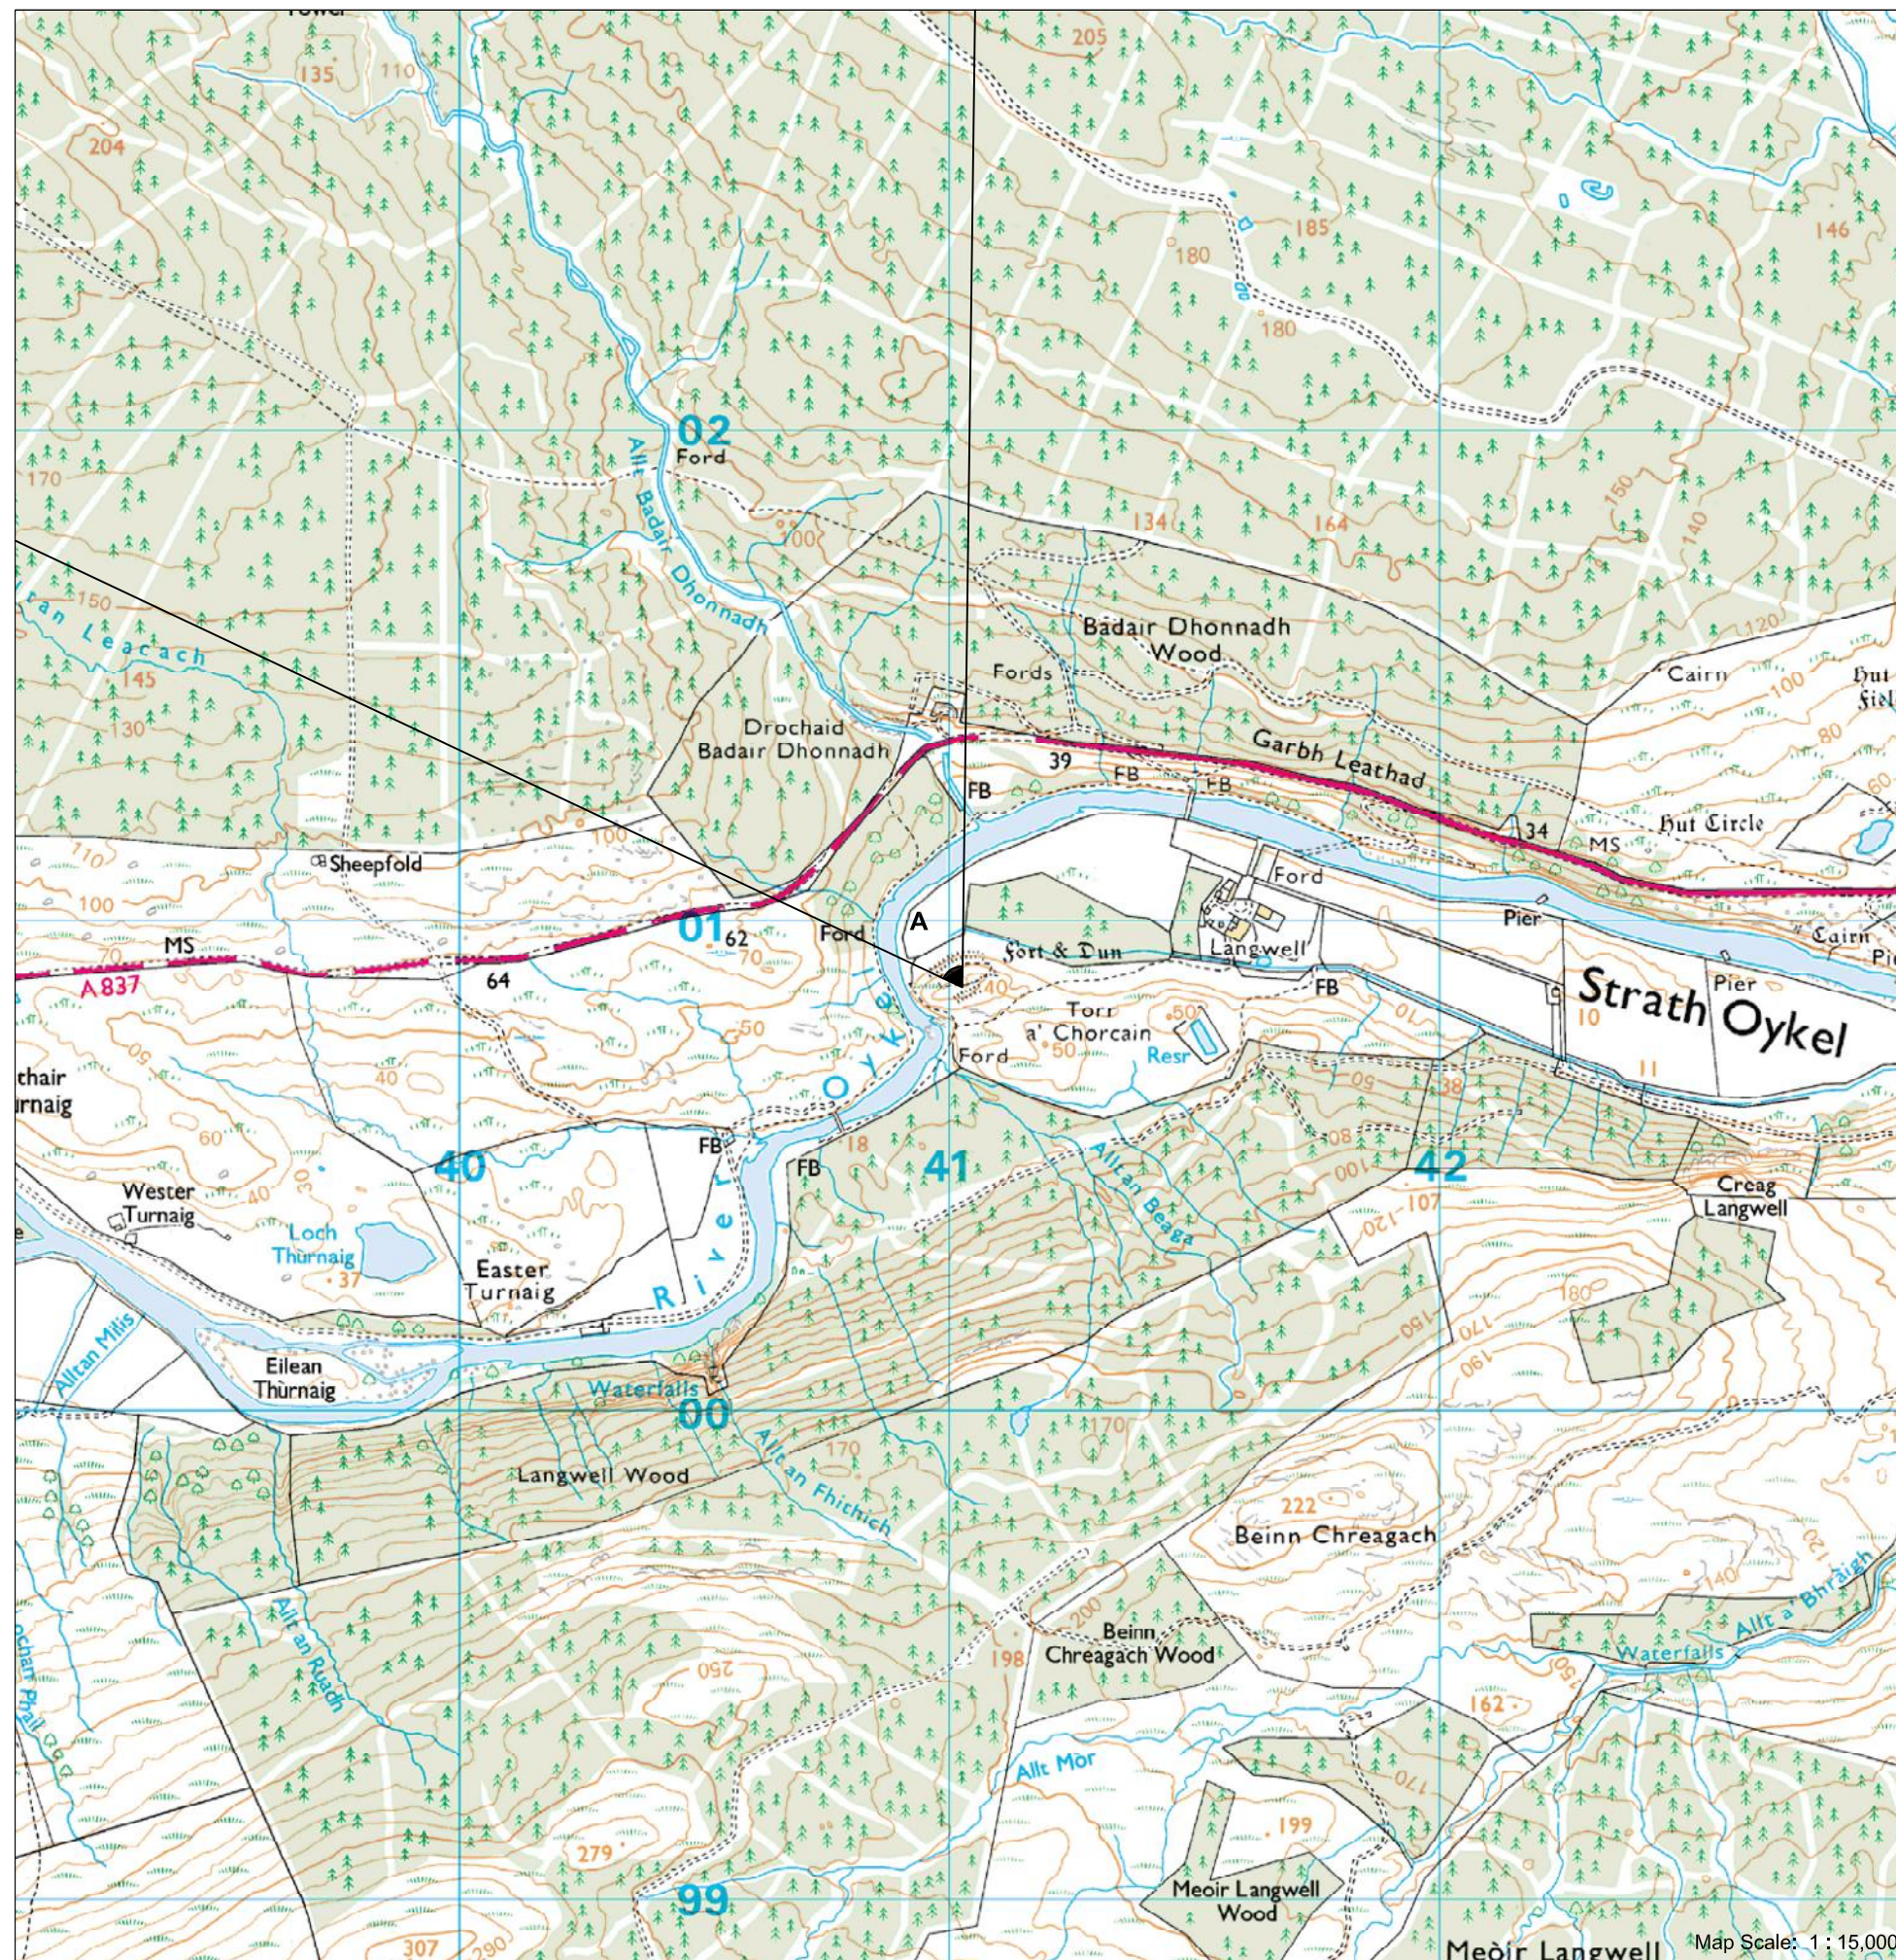
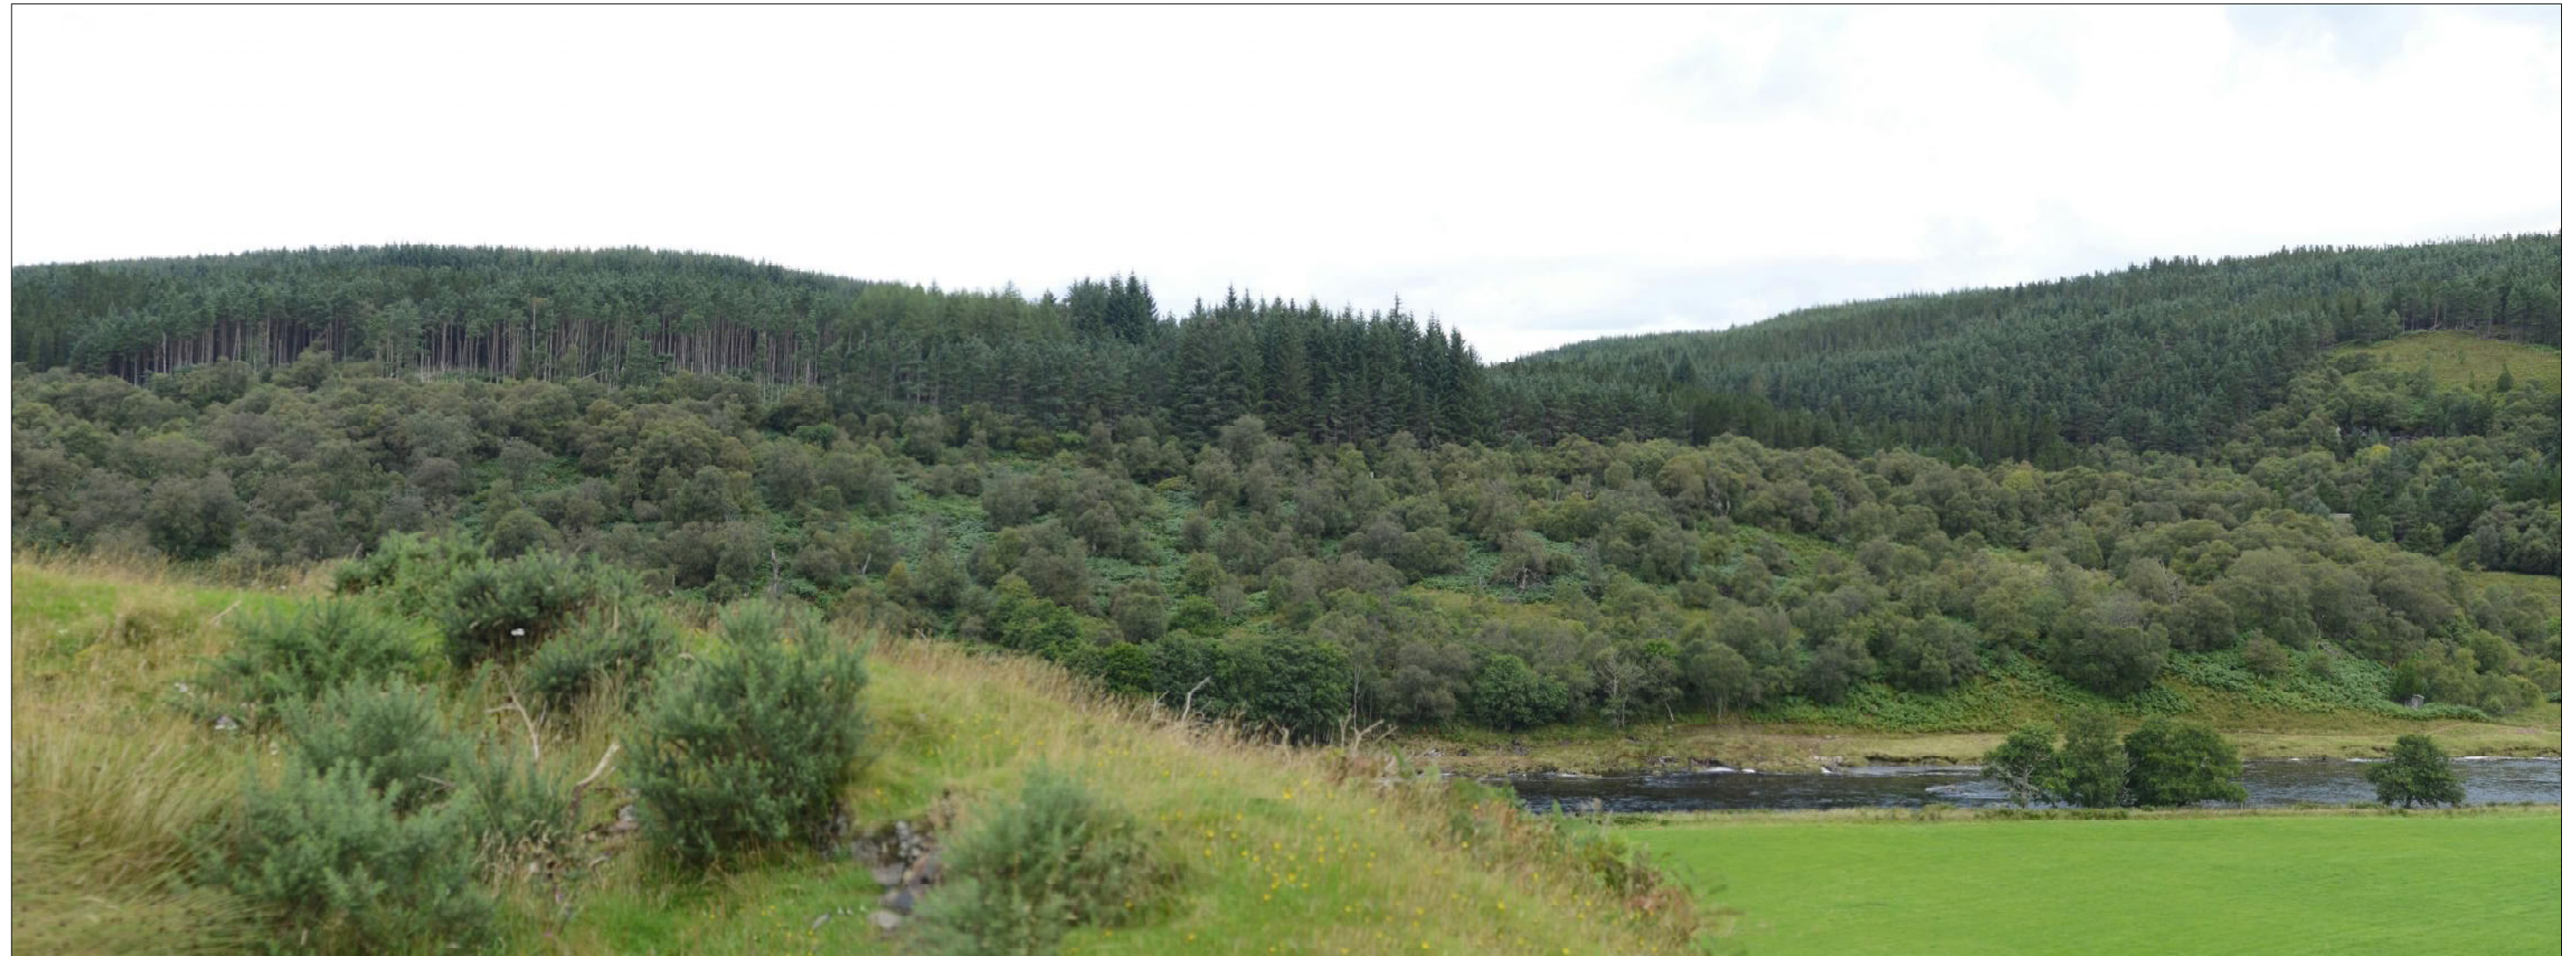
Figure 9.8.1

**Cultural Heritage Viewpoint 1
Langwell Fort and Dun (Site 13)**

View towards turbines from Scheduled Area. Forestry Plantation present in front of turbines. Site occupies high ground to south of River Oykel and A837 and is accessible on foot.

Date:	23rd August 2014	Time:	11:50	Distance to nearest turbine:	5,673 m	Camera type:	Nikon D600	Focal length (horizontal):	28 mm	Focal length (vertical):	50 mm
						Camera height:	1.5 m	Horizontal Field of View:	65.5°	Vertical Field of View:	27°

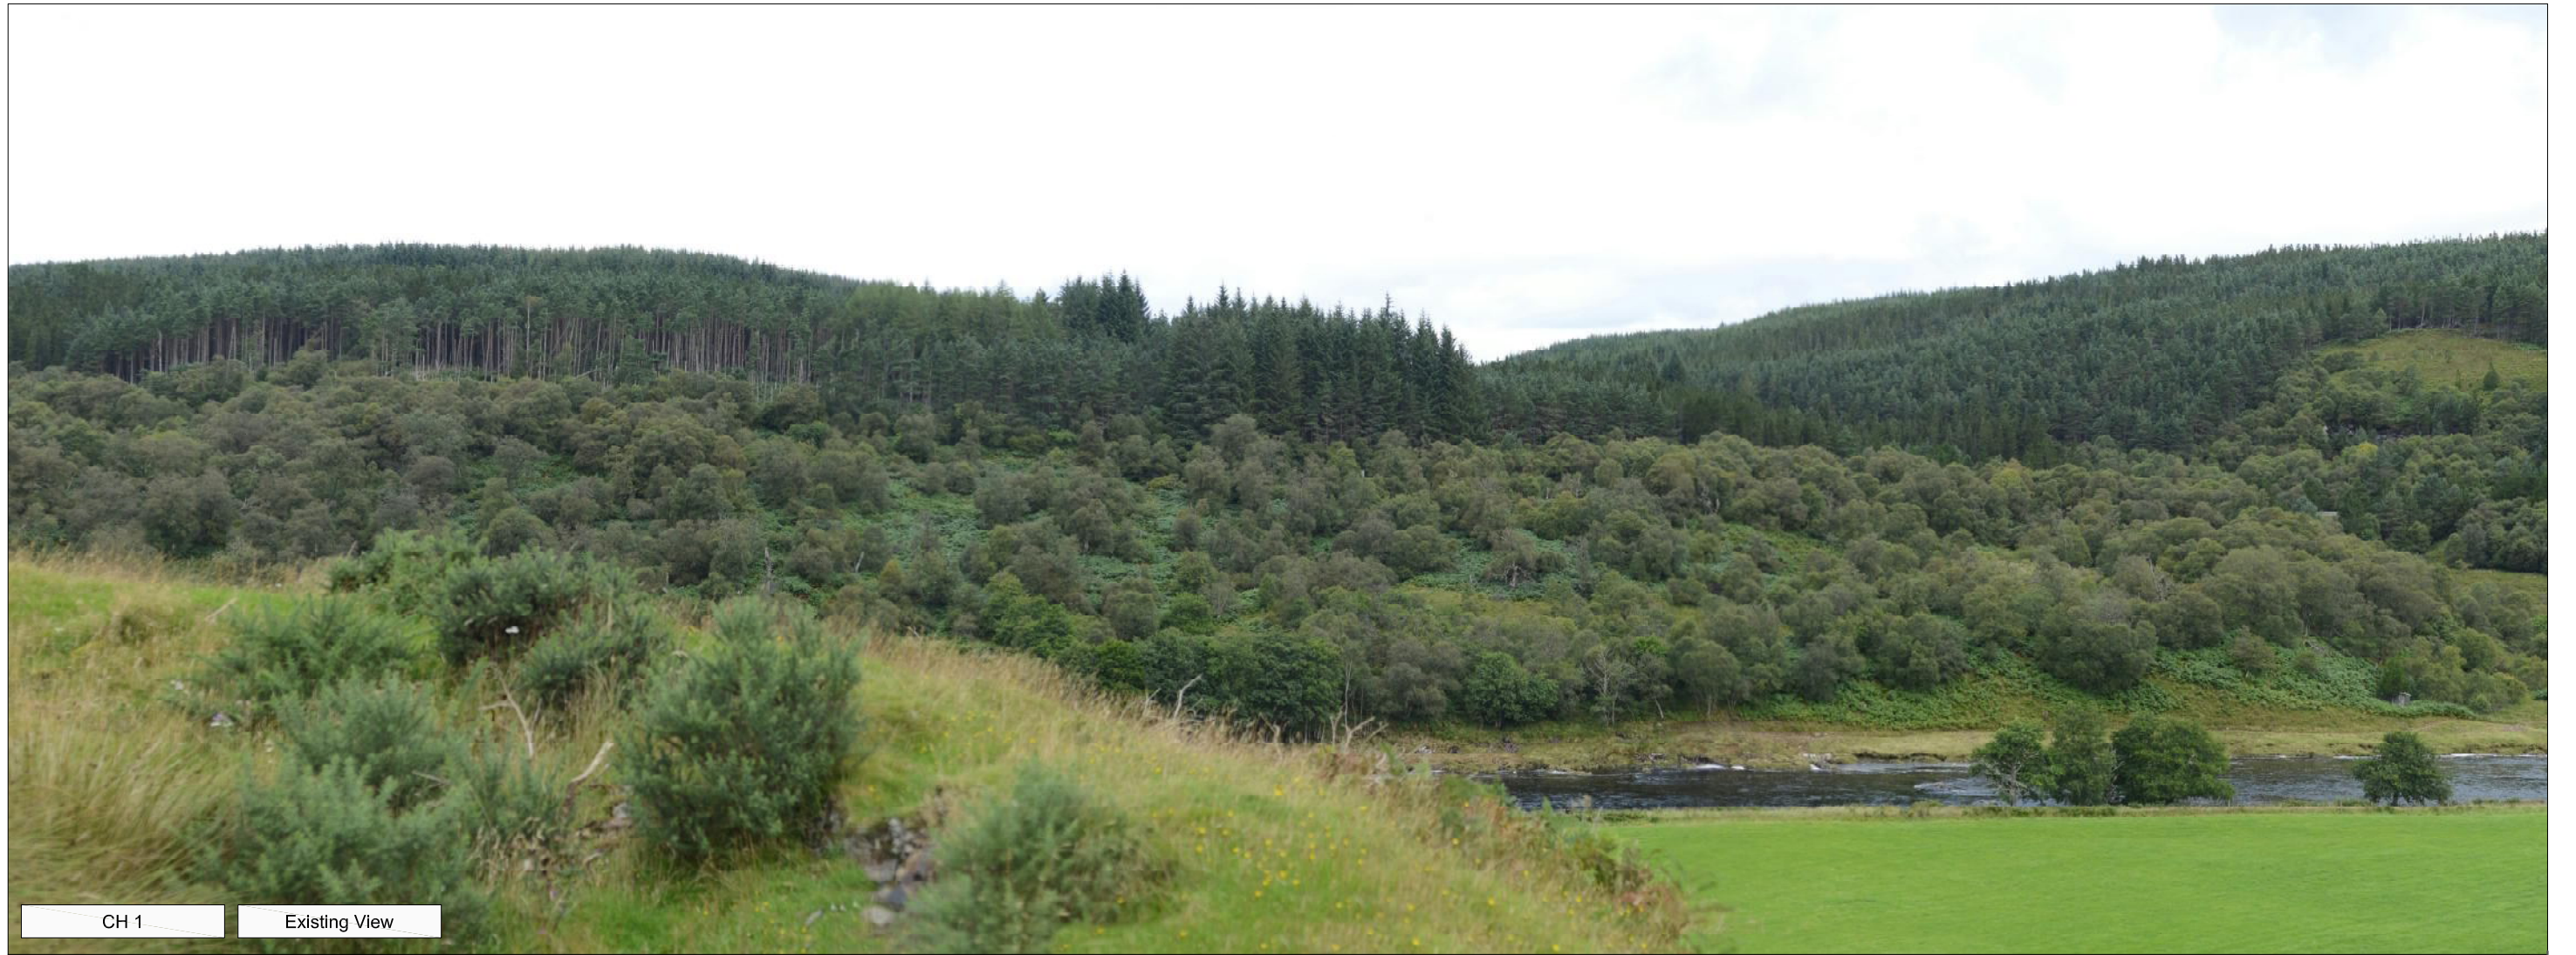
CH 1

Existing View

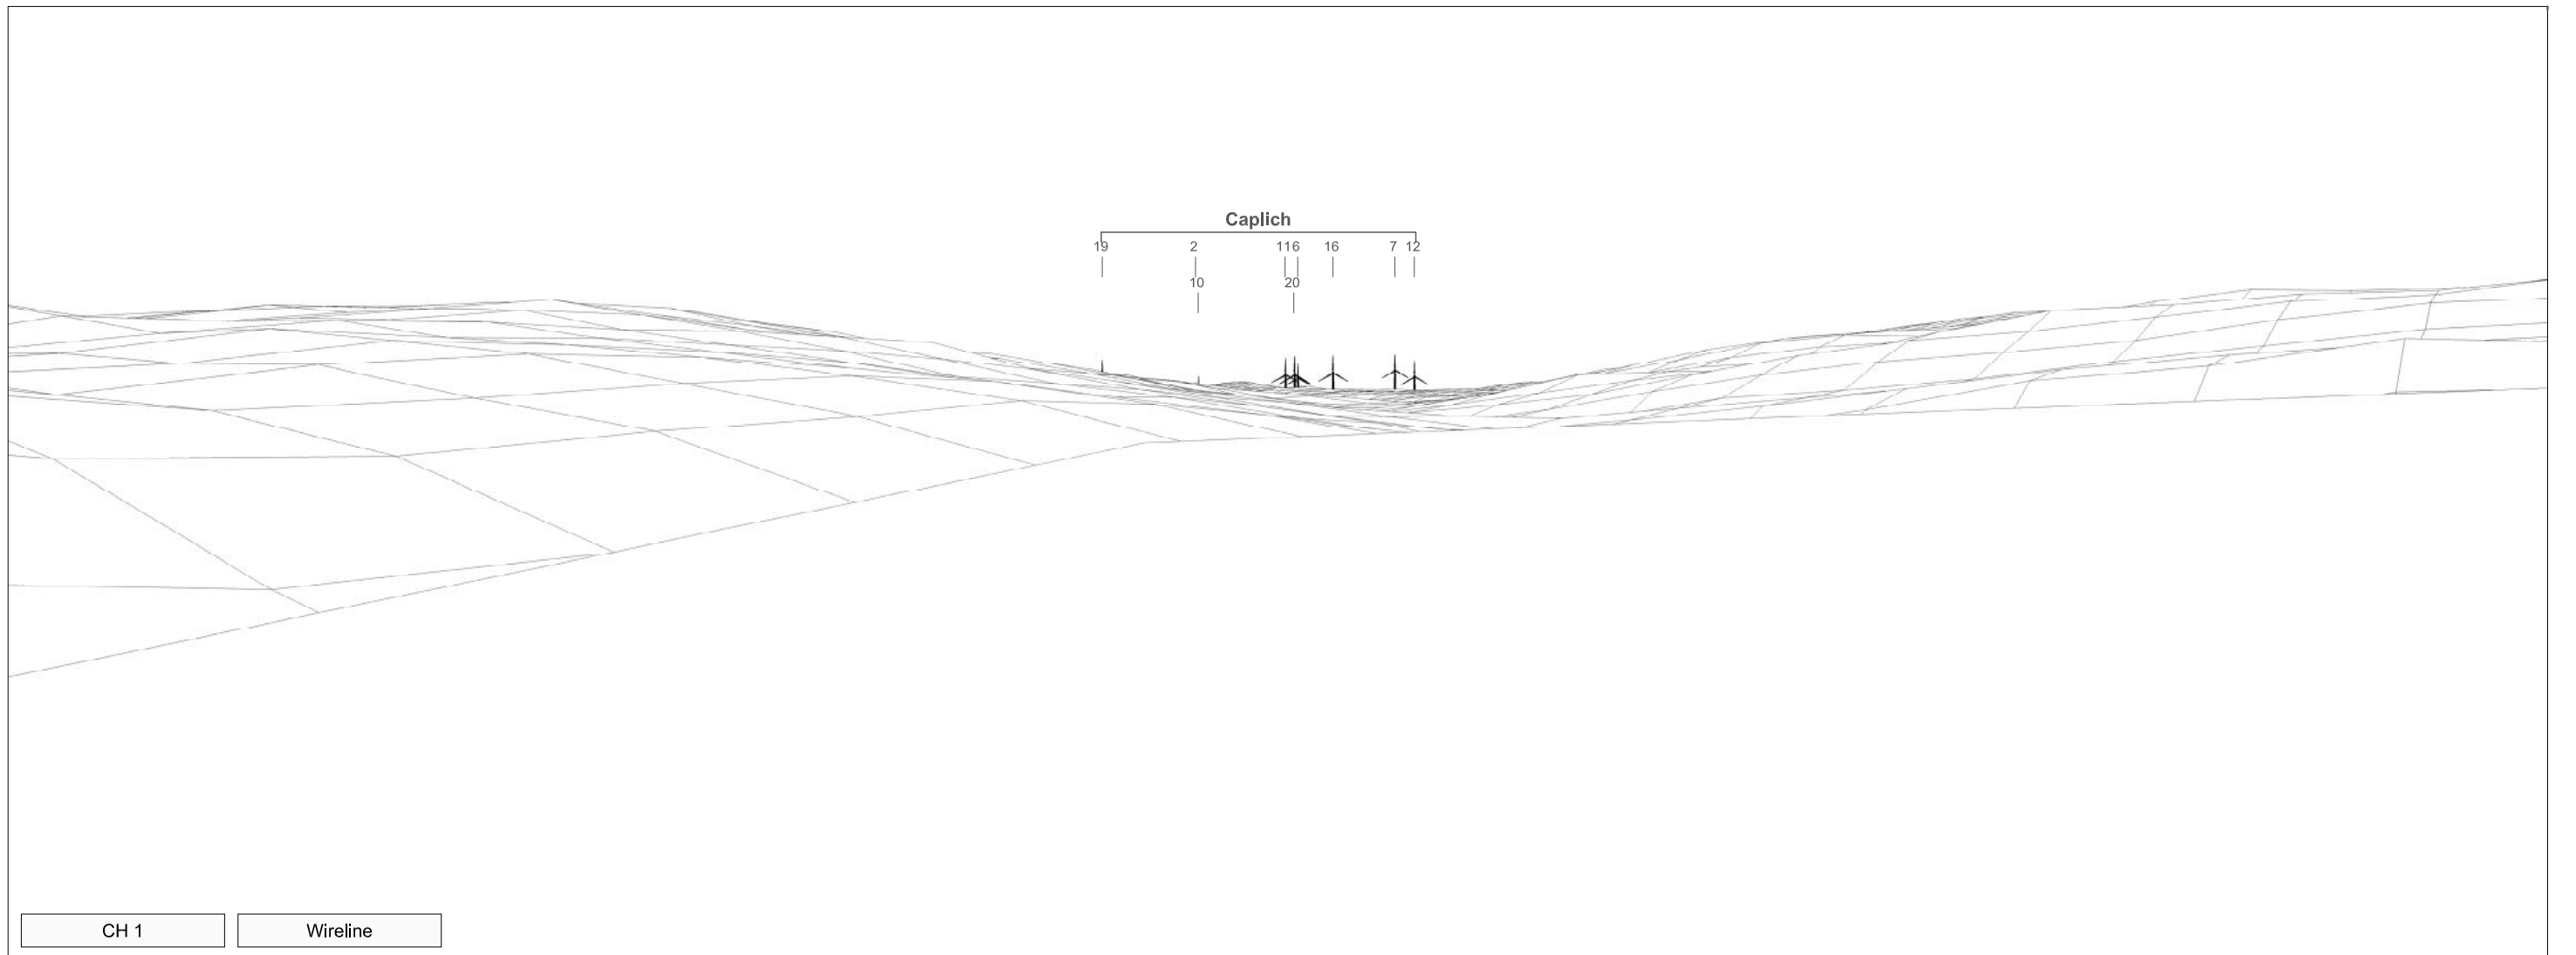
CH 1

If viewed with one eye at a distance of 300mm from exactly the same location and height as the original camera lens, the image will fit the real landscape cues.

Wireline

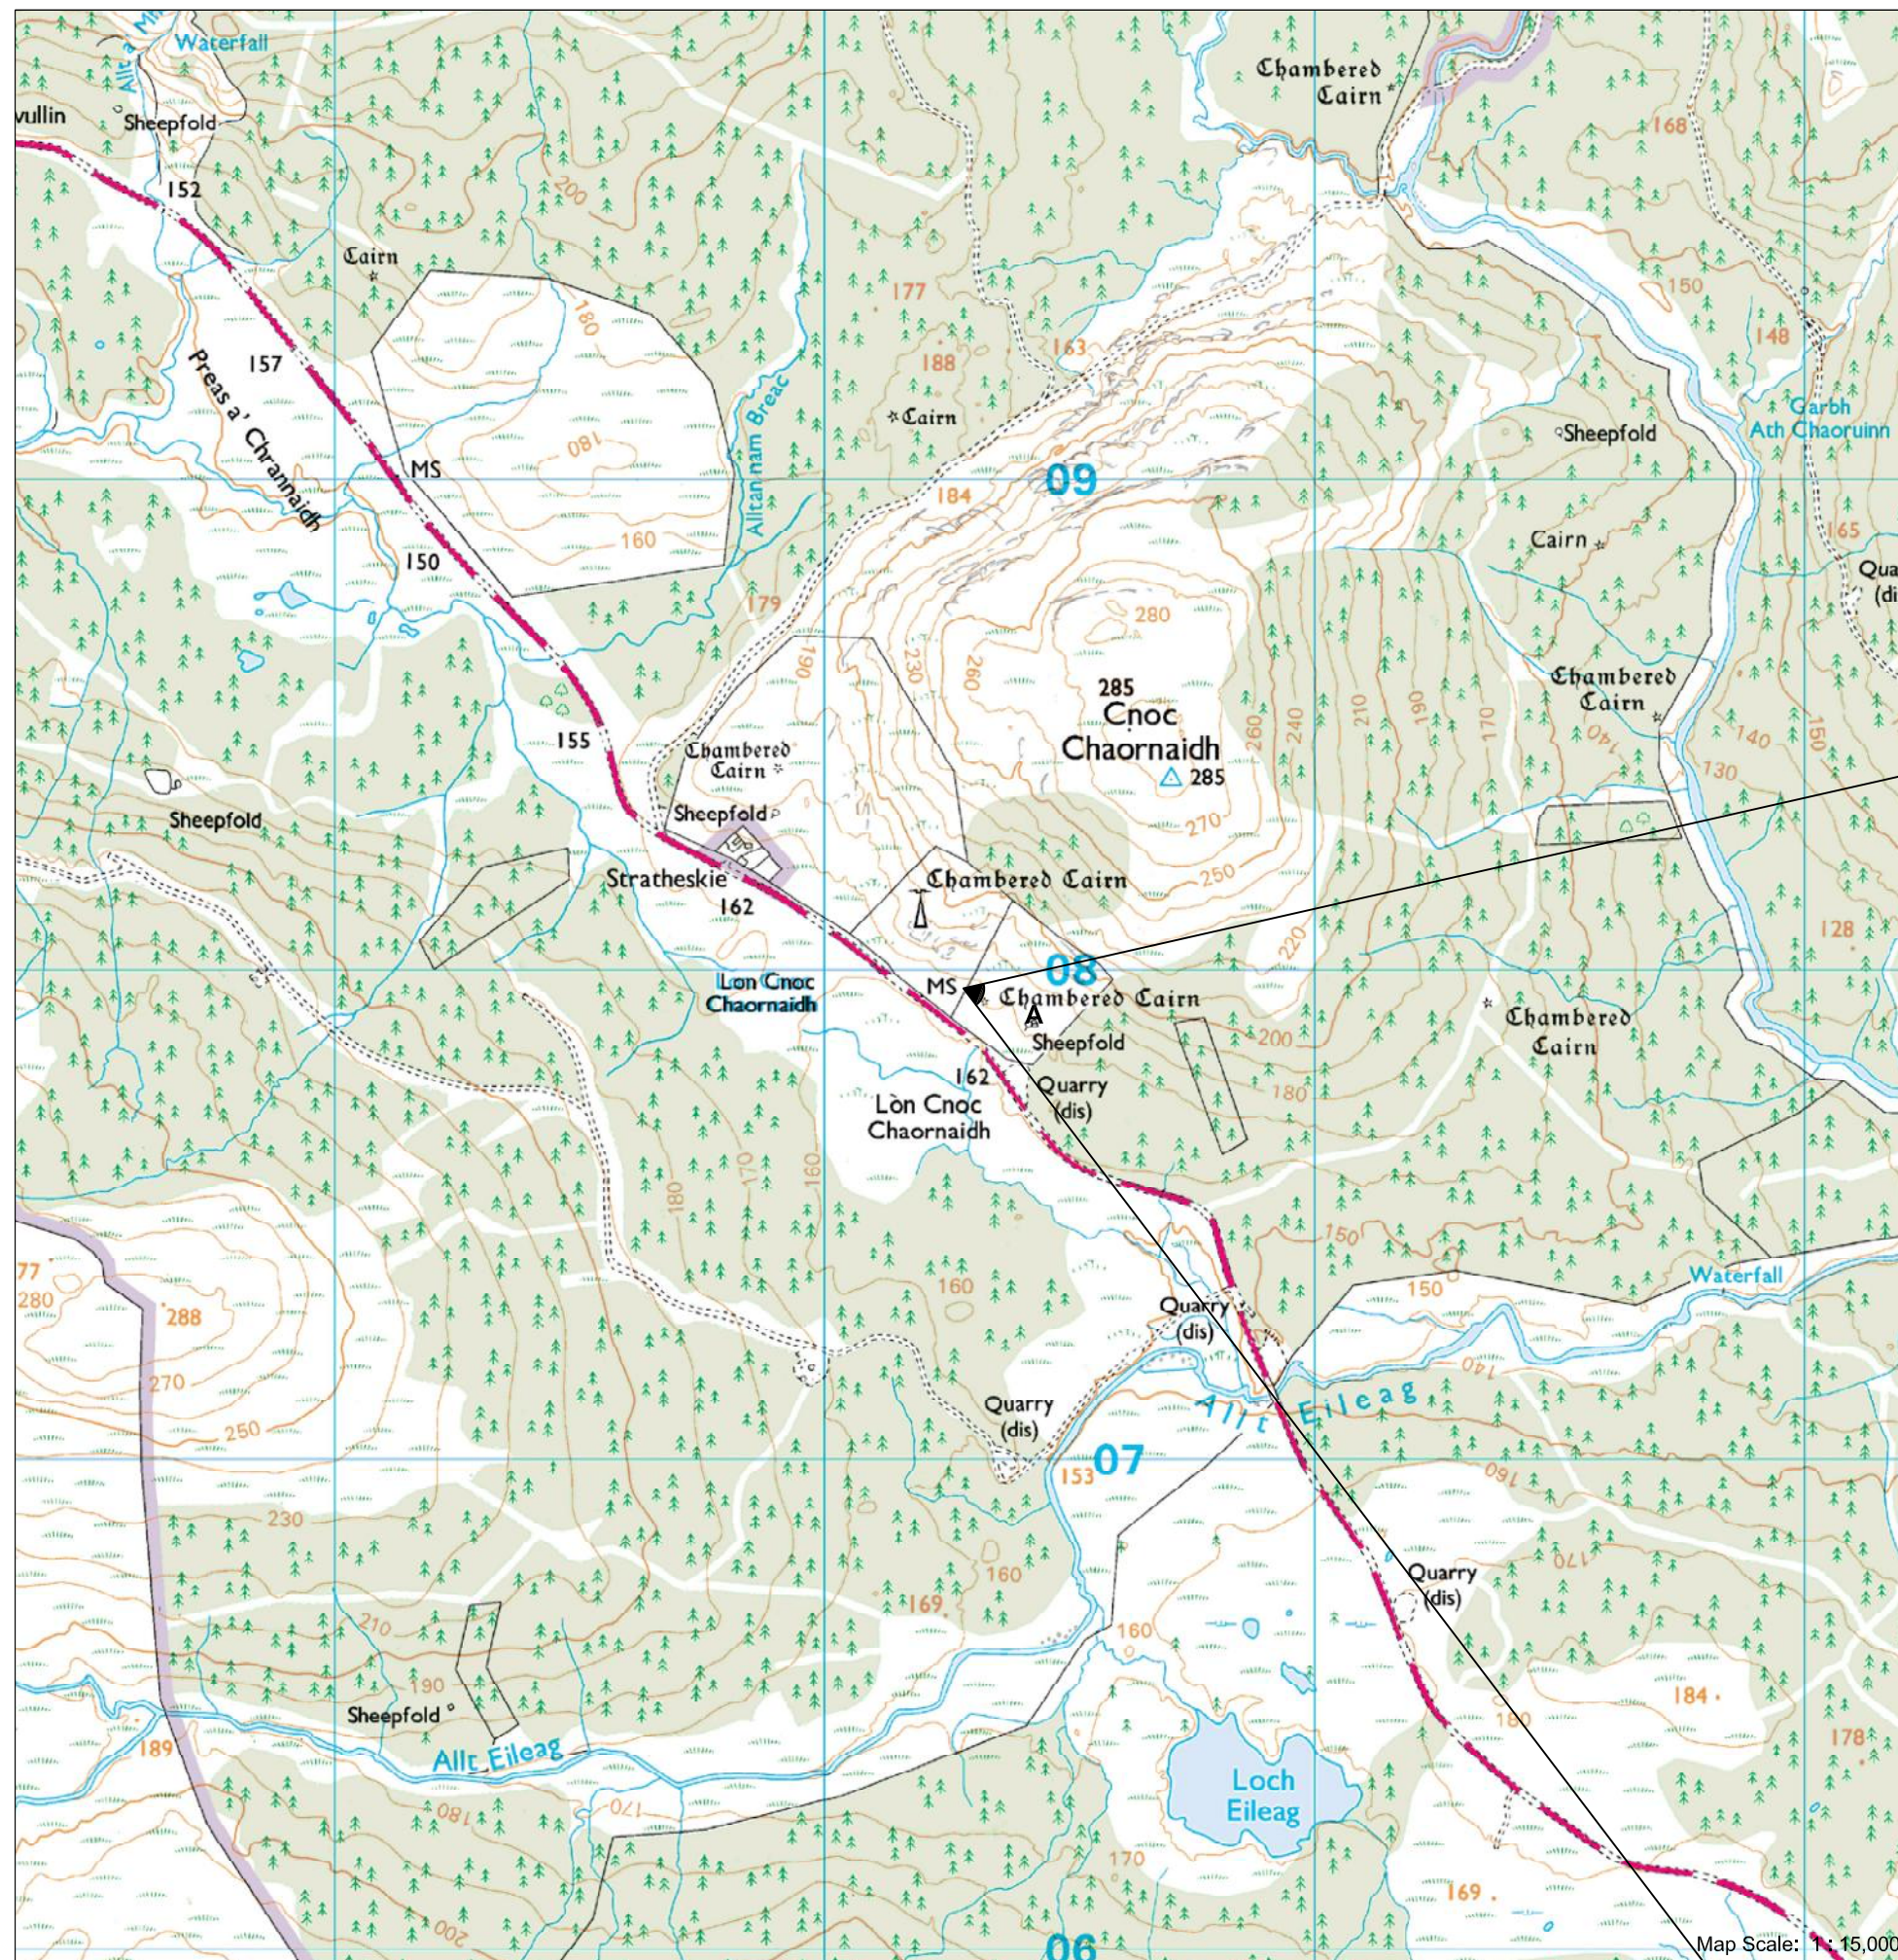
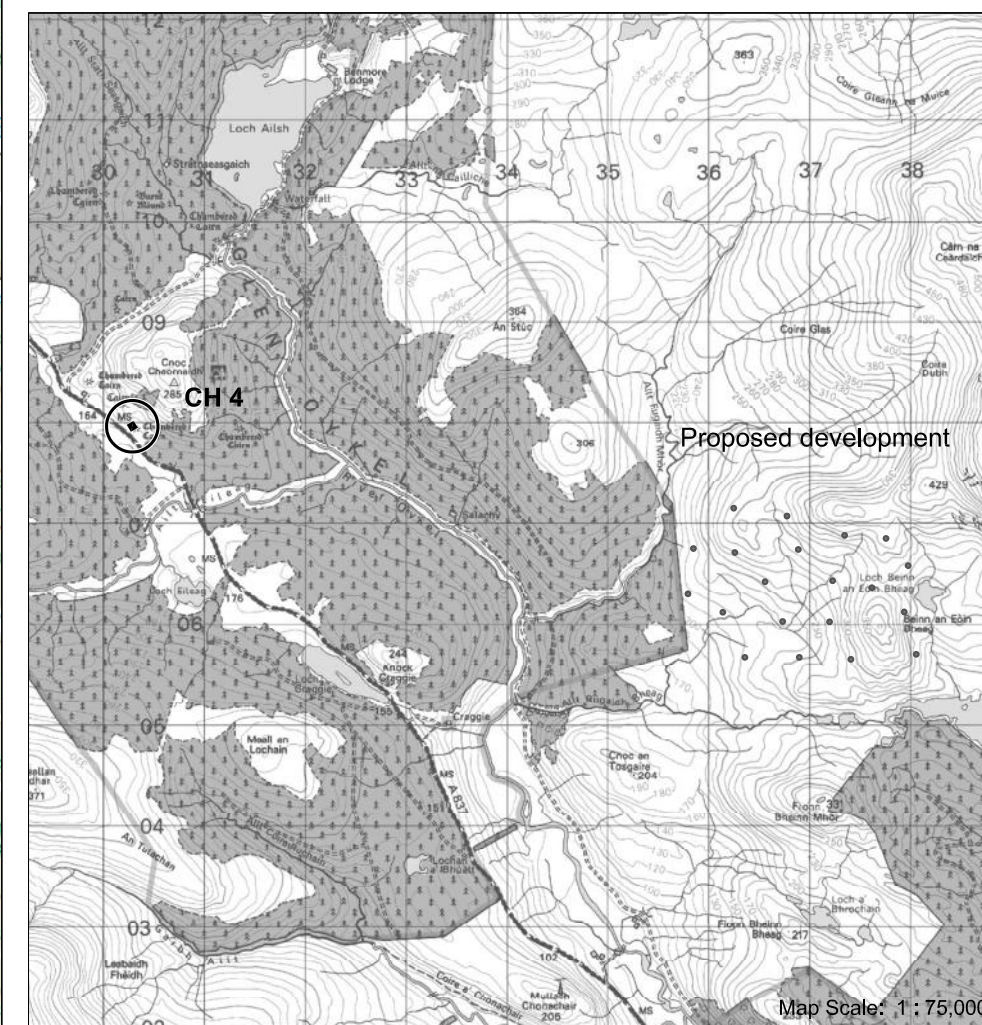
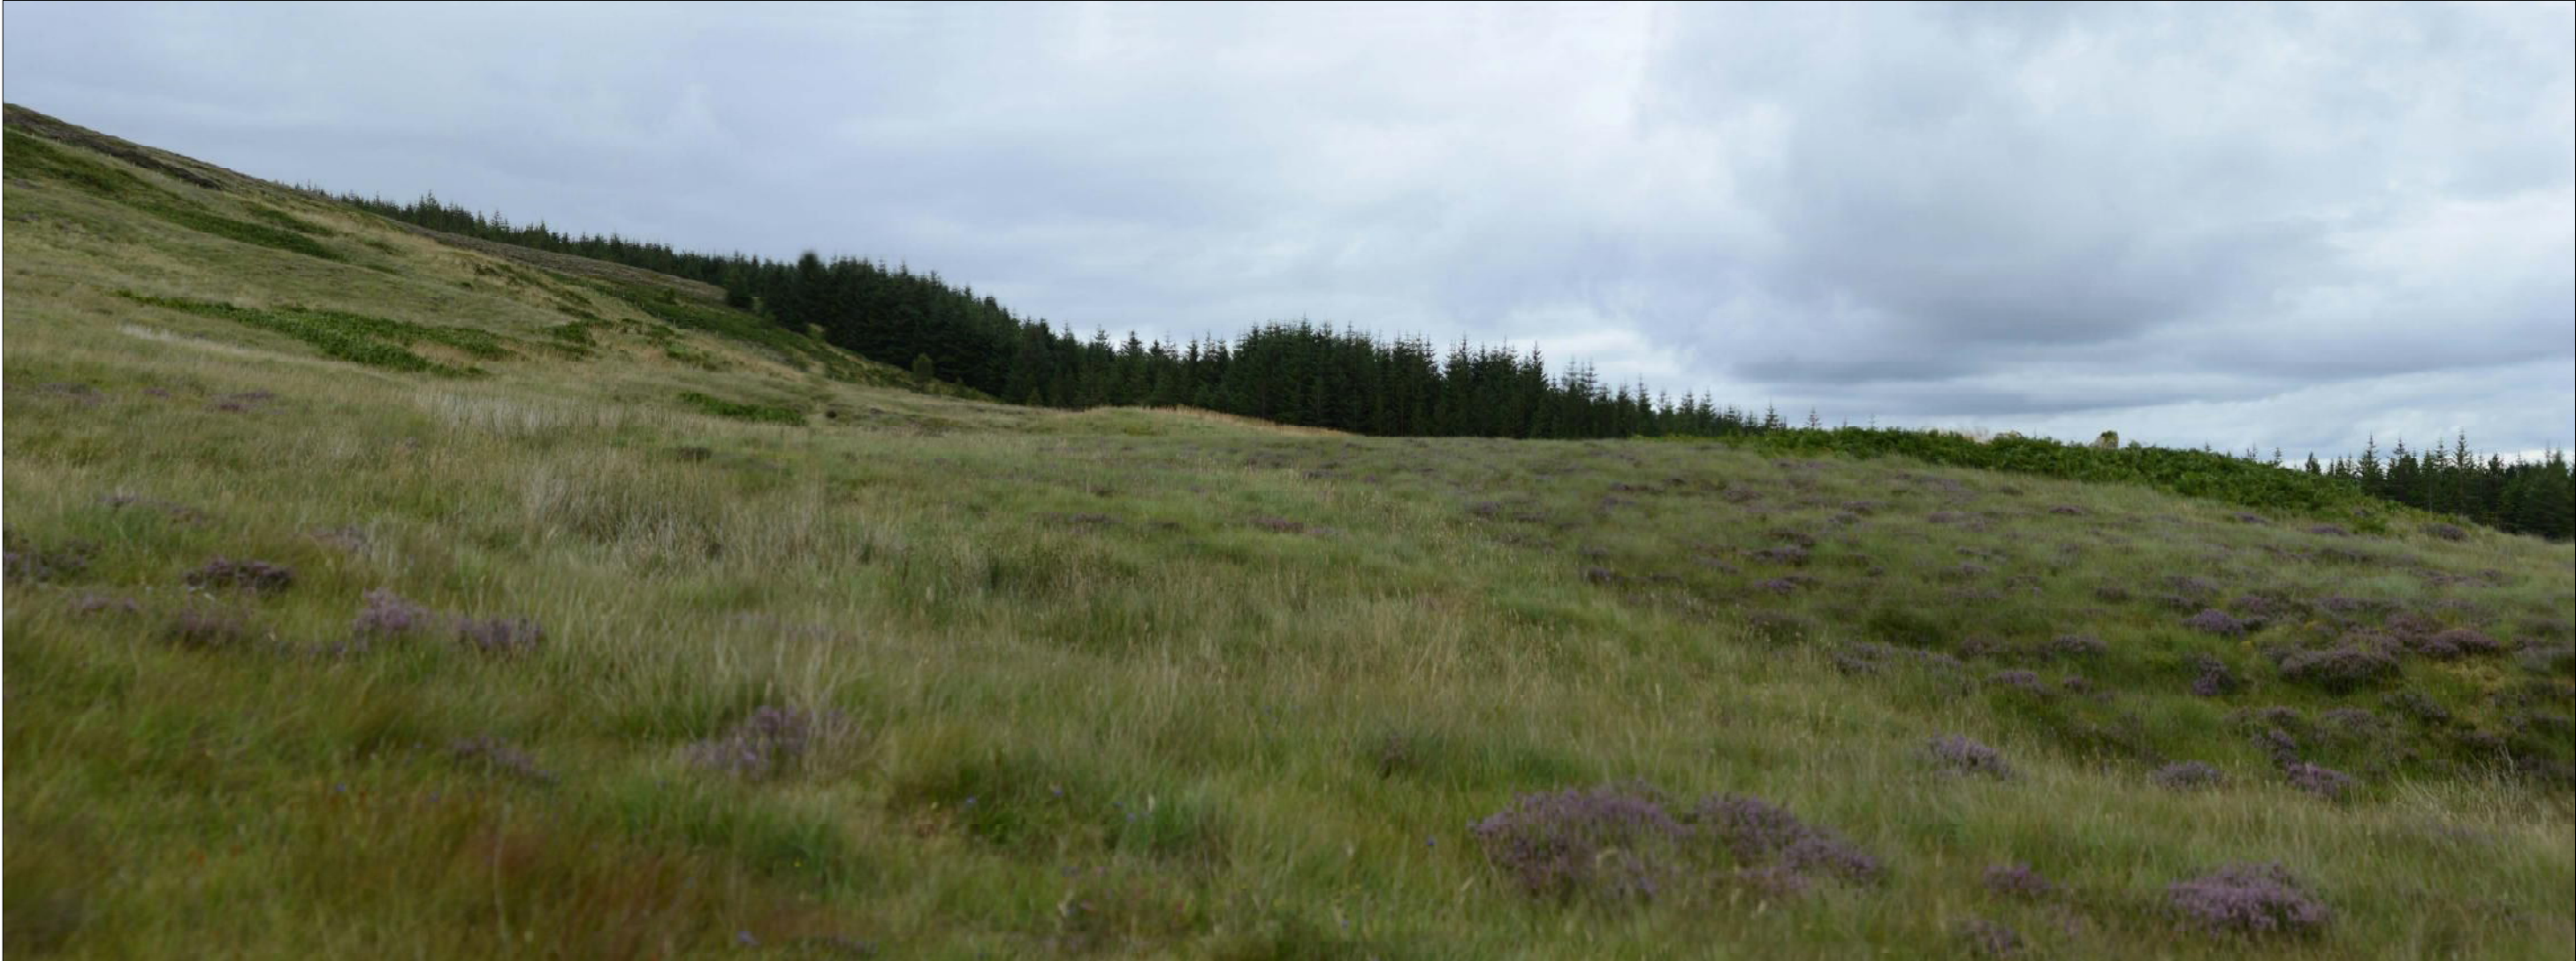
Figure 9.11.1

**Cultural Heritage Viewpoint 4
Cnoc Chaornaidh, Chambered Cairn (Site 14)**

View from field across Cnoc Chaornaidh, Chambered Cairn from west towards turbines. Forestry plantation also visible on high ground to east. Site is located north of A837.

Date:	15th August 2014	Time:	16:25	Distance to nearest turbine:	5,697 m	Camera type:	Nikon D600	Focal length (horizontal):	28 mm	Focal length (vertical):	50 mm
						Camera height:	1.5 m	Horizontal Field of View:	65.5°	Vertical Field of View:	27°

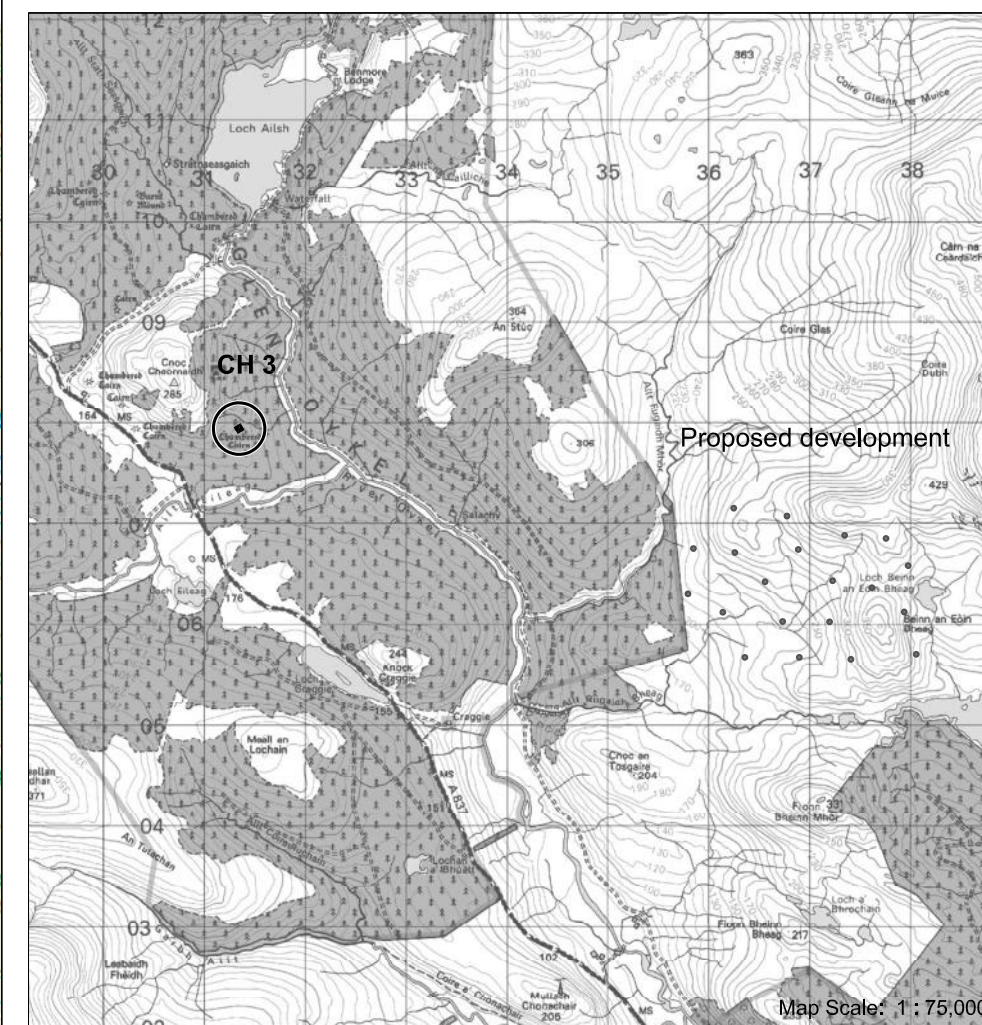
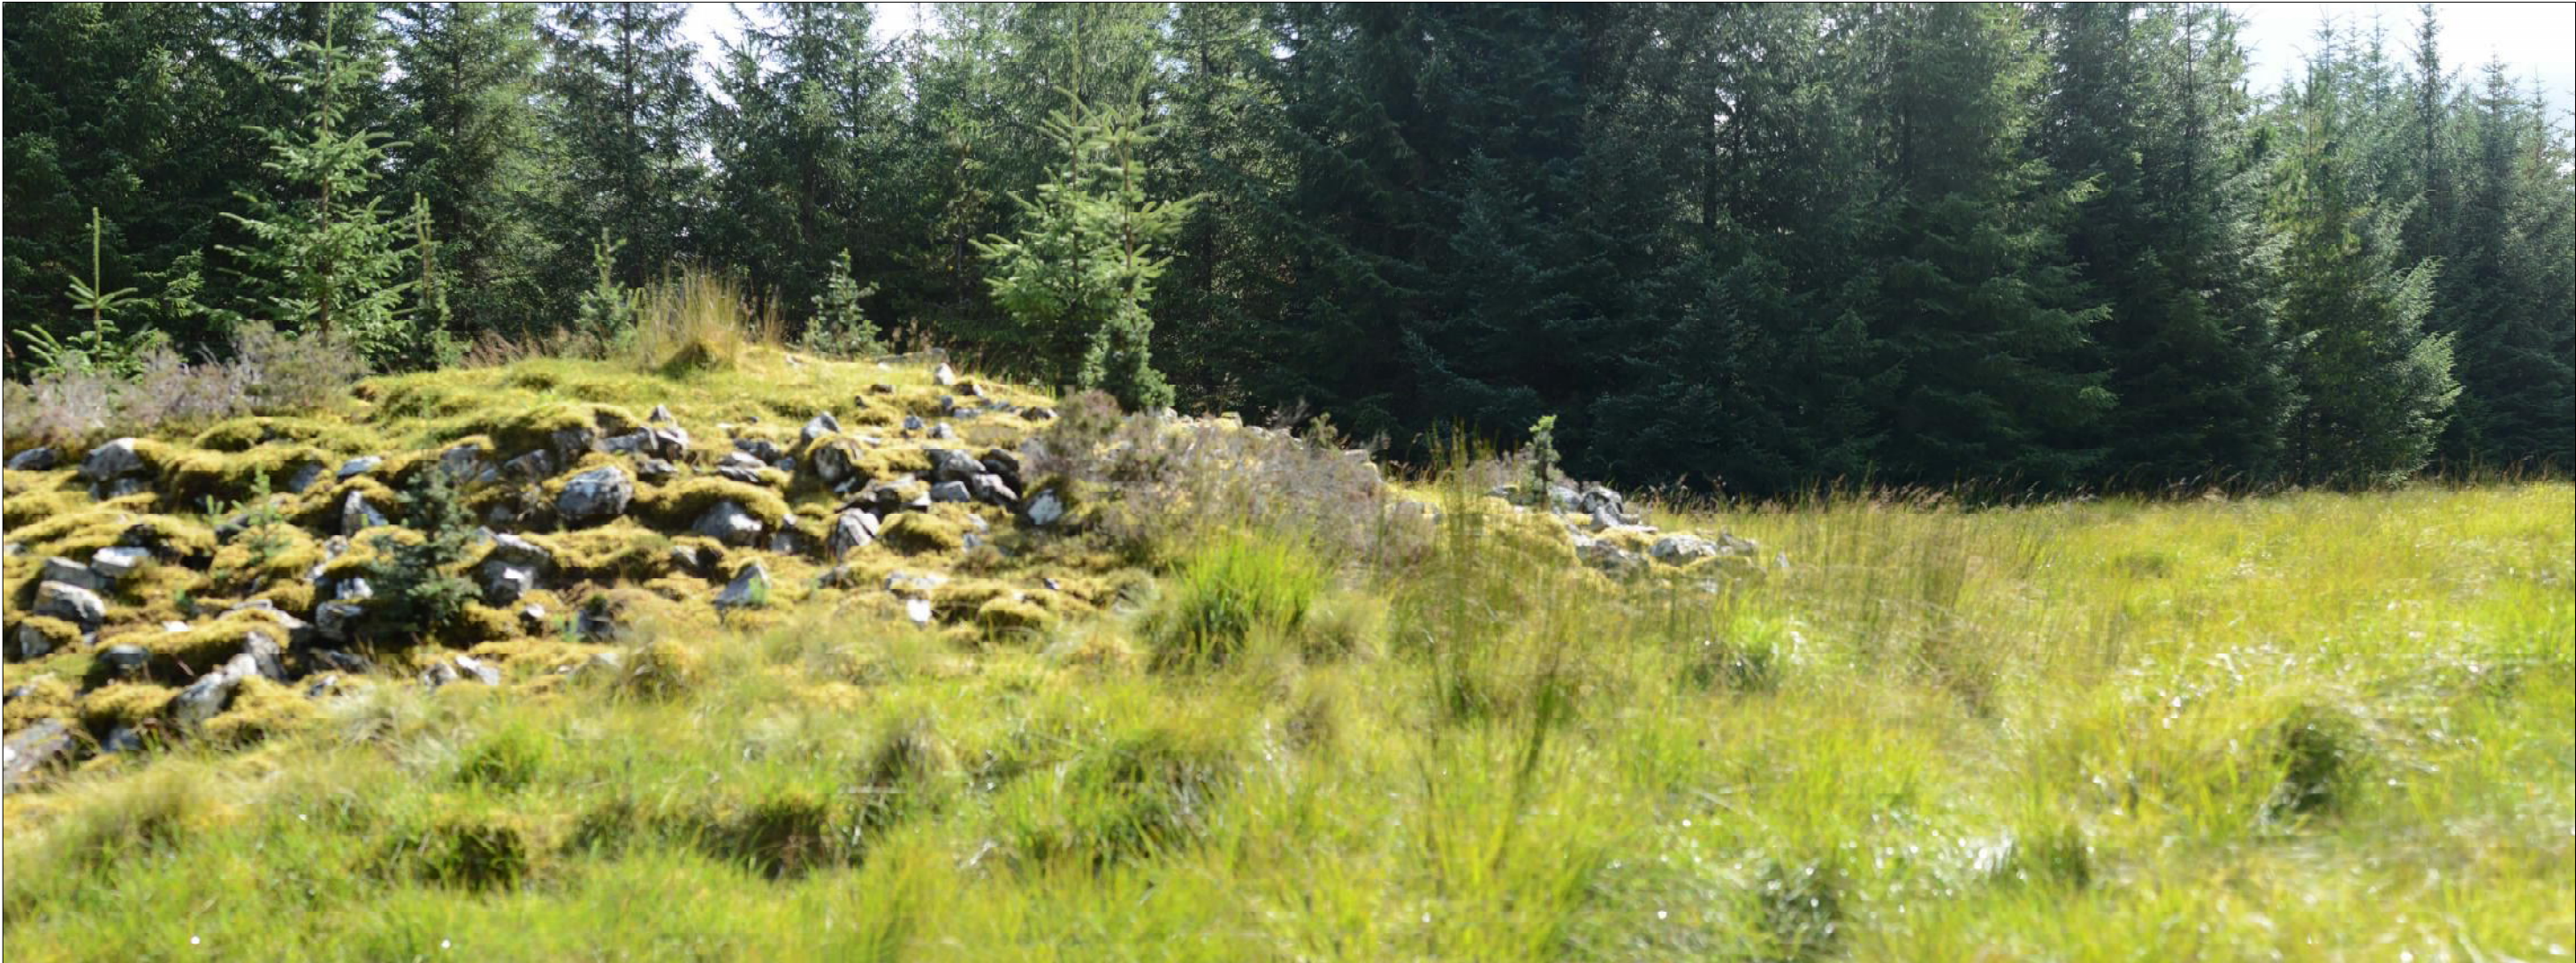
Figure 9.10.1

**Cultural Heritage Viewpoint 3
Allt Eileag, Chambered Cairn (Site 18)**

View from within forestry clearing and adjacent to Allt Eileag, Chambered Cairn towards turbines to east. Forestry plantation present to east.

Date:	23rd August 2014	Time:	13:25	Distance to nearest turbine:	4,661 m	Camera type:	Nikon D600	Focal length (horizontal):	28 mm	Focal length (vertical):	50 mm
						Camera height:	1.5 m	Horizontal Field of View:	65.5°	Vertical Field of View:	27°
