Caplich Wind Farm

Environmental Statement

Volume Two: Main Report

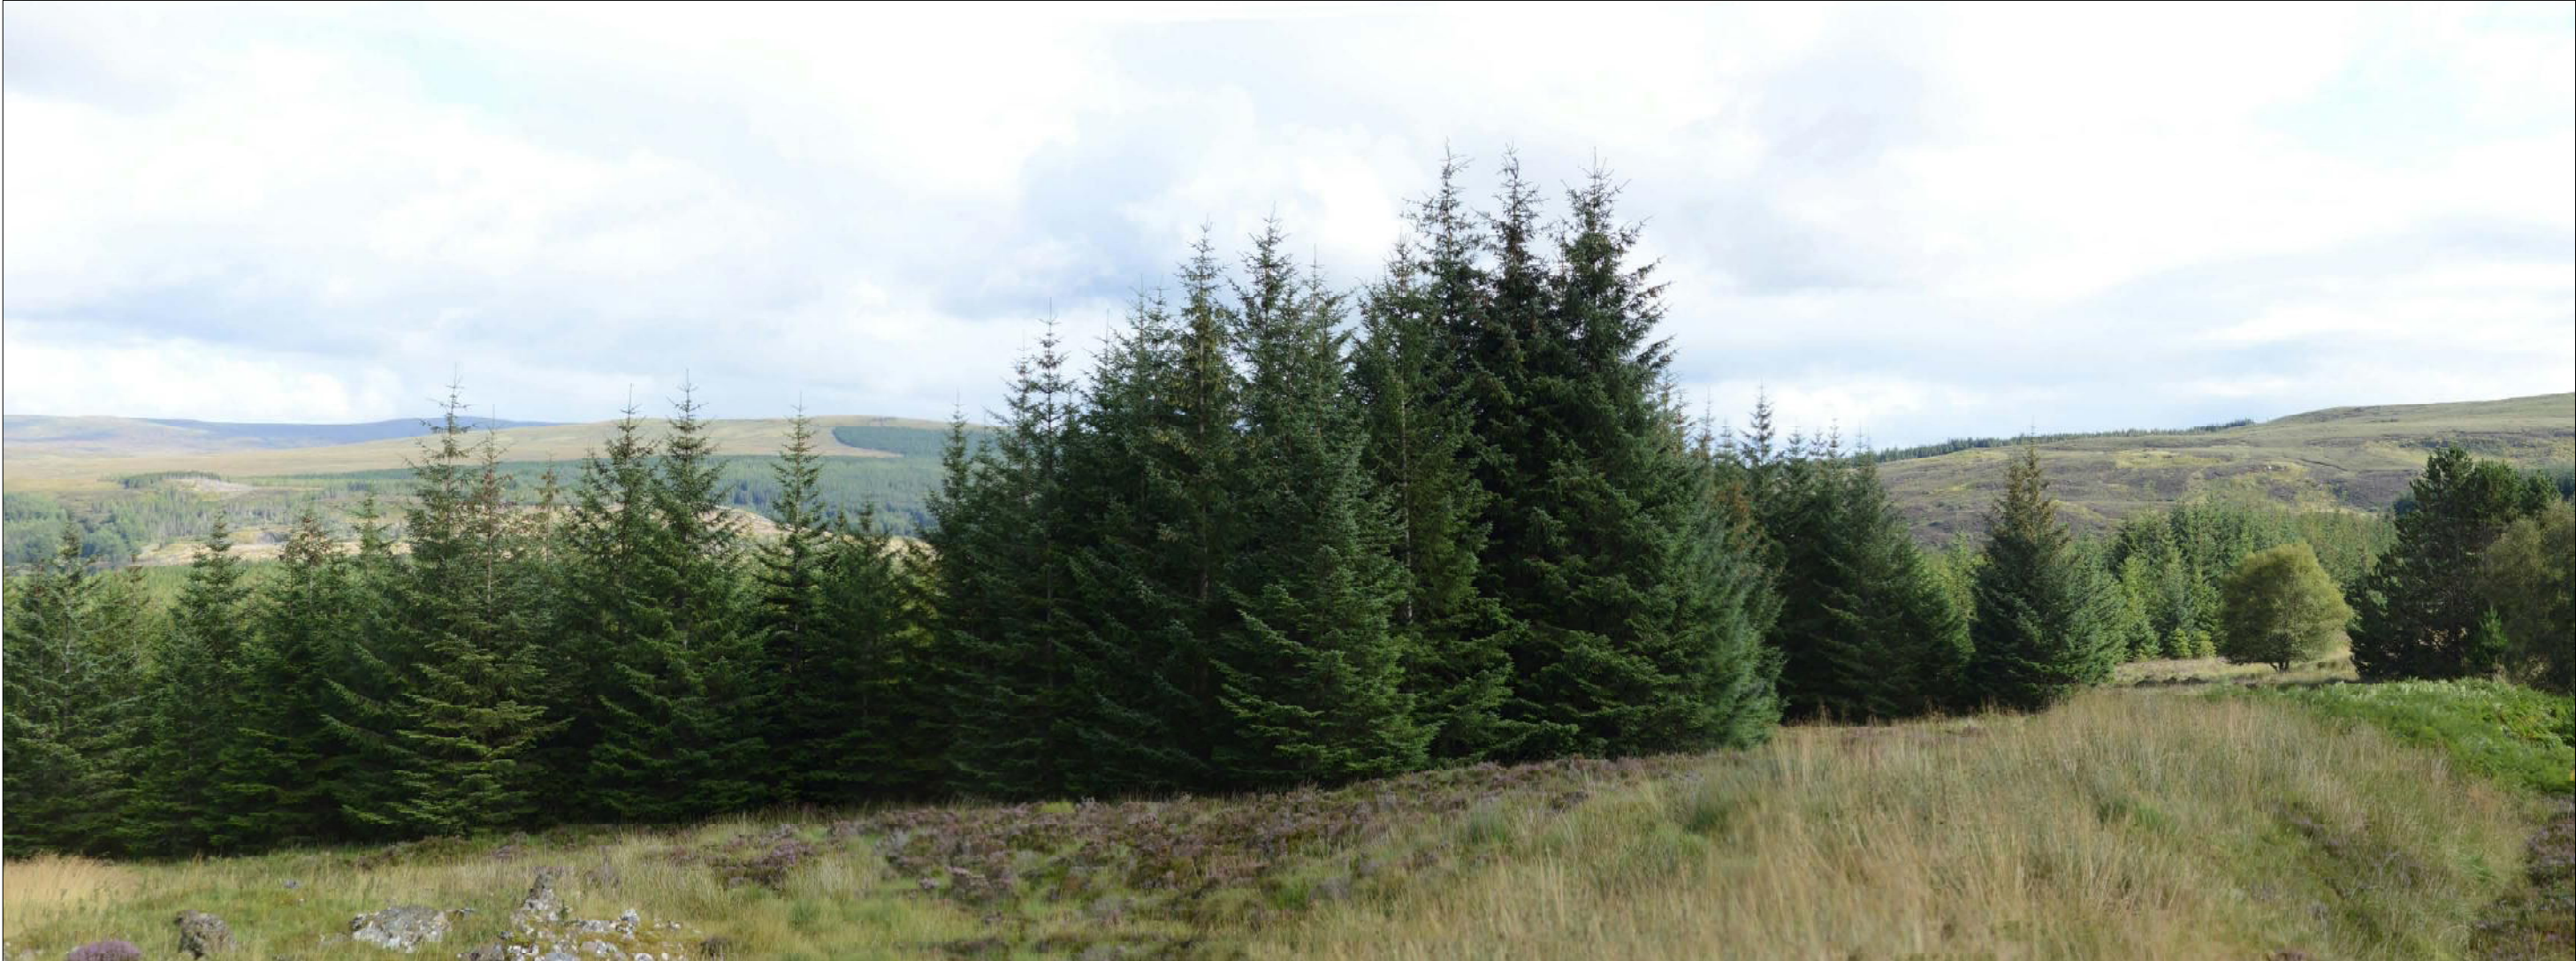
View A Photomontage

Date:	23rd August 2014	Time:	15:30	Distance to nearest turbine:	6,844 m	Camera type:	Nikon D600	Focal length (horizontal):	28 mm	Focal length (vertical):	50 mm
						Camera height:	1.5 m	Horizontal Field of View:	65.5°	Vertical Field of View:	27°

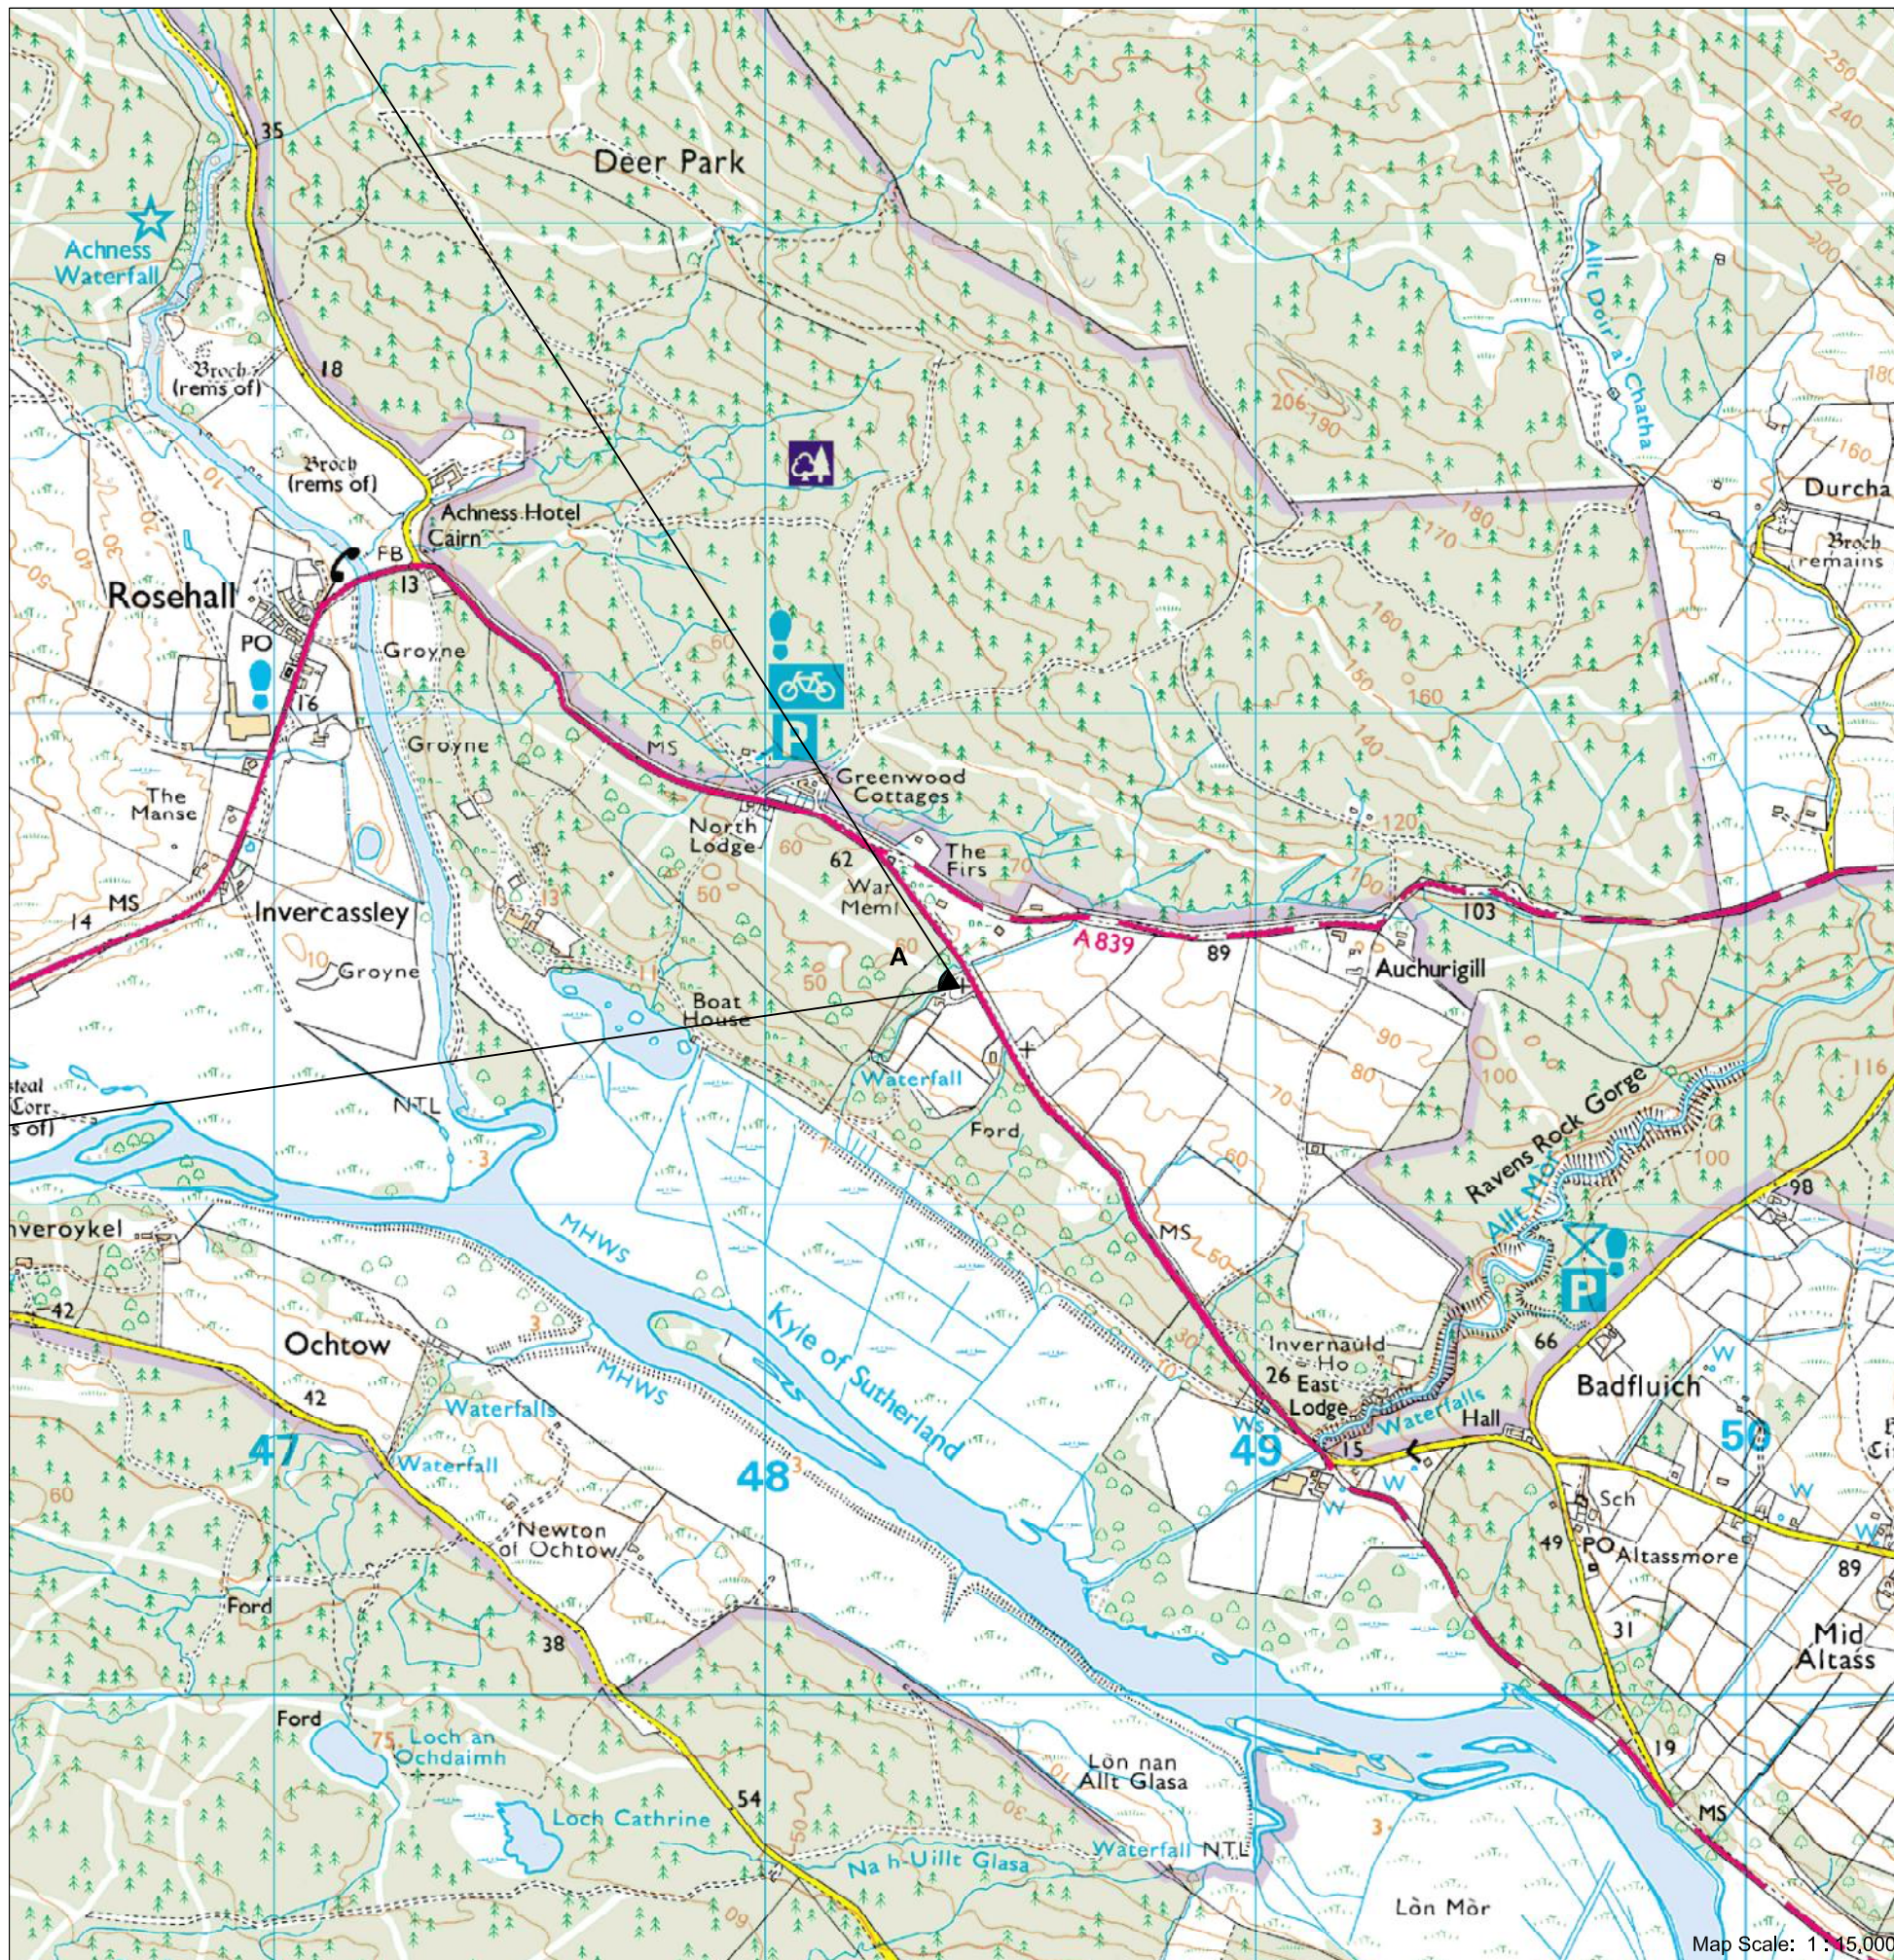
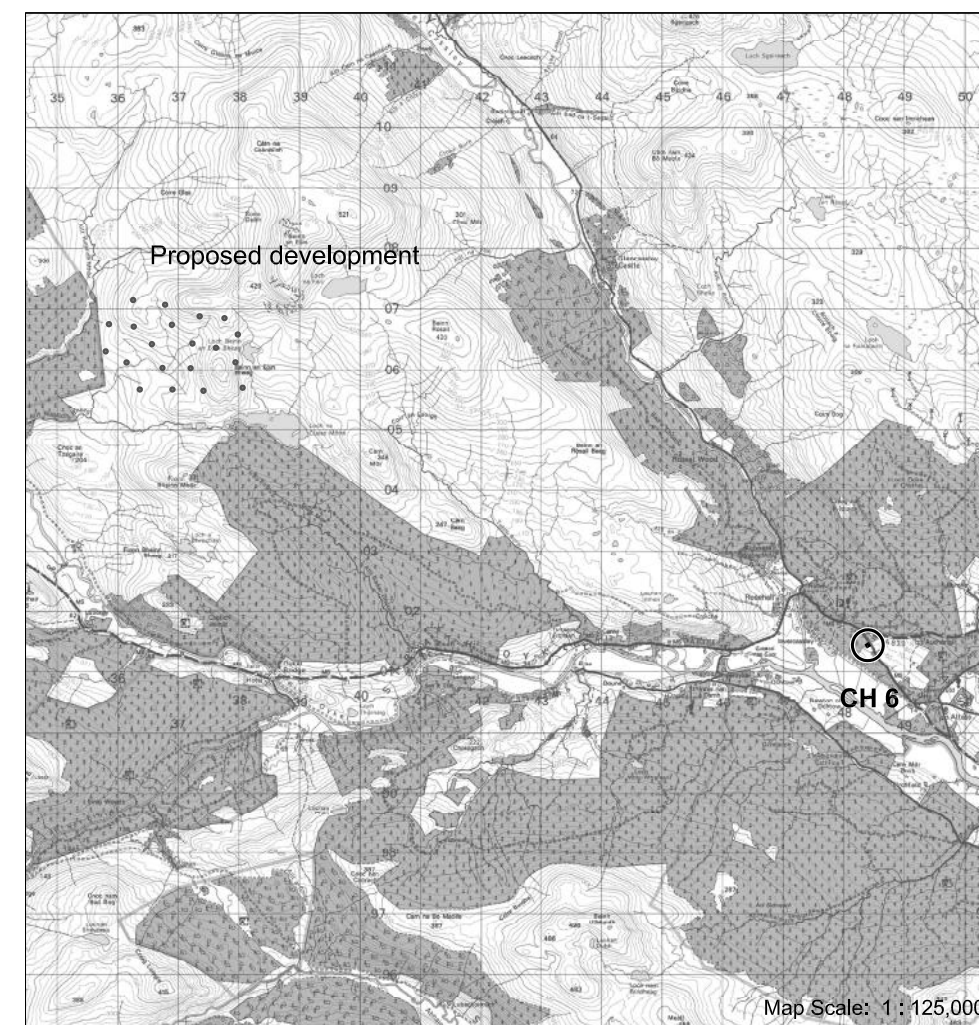
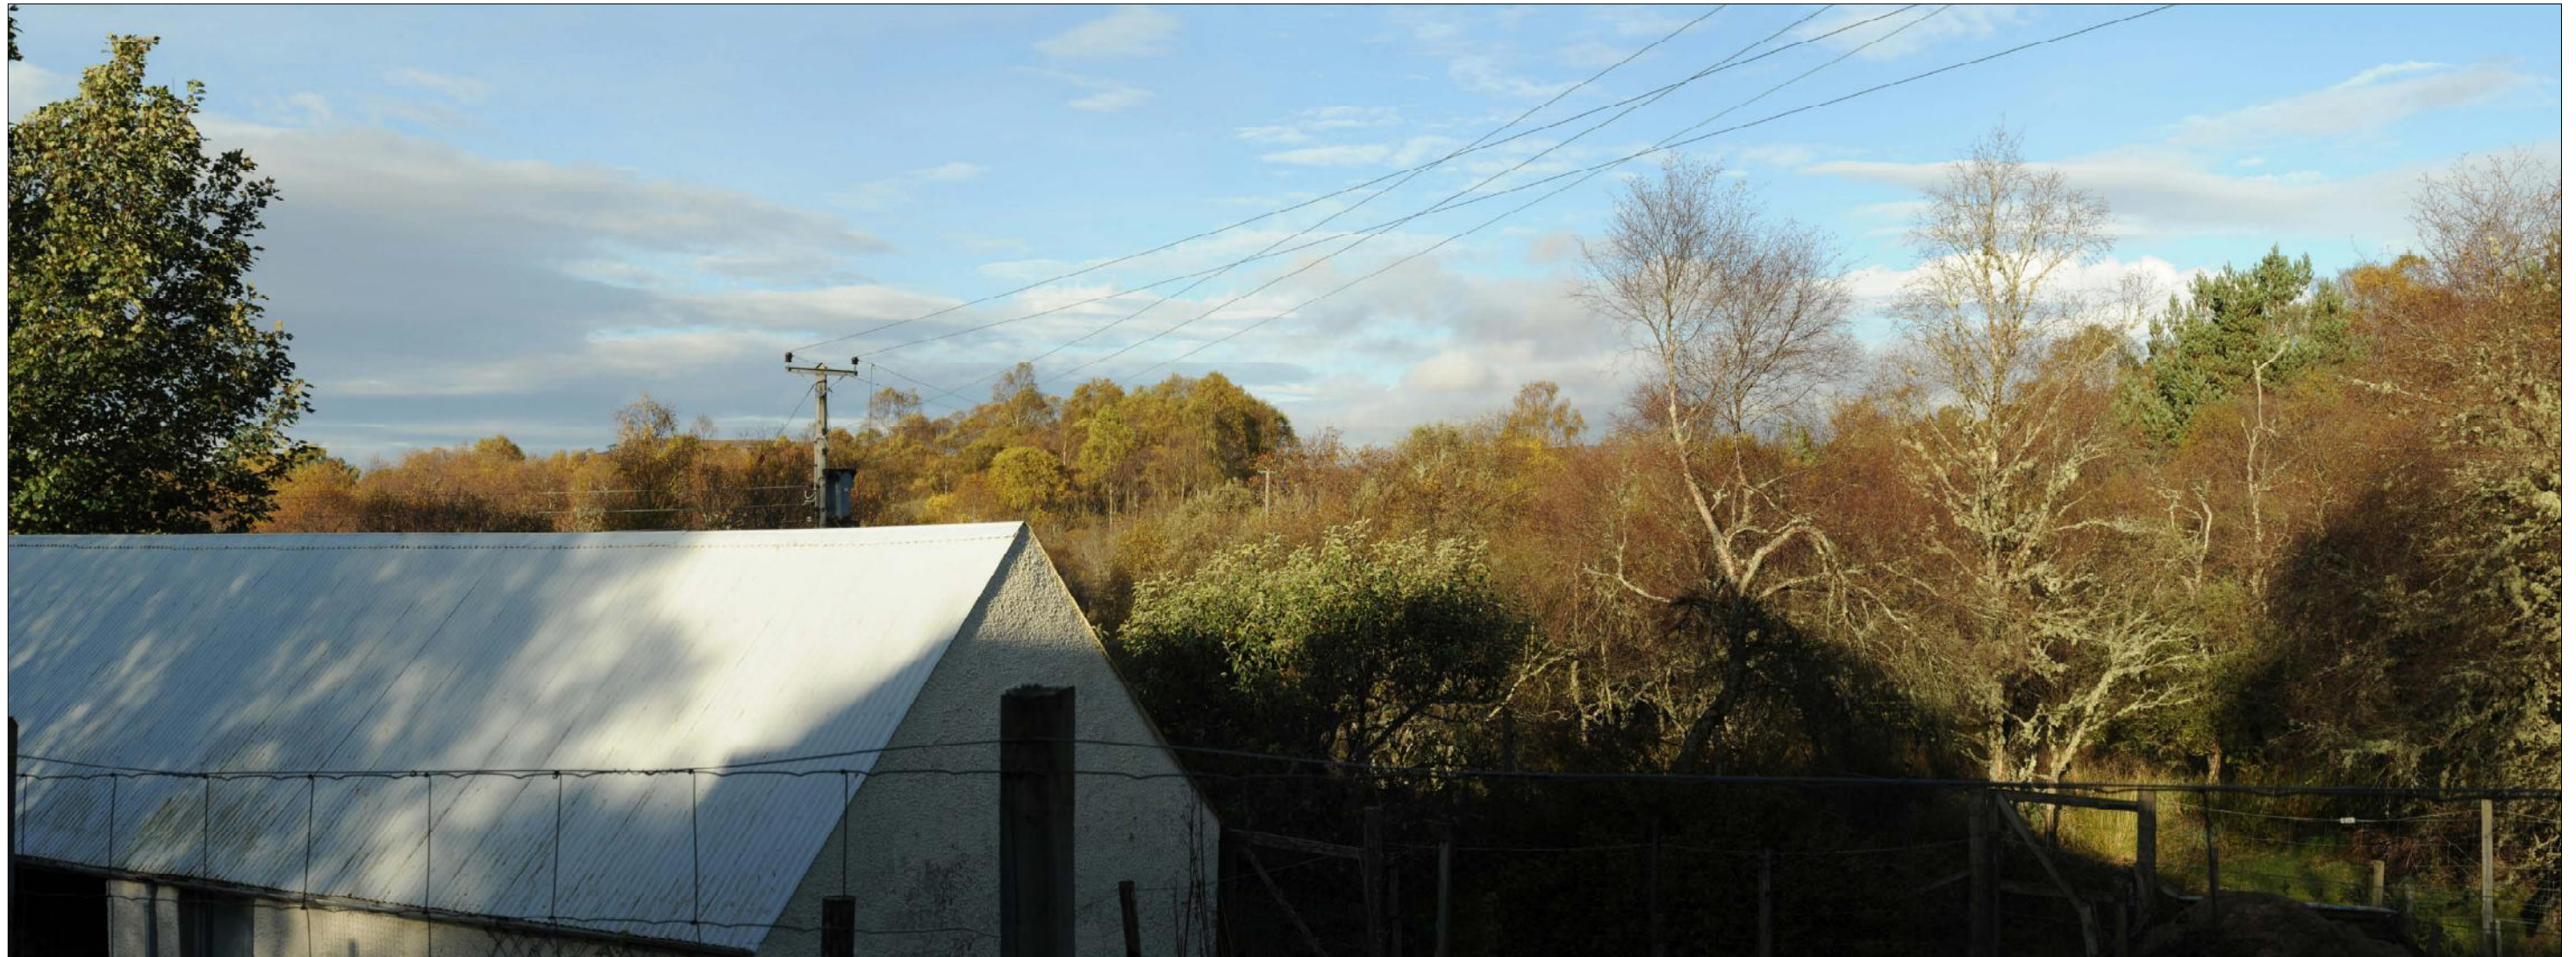
Figure 9.13.1

**Cultural Heritage Viewpoint 6
Rosehall Free Church (Site 4)**

View from rear (west side) of Rosehall Free Church towards turbines, from within the grounds of the church.

Date:	16th October 2014	Time:	10:10	Distance to nearest turbine:	11,179 m	Camera type:	Nikon D700	Focal length (horizontal):	28 mm	Focal length (vertical):	50 mm
						Camera height:	1.5 m	Horizontal Field of View:	65.5°	Vertical Field of View:	27°

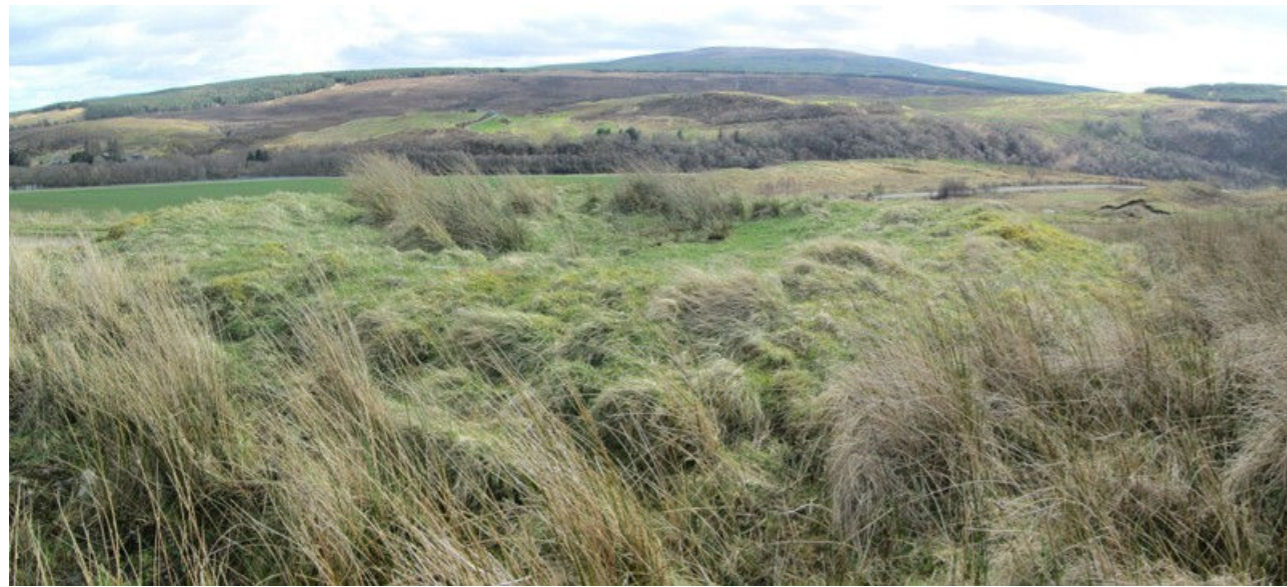
Plate 1: Strath Oykel hut circle (Site 27.1) from north-west

The field system remains and hut circles recorded near the access track at Strath Oykel (**Site 27**), in spite of the damage caused to elements of them, especially the south-eastern hut circle (**Site 27.3**) are judged as a whole to be of potentially Regional Cultural Value, as an example of late prehistoric settlement. The hut circle and field system provide evidence for prehistoric, and perhaps later, agricultural utilisation of the area around the access route. A possible outlying clearance cairn (**Site 47**) is judged to be of Negligible Cultural Value, as, even if real, is a relatively common feature of little importance. Similarly, the sheepfold (**Site 33**) in the north-west of the proposed development area and the road with associated quarrying (**Site 32**) identified near the south of the access track are common features of limited importance, and are judged to be of at most Negligible Cultural Value. The other features identified, including a quarry (**Site 46**) likely associated with the construction of the forestry track and a small walker's cairn (**Site 48**) are common features of recent date and judged to be of no Cultural Heritage Value.

The prehistoric hut circles and field system remains at Strath Oykel, although already damaged in areas by the existing forestry track, would potentially incur impacts on peripheral elements, in particular around surviving remains of hut circles on either side of the track (**Sites 27.1 & 27.3**) and a clearance cairn (**Site 27.4**). However, the design of the access track utilises the existing forestry track. The access track design will avoid widening of the track, e.g. for passing places, where adjacent to visible remains, in particular in the vicinity of the relatively undamaged hut circle to the north-west of the track (**Site 27.1**); the hut circle to the south-east (**Site 27.3**) of the track and the clearance cairn to the north (**Site 27.4**). Additionally, the track will be reduced to 4.0 m running width where necessary, overlying the existing track, and would therefore not impact visible remains. As a result, there is potential for at worst the loss of a small quantity of peripheral deposits associated with the heritage asset. This would be at worst an impact of Marginal magnitude and *Minor* significance, and thus not significant in terms of EIA regulations. The route of the access track would avoid all impacts on the possible clearance cairn at Strath Oykel (**Site 47**) and the sheepfold at Allt a' Choire Bhuidhe (**Site 33**), though the former is likely to require a visible buffer to avoid inadvertent damage from plant movement. The works at the entrance to the access track are likely to cause only minimal impacts to remains of the late post-medieval road that preceded the A837, perhaps including the removal of evidence for associated quarrying (**Site 32**). This would be at worst a Low magnitude impact of *Negligible* significance.

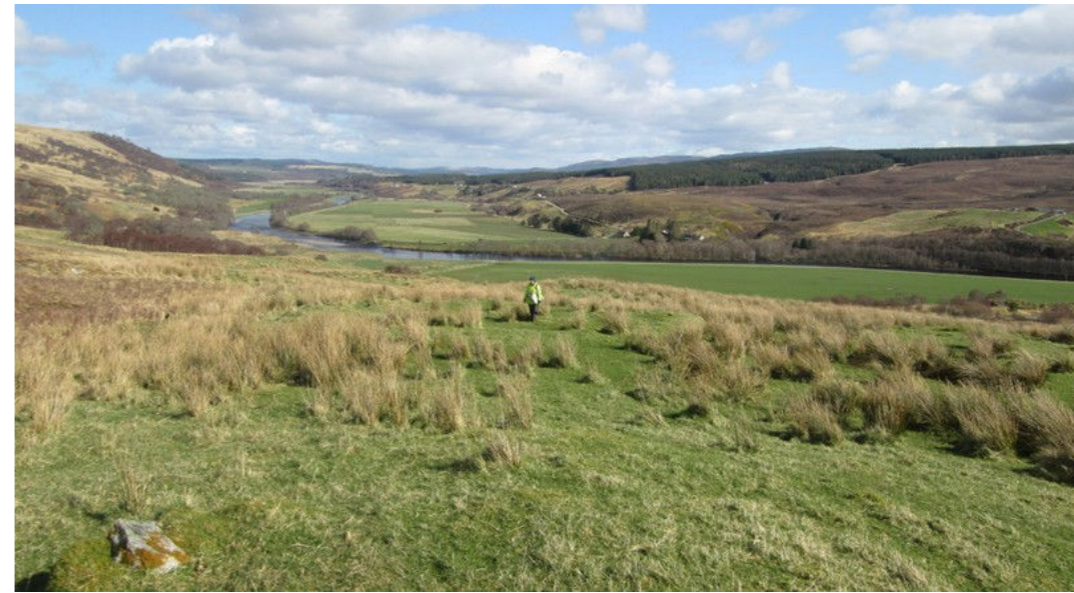
Plate 3: Northern Strath Oykel hut circle (Site 27.2) from west

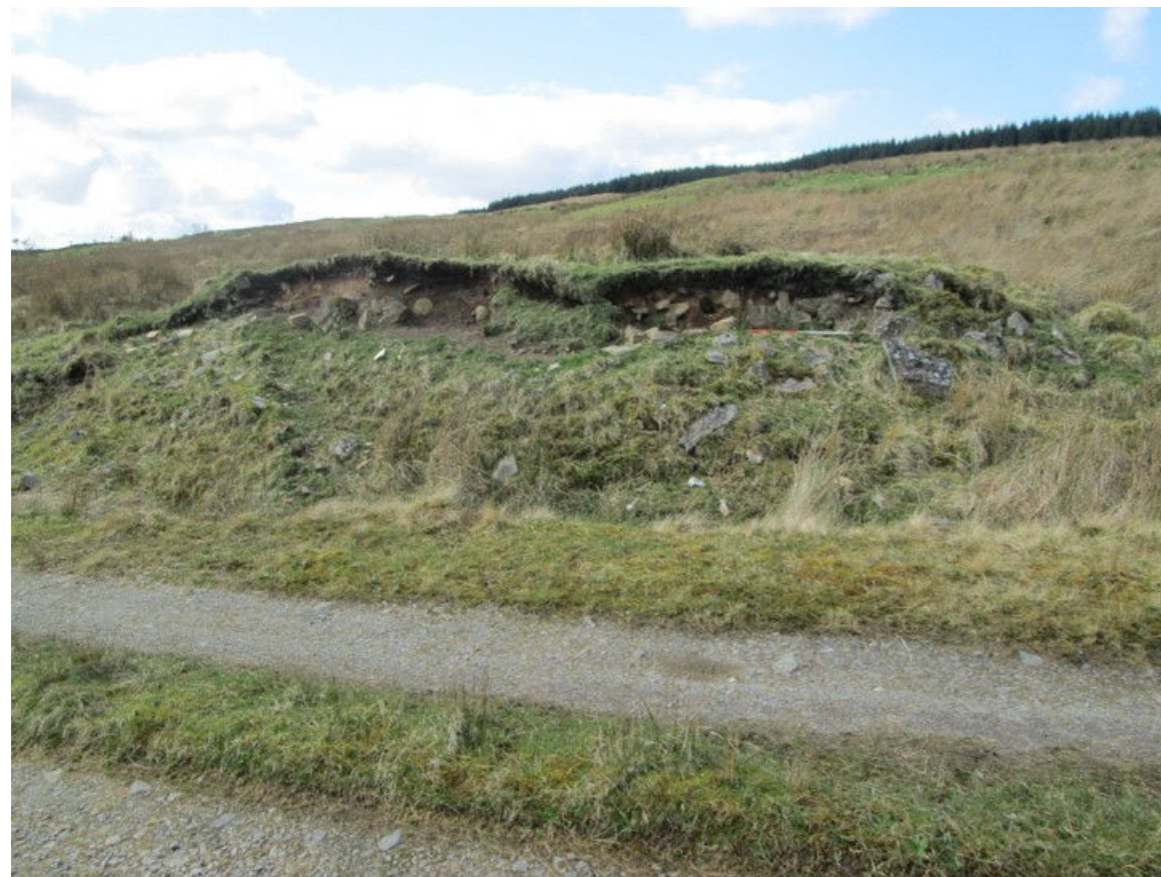
Plate 2: Damage to south side of Strath Oykel hut circle (Site 27.1)

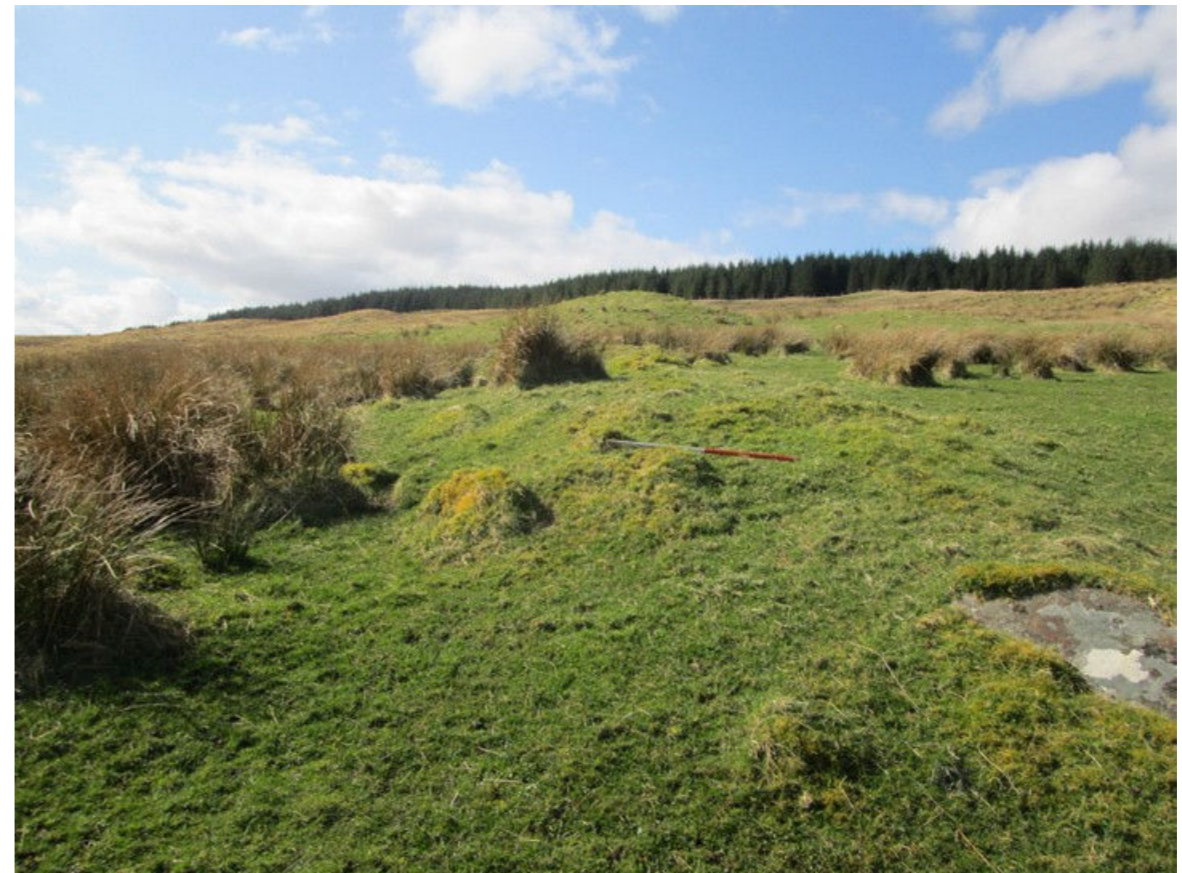
Plate 4: Possible lynchet at Strath Oykel (Site 27.7) from south-east

The access track follows an existing forestry access track, which at first rises over moorland pasture from the A837, near Tuiteam Tarbhach. To the west of the access, off the road, is an area of undulating ground and bedrock, perhaps the remains of a former quarry associated with the earlier form of the A837 (**Site 32**). To the north is an area in which are recorded hut circles and field systems at Strath Oykel (**Site 27**). Several elements of this site were identified within the proposed development area during the walkover survey. Of three previously recorded hut circles, only two are now clearly visible. One hut circle (**Site 27.1**), likely that recorded on the NMRS as 'A', was visible on a slight rise above and north of the existing forestry track, and was centred at NC 43083 01300 (**Technical Appendix 9.2**; Plate 1). It was damaged to the south by the forestry track and perhaps by earlier erosion (**Technical Appendix 9.2**; Plate 2), and appeared to have an entrance to the east. It was marked by a c.2 m wide grass-covered bank and had a diameter of less than 10 m. To the north, at NC 43012 01382, a hut circle (**Site 27.2**), likely 'C', was identified with an internal diameter of c. 10-11 m, and a wall width (marked by a low earthwork bank with stones) of between 2 m and 2.5 m, and a height of up to 0.5 m (**Technical Appendix 9.2**; Plate 3). Near this hut circle, a small earth bank (**Site 27.8**), c. 0.3 m high and 10 m long, aligned NW/SE, was visible between NC 43025 01391 and NC 43032 01386). Another earth bank, up to 0.5 m high and between 2 m and 3 m wide, representing a potential lynchet (**Site 27.7**), was visible between NC 43012 01364 and NC 42992 01366), with a corner at NC 42995 01371 (**Technical Appendix 9.2**; Plate 4).

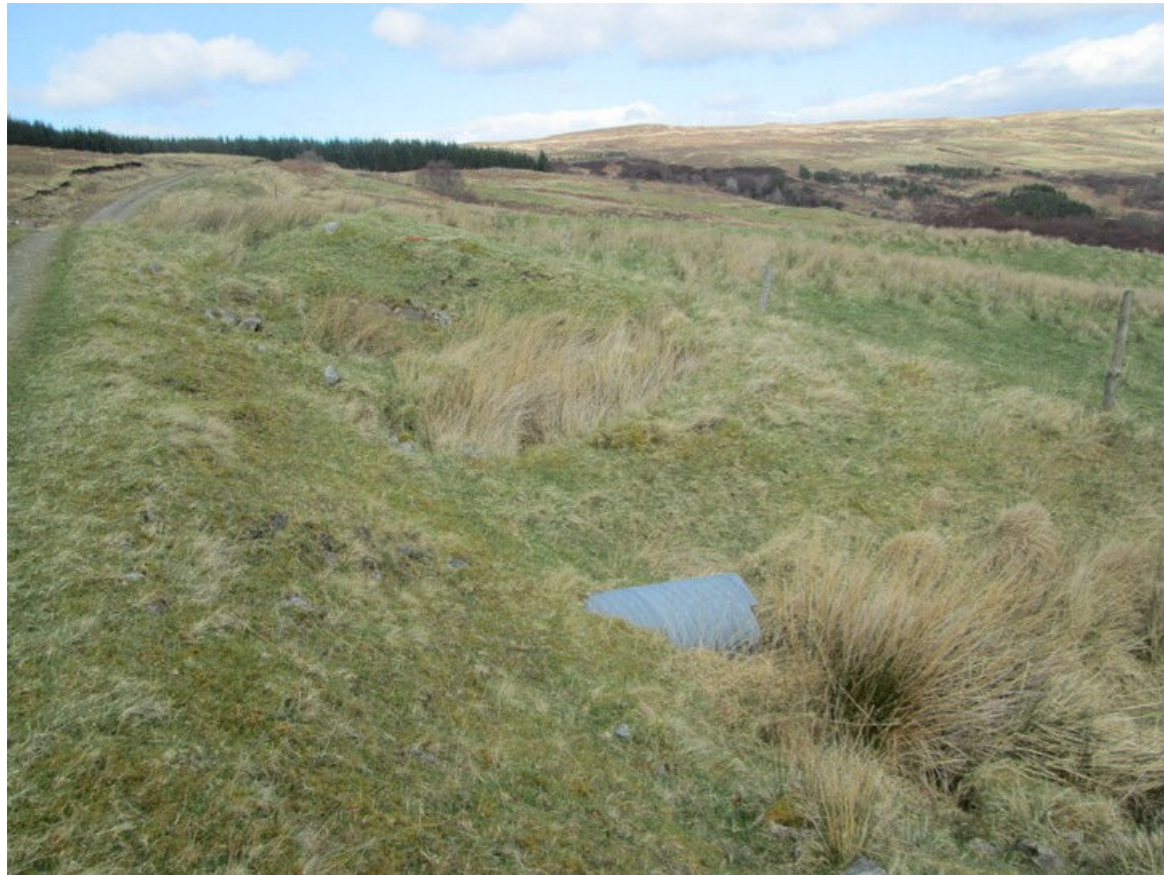
Plate 5: Possible former location of Strath Oykel hut circle (Site 27.3) from west

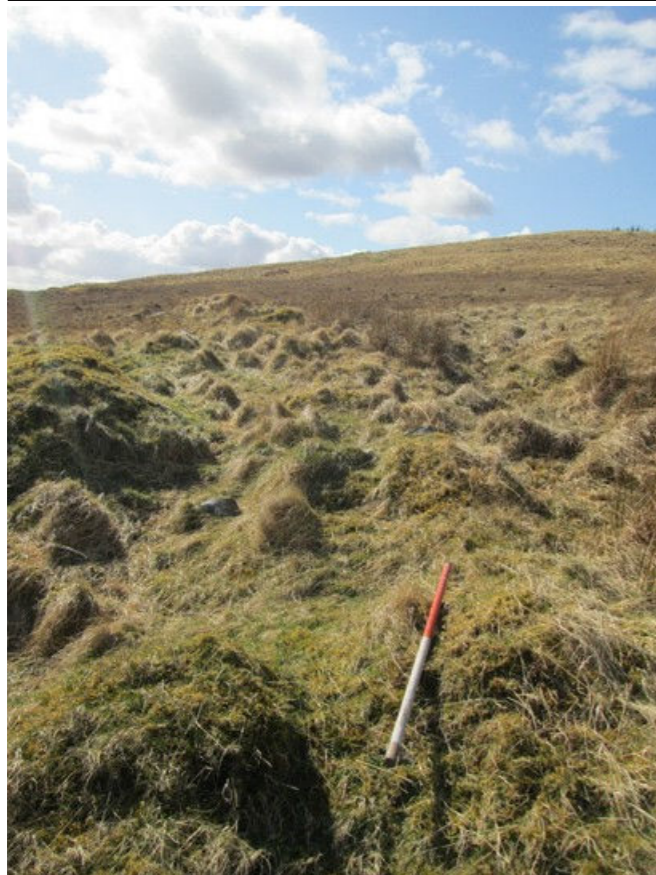
Plate 6: Bank at Strath Oykel (Site 27.9) from east

An earth and stone bank (**Site 27.9**), between 1 m and 1.5 m wide and up to 1 m high, though commonly much lower, was seen to curve from west to east between NC 43147 01494 and NC 43168 01498, with a pronounced curve at its centre around NC 43155 01498 (**Technical Appendix 9.2**; Plate 6). Various potential clearance cairns associated with the field system around the hut circles were also identified during the walkover survey (**Sites 27.4-27.6**). A potential clearance cairn located a little further north (**Site 47**) may also be an outlying element of **Site 27**.

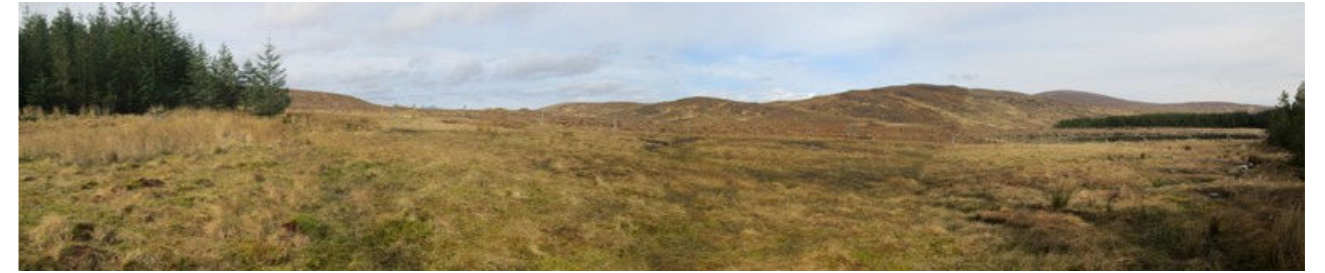
Plate 7: View across south of proposed turbine area from north of access track

The main part of the Wind Farm development area, to the north-west of the access track, is marked by open hilly moorland, commonly with extensive views (**Technical Appendix 9.2**; Plates 7 & 8), in particular from such heights as Beinn an Eoin Bheag (372 m AOD) and minor summits to the south-west of Beinn An Eoin. There are numerous bedrock outcrops and areas of peat hacks. Within the main turbine area, the sheepfold at Allt a' Choire Bhuidhe (**Site 33**) visible on 19th to 21st century mapping, was found to be still largely upright, with walls up to 1.5 m in height and 0.8 m in width (**Technical Appendix 9.2**; Plate 9). It appears that entrances have been blocked in the past. Possible entrances may have existed to the west, north and south-east. Apart from this feature the area is largely devoid of signs of human activity, with the exception of drainage cuts. A small walkers' cairn was found at the summit of Beinn an Eoin Bheag (**Site 48**) (**Technical Appendix 9.2**; Plate 10).

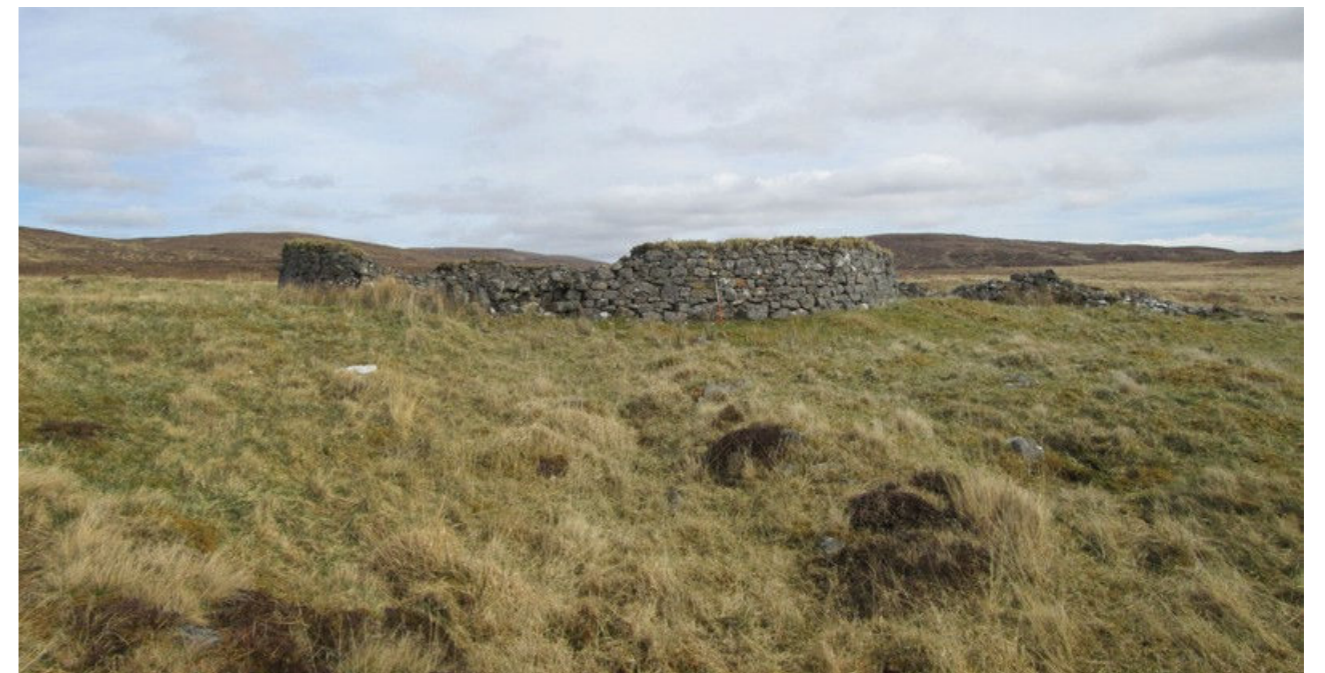
Plate 9: Sheepfold at Allt a' Choire Bhuidhe (Site 33) from west

Design works have led to the avoidance of a sheepfold at Allt a' Choire Bhuidhe (**Site 33**) and a possible clearance cairn at Strath Oykel (**Site 47**). However, the latter of these heritage assets should be fenced off to avoid inadvertent damage by plant. As works at the entrance to the access track are likely to cause only minimal impacts to peripheral remains of the late post-medieval road, and associated quarrying, that preceded the A837 (**Site 32**) it is not considered that specific mitigation works are required.

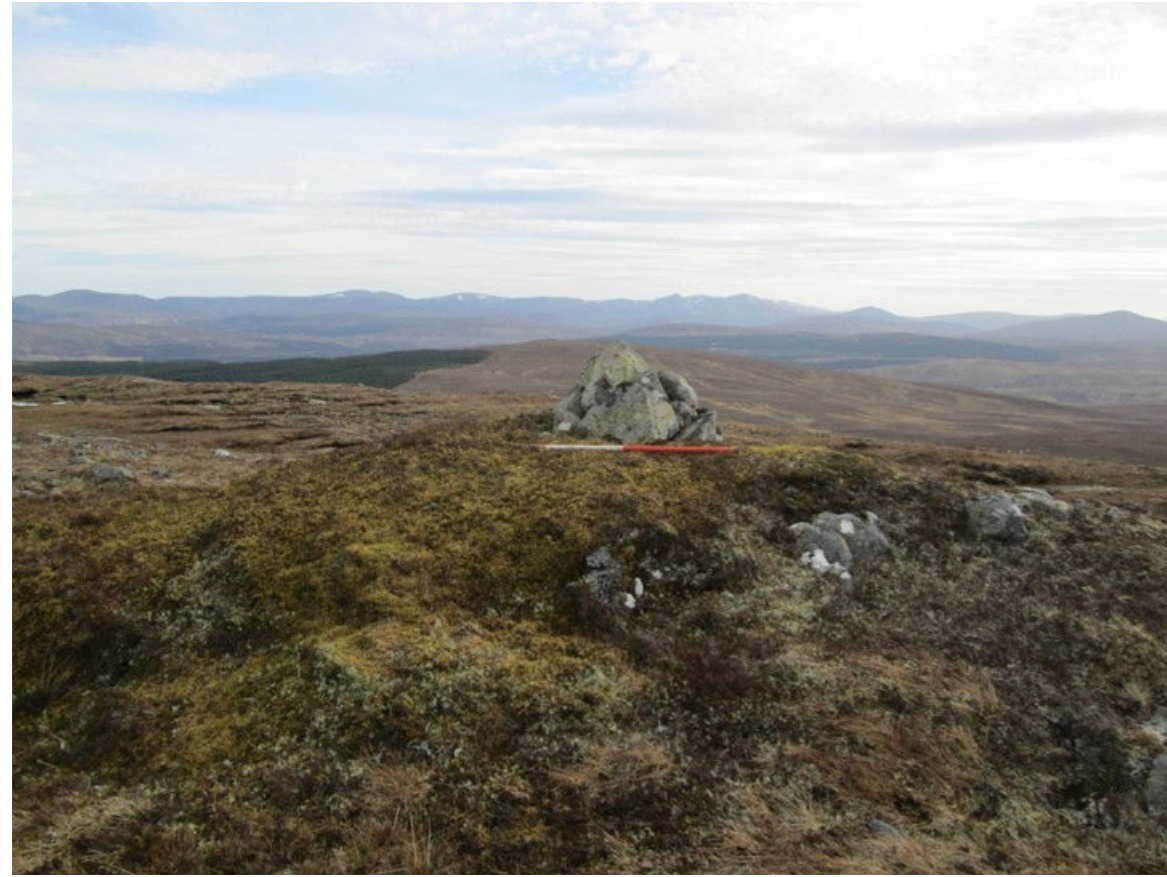
Plate 10: Walkers' cairn on summit of Beinn an Eoin Bheag (Site 48) from north
